## Flood Control Project Maintenance Levee Inspections

### Fall 2023 Levee Maintenance Deficiency Summary Report

#### Sacramento River Basin

**Reclamation District No. 1000 Natomas**

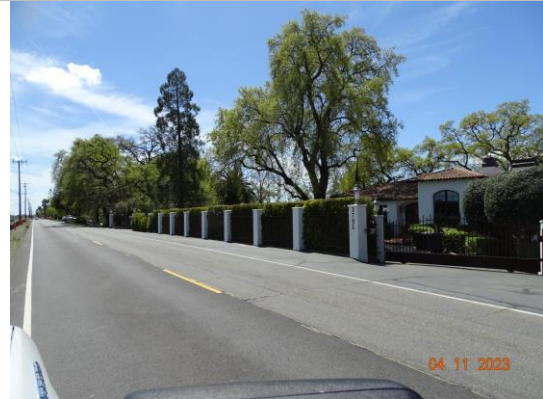
Photo 1 of 1 : FA\_2023\_RD1000\_31\_46\_20231016\_00025.jpg

LM Start	13.41	Rating **	M	Issue No.	46
LM End	13.43	Issue Type +	En	Location *	WS
Category	Earthen Levee			GPS Latitude/Longitude	
				Start	End
Item	Vegetation			38.636522°	38.636250°
				-121.561743°	-121.561667°
DWR ID	DWR_RD1000_01_s _ 2012_46				
Comment Code					
V6 : Landscaping					
Inspector Comment					
The landscape vegetation limits the ability to see the waterside slope and will make it difficult to access for flood fight.

View on waterside looking downstream of where the vegetation covers the front of the fence (Spring 2023).

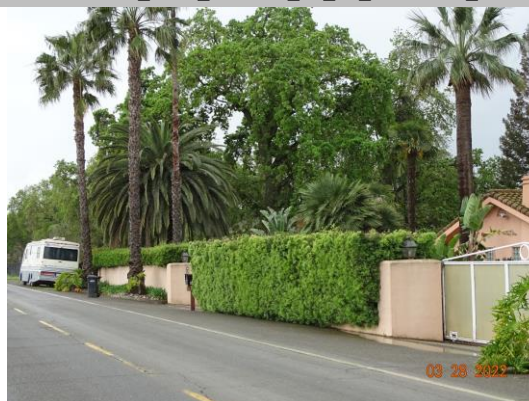
Photo 1 of 1 : FA\_2023\_RD1000\_31\_43\_20231016\_00024.jpg

LM Start	13.64	Rating **	U	Issue No.	43
LM End	13.68	Issue Type +	En	Location *	WS
Category	Earthen Levee			GPS Latitude/Longitude	
				Start	End
Item	Encroachments			38.633238°	38.632590°
				-121.561097°	-121.560915°
DWR ID	DWR_RD1000_01_s_2012_43				
Comment Code					
FE : Fence					
Inspector Comment

This photo was taken from the crown facing downstream looking down the waterward levee slope at an unacceptable fence.

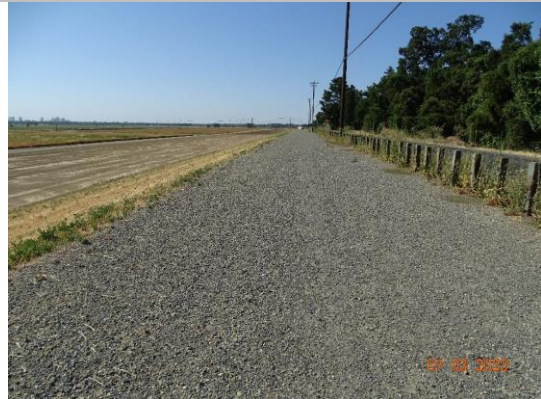
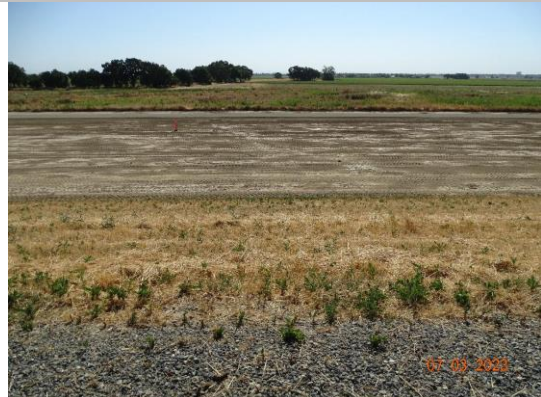
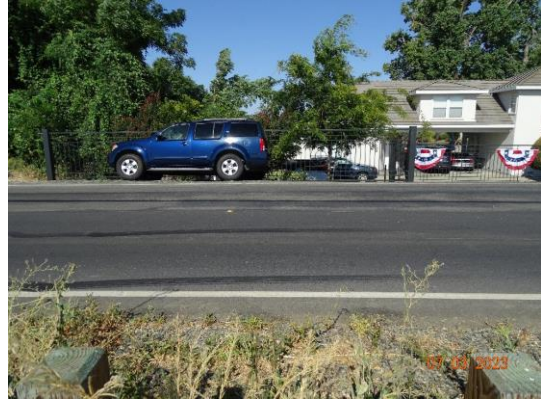
LM Start	13.86	Rating **	M	Issue No.	271
LM End	13.86	Issue Type +	En	Location *	
Category	Supplemental			GPS Latitude/Longitude	
				Start	End
Item	DWR UCIP Field Study			38.629977°	38.629977°
				-121.560496°	-121.560496°
DWR ID	25164				
Comment Code					
Inspector Comment					
DS_ID:25164 FS_ID:80672 EP_NO: N/A Repair Type: Non-Urgent EVAL Issue: Crossing Status: Not Found UCIP Comments: 07/03/2023 Record updated to Non-Urgent. Crossing not found. Unauthorized encroachment recorded in Levee Log. (M. Thao - DWR UCIP)  FIELD_STRUCT_DESC: Two 3-inch diameter steel conduits through the levee, 3.0 feet below the crown. [Additional Reference(s): DWR Levee Log, 2002 (HLM 14.10)]. FS Date: 7/3/2023

Levee crown looking downstream.

LS view: General overview looking from crown.

WS view: General overview looking from crown.

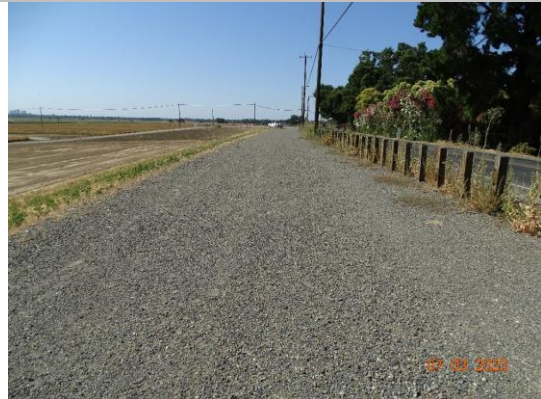
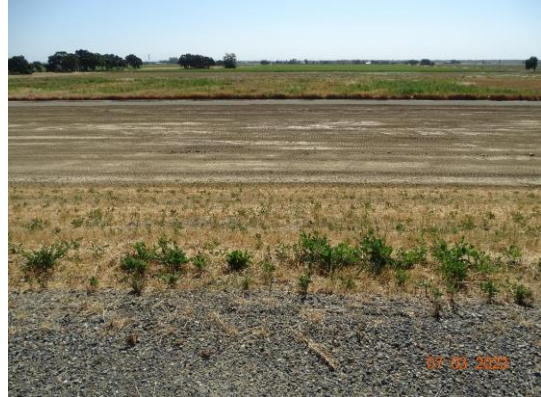
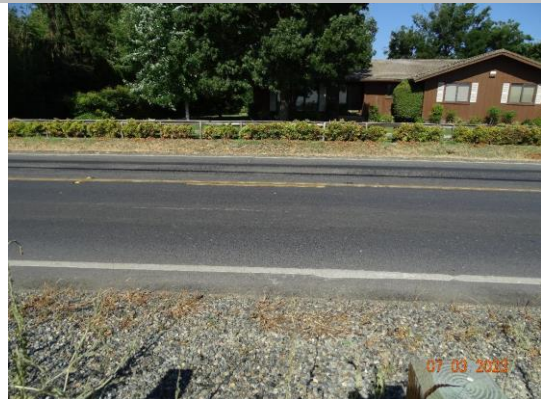
DS\_ID:25208  
 FS\_ID:81031  
 EP\_NO: 13167  
 Repair Type: Non-Urgent  
 EVAL Issue:  
 Crossing Status: Not Found  
 UCIP Comments: 07/03/2023 Record updated to Non-Urgent. Crossing not found. (M. Thao - DWR UCIP)  
 FIELD\_STRUCT\_DESC: Two 3-inch PVC (electrical and communication) conduits through the levee, 3.0 feet below the Garden Highway. (Permit No. 13167, 1981 - Sacramento Municipal Utility District). [Additional Reference(s): DWR Levee Log, 2002 (HLM 14.19)].  
 FS Date: 7/3/2023

Levee crown looking downstream.

LS view: General overview looking from crown.

WS view: General overview looking from crown.

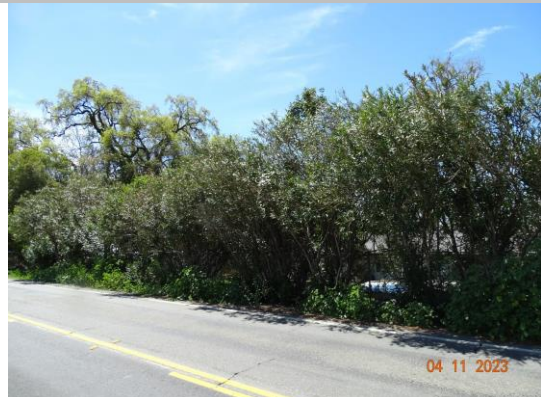
Photo 1 of 1 : FA\_2023\_RD1000\_31\_42\_20231016\_00023.jpg

LM Start	13.98	Rating **	U	Issue No.	42
LM End	14.01	Issue Type +	En	Location *	WS
Category	Earthen Levee			GPS Latitude/Longitude	
				Start	End
Item	Vegetation			38.628300°	38.627873°
				-121.560180°	-121.560202°
DWR ID	DWR_RD1000_01_s_2012_42				
Comment Code					
V6 : Landscaping					
Inspector Comment					
The landscape vegetation prevents the ability to see waterside slope and will make it difficult to access for flood fight.

View on waterside looking downstream of where the vegetation covers the front of the fence (Spring 2023).

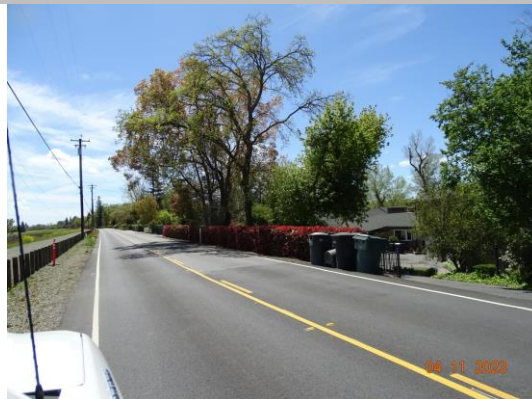
Photo 1 of 1 : FA\_2023\_RD1000\_31\_40\_20231016\_00022.jpg

LM Start	14.03	Rating **	U	Issue No.	40
LM End	14.17	Issue Type +	En	Location *	WS
Category	Earthen Levee			GPS Latitude/Longitude	
				Start	End
Item	Vegetation			38.627543°	38.625614°
				-121.560111°	-121.560245°
DWR ID	DWR_RD1000_01_s_2015_40				
Comment Code					
V6 : Landscaping					
Inspector Comment					
The landscape vegetation prevents the ability to see waterside slope and will make it difficult to access for flood fight.

View taken from the crown facing downstream looking at the waterward levee slope at landscaping (Spring 2023).

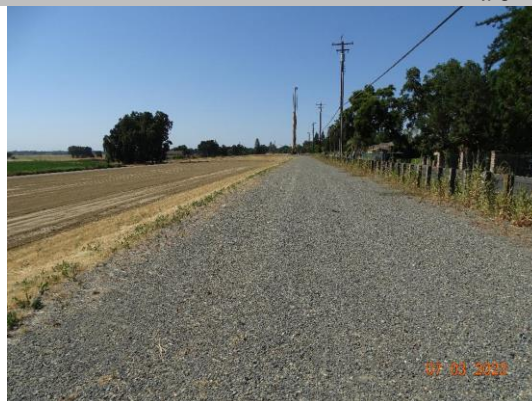
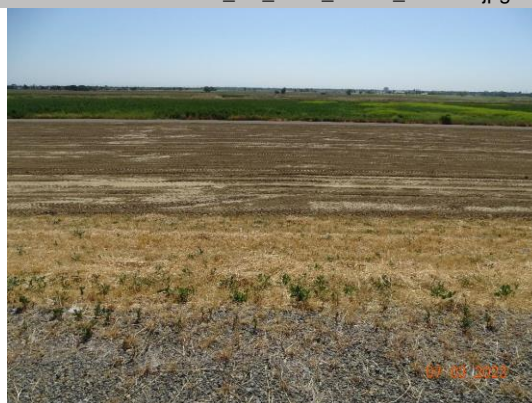
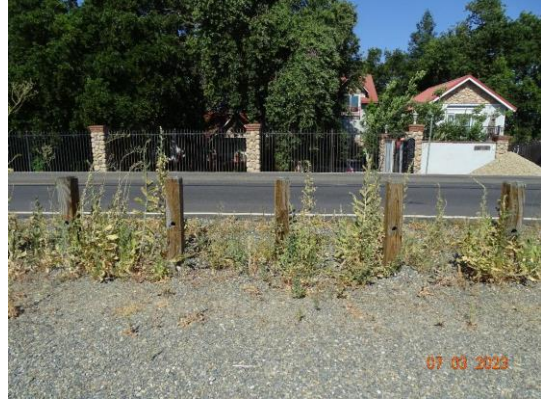
LM Start	14.41	Rating **	M	Issue No.	273
LM End	14.41	Issue Type +	En	Location *	
Category	Supplemental			GPS Latitude/Longitude	
				Start	End
Item	DWR UCIP Field Study			38.622156°	38.622156°
				-121.560254°	-121.560254°
DWR ID	25360				
Comment Code					
Inspector Comment					
DS_ID:25360 FS_ID:80681 EP_NO: N/A Repair Type: Non-Urgent EVAL Issue: Crossing Status: Not Found UCIP Comments: 07/03/2023 Record updated to Non-Urgent. Crossing not found. (M. Thao - DWR UCIP) FIELD_STRUCT_DESC: Two 3-inch steel conduits through the levee, 4 feet below the Garden Highway. (Two 3-inch conduits authorized under Permit No. 7091, 1970 - Sacramento Municipal Utility District). FS Date: 7/3/2023

Levee crown looking downstream.

LS view: General overview looking from crown.

WS view: General overview looking from crown.

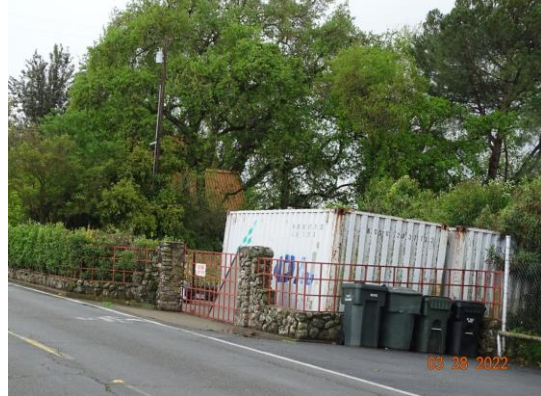
Photo 1 of 1 : FA\_2023\_RD1000\_31\_53\_20231016\_00028.jpg

LM Start	14.61	Rating **	M	Issue No.	53
LM End	14.61	Issue Type +	En	Location *	WS
Category	Earthen Levee			GPS Latitude/Longitude	
				Start	End
Item	Encroachments			38.619219°	38.619219°
				-121.560130°	-121.560130°
DWR ID	DWR_RD1000_01_f_2018_53				
Comment Code					
BU : Building					
Inspector Comment					
Storage container should be removed.

View of storage container from the landside of the crown facing the waterside of the levee.

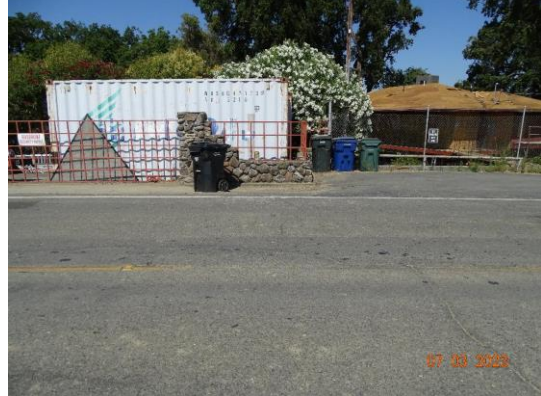
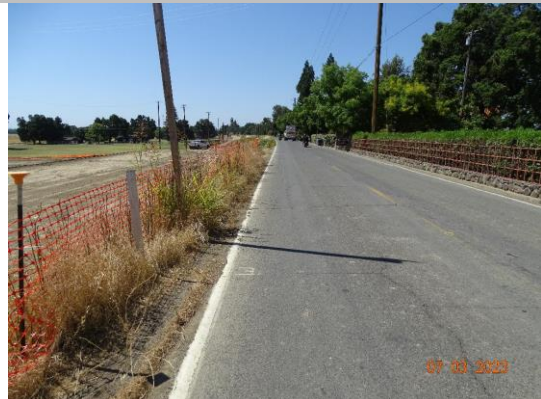
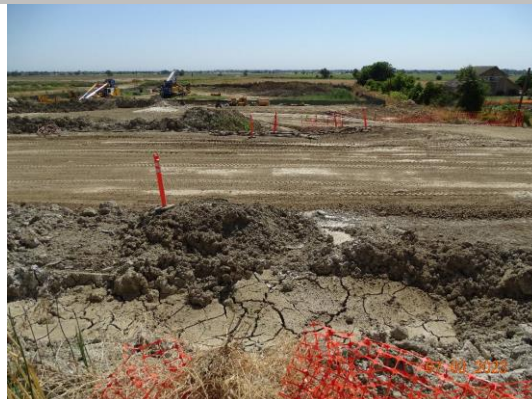
Comment Code						
Inspector Comment						
DS_ID:25217 FS_ID:80683 EP_NO: N/A Repair Type: Non-Urgent EVAL Issue: Crossing Status: Not Found UCIP Comments: 07/03/2023 Record updated to Non-Urgent. Crossing not found. (M. Thao - DWR UCIP)  FIELD_STRUCT_DESC: Two 3-inch PVC conduits through the levee, 3 feet below the Garden Highway. Two 12 kV conductors in one 3-inch conduit and service wires in the other conduit. (Two 3-inch conduits authorized under Permit No. 12435, 1978 - Sacramento Municipal Utility District; service wires placed in one other the conduits under Permit No. 12459-A, 1979 - Pacific Telephone and Telegraph Company). [Additional Reference(s): DWR Levee Log, 2002 (HLM 14.86)]. FS Date: 7/3/2023

WS view: General overview looking from crown.

Levee crown looking downstream.

LS view: General overview looking from crown.

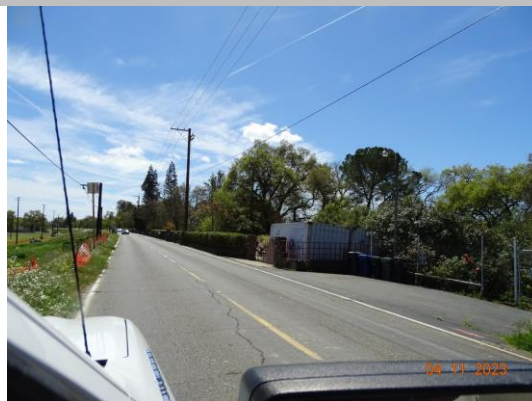
Photo 1 of 1 : FA\_2023\_RD1000\_31\_37\_20231016\_00021.jpg

LM Start	14.62	Rating **	M	Issue No.	37
LM End	14.66	Issue Type +	En	Location *	WS
Category	Earthen Levee			GPS Latitude/Longitude	
				Start	End
Item	Vegetation			38.619112°	38.618493°
				-121.560113°	-121.560070°
DWR ID	DWR_RD1000_01_s_2012_37				
Comment Code					
V6 : Landscaping					
Inspector Comment					
The landscape vegetation limits the ability to see the waterside slope and will make it difficult to access for flood fight.

View taken from the crown facing downstream looking at the waterward levee slope at landscaping (Spring 2023).

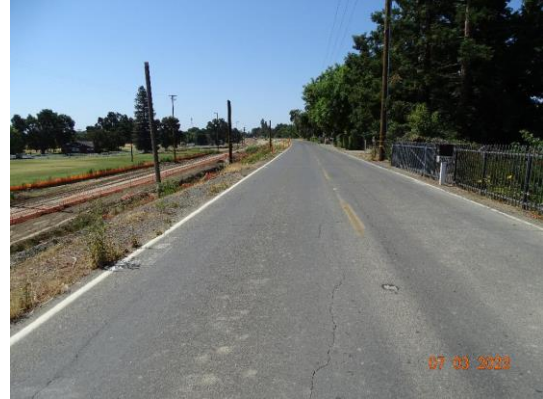
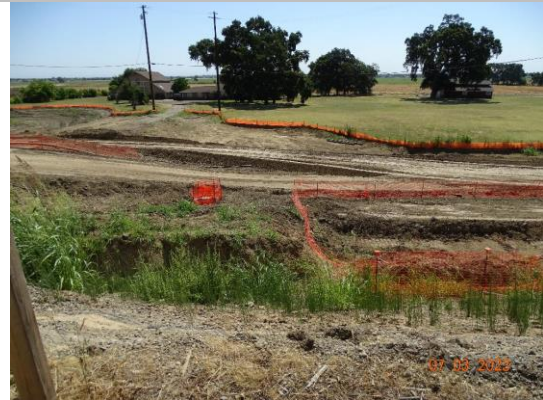
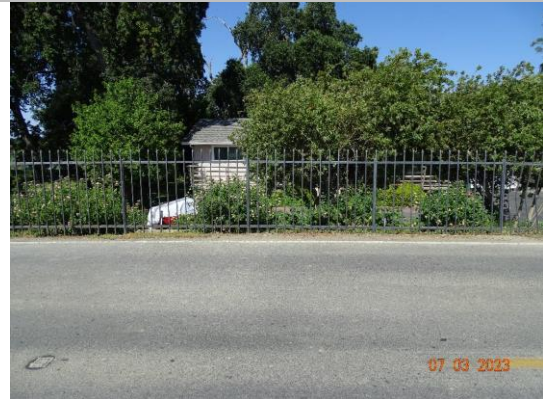
LM Start	14.67	Rating **	M	Issue No.	275	
LM End	14.67	Issue Type +	En	Location *		
Category	Supplemental			GPS Latitude/Longitude		
				Start	End	
Item	DWR UCIP Field Study			38.618306 °	38.618306 °	
				-121.560041 °	-121.560041 °	
DWR ID	25218					
Comment Code						
Inspector Comment						
DS_ID:25218 FS_ID:80684 EP_NO: N/A Repair Type: Non-Urgent EVAL Issue: Crossing Status: Not Found UCIP Comments: 07/03/2023 Record updated to Non-Urgent. Crossing not found. (M. Thao - DWR UCIP)  FIELD_STRUCT_DESC: Two 3-inch PVC (electrical and communication) conduits through the levee, 6 feet below the Garden Highway. (Two 3-inch conduits authorized under Permit No. 12435, 1978 - Sacramento Municipal Utility District). [Additional Reference(s): DWR Levee Log, 2002 (HLM 14.92)]. FS Date: 7/3/2023

Levee crown looking downstream.

LS view: General overview looking from crown.

WS view: General overview looking from crown.

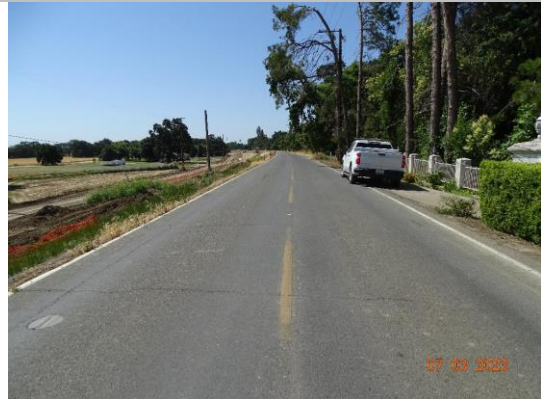
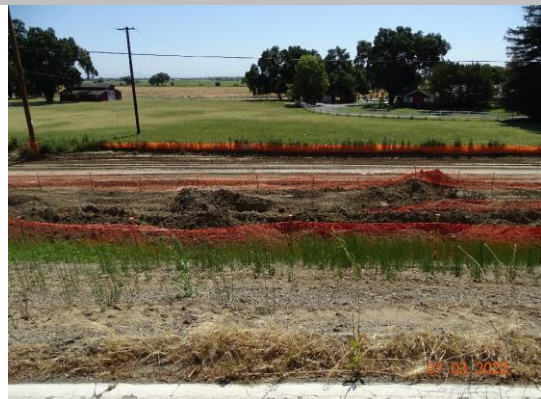
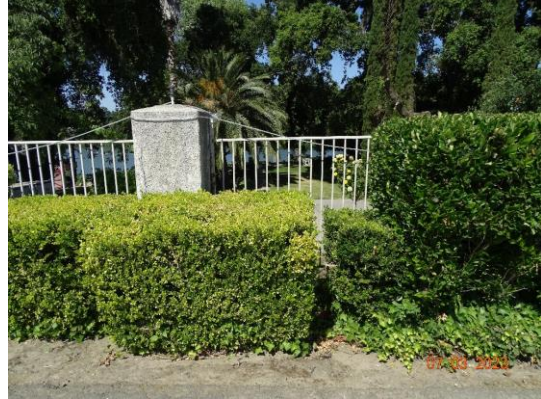
Comment Code						
Inspector Comment						
DS_ID:25211 FS_ID:80685 EP_NO: N/A Repair Type: Non-Urgent EVAL Issue: Crossing Status: Not Found UCIP Comments: 07/03/2023 Record updated to Non-Urgent. Crossing not found. (M. Thao - DWR UCIP)  FIELD_STRUCT_DESC: Two 3-inch PVC conduits through the levee, 3 feet below the Garden Highway. Two 12 kV conductors in one 3-inch conduit and service wires in the other conduit. (Two 3-inch conduits authorized under Permit No. 12435, 1978 - Sacramento Municipal Utility District; service wires placed in one other the conduits under Permit No. 12459-A, 1979 - Pacific Telephone and Telegraph Company). [Additional Reference(s): DWR Levee Log, 2002 (HLM 15.00)]. FS Date: 7/3/2023

Levee crown looking downstream.

LS view: General overview looking from crown.

WS view: General overview looking from crown.

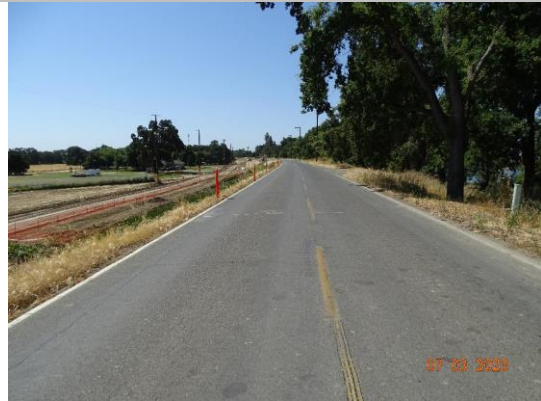
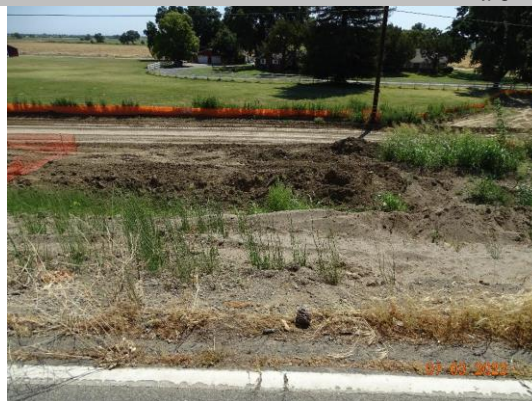
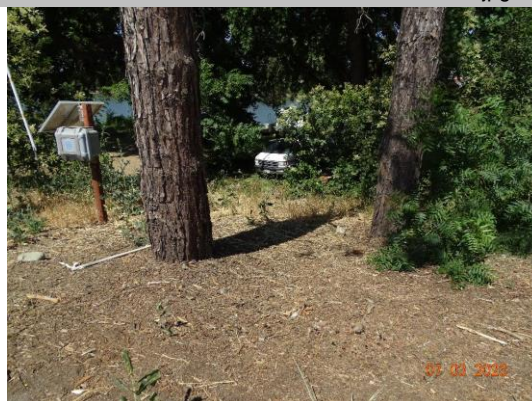
Photo 1 of 3 : UCIP\_FA\_2023\_80686\_116732.jpg

DS\_ID:25220  
FS\_ID:80686  
EP\_NO: N/A  
Repair Type: Non-Urgent  
EVAL Issue:  
Crossing Status: Not Found  
UCIP Comments: 07/03/2023 Record updated to Non-Urgent. Crossing not found. (M. Thao - DWR UCIP)

FIELD\_STRUCT\_DESC: 4-inch galvanized sewer pipe through the levee, 3 feet below the crown. Pump station mahole located approximately 160 feet from Garden Highway centerline. (4-inch pipe authorized under Permit No. 12242-A, 1979 - Mr. Robert A. Sieglitz). [Additional Reference(s): DWR Levee Log, 2002 (HLM 15.02)].  
FS Date: 7/3/2023

Levee crown looking downstream.

LS view: General overview looking from crown.

WS view: General overview looking from crown.

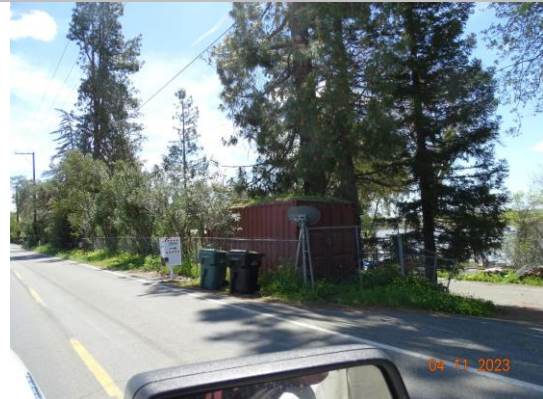
Photo 1 of 1 : FA\_2023\_RD1000\_31\_76\_20231016\_00035.jpg

LM Start	15.09	Rating **	M	Issue No.	76
LM End	15.09	Issue Type +	En	Location *	WS
Category	Earthen Levee			GPS Latitude/Longitude	
				Start	End
Item	Encroachments			38.612340°	38.612340°
				-121.558633°	-121.558633°
DWR ID	DWR_RD1000_01_f_2012_76				
Comment Code					
BU : Building					
Inspector Comment					
Cargo container on the waterside slope is blocking visibility and needs to be removed.

Cargo container on levee shoulder, the property appears to be on fill material (Spring 2023).

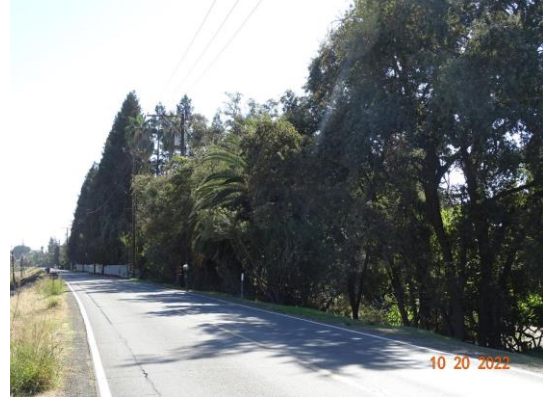
Photo 1 of 1 : FA\_2023\_RD1000\_31\_30\_20231016\_00018.jpg

LM Start	15.44	Rating **	M	Issue No.	30
LM End	15.48	Issue Type +	En	Location *	WS
Category	Earthen Levee			GPS Latitude/Longitude	
				Start	End
Item	Vegetation			38.607715°	38.607345°
				-121.555847°	-121.555538°
DWR ID	DWR_RD1000_01_s_2012_30				
Comment Code					
V6 : Landscaping					
Inspector Comment					
The landscape vegetation limits the ability to see the waterside slope and will make it difficult to access for flood fight.

This photo was taken from the crown facing downstream looking down the waterward levee slope at unacceptable landscaping, Fall 2022.

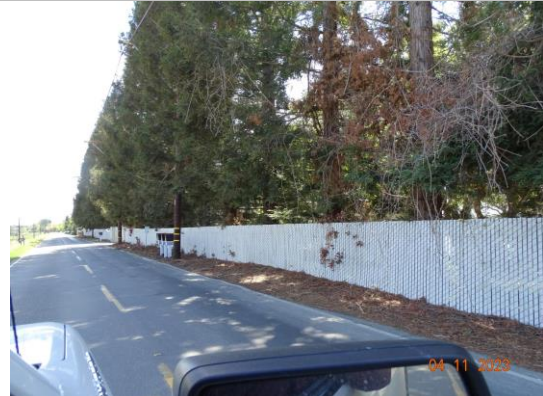
Photo 1 of 1 : FA\_2023\_RD1000\_31\_29\_20231016\_00017.jpg

LM Start	15.49	Rating **	U	Issue No.	29
LM End	15.57	Issue Type +	En	Location *	WS
Category	Earthen Levee			GPS Latitude/Longitude	
				Start	End
Item	Encroachments			38.607207°	38.606255°
				-121.555465°	-121.554582°
DWR ID	DWR_RD1000_01_s_2012_29				
Comment Code					
FE : Fence					
Inspector Comment					
The fence blocks visibility and access.

View taken from the crown facing downstream looking at the waterward levee slope at fence (Spring 2023).

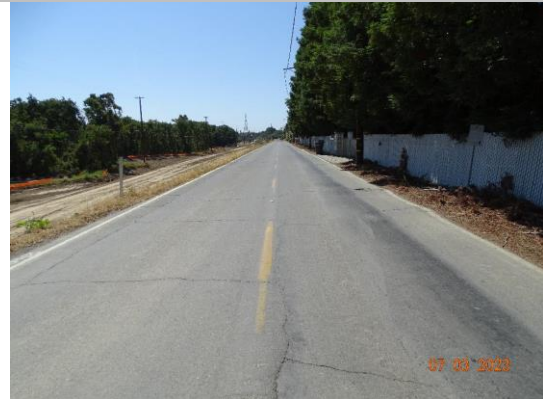
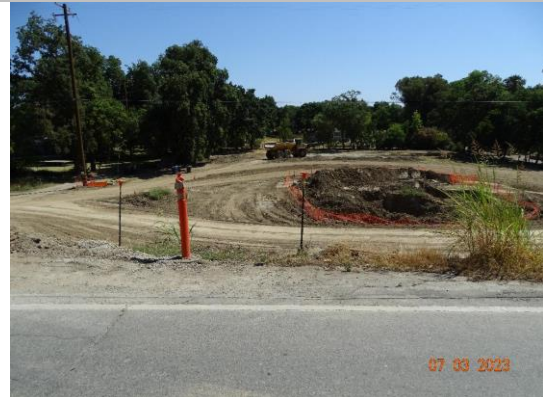
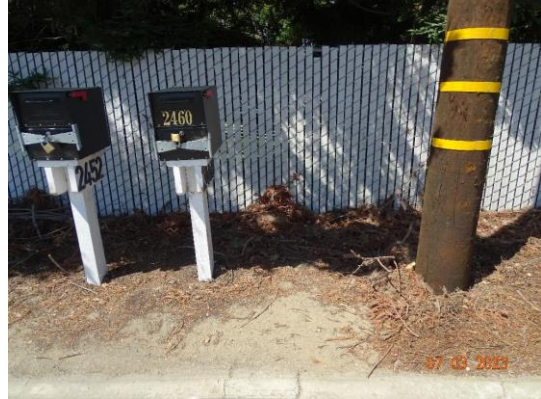
Photo 1 of 3 : UCIP\_FA\_2023\_80687\_116734.jpg

LM Start	15.52	Rating **	M	Issue No.	278
LM End	15.52	Issue Type +	En	Location *	
Category	Supplemental			GPS Latitude/Longitude	
				Start	End
Item	DWR UCIP Field Study			38.606831 °	38.606831 °
				-121.555089 °	-121.555089 °
DWR ID	25221				
Comment Code					
Inspector Comment					
DS_ID:25221 FS_ID:80687 EP_NO: N/A Repair Type: Non-Urgent EVAL Issue: Crossing Status: Not Found UCIP Comments: 07/03/2023 Record updated to Non-Urgent. Crossing not found. (M. Thao - DWR UCIP)  FIELD_STRUCT_DESC: 4-inch PVC electrical conduit through levee, 2.5 feet below the crown. (4-inch pipe authorized under Permit No. 15547, 1990 - Sacramento Municipal Utility District). [Additional Reference(s): DWR Levee Log, 2002 (HLM 15.78)]. FS Date: 7/3/2023

Levee crown looking downstream.

LS view: General overview looking from crown.

WS view: General overview looking from crown.

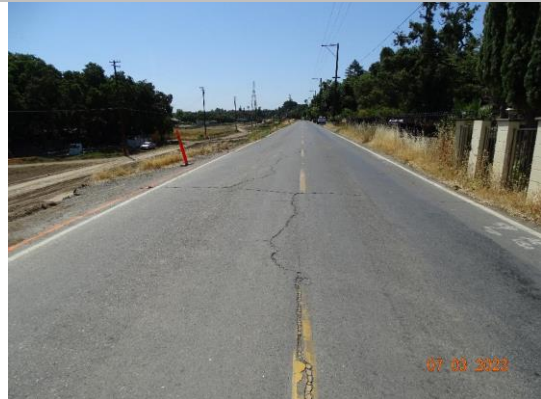
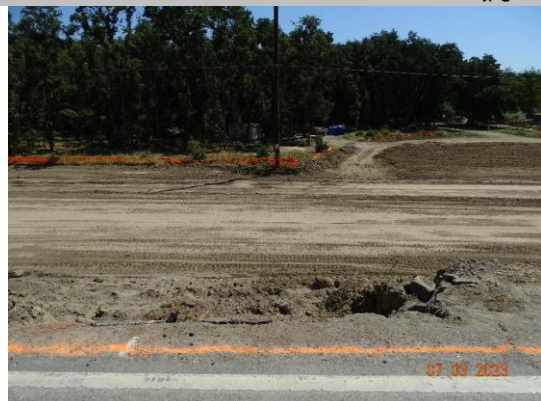
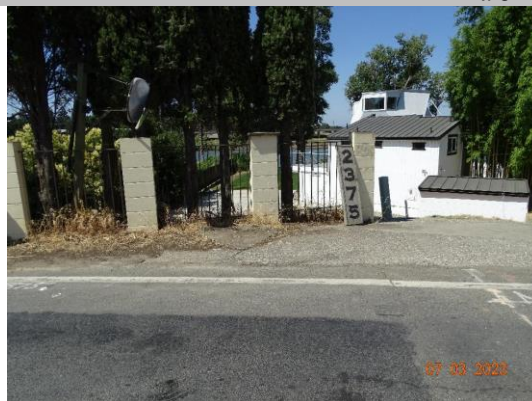
Photo 1 of 3 : UCIP\_FA\_2023\_80692\_116743.jpg

LM Start	15.67	Rating **	M	Issue No.	280
LM End	15.67	Issue Type +	En	Location *	
Category	Supplemental			GPS Latitude/Longitude	
				Start	End
Item	DWR UCIP Field Study			38.605088°	38.605088°
				-121.553508°	-121.553508°
DWR ID	25369				
Comment Code					
Inspector Comment					
DS_ID:25369 FS_ID:80692 EP_NO: N/A Repair Type: Non-Urgent EVAL Issue: Crossing Status: Not Found UCIP Comments: 07/03/2023 Record updated to Non-Urgent. Crossing not found. (M. Thao - DWR UCIP)  FIELD_STRUCT_DESC: Two 3-inch rigid steel conduits through the levee, 3 feet below the crown. (Two 3-inch conduits authorized under Permit No. 9103, 1973 - Sacramento Municipal Utility District). FS Date: 7/3/2023

Levee crown looking downstream.

LS view: General overview looking from crown.

WS view: General overview looking from crown.

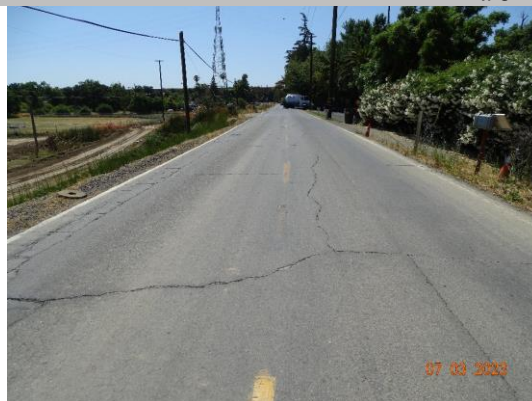
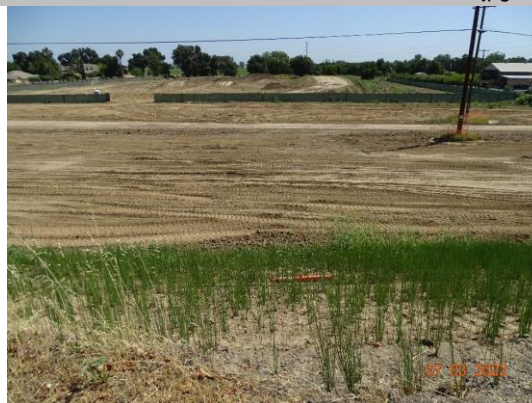
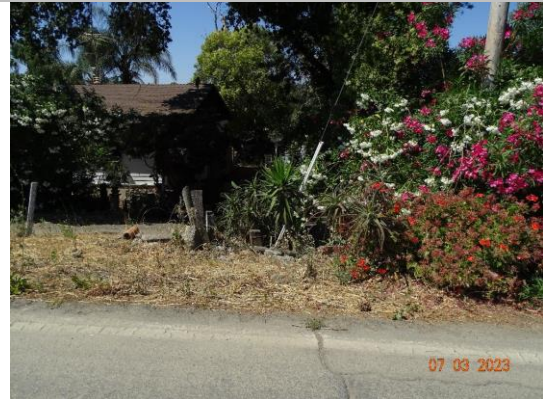
Photo 1 of 3 : UCIP\_FA\_2023\_81268\_116758.jpg

LM Start	15.88	Rating **	M	Issue No.	282
LM End	15.88	Issue Type +	En	Location *	
Category	Supplemental			GPS Latitude/Longitude	
				Start	End
Item	DWR UCIP Field Study			38.602554°	38.602554°
				-121.551149°	-121.551149°
DWR ID	25298				
Comment Code					
Inspector Comment					
DS_ID:25298					
FS_ID:81268					
EP_NO: N/A					
Repair Type: Non-Urgent					
EVAL Issue:					
Crossing Status: Not Found					
UCIP Comments: 07/03/2023 Record updated to Non-Urgent. No inspection records were available to determine status of line through the levee. Crossing not found. (M. Thao - DWR UCIP)					
FIELD_STRUCT_DESC: Replace twin gaslines across Sacramento River with two 12.75 gas lines.					
FS Date: 7/3/2023

Levee crown looking downstream.

LS view: General overview looking from crown.

WS view: General overview looking from crown.

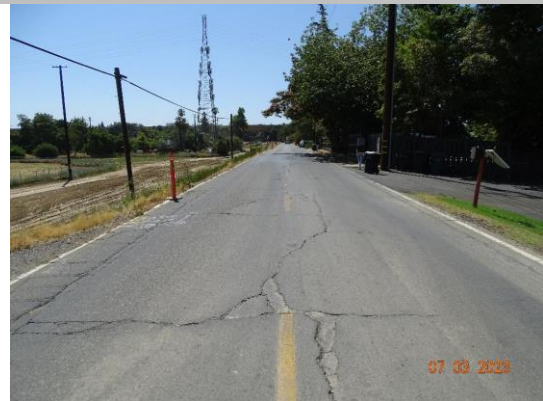
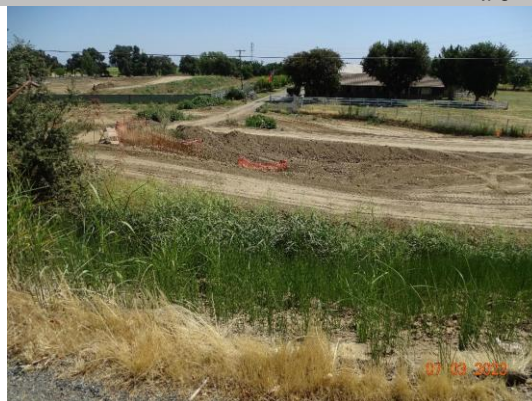
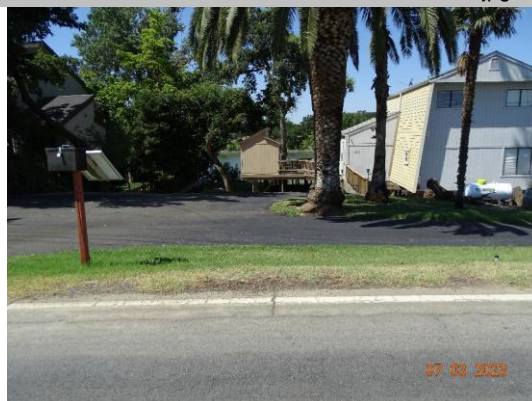
Photo 1 of 3 : UCIP\_FA\_2023\_80700\_116770.jpg

DS\_ID:25344  
 FS\_ID:80700  
 EP\_NO: N/A  
 Repair Type: Non-Urgent  
 EVAL Issue:  
 Crossing Status: Not Found  
 UCIP Comments: 07/03/2023 Record updated to Non-Urgent. Crossing not found. (M. Thao - DWR UCIP)

FIELD\_STRUCT\_DESC: Two 3-inch PVC (electrical and communication) conduits through the levee, 3 feet below the crown. (Two 3-inch conduits authorized under Permit No. 12288, 1978 - Sacramento Municipal Utility District).  
 FS Date: 7/3/2023

Levee crown looking downstream.

LS view: General overview looking from crown.

WS view: General overview looking from crown.

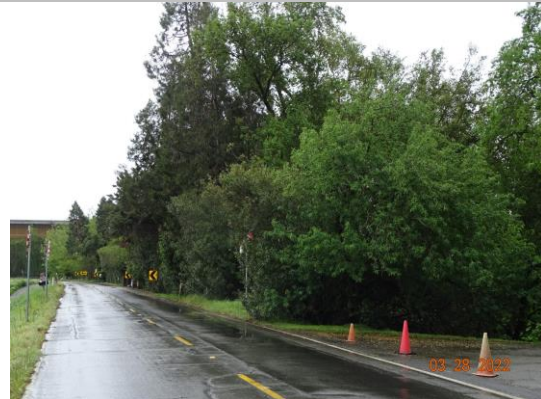
Photo 1 of 1 : FA\_2023\_RD1000\_31\_19\_20231016\_00015.jpg

LM Start	16.03	Rating **	U	Issue No.	19
LM End	16.06	Issue Type +	En	Location *	WS
Category	Earthen Levee			GPS Latitude/Longitude	
				Start	End
Item	Vegetation			38.600988 °	38.600665 °
				-121.549198 °	-121.548795 °
DWR ID	DWR_RD1000_01_s_ 2012_19				
Comment Code					
V6 : Landscaping					
Inspector Comment					
The landscape vegetation prevents the ability to see waterside slope and will make it difficult to access for flood fight.

View on waterside looking downstream of property covered by Oleander Bushes.

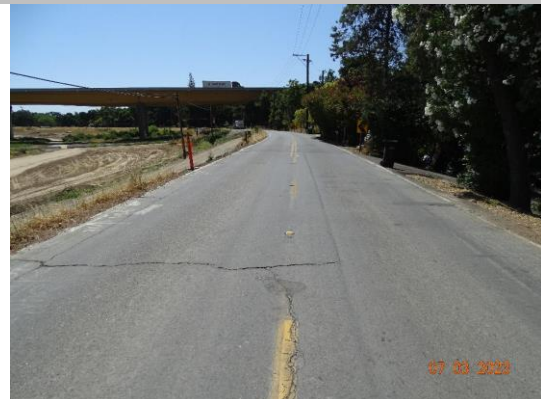
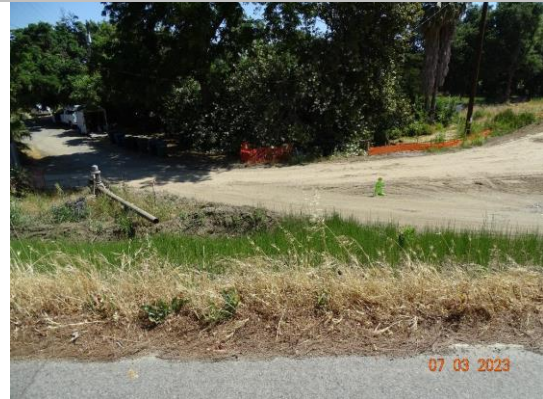
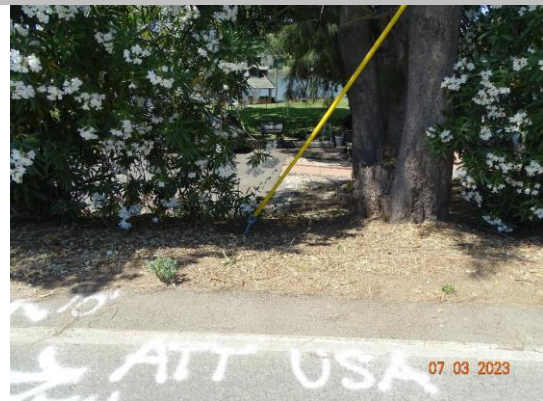
Photo 1 of 3 : UCIP\_FA\_2023\_80701\_116775.jpg

LM Start	16.05	Rating **	M	Issue No.	284
LM End	16.05	Issue Type +	En	Location *	
Category	Supplemental			GPS Latitude/Longitude	
				Start	End
Item	DWR UCIP Field Study			38.600803°	38.600803°
				-121.549009°	-121.549009°
DWR ID	25224				
Comment Code					
Inspector Comment					
DS_ID:25224 FS_ID:80701 EP_NO: N/A Repair Type: Non-Urgent EVAL Issue: Crossing Status: Not Found UCIP Comments: 07/03/2023 Record updated to Non-Urgent. No inspection records were available to determine status of line through the levee. Crossing not found. (M. Thao - DWR UCIP)  FIELD_STRUCT_DESC: Two 10.625-inch gas lines through the levee, 4.0 feet below the crown. (Two 10-inch pipes authorized under Permit No. 1437, 1949 - Pacific Gas & Electric Company). [Additional Reference(s): DWR Levee Log, 2002 (HLM 16.32)]. FS Date: 7/3/2023

Levee crown looking downstream.

LS view: General overview looking from crown.

WS view: General overview looking from crown.

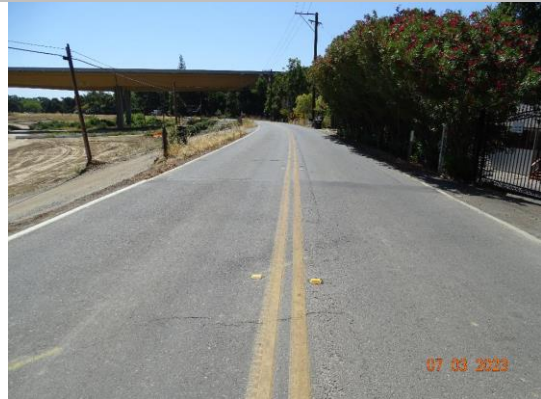
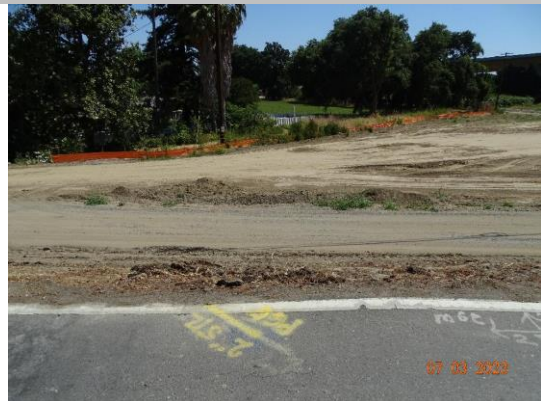
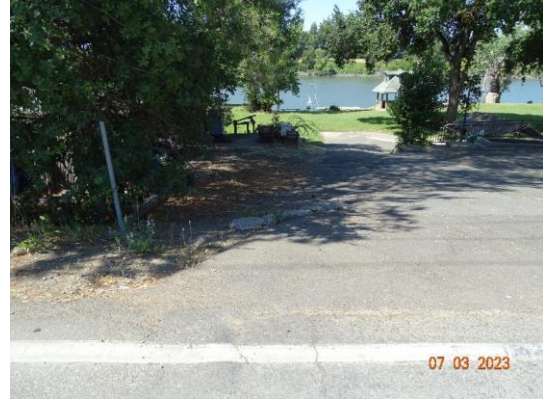
Photo 1 of 3 : UCIP\_FA\_2023\_80707\_116796.jpg

LM Start	16.08	Rating **	M	Issue No.	285	
LM End	16.08	Issue Type +	En	Location *		
Category	Supplemental			GPS Latitude/Longitude		
				Start	End	
Item	DWR UCIP Field Study			38.600497°	38.600497°	
				-121.548628°	-121.548628°	
DWR ID	25291					
Comment Code						
Inspector Comment						
DS_ID:25291						
FS_ID:80707						
EP_NO: N/A						
Repair Type: Non-Urgent						
EVAL Issue:						
Crossing Status: Not Found						
UCIP Comments: 07/03/2023 Record updated to Non-Urgent. Crossing not found. (M. Thao - DWR UCIP)						
FIELD_STRUCT_DESC: An electrical conduit of unknown size through the levee, 3 feet below the crown. (Electrical conduit authorized under Permit No. 5625, 1967 - Sacramento Municipal Utility District).						
FS Date: 7/3/2023

Levee crown looking downstream.

LS view: General overview looking from crown.

WS view: General overview looking from crown.

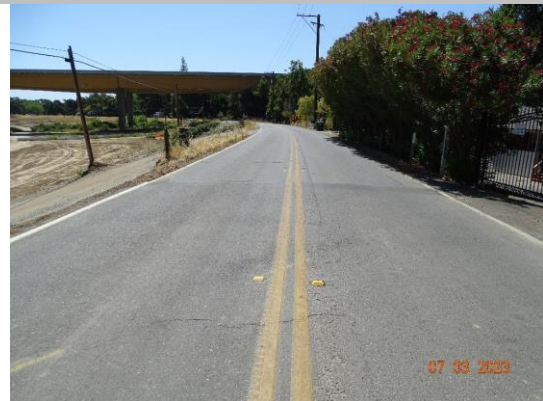
Photo 1 of 3 : UCIP\_FA\_2023\_80705\_116789.jpg

DS\_ID:25225  
 FS\_ID:80705  
 EP\_NO: N/A  
 Repair Type: Non-Urgent  
 EVAL Issue:  
 Crossing Status: Not Found  
 UCIP Comments: 07/03/2023 Record updated to Non-Urgent. No inspection records were available to determine status of line through the levee. Crossing not found. (M. Thao - DWR UCIP)

FIELD\_STRUCT\_DESC: 12-inch gas line through the levee, 2 feet below the crown. (Permit No. 2348, 1956 - Pacific Gas and Electric Company). [Additional Reference(s): DWR Levee Log, 2002 (HLM 16.35)].  
 FS Date: 7/3/2023

Levee crown looking downstream.

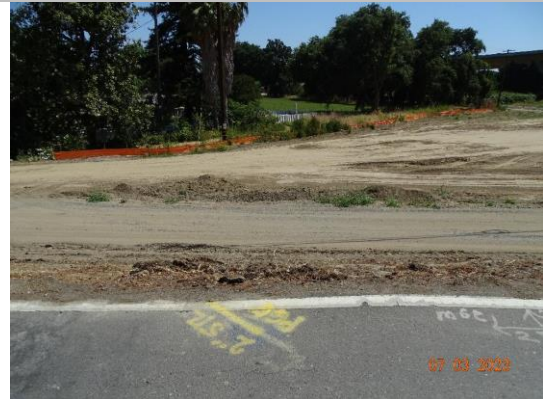
Photo 2 of 3 : UCIP\_FA\_2023\_80705\_116790.jpg

LS view: General overview looking from crown.

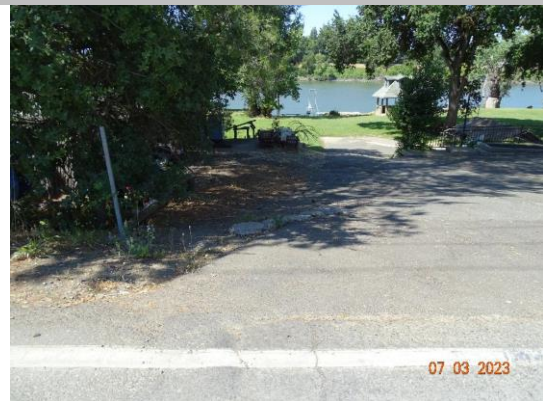
Photo 3 of 3 : UCIP\_FA\_2023\_80705\_116788.jpg

WS view: General overview looking from crown.

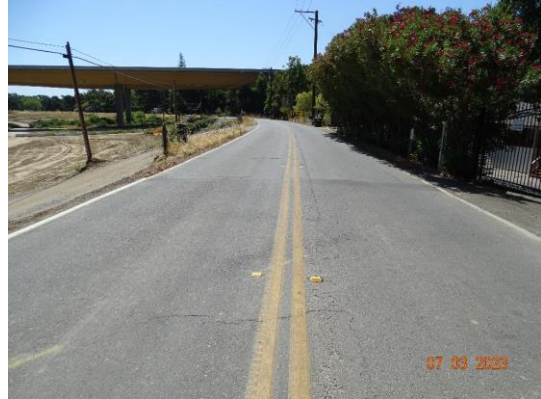
Photo 1 of 3 : UCIP\_FA\_2023\_80992\_117036.jpg

Comment Code						
Inspector Comment						
DS_ID:25278 FS_ID:80992 EP_NO: N/A Repair Type: Non-Urgent EVAL Issue: Crossing Status: Not Found UCIP Comments: 07/03/2023 Record updated to Non-Urgent. No inspection records were available to determine status of line through the levee. Crossing not found. (M. Thao - DWR UCIP) FIELD_STRUCT_DESC: Steel gas line of an unknown size through the levee, at an unknown depth. [Additional Reference(s): USACE Sacramento O&M Manual, Unit No. 124, June 1953, Revised 25 February 2022, (River Mile 62.78), pipe diameter not listed. USACE As-Built Drawing No. 50-13-2810, November 1922, River Mile 62.78]. FS Date: 7/3/2023

Levee crown looking downstream.

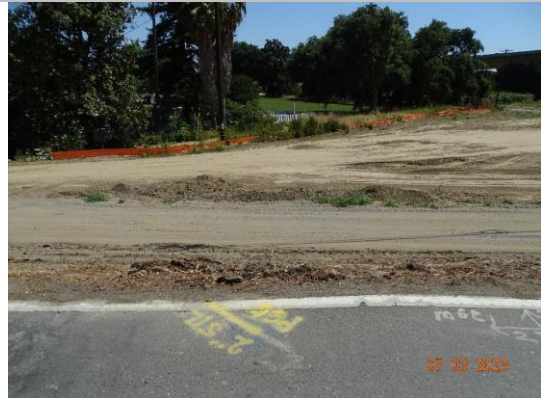
Photo 2 of 3 : UCIP\_FA\_2023\_80992\_117037.jpg

LS view: General overview looking from crown.

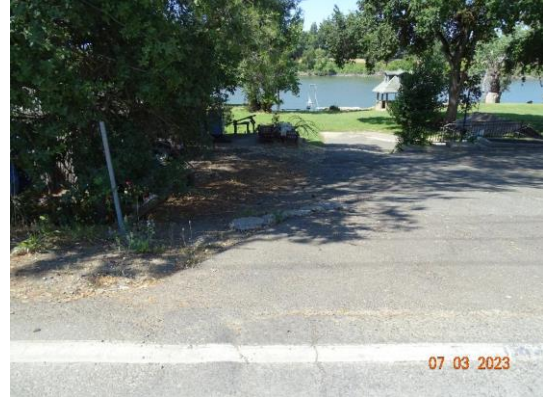
Photo 3 of 3 : UCIP\_FA\_2023\_80992\_117038.jpg

WS view: General overview looking from crown.

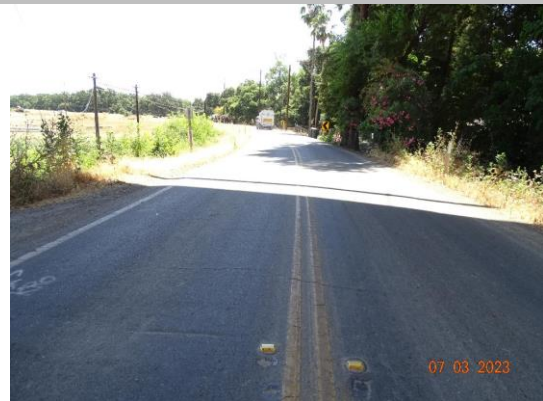
Photo 1 of 3 : UCIP\_FA\_2023\_81071\_117057.jpg

DS\_ID:25358  
 FS\_ID:81071  
 EP\_NO: N/A  
 Repair Type: Non-Urgent  
 EVAL Issue:  
 Crossing Status: Not Found  
 UCIP Comments: 07/03/2023 Record updated to Non-Urgent. Crossing not found. (M. Thao - DWR UCIP)  
 FIELD\_STRUCT\_DESC: 26-inch dredge pipe through the levee, 3 feet below the crown with a cut-off wall. (26-inch pipe installed under Permit 5893, 1967 - Shellmaker Incorporated; 26-inch pipe retained under Permit No. 5954, 1967 - Peter Kiewit Sons' Company; 26-inch pipe taken over under Permit No. 6286, 1968 - Murphy Pacific Enterprises).  
 FS Date: 7/3/2023

Levee crown looking downstream.

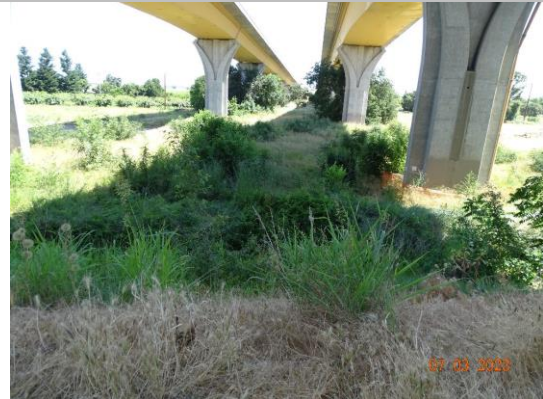
Photo 2 of 3 : UCIP\_FA\_2023\_81071\_117056.jpg

LS view: General overview looking from crown.

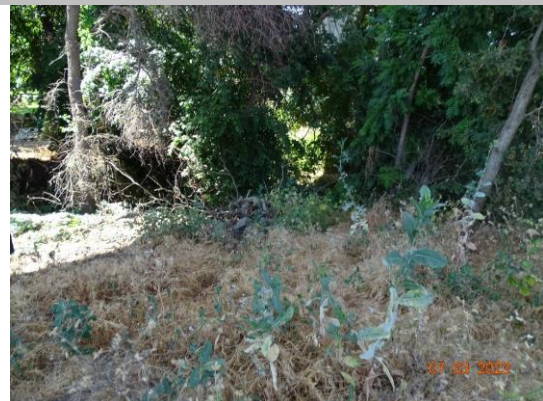
Photo 3 of 3 : UCIP\_FA\_2023\_81071\_117058.jpg

WS view: General overview looking from crown.

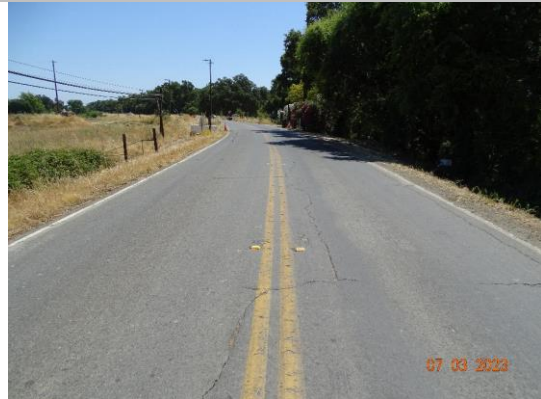
Photo 1 of 3 : UCIP\_FA\_2023\_80744\_116882.jpg

LM Start	16.26	Rating **	M	Issue No.	289
LM End	16.26	Issue Type +	En	Location *	
Category	Supplemental			GPS Latitude/Longitude	
				Start	End
Item	DWR UCIP Field Study			38.599633°	38.599633°
				-121.545685°	-121.545685°
DWR ID	25214				
Comment Code					
Inspector Comment					
DS_ID:25214 FS_ID:80744 EP_NO: N/A Repair Type: Non-Urgent EVAL Issue: Crossing Status: Not Found UCIP Comments: 07/03/2023 Record updated to Non-Urgent. Crossing not found. (M. Thao - DWR UCIP)  FIELD_STRUCT_DESC: Two 3-inch PVC conduits (power and communication) through the levee, 3 feet below the crown. A service box located approximately 10 feet off the waterside (WS) toe. (Two 3-inch conduits authorized under Permit No. 13268, 1981 - Sacramento Municipal Utility District). [Additional Reference(s): DWR Levee Log, 2002 (HLM 16.53)] FS Date: 7/3/2023

Levee crown looking downstream.

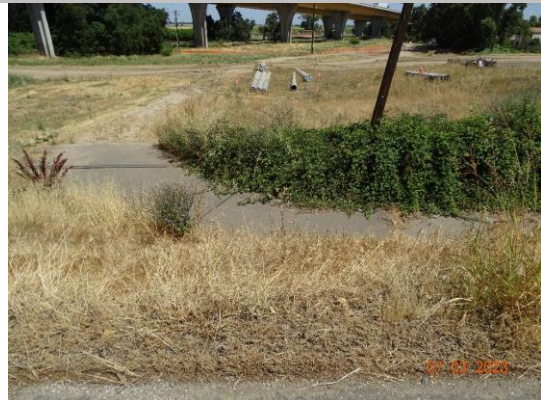
Photo 2 of 3 : UCIP\_FA\_2023\_80744\_116881.jpg

LS view: General overview looking from crown.

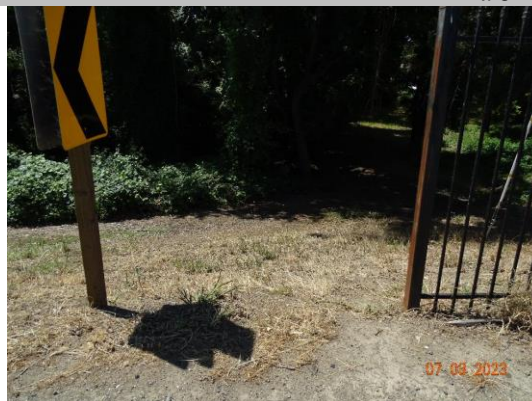
Photo 3 of 3 : UCIP\_FA\_2023\_80744\_116883.jpg

WS view: General overview looking from crown.

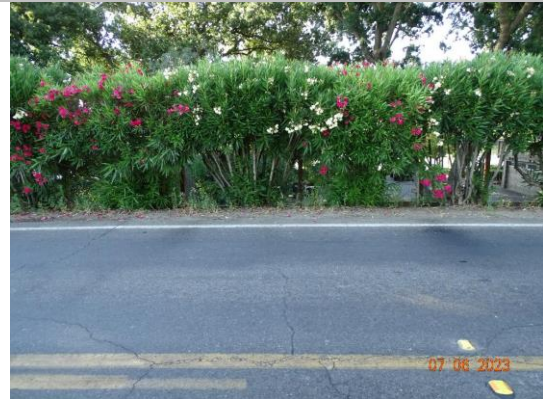
Photo 1 of 3 : UCIP\_FA\_2023\_80754\_116896.jpg

LM Start	16.62	Rating **	M	Issue No.	290
LM End	16.62	Issue Type +	En	Location *	
Category	Supplemental			GPS Latitude/Longitude	
				Start	End
Item	DWR UCIP Field Study			38.602576°	38.602576°
				-121.540235°	-121.540235°
DWR ID	25335				
Comment Code					
Inspector Comment					
DS_ID:25335 FS_ID:80754 EP_NO: N/A Repair Type: Non-Urgent EVAL Issue: Crossing Status: Not Found UCIP Comments: 07/06/2023 Record updated to Non-Urgent. Crossing not found. (M. Thao - DWR UCIP) FIELD_STRUCT_DESC: 24-inch steel sleeve pipe for emergency irrigation, 3 feet below the crown with a corrugated metal cut-off wall. (24-inch pipe authorized under Permit 9689, 1974 - Natomas Central Mutual Water Company). FS Date: 7/6/2023

WS view: General overview looking from crown.

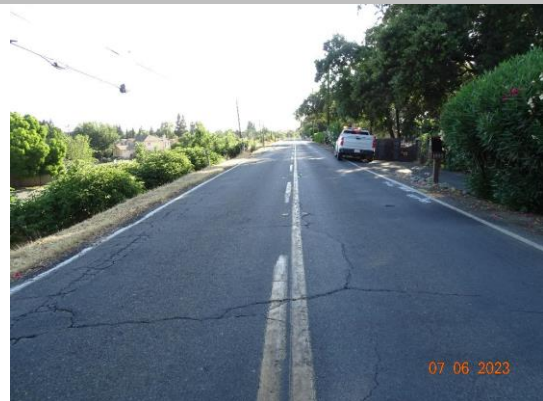
Photo 2 of 3 : UCIP\_FA\_2023\_80754\_116897.jpg

Levee crown looking downstream.

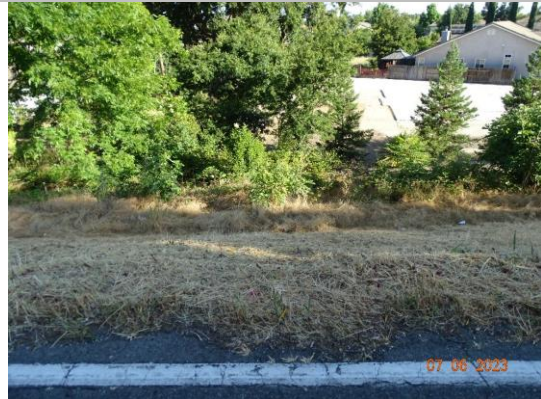
Photo 3 of 3 : UCIP\_FA\_2023\_80754\_116898.jpg

LS view: General overview looking from crown.

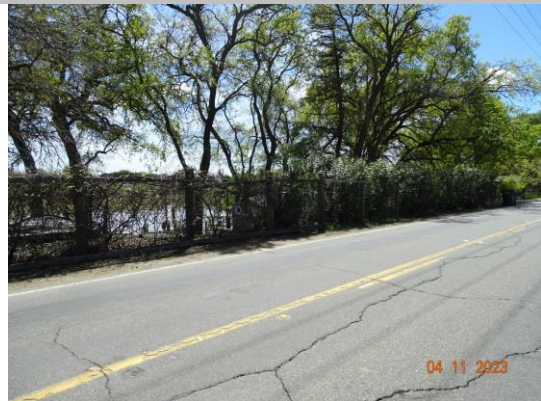
Photo 1 of 1 : FA\_2023\_RD1000\_31\_15\_20231016\_00014.jpg

LM Start	16.63	Rating **	M	Issue No.	15
LM End	16.67	Issue Type +	En	Location *	WS
Category	Earthen Levee			GPS Latitude/Longitude	
				Start	End
Item	Vegetation			38.602693°	38.603092°
				-121.540165°	-121.539490°
DWR ID	DWR_RD1000_01_s_2012_15				
Comment Code					
V6 : Landscaping					
Inspector Comment					
The landscape vegetation limits the ability to see the waterside slope and will make it difficult to access for flood fight.

View landscaping that is interwoven into fence on the waterside shoulder (Spring 2023).

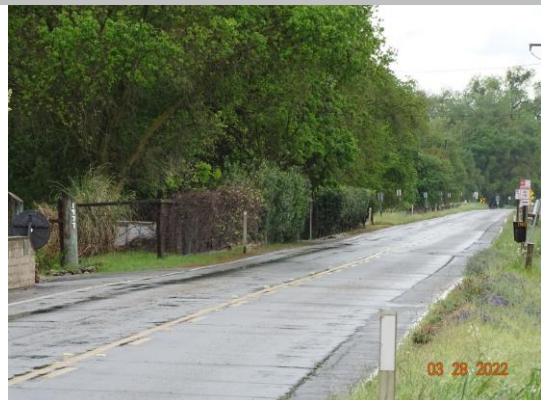
Photo 1 of 1 : FA\_2023\_RD1000\_31\_14\_20231016\_00013.jpg

LM Start	16.68	Rating **	M	Issue No.	14
LM End	16.72	Issue Type +	En	Location *	WS
Category	Earthen Levee			GPS Latitude/Longitude	
				Start	End
Item	Encroachments			38.603242°	38.603597°
				-121.539318°	-121.538875°
DWR ID	DWR_RD1000_01_s_2012_14				
Comment Code					
FE : Fence					
Inspector Comment					
Fence/retaining wall should not inhibit operations but monitor surrounding landscaping to ensure it does not impede ability to identify flood threats or access.

View on waterside looking across at the fence covered by vegetation.

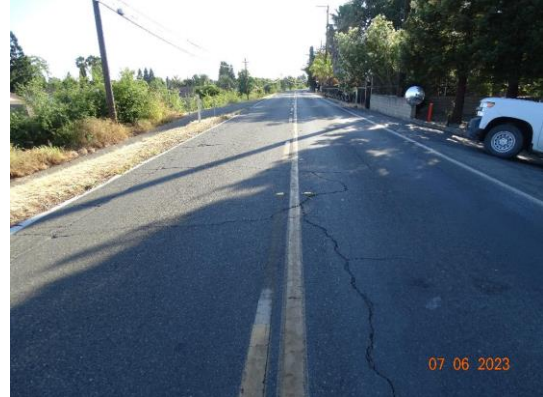
Photo 1 of 3 : UCIP\_FA\_2023\_80993\_117041.jpg

LM Start	16.71	Rating **	M	Issue No.	292	
LM End	16.71	Issue Type +	En	Location *		
Category	Supplemental			GPS Latitude/Longitude		
				Start		End
Item	DWR UCIP Field Study			38.603376°		38.603376°
				-121.538967°		-121.538967°
DWR ID	25279					
Comment Code						
Inspector Comment						
DS_ID:25279 FS_ID:80993 EP_NO: N/A Repair Type: Non-Urgent EVAL Issue: Crossing Status: Not Found UCIP Comments: 07/06/2023 Record updated to Non-Urgent. Crossing not found. (M. Thao - DWR UCIP)						
FIELD_STRUCT_DESC: 10-inch steel pipe of an unknown purpose through the levee, at an unknown depth. [Additional Reference(s): USACE Sacramento O&M Manual, Unit No. 124, June 1953, Revised 25 February 2022, (River Mile 62.14), listed as 10-inch pipe. USACE As-Built Drawing No. 50-13-2810, November 1922, River Mile 62.14]. FS Date: 7/6/2023

Levee crown looking downstream.

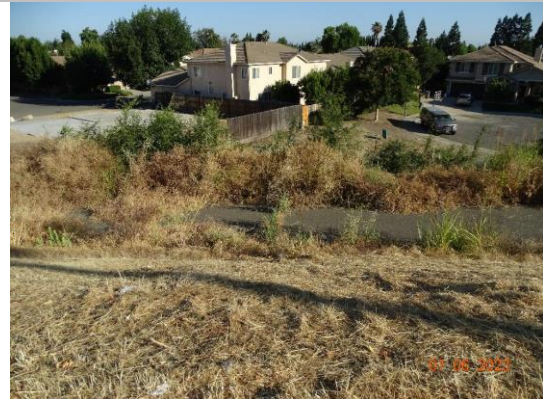
Photo 2 of 3 : UCIP\_FA\_2023\_80993\_117042.jpg

LS view: General overview looking from crown.

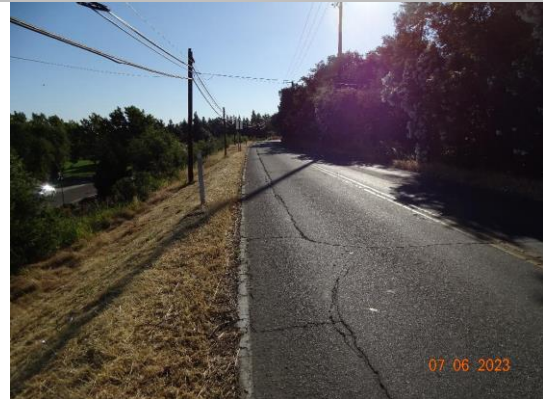
Photo 1 of 3 : UCIP\_FA\_2023\_80753\_116902.jpg

LM Start	16.83	Rating **	M	Issue No.	293
LM End	16.83	Issue Type +	En	Location *	
Category	Supplemental			GPS Latitude/Longitude	
				Start	End
Item	DWR UCIP Field Study			38.604458°	38.604458°
				-121.537070°	-121.537070°
DWR ID	25195				
Comment Code					
Inspector Comment					
DS_ID:25195 FS_ID:80753 EP_NO: N/A Repair Type: Non-Urgent EVAL Issue: Crossing Status: Not Found UCIP Comments: 07/06/2023 Record updated to Non-Urgent. Overgrown vegetation on waterside limits inspection of levee at this crossing. (M. Thao - DWR UCIP)  FIELD_STRUCT_DESC: Two 3-inch (electrical and communication) conduits through the levee, 3.0 feet below the crown. (Two 3-inch conduits authorized under Permit No. 8488, 1972 - Sacramento Municipal Utility District). [Additional Reference(s): DWR Levee Log, 2002 (HLM 17.12)]. FS Date: 7/6/2023

Levee crown looking downstream.

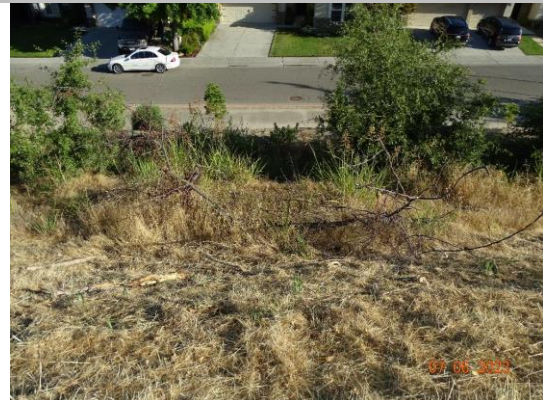
Photo 2 of 3 : UCIP\_FA\_2023\_80753\_116903.jpg

LS view: General overview looking from crown.

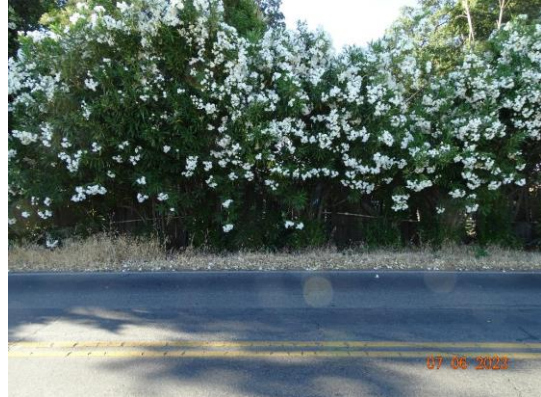
Photo 3 of 3 : UCIP\_FA\_2023\_80753\_116904.jpg

WS view: Dense vegetation on slope limiting inspection.
