## Flood Control Project Maintenance Levee Inspections

### Fall 2023 Levee Maintenance Deficiency Summary Report

#### Sacramento River Basin

**Reclamation District No. 1000 Natomas**

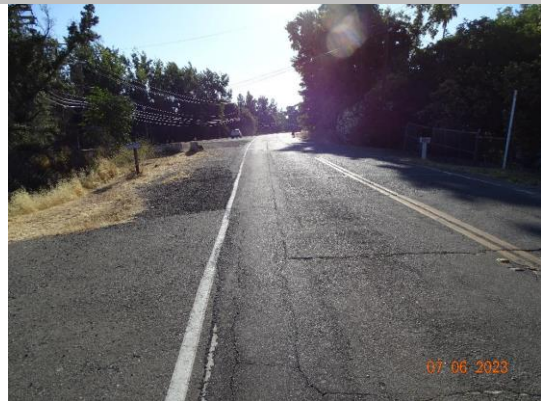
Photo 1 of 3 : UCIP\_FA\_2023\_81271\_116908.jpg

DS\_ID:25196  
FS\_ID:81271  
EP\_NO: 14911  
Repair Type: Non-Urgent  
EVAL Issue:  
Crossing Status: Found  
UCIP Comments: 07/06/2023 Record updated to Non-Urgent. Metal gate along waterside toe limits inspection of flap gates at this crossing. Coordinates have been updated from 38.605171, -121.534910 to 38.605125, -121.535123 based on field inspection. (M. Thao - DWR UCIP)  
FIELD\_STRUCT\_DESC: [Shorebird Discharge Structure (Sump 160)] 1 of 5: 54-inch pipe through the levee, 2 feet below the crown. Siphon breaker in a 48-inch CMP riser on landside (LS) shoulder. Pump house located on LS end approximately 80 feet off toe. Concrete outfall structure with flap gate on waterside (WS) river bank slope approximately 160 feet off toe. (Pump station authorized under Permit No. 14911, 1992 - City of Sacramento). [Additional Reference(s): DWR Levee Log, 2002 (HLM 17.25)].  
FS Date: 7/6/2023

Levee crown looking downstream.

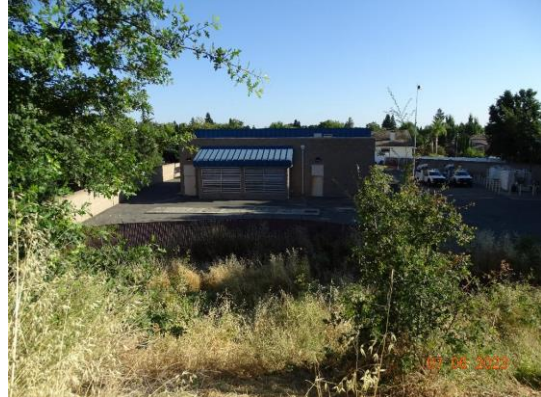
Photo 2 of 3 : UCIP\_FA\_2023\_81271\_116909.jpg

LS view: Pump hose located approximately 115 feet off toe.

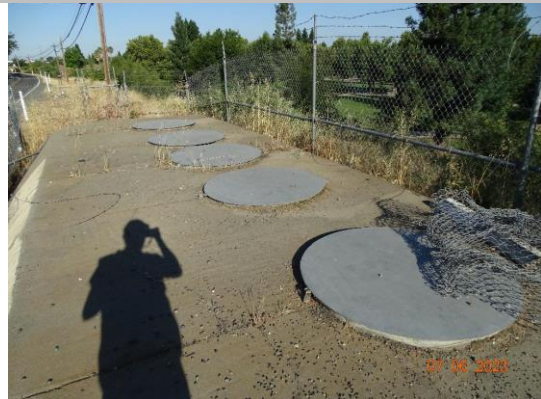
Photo 3 of 3 : UCIP\_FA\_2023\_81271\_116910.jpg

LS view: Siphon breakers in risers on shoulder.

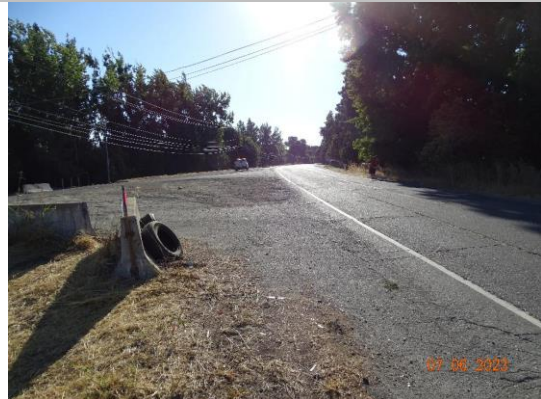
Photo 1 of 3 : UCIP\_FA\_2023\_80757\_116912.jpg

LM Start	16.97	Rating **	M	Issue No.	295	
LM End	16.97	Issue Type +	En	Location *		
Category	Supplemental			GPS Latitude/Longitude		
				Start	End	
Item	DWR UCIP Field Study			38.605212°	38.605212°	
				-121.534737°	-121.534737°	
DWR ID	25347					
Comment Code						
Inspector Comment						
DS_ID:25347 FS_ID:80757 EP_NO: N/A Repair Type: Non-Urgent EVAL Issue: Crossing Status: Not Found UCIP Comments: 07/06/2023 Record updated to Non-Urgent. Crossing not found. (M. Thao - DWR UCIP)  FIELD_STRUCT_DESC: TO INSTALL 1.14 MI OF ARRIVAL ?? TELEVISION CABLE AT THE LANDMARK TOES OF THE LT. BK. LEVEE OF THE SACTO. RIV. BETWEEN COL CONTRO. RD. & GATEWAY OAK D. IN SACTO. (Permit No. 14239, 1985 - Sacramento Cable Television, Inc.) FS Date: 7/6/2023

Levee crown looking downstream.

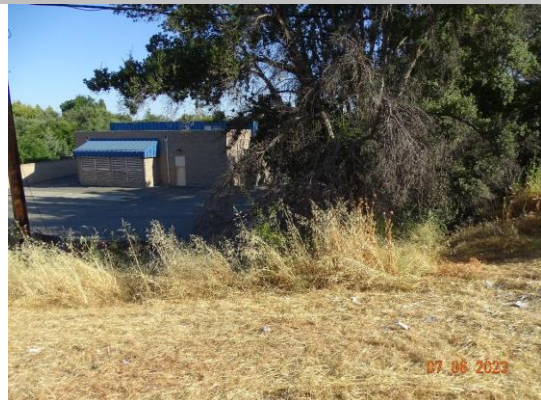
Photo 2 of 3 : UCIP\_FA\_2023\_80757\_116913.jpg

LS view: General overview looking from crown.

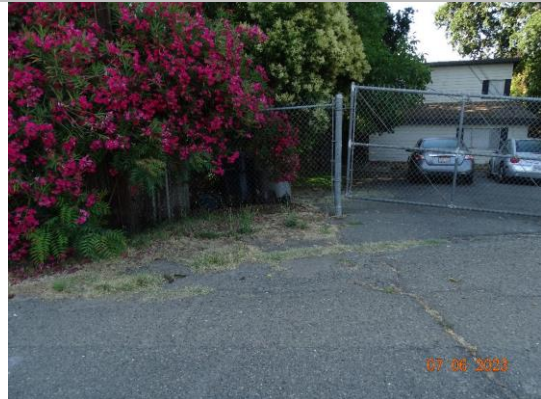
Photo 3 of 3 : UCIP\_FA\_2023\_80757\_116911.jpg

WS view: General overview looking from crown.

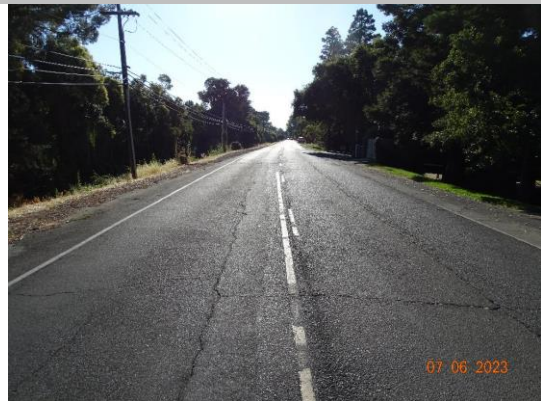
Photo 1 of 3 : UCIP\_FA\_2023\_81277\_117137.jpg

DS\_ID:25197  
 FS\_ID:81277  
 EP\_NO: 13672  
 Repair Type: Non-Urgent  
 EVAL Issue:  
 Crossing Status: Not Found  
 UCIP Comments: 07/06/2023 Record updated to Non-Urgent. Crossing not found. (M. Thao - DWR UCIP)  
 FIELD\_STRUCT\_DESC: 12-inch sewer pipe through levee, 4 feet below the crown. (12-inch pipe authorized under Permit No. 7610-E, 1981 - Michael Coyne). [Additional Reference(s): DWR Levee Log, 2002 (HLM 17.36)].  
 FS Date: 7/6/2023

Levee crown looking downstream.

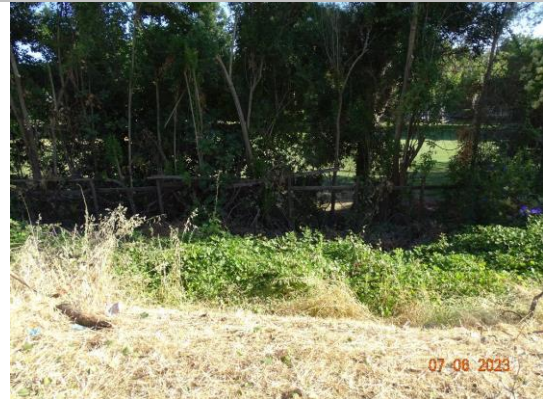
Photo 2 of 3 : UCIP\_FA\_2023\_81277\_117138.jpg

LS view: General overview looking from crown.

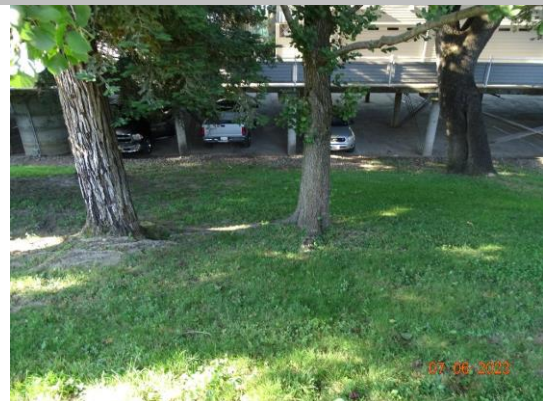
Photo 3 of 3 : UCIP\_FA\_2023\_81277\_117136.jpg

WS view: General overview looking from crown.

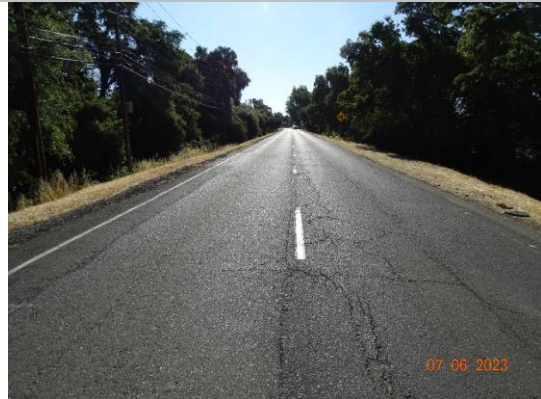
Photo 1 of 3 : UCIP\_FA\_2023\_81276\_117133.jpg

LM Start	17.15	Rating **	M	Issue No.	299
LM End	17.15	Issue Type +	En	Location *	
Category	Supplemental			GPS Latitude/Longitude	
				Start	End
Item	DWR UCIP Field Study			38.605531°	38.605531°
				-121.531524°	-121.531524°
DWR ID	25200				
Comment Code					
Inspector Comment					
DS_ID:25200 FS_ID:81276 EP_NO: 13672 Repair Type: Non-Urgent EVAL Issue: Crossing Status: Not Found UCIP Comments: 07/06/2023 Record updated to Non-Urgent. Crossing not found. (M. Thao - DWR UCIP) FIELD_STRUCT_DESC: 10-inch pipe and 4-inch pipe through the levee, 4 feet below the crown. Siphon breakers on landward side. (10-inch and 4-inch pipes authorized under Permit No. 7610-E, 1981 - Michael Coyne). [Additional Reference(s): DWR Levee Log, 2002 (HLM 17.44)]. FS Date: 7/6/2023

Crown looking downstream.

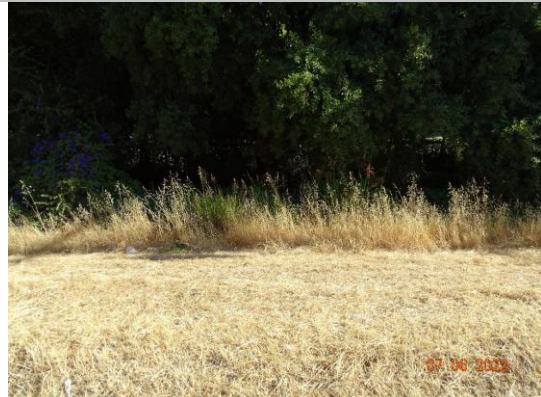
Photo 2 of 3 : UCIP\_FA\_2023\_81276\_117134.jpg

LS view: General overview looking from crown.

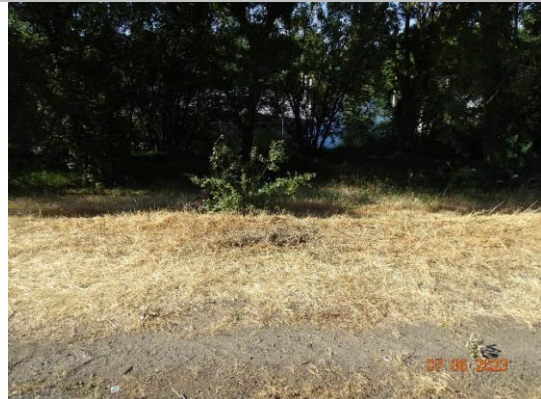
Photo 3 of 3 : UCIP\_FA\_2023\_81276\_117135.jpg

WS view: General overview looking from crown.

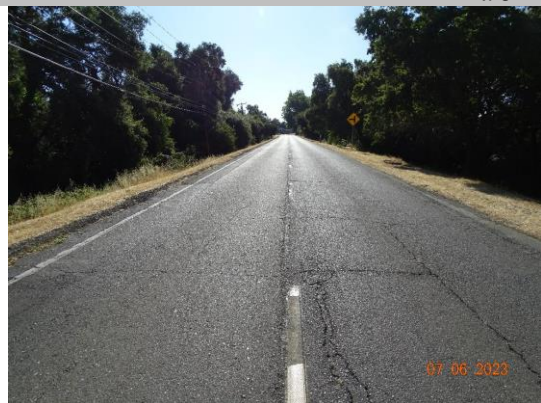
Photo 1 of 3 : UCIP\_FA\_2023\_81278\_117140.jpg

DS\_ID:25293  
 FS\_ID:81278  
 EP\_NO: N/A  
 Repair Type: Non-Urgent  
 EVAL Issue:  
 Crossing Status: Not Found  
 UCIP Comments: 07/06/2023 Record updated to Non-Urgent. Crossing not found. No inspector notes to confirm if crossing was ever installed. (M. Thao - DWR UCIP)  
 FIELD\_STRUCT\_DESC: Two 3-inch PVC (electrical and communication) conduits through the levee, 3 feet below the crown. (Two 3-inch conduits authorized under Permit No. 8174-A, 1973 - Sacramento Municipal Utility District).  
 FS Date: 7/6/2023

Levee crown looking downstream.

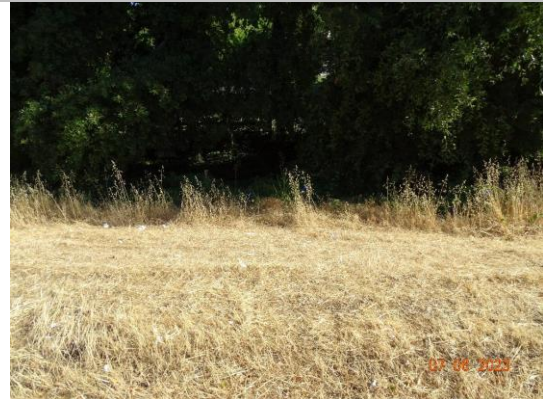
Photo 2 of 3 : UCIP\_FA\_2023\_81278\_117141.jpg

LS view: General overview looking from crown.

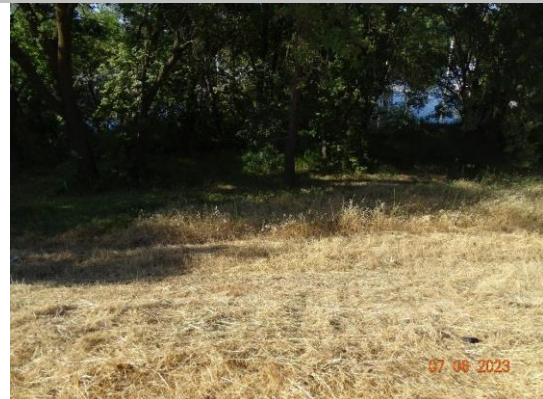
Photo 3 of 3 : UCIP\_FA\_2023\_81278\_117139.jpg

WS view: General overview looking from crown.

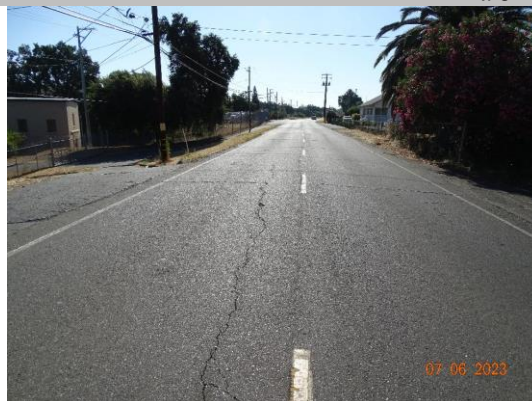
Photo 1 of 3 : UCIP\_FA\_2023\_80995\_117044.jpg

LM Start	17.46	Rating **	M	Issue No.	302
LM End	17.46	Issue Type +	En	Location *	
Category	Supplemental			GPS Latitude/Longitude	
				Start	End
Item	DWR UCIP Field Study			38.605506°	38.605506°
				-121.525743°	-121.525743°
DWR ID	25202				
Comment Code					
Inspector Comment					
DS_ID:25202 FS_ID:80995 EP_NO: N/A Repair Type: Non-Urgent EVAL Issue: Crossing Status: Not Found UCIP Comments: 07/06/2023 Record updated to Non-Urgent. Crossing not found. (M. Thao - DWR UCIP)  FIELD_STRUCT_DESC: 10-inch steel pipe of an unknown purpose through the levee, 7.4 feet below the crown. One cutoff wall. Pump on waterside (WS) end. [Additional Reference(s): USACE Sacramento O&M Manual, Unit No. 124, June 1953, Revised 25 February 2022, (River Mile 61.25), listed as 10-inch pipe. USACE As-Built Drawing No. 50-13-2810, November 1922, River Mile 61.25]. FS Date: 7/6/2023

Levee crown looking downstream.

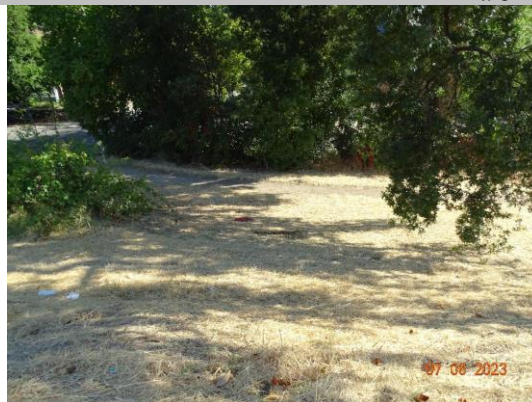
Photo 2 of 3 : UCIP\_FA\_2023\_80995\_117045.jpg

LS view: General overview looking from crown.

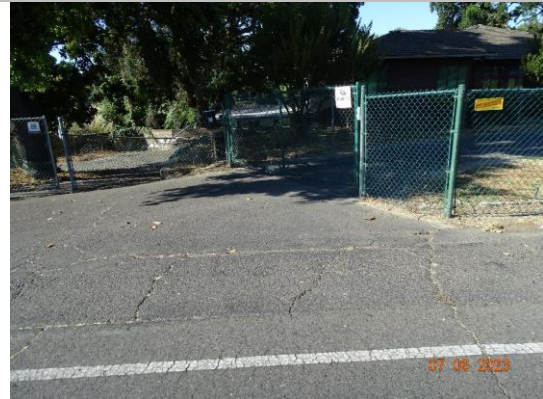
Photo 3 of 3 : UCIP\_FA\_2023\_80995\_117043.jpg

WS view: General overview looking from crown.

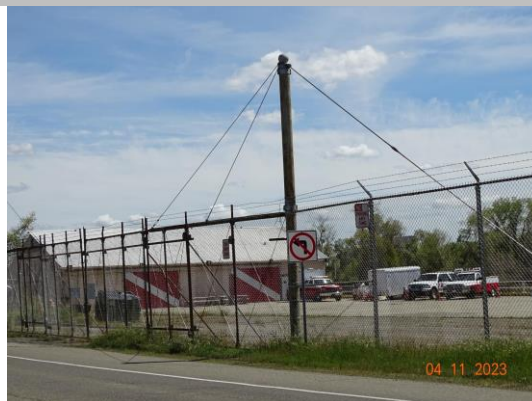
Photo 1 of 1 : FA\_2023\_RD1000\_31\_8\_20231016\_00008.jpg

LM Start	17.52	Rating **	U	Issue No.	8
LM End	17.61	Issue Type +	En	Location *	WS
Category	Earthen Levee			GPS Latitude/Longitude	
				Start	End
Item	Encroachments			38.605445°	38.605305°
				-121.524675°	-121.522958°
DWR ID	DWR_RD1000_01_s_2012_8				
Comment Code					
BU : Building					
Inspector Comment

This photo was taken from the crown facing downstream looking down the waterward levee slope at an unpermitted building (Spring 2023).

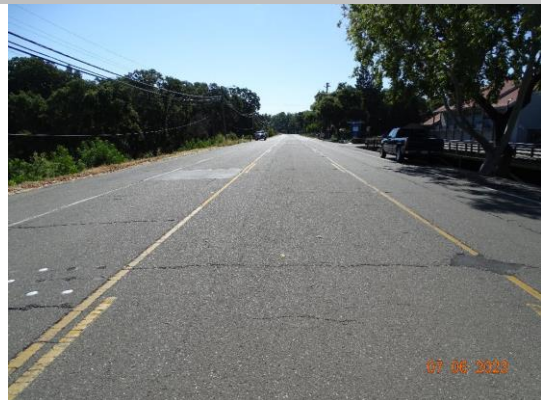
Photo 1 of 3 : UCIP\_FA\_2023\_81328\_117314.jpg

LM Start	17.98	Rating **	M	Issue No.	305	
LM End	17.98	Issue Type +	En	Location *		
Category	Supplemental			GPS Latitude/Longitude		
				Start	End	
Item	DWR UCIP Field Study			38.604370°	38.604370°	
				-121.517378°	-121.517378°	
DWR ID	25205					
Comment Code						
Inspector Comment						
DS_ID:25205						
FS_ID:81328						
EP_NO: N/A						
Repair Type: Non-Urgent						
EVAL Issue:						
Crossing Status: Not Found						
UCIP Comments: 07/06/2023 Record updated to Non-Urgent. Crossing not found. (M. Thao - DWR UCIP)						
FIELD_STRUCT_DESC: Pipe of an unknown size through the levee, at an unknow depth. [Additional Reference(s): DWR Levee Log, 2002 (HLM 18.23)].						
FS Date: 7/6/2023

Levee crown looking downstream.

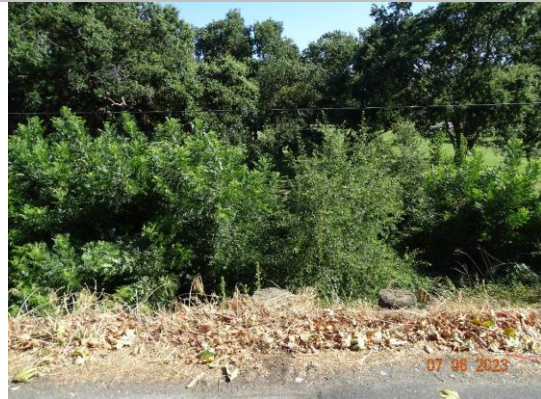
Photo 2 of 3 : UCIP\_FA\_2023\_81328\_117315.jpg

LS view: General overview looking from crown.

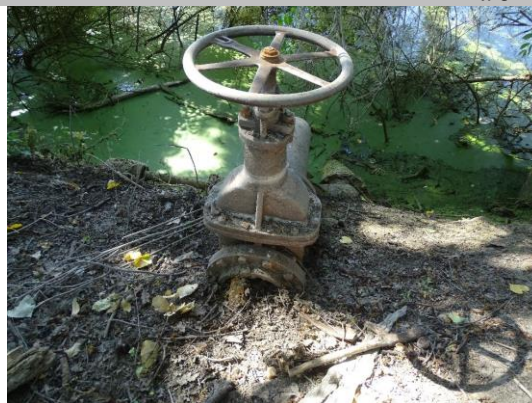
Photo 1 of 3 : UCIP\_FA\_2023\_80395\_116053.jpg

Comment Code						
Inspector Comment						
DS_ID:25233						
FS_ID:80395						
EP_NO: N/A						
Repair Type: Urgent						
EVAL Issue: 3b, Flood Risk						
Crossing Status: Found						
UCIP Comments: 6/5/2023 Record updated to Urgent. A section of pipe was observed missing just after the gate valve that can potentially allow uncontrolled flood water from waterside to landside. A 4-inch deep void was observed along the waterside slope. Crossing appears abandoned. Recommend owner to contact CVFPB to abandon pipe properly or remove pipe from levee. (M. Thao - DWR UCIP)						
FIELD_STRUCT_DESC: Abandoned 12-inch pipe through the levee, 8.8 feet below the crown. Plugged on the waterward end.						
FS Date: 6/5/2023

WS view: Gate valve with missing pipe section.

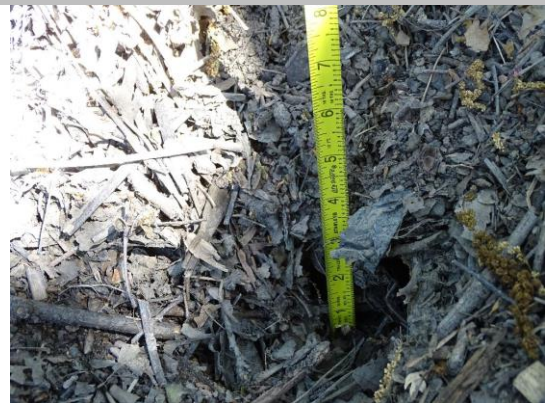
Photo 3 of 3 : UCIP\_FA\_2023\_80395\_116056.jpg

WS view: Close-up view of void along pipe alignment.

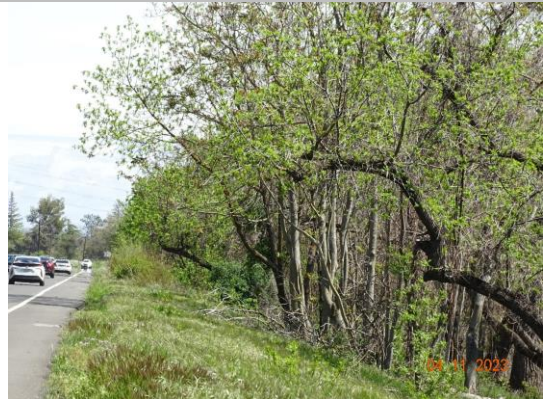
Photo 1 of 1 : FA\_2023\_RD1000\_32\_3\_20231016\_00002.jpg

LM Start	1.31	Rating **	M	Issue No.	3
LM End	1.63	Issue Type +	Ma	Location *	WS
Category	Earthen Levee			GPS Latitude/Longitude	
				Start	End
Item	Trim / Thin Trees			38.608310°	38.607566°
				-121.488096°	-121.482200°
DWR ID	DWR_RD1000_02_s_2021_3				
Comment Code					
T1 : Trim and thin trees to at least five feet above ground level to allow visibility of the ground and room to flood fight.					
Inspector Comment					
Remove starter trees and woody debris on the waterside slope.

View of starter trees and woody debris on the waterside slope (Spring 2023).

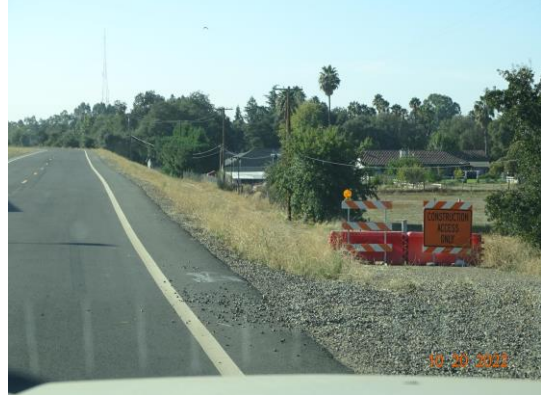
Photo 1 of 1 : FA\_2023\_RD1000\_33\_11\_20231016\_00005.jpg

LM Start	0.05	Rating **	A/W	Issue No.	11
LM End	4.20	Issue Type +	Ob	Location *	CR
Category	Earthen Levee			GPS Latitude/Longitude	
				Start	End
Item	Encroachments			38.606454°	38.665724°
				-121.469943°	-121.477500°
DWR ID	DWR_RD1000_03_f_2020_11				
Comment Code					
LC : Authorized Levee Construction					
Inspector Comment					
Reach H- USACE Project. Construction is nearing completion but has not been turned over to RD 1000.

View of the levee under construction, Reach H-USACE Project, Fall 2022.

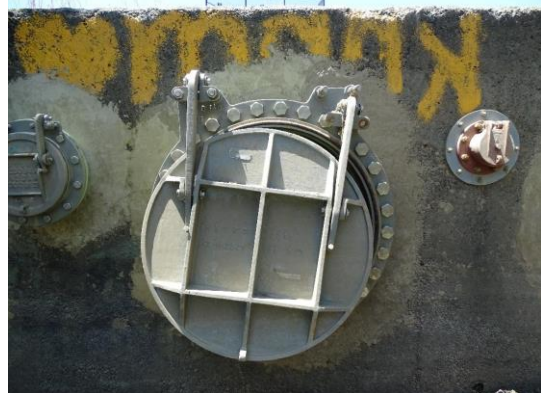
Photo 1 of 2 : UCIP\_FA\_2023\_80527\_116153.jpg

Comment Code						
Inspector Comment						
DS_ID:25417 FS_ID:80527 EP_NO: N/A Repair Type: Non-Urgent EVAL Issue: 4b, Safety Issue Crossing Status: Found UCIP Comments: 06/05/2023 Record updated to Non-Urgent. Flap gate is loose and hanging by one hinge; permittee needs to fix the flap gate. The loose flap gate also presents safety concerns. (M.Thao - DWR UCIP) FIELD_STRUCT_DESC: 3 of 4. [City of Sacramento Pumping Plant No. 2] 36-inch pipe through the levee, 4 feet below the crown. One CM cutoff wall on each pipe. Pump over pump sump on the landward side. Siphon breaker on the waterward shoulder. Concrete headwall, flap gates, and splash apron on the waterward slope. Waterward slope cobble revetted. Concrete steps on landward slope. (Permit No. 5725-1968 , City of Sacramento) FS Date: 6/5/2023

WS view: 36-inch pipe flap gate hanging loose and being held on by only one hinge.

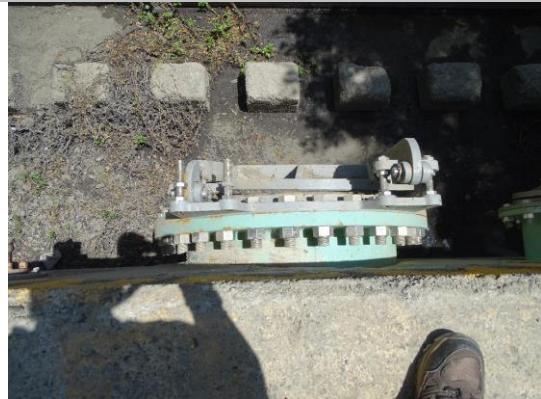
Photo 2 of 2 : UCIP\_FA\_2023\_80527\_116154.jpg

WS view: Looking down at the 36-inch pipe flap gate hanging loose and being held on by only one hinge.

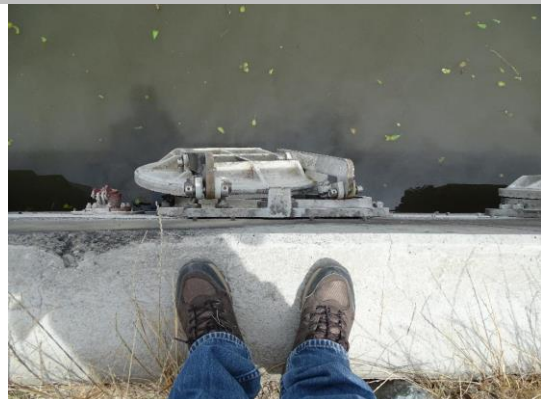
Photo 1 of 2 : UCIP\_FA\_2023\_80483\_116292.jpg

DS\_ID:25422  
 FS\_ID:80483  
 EP\_NO: 13256  
 Repair Type: Non-Urgent  
 EVAL Issue: 11, Maintenance Compliance Issue  
 Crossing Status: Found  
 UCIP Comments: 06/05/2023 Record updated to Non-Urgent. Flap gate is being held by one hinge and cannot be closed properly. Recommend permittee repair flap gate. (M. Thao - DWR UCIP)  
 FIELD\_STRUCT\_DESC: 5 of 9. [Reclamation District 1000 Pumping Plant No. 8] 36-inch-diameter storm drain discharge pipe through the west levee of Natomas East Main Drainage Canal at approximately 6.2 feet below crown. Pump station located on landward side. Siphon breaker located on waterward levee shoulder inside concrete valve box. Flap gate located on waterward side. Concrete discharge structure with apron located on waterward toe. (Permit No. 13256-1983, Morton & Pitato, Inc.)  
 FS Date: 6/5/2023

WS view: Loose flap gate being held by hinge.

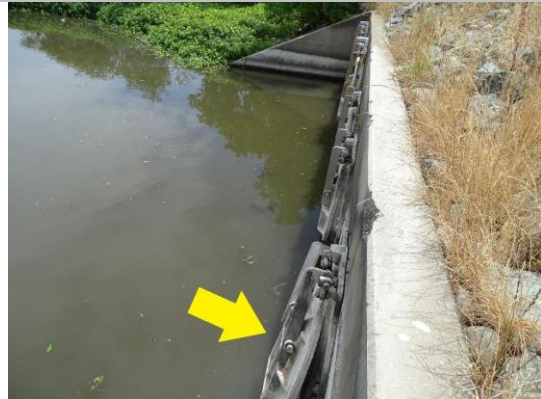
Photo 2 of 2 : UCIP\_FA\_2023\_80483\_116293.jpg

WS view: Concrete headwall and loose flap gate on toe; yellow arrow is pointing to crossing associated with this record.

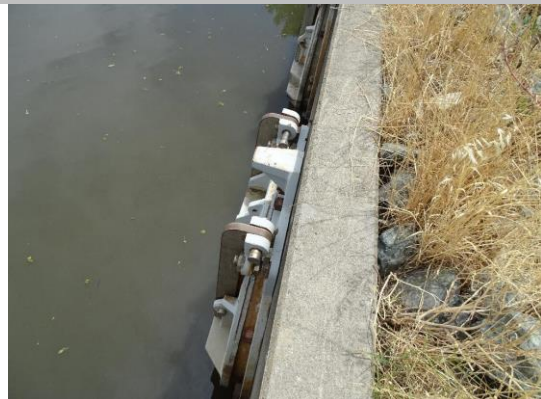
Photo 1 of 2 : UCIP\_FA\_2023\_80485\_116298.jpg

DS\_ID:25424  
 FS\_ID:80485  
 EP\_NO: 13256  
 Repair Type: Non-Urgent  
 EVAL Issue: 11, Maintenance Compliance Issue  
 Crossing Status: Found  
 UCIP Comments: 06/05/2023 Record updated to Non-Urgent. Flap gate hinge pin is loose; recommend permittee tighten hinge pin. (M. Thao - DWR UCIP)  
 FIELD\_STRUCT\_DESC: 7 of 9. [Reclamation District 1000 Pumping Plant No. 8] 54-inch-diameter storm drain discharge pipe through the west levee of Natomas East Main Drainage Canal at approximately 6.2 feet below crown. Pump station located on landward side. Siphon breaker located on waterward levee shoulder inside concrete valve box. Flap gate located on waterward side. Concrete discharge structure with apron located on waterward toe. (Permit No. 13256-1983, Morton & Pitalo, Inc.)  
 FS Date: 6/5/2023

WS view: Flap gate with loose hinge pin.

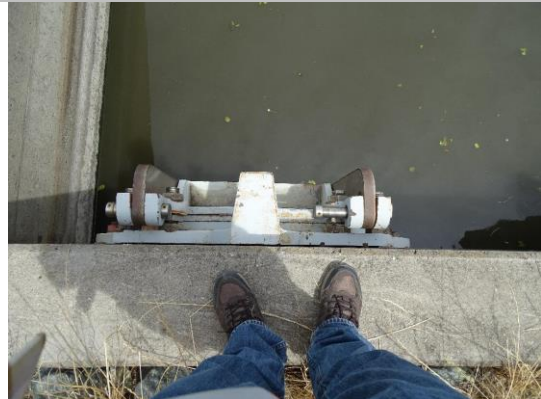
Photo 2 of 2 : UCIP\_FA\_2023\_80485\_116302.jpg

WS view: Flap gate with loose hinge pin (different angle).

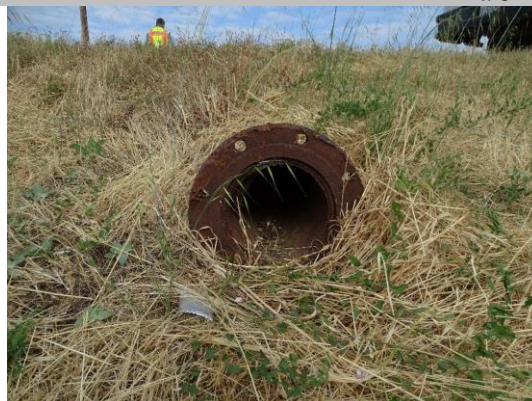
Photo 2 of 2 : UCIP\_FA\_2023\_80532\_116190.jpg

DS\_ID:25251  
 FS\_ID:80532  
 EP\_NO: N/A  
 Repair Type: Urgent  
 EVAL Issue: 3a, Flood Risk  
 Crossing Status: Found  
 UCIP Comments: 06/08/2023 Record updated to Urgent. Pipe is opened on both the landside and waterside. (M.Thao - DWR UCIP)  
 FIELD\_STRUCT\_DESC: Abandoned 7-inch pipe through the levee, 1.8 feet below the crown. Concrete sump on the waterward side. Plate welded on waterward end.  
 FS Date: 6/8/2023

WS view: Pipe daylights on slope and is opened.

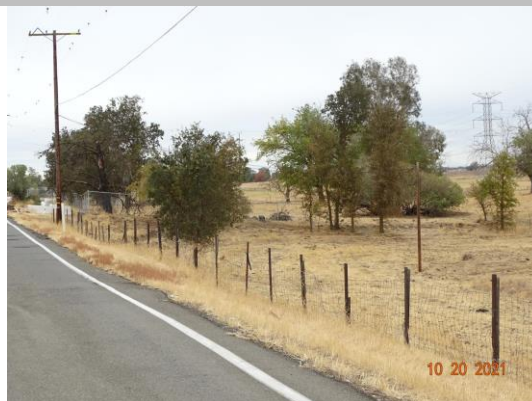
Photo 1 of 1 : FA\_2023\_RD1000\_33\_8\_20231016\_00002.jpg

LM Start	6.27	Rating **	M	Issue No.	8
LM End	6.36	Issue Type +	En	Location *	LS
Category	Earthen Levee			GPS Latitude/Longitude	
				Start	End
Item	Encroachments			38.692847°	38.694141°
				-121.485595°	-121.485596°
DWR ID	DWR_RD1000_03_f_2015_8				
Comment Code					
FE : Fence					
Inspector Comment					
A fence is located on the landside levee slope.

View of fence on landside levee slope, looking downstream, Fall 2021.

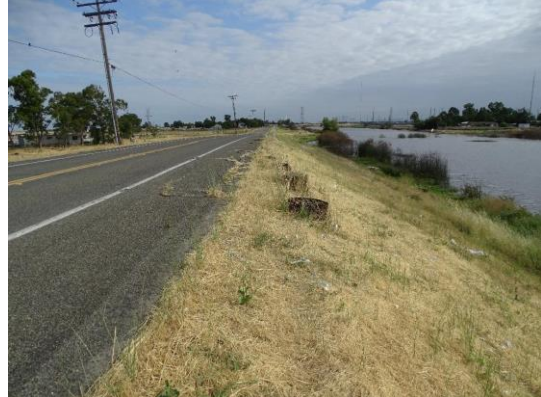
Photo 2 of 3 : UCIP\_FA\_2023\_80533\_116193.jpg

LM Start	6.57	Rating **	M	Issue No.	27
LM End	6.57	Issue Type +	En	Location *	
Category	Supplemental			GPS Latitude/Longitude	
				Start	End
Item	DWR UCIP Field Study			38.697213°	38.697213°
				-121.485585°	-121.485585°
DWR ID	25240				
Comment Code					
Inspector Comment					
DS_ID:25240 FS_ID:80533 EP_NO: N/A Repair Type: Non-Urgent EVAL Issue: 4b, Safety Issue Crossing Status: Found UCIP Comments: 06/08/2023 Record updated to Non-Urgent. Missing lid located on waterside shoulder creates fall potential. Water on waterside limits inspection of flap gate at this crossing. (M.Thao - DWR UCIP) FIELD_STRUCT_DESC: R.D. 1000 Drainage Pumping Plant on the landward side. Four discharge lines. Four siphon breakers on the waterward shoulder. (Permit No. 7548- , ) FS Date: 6/8/2023

WS view: 24-inch steel risers on waterside shoulder.

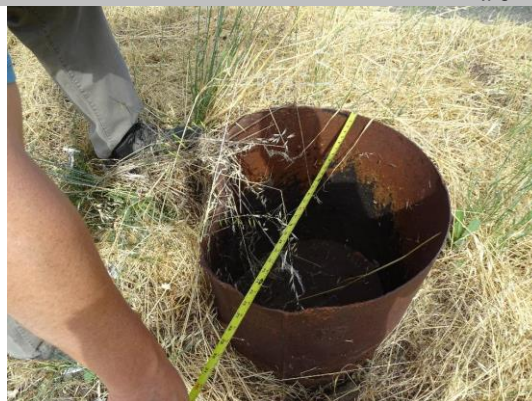
Photo 3 of 3 : UCIP\_FA\_2023\_80533\_116194.jpg

WS view: Close-up view of the 24-inch steel riser on waterside shoulder.

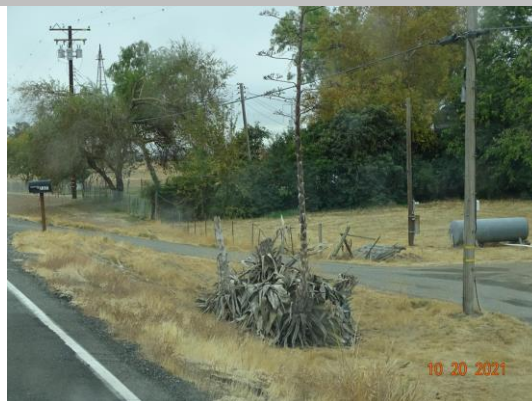
Photo 1 of 1 : FA\_2023\_RD1000\_33\_2\_20231016\_00001.jpg

LM Start	6.96	Rating **	M	Issue No.	2
LM End	6.96	Issue Type +	En	Location *	LS
Category	Earthen Levee			GPS Latitude/Longitude	
				Start	End
Item	Vegetation			38.702801°	38.702801°
				-121.485652°	-121.485652°
DWR ID	DWR_RD1000_03_f_2015_2				
Comment Code					
V6 : Landscaping					
Inspector Comment					
Landscaping on the landside slope needs to be removed.

View of the landscaping at the landside levee toe, Fall 2021.

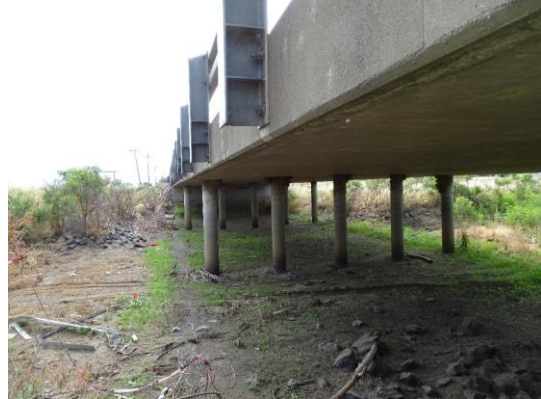
Photo 1 of 1 : UCIP\_FA\_2023\_80454\_116226.jpg

Comment Code					
Inspector Comment					
DS_ID:25387					
FS_ID:80454					
EP_NO: N/A					
Repair Type: Non-Urgent					
EVAL Issue: 10, Unauthorized Modification or Non-Compliant Permit					
Crossing Status: Indicator Found					
UCIP Comments: 06/08/2023 Record updated to Non-Urgent. Cable appears to be buried under canal rather than attached to the bridge as stated in Permit No. 12125. Unable to find a permit for modification. (M.Thao - DWR UCIP)					
FIELD_STRUCT_DESC: To bury a telephone distribution cable across the levee section of the East Levee Road at the intersection of Riego Road just West of existing joint pole and 10.8 metres (35 feet) East of levee, and attach the cable to the bridge crossing the Natomas East Main Drainage Canal (permit 12125)					
FS Date: 6/8/2023

WS view: Indicators across canal and not attached to bridge as stated in Permit No. 12125.

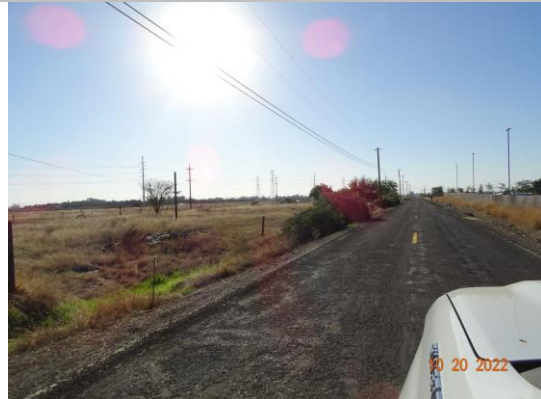
Photo 1 of 1 : FA\_2023\_RD1000\_33\_10\_20231016\_00004.jpg

LM Start	12.41	Rating **	M	Issue No.	10
LM End	12.46	Issue Type +	En	Location *	WS
Category	Earthen Levee			GPS Latitude/Longitude	
				Start	End
Item	Vegetation			38.779037°	38.779505°
				-121.500397°	-121.500955°
DWR ID	DWR_RD1000_03_s_2012_10				
Comment Code					
V6 : Landscaping					
Inspector Comment					
This is high ground and the channel flows away, both directions.

View of landscaping on the waterside levee slope, Fall 2022

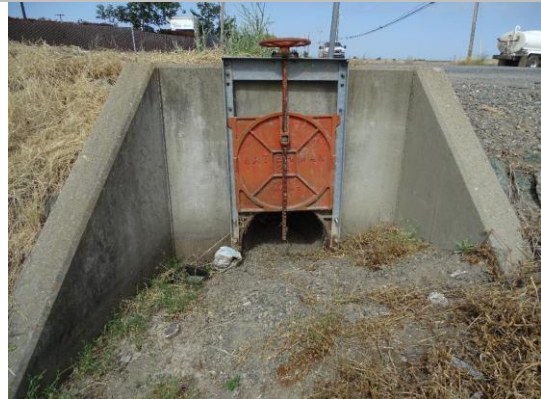
Photo 2 of 2 : UCIP\_FA\_2023\_80535\_116236.jpg

LM Start	12.50	Rating **	U	Issue No.	30
LM End	12.50	Issue Type +	En	Location *	
Category	Supplemental			GPS Latitude/Longitude	
				Start	End
Item	DWR UCIP Field Study			38.780134°	38.780134°
				-121.501154°	-121.501154°
DWR ID	25254				
Comment Code					
Inspector Comment					
DS_ID:25254 FS_ID:80535 EP_NO: N/A Repair Type: Urgent EVAL Issue: 3a, Flood Risk Crossing Status: Found UCIP Comments: 06/08/2023 Record updated to Urgent. Pipe is filled approximately half full preventing the slide gate from closing properly. Recommend removal of sediment. (M.Thao - DWR UCIP) FIELD_STRUCT_DESC: 24-inch pipe through the levee, 2.0 feet below the crown. Slide gate on the waterward end. Concrete headwalls on both sides. FS Date: 6/8/2023

WS view: Concrete headwall and slide gate at toe. Pipe is half filled with sediment.

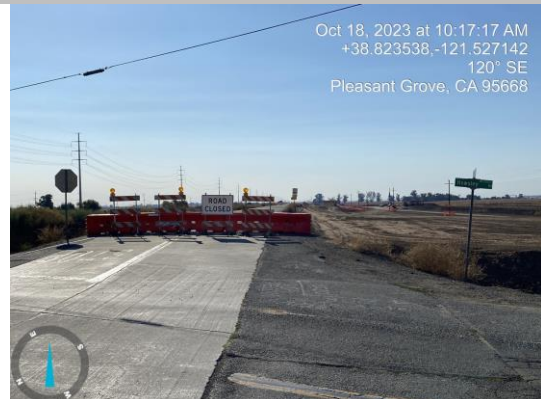
Photo 1 of 1 : FA\_2023\_RD1000\_33\_15\_20231025\_00023.jpg

LM Start	12.51	Rating **	A/W	Issue No.	15
LM End	15.81	Issue Type +	En	Location *	CR
Category	Earthen Levee			GPS Latitude/Longitude	
				Start	End
Item	Encroachments			38.780258°	38.823545°
				-121.501157°	-121.527092°
DWR ID	DWR_RD1000_03_f_2023_15				
Comment Code					
LC : Authorized Levee Construction					
Inspector Comment

View of levee construction (Fall 2023).

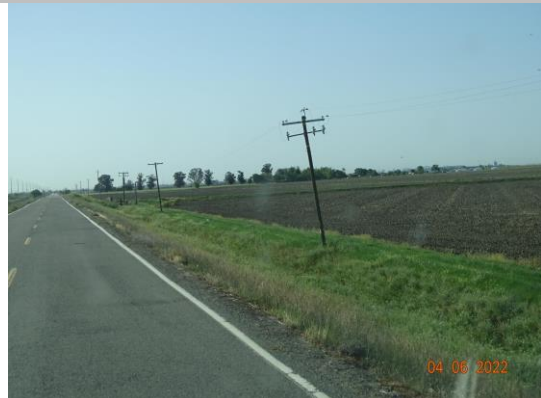
Photo 1 of 1 : FA\_2023\_RD1000\_33\_22\_20231016\_00006.jpg

LM Start	14.01	Rating **	A/W	Issue No.	22
LM End	14.70	Issue Type +	En	Location *	LS
Category	Earthen Levee			GPS Latitude/Longitude	
				Start	End
Item	Encroachments			38.799892°	38.808969°
				-121.513194°	-121.518536°
DWR ID	DWR_RD1000_03_f_2016_22				
Comment Code					
DT : Ditch					
Inspector Comment					
Issue has been changed to A/W due to levee construction, Fall 2023.

View of landside ditch at toe of levee, looking downstream, Spring 2022.

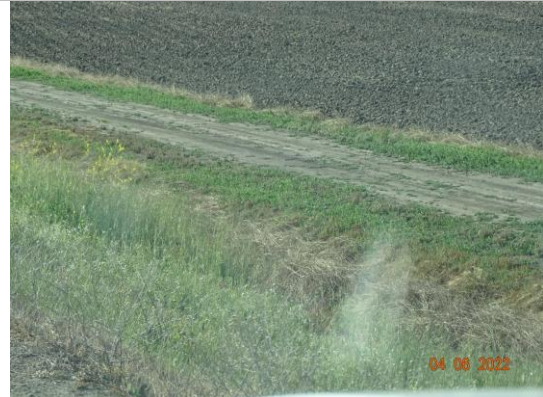
Photo 1 of 1 : FA\_2023\_RD1000\_33\_9\_20231016\_00003.jpg

LM Start	15.25	Rating **	A/W	Issue No.	9
LM End	15.79	Issue Type +	En	Location *	LS
Category	Earthen Levee			GPS Latitude/Longitude	
				Start	End
Item	Encroachments			38.816259°	38.823314°
				-121.522787°	-121.526942°
DWR ID	DWR_RD1000_03_s_2012_9				
Comment Code					
DT : Ditch					
Inspector Comment					
Issue has been changed to A/W due to levee construction, Fall 2023.

View looking downstream landside at a ditch at the toe, Spring 2022.

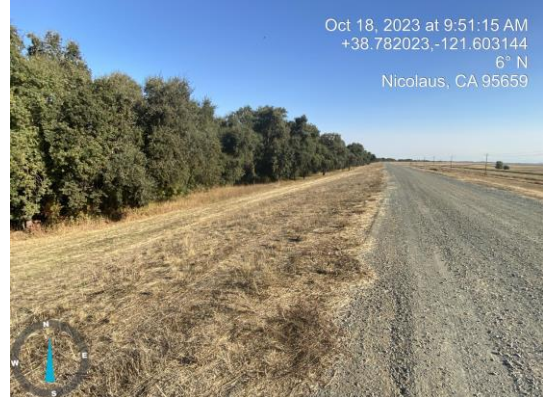
Photo 1 of 1 : FA\_2023\_RD1000\_34\_1\_20231025\_00001.jpg

LM Start	4.20	Rating **	A	Issue No.	1
LM End	4.20	Issue Type +	Ma	Location *	WS
Category	Earthen Levee			GPS Latitude/Longitude	
				Start	End
Item	Vegetation			38.781952°	38.781952°
				-121.603193°	-121.603193°
DWR ID	DWR_RD1000_04_f _ 2023_1				
Comment Code					
V1 : Control annual grass and weeds on the levee slopes and easements.					
Inspector Comment

View of acceptable vegetation on the waterside slope (Fall 2023).
