Flood Control Project Maintenance Levee Inspections

Fall 2024 Levee Maintenance Deficiency Summary Report

Sacramento River Basin

Reclamation District No. 1000 Natomas

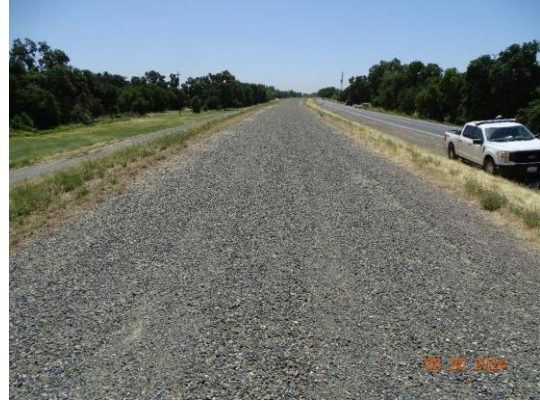
Photo 1 of 3 : UCIP_FA_2024_83986_123684.jpg

Levee crown looking downstream.

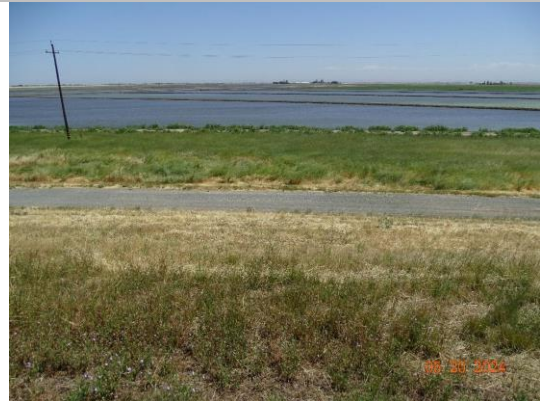
Photo 2 of 3 : UCIP_FA_2024_83986_123685.jpg

LS view: General overview looking from crown.

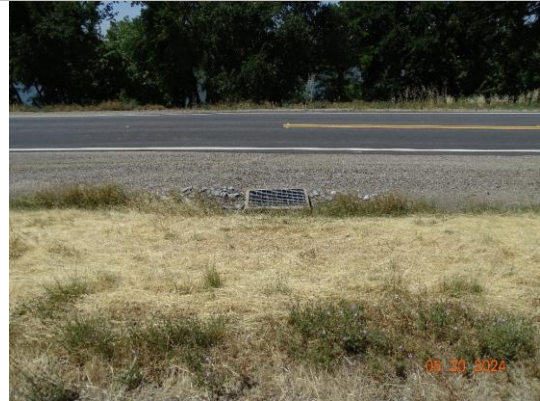
Photo 3 of 3 : UCIP_FA_2024_83986_123686.jpg

WS view: Drainage inlet located in the swale between the setback levee and Garden Highway; looking from crown.

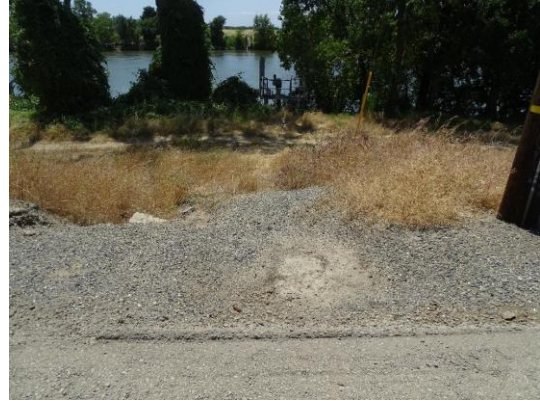
Photo 2 of 3 : UCIP_FA_2024_81707_118469.jpg

DS_ID:25820
FS_ID:81707
EP_NO: 4722
Repair Type: Non-Urgent
EVAL Issue: 4b, Safety Issue
Crossing Status: Found
UCIP Comments: 06/08/2023 Record updated to Non-Urgent. A minor (less than 1/2-foot) surface erosion located waterward of Garden Highway. Lid was not closed on landside riser creating a safety hazard. (M. Thao - DWR UCIP)
FIELD_STRUCT_DESC: [Cummings River Pump Crossing] 10-inch steel irrigation pipe through the levee, 2.0 feet below the crown. Slant pump on a steel pile structure on the river bank. Wooden power pole with 3-inch electrical conduit located on the waterside (WS) shoulder of the Garden Highway. (10-inch pipe authorized under Permit No. 4722, 1966 - E.L. Kearns).
FS Date: 6/8/2023

WS view: Minor (less than 1/2 foot) surface erosion on waterward shoulder of the Garden Highway.

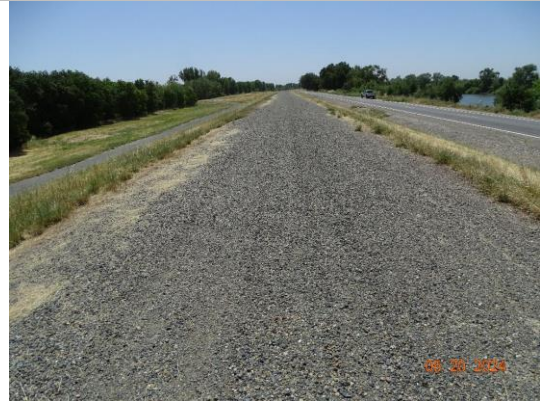
Photo 1 of 3 : UCIP_FA_2024_83985_123680.jpg

Levee crown looking downstream.

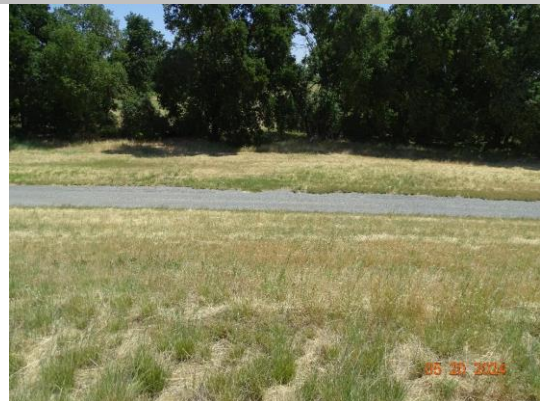
Photo 2 of 3 : UCIP_FA_2024_83985_123681.jpg

LS view: General overview looking from crown.

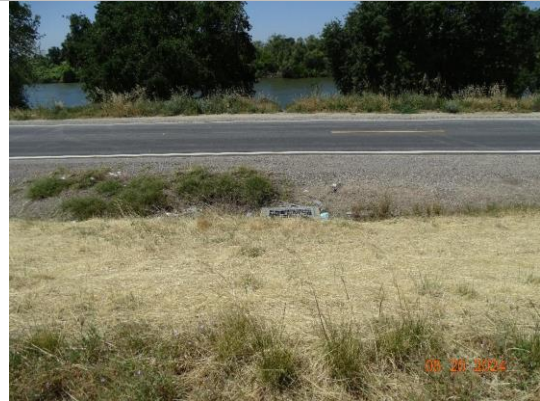
Photo 3 of 3 : UCIP_FA_2024_83985_123682.jpg

WS view: Drainage inlet located in the swale between the setback levee and Garden Highway; looking from crown.

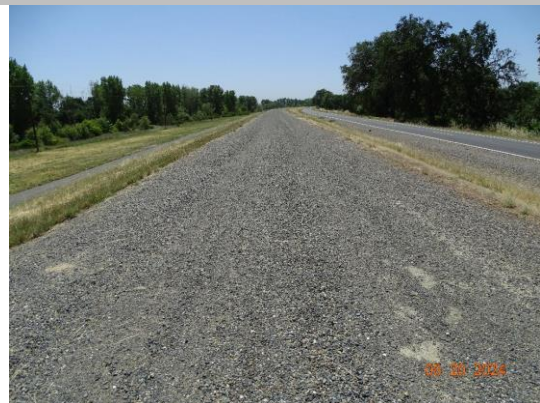
Photo 1 of 3 : UCIP_FA_2024_83984_123676.jpg

Levee crown looking downstream.

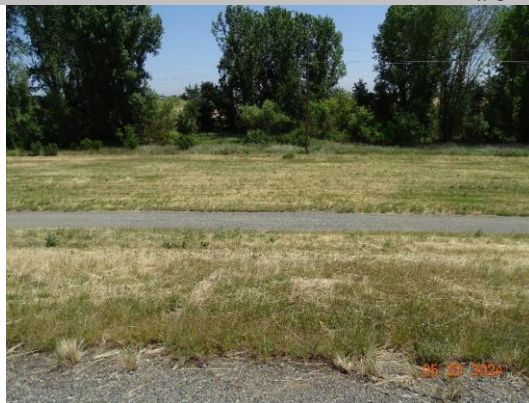
Photo 2 of 3 : UCIP_FA_2024_83984_123677.jpg

LS view: General overview looking from crown.

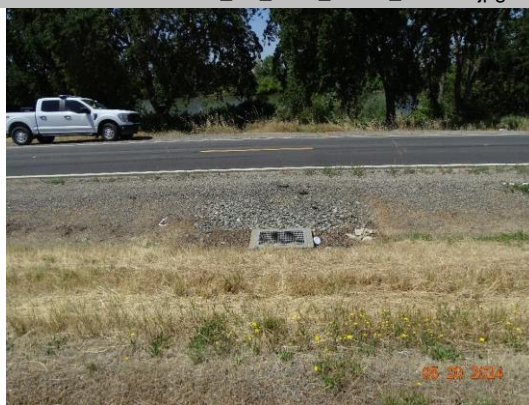
Photo 3 of 3 : UCIP_FA_2024_83984_123678.jpg

WS view: Drainage inlet located in the swale between the setback levee and Garden Highway; looking from crown.

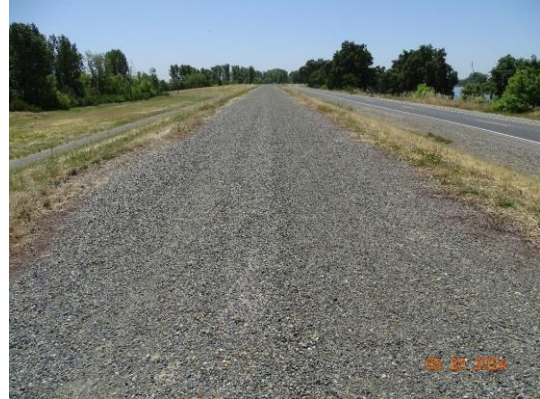
Photo 1 of 3 : UCIP_FA_2024_83983_123672.jpg

Levee crown looking downstream.

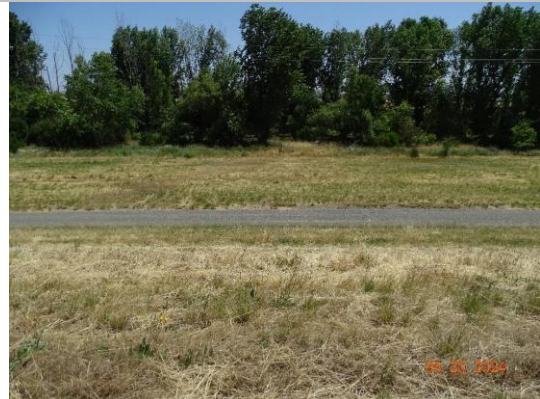
Photo 2 of 3 : UCIP_FA_2024_83983_123673.jpg

LS view: General overview looking from crown.

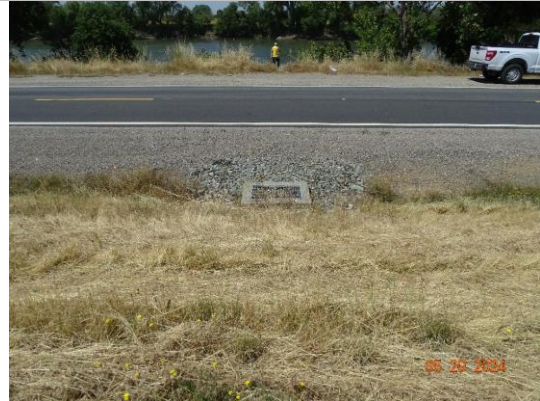
Photo 3 of 3 : UCIP_FA_2024_83983_123674.jpg

WS view: Drainage inlet located in the swale between the setback levee and Garden Highway; looking from crown.

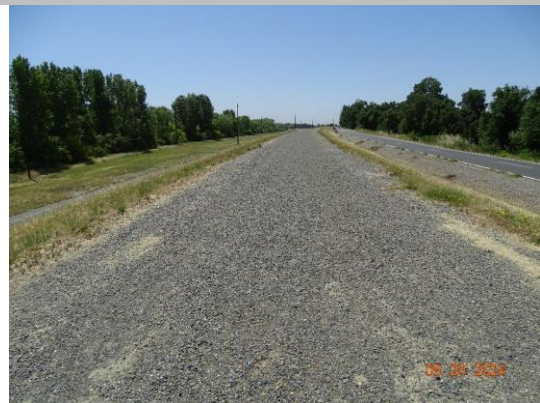
Photo 1 of 3 : UCIP_FA_2024_83982_123668.jpg

Levee crown looking downstream.

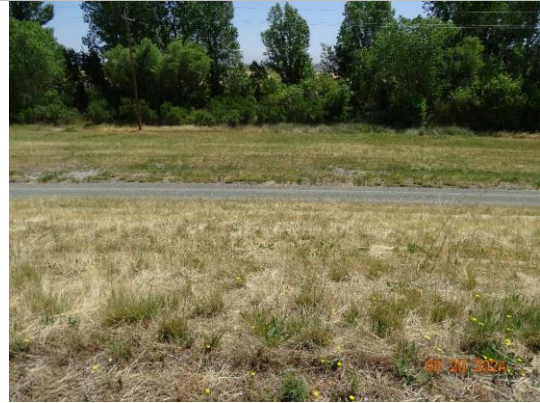
Photo 2 of 3 : UCIP_FA_2024_83982_123669.jpg

LS view: General overview looking from crown.

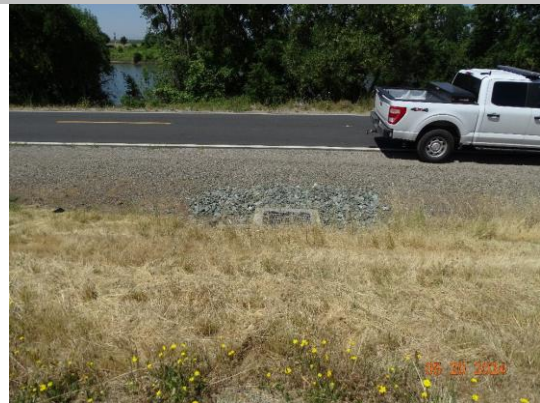
Photo 3 of 3 : UCIP_FA_2024_83982_123670.jpg

WS view: Drainage inlet located in the swale between the setback levee and Garden Highway; looking from crown.

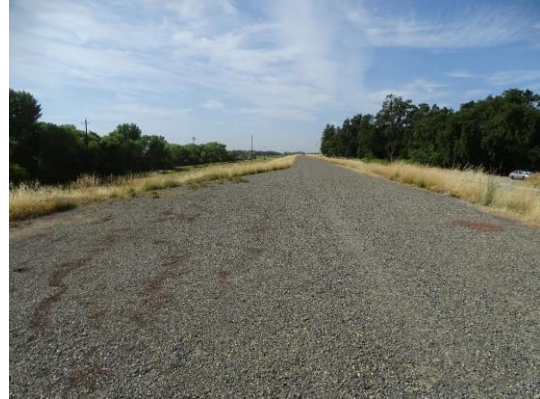
Photo 1 of 3 : UCIP_FA_2024_81709_118479.jpg

Levee crown looking downstream.

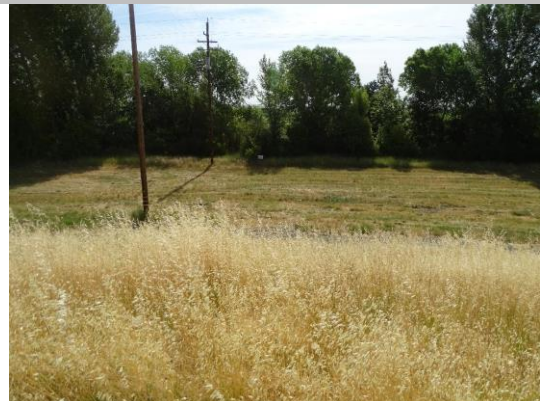
Photo 2 of 3 : UCIP_FA_2024_81709_118478.jpg

LS view: General overview looking from crown.

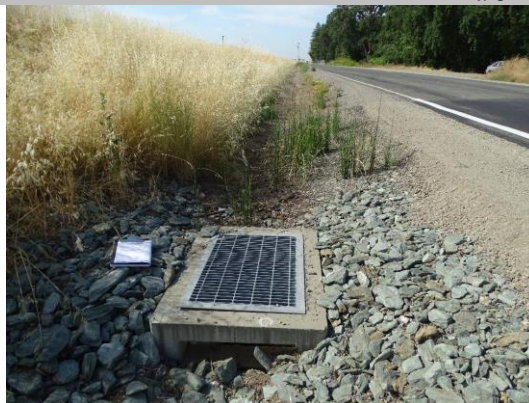
Photo 3 of 3 : UCIP_FA_2024_81709_118477.jpg

WS view: Pipe inlet located in the swale between the setback levee and Garden Highway; looking in the downstream direction.

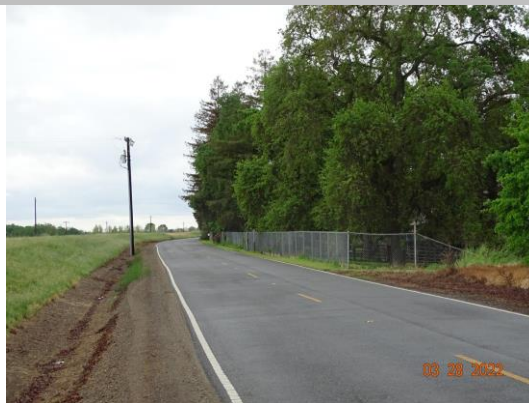
Photo 1 of 1 : FA_2024_RD1000_31_136_20240911_00064.jpg

LM Start	1.63	Rating **	M	Issue No.	136
LM End	1.69	Issue Type +	En	Location *	WS
Category	Earthen Levee			GPS Latitude/Longitude	
				Start	End
Item	Encroachments			38.759320°	38.758415°
				-121.591343°	-121.591348°
DWR ID	DWR_RD1000_01_s_2012_136				
Comment Code					
FE : Fence					
Inspector Comment					
A fence on the waterside slope prevents access.

View of the fence encroachment (Spring 2022).

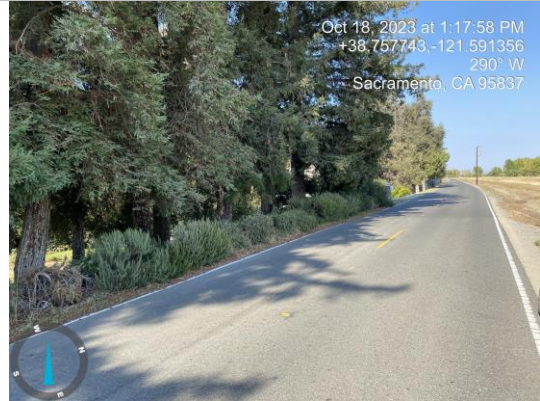
Photo 1 of 1 : FA_2024_RD1000_31_135_20240911_00063.jpg

LM Start	1.72	Rating **	M	Issue No.	135
LM End	1.75	Issue Type +	En	Location *	WS
Category	Earthen Levee			GPS Latitude/Longitude	
				Start	End
Item	Vegetation			38.757962 °	38.757480 °
				-121.591342 °	-121.591147 °
DWR ID	DWR_RD1000_01_s_2012_135				
Comment Code					
V6 : Landscaping					
Inspector Comment					
The landscape vegetation limits the ability to see the waterside slope and will make it difficult to access for flood fight.

View taken from the crown facing upstream looking at the waterward levee slope at the landscaping (Fall 2023).

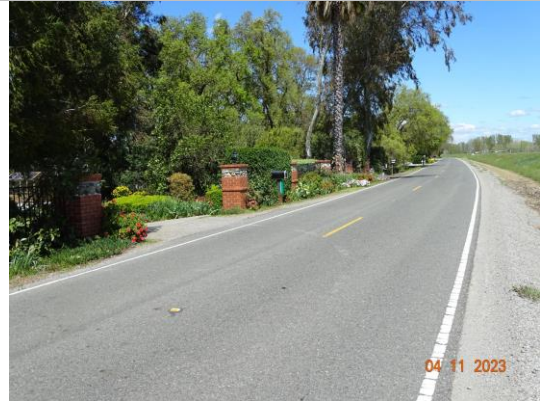
Photo 1 of 1 : FA_2024_RD1000_31_132_20240911_00062.jpg

LM Start	1.93	Rating **	U	Issue No.	132
LM End	1.96	Issue Type +	En	Location *	WS
Category	Earthen Levee			GPS Latitude/Longitude	
				Start	End
Item	Vegetation			38.754971 °	38.754562 °
				-121.591754 °	-121.591795 °
DWR ID	DWR_RD1000_01_s_2012_132				
Comment Code					
V6 : Landscaping					
Inspector Comment					
The landscape vegetation prevents the ability to see waterside slope and will make it difficult to access for flood fight.

View taken from the crown facing upstream looking at the waterward levee slope at the landscaping (Spring 2023).

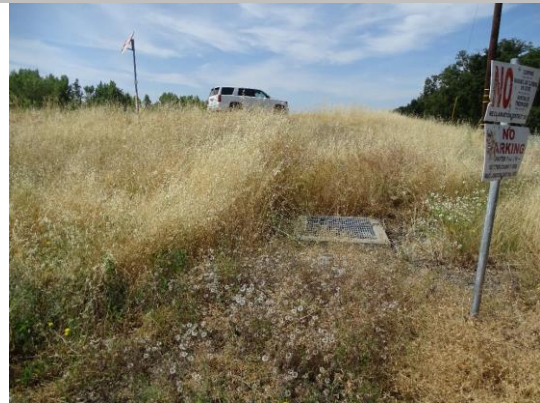
Photo 1 of 3 : UCIP_FA_2024_82119_118892.jpg

WS view: Drainage inlet located between the Garden Highway and setback levee.

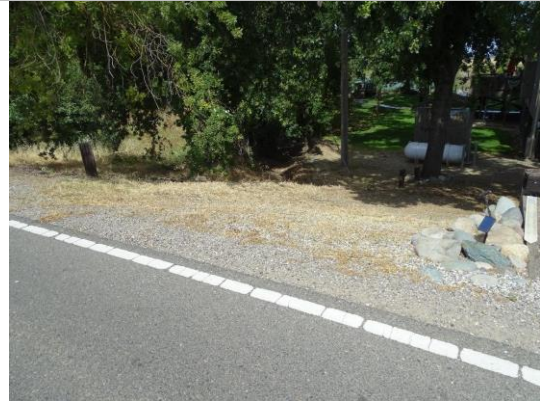
Photo 2 of 3 : UCIP_FA_2024_82119_118893.jpg

WS view: Looking from Garden Highway toward pipe outlet.

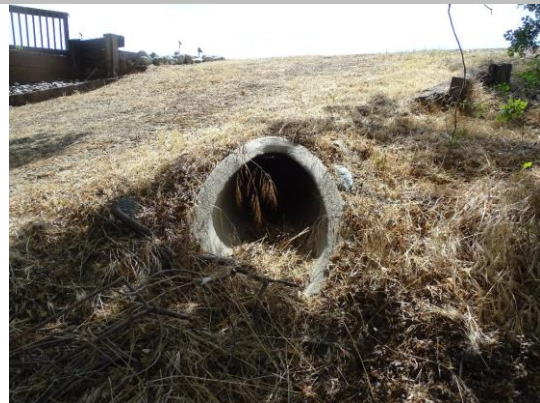
Photo 3 of 3 : UCIP_FA_2024_82119_118894.jpg

WS view: Pipe outlet located on slope; looking toward levee.

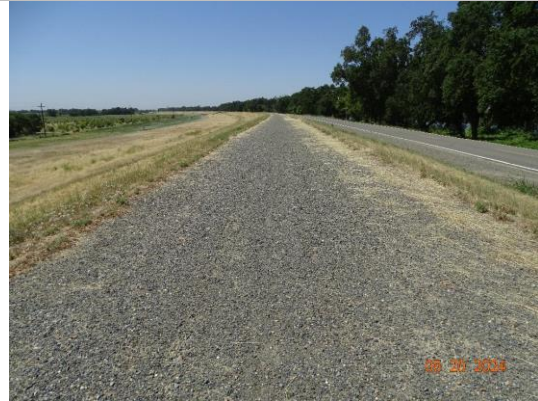
Photo 1 of 3 : UCIP_FA_2024_83972_123629.jpg

DS_ID:25856
FS_ID:83972
EP_NO: N/A
Repair Type: No Action Needed
EVAL Issue:
Crossing Status: Found
UCIP Comments: 05/20/2024 Record updated to No Action Needed. No issues observed during inspection. (M. Thao - DWR UCIP)
FIELD_STRUCT_DESC: *NOT THROUGH LEVEE* 24-inch reinforced concrete gravity drainage pipe, 4 feet below the Garden Highway (old levee crown). Drainage inlet located in the drainage swale between the setback levee and Garden Highway. Pipe outlet is located at the waterside (WS) slope with rip rap. (24-inch pipe authorized under the Natomas Levee Improvement Project under Permit No. 18159-3, 2009 - Sacramento Area Flood Control Agency). [Additional Reference(s): SAFCA As-Built Drawing No. 6-04-2269, 19 August 2013, Sheet 89 (C-404), Station 148+15, listed as Drain 9].
FS Date: 5/20/2024 11:11:12 AM

Levee crown looking downstream.

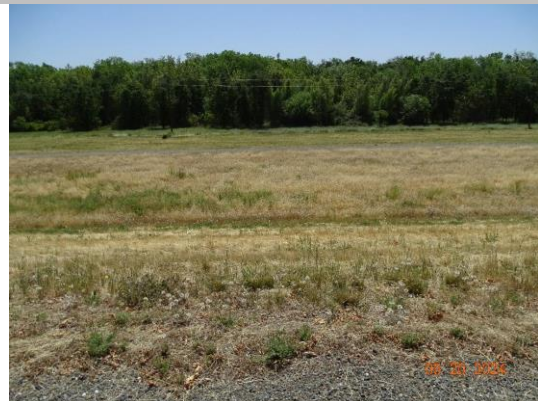
Photo 2 of 3 : UCIP_FA_2024_83972_123630.jpg

LS view: General overview looking from crown.

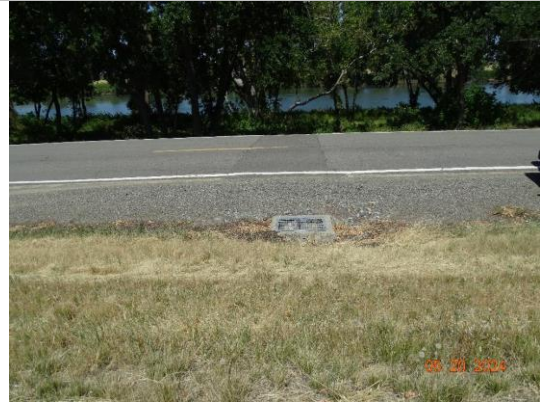
Photo 3 of 3 : UCIP_FA_2024_83972_123631.jpg

WS view: Drainage inlet located in the swale between the setback levee and Garden Highway; looking from crown.

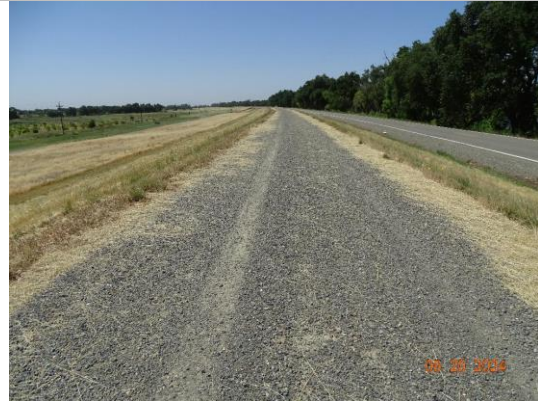
Photo 1 of 3 : UCIP_FA_2024_83971_123625.jpg

DS_ID:25857
FS_ID:83971
EP_NO: 18159-3
Repair Type: No Action Needed
EVAL Issue:
Crossing Status: Found
UCIP Comments: 05/20/2024 Record updated to No Action Needed. No issues observed during inspection. (M. Thao - DWR UCIP)
FIELD_STRUCT_DESC: *NOT THROUGH LEVEE* 24-inch reinforced concrete gravity drainage pipe, 4 feet below the Garden Highway (old levee crown). Drainage inlet is located in the drainage swale between the setback levee and Garden Highway. Pipe outlet is located at the waterside (WS) slope with rip rap. (24-inch pipe authorized under the Natomas Levee Improvement Project under Permit No. 18159-3, 2009 - Sacramento Area Flood Control Agency). [Additional Reference(s): SAFCA As-Built Drawing No. 6-04-2269, 19 August 2013, Sheet 89 (C-404), Station 157+76.61, listed as Drain 10].
FS Date: 5/20/2024 11:07:47 AM

Levee crown looking downstream.

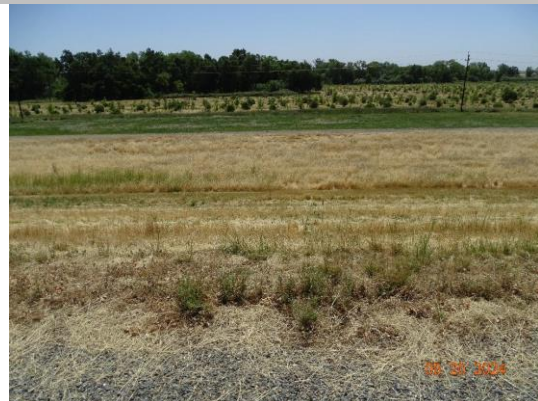
Photo 2 of 3 : UCIP_FA_2024_83971_123626.jpg

LS view: General overview looking from crown.

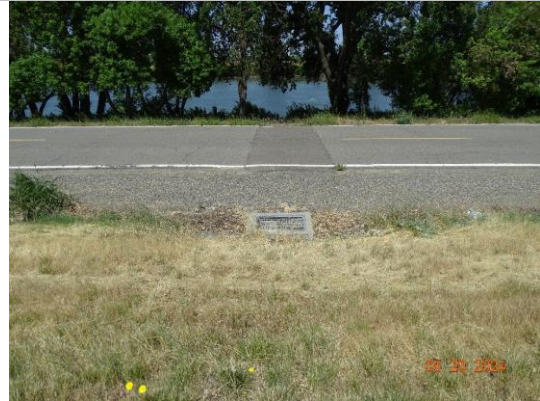
Photo 3 of 3 : UCIP_FA_2024_83971_123627.jpg

WS view: Drainage inlet located in the swale between the setback levee and Garden Highway; looking from crown.

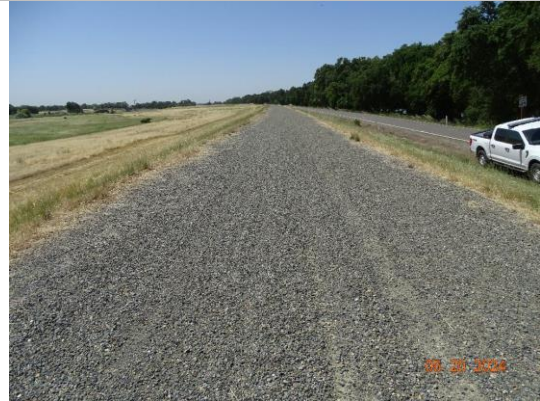
Photo 1 of 3 : UCIP_FA_2024_83970_123621.jpg

DS_ID:25858
FS_ID:83970
EP_NO: N/A
Repair Type: No Action Needed
EVAL Issue:
Crossing Status: Found
UCIP Comments: 05/20/2024 Record updated to No Action Needed. No issues observed during inspection. (M. Thao - DWR UCIP)
FIELD_STRUCT_DESC: *NOT THROUGH LEVEE* 24-inch reinforced concrete gravity drainage pipe, 4 feet below the Garden Highway (old levee crown). Drainage inlet is located in the drainage swale between the setback levee and Garden Highway. Pipe outlet is located at the waterside (WS) toe. (24-inch pipe authorized under the Natomas Levee Improvement Project under Permit No. 18159-3, 2009 - Sacramento Area Flood Control Agency). [Additional Reference(s): SAFCA As-Built Drawing No. 6-04-2269, 19 August 2013, Sheet 90 (C-405), Station 178+18.99, listed as Drain 11].
FS Date: 5/20/2024 11:02:35 AM

Levee crown looking downstream.

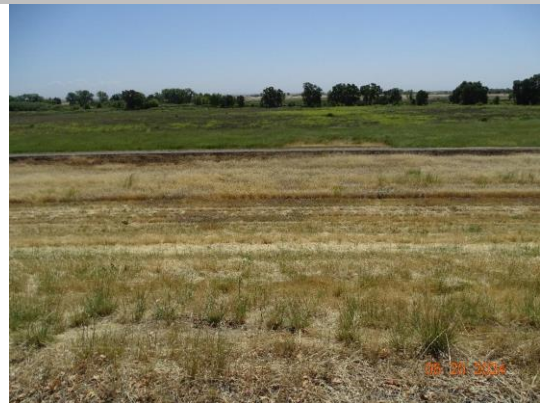
Photo 2 of 3 : UCIP_FA_2024_83970_123622.jpg

LS view: General overview looking from crown.

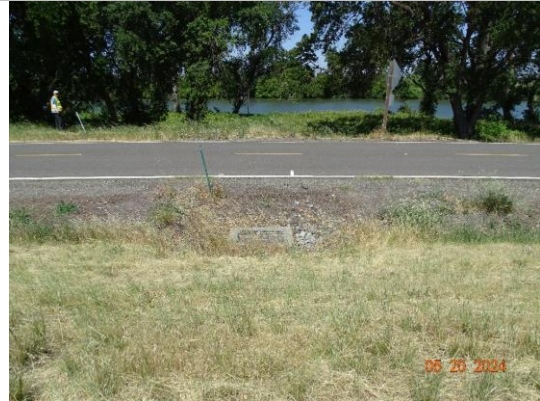
Photo 3 of 3 : UCIP_FA_2024_83970_123623.jpg

WS view: Drainage inlet located in the swale between the setback levee and Garden Highway; looking from crown.

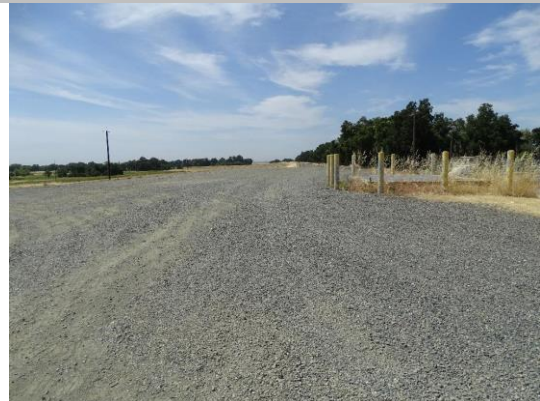
Photo 1 of 3 : UCIP_FA_2024_82056_118862.jpg

DS_ID:25878
FS_ID:82056
EP_NO: N/A
Repair Type: Non-Urgent
EVAL Issue: 11, Maintenance Compliance Issue
Crossing Status: Found
UCIP Comments: 06/15/2023 Record updated to Non-Urgent. Flap gate not closing properly due to missing hinge; recommend fixing flap gate. (M. Thao - DWR UCIP)

Levee crown looking downstream.

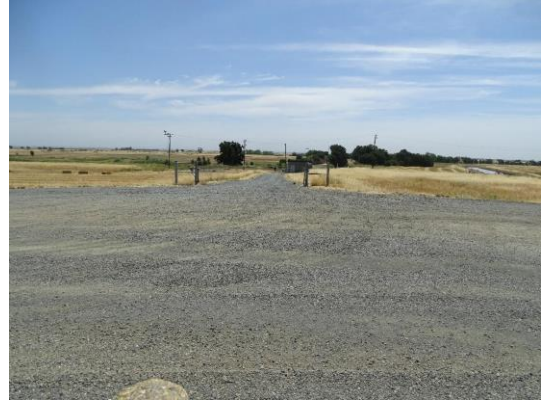
Photo 2 of 3 : UCIP_FA_2024_82056_118866.jpg

LS view: General overview looking from crown; pump house located approximately 450 feet from toe.

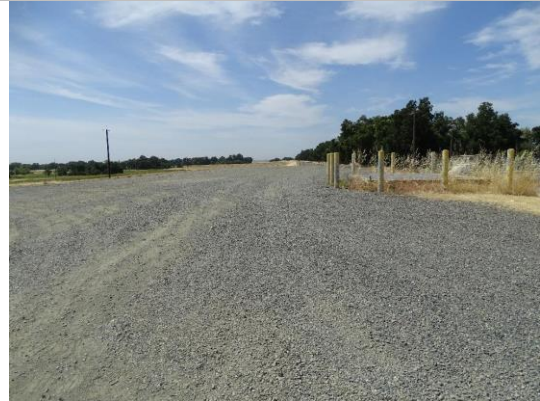
Photo 1 of 3 : UCIP_FA_2024_82096_118871.jpg

Comment Code						
Inspector Comment						
DS_ID:25879 FS_ID:82096 EP_NO: N/A Repair Type: Non-Urgent EVAL Issue: 11, Maintenance Compliance Issue Crossing Status: Found UCIP Comments: 06/15/2023 Record updated to Non-Urgent. Flap gate is missing; recommend installing a new flap gate. (M. Thao - DWR UCIP) FIELD_STRUCT_DESC: [Reclamation District 1000 Pumping Plant No. 2] 2 of 2: 30-inch welded steel drainage pipe through the levee, 2.5 feet below the crown. Concrete positive closure vault on the waterside (WS) shoulder. Pump station located approximately 450 feet from LS toe. Concrete headwall and flap gate located approximately 140 feet waterward of the Garden Highway centerline. (30-inch pipe authorized under Permit No. 18719, 2012 - Reclamation District 1000). FS Date: 6/15/2023

Levee crown looking downstream.

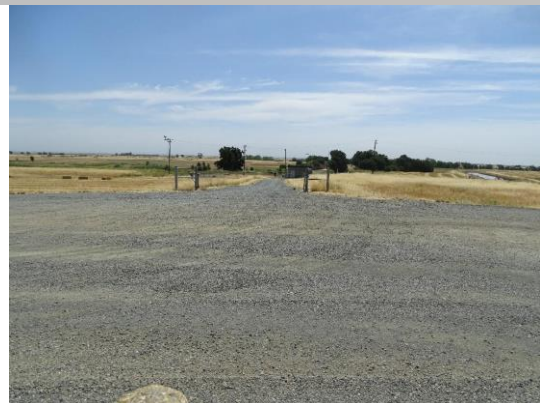
Photo 2 of 3 : UCIP_FA_2024_82096_118874.jpg

LS view: General overview looking from crown; pump house located approximately 450 feet from toe.

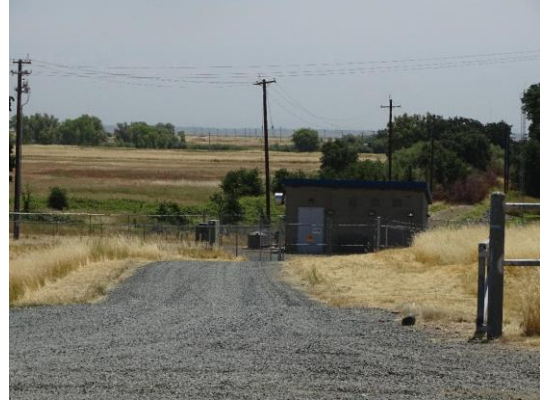
Photo 3 of 3 : UCIP_FA_2024_82096_118875.jpg

LS view: Close-up view of pump house located approximately 450 feet from toe.

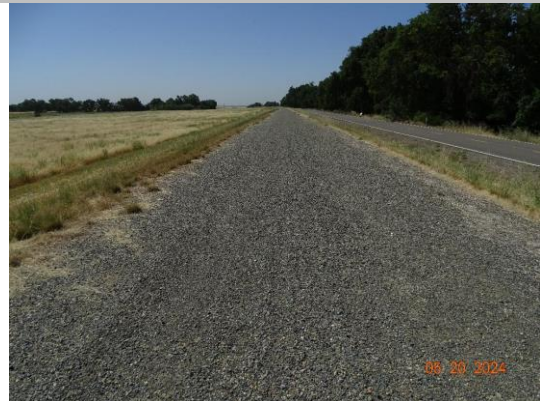
Photo 1 of 3 : UCIP_FA_2024_83969_123617.jpg

DS_ID:25859
FS_ID:83969
EP_NO: N/A
Repair Type: No Action Needed
EVAL Issue:
Crossing Status: Found
UCIP Comments: 05/20/2024 Record updated to No Action Needed. No issues observed during inspection. (M. Thao - DWR UCIP)

Levee crown looking downstream.

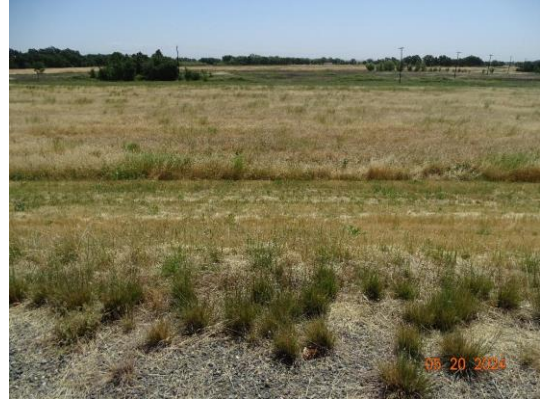
Photo 2 of 3 : UCIP_FA_2024_83969_123618.jpg

LS view: General overview looking from crown.

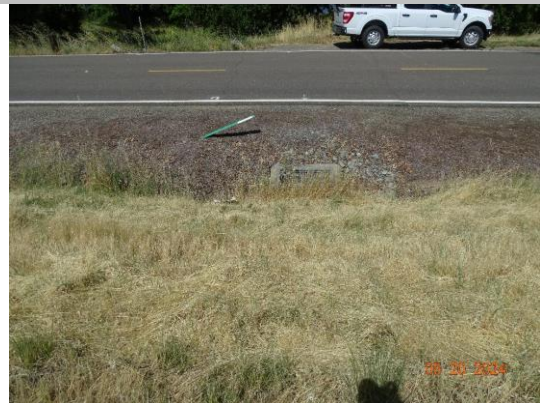
Photo 3 of 3 : UCIP_FA_2024_83969_123619.jpg

WS view: Drainage inlet located in the swale between the setback levee and Garden Highway; looking from crown.

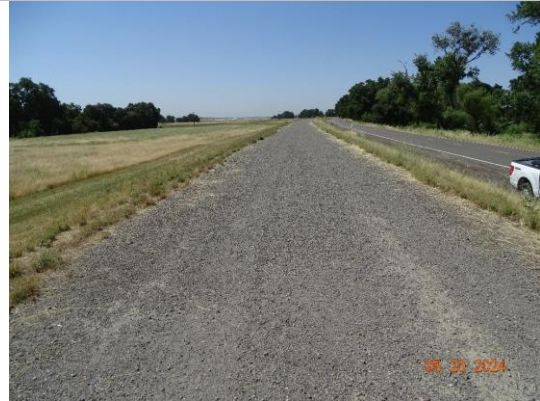
Photo 1 of 3 : UCIP_FA_2024_83968_123613.jpg

Comment Code					
Inspector Comment					
DS_ID:25860 FS_ID:83968 EP_NO: N/A Repair Type: No Action Needed EVAL Issue: Crossing Status: Found UCIP Comments: 05/20/2024 Record updated to No Action Needed. No issues observed during inspection. (M. Thao - DWR UCIP) FIELD_STRUCT_DESC: *NOT THROUGH THE LEVEE* 24-inch reinforced concrete gravity drainage pipe, 3.5 feet below the Garden Highway (old levee crown). Drainage inlet is located in the drainage swale between the setback levee and Garden Highway. Pipe outlet is located at the waterside (WS) toe. (24-inch pipe authorized under the Natomas Levee Improvement Project under Permit No. 18159-3, 2009 - Sacramento Area Flood Control Agency). [Additional Reference(s): SAFCA As-Built Drawing No. 6-04-2269, 19 August 2013, Sheet 43 (C-401), Station 223+57, listed as Drain 13]. FS Date: 5/20/2024 10:44:52 AM

Levee crown looking downstream.

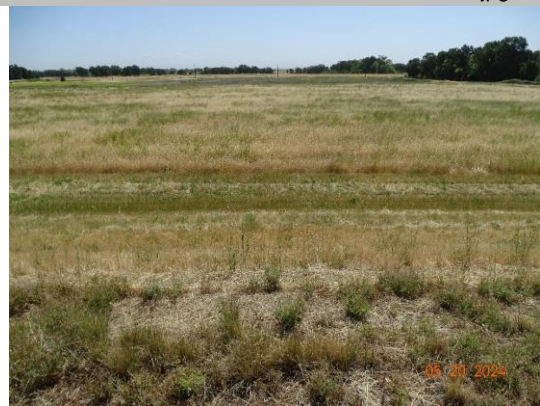
Photo 2 of 3 : UCIP_FA_2024_83968_123614.jpg

LS view: General overview looking from crown.

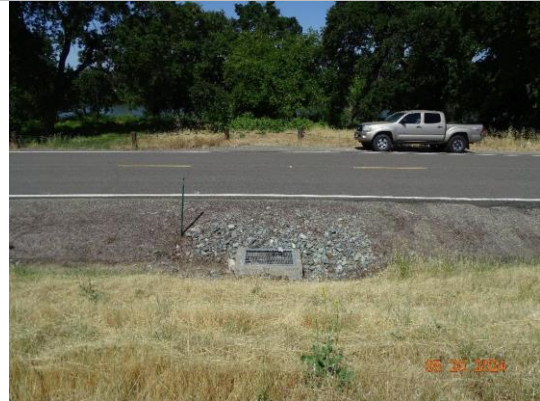
Photo 3 of 3 : UCIP_FA_2024_83968_123615.jpg

WS view: Drainage inlet located in the swale between the setback levee and Garden Highway; looking from crown.

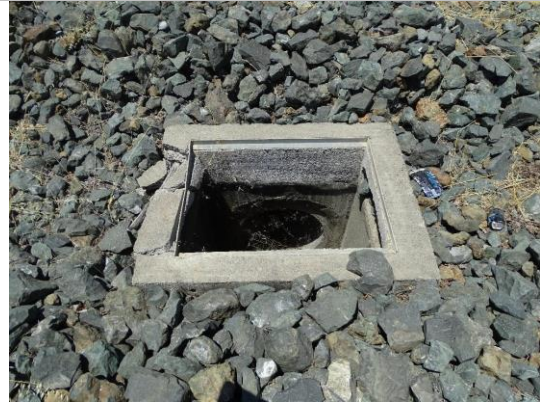
Photo 2 of 2 : UCIP_FA_2024_81713_118480.jpg

DS_ID:25822
FS_ID:81713
EP_NO: N/A
Repair Type: Non-Urgent
EVAL Issue: 4b, Safety Issue
Crossing Status: Found
UCIP Comments: 06/15/2023 Record updated to Non-Urgent. No cover was present on the drainage inlet causing a safety hazard; recommend adding a cover. Other than the missing cover, no issues observed during inspection. (M. Thao - DWR UCIP)
FIELD_STRUCT_DESC: *NOT THROUGH LEVEE* 24-inch reinforced concrete gravity drainage pipe, 4.5 feet below the Garden Highway (old levee crown). Drainage inlet is located in the drainage swale between the setback levee and Garden Highway. Pipe outlet is located at the waterside (WS) toe. (24-inch pipe authorized under the Natomas Levee Improvement Project under Permit No. 18159-4, 2010 - Sacramento Area Flood Control Agency). [Additional Reference(s): SAFCA As-Built Drawing No. 6-04-2270, 28 June 2013, Sheet 120 (C-401), Station 245+56, listed as Drain 14A].

WS view: Close-up view of drainage inlet without a cover located between the setback levee and Garden Highway.

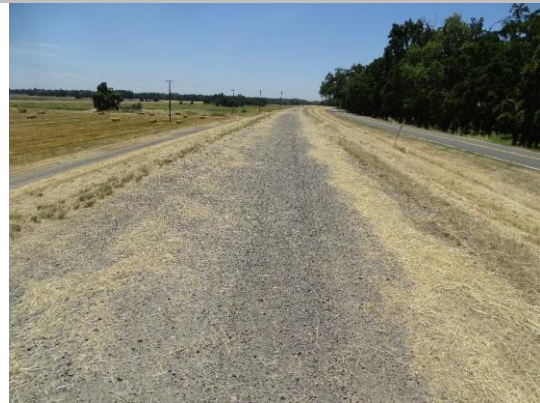
Photo 1 of 3 : UCIP_FA_2024_84115_118486.jpg

DS_ID:25823
FS_ID:84115
EP_NO: N/A
Repair Type: No Action Needed
EVAL Issue:
Crossing Status: Found
UCIP Comments: 06/15/2023 Record updated to No Action Needed. No issues observed during inspection. (M. Thao - DWR UCIP)
FIELD_STRUCT_DESC: *NOT THROUGH LEVEE* 24-inch reinforced concrete gravity drainage pipe, 3.5 feet below the Garden Highway. Drainage inlet located in the drainage swale between the setback levee and Garden Highway. Pipe outlet is located at the waterside (WS) slope with rip rap. (24-inch pipe authorized under the Natomas Levee Improvement Project under Permit No. 18159-4, 2010 - Sacramento Area Flood Control Agency). [Additional Reference(s): SAFCA As-Built Drawing No. 6-04-2270, 28 June 2013, Sheet 120 (C-401) , Station 265+56.03, listed as Drain 16].
FS Date: 6/15/2023

Levee crown looking downstream.

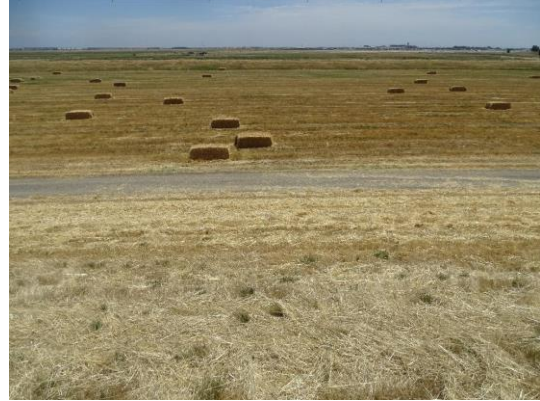
Photo 2 of 3 : UCIP_FA_2024_84115_118487.jpg

LS view: General overview looking from crown.

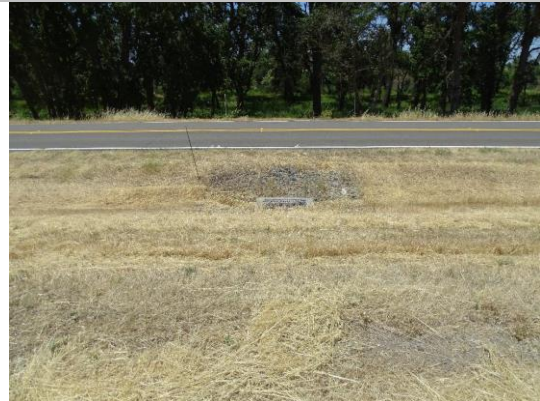
Photo 3 of 3 : UCIP_FA_2024_84115_118488.jpg

WS view: Drainage inlet located in the swale between the setback levee and Garden Highway; looking from crown.

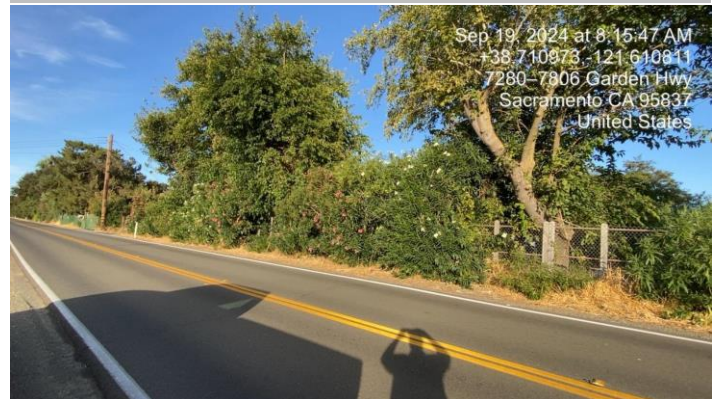
Photo 1 of 1 : FA_2024_RD1000_31_120_20240920_00474.jpg

LM Start	5.17	Rating **	U	Issue No.	120
LM End	5.21	Issue Type +	En	Location *	WS
Category	Earthen Levee			GPS Latitude/Longitude	
				Start	End
Item	Vegetation			38.711248°	38.710806°
				-121.610500°	-121.611110°
DWR ID	DWR_RD1000_01_s_2012_120				
Comment Code					
V6 : Landscaping					
Inspector Comment					
The landscape vegetation prevents the ability to see waterside slope and will make it difficult to access for flood fight.

View of landscape vegetation on the waterside slope (Fall 2024).

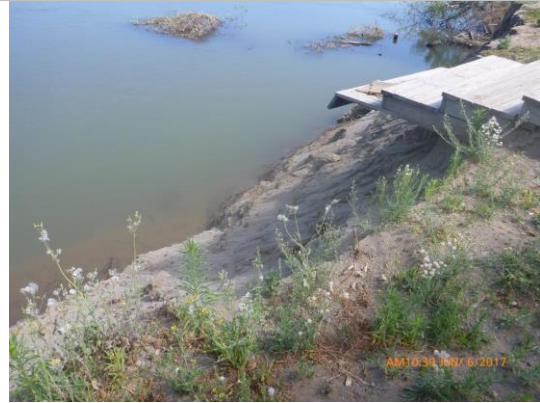
Photo 1 of 3 : LEVAL_FA_2024_45_1257.jpg

LM Start	5.21	Rating **	A/W	Issue No.	4
LM End	5.21	Issue Type +	Ma	Location *	WS
Category	Earthen Levee			GPS Latitude/Longitude	
				Start	End
Item	Erosion / Bank Caving			38.710830 °	38.710830 °
				-121.611100 °	-121.611100 °
DWR ID	LMA-12				
Comment Code					
E1 : Note and monitor erosion site.					
Inspector Comment					
Erosion site is at a private residence.					
Site ID No:45					
Site Designation:LMA-12

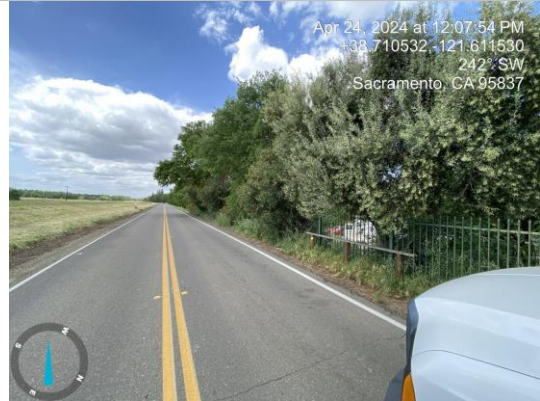
Photo 1 of 1 : FA_2024_RD1000_31_119_20240911_00058.jpg

LM Start	5.24	Rating **	M	Issue No.	119
LM End	5.28	Issue Type +	En	Location *	WS
Category	Earthen Levee			GPS Latitude/Longitude	
				Start	End
Item	Vegetation			38.710508 °	38.710132 °
				-121.611450 °	-121.611882 °
DWR ID	DWR_RD1000_01_s_2012_119				
Comment Code					
V6 : Landscaping					
Inspector Comment					
The landscape vegetation limits the ability to see the waterside slope and will make it difficult to access for flood fight.

View of landscape vegetation on the waterside slope (Spring 2024).

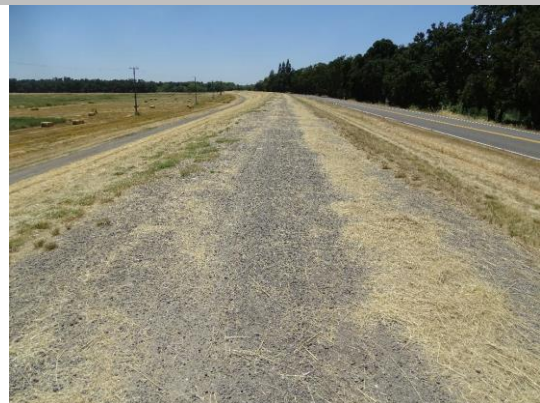
Photo 1 of 3 : UCIP_FA_2024_84116_118492.jpg

Comment Code					
Inspector Comment					
DS_ID:25824 FS_ID:84116 EP_NO: N/A Repair Type: No Action Needed EVAL Issue: Crossing Status: Found UCIP Comments: 06/15/2023 Record updated to No Action Needed. No issues observed during inspection. (M. Thao - DWR UCIP) FIELD_STRUCT_DESC: *NOT THROUGH LEVEE* 24-inch reinforced concrete gravity drainage pipe, 4.5 feet below the Garden Highway (old levee crown). Drainage inlet located in the drainage swale between the setback levee and Garden Highway. Pipe outlet is located at the waterside (WS) slope with rip rap. (24-inch pipe authorized under the Natomas Levee Improvement Project under Permit No. 18159-4, 2010 - Sacramento Area Flood Control Agency). [Additional Reference(s): SAFCA As-Built Drawing No. 6-04-2270, 28 June 2013, Sheet 121 (C-402) , Station 282+75, listed as Drain 17]. FS Date: 6/15/2023

Levee crown looking downstream.

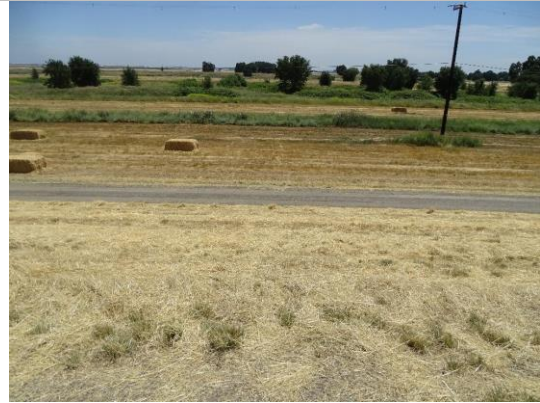
Photo 2 of 3 : UCIP_FA_2024_84116_118493.jpg

LS view: General overview looking from crown.

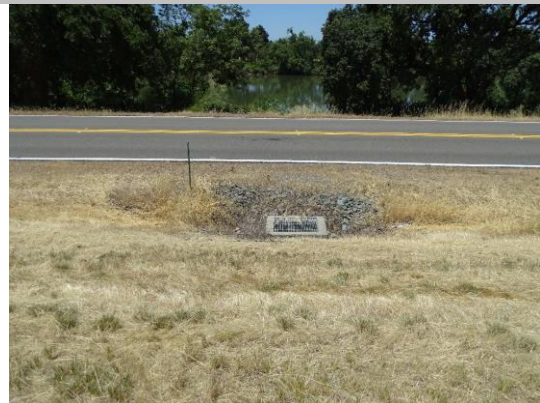
Photo 3 of 3 : UCIP_FA_2024_84116_118494.jpg

WS view: Pipe inlet located in the swale between the setback levee and Garden Highway; looking from crown.

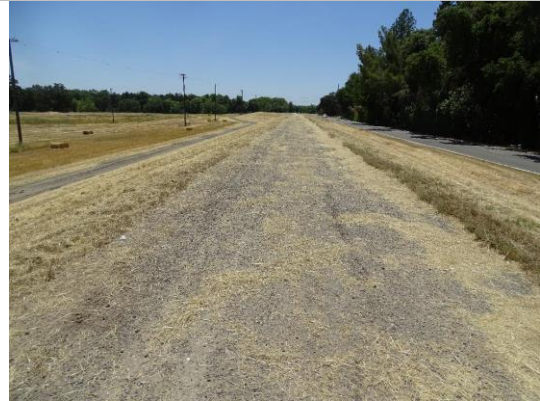
Photo 1 of 3 : UCIP_FA_2024_84117_118497.jpg

DS_ID:25825
FS_ID:84117
EP_NO: N/A
Repair Type: No Action Needed
EVAL Issue:
Crossing Status: Found
UCIP Comments: 06/15/2023 Record updated to No Action Needed. No issues observed during inspection. (M. Thao - DWR UCIP)
FIELD_STRUCT_DESC: *NOT THROUGH LEVEE* 24-inch reinforced concrete gravity drainage pipe, 4.0 feet below the Garden Highway (old levee crown). Drainage inlet located in the drainage swale between the setback levee and Garden Highway. Pipe outlet is located at the waterside (WS) slope with rip rap. (24-inch pipe authorized under the Natomas Levee Improvement Project under Permit No. 18159-4, 2010 - Sacramento Area Flood Control Agency). [Additional Reference(s): SAFCA As-Built Drawing No. 6-04-2270, 28 June 2013, Sheet 121 (C-402) , Station 282+75, listed as Drain 18].
FS Date: 6/15/2023

Levee crown looking downstream.

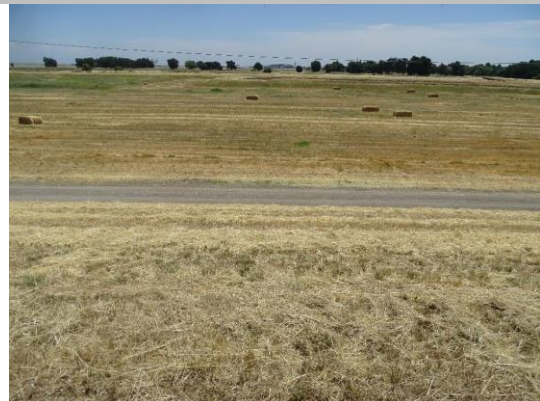
Photo 2 of 3 : UCIP_FA_2024_84117_118498.jpg

LS view: General overview looking from crown.

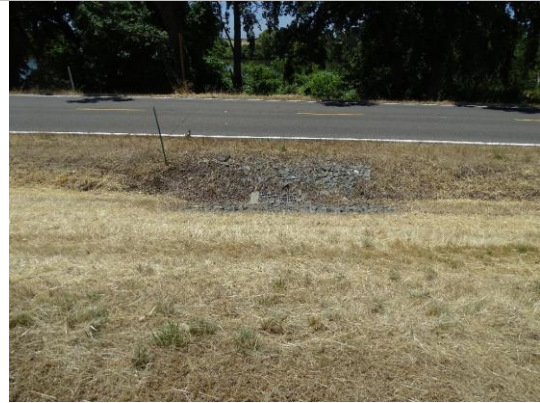
Photo 3 of 3 : UCIP_FA_2024_84117_118499.jpg

WS view: Pipe inlet located in the swale between the setback levee and Garden Highway; looking from crown.

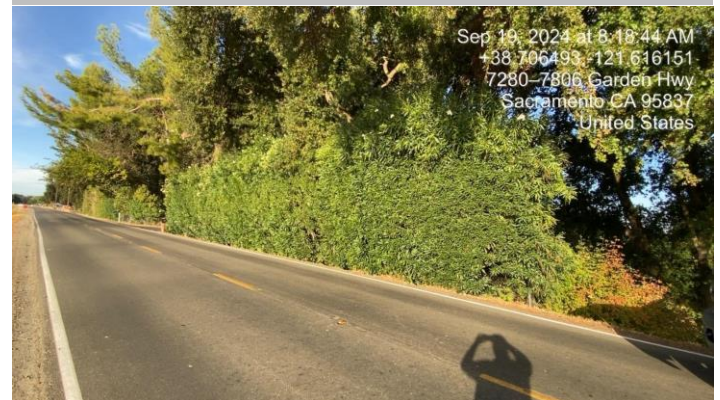
Photo 1 of 1 : FA_2024_RD1000_31_118_20240920_00475.jpg

LM Start	5.62	Rating **	U	Issue No.	118
LM End	5.69	Issue Type +	En	Location *	WS
Category	Earthen Levee			GPS Latitude/Longitude	
				Start	End
Item	Vegetation			38.706456 °	38.705708 °
				-121.616223 °	-121.617002 °
DWR ID	DWR_RD1000_01_s_2012_118				
Comment Code					
V6 : Landscaping					
Inspector Comment					
The landscape vegetation prevents the ability to see waterside slope and will make it difficult to access for flood fight.

View of landscape vegetation on the waterside slope (Fall 2024).

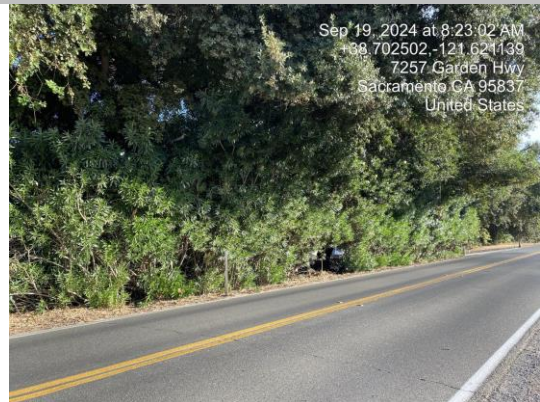
Photo 1 of 1 : FA_2024_RD1000_31_116_20240920_00476.jpg

LM Start	5.97	Rating **	U	Issue No.	116
LM End	6.00	Issue Type +	En	Location *	WS
Category	Earthen Levee			GPS Latitude/Longitude	
				Start	End
Item	Vegetation			38.702742 °	38.702467 °
				-121.620557 °	-121.620947 °
DWR ID	DWR_RD1000_01_s_2012_116				
Comment Code					
V6 : Landscaping					
Inspector Comment					
The landscape vegetation prevents the ability to see waterside slope and will make it difficult to access for flood fight.

View of landscape vegetation on the waterside slope (Fall 2024).

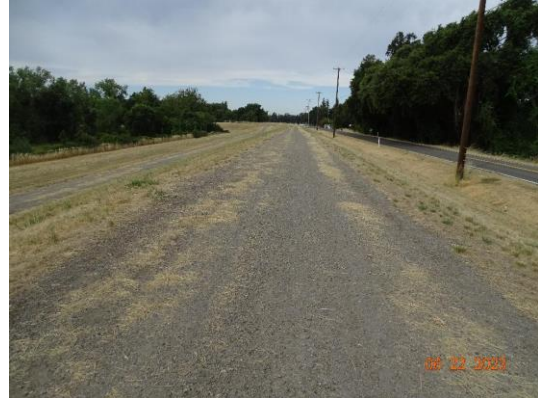
Photo 1 of 3 : UCIP_FA_2024_81720_118504.jpg

Comment Code						
Inspector Comment						
DS_ID:25827 FS_ID:81720 EP_NO: N/A Repair Type: Non-Urgent EVAL Issue: Crossing Status: Found UCIP Comments: 06/15/2023 Record updated to Non-Urgent. Overgrown vegetation on WS slope limits inspection of WS. (M. Thao - DWR UCIP) FIELD_STRUCT_DESC: *NOT THROUGH LEVEE* 24-inch reinforced concrete gravity drainage pipe (RCP), 5.0 feet below the Garden Highway. Drainage inlet located in the drainage swale between the setback levee and Garden Highway. Pipe outlet is located at the waterside (WS) slope with rip rap. Another drainage inlet located on the Garden Highway WS toe and discharges into the main channel. (24-inch pipe authorized under the Natomas Levee Improvement Project under Permit No. 18159-4, 2010 - Sacramento Area Flood Control Agency). [Additional Reference(s): SAFCA As-Built Drawing No. 6-04-2270, 28 June 2013, Sheet 122 (C-403), Station 317+56, listed as Drain 19B]. FS Date: 6/22/2023

Levee crown looking downstream.

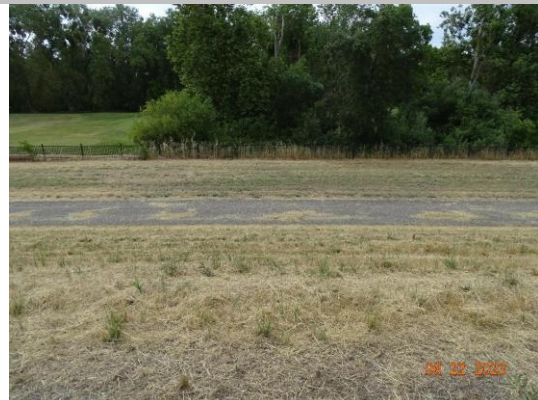
Photo 2 of 3 : UCIP_FA_2024_81720_118506.jpg

LS view: General overview looking from crown.

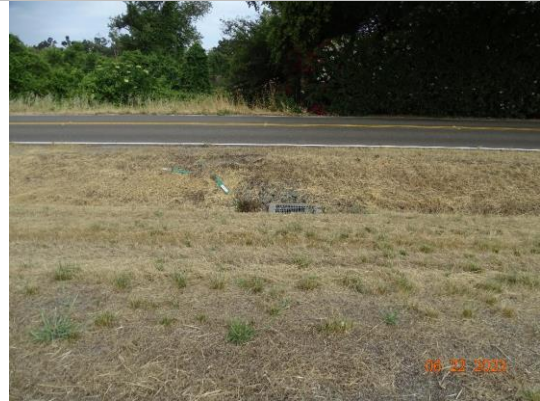
Photo 3 of 3 : UCIP_FA_2024_81720_118505.jpg

WS view: Pipe drop inlet located in the swale between the setback levee and Garden Highway; looking from crown.

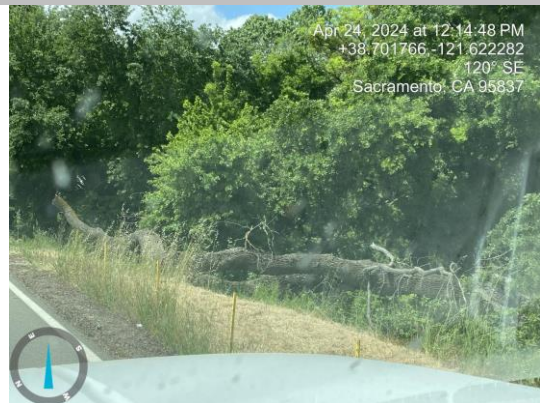
Photo 1 of 1 : FA_2024_RD1000_31_213_20240911_00073.jpg

LM Start	6.09	Rating **	M	Issue No.	213
LM End	6.09	Issue Type +	Ma	Location *	WS
Category	Earthen Levee			GPS Latitude/Longitude	
				Start	End
Item	Trim / Thin Trees			38.701704°	38.701704°
				-121.622412°	-121.622412°
DWR ID	DWR_RD1000_01_f_2023_213				
Comment Code					
T2 : Tree or limb.					
Inspector Comment					
Remove fallen tree and limbs from waterside slope.

View of fallen tree on the waterside slope (Spring 2024).

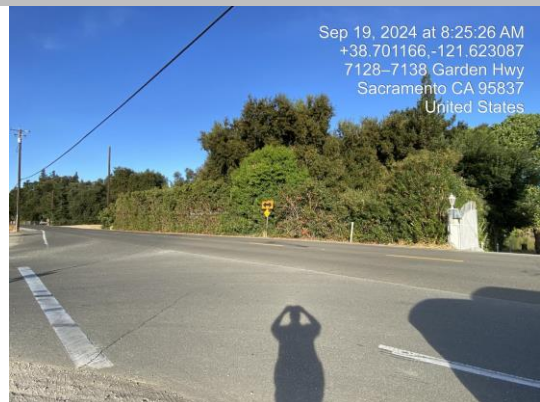
Photo 1 of 1 : FA_2024_RD1000_31_113_20240920_00477.jpg

LM Start	6.15	Rating **	U	Issue No.	113
LM End	6.17	Issue Type +	En	Location *	WS
Category	Earthen Levee			GPS Latitude/Longitude	
				Start	End
Item	Vegetation			38.701160°	38.700987°
				-121.623146°	-121.623564°
DWR ID	DWR_RD1000_01_s_2012_113				
Comment Code					
V6 : Landscaping					
Inspector Comment					
The landscape vegetation prevents the ability to see waterside slope and will make it difficult to access for flood fight.

View of landscape vegetation on the waterside slope (Fall 2024).

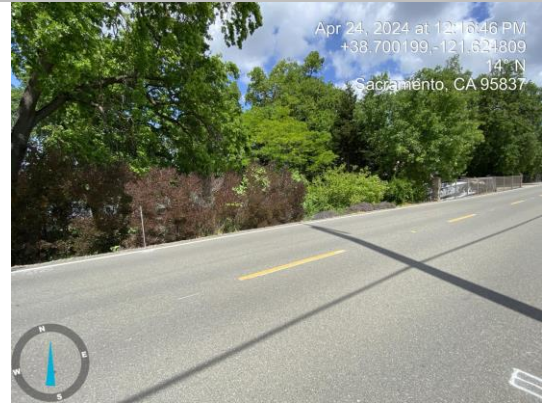
Photo 1 of 1 : FA_2024_RD1000_31_214_20240911_00074.jpg

LM Start	6.24	Rating **	M	Issue No.	214
LM End	6.27	Issue Type +	En	Location *	WS
Category	Earthen Levee			GPS Latitude/Longitude	
				Start	End
Item	Vegetation			38.700375 °	38.700138 °
				-121.624575 °	-121.624956 °
DWR ID	DWR_RD1000_01_f_2023_214				
Comment Code					
V6 : Landscaping					
Inspector Comment					
The landscape vegetation limits the ability to see the waterside slope and will make it difficult to access for flood fight.

View of landscape vegetation on the waterside slope (Spring 2024).

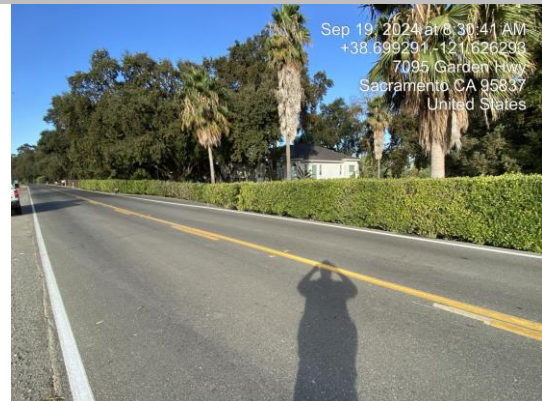
Photo 1 of 1 : FA_2024_RD1000_31_68_20240920_00478.jpg

LM Start	6.36	Rating **	U	Issue No.	68
LM End	6.40	Issue Type +	En	Location *	WS
Category	Earthen Levee			GPS Latitude/Longitude	
				Start	End
Item	Vegetation			38.699313 °	38.698978 °
				-121.626281 °	-121.626777 °
DWR ID	DWR_RD1000_01_s_2015_68				
Comment Code					
V6 : Landscaping					
Inspector Comment					
The landscape vegetation prevents the ability to see waterside slope and will make it difficult to access for flood fight.

View of landscape vegetation on the waterside slope (Fall 2024).

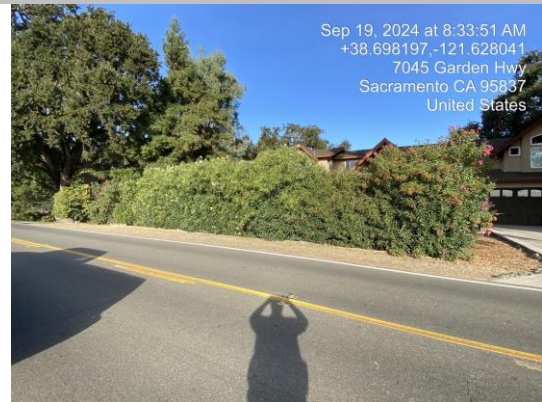
Photo 1 of 1 : FA_2024_RD1000_31_125_20240920_00479.jpg

LM Start	6.48	Rating **	U	Issue No.	125
LM End	6.50	Issue Type +	En	Location *	WS
Category	Earthen Levee			GPS Latitude/Longitude	
				Start	End
Item	Vegetation			38.698198°	38.698046°
				-121.628024°	-121.628226°
DWR ID	DWR_RD1000_01_s_2012_125				
Comment Code					
V6 : Landscaping					
Inspector Comment					
The landscape vegetation prevents the ability to see waterside slope and will make it difficult to access for flood fight.

View of landscape vegetation on the waterside slope (Fall 2024).

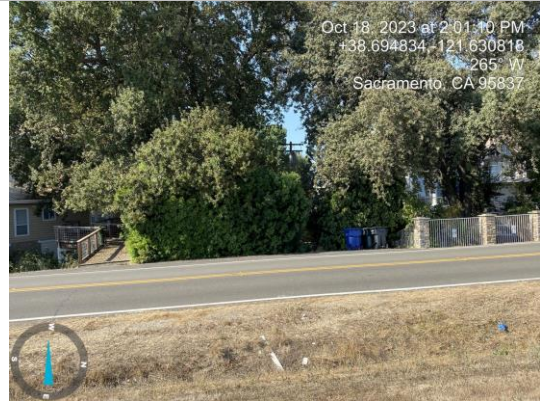
Photo 1 of 1 : FA_2024_RD1000_31_216_20240911_00076.jpg

LM Start	6.76	Rating **	M	Issue No.	216
LM End	6.79	Issue Type +	En	Location *	WS
Category	Earthen Levee			GPS Latitude/Longitude	
				Start	End
Item	Vegetation			38.694800 °	38.694461 °
				-121.630888 °	-121.631126 °
DWR ID	DWR_RD1000_01_f_2023_216				
Comment Code					
V6 : Landscaping					
Inspector Comment					
The landscape vegetation limits the ability to see the waterside slope and will make it difficult to access for flood fight.

View of landscaping on the waterside slope (Fall 2023).

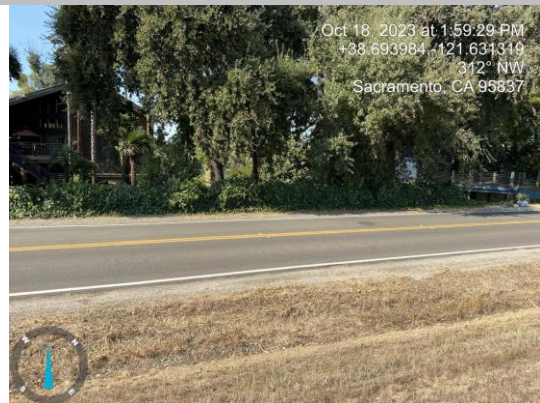
Photo 1 of 1 : FA_2024_RD1000_31_215_20240911_00075.jpg

LM Start	6.80	Rating **	M	Issue No.	215
LM End	6.83	Issue Type +	En	Location *	WS
Category	Earthen Levee			GPS Latitude/Longitude	
				Start	End
Item	Vegetation			38.694273 °	38.693865 °
				-121.631076 °	-121.631349 °
DWR ID	DWR_RD1000_01_f_2023_215				
Comment Code					
V6 : Landscaping					
Inspector Comment					
The landscape vegetation limits the ability to see the waterside slope and will make it difficult to access for flood fight.

View of landscaping on the waterside slope (Fall 2023).

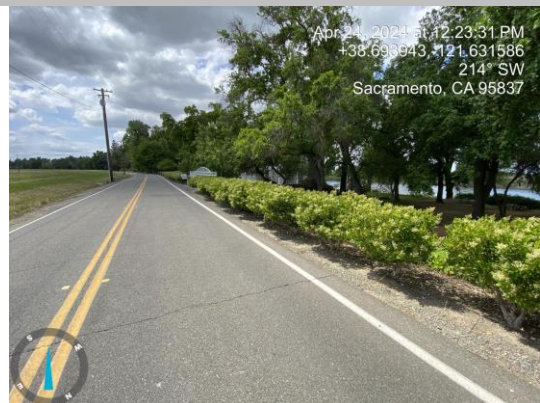
Photo 1 of 1 : FA_2024_RD1000_31_104_20240911_00054.jpg

LM Start	6.83	Rating **	M	Issue No.	104
LM End	6.87	Issue Type +	En	Location *	WS
Category	Earthen Levee			GPS Latitude/Longitude	
				Start	End
Item	Vegetation			38.693935 °	38.693412 °
				-121.631478 °	-121.631765 °
DWR ID	DWR_RD1000_01_s_2024_104				
Comment Code					
V6 : Landscaping					
Inspector Comment					
The landscape vegetation limits the ability to see the waterside slope and will make it difficult to access for flood fight.

View of landscape vegetation on the waterside slope (Spring 2024).
