Flood Control Project Maintenance Levee Inspections

Fall 2024 Levee Maintenance Deficiency Summary Report

Sacramento River Basin

Reclamation District No. 1000 Natomas

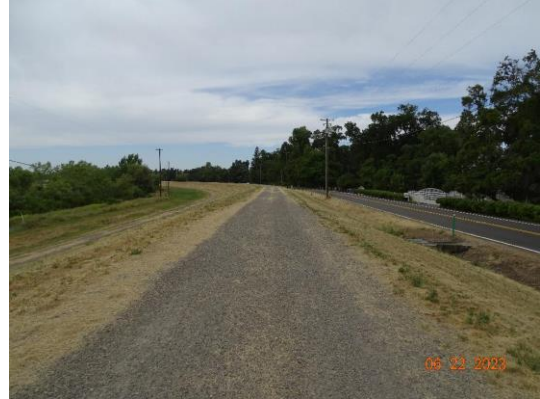
Photo 1 of 3 : UCIP_FA_2024_81724_118510.jpg

Comment Code						
Inspector Comment						
DS_ID:25828 FS_ID:81724 EP_NO: N/A Repair Type: Non-Urgent EVAL Issue: Crossing Status: Found UCIP Comments: 06/22/2023 Record updated to Non-Urgent. Overgrown vegetation on WS slope limits inspection of WS. (M. Thao - DWR UCIP) FIELD_STRUCT_DESC: *NOT THROUGH LEVEE* 24-inch reinforced concrete gravity drainage pipe, 5.0 feet below the Garden Highway. Drainage inlet located in the drainage swale between the setback levee and Garden Highway. Pipe outlet is located at the waterside (WS) toe with rip rap. Another drainage inlet is located on the Garden Highway WS toe and discharges into the main channel. (24-inch pipe authorized under the Natomas Levee Improvement Project under Permit No. 18159-4, 2010 - Sacramento Area Flood Control Agency). [Additional Reference(s): SAFCA As-Built Drawing No. 6-04-2270, 28 June 2013, Sheet 122 (C-403), Station 361+53.38, listed as Drain 20F]. FS Date: 6/22/2023

Levee crown looking downstream.

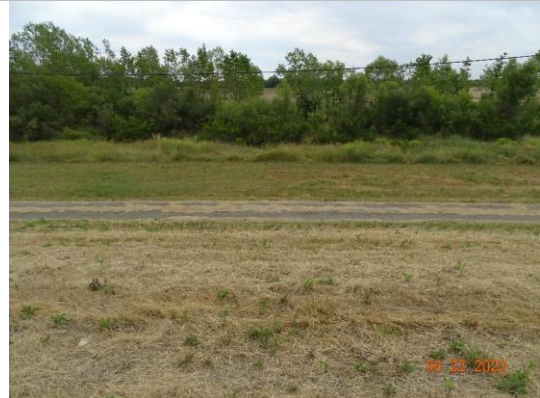
Photo 2 of 3 : UCIP_FA_2024_81724_118512.jpg

LS view: General overview looking from crown.

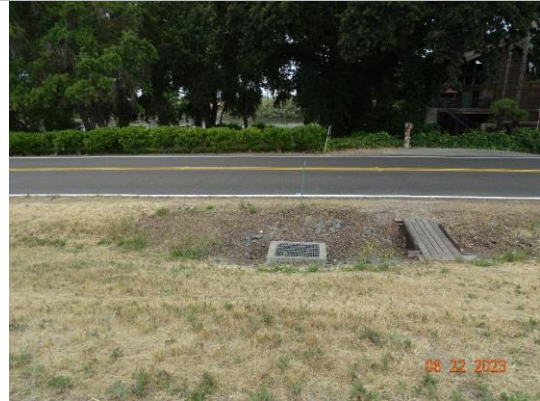
Photo 3 of 3 : UCIP_FA_2024_81724_118511.jpg

WS view: Pipe drop inlet located in the swale between the setback levee and Garden Highway; looking from crown.

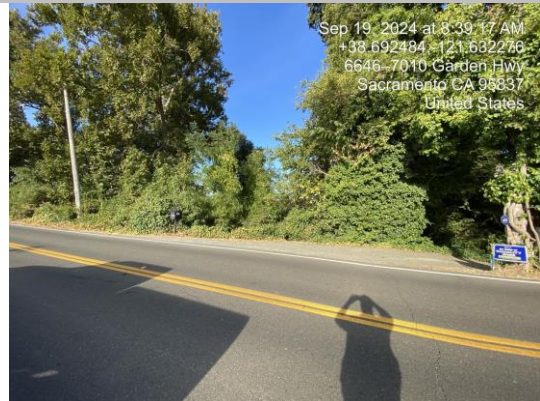
Photo 1 of 1 : FA_2024_RD1000_31_102_20240920_00480.jpg

LM Start	6.90	Rating **	U	Issue No.	102
LM End	6.97	Issue Type +	En	Location *	WS
Category	Earthen Levee			GPS Latitude/Longitude	
				Start	End
Item	Vegetation			38.693037 °	38.692035 °
				-121.632097 °	-121.632444 °
DWR ID	DWR_RD1000_01_s_2012_102				
Comment Code					
V6 : Landscaping					
Inspector Comment					
The landscape vegetation prevents the ability to see waterside slope and will make it difficult to access for flood fight.

View of landscape vegetation on the waterside slope (Fall 2024).

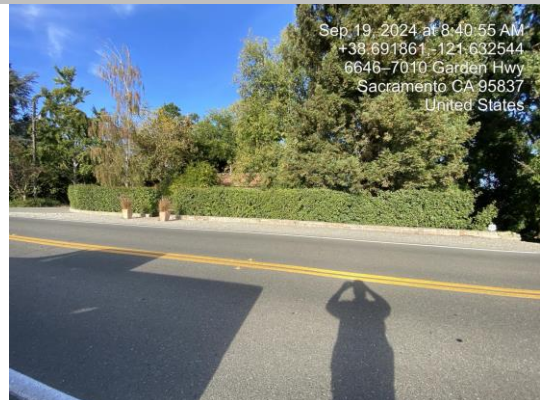
Photo 1 of 1 : FA_2024_RD1000_31_100_20240920_00481.jpg

LM Start	7.00	Rating **	U	Issue No.	100
LM End	7.05	Issue Type +	En	Location *	WS
Category	Earthen Levee			GPS Latitude/Longitude	
				Start	End
Item	Vegetation			38.691678 °	38.690985 °
				-121.632649 °	-121.632679 °
DWR ID	DWR_RD1000_01_s_2012_100				
Comment Code					
V6 : Landscaping					
Inspector Comment					
The landscape vegetation prevents the ability to see waterside slope and will make it difficult to access for flood fight.

View of landscape vegetation on the waterside slope (Fall 2024).

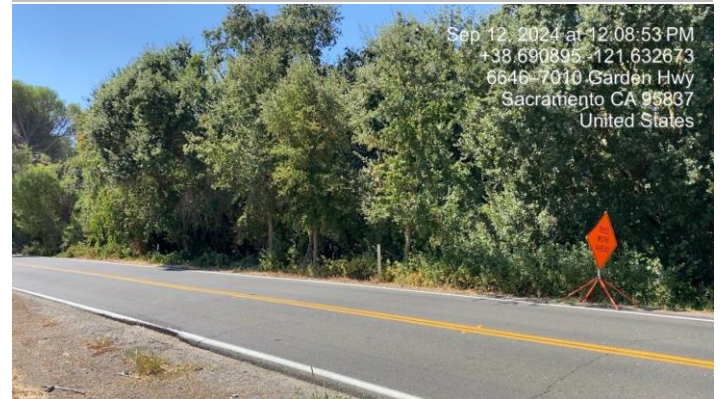
Photo 1 of 1 : FA_2024_RD1000_31_202_20240916_00466.jpg

LM Start	7.05	Rating **	M	Issue No.	202
LM End	7.09	Issue Type +	En	Location *	WS
Category	Earthen Levee			GPS Latitude/Longitude	
				Start	End
Item	Vegetation			38.690978 °	38.690338 °
				-121.632675 °	-121.632790 °
DWR ID	DWR_RD1000_01_f_2024_202				
Comment Code					
V6 : Landscaping					
Inspector Comment					
The landscape vegetation limits the ability to see waterside slope and will make it difficult to access for flood fight.

View of landscaping on the waterside slope (Fall 2024).

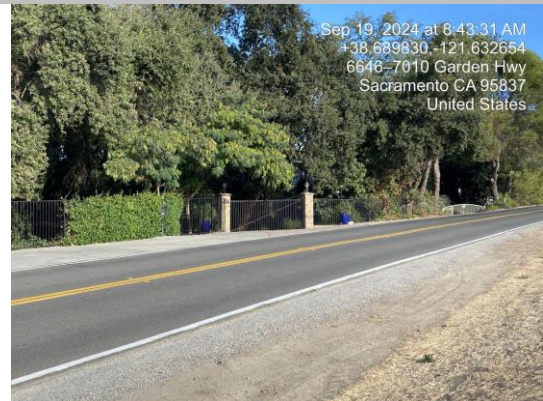
Photo 1 of 1 : FA_2024_RD1000_31_217_20240920_00482.jpg

LM Start	7.12	Rating **	M	Issue No.	217
LM End	7.13	Issue Type +	En	Location *	WS
Category	Earthen Levee			GPS Latitude/Longitude	
				Start	End
Item	Vegetation			38.690001 °	38.689753 °
				-121.632728 °	-121.632797 °
DWR ID	DWR_RD1000_01_f_2023_217				
Comment Code					
V6 : Landscaping					
Inspector Comment					
The landscape vegetation limits the ability to see the waterside slope and will make it difficult to access for flood fight.

View of landscape vegetation on the waterside slope (Fall 2024).

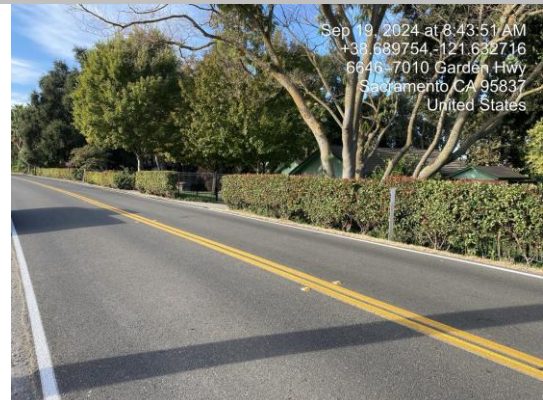
Photo 1 of 1 : FA_2024_RD1000_31_16_20240920_00483.jpg

LM Start	7.14	Rating **	U	Issue No.	16
LM End	7.18	Issue Type +	En	Location *	WS
Category	Earthen Levee			GPS Latitude/Longitude	
				Start	End
Item	Vegetation			38.689699 °	38.688992 °
				-121.632795 °	-121.632710 °
DWR ID	DWR_RD1000_01_f_2024_16				
Comment Code					
V6 : Landscaping					
Inspector Comment					
The landscape vegetation prevents the ability to see the waterside slope and will make it difficult to access for flood fight.

View of landscape vegetation on the waterside slope (Fall 2024).

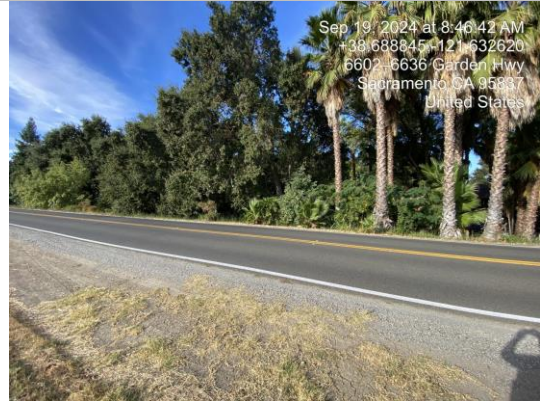
Photo 1 of 1 : FA_2024_RD1000_31_197_20240920_00484.jpg

LM Start	7.19	Rating **	M	Issue No.	197
LM End	7.24	Issue Type +	En	Location *	WS
Category	Earthen Levee			GPS Latitude/Longitude	
				Start	End
Item	Vegetation			38.688861 °	38.688253 °
				-121.632604 °	-121.632586 °
DWR ID	DWR_RD1000_01_f _ 2024_197				
Comment Code					
V6 : Landscaping					
Inspector Comment					
The landscape vegetation prevents the ability to see the waterside slope and will make it difficult to access for flood fight.

View of landscape vegetation on the waterside slope (Fall 2024).

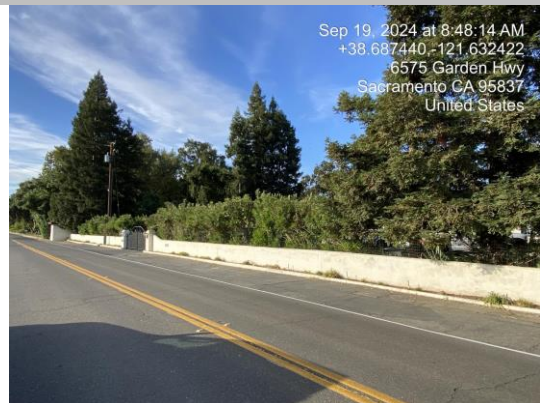
Photo 1 of 1 : FA_2024_RD1000_31_96_20240920_00485.jpg

LM Start	7.30	Rating **	M	Issue No.	96
LM End	7.34	Issue Type +	En	Location *	WS
Category	Earthen Levee			GPS Latitude/Longitude	
				Start	End
Item	Vegetation			38.687347°	38.686780°
				-121.632433°	-121.632138°
DWR ID	DWR_RD1000_01_f_2023_96				
Comment Code					
V6 : Landscaping					
Inspector Comment					
The landscape vegetation limits the ability to see the waterside slope and will make it difficult to access for flood fight.

View of landscape vegetation on the waterside slope (Fall 2024).

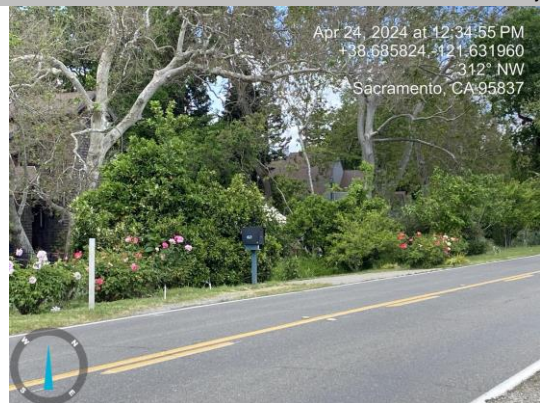
Photo 1 of 1 : FA_2024_RD1000_31_1_20240911_00001.jpg

LM Start	7.41	Rating **	M	Issue No.	1
LM End	7.44	Issue Type +	En	Location *	WS
Category	Earthen Levee			GPS Latitude/Longitude	
				Start	End
Item	Vegetation			38.685843°	38.685344°
				-121.632012°	-121.631912°
DWR ID	DWR_RD1000_01_s_2012_1				
Comment Code					
V6 : Landscaping					
Inspector Comment					
The landscape vegetation limits the ability to see the waterside slope and will make it difficult to access for flood fight.

View of landscape vegetation on the waterside slope (Spring 2024).

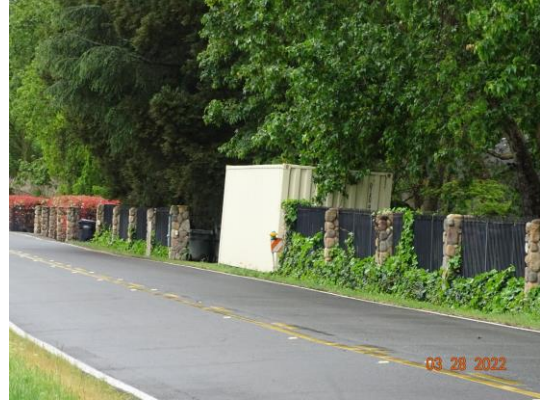
Photo 1 of 1 : FA_2024_RD1000_31_9_20240911_00008.jpg

LM Start	7.55	Rating **	M	Issue No.	9
LM End	7.55	Issue Type +	En	Location *	WS
Category	Earthen Levee			GPS Latitude/Longitude	
				Start	End
Item	Encroachments			38.683799 °	38.683799 °
				-121.631432 °	-121.631432 °
DWR ID	DWR_RD1000_01_s _ 2022_9				
Comment Code					
EQ : Equipment					
Inspector Comment					
Shipping container on waterside slope is blocking access and visibility and should be removed.

View of shipping container on waterside (Spring 2022).

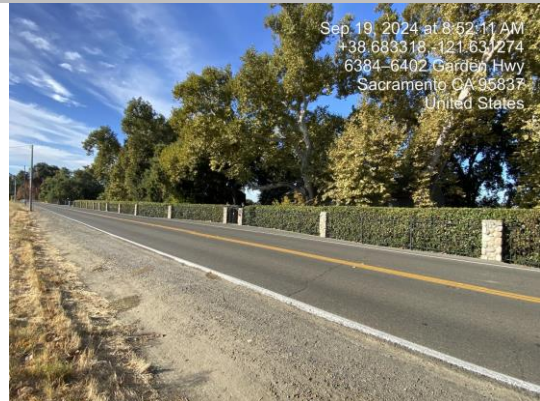
Photo 1 of 1 : FA_2024_RD1000_31_95_20240920_00486.jpg

LM Start	7.56	Rating **	U	Issue No.	95
LM End	7.62	Issue Type +	En	Location *	WS
Category	Earthen Levee			GPS Latitude/Longitude	
				Start	End
Item	Vegetation			38.683620 °	38.682742 °
				-121.631180 °	-121.631190 °
DWR ID	DWR_RD1000_01_s _ 2012_95				
Comment Code					
V6 : Landscaping					
Inspector Comment					
The landscape vegetation prevents the ability to see the waterside slope and will make it difficult to access for flood fight.

View of landscape vegetation on the waterside slope (Fall 2024).

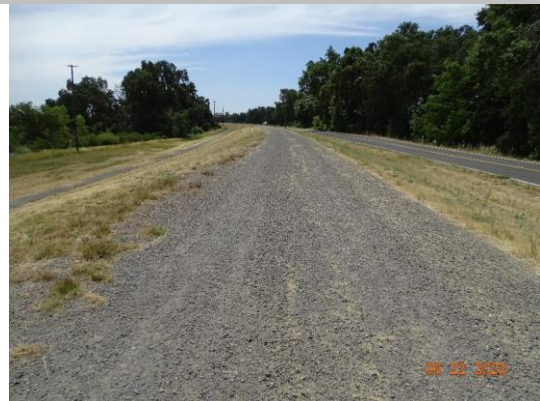
Photo 1 of 3 : UCIP_FA_2024_84148_118514.jpg

Comment Code					
Inspector Comment					
DS_ID:25844 FS_ID:84148 EP_NO: N/A Repair Type: No Action Needed EVAL Issue: Crossing Status: Found UCIP Comments: 06/22/2023 Record updated to No Action Needed. No issues observed during inspection. (M. Thao - DWR UCIP) FIELD_STRUCT_DESC: *NOT THROUGH LEVEE* 24-inch reinforced concrete gravity drainage pipe, 3.5 feet below the Garden Highway (old levee crown). Drainage inlet is located in the drainage swale between the setback levee and Garden Highway. Pipe outlet is located at the waterside (WS) slope with rip rap. Another drainage inlet is located on the Garden Highway WS toe and discharges in the main channel. (24-inch pipe authorized under the Natomas Levee Improvement Project under Permit No. 18159-4, 2010 - Sacramento Area Flood Control Agency). [Additional Reference(s): SAFCA As-Built Drawing No. 6-04-2270, 28 June 2013, Sheet 124 (C-405), Station 411+47.79, listed as Drain 23E]. FS Date: 6/22/2023

Levee crown looking downstream.

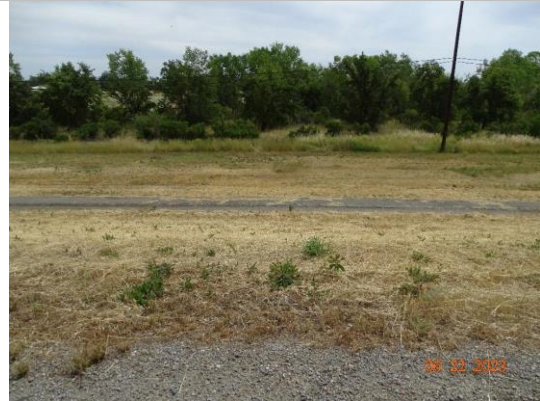
Photo 2 of 3 : UCIP_FA_2024_84148_118515.jpg

LM Start	7.78	Rating **	A	Issue No.	250 (cont)
LM End	7.78	Issue Type +	Ma	Location *	
Category	Supplemental			GPS Latitude/Longitude	
				Start	End
Item	DWR UCIP LMA Responsibility			38.680565°	38.680565°
				-121.630465°	-121.630465°
DWR ID	25844

LS view: General overview looking from crown.

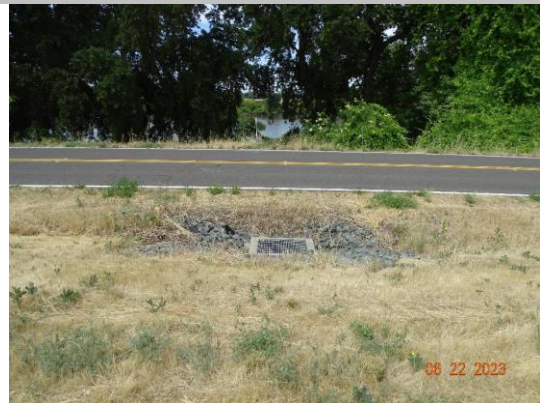
Photo 3 of 3 : UCIP_FA_2024_84148_118516.jpg

WS view: Pipe drop inlet located in the swale between the setback levee and Garden Highway; looking from crown.

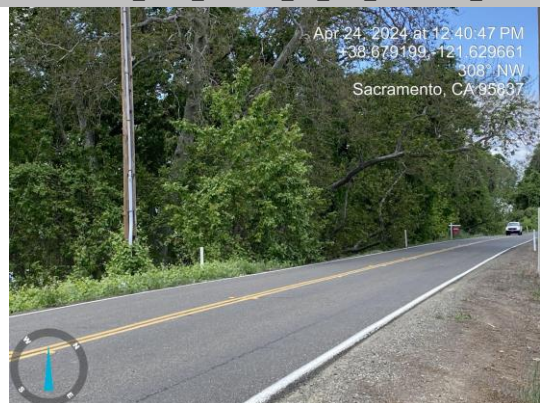
Photo 1 of 1 : FA_2024_RD1000_31_218_20240911_00078.jpg

LM Start	7.87	Rating **	M	Issue No.	218
LM End	7.87	Issue Type +	En	Location *	WS
Category	Earthen Levee			GPS Latitude/Longitude	
				Start	End
Item	Vegetation			38.679421°	38.679421°
				-121.629776°	-121.629776°
DWR ID	DWR_RD1000_01_f_2023_218				
Comment Code					
V6 : Landscaping					
Inspector Comment					
The landscape vegetation limits the ability to see the waterside slope and will make it difficult to access for flood fight.

View of landscape vegetation on the waterside slope (Spring 2024).

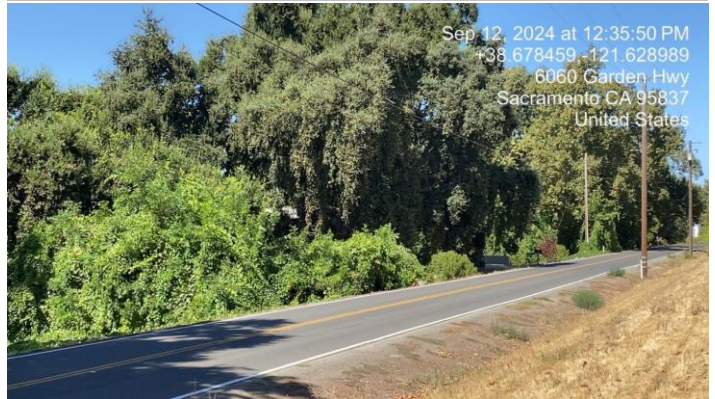
Photo 1 of 1 : FA_2024_RD1000_31_203_20240916_00468.jpg

LM Start	7.91	Rating **	U	Issue No.	203
LM End	7.96	Issue Type +	En	Location *	
Category	Earthen Levee			GPS Latitude/Longitude	
				Start	End
Item	Vegetation			38.678804 °	38.678220 °
				-121.629382 °	-121.628975 °
DWR ID	DWR_RD1000_01_f_2024_203				
Comment Code					
V6 : Landscaping					
Inspector Comment					
The landscape vegetation prevents the ability to see the waterside slope and will make it difficult to access for flood fight.

View of landscape vegetation on the waterside slope (Fall 2024).

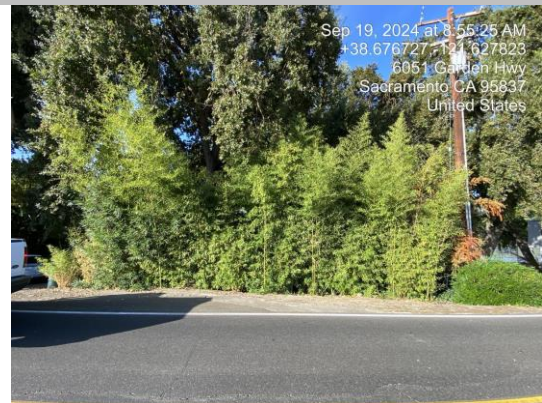
Photo 1 of 1 : FA_2024_RD1000_31_220_20240920_00487.jpg

LM Start	8.08	Rating **	U	Issue No.	220
LM End	8.09	Issue Type +	En	Location *	WS
Category	Earthen Levee			GPS Latitude/Longitude	
				Start	End
Item	Vegetation			38.676840 °	38.676605 °
				-121.627720 °	-121.627629 °
DWR ID	DWR_RD1000_01_f_2023_220				
Comment Code					
V6 : Landscaping					
Inspector Comment					
The landscape vegetation prevents the ability to see the waterside slope and will make it difficult to access for flood fight.

View of landscape vegetation on the waterside slope (Fall 2024).

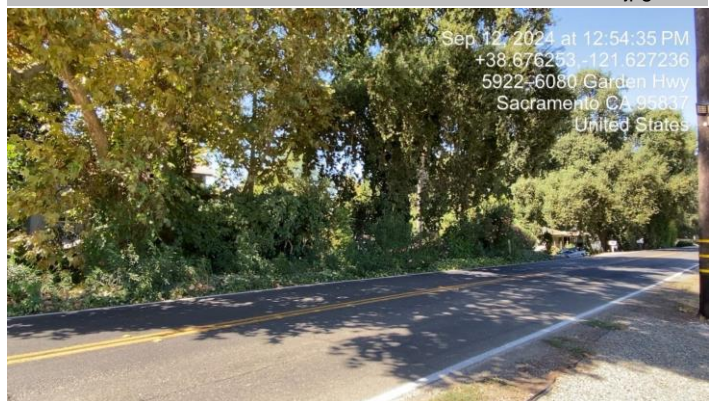
Photo 1 of 1 : FA_2024_RD1000_31_90_20240916_00469.jpg

LM Start	8.11	Rating **	U	Issue No.	90
LM End	8.14	Issue Type +	En	Location *	WS
Category	Earthen Levee			GPS Latitude/Longitude	
				Start	End
Item	Vegetation			38.676425 °	38.676038 °
				-121.627462 °	-121.627063 °
DWR ID	DWR_RD1000_01_s_2012_90				
Comment Code					
V6 : Landscaping					
Inspector Comment					
The landscape vegetation prevents the ability to see the waterside slope and will make it difficult to access for flood fight.

View of landscape vegetation on the waterside slope (Fall 2024).

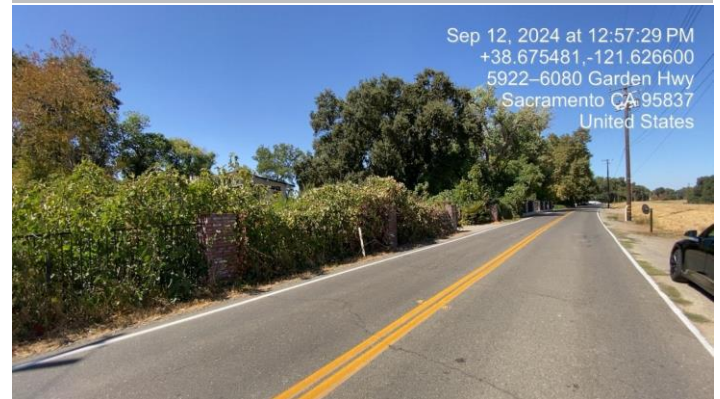
Photo 1 of 1 : FA_2024_RD1000_31_209_20240916_00470.jpg

LM Start	8.17	Rating **	U	Issue No.	209
LM End	8.19	Issue Type +	En	Location *	WS
Category	Earthen Levee			GPS Latitude/Longitude	
				Start	End
Item	Vegetation			38.675717 °	38.675457 °
				-121.626913 °	-121.626552 °
DWR ID	DWR_RD1000_01_f_2024_209				
Comment Code					
V6 : Landscaping					
Inspector Comment					
The landscape vegetation prevents the ability to see the waterside slope and will make it difficult to access for flood fight.

View of landscape vegetation on the waterside slope (Fall 2024).

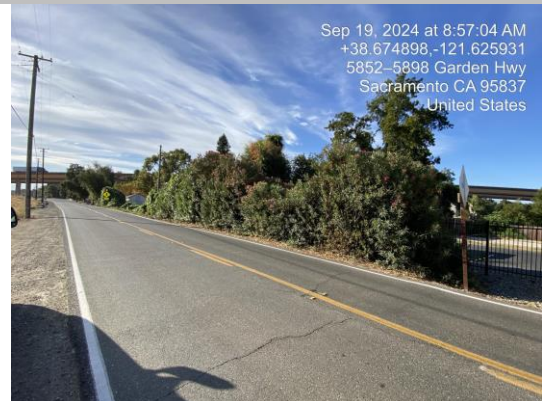
Photo 1 of 1 : FA_2024_RD1000_31_219_20240920_00488.jpg

LM Start	8.24	Rating **	U	Issue No.	219
LM End	8.30	Issue Type +	En	Location *	WS
Category	Earthen Levee			GPS Latitude/Longitude	
				Start	End
Item	Vegetation			38.674921 °	38.674313 °
				-121.625833 °	-121.625145 °
DWR ID	DWR_RD1000_01_f_2023_219				
Comment Code					
V6 : Landscaping					
Inspector Comment					
The landscape vegetation prevents the ability to see the waterside slope and will make it difficult to access for flood fight.

View of landscape vegetation on the waterside slope (Fall 2024).

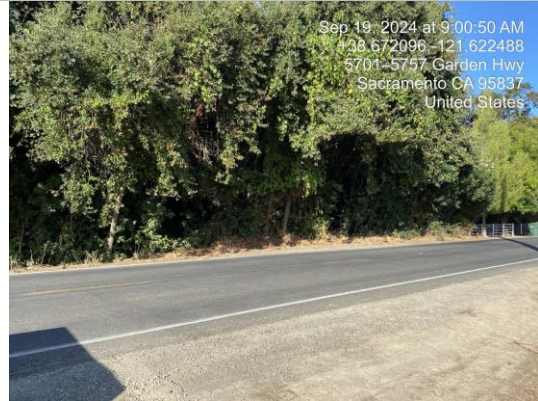
Photo 1 of 1 : FA_2024_RD1000_31_204_20240920_00489.jpg

LM Start	8.50	Rating **	U	Issue No.	204
LM End	8.57	Issue Type +	En	Location *	WS
Category	Earthen Levee			GPS Latitude/Longitude	
				Start	End
Item	Vegetation			38.672165 °	38.671441 °
				-121.622688 °	-121.621832 °
DWR ID	DWR_RD1000_01_s_2024_204				
Comment Code					
V6 : Landscaping					
Inspector Comment					
The landscape vegetation prevents the ability to see the waterside slope and will make it difficult to access for flood fight.

View of landscape vegetation on the waterside slope (Fall 2024).

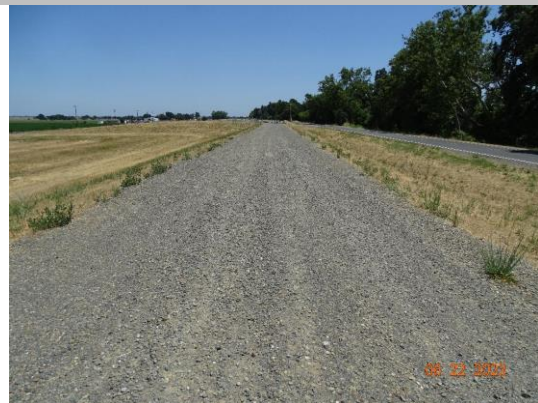
Photo 1 of 3 : UCIP_FA_2024_84149_118905.jpg

Comment Code					
Inspector Comment					
DS_ID:25903 FS_ID:84149 EP_NO: N/A Repair Type: No Action Needed EVAL Issue: Crossing Status: Found UCIP Comments: 06/22/2023 Record updated to No Action Needed. No issues observed during inspection. (M. Thao - DWR UCIP) FIELD_STRUCT_DESC: *NOT THROUGH LEVEE* 24-inch reinforced concrete gravity drainage pipe, 3 feet below the Garden Highway (old levee crown). Drainage inlet is located in the drainage swale between the setback levee and Garden Highway. Pipe outlet is located at the waterside (WS) toe with rip rap. (24-inch pipe authorized under the Natomas Levee Improvement Project under Permit No. 18159-4, 2010 - Sacramento Area Flood Control Agency). [Additional Reference(s): SAFCA As-Built Drawing No. 6-04-2270, 28 June 2013, Sheet 56 (G-220) , Station 454+05, listed as Drain 24C]. FS Date: 6/22/2023

Levee crown looking downstream.

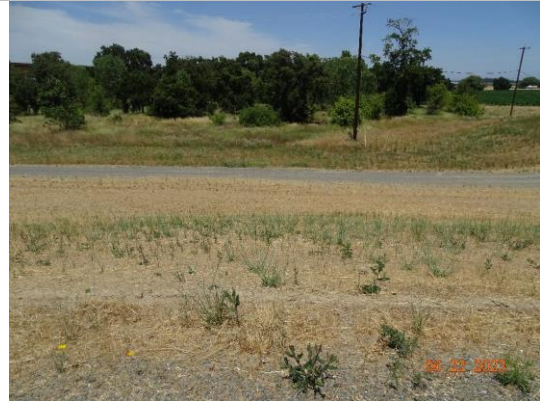
Photo 2 of 3 : UCIP_FA_2024_84149_118906.jpg

LS view: General overview looking from crown.

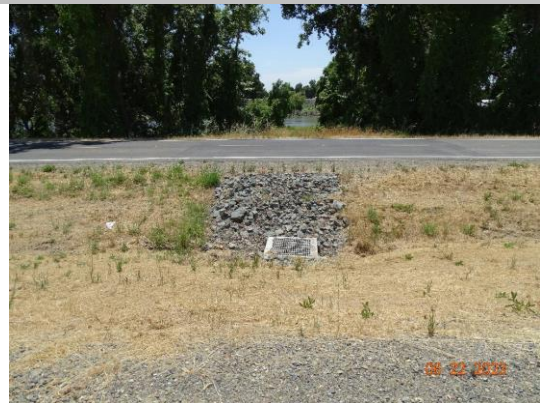
Photo 3 of 3 : UCIP_FA_2024_84149_118907.jpg

WS view: Drainage inlet located in the swale between the Garden Highway and setback levee; looking from crown.

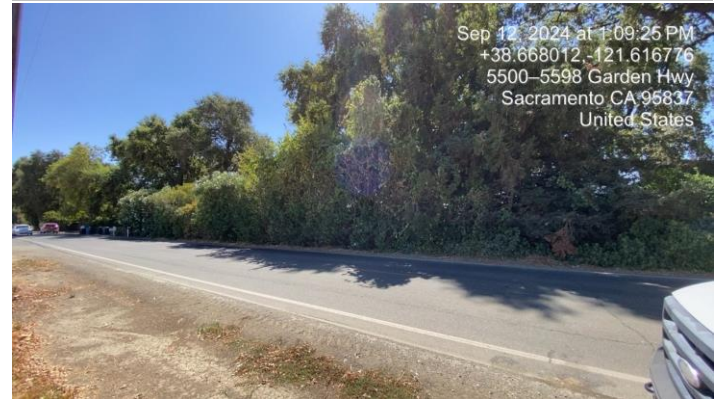
Photo 1 of 1 : FA_2024_RD1000_31_81_20240916_00471.jpg

LM Start	8.90	Rating **	U	Issue No.	81
LM End	8.96	Issue Type +	En	Location *	WS
Category	Earthen Levee			GPS Latitude/Longitude	
				Start	End
Item	Vegetation			38.668312 °	38.667783 °
				-121.617138 °	-121.616382 °
DWR ID	DWR_RD1000_01_s _ 2012_81				
Comment Code					
V6 : Landscaping					
Inspector Comment					
The landscape vegetation prevents the ability to see the waterside slope and will make it difficult to access for flood fight.

View of landscape vegetation on the waterside slope (Fall 2024).

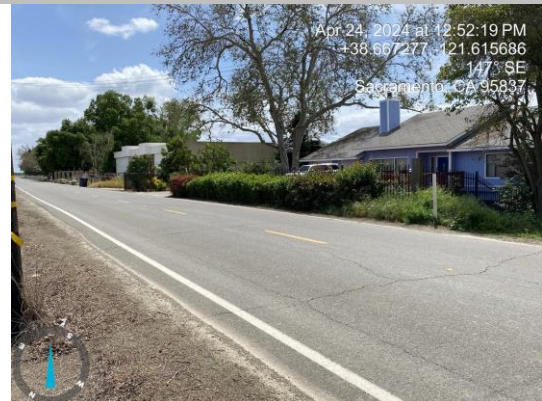
Photo 1 of 1 : FA_2024_RD1000_31_78_20240911_00042.jpg

LM Start	9.02	Rating **	M	Issue No.	78
LM End	9.04	Issue Type +	En	Location *	WS
Category	Earthen Levee			GPS Latitude/Longitude	
				Start	End
Item	Vegetation			38.667250°	38.667028°
				-121.615522°	-121.615115°
DWR ID	DWR_RD1000_01_s _ 2012_78				
Comment Code					
V6 : Landscaping					
Inspector Comment					
The landscape vegetation limits the ability to see the waterside slope and will make it difficult to access for flood fight.

View of landscape vegetation on the waterside slope (Spring 2024).

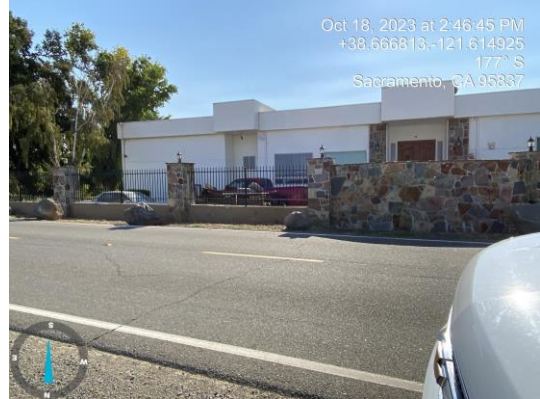
Photo 1 of 1 : FA_2024_RD1000_31_2_20240911_00002.jpg

LM Start	9.06	Rating **	M	Issue No.	2
LM End	9.08	Issue Type +	En	Location *	WS
Category	Earthen Levee			GPS Latitude/Longitude	
				Start	End
Item	Encroachments			38.666821 °	38.666604 °
				-121.615019 °	-121.614672 °
DWR ID	DWR_RD1000_01_s_2012_2				
Comment Code					
FE : Fence					
Inspector Comment					
There is an unacceptable fence at this location. According to the NOV, all panels of the fence are to be removed. The owner has removed some of the panels between the posts.

This photo was taken from the crown facing downstream on the waterward levee slope at a fence enforcement issue (Fall 2023).

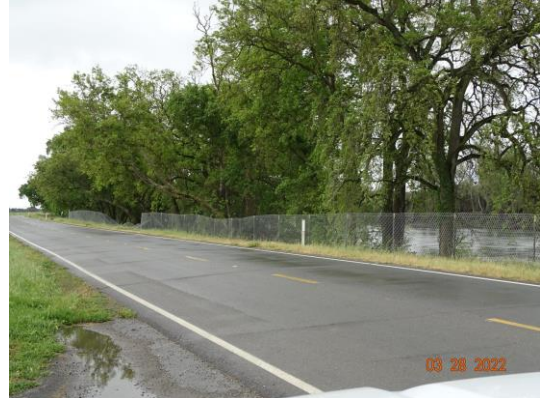
Photo 1 of 1 : FA_2024_RD1000_31_10_20240911_00009.jpg

LM Start	9.09	Rating **	M	Issue No.	10
LM End	9.18	Issue Type +	En	Location *	WS
Category	Earthen Levee			GPS Latitude/Longitude	
				Start	End
Item	Encroachments			38.666650 °	38.665750 °
				-121.614461 °	-121.613078 °
DWR ID	DWR_RD1000_01_f _ 2017_10				
Comment Code					
FE : Fence					
Inspector Comment					
Non-permitted fence needs to be removed.

View on waterside of a non-permitted fence (Spring 2022).

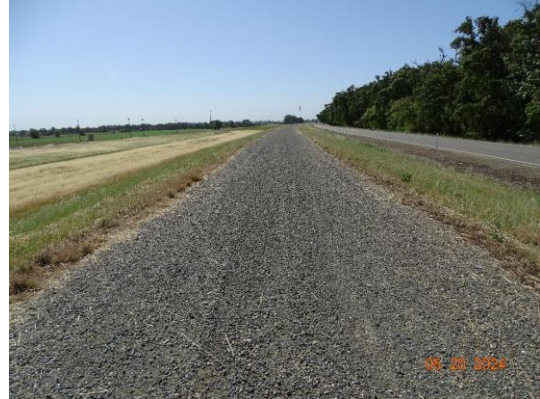
Photo 1 of 3 : UCIP_FA_2024_83960_123584.jpg

Levee crown looking downstream.

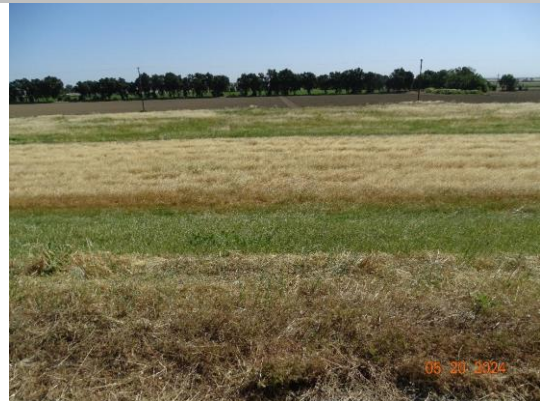
Photo 2 of 3 : UCIP_FA_2024_83960_123585.jpg

LS view: General overview looking from crown.

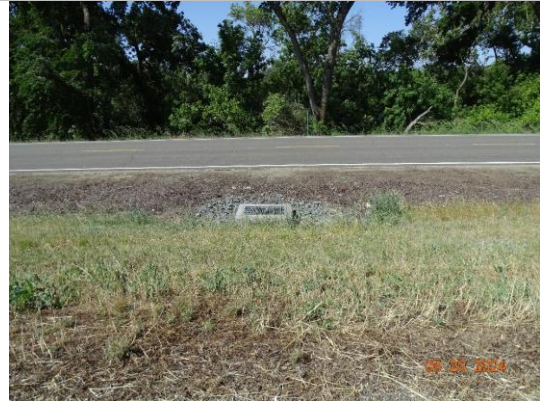
Photo 3 of 3 : UCIP_FA_2024_83960_123586.jpg

WS view: Drainage inlet located in the swale between the setback levee and Garden Highway; looking from crown.

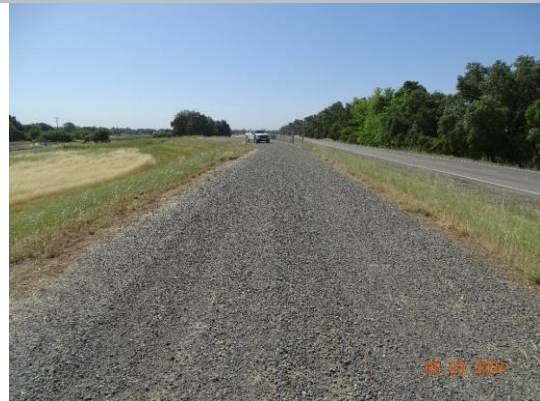
Photo 1 of 3 : UCIP_FA_2024_83959_123580.jpg

Levee crown looking downstream.

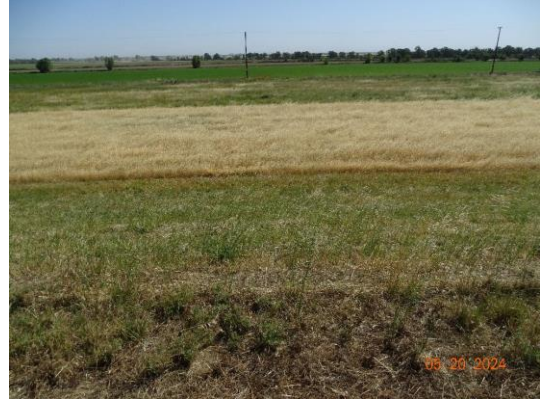
Photo 2 of 3 : UCIP_FA_2024_83959_123582.jpg

LS view: General overview looking from crown.

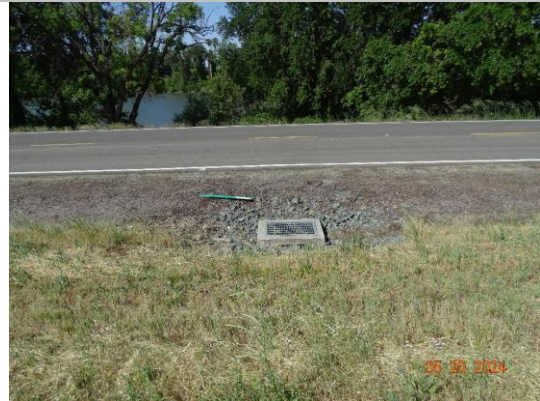
Photo 3 of 3 : UCIP_FA_2024_83959_123581.jpg

WS view: Drainage inlet located in the swale between the setback levee and Garden Highway; looking from crown.

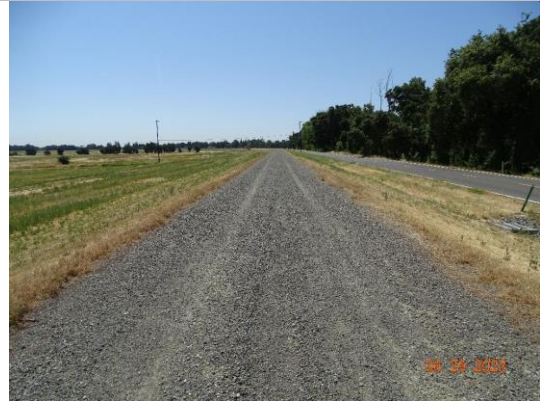
Photo 1 of 3 : UCIP_FA_2024_81728_118520.jpg

Comment Code						
Inspector Comment						
DS_ID:25847 FS_ID:81728 EP_NO: N/A Repair Type: Non-Urgent EVAL Issue: Crossing Status: Found UCIP Comments: 06/29/2023 Record updated to Non-Urgent. Dense vegetation limits inspection of levee on WS (M. Thao - DWR UCIP) FIELD_STRUCT_DESC: *NOT THROUGH LEVEE* 24-inch reinforced concrete gravity drainage pipe, 3 feet below the Garden Highway. Drainage inlet is located in the drainage swale between the setback levee and Garden Highway. Pipe outlet is located at the waterside (WS) slope with rip rap. (24-inch pipe authorized under Permit No. 18159-7, 2011 - Sacramento Area Flood Control Agency). [Additional Reference(s): SAFCA As-Built Drawing No. 6-04-2271, 19 April 2013, Sheet 113 (C-402), Station 554+86, listed as Drain 28]. FS Date: 6/29/2023

Levee crown looking downstream.

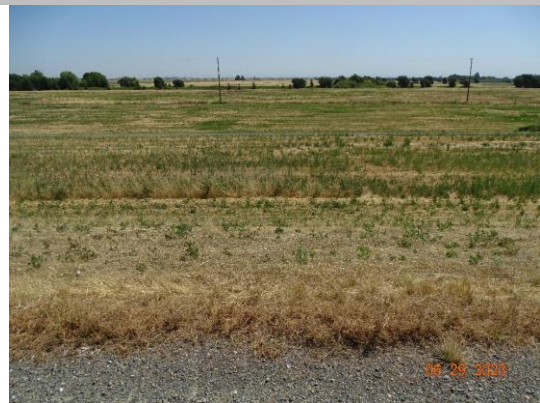
Photo 2 of 3 : UCIP_FA_2024_81728_118521.jpg

LS view: General overview looking from crown.

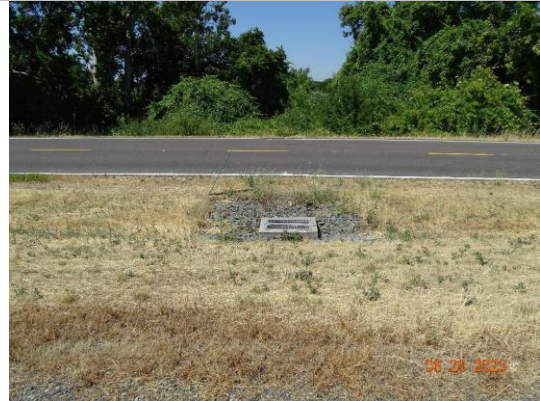
Photo 3 of 3 : UCIP_FA_2024_81728_118522.jpg

WS view: Pipe drop inlet located in the swale between the setback levee and Garden Highway; looking from crown.

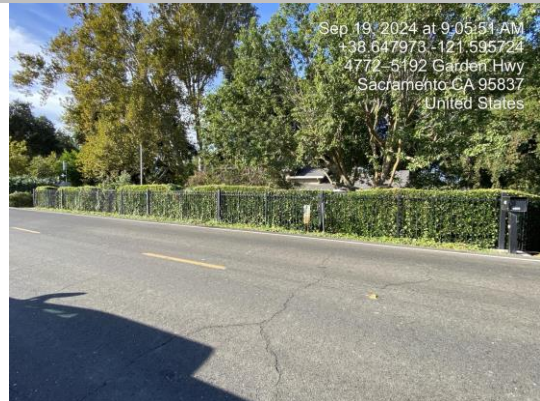
Photo 1 of 1 : FA_2024_RD1000_31_74_20240920_00490.jpg

LM Start	10.72	Rating **	U	Issue No.	74
LM End	10.76	Issue Type +	En	Location *	WS
Category	Earthen Levee			GPS Latitude/Longitude	
				Start	End
Item	Vegetation			38.648127 °	38.647663 °
				-121.595872 °	-121.595483 °
DWR ID	DWR_RD1000_01_s_2012_74				
Comment Code					
V6 : Landscaping					
Inspector Comment					
The landscape vegetation prevents the ability to see the waterside slope and will make it difficult to access for flood fight.

View of landscape vegetation on the waterside slope (Fall 2024).

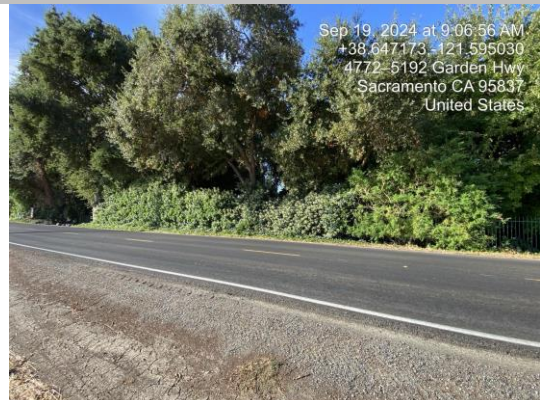
Photo 1 of 1 : FA_2024_RD1000_31_73_20240920_00491.jpg

LM Start	10.78	Rating **	U	Issue No.	73
LM End	10.83	Issue Type +	En	Location *	WS
Category	Earthen Levee			GPS Latitude/Longitude	
				Start	End
Item	Vegetation			38.647373 °	38.646825 °
				-121.595248 °	-121.594800 °
DWR ID	DWR_RD1000_01_s_2012_73				
Comment Code					
V6 : Landscaping					
Inspector Comment					
The landscape vegetation prevents the ability to see the waterside slope and will make it difficult to access for flood fight.

View of landscape vegetation on the waterside slope (Fall 2024).

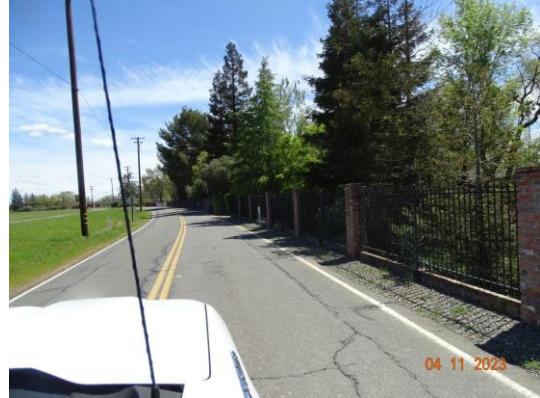
Photo 1 of 1 : FA_2024_RD1000_31_72_20240911_00038.jpg

LM Start	11.06	Rating **	M	Issue No.	72
LM End	11.13	Issue Type +	En	Location *	WS
Category	Earthen Levee			GPS Latitude/Longitude	
				Start	End
Item	Vegetation			38.644548 °	38.644302 °
				-121.591768 °	-121.590572 °
DWR ID	DWR_RD1000_01_s_2012_72				
Comment Code					
V6 : Landscaping					
Inspector Comment					
The landscape vegetation limits the ability to see the waterside slope and will make it difficult to access for flood fight.

View taken from the crown facing downstream looking at the waterward levee slope at the landscaping (Spring 2023).

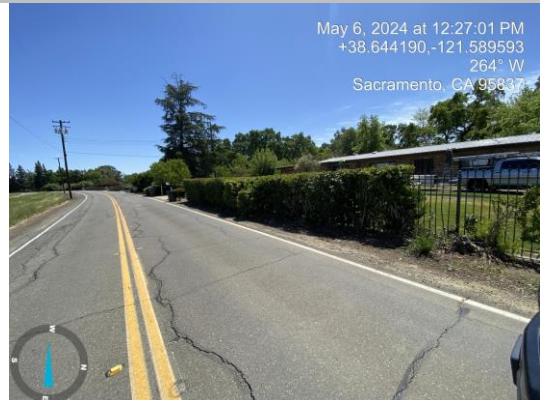
Photo 1 of 1 : FA_2024_RD1000_31_205_20240911_00066.jpg

LM Start	11.18	Rating **	M	Issue No.	205
LM End	11.21	Issue Type +	En	Location *	WS
Category	Earthen Levee			GPS Latitude/Longitude	
				Start	End
Item	Vegetation			38.644167 °	38.644181 °
				-121.589611 °	-121.588993 °
DWR ID	DWR_RD1000_01_s_2024_205				
Comment Code					
V6 : Landscaping					
Inspector Comment					
The landscape vegetation limits the ability to see the waterside slope and will make it difficult to access for flood fight.

View of landscape vegetation on the waterside slope (Spring 2024).

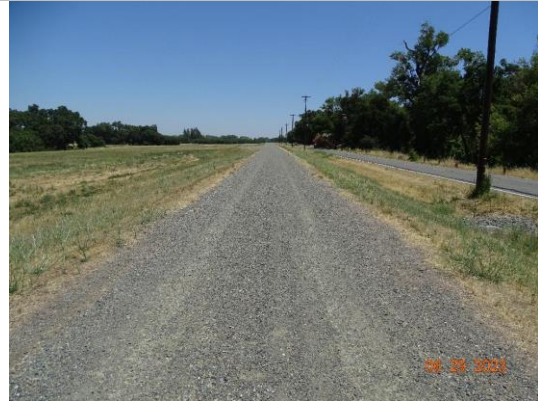
Photo 1 of 3 : UCIP_FA_2024_81730_118523.jpg

Comment Code					
Inspector Comment					
DS_ID:25848 FS_ID:81730 EP_NO: N/A Repair Type: Non-Urgent EVAL Issue: Crossing Status: Found UCIP Comments: 06/29/2023 Record updated to Non-Urgent. Dense vegetation limits inspection of levee and pipe on WS. (M. Thao - DWR UCIP) FIELD_STRUCT_DESC: *NOT THROUGH LEVEE* 24-inch reinforced concrete gravity drainage pipe, 4.5 feet below the Garden Highway (old levee crown). Drainage inlet is located in the drainage swale between the setback levee and Garden Highway. Pipe outlet is located at the waterside (WS) slope with rip rap. (24-inch pipe authorized under the Natomas Levee Improvement Project under Permit No. 18159-7, 2011 - Sacramento Area Flood Control Agency). [Additional Reference(s): SAFCA As-Built Drawing No. 6-04-2271, 19 April 2013, Sheet 114 (C-403), Station 613+05, listed as Drain 29]. FS Date: 6/29/2023

Levee crown looking downstream.

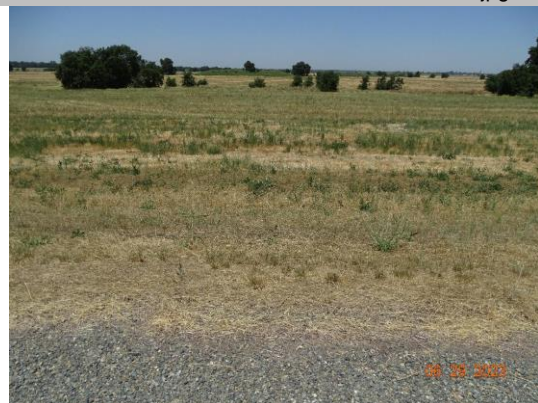
Photo 2 of 3 : UCIP_FA_2024_81730_118524.jpg

LS view: General overview looking from crown.

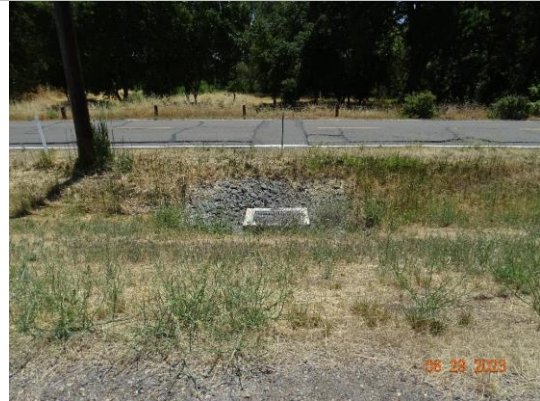
Photo 3 of 3 : UCIP_FA_2024_81730_118525.jpg

WS view: Pipe drop inlet located in the swale between the setback levee and Garden Highway; looking from crown.

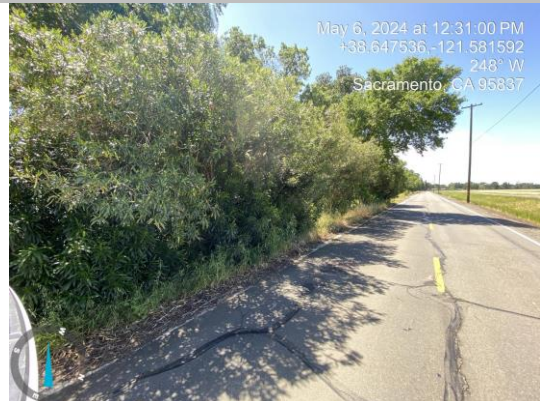
Photo 1 of 1 : FA_2024_RD1000_31_222_20240911_00081.jpg

LM Start	11.67	Rating **	M	Issue No.	222
LM End	11.70	Issue Type +	En	Location *	WS
Category	Earthen Levee			GPS Latitude/Longitude	
				Start	End
Item	Vegetation			38.647460 °	38.647662 °
				-121.581729 °	-121.581377 °
DWR ID	DWR_RD1000_01_f_2023_222				
Comment Code					
V6 : Landscaping					
Inspector Comment					
The landscape vegetation limits the ability to see the waterside slope and will make it difficult to access for flood fight.

View of landscape vegetation on the waterside slope (Spring 2024).

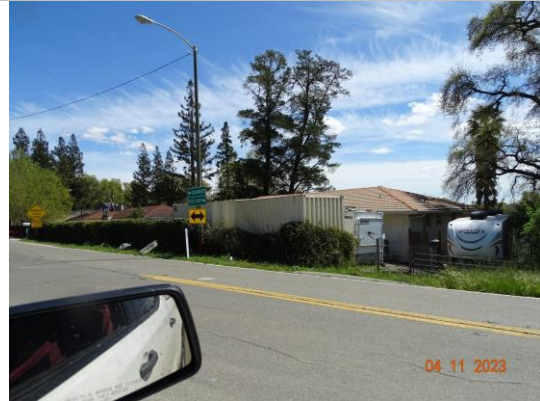
Photo 1 of 1 : FA_2024_RD1000_31_12_20240911_00010.jpg

LM Start	12.00	Rating **	M	Issue No.	12
LM End	12.00	Issue Type +	En	Location *	WS
Category	Earthen Levee			GPS Latitude/Longitude	
				Start	End
Item	Encroachments			38.650103°	38.650103°
				-121.576796°	-121.576796°
DWR ID	DWR_RD1000_01_s_2023_12				
Comment Code					
BU : Building					
Inspector Comment					
Shipping container blocking visibility and access on waterside slope.

View facing downstream looking at the shipping container on the waterside slope (Spring 2023).

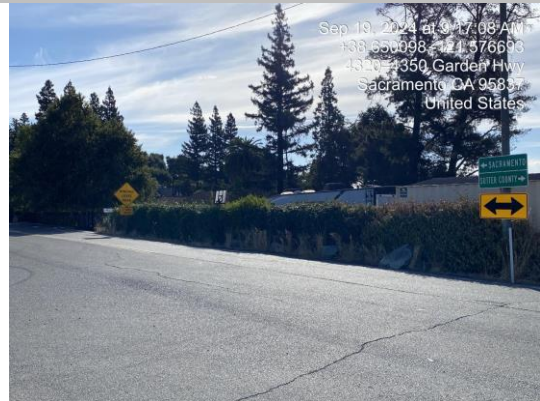
Photo 1 of 1 : FA_2024_RD1000_31_206_20240920_00492.jpg

LM Start	12.00	Rating **	U	Issue No.	206
LM End	12.02	Issue Type +	En	Location *	WS
Category	Earthen Levee			GPS Latitude/Longitude	
				Start	End
Item	Vegetation			38.650059 °	38.650146 °
				-121.576680 °	-121.576328 °
DWR ID	DWR_RD1000_01_s_2024_206				
Comment Code					
V6 : Landscaping					
Inspector Comment					
The landscape vegetation prevents the ability to see the waterside slope and will make it difficult to access for flood fight.

View of landscape vegetation on the waterside slope (Fall 2024).

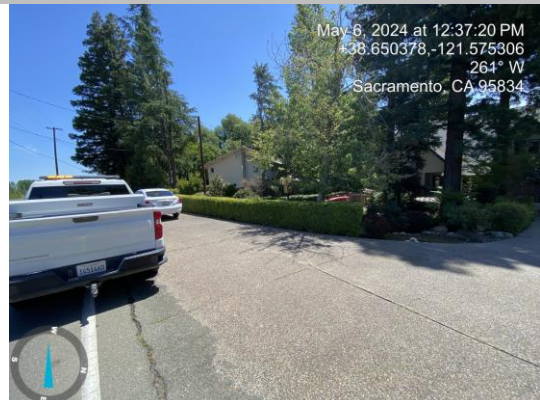
Photo 1 of 1 : FA_2024_RD1000_31_223_20240911_00082.jpg

LM Start	12.08	Rating **	M	Issue No.	223
LM End	12.10	Issue Type +	En	Location *	WS
Category	Earthen Levee			GPS Latitude/Longitude	
				Start	End
Item	Vegetation			38.650326 °	38.650356 °
				-121.575183 °	-121.574940 °
DWR ID	DWR_RD1000_01_f_2023_223				
Comment Code					
V6 : Landscaping					
Inspector Comment					
The landscape vegetation limits the ability to see the waterside slope and will make it difficult to access for flood fight.

View of landscape vegetation on the waterside slope (Spring 2024).

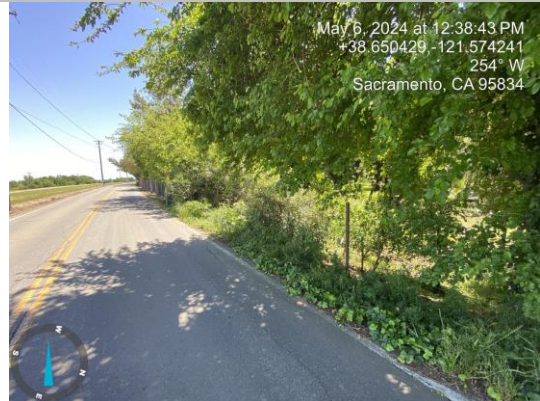
Photo 1 of 1 : FA_2024_RD1000_31_67_20240911_00036.jpg

LM Start	12.12	Rating **	M	Issue No.	67
LM End	12.15	Issue Type +	En	Location *	WS
Category	Earthen Levee			GPS Latitude/Longitude	
				Start	End
Item	Vegetation			38.650419 °	38.650337 °
				-121.574541 °	-121.573886 °
DWR ID	DWR_RD1000_01_s_2012_67				
Comment Code					
V6 : Landscaping					
Inspector Comment					
The landscape vegetation limits the ability to see the waterside slope and will make it difficult to access for flood fight.

View of landscape vegetation on the waterside slope (Spring 2024).

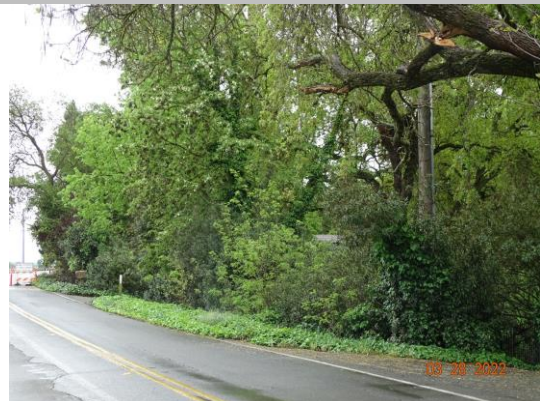
Photo 1 of 1 : FA_2024_RD1000_31_66_20240911_00035.jpg

LM Start	12.24	Rating **	M	Issue No.	66
LM End	12.27	Issue Type +	En	Location *	WS
Category	Earthen Levee			GPS Latitude/Longitude	
				Start	End
Item	Vegetation			38.650245 °	38.650102 °
				-121.572188 °	-121.571816 °
DWR ID	DWR_RD1000_01_s_2012_66				
Comment Code					
V6 : Landscaping					
Inspector Comment					
The landscape vegetation limits the ability to see the waterside slope and will make it difficult to access for flood fight.

View of the landscaping on the waterside levee slope (Spring 2022).

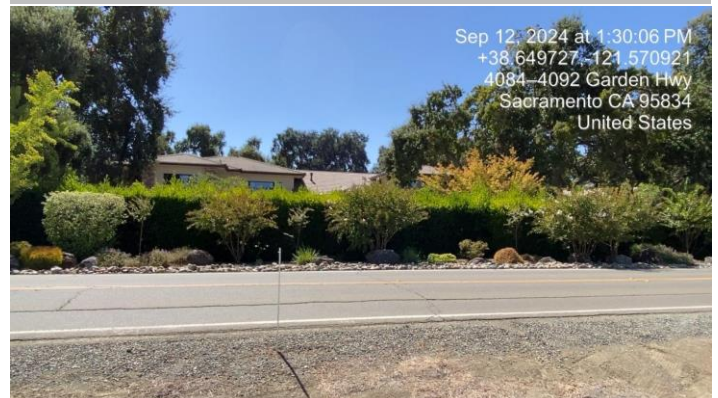
Photo 1 of 1 : FA_2024_RD1000_31_221_20240916_00472.jpg

LM Start	12.29	Rating **	U	Issue No.	221
LM End	12.32	Issue Type +	En	Location *	WS
Category	Earthen Levee			GPS Latitude/Longitude	
				Start	End
Item	Vegetation			38.649961 °	38.649685 °
				-121.571440 °	-121.570843 °
DWR ID	DWR_RD1000_01_f_2024_221				
Comment Code					
V6 : Landscaping					
Inspector Comment					
The landscape vegetation prevents the ability to see the waterside slope and will make it difficult to access for flood fight.

View of landscape vegetation on the waterside slope (Fall 2024).

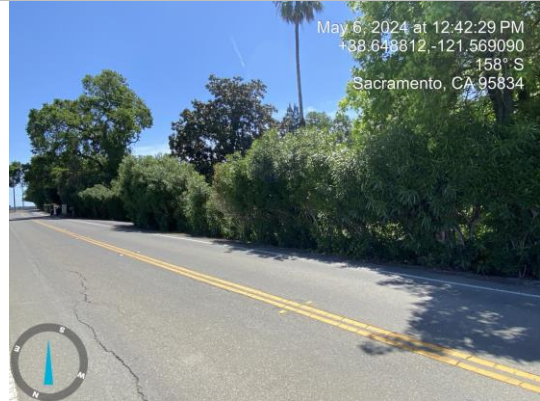
Photo 1 of 1 : FA_2024_RD1000_31_61_20240911_00034.jpg

LM Start	12.44	Rating **	U	Issue No.	61
LM End	12.47	Issue Type +	En	Location *	WS
Category	Earthen Levee			GPS Latitude/Longitude	
				Start	End
Item	Vegetation			38.648897 °	38.648588 °
				-121.569030 °	-121.568467 °
DWR ID	DWR_RD1000_01_s_2012_61				
Comment Code					
V6 : Landscaping					
Inspector Comment					
The landscape vegetation prevents the ability to see the waterside slope and will make it difficult to access for flood fight.

View of landscape vegetation on the waterside slope (Spring 2024).

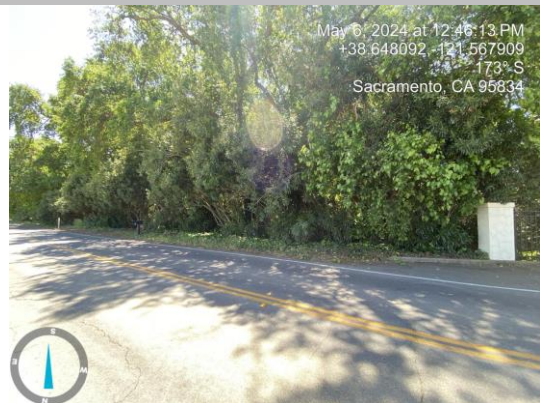
Photo 1 of 1 : FA_2024_RD1000_31_5_20240911_00006.jpg

LM Start	12.52	Rating **	U	Issue No.	5
LM End	12.65	Issue Type +	En	Location *	WS
Category	Earthen Levee			GPS Latitude/Longitude	
				Start	End
Item	Vegetation			38.648056°	38.646750°
				-121.567900°	-121.566227°
DWR ID	DWR_RD1000_01_s_2024_5				
Comment Code					
V6 : Landscaping					
Inspector Comment					
The landscape vegetation prevents the ability to see waterside slope and will make it difficult to access for flood fight.

View of landscape vegetation on the waterside slope (Spring 2024).

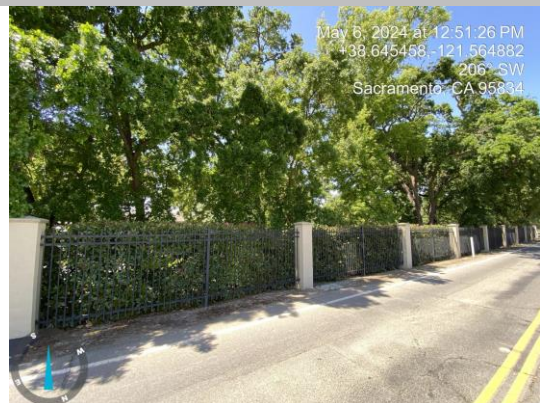
Photo 1 of 1 : FA_2024_RD1000_31_207_20240911_00068.jpg

LM Start	12.73	Rating **	M	Issue No.	207
LM End	12.78	Issue Type +	En	Location *	WS
Category	Earthen Levee			GPS Latitude/Longitude	
				Start	End
Item	Vegetation			38.645854°	38.645299°
				-121.565280°	-121.564710°
DWR ID	DWR_RD1000_01_s_2024_207				
Comment Code					
V6 : Landscaping					
Inspector Comment					
The landscape vegetation limits the ability to see the waterside slope and will make it difficult to access for flood fight.

View of landscape vegetation on the waterside slope (Spring 2024).

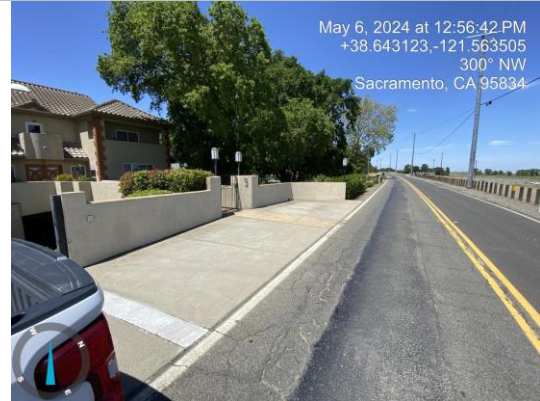
Photo 1 of 1 : FA_2024_RD1000_31_54_20240911_00033.jpg

LM Start	12.93	Rating **	M	Issue No.	54
LM End	12.94	Issue Type +	En	Location *	WS
Category	Earthen Levee			GPS Latitude/Longitude	
				Start	End
Item	Encroachments			38.643380 °	38.643275 °
				-121.563400 °	-121.563307 °
DWR ID	DWR_RD1000_01_s _ 2012_54				
Comment Code					
WL : Wall					
Inspector Comment					
There is a concrete wall running parallel to the levee on the waterside slope that is inhibiting visibility and access to the levee.

View of wall on the waterside slope (Spring 2024).

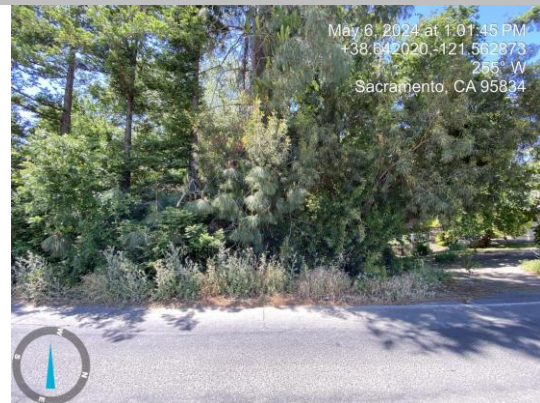
Photo 1 of 1 : FA_2024_RD1000_31_225_20240911_00083.jpg

LM Start	13.00	Rating **	M	Issue No.	225
LM End	13.03	Issue Type +	En	Location *	WS
Category	Earthen Levee			GPS Latitude/Longitude	
				Start	End
Item	Vegetation			38.642323 °	38.641898 °
				-121.563043 °	-121.562894 °
DWR ID	DWR_RD1000_01_f _ 2023_225				
Comment Code					
V6 : Landscaping					
Inspector Comment					
The landscape vegetation limits the ability to see the waterside slope and will make it difficult to access for flood fight.

View of landscape vegetation on the waterside slope (Spring 2024).

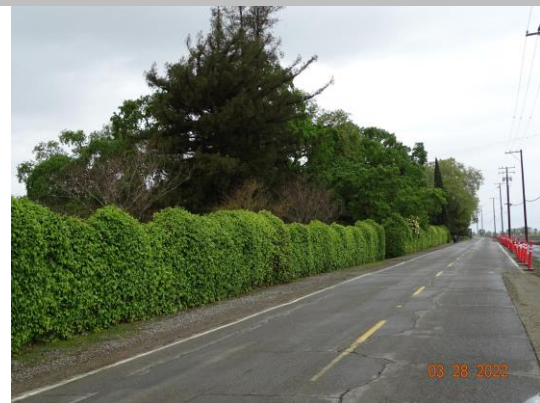
Photo 1 of 1 : FA_2024_RD1000_31_51_20240911_00031.jpg

LM Start	13.15	Rating **	U	Issue No.	51
LM End	13.20	Issue Type +	En	Location *	WS
Category	Earthen Levee			GPS Latitude/Longitude	
				Start	End
Item	Vegetation			38.640205 °	38.639540 °
				-121.562370 °	-121.562238 °
DWR ID	DWR_RD1000_01_s _ 2012_51				
Comment Code					
V6 : Landscaping					
Inspector Comment					
The landscape vegetation prevents the ability to see the waterside slope and will make it difficult to access for flood fight.

View of the landscaping on the waterside levee slope (Spring 2022).

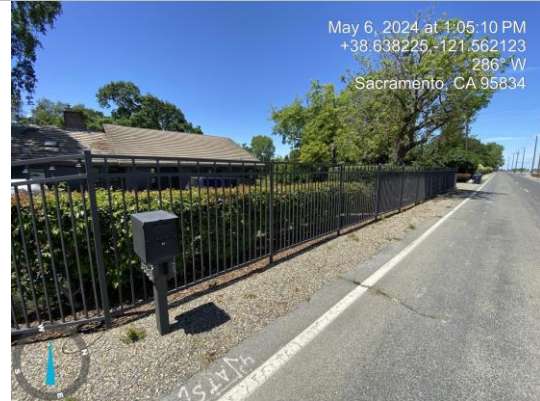
Photo 1 of 1 : FA_2024_RD1000_31_50_20240911_00030.jpg

LM Start	13.26	Rating **	M	Issue No.	50
LM End	13.30	Issue Type +	En	Location *	WS
Category	Earthen Levee			GPS Latitude/Longitude	
				Start	End
Item	Vegetation			38.638668 °	38.638065 °
				-121.562085 °	-121.562015 °
DWR ID	DWR_RD1000_01_s _ 2012_50				
Comment Code					
V6 : Landscaping					
Inspector Comment					
The landscape vegetation limits the ability to see the waterside slope and will make it difficult to access for flood fight.

View of landscape vegetation on the waterside slope (Spring 2024).

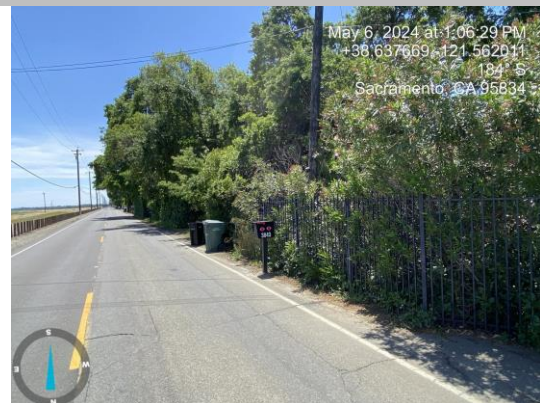
Photo 1 of 1 : FA_2024_RD1000_31_47_20240911_00028.jpg

LM Start	13.37	Rating **	M	Issue No.	47
LM End	13.41	Issue Type +	En	Location *	WS
Category	Earthen Levee			GPS Latitude/Longitude	
				Start	End
Item	Vegetation			38.637052 °	38.636496 °
				-121.561833 °	-121.561740 °
DWR ID	DWR_RD1000_01_s _ 2012_47				
Comment Code					
V6 : Landscaping					
Inspector Comment					
The landscape vegetation limits the ability to see the waterside slope and will make it difficult to access for flood fight.

View of landscape vegetation on the waterside slope (Spring 2024).

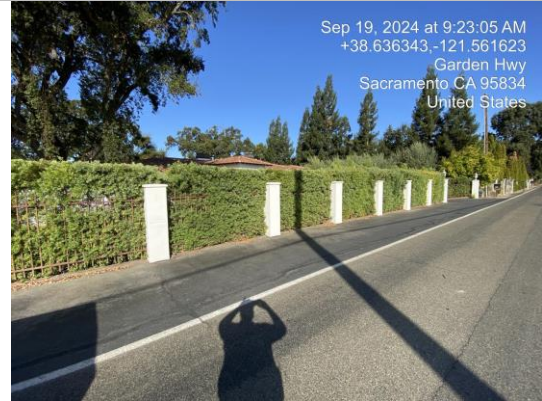
Photo 1 of 1 : FA_2024_RD1000_31_46_20240920_00493.jpg

LM Start	13.41	Rating **	U	Issue No.	46
LM End	13.43	Issue Type +	En	Location *	WS
Category	Earthen Levee			GPS Latitude/Longitude	
				Start	End
Item	Vegetation			38.636522 °	38.636250 °
				-121.561743 °	-121.561667 °
DWR ID	DWR_RD1000_01_s _ 2012_46				
Comment Code					
V6 : Landscaping					
Inspector Comment					
The landscape vegetation prevents the ability to see the waterside slope and will make it difficult to access for flood fight.

View of landscape vegetation on the waterside slope (Fall 2024).
