Flood Control Project Maintenance Levee Inspections

Fall 2024 Levee Maintenance Deficiency Summary Report

Sacramento River Basin

Reclamation District No. 1000 Natomas

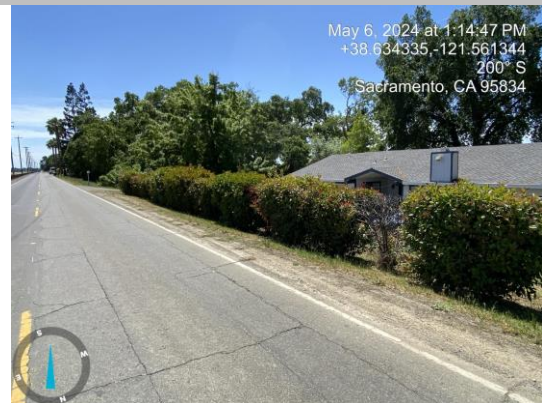
Photo 1 of 1 : FA_2024_RD1000_31_208_20240911_00069.jpg

LM Start	13.56	Rating **	M	Issue No.	208
LM End	13.59	Issue Type +	En	Location *	WS
Category	Earthen Levee			GPS Latitude/Longitude	
				Start	End
Item	Vegetation			38.634333 °	38.633951 °
				-121.561367 °	-121.561320 °
DWR ID	DWR_RD1000_01_s _ 2024_208				
Comment Code					
V6 : Landscaping					
Inspector Comment					
The landscape vegetation limits the ability to see the waterside slope and will make it difficult to access for flood fight.

View of landscape vegetation on the waterside slope (Spring 2024).

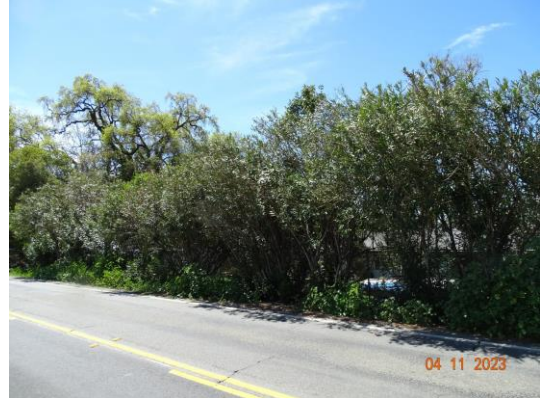
Photo 1 of 1 : FA_2024_RD1000_31_42_20240911_00025.jpg

LM Start	13.98	Rating **	U	Issue No.	42
LM End	14.01	Issue Type +	En	Location *	WS
Category	Earthen Levee			GPS Latitude/Longitude	
				Start	End
Item	Vegetation			38.628300 °	38.627873 °
				-121.560180 °	-121.560202 °
DWR ID	DWR_RD1000_01_s_2012_42				
Comment Code					
V6 : Landscaping					
Inspector Comment					
The landscape vegetation prevents the ability to see waterside slope and will make it difficult to access for flood fight.

View on waterside looking downstream of where the vegetation covers the front of the fence (Spring 2023).

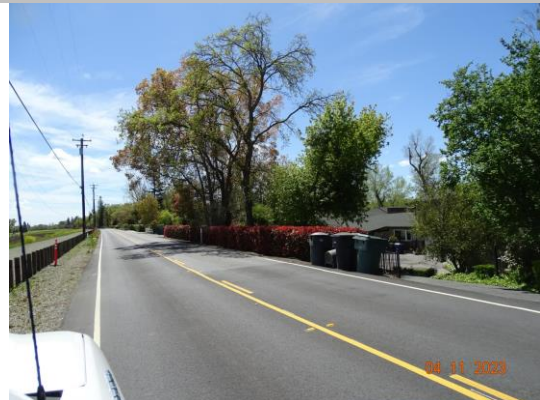
Photo 1 of 1 : FA_2024_RD1000_31_40_20240911_00024.jpg

LM Start	14.09	Rating **	U	Issue No.	40
LM End	14.17	Issue Type +	En	Location *	WS
Category	Earthen Levee			GPS Latitude/Longitude	
				Start	End
Item	Vegetation			38.626677 °	38.625614 °
				-121.560187 °	-121.560245 °
DWR ID	DWR_RD1000_01_s_2015_40				
Comment Code					
V6 : Landscaping					
Inspector Comment					
The landscape vegetation prevents the ability to see the waterside slope and will make it difficult to access for flood fight.

View taken from the crown facing downstream looking at the waterward levee slope at landscaping (Spring 2023).

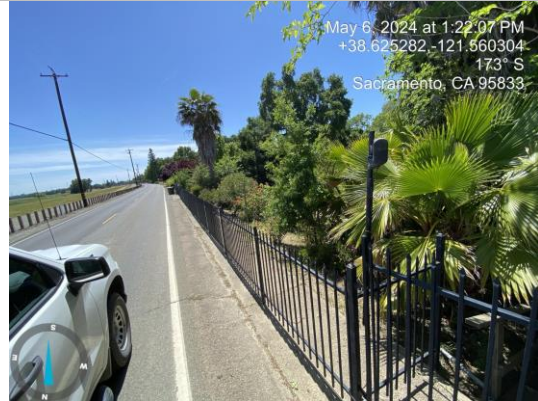
Photo 1 of 1 : FA_2024_RD1000_31_226_20240911_00084.jpg

LM Start	14.19	Rating **	M	Issue No.	226
LM End	14.20	Issue Type +	En	Location *	WS
Category	Earthen Levee			GPS Latitude/Longitude	
				Start	End
Item	Vegetation			38.625289 °	38.625168 °
				-121.560292 °	-121.560303 °
DWR ID	DWR_RD1000_01_f_2023_226				
Comment Code					
V6 : Landscaping					
Inspector Comment					
The landscape vegetation limits the ability to see the waterside slope and will make it difficult to access for flood fight.

View of landscape vegetation on the waterside slope (Spring 2024).

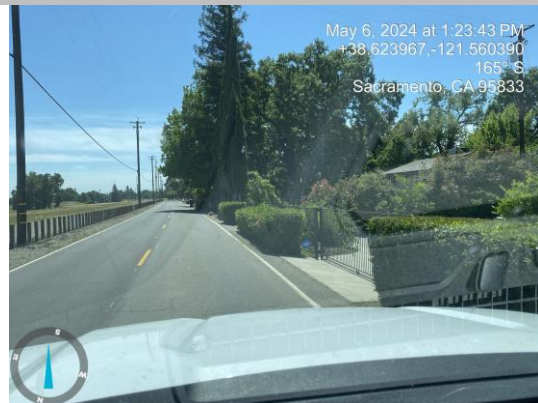
Photo 1 of 1 : FA_2024_RD1000_31_210_20240911_00070.jpg

LM Start	14.28	Rating **	M	Issue No.	210
LM End	14.33	Issue Type +	En	Location *	WS
Category	Earthen Levee			GPS Latitude/Longitude	
				Start	End
Item	Vegetation			38.623975 °	38.623305 °
				-121.560372 °	-121.560352 °
DWR ID	DWR_RD1000_01_s_2024_210				
Comment Code					
V6 : Landscaping					
Inspector Comment					
The landscape vegetation limits the ability to see the waterside slope and will make it difficult to access for flood fight.

View of landscape vegetation on the waterside slope (Spring 2024).

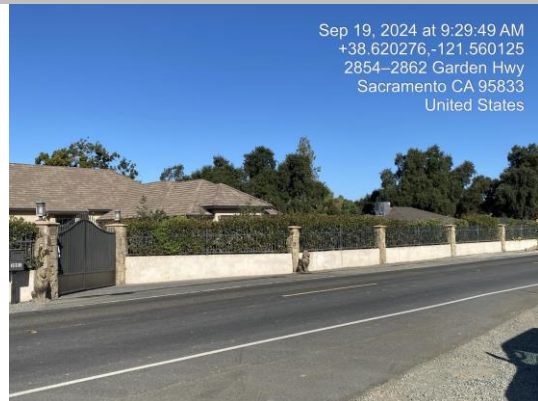
Photo 1 of 1 : FA_2024_RD1000_31_212_20240920_00494.jpg

LM Start	14.51	Rating **	U	Issue No.	212
LM End	14.54	Issue Type +	En	Location *	WS
Category	Earthen Levee			GPS Latitude/Longitude	
				Start	End
Item	Vegetation			38.620648 °	38.620217 °
				-121.560181 °	-121.560078 °
DWR ID	DWR_RD1000_01_s_2024_212				
Comment Code					
V6 : Landscaping					
Inspector Comment					
The landscape vegetation prevents the ability to see the waterside slope and will make it difficult to access for flood fight.

View of landscape vegetation on the waterside slope (Fall 2024).

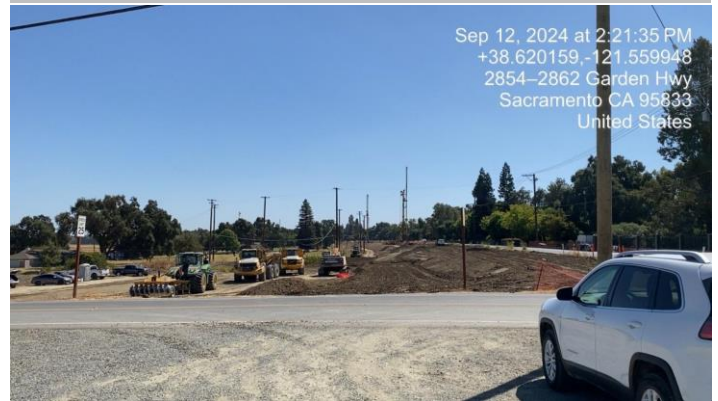
Photo 1 of 1 : FA_2024_RD1000_31_227_20240916_00473.jpg

LM Start	14.54	Rating **	A/W	Issue No.	227
LM End	17.53	Issue Type +	En	Location *	CR
Category	Earthen Levee			GPS Latitude/Longitude	
				Start	End
Item	Encroachments			38.620213 °	38.605511 °
				-121.560076 °	-121.524365 °
DWR ID	DWR_RD1000_01_s_2024_227				
Comment Code					
LC : Authorized Levee Construction					
Inspector Comment

View of levee construction (Fall 2024).

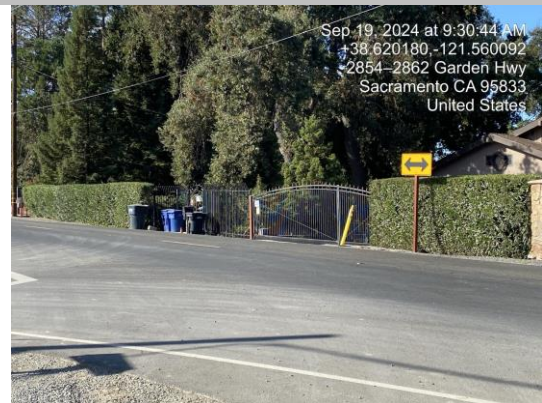
Photo 1 of 1 : FA_2024_RD1000_31_38_20240920_00495.jpg

LM Start	14.55	Rating **	U	Issue No.	38
LM End	14.58	Issue Type +	En	Location *	WS
Category	Earthen Levee			GPS Latitude/Longitude	
				Start	End
Item	Vegetation			38.620077°	38.619630°
				-121.560120°	-121.560067°
DWR ID	DWR_RD1000_01_s_2012_38				
Comment Code					
V6 : Landscaping					
Inspector Comment					
The landscape vegetation prevents the ability to see the waterside slope and will make it difficult to access for flood fight.

View of landscape vegetation on the waterside slope (Fall 2024).

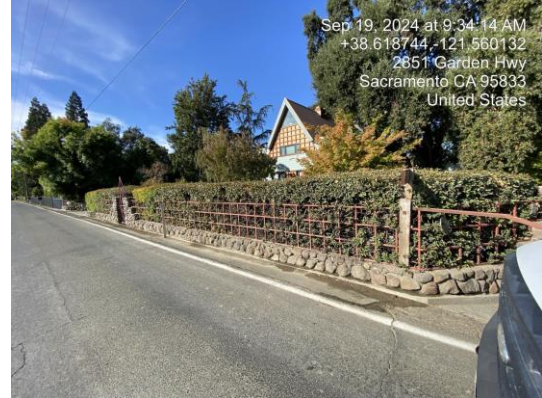
Photo 1 of 1 : FA_2024_RD1000_31_37_20240920_00496.jpg

LM Start	14.64	Rating **	U	Issue No.	37
LM End	14.66	Issue Type +	En	Location *	WS
Category	Earthen Levee			GPS Latitude/Longitude	
				Start	End
Item	Vegetation			38.618744 °	38.618493 °
				-121.560143 °	-121.560070 °
DWR ID	DWR_RD1000_01_s_2012_37				
Comment Code					
V6 : Landscaping					
Inspector Comment					
The landscape vegetation prevents the ability to see the waterside slope and will make it difficult to access for flood fight.

View of landscape vegetation on the waterside slope (Fall 2024).

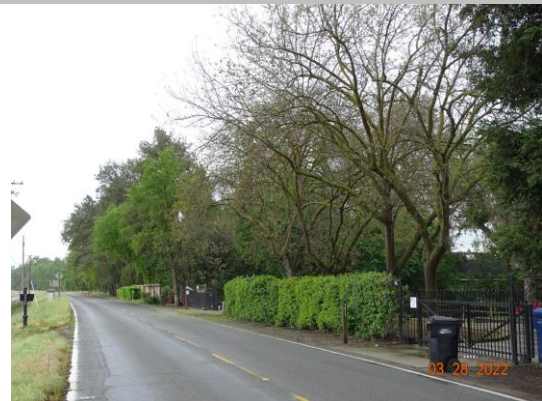
Photo 1 of 1 : FA_2024_RD1000_31_35_20240911_00021.jpg

LM Start	14.69	Rating **	M	Issue No.	35
LM End	14.77	Issue Type +	En	Location *	WS
Category	Earthen Levee			GPS Latitude/Longitude	
				Start	End
Item	Vegetation			38.617972 °	38.616835 °
				-121.560044 °	-121.559807 °
DWR ID	DWR_RD1000_01_s_2012_35				
Comment Code					
V6 : Landscaping					
Inspector Comment					
The landscape vegetation limits the ability to see the waterside slope and will make it difficult to access for flood fight.

View of the landscaping on the waterside levee slope (Spring 2022).

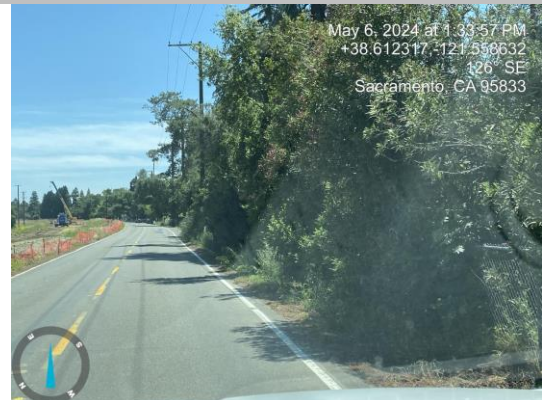
Photo 1 of 1 : FA_2024_RD1000_31_34_20240911_00020.jpg

LM Start	15.08	Rating **	U	Issue No.	34
LM End	15.15	Issue Type +	En	Location *	WS
Category	Earthen Levee			GPS Latitude/Longitude	
				Start	End
Item	Vegetation			38.612555 °	38.611513 °
				-121.558258 °	-121.558250 °
DWR ID	DWR_RD1000_01_s_2012_34				
Comment Code					
V6 : Landscaping					
Inspector Comment					
The landscape vegetation prevents the ability to see the waterside slope and will make it difficult to access for flood fight.

View of landscape vegetation on the waterside slope (Spring 2024).

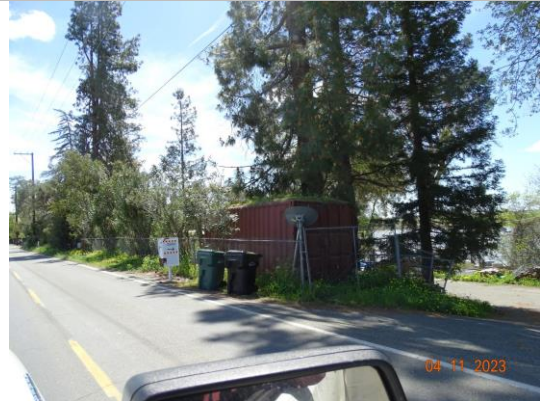
Photo 1 of 1 : FA_2024_RD1000_31_76_20240911_00041.jpg

LM Start	15.09	Rating **	M	Issue No.	76
LM End	15.09	Issue Type +	En	Location *	WS
Category	Earthen Levee			GPS Latitude/Longitude	
				Start	End
Item	Encroachments			38.612340 °	38.612340 °
				-121.558633 °	-121.558633 °
DWR ID	DWR_RD1000_01_f_2012_76				
Comment Code					
BU : Building					
Inspector Comment					
Cargo container on the waterside slope is blocking visibility and needs to be removed.

Cargo container on levee shoulder, the property appears to be on fill material (Spring 2023).

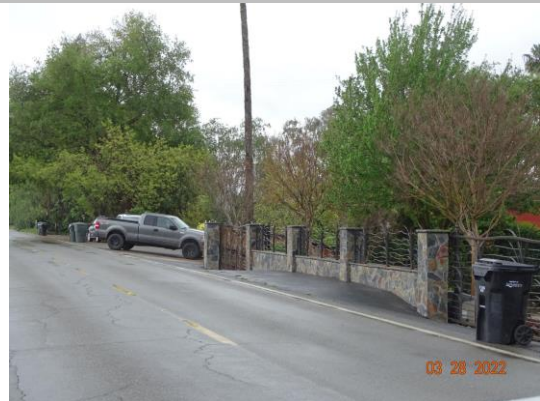
Photo 1 of 1 : FA_2024_RD1000_31_32_20240911_00019.jpg

LM Start	15.25	Rating **	M	Issue No.	32
LM End	15.27	Issue Type +	En	Location *	WS
Category	Earthen Levee			GPS Latitude/Longitude	
				Start	End
Item	Encroachments			38.610180 °	38.609908 °
				-121.557453 °	-121.557328 °
DWR ID	DWR_RD1000_01_s_2012_32				
Comment Code					
FE : Fence					
Inspector Comment					
This rock and wrought iron fence partially blocks visibility and access.

View on waterside looking downstream of a rock and wrought iron fence that partially blocks visibility and access (Spring 2022).

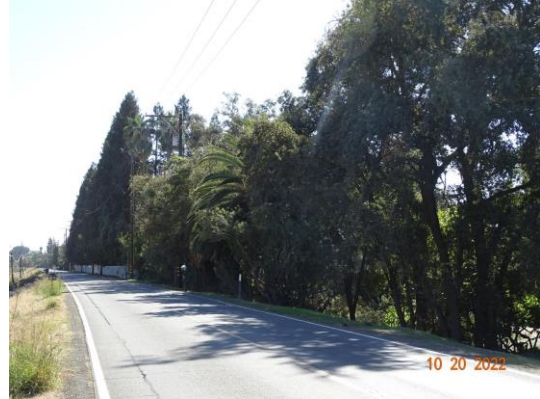
Photo 1 of 1 : FA_2024_RD1000_31_30_20240911_00018.jpg

LM Start	15.44	Rating **	M	Issue No.	30
LM End	15.48	Issue Type +	En	Location *	WS
Category	Earthen Levee			GPS Latitude/Longitude	
				Start	End
Item	Vegetation			38.607715 °	38.607345 °
				-121.555847 °	-121.555538 °
DWR ID	DWR_RD1000_01_s _ 2012_30				
Comment Code					
V6 : Landscaping					
Inspector Comment					
The landscape vegetation limits the ability to see the waterside slope and will make it difficult to access for flood fight.

This photo was taken from the crown facing downstream looking down the waterward levee slope at unacceptable landscaping (Fall 2022).

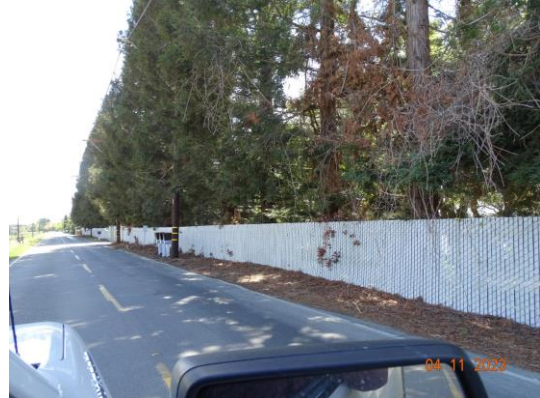
Photo 1 of 1 : FA_2024_RD1000_31_29_20240911_00017.jpg

LM Start	15.49	Rating **	U	Issue No.	29
LM End	15.57	Issue Type +	En	Location *	WS
Category	Earthen Levee			GPS Latitude/Longitude	
				Start	End
Item	Encroachments			38.607207 °	38.606255 °
				-121.555465 °	-121.554582 °
DWR ID	DWR_RD1000_01_s _ 2012_29				
Comment Code					
FE : Fence					
Inspector Comment					
The fence blocks visibility and access.

View taken from the crown facing downstream looking at the waterward levee slope at fence (Spring 2023).

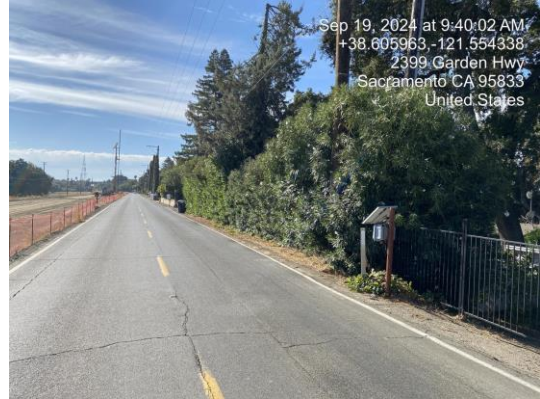
Photo 1 of 1 : FA_2024_RD1000_31_28_20240920_00497.jpg

LM Start	15.59	Rating **	U	Issue No.	28
LM End	15.61	Issue Type +	En	Location *	WS
Category	Earthen Levee			GPS Latitude/Longitude	
				Start	End
Item	Vegetation			38.605915 °	38.605687 °
				-121.554290 °	-121.554070 °
DWR ID	DWR_RD1000_01_s _ 2012_28				
Comment Code					
V6 : Landscaping					
Inspector Comment					
The landscape vegetation prevents the ability to see the waterside slope and will make it difficult to access for flood fight.

View of landscape vegetation on the waterside slope (Fall 2024).

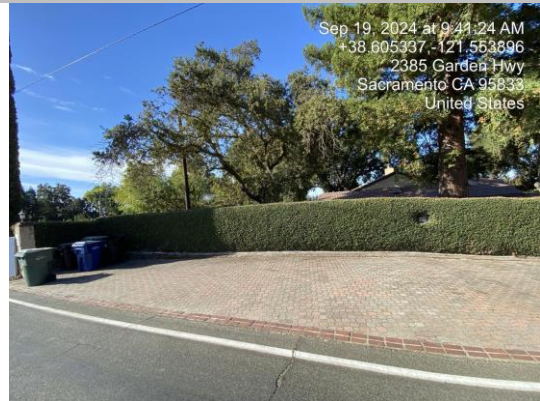
Photo 1 of 1 : FA_2024_RD1000_31_27_20240920_00498.jpg

LM Start	15.62	Rating **	U	Issue No.	27
LM End	15.65	Issue Type +	En	Location *	WS
Category	Earthen Levee			GPS Latitude/Longitude	
				Start	End
Item	Vegetation			38.605585 °	38.605273 °
				-121.553983 °	-121.553663 °
DWR ID	DWR_RD1000_01_s _ 2012_27				
Comment Code					
V6 : Landscaping					
Inspector Comment					
The landscape vegetation prevents the ability to see waterside slope and will make it difficult to access for flood fight.

View of landscape vegetation on the waterside slope (Fall 2024).

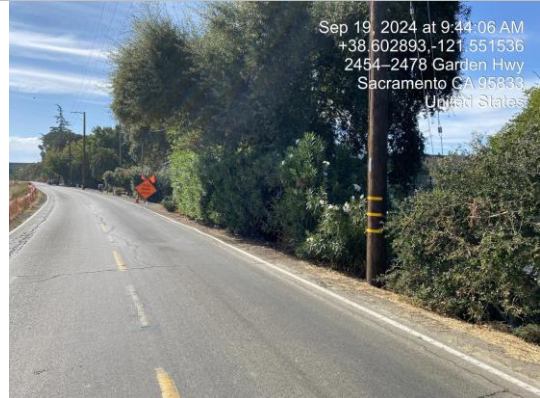
Photo 1 of 1 : FA_2024_RD1000_31_22_20240920_00499.jpg

LM Start	15.85	Rating **	U	Issue No.	22
LM End	15.87	Issue Type +	En	Location *	WS
Category	Earthen Levee			GPS Latitude/Longitude	
				Start	End
Item	Vegetation			38.602870 °	38.602617 °
				-121.551598 °	-121.551330 °
DWR ID	DWR_RD1000_01_s _ 2015_22				
Comment Code					
V6 : Landscaping					
Inspector Comment					
The landscape vegetation prevents the ability to see the waterside slope and will make it difficult to access for flood fight.

View of landscape vegetation on the waterside slope (Fall 2024).

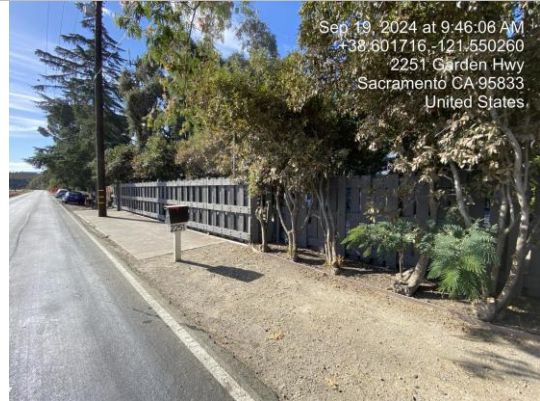
Photo 1 of 1 : FA_2024_RD1000_31_20_20240920_00500.jpg

LM Start	15.94	Rating **	M	Issue No.	20
LM End	15.96	Issue Type +	En	Location *	WS
Category	Earthen Levee			GPS Latitude/Longitude	
				Start	End
Item	Encroachments			38.601977 °	38.601678 °
				-121.550473 °	-121.550142 °
DWR ID	DWR_RD1000_01_s_2012_20				
Comment Code					
FE : Fence					
Inspector Comment					
Unpermitted fence.

View of fence on the waterside shoulder (Fall 2024).

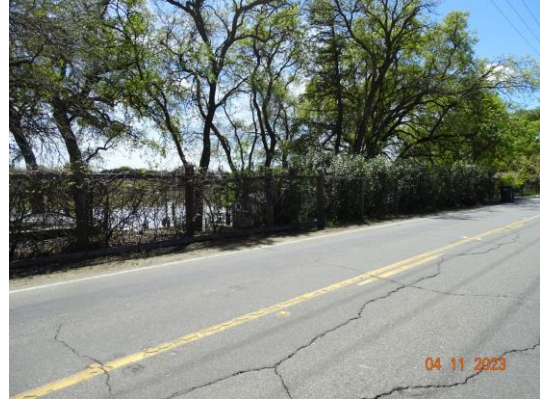
Photo 1 of 1 : FA_2024_RD1000_31_15_20240911_00012.jpg

LM Start	16.63	Rating **	M	Issue No.	15
LM End	16.67	Issue Type +	En	Location *	WS
Category	Earthen Levee			GPS Latitude/Longitude	
				Start	End
Item	Vegetation			38.602693 °	38.603092 °
				-121.540165 °	-121.539490 °
DWR ID	DWR_RD1000_01_s _ 2012_15				
Comment Code					
V6 : Landscaping					
Inspector Comment					
The landscape vegetation limits the ability to see the waterside slope and will make it difficult to access for flood fight.

View landscaping that is interwoven into fence on the waterside shoulder (Spring 2023).

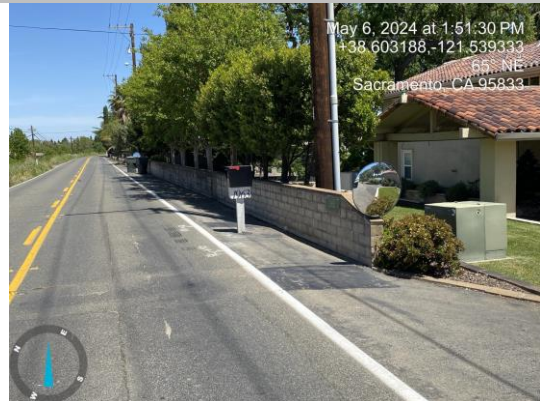
Photo 1 of 1 : FA_2024_RD1000_31_14_20240911_00011.jpg

LM Start	16.68	Rating **	A/W	Issue No.	14
LM End	16.72	Issue Type +	En	Location *	WS
Category	Earthen Levee			GPS Latitude/Longitude	
				Start	End
Item	Encroachments			38.603242 °	38.603597 °
				-121.539318 °	-121.538875 °
DWR ID	DWR_RD1000_01_s _ 2012_14				
Comment Code					
WL : Wall					
Inspector Comment					
Wall is not permitted and should not inhibit operations but monitor surrounding landscaping to ensure it does not impede ability to identify flood threats or access.

View of concrete wall on the waterside slope (Spring 2024).

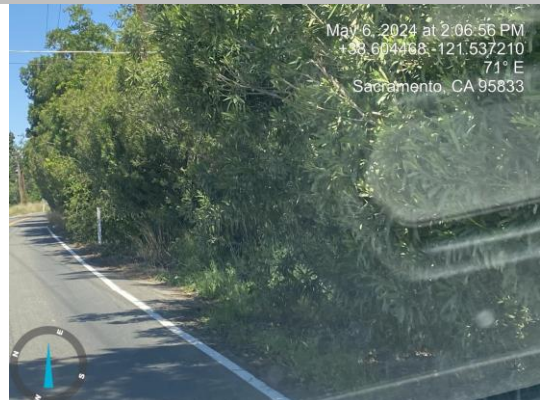
Photo 1 of 1 : FA_2024_RD1000_31_228_20240911_00086.jpg

LM Start	16.79	Rating **	U	Issue No.	228
LM End	16.93	Issue Type +	En	Location *	WS
Category	Earthen Levee			GPS Latitude/Longitude	
				Start	End
Item	Vegetation			38.604129 °	38.604997 °
				-121.537795 °	-121.535484 °
DWR ID	DWR_RD1000_01_s _ 2024_228				
Comment Code					
V6 : Landscaping					
Inspector Comment					
The landscape vegetation prevents the ability to see the waterside slope and will make it difficult to access for flood fight.

View of landscape vegetation on the waterside slope (Spring 2024).

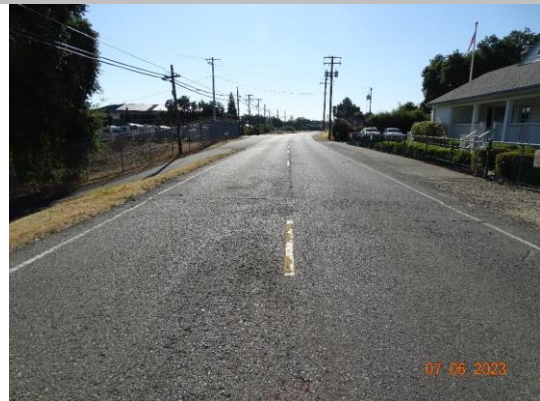
Photo 1 of 3 : UCIP_FA_2024_81787_118570.jpg

Comment Code					
Inspector Comment					
DS_ID:25839 FS_ID:81787 EP_NO: N/A Repair Type: No Action Needed EVAL Issue: Crossing Status: Found UCIP Comments: 07/06/2023 Record updated to No Action Needed. No issues observed during inspection. (M. Thao - DWR UCIP) FIELD_STRUCT_DESC: [Reclamation District 1000 Main Drainage Pumping Plant] 1 of 4: 6-foot by 8-foot concrete culvert through the levee, 12 feet below the crown. Pump house on the landside (LS). Slide gate on the waterside (WS) end. [Additional Reference(s): DWR Levee Log, 2002 (HLM 17.81), only lists two 6-foot by 8-foot culverts. USACE O&M Manual, Unit No. 124, June 1953, Revised 25 February 2022, River Mile 61.21, listed as four 5-foot by 9-foot tunnels. USACE As-Built Drawing No. 50-13-2810, River Mile 61.21, November 1922, listed as four 5-foot by 9-foot tunnels]. FS Date: 7/6/2023

Levee crown looking downstream.

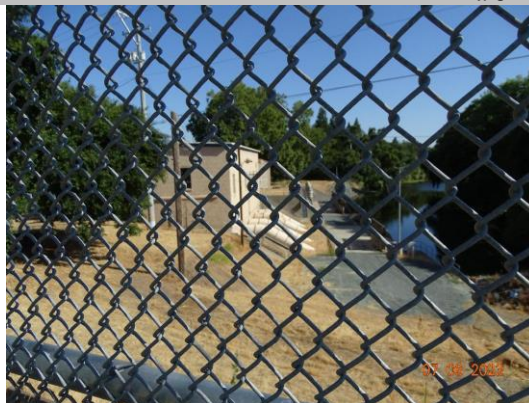
Photo 2 of 3 : UCIP_FA_2024_81787_118571.jpg

LS view: General overview looking from crown; pump house located approximately 80 feet off toe.

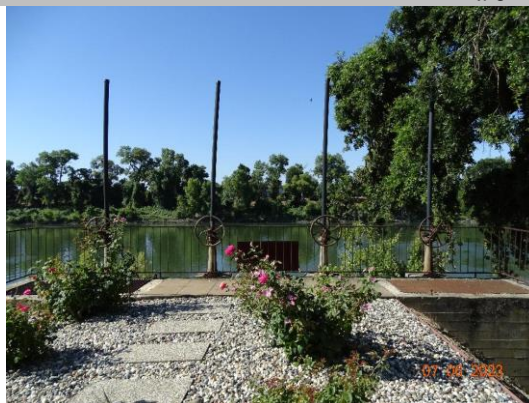
Photo 3 of 3 : UCIP_FA_2024_81787_118568.jpg

WS view: Slide gate actuators located approximately 130 feet from the Garden Highway centerline; on the deck looking away from the levee.

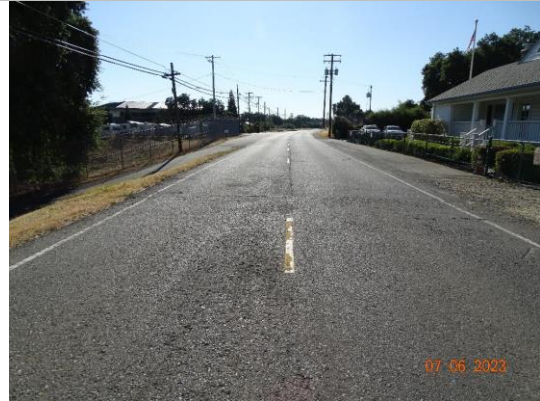
Photo 1 of 3 : UCIP_FA_2024_81793_118577.jpg

LM Start	17.50	Rating **	A	Issue No.	257 (cont)
LM End	17.50	Issue Type +	Ma	Location *

Levee crown looking downstream.

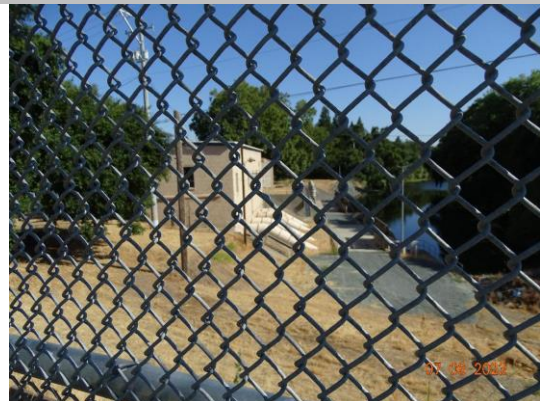
Photo 2 of 3 : UCIP_FA_2024_81793_118578.jpg

LS view: General overview looking from crown; pump house located approximately 80 feet off toe.

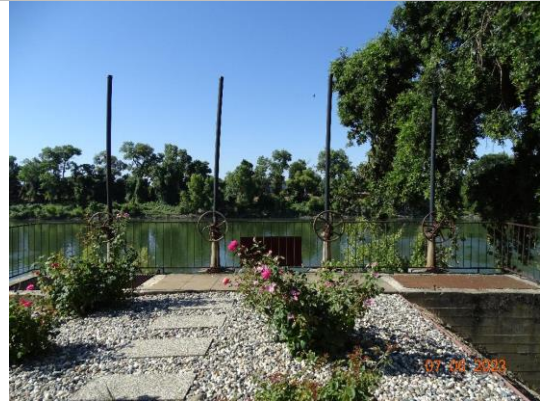
Photo 3 of 3 : UCIP_FA_2024_81793_118575.jpg

LM Start	17.50	Rating **	A	Issue No.	257 (cont)
LM End	17.50	Issue Type +	Ma	Location *	
Category	Supplemental			GPS Latitude/Longitude	
				Start	End
Item	DWR UCIP LMA Responsibility			38.605466 °	38.605466 °
				-121.525008 °	-121.525008 °
DWR ID	25840

WS view: Slide gate actuators located approximately 130 feet from the Garden Highway centerline; on the deck looking away from the levee.

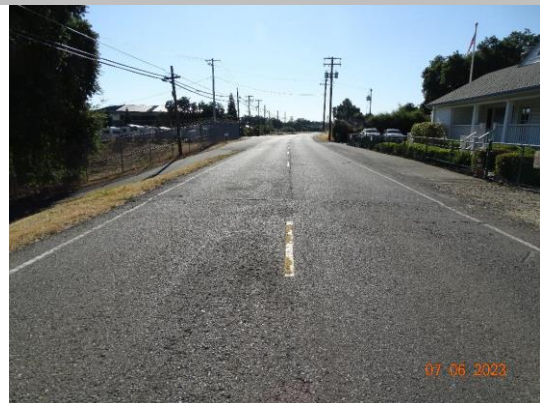
Photo 1 of 3 : UCIP_FA_2024_81794_118584.jpg

DS_ID:25841
FS_ID:81794
EP_NO: N/A
Repair Type: No Action Needed
EVAL Issue:
Crossing Status: Found
UCIP Comments: 07/06/2023 Record updated to No Action Needed. No issues observed during inspection. (M. Thao - DWR UCIP)
FIELD_STRUCT_DESC: [Reclamation District 1000 Main Drainage Pumping Plant] 3 of 4: 6-foot by 8-foot concrete culvert through the levee, 12 feet below the crown. Pump house on the landside (LS). Slide gate on the waterside (WS) end. [Additional Reference(s): DWR Levee Log, 2002 (HLM 17.81), only lists two 6-foot by 8-foot culverts. USACE O&M Manual, Unit No. 124, June 1953, Revised 25 February 2022, River Mile 61.21, listed as four 5-foot by 9-foot tunnels. USACE As-Built Drawing No. 50-13-2810, River Mile 61.21, November 1922, listed as four 5-foot by 9-foot tunnels].
FS Date: 7/6/2023

Levee crown looking downstream.

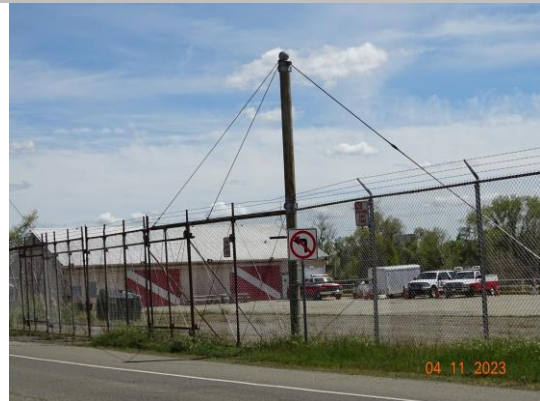
Photo 1 of 1 : FA_2024_RD1000_31_8_20240911_00007.jpg

LM Start	17.52	Rating **	U	Issue No.	8
LM End	17.61	Issue Type +	En	Location *	WS
Category	Earthen Levee			GPS Latitude/Longitude	
				Start	End
Item	Encroachments			38.605445 °	38.605305 °
				-121.524675 °	-121.522958 °
DWR ID	DWR_RD1000_01_s_2012_8				
Comment Code					
BU : Building					
Inspector Comment

This photo was taken from the crown facing downstream looking down the waterward levee slope at an unpermitted building (Spring 2023).

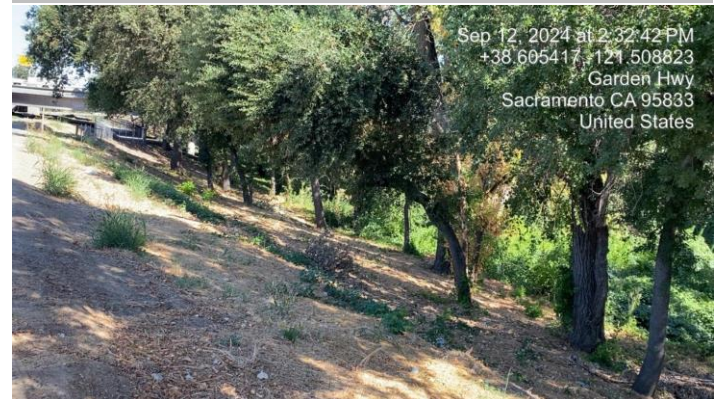
Photo 1 of 1 : FA_2024_RD1000_32_4_20240916_00006.jpg

LM Start	0.15	Rating **	A	Issue No.	4
LM End	0.15	Issue Type +	Ma	Location *	WS
Category	Earthen Levee			GPS Latitude/Longitude	
				Start	End
Item	Vegetation			38.605413 °	38.605413 °
				-121.508881 °	-121.508881 °
DWR ID	DWR_RD1000_02_f _ 2023_4				
Comment Code					
V1 : Control annual grass and weeds on the levee slopes and easements.					
Inspector Comment

View of good vegetation on the waterside slope (Fall 2024).

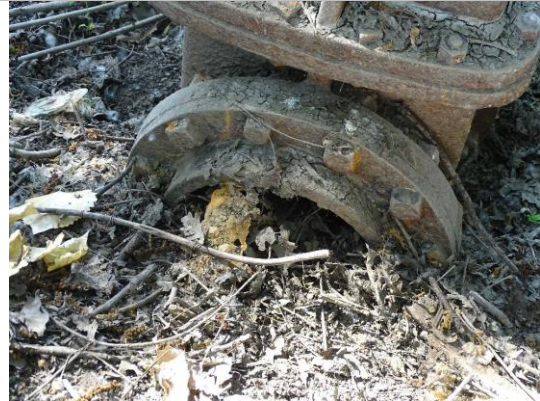
Photo 2 of 3 : UCIP_FA_2024_80395_116054.jpg

Comment Code					
Inspector Comment					
DS_ID:25233 FS_ID:80395 EP_NO: N/A Repair Type: Urgent EVAL Issue: 3b, Flood Risk Crossing Status: Found UCIP Comments: 06/05/2023 Record updated to Urgent. A section of pipe was observed missing at the gate valve on the waterside (WS) that can potentially allow uncontrolled flood water from waterside to landside. A 4-inch deep void was observed along the WS slope. Crossing appears abandoned. Recommend owner to contact CVFPB to abandon pipe properly or remove pipe from levee. (M. Thao - DWR UCIP) FIELD_STRUCT_DESC: 12-inch steel pipe through the levee, 8.8 feet below the crown. [Additional Reference(s): DWR Levee Log, 2002 (HLM 0.45), listed as abandoned and plugged on waterward end. USACE Sacramento O&M Manual, Unit 124, June 1953, Revised 25 February 2022, (HLM 0.425), listed as 12-inch pipe. USACE As-Built Drawing No. 01-04-0391, 27 January 1948, Sheet 1]. FS Date: 6/5/2023

LM Start	0.45	Rating **	U	Issue No.	5 (cont)
LM End	0.45	Issue Type +	En	Location *	
Category	Supplemental			GPS Latitude/Longitude	
				Start	End
Item	DWR UCIP Field Study			38.607146°	38.607146°
				-121.503800°	-121.503800°
DWR ID	25233

WS view: Close-up view of missing pipe section.

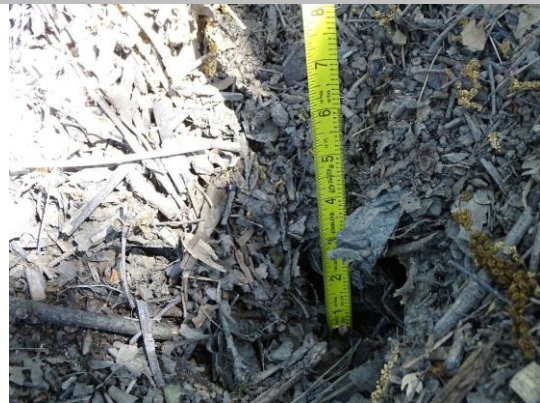
Photo 3 of 3 : UCIP_FA_2024_80395_116056.jpg

LM Start	0.45	Rating **	U	Issue No.	5 (cont)
LM End	0.45	Issue Type +	En	Location *

WS view: Close-up view of void along pipe alignment.

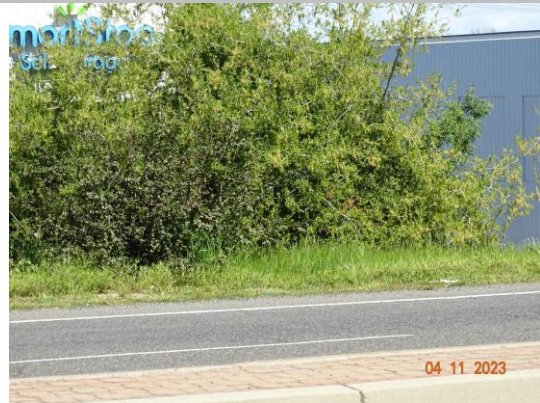
Photo 1 of 1 : FA_2024_RD1000_32_1_20240911_00001.jpg

LM Start	1.74	Rating **	A/W	Issue No.	1
LM End	1.92	Issue Type +	Ma	Location *	LS
Category	Earthen Levee			GPS Latitude/Longitude	
				Start	End
Item	Trim / Thin Trees			38.606986°	38.605841°
				-121.480402°	-121.477402°
DWR ID	DWR_RD1000_02_f_2021_1				
Comment Code					
T1 : Trim and thin trees to at least five feet above ground level to allow visibility of the ground and room to flood fight.					
Inspector Comment					
Issue has been changed to A/W. Trees will be removed as part of levee project.

View of starter trees on the landside slope, Spring 2023.

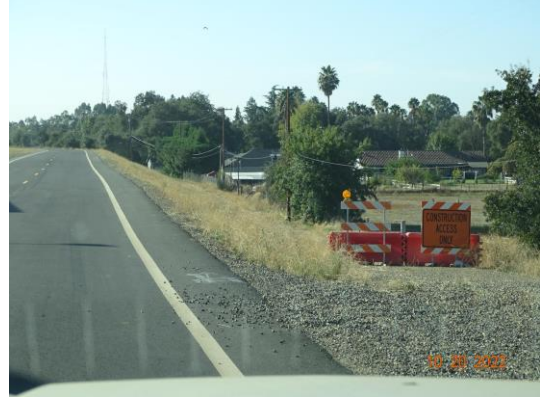
Photo 1 of 1 : FA_2024_RD1000_33_11_20240911_00004.jpg

LM Start	0.05	Rating **	A/W	Issue No.	11
LM End	4.20	Issue Type +	Ob	Location *	CR
Category	Earthen Levee			GPS Latitude/Longitude	
				Start	End
Item	Encroachments			38.606454 °	38.665724 °
				-121.469943 °	-121.477500 °
DWR ID	DWR_RD1000_03_f_2020_11				
Comment Code					
LC : Authorized Levee Construction					
Inspector Comment					
Reach H- USACE Project. Construction is complete but the RD has not received the O&M.

View of the levee under construction, Reach H-USACE Project, Fall 2022.

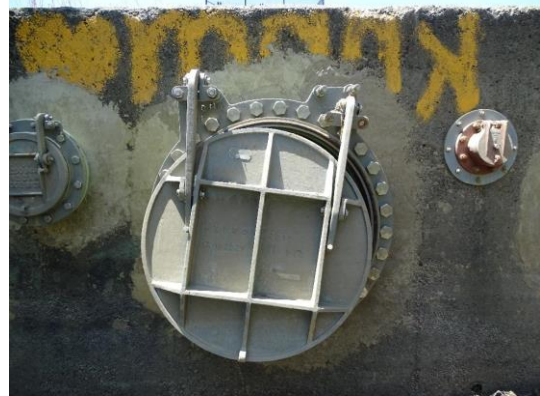
Photo 1 of 2 : UCIP_FA_2024_80527_116153.jpg

LM Start	0.84	Rating **	M	Issue No.	23	
LM End	0.84	Issue Type +	En	Location *		
Category	Supplemental			GPS Latitude/Longitude		
				Start		End
Item	DWR UCIP Field Study			38.617517 °		38.617517 °
				-121.468917 °		-121.468917 °
DWR ID	25417

Comment Code						
Inspector Comment						
DS_ID:25417 FS_ID:80527 EP_NO: N/A Repair Type: Non-Urgent EVAL Issue: 4b, Safety Issue Crossing Status: Found UCIP Comments: 06/05/2023 Record updated to Non-Urgent. Flap gate is loose and hanging by one hinge; permittee needs to fix the flap gate. The loose flap gate also presents safety concerns. (M. Thao - DWR UCIP) FIELD_STRUCT_DESC: [City of Sacramento Pumping Plant No. 2] 3 of 4: 36-inch drainage pipe through the levee, 4 feet below the crown. Pump over concrete sump located approximately 25 feet off landside (LS) toe. Concrete steps on LS slope. Siphon breaker on the waterside (WS) shoulder. Concrete headwall, flap gate, and apron located 18 feet from the WS toe. (36-inch pipe authorized under Permit No. 5725, 1968 - City of Sacramento). [Additional Reference(s): DWR Levee Log, 2002 (HLM 0.87)]. FS Date: 6/5/2023

WS view: 36-inch pipe flap gate hanging loose and being held on by only one hinge.

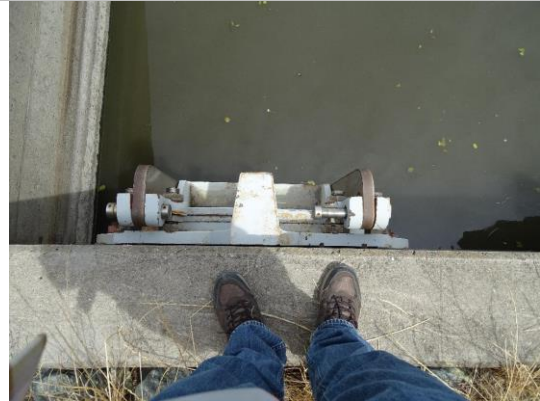
Photo 2 of 2 : UCIP_FA_2024_80485_116302.jpg

DS_ID:25424
FS_ID:80485
EP_NO: 13256
Repair Type: Non-Urgent
EVAL Issue: 11, Maintenance Compliance Issue
Crossing Status: Found
UCIP Comments: 06/05/2023 Record updated to Non-Urgent. Flap gate hinge pin is loose; recommend permittee tighten hinge pin. (M. Thao - DWR UCIP)
FIELD_STRUCT_DESC: [Reclamation District 1000 Pumping Plant No. 8] 7 of 9: 54-inch storm drain discharge pipe through the levee, 6.2 feet below crown. Pump station located approximately 180 feet off the landside (LS) toe. Siphon breaker located on waterside (WS) levee shoulder inside a concrete vault. Concrete discharge structure with apron and flap gate on WS toe. (Pumping plant authorized under Permit No. 13256, 1982 - Morton & Pitalo, Incorporated). [Additional Reference(s): DWR Levee Log, 2002 (HLM 3.11)].
FS Date: 6/5/2023

LM Start	3.08	Rating **	M	Issue No.	25 (cont)
LM End	3.08	Issue Type +	En	Location *	
Category	Supplemental			GPS Latitude/Longitude	
				Start	End
Item	DWR UCIP Field Study			38.649635 °	38.649635 °
				-121.475018 °	-121.475018 °
DWR ID	25424

WS view: Flap gate with loose hinge pin (different angle).

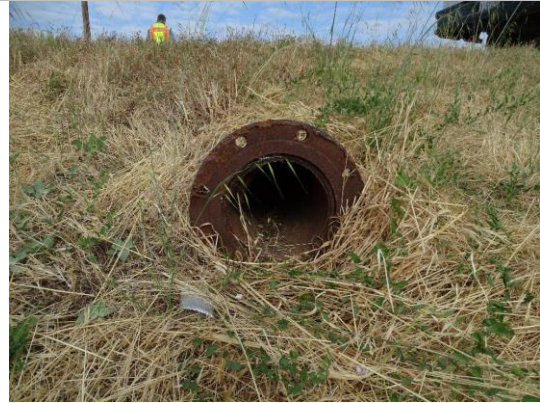
Photo 2 of 2 : UCIP_FA_2024_80532_116190.jpg

DS_ID:25251
FS_ID:80532
EP_NO: N/A
Repair Type: Urgent
EVAL Issue: 3a, Flood Risk
Crossing Status: Found
UCIP Comments: 06/08/2023 Record updated to Urgent. Pipe is opened on both the landside and waterside. No concrete sump found on WS. (M. Thao - DWR UCIP)
FIELD_STRUCT_DESC: 7-inch pipe of an unknown purpose through the levee, 1.8 feet below the crown. Concrete sump on the waterside (WS) end. [Additional Reference(s): DWR Levee Log, 2002 (HLM 6.27), listed as abandoned and plated welded on WS. USACE Sacramento O&M Manual, Unit 125, June 1959, Revised 29 December 2016, (HLM 6.27), listed as 8-inch pipe, invert 3.4 feet below the crown].
FS Date: 6/8/2023

LM Start	6.19	Rating **	U	Issue No.	26 (cont)
LM End	6.19	Issue Type +	En	Location *	
Category	Supplemental			GPS Latitude/Longitude	
				Start	End
Item	DWR UCIP Field Study			38.691630 °	38.691630 °
				-121.485561 °	-121.485561 °
DWR ID	25251

WS view: Pipe daylights on slope and is opened.

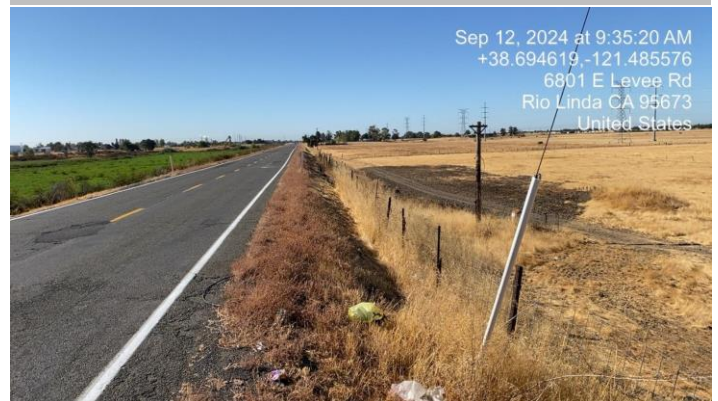
Photo 1 of 1 : FA_2024_RD1000_33_8_20240916_00024.jpg

LM Start	6.27	Rating **	M	Issue No.	8
LM End	6.40	Issue Type +	En	Location *	LS
Category	Earthen Levee			GPS Latitude/Longitude	
				Start	End
Item	Encroachments			38.692847 °	38.694643 °
				-121.485595 °	-121.485647 °
DWR ID	DWR_RD1000_03_f_2015_8				
Comment Code					
FE : Fence					
Inspector Comment					
A fence is located on the landside levee slope.

View of fence on landside levee slope, looking downstream (Fall 2024).

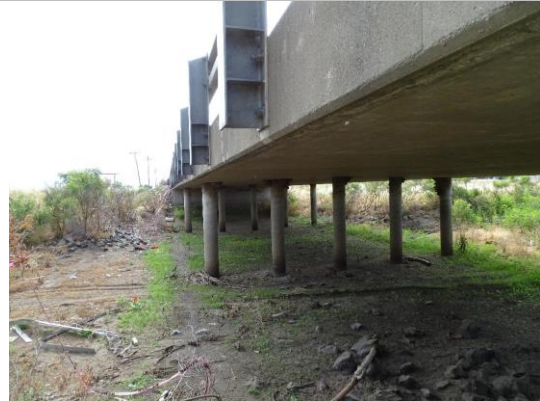
Photo 1 of 1 : UCIP_FA_2024_80454_116226.jpg

Comment Code						
Inspector Comment						
DS_ID:25387 FS_ID:80454 EP_NO: N/A Repair Type: Non-Urgent EVAL Issue: 10, Unauthorized Modification or Non-Compliant Permit Crossing Status: Indicator Found UCIP Comments: 06/08/2023 Record updated to Non-Urgent. Cable appears to be buried under canal rather than attached to the bridge as stated in Permit No. 12125. Unable to find a permit for modification. (M. Thao - DWR UCIP) FIELD_STRUCT_DESC: 1-inch telephone cable through the levee, 2 feet below the crown. Cable attached to bridge on the waterside (WS). (Telephone cable authorized under Permit No. 12125, 1977 - Pacific Telephone and Telegraph Co). FS Date: 6/8/2023

WS view: Indicators across canal and not attached to bridge as stated in Permit No. 12125.

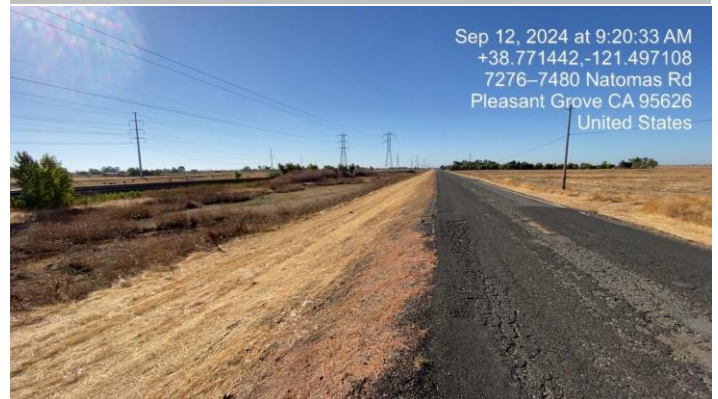
Photo 1 of 1 : FA_2024_RD1000_33_18_20240916_00025.jpg

LM Start	11.86	Rating **	A	Issue No.	18
LM End	11.86	Issue Type +	Ma	Location *	WS
Category	Earthen Levee			GPS Latitude/Longitude	
				Start	End
Item	Vegetation			38.771436 °	38.771436 °
				-121.497195 °	-121.497195 °
DWR ID	DWR_RD1000_03_f_2024_18				
Comment Code					
V1 : Control annual grass and weeds on the levee slopes and easements.					
Inspector Comment

View of waterside vegetation (Fall 2024).

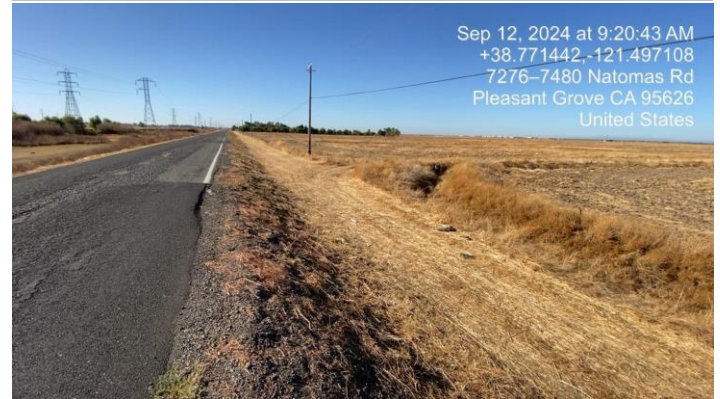
Photo 1 of 1 : FA_2024_RD1000_33_19_20240916_00026.jpg

LM Start	11.86	Rating **	A	Issue No.	19
LM End	11.86	Issue Type +	Ma	Location *	LS
Category	Earthen Levee	GPS Latitude/Longitude			
		Start		End	
Item	Vegetation	38.771437°		38.771437°	
		-121.497195°		-121.497195°	
DWR ID	DWR_RD1000_03_f_2024_19				
Comment Code					
V1 : Control annual grass and weeds on the levee slopes and easements.					
Inspector Comment

View of landside vegetation (Fall 2024).

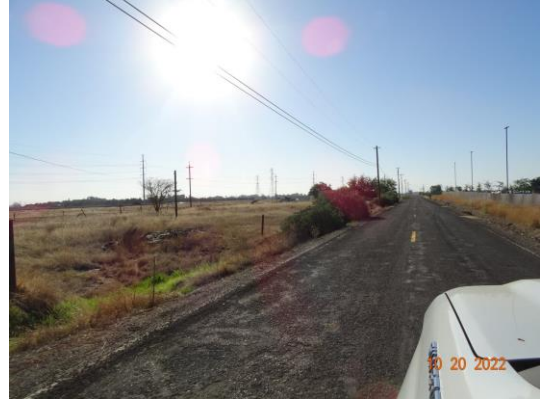
Photo 1 of 1 : FA_2024_RD1000_33_10_20240911_00003.jpg

LM Start	12.41	Rating **	M	Issue No.	10
LM End	12.46	Issue Type +	En	Location *	WS
Category	Earthen Levee			GPS Latitude/Longitude	
				Start	End
Item	Vegetation			38.779037°	38.779505°
				-121.500397°	-121.500955°
DWR ID	DWR_RD1000_03_s_2012_10				
Comment Code					
V6 : Landscaping					
Inspector Comment					
This is high ground and the channel flows away, both directions.

View of landscaping on the waterside levee slope, Fall 2022

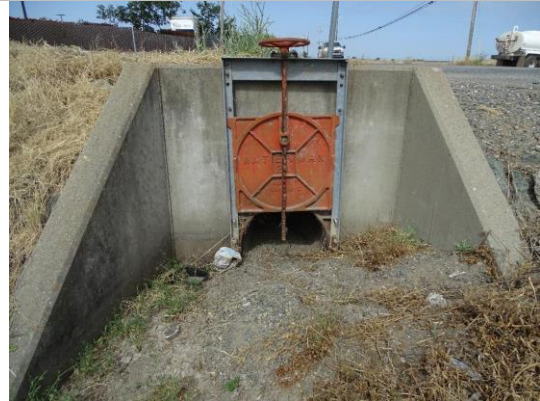
Photo 2 of 2 : UCIP_FA_2024_80535_116236.jpg

Comment Code						
Inspector Comment						
DS_ID:25254 FS_ID:80535 EP_NO: N/A Repair Type: Urgent EVAL Issue: 3a, Flood Risk Crossing Status: Found UCIP Comments: 06/08/2023 Record updated to Urgent. Pipe on WS end is half filled with sediment preventing the slide gate from closing properly. Pipe on LS end is approximately 60% filled with sediment. Recommend removal of sediment. (M. Thao - DWR UCIP) FIELD_STRUCT_DESC: 24-inch corrugated metal pipe of an unknown purpose through the levee, 2.0 feet below the crown. Concrete headwall with slide gate on the waterside (WS) toe. [Additional Reference(s): DWR Levee Log, 2002 (HLM 12.68). USACE Sacramento O&M Manual, Unit 125, June 1959, Revised 29 December 2016, (HLM 12.62), listed as 24-inch pipe, invert 9.4 feet below the crown]. FS Date: 6/8/2023

LM Start	12.50	Rating **	U	Issue No.	33 (cont)
LM End	12.50	Issue Type +	En	Location *	
Category	Supplemental		GPS Latitude/Longitude		
			Start	End	
Item	DWR UCIP Field Study		38.780134 °	38.780134 °	
			-121.501154 °	-121.501154 °	
DWR ID	25254

WS view: Concrete headwall and slide gate at toe. Pipe is half filled with sediment.

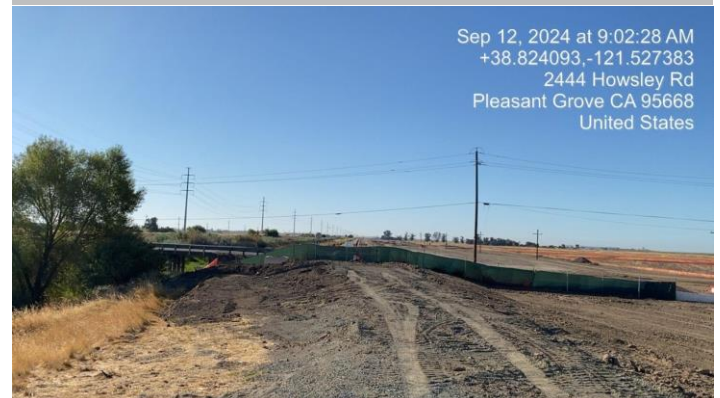
Photo 1 of 1 : FA_2024_RD1000_33_15_20240916_00027.jpg

LM Start	12.51	Rating **	A/W	Issue No.	15
LM End	15.95	Issue Type +	En	Location *	CR
Category	Earthen Levee			GPS Latitude/Longitude	
				Start	End
Item	Encroachments			38.780258 °	38.825328 °
				-121.501157 °	-121.528464 °
DWR ID	DWR_RD1000_03_f _ 2023_15				
Comment Code					
LC : Authorized Levee Construction					
Inspector Comment

View of levee construction (Fall 2024).

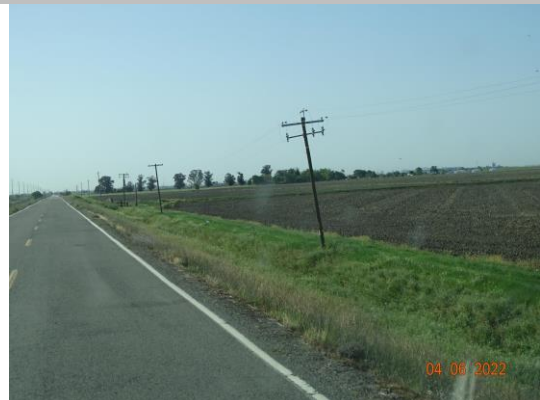
Photo 1 of 1 : FA_2024_RD1000_33_22_20240911_00006.jpg

LM Start	14.01	Rating **	A/W	Issue No.	22
LM End	14.70	Issue Type +	En	Location *	LS
Category	Earthen Levee			GPS Latitude/Longitude	
				Start	End
Item	Encroachments			38.799892 °	38.808969 °
				-121.513194 °	-121.518536 °
DWR ID	DWR_RD1000_03_f_2016_22				
Comment Code					
DT : Ditch					
Inspector Comment					
Issue has been changed to A/W due to levee construction.

View of landside ditch at toe of levee, looking downstream (Spring 2022).

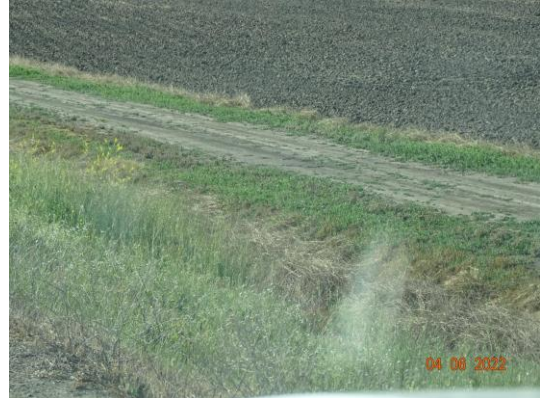
Photo 1 of 1 : FA_2024_RD1000_33_9_20240911_00002.jpg

LM Start	15.25	Rating **	A/W	Issue No.	9
LM End	15.79	Issue Type +	En	Location *	LS
Category	Earthen Levee			GPS Latitude/Longitude	
				Start	End
Item	Encroachments			38.816259 °	38.823314 °
				-121.522787 °	-121.526942 °
DWR ID	DWR_RD1000_03_s_2012_9				
Comment Code					
DT : Ditch					
Inspector Comment					
Issue has been changed to A/W due to levee construction.

View looking downstream landside at a ditch at the toe (Spring 2022).

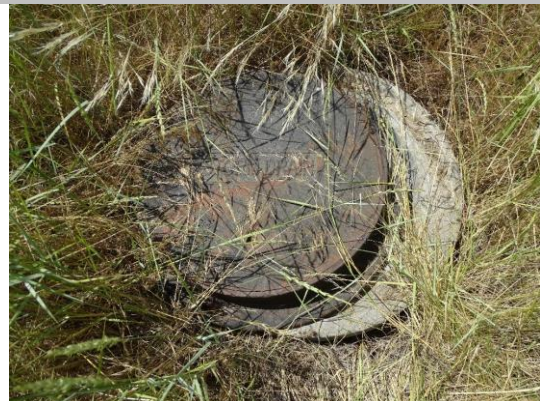
Photo 1 of 1 : UCIP_FA_2024_80472_116267.jpg

Comment Code						
Inspector Comment						
DS_ID:25260 FS_ID:80472 EP_NO: N/A Repair Type: Non-Urgent EVAL Issue: 10, Unauthorized Modification or Non-Compliant Permit Crossing Status: Found UCIP Comments: 06/08/2023 Record updated to Non-Urgent. No concrete headwall found at landside toe, but instead a manhole was located at the landside toe. Unable to find a permit for modification. No permit has been identified authorizing pipe. (M. Thao - DWR UCIP) FIELD_STRUCT_DESC: 24-inch pipe through the levee, 17 feet below the crown. Slide gate in a corrugated metal riser on the waterside (WS) slope. Concrete headwall at the landside (LS) toe. [Additional Reference(s): DWR Levee Log, 2002 (HLM 16.08). USACE Sacramento O&M Manual, Unit 125, June 1959, Revised 29 December 2016, (HLM 15.96), listed as 24-inch pipe]. FS Date: 6/8/2023

LS view: 36-inch outside diameter manhole present at toe.

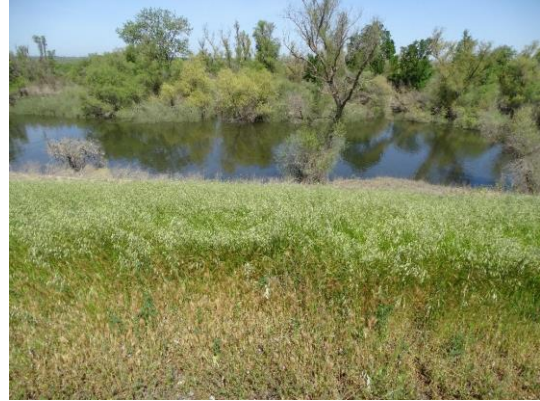
Photo 1 of 2 : UCIP_FA_2024_84228_115502.jpg

Comment Code						
Inspector Comment						
DS_ID:25400 FS_ID:84228 EP_NO: 9779 Repair Type: Non-Urgent EVAL Issue: 10, Unauthorized Modification or Non-Compliant Permit Crossing Status: Not Found UCIP Comments: 04/25/2023 Record remains Non-Urgent. Crossing not found. Pumping plant was modified to remove pipe appurtenances in 2019 based on Google Earth historical photo; unsure if pipe through levee was removed. Unable to find a permit for modification. Pipe through levee appear to remain based on SAFCA As-Built Drawing No. SA-04-0168, 11 March 2011, Sheet 58 (PP-14), Station 120+80. (M. Thao - DWR UCIP) FIELD_STRUCT_DESC: [Natomas Mutual Water Company Northern Pumping Station] 1 of 5: 30-inch irrigation pipe through levee, 2.5 feet below the crown. Pump located on steel platform in the channel. Siphon breaker in CM pipe riser on the landside (LS) shoulder. Concrete distribution box in irrigation ditch on LS. (30-inch pipe authorized under Permit No. 9779, 1974 - Natomas Central Mutual Water Company). [Additional Reference(s): DWR Levee Log, 2002 (HLM 2.05)]. FS Date: 4/25/2023

WS view: General overview looking from crown.

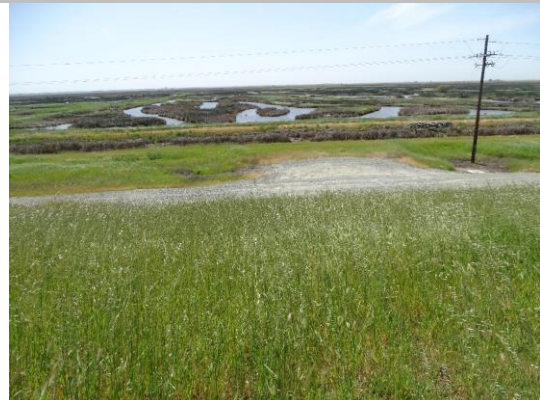
Photo 2 of 2 : UCIP_FA_2024_84228_115500.jpg

LS view: General overview looking from crown.

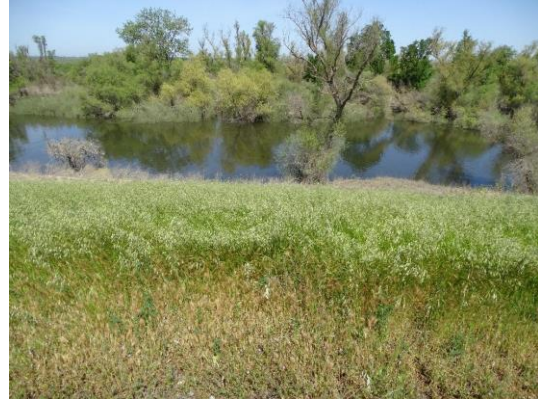
Photo 1 of 2 : UCIP_FA_2024_84239_115506.jpg

Comment Code						
Inspector Comment						
DS_ID:25401 FS_ID:84239 EP_NO: 5490 Repair Type: Non-Urgent EVAL Issue: 10, Unauthorized Modification or Non-Compliant Permit Crossing Status: Not Found UCIP Comments: 04/25/2023 Record remains Non-Urgent. Crossing not found. Pumping plant was modified to remove pipe appurtenances in 2019 based on Google Earth historical photo; unsure if pipe through levee was removed. Unable to find a permit for modification. Pipe through levee appear to remain based on SAFCA As-Built Drawing No. SA-04-0168, 11 March 2011, Sheet 58 (PP-14), Station 120+70. (M. Thao - DWR UCIP) FIELD_STRUCT_DESC: [Natomas Mutual Water Company Northern Pumping Station] 2 of 5: 42-inch pipe through the levee, 2.0 feet below the crown. Pump located on steel platform in the channel. Siphon breaker on the landside (LS) shoulder. Irrigation ditch on LS. This crossing replaces 42-inch pipe (see DSID 25996). (42-inch pipe authorized under Permit No. 5490A, 1974 - Natomas Central Mutual Water Company). [Additional Reference(s): DWR Levee Log, 2002 (HLM 2.05), listed as 30-inch pipe]. FS Date: 4/25/2023

WS view: General overview looking from crown.

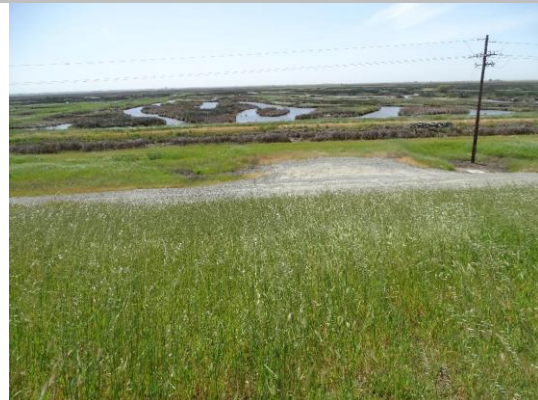
Photo 2 of 2 : UCIP_FA_2024_84239_115504.jpg

LS view: General overview looking from crown.

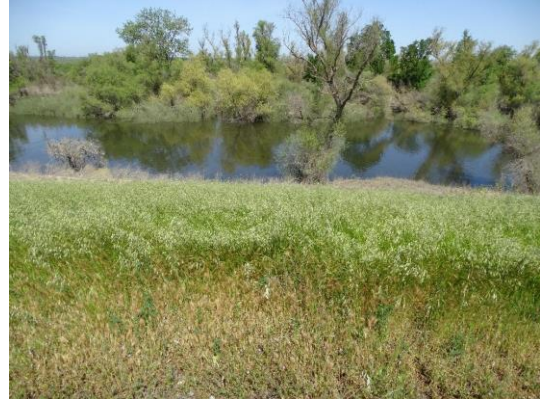
Photo 1 of 2 : UCIP_FA_2024_84230_115510.jpg

Comment Code						
Inspector Comment						
DS_ID:25264 FS_ID:84230 EP_NO: N/A Repair Type: Non-Urgent EVAL Issue: 10, Unauthorized Modification or Non-Compliant Permit Crossing Status: Not Found UCIP Comments: 04/25/2023 Record remains Non-Urgent. Crossing not found. Pumping plant was modified to remove pipe appurtenances in 2019 based on Google Earth historical photo; unsure if pipe through levee was removed. Unable to find a permit for modification. Pipe appears to be present in levee based on SAFCA As-Built Drawing No. SA-04-0168, 11 March 2011, Sheet 58 (PP-14), Station 120+60. (M. Thao - DWR UCIP) FIELD_STRUCT_DESC: [Natomas Mutual Water Company Northern Pumping Station] 3 of 5: 30-inch pipe through the levee, 2.5 feet below the crown. Pump located on steel platform in the channel. Siphon breaker on the landside (LS) shoulder. Irrigation ditch on LS. (30-inch pipe authorized under Permit No. 15955, 1992 - Natomas Central Mutual Water Company). [Additional Reference(s): DWR Levee Log, 2002 (HLM 2.05)]. FS Date: 4/25/2023

WS view: General overview looking from crown.

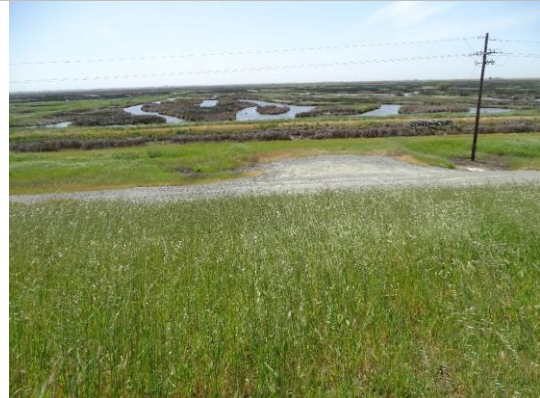
Photo 2 of 2 : UCIP_FA_2024_84230_115508.jpg

LS view: General overview looking from crown.

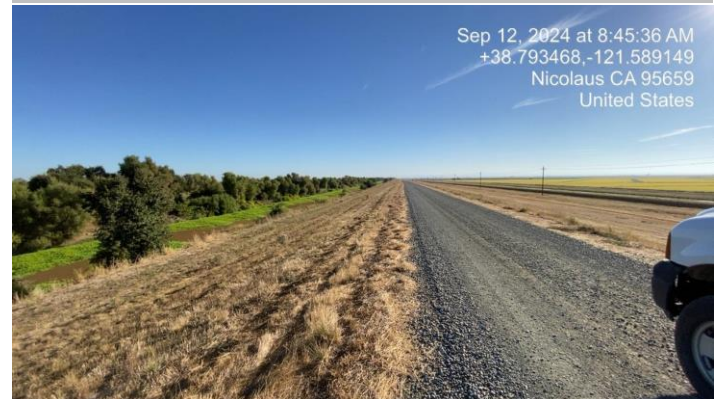
Photo 1 of 1 : FA_2024_RD1000_34_6_20240916_00012.jpg

LM Start	3.06	Rating **	A	Issue No.	6
LM End	3.06	Issue Type +	Ma	Location *	WS
Category	Earthen Levee			GPS Latitude/Longitude	
				Start	End
Item	Vegetation			38.793674 °	38.793674 °
				-121.588688 °	-121.588688 °
DWR ID	DWR_RD1000_04_f _ 2024_6				
Comment Code					
V1 : Control annual grass and weeds on the levee slopes and easements.					
Inspector Comment					
The annual vegetation is well maintained.

View of waterside vegetation (Fall 2024).

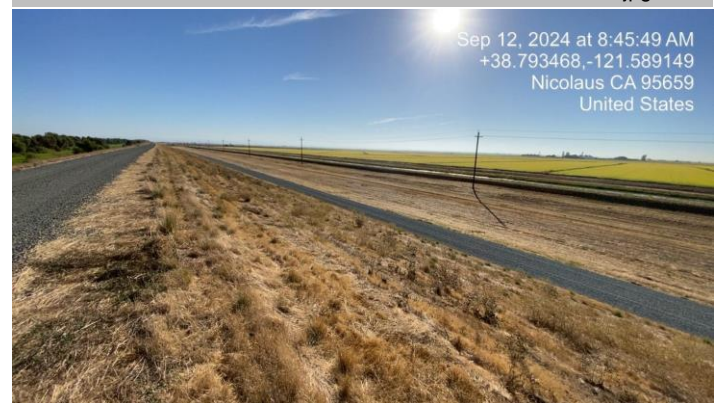
Photo 1 of 1 : FA_2024_RD1000_34_7_20240916_00013.jpg

LM Start	3.06	Rating **	A	Issue No.	7
LM End	3.06	Issue Type +	Ma	Location *	LS
Category	Earthen Levee			GPS Latitude/Longitude	
				Start	End
Item	Vegetation			38.793676 °	38.793676 °
				-121.588690 °	-121.588690 °
DWR ID	DWR_RD1000_04_f_2024_7				
Comment Code					
V1 : Control annual grass and weeds on the levee slopes and easements.					
Inspector Comment					
The annual vegetation is well maintained.

View of landside vegetation (Fall 2024).
