Flood Control Project Maintenance Levee Inspections

Fall 2024 Levee Maintenance Deficiency Summary Report

Sacramento River Basin

Reclamation District No. 1000 Natomas

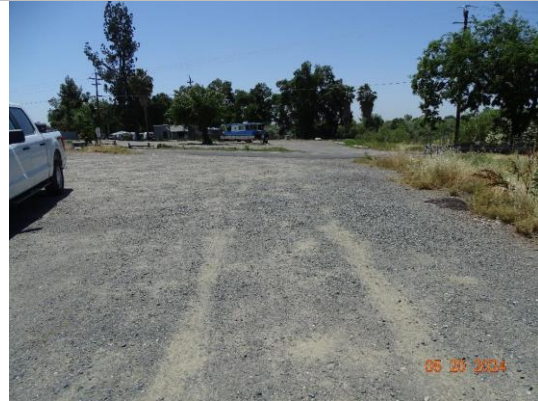
Photo 1 of 3 : UCIP_FA_2024_83906_123379.jpg

Comment Code					
Inspector Comment					
DS_ID:25938 FS_ID:83906 EP_NO: N/A Repair Type: No Action Needed EVAL Issue: Crossing Status: Found UCIP Comments: 05/20/2024 Record remains No Action Needed. No issues observed during inspection. (M. Thao - DWR UCIP) FIELD_STRUCT_DESC: 24-inch reinforced concrete gravity drainage pipe through the levee, 2 feet below the crown. Drainage inlet is located in the drainage swale between the setback levee of Reclamation District 1000 Unit 1 and Garden Highway. Pipe outlet is located at the waterside (WS) toe with rip rap. (24-inch pipe authorized under the Natomas Levee Improvement Project under Permit No. 18159-3, 2009 - Sacramento Area Flood Control Agency). [Additional Reference(s): SAFCA As-Built Drawing No. 6-04-2274, 26 June 2013, Sheet 38A (C-401A), Station 0+14.71, listed as Drain 1]. FS Date: 5/20/2024 4:08:41 PM

Levee crown looking downstream.

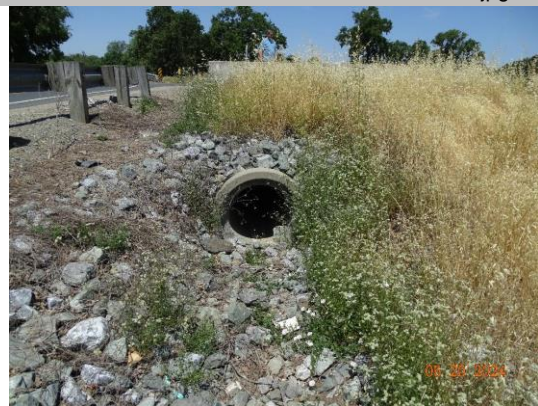
Photo 2 of 3 : UCIP_FA_2024_83906_123380.jpg

LS view: 24-inch reinforced concrete pipe inlet located in the drainage swale between the setback levee of Unit 1 and Garden Highway.

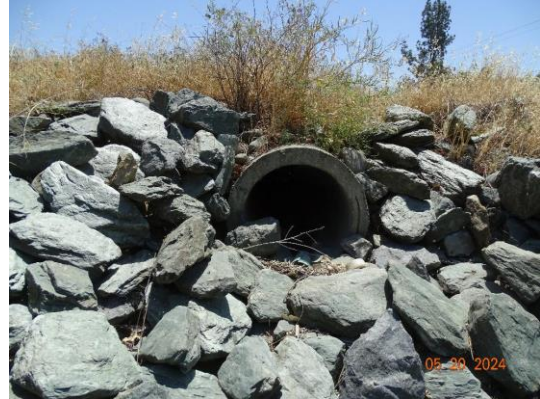
Photo 3 of 3 : UCIP_FA_2024_83906_123381.jpg

WS view: 24-inch reinforced concrete pipe outlet located at toe with rip rap.
