**Flood Control Project Maintenance  
Levee Inspections**  
**LMA District Cover Sheet**  
**Spring 2014 Levee Inspection Results**

**Reclamation District No. 1001 Nicolaus**

**Spring 2014 Levee Inspection Results**

| Unit No. 01 Yankee Slough | | Right | 4.17 |

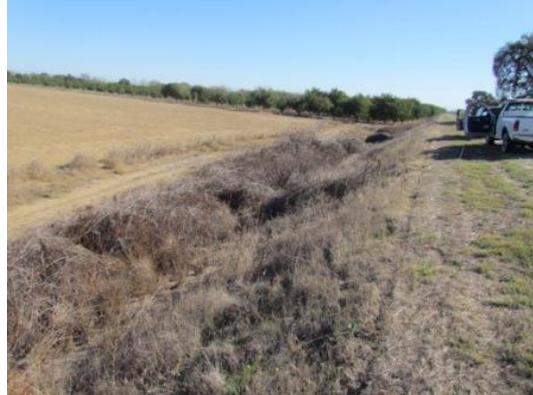
Photo 1 of 1 : mhoffman\_s\_20140401\_295.jpg

The landscape on the levee slope blocks visibility. Spring 2013

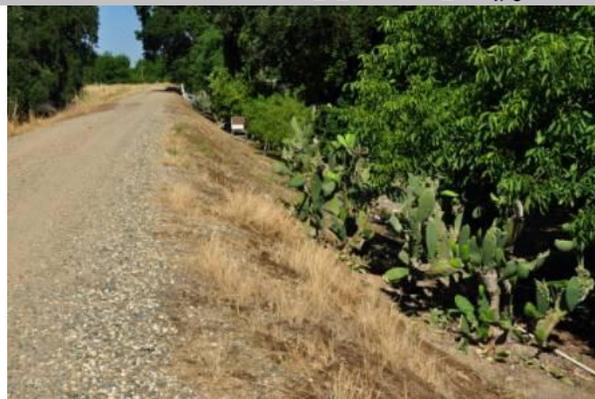
Photo 1 of 2 : mhoffman\_s\_20140512\_506.jpg

View of landscaping on landside slope.

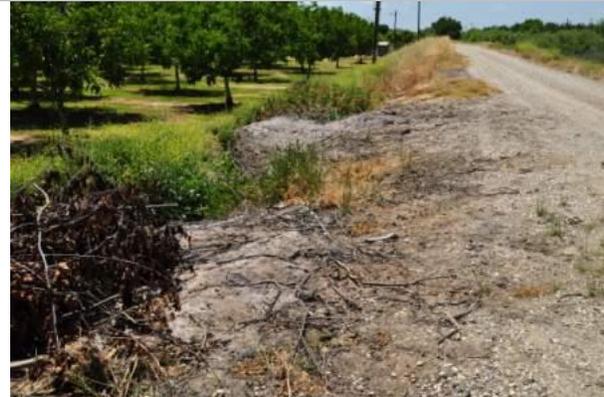
Photo 1 of 1 : mhoffman\_s\_20140401\_552.jpg

RD 1001 Unit 2 - L/S - Pruning Piles

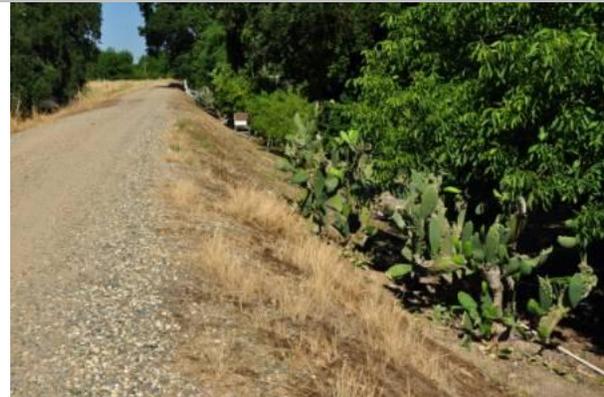
Photo 1 of 1 : mhoffman\_s\_20140512\_506.jpg

This photo was taken from the crown facing west looking down the waterward levee slope at vegetation requiring maintenance. Spring 2014.

| Control annual grass and weeds on the levee slopes and easements. | | | | | |

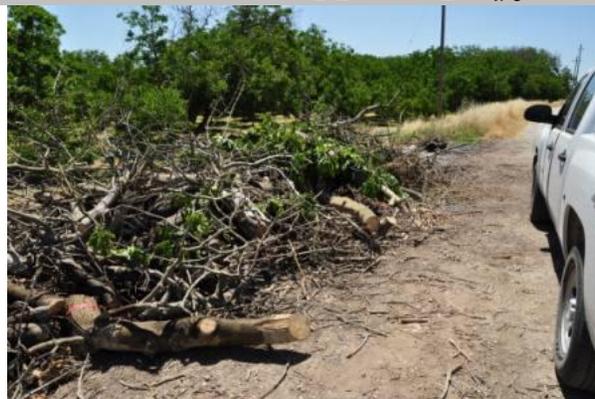
Photo 1 of 1 : mhoffman\_s\_20140401\_549.jpg

RD 1001 Unit 2 - L/S - Pruning Piles

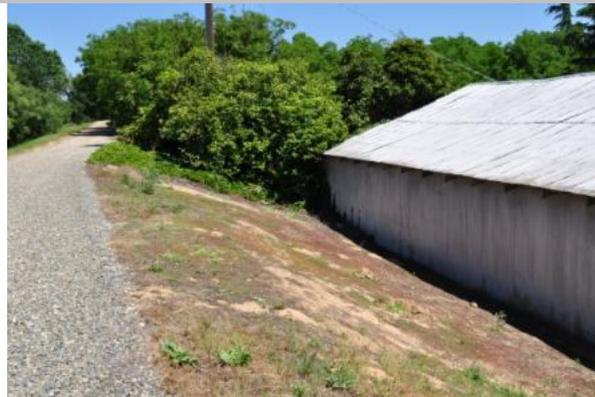
Photo 1 of 1 : mhoffman\_s\_20140401\_550.jpg

RD 1001 Unit 2 - L/S -Landscaping - Trees

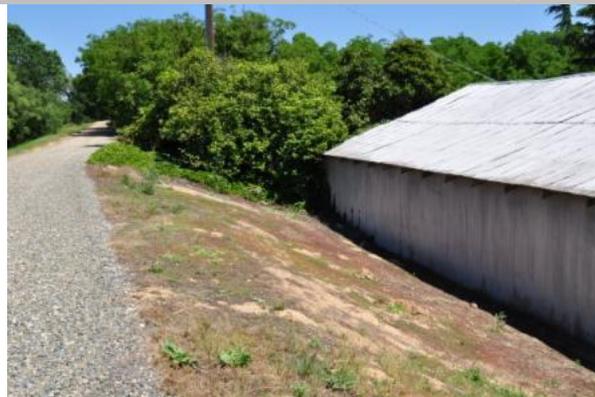
Photo 1 of 1 : mhoffman\_s\_20140401\_551.jpg

RD 1001 Unit 2 - L/S -Building @ toe.

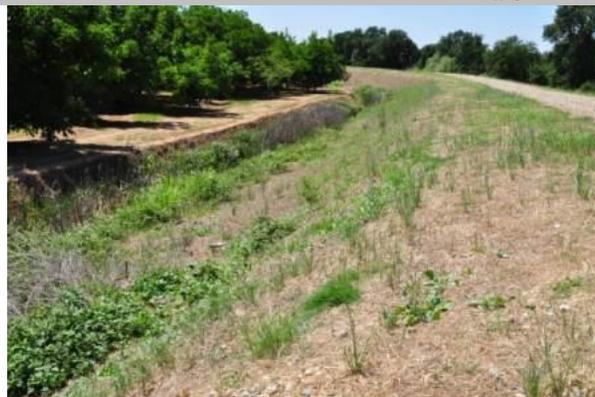
Photo 1 of 1 : mhoffman\_s\_20140401\_554.jpg

RD 1001 Unit 2 - L/S - Drainage Ditch @ toe.

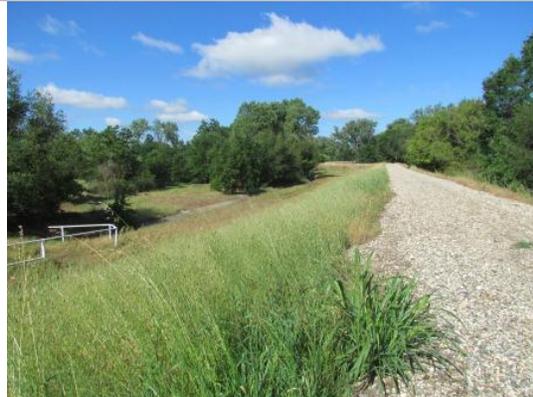
Photo 1 of 1 : mhoffman\_s\_20140512\_502.jpg

This photo was taken from the crown facing west looking down the landward levee slope at vegetation requiring maintenance. Spring 2014.

| Control annual grass and weeds on the levee slopes and easements. | | | | | |

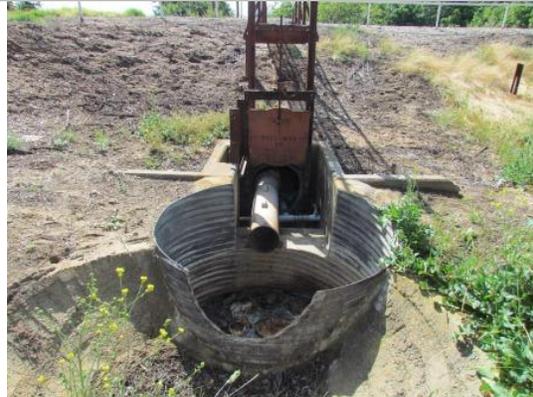
Photo 1 of 2 : mhoffman\_s\_20140512\_503.jpg

| Pipe<br>Inspector Comments: 2 pipes within 1 30" pipe through the levee. | | | | | |

This photo shows a pipe within a pipe on the on the waterward side of the levee. Spring 2014.

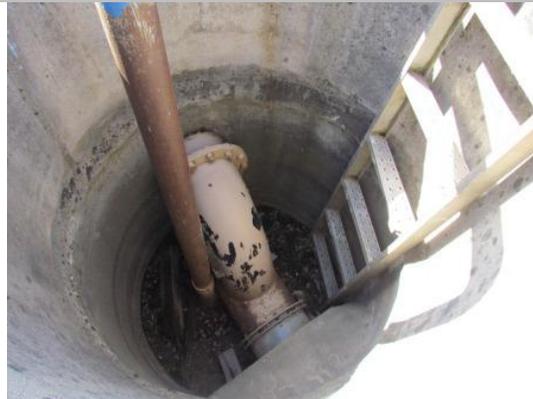
Photo 2 of 2 : mhoffman\_s\_20140512\_504.jpg

This photo shows a pipe within a pipe on the on the landward side of the levee. Spring 2014.

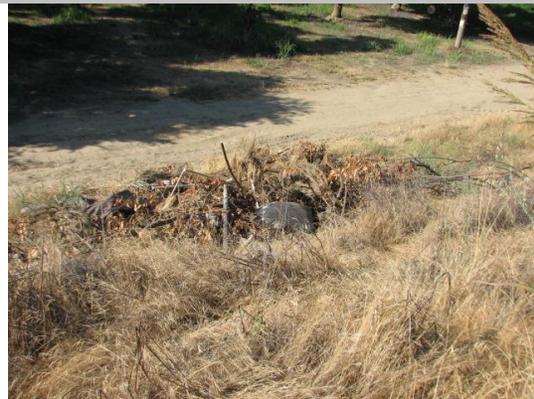
Photo 1 of 1 : mhoffman\_s\_20140401\_872.jpg

Pruning pile on the levee slope. Spring 2013

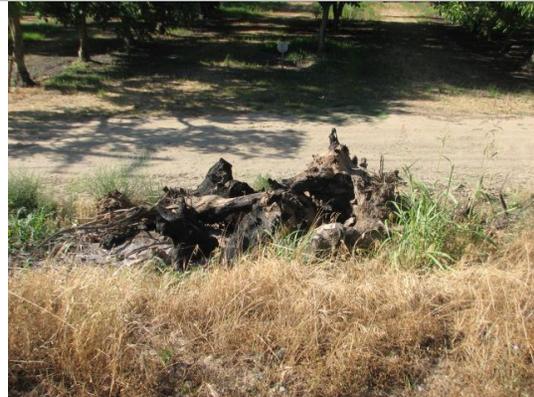
Photo 1 of 1 : mhoffman\_s\_20140401\_873.jpg

Stumps and pruning piled on the levee slope. Spring 2013

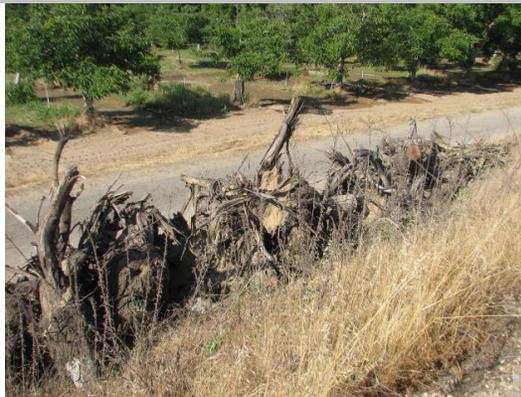
Photo 1 of 1 : mhoffman\_s\_20140401\_875.jpg

Walnut stumps at the levee toe. Spring 2013

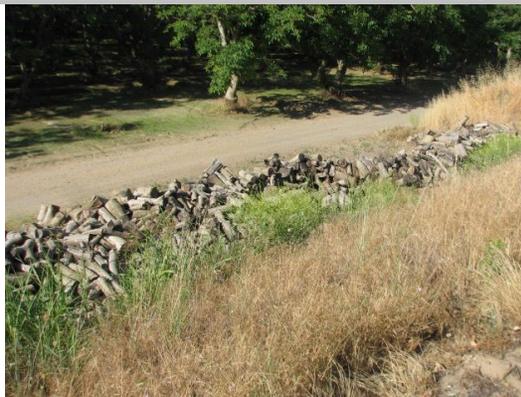
Photo 1 of 1 : mhoffman\_s\_20140401\_876.jpg

Firewood piled up at the levee toe. Spring 2013

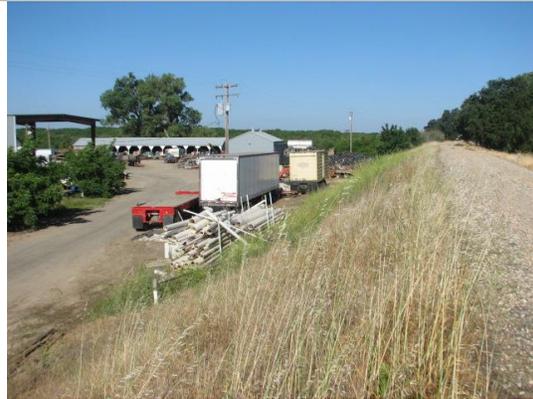
Photo 1 of 1 : mhoffman\_s\_20140401\_841.jpg

Irrigation pipe equipment and plastic cans within the easement of the levee. Spring 2013

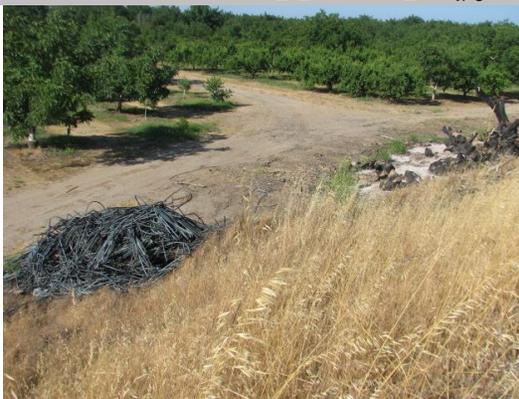
Photo 1 of 1 : mhoffman\_s\_20140401\_843.jpg

Drip irrigation tubing within the easement of the levee. Spring 2013

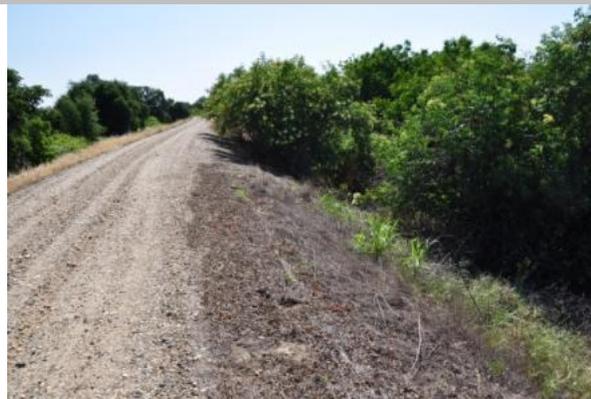
Photo 1 of 1 : mhoffman\_s\_20140401\_883.jpg

| Elderberries are blocking visibility and flood fight capability. | | | | | |

RD 1001 Unit 3 - W/S slope -Elderberries

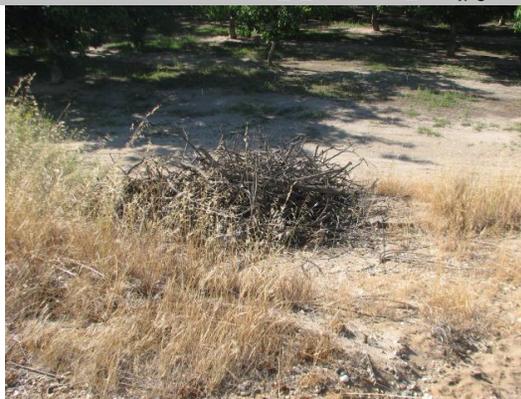
Photo 1 of 1 : mhoffman\_s\_20140401\_877.jpg

Small pruning pile at toe of levee. Spring 2013

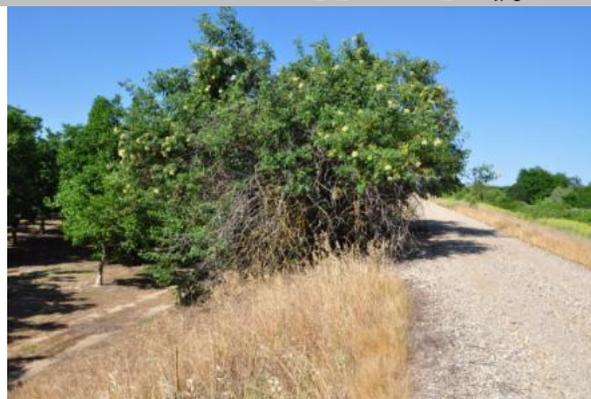
Photo 1 of 1 : mhoffman\_s\_20140401\_886.jpg

| Elderberries are blocking visibility and flood fight capability. | | | | | |

RD 1001 Unit 3 - L/S slope -Elderberries

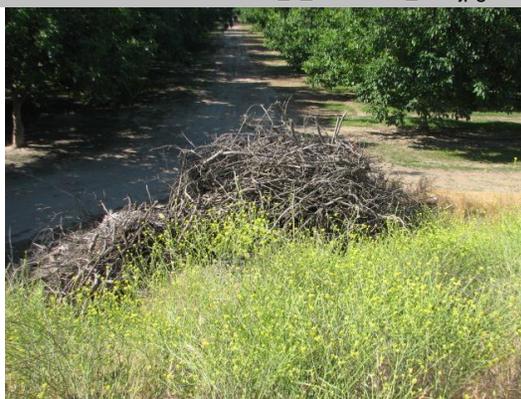
Photo 1 of 1 : mhoffman\_s\_20140401\_851.jpg

Pruning pile at toe of the levee. Spring 2013

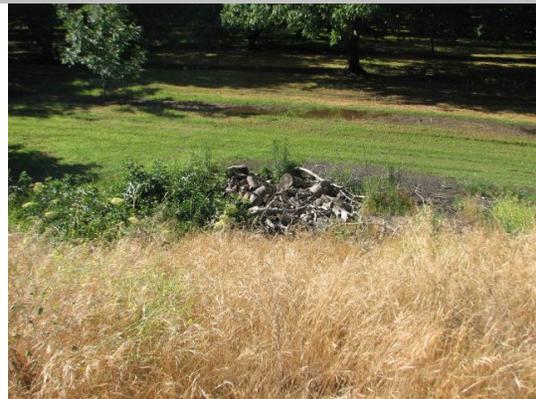
Photo 1 of 1 : mhoffman\_s\_20140401\_842.jpg

Pruning pile within the easement of the levee. Spring 2013

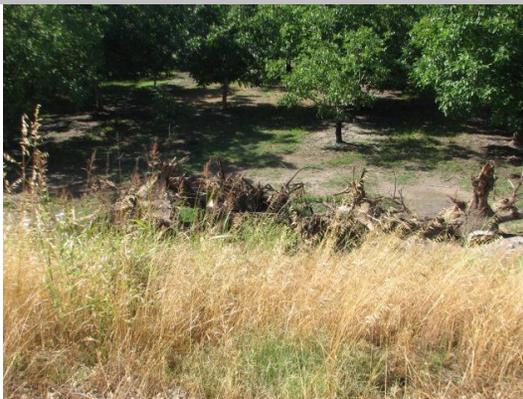
Photo 1 of 1 : mhoffman\_s\_20140401\_880.jpg

Walnut stumps within the easement of the levee. Spring 2013

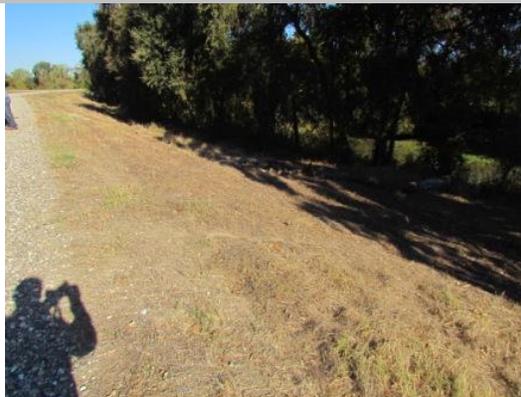
Photo 1 of 1 : mhoffman\_s\_20140401\_882.jpg

| Tree or limb<br>Inspector Comments: Fallen tree on waterward slope. | | | | | |

This photo was taken from the levee crown facing west looking down the waterward slope at a tree that had fallen down.

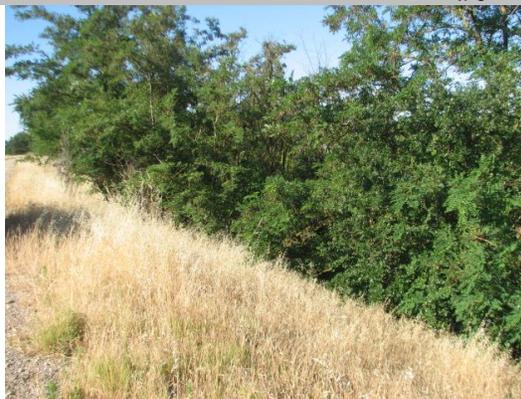
Photo 1 of 1 : mhoffman\_s\_20140401\_863.jpg

Trees partially obstruct visibility. Spring 2013

| Trim and thin trees to allow visibility of the ground and room to flood fight. | | | | | |

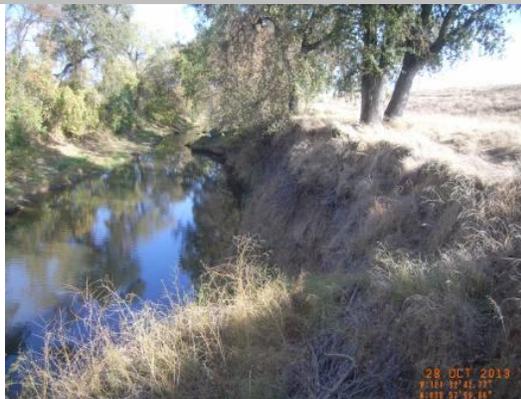
Photo 1 of 1 : USACE2013A\_BER\_2-5\_L\_2.jpg

| Inspector Comments: 2011 - Large section of bank has slumped off. RD has flagged and appears to be watching. 2012 - Slopes slightly steeper. 2013: Minor new erosion. [2013 Site ID: BER_2-5_L] | | | | | |

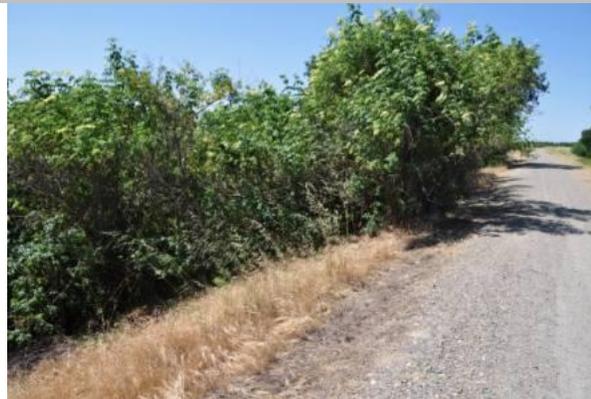
Photo 1 of 1 : mhoffman\_s\_20140401\_862.jpg

| Elderberries are blocking visibility and flood fight capability. | | | | | |

RD 1001 Unit 3 - L/S slope -Elderberries

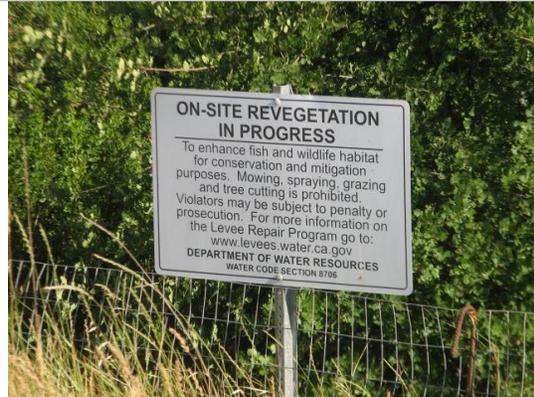
Photo 1 of 1 : mhoffman\_s\_20140401\_864.jpg

Revegetation site in progress. Spring 2013

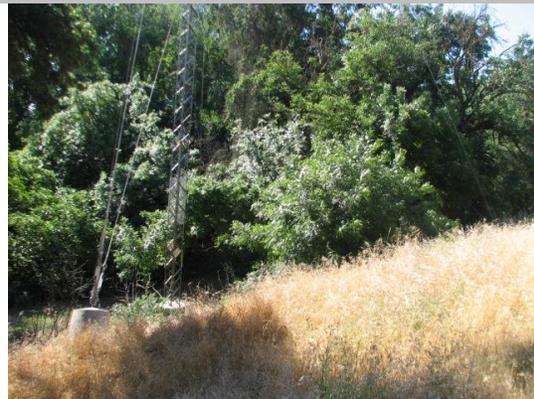
Photo 1 of 1 : mhoffman\_s\_20140401\_681.jpg

Power pole and guy wire on the levee slope. Spring 2013

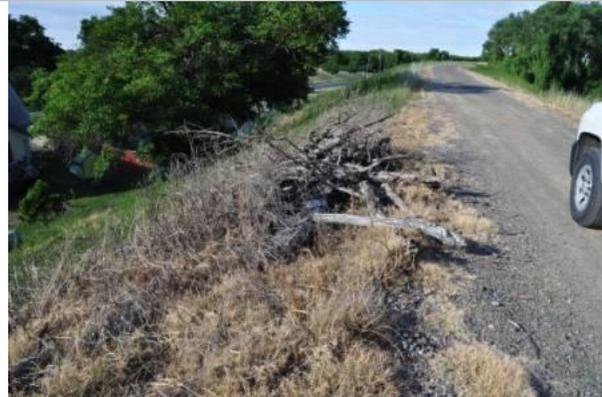
Photo 1 of 1 : mhoffman\_s\_20140401\_695.jpg

RD 1001 Unit 4 - L/S slope - Limb/Wood Pile.

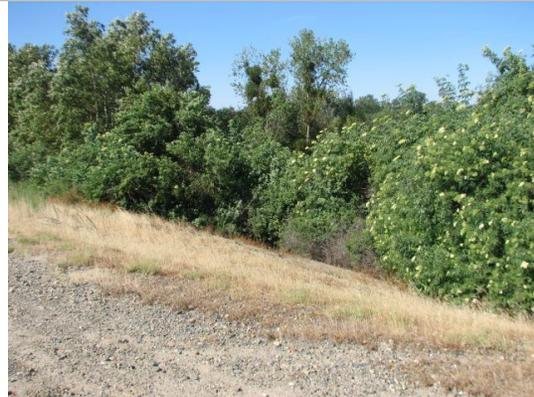
Photo 1 of 1 : mhoffman\_s\_20140401\_690.jpg

| Elderberries are blocking visibility and flood fight capability. | | | | | |

Elderberry Spring 2013

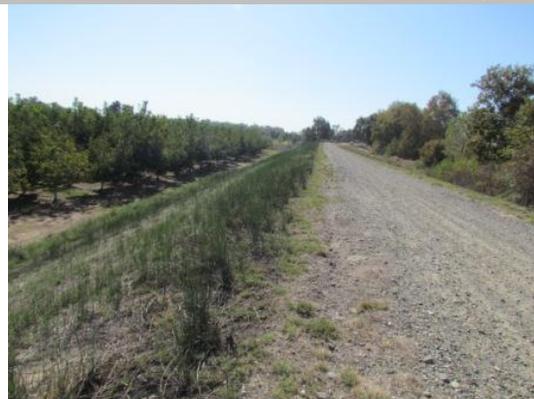
Photo 1 of 1 : mhoffman\_s\_20140401\_694.jpg

This photo was taken from the levee crown facing west looking down at the vegetation on the landward slope.

| Control annual grass and weeds on the levee slopes and easements. Inspector Comments: Maintain tall grass and vegetation on landward slope. | | | | | |

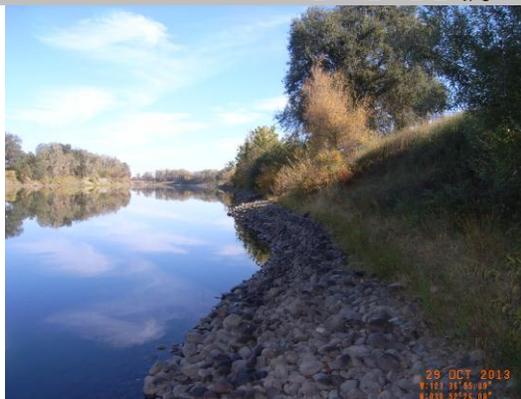
Photo 1 of 1 : USACE2013A\_FHR\_6-6\_L\_3.jpg

| Inspector Comments: 2011 - Erosion pockets from tree popouts. Sections of the lower bank have slumped off. 2013: Scallop from tree popouts no longer visible on site. Minor new erosion at the middle of the bank. [2013 Site ID: FHR_6-6_L] | | | | | |

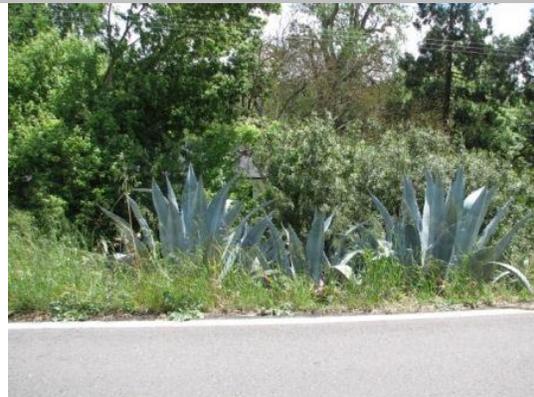
Photo 1 of 2 : mhoffman\_s\_20140401\_679.jpg

Landscaping on the landside shoulder and slope levee mile 6.48.

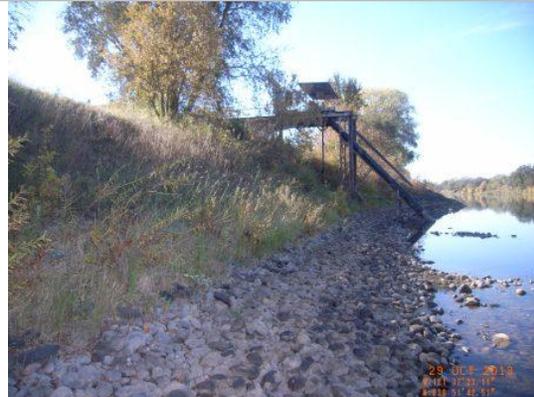
Photo 1 of 1 : USACE2013A\_FHR\_5-8\_L\_1.jpg

| Inspector Comments: 2011 - Large slumped sections on the lower | | | | | |

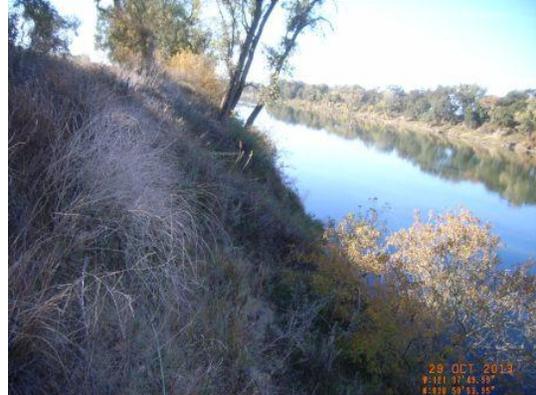
Photo 1 of 1 : USACE2013A\_FHR\_5-0\_L\_1.jpg

| Inspector Comments: 2000 - Steep bank off berm with some slumps and fallen trees, continued erosion. 2002 - Site lengthened upstream and downstream due to vertical bank along most of the reach. 2010 - Site extended upstream. 2011 - Minimal new erosion. 2012 - Site extended on the upstream end, new tree pop-out, and bank erosion continues to worsen. 2013: Minor new erosion at the toe and top of bank. [2013 Site ID: FHR_5-0_L] | | | | | |

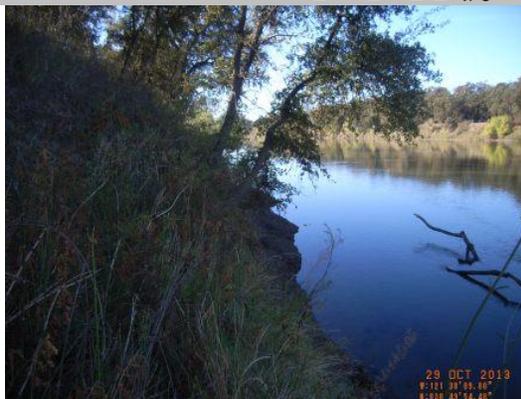
Photo 1 of 1 : USACE2013A\_FHR\_3-8\_L\_2.jpg

| Inspector Comments: 2006 - Sandy, silty bank with intermittent pockets of erosion. Rotational failure and tree pop outs are most of the problem. Some upper slope fluvial erosion. 2010 - Site extended upstream. The lower Feather may benefit from a regional repair. 2011 - Site combined with 3.6. Minimal new erosion. 2013: New erosion observed at bank toe. Trees on site now have exposed roots. [2013 Site ID: FHR_3-8_L] | | | | | |

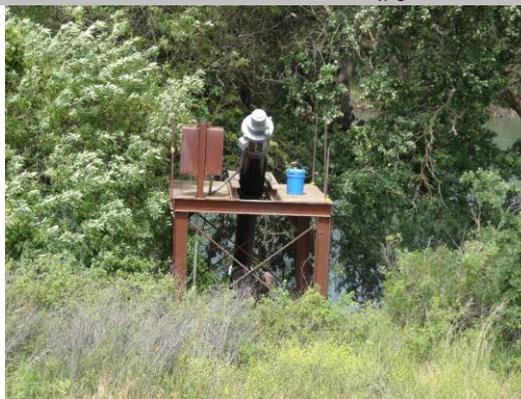
Photo 1 of 1 : UCIP\_1049.jpg

| Inspector Comments: FS_ID:14563<br>EP_NO: 12828<br>Repair Type:<br>Crossing Status:<br>UCIP Comments: - needs detailed investigation for road surface cracks<br>FIELD_STRUCT_DESC: 16-inch asphalt-coated steel irrigation pipe through the levee, 4.3 feet below the crown, 30-horsepower slant pump and platform on the bank (Permit No. 12828, 1979). O&M Manual Sac 141.1, August 1955.<br>FS Date: 5/16/2013 | | | | | |

WS- slanted pipe in steel structure on river bank.

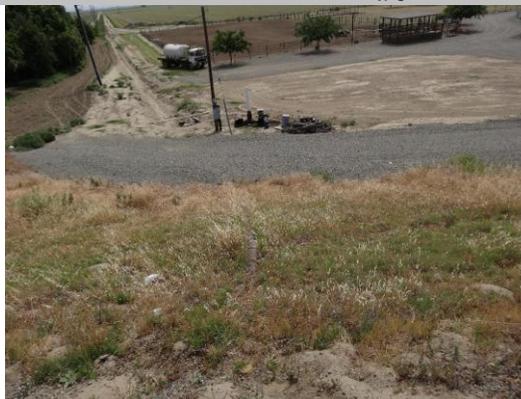
Photo 1 of 1 : UCIP\_1033.jpg

| Inspector Comments: FS_ID:14544<br>EP_NO: N/A<br>Repair Type:<br>Crossing Status:<br>UCIP Comments: - seems abandoned pipe crossing needs properly abandoned a 48" steel tank not found on landside.<br>FIELD_STRUCT_DESC: 12-inch steel irrigation pipe through the levee, 5.0 feet below the crown, pump on the bank, pipe discharges into a 48-inch steel tank at the landward toe (Johnston)<br>FS Date: 5/16/2013 | | | | | |

LS- overview of landside, steel pipe on levee slope.

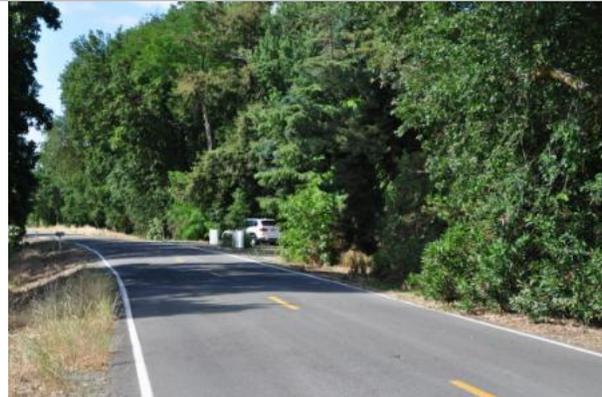
Photo 1 of 1 : mhoffman\_s\_20140401\_683.jpg

RD 1001 Unit 4 - W/S slope -Landscaping/Trees

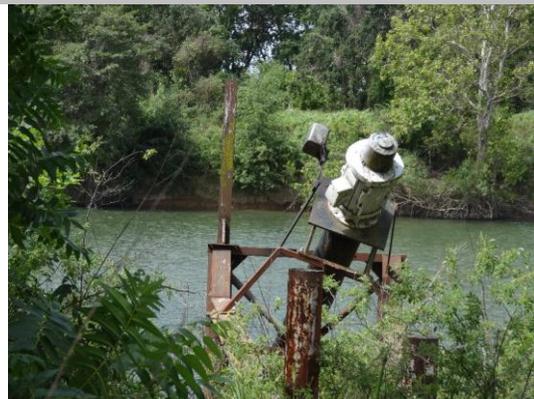
Photo 1 of 1 : UCIP\_1080.jpg

| Inspector Comments: FS_ID:14627<br>EP_NO: 3297<br>Repair Type:<br>Crossing Status:<br>UCIP Comments: - needs properly abandoned.dismantled standpipe found on LS levee slope<br>FIELD_STRUCT_DESC: 12-inch steel pipe through the levee, 3.0 feet below the crown, slant pump mounted on a steel structure on the bank, siphon breaker on the landward shoulder, pipe discharges into a 24-inch concrete standpipe at the landward toe (Permit No. 3297, 1960).<br>FS Date: 5/16/2013 | | | | | |

WS- abandoned slanted pump station in steel pipe structure in river bank.

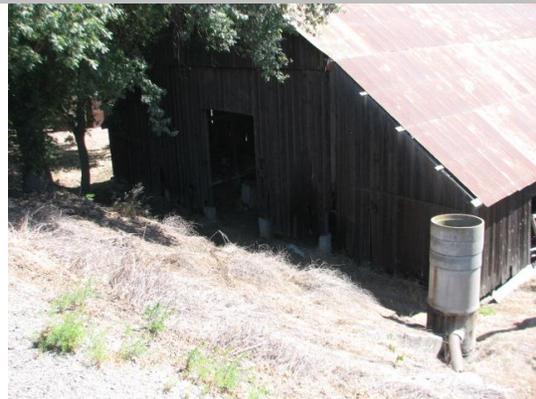
Photo 1 of 1 : mhoffman\_s\_20140401\_692.jpg

| Building | | | | | |

The building is within the easement of the levee. Spring 2013

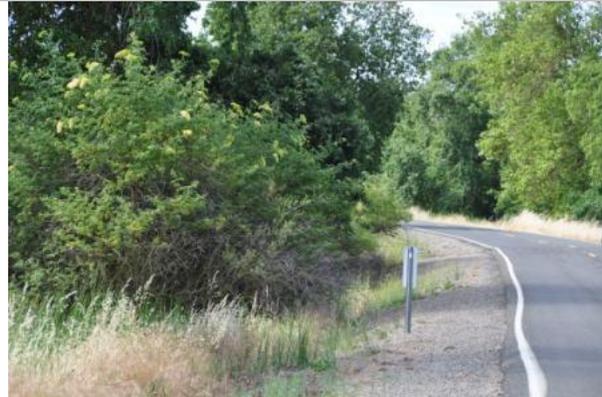
Photo 1 of 1 : mhoffman\_s\_20140401\_684.jpg

| Elderberries are blocking visibility and flood fight capability. | | | | | |

RD 1001 Unit 4 - L/S slope - Elderberries

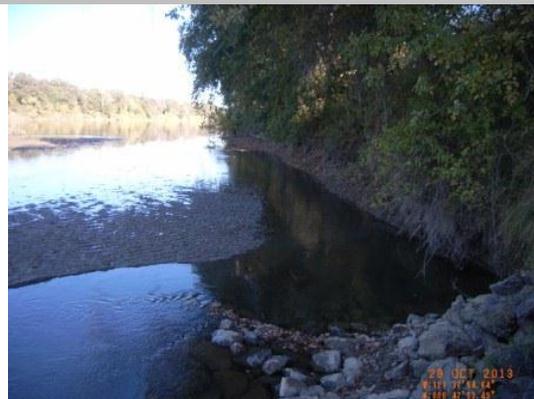
Photo 1 of 1 : USACE2013A\_FHR\_1-0\_L\_2.jpg

| Inspector Comments: 2000 - Site is relatively stable except for some toe erosion at the upstream end, recommend monitoring the upstream end. 2004 - Some new block failures (10ft deep) at the toe of the upstream end. 2007 - Some minor new slumping at the waterline. 2013: Minor new erosion along the toe of the bank. [2013 Site ID: FHR_1-0_L] | | | | | |

USACE 2013 Photo #1

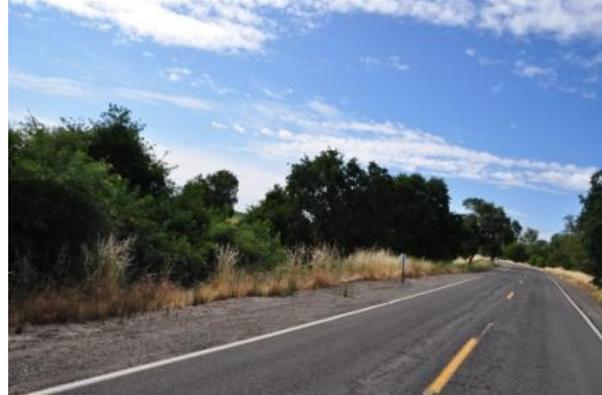
Photo 1 of 1 : mhoffman\_s\_20140401\_685.jpg

| Elderberries are blocking visibility and flood fight capability. | | | | | |

RD 1001 Unit 4 - L/S slope - Elderberries

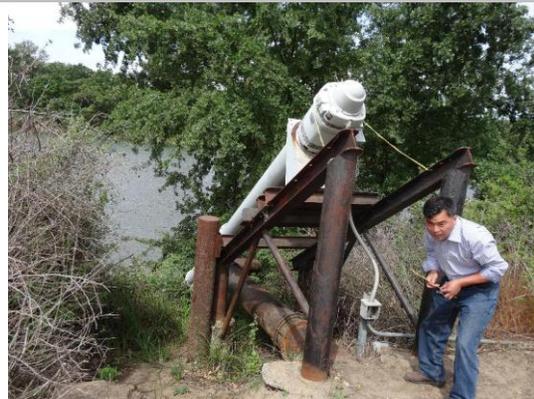
Photo 1 of 1 : UCIP\_1037.jpg

| Inspector Comments: FS_ID:14548<br>EP_NO: 3489<br>Repair Type:<br>Crossing Status:<br>UCIP Comments: - siphon breaker on the landward shoulder not found. cracked road surface along the pipe alienment. Needs more investigations.<br>FIELD_STRUCT_DESC: 16-inch pipe through the levee, 3.0 feet below the crown, 40-horsepower slant pump mounted on a steel structure on the bank, pipe discharges into a 36-inch concrete standpipe on the landward toe (Permit No. 3489, 1960).<br>FS Date: 5/16/2013 | | | | | |

WS- slant pump, pipe on steel piles.

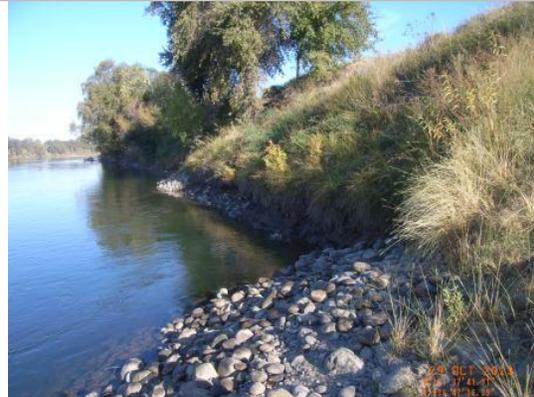
Photo 1 of 1 : USACE2013A\_FHR\_0-6\_L\_1.jpg

| Inspector Comments: 1997- Deposits over top of cobble on the upper slope. 2000 - Old cobble site in poor shape; some toe retreat, but little change; steep bank. 2010 - Site extended upstream due to new toe erosion. 2012 - Minor new erosion at toe, new slumping, animals holes and cracks observed. 2013: No observed changes. [2013 Site ID: FHR_0-6_L] | | | | | |

USACE 2013 Photo #1

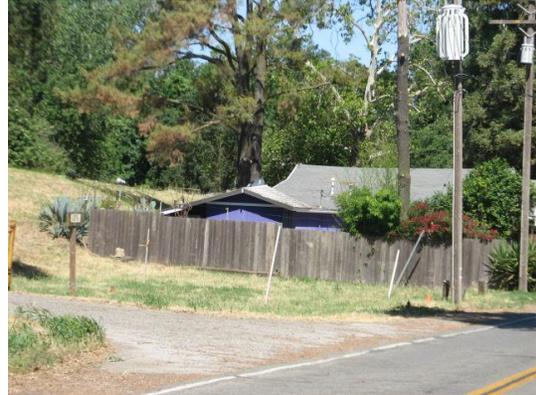
Photo 1 of 2 : mhoffman\_s\_20140401\_687.jpg

A building is at the toe of the levee. Spring 2013

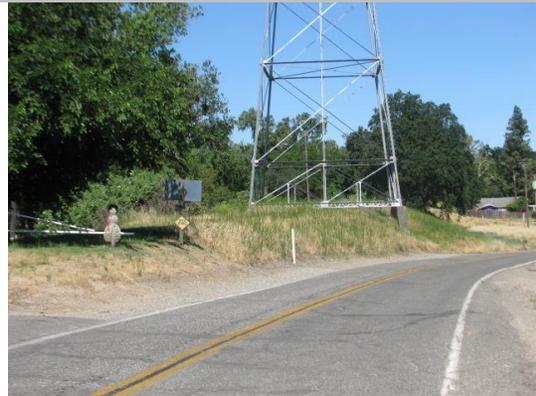
Photo 2 of 2 : mhoffman\_s\_20140401\_688.jpg

A short section of the levee (12.47-12.70) has limited access. Spring 2013

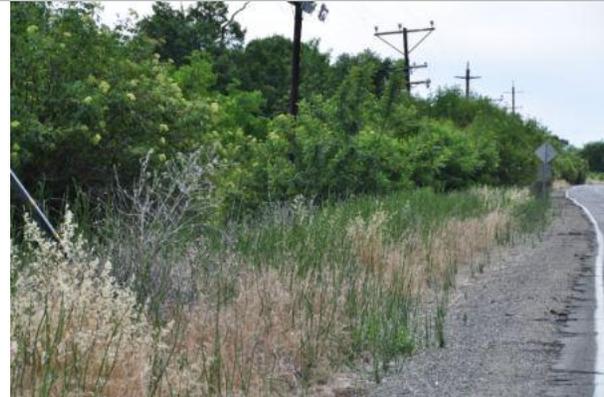
Photo 1 of 1 : mhoffman\_s\_20140401\_676.jpg

| Elderberries are blocking visibility and flood fight capability. | | | | | |

RD 1001 Unit 4 - W/S slope - Elderberries

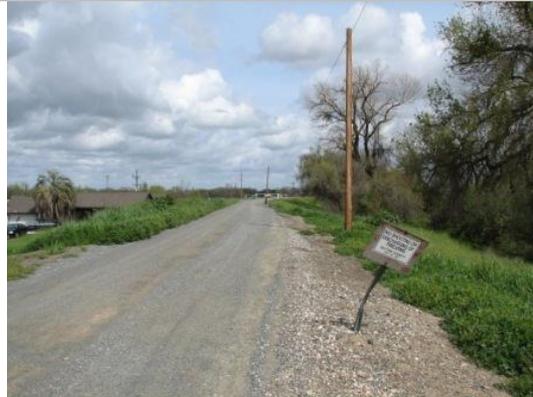
Photo 1 of 2 : mhoffman\_s\_20140401\_777.jpg

Poles on the water side shoulder levee mile 0.00 - 0.75

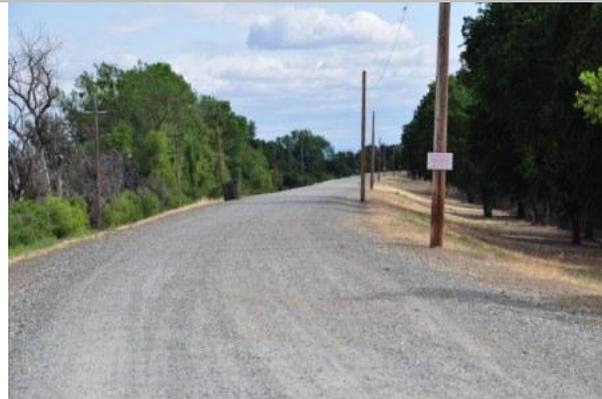
Photo 2 of 2 : mhoffman\_s\_20140401\_778.jpg

RD 1001 Unit 5 - W/S Levee Shoulder - Poles

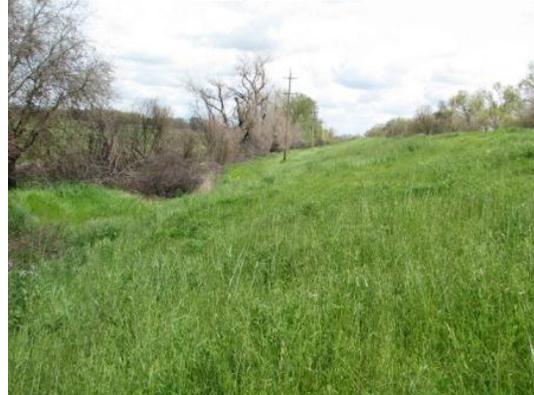
Photo 1 of 2 : mhoffman\_s\_20140401\_781.jpg

Poles at the land side toe levee mile 0.19 - 0.86.

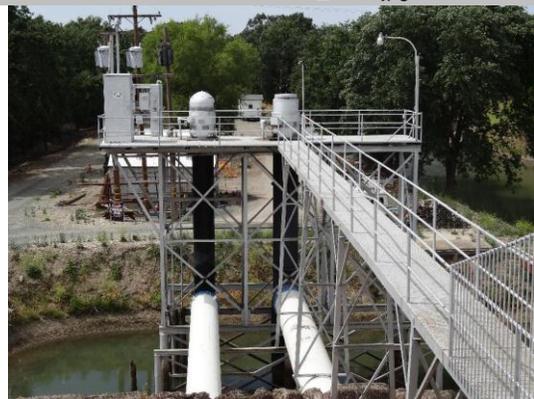
Photo 1 of 1 : UCIP\_1013.jpg

LS- pumps, pipes, and walkway on steel structure

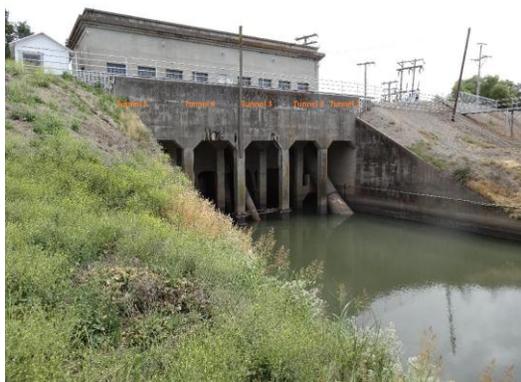
Photo 1 of 1 : UCIP\_1007.jpg

| Inspector Comments: FS_ID:14393<br>EP_NO: N/A<br>Repair Type:<br>Crossing Status:<br>UCIP Comments: - needs repair of concrete piers on waterside. Rebar exposed from the pier. Even though this pier is functionally not linked to the pipe, it needs repair.<br>FIELD_STRUCT_DESC: 5 of 8: A 24-inch pipe through levee, 25 ft. below the levee crown. Five 5-foot-by-7-foot concrete tunnels through the levee, 25.0 feet below the crown, one tunnel has a 60-inch pump installed inside and is gated on the waterward end, two 50-inch pipes through the levee, 25.0 feet below the crown, all tunnels and pipes are gated, concrete headwall and railing along the landward side (R.D. No. 1001)<br>FS Date: 5/15/2013 | | | | | |

LS- Drainage structure with tunnels, pipes and pump house. Tunnel 1 at far right and tunnel 5 at far left. The pipe is located inside tunnel 3.

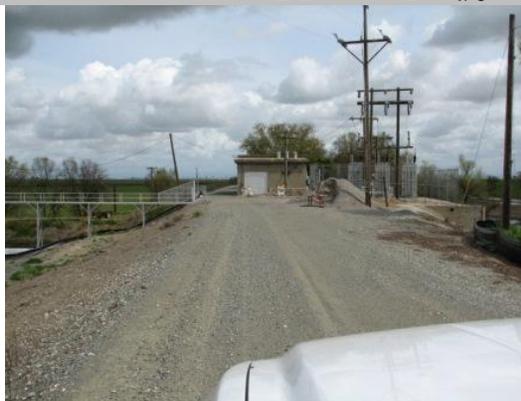
Photo 1 of 2 : mhoffman\_s\_20140401\_779.jpg

Pump house on the water side levee mile 0.83.

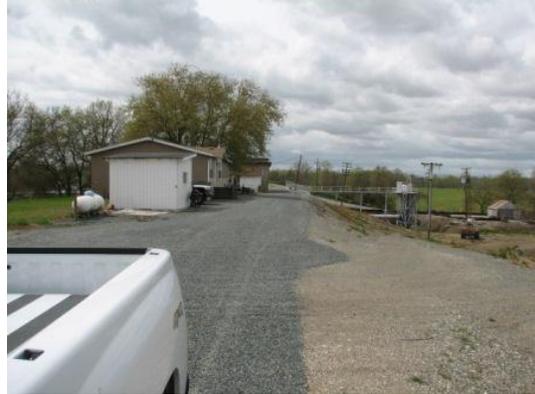
Photo 2 of 2 : mhoffman\_s\_20140401\_780.jpg

Pump house and caretakers home levee mile 0.83

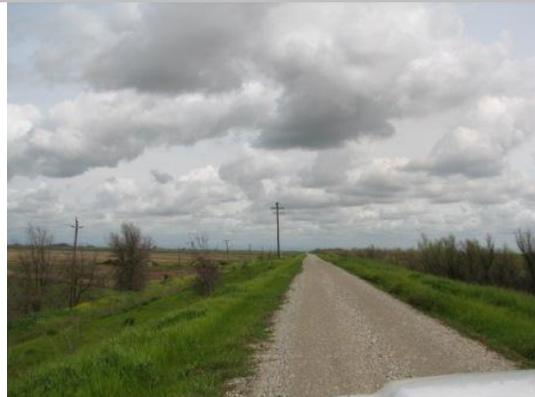
Photo 1 of 2 : mhoffman\_s\_20140401\_783.jpg

Pole on land side shoulder levee mile 1.15.

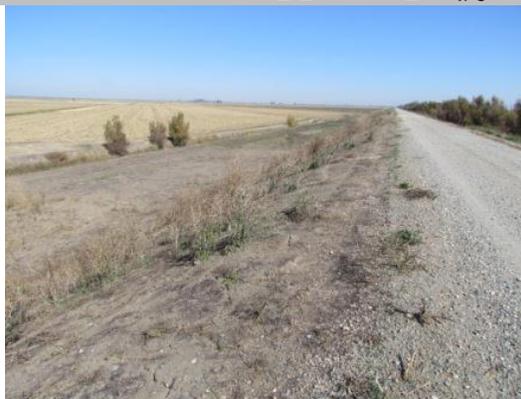
Photo 1 of 1 : mhoffman\_s\_20140401\_791.jpg

This photo was taken from the levee crown facing east looking at the vegetation on the landward slope.

| Control annual grass and weeds on the levee slopes and easements. | | | | | |

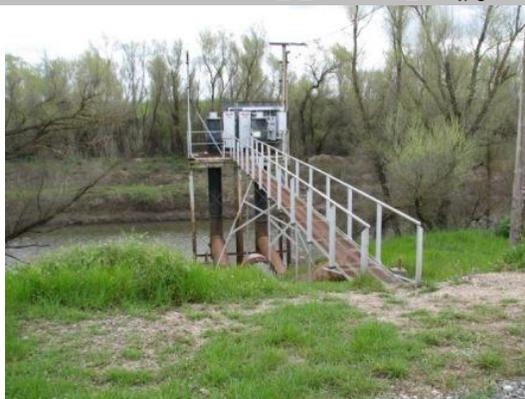
Photo 1 of 1 : mhoffman\_s\_20140401\_786.jpg

Pump water side levee mile 3.69.

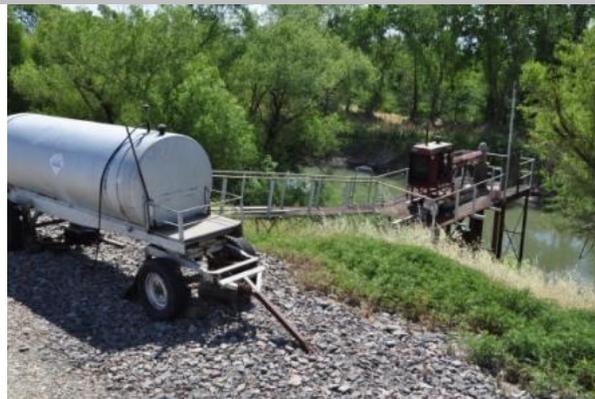
Photo 1 of 2 : mhoffman\_s\_20140401\_787.jpg

RD 1001 Unit 5 - W/S slope -Equipment & Portable Tank

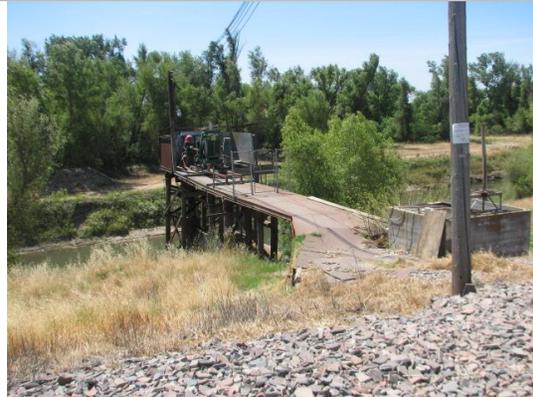
Photo 1 of 1 : mhoffman\_s\_20140401\_790.jpg

Pump and pipe through the levee with positive closure on the waterside. Spring 2013

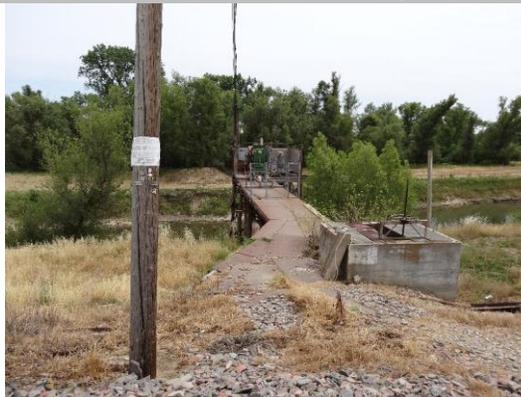
Photo 1 of 1 : UCIP\_1022.jpg

| Inspector Comments: FS_ID:14484<br>EP_NO: 1896<br>Repair Type:<br>Crossing Status:<br>UCIP Comments: - slide gate in concrete box on waterside levee toe. cracked headwall on landsideworking during field survey<br>FIELD_STRUCT_DESC: 1 of 3: A 20-inch steel pipe of three pipes (a 30-inch and two 20-inch corrugated-metal asbestos-bonded pipe) through the levee, 2.13 feet below the crown, three vertical pumps on a wooden piling structure in the stream, walkway to the pumps, slide gate in a concrete box on the waterward side (Permit No. 1896)<br>FS Date: 5/15/2013 | | | | | |

WS- overview of pump station, walkway, and slide gate in concrete box.

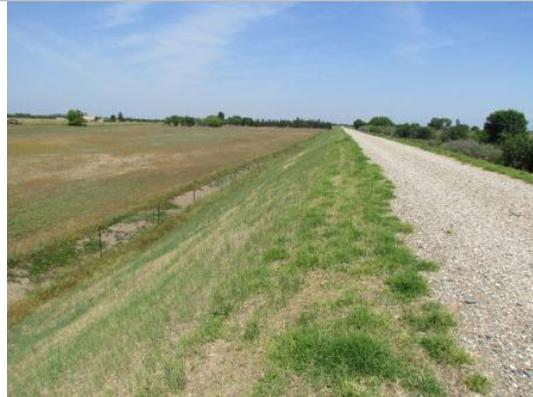
Photo 1 of 1 : mhoffman\_s\_20140512\_509.jpg

This photo was taken from the crown facing north looking down the landward levee slope at acceptable vegetation control. Spring 2014.

| Control annual grass and weeds on the levee slopes and easements. | | | | | |

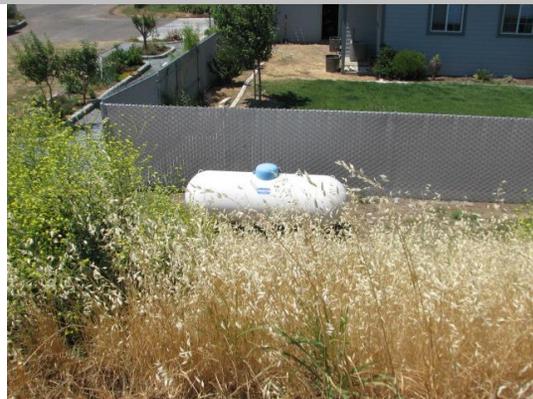
Photo 1 of 1 : mhoffman\_s\_20140401\_050.jpg

A propane tank is within the easement of the levee. Spring 2013

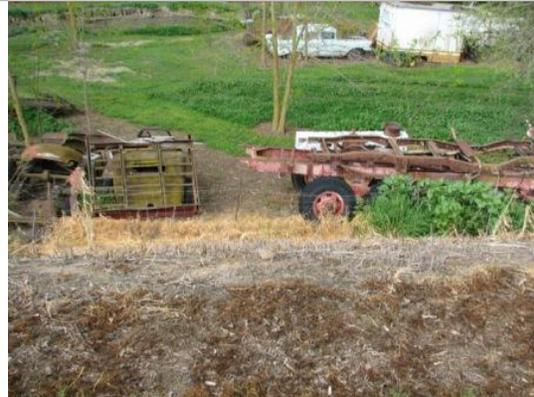
Photo 1 of 1 : mhoffman\_s\_20140401\_046.jpg

Equipment at the landside toe LM 1.37.

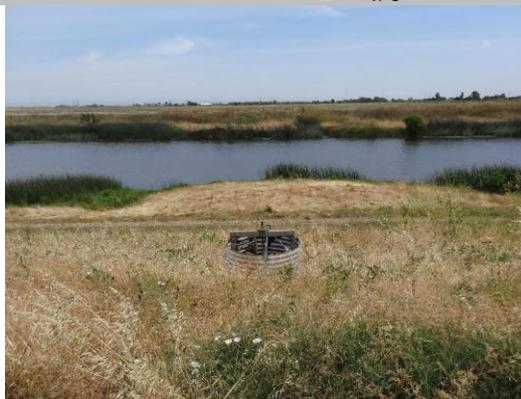
Photo 1 of 1 : UCIP\_971.jpg

| Inspector Comments: FS_ID:14244<br>EP_NO: N/A<br>Repair Type:<br>Crossing Status:<br>UCIP Comments: - visible damage to pipe on opening at inlet due to high corrosion.video inspection recommended.<br>FIELD_STRUCT_DESC: 36-inch corrugated-metal drainage pipe through the levee, 12.5 feet below the crown, slide gate in a 48-inch corrugated-metal pipe riser on the waterward slope, concrete headwall at the landward toe, the pipe crosses under the channel.<br>FS Date: 5/15/2013 | | | | | |

WS- slide gate in CMP riser on levee slope.

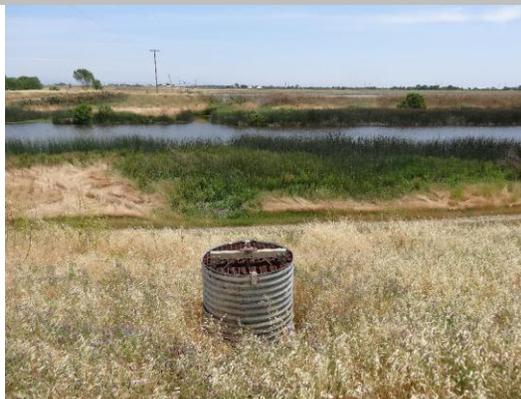
Photo 1 of 1 : UCIP\_968.jpg

| Inspector Comments: FS_ID:14223<br>EP_NO: N/A<br>Repair Type:<br>Crossing Status:<br>UCIP Comments: - pipe buried/submerged on LSneeds cleaning of LS pipe end opening.<br>FIELD_STRUCT_DESC: 24-inch corrugated-metal drainage pipe through the levee, 15.5 feet below the crown, slide gate in a 36-inch corrugated-metal pipe riser on the waterward slope, concrete headwall at the landward toe, the pipe crosses under the channel<br>FS Date: 5/15/2013 | | | | | |

WS- slide gate in CMP riser on levee slope.

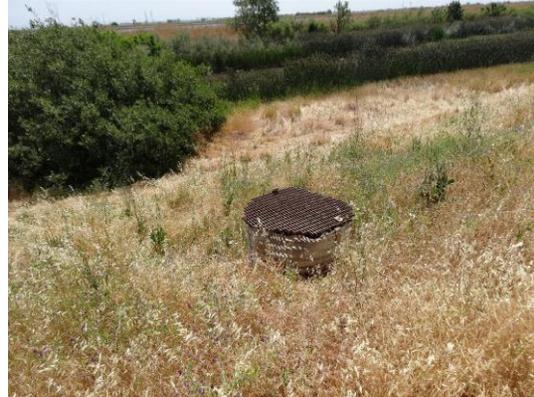
Photo 1 of 1 : UCIP\_960.jpg

| Inspector Comments: FS_ID:14167<br>EP_NO: N/A<br>Repair Type:<br>Crossing Status:<br>UCIP Comments: - pipe opens in irrigation ditch on landside. vegetation cleaning on LS pipe opening.<br>FIELD_STRUCT_DESC: 24-inch corrugated-metal drainage pipe through the levee, 12.0 feet below the crown, slide gate in a 36-inch corrugated-metal pipe riser on the waterward slope, concrete headwall at the landward toe, the pipe crosses under the channel<br>FS Date: 5/15/2013 | | | | | |

WS- slide gate in CMP riser on levee slope

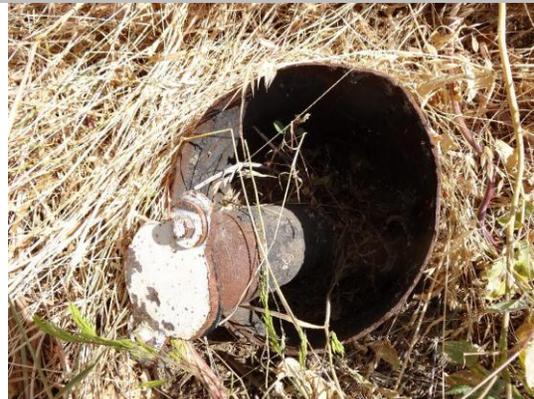
Photo 1 of 1 : UCIP\_868.jpg

| Inspector Comments: FS_ID:13523<br>EP_NO: N/A<br>Repair Type:<br>Crossing Status:<br>UCIP Comments: - needs filling/plugging gap between 4-inch and 10-inch pipes.<br>FIELD_STRUCT_DESC: 1 of 2: A capped 4-inch steel pipe sleeved through a 10-inch steel pipe, located just off the top of the slope on waterside of the levee.<br>FS Date: 5/15/2013 | | | | | |

WS- a 4-inch steel pipe sleeved through 10-inch steel pipe.

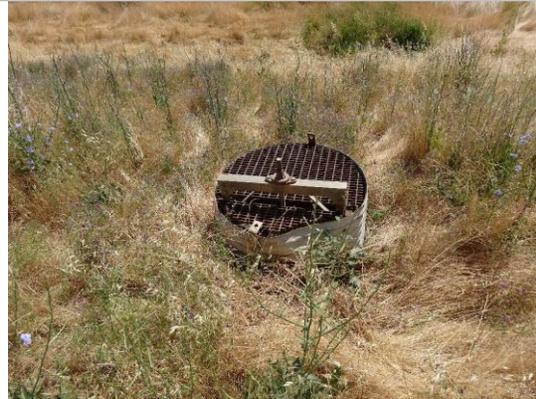
Photo 1 of 1 : UCIP\_866.jpg

| Inspector Comments: FS_ID:13509<br>EP_NO: N/A<br>Repair Type:<br>Crossing Status:<br>UCIP Comments: Only a small section of head wall visible, almost buried.<br>FIELD_STRUCT_DESC: 24-inch corrugated-metal drainage pipe through the levee, 12.0 feet below the crown, slide gate in a 36-inch corrugated-metal pipe riser on the waterward slope, concrete headwall at the landward toe, the pipe crosses under the channel<br>FS Date: 5/15/2013 | | | | | |

WS- fixed slide gate in CMP riser on levee slope.

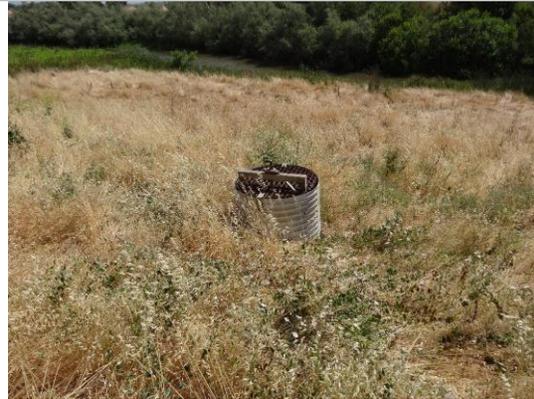
Photo 1 of 1 : UCIP\_856.jpg

| Inspector Comments: FS_ID:13485<br>EP_NO: N/A<br>Repair Type:<br>Crossing Status:<br>UCIP Comments: - mud/soil debris on LS pipe end highly corroded pipe in outlet may require video inspection or pressure test.<br>FIELD_STRUCT_DESC: 24-inch corrugated-metal drainage pipe through the levee, 12.2 feet below the crown, slide gate in a 36-inch corrugated-metal pipe riser on the waterward slope, concrete headwall at the landward toe, the pipe crosses under the channel<br>FS Date: 5/15/2013 | | | | | |

WS- slide gate, air vent in CMP riser on levee slope
