**Flood Control Project Maintenance
Levee Inspections**

Maintenance Issue Types Only, Levee Inspection Report By Mile - Fall 2015

Reclamation District No. 1001 Nicolaus

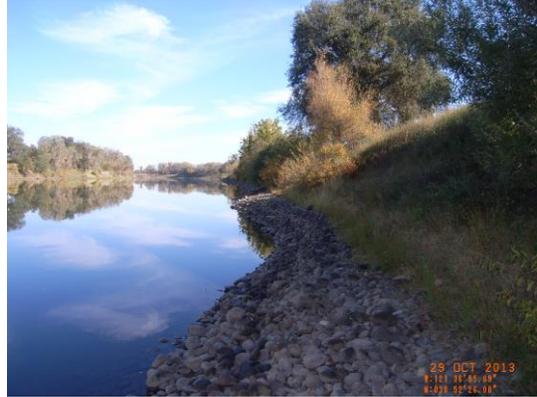
Photo 1 of 1 : USACE2013A_FHR_6-6_L_3.jpg

LM Start	5.80	Rating **	M	Issue No.	2
LM End	5.93	Issue Type +	Ma	Location *	WS
Category	Supplemental			GPS Latitude/Longitude	
				Start	End
Item	2015 USACE Erosion Survey, DRAFT			38.874113 °	38.872373 °
DWR ID				-121.615380 °	-121.616504 °
Action/Comments					
Inspector Comments: 2011 - Erosion pockets from tree popouts. Sections of the lower bank have slumped off. 2013 - Scallops from tree popouts no longer visible on site. Minor new erosion at the middle of the bank. 2015: Fresh erosion from human use. [2015 Site ID: FHR_6-6_L]

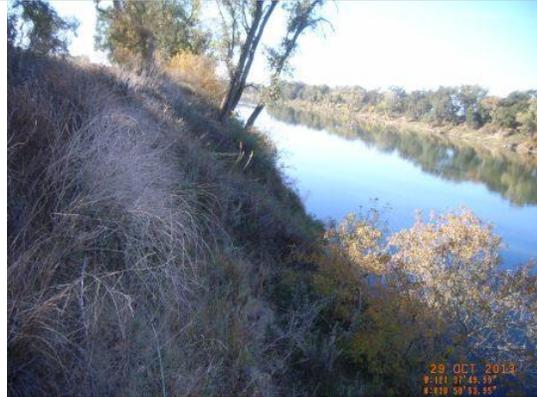
Photo 1 of 1 : USACE2013A_FHR_5-0_L_1.jpg

LM Start	7.47	Rating **	M	Issue No.	8
LM End	7.79	Issue Type +	Ma	Location *	WS
Category	Supplemental			GPS Latitude/Longitude	
				Start	End
Item	2015 USACE Erosion Survey, DRAFT			38.852394 °	38.848004 °
				-121.629231 °	-121.630873 °
DWR ID					
Action/Comments					
Inspector Comments: 2000 - Steep bank off berm with some slumps and fallen trees, continued erosion. 2002 - Site lengthened upstream and downstream due to vertical bank along most of the reach. 2010 - Site extended upstream. 2011 - Minimal new erosion. 2012 - Site extended on the upstream end, new tree pop-out, and bank erosion continues to worsen. 2013 - Minor new erosion at the toe and top of bank. 2015: No observed changes. [2015 Site ID: FHR_5-0_L]
