**Flood Control Project Maintenance
Levee Inspections**

Fall 2014 Levee Maintenance Deficiency Summary Report

Reclamation District No. 1500 Sutter Basin

Fall 2014 Levee Inspection Results

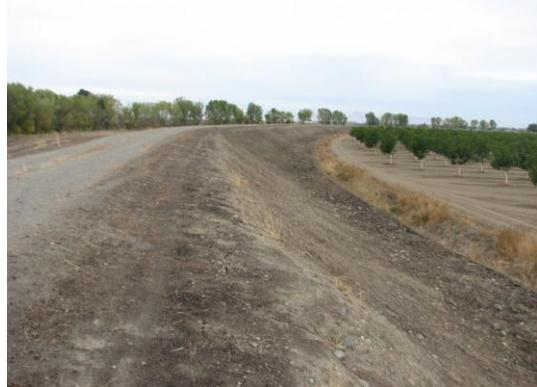
Photo 1 of 1 : FA_2014_RD1500_189_39_20141030_00153.jpg

LM Start	0.00	Rating **	A	Issue No.	39
LM End	33.58	Issue Type +	Ma	Location *	LS
Category	Earthen Levee		GPS Latitude/Longitude		
			Start	End	
Item	Vegetation		°	°	
			°	°	
DWR ID	DWR_RD1500_01_s_2012_39				
Action/Comments					
Control annual grass and weeds on the levee slopes and easements.

Levee mile 26.84, vegetation on the land side levee slope. Fall 2014.

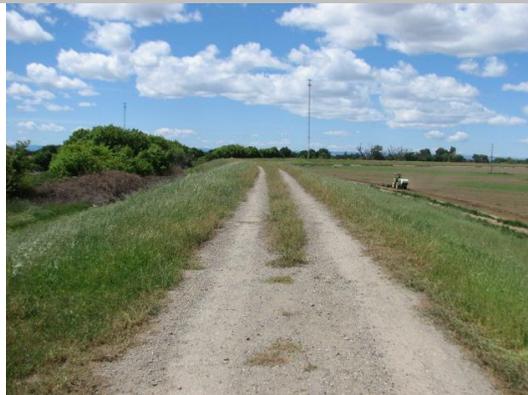
Photo 1 of 1 : FA_2014_RD1500_189_1337_20141014_00095.jpg

LM Start	0.53	Rating **	M	Issue No.	1337
LM End	1.36	Issue Type +	Ma	Location *	CR
Category	Earthen Levee		GPS Latitude/Longitude		
			Start	End	
Item	Vegetation		38.764503 °	38.770175 °	
			-121.682482 °	-121.690209 °	
DWR ID	DWR_RD1500_01_s_2014_1337				
Action/Comments					
Keep the crown roadway free of vegetation.

Control unwanted vegetation on the levee crown. Spring 2014

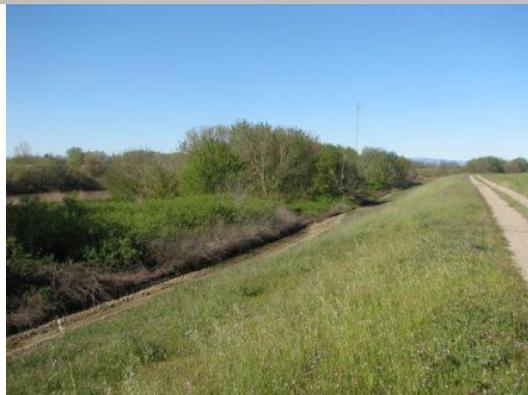
Photo 1 of 2 : FA_2014_RD1500_189_72_20141014_00059.jpg

LM Start	0.57	Rating **	A/W	Issue No.	72
LM End	0.83	Issue Type +	Ma	Location *	WS
Category	Earthen Levee		GPS Latitude/Longitude		
			Start	End	
Item	Vegetation		38.764462 °	38.764638 °	
			-121.683167 °	-121.687690 °	
DWR ID	DWR_RD1500_01_s_2012_72				
Action/Comments					
Environmental Requirements.

A view of the revegetation site.

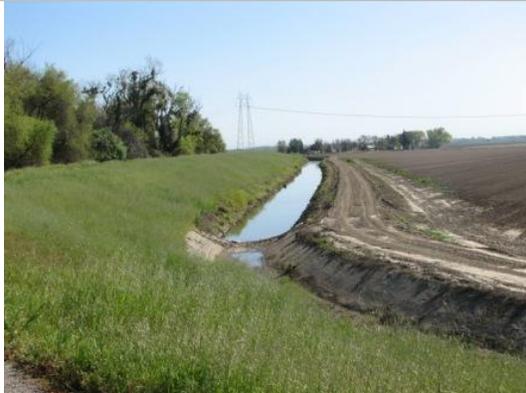
Photo 1 of 1 : FA_2014_RD1500_189_963_20141014_00081.jpg

LM Start	2.57	Rating **	M	Issue No.	963
LM End	3.83	Issue Type +	En	Location *	LS
Category	Earthen Levee		GPS Latitude/Longitude		
			Start	End	
Item	Encroachments		38.785351 °	38.797174 °	
			-121.689075 °	-121.693045 °	
DWR ID	DWR_RD1500_01_s_2012_963				
Action/Comments					
Ditch

Agricultural ditch, photo was taken in spring 2010.

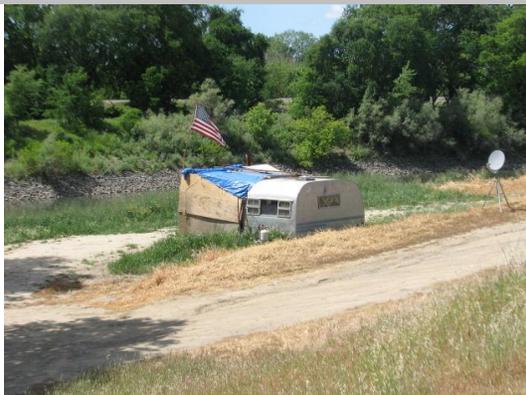
Photo 1 of 1 : FA_2014_RD1500_189_1339_20141014_00097.jpg

LM Start	3.98	Rating **	M	Issue No.	1339
LM End	3.98	Issue Type +	En	Location *	WS
Category	Earthen Levee		GPS Latitude/Longitude		
			Start	End	
Item	Encroachments		38.797605 °	38.797605 °	
			-121.695750 °	-121.695750 °	
DWR ID	DWR_RD1500_01_s_2014_1339				
Action/Comments					
Building

A trailer and small shack is on the waterside berm. This was up stream a couple of years ago. Spring 2014

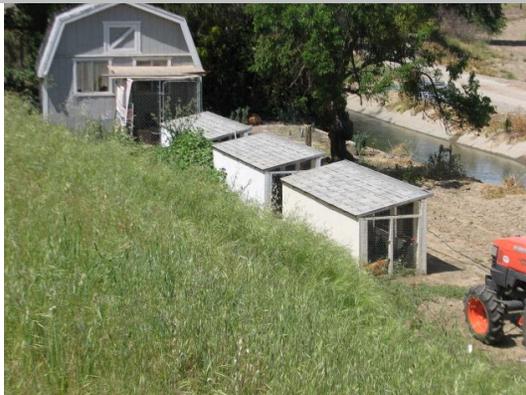
Photo 2 of 2 : FA_2014_RD1500_189_7_20141014_00007.jpg

LM Start	3.98	Rating **	M	Issue No.	7 (cont)
LM End	3.98	Issue Type +	En	Location *	LS
Category	Earthen Levee		GPS Latitude/Longitude		
			Start	End	
Item	Encroachments		38.797607 °	38.797607 °	
			-121.695862 °	-121.695862 °	
DWR ID	DWR_RD1500_01_s_2012_7				
Action/Comments					
Building

Chicken coupes have been added along the toe of the levee. Spring 2014

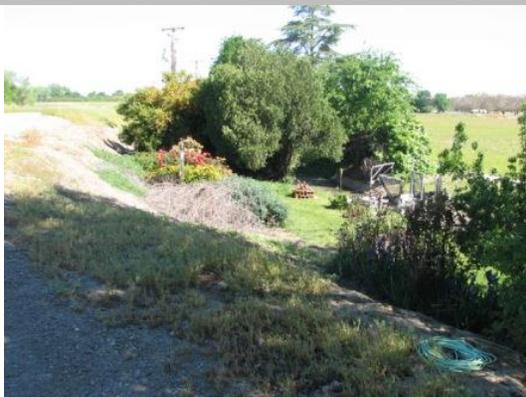
Photo 1 of 1 : FA_2014_RD1500_189_8_20141014_00008.jpg

LM Start	4.01	Rating **	M	Issue No.	8
LM End	4.01	Issue Type +	En	Location *	LS
Category	Earthen Levee		GPS Latitude/Longitude		
			Start	End	
Item	Vegetation		38.797827 °	38.797827 °	
			-121.695985 °	-121.695985 °	
DWR ID	DWR_RD1500_01_s_2012_8				
Action/Comments					
Landscaping

The landscape is planted into the encroachment zone within 15' of the toe.

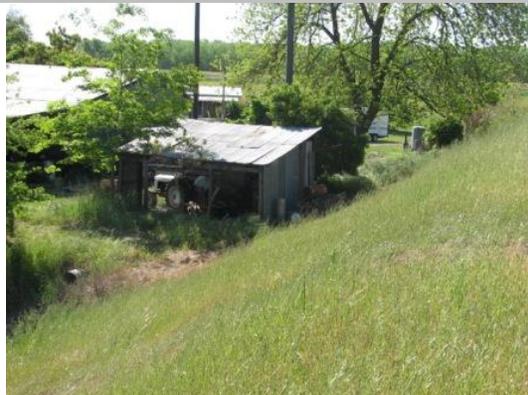
Photo 1 of 1 : FA_2014_RD1500_189_11_20141014_00010.jpg

LM Start	4.19	Rating **	M	Issue No.	11
LM End	4.19	Issue Type +	En	Location *	LS
Category	Earthen Levee			GPS Latitude/Longitude	
				Start	End
Item	Encroachments			38.800548 °	38.800548 °
				-121.696751 °	-121.696751 °
DWR ID	DWR_RD1500_01_s_2012_11				
Action/Comments					
Building

The equipment shed encroaches into the toe of the levee.

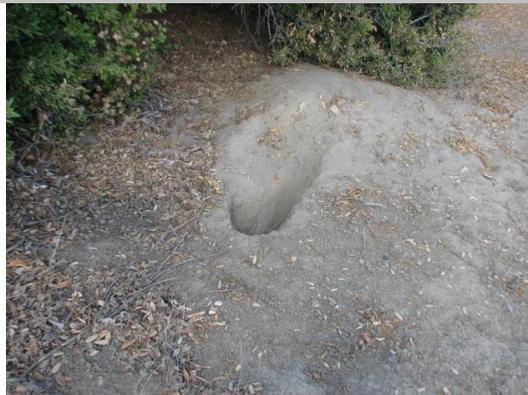
Photo 1 of 1 : FA_2014_RD1500_189_1342_20141014_00100.jpg

LM Start	5.30	Rating **	M	Issue No.	1342
LM End	5.30	Issue Type +	Ma	Location *	LS
Category	Earthen Levee		GPS Latitude/Longitude		
			Start	End	
Item	Animal Control		38.802826 °	38.802826 °	
			-121.714044 °	-121.714044 °	
DWR ID	DWR_RD1500_01_s_2014_1342				
Action/Comments					
Exterminate rodents and backfill and compact or grout burrows.

A rodent hole on the landside levee slope. Spring 2014

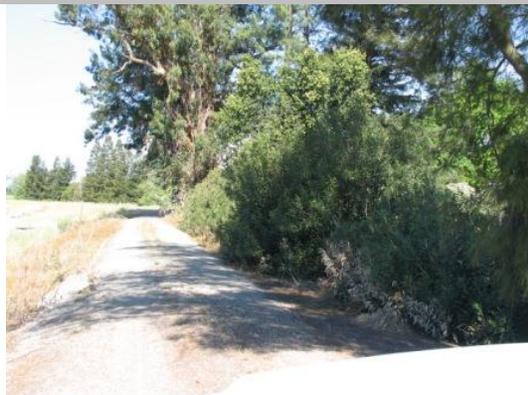
Photo 1 of 1 : FA_2014_RD1500_189_14_20141014_00012.jpg

LM Start	5.38	Rating **	M	Issue No.	14
LM End	5.38	Issue Type +	En	Location *	LS
Category	Earthen Levee		GPS Latitude/Longitude		
			Start	End	
Item	Vegetation		38.803240 °	38.803240 °	
			-121.715402 °	-121.715402 °	
DWR ID	DWR_RD1500_01_s_2012_14				
Action/Comments					
Landscaping

The landscape completely blocks the landside slope and toe.

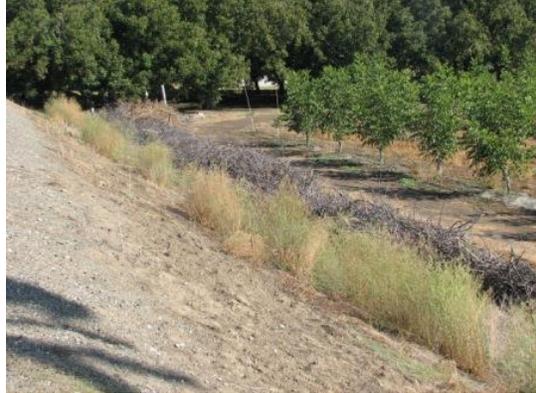
Photo 1 of 2 : FA_2014_RD1500_189_216_20141014_00076.jpg

LM Start	7.18	Rating **	M	Issue No.	216
LM End	7.18	Issue Type +	Ma	Location *	LS
Category	Earthen Levee		GPS Latitude/Longitude		
			Start	End	
Item	Encroachments		38.823781 °	38.823781 °	
			-121.722752 °	-121.722752 °	
DWR ID	DWR_RD1500_01_s_2012_216				
Action/Comments					
Prunings

The landowner has piled prunings along the levee toe.

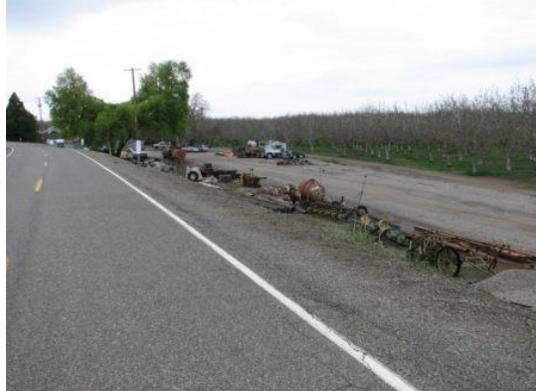
Photo 1 of 1 : FA_2014_RD1500_189_16_20141014_00014.jpg

LM Start	7.57	Rating **	M	Issue No.	16
LM End	7.57	Issue Type +	Ma	Location *	LS
Category	Earthen Levee		GPS Latitude/Longitude		
			Start	End	
Item	Encroachments		38.828975 °	38.828975 °	
			-121.724265 °	-121.724265 °	
DWR ID	DWR_RD1500_01_s_2012_16				
Action/Comments					
Equipment

Equipment along landside toe. Photo was taken in spring 2010.

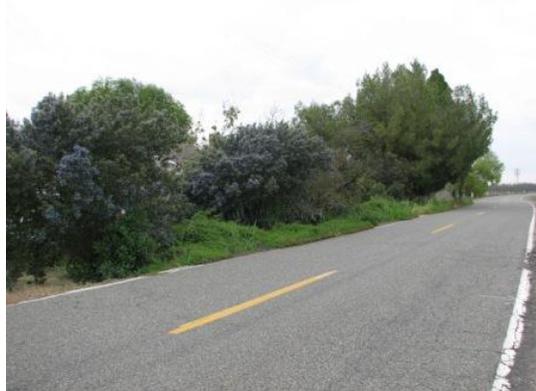
Photo 1 of 2 : FA_2014_RD1500_189_17_20141014_00015.jpg

LM Start	7.66	Rating **	M	Issue No.	17
LM End	7.66	Issue Type +	En	Location *	LS
Category	Earthen Levee		GPS Latitude/Longitude		
			Start	End	
Item	Vegetation		38.830260 °	38.830260 °	
			-121.725357 °	-121.725357 °	
DWR ID	DWR_RD1500_01_s_2012_17				
Action/Comments					
Landscaping

Landscape shrubs, photo taken in spring 2010.

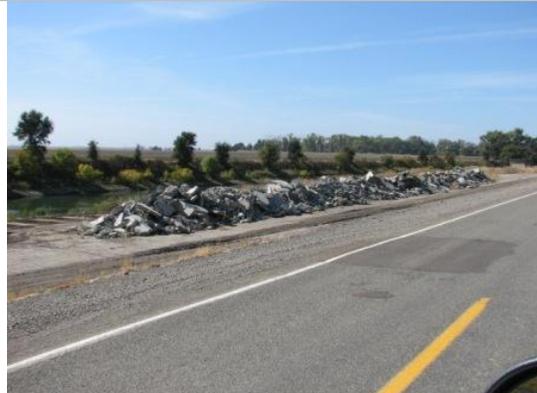
Photo 1 of 1 : FA_2014_RD1500_189_56_20141014_00051.jpg

LM Start	12.02	Rating **	M	Issue No.	56
LM End	12.02	Issue Type +	En	Location *	WS
Category	Earthen Levee		GPS Latitude/Longitude		
			Start	End	
Item	Encroachments		38.871540 °	38.871540 °	
			-121.751203 °	-121.751203 °	
DWR ID	DWR_RD1500_01_f_2013_56				
Action/Comments					
Debris

Another pile of concrete debris on the waterside. Fall 2013

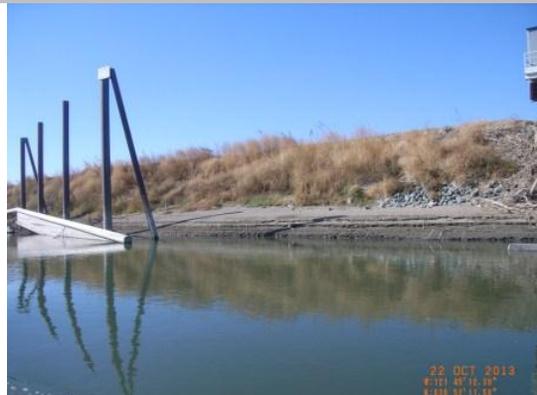
Photo 1 of 1 : FA_2014_RD1500_189_10_20141014_00009.jpg

LM Start	12.14	Rating **	M	Issue No.	10
LM End	12.14	Issue Type +	Ma	Location *	WS
Category	Supplemental		GPS Latitude/Longitude		
			Start	End	
Item	USACE Erosion Survey		38.870474 °	38.869139 °	
			-121.752237 °	-121.757108 °	
DWR ID	DWR_RD1500_01_f_2014_10				
Action/Comments					
Inspector Comments: 2000 - Vertical Modesto Formation bank with mass failure. 2003 - Upstream end has some new bank retreat. 2004 - Upstream end is worse. 2006 - Some new erosion, mainly on the steep slope and scarps. (Pumping station is not part of the erosion site.) 2010 - Some new erosion and deposition at upstream end, definite encroachments. 2011 - Minor new erosion at the toe. 2013: No observed changes. [2013 Site ID: SAC_96-2_L]

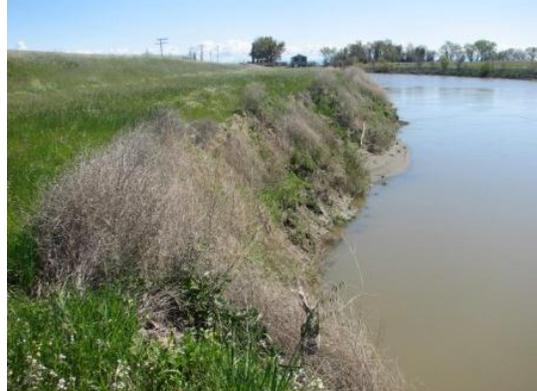
Photo 1 of 1 : FA_2014_RD1500_189_50_20141014_00044.jpg

LM Start	12.31	Rating **	A/W	Issue No.	50
LM End	12.31	Issue Type +	Ma	Location *	WS
Category	Earthen Levee		GPS Latitude/Longitude		
			Start	End	
Item	Erosion / Bank Caving		38.869700 °	38.869700 °	
			-121.755945 °	-121.755945 °	
DWR ID	DWR_RD1500_01_s_2012_50				
Action/Comments					
Note and monitor erosion site. Inspector Comments: wide berm

An erosion site along the embankment, photo taken spring 2012.

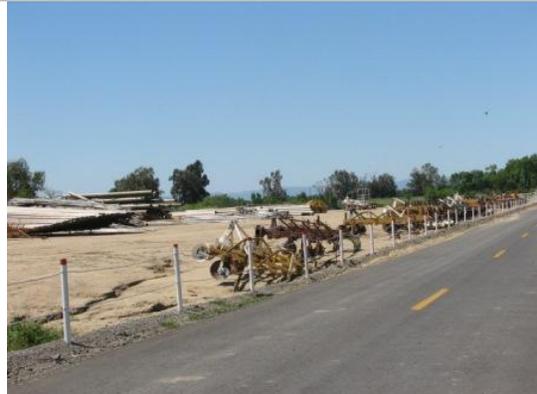
Photo 1 of 1 : FA_2014_RD1500_189_25_20141014_00024.jpg

LM Start	12.93	Rating **	A/W	Issue No.	25
LM End	12.93	Issue Type +	Ma	Location *	CR
Category	Earthen Levee		GPS Latitude/Longitude		
			Start	End	
Item	Encroachments		38.865127 °	38.865127 °	
			-121.765157 °	-121.765157 °	
DWR ID	DWR_RD1500_01_s_2012_25				
Action/Comments					
Equipment

On top of the crown is farm equipment and irrigation pipe.

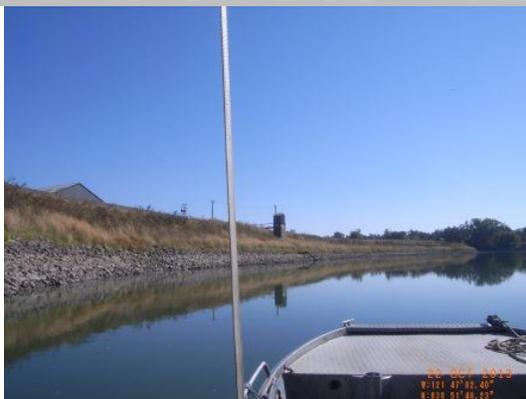
Photo 1 of 1 : FA_2014_RD1500_189_15_20141014_00013.jpg

LM Start	13.98	Rating **	M	Issue No.	15
LM End	13.98	Issue Type +	Ma	Location *	WS
Category	Supplemental		GPS Latitude/Longitude		
			Start	End	
Item	USACE Erosion Survey		38.857239 °	38.861899 °	
			-121.783771 °	-121.784057 °	
DWR ID	DWR_RD1500_01_f_2014_15				
Action/Comments					
Inspector Comments: 1997 - Intermittent toe failure of the hand placed riprap; failure of toe materials. 2013: No observed changes. [2013 Site ID: SAC_99-0_L]

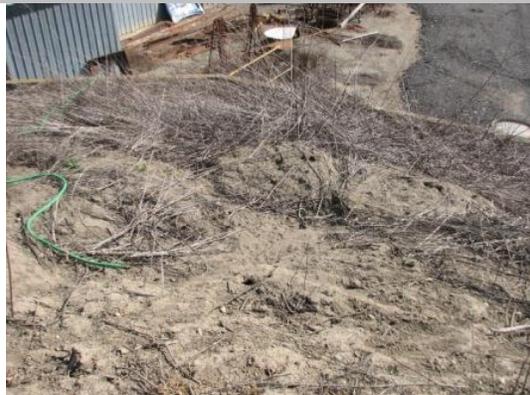
Photo 1 of 1 : FA_2014_RD1500_189_89_20141014_00072.jpg

LM Start	14.32	Rating **	M	Issue No.	89
LM End	14.32	Issue Type +	Ma	Location *	LS
Category	Earthen Levee		GPS Latitude/Longitude		
			Start	End	
Item	Animal Control		38.860452 °	38.860452 °	
			-121.783294 °	-121.783294 °	
DWR ID	DWR_RD1500_01_s_2013_89				
Action/Comments					
Exterminate rodents and backfill and compact or grout burrows.

Rodent hole in the levee slope above the retaining wall, Spring 2013

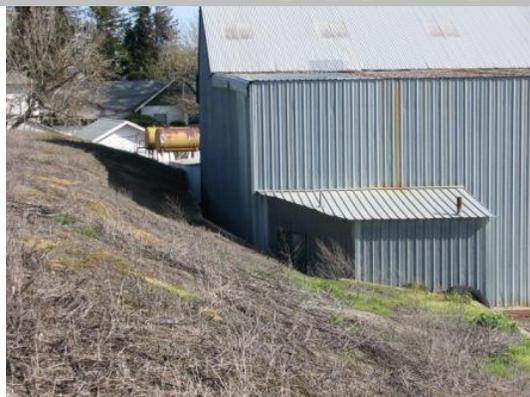
Photo 1 of 1 : FA_2014_RD1500_189_30_20141014_00028.jpg

LM Start	14.35	Rating **	M	Issue No.	30
LM End	14.35	Issue Type +	En	Location *	LS
Category	Earthen Levee		GPS Latitude/Longitude		
			Start	End	
Item	Encroachments		38.860848 °	38.860848 °	
			-121.783307 °	-121.783307 °	
DWR ID	DWR_RD1500_01_s_2012_30				
Action/Comments					
Building Inspector Comments: Concrete stemwall into levee embankment.

Building and wall into levee. Photo was taken in spring 2010.

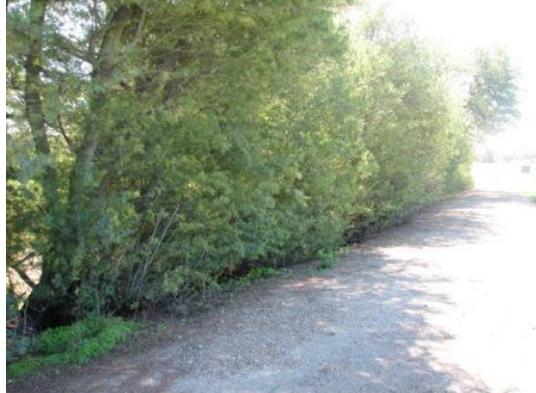
Photo 1 of 2 : FA_2014_RD1500_189_77_20141014_00065.jpg

LM Start	14.42	Rating **	U	Issue No.	77
LM End	14.42	Issue Type +	Ma	Location *	LS
Category	Earthen Levee		GPS Latitude/Longitude		
			Start	End	
Item	Trim / Thin Trees		38.861793 °	38.861793 °	
			-121.783703 °	-121.783703 °	
DWR ID	DWR_RD1500_01_s_2012_77				
Action/Comments					
Trim and thin trees to allow visibility of the ground and room to flood fight.

The trees on the landside slope blocks the view of the slope, photo taken spring 2012.

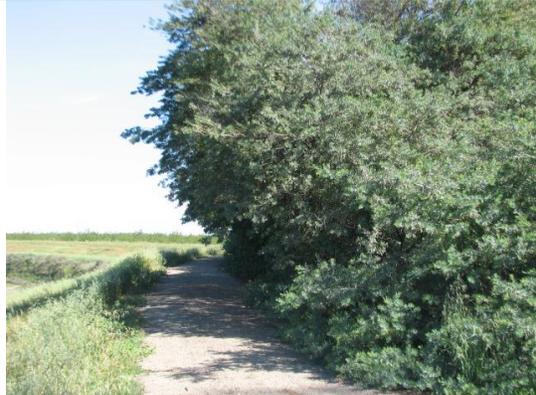
Photo 2 of 2 : FA_2014_RD1500_189_77_20141014_00066.jpg

The trees on the levee slope completely bocks visibility. Spring 2014

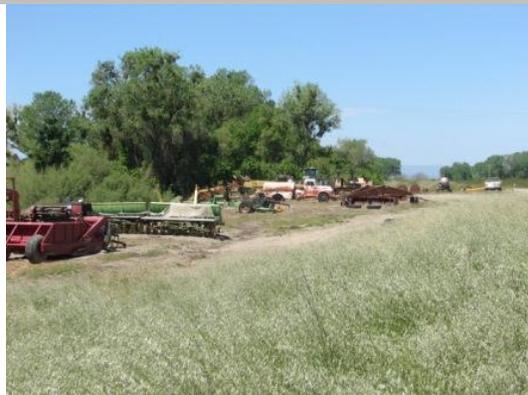
Photo 1 of 1 : FA_2014_RD1500_189_32_20141014_00030.jpg

LM Start	15.94	Rating **	A/W	Issue No.	32
LM End	15.94	Issue Type +	En	Location *	WS
Category	Earthen Levee		GPS Latitude/Longitude		
			Start	End	
Item	Encroachments		38.871960 °	38.871960 °	
			-121.804440 °	-121.804440 °	
DWR ID	DWR_RD1500_01_s_2012_32				
Action/Comments					
Equipment

Farm equipment has been parked on the waterside berm.

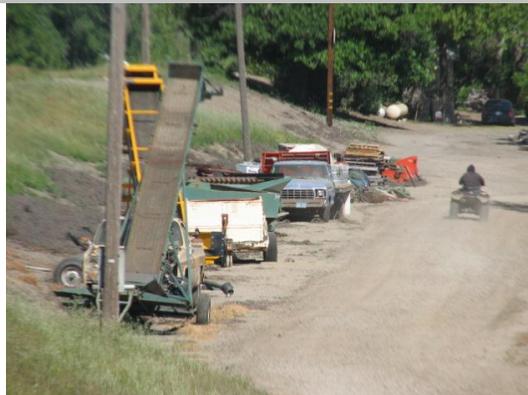
Photo 2 of 2 : FA_2014_RD1500_189_78_20141014_00068.jpg

LM Start	16.37	Rating **	M	Issue No.	78 (cont)
LM End	16.37	Issue Type +	En	Location *	LS
Category	Earthen Levee		GPS Latitude/Longitude		
			Start	End	
Item	Encroachments		38.874623 °	38.874623 °	
			-121.811272 °	-121.811272 °	
DWR ID	DWR_RD1500_01_s_2012_78				
Action/Comments					
Equipment

A current view of equipment at the toe of the levee. Spring 2014

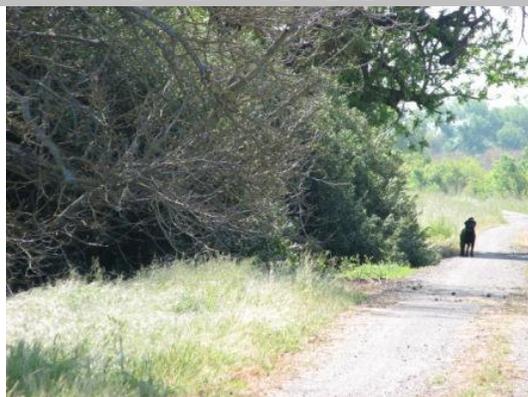
Photo 1 of 1 : FA_2014_RD1500_189_33_20141014_00031.jpg

LM Start	16.48	Rating **	U	Issue No.	33
LM End	16.48	Issue Type +	En	Location *	LS
Category	Earthen Levee		GPS Latitude/Longitude		
			Start	End	
Item	Vegetation		38.875873 °	38.875873 °	
			-121.812410 °	-121.812410 °	
DWR ID	DWR_RD1500_01_s_2012_33				
Action/Comments					
Landscaping Inspector Comments: oleanders and other shrubs

Landscape shrubs, photo taken in spring 2010.

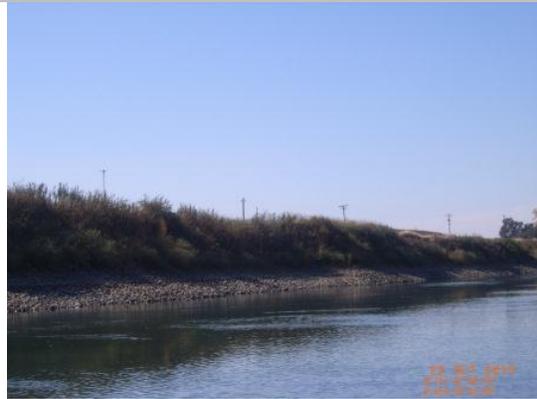
Photo 1 of 1 : FA_2014_RD1500_189_22_20141014_00020.jpg

LM Start	18.51	Rating **	M	Issue No.	22
LM End	18.51	Issue Type +	Ma	Location *	WS
Category	Supplemental		GPS Latitude/Longitude		
			Start	End	
Item	USACE Erosion Survey		38.901337 °	38.902721 °	
			-121.801175 °	-121.790677 °	
DWR ID	DWR_RD1500_01_f_2014_22				
Action/Comments					
Inspector Comments: 1997 - Pocket failures of cobble revetment toe; scallops of rock loss along the bank; irregular bankline developing. 2001 - Small scallops in the toe of the berm. 2005 - Still multiple erosion pockets in the toe. 2006 - Two new small slumps. 2011 - Old cobble continue to fail causing minor slumping. 2012 - Portions of site appears to be stabilizing. 2013: No observed changes. [2013 Site ID: SAC_104-0_L]

USACE 2013 Photo #1

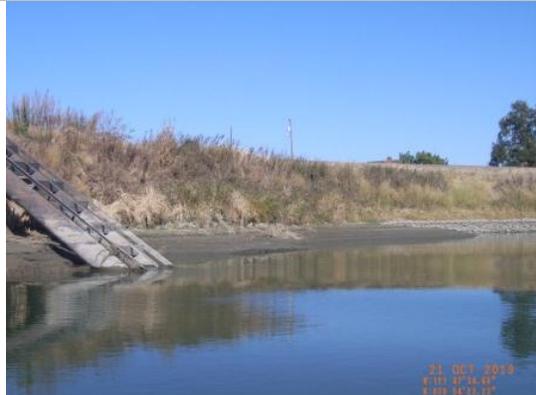
Photo 1 of 1 : FA_2014_RD1500_189_23_20141014_00021.jpg

LM Start	19.24	Rating **	M	Issue No.	23
LM End	19.24	Issue Type +	Ma	Location *	WS
Category	Supplemental		GPS Latitude/Longitude		
			Start	End	
Item	USACE Erosion Survey		38.904041 °	38.906697 °	
			-121.790298 °	-121.792796 °	
DWR ID	DWR_RD1500_01_f_2014_23				
Action/Comments					
Inspector Comments: 1997 - Cobbles eroded off the clay materials; not much evidence of erosion on the toe; cobble loss on the toe. 2011 - Some minor new erosion. 2013: No observed changes. [2013 Site ID: SAC_104-5_L]

USACE 2013 Photo #1

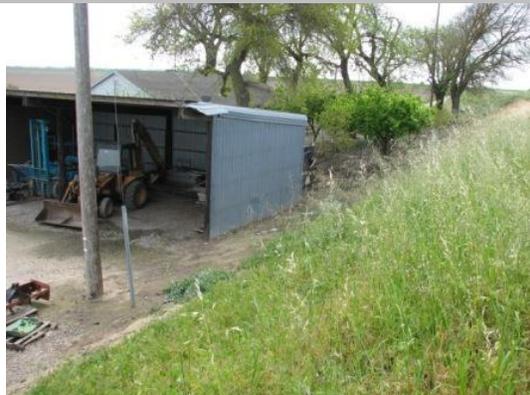
Photo 1 of 1 : FA_2014_RD1500_189_42_20141014_00039.jpg

LM Start	24.04	Rating **	M	Issue No.	42
LM End	24.04	Issue Type +	En	Location *	LS
Category	Earthen Levee		GPS Latitude/Longitude		
			Start	End	
Item	Encroachments		38.931838 °	38.931838 °	
			-121.834437 °	-121.834437 °	
DWR ID	DWR_RD1500_01_s_2012_42				
Action/Comments					
Building Inspector Comments: Some equipment at landside toe.

Pole barn and some equipment, photo taken in spring 2010.

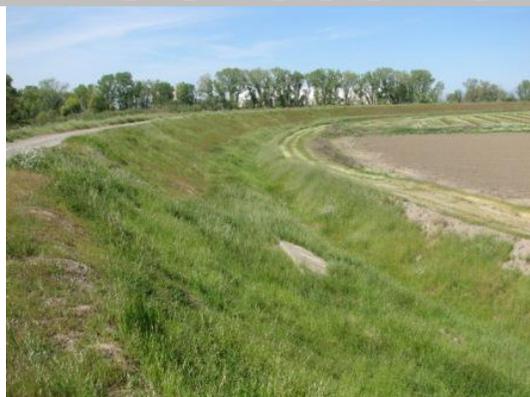
Photo 1 of 2 : FA_2014_RD1500_189_979_20141014_00086.jpg

LM Start	24.44	Rating **	M	Issue No.	979
LM End	24.60	Issue Type +	En	Location *	LS
Category	Earthen Levee		GPS Latitude/Longitude		
			Start	End	
Item	Encroachments		38.936282 °	38.938430 °	
			-121.830192 °	-121.829359 °	
DWR ID	DWR_RD1500_01_s_2012_979				
Action/Comments					
Ditch

Agricultural ditch, photo taken in spring 2010.

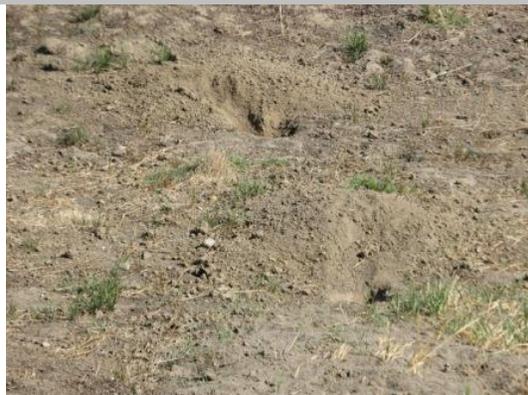
Photo 1 of 2 : FA_2014_RD1500_189_69_20141014_00057.jpg

Multiple rodent burrows on landside slope. Fall 2013

LM Start	25.17	Rating **	M	Issue No.	69
LM End	25.17	Issue Type +	Ma	Location *	LS
Category	Earthen Levee		GPS Latitude/Longitude		
			Start	End	
Item	Animal Control		38.944340 °	38.944340 °	
			-121.835790 °	-121.835790 °	
DWR ID	DWR_RD1500_01_f_2013_69				
Action/Comments					
Exterminate rodents and backfill and compact or grout burrows.

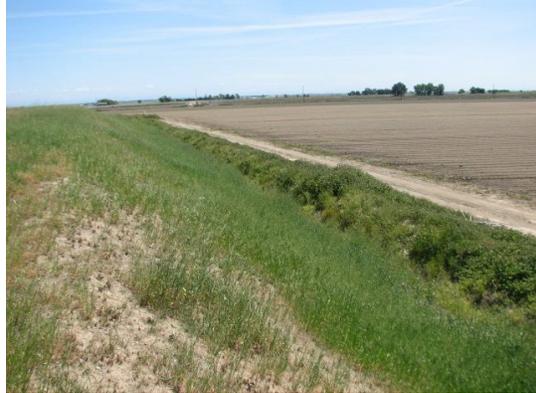
Photo 2 of 2 : FA_2014_RD1500_189_983_20141014_00090.jpg

LM Start	27.63	Rating **	M	Issue No.	983 (cont)
LM End	27.78	Issue Type +	En	Location *	LS
Category	Earthen Levee		GPS Latitude/Longitude		
			Start	End	
Item	Encroachments		38.972440 °	38.972848 °	
			-121.825892 °	-121.823098 °	
DWR ID	DWR_RD1500_01_s_2012_983				
Action/Comments					
Ditch

The agricultural ditch runs along the toe of the levee. Spring 2014

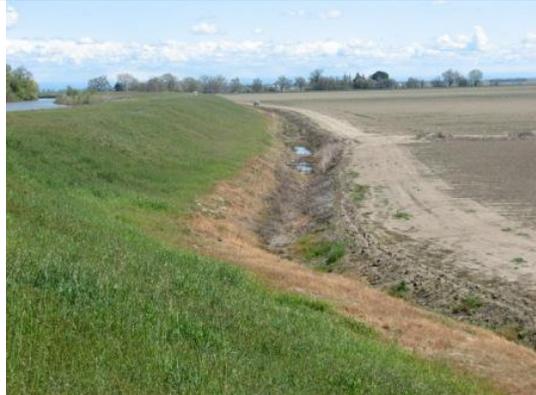
Photo 1 of 2 : FA_2014_RD1500_189_38_20141014_00037.jpg

LM Start	28.57	Rating **	M	Issue No.	38
LM End	29.60	Issue Type +	En	Location *	LS
Category	Earthen Levee		GPS Latitude/Longitude		
			Start	End	
Item	Encroachments		38.983081 °	38.988512 °	
			-121.819924 °	-121.806463 °	
DWR ID	DWR_RD1500_01_s_2012_38				
Action/Comments					
Ditch

The agricultural ditch runs along the toe of the levee, photo taken spring 2012.

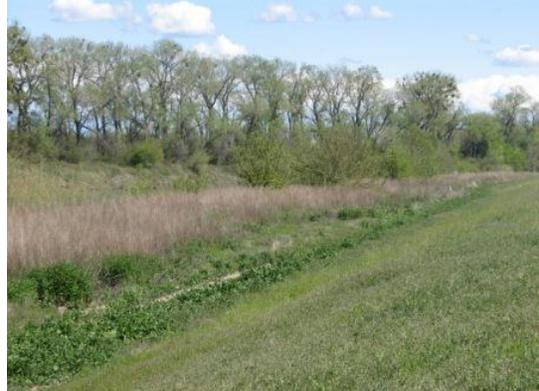
Photo 1 of 2 : FA_2014_RD1500_189_84_20141014_00069.jpg

LM Start	29.31	Rating **	A/W	Issue No.	84
LM End	29.54	Issue Type +	Ma	Location *	WS
Category	Earthen Levee		GPS Latitude/Longitude		
			Start	End	
Item	Vegetation		38.988078 °	38.988595 °	
			-121.811692 °	-121.807532 °	
DWR ID	DWR_RD1500_01_s_2012_84				
Action/Comments					
Environmental Requirements.

A photo of the revegetation site.

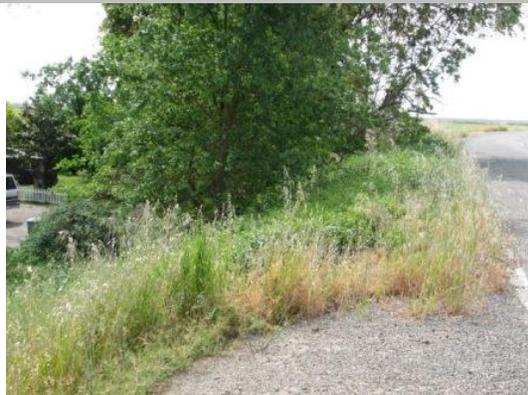
Photo 1 of 1 : FA_2014_RD1500_189_45_20141014_00040.jpg

LM Start	30.60	Rating **	M	Issue No.	45
LM End	30.60	Issue Type +	En	Location *	LS
Category	Earthen Levee		GPS Latitude/Longitude		
			Start	End	
Item	Vegetation		38.996980 °	38.996980 °	
			-121.794723 °	-121.794723 °	
DWR ID	DWR_RD1500_01_s_2012_45				
Action/Comments					
Landscaping

The groundcover in the landscape makes it hard to see the levee slope.

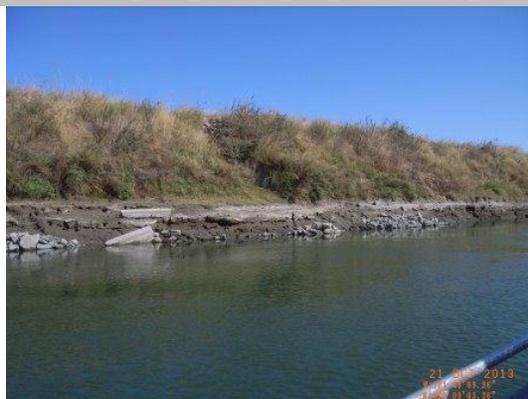
Photo 1 of 1 : FA_2014_RD1500_189_29_20141014_00027.jpg

LM Start	30.91	Rating **	M	Issue No.	29
LM End	30.91	Issue Type +	Ma	Location *	WS
Category	Supplemental		GPS Latitude/Longitude		
			Start	End	
Item	USACE Erosion Survey		38.999745 °	39.001413 °	
			-121.800898 °	-121.802889 °	
DWR ID	DWR_RD1500_01_f_2014_29				
Action/Comments					
Inspector Comments: 2000 - Eroding, vertical berm slope over a vertical cohesive toe; slow erosion but getting close to the toe. 2002 - Erosion is getting close to the levee, still eroding with some new small slumps. 2004 - Some minor new erosion. 2006 - Some new erosion, cleaned off older scars and slump faces. 2008 - New, small, partial rotational failure. 2011 - Some new minor erosion. 2013: No observed changes. [2013 Site ID: SAC_116-0_L]

USACE 2013 Photo #1

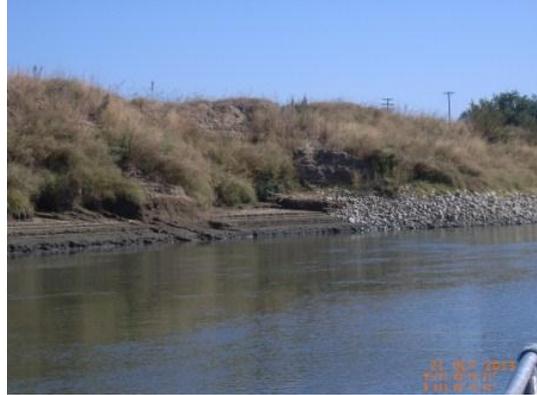
Photo 1 of 1 : FA_2014_RD1500_189_34_20141014_00032.jpg

LM Start	31.38	Rating **	M	Issue No.	34
LM End	31.38	Issue Type +	Ma	Location *	WS
Category	Supplemental			GPS Latitude/Longitude	
				Start	End
Item	USACE Erosion Survey			39.003301 °	39.006072 °
				-121.805024 °	-121.815926 °
DWR ID	DWR_RD1500_01_f_2014_34				
Action/Comments					
Inspector Comments: 2003 - New sedimentation and some new small toe scallops at the upstream end; downstream end has some new erosion. 2004 - Some new erosion at the toe and upper bank and some small new rotational failures (mainly minor, except at the downstream end). 2007 - Some new slumps. 2009 - Some new scallops and site was extended upstream. 2010 - New deposition along upstream end of site, however there is also new erosion throughout the site. Site seems to be worsening, and eroding fast. Large habitat for bank swallows. 2011 - Some new minor erosion. 2012 - Minor new erosion. 2013: No observed changes. [2013 Site ID: SAC_116-5_L]

USACE 2013 Photo #1

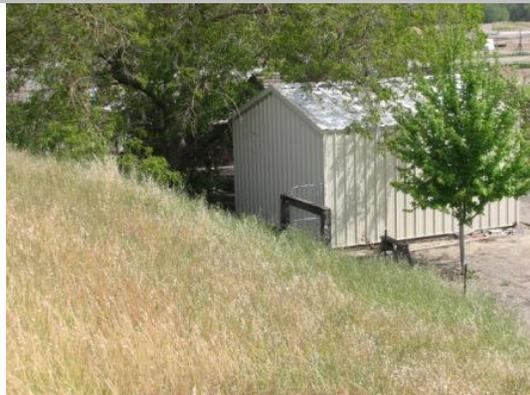
Photo 1 of 1 : FA_2014_RD1500_189_46_20141014_00041.jpg

LM Start	33.39	Rating **	M	Issue No.	46
LM End	33.39	Issue Type +	En	Location *	LS
Category	Earthen Levee		GPS Latitude/Longitude		
			Start	End	
Item	Encroachments		39.020550 °	39.020550 °	
			-121.820315 °	-121.820315 °	
DWR ID	DWR_RD1500_01_s_2012_46				
Action/Comments					
Building

The building is within the easement of the levee toe.

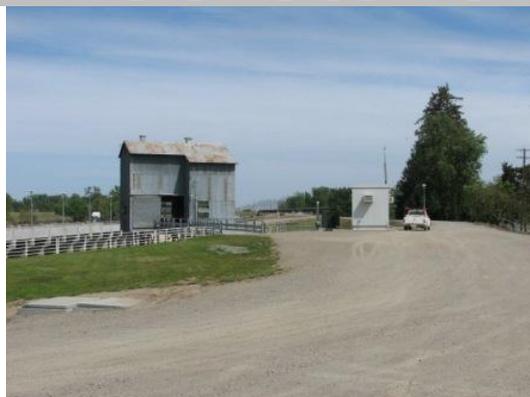
Photo 1 of 1 : FA_2014_RD1500_189_48_20141014_00043.jpg

LM Start	33.41	Rating **	A	Issue No.	48
LM End	33.41	Issue Type +	En	Location *	WS
Category	Earthen Levee		GPS Latitude/Longitude		
			Start	End	
Item	Encroachments		39.020875 °	39.020875 °	
			-121.820273 °	-121.820273 °	
DWR ID	DWR_RD1500_01_s_2012_48				
Action/Comments					
Building Inspector Comments: Pumping Plant Intake structure

The buildings are on the waterside of the crown. Control buildings for the pumping plant.

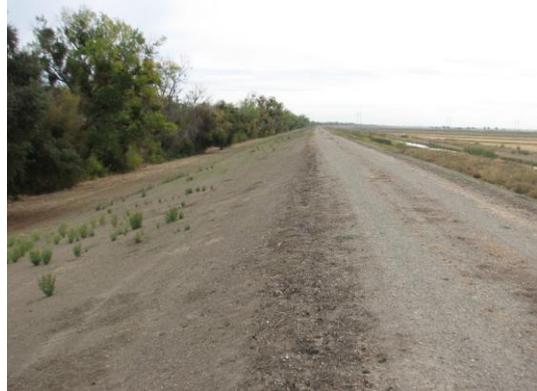
Photo 1 of 1 : FA_2014_RD1500_190_2_20141030_00020.jpg

Levee mile 16.71, vegetation on the water side slope. Fall 2014

LM Start	0.00	Rating **	A	Issue No.	2
LM End	20.77	Issue Type +	Ma	Location *	WS
Category	Earthen Levee		GPS Latitude/Longitude		
			Start	End	
Item	Vegetation			°	°
DWR ID	DWR_RD1500_02_f_2014_2				
Action/Comments					
Control annual grass and weeds on the levee slopes and easements.

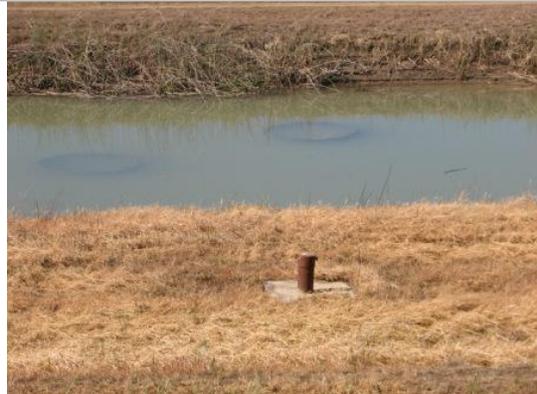
Photo 1 of 1 : FA_2014_RD1500_190_4_20141014_00002.jpg

LM Start	14.22	Rating **	A/W	Issue No.	4
LM End	14.22	Issue Type +	Ma	Location *	LS
Category	Earthen Levee		GPS Latitude/Longitude		
			Start	End	
Item	Underseepage Relief Wells		38.947582 °	38.947582 °	
			-121.669740 °	-121.669740 °	
DWR ID	DWR_RD1500_02_s_2012_4				
Action/Comments

The relief well at boil 12, photo taken spring 2012.

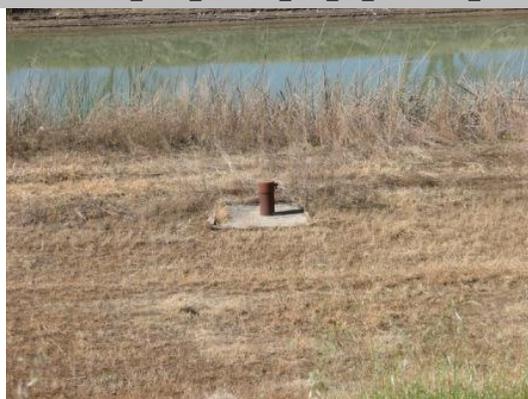
Photo 1 of 1 : FA_2014_RD1500_190_11_20141014_00007.jpg

LM Start	14.56	Rating **	A/W	Issue No.	11
LM End	14.56	Issue Type +	Ma	Location *	LS
Category	Earthen Levee		GPS Latitude/Longitude		
			Start	End	
Item	Underseepage Relief Wells		38.951398 °	38.951398 °	
			-121.673827 °	-121.673827 °	
DWR ID	DWR_RD1500_02_s_2012_11				
Action/Comments

A relief well at boil 16, photo taken spring 2012.

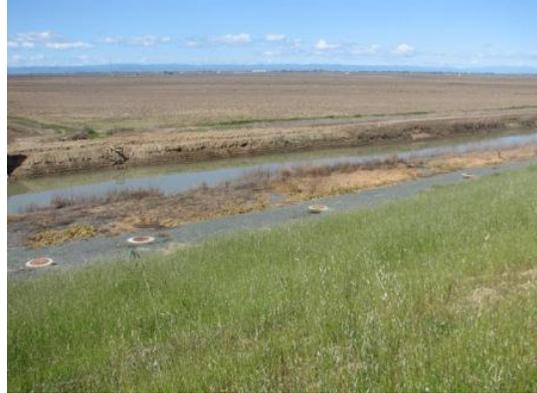
Photo 2 of 2 : FA_2014_RD1500_190_13_20141014_00011.jpg

LM Start	18.24	Rating **	A/W	Issue No.	13 (cont)
LM End	18.24	Issue Type +	Ma	Location *	LS
Category	Earthen Levee		GPS Latitude/Longitude		
			Start	End	
Item	Underseepage Relief Wells		38.987092 °	38.987092 °	
			-121.725097 °	-121.725097 °	
DWR ID	DWR_RD1500_02_s_2012_13				
Action/Comments

Toe drainage systems along the toe berm four total, photo taken spring 2012.
