**Flood Control Project Maintenance
Levee Inspections**

Fall 2015 Levee Maintenance Deficiency Summary Report

Sacramento River Basin

Reclamation District No. 1500 Sutter Basin

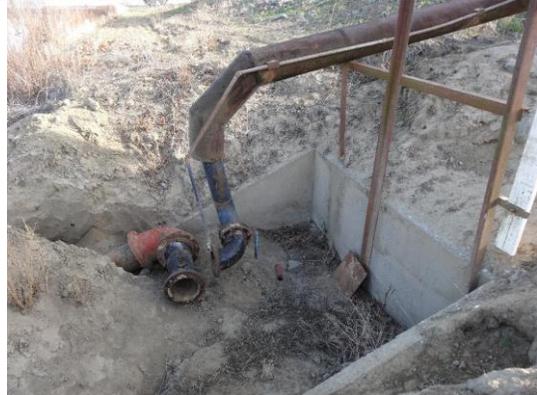
Photo 2 of 3 : UCIP_FA_2015_3271.jpg

WS view: U type headwall and 8-inch pipe sleeved into 14-inch steel pipe. Pump was removed from the pipe.

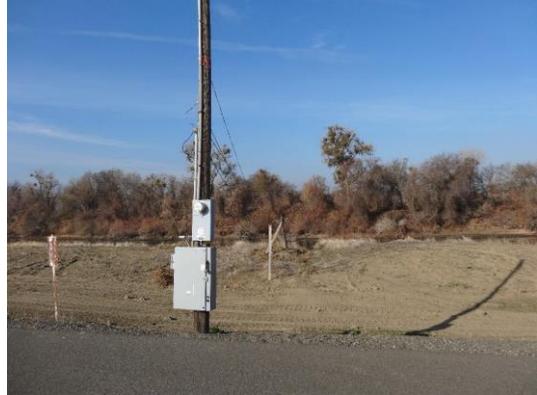
Photo 3 of 3 : UCIP_FA_2015_2992.jpg

WS view: Service pole with control panel on levee shoulder.

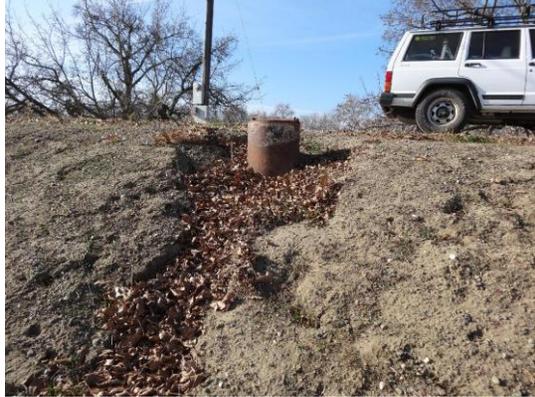
Photo 2 of 3 : UCIP_FA_2015_3053.jpg

LS view: siphon breaker in CMP riser. Levee slope erosion due to leaky siphon breaker.

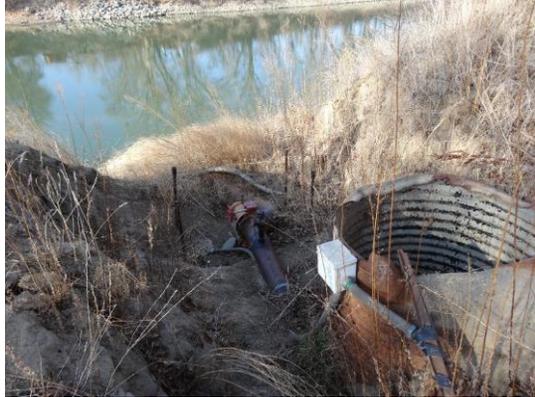
Photo 3 of 3 : UCIP_FA_2015_3054.jpg

WS view: Pump (removed and plywood plated), pipe, and gate valve in CMP riser on river bank.

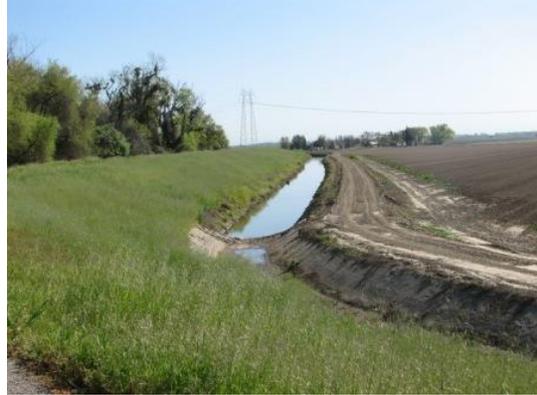
Photo 1 of 1 : FA_2015_RD1500_189_963_20150914_00067.jpg

LM Start	2.54	Rating **	M	Issue No.	963
LM End	3.79	Issue Type +	En	Location *	LS
Category	Earthen Levee		GPS Latitude/Longitude		
			Start	End	
Item	Encroachments		38.785351 °	38.797174 °	
			-121.689075 °	-121.693045 °	
DWR ID	DWR_RD1500_01_s_2012_963				
Action/Comments					
Ditch

Agricultural ditch, photo was taken in spring 2010.

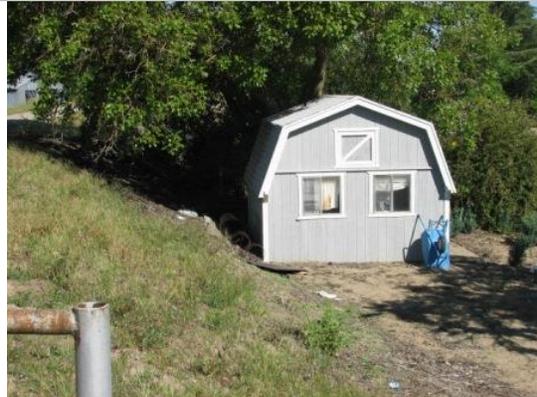
Photo 1 of 2 : FA_2015_RD1500_189_7_20150914_00005.jpg

LM Start	3.95	Rating **	M	Issue No.	7
LM End	3.95	Issue Type +	En	Location *	LS
Category	Earthen Levee		GPS Latitude/Longitude		
			Start	End	
Item	Encroachments		38.797607 °	38.797607 °	
			-121.695862 °	-121.695862 °	
DWR ID	DWR_RD1500_01_s_2012_7				
Action/Comments					
Building

A small building is encroaching into the landside levee toe.

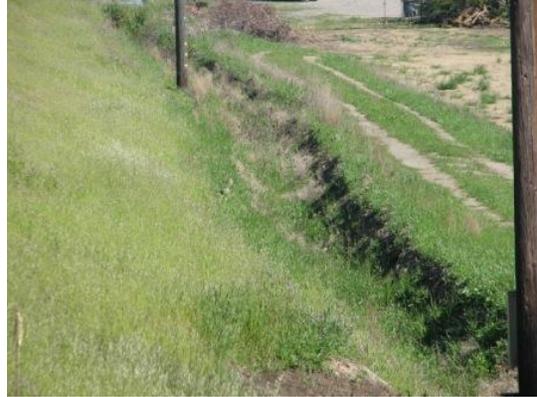
Photo 1 of 1 : FA_2015_RD1500_189_54_20150914_00045.jpg

LM Start	4.02	Rating **	M	Issue No.	54
LM End	4.12	Issue Type +	En	Location *	LS
Category	Earthen Levee		GPS Latitude/Longitude		
			Start	End	
Item	Encroachments		38.798572 °	38.800080 °	
			-121.696392 °	-121.696653 °	
DWR ID	DWR_RD1500_01_s_2012_54				
Action/Comments					
Ditch

An agricultural ditch runs along the toe of the levee, photo taken spring 2012.

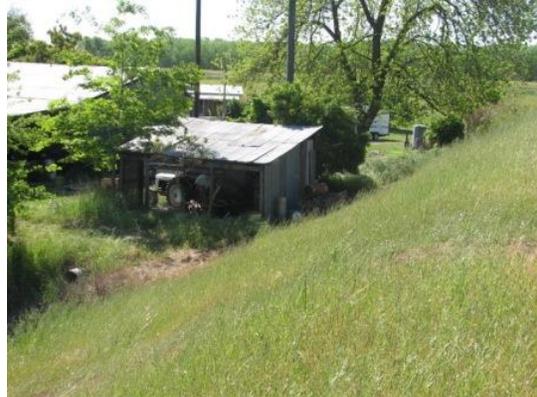
Photo 1 of 1 : FA_2015_RD1500_189_11_20150914_00009.jpg

LM Start	4.16	Rating **	M	Issue No.	11
LM End	4.16	Issue Type +	En	Location *	LS
Category	Earthen Levee		GPS Latitude/Longitude		
			Start	End	
Item	Encroachments		38.800548 °	38.800548 °	
			-121.696751 °	-121.696751 °	
DWR ID	DWR_RD1500_01_s_2012_11				
Action/Comments					
Building

The equipment shed encroaches into the toe of the levee.

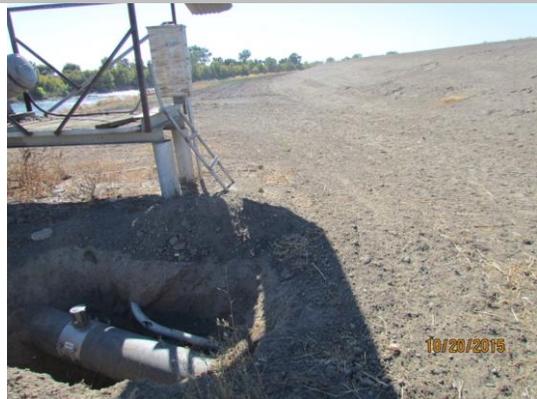
Photo 1 of 3 : FA_2015_RD1500_189_107_20151026_00139.jpg

LM Start	4.68	Rating **	M	Issue No.	107
LM End	4.68	Issue Type +	En	Location *	WS
Category	Earthen Levee			GPS Latitude/Longitude	
				Start	End
Item	Encroachments			38.802986 °	38.802986 °
				-121.704134 °	-121.704134 °
DWR ID	DWR_RD1500_01_f_2015_107				
Action/Comments					
Pipe Inspector Comments: Seems like owner is trying to fix the conduit next to the pipe.

View of the pipe exposure on the waterward side of the levee looking upstream. Fall 2015.

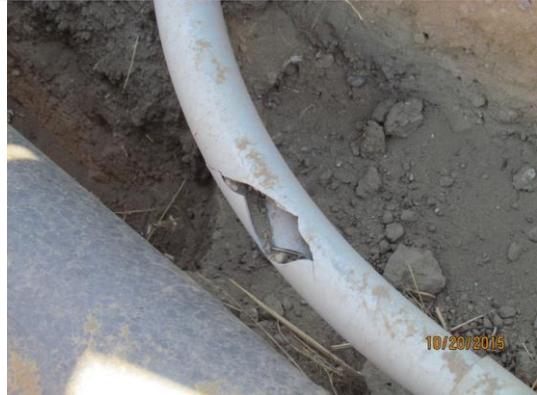
Photo 3 of 3 : FA_2015_RD1500_189_107_20151026_00141.jpg

LM Start	4.68	Rating **	M	Issue No.	107 (cont)
LM End	4.68	Issue Type +	En	Location *	WS
Category	Earthen Levee			GPS Latitude/Longitude	
				Start	End
Item	Encroachments			38.802986 °	38.802986 °
				-121.704134 °	-121.704134 °
DWR ID	DWR_RD1500_01_f_2015_107				
Action/Comments					
Pipe Inspector Comments: Seems like owner is trying to fix the conduit next to the pipe.

There is a hole on the culvert next to the pipe. Fall 2015.

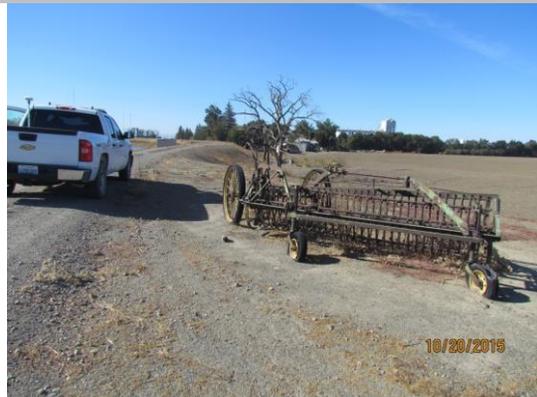
Photo 1 of 1 : FA_2015_RD1500_189_108_20151026_00142.jpg

LM Start	5.14	Rating **	M	Issue No.	108
LM End	5.14	Issue Type +	En	Location *	LS
Category	Earthen Levee			GPS Latitude/Longitude	
				Start	End
Item	Encroachments			38.801962 °	38.801962 °
				-121.712118 °	-121.712118 °
DWR ID	DWR_RD1500_01_f_2015_108				
Action/Comments					
Equipment

View of the equipment on the landward side of the levee looking upstream. Fall 2015.

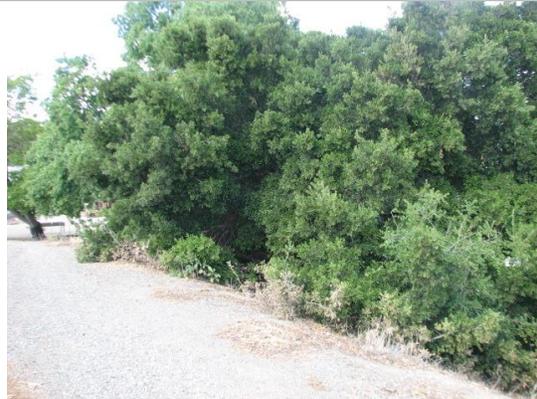
Photo 1 of 1 : FA_2015_RD1500_189_1341_20150914_00077.jpg

Trees need to be trimmed up to at least 5' they are blocking the visibility. Spring 2014

LM Start	5.26	Rating **	M	Issue No.	1341
LM End	5.26	Issue Type +	Ma	Location *	LS
Category	Earthen Levee			GPS Latitude/Longitude	
				Start	End
Item	Trim / Thin Trees			38.802827 °	38.802827 °
				-121.714043 °	-121.714043 °
DWR ID	DWR_RD1500_01_s_2014_1341				
Action/Comments					
Trim trees to at least five feet above ground level.

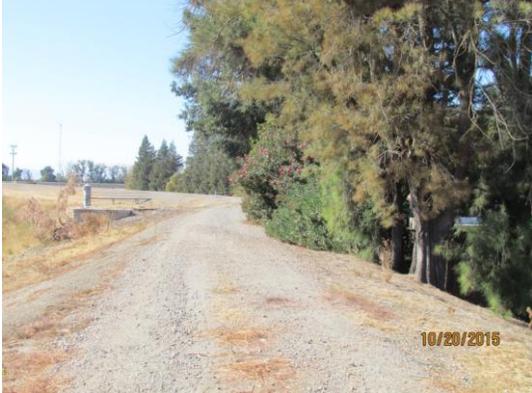
Photo 1 of 1 : FA_2015_RD1500_189_14_20151026_00143.jpg

LM Start	5.34	Rating **	M	Issue No.	14
LM End	5.34	Issue Type +	En	Location *	LS
Category	Earthen Levee		GPS Latitude/Longitude		
			Start	End	
Item	Vegetation		38.803240 °	38.803240 °	
			-121.715402 °	-121.715402 °	
DWR ID	DWR_RD1500_01_s_2012_14				
Action/Comments					
Landscaping

View of the landscape on the landward side of the levee looking upstream. Fall 2015.

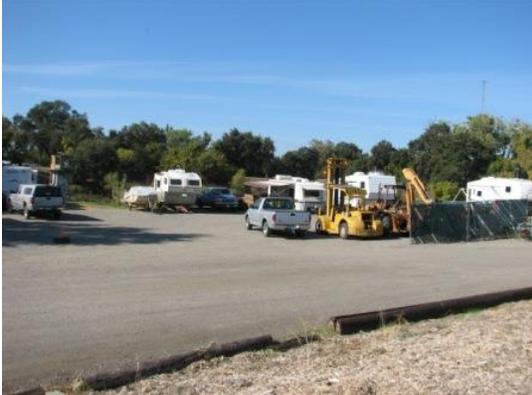
Photo 1 of 2 : FA_2015_RD1500_189_52_20150914_00042.jpg

LM Start	5.61	Rating **	M	Issue No.	52
LM End	5.69	Issue Type +	En	Location *	WS
Category	Earthen Levee		GPS Latitude/Longitude		
			Start	End	
Item	Encroachments		38.803005 °	38.803238 °	
			-121.720380 °	-121.71847 °	
DWR ID	DWR_RD1500_01_s_2012_52				
Action/Comments					
Building Inspector Comments: Sting Rayz Beach Boardwalk Marina on the waterside berm.

String Rayzs RV park, Fall 2013

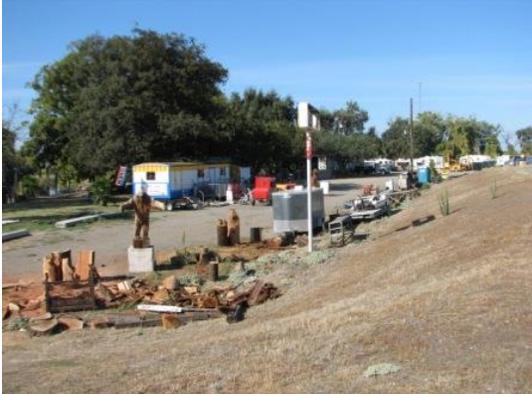
Photo 2 of 2 : FA_2015_RD1500_189_52_20150914_00043.jpg

String Rayzs, Fall 2013

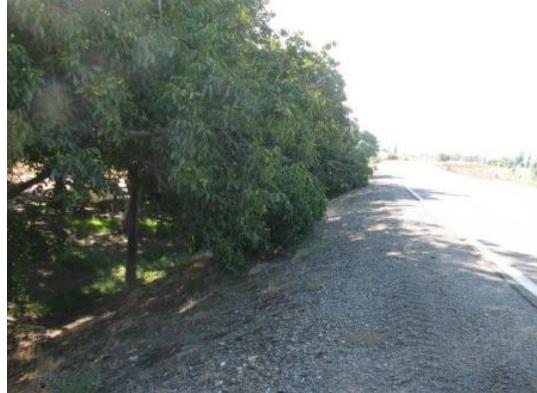
Photo 1 of 1 : FA_2015_RD1500_189_217_20150914_00064.jpg

Trees need to be trimmed to the height of 5 feet to see the slope.

LM Start	7.15	Rating **	M	Issue No.	217
LM End	7.15	Issue Type +	Ma	Location *	LS
Category	Earthen Levee			GPS Latitude/Longitude	
				Start	End
Item	Trim / Thin Trees			38.824119 °	38.824119 °
				-121.722776 °	-121.722776 °
DWR ID	DWR_RD1500_01_s_2012_217				
Action/Comments					
Trim trees to at least five feet above ground level.

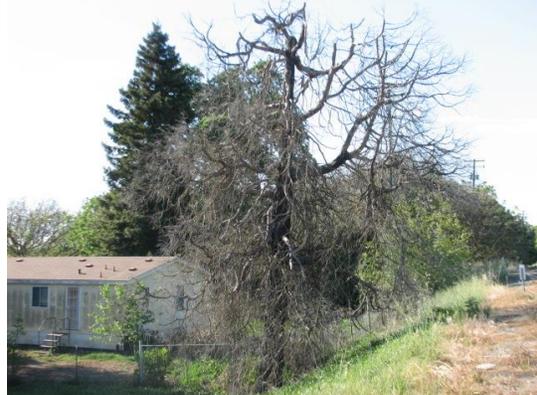
Photo 1 of 1 : FA_2015_RD1500_189_1343_20150914_00079.jpg

LM Start	7.20	Rating **	A/W	Issue No.	1343
LM End	7.20	Issue Type +	Ma	Location *	LS
Category	Earthen Levee		GPS Latitude/Longitude		
			Start	End	
Item	Vegetation		38.824900 °	38.824900 °	
			-121.722851 °	-121.722851 °	
DWR ID	DWR_RD1500_01_s_2014_1343				
Action/Comments					
Trees / Woody Vegetation

Monitor tree that may pose a future threat to the integrity of the levee. Spring 2014

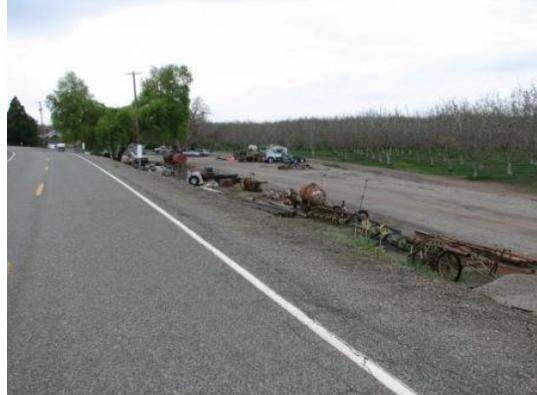
Photo 1 of 1 : FA_2015_RD1500_189_16_20150914_00013.jpg

LM Start	7.49	Rating **	M	Issue No.	16
LM End	7.49	Issue Type +	Ma	Location *	LS
Category	Earthen Levee		GPS Latitude/Longitude		
			Start	End	
Item	Encroachments		38.828975 °	38.828975 °	
			-121.724265 °	-121.724265 °	
DWR ID	DWR_RD1500_01_s_2012_16				
Action/Comments					
Equipment

Equipment along landside toe. Photo was taken in spring 2010.

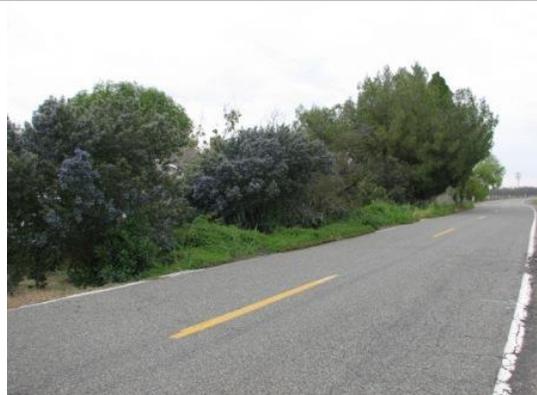
Photo 1 of 2 : FA_2015_RD1500_189_17_20150914_00014.jpg

LM Start	7.60	Rating **	M	Issue No.	17
LM End	7.60	Issue Type +	En	Location *	LS
Category	Earthen Levee		GPS Latitude/Longitude		
			Start	End	
Item	Vegetation		38.830260 °	38.830260 °	
			-121.725357 °	-121.725357 °	
DWR ID	DWR_RD1500_01_s_2012_17				
Action/Comments					
Landscaping

Landscape shrubs, photo taken in spring 2010.

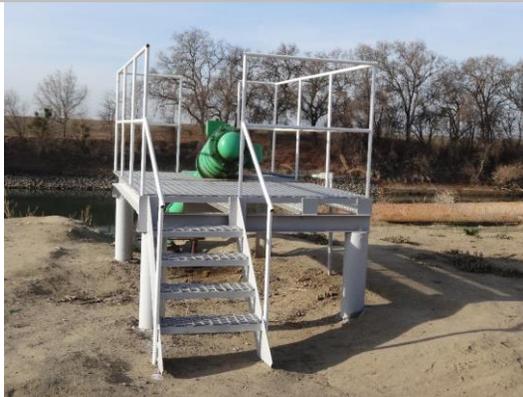
Photo 2 of 2 : UCIP_FA_2015_2932.jpg

Inspector Comments: FS_ID:42935
DS_ID:20049
EP_NO: 8147
FS_HLM: 7.78
Repair Type: Urgent
Crossing Status: Found
UCIP Comments: Not found- slide gate in 48-inch corrugated metal riser at waterside toe.Repair works under way. Contact LMA for repair works information.Sign of leaky pipe and siphon breaker. This needs detailed investigation.
FIELD_STRUCT_DESC: 12-inch steel irrigation pipe through levee, 4.8 feet below crown. Slant pump mounted on steel structure at the edge of berm. A 4 X 4 foot concrete distribution box at landward toe. (App. No. 8147 - Driver)
FS Date: 01/10/2014

WS view: slant pump on steel platform on end of berm.

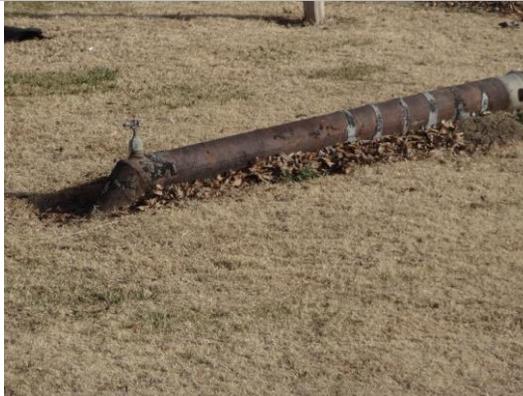
Photo 1 of 3 : UCIP_FA_2015_3083.jpg

Inspector Comments: FS_ID:28323
DS_ID:20051
EP_NO: 13882
FS_HLM: 8.04
Repair Type: Non-Urgent
Crossing Status: Found
UCIP Comments: Power pole on landside. 2-inch conduit through the levee. Service box on waterside. Concrete pad on waterside. Not found- Concrete distribution box on landward side; not found- gate valve on waterside.Need proper abandonment.Pipe visible on river bank, waterside levee slope and landside field.
FIELD_STRUCT_DESC: Abandoned 6-inch diameter steel irrigation pipe and electric conduit through levee, 4.9 feet below crown. 1-1/2 conduit through levee, 4.0 feet below crown. Service pole at landward levee toe. (ABO. No. 10062-Moroni, App. No. 13882)
FS Date: 01/10/2014

LS view: outlet steel pipe across the residential road off the levee toe on field.

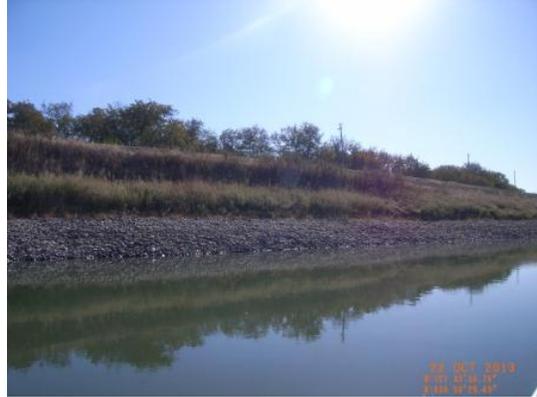
Photo 1 of 1 : USACE2013A_SAC_92-8_L_2.jpg

LM Start	8.33	Rating **	M	Issue No.	3
LM End	8.47	Issue Type +	Ma	Location *	WS
Category	Supplemental			GPS Latitude/Longitude	
				Start	End
Item	2015 USACE Erosion Survey, DRAFT			38.839546 °	38.840347 °
				-121.729591 °	-121.726857 °
DWR ID					
Action/Comments					
Inspector Comments: 1997 - Damage to cobble revetment on top left bank and toe damage. 2004 - Site is pretty minor. 2010 - Cobbles continue to deteriorate. 2011 - Minor new erosion at the toe. 2013 - Might be able to shorten due to deposition. 2015: Site shortened, downstream end has plenty of berm and deposited material, well vegetated. [2015 Site ID: SAC_92-8_L]

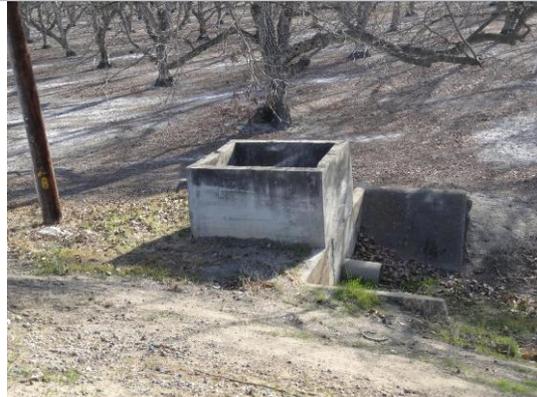
Photo 1 of 3 : UCIP_FA_2015_3086.jpg

LM Start	8.35	Rating **	M	Issue No.	2564
LM End	8.35	Issue Type +	En	Location *	WS
Category	Supplemental			GPS Latitude/Longitude	
				Start	End
Item	DWR UCIP Field Study			38.839446 °	38.839446 °
				-121.728901 °	-121.728901 °
DWR ID					
Action/Comments					
Inspector Comments: FS_ID:28324 DS_ID:20053 EP_NO: 10064 FS_HLM: 8.421 Repair Type: Non-Urgent Crossing Status: Found UCIP Comments: Looks abandoned as service pole not found. May need proper abandonment. FIELD_STRUCT_DESC: 2 foot by 2 foot concrete box culvert through levee, 13.0 feet below crown. Pump on 6 foot diameter concrete pump well on berm. Slide gate in 42-inch CM riser on waterward slope. 4.5 foot by 6 foot concrete distribution box at landward toe. (ABO No. 10064 - Nix) FS Date: 01/10/2014

LS view: concrete distribution box on levee toe.

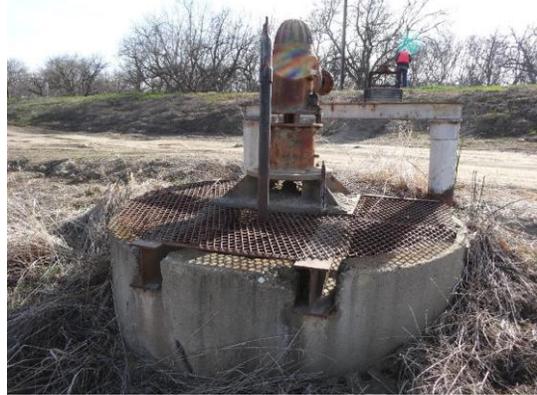
Photo 2 of 3 : UCIP_FA_2015_3087.jpg

WS view: vertical pump on concrete sump on levee berm. Looks abandoned.

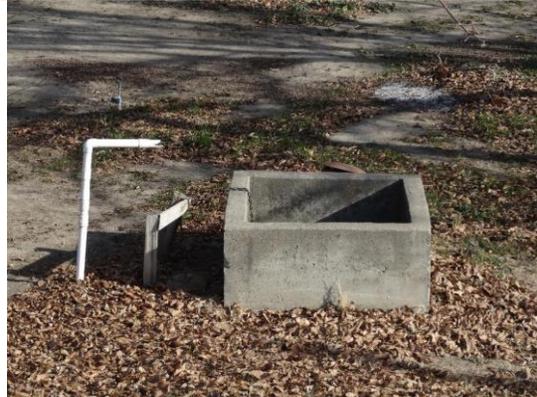
Photo 1 of 3 : UCIP_FA_2015_3089.jpg

LM Start	8.67	Rating **	M	Issue No.	2565
LM End	8.67	Issue Type +	En	Location *	WS
Category	Supplemental			GPS Latitude/Longitude	
				Start	End
Item	DWR UCIP Field Study			38.842218 °	38.842218 °
				-121.725728 °	-121.725728 °
DWR ID					
Action/Comments					
Inspector Comments: FS_ID:28343 DS_ID:20054 EP_NO: 5518 FS_HLM: 8.743 Repair Type: Non-Urgent Crossing Status: Found

LS view: concrete distribution box on landside toe.

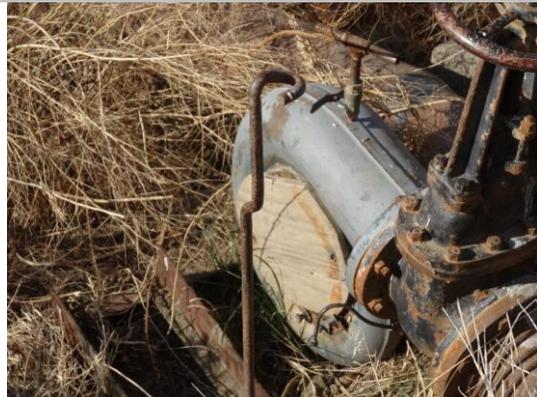
Photo 2 of 3 : UCIP_FA_2015_3259.jpg

WS view: pipe, pump (removed and capped with plywood), and gate valve on river bank.

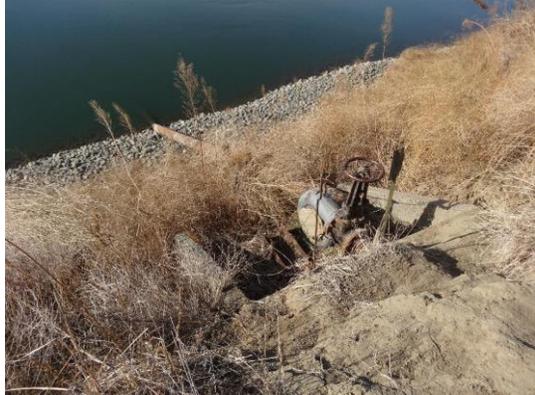
Photo 3 of 3 : UCIP_FA_2015_3260.jpg

WS view: U type concrete headwall, pipe, and pump on river bank.

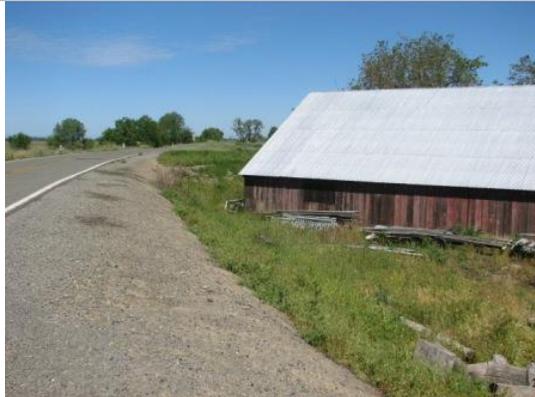
Photo 1 of 1 : FA_2015_RD1500_189_18_20150914_00016.jpg

LM Start	8.72	Rating **	M	Issue No.	18
LM End	8.72	Issue Type +	En	Location *	LS
Category	Earthen Levee			GPS Latitude/Longitude	
				Start	End
Item	Encroachments			38.842673 °	38.842673 °
				-121.726442 °	-121.726442 °
DWR ID	DWR_RD1500_01_s_2012_18				
Action/Comments					
Building

The corner of the building has encroached into the toe.

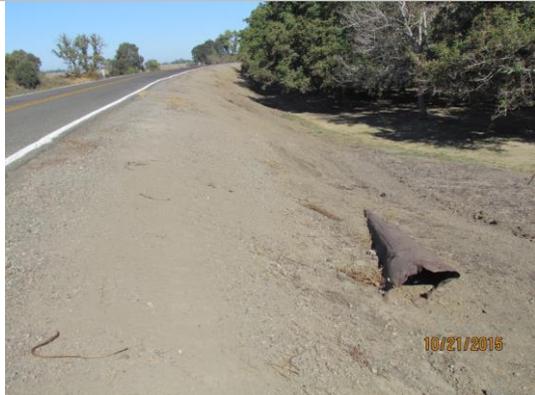
Photo 1 of 1 : FA_2015_RD1500_189_109_20151026_00144.jpg

LM Start	8.79	Rating **	M	Issue No.	109
LM End	8.79	Issue Type +	En	Location *	LS
Category	Earthen Levee			GPS Latitude/Longitude	
				Start	End
Item	Encroachments			38.843481 °	38.843481 °
				-121.727256 °	-121.727256 °
DWR ID	DWR_RD1500_01_f_2015_109				
Action/Comments					
Debris Inspector Comments: Abandoned pipe is embedded into levee slope.

View of the abandoned pipe on the landward side of the levee looking upstream. Fall 2015.

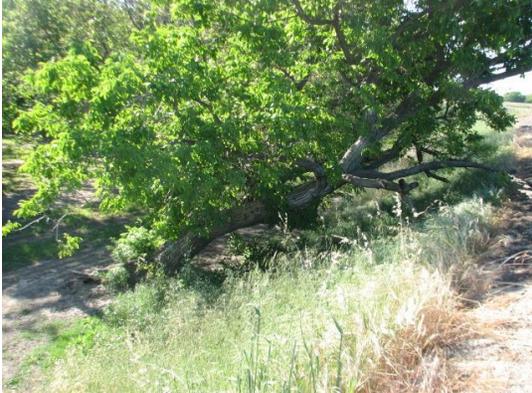
Photo 1 of 3 : FA_2015_RD1500_189_1344_20150914_00080.jpg

LM Start	8.92	Rating **	A/W	Issue No.	1344
LM End	8.92	Issue Type +	Ma	Location *	LS
Category	Earthen Levee			GPS Latitude/Longitude	
				Start	End
Item	Vegetation			38.845076 °	38.845076 °
				-121.728301 °	-121.728301 °
DWR ID	DWR_RD1500_01_s_2014_1344				
Action/Comments					
Trees / Woody Vegetation

The walnut tree at the toe has fallen. The roots are exposed and the branches are holding it up. Spring 2014

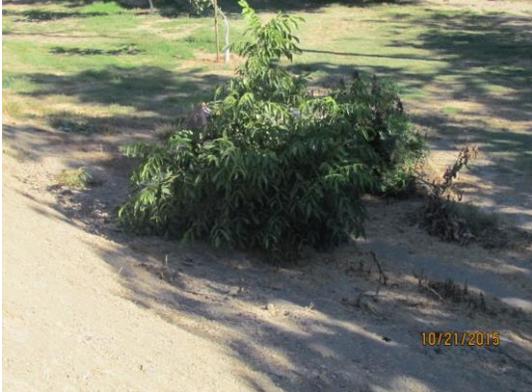
Photo 2 of 3 : FA_2015_RD1500_189_1344_20151026_00145.jpg

The walnut tree has been trimmed but still remains at the landward toe of the levee. Fall 2015.

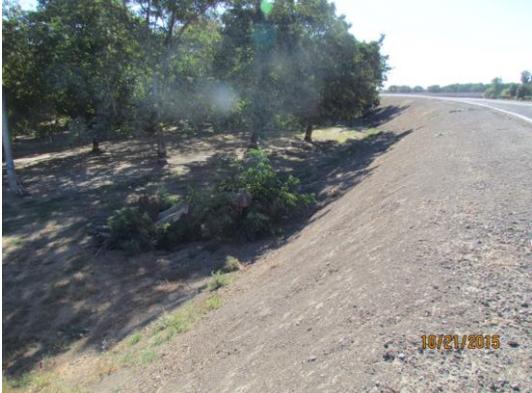
Photo 3 of 3 : FA_2015_RD1500_189_1344_20151026_00146.jpg

Perspective view of the walnut tree on the landward side of the levee looking downstream. Fall 2015.

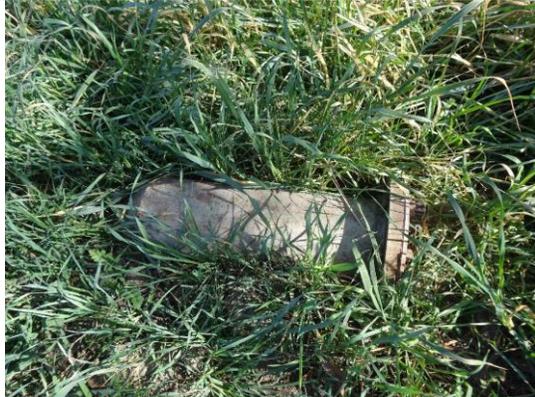
Photo 1 of 3 : UCIP_FA_2015_3261.jpg

LM Start	8.95	Rating **	M	Issue No.	2566
LM End	8.95	Issue Type +	En	Location *	LS
Category	Supplemental			GPS Latitude/Longitude	
				Start	End
Item	DWR UCIP Field Study			38.845578 °	38.845578 °
				-121.728406 °	-121.728406 °
DWR ID					
Action/Comments					
Inspector Comments: FS_ID:28363 DS_ID:20055 EP_NO: 8503 FS_HLM: 9.03 Repair Type: Non-Urgent Crossing Status: Found

LS view: pipe end capped with steel plate on levee toe. Looks abandoned.

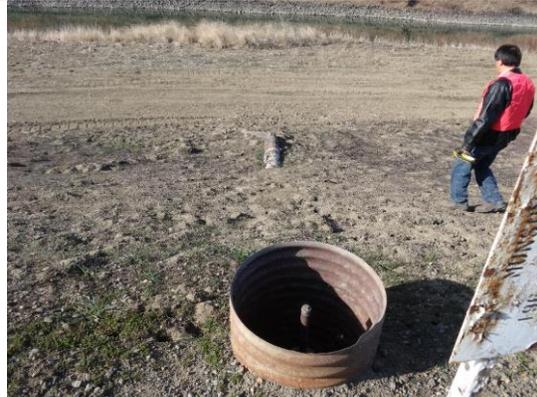
Photo 3 of 3 : UCIP_FA_2015_3263.jpg

WS view: siphon breaker in CMP riser on levee slope.

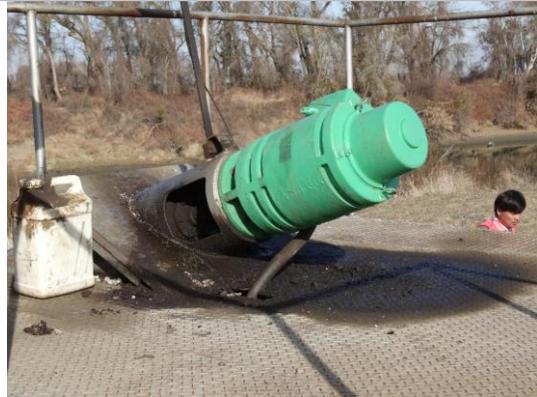
Photo 1 of 3 : UCIP_FA_2015_1220.jpg

LM Start	9.13	Rating **	M	Issue No.	2567
LM End	9.13	Issue Type +	En	Location *	LS
Category	Supplemental			GPS Latitude/Longitude	
				Start	End
Item	DWR UCIP Field Study			38.847841 °	38.847841 °
				-121.727172 °	-121.727172 °
DWR ID					
Action/Comments					
Inspector Comments: FS_ID:28364 DS_ID:20056 EP_NO: 5598 FS_HLM: 9.2 Repair Type: Non-Urgent Crossing Status: Found UCIP Comments: Not found- Wood headwall 18 ft from landward toe. Not found- Flap gate on landward side.No outlet structure found. Only a capped pipe found, but not sure whether it is connected to the crossing. FIELD_STRUCT_DESC: 12-inch steel irrigation pipe through levee, 4.8 feet below crown. Electrical conduit through levee, 4.8 feet below crown. Slant pump on steel structure. Siphon breaker in landward shoulder. Service pole on landside toe. Discharges into field. Installed 1967. (App. No. 5598 & 8505 - James) FS Date: 01/10/2014

WS view: slant pump on steel platform on levee berm. Excessive oil leak from the pump.

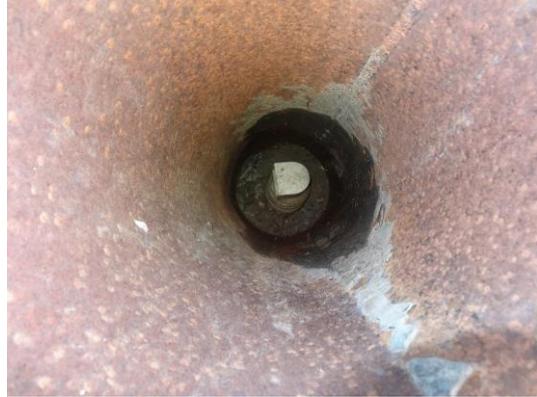
Photo 2 of 3 : UCIP_FA_2015_1221.jpg

LS view: air vent in steel pipe riser on levee slope.

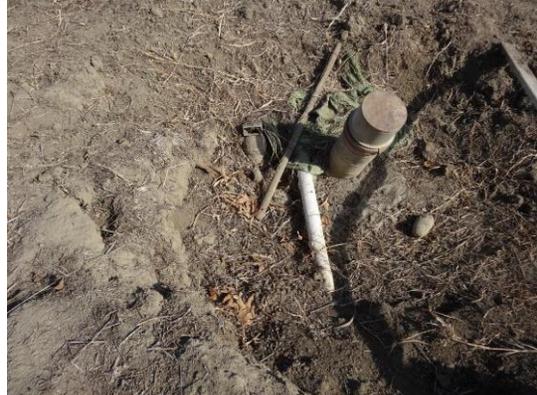
Photo 3 of 3 : UCIP_FA_2015_3264.jpg

LS view: capped outlet pipe on levee toe.

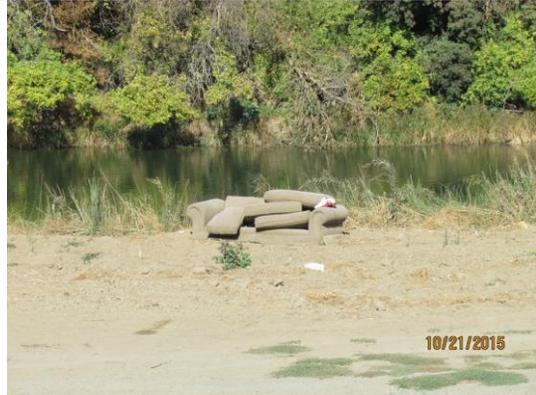
Photo 1 of 1 : FA_2015_RD1500_189_111_20151026_00147.jpg

LM Start	9.28	Rating **	M	Issue No.	111
LM End	9.28	Issue Type +	En	Location *	WS
Category	Earthen Levee		GPS Latitude/Longitude		
			Start	End	
Item	Encroachments		38.849171 °	38.849171 °	
			-121.724840 °	-121.724840 °	
DWR ID	DWR_RD1500_01_f_2015_111				
Action/Comments					
Debris

The couch is on the berm of the waterward side of the levee. Fall 2015.

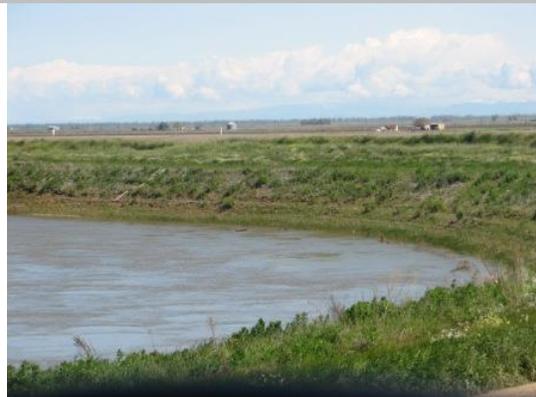
Photo 1 of 2 : FA_2015_RD1500_189_74_20150914_00051.jpg

LM Start	9.40	Rating **	A/W	Issue No.	74
LM End	9.63	Issue Type +	Ma	Location *	WS
Category	Earthen Levee		GPS Latitude/Longitude		
			Start	End	
Item	Vegetation		38.850267 °	38.853222 °	
			-121.723275 °	-121.724062 °	
DWR ID	DWR_RD1500_01_s_2012_74				
Action/Comments					
Environmental Requirements.

A revegetation site on the waterside bank with sprinklers installed.

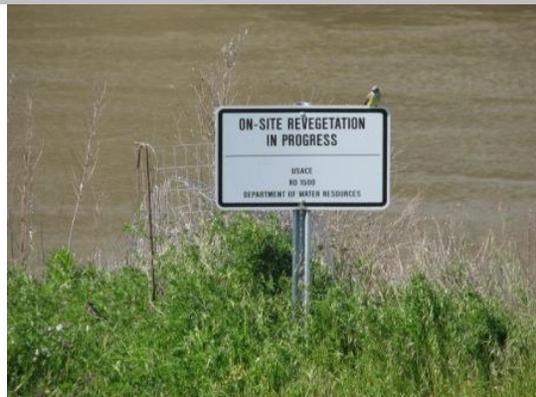
Photo 2 of 2 : FA_2015_RD1500_189_74_20150914_00052.jpg

Another revegetation site photo taken spring 2012.

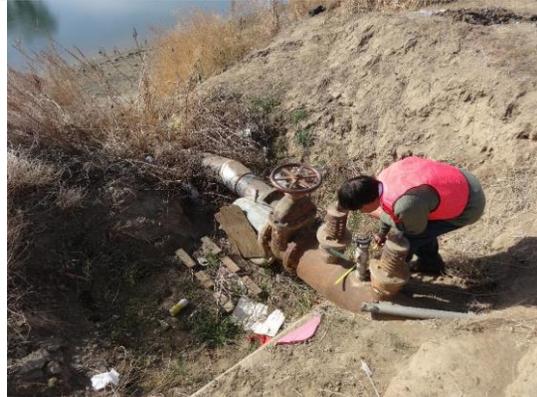
Photo 1 of 3 : UCIP_FA_2015_1222.jpg

LM Start	9.66	Rating **	M	Issue No.	2568
LM End	9.66	Issue Type +	En	Location *	WS
Category	Supplemental			GPS Latitude/Longitude	
				Start	End
Item	DWR UCIP Field Study			38.853364 °	38.853364 °
				-121.724617 °	-121.724617 °
DWR ID					
Action/Comments					
Inspector Comments: FS_ID:28365 DS_ID:20057 EP_NO: N/A FS_HLM: 9.74 Repair Type: Non-Urgent Crossing Status: Found

LS view: U type concrete headwall, pipe, gate valve, and pump (removed and plugged with plywood) on river bank.

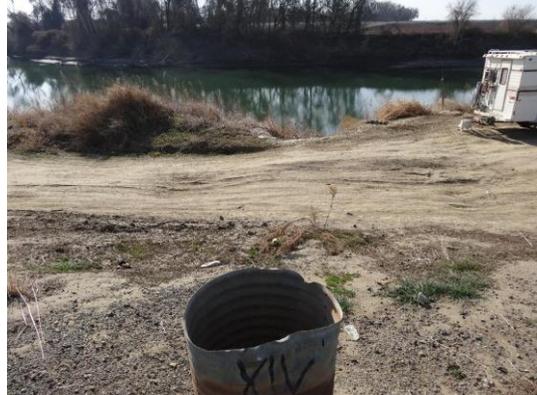
Photo 3 of 3 : UCIP_FA_2015_1224.jpg

WS view: CMP riser with siphon breaker on levee slope.

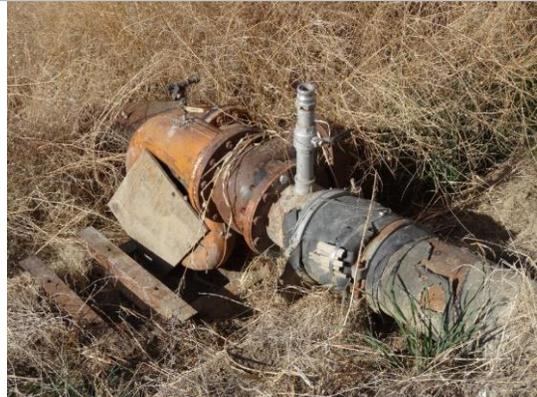
Photo 1 of 3 : UCIP_FA_2015_1225.jpg

LM Start	10.12	Rating **	M	Issue No.	2569
LM End	10.12	Issue Type +	En	Location *	WS
Category	Supplemental			GPS Latitude/Longitude	
				Start	End
Item	DWR UCIP Field Study			38.857853 °	38.857853 °
				-121.728222 °	-121.728222 °
DWR ID					
Action/Comments					
Inspector Comments: FS_ID:28366 DS_ID:20058 EP_NO: 10068 FS_HLM: 10.205 Repair Type: Non-Urgent Crossing Status: Found UCIP Comments: Surface erosion along pipe alignment on landside. 30-inch concrete pipe in CMP riser on waterside. 30-inch x 24-inch concrete culvert on landside. FIELD_STRUCT_DESC: A 2 foot by 2.5 foot concrete box culvert through levee, 13.0 feet below crown. A pump on river bank, power pole and switch panel on waterside berm. Concrete surge box with slide gate on waterside berm. Concrete distribution box at landward toe. (ABO. No. 10068-Reel) O&M Manual Sac 128, March 1960. FS Date: 01/10/2014

WS view: pipe and pump with appurtenances on river bank. Pump removed and plugged with plywood.

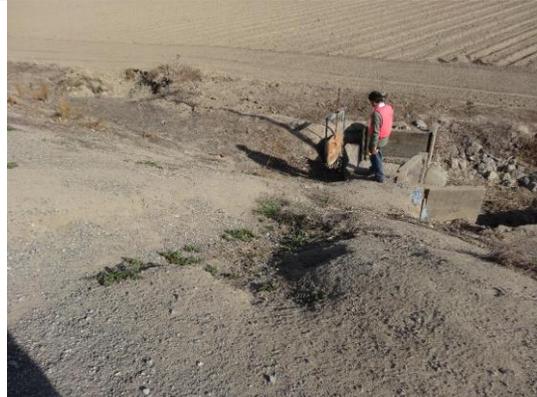
Photo 2 of 3 : UCIP_FA_2015_3334.jpg

LS view: surface erosion along pipe alignment on landside.

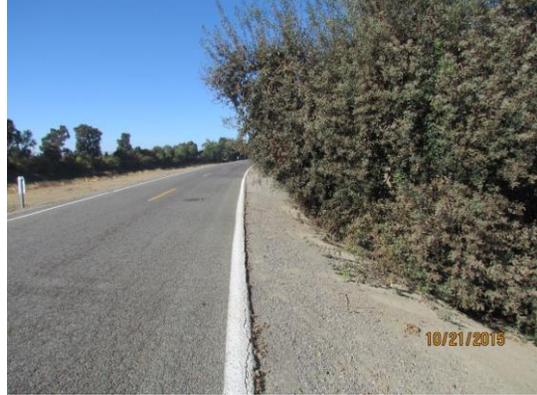
Photo 1 of 1 : FA_2015_RD1500_189_112_20151026_00148.jpg

View of the trees on the landward side of the levee looking upstream. Fall 2015.

LM Start	10.54	Rating **	M	Issue No.	112
LM End	10.54	Issue Type +	Ma	Location *	LS
Category	Earthen Levee			GPS Latitude/Longitude	
				Start	End
Item	Trim / Thin Trees			38.861027 °	38.861027 °
				-121.734094 °	-121.734094 °
DWR ID	DWR_RD1500_01_f_2015_112				
Action/Comments					
Trim trees to at least five feet above ground level.

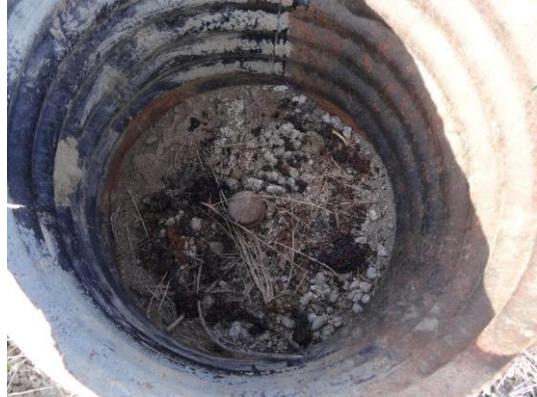
Photo 1 of 3 : UCIP_FA_2015_2933.jpg

LM Start	10.70	Rating **	M	Issue No.	2570
LM End	10.70	Issue Type +	En	Location *	LS
Category	Supplemental			GPS Latitude/Longitude	
				Start	End
Item	DWR UCIP Field Study			38.861550 °	38.861550 °
				-121.737006 °	-121.737006 °
DWR ID					
Action/Comments					
Inspector Comments: FS_ID:28925 DS_ID:20059 EP_NO: N/A FS_HLM: 10.79 Repair Type: Non-Urgent Crossing Status: Found UCIP Comments: Pump removed. Obstructed siphon breaker in CMP riser on landside. FIELD_STRUCT_DESC: A 12-inch diameter steel irrigation pipe through levee, 4.3 feet below crown. A 1-1/2 conduit through levee. 2.0 feet below crown. Pump on river bank, siphon breaker on landside shoulder. A 8x6 ft. concrete distribution box and service pole at landside toe. O&M Manual Sac 128, March 1960. FS Date: 01/10/2014

LS view: obstructed siphon breaker in CMP riser (bottom) on levee slope.

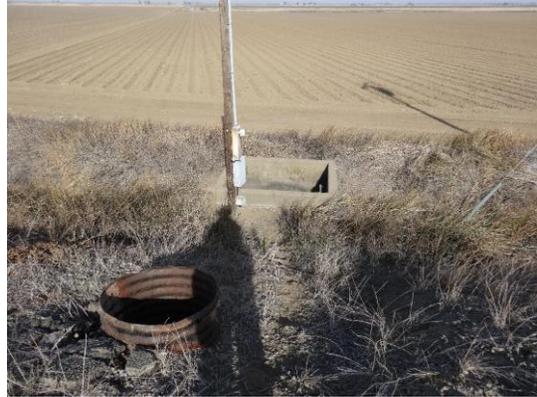
Photo 2 of 3 : UCIP_FA_2015_2934.jpg

LM Start	10.70	Rating **	M	Issue No.	2570 (cont)
LM End	10.70	Issue Type +	En	Location *	LS
Category	Supplemental			GPS Latitude/Longitude	
				Start	End
Item	DWR UCIP Field Study			38.861550 °	38.861550 °
				-121.737006 °	-121.737006 °
DWR ID					
Action/Comments					
Inspector Comments: FS_ID:28925 DS_ID:20059 EP_NO: N/A FS_HLM: 10.79 Repair Type: Non-Urgent Crossing Status: Found UCIP Comments: Pump removed. Obstructed siphon breaker in CMP riser on landside. FIELD_STRUCT_DESC: A 12-inch diameter steel irrigation pipe through levee, 4.3 feet below crown. A 1-1/2 conduit through levee. 2.0 feet below crown. Pump on river bank, siphon breaker on landside shoulder. A 8x6 ft. concrete distribution box and service pole at landside toe. O&M Manual Sac 128, March 1960. FS Date: 01/10/2014

LS view: siphon breaker in CMP riser (bottom) on levee slope and concrete distribution box (top) on levee toe.

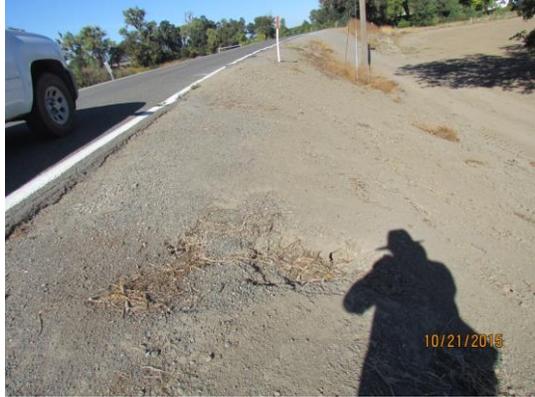
Photo 1 of 1 : FA_2015_RD1500_189_113_20151026_00149.jpg

LM Start	11.23	Rating **	M	Issue No.	113
LM End	11.23	Issue Type +	Ma	Location *	LS
Category	Earthen Levee			GPS Latitude/Longitude	
				Start	End
Item	Erosion / Bank Caving			38.865598 °	38.865598 °
				-121.745196 °	-121.745196 °
DWR ID	DWR_RD1500_01_f_2015_113				
Action/Comments					
Schedule repair of erosion site prior to the next inspection.

View of the erosion on the landward side of the levee looking upstream. Fall 2015.

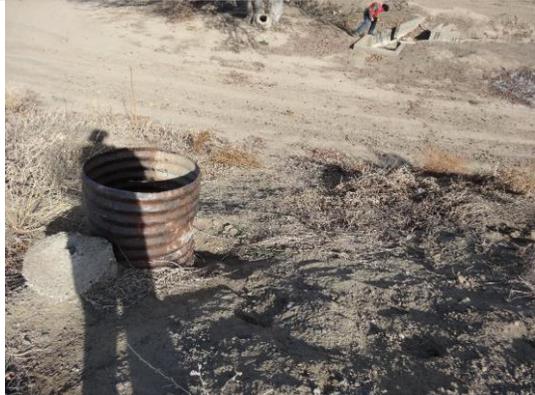
Photo 1 of 3 : UCIP_FA_2015_3336.jpg

LM Start	11.24	Rating **	U	Issue No.	2571
LM End	11.24	Issue Type +	En	Location *	WS
Category	Supplemental			GPS Latitude/Longitude	
				Start	End
Item	DWR UCIP Field Study			38.865649 °	38.865649 °
				-121.745279 °	-121.745279 °
DWR ID					
Action/Comments					
Inspector Comments: FS_ID:44406 DS_ID:20060 EP_NO: N/A FS_HLM: 11.34 Repair Type: Urgent Crossing Status: Found

LS view: siphon breaker in CMP riser on levee slope and concrete distribution box on levee toe (top0).

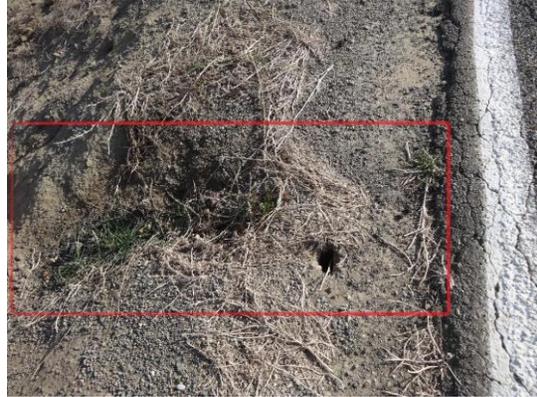
Photo 2 of 3 : UCIP_FA_2015_3337.jpg

LM Start	11.24	Rating **	U	Issue No.	2571 (cont)
LM End	11.24	Issue Type +	En	Location *	WS
Category	Supplemental			GPS Latitude/Longitude	
				Start	End
Item	DWR UCIP Field Study			38.865649 °	38.865649 °
				-121.745279 °	-121.745279 °
DWR ID					
Action/Comments					
Inspector Comments: FS_ID:44406 DS_ID:20060 EP_NO: N/A FS_HLM: 11.34 Repair Type: Urgent Crossing Status: Found UCIP Comments: Pump removed.10-inch pipe joined to 14-inch pipe.Wet, some vegetations, and subsidence along pipe alignment on landside. This needs detailed investigation. FIELD_STRUCT_DESC: 14-inch diameter steel irrigation pipe through levee. 4.7 feet below crown. Pump and gate valve on concrete platform on bank. Switch control house and service pole on shoulder. Siphon breaker on landside slope. Concrete distribution box on landward side. O&M Manual Sac 128, March 1960, ABO No. 10068. FS Date: 01/10/2014

LS view: wet, some vegetations, and subsidence along pipe alignment on landside.

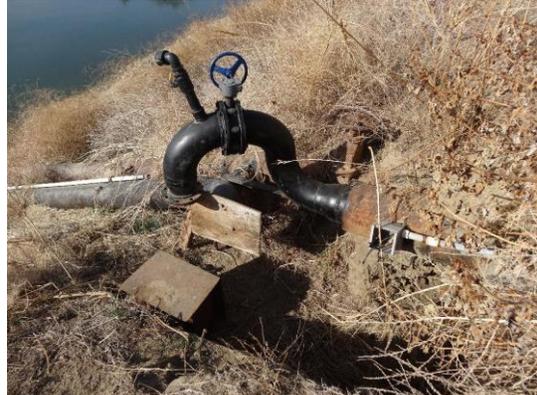
Photo 3 of 3 : UCIP_FA_2015_3338.jpg

WS view: pipe, pump (removed and plugged with plywood plate), and appurtenances on river bank.

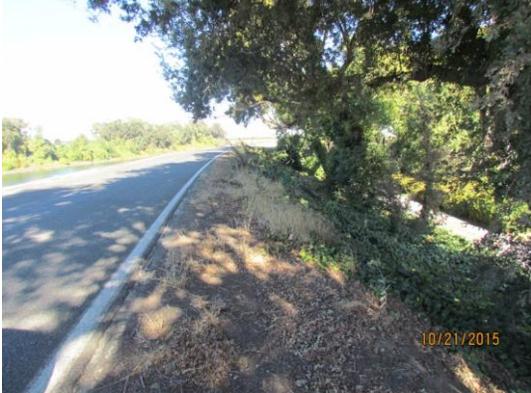
Photo 1 of 1 : FA_2015_RD1500_189_20_20151026_00150.jpg

LM Start	11.33	Rating **	M	Issue No.	20
LM End	11.33	Issue Type +	En	Location *	LS
Category	Earthen Levee		GPS Latitude/Longitude		
			Start	End	
Item	Vegetation		38.866762 °	38.866762 °	
			-121.746125 °	-121.746125 °	
DWR ID	DWR_RD1500_01_s_2012_20				
Action/Comments					
Landscaping

View of the landscaping on the landward side of the levee looking upstream. Fall 2015.

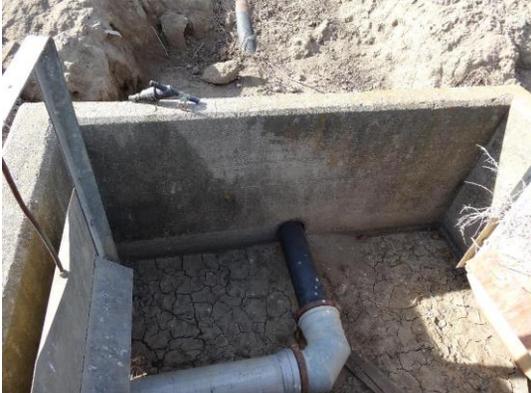
Photo 1 of 3 : UCIP_FA_2015_0608.jpg

LM Start	11.45	Rating **	U	Issue No.	2572
LM End	11.45	Issue Type +	En	Location *	LS
Category	Supplemental		GPS Latitude/Longitude		
			Start	End	
Item	DWR UCIP Field Study		38.868544 °	38.868544 °	
			-121.746471 °	-121.746471 °	
DWR ID					
Action/Comments					
Inspector Comments: FS_ID:43085 DS_ID:20061 EP_NO: 10041 FS_HLM: 11.56 Repair Type: Urgent Crossing Status: Found UCIP Comments: Depressions on both sides of the levee slope. It needs more investigation. Pump removed. FIELD_STRUCT_DESC: 8-inch steel irrigation pipe through levee, 4.0 feet below crown. Pump and gate valve on concrete pump platform on bank. Corrugated metal switch house on waterside. Service pole on waterside shoulder. 8 foot by 6 foot I.D. concrete distribution box on landside. Overhead power line. Pole at landward toe. (ABO No. 10041 - Duffy) O&M Manual Sac 128, March 1960. FS Date: 01/10/2014

LS view: concrete distribution box on levee toe. Exposed pipe and depression (top) visible on levee slope.

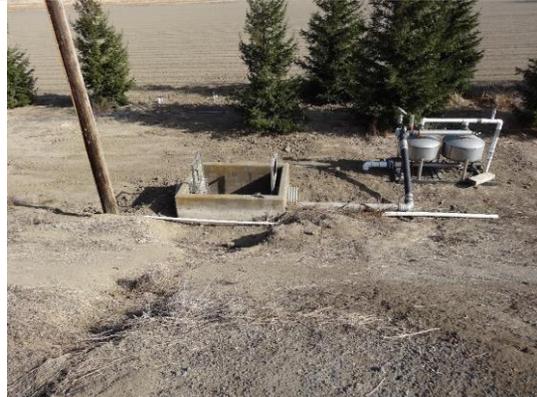
Photo 2 of 3 : UCIP_FA_2015_2915.jpg

Action/Comments
 Inspector Comments: FS_ID:43085
 DS_ID:20061
 EP_NO: 10041
 FS_HLM: 11.56
 Repair Type: Urgent
 Crossing Status: Found
 UCIP Comments: Depressions on both sides of the levee slope. It needs more investigation. Pump removed.
 FIELD_STRUCT_DESC: 8-inch steel irrigation pipe through levee, 4.0 feet below crown. Pump and gate valve on concrete pump platform on bank. Corrugated metal switch house on waterside. Service pole on waterside shoulder. 8 foot by 6 foot I.D. concrete distribution box on landside. Overhead power line. Pole at landward toe. (ABO No. 10041 - Duffy) O&M Manual Sac 128, March 1960.
 FS Date: 01/10/2014

LS view: depressions along the pipe alignment on levee slope. It needs detailed investigation.

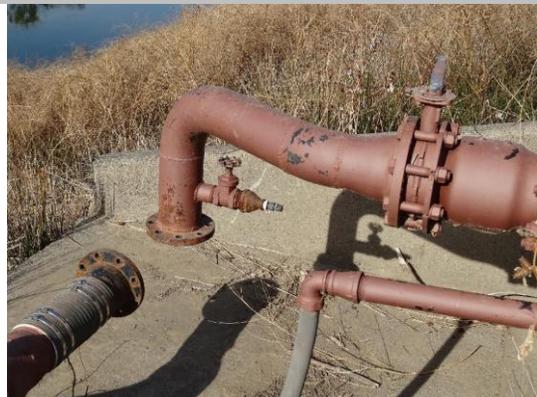
Photo 3 of 3 : UCIP_FA_2015_2916.jpg

WS view: pipe, pump (removed), headwall, and appurtenances on river bank.

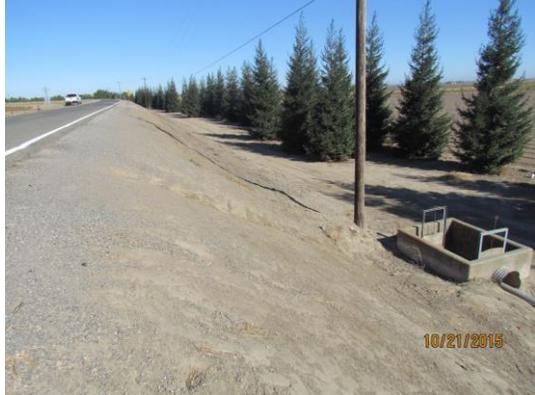
Photo 1 of 3 : FA_2015_RD1500_189_114_20151026_00155.jpg

LM Start	11.45	Rating **	M	Issue No.	114
LM End	11.45	Issue Type +	En	Location *	LS
Category	Earthen Levee		GPS Latitude/Longitude		
			Start	End	
Item	Encroachments		38.868577 °	38.868577 °	
			-121.746487 °	-121.746487 °	
DWR ID	DWR_RD1500_01_f_2015_114				
Action/Comments					
Stairway Inspector Comments: There is erosion at the toe of the levee where the concrete box is located.

Perspective view of the concrete box on the landward side of the levee looking upstream. Fall 2015.

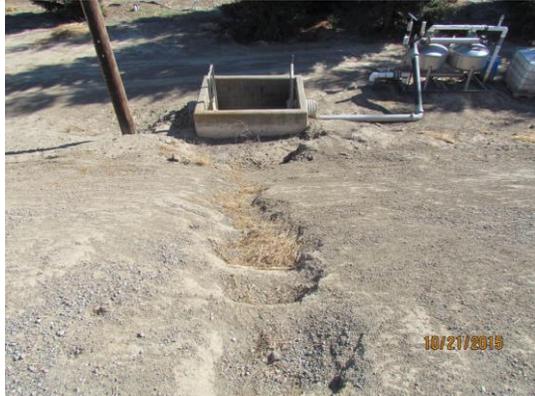
Photo 2 of 3 : FA_2015_RD1500_189_114_20151026_00152.jpg

There is erosion at the levee toe around the concrete box. There are also stairs leading down the slope. Fall 2015.

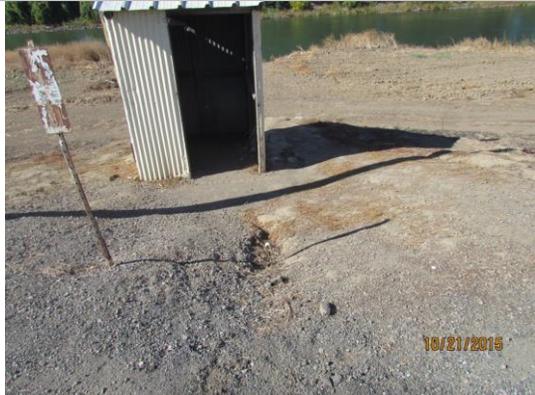
Photo 3 of 3 : FA_2015_RD1500_189_114_20151026_00156.jpg

There is slight erosion on the waterward side of the levee where the pipe seems to run through the levee. Fall 2015.

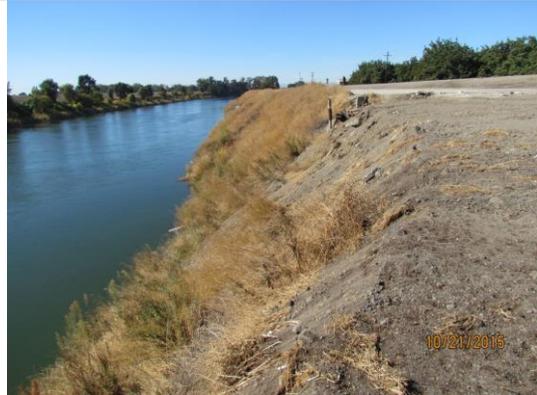
Photo 1 of 2 : FA_2015_RD1500_189_115_20151026_00157.jpg

LM Start	11.82	Rating **	A/W	Issue No.	115
LM End	11.82	Issue Type +	Ma	Location *	WS
Category	Earthen Levee			GPS Latitude/Longitude	
				Start	End
Item	Erosion / Bank Caving			38.872124 °	38.872124 °
				-121.749720 °	-121.749720 °
DWR ID	DWR_RD1500_01_f_2015_115				
Action/Comments					
Note and monitor erosion site. Inspector Comments: Erosion site is on the edge of the river.

View of the erosion at the edge of the waterward berm looking upstream. Fall 2015.

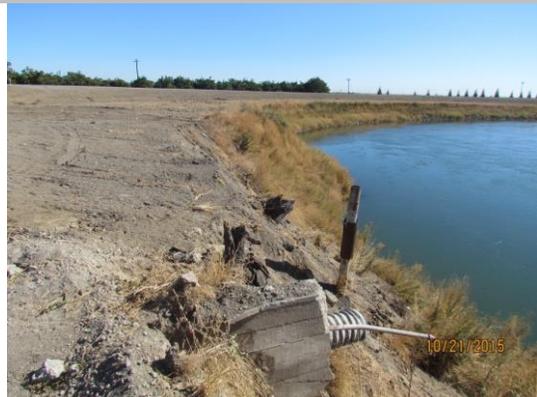
Photo 2 of 2 : FA_2015_RD1500_189_115_20151026_00158.jpg

View of the erosion at the edge of the river looking downstream. Fall 2015.

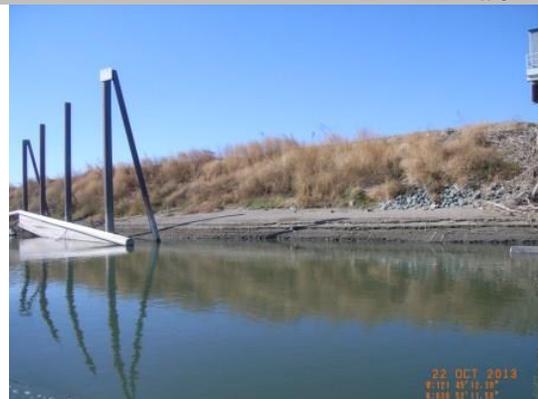
Photo 1 of 1 : USACE2013A_SAC_96-2_L_11.jpg

LM Start	11.99	Rating **	A/W	Issue No.	1
LM End	12.26	Issue Type +	Ma	Location *	WS
Category	Supplemental			GPS Latitude/Longitude	
				Start	End
Item	2015 USACE Erosion Survey, DRAFT			38.870474 °	38.869139 °
				-121.752237 °	-121.757108 °
DWR ID					
Action/Comments					
Inspector Comments: 2000 - Vertical Modesto Formation bank with mass failure. 2003 - Upstream end has some new bank retreat. 2004 - Upstream end is worse. 2006 - Some new erosion, mainly on the steep slope and scarps. (Pumping station is not part of the erosion site.) 2010 - Some new erosion and deposition at upstream end, definite encroachments. 2011 - Minor new erosion at the toe. 2015: Site removed, sufficient berm width. [2015 Site ID: SAC_96-2_L]

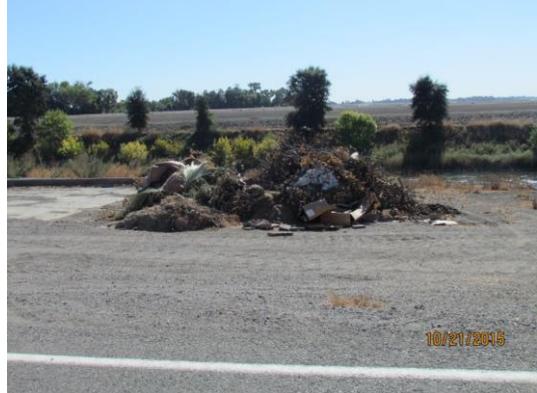
Photo 1 of 1 : FA_2015_RD1500_189_116_20151026_00159.jpg

LM Start	11.99	Rating **	M	Issue No.	116
LM End	11.99	Issue Type +	En	Location *	WS
Category	Earthen Levee		GPS Latitude/Longitude		
			Start	End	
Item	Encroachments		38.870840 °	38.870840 °	
			-121.752594 °	-121.752594 °	
DWR ID	DWR_RD1500_01_f_2015_116				
Action/Comments					
Garbage

View of the debris on the waterward side of the levee. Fall 2015.

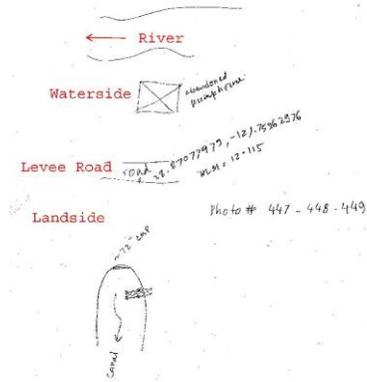
Photo 1 of 3 : UCIP_FA_2015_3224.jpg

LM Start	12.00	Rating **	M	Issue No.	2573
LM End	12.00	Issue Type +	En	Location *	WS
Category	Supplemental		GPS Latitude/Longitude		
			Start	End	
Item	DWR UCIP Field Study		38.870780 °	38.870780 °	
			-121.752630 °	-121.752630 °	
DWR ID					
Action/Comments					
Inspector Comments: FS_ID:41744 DS_ID:20008 EP_NO: N/A FS_HLM: 12.115 Repair Type: Non-Urgent Crossing Status: Indicator Found UCIP Comments: An abandoned pump house on waterside and a 72-inch corrugated metal pipe on landside. The pipe discharges into irrigation ditch (canal). Water was flowing during the field visit. Needs to verify from LMA whether this pipe is through the levee or not. FIELD_STRUCT_DESC: 1 of 2: Two 4 foot and 3.5 foot concrete culverts through levee, 17 feet below the crown, pump on WS. FS Date: 01/10/2014

Sketch of Utility Crossing @HLM 12.115

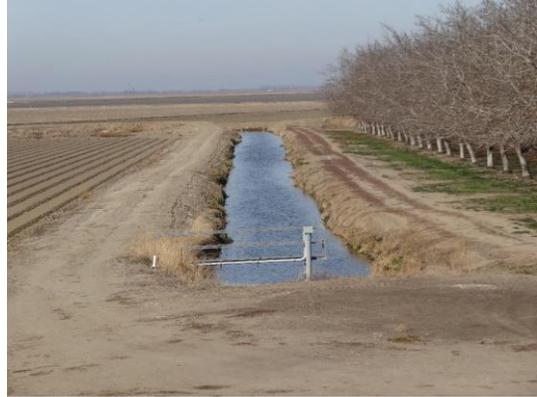
Photo 2 of 3 : UCIP_FA_2015_3225.jpg

Inspector Comments: FS_ID:41744
 DS_ID:20008
 EP_NO: N/A
 FS_HLM: 12.115
 Repair Type: Non-Urgent
 Crossing Status: Indicator Found
 UCIP Comments: An abandoned pump house on waterside and a 72-inch corrugated metal pipe on landside. The pipe discharges into irrigation ditch (canal). Water was flowing during the field visit. Needs to verify from LMA whether this pipe is through the levee or not.
 FIELD_STRUCT_DESC: 1 of 2: Two 4 foot and 3.5 foot concrete culverts through levee, 17 feet below the crown, pump on WS.
 FS Date: 01/10/2014

LS view: overview of irrigation ditch on toe of levee.

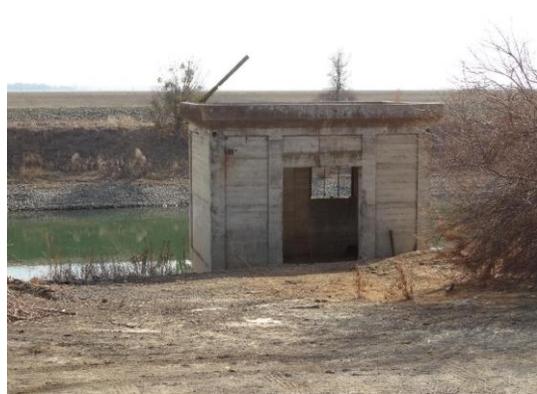
Photo 3 of 3 : UCIP_FA_2015_3226.jpg

WS view: abandoned concrete pump house. No pump and pipe found.

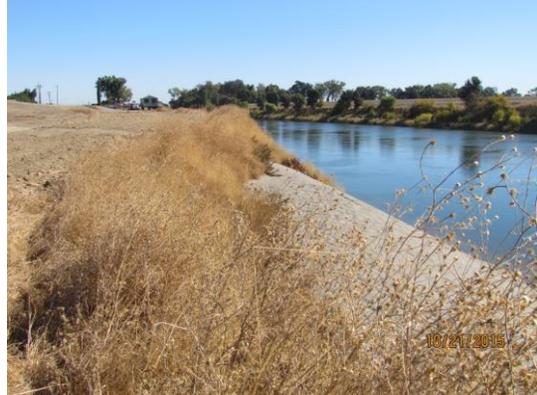
Photo 1 of 2 : FA_2015_RD1500_189_50_20151026_00161.jpg

LM Start	12.19	Rating **	A/W	Issue No.	50
LM End	12.19	Issue Type +	Ma	Location *	WS
Category	Earthen Levee		GPS Latitude/Longitude		
			Start	End	
Item	Erosion / Bank Caving		38.869700 °	38.869700 °	
			-121.755945 °	-121.755945 °	
DWR ID	DWR_RD1500_01_s_2012_50				
Action/Comments					
Note and monitor erosion site. Inspector Comments: The levee has a wide berm at this location.

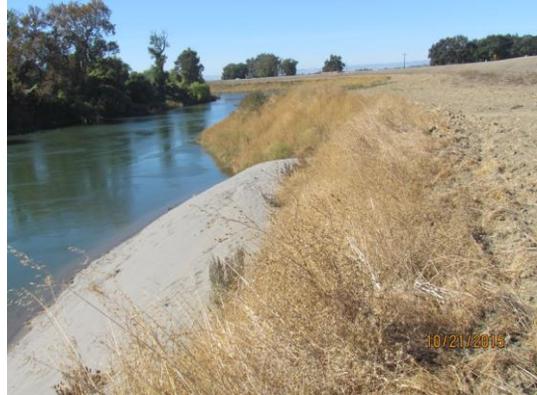
Photo 2 of 2 : FA_2015_RD1500_189_50_20151026_00160.jpg

View of the erosion site along the embankment looking downstream. Fall 2015.

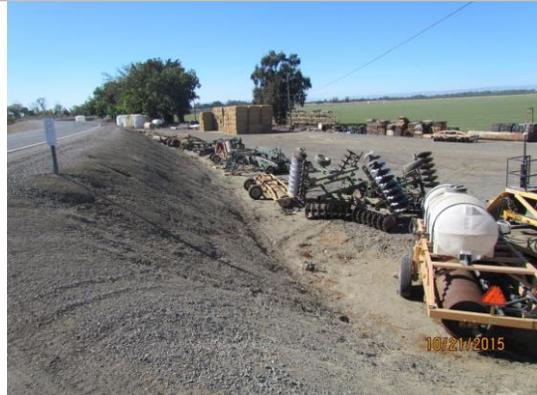
Photo 1 of 1 : FA_2015_RD1500_189_24_20151026_00162.jpg

LM Start	12.43	Rating **	M	Issue No.	24
LM End	12.53	Issue Type +	Ma	Location *	LS
Category	Earthen Levee		GPS Latitude/Longitude		
			Start	End	
Item	Encroachments		38.868717 °	38.867492 °	
			-121.760133 °	-121.760903 °	
DWR ID	DWR_RD1500_01_s_2012_24				
Action/Comments					
Equipment

View of the equipment on the landward side of the levee looking upstream. Fall 2015.
