**Flood Control Project Maintenance
Levee Inspections**

Fall 2015 Levee Maintenance Deficiency Summary Report

Sacramento River Basin

Reclamation District No. 1500 Sutter Basin

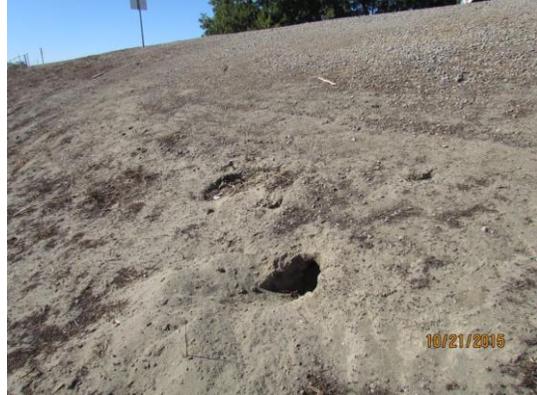
Photo 1 of 1 : FA_2015_RD1500_189_117_20151026_00163.jpg

View of the rodent hole on the waterward side of the levee looking upstream. Fall 2015.

LM Start	12.50	Rating **	M	Issue No.	117
LM End	12.50	Issue Type +	Ma	Location *	WS
Category	Earthen Levee		GPS Latitude/Longitude		
			Start	End	
Item	Animal Control		38.867902 °	38.867902 °	
			-121.760631 °	-121.760631 °	
DWR ID	DWR_RD1500_01_f_2015_117				
Action/Comments					
No rodents visible, but rodent burrows visible; need to backfill and compact or grout burrows.

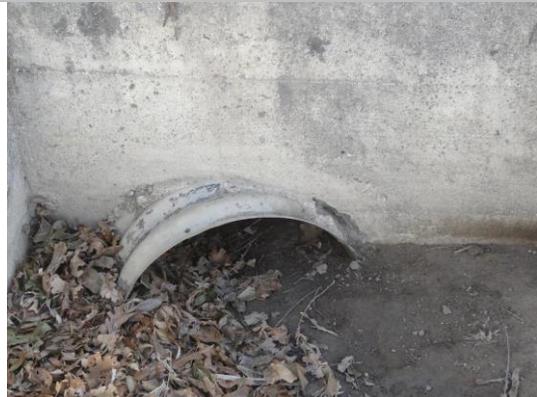
Photo 1 of 3 : UCIP_FA_2015_3027.jpg

LM Start	12.55	Rating **	M	Issue No.	2574
LM End	12.55	Issue Type +	En	Location *	WS
Category	Supplemental		GPS Latitude/Longitude		
			Start	End	
Item	DWR UCIP Field Study		38.867254 °	38.867254 °	
			-121.761212 °	-121.761212 °	
DWR ID					
Action/Comments					
Inspector Comments: FS_ID:28463 DS_ID:20063 EP_NO: N/A FS_HLM: 12.677 Repair Type: Non-Urgent Crossing Status: Found UCIP Comments: Needs proper abandonment. FIELD_STRUCT_DESC: Abandoned 18-inch Corrugated Metal drainpipe through levee, 15.0 feet below crown. Slide gate in 4 foot by 4 foot concrete box at waterward toe. Concrete box at landward toe. Pipe across overflow area to river. O&M Manual Sac 128, March 1960. FS Date: 01/10/2014

LS view: silted CMP in concrete intake box on levee toe.

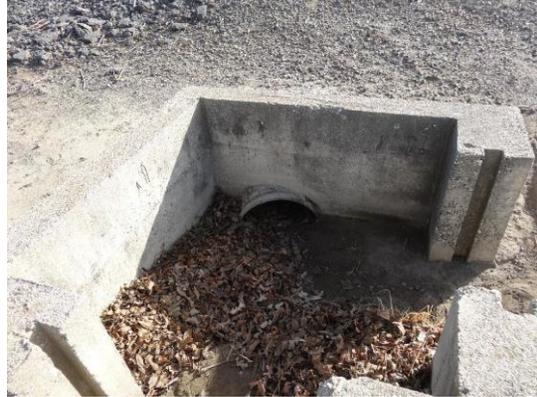
Photo 2 of 3 : UCIP_FA_2015_3028.jpg

LM Start	12.55	Rating **	M	Issue No.	2574 (cont)
LM End	12.55	Issue Type +	En	Location *	WS
Category	Supplemental			GPS Latitude/Longitude	
				Start	End
Item	DWR UCIP Field Study			38.867254 °	38.867254 °
				-121.761212 °	-121.761212 °
DWR ID					
Action/Comments					
Inspector Comments: FS_ID:28463 DS_ID:20063 EP_NO: N/A FS_HLM: 12.677 Repair Type: Non-Urgent Crossing Status: Found UCIP Comments: Needs proper abandonment. FIELD_STRUCT_DESC: Abandoned 18-inch Corrugated Metal drainpipe through levee, 15.0 feet below crown. Slide gate in 4 foot by 4 foot concrete box at waterward toe. Concrete box at landward toe. Pipe across overflow area to river. O&M Manual Sac 128, March 1960. FS Date: 01/10/2014

LS view: concrete intake box on levee toe.

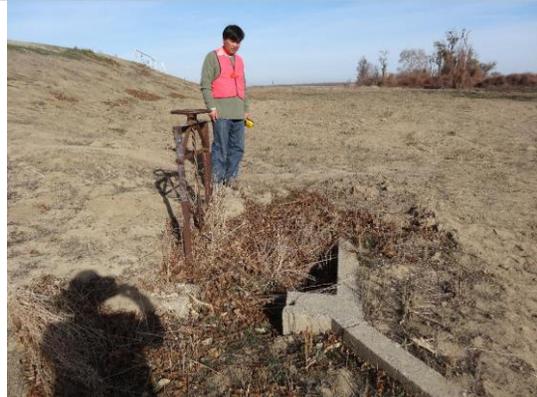
Photo 3 of 3 : UCIP_FA_2015_3029.jpg

WS view: slide gate (left) in concrete box at levee toe. Slide gate and the box mostly buried.

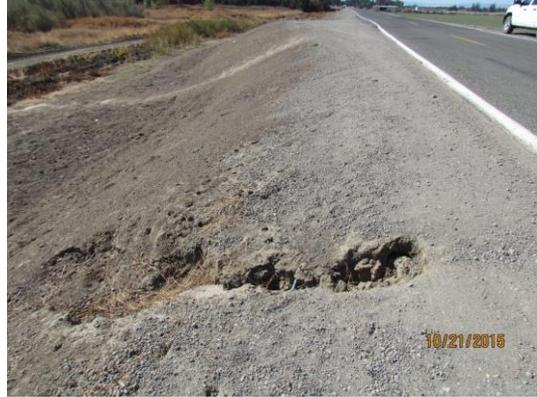
Photo 1 of 1 : FA_2015_RD1500_189_118_20151026_00164.jpg

View of the erosion on the waterward side of the levee looking upstream. Fall 2015.

LM Start	12.57	Rating **	M	Issue No.	118
LM End	12.57	Issue Type +	Ma	Location *	WS
Category	Earthen Levee		GPS Latitude/Longitude		
			Start	End	
Item	Erosion / Bank Caving		38.867108 °	38.867108 °	
			-121.761498 °	-121.761498 °	
DWR ID	DWR_RD1500_01_f_2015_118				
Action/Comments					
Schedule repair of erosion site prior to the next inspection.

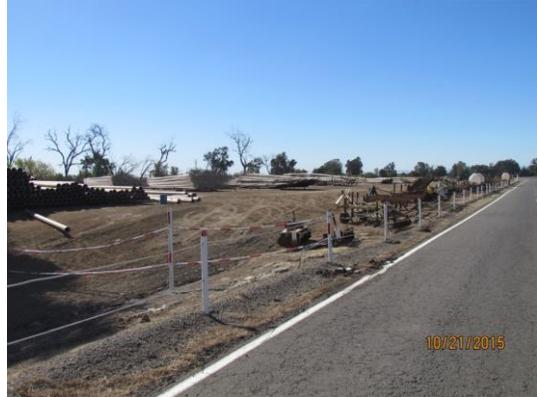
Photo 1 of 1 : FA_2015_RD1500_189_25_20151026_00165.jpg

LM Start	12.81	Rating **	A/W	Issue No.	25
LM End	12.81	Issue Type +	Ma	Location *	CR
Category	Earthen Levee		GPS Latitude/Longitude		
			Start	End	
Item	Encroachments		38.865127 °	38.865127 °	
			-121.765157 °	-121.765157 °	
DWR ID	DWR_RD1500_01_s_2012_25				
Action/Comments					
Equipment

View of the equipment on the crown of the levee looking upstream. Fall 2015.

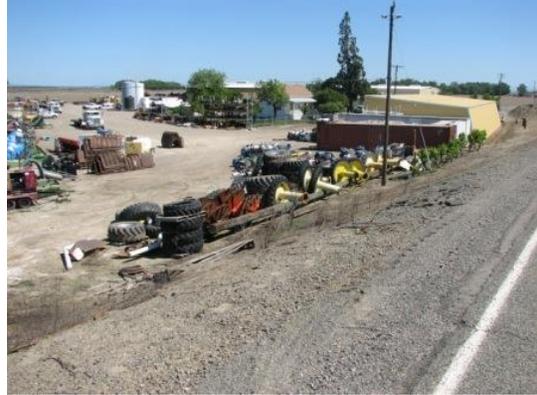
Photo 1 of 1 : FA_2015_RD1500_189_992_20150914_00074.jpg

LM Start	13.05	Rating **	M	Issue No.	992
LM End	13.05	Issue Type +	Ma	Location *	LS
Category	Earthen Levee		GPS Latitude/Longitude		
			Start	End	
Item	Encroachments		38.863081 °	38.863081 °	
			-121.768781 °	-121.768781 °	
DWR ID	DWR_RD1500_01_s_2012_992				
Action/Comments					
Equipment Inspector Comments: There are equipment and tires at this location.

Next to the building there are tires and axles stored at the toe.

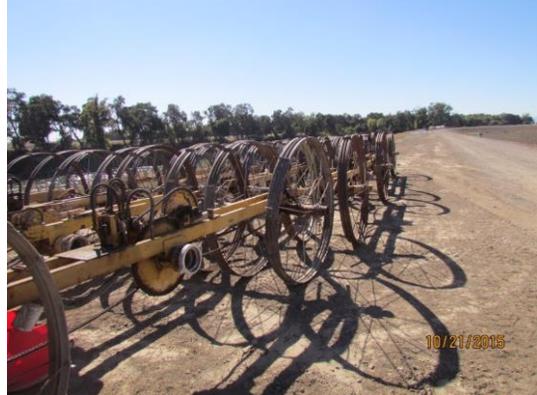
Photo 1 of 1 : FA_2015_RD1500_189_119_20151026_00166.jpg

LM Start	13.78	Rating **	M	Issue No.	119
LM End	13.78	Issue Type +	En	Location *	CR
Category	Earthen Levee		GPS Latitude/Longitude		
			Start	End	
Item	Encroachments		38.859715 °	38.859715 °	
			-121.780817 °	-121.780817 °	
DWR ID	DWR_RD1500_01_f_2015_119				
Action/Comments					
Equipment

View of the equipment on the crown of the levee looking upstream. Fall 2015.

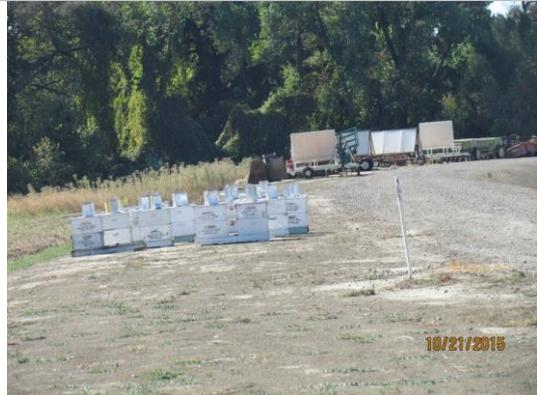
Photo 1 of 1 : FA_2015_RD1500_189_120_20151026_00167.jpg

LM Start	13.84	Rating **	M	Issue No.	120
LM End	13.84	Issue Type +	En	Location *	CR
Category	Earthen Levee		GPS Latitude/Longitude		
			Start	End	
Item	Encroachments		38.859005 °	38.859005 °	
			-121.781440 °	-121.781440 °	
DWR ID	DWR_RD1500_01_f_2015_120				
Action/Comments					
Building

View of the beehives on the crown of the levee looking upstream. Fall 2015.

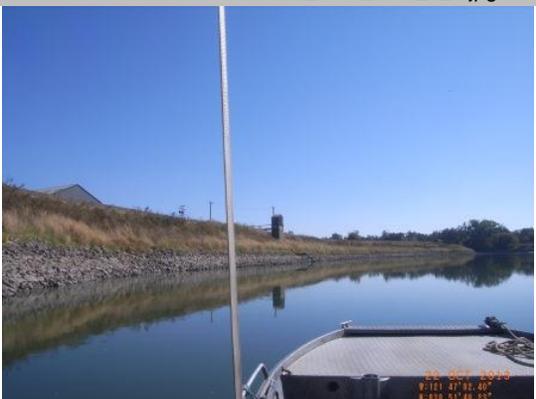
Photo 1 of 1 : USACE2013A_SAC_99-0_L_1.jpg

LM Start	13.98	Rating **	M	Issue No.	10
LM End	14.26	Issue Type +	Ma	Location *	WS
Category	Supplemental		GPS Latitude/Longitude		
			Start	End	
Item	2015 USACE Erosion Survey, DRAFT		38.857239 °	38.861899 °	
			-121.783771 °	-121.784057 °	
DWR ID					
Action/Comments					
Inspector Comments: 1997 - Intermittent toe failure of the hand placed riprap; failure of toe materials. 2015: No observed changes. [2015 Site ID: SAC_99-0_L]

USACE 2013 Photo #1

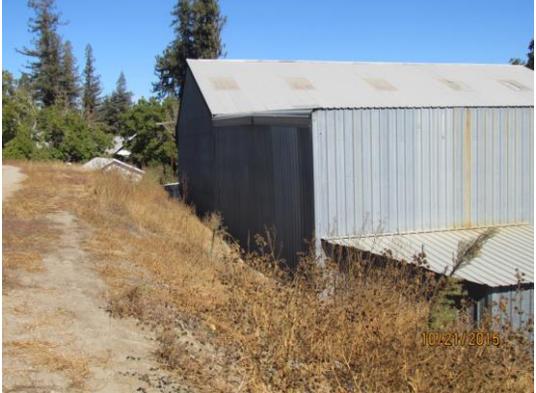
Photo 1 of 1 : FA_2015_RD1500_189_30_20151026_00169.jpg

LM Start	14.21	Rating **	M	Issue No.	30
LM End	14.21	Issue Type +	En	Location *	LS
Category	Earthen Levee		GPS Latitude/Longitude		
			Start	End	
Item	Encroachments		38.860848 °	38.860848 °	
			-121.783307 °	-121.783307 °	
DWR ID	DWR_RD1500_01_s_2012_30				
Action/Comments					
Building Inspector Comments: Concrete stemwall into levee embankment.

View of the building on the landward side of the levee looking upstream. Fall 2015.

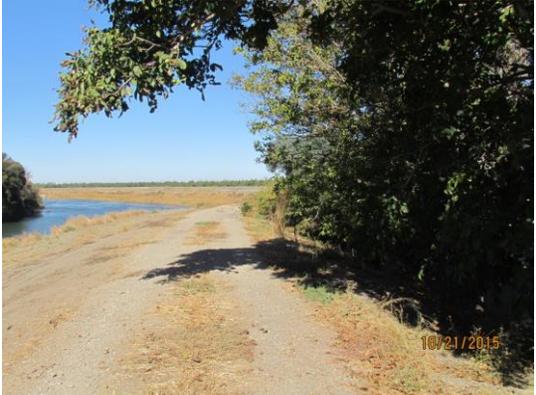
Photo 1 of 1 : FA_2015_RD1500_189_31_20151026_00170.jpg

LM Start	14.25	Rating **	M	Issue No.	31
LM End	14.25	Issue Type +	En	Location *	LS
Category	Earthen Levee		GPS Latitude/Longitude		
			Start	End	
Item	Vegetation		38.861513 °	38.861513 °	
			-121.783588 °	-121.783588 °	
DWR ID	DWR_RD1500_01_s_2012_31				
Action/Comments					
Landscaping

View of the landscaping on the landward side of the levee looking upstream. Fall 2015.

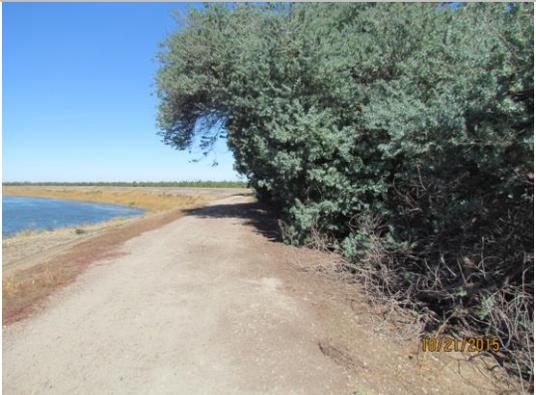
Photo 1 of 1 : FA_2015_RD1500_189_77_20151026_00171.jpg

View of the trees on the landward side of the levee looking upstream. Blocking visibility. Fall 2015.

LM Start	14.27	Rating **	U	Issue No.	77
LM End	14.27	Issue Type +	Ma	Location *	LS
Category	Earthen Levee		GPS Latitude/Longitude		
			Start	End	
Item	Trim / Thin Trees		38.861793 °	38.861793 °	
			-121.783703 °	-121.783703 °	
DWR ID	DWR_RD1500_01_s_2012_77				
Action/Comments					
Trim and thin trees to allow visibility of the ground and room to flood fight.

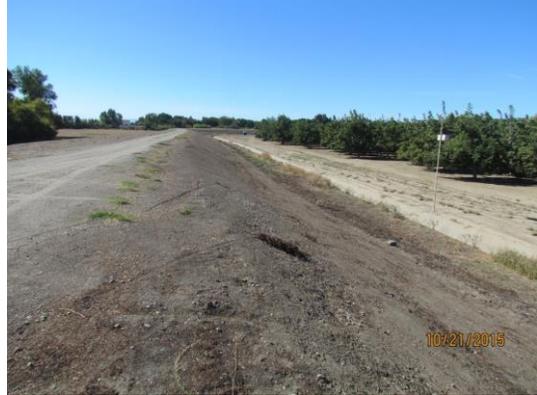
Photo 1 of 1 : FA_2015_RD1500_189_969_20151026_00172.jpg

LM Start	14.71	Rating **	M	Issue No.	969
LM End	15.76	Issue Type +	En	Location *	LS
Category	Earthen Levee			GPS Latitude/Longitude	
				Start	End
Item	Encroachments			38.865473 °	38.871752 °
				-121.789413 °	-121.804257 °
DWR ID	DWR_RD1500_01_s_2012_969				
Action/Comments					
Ditch Inspector Comments: Ditch is at the levee toe.

View of the ditch on the landward side of the levee looking upstream. Fall 2015.

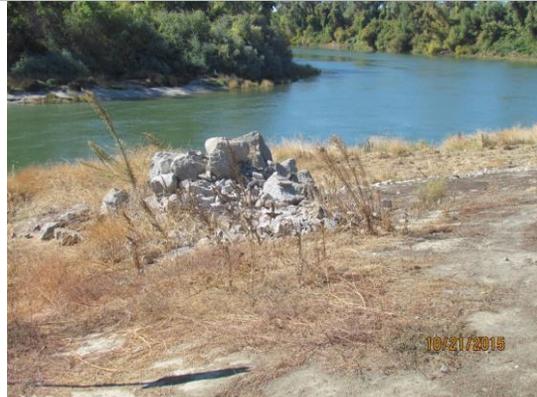
Photo 1 of 1 : FA_2015_RD1500_189_21_20151026_00173.jpg

LM Start	15.11	Rating **	M	Issue No.	21
LM End	15.11	Issue Type +	En	Location *	WS
Category	Earthen Levee			GPS Latitude/Longitude	
				Start	End
Item	Encroachments			38.866827 °	38.866827 °
				-121.794020 °	-121.794020 °
DWR ID	DWR_RD1500_01_s_2012_21				
Action/Comments					
Debris Inspector Comments: A pile of rip rap and concrete needs to be removed.

View of the concrete debris on the waterward side of the levee. Fall 2015.

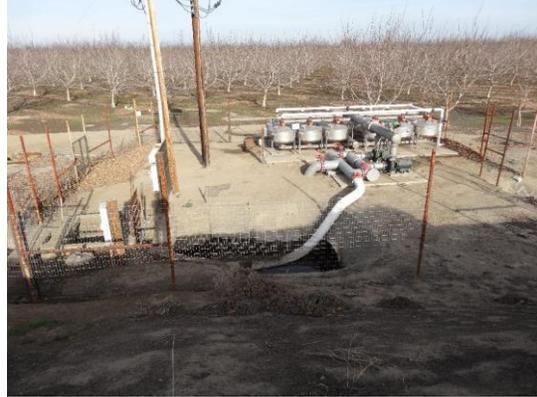
Photo 1 of 3 : UCIP_FA_2015_3068.jpg

LM Start	15.11	Rating **	M	Issue No.	2575
LM End	15.11	Issue Type +	En	Location *	WS
Category	Supplemental			GPS Latitude/Longitude	
				Start	End
Item	DWR UCIP Field Study			38.866841 °	38.866841 °
				-121.794047 °	-121.794047 °
DWR ID					
Action/Comments					
Inspector Comments: FS_ID:28486 DS_ID:20010 EP_NO: 10037 FS_HLM: 15.27 Repair Type: Non-Urgent Crossing Status: Found UCIP Comments: Water treatment plant on landside. Working during field visit. Not found- Flap Gate in 6.5 foot by 7.0 foot O.D. concrete distribution box at landward toe. FIELD_STRUCT_DESC: 22-inch concrete encased steel irrigation pipe through levee, 17.5 feet below crown. 1.5 -inch conduit through levee, 6.0 feet below crown. Slant pump on river bank. Gate valve in CMP riser on waterside. A 6.5 foot by 7.0 foot O.D. concrete distribution box at landward toe. (ABO. No. 10037 - Clauss) O&M Manual Sac 128, March 1960. FS Date: 01/10/2014

LS view: concrete distribution box on levee toe. Water filtration plant off the levee toe.

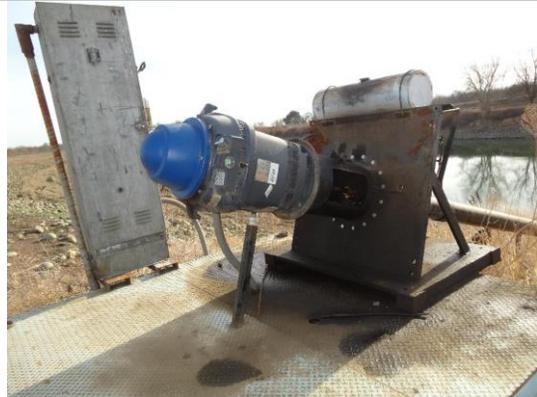
Photo 2 of 3 : UCIP_FA_2015_3069.jpg

WS view: oil leaking slant pump on steel platform.

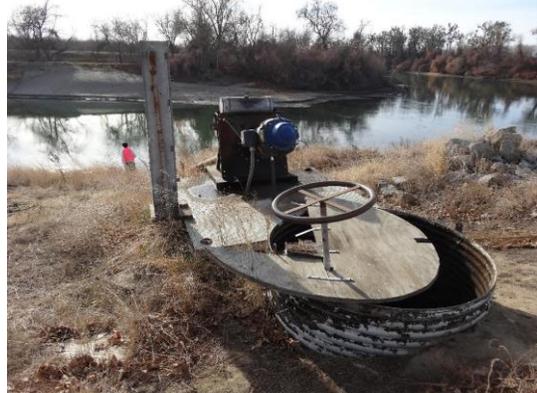
Photo 3 of 3 : UCIP_FA_2015_3070.jpg

LM Start	15.11	Rating **	M	Issue No.	2575 (cont)
LM End	15.11	Issue Type +	En	Location *	WS
Category	Supplemental			GPS Latitude/Longitude	
				Start	End
Item	DWR UCIP Field Study			38.866841 °	38.866841 °
				-121.794047 °	-121.794047 °
DWR ID					
Action/Comments					
Inspector Comments: FS_ID:28486 DS_ID:20010 EP_NO: 10037 FS_HLM: 15.27 Repair Type: Non-Urgent Crossing Status: Found

WS view: CMP riser with gate valve and slant pump on steel platform.

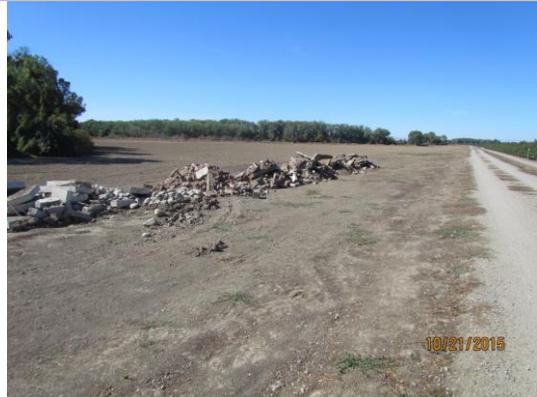
Photo 1 of 1 : FA_2015_RD1500_189_110_20151026_00174.jpg

LM Start	15.27	Rating **	M	Issue No.	110
LM End	15.27	Issue Type +	En	Location *	WS
Category	Earthen Levee			GPS Latitude/Longitude	
				Start	End
Item	Encroachments			38.868244 °	38.868244 °
				-121.796220 °	-121.796220 °
DWR ID	DWR_RD1500_01_f_2014_110				
Action/Comments					
Debris

View of the debris on the waterward side of the levee. The abandoned pipe has been removed. Fall 2015.

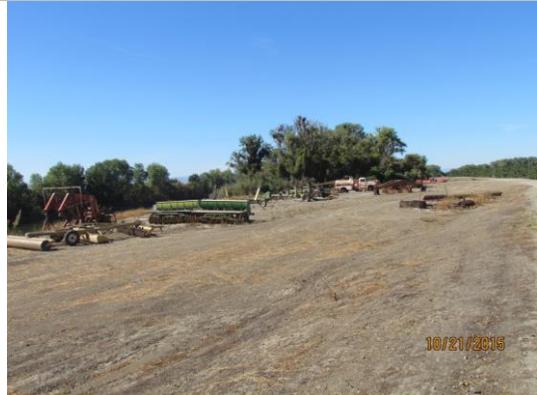
Photo 1 of 1 : FA_2015_RD1500_189_32_20151026_00175.jpg

LM Start	15.78	Rating **	A/W	Issue No.	32
LM End	15.78	Issue Type +	En	Location *	WS
Category	Earthen Levee			GPS Latitude/Longitude	
				Start	End
Item	Encroachments			38.871960 °	38.871960 °
				-121.804440 °	-121.804440 °
DWR ID	DWR_RD1500_01_s_2012_32				
Action/Comments					
Equipment

View of the equipment on the waterward side of the levee looking upstream. Fall 2015.

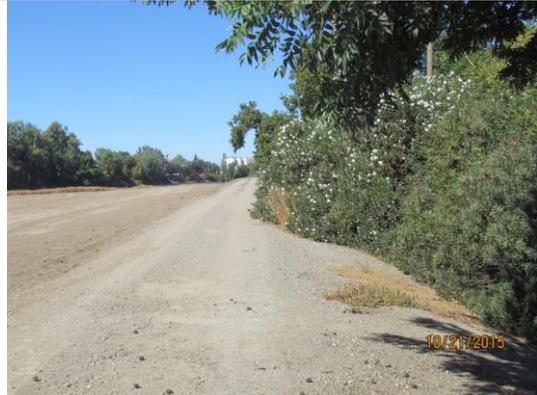
Photo 1 of 1 : FA_2015_RD1500_189_33_20151026_00176.jpg

LM Start	16.30	Rating **	U	Issue No.	33
LM End	16.30	Issue Type +	En	Location *	LS
Category	Earthen Levee			GPS Latitude/Longitude	
				Start	End
Item	Vegetation			38.875873 °	38.875873 °
				-121.812410 °	-121.812410 °
DWR ID	DWR_RD1500_01_s_2012_33				
Action/Comments					
Landscaping Inspector Comments: There is landscaping, including oleanders and other shrubs at this location.

View of the shrubs on the landward side of the levee looking upstream. Fall 2015.

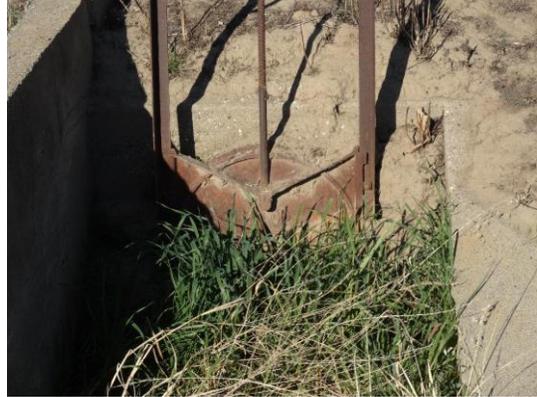
Photo 1 of 3 : UCIP_FA_2015_3090.jpg

Action/Comments
 Inspector Comments: FS_ID:28489
 DS_ID:20081
 EP_NO: 8510
 FS_HLM: 17.155
 Repair Type: Non-Urgent
 Crossing Status: Found
 UCIP Comments: Pipe not visible on river bank. Cleaning and clearing require around slide gates. May be abandoned.
 FIELD_STRUCT_DESC: 24-inch CM irrigation pipe through levee, 15.0 feet below crown. Slide gate in 36-inch CM riser on waterward slope. Slide gate on concrete "U" headwall an irrigation ditch at landward toe.
 (App No. 8510, 11/1972 - Clauss) O&M Manual Sac 128, March 1960.
 FS Date: 01/14/2014

LS view: U type concrete headwall with slide gate on levee toe.

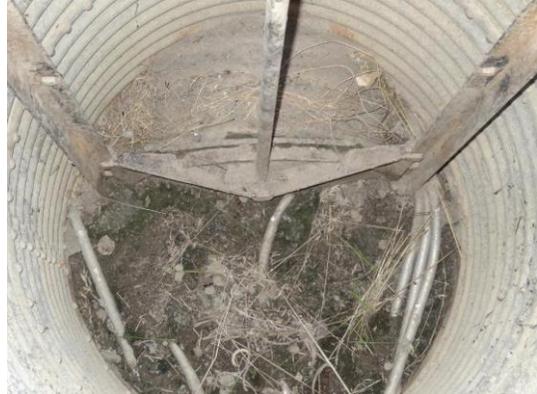
Photo 2 of 3 : UCIP_FA_2015_3091.jpg

WS view: cleaning and clearing require around slide gate in CMP riser.

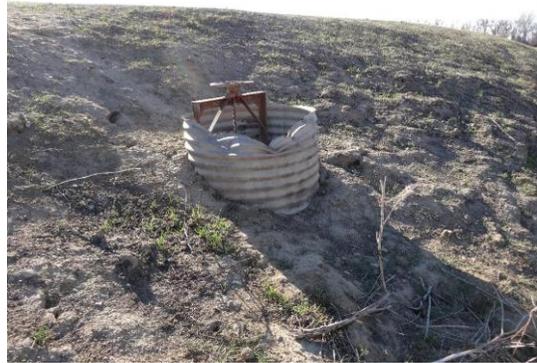
Photo 3 of 3 : UCIP_FA_2015_3092.jpg

LM Start	16.97	Rating **	M	Issue No.	2576 (cont)
LM End	16.97	Issue Type +	En	Location *	LS
Category	Supplemental			GPS Latitude/Longitude	
				Start	End
Item	DWR UCIP Field Study			38.885098 °	38.885098 °
				-121.812884 °	-121.812884 °
DWR ID					
Action/Comments					
Inspector Comments: FS_ID:28489 DS_ID:20081 EP_NO: 8510 FS_HLM: 17.155 Repair Type: Non-Urgent Crossing Status: Found

WS view: CMP riser with slide gate on levee slope.

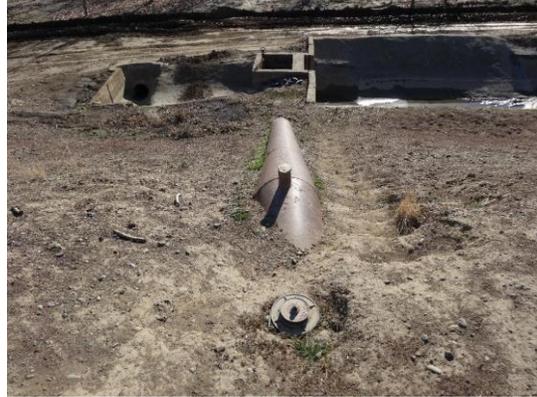
Photo 2 of 3 : UCIP_FA_2015_3094.jpg

LS view: siphon breaker (bottom) without protection, exposed pipe on levee slope, and distribution box on levee toe.

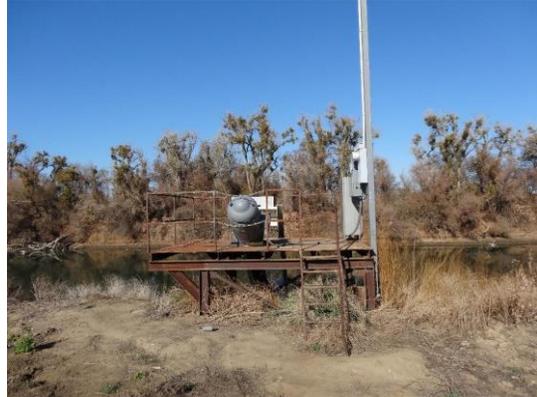
Photo 3 of 3 : UCIP_FA_2015_3095.jpg

WS view: slant pump on steel platform on levee berm.

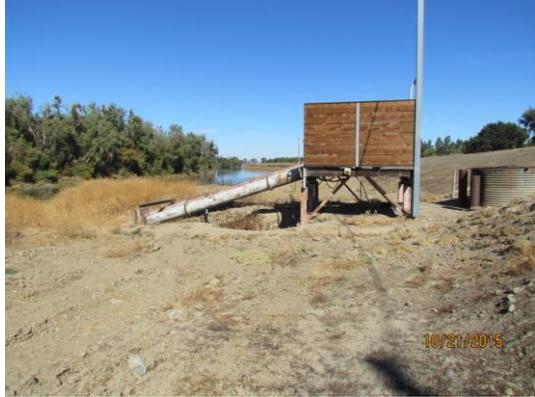
Photo 1 of 3 : FA_2015_RD1500_189_121_20151026_00179.jpg

LM Start	17.34	Rating **	M	Issue No.	121
LM End	17.34	Issue Type +	En	Location *	WS
Category	Earthen Levee		GPS Latitude/Longitude		
			Start	End	
Item	Encroachments		38.888137 °	38.888137 °	
			-121.807273 °	-121.807273 °	
DWR ID	DWR_RD1500_01_f_2015_121				
Action/Comments					
Pipe Inspector Comments: Pipe is causing the erosion on the berm of the levee.

Perspective view of the pump on the waterward side of the levee looking upstream. Fall 2015.

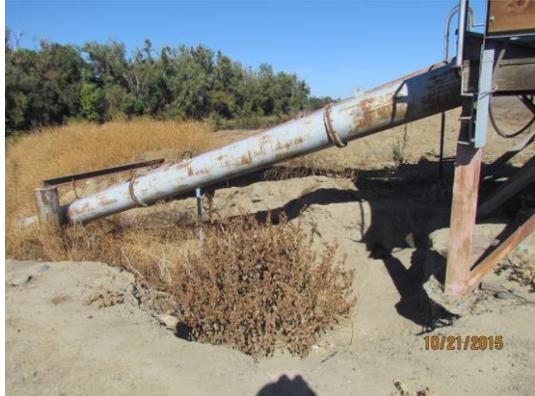
Photo 2 of 3 : FA_2015_RD1500_189_121_20151026_00177.jpg

There is erosion underneath the pipe on the waterward berm area. Fall 2015.

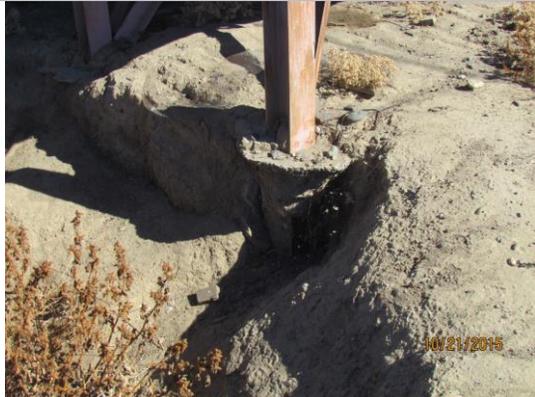
Photo 3 of 3 : FA_2015_RD1500_189_121_20151026_00178.jpg

The concrete for the base stand has been exposed due to erosion.

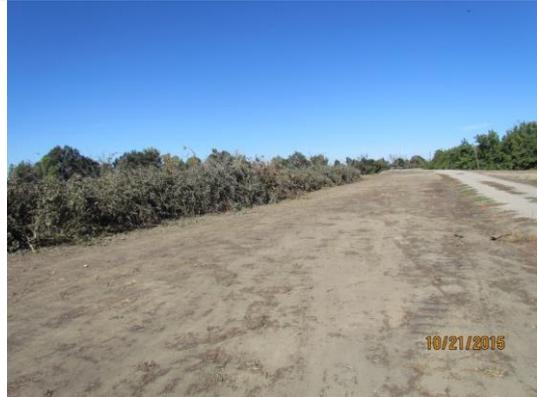
Photo 1 of 1 : FA_2015_RD1500_189_122_20151026_00180.jpg

LM Start	17.63	Rating **	M	Issue No.	122
LM End	17.66	Issue Type +	En	Location *	WS
Category	Earthen Levee		GPS Latitude/Longitude		
			Start	End	
Item	Encroachments		38.891795 °	38.892291 °	
			-121.804829 °	-121.804734 °	
DWR ID	DWR_RD1500_01_f_2015_122				
Action/Comments					
Prunings

View of the prunings on the waterward side of the levee looking upstream. Fall 2015.

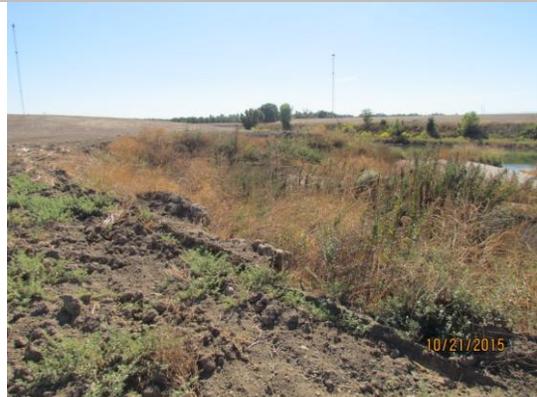
Photo 1 of 2 : FA_2015_RD1500_189_51_20151026_00182.jpg

Looking downstream at the embankment erosion. Fall 2015.

LM Start	18.29	Rating **	A/W	Issue No.	51
LM End	18.29	Issue Type +	Ma	Location *	WS
Category	Earthen Levee		GPS Latitude/Longitude		
			Start	End	
Item	Erosion / Bank Caving		38.900873 °	38.900873 °	
			-121.802680 °	-121.802680 °	
DWR ID	DWR_RD1500_01_s_2012_51				
Action/Comments					
Note and monitor erosion site.

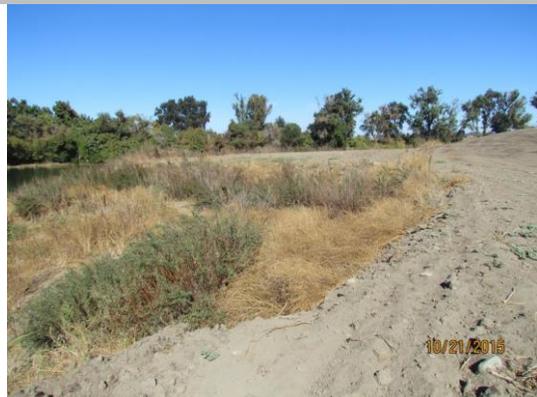
Photo 2 of 2 : FA_2015_RD1500_189_51_20151026_00181.jpg

Looking upstream at the same embankment erosion. Fall 2015.

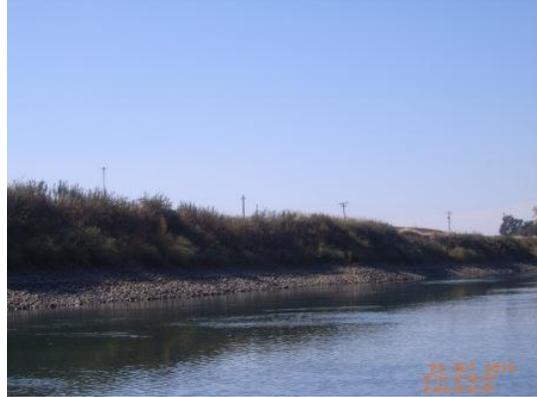
Photo 1 of 1 : USACE2013A_SAC_104-0_L_11.jpg

LM Start	18.38	Rating **	M	Issue No.	13
LM End	19.06	Issue Type +	Ma	Location *	WS
Category	Supplemental			GPS Latitude/Longitude	
				Start	End
Item	2015 USACE Erosion Survey, DRAFT			38.901337 °	38.902721 °
				-121.801175 °	-121.790677 °
DWR ID					
Action/Comments					
Inspector Comments: 1997 - Pocket failures of cobble revetment toe; scallops of rock loss along the bank; irregular bankline developing. 2001 - Small scallops in the toe of the berm. 2005 - Still multiple erosion pockets in the toe. 2006 - Two new small slumps. 2011 - Old cobble continue to fail causing minor slumping. 2012 - Portions of site appears to be stabilizing. 2015: No observed changes. [2015 Site ID:

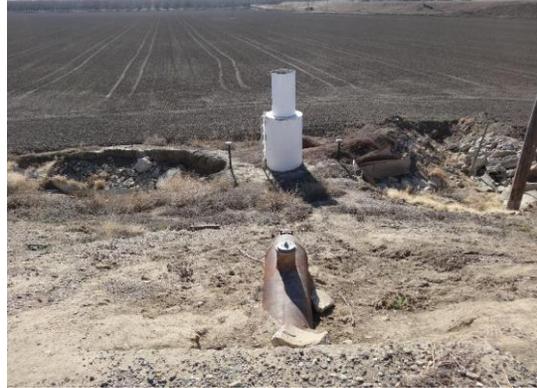
Photo 2 of 3 : UCIP_FA_2015_1227.jpg

Inspector Comments: FS_ID:28505
 DS_ID:20068
 EP_NO: 2425
 FS_HLM: 18.56
 Repair Type: Non-Urgent
 Crossing Status: Found
 UCIP Comments: Concrete pad on both sides of the levee shoulders. Oil leaks from pump set.
 FIELD_STRUCT_DESC: 14-inch steel irrigation pipe through levee, 3.0 feet below crown. Slant pump in Corrugated metal pump house on steel structure on bank. Meter pole on slope. Siphon breaker on landward shoulder. Discharges into 36-inch concrete standpipe at landward toe.
 (App. No. 2425 - Hiatt). O&M Manual Sac 128, March 1960.
 FS Date: 01/14/2014

LS view: siphon breaker (bottom) on exposed steel pipe on levee slope and steel stand pipe (top) on levee toe.

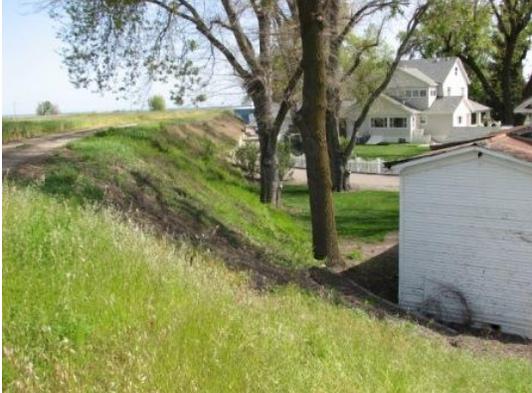
Photo 1 of 2 : FA_2015_RD1500_189_36_20150914_00032.jpg

LM Start	18.98	Rating **	M	Issue No.	36
LM End	18.98	Issue Type +	En	Location *	LS
Category	Earthen Levee		GPS Latitude/Longitude		
			Start	End	
Item	Encroachments		38.901570 °	38.901570 °	
			-121.791235 °	-121.791235 °	
DWR ID	DWR_RD1500_01_s_2012_36				
Action/Comments					
Building Inspector Comments: Concrete retaining wall toe of landside levee. Permit #10065

Building and wall into levee with landscape, photo taken in spring 2010.

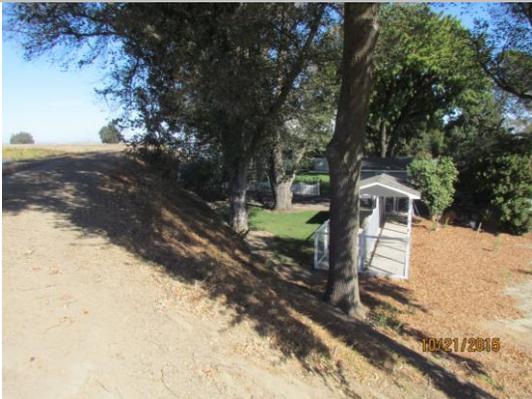
Photo 2 of 2 : FA_2015_RD1500_189_36_20151026_00183.jpg

View of the building on the landward side of the levee looking upstream. Fall 2015.

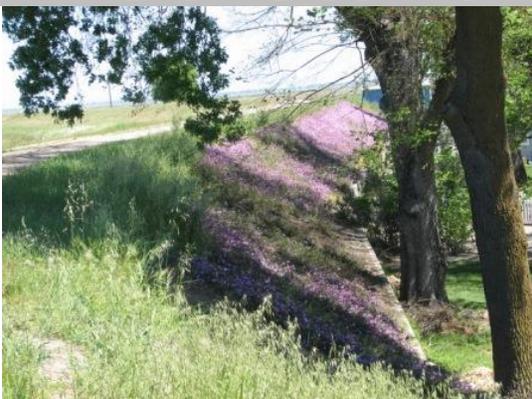
Photo 1 of 2 : FA_2015_RD1500_189_37_20150914_00033.jpg

LM Start	19.01	Rating **	M	Issue No.	37
LM End	19.01	Issue Type +	En	Location *	LS
Category	Earthen Levee		GPS Latitude/Longitude		
			Start	End	
Item	Vegetation		38.901965 °	38.901965 °	
			-121.790993 °	-121.790993 °	
DWR ID	DWR_RD1500_01_s_2012_37				
Action/Comments					
Landscaping Inspector Comments: Concrete retaining wall along toe of landside levee. Permit #10065

The groundcover is on the levee slope above the concrete retaining wall. The groundcover is irrigated.

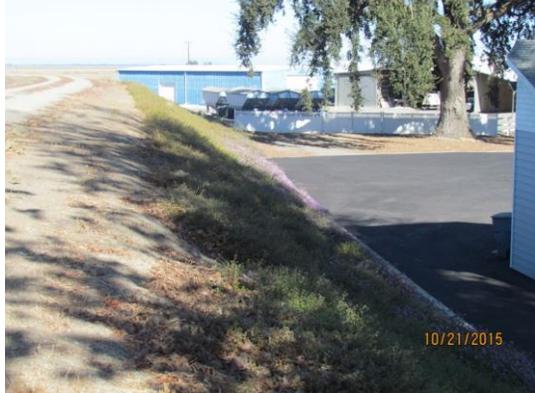
Photo 2 of 2 : FA_2015_RD1500_189_37_20151026_00184.jpg

View of the groundcover on the landward side of the levee looking upstream. Fall 2015.

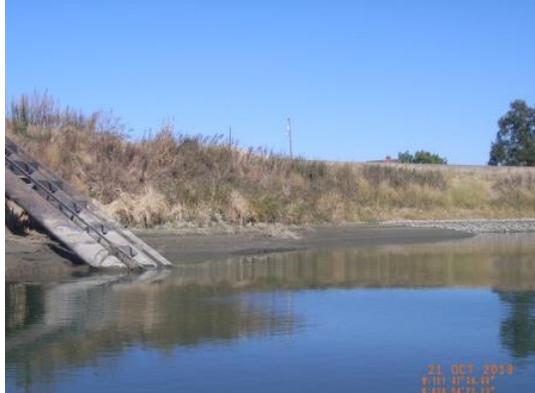
Photo 1 of 1 : USACE2013A_SAC_104-5_L_3.jpg

LM Start	19.16	Rating **	M	Issue No.	5
LM End	19.47	Issue Type +	Ma	Location *	WS
Category	Supplemental			GPS Latitude/Longitude	
				Start	End
Item	2015 USACE Erosion Survey, DRAFT			38.904041 °	38.906697 °
				-121.790298 °	-121.792796 °
DWR ID					
Action/Comments					
Inspector Comments: 1997 - Cobbles eroded off the clay materials; not much evidence of erosion on the toe; cobble loss on the toe. 2011 - Some minor new erosion. 2015: No observed changes. [2015 Site ID: SAC_104-5_L]

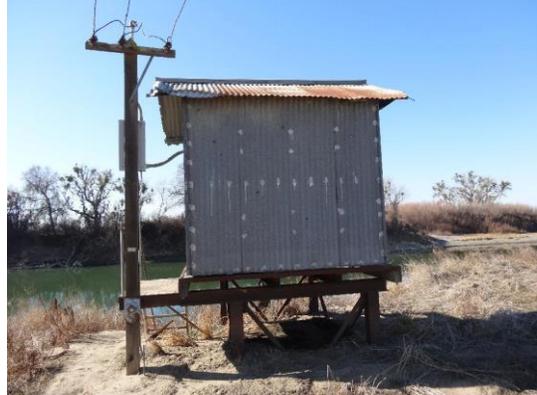
Photo 3 of 3 : UCIP_FA_2015_1231.jpg

WS view: slant pump in CM shed on levee berm. Oil leaks from the pump.

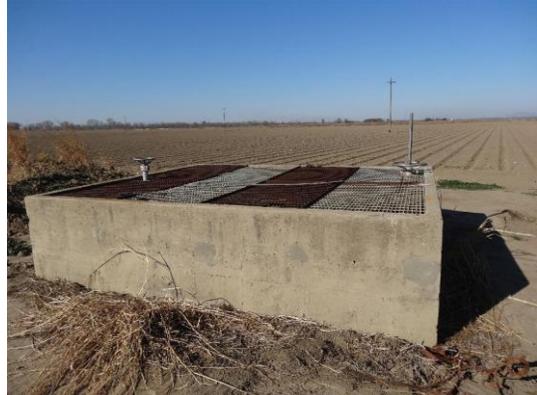
Photo 1 of 3 : UCIP_FA_2015_3344.jpg

LS view: concrete distribution box on levee toe.

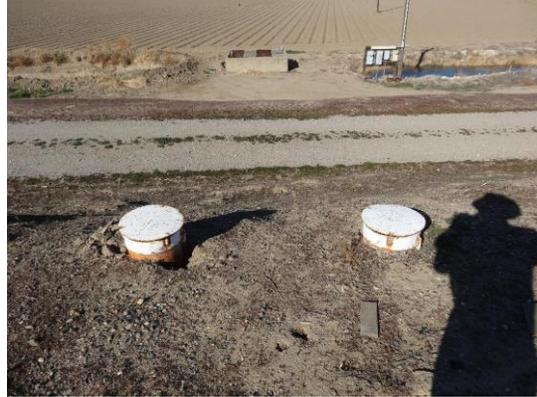
Photo 2 of 3 : UCIP_FA_2015_3345.jpg

LS view: siphon breakers in steel pipe risers (bottom) on levee slope and concrete distribution (top) box on levee toe.

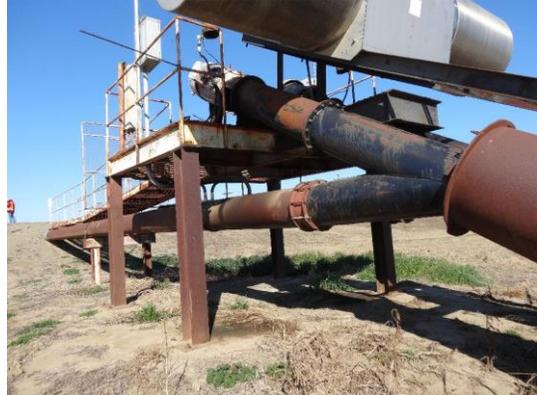
Photo 3 of 3 : UCIP_FA_2015_3346.jpg

WS view: pipe, walkway, slant pump, and steel platform on levee berm.

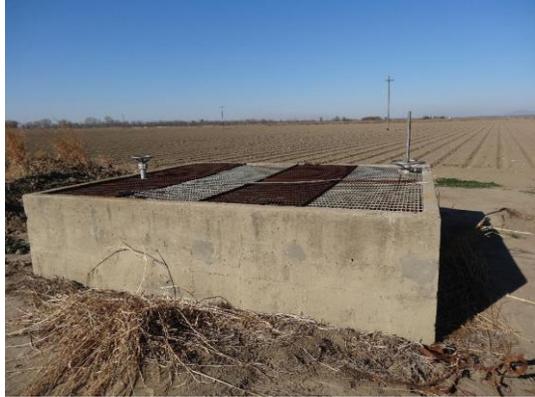
Photo 1 of 3 : UCIP_FA_2015_2936.jpg

LS view: concrete distribution box on levee toe.

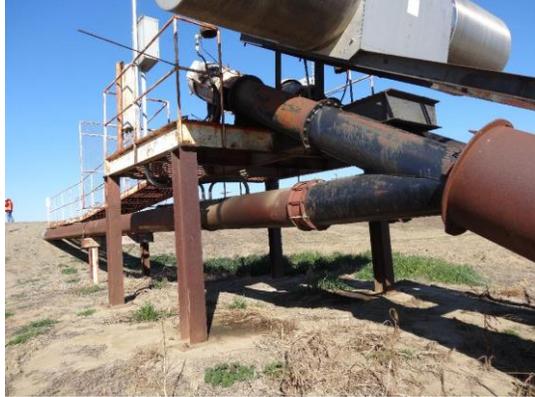
Photo 3 of 3 : UCIP_FA_2015_2938.jpg

WS view: pipe, walkway, slant pump, and steel platform on levee berm.

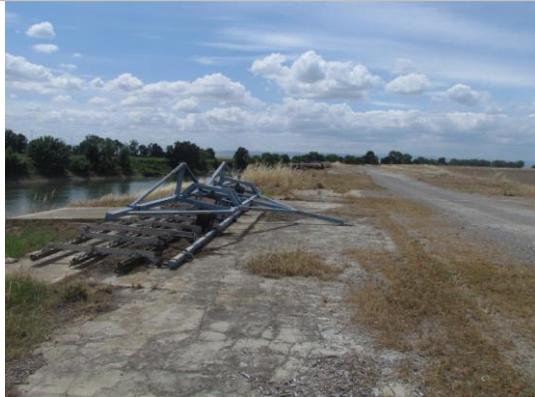
Photo 1 of 1 : FA_2015_RD1500_189_2549_20150914_00090.jpg

LM Start	19.56	Rating **	M	Issue No.	2549
LM End	19.56	Issue Type +	En	Location *	WS
Category	Earthen Levee			GPS Latitude/Longitude	
				Start	End
Item	Encroachments			38.906565 °	38.906565 °
				-121.794472 °	-121.794472 °
DWR ID	DWR_RD1500_01_s_2015_2549				
Action/Comments					
Equipment

View of the equipment on the waterward side of the levee looking upstream. Spring 2015.

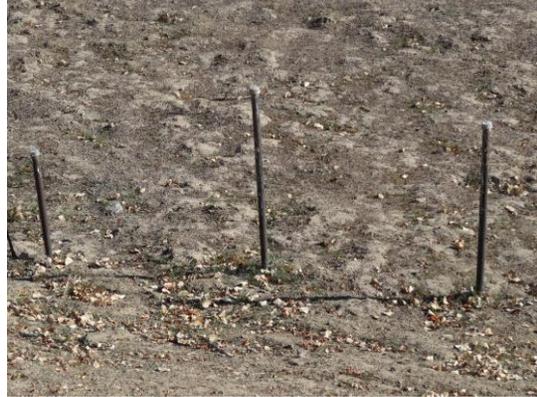
Photo 1 of 3 : UCIP_FA_2015_2939.jpg

LS view: three 1" standpipes (may be piezometers) on levee toe.

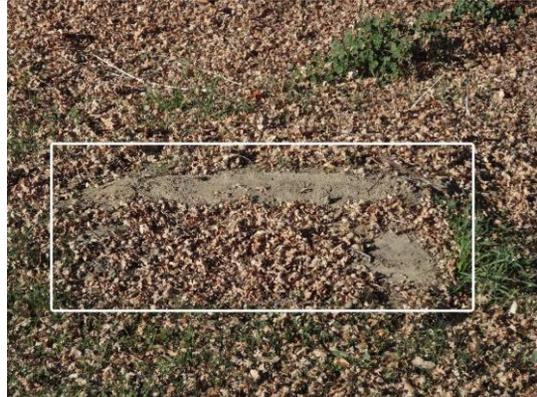
Photo 3 of 3 : UCIP_FA_2015_3348.jpg

WS view: a concrete pad on waterside levee toe.

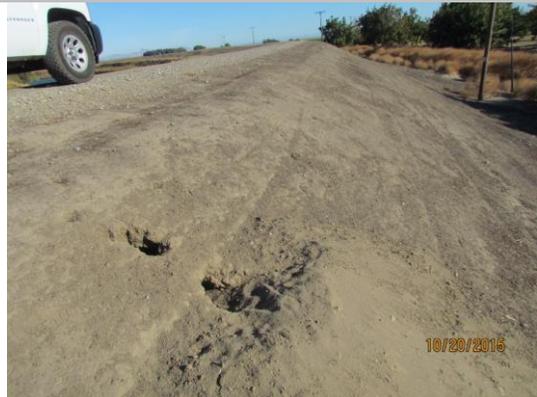
Photo 1 of 1 : FA_2015_RD1500_189_101_20151026_00133.jpg

LM Start	21.06	Rating **	M	Issue No.	101
LM End	21.06	Issue Type +	Ma	Location *	LS
Category	Earthen Levee			GPS Latitude/Longitude	
				Start	End
Item	Animal Control			38.911910 °	38.911910 °
				-121.803666 °	-121.803666 °
DWR ID	DWR_RD1500_01_f_2015_101				
Action/Comments					
No rodents visible, but rodent burrows visible; need to backfill and compact or grout burrows.

View of the rodent hole on the landward side of the levee looking upstream. Fall 2015.

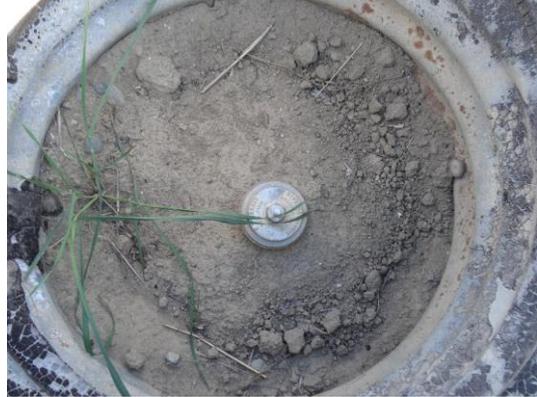
Photo 1 of 3 : UCIP_FA_2015_0619.jpg

Inspector Comments: FS_ID:28527
 DS_ID:20070
 EP_NO: 11959A
 FS_HLM: 21.495
 Repair Type: Non-Urgent
 Crossing Status: Found
 UCIP Comments: Siphon breaker (obstructed) in CMP on landside slope. Power pole on landside toe.
 FIELD_STRUCT_DESC: 10-inch steel pipe through levee, 3.0 feet below crown with slant pump on steel platform. Siphon breaker (obstructed) in CMP on landside slope. A 6 foot by 6 foot concrete distribution box on landward side. (App. No. 11959A - Van Ruiten) O&M Manual Sac 128, March 1960.
 FS Date: 01/14/2014

LS view: obstructed siphon breaker in CMP riser on levee slope.

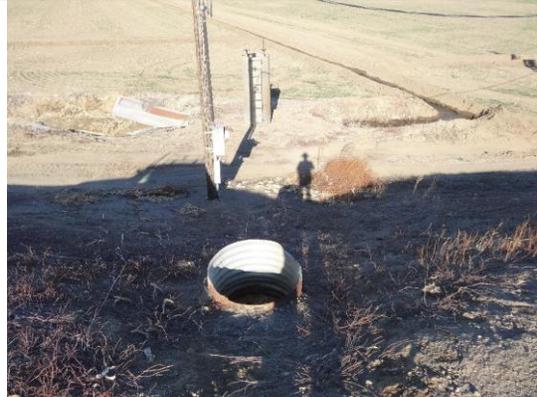
Photo 1 of 3 : UCIP_FA_2015_2994.jpg

LS view: siphon breaker in CMP riser on levee slope (bottom) and CMP stand pipe (top) on the levee toe.

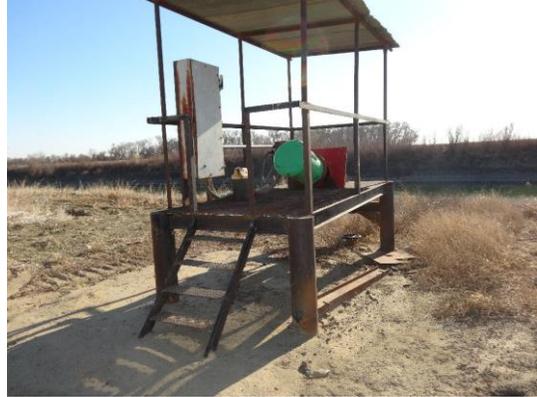
Photo 3 of 3 : UCIP_FA_2015_2996.jpg

WS view: slant pump on steel platform on levee berm.

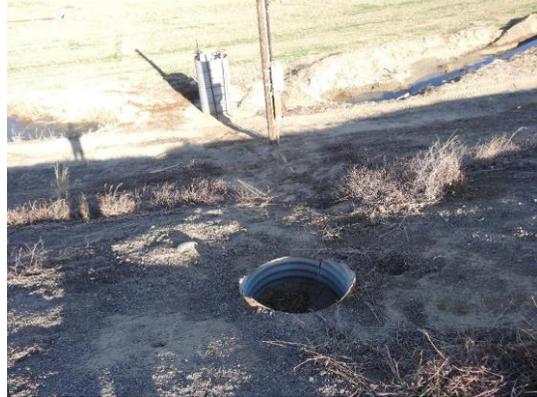
Photo 1 of 3 : UCIP_FA_2015_3031.jpg

LM Start	22.73	Rating **	M	Issue No.	2586
LM End	22.73	Issue Type +	En	Location *	LS
Category	Supplemental			GPS Latitude/Longitude	
				Start	End
Item	DWR UCIP Field Study			38.919717 °	38.919717 °
				-121.829113 °	-121.829113 °
DWR ID					
Action/Comments					
Inspector Comments: FS_ID:28583 DS_ID:19995 EP_NO: 10851 FS_HLM: 22.991 Repair Type: Non-Urgent Crossing Status: Found UCIP Comments: Exposed conduit on both slopes of the levee. Plant was working during field visit. Water was leaking from pipe joint near pump. Obstructed siphon breaker in CMP. FIELD_STRUCT_DESC: 14-inch steel irrigation pipe through levee, 6.2 feet below crown. Pump and gate valve on steel platform. Switch panel on berm. Siphon breaker in 24-inch CM riser on landward shoulder. Discharges into 36-inch CM standpipe at landward toe. 2-inch conduit through levee, 5.0 feet below crown. Service pole at landward toe. Pumping plant No. 2. (App. No. 10851, 2895 - Van Ruiten) FS Date: 01/14/2014

LS view: siphon breaker in CMP riser on levee slope (bottom) and CMP stand pipe (top) on levee toe.

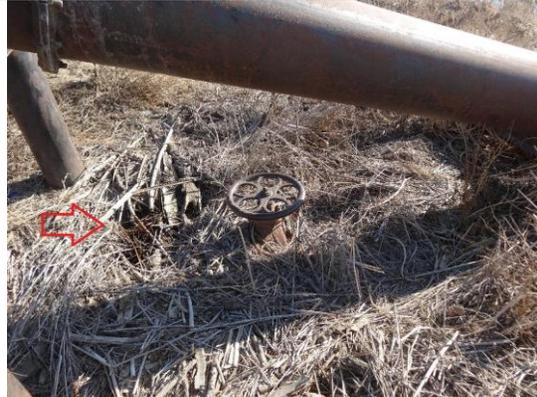
Photo 2 of 3 : UCIP_FA_2015_3032.jpg

WS view: gate valve beneath slant pipe on levee berm. Water leaking from this pipe (marked).

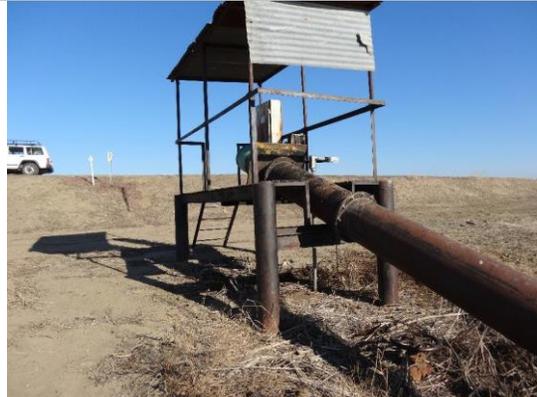
Photo 3 of 3 : UCIP_FA_2015_3033.jpg

WS view: slant pump on steel platform on levee berm.

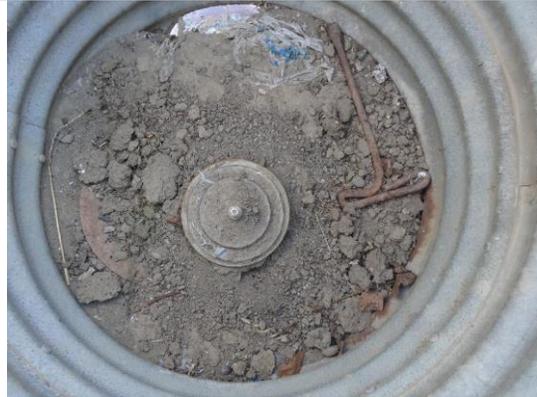
Photo 1 of 3 : UCIP_FA_2015_3073.jpg

LM Start	23.65	Rating **	M	Issue No.	2587
LM End	23.65	Issue Type +	En	Location *	LS
Category	Supplemental			GPS Latitude/Longitude	
				Start	End
Item	DWR UCIP Field Study			38.930242 °	38.930242 °
				-121.834956 °	-121.834956 °
DWR ID					
Action/Comments					
Inspector Comments: FS_ID:28586 DS_ID:20072 EP_NO: 2895 FS_HLM: 23.927 Repair Type: Non-Urgent Crossing Status: Found UCIP Comments: Most of the pipe exposed on levee slopes. Leaky pump. Obstructed siphon breaker. Not found- Concrete headwall at landward toe. FIELD_STRUCT_DESC: 14-inch steel irrigation pipe through levee, 6.5 feet below crown. 1-1/2 inch conduit through levee, 4.0 feet below crown. Slant pump and control panel on steel structure on berm. Siphon breaker in 24-inch corrugated metal riser on landward shoulder. 36-inch CM standpipe at landward toe. Service pole at landward toe. Pumping- Plant No. 1. (App. No. 2895 - Van Ruiten) O&M Manual Sac 128, March 1960. FS Date: 01/14/2014

LS view: obstructed siphon breaker in CMP riser on levee slope.

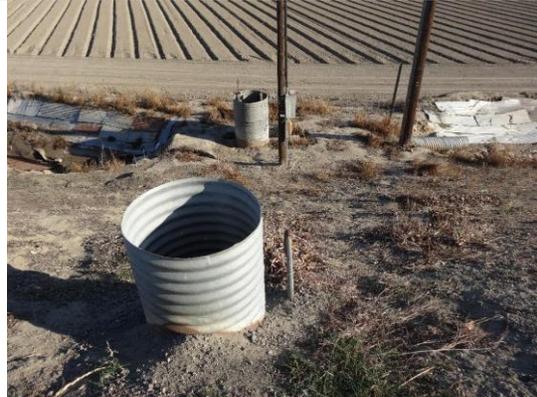
Photo 2 of 3 : UCIP_FA_2015_3074.jpg

Item	DWR UCIP Field Study			38.930242 °	38.930242 °	
				-121.834956 °	-121.834956 °	
DWR ID						
Action/Comments						
Inspector Comments: FS_ID:28586 DS_ID:20072 EP_NO: 2895 FS_HLM: 23.927 Repair Type: Non-Urgent Crossing Status: Found UCIP Comments: Most of the pipe exposed on levee slopes. Leaky pump. Obstructed siphon breaker. Not found- Concrete headwall at landward toe. FIELD_STRUCT_DESC: 14-inch steel irrigation pipe through levee, 6.5 feet below crown. 1-1/2 inch conduit through levee, 4.0 feet below crown. Slant pump and control panel on steel structure on berm. Siphon breaker in 24-inch corrugated metal riser on landward shoulder. 36-inch CM standpipe at landward toe. Service pole at landward toe. Pumping- Plant No. 1. (App. No. 2895 - Van Ruiten) O&M Manual Sac 128, March 1960. FS Date: 01/14/2014

LS view: siphon breaker in CMP riser on levee slope (bottom) and CM standpipe (top) on levee toe.

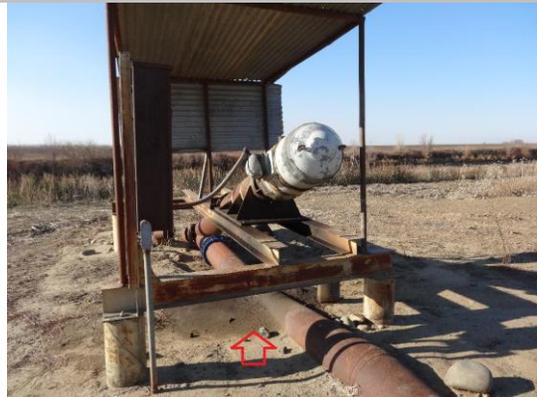
Photo 3 of 3 : UCIP_FA_2015_3075.jpg

WS view: slant pump on steel platform on levee berm. Oil leaks from the pump (marked). Exposed pipe on the berm.

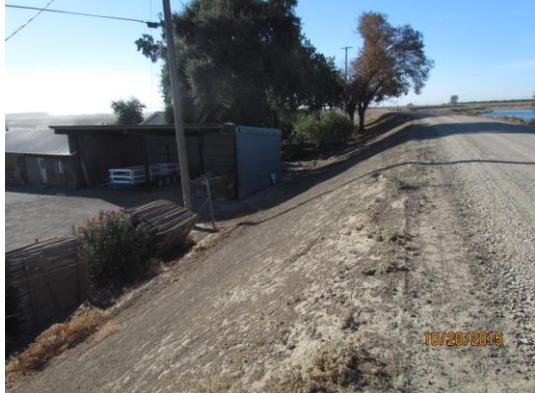
Photo 1 of 1 : FA_2015_RD1500_189_42_20151026_00134.jpg

LM Start	23.77	Rating **	M	Issue No.	42
LM End	23.77	Issue Type +	En	Location *	LS
Category	Earthen Levee		GPS Latitude/Longitude		
			Start	End	
Item	Encroachments		38.931838 °	38.931838 °	
			-121.834437 °	-121.834437 °	
DWR ID	DWR_RD1500_01_s_2012_42				
Action/Comments					
Building Inspector Comments: Some equipment at landside toe.

View of the barn and equipment on the landward side of the levee looking downstream. Fall 2015.

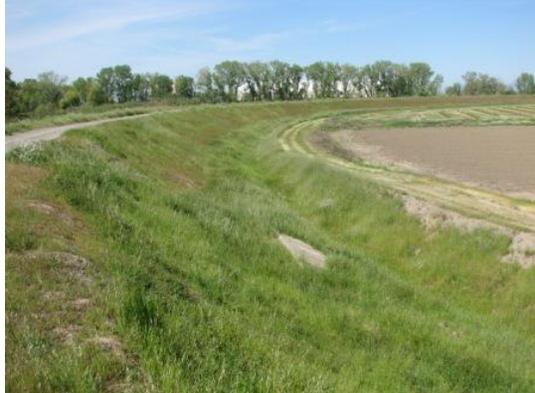
Photo 1 of 2 : FA_2015_RD1500_189_979_20150914_00070.jpg

LM Start	24.16	Rating **	M	Issue No.	979
LM End	24.31	Issue Type +	En	Location *	LS
Category	Earthen Levee		GPS Latitude/Longitude		
			Start	End	
Item	Encroachments		38.936282 °	38.938430 °	
			-121.830192 °	-121.829359 °	
DWR ID	DWR_RD1500_01_s_2012_979				
Action/Comments					
Ditch

Agricultural ditch, photo taken in spring 2010.

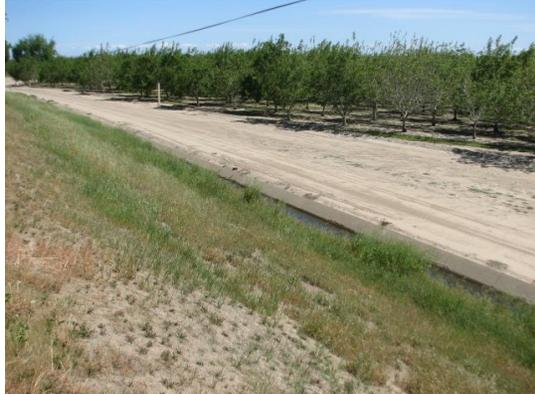
Photo 2 of 2 : FA_2015_RD1500_189_979_20150914_00071.jpg

Agricultural ditch runs along the toe of the levee. Spring 2014

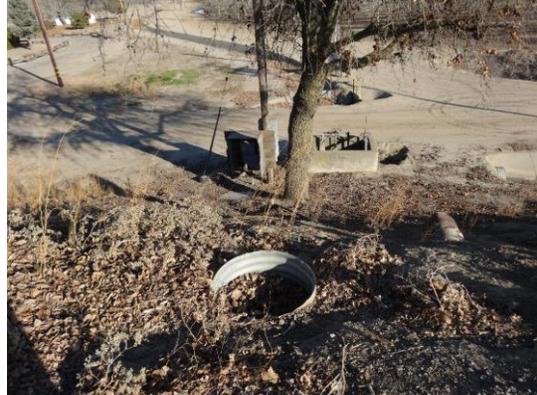
Photo 1 of 3 : UCIP_FA_2015_3076.jpg

LS view: siphon breaker in CMP riser on levee slope (bottom) and concrete distribution box (top) on levee toe.

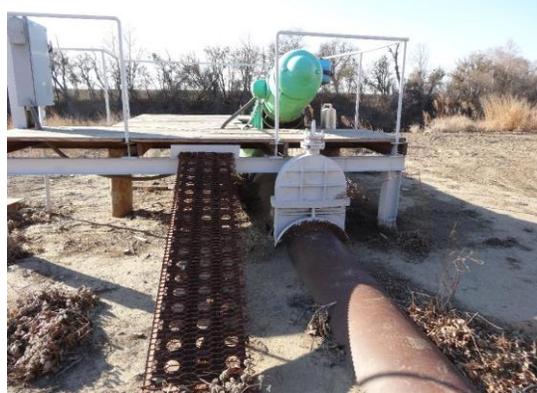
Photo 3 of 3 : UCIP_FA_2015_3103.jpg

WS view: slant pump on steel platform at levee berm. Walkway, exposed pipe, and gate valve on the berm.

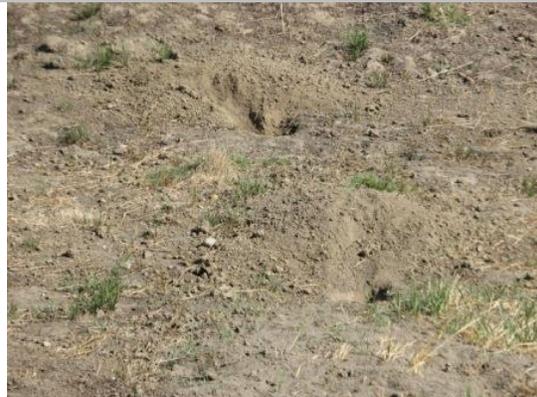
Photo 1 of 2 : FA_2015_RD1500_189_69_20150914_00047.jpg

Multiple rodent burrows on landside slope. Fall 2013

LM Start	24.88	Rating **	M	Issue No.	69
LM End	24.88	Issue Type +	Ma	Location *	LS
Category	Earthen Levee			GPS Latitude/Longitude	
				Start	End
Item	Animal Control			38.944340 °	38.944340 °
				-121.835790 °	-121.835790 °
DWR ID	DWR_RD1500_01_f_ 2013_69				
Action/Comments					
Exterminate rodents and backfill and compact or grout burrows.

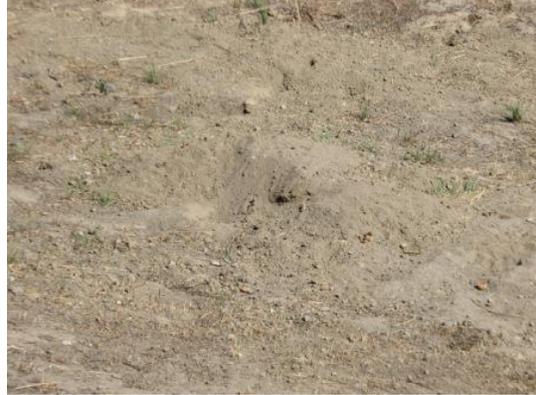
Photo 2 of 2 : FA_2015_RD1500_189_69_20150914_00048.jpg

A rodent burrow on the landside Fall 2013

LM Start	24.88	Rating **	M	Issue No.	69 (cont)
LM End	24.88	Issue Type +	Ma	Location *	LS
Category	Earthen Levee			GPS Latitude/Longitude	
				Start	End
Item	Animal Control			38.944340 °	38.944340 °
				-121.835790 °	-121.835790 °
DWR ID	DWR_RD1500_01_f_2013_69				
Action/Comments					
Exterminate rodents and backfill and compact or grout burrows.

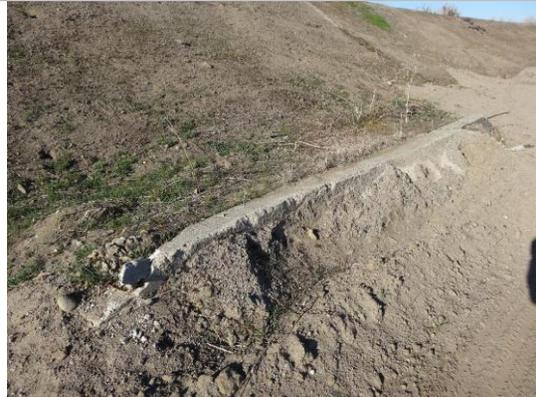
Photo 1 of 2 : UCIP_FA_2015_3104.jpg

LM Start	25.49	Rating **	M	Issue No.	2589
LM End	25.49	Issue Type +	En	Location *	LS
Category	Supplemental			GPS Latitude/Longitude	
				Start	End
Item	DWR UCIP Field Study			38.952803 °	38.952803 °
				-121.837618 °	-121.837618 °
DWR ID					
Action/Comments					
Inspector Comments: FS_ID:41728 DS_ID:20074 EP_NO: 8765 FS_HLM: 25.79 Repair Type: Non-Urgent Crossing Status: Found UCIP Comments: Buried Concrete headwall on landside toe. Should verify pipe has been properly abandoned.Utility tag plate on waterside shoulder.No pipe found. FIELD_STRUCT_DESC: Abandoned 4 foot by 4 foot reinforced concrete pipe through levee, 10 feet below the crown. App. No. 8765 has been approved to sleeve a 20-inch pipe through existing pipe from a new pumping facility. (App. No. 8765 & 9175 - Lewis) O&M Manual Sac 128, March 1960. FS Date: 01/15/2014

LS view: concrete headwall on landside toe. No pipe found.

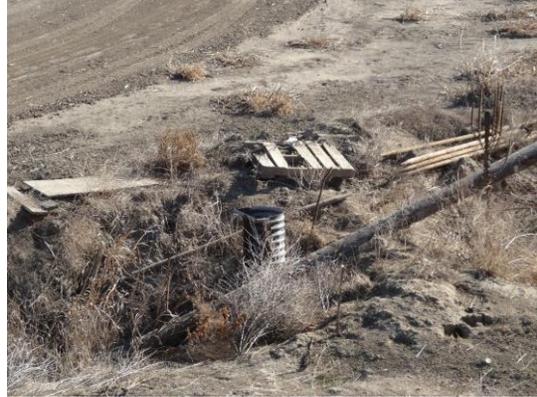
Photo 1 of 2 : UCIP_FA_2015_3267.jpg

LS view: abandoned CMP risers on levee toe.

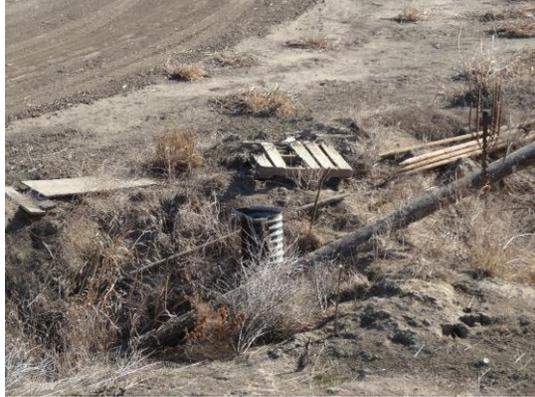
Photo 1 of 2 : UCIP_FA_2015_3265.jpg

LS view: abandoned CMP risers on levee toe.

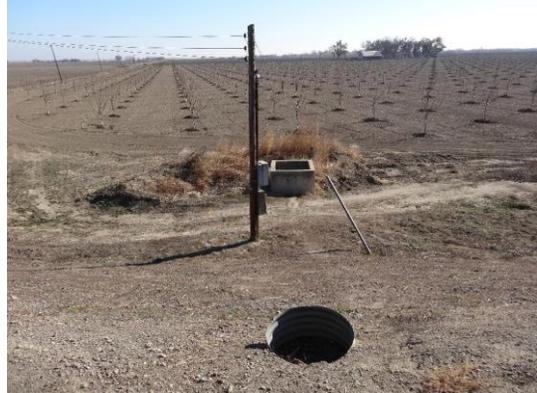
Photo 1 of 3 : UCIP_FA_2015_3349.jpg

LS view: siphon breaker in CMP riser on levee slope (bottom) and concrete distribution box on levee toe.

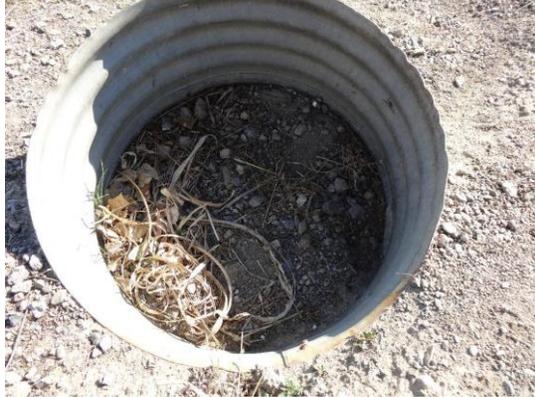
Photo 3 of 3 : UCIP_FA_2015_3351.jpg

LM Start	26.74	Rating **	M	Issue No.	2592 (cont)
LM End	26.74	Issue Type +	En	Location *	LS
Category	Supplemental			GPS Latitude/Longitude	
				Start	End
Item	DWR UCIP Field Study			38.968093 °	38.968093 °
				-121.833708 °	-121.833708 °
DWR ID					
Action/Comments					
Inspector Comments: FS_ID:28631 DS_ID:20015 EP_NO: 10052 FS_HLM: 27.064 Repair Type: Non-Urgent Crossing Status: Found

LS view: obstructed siphon breaker in CMP riser on levee slope.
