**Flood Control Project Maintenance
Levee Inspections**

Fall 2015 Levee Maintenance Deficiency Summary Report

Sacramento River Basin

Reclamation District No. 1500 Sutter Basin

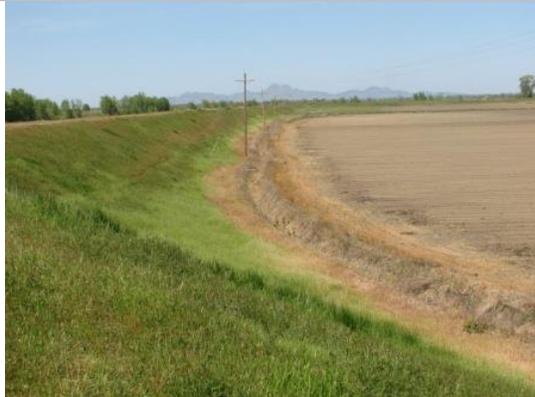
Photo 1 of 2 : FA_2015_RD1500_189_983_20150914_00072.jpg

LM Start	27.29	Rating **	M	Issue No.	983
LM End	27.44	Issue Type +	En	Location *	LS
Category	Earthen Levee			GPS Latitude/Longitude	
				Start	End
Item	Encroachments			38.972440 °	38.972848 °
				-121.825892 °	-121.823098 °
DWR ID	DWR_RD1500_01_s_2015_983				
Action/Comments					
Ditch

Agricultural ditch, photo taken in spring 2010.

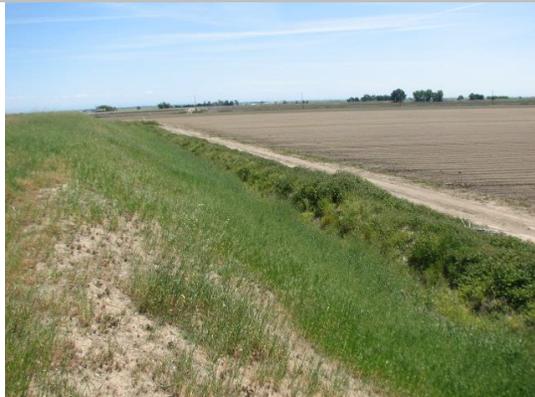
Photo 2 of 2 : FA_2015_RD1500_189_983_20150914_00073.jpg

LM Start	27.29	Rating **	M	Issue No.	983 (cont)
LM End	27.44	Issue Type +	En	Location *	LS

The agricultural ditch runs along the toe of the levee. Spring 2014

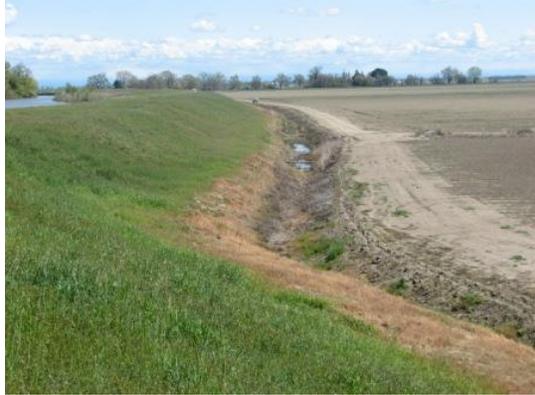
Photo 1 of 2 : FA_2015_RD1500_189_38_20150914_00034.jpg

LM Start	28.22	Rating **	M	Issue No.	38
LM End	29.23	Issue Type +	En	Location *	LS
Category	Earthen Levee		GPS Latitude/Longitude		
			Start	End	
Item	Encroachments		38.983081 °	38.988512 °	
			-121.819924 °	-121.806463 °	
DWR ID	DWR_RD1500_01_s_2012_38				
Action/Comments					
Ditch

The agricultural ditch runs along the toe of the levee, photo taken spring 2012.

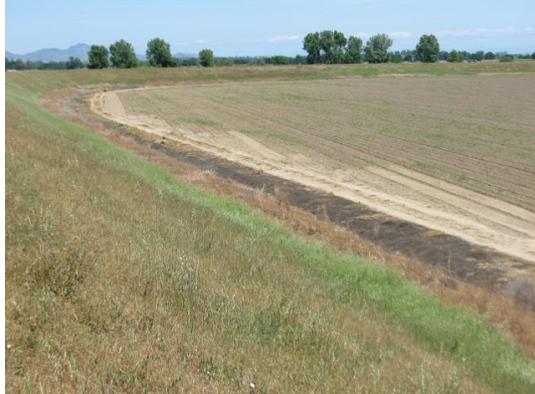
Photo 2 of 2 : FA_2015_RD1500_189_38_20150914_00035.jpg

LM Start	28.22	Rating **	M	Issue No.	38 (cont)
LM End	29.23	Issue Type +	En	Location *	LS

A current view of the agricultural ditch along the toe. Spring 2014

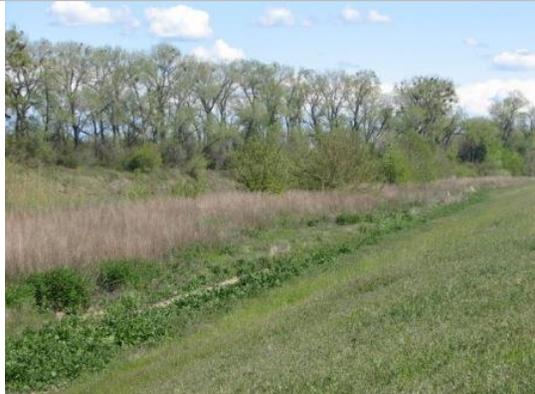
Photo 1 of 2 : FA_2015_RD1500_189_84_20150914_00059.jpg

LM Start	28.95	Rating **	A/W	Issue No.	84
LM End	29.17	Issue Type +	Ma	Location *	WS
Category	Earthen Levee		GPS Latitude/Longitude		
			Start	End	
Item	Vegetation		38.988078 °	38.988595 °	
			-121.811692 °	-121.807532 °	
DWR ID	DWR_RD1500_01_s_2012_84				
Action/Comments					
Environmental Requirements.

A photo of the revegetation site.

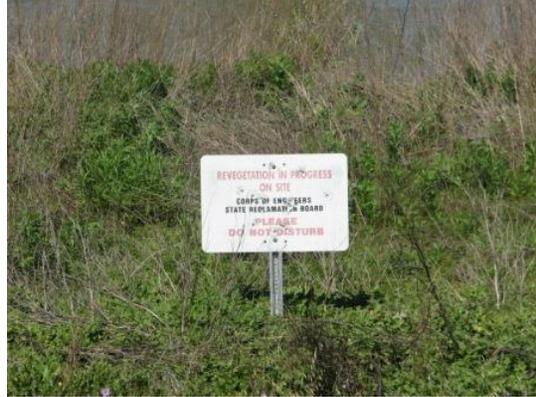
Photo 2 of 2 : FA_2015_RD1500_189_84_20150914_00060.jpg

LM Start	28.95	Rating **	A/W	Issue No.	84 (cont)
LM End	29.17	Issue Type +	Ma	Location *	WS
Category	Earthen Levee			GPS Latitude/Longitude	
				Start	End
Item	Vegetation			38.988078 °	38.988595 °
				-121.811692 °	-121.807532 °
DWR ID	DWR_RD1500_01_s_2012_84				
Action/Comments					
Environmental Requirements.

Another revegetation site on the waterside berm, photo taken spring 2012.

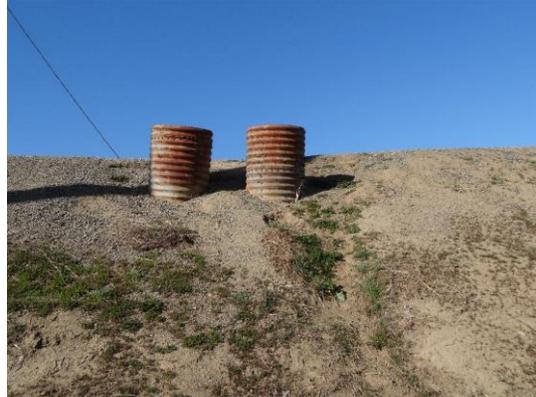
Photo 1 of 3 : UCIP_FA_2015_2965.jpg

LM Start	29.91	Rating **	U	Issue No.	2593
LM End	29.91	Issue Type +	En	Location *	WS
Category	Supplemental			GPS Latitude/Longitude	
				Start	End
Item	DWR UCIP Field Study			38.993006 °	38.993006 °
				-121.796025 °	-121.796025 °
DWR ID					
Action/Comments					
Inspector Comments: FS_ID:42929 DS_ID:20113 EP_NO: 10054 FS_HLM: 30.289 Repair Type: Urgent Crossing Status: Found UCIP Comments: Levee slope erosion due to leakage from siphon breaker. Water leaking from pipe near distribution box on landside levee toe. Overhead powerline. FIELD_STRUCT_DESC: 2 of 2: 16-inch steel irrigation pipe through levee, 5.0 feet below crown. Siphon breaker in 24-inch CM riser on landward shoulder. 20-inch steel irrigation pipe through levee, 5.0 feet below crown. Siphon breaker in 24-inch CM riser on landward shoulder. Slant pumps in CM pump house mounted on steel pile structure on the berm 4 foot by 7 foot concrete inspection box for Hersey-Sparling water meter on berm in front of pump house. Flap gates in 9.7 foot by 10.6 foot O.D. concrete distribution box at landward toe. (ABO No. 10054 - Larner) O&M Manual Sac 128, March 1960. FS Date: 01/15/2014

LS view: CMPs with leaky siphon breakers. Slope erosion and excessive vegetation on levee slope.

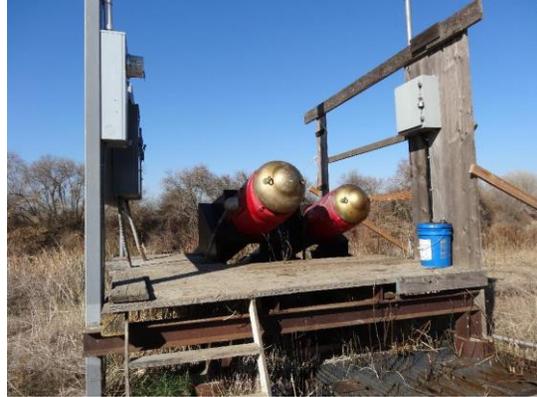
Photo 2 of 3 : UCIP_FA_2015_2966.jpg

LM Start	29.91	Rating **	U	Issue No.	2593 (cont)
LM End	29.91	Issue Type +	En	Location *	WS
Category	Supplemental			GPS Latitude/Longitude	
				Start	End
Item	DWR UCIP Field Study			38.993006 °	38.993006 °
				-121.796025 °	-121.796025 °
DWR ID					
Action/Comments					
Inspector Comments: FS_ID:42929 DS_ID:20113 EP_NO: 10054 FS_HLM: 30.289 Repair Type: Urgent Crossing Status: Found UCIP Comments: Levee slope erosion due to leakage from siphon breaker. Water leaking from pipe near distribution box on landside levee toe. Overhead powerline. FIELD_STRUCT_DESC: 2 of 2: 16-inch steel irrigation pipe through levee, 5.0 feet below crown. Siphon breaker in 24-inch CM riser on landward shoulder. 20-inch steel irrigation pipe through levee, 5.0 feet below crown. Siphon breaker in 24-inch CM riser on landward shoulder. Slant pumps in CM pump house mounted on steel pile structure on the berm 4 foot by 7 foot concrete inspection box for Hersey-Sparling water meter on berm in front of pump house. Flap gates in 9.7 foot by 10.6 foot O.D. concrete distribution box at landward toe. (ABO No. 10054 - Larner) O&M Manual Sac 128, March 1960. FS Date: 01/15/2014

WS view: two slant pumps on wooden platform on levee berm.

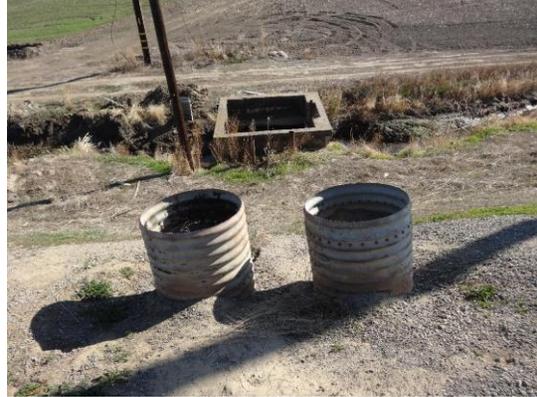
Photo 3 of 3 : UCIP_FA_2015_3396.jpg

LM Start	29.91	Rating **	U	Issue No.	2593 (cont)
LM End	29.91	Issue Type +	En	Location *	WS
Category	Supplemental			GPS Latitude/Longitude	
				Start	End
Item	DWR UCIP Field Study			38.993006 °	38.993006 °
				-121.796025 °	-121.796025 °
DWR ID					
Action/Comments					
Inspector Comments: FS_ID:42929 DS_ID:20113 EP_NO: 10054 FS_HLM: 30.289 Repair Type: Urgent Crossing Status: Found UCIP Comments: Levee slope erosion due to leakage from siphon breaker. Water leaking from pipe near distribution box on landside levee toe. Overhead powerline. FIELD_STRUCT_DESC: 2 of 2: 16-inch steel irrigation pipe through levee, 5.0 feet below crown. Siphon breaker in 24-inch CM riser on landward shoulder. 20-inch steel irrigation pipe through levee, 5.0 feet below crown. Siphon breaker in 24-inch CM riser on landward shoulder. Slant pumps in CM pump house mounted on steel pile structure on the berm 4 foot by 7 foot concrete inspection box for Hersey-Sparling water meter on berm in front of pump house. Flap gates in 9.7 foot by 10.6 foot O.D. concrete distribution box at landward toe. (ABO No. 10054 - Larner) O&M Manual Sac 128, March 1960. FS Date: 01/15/2014

LS view: siphon breakers in CMP riser on levee slope and distribution box on levee toe.

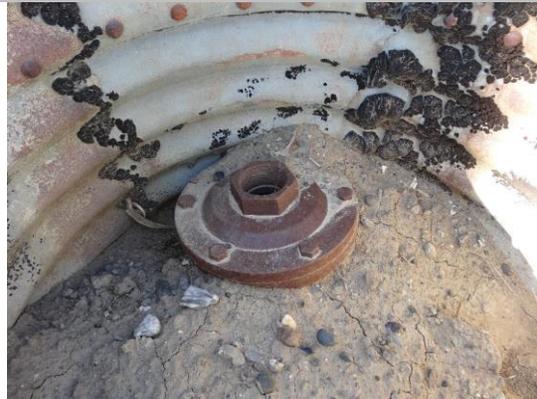
Photo 1 of 3 : UCIP_FA_2015_3393.jpg

Inspector Comments: FS_ID:42930
 DS_ID:20084
 EP_NO: 10054
 FS_HLM: 30.28
 Repair Type: Urgent
 Crossing Status: Found
 UCIP Comments: Levee slope erosion due to leakage from siphon breaker. Water leaking from pipe near distribution box on landside levee toe. Overhead powerline.
 FIELD_STRUCT_DESC: 1 of 2: 20-inch steel irrigation pipe through levee, 5.0 feet below crown. Siphon breaker in 24-inch CM riser on landward slope. Another 16-inch steel irrigation pipe through levee, 5.0 feet below crown. Siphon breaker in 24-inch CM riser on landward shoulder. Slant pumps in CM pump house mounted on steel pile structure on the berm. A 4 foot by 7 foot concrete inspection box for Hersey-Sparling water meter on berm in front of pump house. Flap gates in 9.7 foot by 10.6 foot O.D. concrete distribution box at landward toe. (ABO No. 10054 - Larner) O&M Manual Sac 128, March 1960.
 FS Date: 01/15/2014

LS view: obstructed and leaky siphon breaker in CMP riser on levee slope.

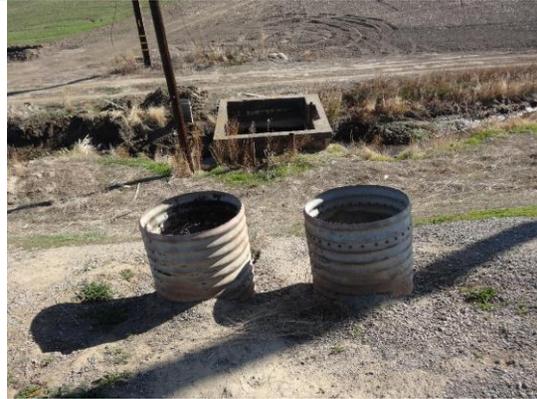
Photo 2 of 3 : UCIP_FA_2015_3394.jpg

Inspector Comments: FS_ID:42930
 DS_ID:20084
 EP_NO: 10054
 FS_HLM: 30.28
 Repair Type: Urgent
 Crossing Status: Found
 UCIP Comments: Levee slope erosion due to leakage from siphon breaker. Water leaking from pipe near distribution box on landside levee toe. Overhead powerline.
 FIELD_STRUCT_DESC: 1 of 2: 20-inch steel irrigation pipe through levee, 5.0 feet below crown. Siphon breaker in 24-inch CM riser on landward slope. Another 16-inch steel irrigation pipe through levee, 5.0 feet below crown. Siphon breaker in 24-inch CM riser on landward shoulder. Slant pumps in CM pump house mounted on steel pile structure on the berm. A 4 foot by 7 foot concrete inspection box for Hersey-Sparling water meter on berm in front of pump house. Flap gates in 9.7 foot by 10.6 foot O.D. concrete distribution box at landward toe. (ABO No. 10054 - Larner) O&M Manual Sac 128, March 1960.
 FS Date: 01/15/2014

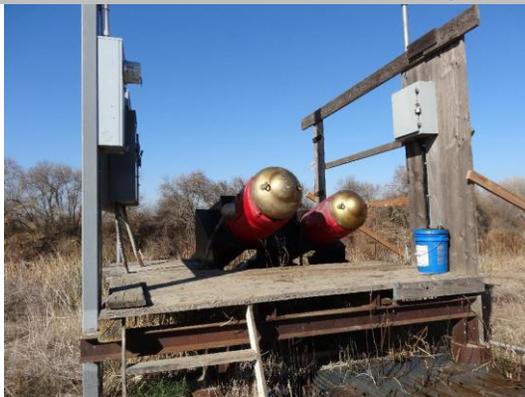
Photo 3 of 3 : UCIP_FA_2015_3395.jpg

LM Start	29.91	Rating **	U	Issue No.	2594 (cont)
LM End	29.91	Issue Type +	En	Location *	WS
Category	Supplemental			GPS Latitude/Longitude	
				Start	End
Item	DWR UCIP Field Study			38.993006 °	38.993006 °
				-121.796025 °	-121.796025 °
DWR ID					
Action/Comments					
Inspector Comments: FS_ID:42930 DS_ID:20084 EP_NO: 10054 FS_HLM: 30.28 Repair Type: Urgent Crossing Status: Found UCIP Comments: Levee slope erosion due to leakage from siphon breaker. Water leaking from pipe near distribution box on landside levee toe. Overhead powerline. FIELD_STRUCT_DESC: 1 of 2: 20-inch steel irrigation pipe through levee, 5.0 feet below crown. Siphon breaker in 24-inch CM riser on landward slope. Another 16-inch steel irrigation pipe through levee, 5.0 feet below crown. Siphon breaker in 24-inch CM riser on landward shoulder. Slant pumps in CM pump house mounted on steel pile structure on the berm. A 4 foot by 7 foot concrete inspection box for Hersey-Sparling water meter on berm in front of pump house. Flap gates in 9.7 foot by 10.6 foot O.D. concrete distribution box at landward toe. (ABO No. 10054 - Larner) O&M Manual Sac 128, March 1960. FS Date: 01/15/2014

WS view: slant pumps and control boxes on steel platform at levee berm.

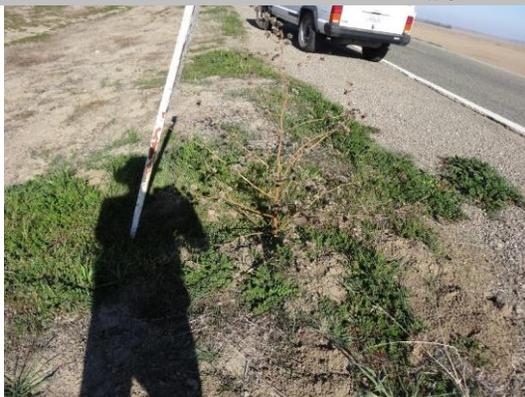
Photo 1 of 3 : UCIP_FA_2015_3341.jpg

LM Start	30.07	Rating **	U	Issue No.	2595
LM End	30.07	Issue Type +	En	Location *	WS
Category	Supplemental			GPS Latitude/Longitude	
				Start	End
Item	DWR UCIP Field Study			38.994988 °	38.994988 °
				-121.794484 °	-121.794484 °
DWR ID					
Action/Comments					
Inspector Comments: FS_ID:28163 DS_ID:20107 EP_NO: 6169 FS_HLM: 30.452 Repair Type: Urgent Crossing Status: Found UCIP Comments: Leaky pump and excessive vegetation observed along pipe alignment on waterside slope of the levee. It needs more investigations. May have new permit for slant pump. FIELD_STRUCT_DESC: 30-inch reinforced concrete encased steel irrigation pipe through levee, 15.5 feet below crown. Slant pump and switch panel on steel pile structure at edge of berm. Slide gate in 2.5 foot by 3.5 foot I.D. concrete box on berm. 6 foot by 8 foot concrete distribution box at landward toe. 2-inch conduit through levee, 2.5 feet below crown. (App. No. 6169 - Butler) Pipe through levee was initially installed in 1952. O&M Manual Sac 128, March 1960. FS Date: 01/15/2014

WS view: excessive vegetation along pipe alignment on levee slope.

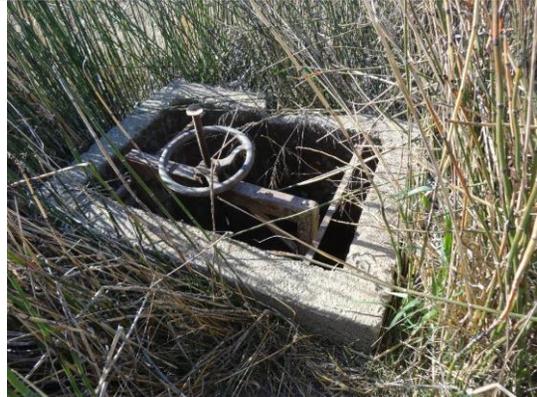
Photo 2 of 3 : UCIP_FA_2015_3342.jpg

LM Start	30.07	Rating **	U	Issue No.	2595 (cont)
LM End	30.07	Issue Type +	En	Location *	WS
Category	Supplemental			GPS Latitude/Longitude	
				Start	End
Item	DWR UCIP Field Study			38.994988 °	38.994988 °
DWR ID				-121.794484 °	-121.794484 °
Action/Comments					
Inspector Comments: FS_ID:28163 DS_ID:20107 EP_NO: 6169 FS_HLM: 30.452 Repair Type: Urgent Crossing Status: Found UCIP Comments: Leaky pump and excessive vegetation observed along pipe alignment on waterside slope of the levee. It needs more investigations. May have new permit for slant pump. FIELD_STRUCT_DESC: 30-inch reinforced concrete encased steel irrigation pipe through levee, 15.5 feet below crown. Slant pump and switch panel on steel pile structure at edge of berm. Slide gate in 2.5 foot by 3.5 foot I.D. concrete box on berm. 6 foot by 8 foot concrete distribution box at landward toe. 2-inch conduit through levee, 2.5 feet below crown. (App. No. 6169 - Butler) Pipe through levee was initially installed in 1952. O&M Manual Sac 128, March 1960. FS Date: 01/15/2014

WS view: concrete surge box with slide gate on levee berm.

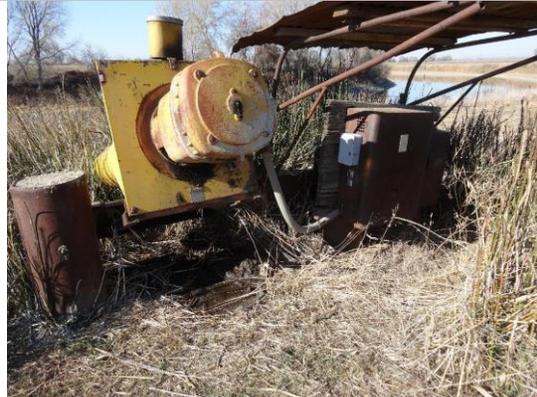
Photo 3 of 3 : UCIP_FA_2015_3343.jpg

LM Start	30.07	Rating **	U	Issue No.	2595 (cont)
LM End	30.07	Issue Type +	En	Location *	WS

WS view: leaky slant pump on levee berm.

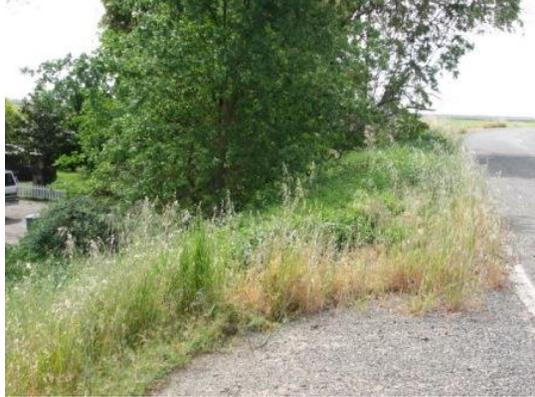
Photo 1 of 1 : FA_2015_RD1500_189_45_20150914_00037.jpg

LM Start	30.21	Rating **	M	Issue No.	45
LM End	30.21	Issue Type +	En	Location *	LS
Category	Earthen Levee			GPS Latitude/Longitude	
				Start	End
Item	Vegetation			38.996980 °	38.996980 °
				-121.794723 °	-121.794723 °
DWR ID	DWR_RD1500_01_s_2012_45				
Action/Comments					
Landscaping

The groundcover in the landscape makes it hard to see the levee slope.

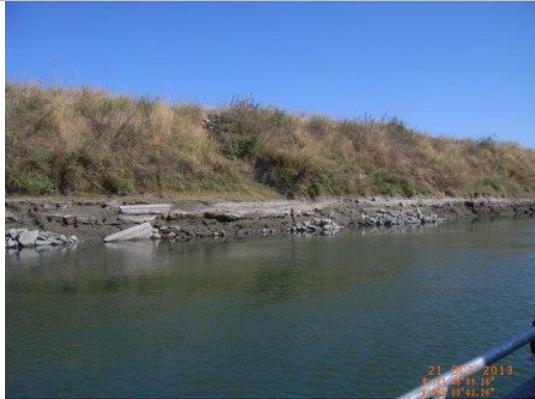
Photo 1 of 1 : USACE2013A_SAC_116-0_L_4.jpg

LM Start	30.60	Rating **	M	Issue No.	22
LM End	30.75	Issue Type +	Ma	Location *	WS
Category	Supplemental			GPS Latitude/Longitude	
				Start	End
Item	2015 USACE Erosion Survey, DRAFT			38.999745 °	39.001413 °
				-121.800898 °	-121.802889 °
DWR ID					
Action/Comments					
Inspector Comments: 2000 - Eroding, vertical berm slope over a vertical cohesive toe; slow erosion but getting close to the toe. 2002 - Erosion is getting close to the levee, still eroding with some new small slumps. 2004 - Some minor new erosion. 2006 - Some new erosion, cleaned off older scars and slump faces. 2008 - New, small, partial rotational failure. 2011 - Some new minor erosion. 2015: No observed changes. [2015 Site ID: SAC_116-0_L]

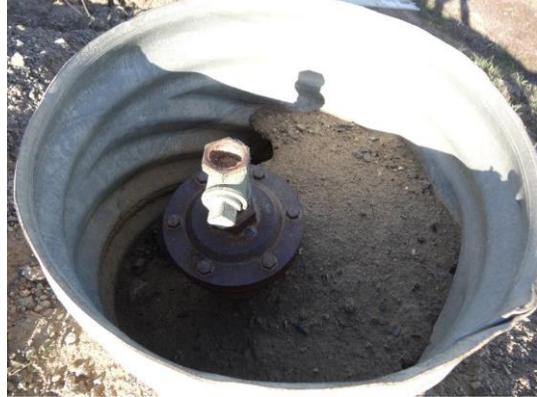
Photo 1 of 2 : UCIP_FA_2015_3339.jpg

Inspector Comments: FS_ID:28144
 DS_ID:20000
 EP_NO: 15916
 FS_HLM: 31.261
 Repair Type: Non-Urgent
 Crossing Status: Found
 UCIP Comments: Surface erosion due to leaky pressure breaker on landside slope.
 FIELD_STRUCT_DESC: 18-inch steel irrigation pipe through levee. Siphon breaker in 24-inch CM riser on landward slope. Discharges into 6 foot by 8 foot I.D. concrete distribution box at landward toe. (App. No. 15916 - Butler) 18-inch replaced original 12-inch pipe (10034 - Butler)
 FS Date: 01/15/2014

LS view: obstructed and leaked pressure breaker in CMP on levee slope.

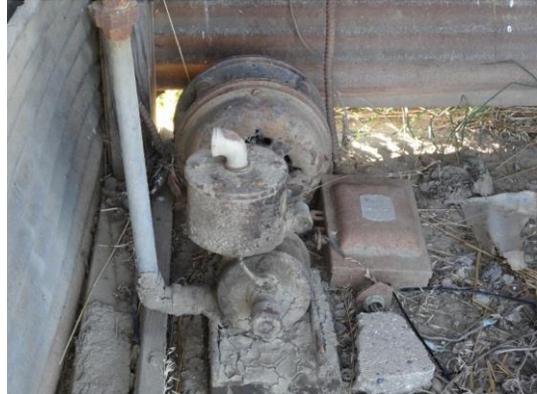
Photo 2 of 2 : UCIP_FA_2015_3340.jpg

WS view: pump in CM pump house on levee shoulder. Looks abandoned.

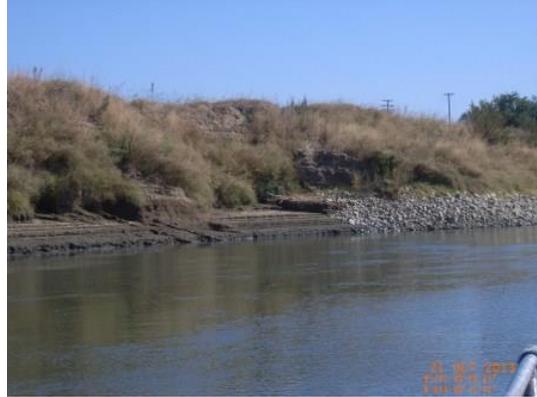
Photo 1 of 1 : USACE2013A_SAC_116-5_L_10.jpg

LM Start	30.94	Rating **	M	Issue No.	15
LM End	31.60	Issue Type +	Ma	Location *	WS
Category	Supplemental			GPS Latitude/Longitude	
				Start	End
Item	2015 USACE Erosion Survey, DRAFT			39.003301 °	39.006072 °
				-121.805024 °	-121.815926 °
DWR ID					
Action/Comments					
Inspector Comments: 2003 - New sedimentation and some new small toe scallops at the upstream end; downstream end has some new erosion. 2004 - Some new erosion at the toe and upper bank and some small new rotational failures (mainly minor, except at the downstream end). 2007 - Some new slumps. 2009 - Some new scallops and site was extended upstream. 2010 - New deposition along

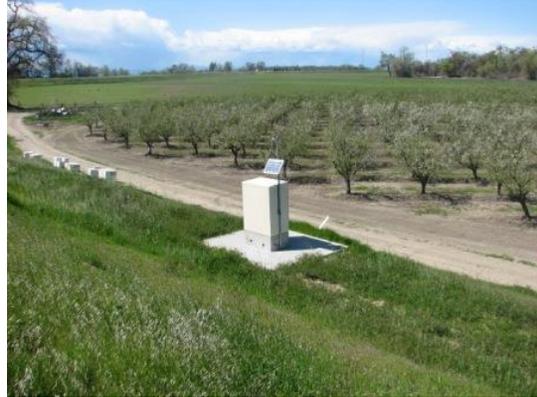
Photo 1 of 1 : FA_2015_RD1500_189_86_20150914_00061.jpg

LM Start	31.53	Rating **	A/W	Issue No.	86
LM End	31.53	Issue Type +	En	Location *	WS
Category	Earthen Levee			GPS Latitude/Longitude	
				Start	End
Item	Underseepage Relief Wells			39.006722 °	39.006722 °
				-121.814752 °	-121.814752 °
DWR ID	DWR_RD1500_01_s_2012_86				
Action/Comments

The control unit for pizometers installed in 2012, photo taken spring 2012.

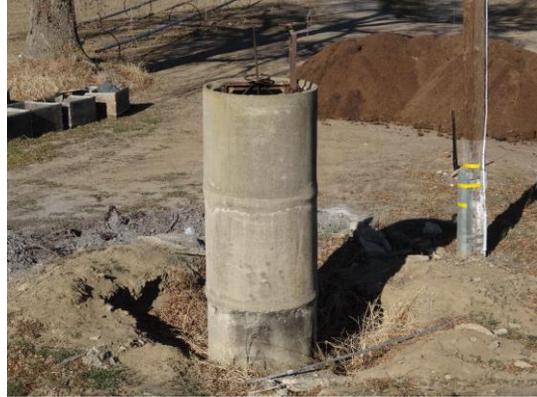
Photo 1 of 3 : UCIP_FA_2015_3297.jpg

LM Start	31.61	Rating **	M	Issue No.	2597
LM End	31.61	Issue Type +	En	Location *	WS
Category	Supplemental			GPS Latitude/Longitude	
				Start	End
Item	DWR UCIP Field Study			39.006484 °	39.006484 °
				-121.816168 °	-121.816168 °
DWR ID					
Action/Comments					
Inspector Comments: FS_ID:28143 DS_ID:20077 EP_NO: 9657 FS_HLM: 32.018 Repair Type: Non-Urgent Crossing Status: Found UCIP Comments: Looks abandoned. May need proper abandonment. Overhead power line. FIELD_STRUCT_DESC: Abandoned 20-inch diameter steel pipe through levee, 15.0 feet below crown. Pump on elevated structure. Slide gate in riser, concrete surge box on waterward slope. Switch panel on berm. (App. Nos. 13536 & 13941 - Niechen 10/82) Discharges into 36-inch I.D. concrete standpipe on landward side. (App. No. 9657 ABO No. 10030 - Bell) O&M Manual Sac 128, March 1960. FS Date: 01/15/2014

LS view: concrete standpipe on levee toe.

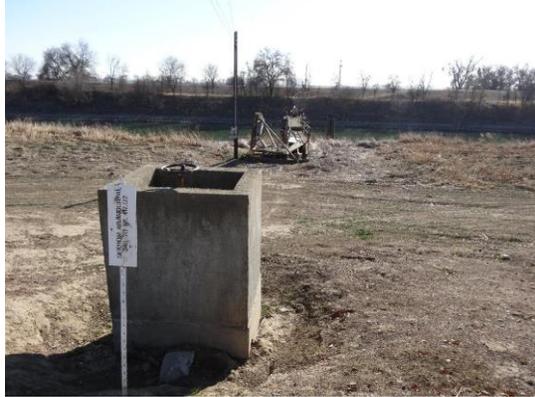
Photo 3 of 3 : UCIP_FA_2015_3299.jpg

LM Start	31.61	Rating **	M	Issue No.	2597 (cont)
LM End	31.61	Issue Type +	En	Location *	WS
Category	Supplemental			GPS Latitude/Longitude	
				Start	End
Item	DWR UCIP Field Study			39.006484 °	39.006484 °
				-121.816168 °	-121.816168 °
DWR ID					
Action/Comments					
Inspector Comments: FS_ID:28143 DS_ID:20077 EP_NO: 9657 FS_HLM: 32.018 Repair Type: Non-Urgent Crossing Status: Found

WS view: concrete surge box on levee slope.

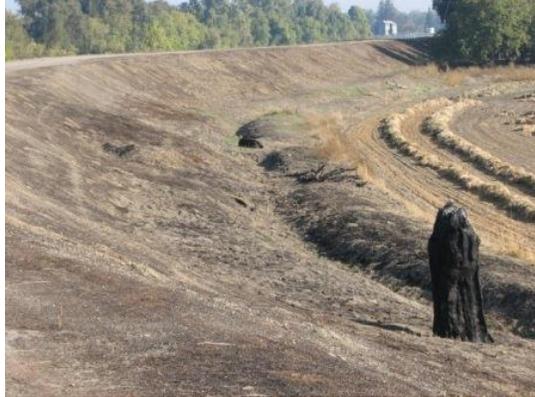
Photo 1 of 1 : FA_2015_RD1500_189_60_20150914_00046.jpg

LM Start	32.42	Rating **	M	Issue No.	60
LM End	32.58	Issue Type +	En	Location *	LS
Category	Earthen Levee			GPS Latitude/Longitude	
				Start	End
Item	Encroachments			39.013720 °	39.015640 °
				-121.825038 °	-121.823397 °
DWR ID	DWR_RD1500_01_s_2012_60				
Action/Comments					
Ditch

Older, unused agricultural ditch. Tree stump needs to be removed.

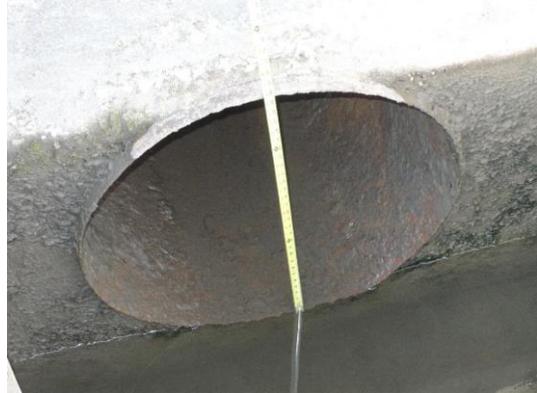
Photo 1 of 3 : UCIP_FA_2015_3458.jpg

LM Start	32.55	Rating **	M	Issue No.	2598
LM End	32.55	Issue Type +	En	Location *	LS
Category	Supplemental			GPS Latitude/Longitude	
				Start	End
Item	DWR UCIP Field Study			39.015277 °	39.015277 °
				-121.823735 °	-121.823735 °
DWR ID					
Action/Comments					
Inspector Comments: FS_ID:28943 DS_ID:20018 EP_NO: N/A FS_HLM: 32.969 Repair Type: Non-Urgent Crossing Status: Found UCIP Comments: Pipe leaks near pump through a hole in the pipe. Needs repair. An electric conduit through the levee. Concrete distribution box on landside levee toe. Slide gate in CMP on waterside slope. FIELD_STRUCT_DESC: 30-inch pipe and electric conduit through levee, 14.3 feet below the crown, Pump and headwall on waterside. Slide gate in CMP on waterside slope. Electric control box on waterside. Concrete distribution box on landside levee toe. O&M Manual Sac 128, March 1960. FS Date: 01/15/2014

LS view: steel pipe in concrete distribution box on levee toe.

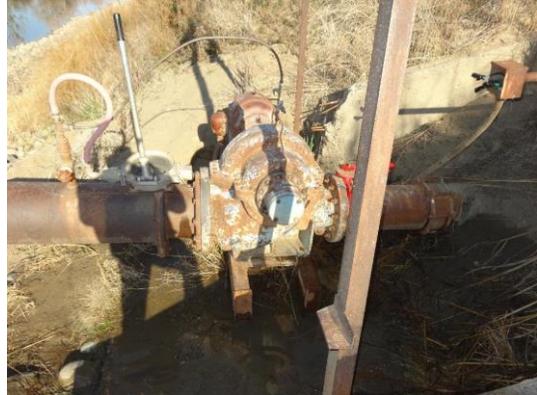
Photo 2 of 3 : UCIP_FA_2015_3459.jpg

WS view: pump on river bank protected by concrete headwall. Leaky pipe near pump.

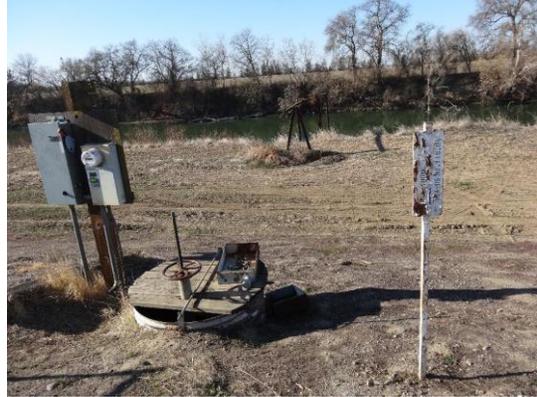
Photo 3 of 3 : UCIP_FA_2015_3460.jpg

WS view: power control panel and CMP riser with slide gate on levee slope.

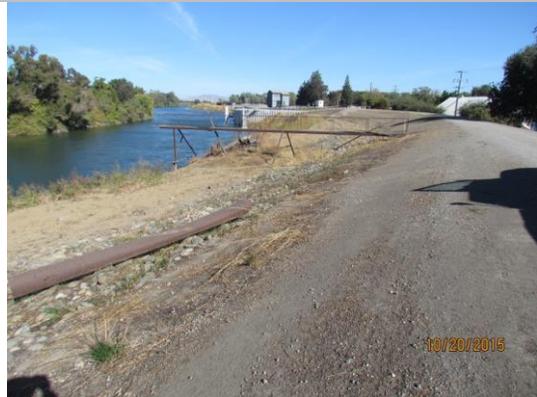
Photo 1 of 1 : FA_2015_RD1500_189_104_20151026_00136.jpg

LM Start	32.84	Rating **	M	Issue No.	104
LM End	32.84	Issue Type +	En	Location *	WS
Category	Earthen Levee			GPS Latitude/Longitude	
				Start	End
Item	Encroachments			39.018848 °	39.018848 °
				-121.820761 °	-121.820761 °
DWR ID	DWR_RD1500_01_f_2015_104				
Action/Comments					
Debris

View of the abandoned pipe on the waterward side of the levee looking upstream. Fall 2015.

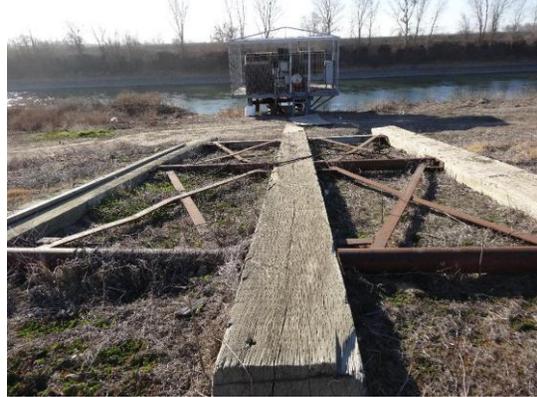
Photo 3 of 3 : UCIP_FA_2015_3484.jpg

WS view: slant pumps on steel platform in shed on berm.

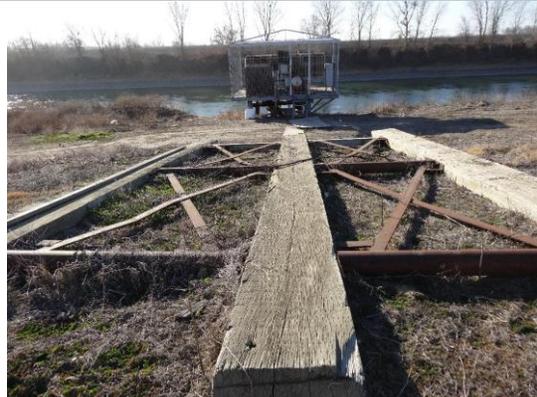
Photo 3 of 3 : UCIP_FA_2015_3463.jpg

WS view: pump platform and shed on levee berm.

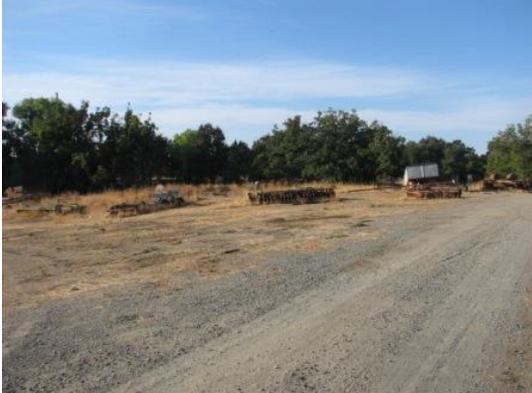
Photo 1 of 2 : FA_2015_RD1500_190_12_20150914_00005.jpg

LM Start	0.00	Rating **	M	Issue No.	12
LM End	0.00	Issue Type +	Ma	Location *	WS
Category	Earthen Levee		GPS Latitude/Longitude		
			Start	End	
Item	Encroachments		38.761121 °	38.761121 °	
			-121.674592 °	-121.674592 °	
DWR ID	DWR_RD1500_02_s_2012_12				
Action/Comments					
Equipment

Farm equipment is parked on the levee slope. Photo fall 2012.

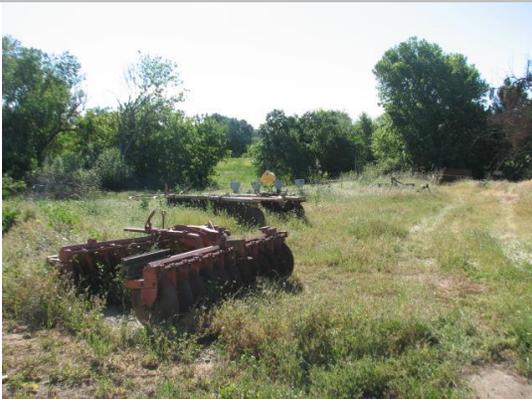
Photo 2 of 2 : FA_2015_RD1500_190_12_20150914_00006.jpg

Farm equipment is on the levee crown. Spring 2014

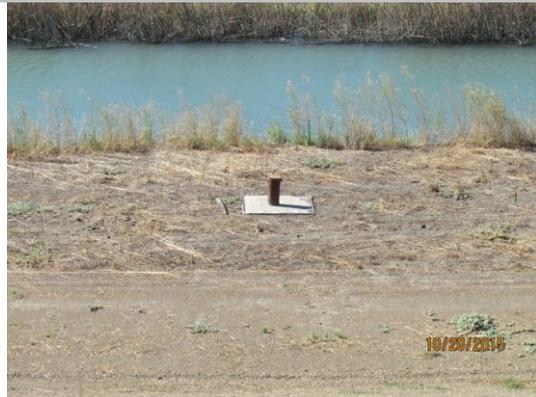
Photo 1 of 1 : FA_2015_RD1500_190_4_20151026_00018.jpg

LM Start	14.13	Rating **	A/W	Issue No.	4
LM End	14.13	Issue Type +	Ma	Location *	LS
Category	Earthen Levee		GPS Latitude/Longitude		
			Start	End	
Item	Underseepage Relief Wells		38.947582 °	38.947582 °	
			-121.669740 °	-121.669740 °	
DWR ID	DWR_RD1500_02_s_2012_4				
Action/Comments

View of the relief well at historical boil 12. Fall 2015.
