**Flood Control Project Maintenance
Levee Inspections**
LMA District Cover Sheet
Spring 2014 Levee Inspection Results

Reclamation District No. 1500 Sutter Basin

Spring 2014 Levee Inspection Results

Waterway		Bank	Unit Miles
Unit No. 01 Sacramento River		Left	33.58

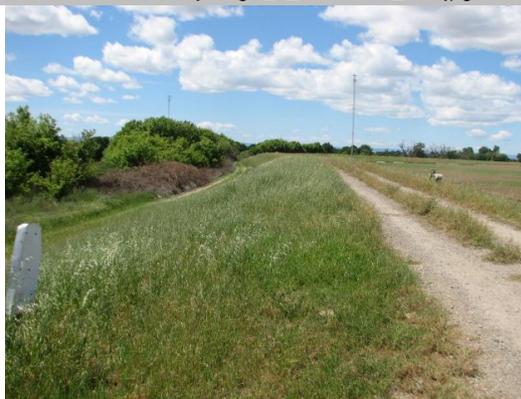
Photo 1 of 1 : johngw_s_20140428_878.jpg

LM Start	0.00	Rating **	M	Issue No.	1333
LM End	33.56	Issue Type +	Ma	Location *	WS
Category	Earthen Levee		GPS Latitude/Longitude		
			Start	End	
Item	Vegetation		38.761088 °	39.022821 °	
			-121.674633 °	-121.820698 °	
DWR ID	DWR_RD1500_01_s_2014_1333				
Action/Comments					
Control annual grass and weeds on the levee slopes and easements.

Tall grasses partially blocks visibility. Spring 2014

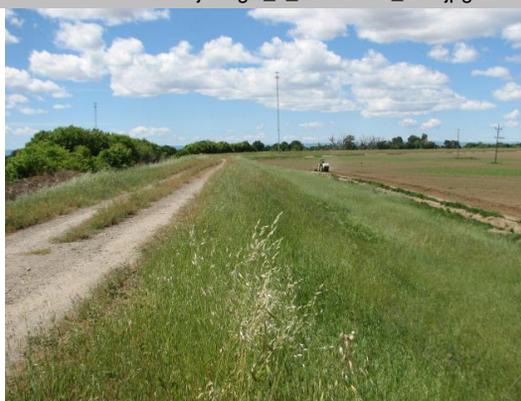
Photo 1 of 1 : johngw_s_20140428_879.jpg

LM Start	0.00	Rating **	M	Issue No.	1334
LM End	1.37	Issue Type +	Ma	Location *	LS
Category	Earthen Levee		GPS Latitude/Longitude		
			Start	End	
Item	Vegetation		38.761087 °	38.770244 °	
			-121.674631 °	-121.690050 °	
DWR ID	DWR_RD1500_01_s_2014_1334				
Action/Comments					
Control annual grass and weeds on the levee slopes and easements.

Tall grasses partially blocks visibility Spring 2014

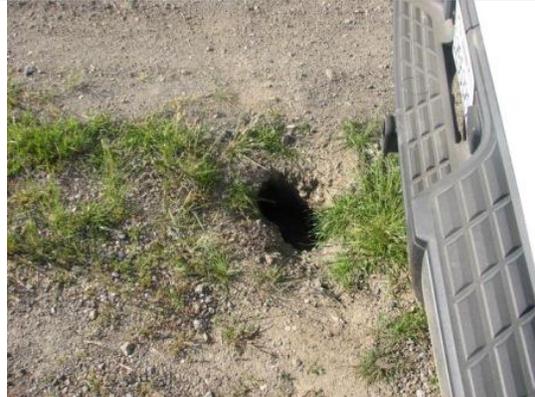
Photo 1 of 2 : johngw_s_20140414_218.jpg

LM Start	0.04	Rating **	M	Issue No.	35
LM End	0.04	Issue Type +	Ma	Location *	CR
Category	Earthen Levee			GPS Latitude/Longitude	
				Start	End
Item	Animal Control			38.761055 °	38.761055 °
				-121.675322 °	-121.675322 °
DWR ID	DWR_RD1500_01_s_2012_35				
Action/Comments					
No rodents visible, but rodent burrows visible; need to backfill and

A rodent hole in the levee crown, photo taken spring 2012.

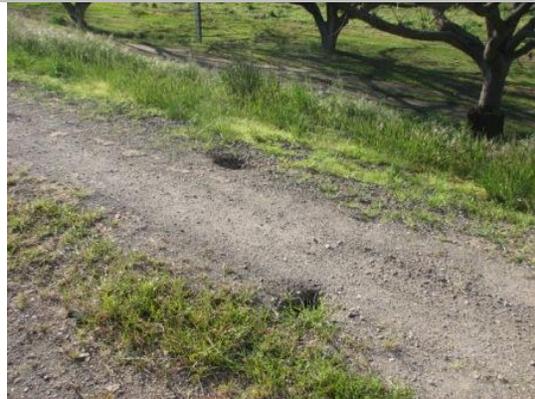
Photo 2 of 2 : johngw_s_20140414_219.jpg

LM Start	0.04	Rating **	M	Issue No.	35 (cont)
LM End	0.04	Issue Type +	Ma	Location *	CR

Two more rodent hole in the crown, photo taken spring 2012.

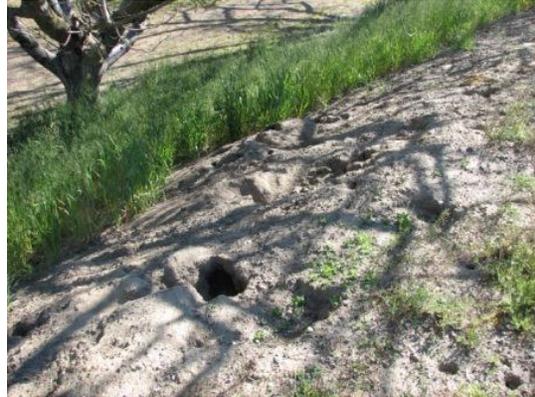
Photo 1 of 1 : johngw_s_20140414_183.jpg

LM Start	0.07	Rating **	M	Issue No.	5
LM End	0.07	Issue Type +	Ma	Location *	LS
Category	Earthen Levee			GPS Latitude/Longitude	
				Start	End
Item	Animal Control			38.761071 °	38.761071 °
				-121.675957 °	-121.675957 °
DWR ID	DWR_RD1500_01_s_2012_5				
Action/Comments					
No rodents visible, but rodent burrows visible; need to backfill and compact or grout burrows.

There are some old and a few new rodent holes that need to be backfilled.

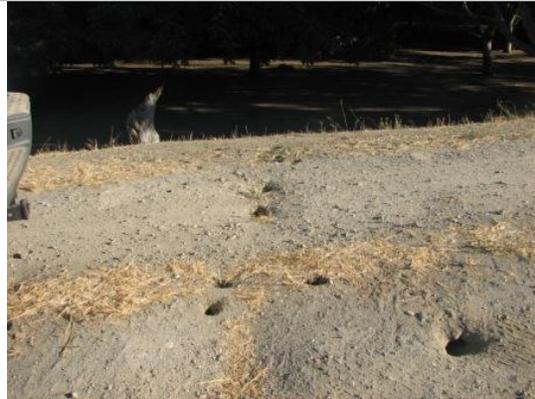
Photo 2 of 2 : johngw_s_20140414_280.jpg

LM Start	0.10	Rating **	M	Issue No.	212 (cont)
LM End	0.10	Issue Type +	Ma	Location *	WS
Category	Earthen Levee			GPS Latitude/Longitude	
				Start	End
Item	Animal Control			38.761090 °	38.761090 °
				-121.676346 °	-121.676346 °
DWR ID	DWR_RD1500_01_s_2012_212				
Action/Comments					
No rodents visible, but rodent burrows visible; need to backfill and compact or grout burrows. Inspector Comments: There are burrow holes on the landside too. There are depressions on crown and appears to be part of the burrows.

Many rodent holes in the levee crown. Photo fall 2012.

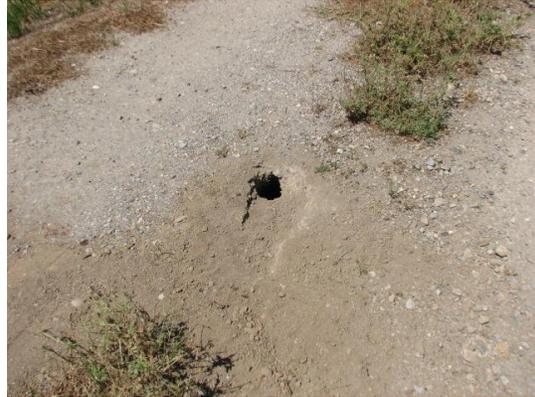
Photo 1 of 1 : johngw_s_20140428_881.jpg

LM Start	0.28	Rating **	M	Issue No.	1332
LM End	0.28	Issue Type +	Ma	Location *	CR
Category	Earthen Levee			GPS Latitude/Longitude	
				Start	End
Item	Animal Control			38.762868 °	38.762868 °
				-121.678744 °	-121.678744 °
DWR ID	DWR_RD1500_01_s_2014_1332				
Action/Comments					
Exterminate rodents and backfill and compact or grout burrows.

Rodent hole in the crown maybe connected to the holes on landside and waterside. Spring 2014

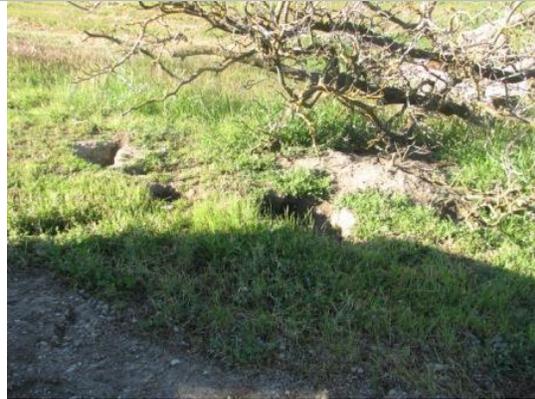
Photo 1 of 1 : johngw_s_20140414_262.jpg

LM Start	0.28	Rating **	M	Issue No.	67
LM End	0.28	Issue Type +	Ma	Location *	WS
Category	Earthen Levee			GPS Latitude/Longitude	
				Start	End
Item	Animal Control			38.762810 °	38.762810 °
				-121.678702 °	-121.678702 °
DWR ID	DWR_RD1500_01_s_2012_67				
Action/Comments					
No rodents visible, but rodent burrows visible; need to backfill and compact or grout burrows.

Several rodent holes on the waterside levee slope, photo taken spring 2012.

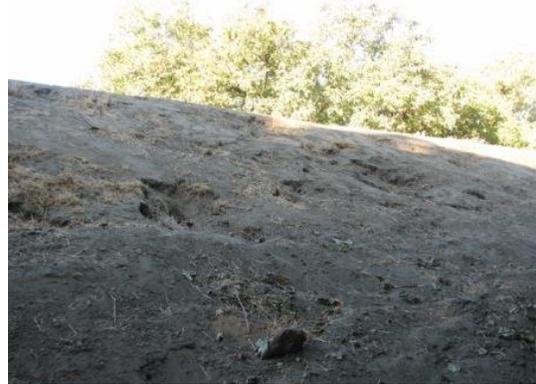
Photo 2 of 3 : johngw_s_20140414_264.jpg

LM Start	0.30	Rating **	U	Issue No.	68 (cont)
LM End	0.30	Issue Type +	Ma	Location *	LS
Category	Earthen Levee		GPS Latitude/Longitude		
			Start	End	
Item	Animal Control		38.763128 °	38.763128 °	
			-121.678950 °	-121.678950 °	
DWR ID	DWR_RD1500_01_s_2012_68				
Action/Comments					
No rodents visible, but rodent burrows visible; need to backfill and compact or grout burrows.

Many rodent holes in a small area. Photo fall 2012.

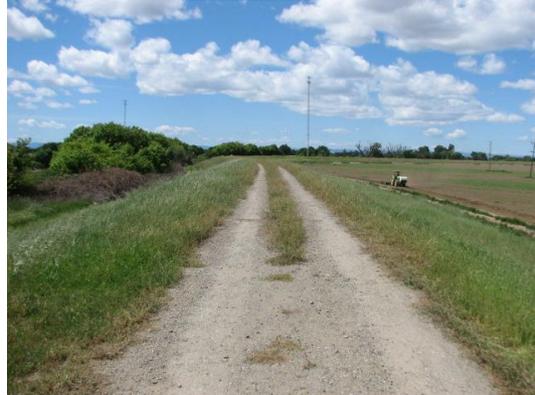
Photo 1 of 1 : johngw_s_20140428_883.jpg

LM Start	0.53	Rating **	M	Issue No.	1337
LM End	1.36	Issue Type +	Ma	Location *	CR
Category	Earthen Levee		GPS Latitude/Longitude		
			Start	End	
Item	Vegetation		38.764503 °	38.770175 °	
			-121.682482 °	-121.690209 °	
DWR ID	DWR_RD1500_01_s_2014_1337				
Action/Comments					
Keep the crown roadway free of vegetation.

Control unwanted vegetation on the levee crown. Spring 2014

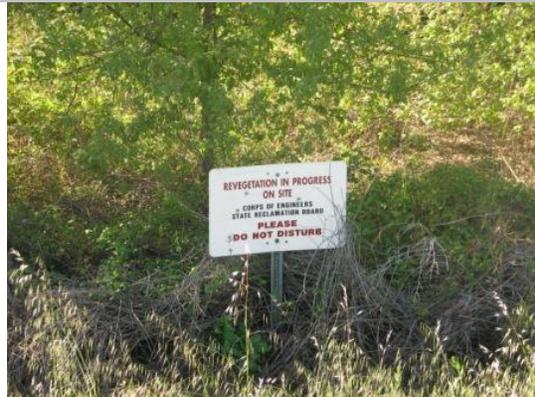
Photo 1 of 2 : johngw_s_20140414_268.jpg

LM Start	0.57	Rating **	A/W	Issue No.	72
LM End	0.83	Issue Type +	Ma	Location *	WS
Category	Earthen Levee		GPS Latitude/Longitude		
			Start	End	
Item	Vegetation		38.764462 °	38.764638 °	
			-121.683167 °	-121.687690 °	
DWR ID	DWR_RD1500_01_s_2012_72				
Action/Comments					
Environmental Requirements.

A revegetation site waterside toe, photo taken spring 2012.

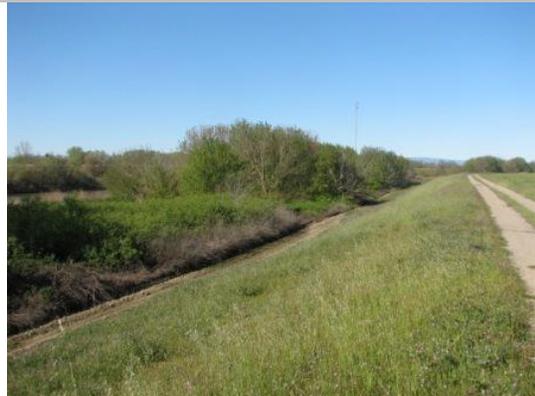
Photo 2 of 2 : johngw_s_20140414_269.jpg

LM Start	0.57	Rating **	A/W	Issue No.	72 (cont)
LM End	0.83	Issue Type +	Ma	Location *	WS

A view of the revegetation site.

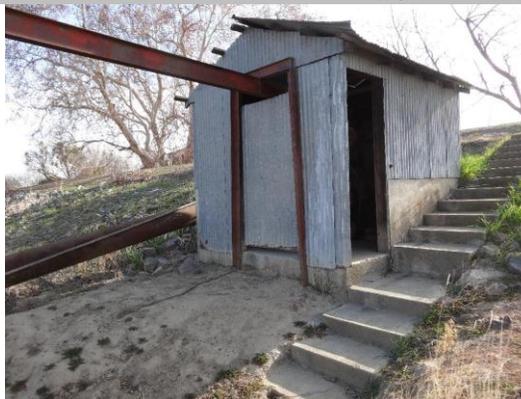
Photo 1 of 1 : UCIP_5782.jpg

LM Start	1.31	Rating **	M	Issue No.	1287
LM End	1.31	Issue Type +	En	Location *	LS
Category	Supplemental			GPS Latitude/Longitude	
				Start	End
Item	DWR UCIP Field Study			38.769697 °	38.769697 °
				-121.691024 °	-121.691024 °
DWR ID	DWR_RD1500_01_s_2014_1287				
Action/Comments					
Inspector Comments: FS_ID:28903 EP_NO: 10080 Repair Type: Crossing Status: UCIP Comments: Pump removed from concrete pad and kept inside pump house (may be for storage purpose) on waterside. A 8-inch steel pipe inside 14-inch pipe. FIELD_STRUCT_DESC: 14-inch steel irrigation pipe through levee, 5.2 feet below crown. Pump on river bank. Butterfly valve on waterward side. Concrete stairway on waterward slope. 1-3/4-inch galvanized iron waterline with tap exposed on landward slope 3.4 feet below crown. 4 foot by 5.1 foot concrete distribution box at landward toe. 1-1/4-inch conduit through levee, 2.0 feet below crown. (ABO No. 10080 - Yturralde) FS Date: 1/9/2014

WS view: pipe (left), pump house/store, and concrete steps.

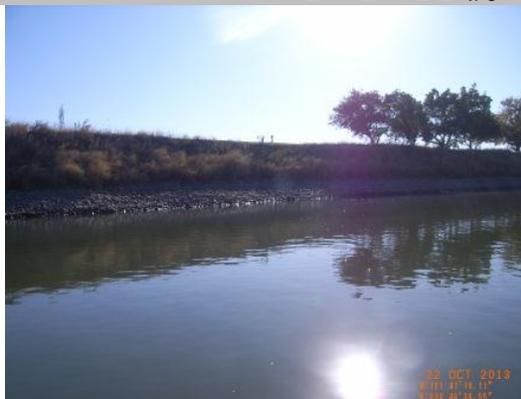
Photo 1 of 1 : USACE2013A_SAC_86-3_L_2.jpg

LM Start	1.32	Rating **	M	Issue No.	1
LM End	1.32	Issue Type +	Ma	Location *	WS
Category	Supplemental			GPS Latitude/Longitude	
				Start	End
Item	USACE Erosion Survey			38.770390 °	38.777282 °
				-121.690553 °	-121.685841 °
DWR ID					
Action/Comments					
Inspector Comments: 2006 - New erosion upstream, new bank failures near levee but still fairly wide berm in most places. 2008 - Large berm, questionable as to if it should remain in the inventory. 2010 - Minor new erosion, old cobble starting to fail. 2011 - Cobble continues to unravel and additional slumping. 2014 - Minor new erosion at bank mid point. 2013: Minor new erosion. [2013 Site ID: SAC_86-3_L]

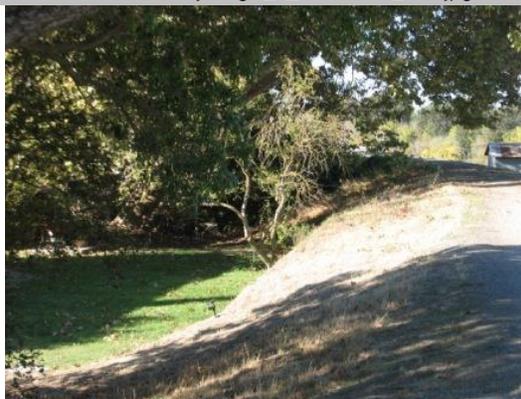
Photo 1 of 1 : johngw_s_20140414_182.jpg

LM Start	1.34	Rating **	M	Issue No.	4
LM End	1.34	Issue Type +	En	Location *	LS
Category	Earthen Levee			GPS Latitude/Longitude	
				Start	End
Item	Vegetation			38.770003 °	38.770003 °
				-121.690607 °	-121.690607 °
DWR ID	DWR_RD1500_01_s_2012_4				
Action/Comments					
Landscaping Inspector Comments: retaining wall into levee

Landscape with retaining wall that is in the USACE as-builts Fall 2013

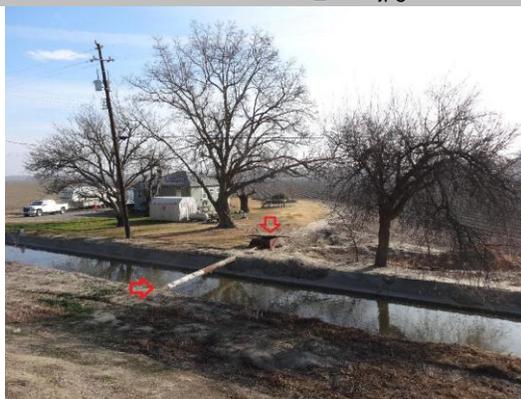
Photo 1 of 1 : UCIP_5582.jpg

LM Start	1.64	Rating **	M	Issue No.	1288
LM End	1.64	Issue Type +	En	Location *	LS
Category	Supplemental			GPS Latitude/Longitude	
				Start	End
Item	DWR UCIP Field Study			38.772862 °	38.772862 °
				-121.686453 °	-121.686453 °
DWR ID	DWR_RD1500_01_s_2014_1288				
Action/Comments					
Inspector Comments: FS_ID:28204 EP_NO: N/A Repair Type: Crossing Status: UCIP Comments: - pump removed erosion around pump station. overhead electrical line. FIELD_STRUCT_DESC: 10-inch diameter steel irrigation pipeline through levee, 10.0 feet below crown. Pump and gate valve on bank. Service pole and switch panel on waterward shoulder. Pipe crosses irrigation ditch and discharges into steel distribution box on the field. FS Date: 1/9/2014

LS view: pipe crosses irrigation ditch. Steel distribution box across irrigation ditch.

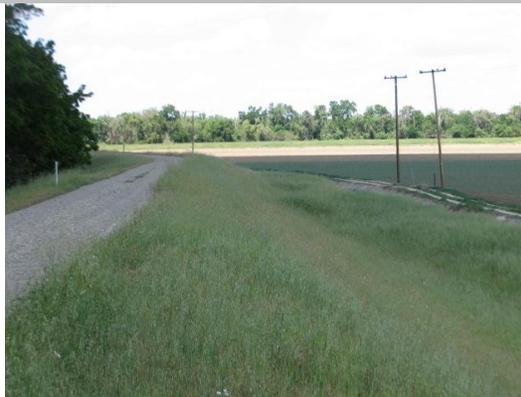
Photo 1 of 1 : johngw_s_20140428_885.jpg

LM Start	1.95	Rating **	M	Issue No.	63
LM End	33.56	Issue Type +	Ma	Location *	LS
Category	Earthen Levee			GPS Latitude/Longitude	
				Start	End
Item	Vegetation			38.777106 °	39.022818 °
				-121.685306 °	-121.820699 °
DWR ID	DWR_RD1500_01_s_2014_63				
Action/Comments					
Control annual grass and weeds on the levee slopes and easements.

Tall grasses partially blocks visibility. Spring 2014

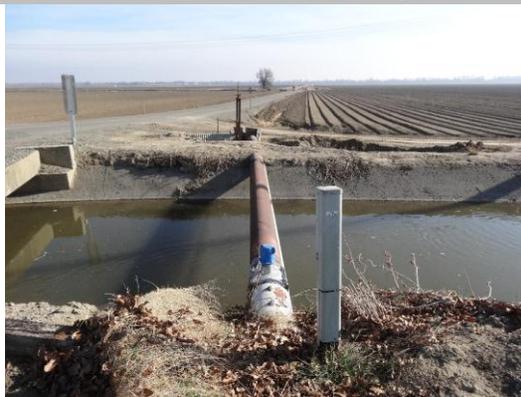
Photo 1 of 1 : UCIP_5599.jpg

LM Start	1.97	Rating **	M	Issue No.	1289
LM End	1.97	Issue Type +	En	Location *	LS
Category	Supplemental			GPS Latitude/Longitude	
				Start	End
Item	DWR UCIP Field Study			38.777433 °	38.777433 °
				-121.685348 °	-121.685348 °
DWR ID	DWR_RD1500_01_s_2014_1289				
Action/Comments					
Inspector Comments: FS_ID:28263 EP_NO: 16146 Repair Type: Crossing Status: UCIP Comments: - pump removed overhead powerline pile structure abandoned levee slope erosion due to leaky siphon breaker on landside. FIELD_STRUCT_DESC: 12-inch diameter steel pipe through levee, 12.0 feet below crown. Pump mounted on river bank, butterfly valve on waterward side. Power pole with one anchor on waterside slope. Pump discharges into 5 foot by 5 foot concrete distribution box (damaged) across the irrigation ditch on the landside. (Cat. I Furlan) (App. No. 16146) O&M Manual Sac 128, March 1960. FS Date: 1/9/2014

LS view: discharge pipe crossing irrigation ditch.

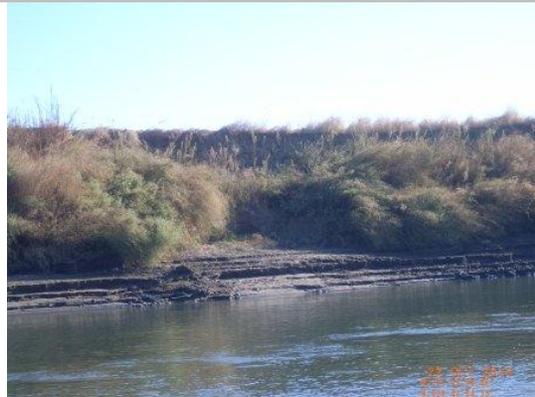
Photo 1 of 1 : USACE2013A_SAC_87-1_L_3.jpg

LM Start	2.34	Rating **	M	Issue No.	2
LM End	2.34	Issue Type +	Ma	Location *	WS
Category	Supplemental		GPS Latitude/Longitude		
			Start	End	
Item	USACE Erosion Survey		38.781962 °	38.784936 °	
			-121.688033 °	-121.690033 °	
DWR ID					
Action/Comments					
Inspector Comments: 2010 - The upstream end of the repair site at 87.0. Repair did not extend far enough upstream. 2011 - New erosion pockets. 2012 - Minor new erosion at toe. 2013: Minor new erosion. [2013 Site ID: SAC_87-1_L]

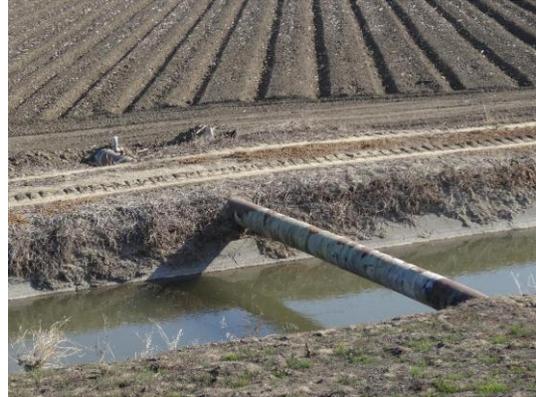
Photo 1 of 1 : UCIP_5603.jpg

LM Start	2.40	Rating **	M	Issue No.	1290
LM End	2.40	Issue Type +	En	Location *	WS
Category	Supplemental			GPS Latitude/Longitude	
				Start	End
Item	DWR UCIP Field Study			38.783184 °	38.783184 °
				-121.688136 °	-121.688136 °
DWR ID	DWR_RD1500_01_s_2014_1290				
Action/Comments					
Inspector Comments: FS_ID:28264 EP_NO: 10029 Repair Type: Crossing Status: UCIP Comments: - pump removed butlet plugged looks abandoned. Found abandoned pipe parts on levee slope and berm. overhead powerline FIELD_STRUCT_DESC: Abandoned 12-inch steel irrigation pipe through levee, 11.0-feet below crown. Two metal cutoff walls installed. Pump on bank during irrigation season. Gate valve at waterward toe. Discharges into 2.5x2.5 foot concrete distribution box on landward side of irrigation ditch. (ABO No. 10029 - Anderson). O&M Manual Sac 128, March 1960. FS Date: 1/9/2014

LS view: discharge pipe crossing irrigation ditch on landside.

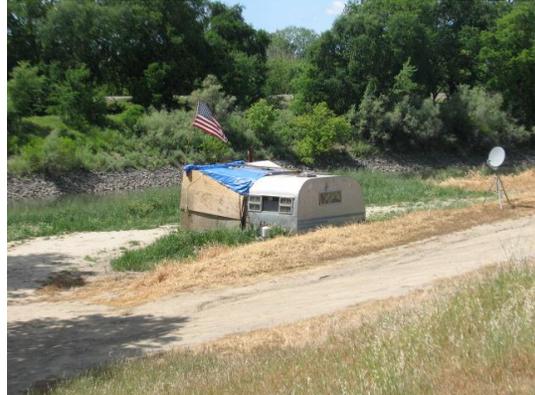
Photo 1 of 1 : johngw_s_20140428_887.jpg

LM Start	3.98	Rating **	M	Issue No.	1339
LM End	3.98	Issue Type +	En	Location *	WS
Category	Earthen Levee		GPS Latitude/Longitude		
			Start	End	
Item	Encroachments		38.797605 °	38.797605 °	
			-121.695750 °	-121.695750 °	
DWR ID	DWR_RD1500_01_s_2014_1339				
Action/Comments					
Building

A trailer and small shack is on the waterside berm. This was up stream a couple of years ago. Spring 2014

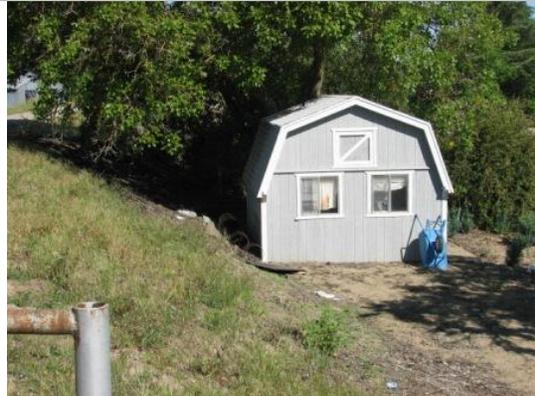
Photo 1 of 2 : johngw_s_20140414_184.jpg

LM Start	3.98	Rating **	M	Issue No.	7
LM End	3.98	Issue Type +	En	Location *	LS
Category	Earthen Levee		GPS Latitude/Longitude		
			Start	End	
Item	Encroachments		38.797607 °	38.797607 °	
			-121.695862 °	-121.695862 °	
DWR ID	DWR_RD1500_01_s_2012_7				
Action/Comments					
Building

A small building is encroaching into the landside levee toe.

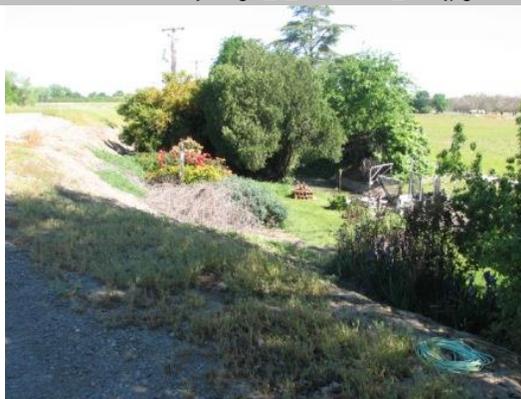
Photo 1 of 1 : johngw_s_20140414_185.jpg

LM Start	4.01	Rating **	M	Issue No.	8
LM End	4.01	Issue Type +	En	Location *	LS
Category	Earthen Levee		GPS Latitude/Longitude		
			Start	End	
Item	Vegetation		38.797827 °	38.797827 °	
			-121.695985 °	-121.695985 °	
DWR ID	DWR_RD1500_01_s_2012_8				
Action/Comments					
Landscaping

The landscape is planted into the encroachment zone within 15' of the toe.

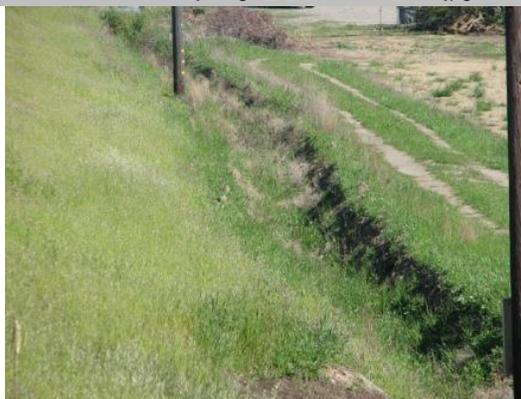
Photo 1 of 1 : johngw_s_20140414_253.jpg

LM Start	4.04	Rating **	M	Issue No.	54
LM End	4.16	Issue Type +	En	Location *	LS
Category	Earthen Levee		GPS Latitude/Longitude		
			Start	End	
Item	Encroachments		38.798572 °	38.800080 °	
			-121.696392 °	-121.696653 °	
DWR ID	DWR_RD1500_01_s_2012_54				
Action/Comments					
Ditch

An agricultural ditch runs along the toe of the levee, photo taken spring 2012.

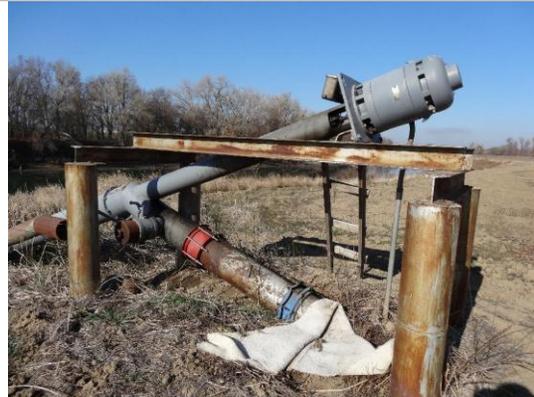
Photo 1 of 1 : UCIP_5612.jpg

LM Start	4.04	Rating **	M	Issue No.	1291
LM End	4.04	Issue Type +	En	Location *	LS
Category	Supplemental			GPS Latitude/Longitude	
				Start	End
Item	DWR UCIP Field Study			38.798436 °	38.798436 °
				-121.696280 °	-121.696280 °
DWR ID	DWR_RD1500_01_s_2014_1291				
Action/Comments					
Inspector Comments: FS_ID:28272 EP_NO: 3638 Repair Type: Crossing Status: UCIP Comments: - No protection for pressure breaker. FIELD_STRUCT_DESC: 12-inch steel irrigation pipe through levee, 2.4 feet below crown. Slant pump on berm. Pressure breaker on landward slope. Service pole at landward toe. Discharges into 36-inch diameter concrete standpipe on landside. (App. No. 3638 - J. Waters) FS Date: 1/9/2014

WS view: slant pump on steel frame on levee berm.

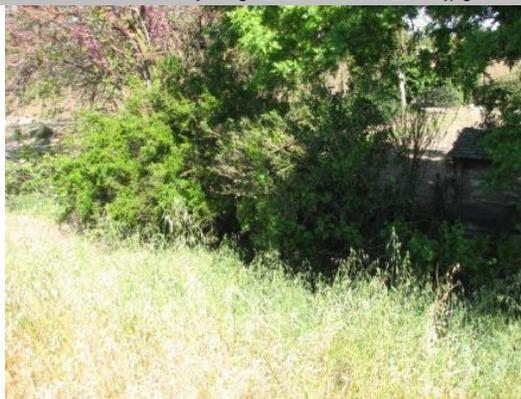
Photo 1 of 1 : johngw_s_20140414_190.jpg

LM Start	4.64	Rating **	M	Issue No.	12
LM End	4.64	Issue Type +	En	Location *	LS
Category	Earthen Levee		GPS Latitude/Longitude		
			Start	End	
Item	Vegetation		38.803585 °	38.803585 °	
			-121.702910 °	-121.702910 °	
DWR ID	DWR_RD1500_01_s_2012_12				
Action/Comments					
Landscaping

The landscape is planted within the encroachment area of 15'.

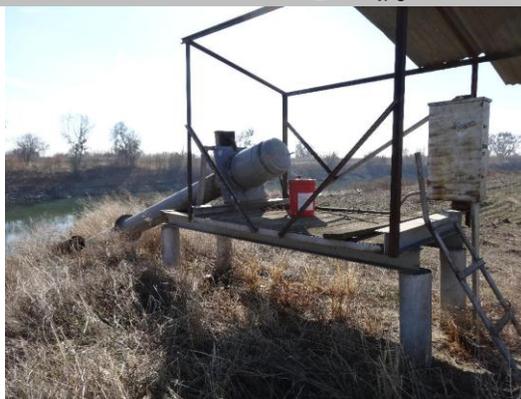
Photo 1 of 1 : UCIP_5787.jpg

LM Start	4.71	Rating **	M	Issue No.	1292
LM End	4.71	Issue Type +	En	Location *	LS
Category	Supplemental		GPS Latitude/Longitude		
			Start	End	
Item	DWR UCIP Field Study		38.803025 °	38.803025 °	
			-121.704091 °	-121.704091 °	
DWR ID	DWR_RD1500_01_s_2014_1292				
Action/Comments					
Inspector Comments: FS_ID:28912 EP_NO: 5031 Repair Type: Crossing Status: UCIP Comments: New butterfly valve in CMP riser on waterside slope. New pipe and pump needs cleaning and clearing of siphon breaker in CMP on landside. Abandoned pipe found on both sides of the levee. Abandoned 5x5 foot concrete distribution box on landside. FIELD_STRUCT_DESC: 12-inch diameter steel irrigation pipe through levee at slight angle, 4.2 feet below crown. A 2-inch diameter conduit through levee, 2.0 feet below crown. Slant pump on steel platform on berm. (App. No. 5031-Knox.) Discharges into irrigation ditch and an abandoned 5x5 foot concrete distribution box on landside. Pipe originally installed in 1950 under App. No.1466 By Estate of Caroline L. Knox reinstalled by USCE, in 1958; O&M Manual Sac 128, March 1960. FS Date: 1/9/2014

WS view: slant pump and switch panel in shed on levee berm.

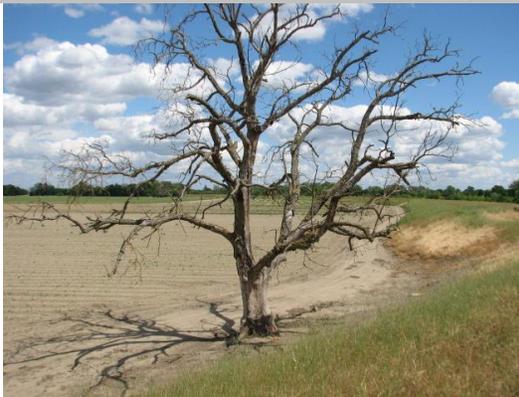
Photo 1 of 1 : johngw_s_20140428_889.jpg

LM Start	5.20	Rating **	A/W	Issue No.	1340
LM End	5.20	Issue Type +	Ma	Location *	LS
Category	Earthen Levee			GPS Latitude/Longitude	
				Start	End
Item	Vegetation			38.802164 °	38.802164 °
				-121.712560 °	-121.712560 °
DWR ID	DWR_RD1500_01_s_2014_1340				
Action/Comments					
Trees / Woody Vegetation

Monitor tree that may pose a future threat to the integrity of the levee. Spring 2014

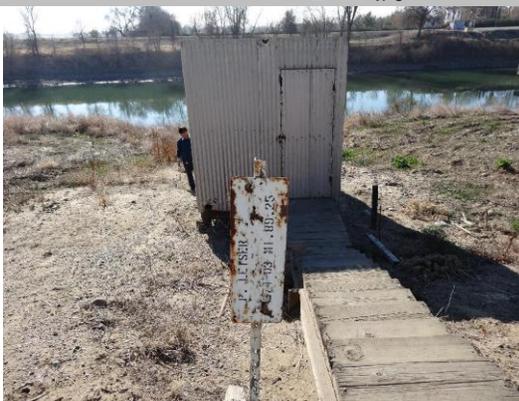
Photo 1 of 1 : UCIP_5790.jpg

LM Start	5.23	Rating **	M	Issue No.	1293
LM End	5.23	Issue Type +	En	Location *	LS
Category	Supplemental			GPS Latitude/Longitude	
				Start	End
Item	DWR UCIP Field Study			38.802322 °	38.802322 °
				-121.712908 °	-121.712908 °
DWR ID	DWR_RD1500_01_s_2014_1293				
Action/Comments					
Inspector Comments: FS_ID:28913					
EP_NO: 10056					
Repair Type:					
Crossing Status:					
UCIP Comments: Depression on landside levee slope around siphon breaker due to leakage. Siphon breaker needs protection.					
FIELD_STRUCT_DESC: 18-inch steel irrigation pipe through levee, 4.0 feet below crown. 1 1/2-inch conduit through levee, 20 ft below crown. Slant pump in CM pump house on waterside. Wooden steps on waterside slope. Siphon breaker on landside slope. A 5 ft x 5 ft Concrete distribution box at landward toe. (ABO No. 10056 - Leiser) O&M Manual Sac 128, March 1960.					
FS Date: 1/9/2014

WS view: wooden steps to pump house on levee berm.

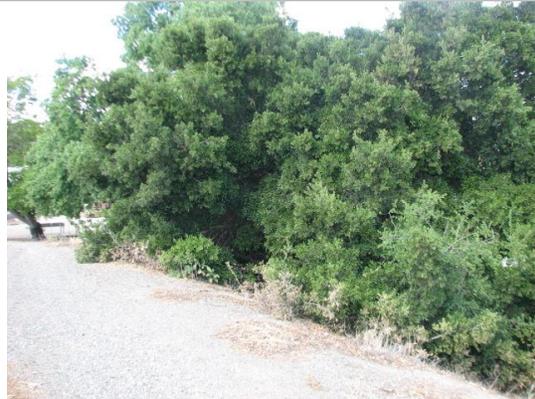
Photo 1 of 1 : johngw_s_20140428_890.jpg

Trees need to be trimmed up to at least 5' they are blocking the visibility. Spring 2014

LM Start	5.30	Rating **	M	Issue No.	1341
LM End	5.30	Issue Type +	Ma	Location *	LS
Category	Earthen Levee		GPS Latitude/Longitude		
			Start	End	
Item	Trim / Thin Trees		38.802827 °	38.802827 °	
			-121.714043 °	-121.714043 °	
DWR ID	DWR_RD1500_01_s_2014_1341				
Action/Comments					
Trim trees to at least five feet above ground level.

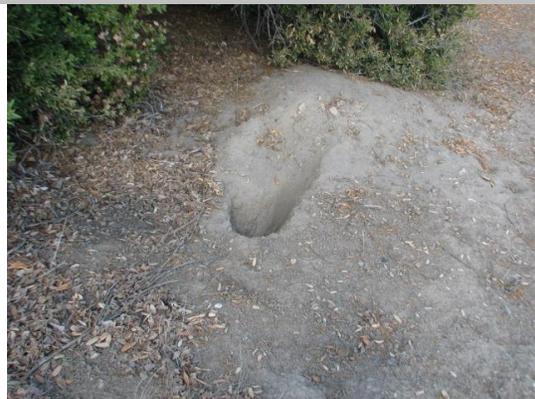
Photo 1 of 1 : johngw_s_20140428_891.jpg

A rodent hole on the landside leveehslope. Spring 2014

LM Start	5.30	Rating **	M	Issue No.	1342
LM End	5.30	Issue Type +	Ma	Location *	LS
Category	Earthen Levee		GPS Latitude/Longitude		
			Start	End	
Item	Animal Control		38.802826 °	38.802826 °	
			-121.714044 °	-121.714044 °	
DWR ID	DWR_RD1500_01_s_2014_1342				
Action/Comments					
Exterminate rodents and backfill and compact or grout burrows.

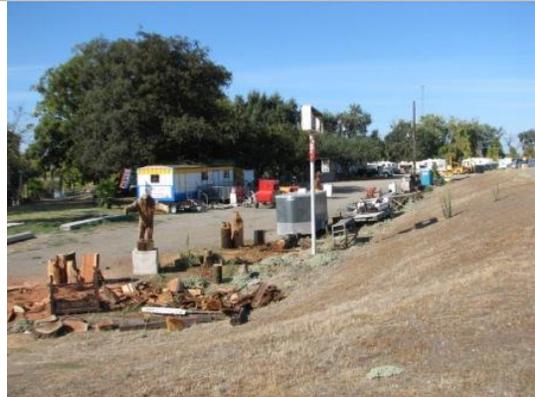
Photo 1 of 2 : johngw_s_20140414_250.jpg

LM Start	5.67	Rating **	M	Issue No.	52
LM End	5.75	Issue Type +	En	Location *	WS
Category	Earthen Levee		GPS Latitude/Longitude		
			Start	End	
Item	Encroachments		38.803005 °	38.803238 °	
			-121.720380 °	-121.721847 °	
DWR ID	DWR_RD1500_01_s_2012_52				
Action/Comments					
Building Inspector Comments: Sting Rayz Beach Boardwalk Marina on the waterside berm.

String Razs Fall 2013

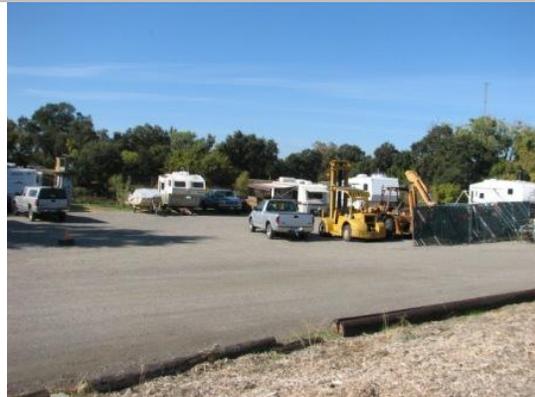
Photo 2 of 2 : johngw_s_20140414_251.jpg

LM Start	5.67	Rating **	M	Issue No.	52 (cont)
LM End	5.75	Issue Type +	En	Location *	WS

String Razs RV park Fall 2013

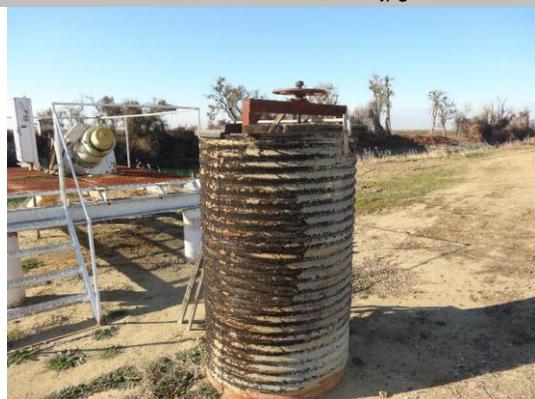
Photo 1 of 1 : UCIP_5615.jpg

LM Start	6.53	Rating **	M	Issue No.	1294
LM End	6.53	Issue Type +	En	Location *	WS
Category	Supplemental		GPS Latitude/Longitude		
			Start	End	
Item	DWR UCIP Field Study		38.814501 °	38.814501 °	
			-121.723040 °	-121.723040 °	
DWR ID	DWR_RD1500_01_s_2014_1294				
Action/Comments					
Inspector Comments: FS_ID:28286

WS view: CMP riser with slide gate and slant pump on steel platform on levee berm.

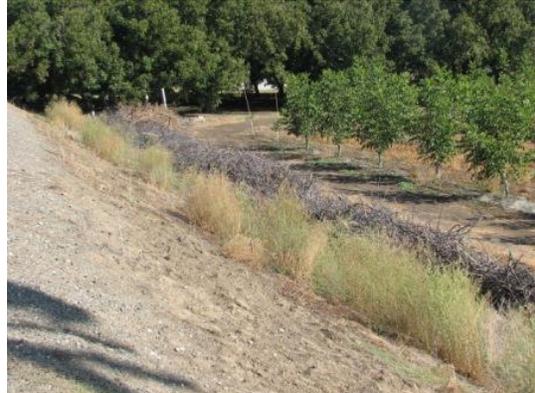
Photo 1 of 2 : johngw_s_20140414_282.jpg

LM Start	7.18	Rating **	M	Issue No.	216
LM End	7.18	Issue Type +	Ma	Location *	LS
Category	Earthen Levee		GPS Latitude/Longitude		
			Start	End	
Item	Encroachments		38.823781 °	38.823781 °	
			-121.722752 °	-121.722752 °	
DWR ID	DWR_RD1500_01_s_2012_216				
Action/Comments					
Prunings

The landowner has piled prunings along the levee toe.

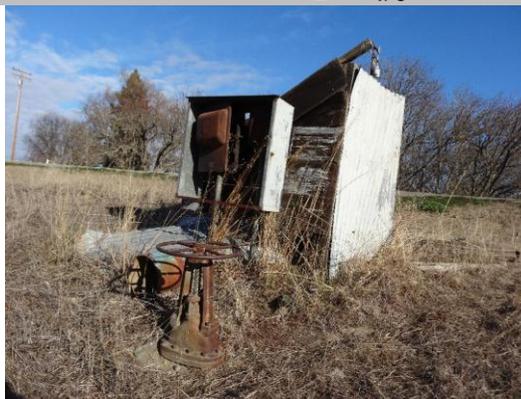
Photo 1 of 1 : UCIP_5793.jpg

LM Start	7.22	Rating **	M	Issue No.	1295
LM End	7.22	Issue Type +	En	Location *	LS
Category	Supplemental			GPS Latitude/Longitude	
				Start	End
Item	DWR UCIP Field Study			38.824208 °	38.824208 °
				-121.722793 °	-121.722793 °
DWR ID	DWR_RD1500_01_s_2014_1295				
Action/Comments					
Inspector Comments: FS_ID:28923 EP_NO: 10048 Repair Type: Crossing Status: UCIP Comments: An abandoned pipe. Highly deteriorated pipe on river bank. Needs proper abandonment. Not found- Siphon breaker at landward levee toe. FIELD_STRUCT_DESC: Abandoned 10-inch diameter irrigation pipe through levee, 4.5 feet below crown. A 1-inch conduit through levee, 4.5 feet below crown. A pump in metal shed on bank. Gate valve on waterside end. Service pole and 24-inch Concrete standpipe at landside toe. Installed by USCE, 1958 (ABO. No. 10048-King) O&M Manual Sac 128, March 1960. FS Date: 1/9/2014

WS view: dilapidated and abandoned CM pump house on berm. Pipe and gate valve also on berm.

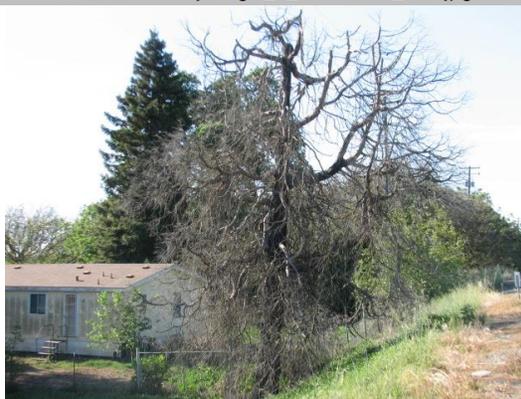
Photo 1 of 1 : johngw_s_20140428_900.jpg

LM Start	7.26	Rating **	A/W	Issue No.	1343
LM End	7.26	Issue Type +	Ma	Location *	LS
Category	Earthen Levee			GPS Latitude/Longitude	
				Start	End
Item	Vegetation			38.824900 °	38.824900 °
				-121.722851 °	-121.722851 °
DWR ID	DWR_RD1500_01_s_2014_1343				
Action/Comments					
Trees / Woody Vegetation

Monitor tree that may pose a future threat to the integrity of the levee. Spring 2014

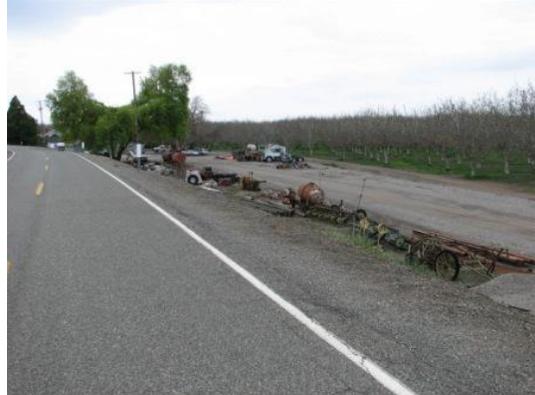
Photo 1 of 1 : johngw_s_20140414_193.jpg

LM Start	7.57	Rating **	M	Issue No.	16
LM End	7.57	Issue Type +	Ma	Location *	LS
Category	Earthen Levee		GPS Latitude/Longitude		
			Start	End	
Item	Encroachments		38.828975 °	38.828975 °	
			-121.724265 °	-121.724265 °	
DWR ID	DWR_RD1500_01_s_2012_16				
Action/Comments					
Equipment

Equipment along landside toe. Photo was taken in spring 2010.

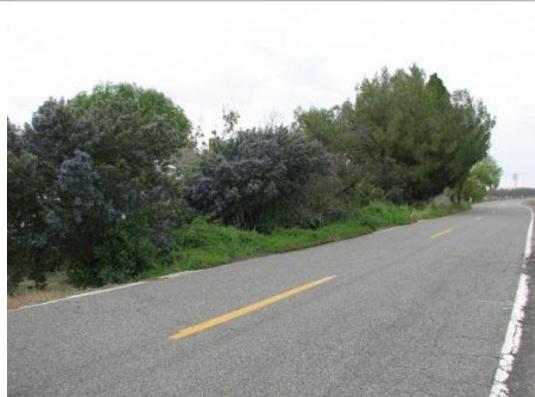
Photo 1 of 2 : johngw_s_20140414_194.jpg

LM Start	7.66	Rating **	M	Issue No.	17
LM End	7.66	Issue Type +	En	Location *	LS
Category	Earthen Levee		GPS Latitude/Longitude		
			Start	End	
Item	Vegetation		38.830260 °	38.830260 °	
			-121.725357 °	-121.725357 °	
DWR ID	DWR_RD1500_01_s_2012_17				
Action/Comments					
Landscaping

Landscape shrubs, photo taken in spring 2010.

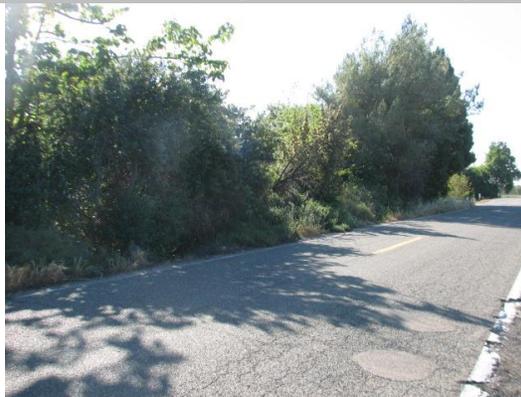
Photo 2 of 2 : johngw_s_20140428_901.jpg

LM Start	7.66	Rating **	M	Issue No.	17 (cont)
LM End	7.66	Issue Type +	En	Location *	LS
Category	Earthen Levee			GPS Latitude/Longitude	
				Start	End
Item	Vegetation			38.830260 °	38.830260 °
				-121.725357 °	-121.725357 °
DWR ID	DWR_RD1500_01_s_2012_17				
Action/Comments					
Landscaping

A current view of the landscape on the levee slope. Spring 2014

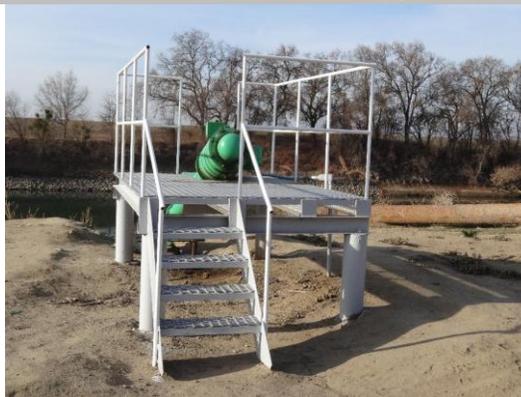
Photo 1 of 1 : UCIP_5795.jpg

LM Start	7.78	Rating **	M	Issue No.	1296
LM End	7.78	Issue Type +	En	Location *	LS
Category	Supplemental			GPS Latitude/Longitude	
				Start	End
Item	DWR UCIP Field Study			38.831638 °	38.831638 °
				-121.726580 °	-121.726580 °
DWR ID	DWR_RD1500_01_s_2014_1296				
Action/Comments					
Inspector Comments: FS_ID:28924 EP_NO: 8147 Repair Type: Crossing Status: UCIP Comments: Not found- slide gate in 48-inch corrugated metal riser at waterside to repair works under way. Contact LMA for repair works information. Sign of leaky pipe and siphon breaker. This needs detailed investigation. FIELD_STRUCT_DESC: 12-inch steel irrigation pipe through levee, 4.8 feet below crown. Slant pump mounted on steel structure at the edge of berm. A 4 X 4 foot concrete distribution box at landward toe. (App. No. 8147 - Driver) FS Date: 1/10/2014

WS view: slant pump on steel platform on end of berm.

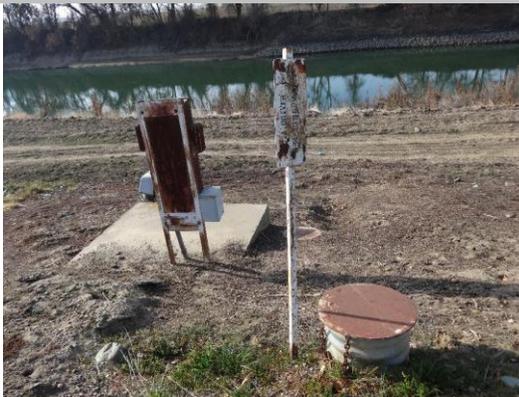
Photo 1 of 1 : UCIP_5618.jpg

LM Start	8.04	Rating **	M	Issue No.	1297
LM End	8.04	Issue Type +	En	Location *	LS
Category	Supplemental			GPS Latitude/Longitude	
				Start	End
Item	DWR UCIP Field Study			38.834260 °	38.834260 °
				-121.729566 °	-121.729566 °
DWR ID	DWR_RD1500_01_s_2014_1297				
Action/Comments					
Inspector Comments: FS_ID:28323 EP_NO: 13882 Repair Type: Crossing Status: UCIP Comments: Power pole on landside. 2-inch conduit through the levee. Service box on waterside. Concrete pad on waterside. Not found- Concrete distribution box on landward side; not found- gate valve on waterside. Need proper abandonment. Pipe visible on river bank, waterside levee slope and landside field. FIELD_STRUCT_DESC: Abandoned 6-inch diameter steel irrigation pipe and electric conduit through levee, 4.9 feet below crown. 1-1/2 conduit through levee, 4.0 feet below crown. Service pole at landward levee toe. (ABO. No. 10062-Moroni, App. No. 13882) FS Date: 1/10/2014

WS view: CMP with air vent (right), concrete pad (left), and switch panel (left) on levee slope.

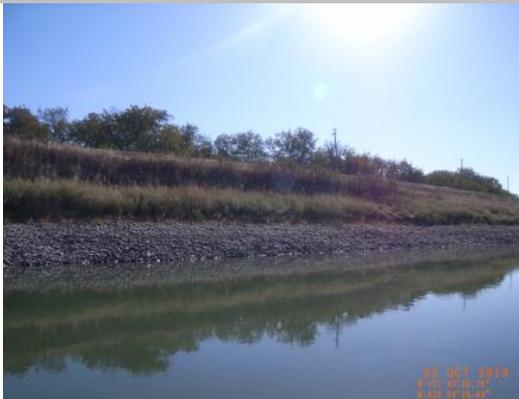
Photo 1 of 1 : USACE2013A_SAC_92-8_L_2.jpg

LM Start	8.30	Rating **	M	Issue No.	3
LM End	8.30	Issue Type +	Ma	Location *	WS
Category	Supplemental			GPS Latitude/Longitude	
				Start	End
Item	USACE Erosion Survey			38.838464 °	38.840347 °
				-121.730205 °	-121.726857 °
DWR ID					
Action/Comments					
Inspector Comments: 1997 - Damage to cobble revetment on top left bank and toe damage. 2004 - Site is pretty minor. 2010 - Cobbles continue to deteriorate. 2011 - Minor new erosion at the toe. 2013: Might be able to shorten due to deposition. [2013 Site ID: SAC_92-8_L]

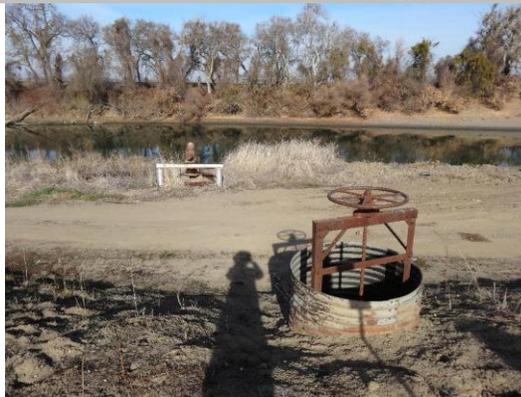
Photo 1 of 1 : UCIP_5621.jpg

LM Start	8.42	Rating **	M	Issue No.	1298
LM End	8.42	Issue Type +	En	Location *	WS
Category	Supplemental		GPS Latitude/Longitude		
			Start	End	
Item	DWR UCIP Field Study		38.839446 °	38.839446 °	
			-121.728901 °	-121.728901 °	
DWR ID	DWR_RD1500_01_s_2014_1298				
Action/Comments					
Inspector Comments: FS_ID:28324 EP_NO: 10064 Repair Type: Crossing Status: UCIP Comments: Looks abandoned as service pole not found. May need proper abandonment. FIELD_STRUCT_DESC: 2 foot by 2 foot concrete box culvert through levee, 13.0 feet below crown. Pump on 6 foot diameter concrete pump well on berm. Slide gate in 42-inch CM riser on waterward slope. 4.5 foot by 6 foot concrete distribution box at landward toe. (ABO No. 10064 - Nix) FS Date: 1/10/2014

WS view: slide gate in CMP riser on levee slope. Looks abandoned.

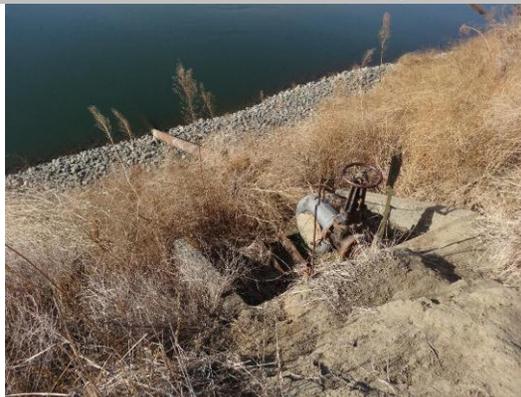
Photo 1 of 1 : UCIP_5624.jpg

LM Start	8.74	Rating **	M	Issue No.	1299
LM End	8.74	Issue Type +	En	Location *	WS
Category	Supplemental		GPS Latitude/Longitude		
			Start	End	
Item	DWR UCIP Field Study		38.842218 °	38.842218 °	
			-121.725728 °	-121.725728 °	
DWR ID	DWR_RD1500_01_s_2014_1299				
Action/Comments					
Inspector Comments: FS_ID:28343 EP_NO: 5518 Repair Type: Crossing Status: UCIP Comments: Not found- siphon breaker on landward shoulder. Pump removed. FIELD_STRUCT_DESC: 10-inch diameter steel irrigation pipe through levee, 2.5 feet below crown. Pump on concrete platform. 1-inch conduit installed in joint trench. Service pole at landward levee toe. Discharges into 4x4 foot concrete distribution box on landward side. Installed in 1966 under application No. 5518 by I.E. Bundock-M.Bundock, River Mile 92.9. FS Date: 1/10/2014

WS view: U type concrete headwall, pipe, and pump on river bank.

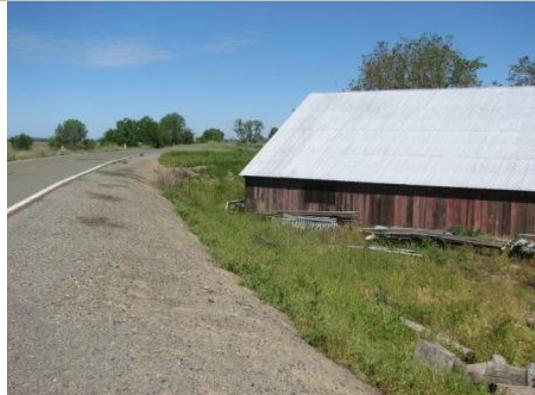
Photo 1 of 1 : johngw_s_20140414_195.jpg

LM Start	8.79	Rating **	M	Issue No.	18
LM End	8.79	Issue Type +	En	Location *	LS
Category	Earthen Levee		GPS Latitude/Longitude		
			Start	End	
Item	Encroachments		38.842673 °	38.842673 °	
			-121.726442 °	-121.726442 °	
DWR ID	DWR_RD1500_01_s_2012_18				
Action/Comments					
Building

The corner of the building has encroached into the toe.

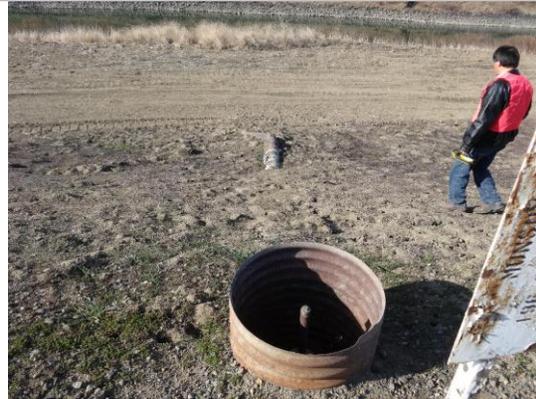
Photo 1 of 1 : UCIP_5627.jpg

LM Start	9.03	Rating **	M	Issue No.	1300
LM End	9.03	Issue Type +	En	Location *	LS
Category	Supplemental			GPS Latitude/Longitude	
				Start	End
Item	DWR UCIP Field Study			38.845578 °	38.845578 °
				-121.728406 °	-121.728406 °
DWR ID	DWR_RD1500_01_s_2014_1300				
Action/Comments					
Inspector Comments: FS_ID:28363 EP_NO: 8503 Repair Type: Crossing Status: UCIP Comments: Looks abandoned. No pump found on WS. New well near landside. May need proper abandonment. Exposed pipe on waterside. Found steel plate closed pipe on landside. FIELD_STRUCT_DESC: Abandoned 12-inch steel irrigation pipe through levee, 3.8 feet below crown. Pump on concrete pad with headwall. Siphon breaker in 24-inch CM riser on waterward slope. 1-1/4-inch conduit through levee, 3.0 feet below crown. Service pole with switch panel at landward toe. Concrete distribution box on landward toe. (App. No. 8503 - Munson) O&M Manual Sac 128, March 1960. FS Date: 1/10/2014

WS view: siphon breaker in CMP riser on levee slope.

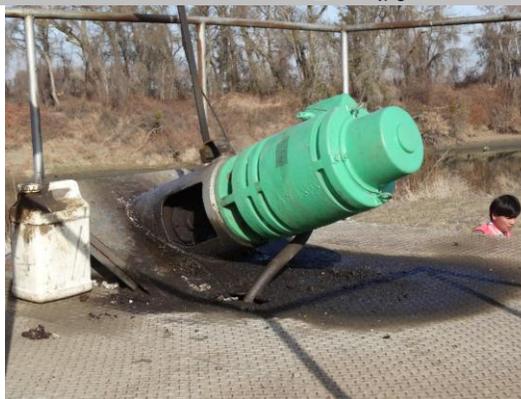
Photo 1 of 1 : UCIP_5631.jpg

LM Start	9.20	Rating **	M	Issue No.	1301
LM End	9.20	Issue Type +	En	Location *	LS
Category	Supplemental			GPS Latitude/Longitude	
				Start	End
Item	DWR UCIP Field Study			38.847841 °	38.847841 °
				-121.727172 °	-121.727172 °
DWR ID	DWR_RD1500_01_s_2014_1301				
Action/Comments					
Inspector Comments: FS_ID:28364 EP_NO: 5598 Repair Type: Crossing Status: UCIP Comments: Not found- Wood headwall 18 ft from landward toe. Not found- Flap gate on landward side. No outlet structure found. Only a capped pipe found, but not sure whether it is connected to the crossing. FIELD_STRUCT_DESC: 12-inch steel irrigation pipe through levee, 4.8 feet below crown. Electrical conduit through levee, 4.8 feet below crown. Slant pump on steel structure. Siphon breaker in landward shoulder. Service pole on landside toe. Discharges into field. Installed 1967. (App. No. 5598 & 8505 - James) FS Date: 1/10/2014

WS view: slant pump on steel platform on levee berm. Excessive oil leak from the pump.

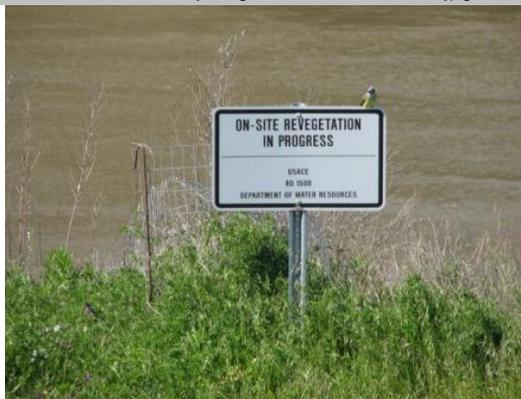
Photo 1 of 2 : johngw_s_20140414_270.jpg

LM Start	9.47	Rating **	A/W	Issue No.	74
LM End	9.71	Issue Type +	Ma	Location *	WS
Category	Earthen Levee			GPS Latitude/Longitude	
				Start	End
Item	Vegetation			38.850267 °	38.853222 °
				-121.723275 °	-121.724062 °
DWR ID	DWR_RD1500_01_s_2012_74				
Action/Comments					
Environmental Requirements.

Another revegetation site photo taken spring 2012.

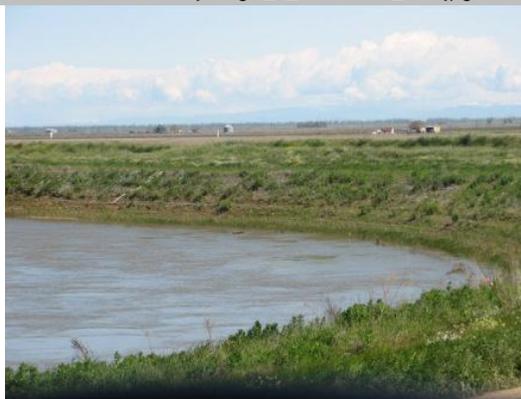
Photo 2 of 2 : johngw_s_20140414_271.jpg

LM Start	9.47	Rating **	A/W	Issue No.	74 (cont)
LM End	9.71	Issue Type +	Ma	Location *	WS
Category	Earthen Levee			GPS Latitude/Longitude	
				Start	End
Item	Vegetation			38.850267 °	38.853222 °
				-121.723275 °	-121.724062 °
DWR ID	DWR_RD1500_01_s_2012_74				
Action/Comments					
Environmental Requirements.

A revegetation site on the waterside bank with sprinklers installed.

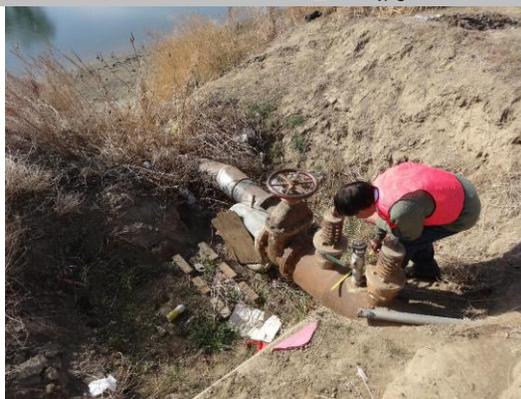
Photo 1 of 1 : UCIP_5633.jpg

LM Start	9.74	Rating **	M	Issue No.	1302
LM End	9.74	Issue Type +	En	Location *	WS
Category	Supplemental			GPS Latitude/Longitude	
				Start	End
Item	DWR UCIP Field Study			38.853364 °	38.853364 °
				-121.724617 °	-121.724617 °
DWR ID	DWR_RD1500_01_s_2014_1302				
Action/Comments					
Inspector Comments: FS_ID:28365 EP_NO: N/A Repair Type: Crossing Status: UCIP Comments: Looks abandoned. Pump has been removed. No outlet pipe found. Not found- Wooden service panel and 3x5 foot concrete distribution box at landward shoulder may need proper abandonment. FIELD_STRUCT_DESC: 14-inch diameter steel irrigation pipe through levee, 4.2 feet below crown. Pump and gate valve on concrete pump platform on bank. Siphon breaker on waterward shoulder. Service panel and pole on waterside shoulder. O&M Manual Sac 128, March 1960. FS Date: 1/10/2014

LS view: U type concrete headwall, pipe, gate valve, and pump (removed and plugged with plywood) on river bank.

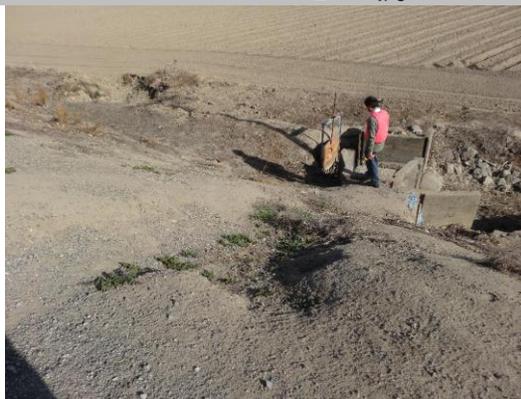
Photo 1 of 1 : UCIP_5637.jpg

LM Start	10.21	Rating **	M	Issue No.	1303
LM End	10.21	Issue Type +	En	Location *	WS
Category	Supplemental			GPS Latitude/Longitude	
				Start	End
Item	DWR UCIP Field Study			38.857853 °	38.857853 °
				-121.728222 °	-121.728222 °
DWR ID	DWR_RD1500_01_s_2014_1303				
Action/Comments					
Inspector Comments: FS_ID:28366 EP_NO: 10068 Repair Type: Crossing Status: UCIP Comments: Surface erosion along pipe alignment on landside FIELD_STRUCT_DESC: A 2 foot by 2.5 foot concrete box culvert through levee, 13.0 feet below crown. A pump on river bank, power pole and switch panel on waterside berm. Concrete surge box with slide gate on waterside berm. Concrete distribution box at landward toe. (ABO. No. 10068-Reel) O&M Manual Sac 128, March 1960. FS Date: 1/10/2014

LS view: surface erosion along pipe alignment on landside.

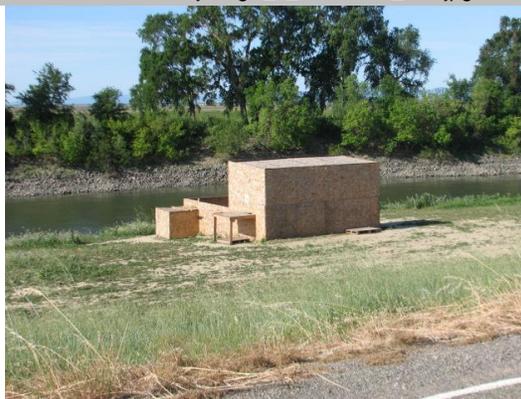
Photo 1 of 1 : johngw_s_20140428_903.jpg

LM Start	10.69	Rating **	M	Issue No.	1345
LM End	10.69	Issue Type +	En	Location *	WS
Category	Earthen Levee			GPS Latitude/Longitude	
				Start	End
Item	Encroachments			38.861168 °	38.861168 °
				-121.735150 °	-121.735150 °
DWR ID	DWR_RD1500_01_s_2014_1345				
Action/Comments					
Building

A temporary building (fishing shack) is on the waterside berm. Spring 2014

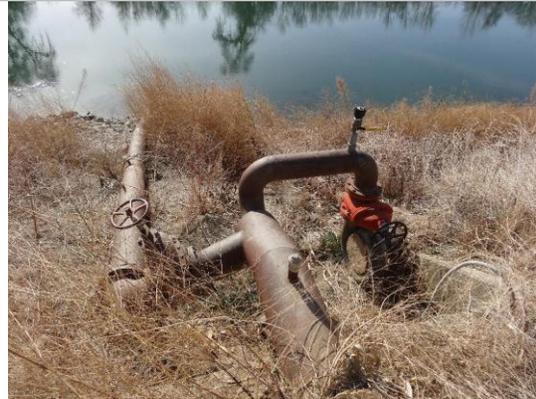
Photo 1 of 1 : UCIP_5801.jpg

LM Start	10.79	Rating **	M	Issue No.	1304
LM End	10.79	Issue Type +	En	Location *	WS
Category	Supplemental			GPS Latitude/Longitude	
				Start	End
Item	DWR UCIP Field Study			38.861550 °	38.861550 °
				-121.737006 °	-121.737006 °
DWR ID	DWR_RD1500_01_s_2014_1304				
Action/Comments					
Inspector Comments: FS_ID:28925 EP_NO: N/A Repair Type: Crossing Status: UCIP Comments: Pump removed obstructed siphon breaker in CMP riser on landside. FIELD_STRUCT_DESC: A 12-inch diameter steel irrigation pipe through levee, 4.3 feet below crown. A 1-1/2 conduit through levee. 2.0 feet below crown. Pump on river bank, siphon breaker on landside shoulder. A 8x6 ft. concrete distribution box and service pole at landside toe. O&M Manual Sac 128, March 1960. FS Date: 1/10/2014

WS view: pipe, pump (removed and plugged with plywood), headwall, and appurtenances on river bank.

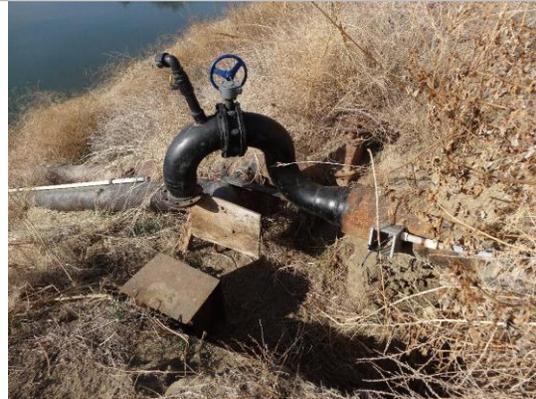
Photo 1 of 1 : UCIP_5643.jpg

LM Start	11.34	Rating **	M	Issue No.	1305
LM End	11.34	Issue Type +	En	Location *	WS
Category	Supplemental		GPS Latitude/Longitude		
			Start	End	
Item	DWR UCIP Field Study		38.865649 °	38.865649 °	
			-121.745279 °	-121.745279 °	
DWR ID	DWR_RD1500_01_s_2014_1305				
Action/Comments					
Inspector Comments: FS_ID:28384 EP_NO: N/A Repair Type: Crossing Status: UCIP Comments: Pump removed 10-inch pipe joined to 14-inch pipe. Wet, some vegetations, and subsidence along pipe alignment on landside. This needs detailed investigation. FIELD_STRUCT_DESC: 14-inch diameter steel irrigation pipe through levee. 4.7 feet below crown. Pump and gate valve on concrete platform on bank. Switch control house and service pole on shoulder. Siphon breaker on landside slope. Concrete distribution box on landward side. O&M Manual Sac 128, March 1960. FS Date: 1/10/2014

WS view: pipe, pump (removed and plugged with plywood plate), and appurtenances on river bank.

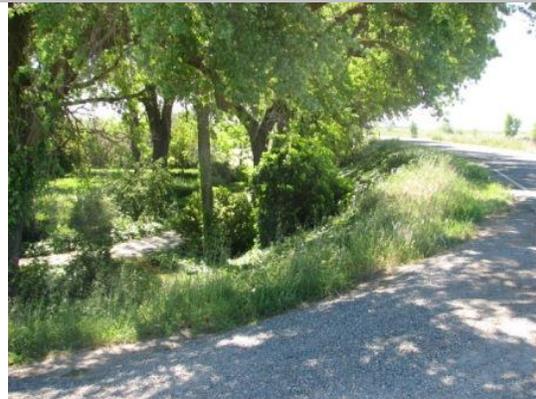
Photo 1 of 1 : johngw_s_20140414_199.jpg

LM Start	11.43	Rating **	M	Issue No.	20
LM End	11.43	Issue Type +	En	Location *	LS
Category	Earthen Levee		GPS Latitude/Longitude		
			Start	End	
Item	Vegetation		38.866762 °	38.866762 °	
			-121.746125 °	-121.746125 °	
DWR ID	DWR_RD1500_01_s_2012_20				
Action/Comments					
Landscaping

The homeowner has landscaped the levee slope.

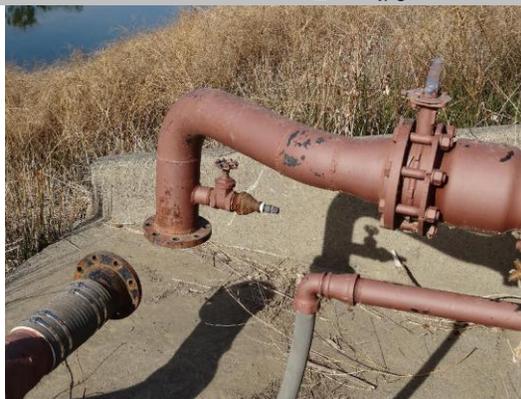
Photo 1 of 1 : UCIP_5647.jpg

LM Start	11.56	Rating **	M	Issue No.	1306
LM End	11.56	Issue Type +	En	Location *	LS
Category	Supplemental			GPS Latitude/Longitude	
				Start	End
Item	DWR UCIP Field Study			38.868544 °	38.868544 °
				-121.746471 °	-121.746471 °
DWR ID	DWR_RD1500_01_s_2014_1306				
Action/Comments					
Inspector Comments: FS_ID:28385 EP_NO: 10041 Repair Type: Crossing Status: UCIP Comments: Depressions on both sides of the levee slope. It needs more investigation. Pump removed. FIELD_STRUCT_DESC: 8-inch steel irrigation pipe through levee, 4.0 feet below crown. Pump and gate valve on concrete pump platform on bank. Corrugated metal switch house on waterside. Service pole on waterside shoulder. 8 foot by 6 foot I.D. concrete distribution box on landside. Overhead power line. Pole at landward toe. (ABO No. 10041 - Duffy) O&M Manual Sac 128, March 1960. FS Date: 1/10/2014

WS view: pipe, pump (removed), headwall, and appurtenances on river bank.

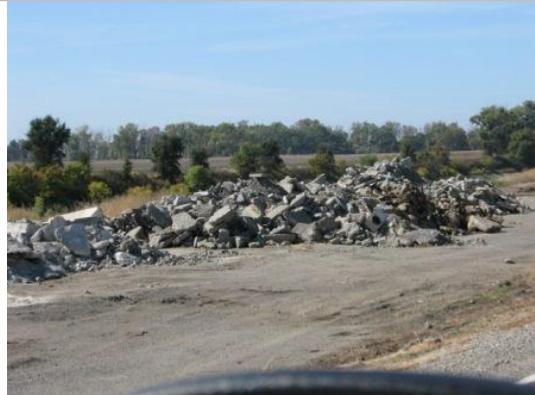
Photo 1 of 2 : johngw_s_20140414_284.jpg

LM Start	11.93	Rating **	M	Issue No.	219
LM End	11.93	Issue Type +	Ma	Location *	WS
Category	Earthen Levee		GPS Latitude/Longitude		
			Start	End	
Item	Encroachments		38.872220 °	38.872220 °	
			-121.749785 °	-121.749785 °	
DWR ID	DWR_RD1500_01_s_2012_219				
Action/Comments					
Debris

Concrete debris stockpiled on the waterside. Fall 2013

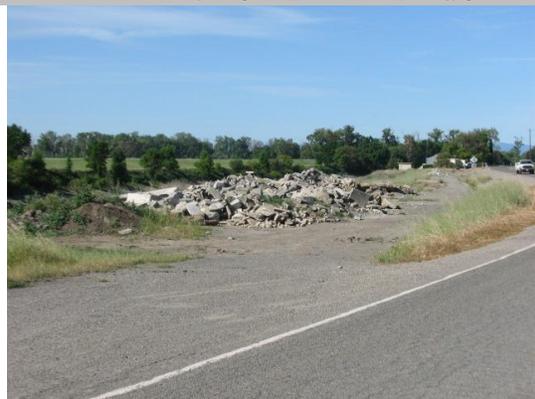
Photo 2 of 2 : johngw_s_20140428_904.jpg

LM Start	11.93	Rating **	M	Issue No.	219 (cont)
LM End	11.93	Issue Type +	Ma	Location *	WS

Concrete debris is along the berm area. Spring 2014
