**Flood Control Project Maintenance
Levee Inspections**
LMA District Cover Sheet
Spring 2014 Levee Inspection Results

Reclamation District No. 1500 Sutter Basin

Spring 2014 Levee Inspection Results

Waterway		Bank	Unit Miles
Unit No. 01 Sacramento River		Left	33.58

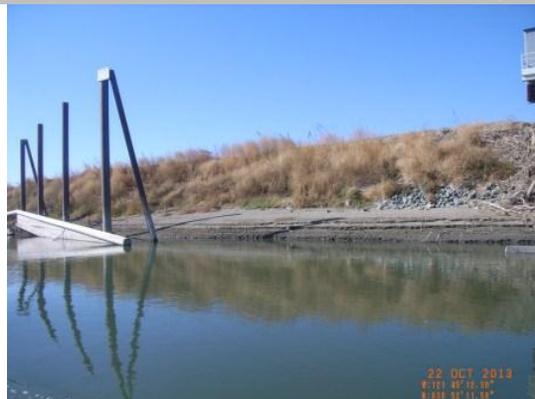
Photo 1 of 1 : USACE2013A_SAC_96-2_L_11.jpg

LM Start	12.14	Rating **	M	Issue No.	10
LM End	12.14	Issue Type +	Ma	Location *	WS
Category	Supplemental			GPS Latitude/Longitude	
				Start	End
Item	USACE Erosion Survey			38.870474 °	38.869139 °
				-121.752237 °	-121.757108 °
DWR ID					
Action/Comments					
Inspector Comments: 2000 - Vertical Modesto Formation bank with mass failure. 2003 - Upstream end has some new bank retreat. 2004 - Upstream end is worse. 2006 - Some new erosion, mainly on the steep slope and scarps. (Pumping station is not part of the erosion site.) 2010 - Some new erosion and deposition at upstream end, definite encroachments. 2011 - Minor new erosion at the toe. 2013: No observed changes. [2013 Site ID: SAC_96-2_L]

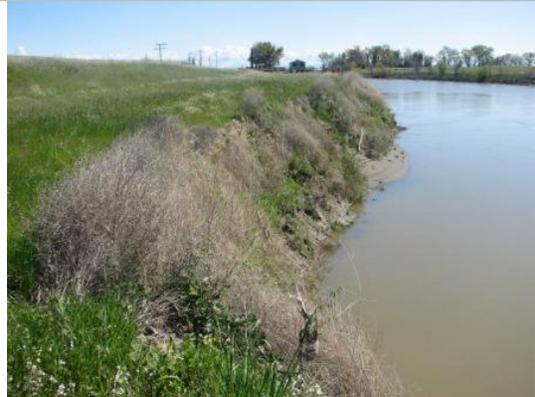
Photo 1 of 1 : johngw_s_20140414_247.jpg

LM Start	12.31	Rating **	A/W	Issue No.	50
LM End	12.31	Issue Type +	Ma	Location *	WS
Category	Earthen Levee			GPS Latitude/Longitude	
				Start	End
Item	Erosion / Bank Caving			38.869700 °	38.869700 °
				-121.755945 °	-121.755945 °
DWR ID	DWR_RD1500_01_s_2012_50				
Action/Comments					
Note and monitor erosion site. Inspector Comments: wide berm

An erosion site along the embankment, photo taken spring 2012.

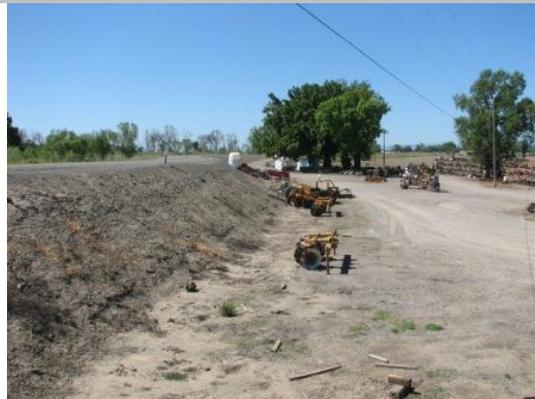
Photo 1 of 2 : johngw_s_20140414_201.jpg

LM Start	12.55	Rating **	M	Issue No.	24
LM End	12.55	Issue Type +	Ma	Location *	LS
Category	Earthen Levee			GPS Latitude/Longitude	
				Start	End
Item	Encroachments			38.868717 °	38.868717 °
				-121.760133 °	-121.760133 °
DWR ID	DWR_RD1500_01_s_2012_24				
Action/Comments					
Equipment

There is equipment parked along the toe of the levee.

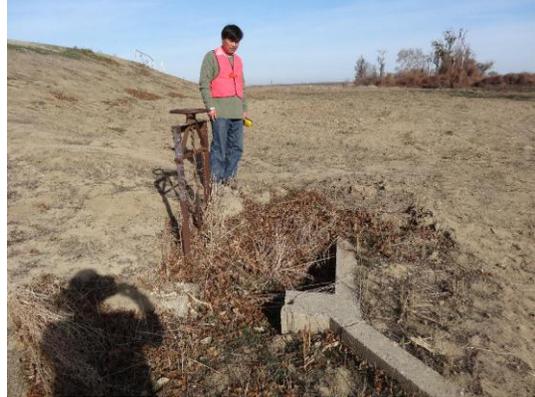
Photo 1 of 1 : UCIP_5655.jpg

LM Start	12.68	Rating **	M	Issue No.	1307
LM End	12.68	Issue Type +	En	Location *	LS
Category	Supplemental		GPS Latitude/Longitude		
			Start	End	
Item	DWR UCIP Field Study		38.867254 °	38.867254 °	
			-121.761212 °	-121.761212 °	
DWR ID	DWR_RD1500_01_s_2014_1307				
Action/Comments					
Inspector Comments: FS_ID:28463

WS view: slide gate (left) in concrete box at levee toe. Slide gate and the box mostly buried.

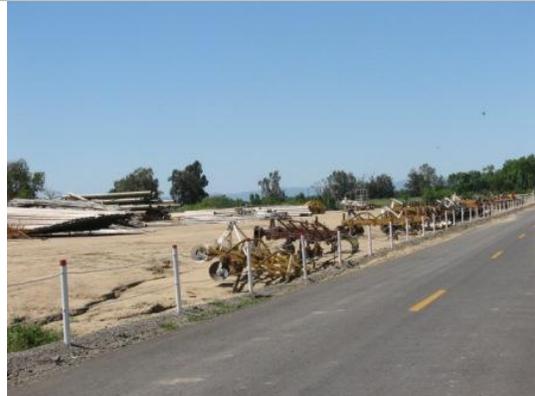
Photo 1 of 1 : johngw_s_20140414_202.jpg

LM Start	12.93	Rating **	A/W	Issue No.	25
LM End	12.93	Issue Type +	Ma	Location *	CR
Category	Earthen Levee		GPS Latitude/Longitude		
			Start	End	
Item	Encroachments		38.865127 °	38.865127 °	
			-121.765157 °	-121.765157 °	
DWR ID	DWR_RD1500_01_s_2012_25				
Action/Comments					
Equipment

On top of the crown is farm equipment and irrigation pipe.

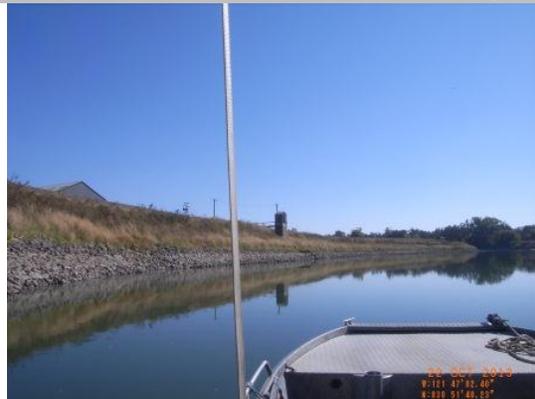
Photo 1 of 1 : USACE2013A_SAC_99-0_L_1.jpg

LM Start	13.98	Rating **	M	Issue No.	15
LM End	13.98	Issue Type +	Ma	Location *	WS
Category	Supplemental		GPS Latitude/Longitude		
			Start	End	
Item	USACE Erosion Survey		38.857239 °	38.861899 °	
			-121.783771 °	-121.784057 °	
DWR ID					
Action/Comments					
Inspector Comments: 1997 - Intermittent toe failure of the hand placed riprap; failure of toe materials. 2013: No observed changes. [2013 Site ID: SAC_99-0_L]

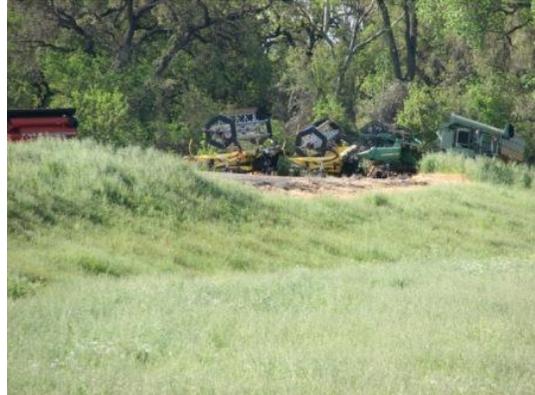
Photo 1 of 1 : johngw_s_20140414_205.jpg

LM Start	14.13	Rating **	A/W	Issue No.	28
LM End	14.13	Issue Type +	Ma	Location *	WS
Category	Earthen Levee		GPS Latitude/Longitude		
			Start	End	
Item	Encroachments		38.857792 °	38.857792 °	
			-121.783265 °	-121.783265 °	
DWR ID	DWR_RD1500_01_s_2012_28				
Action/Comments					
Equipment

View of equipment. Photo was taken in spring 2010.

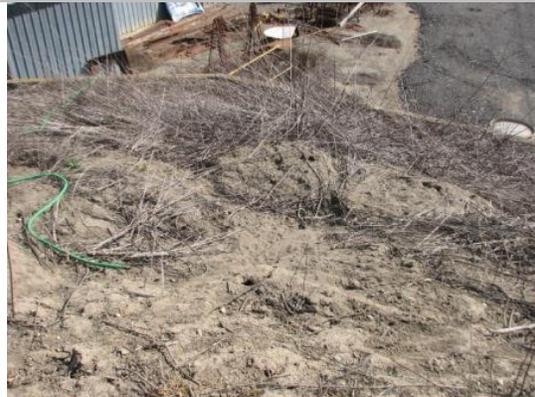
Photo 1 of 1 : johngw_s_20140414_278.jpg

Rodent hole in the levee slope above the retaining wall, Spring 2013

LM Start	14.32	Rating **	M	Issue No.	89
LM End	14.32	Issue Type +	Ma	Location *	LS
Category	Earthen Levee		GPS Latitude/Longitude		
			Start	End	
Item	Animal Control		38.860452 °	38.860452 °	
			-121.783294 °	-121.783294 °	
DWR ID	DWR_RD1500_01_s_2013_89				
Action/Comments					
Exterminate rodents and backfill and compact or grout burrows.

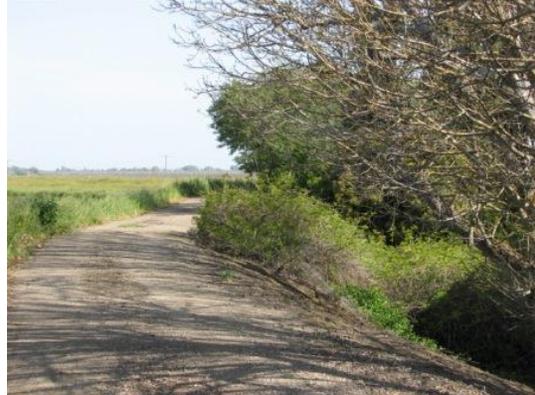
Photo 1 of 1 : johngw_s_20140414_211.jpg

LM Start	14.39	Rating **	M	Issue No.	31
LM End	14.39	Issue Type +	En	Location *	LS
Category	Earthen Levee		GPS Latitude/Longitude		
			Start	End	
Item	Vegetation		38.861513 °	38.861513 °	
			-121.783588 °	-121.783588 °	
DWR ID	DWR_RD1500_01_s_2012_31				
Action/Comments					
Landscaping

Landscape shrubs on shoulder. Photo was taken in spring 2010.

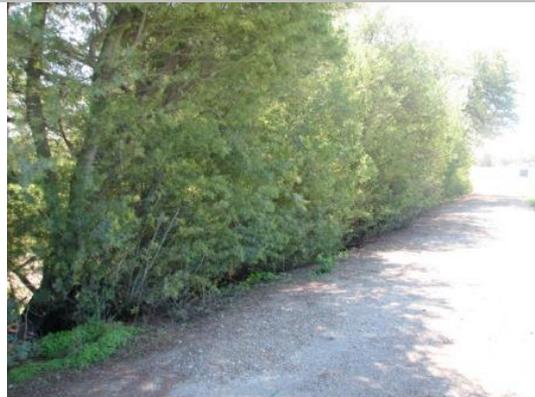
Photo 1 of 2 : johngw_s_20140414_273.jpg

The trees on the landside slope blocks the view of the slope, photo taken spring 2012.

LM Start	14.42	Rating **	U	Issue No.	77
LM End	14.42	Issue Type +	Ma	Location *	LS
Category	Earthen Levee		GPS Latitude/Longitude		
			Start	End	
Item	Trim / Thin Trees		38.861793 °	38.861793 °	
			-121.783703 °	-121.783703 °	
DWR ID	DWR_RD1500_01_s_2012_77				
Action/Comments					
Trim and thin trees to allow visibility of the ground and room to flood fight.

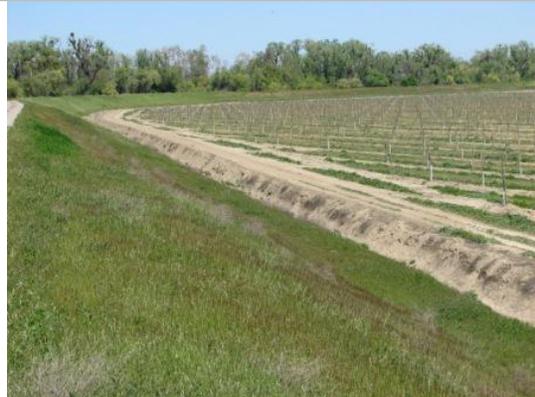
Photo 1 of 1 : johngw_s_20140414_286.jpg

LM Start	14.86	Rating **	M	Issue No.	969
LM End	15.93	Issue Type +	En	Location *	LS
Category	Earthen Levee		GPS Latitude/Longitude		
			Start	End	
Item	Encroachments		38.865473 °	38.871752 °	
			-121.789413 °	-121.804257 °	
DWR ID	DWR_RD1500_01_s_2012_969				
Action/Comments					
Ditch

Agricultural ditch, photo taken in spring 2010.

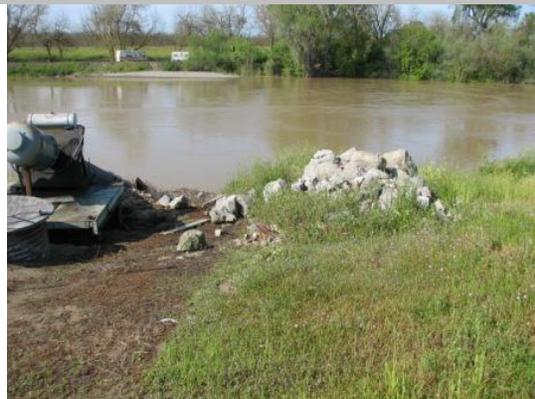
Photo 1 of 1 : johngw_s_20140414_200.jpg

LM Start	15.27	Rating **	M	Issue No.	21
LM End	15.27	Issue Type +	En	Location *	WS
Category	Earthen Levee		GPS Latitude/Longitude		
			Start	End	
Item	Encroachments		38.866827 °	38.866827 °	
			-121.794020 °	-121.794020 °	
DWR ID	DWR_RD1500_01_s_2012_21				
Action/Comments					
Debris Inspector Comments: A pile of rip rap and concrete needs to be removed.

Rip rap and concrete debris, photo taken in spring 2010.

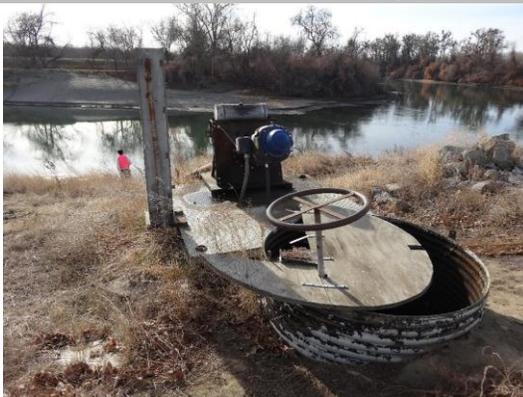
Photo 1 of 1 : UCIP_5658.jpg

LM Start	15.27	Rating **	M	Issue No.	1308
LM End	15.27	Issue Type +	En	Location *	WS
Category	Supplemental		GPS Latitude/Longitude		
			Start	End	
Item	DWR UCIP Field Study		38.866841 °	38.866841 °	
			-121.794047 °	-121.794047 °	
DWR ID	DWR_RD1500_01_s_2014_1308				
Action/Comments					
Inspector Comments: FS_ID:28486 EP_NO: 10037 Repair Type: Crossing Status: UCIP Comments: Water treatment plant on landside working during field visit. Not found- Flap Gate in 6.5 foot by 7.0 foot O.D. concrete distribution box at landward toe. FIELD_STRUCT_DESC: 22-inch concrete encased steel irrigation pipe through levee, 17.5 feet below crown. 1.5 -inch conduit through levee, 6.0 feet below crown. Slant pump on river bank. Gate valve in CMP riser on waterside. A 6.5 foot by 7.0 foot O.D. concrete distribution box at landward toe. (ABO. No. 10037 - Clauss) O&M Manual Sac 128, March 1960. FS Date: 1/10/2014

WS view: CMP riser with gate valve and slant pump on steel platform.

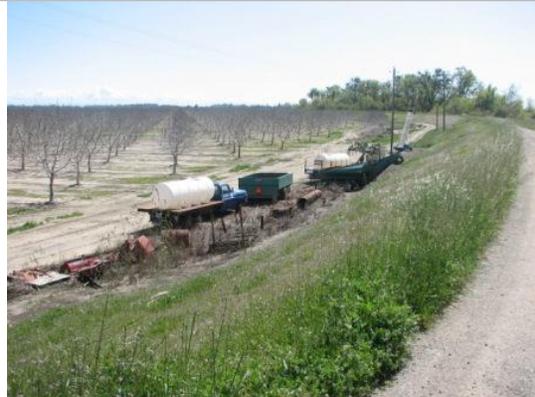
Photo 1 of 2 : johngw_s_20140414_274.jpg

LM Start	16.37	Rating **	M	Issue No.	78
LM End	16.37	Issue Type +	En	Location *	LS
Category	Earthen Levee		GPS Latitude/Longitude		
			Start	End	
Item	Encroachments		38.874623 °	38.874623 °	
			-121.811272 °	-121.811272 °	
DWR ID	DWR_RD1500_01_s_2012_78				
Action/Comments					
Equipment

The equipment is parked along the toe of the levee, photo taken spring 2012.

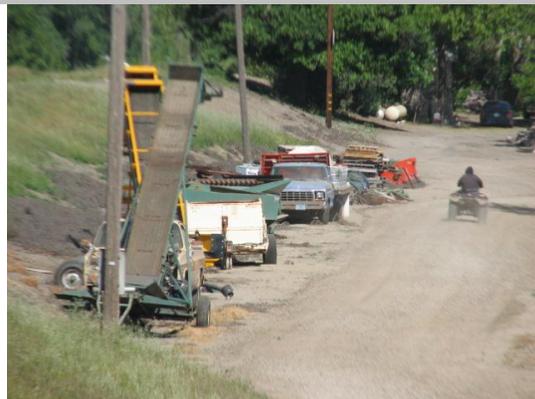
Photo 2 of 2 : johngw_s_20140428_908.jpg

A current view of equipment at the toe of the levee. Spring 2014

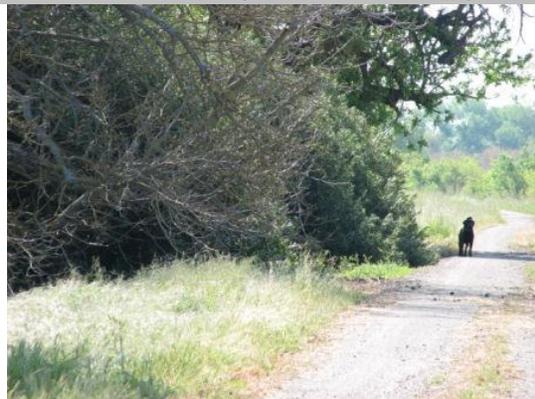
Photo 1 of 1 : johngw_s_20140414_213.jpg

LM Start	16.48	Rating **	U	Issue No.	33
LM End	16.48	Issue Type +	En	Location *	LS
Category	Earthen Levee		GPS Latitude/Longitude		
			Start	End	
Item	Vegetation		38.875873 °	38.875873 °	
			-121.812410 °	-121.812410 °	
DWR ID	DWR_RD1500_01_s_2012_33				
Action/Comments					
Landscaping

Landscape shrubs, photo taken in spring 2010.

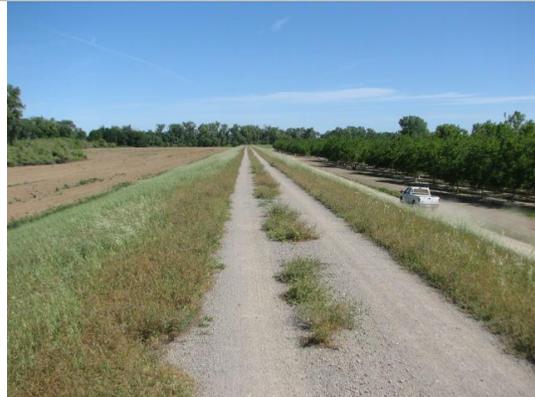
Photo 1 of 1 : johngw_s_20140428_910.jpg

Maintain unwanted vegetation on the levee crown. Spring 2014

LM Start	16.54	Rating **	M	Issue No.	1348
LM End	19.11	Issue Type +	Ma	Location *	CR
Category	Earthen Levee		GPS Latitude/Longitude		
			Start	End	
Item	Vegetation		38.876629 °	38.900677 °	
			-121.813050 °	-121.792113 °	
DWR ID	DWR_RD1500_01_s_2014_1348				
Action/Comments					
Keep the crown roadway free of vegetation.

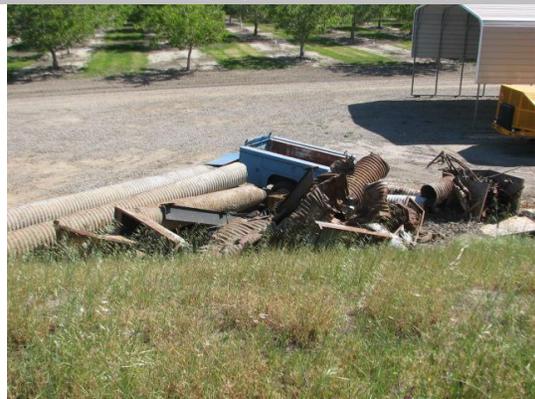
Photo 1 of 1 : johngw_s_20140428_909.jpg

LM Start	16.54	Rating **	M	Issue No.	1347
LM End	16.54	Issue Type +	En	Location *	LS
Category	Earthen Levee		GPS Latitude/Longitude		
			Start	End	
Item	Encroachments		38.876629 °	38.876629 °	
			-121.813046 °	-121.813046 °	
DWR ID	DWR_RD1500_01_s_2014_1347				
Action/Comments					
Debris

Pipe and debris is placed along the levee toe. Spring 2014

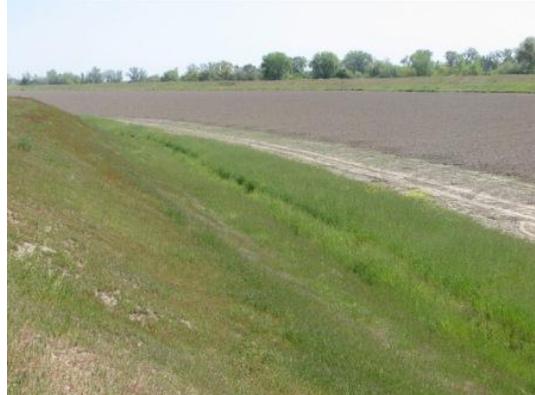
Photo 1 of 2 : johngw_s_20140414_287.jpg

LM Start	16.86	Rating **	M	Issue No.	972
LM End	17.45	Issue Type +	En	Location *	LS
Category	Earthen Levee		GPS Latitude/Longitude		
			Start	End	
Item	Encroachments		38.881092 °	38.887335 °	
			-121.813713 °	-121.808187 °	
DWR ID	DWR_RD1500_01_s_2012_972				
Action/Comments					
Ditch

Agricultural ditch, photo taken in spring 2010.

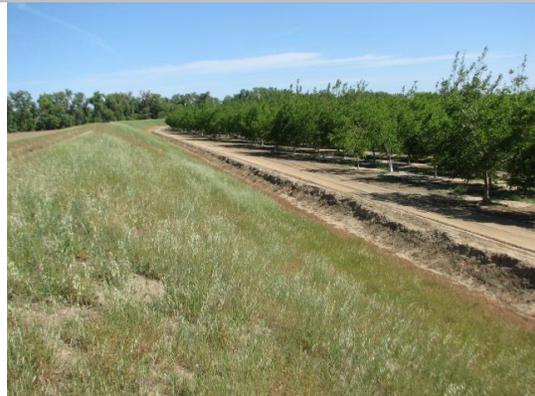
Photo 2 of 2 : johngw_s_20140428_912.jpg

Agricultural ditch runs along the toe of the levee. Spring 2014

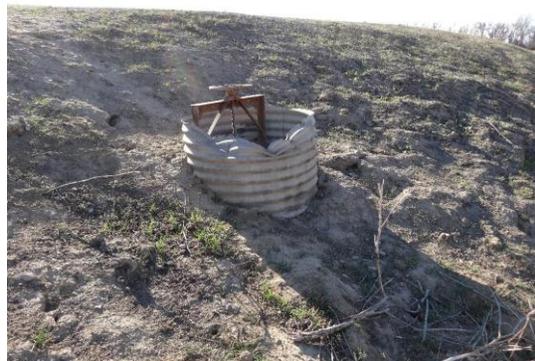
Photo 1 of 1 : UCIP_5661.jpg

LM Start	17.16	Rating **	M	Issue No.	1309
LM End	17.16	Issue Type +	En	Location *	LS
Category	Supplemental		GPS Latitude/Longitude		
			Start	End	
Item	DWR UCIP Field Study		38.885098 °	38.885098 °	
			-121.812884 °	-121.812884 °	
DWR ID	DWR_RD1500_01_s_2014_1309				
Action/Comments					
Inspector Comments: FS_ID:28489

WS view: CMP riser with slide gate on levee slope.

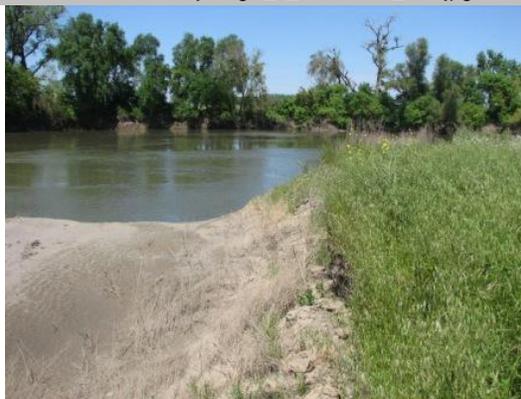
Photo 2 of 2 : johngw_s_20140414_249.jpg

This is an upstream view of the same erosion.

LM Start	18.50	Rating **	A/W	Issue No.	51 (cont)
LM End	18.50	Issue Type +	Ma	Location *	WS
Category	Earthen Levee			GPS Latitude/Longitude	
				Start	End
Item	Erosion / Bank Caving			38.900873 °	38.900873 °
				-121.802680 °	-121.802680 °
DWR ID	DWR_RD1500_01_s_2012_51				
Action/Comments					
Note and monitor erosion site.

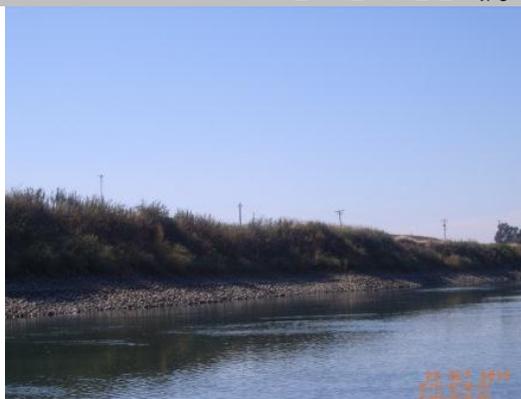
Photo 1 of 1 : USACE2013A_SAC_104-0_L_11.jpg

LM Start	18.51	Rating **	M	Issue No.	22
LM End	18.51	Issue Type +	Ma	Location *	WS
Category	Supplemental			GPS Latitude/Longitude	
				Start	End
Item	USACE Erosion Survey			38.901337 °	38.902721 °
				-121.801175 °	-121.790677 °
DWR ID					
Action/Comments					
Inspector Comments: 1997 - Pocket failures of cobble revetment toe; scallops of rock loss along the bank; irregular bankline developing. 2001 - Small scallops in the toe of the berm. 2005 - Still multiple erosion pockets in the toe. 2006 - Two new small slumps. 2011 - Old cobble continue to fail causing minor slumping. 2012 - Portions of site appears to be stabilizing. 2013: No observed changes. [2013 Site ID: SAC_104-0_L]

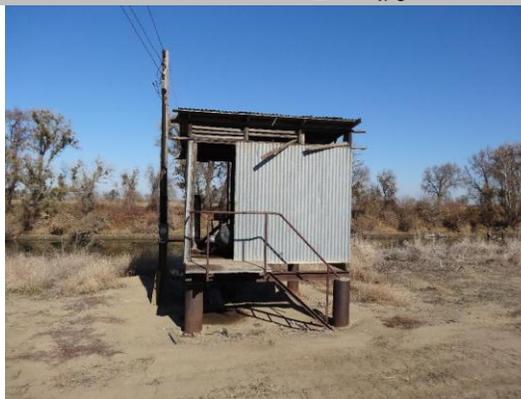
Photo 1 of 1 : UCIP_5667.jpg

LM Start	18.56	Rating **	M	Issue No.	1311
LM End	18.56	Issue Type +	En	Location *	WS
Category	Supplemental		GPS Latitude/Longitude		
			Start	End	
Item	DWR UCIP Field Study		38.900885 °	38.900885 °	
			-121.800999 °	-121.800999 °	
DWR ID	DWR_RD1500_01_s_2014_1311				
Action/Comments					
Inspector Comments: FS_ID:28505 EP_NO: 2425 Repair Type: Crossing Status: UCIP Comments: Concrete pad on both sides of the levee shoulder. Oil leaks from pump set. FIELD_STRUCT_DESC: 14-inch steel irrigation pipe through levee, 3.0 feet below crown. Slant pump in Corrugated metal pump house on steel structure on bank. Meter pole on slope. Siphon breaker on landward shoulder. Discharges into 36-inch concrete standpipe at landward toe. (App. No. 2425 - Hiatt). O&M Manual Sac 128, March 1960. FS Date: 1/14/2014

WS view: slant pump in CM shed on levee berm. Oil leaks from the pump.

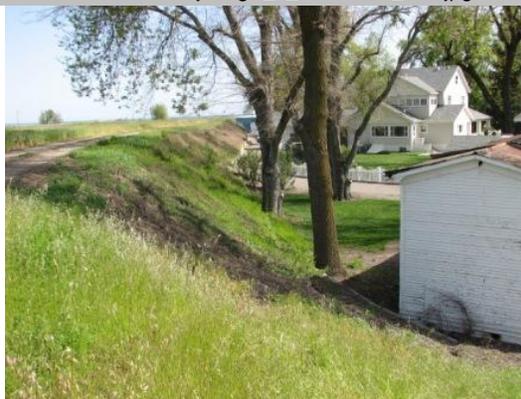
Photo 1 of 1 : johngw_s_20140414_220.jpg

LM Start	19.19	Rating **	M	Issue No.	36
LM End	19.19	Issue Type +	En	Location *	LS
Category	Earthen Levee		GPS Latitude/Longitude		
			Start	End	
Item	Encroachments		38.901570 °	38.901570 °	
			-121.791235 °	-121.791235 °	
DWR ID	DWR_RD1500_01_s_2012_36				
Action/Comments					
Building Inspector Comments: Concrete retaining wall toe of landside levee. Permit #10065

Building and wall into levee with landscape, photo taken in spring 2010.

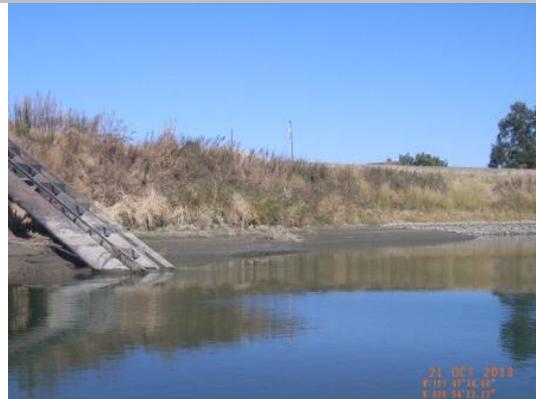
Photo 1 of 1 : USACE2013A_SAC_104-5_L_3.jpg

LM Start	19.24	Rating **	M	Issue No.	23
LM End	19.24	Issue Type +	Ma	Location *	WS
Category	Supplemental		GPS Latitude/Longitude		
			Start	End	
Item	USACE Erosion Survey		38.904041 °	38.906697 °	
			-121.790298 °	-121.792796 °	
DWR ID					
Action/Comments					
Inspector Comments: 1997 - Cobbles eroded off the clay materials; not much evidence of erosion on the toe; cobble loss on the toe. 2011 - Some minor new erosion. 2013: No observed changes. [2013 Site ID: SAC_104-5_L]

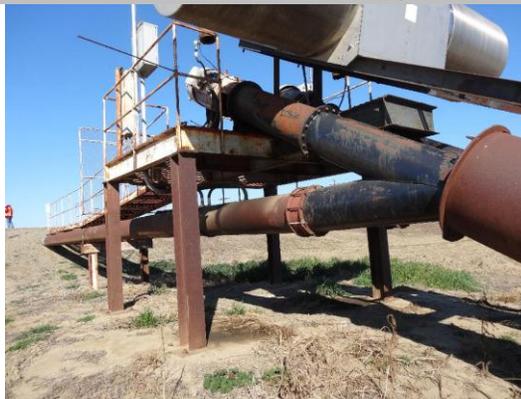
Photo 1 of 1 : UCIP_5804.jpg

LM Start	19.69	Rating **	M	Issue No.	1314
LM End	19.69	Issue Type +	En	Location *	WS
Category	Supplemental			GPS Latitude/Longitude	
				Start	End
Item	DWR UCIP Field Study			38.907028 °	38.907028 °
				-121.792959 °	-121.792959 °
DWR ID	DWR_RD1500_01_s_2014_1314				
Action/Comments					
Inspector Comments: FS_ID:28927 EP_NO: 15681 Repair Type: Crossing Status: UCIP Comments: Obstructed siphon breakers on landside two 3-inch conduit through the levee service box on pump platform. Pumping plant was working during the field visit. FIELD_STRUCT_DESC: 2 of 2: Two slant pumps supported by steel piling on the riverbank. 18 and 16-inches steel pipelines, asphalt coated inside and out and wrapped with asphalt saturated felt through the levee section to a concrete discharge box located landward of the landward levee toe. Pipes 1.5 feet below the crown. Siphon breakers in steel pipe risers on levee slope. (App. No. 15681) FS Date: 1/14/2014

WS view: pipe, walkway, slant pump, and steel platform on levee berm.

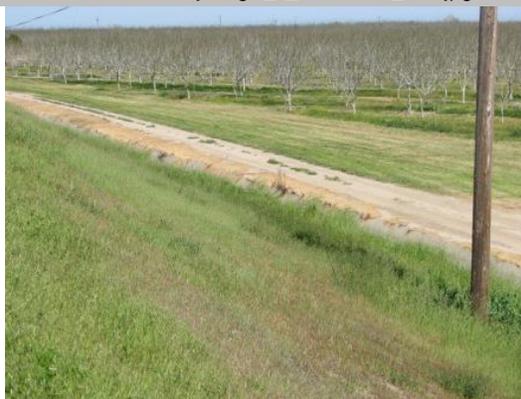
Photo 1 of 1 : johngw_s_20140414_288.jpg

LM Start	20.86	Rating **	M	Issue No.	975
LM End	21.40	Issue Type +	En	Location *	LS
Category	Earthen Levee			GPS Latitude/Longitude	
				Start	End
Item	Encroachments			38.910177 °	38.913267 °
				-121.810352 °	-121.803142 °
DWR ID	DWR_RD1500_01_s_2012_975				
Action/Comments					
Ditch

Agricultural ditch, photo taken in spring 2010.

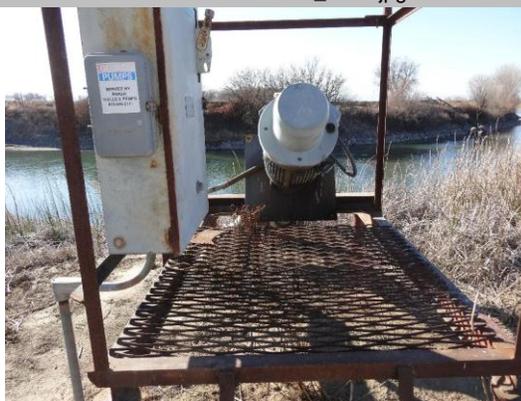
Photo 1 of 1 : UCIP_5677.jpg

LM Start	21.50	Rating **	M	Issue No.	1315
LM End	21.50	Issue Type +	En	Location *	LS
Category	Supplemental		GPS Latitude/Longitude		
			Start	End	
Item	DWR UCIP Field Study		38.914659 °	38.914659 °	
			-121.803609 °	-121.803609 °	
DWR ID	DWR_RD1500_01_s_2014_1315				
Action/Comments					
Inspector Comments: FS_ID:28527 EP_NO: 11959A Repair Type: Crossing Status: UCIP Comments: Siphon breaker (obstructed) in CMP on landside slope. Power pole on landside toe. FIELD_STRUCT_DESC: 10-inch steel pipe through levee, 3.0 feet below crown with slant pump on steel platform. Siphon breaker (obstructed) in CMP on landside slope. A 6 foot by 6 foot concrete distribution box on landward side. (App. No. 11959A - Van Ruiten) O&M Manual Sac 128, March 1960. FS Date: 1/14/2014

WS view: slant pump on steel platform on levee berm.

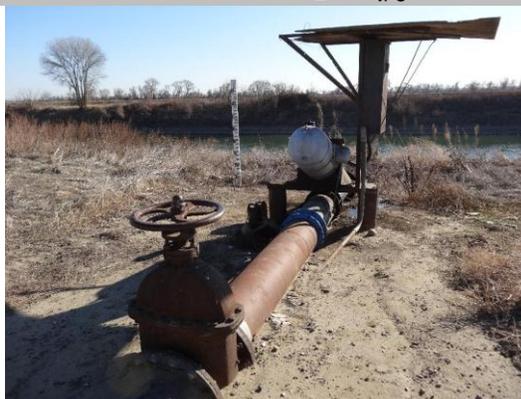
Photo 1 of 1 : UCIP_5681.jpg

LM Start	21.83	Rating **	M	Issue No.	1316
LM End	21.83	Issue Type +	En	Location *	LS
Category	Supplemental		GPS Latitude/Longitude		
			Start	End	
Item	DWR UCIP Field Study		38.916180 °	38.916180 °	
			-121.808904 °	-121.808904 °	
DWR ID	DWR_RD1500_01_s_2014_1316				
Action/Comments					
Inspector Comments: FS_ID:28528 EP_NO: 10063 Repair Type: Crossing Status: UCIP Comments: Water leaks near pump. Obstructed siphon breaker in CMP on landside. Plant was working during field visit. FIELD_STRUCT_DESC: 16-inch steel irrigation pipe through levee 6.3 feet below crown. 1-1/2-inch conduit through levee, 6.5 feet below crown. Slant pump and gate valve on berm. Siphon breaker in 24-inch corrugated metal riser on landward slope. CMP standpipe on landside toe. Power pole and one anchor at landward toe. (ABO. No. 10063, 11/1974 - Nelson) O&M Manual Sac 128, March 1960. FS Date: 1/14/2014

WS view: slant pump on steel platform on levee berm. Exposed steel pipe with gate valve also on levee berm.

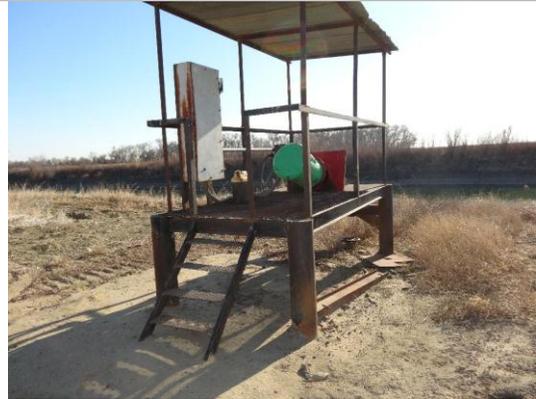
Photo 1 of 1 : UCIP_5685.jpg

LM Start	22.16	Rating **	M	Issue No.	1317
LM End	22.16	Issue Type +	En	Location *	LS
Category	Supplemental			GPS Latitude/Longitude	
				Start	End
Item	DWR UCIP Field Study			38.916606 °	38.916606 °
				-121.814881 °	-121.814881 °
DWR ID	DWR_RD1500_01_s_2014_1317				
Action/Comments					
Inspector Comments: FS_ID:28543 EP_NO: 10851 Repair Type: Crossing Status: UCIP Comments: Obstructed siphon breaker plant was working during field visit. FIELD_STRUCT_DESC: 12-inch steel irrigation pipe through levee, 5.8 feet below crown. 1.5-inch conduit through levee, 4 feet below crown. Pump and gate valve on bank. Switch panel on berm. Siphon breaker in 24-inch CM riser on landward slope. Discharges into 36-inch CM standpipe on landward side. Service pole at landward toe. Pumping Plant No. 3. (App. No. 10851, 2895 - George Van Ruiten). FS Date: 1/14/2014

WS view: slant pump on steel platform on levee berm.

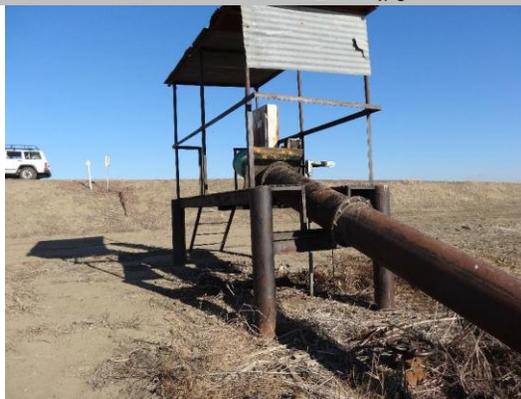
Photo 1 of 1 : UCIP_5690.jpg

LM Start	22.99	Rating **	M	Issue No.	1318
LM End	22.99	Issue Type +	En	Location *	LS
Category	Supplemental		GPS Latitude/Longitude		
			Start	End	
Item	DWR UCIP Field Study		38.919717 °	38.919717 °	
			-121.829113 °	-121.829113 °	
DWR ID	DWR_RD1500_01_s_2014_1318				
Action/Comments					
Inspector Comments: FS_ID:28583 EP_NO: 10851 Repair Type: Crossing Status: UCIP Comments: Exposed conduit on both slopes of the levee. Plant was working during field visit. Water was leaking from pipe joint near pump. Obstructed siphon breaker in CMP. FIELD_STRUCT_DESC: 14-inch steel irrigation pipe through levee, 6.2 feet below crown. Pump and gate valve on steel platform. Switch panel on berm. Siphon breaker in 24-inch CM riser on landward shoulder. Discharges into 36-inch CM standpipe at landward toe. 2-inch conduit through levee, 5.0 feet below crown. Service pole at landward toe. Pumping plant No. 2. (App. No. 10851, 2895 - Van Ruiten) FS Date: 1/14/2014

WS view: slant pump on steel platform on levee berm.

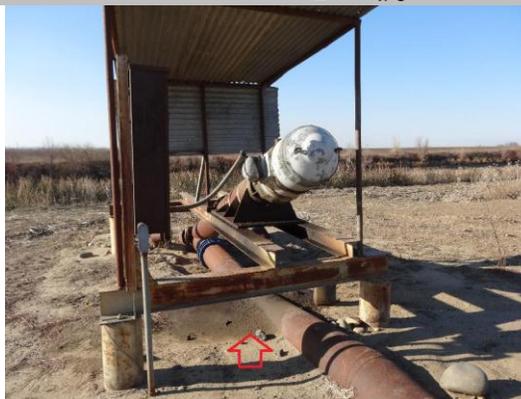
Photo 1 of 1 : UCIP_5701.jpg

LM Start	23.93	Rating **	M	Issue No.	1319
LM End	23.93	Issue Type +	En	Location *	LS
Category	Supplemental		GPS Latitude/Longitude		
			Start	End	
Item	DWR UCIP Field Study		38.930242 °	38.930242 °	
			-121.834956 °	-121.834956 °	
DWR ID	DWR_RD1500_01_s_2014_1319				
Action/Comments					
Inspector Comments: FS_ID:28586 EP_NO: 2895 Repair Type: Crossing Status: UCIP Comments: Most of the pipe exposed on levee slope is leaky pump. Obstructed siphon breaker Not found- Concrete headwall at landward toe. FIELD_STRUCT_DESC: 14-inch steel irrigation pipe through levee, 6.5 feet below crown. 1-1/2 inch conduit through levee, 4.0 feet below crown. Slant pump and control panel on steel structure on berm. Siphon breaker in 24-inch corrugated metal riser on landward shoulder. 36-inch CM standpipe at landward toe. Service pole at landward toe. Pumping- Plant No. 1. (App. No. 2895 - Van Ruiten) O&M Manual Sac 128, March 1960. FS Date: 1/14/2014

WS view: slant pump on steel platform on levee berm. Oil leaks from the pump (marked). Exposed pipe on the berm.

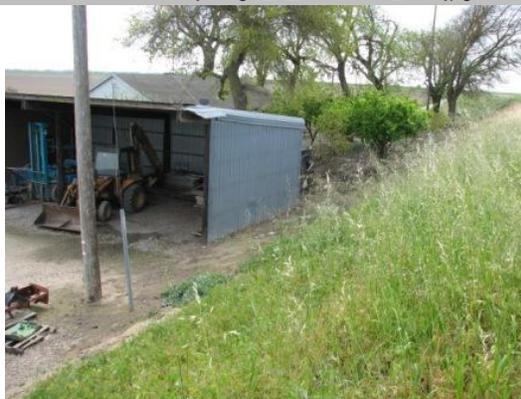
Photo 1 of 1 : johngw_s_20140414_229.jpg

LM Start	24.04	Rating **	M	Issue No.	42
LM End	24.04	Issue Type +	En	Location *	LS
Category	Earthen Levee		GPS Latitude/Longitude		
			Start	End	
Item	Encroachments		38.931838 °	38.931838 °	
			-121.834437 °	-121.834437 °	
DWR ID	DWR_RD1500_01_s_2012_42				
Action/Comments					
Building Inspector Comments: Some equipment at landside toe.

Pole barn and some equipment, photo taken in spring 2010.

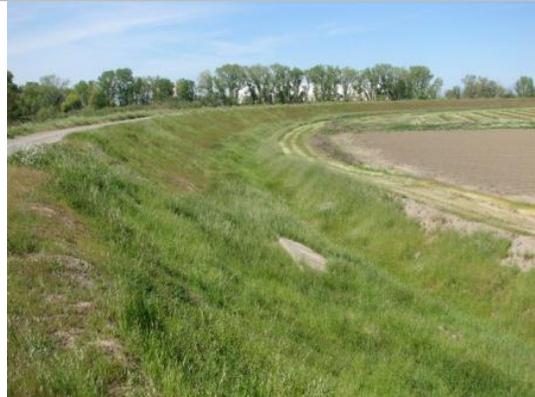
Photo 1 of 2 : johngw_s_20140414_289.jpg

LM Start	24.44	Rating **	M	Issue No.	979
LM End	24.60	Issue Type +	En	Location *	LS
Category	Earthen Levee		GPS Latitude/Longitude		
			Start	End	
Item	Encroachments		38.936282 °	38.938430 °	
			-121.830192 °	-121.829359 °	
DWR ID	DWR_RD1500_01_s_2012_979				
Action/Comments					
Ditch

Agricultural ditch, photo taken in spring 2010.

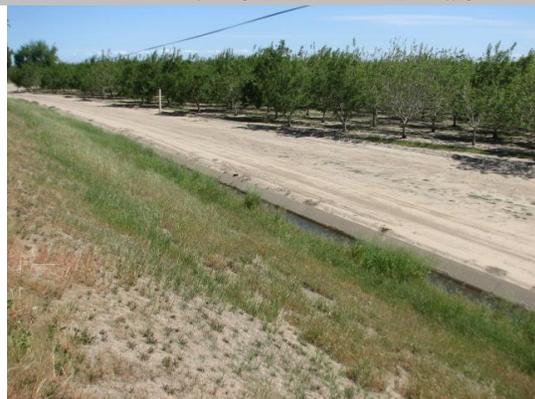
Photo 2 of 2 : johngw_s_20140428_914.jpg

Agricultural ditch runs along the toe of the levee. Spring 2014

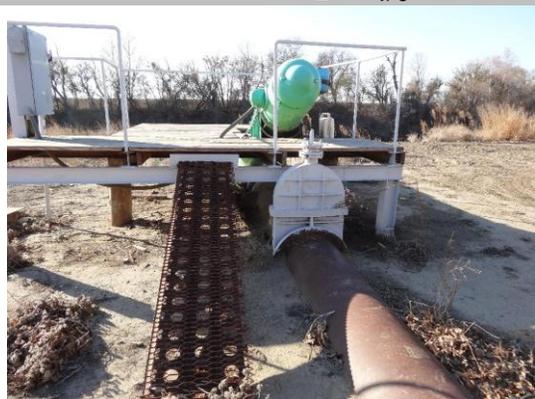
Photo 1 of 1 : UCIP_5704.jpg

LM Start	24.60	Rating **	M	Issue No.	1320
LM End	24.60	Issue Type +	En	Location *	LS
Category	Supplemental		GPS Latitude/Longitude		
			Start	End	
Item	DWR UCIP Field Study		38.938431 °	38.938431 °	
			-121.829350 °	-121.829350 °	
DWR ID	DWR_RD1500_01_s_2014_1320				
Action/Comments					
Inspector Comments: FS_ID:28603

WS view: slant pump on steel platform at levee berm. Walkway, exposed pipe, and gate valve on the berm.

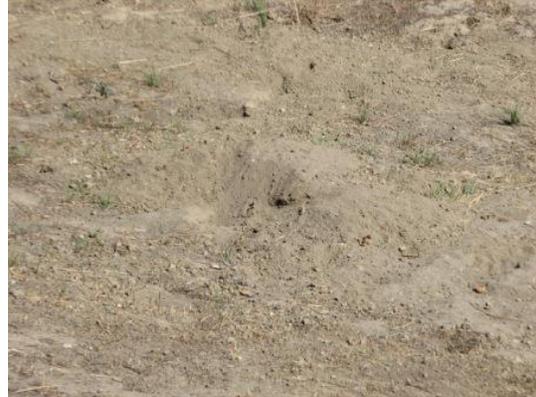
Photo 1 of 2 : johngw_s_20140414_266.jpg

A rodent burrow on the landside Fall 2013

LM Start	25.17	Rating **	M	Issue No.	69
LM End	25.17	Issue Type +	Ma	Location *	LS
Category	Earthen Levee		GPS Latitude/Longitude		
			Start	End	
Item	Animal Control		38.944340 °	38.944340 °	
			-121.835790 °	-121.835790 °	
DWR ID	DWR_RD1500_01_f_2013_69				
Action/Comments					
Exterminate rodents and backfill and compact or grout burrows.

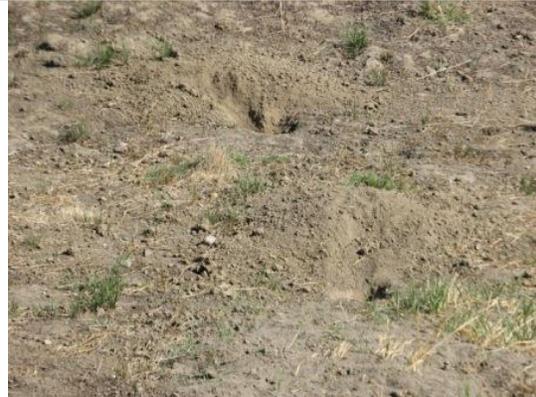
Photo 2 of 2 : johngw_s_20140414_267.jpg

Multiple rodent burrows on landside slope. Fall 2013

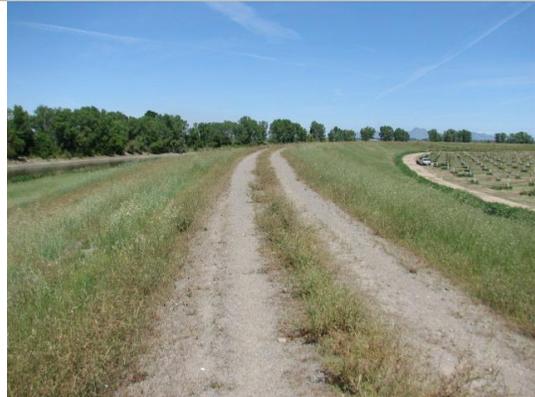
Photo 1 of 1 : johngw_s_20140428_915.jpg

Maintain the unwanted vegetation on the crown. Spring 2014

LM Start	26.84	Rating **	M	Issue No.	1350
LM End	29.93	Issue Type +	Ma	Location *	CR
Category	Earthen Levee		GPS Latitude/Longitude		
			Start	End	
Item	Vegetation		38.964870 °	38.989449 °	
			-121.833676 °	-121.800660 °	
DWR ID	DWR_RD1500_01_s_2014_1350				
Action/Comments					
Keep the crown roadway free of vegetation.

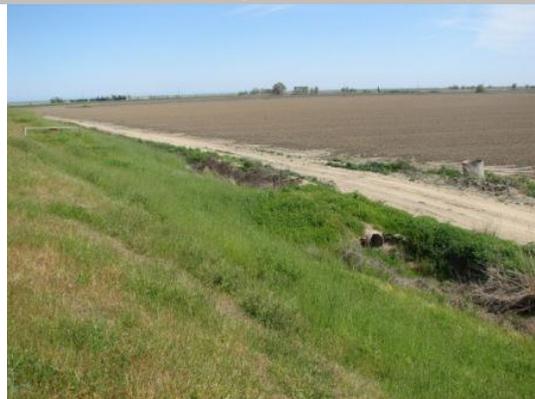
Photo 1 of 1 : johngw_s_20140414_290.jpg

LM Start	26.84	Rating **	M	Issue No.	982
LM End	27.07	Issue Type +	En	Location *	LS
Category	Earthen Levee		GPS Latitude/Longitude		
			Start	End	
Item	Encroachments		38.964850 °	38.968083 °	
			-121.833595 °	-121.833593 °	
DWR ID	DWR_RD1500_01_s_2012_982				
Action/Comments					
Ditch

Agricultural ditch, photo taken in spring 2010.

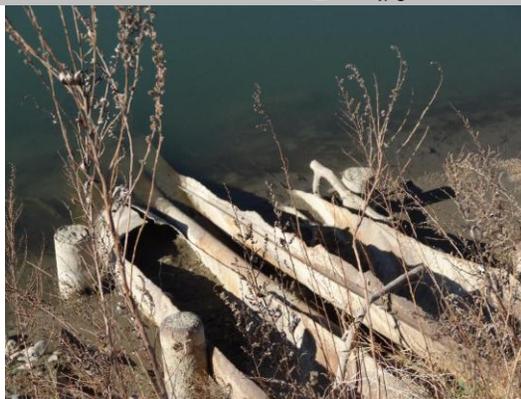
Photo 1 of 1 : UCIP_5710.jpg

LM Start	26.84	Rating **	M	Issue No.	1321
LM End	26.84	Issue Type +	En	Location *	LS
Category	Supplemental			GPS Latitude/Longitude	
				Start	End
Item	DWR UCIP Field Study			38.964915 °	38.964915 °
				-121.833675 °	-121.833675 °
DWR ID	DWR_RD1500_01_s_2014_1321				
Action/Comments					
Inspector Comments: FS_ID:28629 EP_NO: 10057 Repair Type: Crossing Status: UCIP Comments: May need proper abandonment. FIELD_STRUCT_DESC: Abandoned 24-inch pipe through levee, 7.1 feet below the crown, slant pump on WS. O&M Manual Sac 128, March 1960. (ABO No. 10057) FS Date: 1/15/2014

WS view: abandoned 24" and 30" steel pipe on river bank.

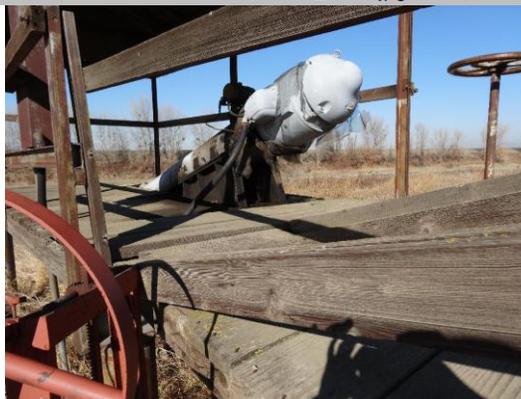
Photo 1 of 1 : UCIP_5712.jpg

LM Start	27.06	Rating **	M	Issue No.	1323
LM End	27.06	Issue Type +	En	Location *	LS
Category	Supplemental			GPS Latitude/Longitude	
				Start	End
Item	DWR UCIP Field Study			38.968093 °	38.968093 °
				-121.833708 °	-121.833708 °
DWR ID	DWR_RD1500_01_s_2014_1323				
Action/Comments					
Inspector Comments: FS_ID:28631 EP_NO: 10052 Repair Type: Crossing Status: UCIP Comments: Obstructed siphon breaker. Leaky pump. FIELD_STRUCT_DESC: 18-inch steel irrigation pipe through levee, 7.1 feet below crown. 2-inch conduit through levee, 5.5 feet below crown. Wood walkway to slant pump and gate valve on wooden pump platform mounted on steel pile structure on berm. Siphon breaker in 24-inch CM riser on landward slope. Meter pole at landward toe. (ABO No. 10052 - Lamb) (RM 112.29) O&M Manual Sac 128, March 1960. FS Date: 1/15/2014

WS view: slant pump and gate valves on wooden platform at levee berm. Wooden walkway to the pump.

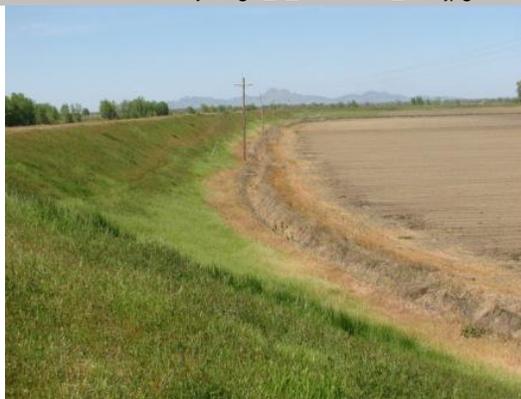
Photo 1 of 2 : johngw_s_20140414_291.jpg

LM Start	27.63	Rating **	M	Issue No.	983
LM End	27.78	Issue Type +	En	Location *	LS
Category	Earthen Levee			GPS Latitude/Longitude	
				Start	End
Item	Encroachments			38.972440 °	38.972848 °
				-121.825892 °	-121.823098 °
DWR ID	DWR_RD1500_01_s_2012_983				
Action/Comments					
Ditch

Agricultural ditch, photo taken in spring 2010.

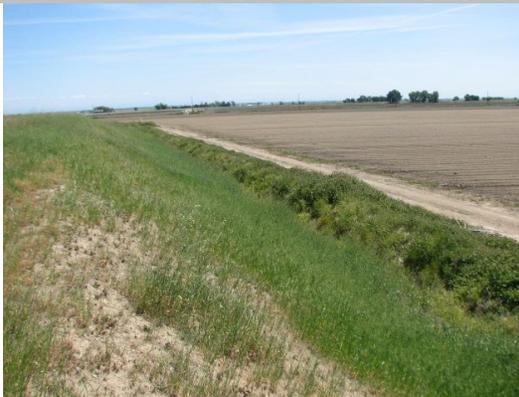
Photo 2 of 2 : johngw_s_20140428_916.jpg

The agricultural ditch runs along the toe of the levee. Spring 2014

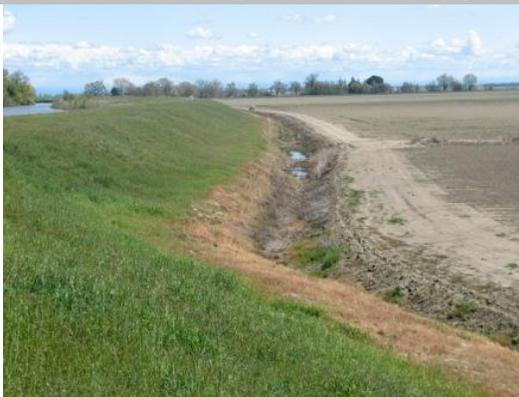
Photo 1 of 2 : johngw_s_20140414_222.jpg

LM Start	28.57	Rating **	M	Issue No.	38
LM End	29.60	Issue Type +	En	Location *	LS
Category	Earthen Levee		GPS Latitude/Longitude		
			Start	End	
Item	Encroachments		38.983081 °	38.988512 °	
			-121.819924 °	-121.806463 °	
DWR ID	DWR_RD1500_01_s_2012_38				
Action/Comments					
Ditch

The agricultural ditch runs along the toe of the levee, photo taken spring 2012.

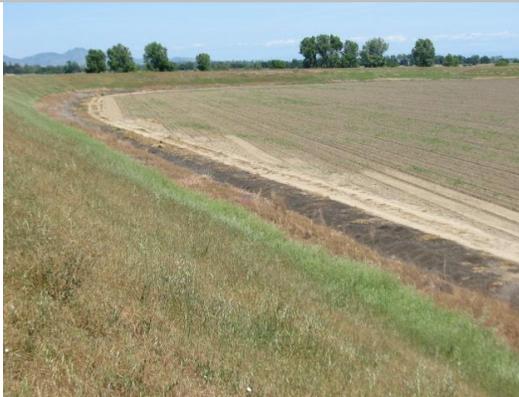
Photo 2 of 2 : johngw_s_20140428_917.jpg

A current view of the agricultural ditch along the toe. Spring 2014

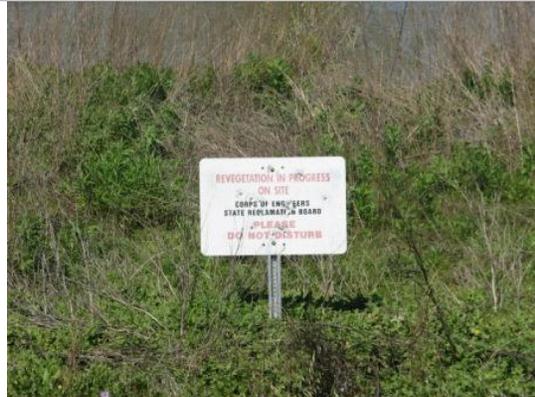
Photo 1 of 2 : johngw_s_20140414_275.jpg

LM Start	29.31	Rating **	A/W	Issue No.	84
LM End	29.54	Issue Type +	Ma	Location *	WS
Category	Earthen Levee		GPS Latitude/Longitude		
			Start	End	
Item	Vegetation		38.988078 °	38.988595 °	
			-121.811692 °	-121.807532 °	
DWR ID	DWR_RD1500_01_s_2012_84				
Action/Comments					
Environmental Requirements.

Another revegetation site on the waterside berm, photo taken spring 2012.

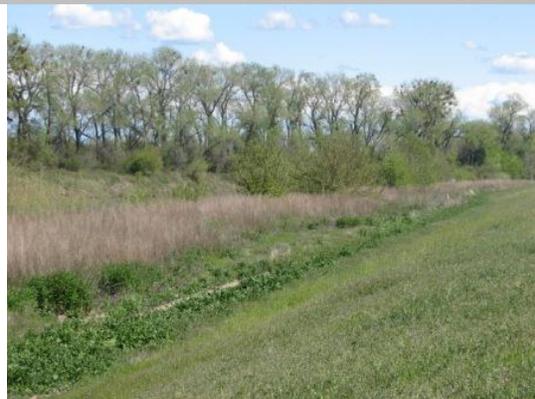
Photo 2 of 2 : johngw_s_20140414_276.jpg

A photo of the revegetation site.

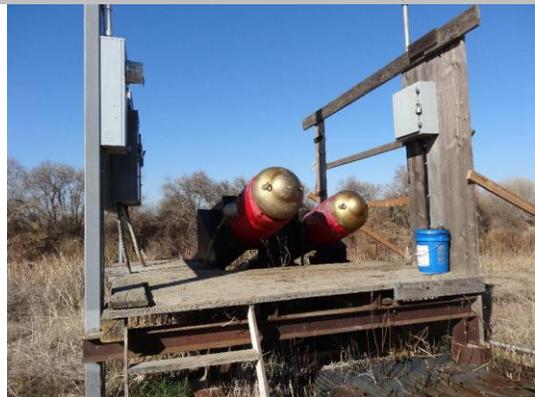
Photo 1 of 1 : UCIP_5745.jpg

LM Start	30.28	Rating **	M	Issue No.	1324
LM End	30.28	Issue Type +	En	Location *	WS
Category	Supplemental		GPS Latitude/Longitude		
			Start	End	
Item	DWR UCIP Field Study		38.993006 °	38.993006 °	
			-121.796025 °	-121.796025 °	
DWR ID	DWR_RD1500_01_s_2014_1324				
Action/Comments					
Inspector Comments: FS_ID:28707

WS view: slant pumps and control boxes on steel platform at levee berm.

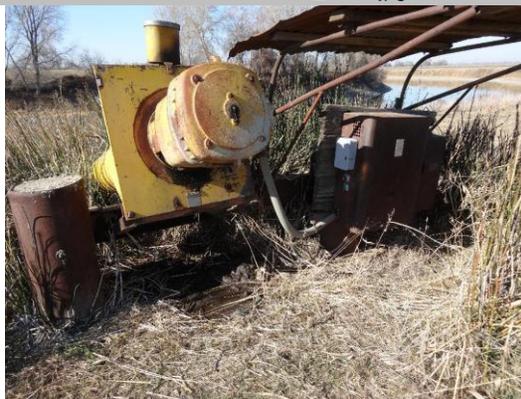
Photo 1 of 1 : UCIP_5574.jpg

LM Start	30.45	Rating **	M	Issue No.	1326
LM End	30.45	Issue Type +	En	Location *	WS
Category	Supplemental			GPS Latitude/Longitude	
				Start	End
Item	DWR UCIP Field Study			38.994988 °	38.994988 °
				-121.794484 °	-121.794484 °
DWR ID	DWR_RD1500_01_s_2014_1326				
Action/Comments					
Inspector Comments: FS_ID:28163 EP_NO: 6169 Repair Type: Crossing Status: UCIP Comments: Leaky pump and excessive vegetation observed along pipe alignment on waterside slope of the levee. It needs more investigations. May have new permit for slant pump. FIELD_STRUCT_DESC: 30-inch reinforced concrete encased steel irrigation pipe through levee, 15.5 feet below crown. Slant pump and switch panel on steel pile structure at edge of berm. Slide gate in 2.5 foot by 3.5 foot I.D. concrete box on berm. 6 foot by 8 foot concrete distribution box at landward toe. 2-inch conduit through levee, 2.5 feet below crown. (App. No. 6169 - Butler) Pipe through levee was initially installed in 1952. O&M Manual Sac 128, March 1960. FS Date: 1/15/2014

WS view: leaky slant pump on levee berm.

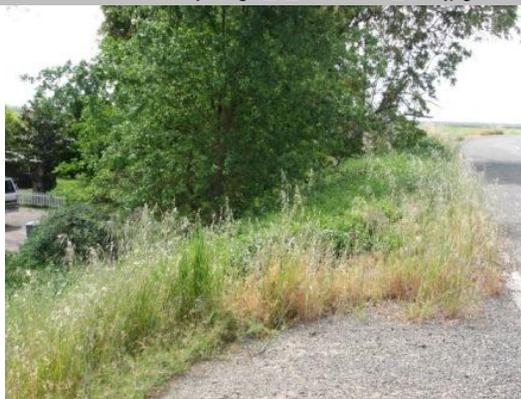
Photo 1 of 1 : johngw_s_20140414_240.jpg

LM Start	30.60	Rating **	M	Issue No.	45
LM End	30.60	Issue Type +	En	Location *	LS
Category	Earthen Levee			GPS Latitude/Longitude	
				Start	End
Item	Vegetation			38.996980 °	38.996980 °
				-121.794723 °	-121.794723 °
DWR ID	DWR_RD1500_01_s_2012_45				
Action/Comments					
Landscaping

The groundcover in the landscape makes it hard to see the levee slope.

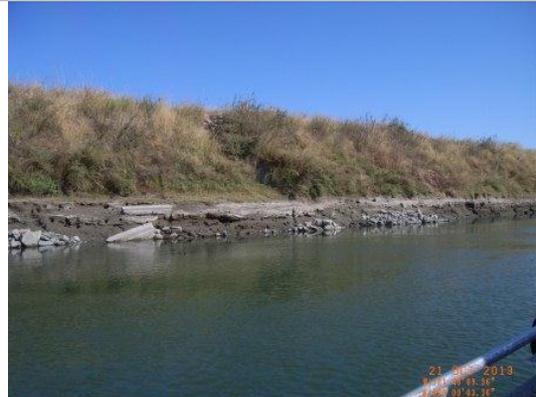
Photo 1 of 1 : USACE2013A_SAC_116-0_L_4.jpg

LM Start	30.91	Rating **	M	Issue No.	29
LM End	30.91	Issue Type +	Ma	Location *	WS
Category	Supplemental		GPS Latitude/Longitude		
			Start	End	
Item	USACE Erosion Survey		38.999745 °	39.001413 °	
			-121.800898 °	-121.802889 °	
DWR ID					
Action/Comments					
Inspector Comments: 2000 - Eroding, vertical berm slope over a vertical cohesive toe; slow erosion but getting close to the toe. 2002 - Erosion is getting close to the levee, still eroding with some new small slumps. 2004 - Some minor new erosion. 2006 - Some new erosion, cleaned off older scars and slump faces. 2008 - New, small, partial rotational failure. 2011 - Some new minor erosion. 2013: No observed changes. [2013 Site ID: SAC_116-0_L]

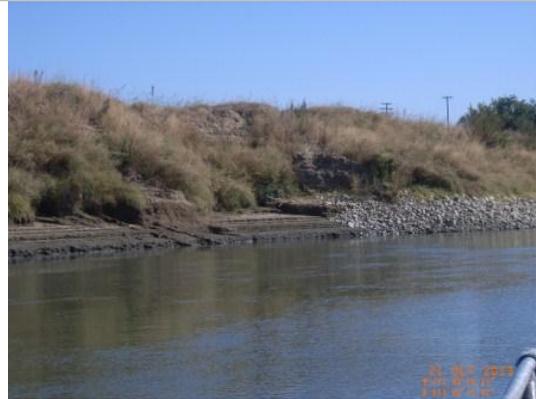
Photo 1 of 1 : USACE2013A_SAC_116-5_L_10.jpg

LM Start	31.38	Rating **	M	Issue No.	34
LM End	31.38	Issue Type +	Ma	Location *	WS
Category	Supplemental		GPS Latitude/Longitude		
			Start	End	
Item	USACE Erosion Survey		39.003301 °	39.006072 °	
			-121.805024 °	-121.815926 °	
DWR ID					
Action/Comments					
Inspector Comments: 2003 - New sedimentation and some new small toe scallops at the upstream end; downstream end has some new erosion. 2004 - Some new erosion at the toe and upper bank and some small new rotational failures (mainly minor, except at the downstream end). 2007 - Some new slumps. 2009 - Some new scallops and site was extended upstream. 2010 - New deposition along upstream end of site, however there is also new erosion throughout the site. Site seems to be worsening, and eroding fast. Large habitat for bank swallows. 2011 - Some new minor erosion. 2012 - Minor new erosion. 2013: No observed changes. [2013 Site ID: SAC_116-5_L]

USACE 2013 Photo #1

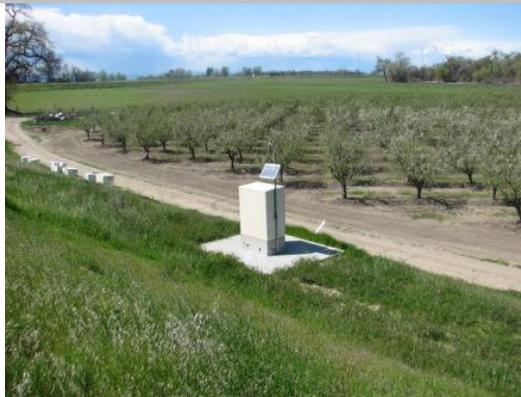
Photo 1 of 1 : johngw_s_20140414_277.jpg

LM Start	31.94	Rating **	A/W	Issue No.	86
LM End	31.94	Issue Type +	En	Location *	WS
Category	Earthen Levee			GPS Latitude/Longitude	
				Start	End
Item	Underseepage Relief Wells			39.006722 °	39.006722 °
				-121.814752 °	-121.814752 °
DWR ID	DWR_RD1500_01_s_2012_86				
Action/Comments

The control unit for piezometers installed in 2012, photo taken spring 2012.

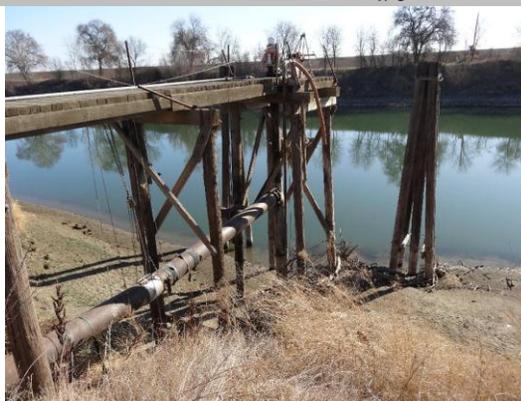
Photo 1 of 1 : UCIP_5566.jpg

LM Start	32.02	Rating **	M	Issue No.	1328
LM End	32.02	Issue Type +	En	Location *	WS
Category	Supplemental			GPS Latitude/Longitude	
				Start	End
Item	DWR UCIP Field Study			39.006484 °	39.006484 °
				-121.816168 °	-121.816168 °
DWR ID	DWR_RD1500_01_s_2014_1328				
Action/Comments					
Inspector Comments: FS_ID:28143 EP_NO: 9657 Repair Type: Crossing Status: UCIP Comments: Looks abandoned. May need proper abandonment. Overhead power line. FIELD_STRUCT_DESC: Abandoned 20-inch diameter steel pipe through levee, 15.0 feet below crown. Pump on elevated structure. Slide gate in riser, concrete surge box on waterward slope. Switch panel on berm. (App. Nos. 13536 & 13941 - Niechen 10/82) Discharges into 36-inch I.D. concrete standpipe on landward side. (App. No. 9657 ABO No. 10030 - Bell) O&M Manual Sac 128, March 1960. FS Date: 1/15/2014

WS view: abandoned walkway, pipe, and pump on river bank.

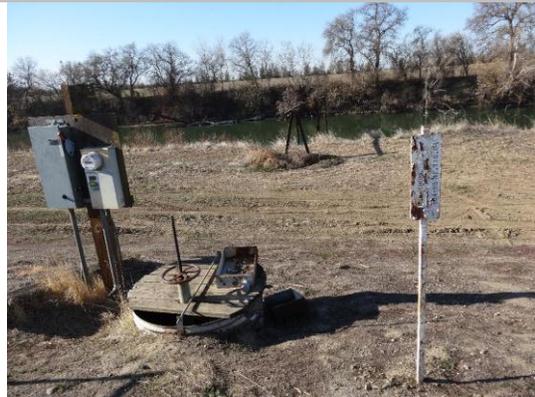
Photo 1 of 1 : UCIP_5808.jpg

LM Start	32.97	Rating **	M	Issue No.	1329
LM End	32.97	Issue Type +	En	Location *	LS
Category	Supplemental		GPS Latitude/Longitude		
			Start	End	
Item	DWR UCIP Field Study		39.015277 °	39.015277 °	
			-121.823735 °	-121.823735 °	
DWR ID	DWR_RD1500_01_s_2014_1329				
Action/Comments					
Inspector Comments: FS_ID:28943 EP_NO: N/A Repair Type: Crossing Status: UCIP Comments: Pipe leaks near pump through a hole in the pipe. Needs repair in electric conduit through the levee Concrete distribution box on landside levee toe. Slide gate in CMP on waterside slope. FIELD_STRUCT_DESC: 30-inch pipe and electric conduit through levee, 14.3 feet below the crown, Pump and headwall on waterside. Slide gate in CMP on waterside slope. Electric control box on waterside. Concrete distribution box on landside levee toe. O&M Manual Sac 128, March 1960. FS Date: 1/15/2014

WS view: power control panel and CMP riser with slide gate on levee slope.

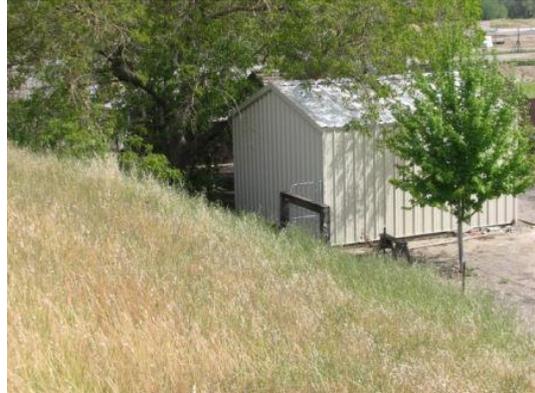
Photo 1 of 1 : johngw_s_20140414_241.jpg

LM Start	33.39	Rating **	M	Issue No.	46
LM End	33.39	Issue Type +	En	Location *	LS
Category	Earthen Levee		GPS Latitude/Longitude		
			Start	End	
Item	Encroachments		39.020550 °	39.020550 °	
			-121.820315 °	-121.820315 °	
DWR ID	DWR_RD1500_01_s_2012_46				
Action/Comments					
Building

The building is within the easement of the levee toe.

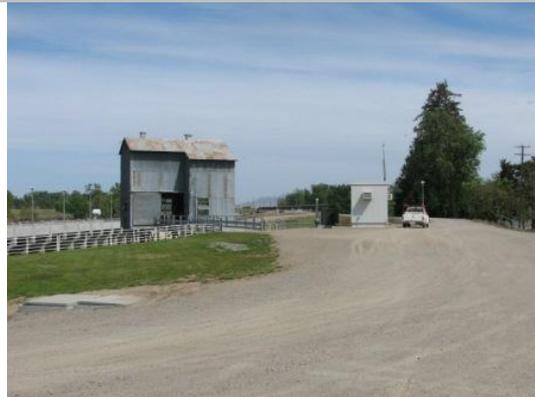
Photo 1 of 1 : johngw_s_20140414_243.jpg

LM Start	33.41	Rating **	A	Issue No.	48
LM End	33.41	Issue Type +	En	Location *	WS
Category	Earthen Levee		GPS Latitude/Longitude		
			Start	End	
Item	Encroachments		39.020875 °	39.020875 °	
			-121.820273 °	-121.820273 °	
DWR ID	DWR_RD1500_01_s_2012_48				
Action/Comments					
Building Inspector Comments: Pumping Plant Intake structure

The buildings are on the waterside of the crown. Control buildings for the pumping plant.

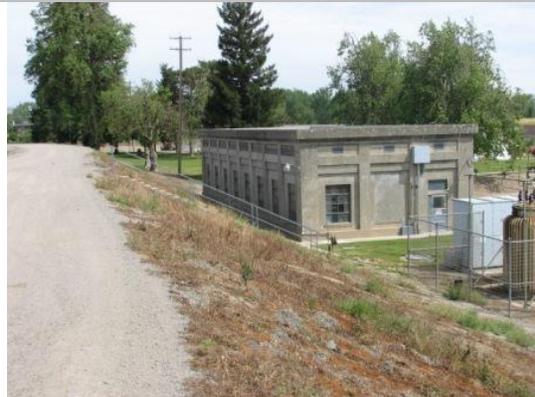
Photo 1 of 1 : johngw_s_20140414_242.jpg

LM Start	33.41	Rating **	A	Issue No.	47
LM End	33.41	Issue Type +	En	Location *	LS
Category	Earthen Levee		GPS Latitude/Longitude		
			Start	End	
Item	Encroachments		39.020875 °	39.020875 °	
			-121.820272 °	-121.820272 °	
DWR ID	DWR_RD1500_01_s_2012_47				
Action/Comments					
Building

The building is the pumping plant for Sutter Municipal.

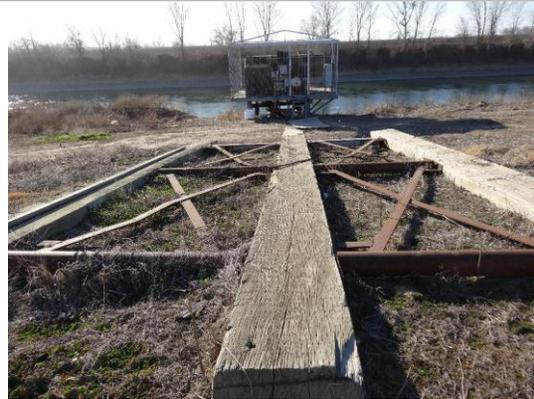
Photo 1 of 1 : UCIP_5818.jpg

LM Start	33.56	Rating **	M	Issue No.	1330
LM End	33.56	Issue Type +	En	Location *	LS
Category	Supplemental			GPS Latitude/Longitude	
				Start	End
Item	DWR UCIP Field Study			39.022938 °	39.022938 °
				-121.820717 °	-121.820717 °
DWR ID	DWR_RD1500_01_s_2014_1330				
Action/Comments					
Inspector Comments: FS_ID:28953 EP_NO: 5617 Repair Type: Crossing Status: UCIP Comments: Not found- slide gate in 54 inch corrugated metal riser on waterside berm. Two 16-inch steel pipes (looks new). Leaky pipe near pump. Plant was working during field visit. Needs more info from LMA. There may be a new permit. FIELD_STRUCT_DESC: 1 of 2. Two 16-inch steel irrigation pipes and conduit through levee, 19.0 feet below crown. Two slant pumps on elevated pump platform on waterside. Gate valves and concrete headwall at landward berm. Meter pole at toe. Discharges into landside ditch. 1-3/4 conduit through levee. (App. No. 5617- Oji Bros.) O&M Manual Sac 128, March 1960. FS Date: 1/15/2014

WS view: slant pumps on steel platform in shed on berm.

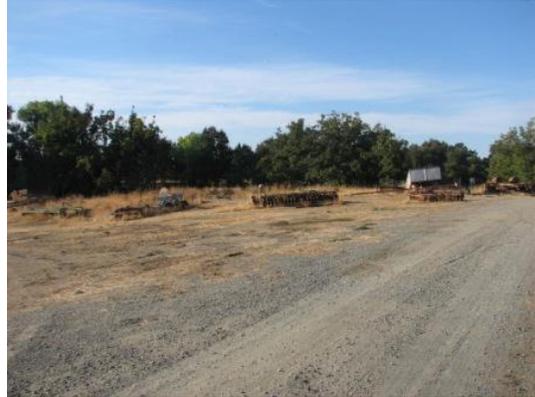
Photo 1 of 2 : johngw_s_20140414_490.jpg

LM Start	0.00	Rating **	M	Issue No.	12
LM End	0.00	Issue Type +	Ma	Location *	WS
Category	Earthen Levee		GPS Latitude/Longitude		
			Start	End	
Item	Encroachments		38.761121 °	38.761121 °	
			-121.674592 °	-121.674592 °	
DWR ID	DWR_RD1500_02_s_2012_12				
Action/Comments					
Equipment

Farm equipment is parked on the levee slope. Photo fall 2012.
