**Flood Control Project Maintenance
Levee Inspections**
LMA District Cover Sheet
Spring 2014 Levee Inspection Results

Reclamation District No. 1500 Sutter Basin

Spring 2014 Levee Inspection Results

Waterway		Bank	Unit Miles
Unit No. 01 Sacramento River		Left	33.58

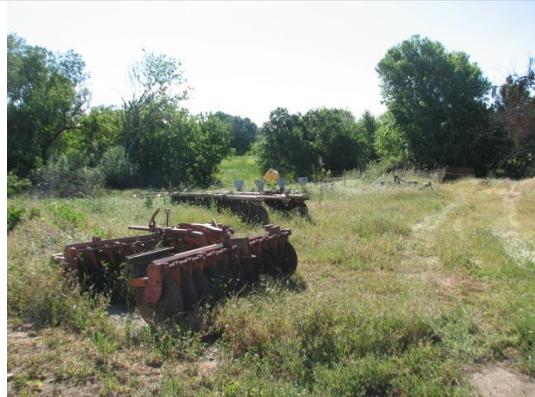
Photo 2 of 2 : johngw_s_20140428_892.jpg

LM Start	0.00	Rating **	M	Issue No.	12 (cont)
LM End	0.00	Issue Type +	Ma	Location *	WS

Farm equipment is on the levee crown. Spring 2014

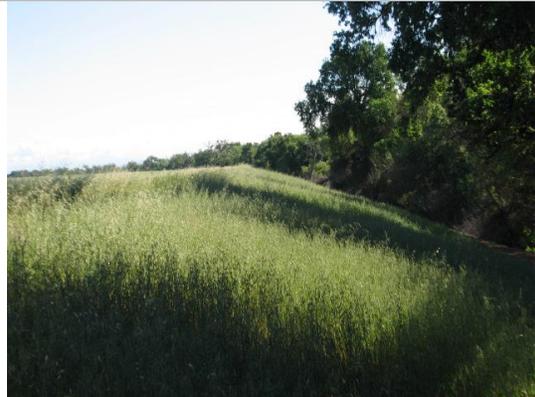
Photo 1 of 1 : johngw_s_20140428_894.jpg

Tall grasses partially blocks visibility. Spring 2014

LM Start	0.01	Rating **	M	Issue No.	300
LM End	20.77	Issue Type +	Ma	Location *	WS
Category	Earthen Levee		GPS Latitude/Longitude		
			Start	End	
Item	Vegetation		38.761159 °	39.021350 °	
			-121.674529 °	-121.741138 °	
DWR ID	DWR_RD1500_02_s_2014_300				
Action/Comments					
Control annual grass and weeds on the levee slopes and easements.

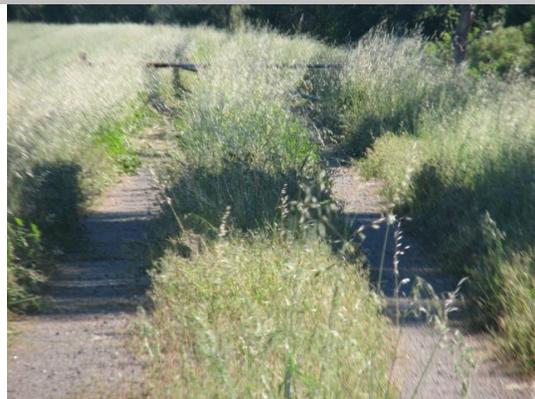
Photo 1 of 1 : johngw_s_20140428_895.jpg

Maintain unwanted vegetation on the levee crown Spring 2014

LM Start	0.16	Rating **	M	Issue No.	302
LM End	1.86	Issue Type +	Ma	Location *	CR
Category	Earthen Levee		GPS Latitude/Longitude		
			Start	End	
Item	Vegetation		38.762750 °	38.782985 °	
			-121.672501 °	-121.655599 °	
DWR ID	DWR_RD1500_02_s_2014_302				
Action/Comments					
Keep the crown roadway free of vegetation.

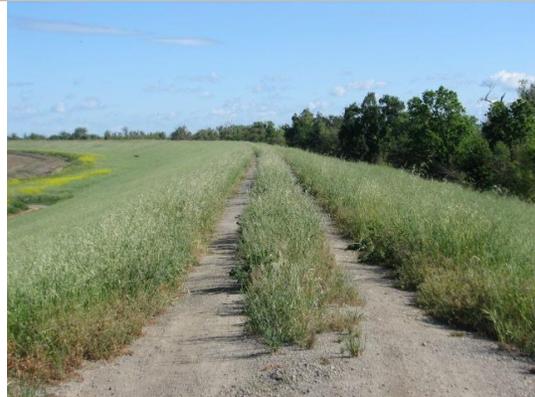
Photo 1 of 1 : johngw_s_20140428_897.jpg

Maintain unwanted vegetation on the levee crown. Spring 2014

LM Start	2.02	Rating **	M	Issue No.	304
LM End	6.67	Issue Type +	Ma	Location *	CR
Category	Earthen Levee		GPS Latitude/Longitude		
			Start	End	
Item	Vegetation		38.785361 °	38.850023 °	
			-121.654617 °	-121.653874 °	
DWR ID	DWR_RD1500_02_s_2014_304				
Action/Comments					
Keep the crown roadway free of vegetation.

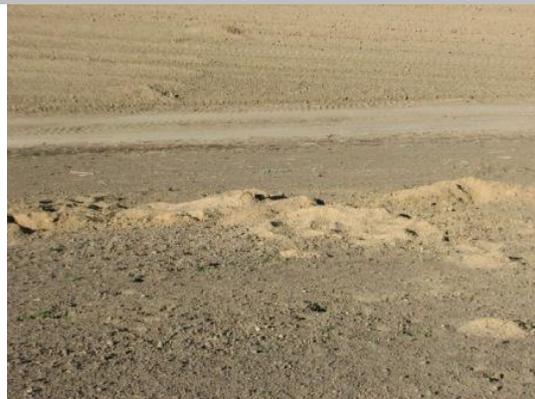
Photo 1 of 1 : johngw_s_20140414_483.jpg

LM Start	3.34	Rating **	M	Issue No.	1
LM End	3.34	Issue Type +	Ma	Location *	LS
Category	Earthen Levee		GPS Latitude/Longitude		
			Start	End	
Item	Animal Control		38.803810 °	38.803810 °	
			-121.657095 °	-121.657095 °	
DWR ID	DWR_RD1500_02_f_2013_1				
Action/Comments					
Exterminate rodents and backfill and compact or grout burrows. Inspector Comments: Unable to see; the grass are too tall.

Rodent hole on the landside levee toe. Fall 2013

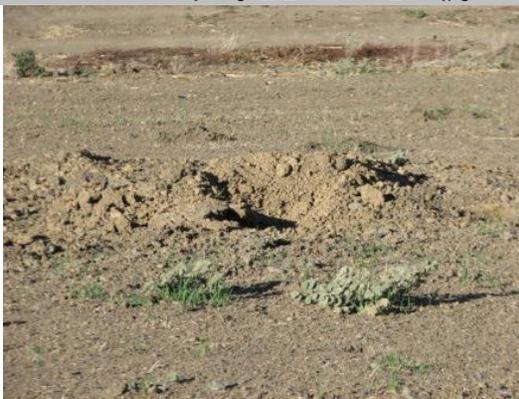
Photo 1 of 1 : johngw_s_20140414_486.jpg

LM Start	3.98	Rating **	M	Issue No.	8
LM End	3.98	Issue Type +	Ma	Location *	LS
Category	Earthen Levee		GPS Latitude/Longitude		
			Start	End	
Item	Animal Control		38.812725 °	38.812725 °	
			-121.660802 °	-121.660802 °	
DWR ID	DWR_RD1500_02_f_2013_8				
Action/Comments					
Exterminate rodents and backfill and compact or grout burrows. Inspector Comments: Unable to see; the grass are too tall.

A large rodent hole on the landside levee slope. Fall 2013

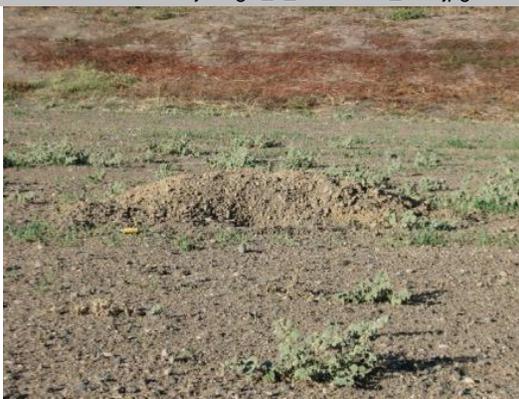
Photo 1 of 1 : johngw_s_20140414_495.jpg

LM Start	4.16	Rating **	M	Issue No.	19
LM End	4.16	Issue Type +	Ma	Location *	LS
Category	Earthen Levee		GPS Latitude/Longitude		
			Start	End	
Item	Animal Control		38.815070 °	38.815070 °	
			-121.661787 °	-121.661787 °	
DWR ID	DWR_RD1500_02_f_2013_19				
Action/Comments					
Exterminate rodents and backfill and compact or grout burrows. Inspector Comments: Unable to see; the grass are too tall.

A rodent hole on the landside levee slope. Fall 2013

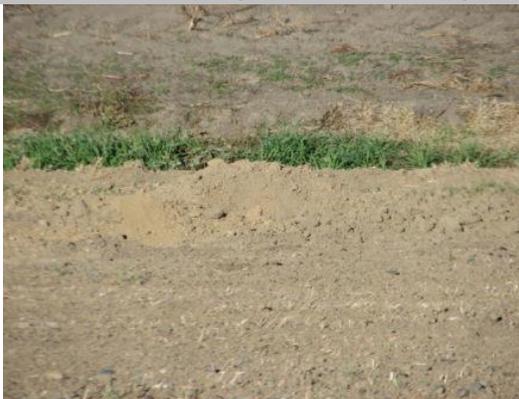
Photo 1 of 1 : johngw_s_20140414_496.jpg

LM Start	6.23	Rating **	M	Issue No.	20
LM End	6.23	Issue Type +	Ma	Location *	LS
Category	Earthen Levee		GPS Latitude/Longitude		
			Start	End	
Item	Animal Control		38.843900 °	38.843900 °	
			-121.656275 °	-121.656275 °	
DWR ID	DWR_RD1500_02_f_2013_20				
Action/Comments					
Exterminate rodents and backfill and compact or grout burrows. Inspector Comments: Unable to see; the grass are too tall.

A rodent hole at the toe. Fall 2013

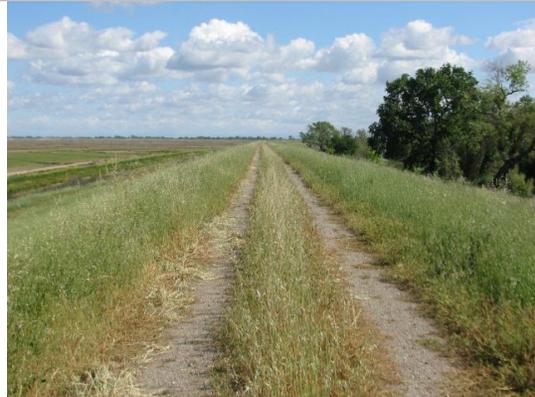
Photo 1 of 1 : johngw_s_20140428_898.jpg

Maintain unwanted vegetation on the crown of the levee. Spring 2014

LM Start	7.18	Rating **	M	Issue No.	305
LM End	10.57	Issue Type +	Ma	Location *	CR
Category	Earthen Levee		GPS Latitude/Longitude		
			Start	End	
Item	Vegetation		38.857051 °	38.902850 °	
			-121.651108 °	-121.638295 °	
DWR ID	DWR_RD1500_02_s_2014_305				
Action/Comments					
Keep the crown roadway free of vegetation.

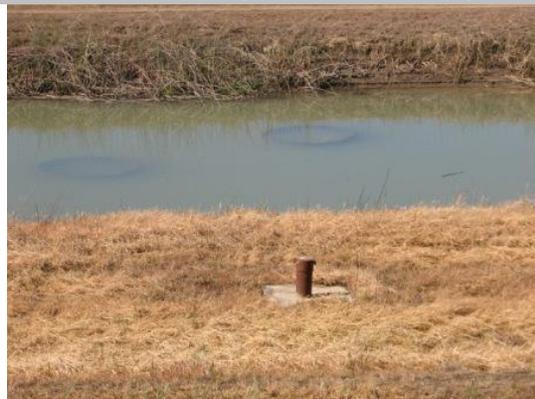
Photo 1 of 1 : johngw_s_20140414_484.jpg

LM Start	14.22	Rating **	A/W	Issue No.	4
LM End	14.22	Issue Type +	Ma	Location *	LS
Category	Earthen Levee		GPS Latitude/Longitude		
			Start	End	
Item	Underseepage Relief Wells		38.947582 °	38.947582 °	
			-121.669740 °	-121.669740 °	
DWR ID	DWR_RD1500_02_s_2012_4				
Action/Comments

The relief well at boil 12, photo taken spring 2012.

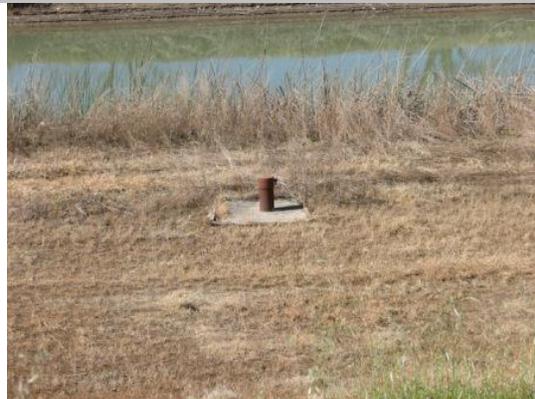
Photo 1 of 1 : johngw_s_20140414_489.jpg

LM Start	14.56	Rating **	A/W	Issue No.	11
LM End	14.56	Issue Type +	Ma	Location *	LS
Category	Earthen Levee		GPS Latitude/Longitude		
			Start	End	
Item	Underseepage Relief Wells		38.951398 °	38.951398 °	
			-121.673827 °	-121.673827 °	
DWR ID	DWR_RD1500_02_s_2012_11				
Action/Comments

A relief well at boil 16, photo taken spring 2012.

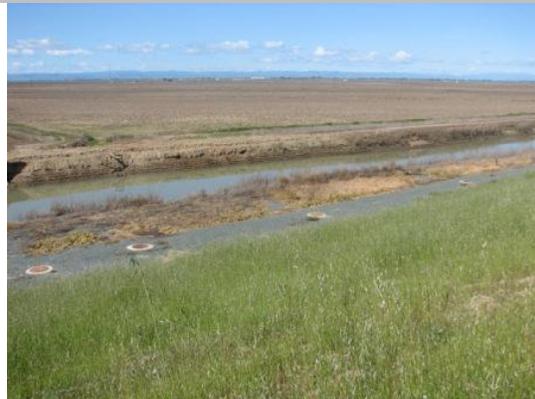
Photo 1 of 2 : johngw_s_20140414_491.jpg

LM Start	18.24	Rating **	A/W	Issue No.	13
LM End	18.24	Issue Type +	Ma	Location *	LS
Category	Earthen Levee		GPS Latitude/Longitude		
			Start	End	
Item	Underseepage Relief Wells		38.987092 °	38.987092 °	
			-121.725097 °	-121.725097 °	
DWR ID	DWR_RD1500_02_s_2012_13				
Action/Comments

Toe drainage systems along the toe berm four total, photo taken spring 2012.

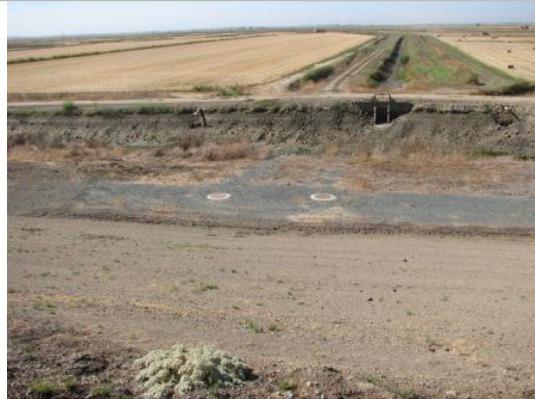
Photo 2 of 2 : johngw_s_20140414_492.jpg

LM Start	18.24	Rating **	A/W	Issue No.	13 (cont)
LM End	18.24	Issue Type +	Ma	Location *	LS
Category	Earthen Levee		GPS Latitude/Longitude		
			Start	End	
Item	Underseepage Relief Wells		38.987092 °	38.987092 °	
			-121.725097 °	-121.725097 °	
DWR ID	DWR_RD1500_02_s_2012_13				
Action/Comments

Two of five drains on the landside berm. Photo fall 2012.

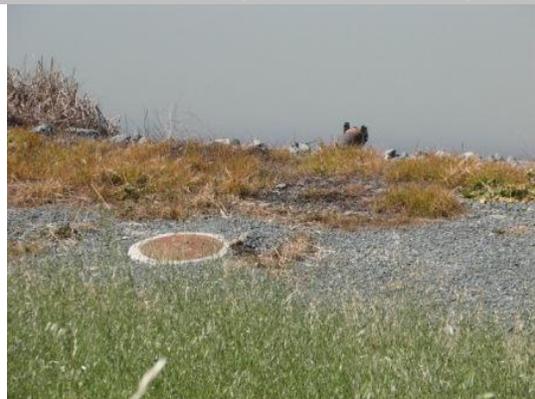
Photo 1 of 2 : johngw_s_20140414_493.jpg

LM Start	18.48	Rating **	A/W	Issue No.	15
LM End	18.48	Issue Type +	Ma	Location *	LS
Category	Earthen Levee		GPS Latitude/Longitude		
			Start	End	
Item	Underseepage Relief Wells		38.989813 °	38.989813 °	
			-121.727763 °	-121.727763 °	
DWR ID	DWR_RD1500_02_s_2012_15				
Action/Comments

A toe drainage system at the toe berm, photo taken spring 2012.

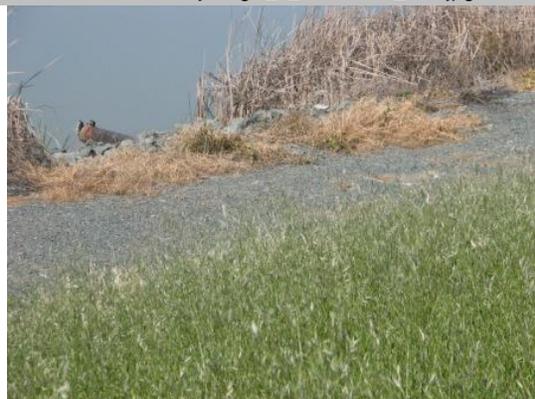
Photo 2 of 2 : johngw_s_20140414_494.jpg

LM Start	18.48	Rating **	A/W	Issue No.	15 (cont)
LM End	18.48	Issue Type +	Ma	Location *	LS

Another toe drainage system close by, photo taken spring 2012.
