**Flood Control Project Maintenance
Levee Inspections**

Maintenance Issue Types Only, Levee Inspection Report By Mile - Fall 2014

Reclamation District No. 1500 Sutter Basin

Waterway	Bank	Unit Miles	Inspection Start/End	Inspector
Unit No. 01 Sacramento River	Left	33.15	10/23/2014 10/23/2014	Clay Thomas

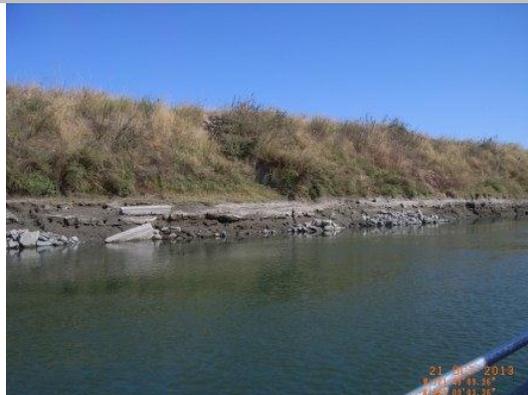
Photo 1 of 1 : FA_2014_RD1500_189_29_20141014_00027.jpg

LM Start	30.91	Rating **	M	Issue No.	29
LM End	30.91	Issue Type +	Ma	Location *	WS
Category	Supplemental			GPS Latitude/Longitude	
				Start	End
Item	USACE Erosion Survey			38.999745 °	39.001413 °
				-121.800898 °	-121.802889 °
DWR ID	DWR_RD1500_01_f_2014_29				
Action/Comments					
Inspector Comments: 2000 - Eroding, vertical berm slope over a vertical cohesive toe; slow erosion but getting close to the toe. 2002 - Erosion is getting close to the levee, still eroding with some new small slumps. 2004 - Some minor new erosion. 2006 - Some new erosion, cleaned off older scars and slump faces. 2008 - New, small, partial rotational failure. 2011 - Some new minor erosion. 2013: No observed
