**Flood Control Project Maintenance
Levee Inspections**

Maintenance Issue Types Only, Levee Inspection Report By Mile - Fall 2015

Reclamation District No. 1500 Sutter Basin

Waterway	Bank	Unit Miles	Inspection Start/End	Inspector
Unit No. 01 Sacramento River	Left	33.15	10/20/2015 10/21/2015	Jai Lor

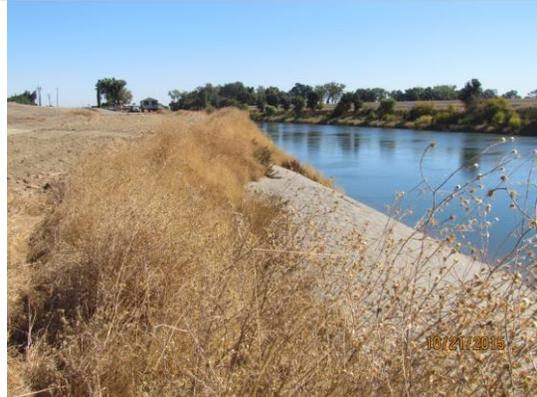
Photo 1 of 2 : FA_2015_RD1500_189_50_20151026_00161.jpg

LM Start	12.19	Rating **	A/W	Issue No.	50
LM End	12.19	Issue Type +	Ma	Location *	WS
Category	Earthen Levee			GPS Latitude/Longitude	
				Start	End
Item	Erosion / Bank Caving			38.869700 °	38.869700 °
				-121.755945 °	-121.755945 °
DWR ID	DWR_RD1500_01_s_2012_50				
Action/Comments					
Note and monitor erosion site. Inspector Comments: The levee has a wide berm at this location.

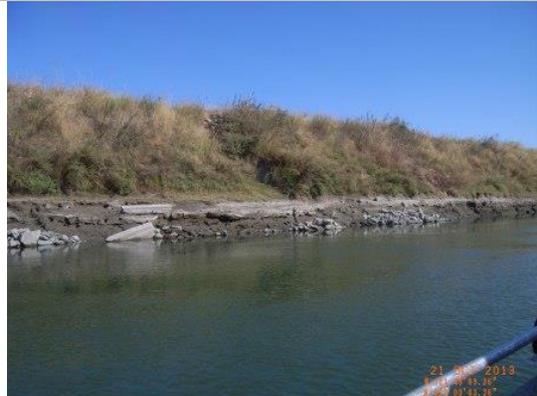
Photo 1 of 1 : USACE2013A_SAC_116-0_L_4.jpg

LM Start	30.60	Rating **	M	Issue No.	22
LM End	30.75	Issue Type +	Ma	Location *	WS
Category	Supplemental		GPS Latitude/Longitude		
			Start	End	
Item	2015 USACE Erosion Survey, DRAFT		38.999745 °	39.001413 °	
			-121.800898 °	-121.802889 °	
DWR ID					
Action/Comments					
Inspector Comments: 2000 - Eroding, vertical berm slope over a vertical cohesive toe; slow erosion but getting close to the toe. 2002 - Erosion is getting close to the levee, still eroding with some new small slumps. 2004 - Some minor new erosion. 2006 - Some new erosion, cleaned off older scars and slump faces. 2008 - New, small, partial rotational failure. 2011 - Some new minor erosion. 2015: No observed

USACE 2013 Photo #1
