**Flood Control Project Maintenance  
Levee Inspections**

**Maintenance Issue Types Only, Levee Inspection Report By Mile - Spring 2015**

**Reclamation District No. 1500 Sutter Basin**

Waterway	Bank	Unit Miles	Inspection Start/End	Inspector
Unit No. 01 Sacramento River	Left	33.15	05/13/2015 05/14/2015	Jai Lor

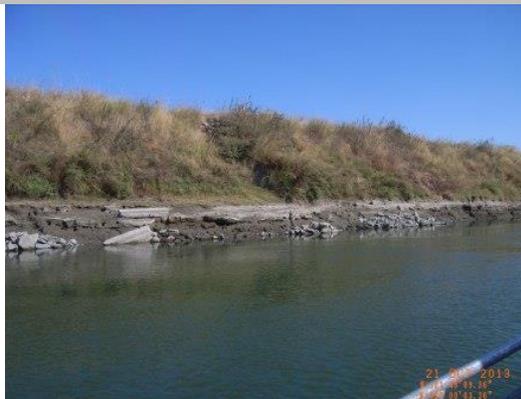
Photo 1 of 1 : SP\_2015\_RD1500\_189\_29\_20150401\_00026.jpg

LM Start	<b>30.60</b>	Rating **	M	Issue No.	<b>29</b>
LM End	<b>30.91</b>	Issue Type +	Ma	Location *	WS
Category	Supplemental			GPS Latitude/Longitude	
				Start	End
Item	USACE Erosion Survey			38.999745 °	39.001413 °
				-121.800898 °	-121.802889 °
DWR ID	DWR_RD1500_01_f_2014_29				
Action/Comments					
Inspector Comments: 2000 - Eroding, vertical berm slope over a vertical cohesive toe; slow erosion but getting close to the toe. 2002 - Erosion is getting close to the levee, still eroding with some new small slumps. 2004 - Some minor new erosion. 2006 - Some new erosion, cleaned off older scars and slump faces. 2008 - New, small, partial rotational failure. 2011 - Some new minor erosion. 2013: No observed
