**Flood Control Project Maintenance
Levee Inspections**

Fall 2012 Levee Maintenance Deficiency Summary Report

Reclamation District No. 1600 Mull

Levee Inspection Report By Mile - Fall 2012

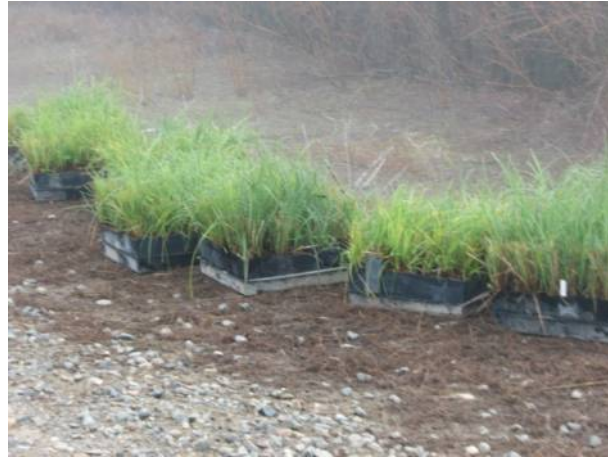
Levee Mile Report Line	12
Start Levee Mile	1.42
End Levee Mile	1.42
Location	Water Side
Category	Earthen Levee
Item	Vegetation

Flats of plant material to be planted at the site.
Fall 2012

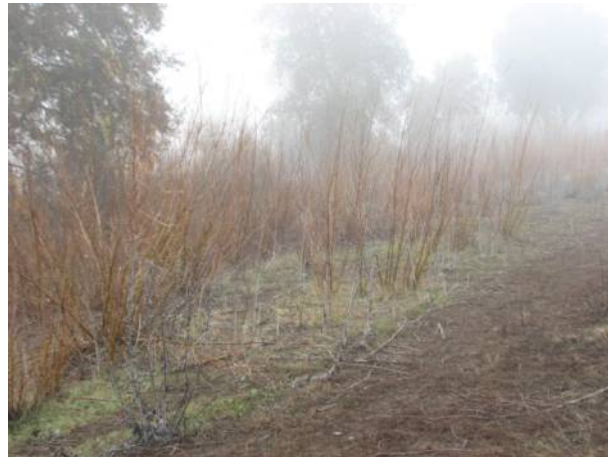
Levee Mile Report Line	13
Start Levee Mile	1.58
End Levee Mile	1.58
Location	Water Side
Category	Earthen Levee
Item	Vegetation

Willows are growing on the waterside shoulder.
They have been grazed by goats. Fall 2012

LMR No.	Levee Mile		Category	Item	Location *	Rating **	Action/Comment	GPS Latitude/Longitude		Issue No. Photo
	Start	End						Start	End	
13	1.58	1.58	Earthen Levee	Vegetation	WS	M Ma	V2 : Remove the wild growth other than native grasses from the levee slopes.	38.696748 ° -121.633201 °	38.696748 ° -121.633201 °	7 Y
DWR ID: DWR_RD1600_01_f_2012_7										
14	1.71	1.71	Earthen Levee	Encroachments	WS	A Ma	MA : Material Inspector Comments: Old metal ramp from unused dock, ramp is on levee shoulder. Ramp was removed by DWR for levee repairs and is due to be placed back.	38.698364 ° -121.631926 °	38.698364 ° -121.631926 °	9 Y
DWR ID: DWR_RD1600_01_s_2012_9										
15	1.73	1.73	Earthen Levee	Vegetation	WSA/W	Ob	V8 : Environmental Requirements.	38.698613 ° -121.631710 °	38.698613 ° -121.631710 °	31 Y
DWR ID: DWR_RD1600_01_s_2012_31										
16	1.84	8.13	Earthen Levee	Vegetation	LS	M Ma	V1 : Control annual grass and weeds on the levee slopes and easements.	38.699877 ° -121.630511 °	38.778233 ° -121.606500 °	12 Y

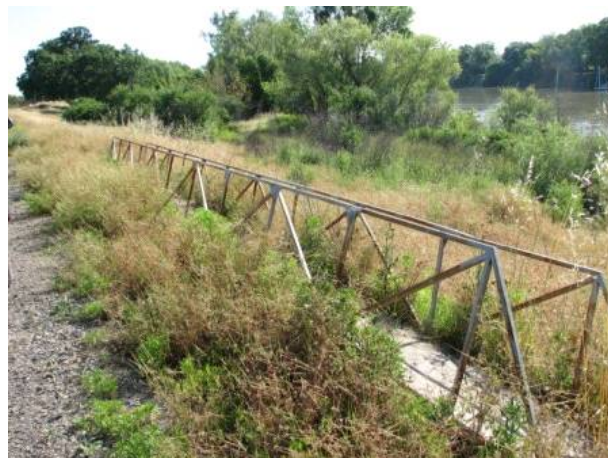
Levee Mile Report Line	14
Start Levee Mile	1.71
End Levee Mile	1.71
Location	Water Side
Category	Earthen Levee
Item	Encroachments

Ramp for dock not being used.

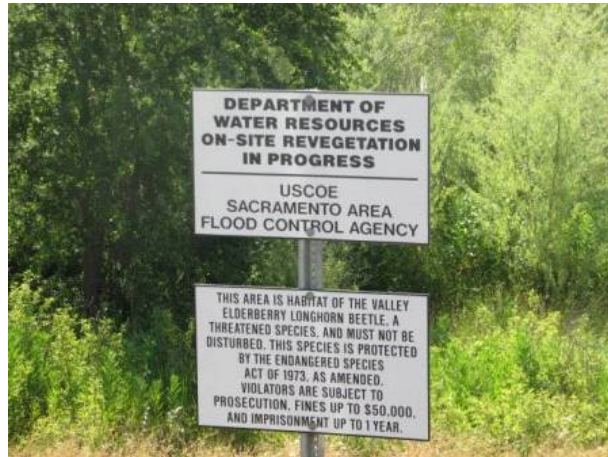
Levee Mile Report Line	15
Start Levee Mile	1.73
End Levee Mile	1.73
Location	Water Side
Category	Earthen Levee
Item	Vegetation

Revegetation site with the Elderberry Beetle. Photo taken spring 2012.

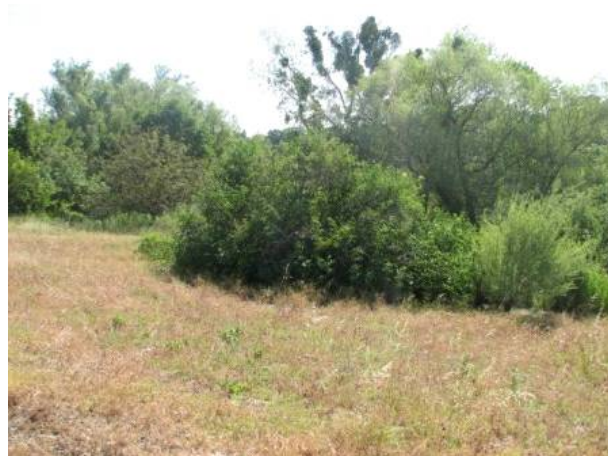
Levee Mile Report Line	15
Start Levee Mile	1.73
End Levee Mile	1.73
Location	Water Side
Category	Earthen Levee
Item	Vegetation

A photo of a Elderberry bush in the area.

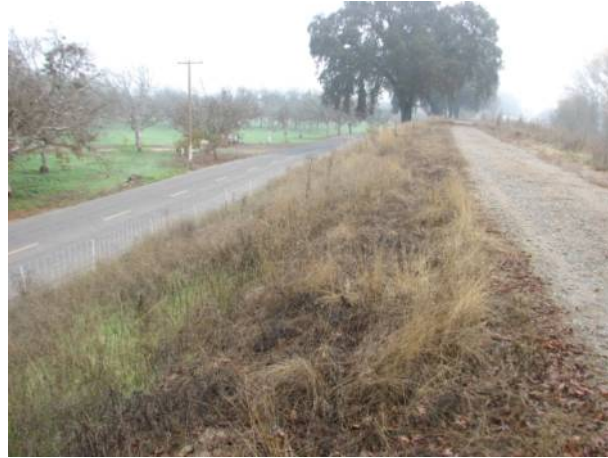
The goats have work up to this point. Vegetation is taller than 12 inches. Fall 2012

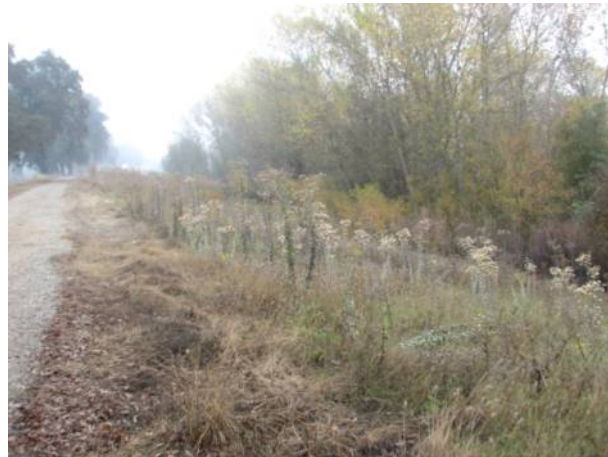
Levee Mile Report Line	17
Start Levee Mile	1.84
End Levee Mile	5.90
Location	Water Side
Category	Earthen Levee
Item	Vegetation

The vegetation is taller than 12 inches. Fall 2012

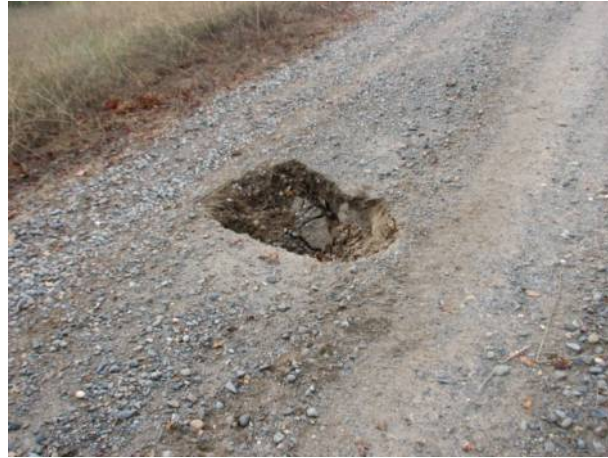
The hole in the crown is 1X2 feet and 1 foot deep.
Fall 2012

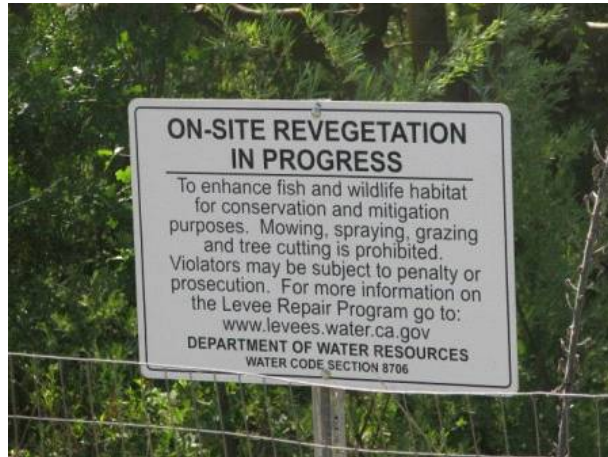
Levee Mile Report Line	21
Start Levee Mile	2.36
End Levee Mile	2.42
Location	Water Side
Category	Earthen Levee
Item	Vegetation

Revegetation site, photo taken spring 2012.

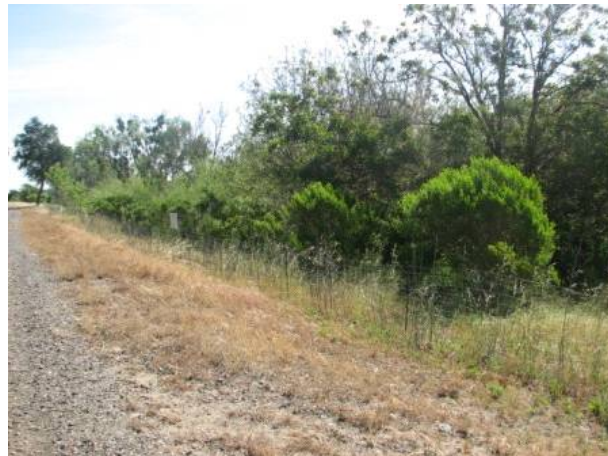
Levee Mile Report Line	21
Start Levee Mile	2.36
End Levee Mile	2.42
Location	Water Side
Category	Earthen Levee
Item	Vegetation

The revegetation site extends almost to the hinge point.

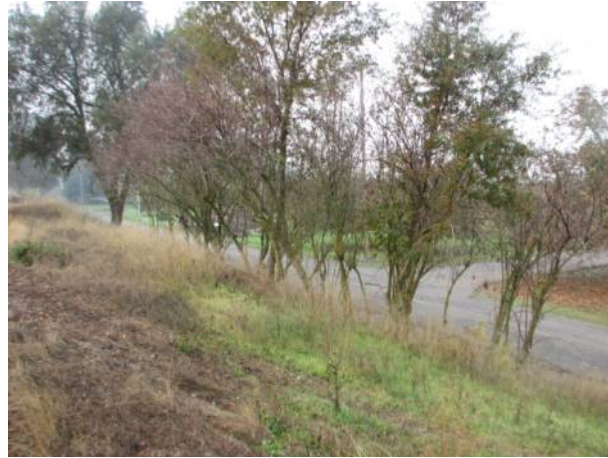
A large stand of elderberries on the landside slope. Fall 2012

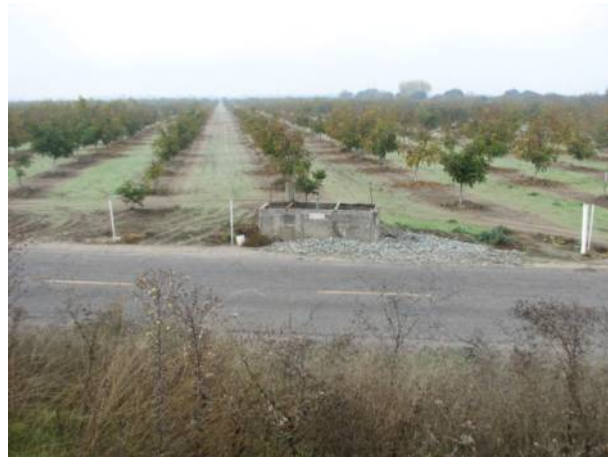
Levee Mile Report Line	25
Start Levee Mile	4.89
End Levee Mile	4.89
Location	Land Side
Category	Earthen Levee
Item	Erosion / Bank Caving

The concrete collection box across the road. Fall 2012

LMR No.	Levee Mile		Category	Item	Location	Rating	Action/Comment	GPS Latitude/Longitude		Issue No.
	Start	End						Start	End	
25	4.89	4.89	Earthen Levee	Erosion / Bank Caving	LS	U Ma	E2 : Schedule repair of erosion site prior to the next inspection. Inspector Comments: Hole in pipe causing erosion of levee slope. Replace pipe and repair damage.	38.736250 ° -121.604605 °	38.736250 ° -121.604605 °	25 Y
DWR ID: DWR_RD1600_01_f_2012_25										
26	5.26	5.26	Earthen Levee	Encroachments	WS	C En	DE : Debris	38.741197 ° -121.602645 °	38.741197 ° -121.602645 °	41 Y
DWR ID: DWR_RD1600_01_s_2012_41										
27	5.43	5.43	Earthen Levee	Vegetation	LS A/W	Ma	V4 : Elderberries are blocking visibility and flood fight capability.	38.743632 ° -121.601173 °	38.743632 ° -121.601173 °	13 Y
DWR ID: DWR_RD1600_01_s_2012_13										
28	5.48	5.81	Earthen Levee	Erosion / Bank Caving	WS	M Ma	E1 : Note and monitor erosion site. Inspector Comments: Levee district had us add this because of the loss of the berm over years of water flows. Erosion is at the waters edge. Walnut trees are close to edge now.	38.744118 ° -121.601104 °	38.748210 ° -121.598025 °	19 Y

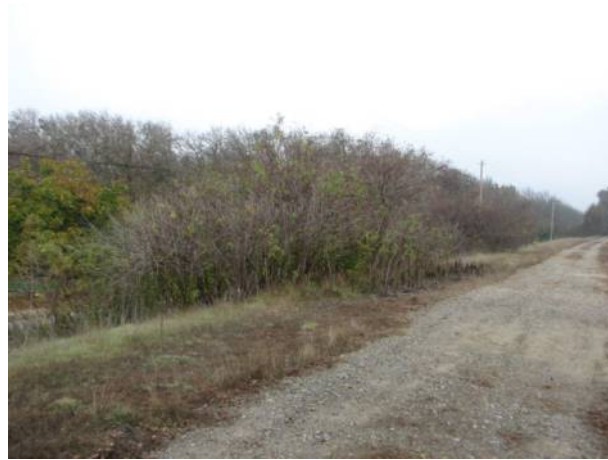
A thick stand of elderberries on the landside. Fall 2012

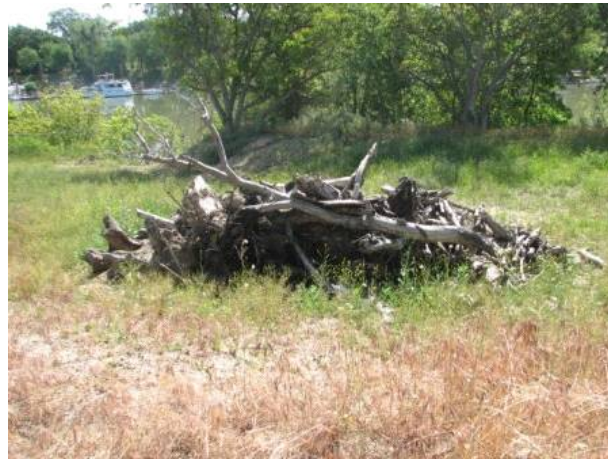
Levee Mile Report Line	29
Start Levee Mile	5.79
End Levee Mile	5.79
Location	Water Side
Category	Earthen Levee
Item	Encroachments

A pruning pile left over from the installation of the new pipe. Photo taken spring 2012.

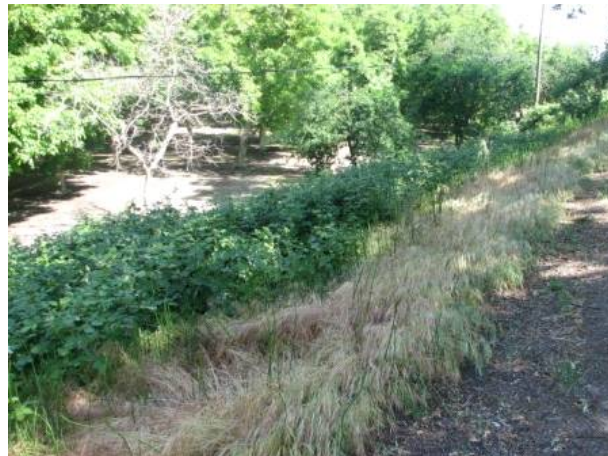
Levee Mile Report Line	30
Start Levee Mile	6.05
End Levee Mile	6.05
Location	Land Side
Category	Earthen Levee
Item	Vegetation

The berries are taking over the slope. Photo taken spring 2012.

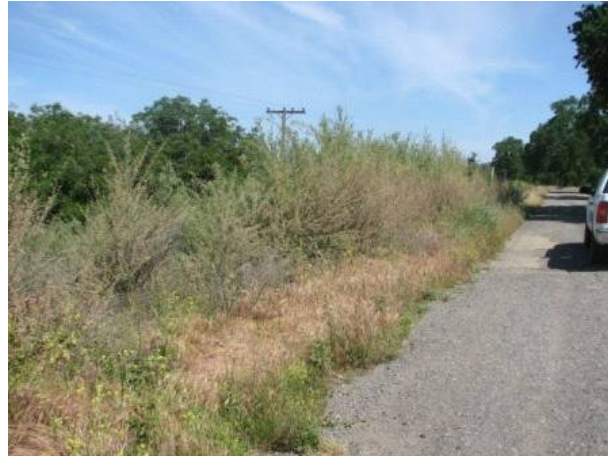
The willows need to be cut for visibility of the slope. Photo taken spring 2012.

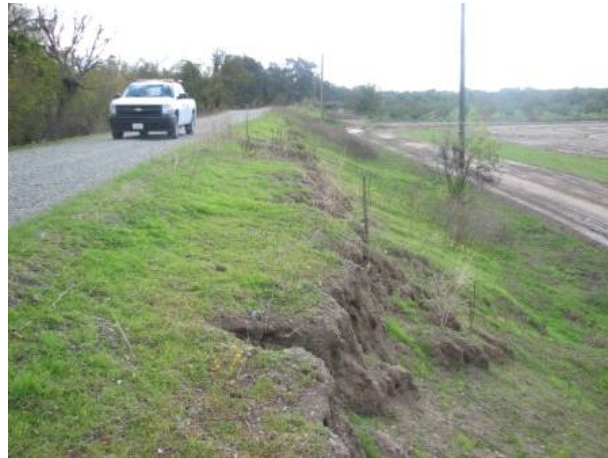
The erosion appears to be moving closer to the shoulder.

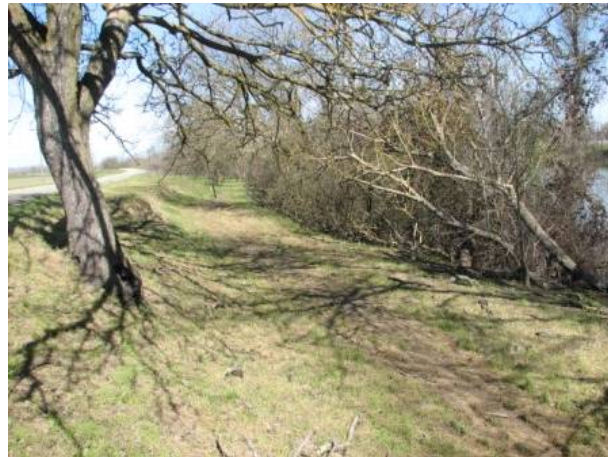
Levee Mile Report Line	36
Start Levee Mile	7.13
End Levee Mile	7.13
Location	Water Side
Category	Earthen Levee
Item	Erosion / Bank Caving

The erosion is eroding away at the berm area.

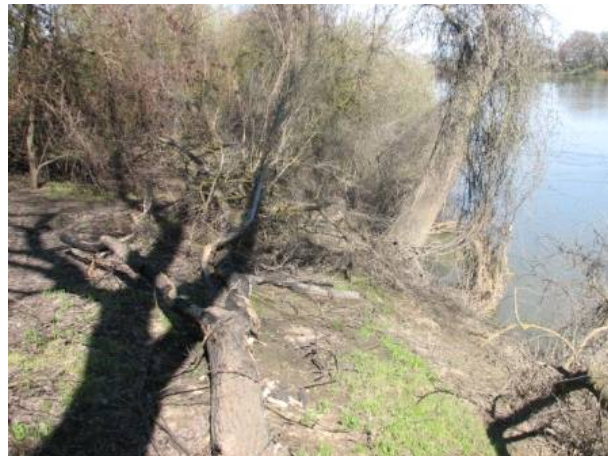
Levee Mile Report Line	36
Start Levee Mile	7.13
End Levee Mile	7.13
Location	Water Side
Category	Earthen Levee
Item	Erosion / Bank Caving

This another view of the site.

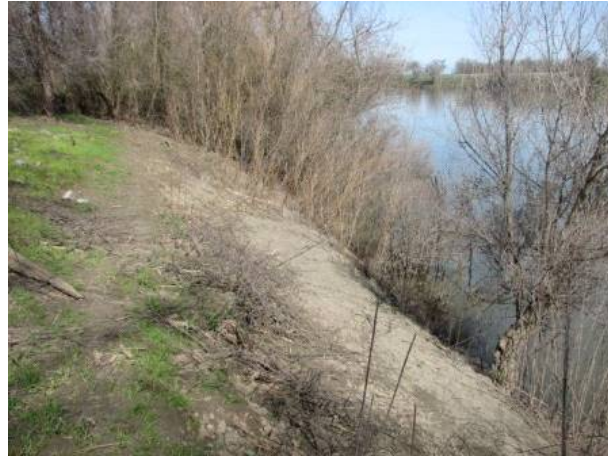
The bank is eroding away and has become very steep.

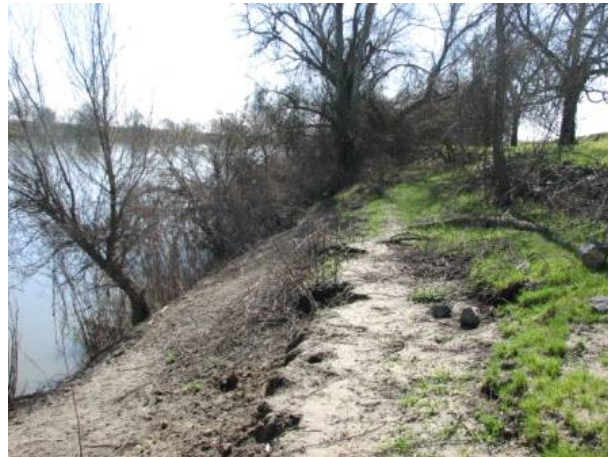
Levee Mile Report Line	37
Start Levee Mile	7.27
End Levee Mile	7.27
Location	Water Side
Category	Earthen Levee
Item	Erosion / Bank Caving

The erosion is eroding away the berm area.

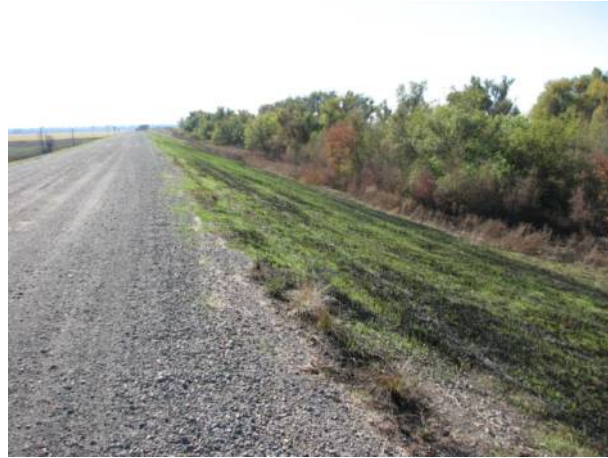
The levee slope complies with standards. Fall 2012

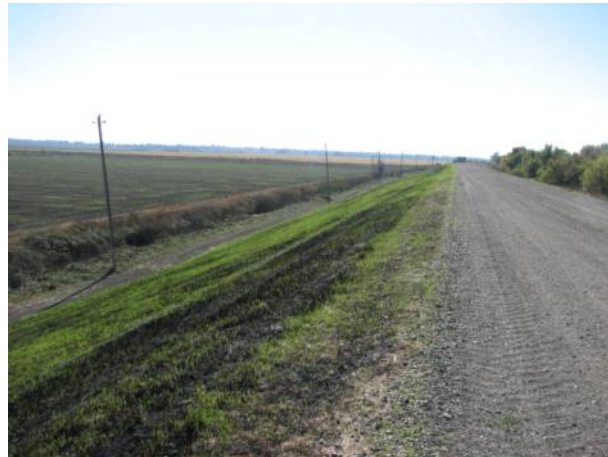
Levee Mile Report Line	2
Start Levee Mile	0.01
End Levee Mile	0.39
Location	Water Side
Category	Earthen Levee
Item	Vegetation

The levee slope complies with standards. Fall 2012

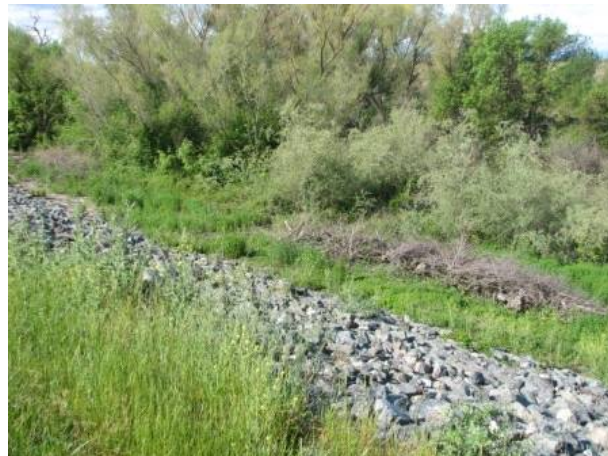
Levee Mile Report Line	4
Start Levee Mile	0.35
End Levee Mile	0.35
Location	Water Side
Category	Earthen Levee
Item	Encroachments

Pruning piles along the toe of the waterside levee. Photo taken spring 2012.

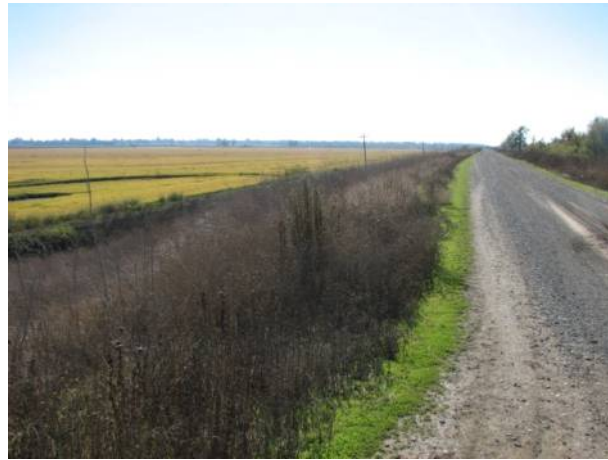
Tall vegetation on the levee slope unable to see.
Fall 2012

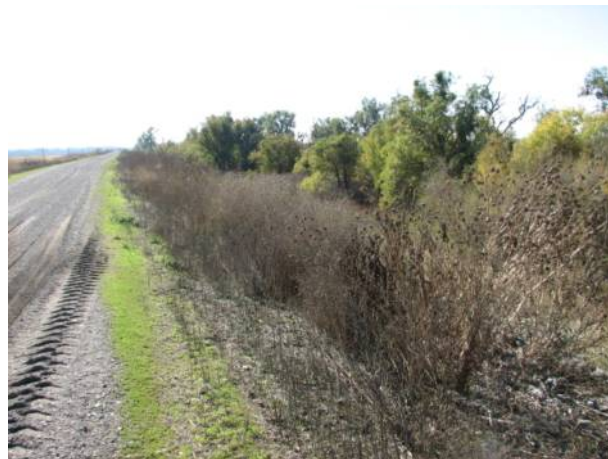
Levee Mile Report Line	6
Start Levee Mile	0.39
End Levee Mile	0.89
Location	Water Side
Category	Earthen Levee
Item	Vegetation

Tall vegetation on the levee slope. Fall 2012

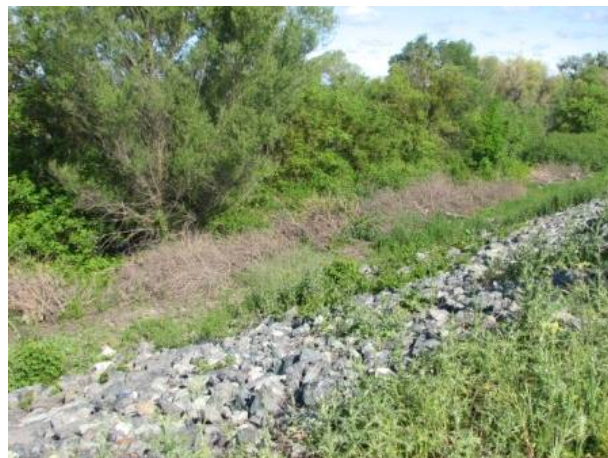
johngw_f_20120911_601.jpg

Pruning piles along the the waterside toe of the levee. Photo taken spring 2012.

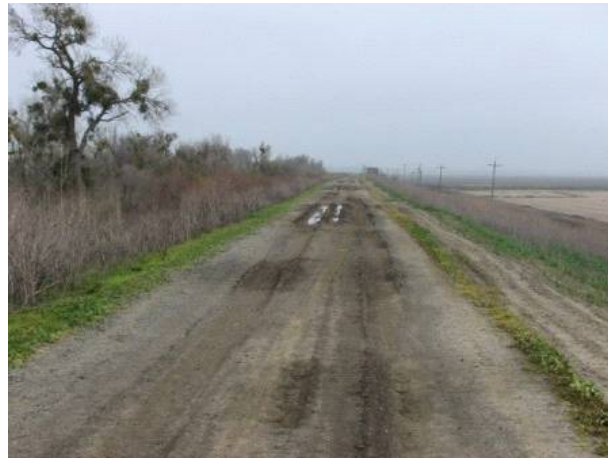
johngw_f_20120911_595.jpg

This area is soft and needs to have AB added to make an all weather surface.

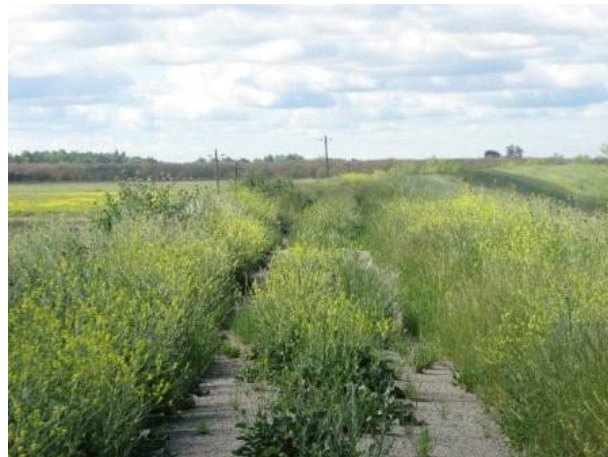
johngw_f_20120911_602.jpg

Levee Mile Report Line	9
Start Levee Mile	0.85
End Levee Mile	4.08
Location	Crown
Category	Earthen Levee
Item	Crown Surface / Depressions / Rutting

The crown roadway needs to be free of weeds. Photo taken spring 2012.

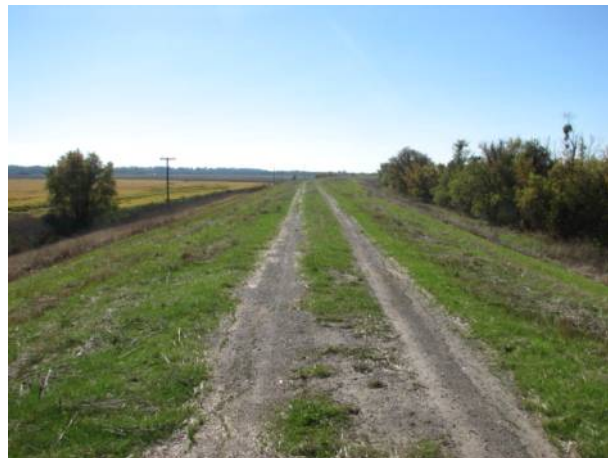
johngw_f_20121107_849.jpg

Levee Mile Report Line	9
Start Levee Mile	0.85
End Levee Mile	4.08
Location	Crown
Category	Earthen Levee
Item	Crown Surface / Depressions / Rutting

The crown of the levee needs to be weed free. Fall 2012

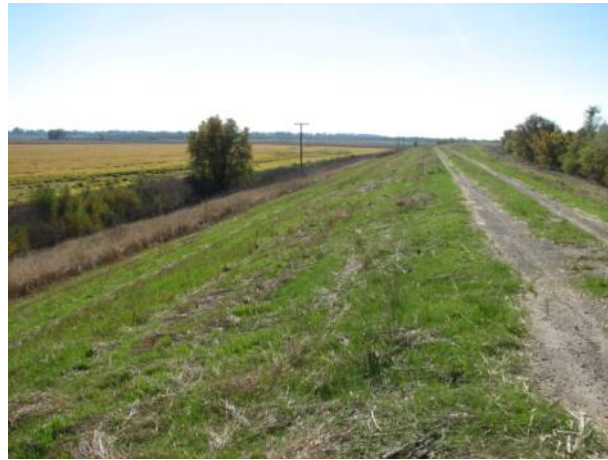
johngw_f_20121107_850.jpg

The goats are doing a good job on vegetation control. Fall 2012

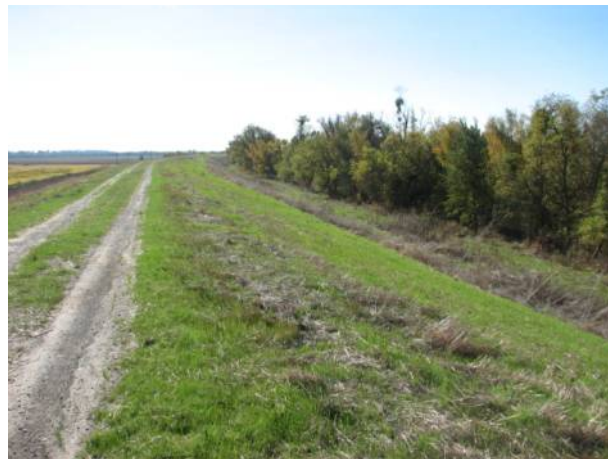
johngw_f_20121107_851.jpg

Levee Mile Report Line	11
Start Levee Mile	0.89
End Levee Mile	4.15
Location	Land Side
Category	Earthen Levee
Item	Vegetation

A look at the waterside of the levee slope. Fall 2012

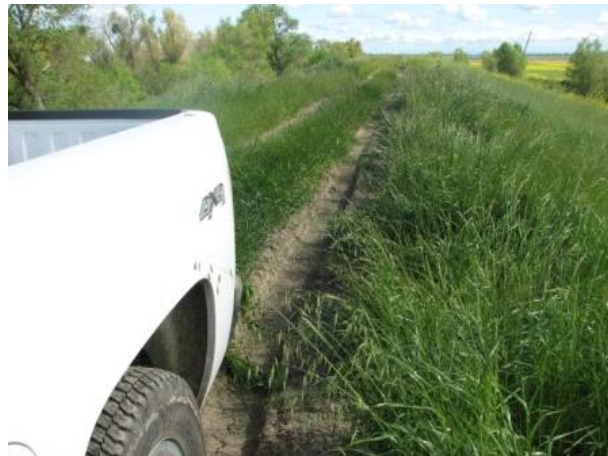
johngw_f_20120911_603.jpg

Levee Mile Report Line	12
Start Levee Mile	1.65
End Levee Mile	1.65
Location	Crown
Category	Earthen Levee
Item	Crown Surface / Depressions / Rutting

Tire ruts are deeper than 6", the crown needs to be graded. Photo taken spring 2012.

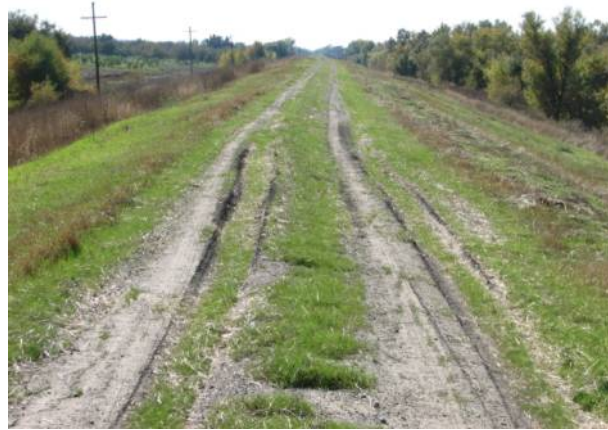
johngw_f_20121107_852.jpg

The crown has ruts deeper then six inches. Fall 2012

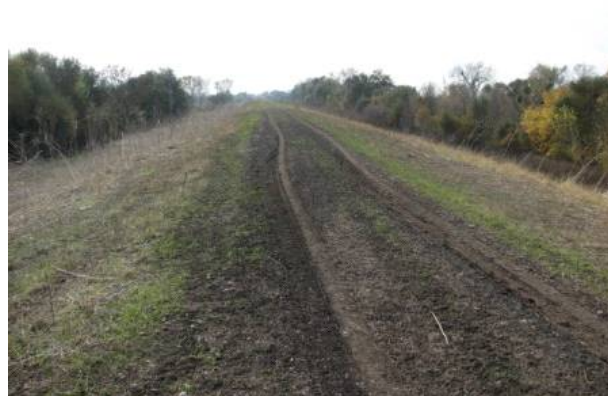
johngw_f_20120911_593.jpg

The crown of the levee needs to have AB added. Some rutting has occurred.
