**Flood Control Project Maintenance  
Levee Inspections**

**Fall 2013 Levee Maintenance Deficiency Summary Report**

**Sacramento River Basin**

**Reclamation District No. 1600 Mull**

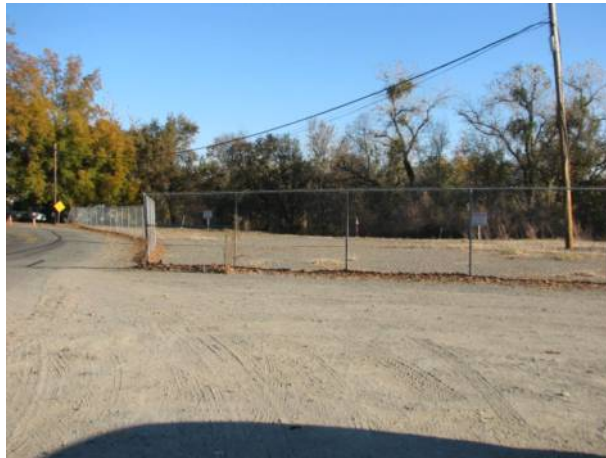
Levee Mile Report Line	4
Start Levee Mile	0.01
End Levee Mile	0.09
Location	Water Side
Category	Earthen Levee
Item	Encroachments
A chain link fence across the crown and waterside levee slope. Fall 2013	
johngw_f_20131114_320.JPG

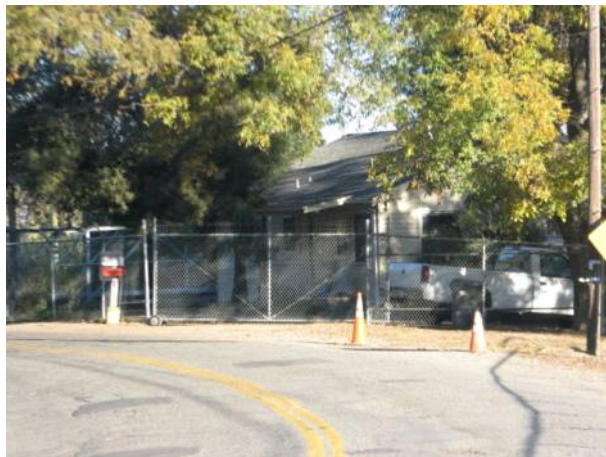
Levee Mile Report Line	5
Start Levee Mile	0.06
End Levee Mile	0.06
Location	Water Side
Category	Earthen Levee
Item	Encroachments
The caretakers home for the operator of the pumping plant (RD 1213). Fall 2013	
johngw_f_20131114_321.JPG

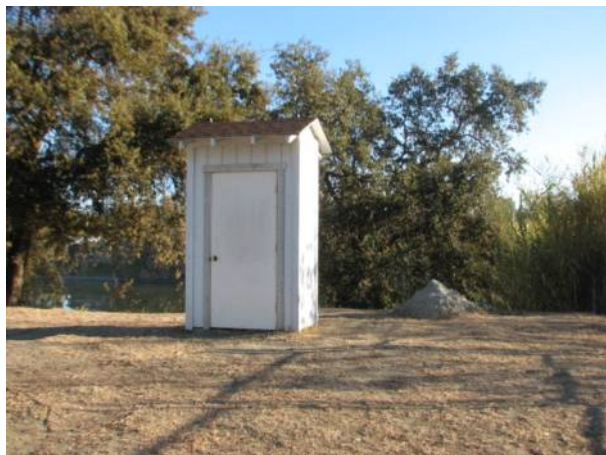
Levee Mile Report Line	6
Start Levee Mile	0.10
End Levee Mile	0.10
Location	Water Side
Category	Earthen Levee
Item	Encroachments
The small building is a pump house for the well. It services the house with water. Fall 2013	
johngw_f_20131114_322.JPG

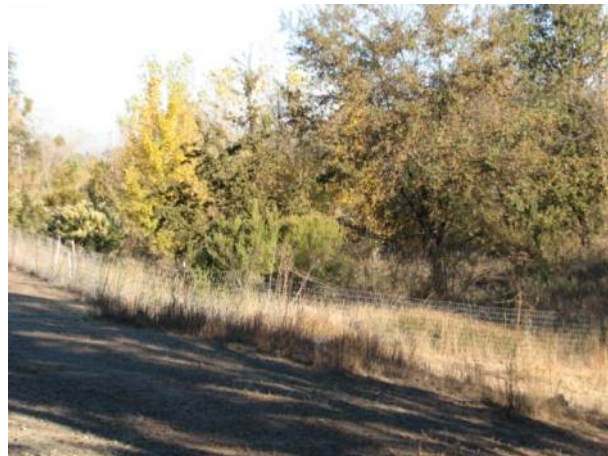
The revegetation area is fenced off but nobody has been caring for it. Fall 2013

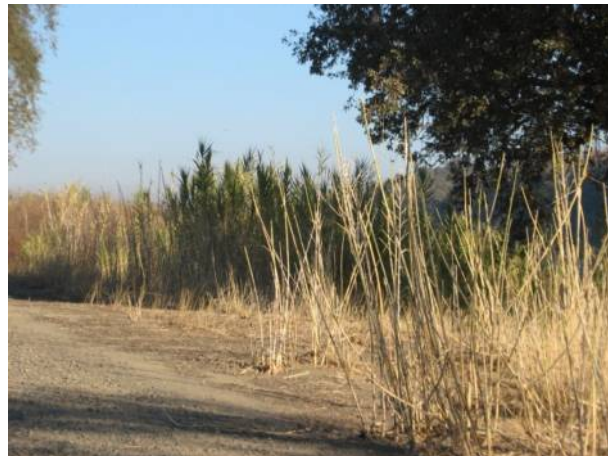
The Arundo has increased in size and obstructs the view of the levee slope. Fall 2013

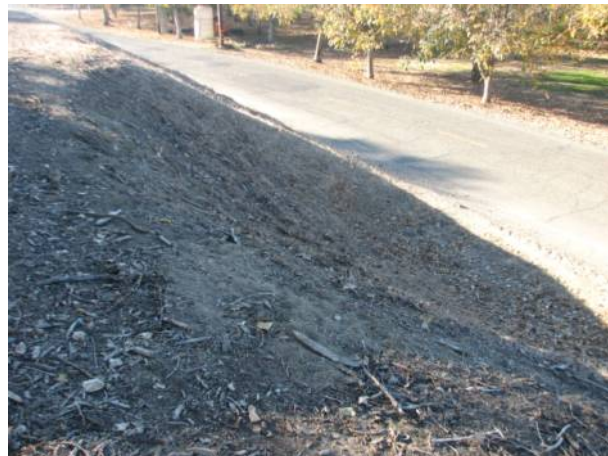
The levee has a deep depression caused by slope stability. Fall 2013

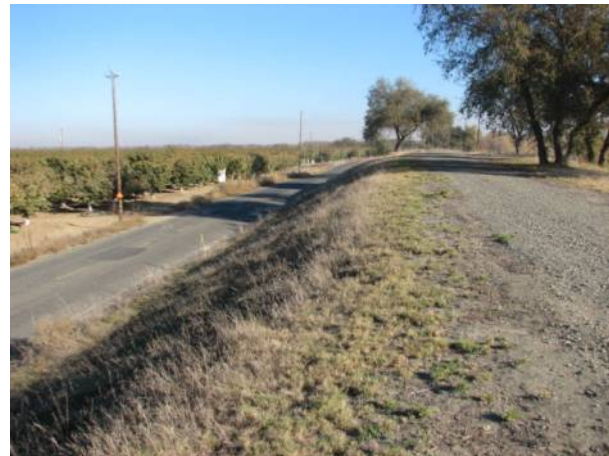
The goats are working through the levee and have not far. Fall 2013

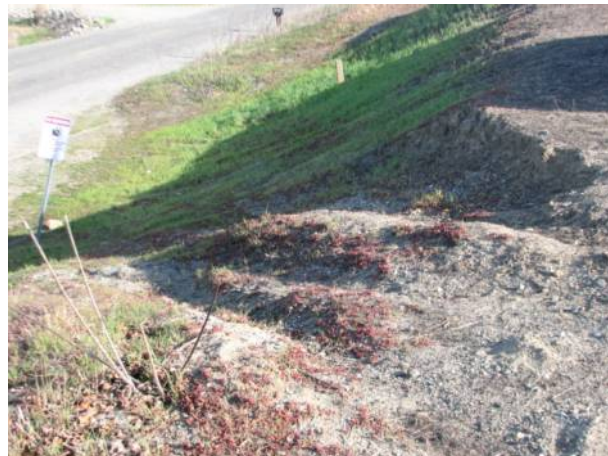
Erosion from vehicles on levee slope. Spring 2013

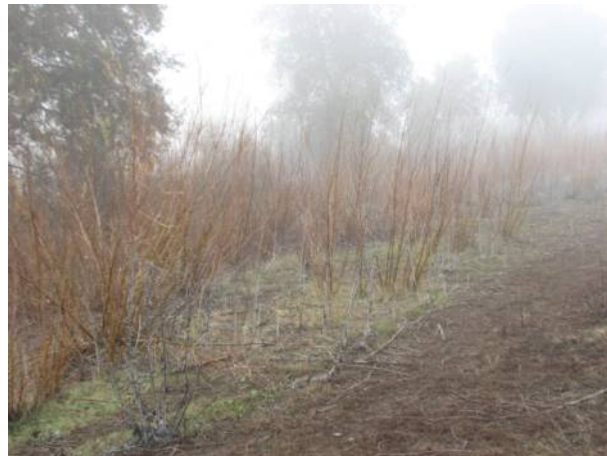
Willows are growing on the waterside shoulder.  
They have been grazed by goats. Fall 2012

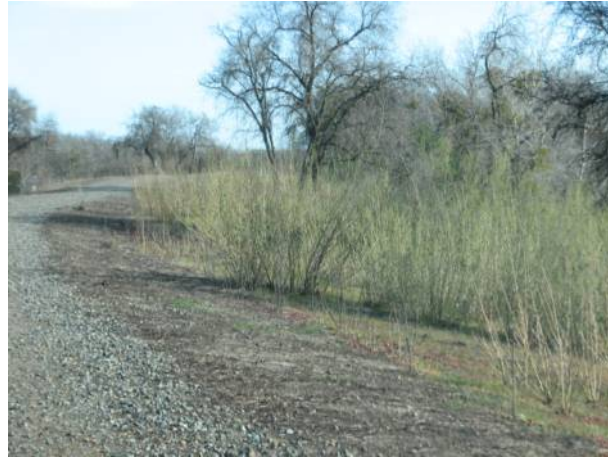
Willows are starting to come back creeping up on to the shoulder. Spring 2013

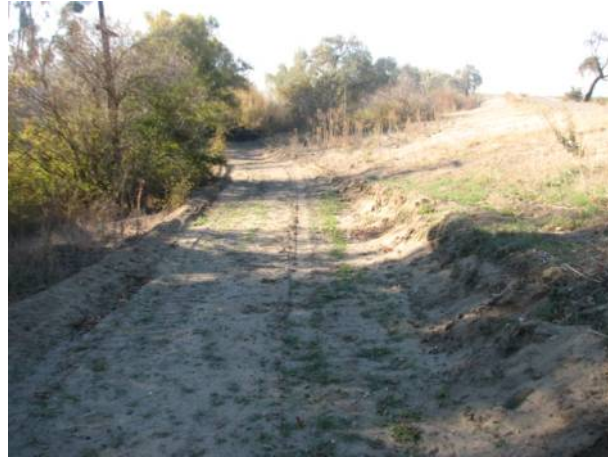
It appears that a dozer has pushed a pile of brush to the waters edge. Fall 2013

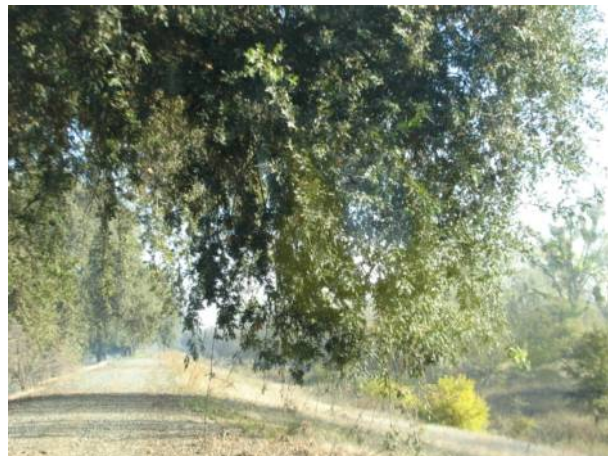
Trees need to be trimmed to at least 12 feet above the crown. Fall 2013

DWR ID: DWR_RD1600_01_f_2013_137										
27	1.94	1.94	Earthen Levee	Trim / Thin Trees	CR	M Ma	T4 : Trim trees over roadway to at least 12 feet above ground level.	38.700862 ° -121.629183 °	38.700862 ° -121.629183 °	138 Y
DWR ID: DWR_RD1600_01_f_2013_138										
28	2.02	2.02	Earthen Levee	Erosion / Bank Caving	LS	M Ma	E2 : Schedule repair of erosion site prior to the next inspection.	38.701590 ° -121.627991 °	38.701590 ° -121.627991 °	17 Y
DWR ID: DWR_RD1600_01_f_2012_17										
29	2.08	2.08	Earthen Levee	Erosion / Bank Caving	CR	U Ma	E2 : Schedule repair of erosion site prior to the next inspection.	38.702121 ° -121.627123 °	38.702121 ° -121.627123 °	24 Y
DWR ID: DWR_RD1600_01_f_2012_24										
30	2.36	2.42	Earthen Levee	Vegetation	WSA/W	V8 : Environmental Requirements.		38.704592 ° -121.623067 °	38.705152 ° -121.622187 °	35 Y
DWR ID: DWR_RD1600_01_s_2012_35										
31	2.42	2.42	Earthen Levee	Slope Stability	LS	M Ma	S1 : Repair slope instability.	38.705152 ° -121.622190 °	38.705152 ° -121.622190 °	143 Y

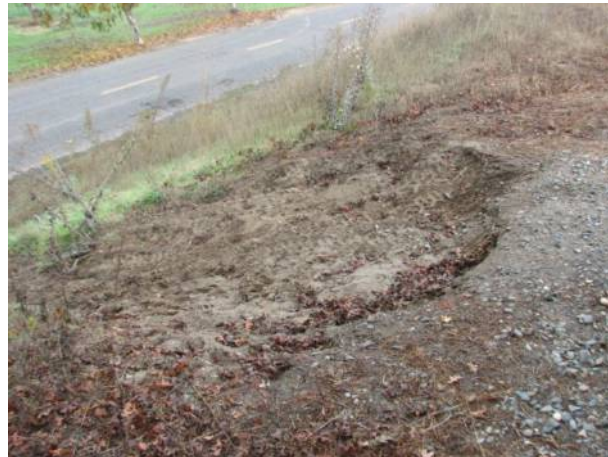
Vehicle and foot traffic has caused erosion. Fall 2012

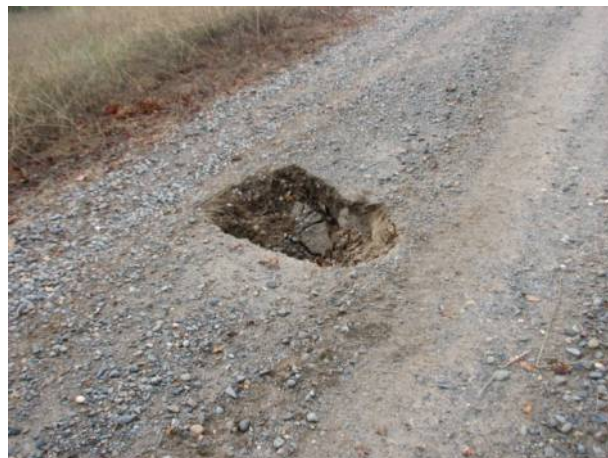
The hole in the crown is 1X2 feet and 1 foot deep. Fall 2012

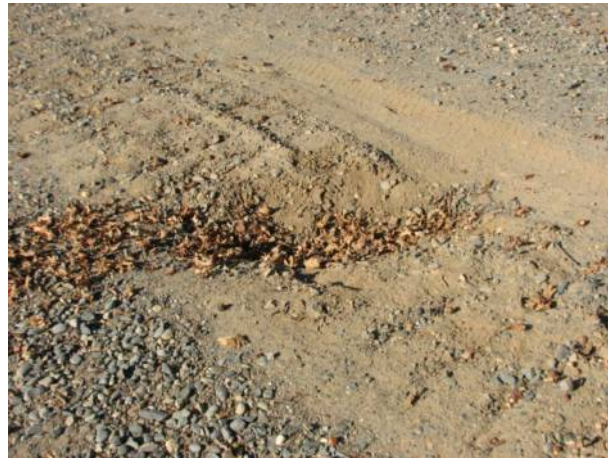
A hole in the crown needs to be repaired. Fall 2013

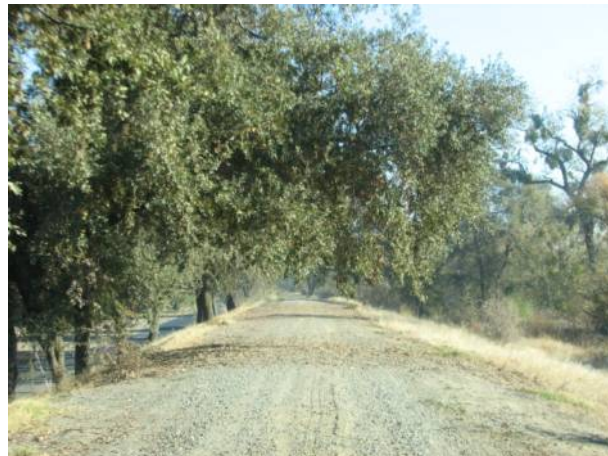
Trees need to be trimmed up to at least 12 feet above the crown. Fall 2013

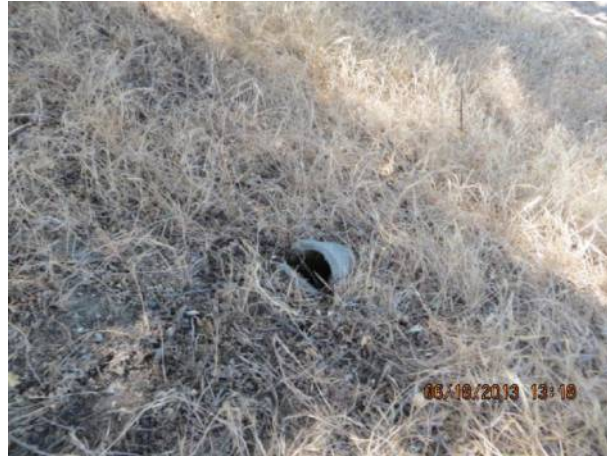
Pipe visible on LS slope.

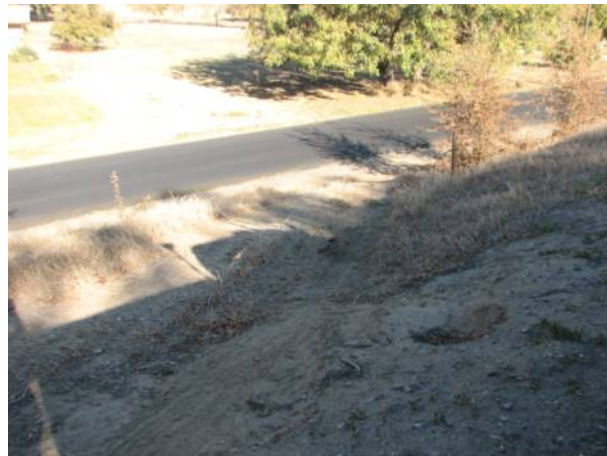
Erosion caused by vehicle traffic on the landside slope. Fall 2013

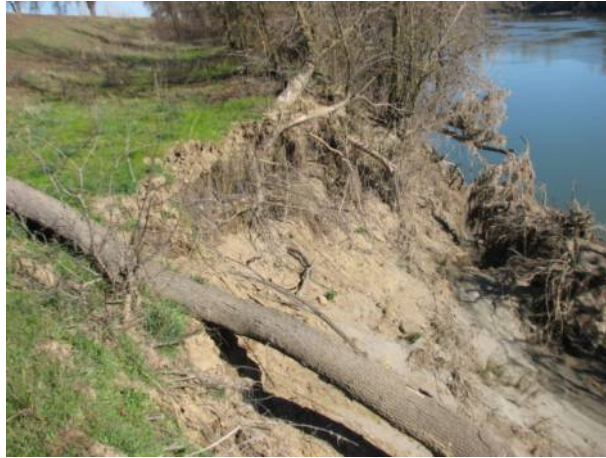
Trees have fallen and the water has created the erosion into the berm. Spring 2013

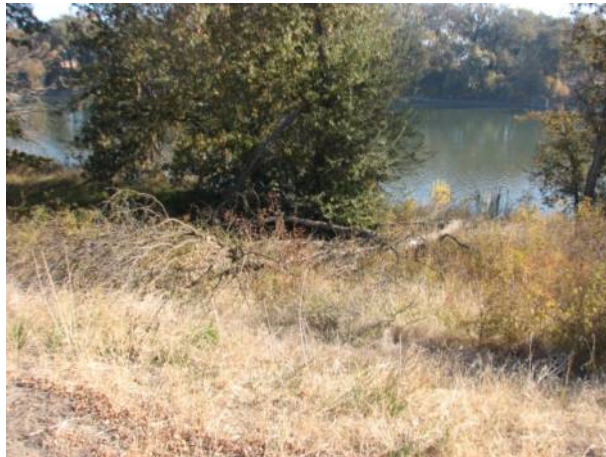
A large tree has fallen on the waterside berm and slope. Fall 2013

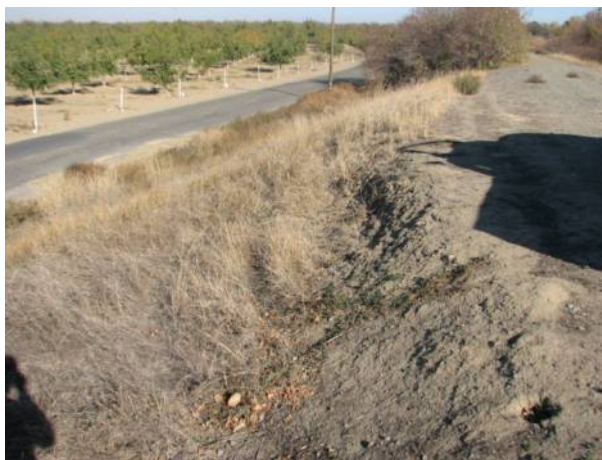
The erosion at the shoulder of the levee could be slope instability. Fall 2013

42	4.80	4.80	Earthen Levee	Slope Stability	LS	M	S1 : Repair slope instability.	38.734840 ° -121.605026 °	38.734840 ° -121.605026 °	141 Y
----	------	------	---------------	-----------------	----	---	--------------------------------	------------------------------	------------------------------	----------

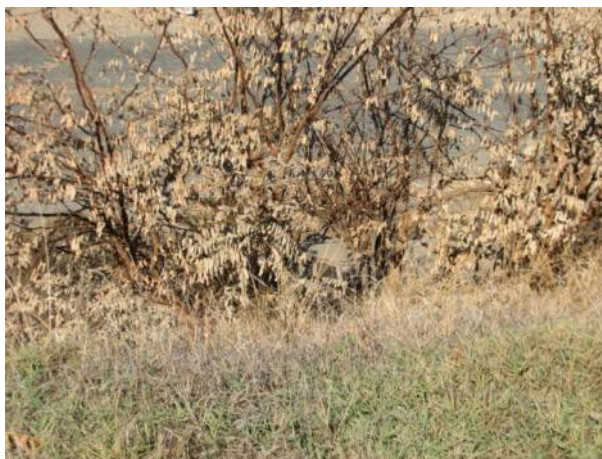
Tree stumps on the levee slope has been sprayed. Fall 2013

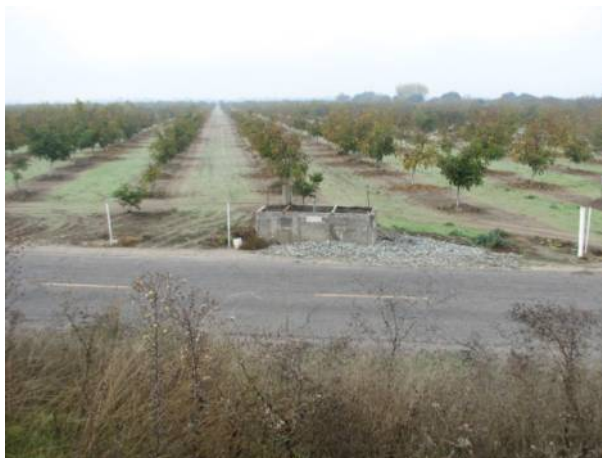
The concrete collection box across the road. Fall 2012

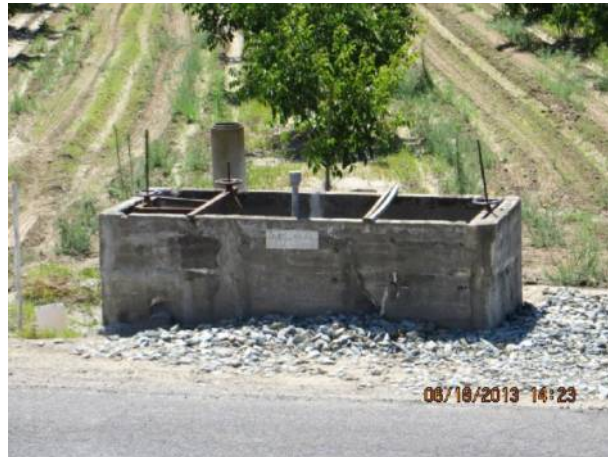
6'X14' concrete distribution box off LS toe.

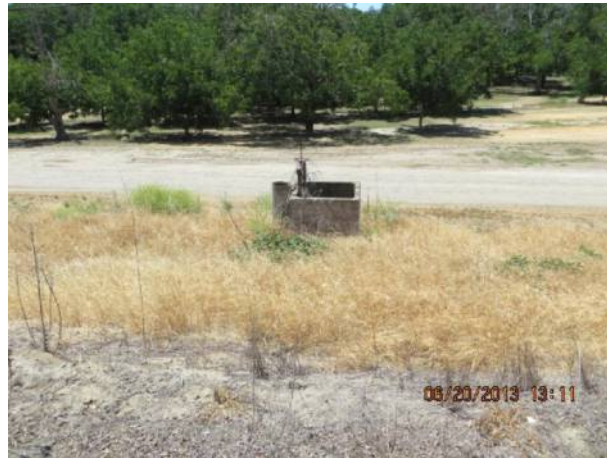
Levee Mile Report Line	50
Start Levee Mile	6.22
End Levee Mile	6.22
Location	Water Side
Category	Supplemental
Item	DWR UCIP Field Study
6'X6' concrete distribution box on LS toe.	
UCIP_8046.jpg

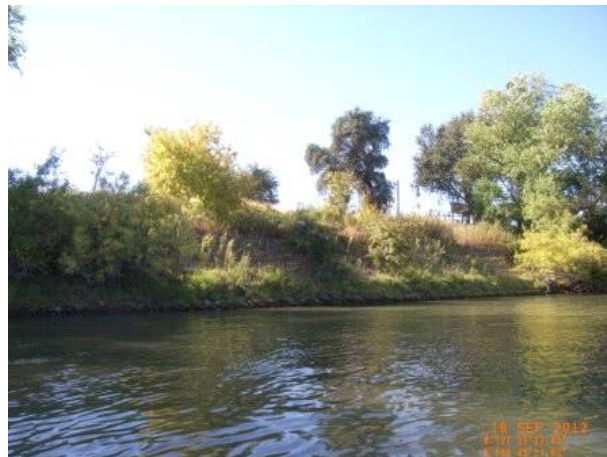
Levee Mile Report Line	51
Start Levee Mile	6.31
End Levee Mile	6.31
Location	Water Side
Category	Supplemental
Item	USACE Erosion Survey
USACE 2012 Photo #1	
USACE2013_SAC_77-0_R_1.jpg

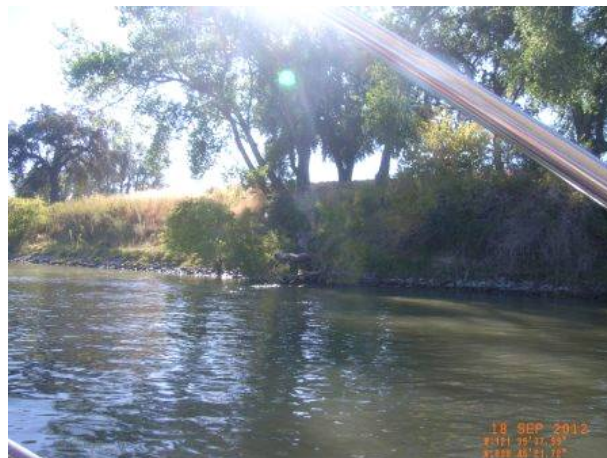
Levee Mile Report Line	51
Start Levee Mile	6.31
End Levee Mile	6.31
Location	Water Side
Category	Supplemental
Item	USACE Erosion Survey
USACE 2012 Photo #2	
USACE2013_SAC_77-0_R_2.jpg

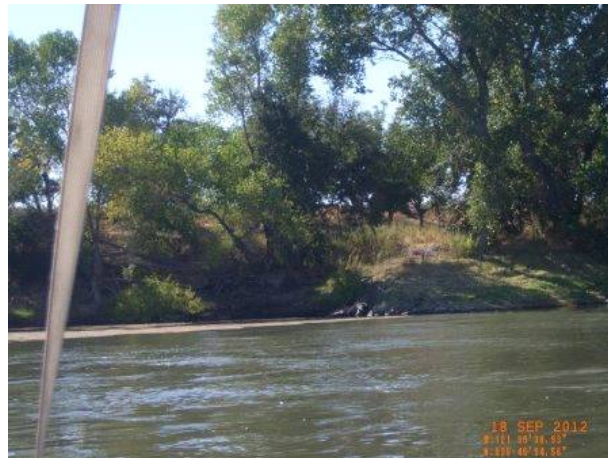
USACE2013\_SAC\_77-7\_R\_2.jpg

USACE 2012 Photo #2

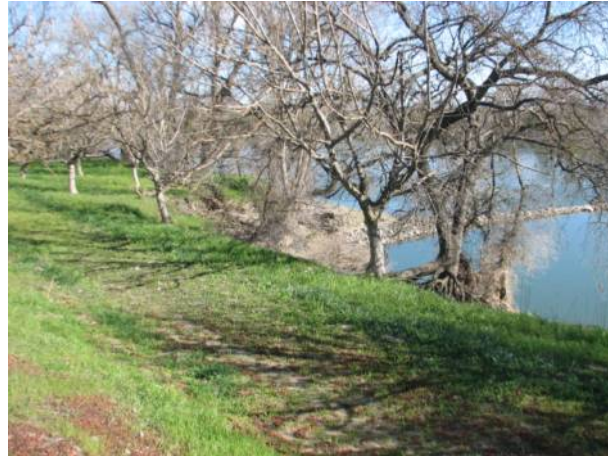
Levee Mile Report Line	53
Start Levee Mile	7.01
End Levee Mile	7.01
Location	Water Side
Category	Earthen Levee
Item	Erosion / Bank Caving
Erosion is into the berm area and needs to be monitored. Spring 2013	
johngw_f_20131021_639.JPG

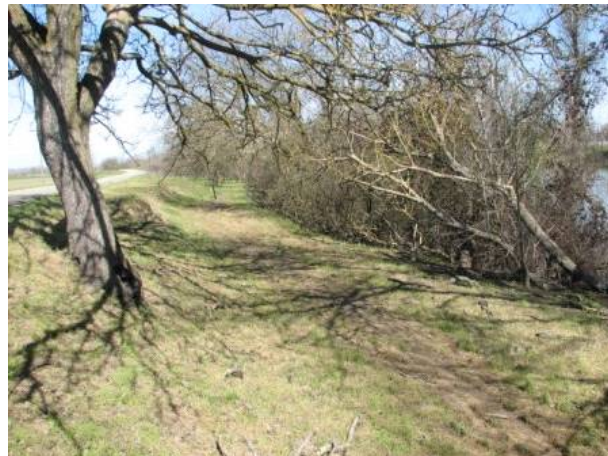
Levee Mile Report Line	55
Start Levee Mile	7.13
End Levee Mile	7.13
Location	Water Side
Category	Earthen Levee
Item	Erosion / Bank Caving
The erosion is eroding away at the berm area.	
johngw_f_20131021_627.jpg

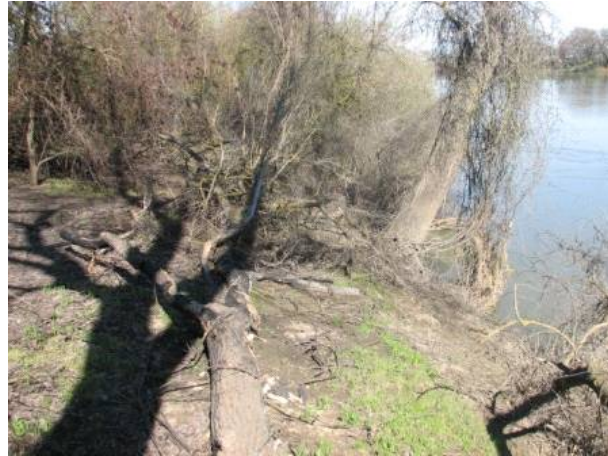
johngw\_f\_20131021\_628.jpg

This another view of the site.

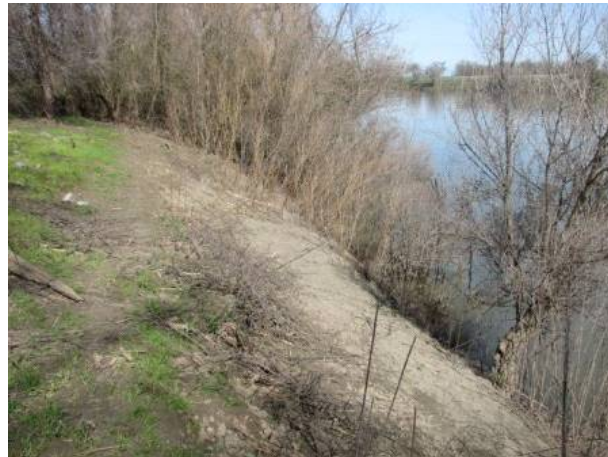
johngw\_f\_20131021\_629.jpg

Levee Mile Report Line	56
Start Levee Mile	7.27
End Levee Mile	7.27
Location	Water Side
Category	Earthen Levee
Item	Erosion / Bank Caving

The bank is eroding away and has become very steep.

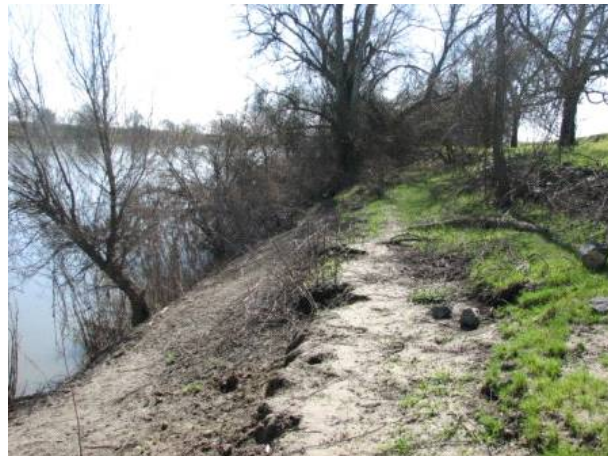
johngw\_f\_20131021\_630.jpg

Levee Mile Report Line	56
Start Levee Mile	7.27
End Levee Mile	7.27
Location	Water Side
Category	Earthen Levee
Item	Erosion / Bank Caving

The erosion is eroding away the berm area.

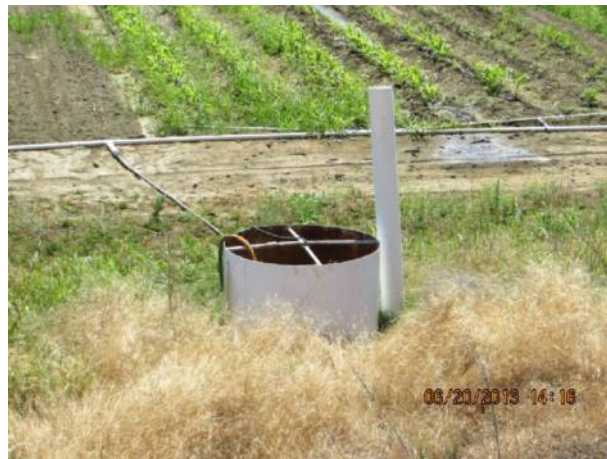
UCIP\_8056.jpg

4-foot diameter steel standpipe at LS toe, may be indicator of pipe location.

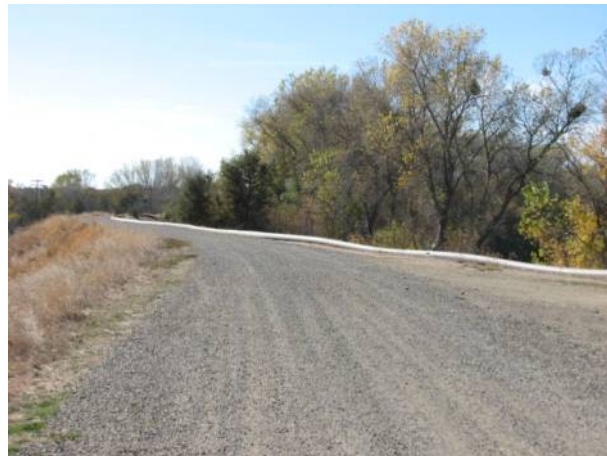
johngw\_f\_20131114\_342.JPG

Levee Mile Report Line	63
Start Levee Mile	9.41
End Levee Mile	9.52
Location	Water Side
Category	Earthen Levee
Item	Encroachments

Irrigation pipe along the shoulder to irrigate reseed area. Fall 2013

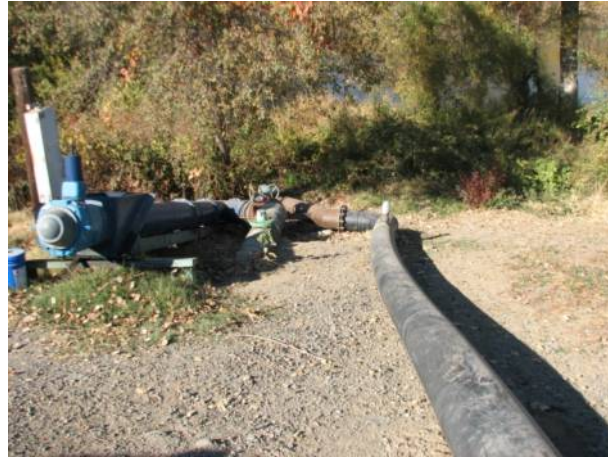
johngw\_f\_20131114\_343.JPG

The connection to the pump for the irrigation pipe.  
A tee post holds it in place. This makes access  
difficult. Fall 2013

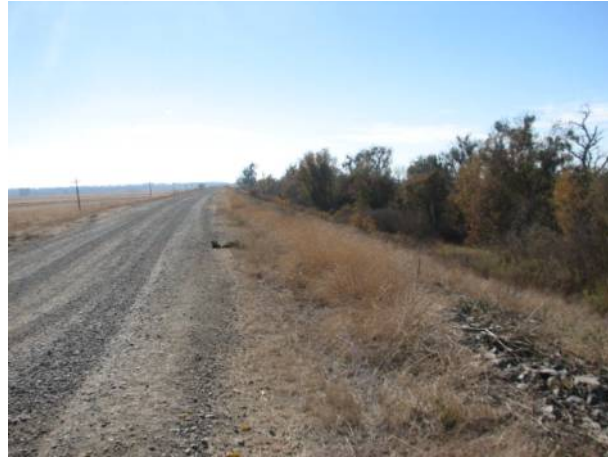
johngw\_f\_20131114\_344.JPG

Tall grasses block the visibility. Fall 2013

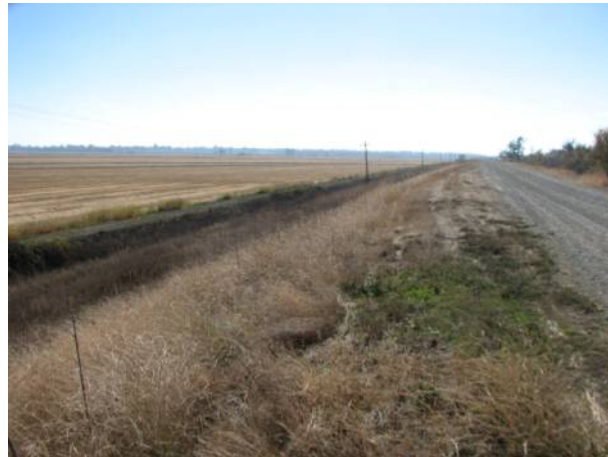
johngw\_f\_20131114\_345.JPG

Levee Mile Report Line	2
Start Levee Mile	0.38
End Levee Mile	3.69
Location	Land Side
Category	Earthen Levee
Item	Vegetation

Tall grasses block visibility. Fall 2013

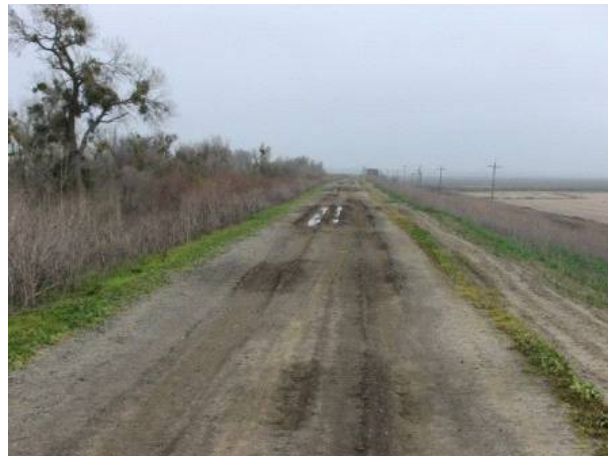
johngw\_f\_20131021\_746.jpg

Levee Mile Report Line	5
Start Levee Mile	0.68
End Levee Mile	0.77
Location	Crown
Category	Earthen Levee
Item	Crown Surface / Depressions / Rutting

This area is soft and needs to have AB added to make an all weather surface.

5	0.68	0.77	Earthen Levee	Crown Surface / Depressions / Rutting	CR A/W	M Ma	C3 : Add appropriate gravel or road base. Grade and compact.	38.726252 ° -121.633424 °	38.724869 ° -121.633411 °	11 Y
DWR ID: DWR_RD1600_02_s_2012_11										
6	0.85	4.08	Earthen Levee	Crown Surface / Depressions / Rutting	CR	M Ma	C3 : Add appropriate gravel or road base. Grade and compact.	38.723730 ° -121.633372 °	38.678393 ° -121.643858 °	31 Y
DWR ID: DWR_RD1600_02_s_2012_31										
7	1.13	1.13	Earthen Levee	Crown Surface / Depressions / Rutting	CR	M Ma	C2 : Repair depressions or ruts in the crown or slope.	38.719719 ° -121.633925 °	38.719719 ° -121.633925 °	2 Y
DWR ID: DWR_RD1600_02_s_2013_2										
8	1.51	1.51	Earthen Levee	Crown Surface / Depressions / Rutting	CR	M Ma	C2 : Repair depressions or ruts in the crown or slope.	38.714343 ° -121.635628 °	38.714343 ° -121.635628 °	6 Y
DWR ID: DWR_RD1600_02_s_2013_6

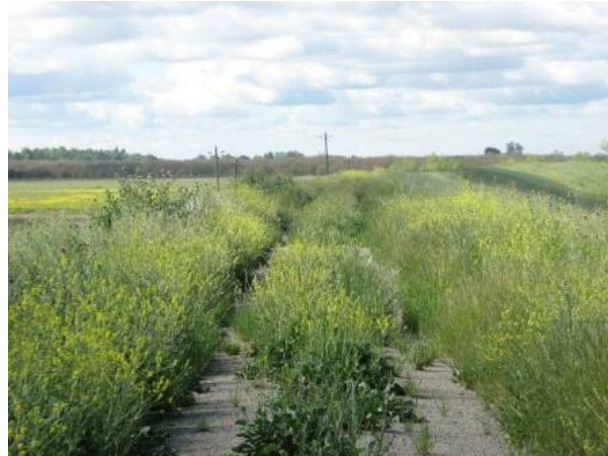
Levee Mile Report Line	6
Start Levee Mile	0.85
End Levee Mile	4.08
Location	Crown
Category	Earthen Levee
Item	Crown Surface / Depressions / Rutting
The crown roadway needs to be free of weeds. Photo taken spring 2012.	
johngw_f_20131021_752.jpg

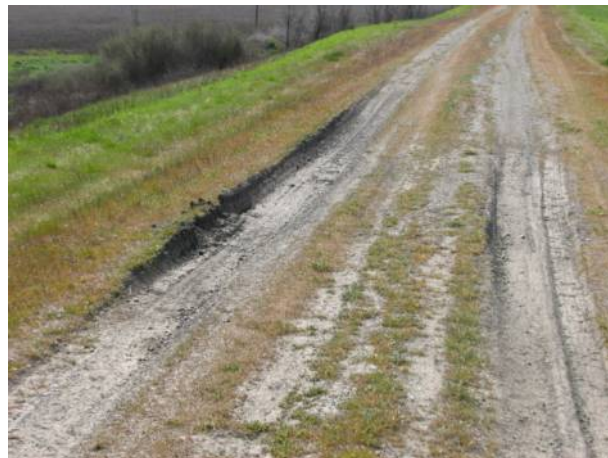
Levee Mile Report Line	7
Start Levee Mile	1.13
End Levee Mile	1.13
Location	Crown
Category	Earthen Levee
Item	Crown Surface / Depressions / Rutting
Ruts in the levee crown Spring 2013	
johngw_f_20131021_743.JPG

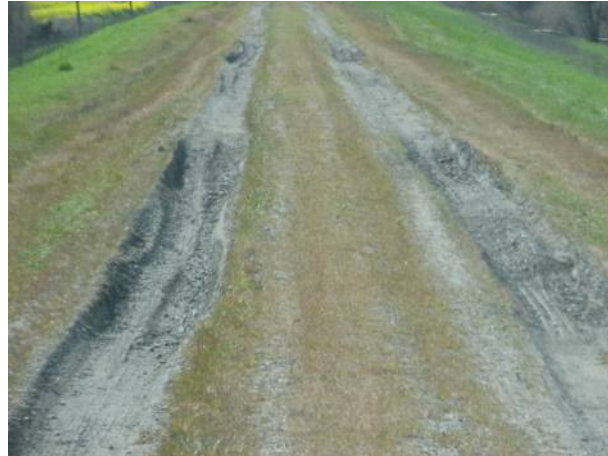
Levee Mile Report Line	8
Start Levee Mile	1.51
End Levee Mile	1.51
Location	Crown
Category	Earthen Levee
Item	Crown Surface / Depressions / Rutting
Ruts in the levee crown. Spring 2013	
johngw_f_20131021_744.JPG

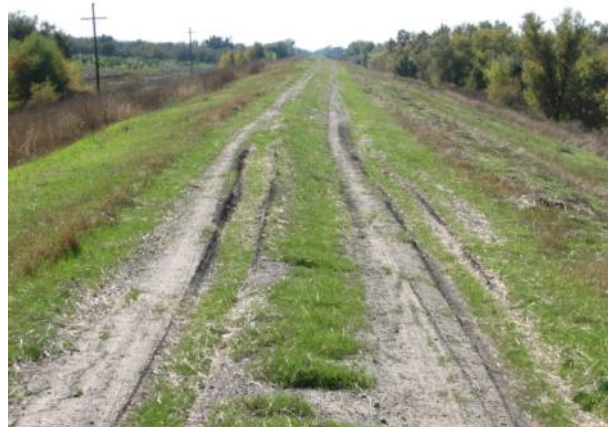
Levee Mile Report Line	9
Start Levee Mile	1.65
End Levee Mile	1.65
Location	Crown
Category	Earthen Levee
Item	Crown Surface / Depressions / Rutting
The crown has ruts deeper then six inches. Fall 2012	
johngw_f_20131021_755.jpg

9	1.65	1.65	Earthen Levee	Crown Surface / Depressions / Rutting	CR	M Ma	C2 : Repair depressions or ruts in the crown or slope.	38.712382 ° -121.636417 °	38.712382 ° -121.636417 °	32 Y
DWR ID: DWR_RD1600_02_s_2012_32										
10	1.74	2.01	Earthen Levee	Erosion / Bank Caving	WS	M Ma	E1 : Note and monitor erosion site.	38.710763 ° -121.637147 °	38.707116 ° -121.638722 °	14 Y
DWR ID: DWR_RD1600_02_s_2012_14										
11	2.02	2.02	Earthen Levee	Crown Surface / Depressions / Rutting	CR	M Ma	C2 : Repair depressions or ruts in the crown or slope.	38.707403 ° -121.638568 °	38.707403 ° -121.638568 °	7 Y
DWR ID: DWR_RD1600_02_s_2013_7										
12	2.12	2.23	Earthen Levee	Erosion / Bank Caving	WS	M Ma	E1 : Note and monitor erosion site. Inspector Comments: This is wave wash damage caused by last high water.	38.705614 ° -121.639357 °	38.704052 ° -121.640016 °	15 Y
DWR ID: DWR_RD1600_02_s_2012_15

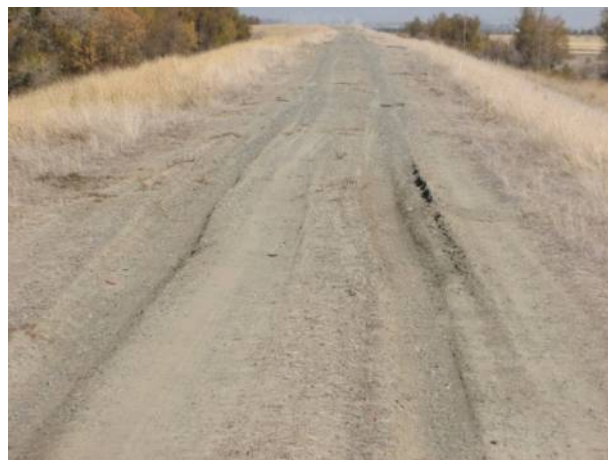
Levee Mile Report Line	9
Start Levee Mile	1.65
End Levee Mile	1.65
Location	Crown
Category	Earthen Levee
Item	Crown Surface / Depressions / Rutting
Tire ruts are deeper than 6 inches on the crown. Fall 2013	
johngw_f_20131114_346.JPG

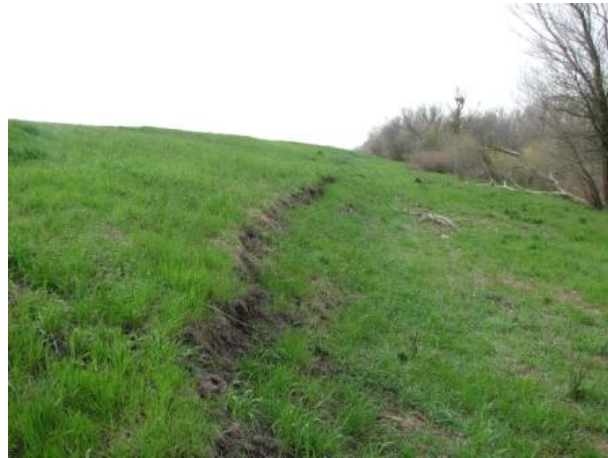
johngw\_f\_20131021\_747.jpg

Wave wash damage along the slope the cut is 1'-2'.

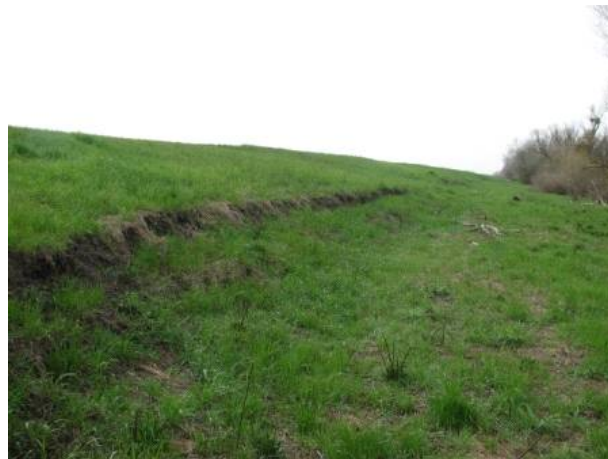
johngw\_f\_20131021\_748.jpg

Levee Mile Report Line	10
Start Levee Mile	1.74
End Levee Mile	2.01
Location	Water Side
Category	Earthen Levee
Item	Erosion / Bank Caving

A closer view of the wave wash damage along the bypass.

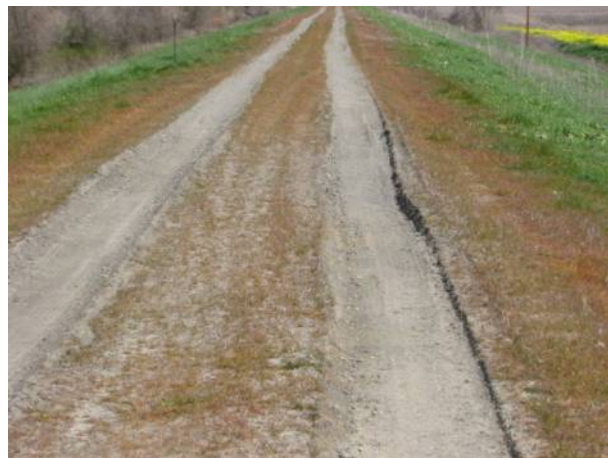
johngw\_f\_20131021\_745.JPG

Levee Mile Report Line	11
Start Levee Mile	2.02
End Levee Mile	2.02
Location	Crown
Category	Earthen Levee
Item	Crown Surface / Depressions / Rutting

Ruts in the levee crown. Spring 2013

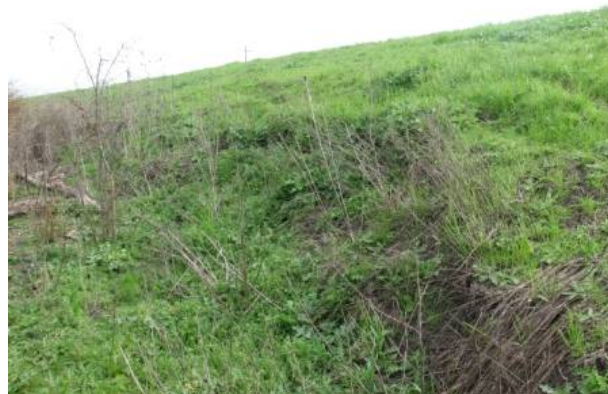
Levee Mile Report Line	12
Start Levee Mile	2.12
End Levee Mile	2.23
Location	Water Side
Category	Earthen Levee
Item	Erosion / Bank Caving
Looking upstream a deeper cut of 2'-3' damage.	
johngw_f_20131021_750.jpg

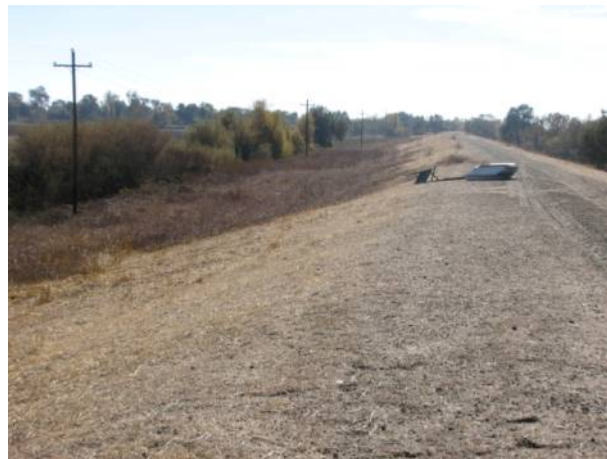
Levee Mile Report Line	15
Start Levee Mile	3.69
End Levee Mile	4.18
Location	Land Side
Category	Earthen Levee
Item	Vegetation
The goats have been through here. No unwanted vegetation on the levee. Fall 2013	
johngw_f_20131114_348.JPG

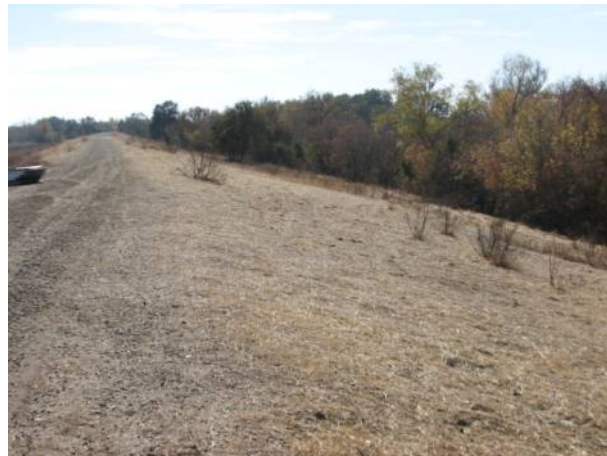
Levee Mile Report Line	16
Start Levee Mile	3.69
End Levee Mile	4.18
Location	Water Side
Category	Earthen Levee
Item	Vegetation
There is no unwanted vegetation on the levee due to the goats. Fall 2013	
johngw_f_20131114_349.JPG
