**Flood Control Project Maintenance  
Levee Inspections**

**Fall 2014 Levee Maintenance Deficiency Summary Report**

**Sacramento River Basin**

**Reclamation District No. 1600 Mull**

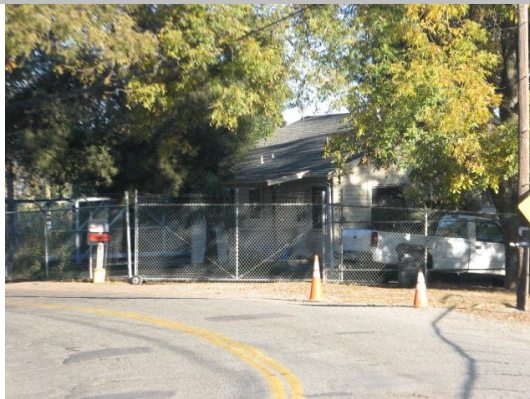
Photo 1 of 1 : FA\_2014\_RD1600\_191\_1\_20141014\_00001.jpg

LM Start	0.06	Rating **	M	Issue No.	1
LM End	0.06	Issue Type +	En	Location *	WS
Category	Earthen Levee			GPS Latitude/Longitude	
				Start	End
Item	Encroachments			38.675998 °	38.675998 °
				-121.630732 °	-121.630732 °
DWR ID	DWR_RD1600_01_s_2012_1				
Action/Comments					
Building					
Inspector Comments: This is the home and pumping plant for RD 2035.

The caretakers home for the operator of the pumping plant (RD 2035).  
Fall 2013

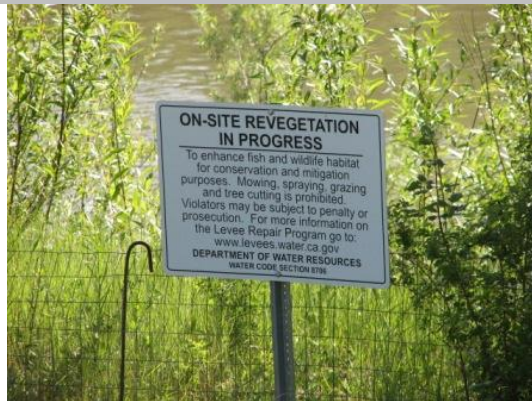
Photo 2 of 2 : FA\_2014\_RD1600\_191\_22\_20141014\_00023.jpg

LM Start	<b>1.02</b>	Rating **	A/W	Issue No.	<b>22 (cont)</b>
LM End	<b>1.11</b>	Issue Type +	Ma	Location *	WS

Revegetation site. Photo taken spring 2012.

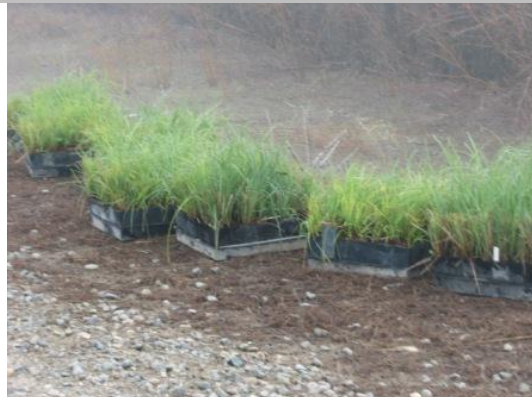
Photo 1 of 2 : FA\_2014\_RD1600\_191\_5\_20141014\_00005.jpg

LM Start	1.42	Rating **	A/W	Issue No.	5
LM End	1.42	Issue Type +	Ma	Location *	WS
Category	Earthen Levee			GPS Latitude/Longitude	
				Start	End
Item	Vegetation			38.694589 °	38.694589 °
				-121.634286 °	-121.634286 °
DWR ID	DWR_RD1600_01_f_2012_5				
Action/Comments					
Environmental Requirements.

Flats of plant material to be planted at the site. Fall 2012

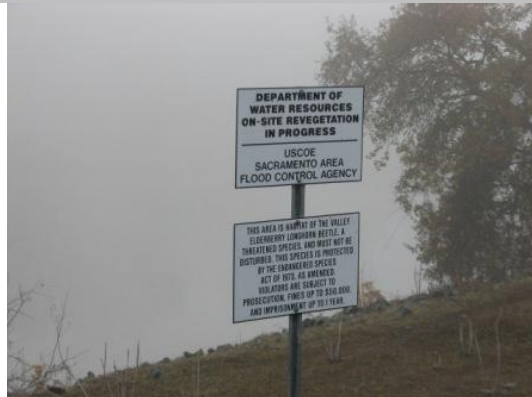
Photo 2 of 2 : FA\_2014\_RD1600\_191\_5\_20141014\_00006.jpg

LM Start	<b>1.42</b>	Rating **	A/W	Issue No.	<b>5 (cont)</b>
LM End	<b>1.42</b>	Issue Type +	Ma	Location *	WS

Revegetation site. Fall 2012.

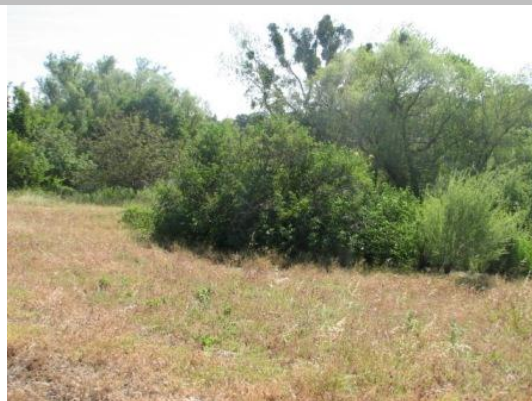
Photo 1 of 2 : FA\_2014\_RD1600\_191\_31\_20141014\_00030.jpg

LM Start	1.73	Rating **	A/W	Issue No.	31
LM End	1.73	Issue Type +	En	Location *	WS
Category	Earthen Levee			GPS Latitude/Longitude	
				Start	End
Item	Vegetation			38.698613 °	38.698613 °
				-121.631710 °	-121.631710 °
DWR ID	DWR_RD1600_01_s_2012_31				
Action/Comments					
Environmental Requirements.

A photo of a Elderberry bush in the area.

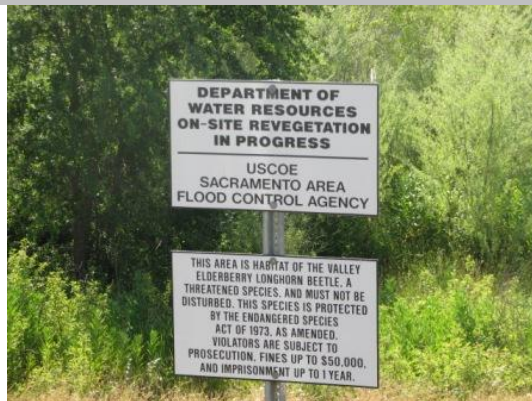
Photo 2 of 2 : FA\_2014\_RD1600\_191\_31\_20141014\_00031.jpg

LM Start	<b>1.73</b>	Rating **	A/W	Issue No.	<b>31 (cont)</b>
LM End	<b>1.73</b>	Issue Type +	En	Location *	WS

Revegetation site with the Elderberry Beetle. Photo taken spring 2012.

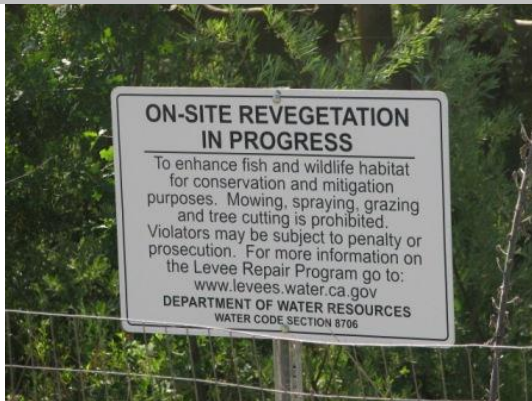
Photo 2 of 2 : FA\_2014\_RD1600\_191\_35\_20141014\_00033.jpg

LM Start	<b>2.36</b>	Rating **	A/W	Issue No.	<b>35 (cont)</b>
LM End	<b>2.42</b>	Issue Type +	Ma	Location *	WS

Revegetation site, photo taken spring 2012.

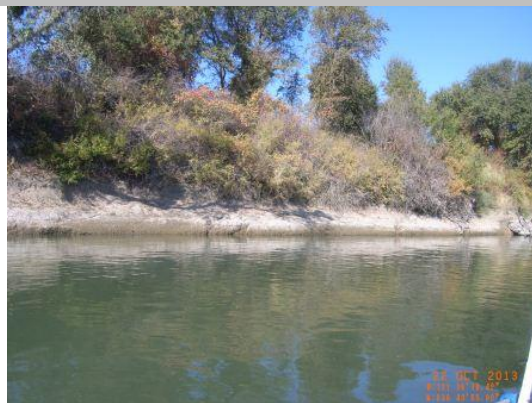
Photo 1 of 1 : FA\_2014\_RD1600\_191\_10\_20141014\_00011.jpg

LM Start	4.21	Rating **	M	Issue No.	10
LM End	4.21	Issue Type +	Ma	Location *	WS
Category	Supplemental			GPS Latitude/Longitude	
				Start	End
Item	USACE Erosion Survey			38.728684 °	38.736110 °
				-121.605844 °	-121.604153 °
DWR ID	DWR_RD1600_01_f_2014_10				
Action/Comments					
Inspector Comments: 1997 - Very steep bank. 2005 - Lots of small trees down along the bank at the upstream end. 2006 - Minor new erosion, but slow. 2010 - Almost all of the roots are exposed on the trees, appears ready to fall. 2011 - New erosion and tree popouts. 2012 - Site has become overgrown with vegetation, making it hard to observe. 2013: No observed changes. [2013 Site ID: SAC_75-3_R]

USACE 2013 Photo #1
