**Flood Control Project Maintenance
Levee Inspections**

Fall 2015 Levee Maintenance Deficiency Summary Report

Sacramento River Basin

Reclamation District No. 1600 Mull

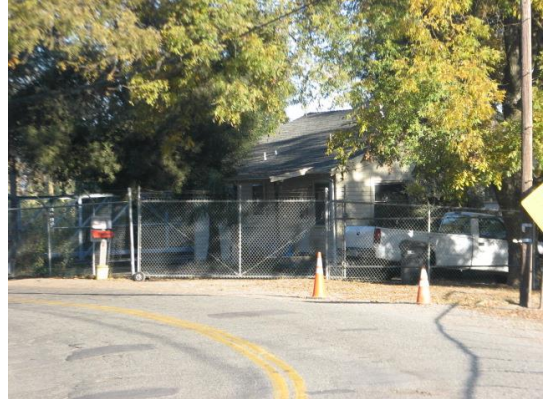
Photo 1 of 1 : FA_2015_RD1600_191_1_20150914_00001.jpg

LM Start	0.06	Rating **	M	Issue No.	1
LM End	0.06	Issue Type +	En	Location *	WS
Category	Earthen Levee			GPS Latitude/Longitude	
				Start	End
Item	Encroachments			38.675998 °	38.675998 °
				-121.630732 °	-121.630732 °
DWR ID	DWR_RD1600_01_s _ 2012_1				
Action/Comments					
Building					
Inspector Comments: This is the home and pumping plant for RD 2035.

The caretakers home for the operator of the pumping plant (RD 2035).
Fall 2013

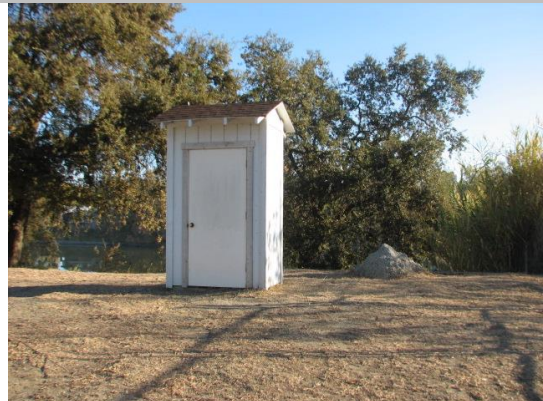
Photo 1 of 1 : FA_2015_RD1600_191_129_20150914_00032.jpg

LM Start	0.10	Rating **	M	Issue No.	129
LM End	0.10	Issue Type +	En	Location *	WS
Category	Earthen Levee			GPS Latitude/Longitude	
				Start	End
Item	Encroachments			38.676467 °	38.676467 °
				-121.631217 °	-121.631217 °
DWR ID	DWR_RD1600_01_f _ 2013_129				
Action/Comments					
Building					
Inspector Comments: This is a well pump house. It is potable water for the house and pumping plant.

The small building is a pump house for the well. It services the house with water. Fall 2013

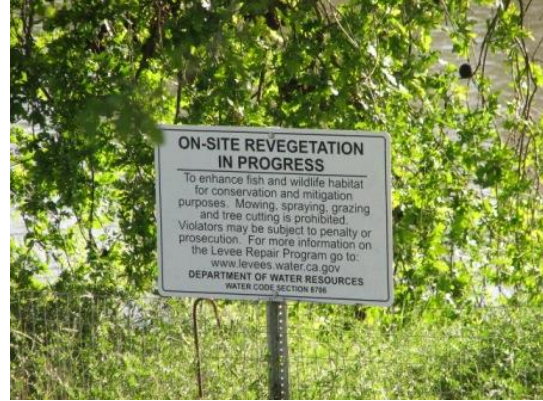
Photo 2 of 2 : FA_2015_RD1600_191_49_20150914_00031.jpg

Revegetation site. Photo taken spring 2012.

LM Start	0.10	Rating **	A/W	Issue No.	49 (cont)
LM End	0.23	Issue Type +	Ob	Location *	WS
Category	Earthen Levee			GPS Latitude/Longitude	
				Start	End
Item	Vegetation			38.676480 °	38.678140 °
				-121.631220 °	-121.632330 °
DWR ID	DWR_RD1600_01_s_2012_49				
Action/Comments					
Environmental Requirements.

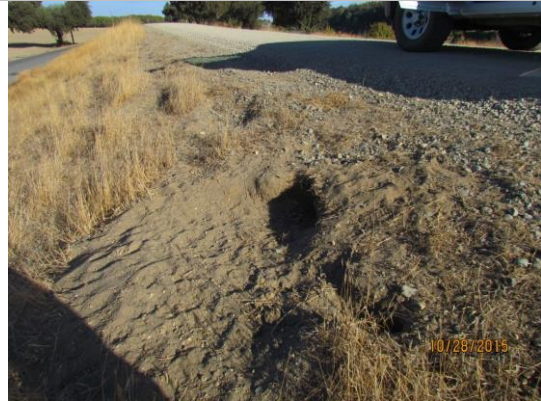
Photo 1 of 1 : FA_2015_RD1600_191_40_20151103_00064.jpg

View of the rodent hole on the landward side of the levee looking upstream. Fall 2015.

LM Start	0.33	Rating **	M	Issue No.	40
LM End	0.33	Issue Type +	Ma	Location *	LS
Category	Earthen Levee			GPS Latitude/Longitude	
				Start	End
Item	Animal Control			38.679472 °	38.679472 °
				-121.633053 °	-121.633053 °
DWR ID	DWR_RD1600_01_f _ 2015_40				
Action/Comments					
No rodents visible, but rodent burrows visible; need to backfill and compact or grout burrows.

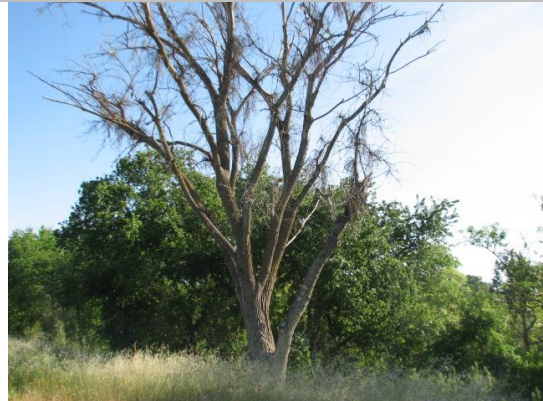
Photo 1 of 1 : FA_2015_RD1600_191_624_20150914_00040.jpg

LM Start	0.78	Rating **	A/W	Issue No.	624
LM End	0.78	Issue Type +	Ma	Location *	WS
Category	Earthen Levee			GPS Latitude/Longitude	
				Start	End
Item	Vegetation			38.685713 °	38.685713 °
				-121.634985 °	-121.634985 °
DWR ID	DWR_RD1600_01_s_2015_624				
Action/Comments					
Trees / Woody Vegetation

The tree is dying and needs to be monitored so there is no threat to the levee. Spring 2014

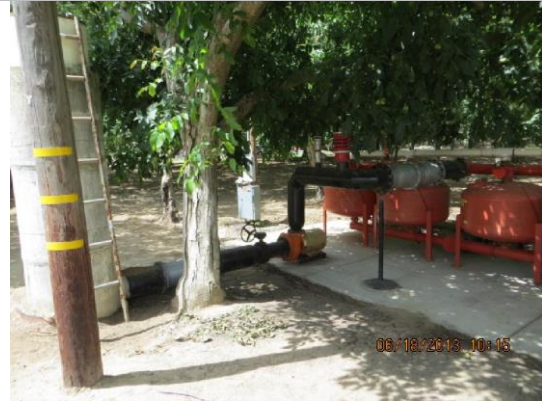
Photo 1 of 3 : UCIP_FA_2015_0794.jpg

Inspector Comments: FS_ID:15285
 DS_ID:21463
 EP_NO: 6100
 FS_HLM: 0.949
 Repair Type: Non-Urgent
 Crossing Status: Found
 UCIP Comments: Gate valve will not open or close.
 FIELD_STRUCT_DESC: 12-inch pipe through levee 3.4 feet below crown. Slant pump and gate valve on the waterward- slope. Siphon breaker in 12-inch steel riser on the landward shoulder. Filter, booster pump, and butterfly valve on LS toe. 2.25-inch galvanized iron electrical conduit at same location (Permit No. 6100, 1968). Replaced 8-inch pipe at same location.
 FS Date: 06/18/2013

Filters, boost pump, and gate valve down stream from concrete standpipe off LS toe.

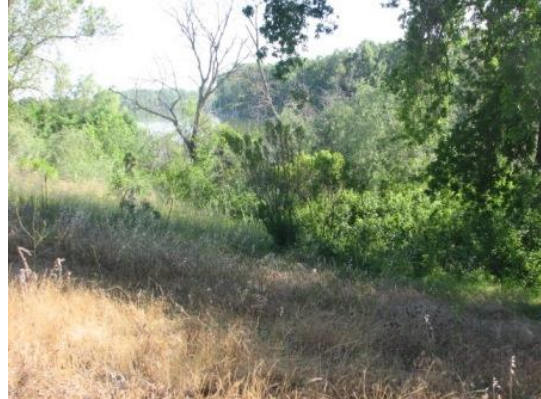
Photo 1 of 2 : FA_2015_RD1600_191_22_20150914_00020.jpg

The revegetation site along the berm and shoulder of the river.

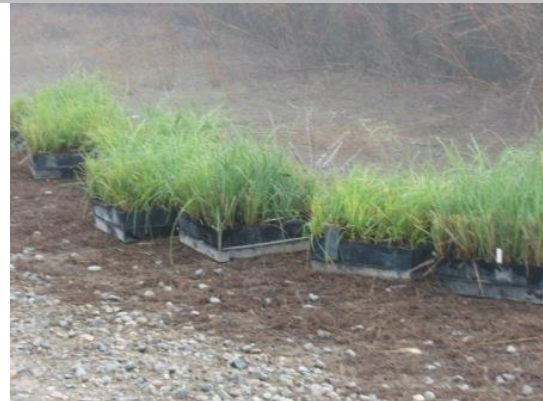
Photo 1 of 2 : FA_2015_RD1600_191_5_20150914_00005.jpg

Flats of plant material to be planted at the site. Fall 2012

LM Start	1.40	Rating **	A/W	Issue No.	5
LM End	1.40	Issue Type +	Ma	Location *	WS
Category	Earthen Levee			GPS Latitude/Longitude	
				Start	End
Item	Vegetation			38.694589 °	38.694589 °
				-121.634286 °	-121.634286 °
DWR ID	DWR_RD1600_01_f_2012_5				
Action/Comments					
Environmental Requirements.

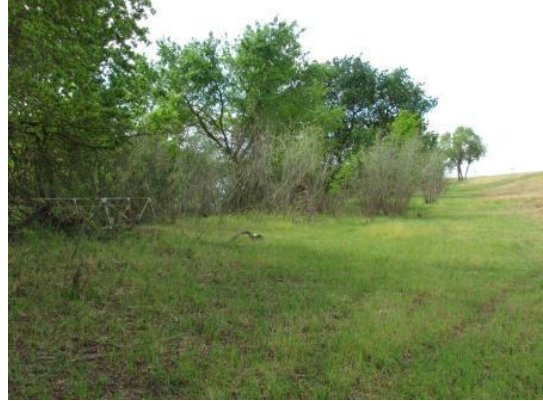
Photo 1 of 1 : FA_2015_RD1600_191_626_20150914_00042.jpg

LM Start	1.70	Rating **	M	Issue No.	626
LM End	1.70	Issue Type +	En	Location *	WS
Category	Earthen Levee			GPS Latitude/Longitude	
				Start	End
Item	Encroachments			38.698415 °	38.698415 °
				-121.631850 °	-121.631850 °
DWR ID	DWR_RD1600_01_s _ 2015_626				
Action/Comments					
Debris

View of debris on the waterward side of the levee looking downstream. Spring 2015.

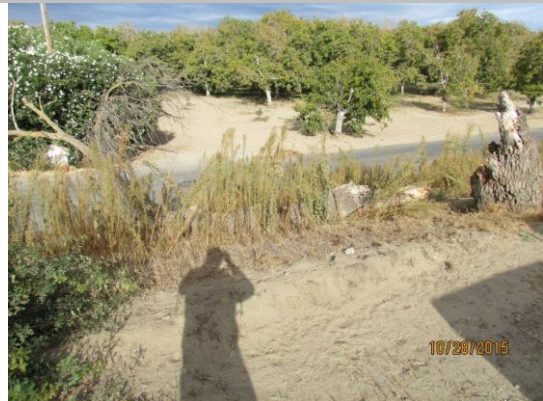
Photo 1 of 1 : FA_2015_RD1600_191_51_20151103_00069.jpg

LM Start	1.70	Rating **	M	Issue No.	51
LM End	1.70	Issue Type +	En	Location *	LS
Category	Earthen Levee			GPS Latitude/Longitude	
				Start	End
Item	Encroachments			38.698471 °	38.698471 °
				-121.631836 °	-121.631836 °
DWR ID	DWR_RD1600_01_f _ 2015_51				
Action/Comments					
Tree or limb

View of the fallen tree on the landward side of the levee. Fall 2015.

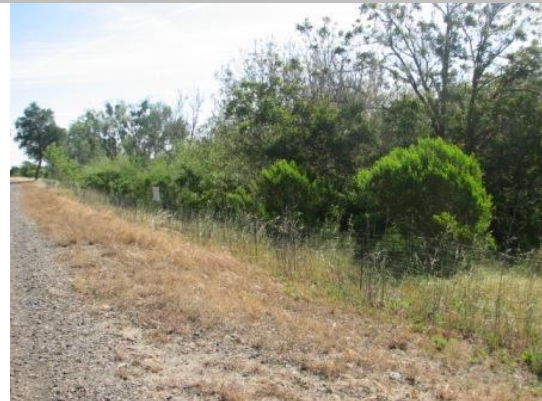
Photo 1 of 2 : FA_2015_RD1600_191_35_20150914_00027.jpg

The revegetation site extends almost to the hinge point.

LM Start	2.34	Rating **	A/W	Issue No.	35
LM End	2.40	Issue Type +	Ma	Location *	WS
Category	Earthen Levee			GPS Latitude/Longitude	
				Start	End
Item	Vegetation			38.704592 °	38.705152 °
				-121.623067 °	-121.622187 °
DWR ID	DWR_RD1600_01_s_2012_35				
Action/Comments					
Environmental Requirements.

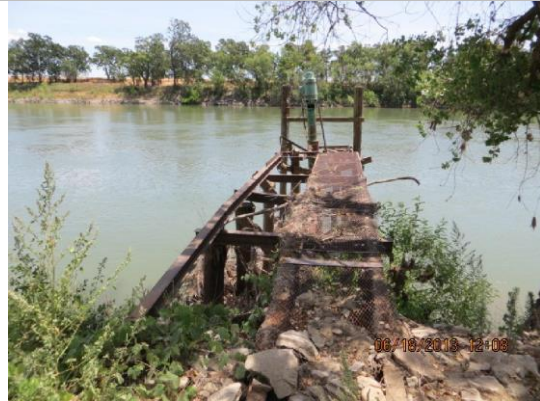
Photo 2 of 3 : UCIP_FA_2015_0827.jpg

Debris buildup at metal platform waterline.

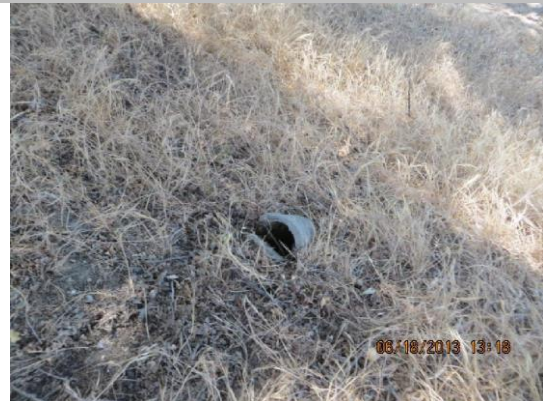
Photo 2 of 2 : UCIP_FA_2015_0830.jpg

Pipe visible on LS slope.

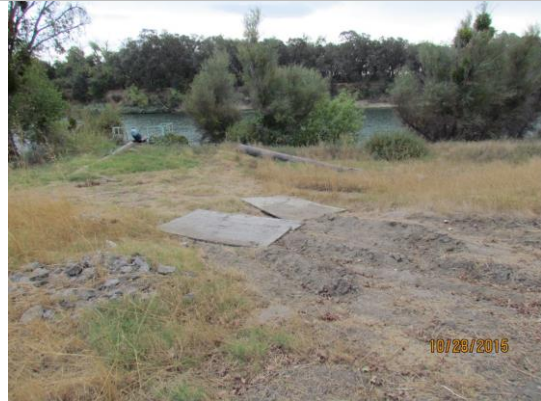
Photo 2 of 2 : FA_2015_RD1600_191_627_20151103_00078.jpg

LM Start	3.57	Rating **	M	Issue No.	627 (cont)
LM End	3.57	Issue Type +	En	Location *	WS
Category	Earthen Levee			GPS Latitude/Longitude	
				Start	End
Item	Encroachments			38.717717 °	38.717717 °
				-121.608015 °	-121.608015 °
DWR ID	DWR_RD1600_01_s _ 2014_627				
Action/Comments					
Debris

View of the metal pipe and wood debris on the berm of the waterward side of the levee. Fall 2015.

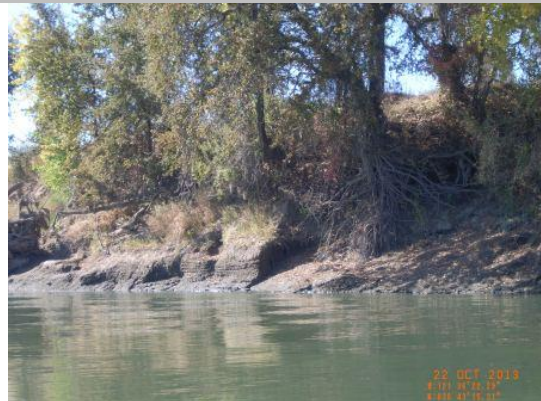
Photo 1 of 1 : USACE2013A_SAC_74-4_R_3.jpg

LM Start	3.58	Rating **	M	Issue No.	3
LM End	3.83	Issue Type +	Ma	Location *	WS
Category	Supplemental			GPS Latitude/Longitude	
				Start	End
Item	2015 USACE Erosion Survey, DRAFT			38.717770 °	38.721351 °
				-121.607423 °	-121.606414 °
DWR ID					
Action/Comments					
Inspector Comments: 1997 - Steep high bank. 2005 - Some small pockets in the low toe near the waterline. 2006 - Minor slope clearing. 2010 - Minor new erosion. 2011 - Multiple trees have fallen since last year. Some other trees look ready to fall. Significant new erosion since last year. 2012 - Minor new erosion. 2013 - Minor new erosion. 2015: New minor erosion at toe. [2015 Site ID: SAC_74-4_R]

USACE 2013 Photo #1

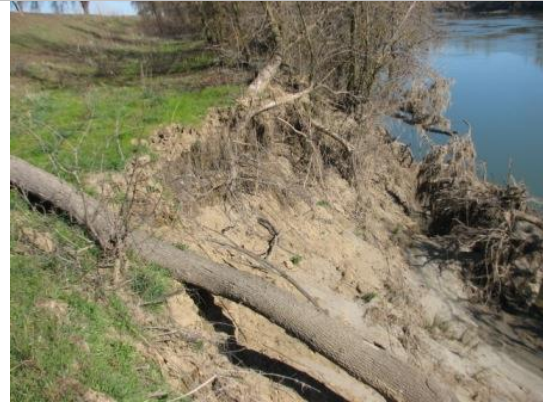
Photo 1 of 1 : FA_2015_RD1600_191_2_20150914_00002.jpg

LM Start	3.76	Rating **	M	Issue No.	2
LM End	3.76	Issue Type +	En	Location *	WS
Category	Earthen Levee			GPS Latitude/Longitude	
				Start	End
Item	Erosion / Bank Caving			38.720417 °	38.720417 °
				-121.606962 °	-121.606962 °
DWR ID	DWR_RD1600_01_s _ 2013_2				
Action/Comments					
Note and monitor erosion site.					
Inspector Comments: Trees have fallen over and created bank erosion.

Trees have fallen and the water has created the erosion into the berm.
Spring 2013

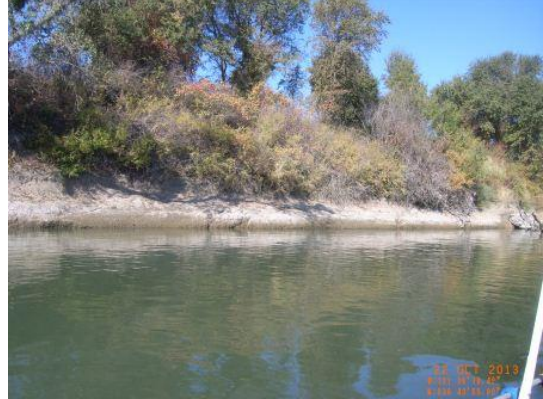
Photo 1 of 1 : USACE2013A_SAC_75-3_R_11.jpg

LM Start	4.34	Rating **	M	Issue No.	8
LM End	4.86	Issue Type +	Ma	Location *	WS
Category	Supplemental			GPS Latitude/Longitude	
				Start	End
Item	2015 USACE Erosion Survey, DRAFT			38.728684 °	38.736110 °
				-121.605844 °	-121.604153 °
DWR ID					
Action/Comments					
Inspector Comments: 1997 - Very steep bank. 2005 - Lots of small trees down along the bank at the upstream end. 2006 - Minor new erosion, but slow. 2010 - Almost all of the roots are exposed on the trees, appears ready to fall. 2011 - New erosion and tree popouts. 2012 - Site has become overgrown with vegetation, making it hard to observe. 2015: Dense vegetation made observation difficult. [2015 Site ID: SAC_75-3_R]

USACE 2013 Photo #1

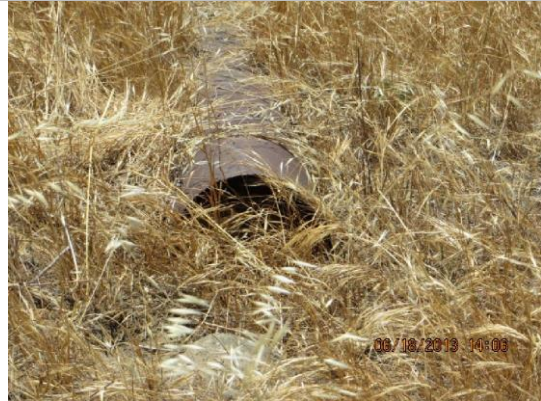
Photo 1 of 2 : UCIP_FA_2015_1458.jpg

Pipe and remnants of grouted pipe on LS slope.

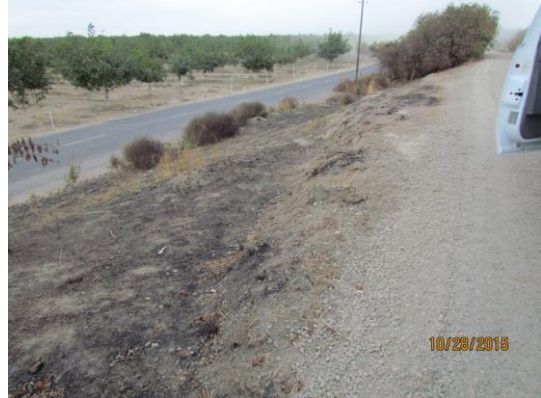
Photo 2 of 2 : FA_2015_RD1600_191_141_20151103_00082.jpg

View of the erosion on the landward side of the levee looking upstream. Fall 2015.

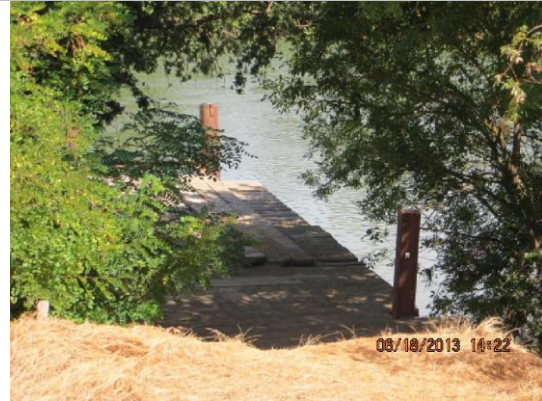
Photo 1 of 3 : UCIP_FA_2015_0651.jpg

Wooden pier off WS toe.

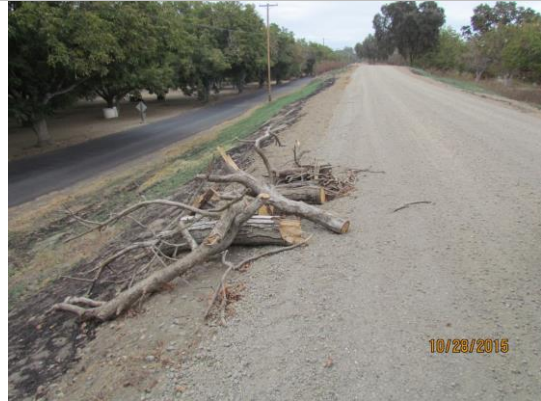
Photo 1 of 1 : FA_2015_RD1600_191_45_20151103_00085.jpg

LM Start	5.56	Rating **	M	Issue No.	45
LM End	5.56	Issue Type +	En	Location *	CR
Category	Earthen Levee			GPS Latitude/Longitude	
				Start	End
Item	Encroachments			38.745605 °	38.745605 °
				-121.599994 °	-121.599994 °
DWR ID	DWR_RD1600_01_f_2015_45				
Action/Comments					
Prunings

View of the prunings on the crown of the levee looking upstream. Fall 2015.

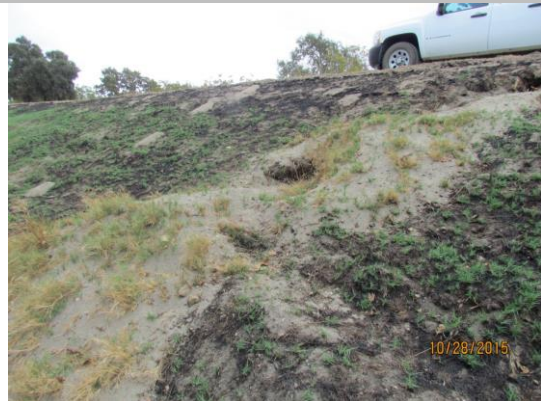
Photo 1 of 1 : FA_2015_RD1600_191_46_20151103_00086.jpg

View of the animal holes on the landward side of the levee. Fall 2015.

LM Start	5.57	Rating **	U	Issue No.	46
LM End	5.57	Issue Type +	Ma	Location *	LS
Category	Earthen Levee			GPS Latitude/Longitude	
				Start	End
Item	Animal Control			38.745677 °	38.745677 °
				-121.599944 °	-121.599944 °
DWR ID	DWR_RD1600_01_f_2015_46				
Action/Comments					
No rodents visible, but rodent burrows visible; need to backfill and compact or grout burrows.

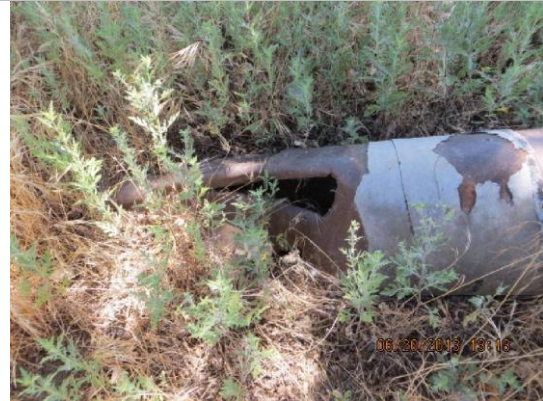
Photo 1 of 3 : UCIP_FA_2015_0741.jpg

Hole in pipe at WS toe.

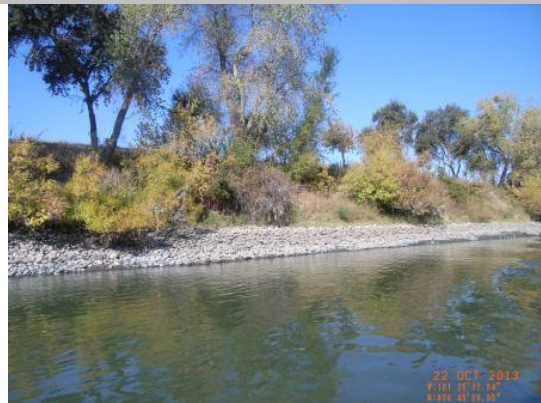
Photo 1 of 1 : USACE2013A_SAC_77-0_R_1.jpg

LM Start	6.30	Rating **	A/W	Issue No.	9
LM End	6.36	Issue Type +	Ma	Location *	WS
Category	Supplemental			GPS Latitude/Longitude	
				Start	End
Item	2015 USACE Erosion Survey, DRAFT			38.755246 °	38.756186 °
				-121.594206 °	-121.594024 °
DWR ID					
Action/Comments					
Inspector Comments: 2011 - Large vertical eroded face from a rotational failure just below pump. 2015: Does not meet critierial. [2015 Site ID: SAC_77-0_R]

USACE 2013 Photo #1

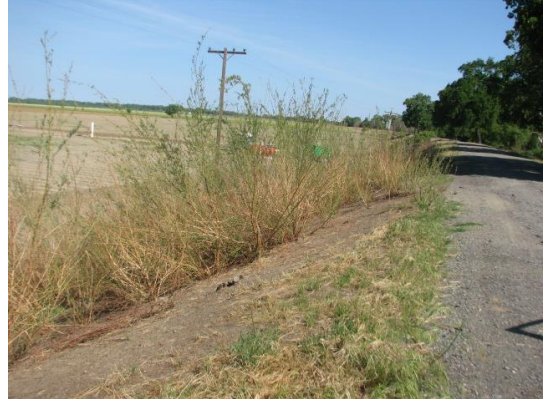
Photo 1 of 2 : FA_2015_RD1600_191_631_20150914_00045.jpg

The tall brush and vegetation blocks visibility. Spring 2014

LM Start	6.60	Rating **	M	Issue No.	631
LM End	6.62	Issue Type +	Ma	Location *	LS
Category	Earthen Levee			GPS Latitude/Longitude	
				Start	End
Item	Vegetation			38.759633 °	38.760013 °
				-121.594128 °	-121.594148 °
DWR ID	DWR_RD1600_01_s _ 2014_631				
Action/Comments					
Remove the wild growth other than native grasses from the levee slopes.

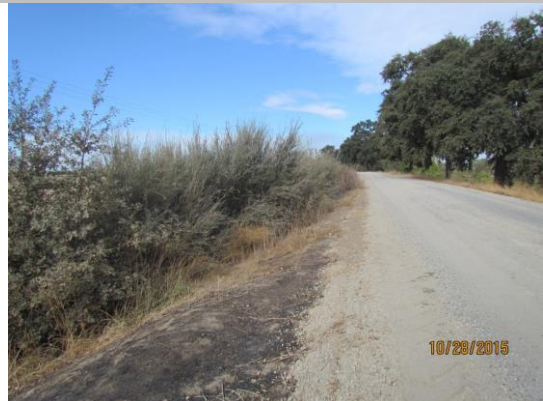
Photo 2 of 2 : FA_2015_RD1600_191_631_20151103_00090.jpg

View of the brush and vegetation on the landward side of the levee. Fall 2015.

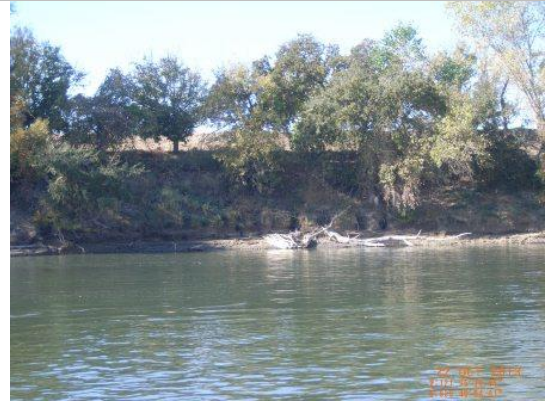
Photo 1 of 1 : USACE2013A_SAC_77-7_R_3.jpg

LM Start	6.95	Rating **	M	Issue No.	6
LM End	6.98	Issue Type +	Ma	Location *	WS
Category	Supplemental			GPS Latitude/Longitude	
				Start	End
Item	2015 USACE Erosion Survey, DRAFT			38.764801 °	38.765219 °
				-121.594926 °	-121.595049 °
DWR ID					
Action/Comments					
Inspector Comments: 2006 - Eddy scour off end of rock causing erosion and scour hole near levee. Sandy silt bank with rock on upstream end. 2010 - Trees are leaning more, minor new erosion. 2011 - Many of the tree roots have scoured out and trees look ready to fall. 2015: No observed changes. [2015 Site ID: SAC_77-7_R]

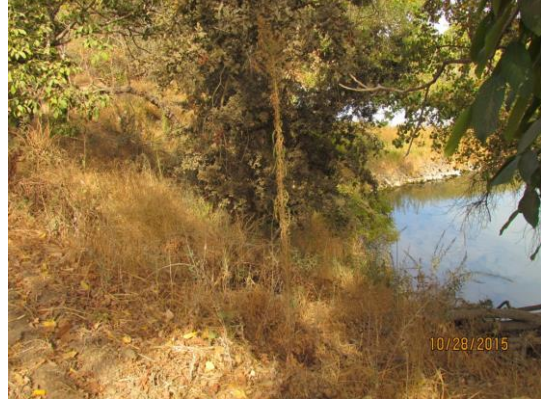
Photo 2 of 2 : FA_2015_RD1600_191_30_20151103_00091.jpg

View of the erosion into the berm area that needs to be monitored. Fall 2015.

LM Start	6.97	Rating **	M	Issue No.	30 (cont)
LM End	6.97	Issue Type +	En	Location *	WS
Category	Earthen Levee			GPS Latitude/Longitude	
				Start	End
Item	Erosion / Bank Caving			38.764943 °	38.764943 °
				-121.595504 °	-121.595504 °
DWR ID	DWR_RD1600_01_s _ 2013_30				
Action/Comments					
Note and monitor erosion site.

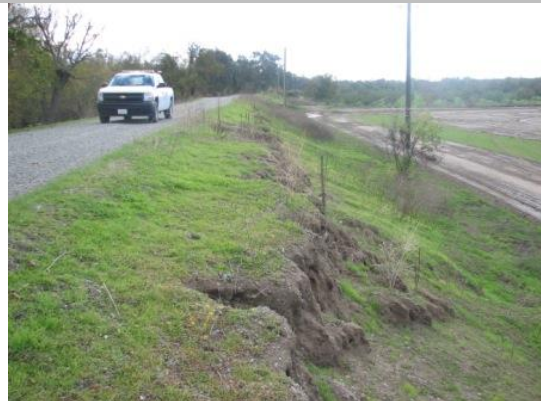
Photo 1 of 2 : FA_2015_RD1600_191_27_20150914_00022.jpg

The erosion appears to be moving closer to the shoulder.

LM Start	6.97	Rating **	M	Issue No.	27
LM End	6.97	Issue Type +	Ma	Location *	LS
Category	Earthen Levee			GPS Latitude/Longitude	
				Start	End
Item	Erosion / Bank Caving			38.764974 °	38.764974 °
				-121.595533 °	-121.595533 °
DWR ID	DWR_RD1600_01_s _ 2012_27				
Action/Comments					
Note and monitor erosion site.

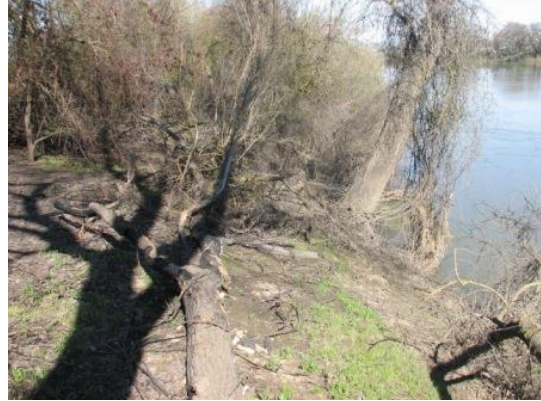
Photo 1 of 4 : FA_2015_RD1600_191_20_20150914_00016.jpg

This another view of the site.

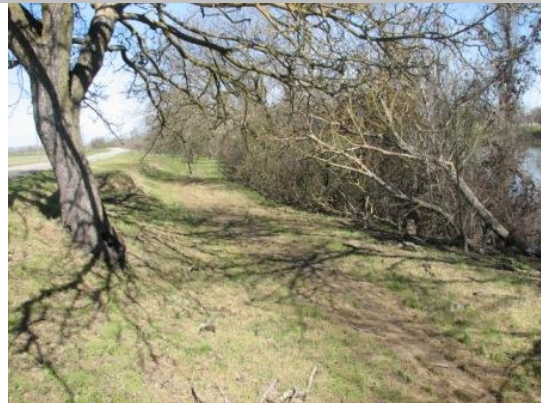
Photo 2 of 4 : FA_2015_RD1600_191_20_20150914_00017.jpg

The erosion is eroding away at the berm area.

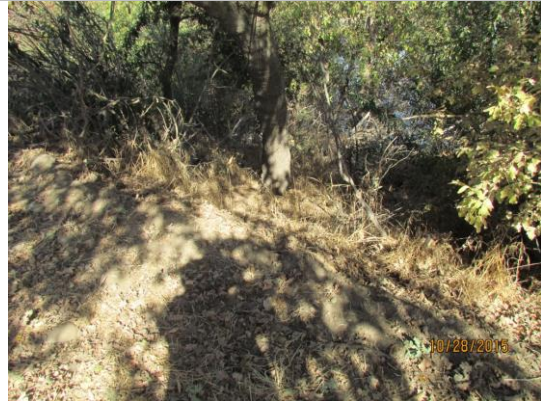
Photo 4 of 4 : FA_2015_RD1600_191_20_20151103_00093.jpg

Looking at the erosion site on the berm. Fall 2015.

LM Start	7.09	Rating **	M	Issue No.	20 (cont)
LM End	7.09	Issue Type +	Ma	Location *	WS
Category	Earthen Levee			GPS Latitude/Longitude	
				Start	End
Item	Erosion / Bank Caving			38.766505 °	38.766505 °
				-121.596214 °	-121.596214 °
DWR ID	DWR_RD1600_01_s_2012_20				
Action/Comments					
Note and monitor erosion site.

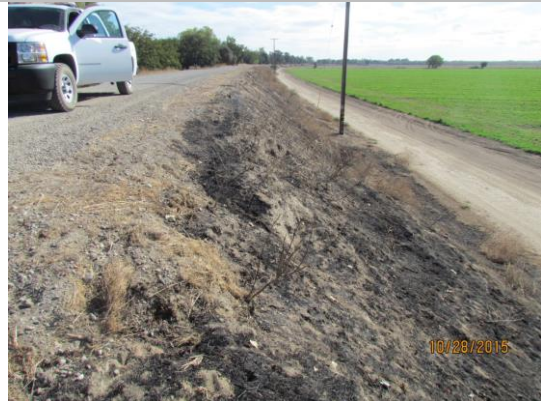
Photo 1 of 1 : FA_2015_RD1600_191_61_20151103_00095.jpg

View of the erosion on the landward side of the levee looking downstream. Fall 2015.

LM Start	7.21	Rating **	M	Issue No.	61
LM End	7.21	Issue Type +	Ma	Location *	LS
Category	Earthen Levee			GPS Latitude/Longitude	
				Start	End
Item	Erosion / Bank Caving			38.768094 °	38.768094 °
				-121.597075 °	-121.597075 °
DWR ID	DWR_RD1600_01_f_2015_61				
Action/Comments					
Note and monitor erosion site.

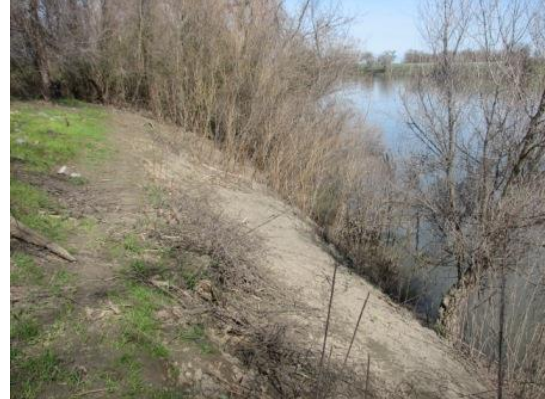
Photo 2 of 3 : FA_2015_RD1600_191_21_20150914_00019.jpg

The bank is eroding away and has become very steep.

LM Start	7.23	Rating **	M	Issue No.	21 (cont)	
LM End	7.23	Issue Type +	Ma	Location *	WS	
Category	Earthen Levee			GPS Latitude/Longitude		
				Start		End
Item	Erosion / Bank Caving			38.768409 °		38.768409
				-121.597213 °		-121.597213
DWR ID	DWR_RD1600_01_s _ 2012_21					
Action/Comments						
Note and monitor erosion site.

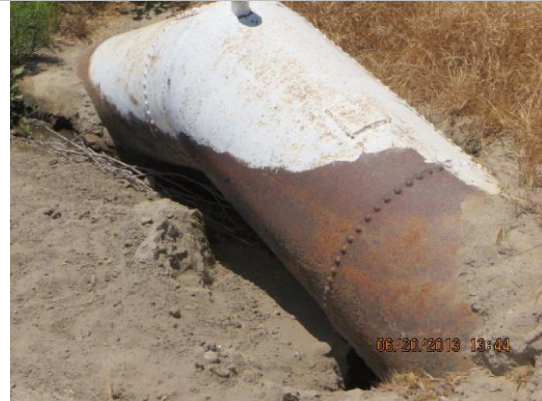
Photo 2 of 3 : UCIP_FA_2015_0792.jpg

Inspector Comments: FS_ID:15264
 DS_ID:21496
 EP_NO: 1596
 FS_HLM: 7.595
 Repair Type: Urgent
 Crossing Status: Found
 UCIP Comments: Pipe leaking and causing erosion on LS slope. Likely this pipe has severe internal corrosion and likely needs to be replaced. No 24-inch pipes found at this location...only a 30-inch.
 FIELD_STRUCT_DESC: 30-inch riveted steel irrigation pipe through the levee 5.5 feet below the crown. Gate valve in pump house on the waterward slope. Slant pump on structure on the bank. Walkway from the pump house to the structure. 2-inch galvanized iron electrical conduit at same location (Permit No. 1596, 1959).
 FS Date: 06/20/2013

Pipe and vent on LS shoulder.

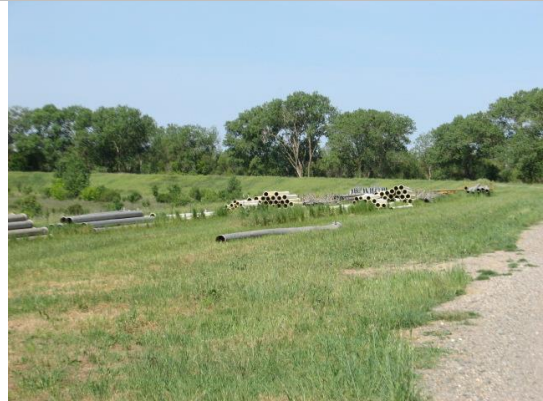
Photo 1 of 2 : FA_2015_RD1600_191_634_20150914_00046.jpg

Irrigation pipe is being stored on the landside. Spring 2014

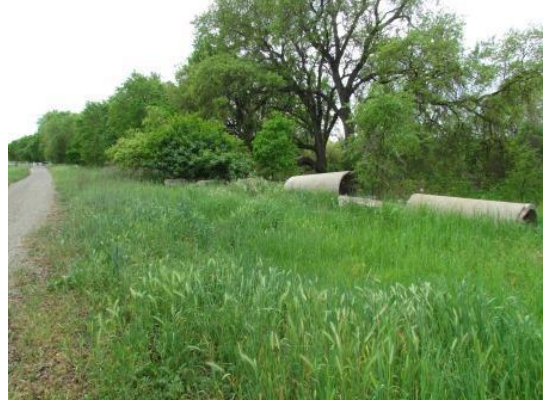
Photo 1 of 1 : FA_2015_RD1600_191_1202_20150914_00050.jpg

LM Start	10.38	Rating **	M	Issue No.	1202
LM End	10.38	Issue Type +	En	Location *	WS
Category	Earthen Levee			GPS Latitude/Longitude	
				Start	End
Item	Encroachments			38.766363 °	38.766363 °
				-121.634317 °	-121.634317 °
DWR ID	DWR_RD1600_01_s _ 2015_1202				
Action/Comments					
Debris

View of debris on the waterward side of the levee looking upstream.
Spring 2015.

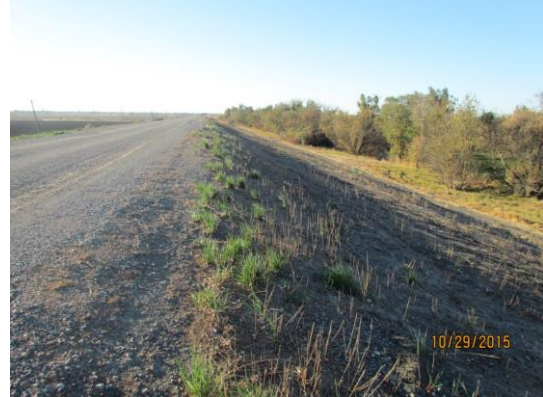
Photo 1 of 1 : FA_2015_RD1600_192_3_20151103_00020.jpg

LM Start	0.00	Rating **	A	Issue No.	3
LM End	0.39	Issue Type +	Ma	Location *	WS
Category	Earthen Levee			GPS Latitude/Longitude	
				Start	End
Item	Vegetation			38.736210 °	38.730609 °
				-121.633662 °	-121.633482 °
DWR ID	DWR_RD1600_02_f_2015_3				
Action/Comments					
Control annual grass and weeds on the levee slopes and easements. Inspector Comments: Levee slope is maintained.

View of the vegetation on the waterward side of the levee looking downstream. Fall 2015.

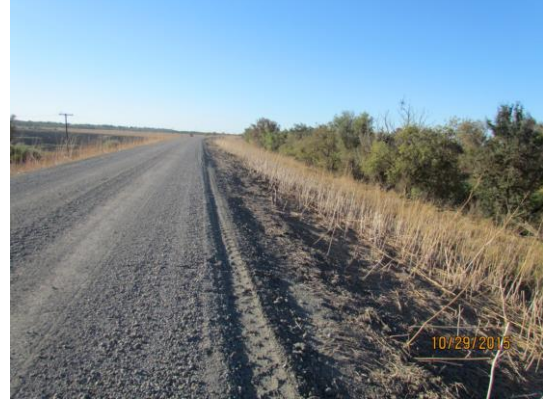
Photo 1 of 1 : FA_2015_RD1600_192_5_20151103_00022.jpg

View of the vegetation on the waterward side of the levee looking downstream. Fall 2015.

LM Start	0.85	Rating **	M	Issue No.	5
LM End	1.02	Issue Type +	Ma	Location *	WS
Category	Earthen Levee			GPS Latitude/Longitude	
				Start	End
Item	Vegetation			38.723975 °	38.721426 °
				-121.633378 °	-121.633613 °
DWR ID	DWR_RD1600_02_f _ 2015_5				
Action/Comments					
Control annual grass and weeds on the levee slopes and easements.
