**Flood Control Project Maintenance
Levee Inspections**

Fall 2016 Levee Maintenance Deficiency Summary Report

Reclamation District No. 1600 Mull

Fall 2016 Levee Inspection Results

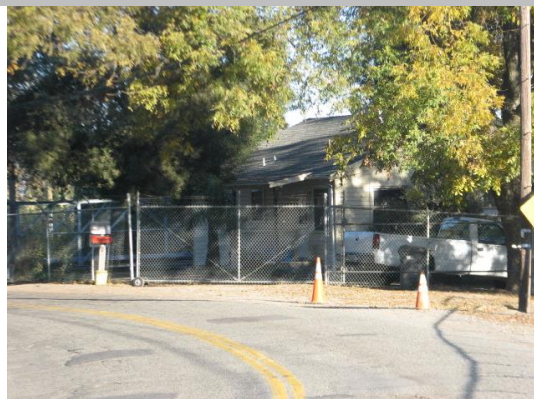
Photo 1 of 3 : FA_2016_RD1600_191_1_20160913_00001.jpg

LM Start	0.06	Rating **	A/W	Issue No.	1
LM End	0.06	Issue Type +	En	Location *	WS
Category	Earthen Levee			GPS Latitude/Longitude	
				Start	End
Item	Encroachments			38.675998 °	38.675998 °
				-121.630732 °	-121.630732 °
DWR ID	DWR_RD1600_01_s_2012_1				
Comment Code					
BU : Building					
Inspector Comment					
This is the home and pumping plant for RD 2035.

The caretakers home for the operator of the pumping plant (RD 2035).
Fall 2013

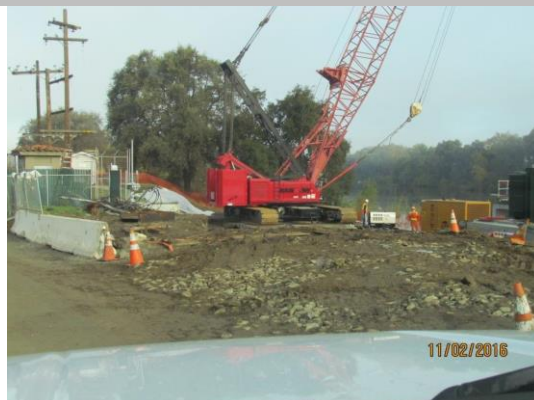
Photo 2 of 3 : FA_2016_RD1600_191_1_20161103_00096.jpg

Building was removed due to a new construction. Fall 2016.

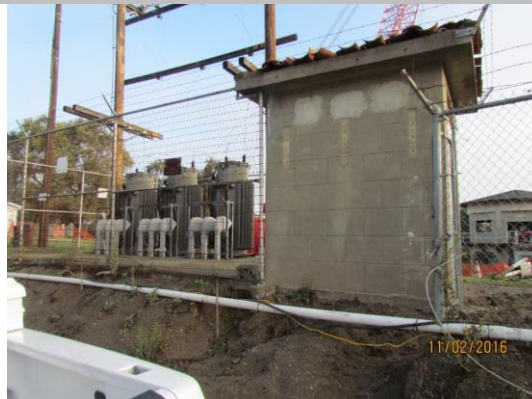
Photo 1 of 4 : FA_2016_RD1600_191_25_20161103_00097.jpg

Building and transformers on waterward side a part of a new pumping plant construction. Fall 2016.

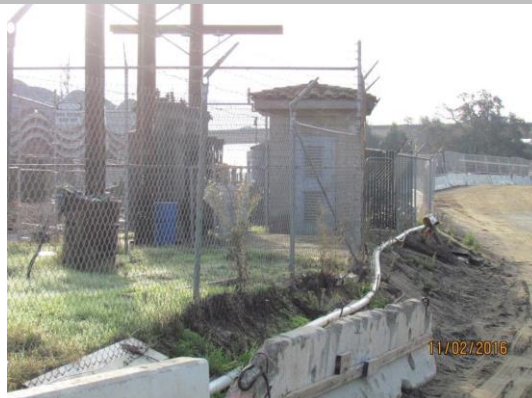
Photo 2 of 4 : FA_2016_RD1600_191_25_20161103_00098.jpg

Another view of the building and transformers. Fall 2016.

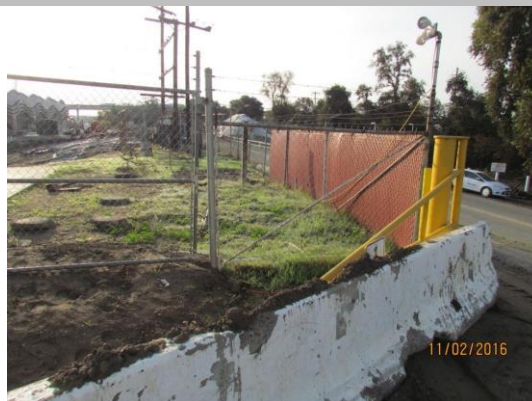
Photo 4 of 4 : FA_2016_RD1600_191_25_20161103_00100.jpg

LM Start	0.08	Rating **	A	Issue No.	25 (cont)	
LM End	0.08	Issue Type +	En	Location *	WS	
Category	Earthen Levee			GPS Latitude/Longitude		
				Start		End
Item	Encroachments			38.676203 °		38.676203 °
				-121.631024 °		-121.631024 °
DWR ID	DWR_RD1600_01_f_2016_25					
Comment Code						
BU : Building						
Inspector Comment						
Permit 18763 to remove existing RD235 pump station and construct a new one with fish screen.

View of construction site. Fall 2016.

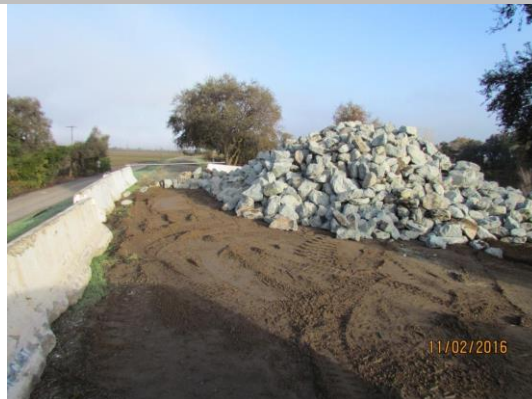
Photo 1 of 2 : FA_2016_RD1600_191_26_20161103_00102.jpg

LM Start	0.13	Rating **	U	Issue No.	26
LM End	0.13	Issue Type +	En	Location *	CR
Category	Earthen Levee			GPS Latitude/Longitude	
				Start	End
Item	Encroachments			38.676775 °	38.676775 °
				-121.631435 °	-121.631435 °
DWR ID	DWR_RD1600_01_f_2016_26				
Comment Code					
MA : Material					
Inspector Comment					
Rockpile blocks levee access.

Rockpile blocks access to the levee trough the gate. Looking upstream. Fall 2016.

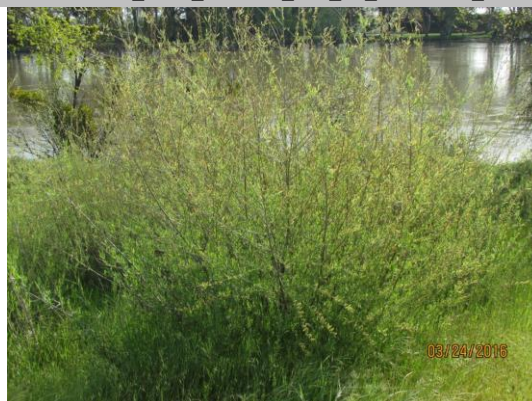
Photo 2 of 3 : FA_2016_RD1600_191_29_20160913_00028.jpg

Willows are growing on the waterward side of the levee. Spring 2016.

LM Start	0.60	Rating **	M	Issue No.	29 (cont)	
LM End	0.62	Issue Type +	Ma	Location *	WS	
Category	Earthen Levee			GPS Latitude/Longitude		
				Start		End
Item	Vegetation			38.683238 °		38.683415 °
				-121.634388 °		-121.634448 °
DWR ID	DWR_RD1600_01_s_2016_29					
Comment Code						
V2 : Remove the wild growth other than native grasses from the levee slopes.						
Inspector Comment						
Recommend removal of willow trees.

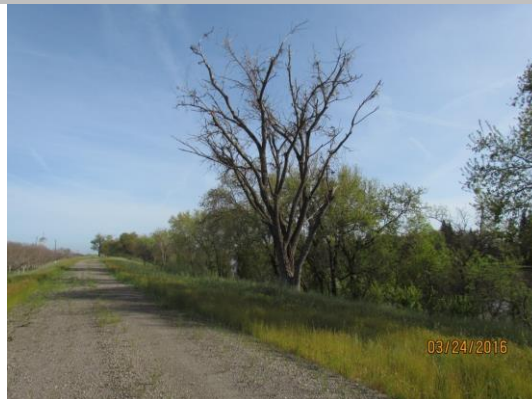
Photo 1 of 2 : FA_2016_RD1600_191_624_20160913_00061.jpg

LM Start	0.78	Rating **	A/W	Issue No.	624
LM End	0.78	Issue Type +	Ma	Location *	WS
Category	Earthen Levee			GPS Latitude/Longitude	
				Start	End
Item	Vegetation			38.685713 °	38.685713 °
				-121.634985 °	-121.634985 °
DWR ID	DWR_RD1600_01_s_2015_624				
Comment Code					
V7 : Trees / Woody Vegetation					
Inspector Comment					
The tree is dying and needs to be monitored.

View of the dying tree on the waterward side of the levee looking upstream. Spring 2016.

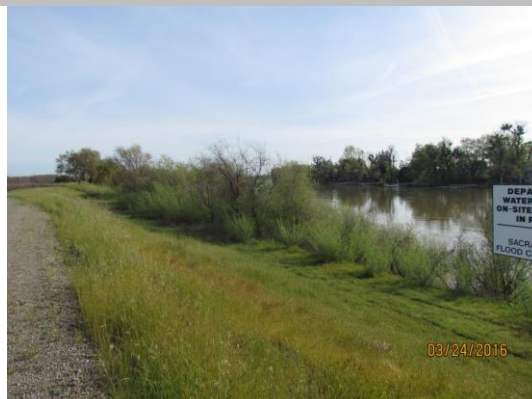
Photo 1 of 2 : FA_2016_RD1600_191_5_20160913_00007.jpg

LM Start	1.40	Rating **	A/W	Issue No.	5
LM End	1.40	Issue Type +	Ob	Location *	WS
Category	Earthen Levee			GPS Latitude/Longitude	
				Start	End
Item	Vegetation			38.694469 °	38.694469 °
				-121.634312 °	-121.634312 °
DWR ID	DWR_RD1600_01_f_2012_5				
Comment Code					
V8 : Environmental Requirements.					
Inspector Comment

View of the revegetation site on the berm of the waterward side of the levee looking upstream. Spring 2016.

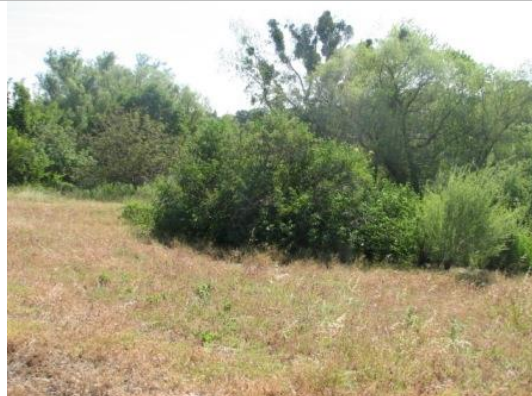
Photo 1 of 2 : FA_2016_RD1600_191_31_20160913_00031.jpg

LM Start	1.72	Rating **	A/W	Issue No.	31
LM End	1.72	Issue Type +	Ma	Location *	WS
Category	Earthen Levee			GPS Latitude/Longitude	
				Start	End
Item	Vegetation			38.698639 °	38.698639 °
				-121.631687 °	-121.631687 °
DWR ID	DWR_RD1600_01_s_2012_31				
Comment Code					
V4 : Elderberries are blocking visibility and flood fight capability.					
Inspector Comment

A photo of a Elderberry bush in the area.

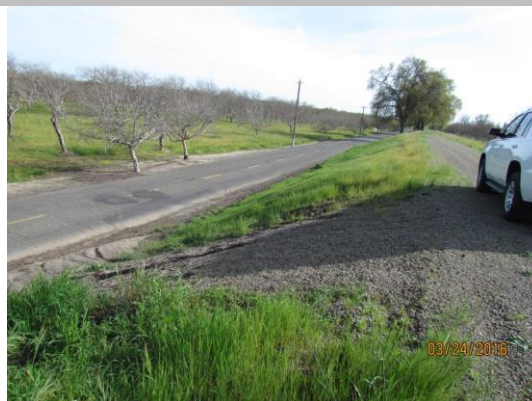
Photo 2 of 3 : FA_2016_RD1600_191_72_20160913_00052.jpg

Perspective view of the erosion on the landward side of the levee looking upstream. Spring 2016.

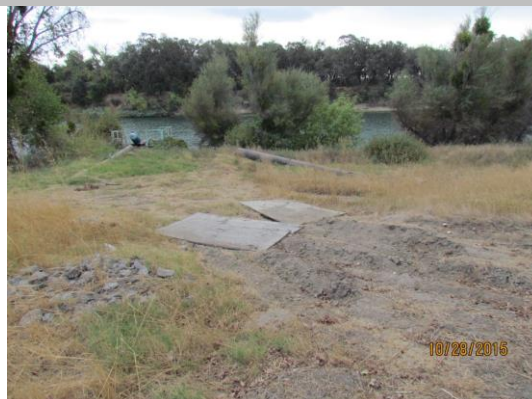
Photo 2 of 2 : FA_2016_RD1600_191_627_20160913_00065.jpg

LM Start	3.57	Rating **	M	Issue No.	627 (cont)	
LM End	3.57	Issue Type +	En	Location *	WS	
Category	Earthen Levee			GPS Latitude/Longitude		
				Start		End
Item	Encroachments			38.717717 °		38.717717 °
				-121.608015 °		-121.608015 °
DWR ID	DWR_RD1600_01_s_2014_627					
Comment Code						
DE : Debris						
Inspector Comment						
Some debris has been removed. Fall 2016.

View of the metal pipe and wood debris on the berm of the waterward side of the levee. Fall 2015.

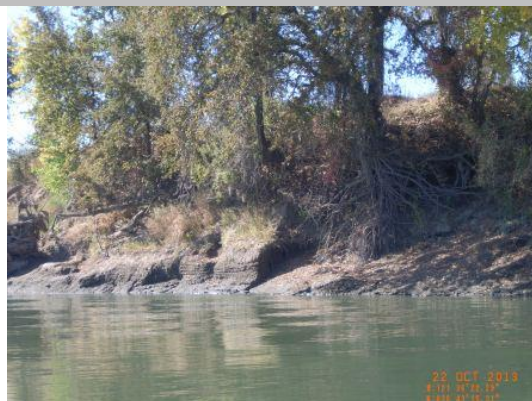
Photo 1 of 1 : FA_2016_RD1600_191_3_20160913_00004.jpg

LM Start	3.58	Rating **	M	Issue No.	3
LM End	3.83	Issue Type +	Ma	Location *	WS
Category	Supplemental			GPS Latitude/Longitude	
				Start	End
Item	2015 USACE Erosion Survey, DRAFT			38.717770 °	38.721351 °
				-121.607423 °	-121.606414 °
DWR ID	DWR_RD1600_01_s_2016_3				
Comment Code					
Inspector Comment					
1997 - Steep high bank. 2005 - Some small pockets in the low toe near the waterline. 2006 - Minor slope clearing. 2010 - Minor new erosion. 2011 - Multiple trees have fallen since last year. Some other trees look ready to fall. Significant new erosion since last year. 2012 - Minor new erosion. 2013 - Minor new erosion. 2015: New minor erosion at toe. [2015 Site ID: SAC_74-4_R]

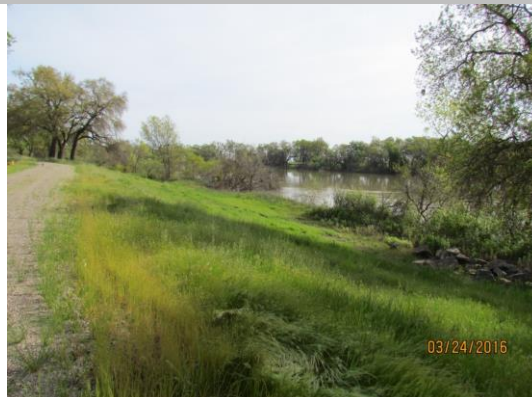
Photo 1 of 2 : FA_2016_RD1600_191_628_20160913_00066.jpg

Perspective view of the concrete pile looking upstream. Spring 2016.

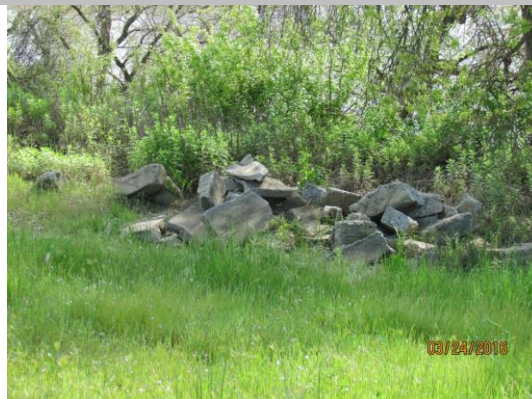
Photo 2 of 2 : FA_2016_RD1600_191_628_20160913_00067.jpg

View of the concrete pile on the berm of the waterward side of the levee. Spring 2016.

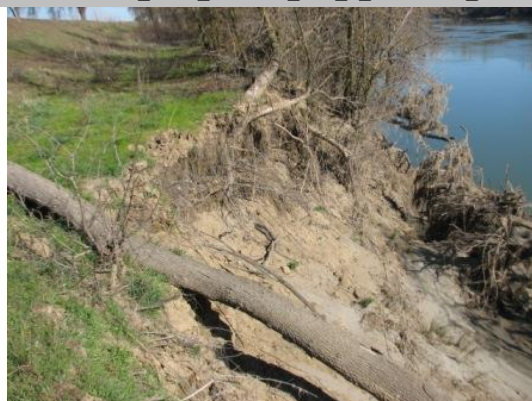
Photo 1 of 2 : FA_2016_RD1600_191_2_20160913_00002.jpg

LM Start	3.76	Rating **	M	Issue No.	2
LM End	3.76	Issue Type +	Ma	Location *	WS
Category	Earthen Levee			GPS Latitude/Longitude	
				Start	End
Item	Erosion / Bank Caving			38.720385 °	38.720385 °
				-121.606953 °	-121.606953 °
DWR ID	DWR_RD1600_01_s_2013_2				
Comment Code					
E1 : Note and monitor erosion site.					
Inspector Comment					
Trees have fallen over and created bank erosion.

Trees have fallen and the water has created the erosion into the berm. Spring 2013

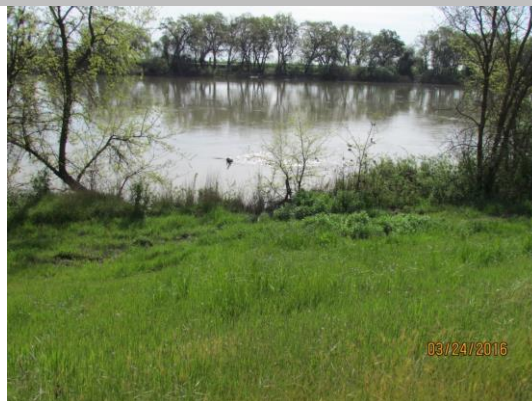
Photo 2 of 2 : FA_2016_RD1600_191_2_20160913_00003.jpg

LM Start	3.76	Rating **	M	Issue No.	2 (cont)	
LM End	3.76	Issue Type +	Ma	Location *	WS	
Category	Earthen Levee			GPS Latitude/Longitude		
				Start		End
Item	Erosion / Bank Caving			38.720385 °		38.720385 °
				-121.606953 °		-121.606953 °
DWR ID	DWR_RD1600_01_s_2013_2					
Comment Code						
E1 : Note and monitor erosion site.						
Inspector Comment						
Trees have fallen over and created bank erosion.

View of the erosion from the top of the levee. Spring 2016.

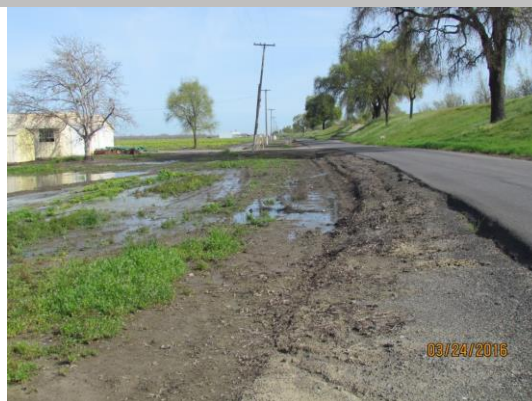
Photo 2 of 2 : FA_2016_RD1600_191_73_20160913_00054.jpg

LM Start	3.76	Rating **	U	Issue No.	73
LM End	3.93	Issue Type +	Ob	Location *	LS
Category	Earthen Levee			GPS Latitude/Longitude	
				Start	End
Item	Seepage / Sandboils			38.720407 °	38.722850 °
				-121.606953 °	-121.606899 °
DWR ID	DWR_RD1600_01_s_2016_73				
Comment Code					
Inspector Comment					
There appears to be a ponding issue and will have to be monitored during next inspection.

View of the seepage by the road looking upstream. Spring 2016.

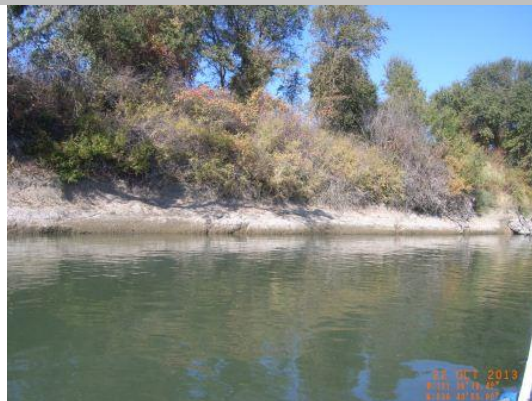
Photo 1 of 1 : FA_2016_RD1600_191_8_20160913_00011.jpg

LM Start	4.34	Rating **	M	Issue No.	8
LM End	4.86	Issue Type +	Ma	Location *	WS
Category	Supplemental			GPS Latitude/Longitude	
				Start	End
Item	2015 USACE Erosion Survey, DRAFT			38.728684 °	38.736110 °
				-121.605844 °	-121.604153 °
DWR ID	DWR_RD1600_01_s_2016_8				
Comment Code					
Inspector Comment					
1997 - Very steep bank. 2005 - Lots of small trees down along the bank at the upstream end. 2006 - Minor new erosion, but slow. 2010 - Almost all of the roots are exposed on the trees, appears ready to fall. 2011 - New erosion and tree popouts. 2012 - Site has become overgrown with vegetation, making it hard to observe. 2015: Dense vegetation made observation difficult. [2015 Site ID: SAC_75-3_R]

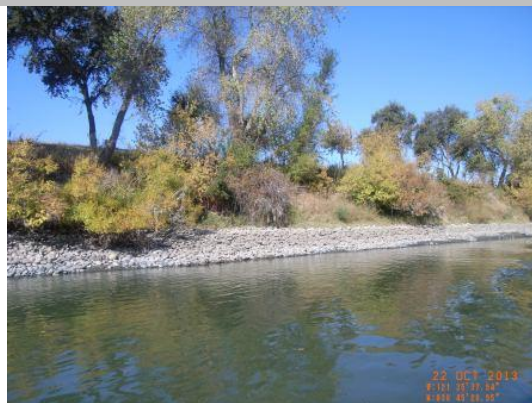
Photo 1 of 1 : FA_2016_RD1600_191_9_20160913_00012.jpg

LM Start	6.30	Rating **	A/W	Issue No.	9
LM End	6.36	Issue Type +	Ma	Location *	WS
Category	Supplemental			GPS Latitude/Longitude	
				Start	End
Item	2015 USACE Erosion Survey, DRAFT			38.755246 °	38.756186 °
				-121.594206 °	-121.594024 °
DWR ID	DWR_RD1600_01_s_2016_9				
Comment Code					
Inspector Comment					
2011 - Large vertical eroded face from a rotational failure just below pump. 2015: Does not meet criterial. [2015 Site ID: SAC_77-0_R]

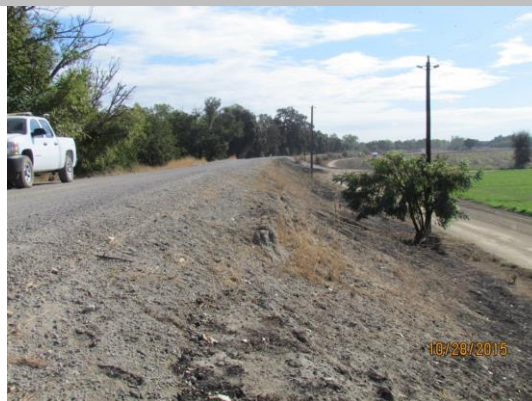
Photo 2 of 3 : FA_2016_RD1600_191_27_20160913_00024.jpg

The erosion seems to have been fixed. There still seems to be some erosion on the landward side of the levee looking downstream. Fall 2015.

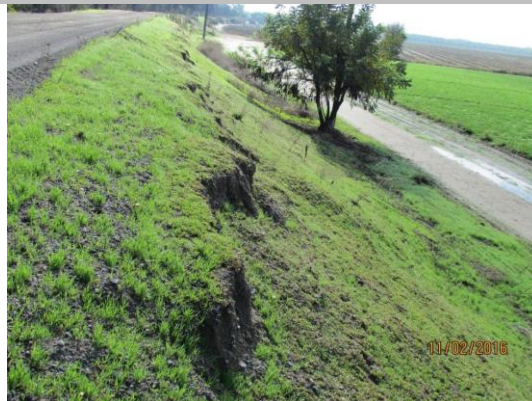
Photo 3 of 3 : FA_2016_RD1600_191_27_20161103_00123.jpg

Updated view of erosion site. Fall 2016.

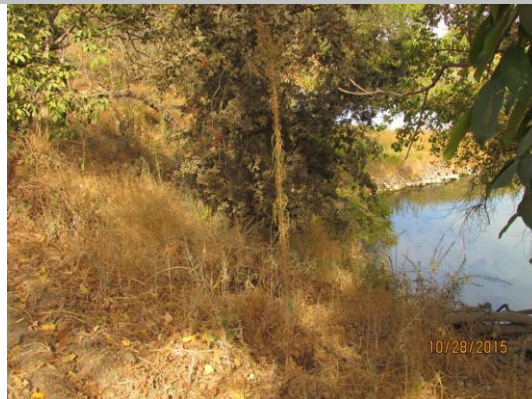
Photo 2 of 2 : FA_2016_RD1600_191_30_20160913_00030.jpg

View of the erosion into the berm area that needs to be monitored. Fall 2015.

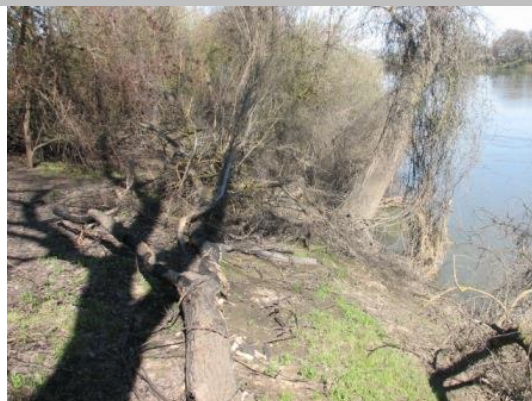
Photo 1 of 5 : FA_2016_RD1600_191_20_20160913_00014.jpg

LM Start	7.10	Rating **	A/W	Issue No.	20
LM End	7.10	Issue Type +	Ma	Location *	WS
Category	Earthen Levee			GPS Latitude/Longitude	
				Start	End
Item	Erosion / Bank Caving			38.766691 °	38.766691 °
				-121.596300 °	-121.596300 °
DWR ID	DWR_RD1600_01_s _ 2012_20				
Comment Code					
E1 : Note and monitor erosion site.					
Inspector Comment					
Erosion present at the berm, and it hasn't got into the levee prism yet.

This another view of the site.

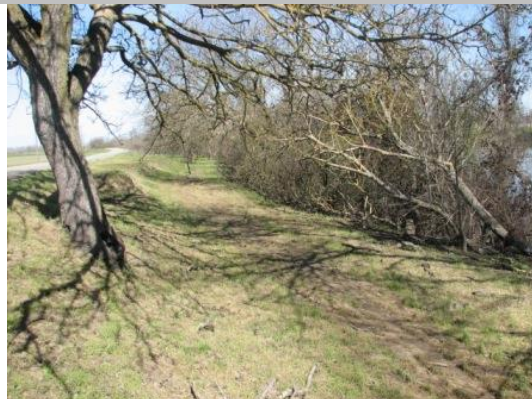
Photo 3 of 5 : FA_2016_RD1600_191_20_20160913_00016.jpg

LM Start	7.10	Rating **	A/W	Issue No.	20 (cont)	
LM End	7.10	Issue Type +	Ma	Location *	WS	
Category	Earthen Levee			GPS Latitude/Longitude		
				Start	End	
Item	Erosion / Bank Caving			38.766691 °	38.766691 °	
				-121.596300 °	-121.596300 °	
DWR ID	DWR_RD1600_01_s_ 2012_20					
Comment Code						
E1 : Note and monitor erosion site.						
Inspector Comment						
Erosion present at the berm, and it hasn't got into the levee prism yet.

The erosion is eroding away at the berm area.

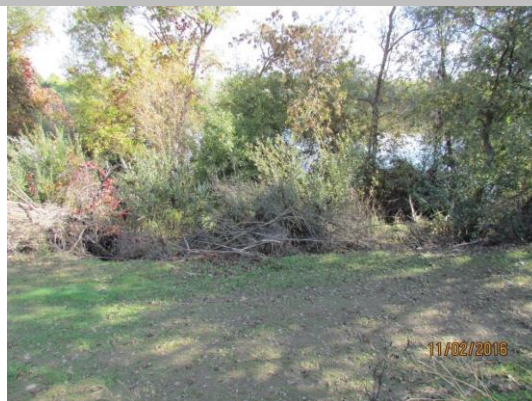
Photo 5 of 5 : FA_2016_RD1600_191_20_20161103_00124.jpg

Updated view of erosion site. Fall 2016.

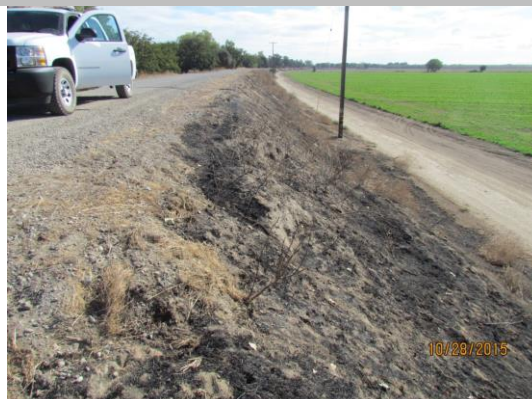
Photo 1 of 1 : FA_2016_RD1600_191_61_20160913_00048.jpg

LM Start	7.21	Rating **	M	Issue No.	61
LM End	7.21	Issue Type +	Ma	Location *	LS
Category	Earthen Levee			GPS Latitude/Longitude	
				Start	End
Item	Erosion / Bank Caving			38.768094 °	38.768094 °
				-121.597075 °	-121.597075 °
DWR ID	DWR_RD1600_01_f_2015_61				
Comment Code					
E1 : Note and monitor erosion site.					
Inspector Comment

View of the erosion on the landward side of the levee looking downstream. Fall 2015.

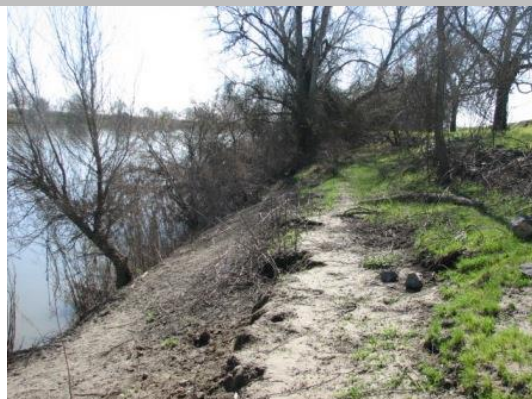
Photo 1 of 3 : FA_2016_RD1600_191_21_20160913_00018.jpg

LM Start	7.23	Rating **	M	Issue No.	21
LM End	7.23	Issue Type +	Ma	Location *	WS
Category	Earthen Levee			GPS Latitude/Longitude	
				Start	End
Item	Erosion / Bank Caving			38.768409 °	38.768409 °
				-121.597213 °	-121.597213 °
DWR ID	DWR_RD1600_01_s_2012_21				
Comment Code					
E1 : Note and monitor erosion site.					
Inspector Comment

The erosion is eroding away the berm area.

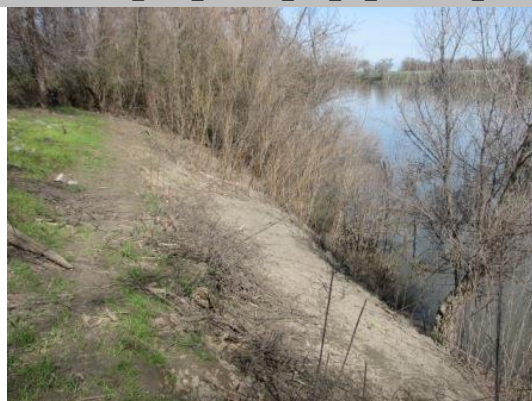
Photo 2 of 3 : FA_2016_RD1600_191_21_20160913_00019.jpg

The bank is eroding away and has become very steep.

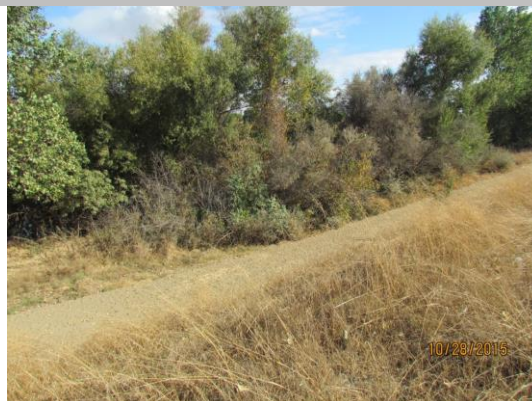
Photo 3 of 3 : FA_2016_RD1600_191_21_20160913_00020.jpg

LM Start	7.23	Rating **	M	Issue No.	21 (cont)
LM End	7.23	Issue Type +	Ma	Location *	WS
Category	Earthen Levee			GPS Latitude/Longitude	
				Start	End
Item	Erosion / Bank Caving			38.768409 °	38.768409 °
				-121.597213 °	-121.597213 °
DWR ID	DWR_RD1600_01_s_2012_21				
Comment Code					
E1 : Note and monitor erosion site.					
Inspector Comment

View of the erosion along the waterward berm of the levee. Fall 2015.

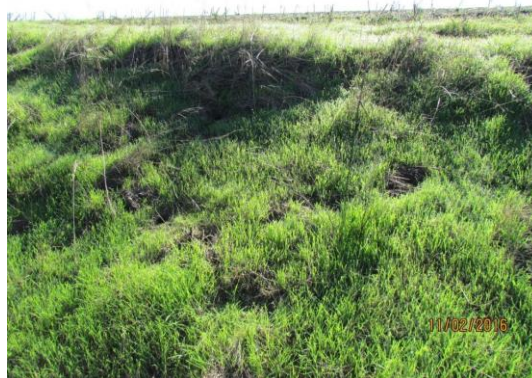
Photo 1 of 1 : FA_2016_RD1600_191_1200_20161103_00127.jpg

LM Start	8.21	Rating **	M	Issue No.	1200
LM End	8.21	Issue Type +	Ma	Location *	WS
Category	Earthen Levee			GPS Latitude/Longitude	
				Start	End
Item	Animal Control			38.778938 °	38.778938 °
				-121.608595 °	-121.608595 °
DWR ID	DWR_RD1600_01_s_2015_1200				
Comment Code					
A1 : Exterminate rodents and backfill and compact or grout burrows.					
Inspector Comment

Rodent holes on waterside slope. Fall 2016.

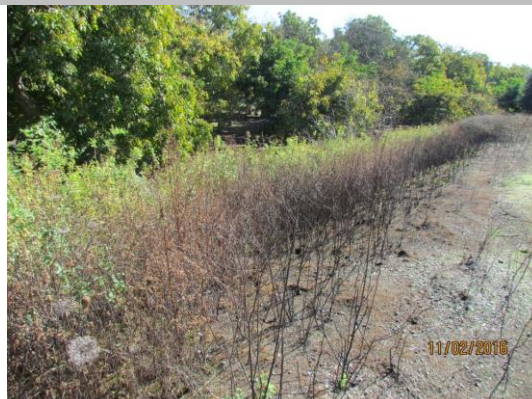
Photo 1 of 1 : FA_2016_RD1600_191_68_20161103_00136.jpg

LM Start	9.86	Rating **	U	Issue No.	68
LM End	9.90	Issue Type +	Ma	Location *	LS
Category	Earthen Levee			GPS Latitude/Longitude	
				Start	End
Item	Vegetation			38.773389 °	38.772705 °
				-121.631723 °	-121.631586 °
DWR ID	DWR_RD1600_01_f_2016_68				
Comment Code					
V2 : Remove the wild growth other than native grasses from the levee slopes.					
Inspector Comment

Vegetation on landside slope blocks visibility. Fall 2016.

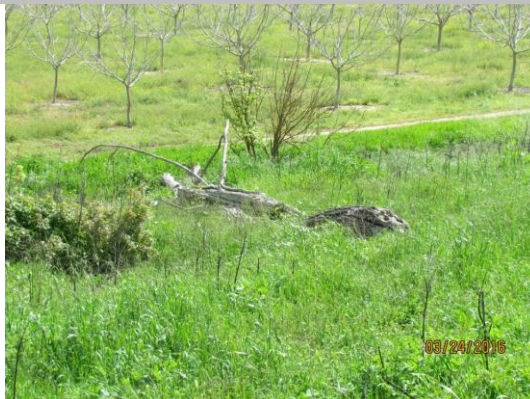
Photo 1 of 2 : FA_2016_RD1600_192_2_20160913_00001.jpg

A tree has fallen on the landward side of the levee. Spring 2016.

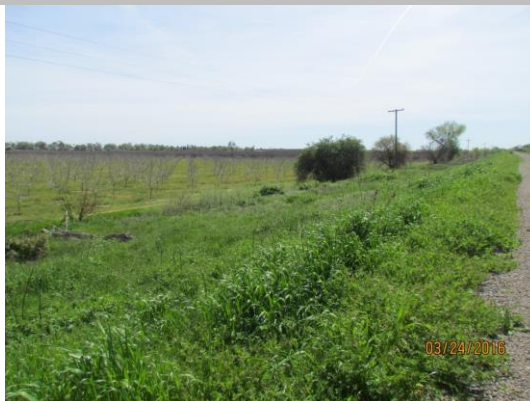
Photo 2 of 2 : FA_2016_RD1600_192_2_20160913_00002.jpg

View of the fallen tree on the landward side of the levee looking downstream. Spring 2016.

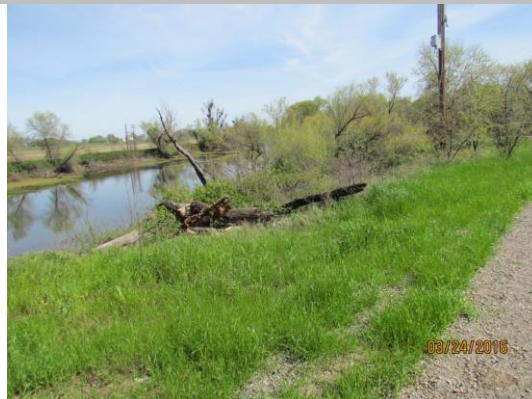
Photo 1 of 2 : FA_2016_RD1600_192_6_20160913_00003.jpg

LM Start	4.19	Rating **	M	Issue No.	6
LM End	4.19	Issue Type +	Ma	Location *	LS
Category	Earthen Levee			GPS Latitude/Longitude	
				Start	End
Item	Encroachments			38.677121 °	38.677121 °
				-121.643466 °	-121.643466 °
DWR ID	DWR_RD1600_02_s_2016_6				
Comment Code					
PR : Prunings					
Inspector Comment

View of the trees on the landward side of the levee looking downstream.
Spring 2016.
