**Flood Control Project Maintenance
Levee Inspections**

Fall 2017 Levee Maintenance Deficiency Summary Report

Sacramento River Basin

Reclamation District No. 1600 Mull

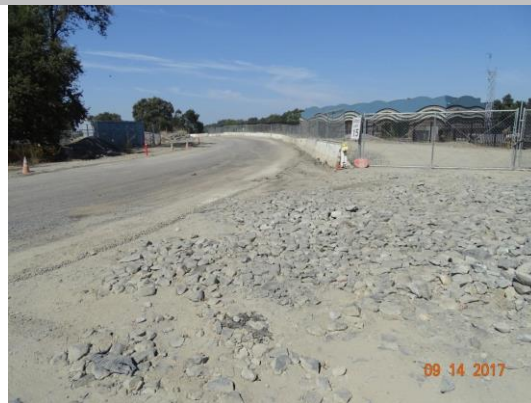
Photo 1 of 2 : FA_2017_RD1600_191_1_20171128_00119.jpg

LM Start	0.06	Rating **	A/W	Issue No.	1
LM End	0.06	Issue Type +	En	Location *	WS
Category	Earthen Levee			GPS Latitude/Longitude	
				Start	End
Item	Encroachments			38.675998 °	38.675998 °
				-121.630732 °	-121.630732 °
DWR ID	DWR_RD1600_01_s_2012_1				
Comment Code					
BU : Building					
Inspector Comment					
This is the new pumping plant for RD 2035.

View of new pumping plant construction. Fall 2017.

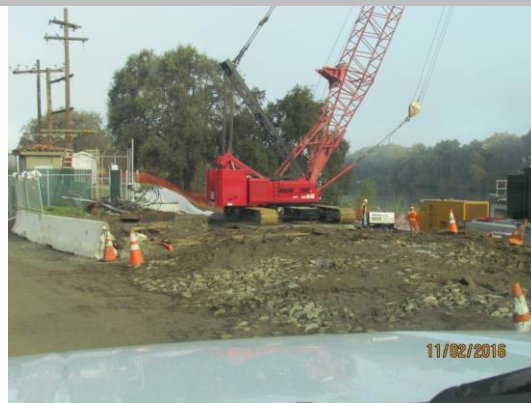
Photo 2 of 2 : FA_2017_RD1600_191_1_20170911_00002.jpg

Building was removed due to a new construction. Fall 2016.

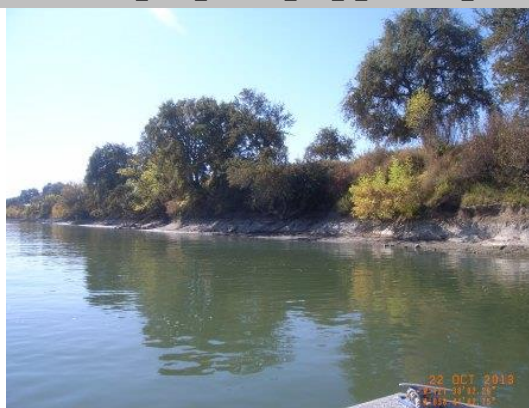
Photo 1 of 1 : FA_2017_RD1600_191_7_20170911_00010.jpg

LM Start	0.56	Rating **	A/W	Issue No.	7
LM End	0.66	Issue Type +	Ma	Location *	WS
Category	Supplemental			GPS Latitude/Longitude	
				Start	End
Item	2015 USACE Erosion Survey, DRAFT			38.682707 °	38.684106 °
				-121.633830 °	-121.634219 °
DWR ID	DWR_RD1600_01_s_2016_7				
Comment Code					
Inspector Comment					
2000 - Very cohesive vertical bank. 2003 - Some minor new erosion. 2006 - Some minor erosion in old pockets. 2009 - Minimal new erosion. 2011 - Multiple new erosion pockets and a few new tree popouts. 2015: No observed changes. [2015 Site ID: SAC_71-3_R]

USACE 2013 Photo #1

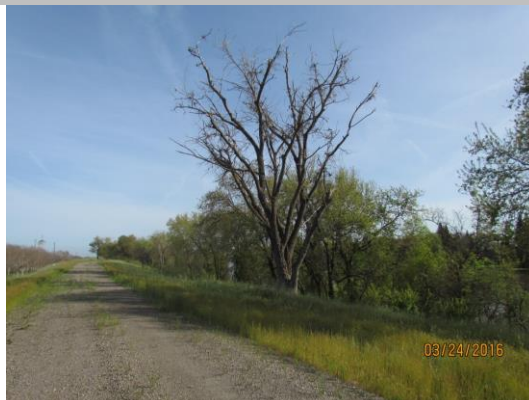
Photo 1 of 2 : FA_2017_RD1600_191_624_20170911_00083.jpg

LM Start	0.78	Rating **	U	Issue No.	624
LM End	0.78	Issue Type +	Ma	Location *	WS
Category	Earthen Levee			GPS Latitude/Longitude	
				Start	End
Item	Trim / Thin Trees			38.685713 °	38.685713 °
				-121.634985 °	-121.634985 °
DWR ID	DWR_RD1600_01_s_2017_624				
Comment Code					
T5 : Tree stumps.					
Inspector Comment					
Burnt stump on waterside slope.

View of the dying tree on the waterward side of the levee looking upstream. Spring 2016.

Dying tree on waterward side was burnt. Fall 2016.

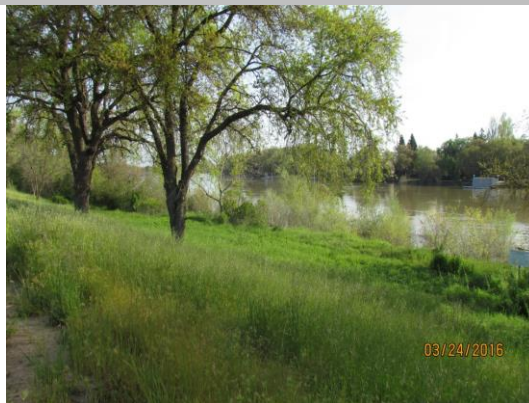
Photo 1 of 2 : FA_2017_RD1600_191_22_20170911_00022.jpg

LM Start	1.01	Rating **	A/W	Issue No.	22
LM End	1.10	Issue Type +	Ma	Location *	WS
Category	Earthen Levee			GPS Latitude/Longitude	
				Start	End
Item	Vegetation			38.689092 °	38.690368 °
				-121.635616 °	-121.635669 °
DWR ID	DWR_RD1600_01_f_2017_22				
Comment Code					
V8 : Environmental Requirements.					
Inspector Comment

View of the revegetation site at the berm edge on the waterward side of the levee looking upstream. Spring 2016.

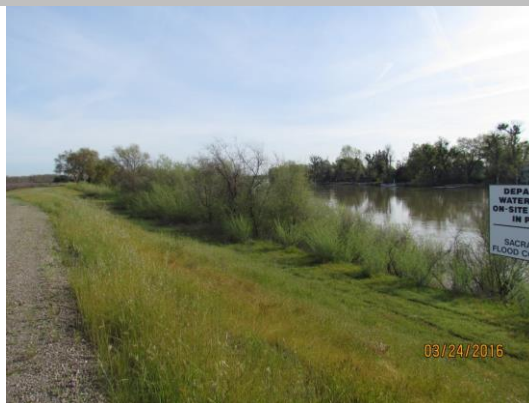
Photo 1 of 2 : FA_2017_RD1600_191_5_20170911_00007.jpg

LM Start	1.40	Rating **	A/W	Issue No.	5
LM End	1.40	Issue Type +	Ob	Location *	WS
Category	Earthen Levee			GPS Latitude/Longitude	
				Start	End
Item	Vegetation			38.694469 °	38.694469 °
				-121.634312 °	-121.634312 °
DWR ID	DWR_RD1600_01_f_2012_5				
Comment Code					
V8 : Environmental Requirements.					
Inspector Comment

View of the revegetation site on the berm of the waterward side of the levee looking upstream. Spring 2016.

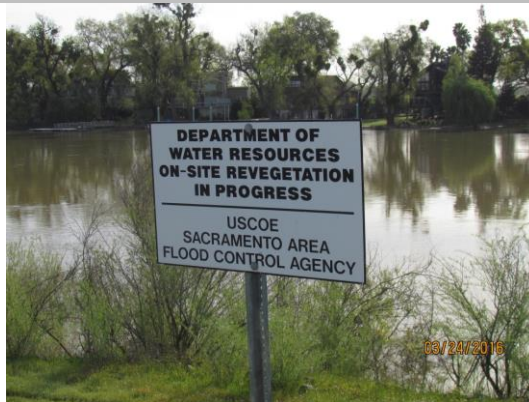
Photo 2 of 2 : FA_2017_RD1600_191_5_20170911_00008.jpg

DWR revegetation site. Spring 2016.

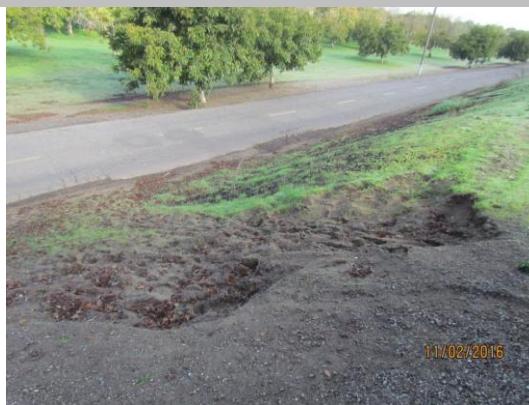
Photo 2 of 4 : FA_2017_RD1600_191_72_20170911_00066.jpg

Updated view of the erosion site. Fall 2016.

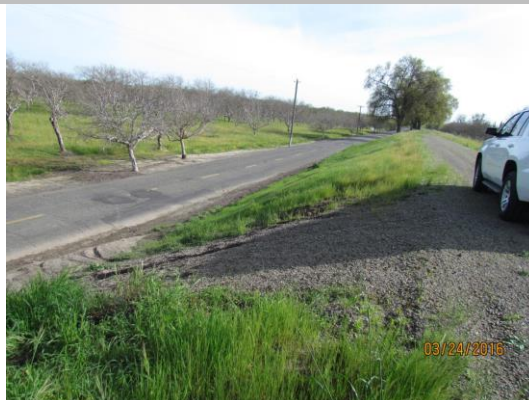
Photo 3 of 4 : FA_2017_RD1600_191_72_20170911_00067.jpg

Perspective view of the erosion on the landward side of the levee looking upstream. Spring 2016.

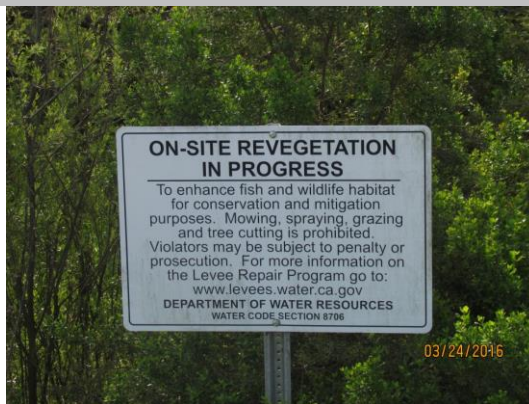
Photo 1 of 2 : FA_2017_RD1600_191_35_20170911_00037.jpg

LM Start	2.35	Rating **	A/W	Issue No.	35
LM End	2.40	Issue Type +	Ob	Location *	WS
Category	Earthen Levee			GPS Latitude/Longitude	
				Start	End
Item	Vegetation			38.704624 °	38.705152 °
				-121.623034 °	-121.622187 °
DWR ID	DWR_RD1600_01_s_2012_35				
Comment Code					
V8 : Environmental Requirements.					
Inspector Comment

Sign for revegetation site. Spring 2016.

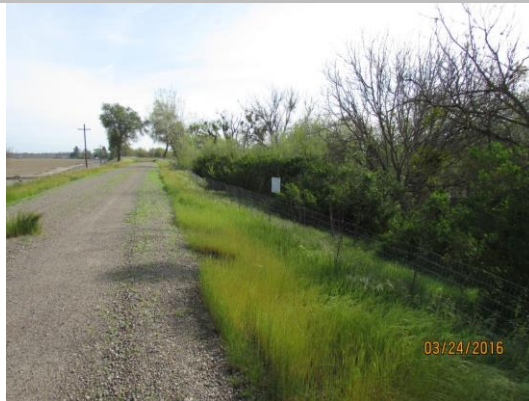
Photo 2 of 2 : FA_2017_RD1600_191_35_20170911_00038.jpg

View of the revegetation site on the waterward side of the levee looking upstream. Spring 2016.

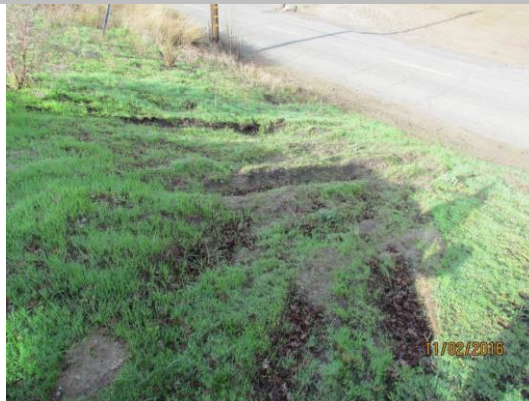
Photo 1 of 1 : FA_2017_RD1600_191_43_20170911_00041.jpg

LM Start	2.41	Rating **	M	Issue No.	43
LM End	2.41	Issue Type +	Ma	Location *	LS
Category	Earthen Levee			GPS Latitude/Longitude	
				Start	End
Item	Slope Stability			38.705203 °	38.705203 °
				-121.622184 °	-121.622184 °
DWR ID	DWR_RD1600_01_f_2016_43				
Comment Code					
S1 : Repair slope instability.					
Inspector Comment

LS slope damaged by a vehicle. Fall 2016.

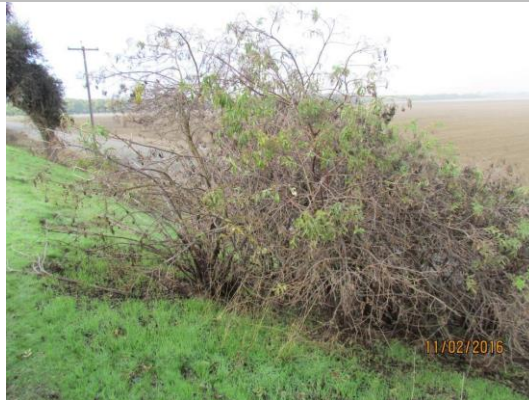
Photo 1 of 1 : FA_2017_RD1600_191_45_20170911_00043.jpg

LM Start	2.61	Rating **	A/W	Issue No.	45
LM End	2.61	Issue Type +	Ma	Location *	LS
Category	Earthen Levee			GPS Latitude/Longitude	
				Start	End
Item	Vegetation			38.707311 °	38.707311 °
				-121.619517 °	-121.619517 °
DWR ID	DWR_RD1600_01_f_2016_45				
Comment Code					
V4 : Elderberries are blocking visibility and flood fight capability.					
Inspector Comment

Elderberry tree on landside slope. Fall 2016.

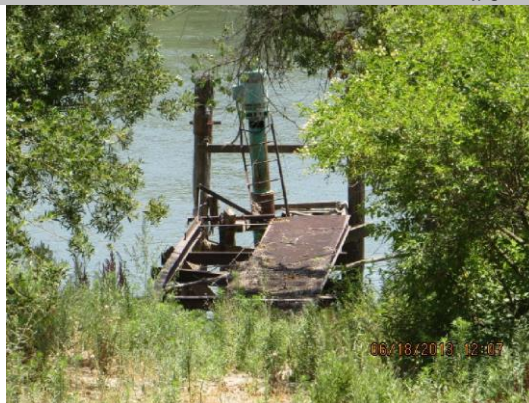
Photo 1 of 3 : UCIP_FA_2017_15108_24826.jpg

Pump on metal platform off WS berm.

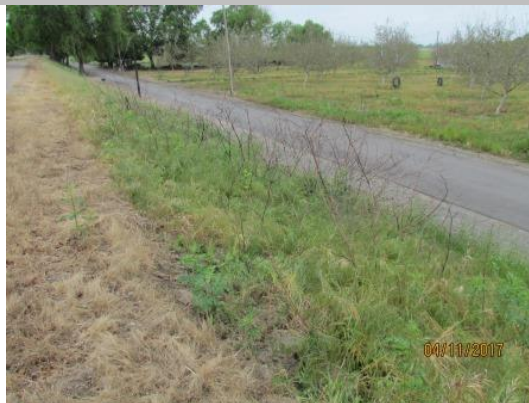
Photo 1 of 1 : FA_2017_RD1600_191_75_20170911_00072.jpg

LM Start	3.00	Rating **	M	Issue No.	75
LM End	3.00	Issue Type +	Ma	Location *	LS
Category	Earthen Levee			GPS Latitude/Longitude	
				Start	End
Item	Vegetation			38.711232 °	38.711232 °
				-121.614401 °	-121.614401 °
DWR ID	DWR_RD1600_01_s_2017_75				
Comment Code					
V2 : Remove the wild growth other than native grasses from the levee slopes.					
Inspector Comment					
Remove wild growth on landside levee slope.

Wild growth on landside levee slope. Spring 2017.

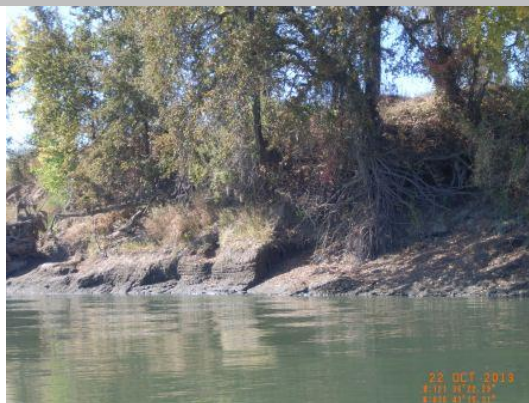
Photo 1 of 1 : FA_2017_RD1600_191_3_20170911_00004.jpg

LM Start	3.58	Rating **	M	Issue No.	3
LM End	3.83	Issue Type +	Ma	Location *	WS
Category	Supplemental			GPS Latitude/Longitude	
				Start	End
Item	2015 USACE Erosion Survey, DRAFT			38.717770 °	38.721351 °
				-121.607423 °	-121.606414 °
DWR ID	DWR_RD1600_01_s_2016_3				
Comment Code					
Inspector Comment					
1997 - Steep high bank. 2005 - Some small pockets in the low toe near the waterline. 2006 - Minor slope clearing. 2010 - Minor new erosion. 2011 - Multiple trees have fallen since last year. Some other trees look ready to fall. Significant new erosion since last year. 2012 - Minor new erosion. 2013 - Minor new erosion. 2015: New minor erosion at toe. [2015 Site ID: SAC 74-4 R]

USACE 2013 Photo #1

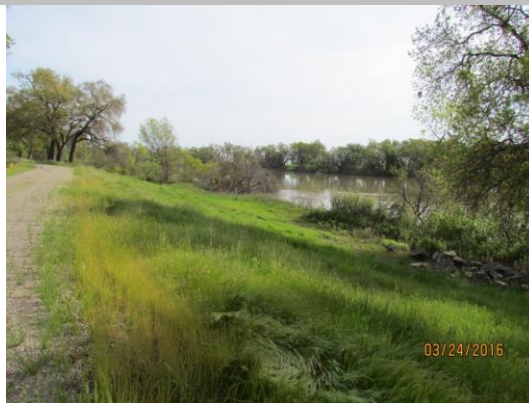
Photo 1 of 2 : FA_2017_RD1600_191_628_20170911_00087.jpg

LM Start	3.59	Rating **	M	Issue No.	628
LM End	3.59	Issue Type +	En	Location *	WS
Category	Earthen Levee			GPS Latitude/Longitude	
				Start	End
Item	Encroachments			38.718080 °	38.718080 °
				-121.607815 °	-121.607815 °
DWR ID	DWR_RD1600_01_s_2014_628				
Comment Code					
DE : Debris					
Inspector Comment

Perspective view of the concrete pile looking upstream. Spring 2016.

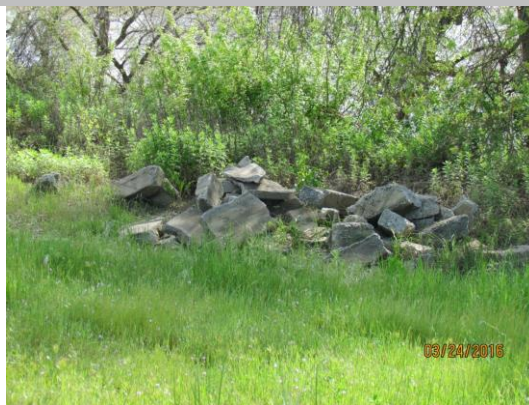
Photo 2 of 2 : FA_2017_RD1600_191_628_20170911_00088.jpg

View of the concrete pile on the berm of the waterward side of the levee. Spring 2016.

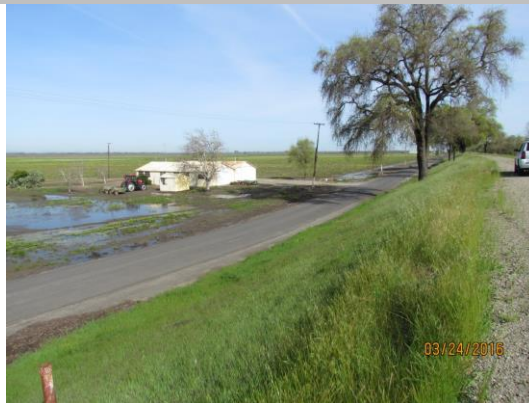
Photo 1 of 2 : FA_2017_RD1600_191_73_20170911_00069.jpg

LM Start	3.76	Rating **	A	Issue No.	73
LM End	3.93	Issue Type +	Ob	Location *	LS
Category	Earthen Levee			GPS Latitude/Longitude	
				Start	End
Item	Seepage / Sandboils			38.720407 °	38.722850 °
				-121.606953 °	-121.606899 °
DWR ID	DWR_RD1600_01_s_2016_73				
Comment Code					
Inspector Comment					
There appears to be a ponding issue and will have to be monitored during next inspection.

View taken from the crown of the levee of the seepage. Spring 2016.

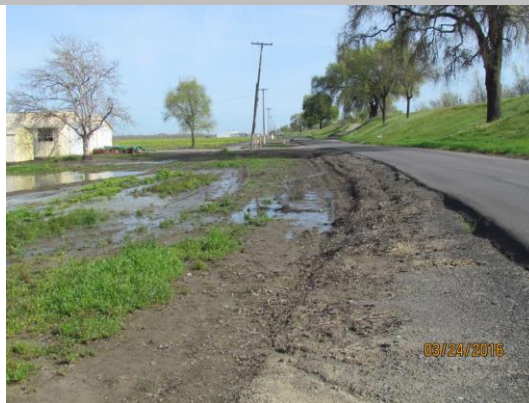
Photo 2 of 2 : FA_2017_RD1600_191_73_20170911_00070.jpg

View of the seepage by the road looking upstream. Spring 2016.

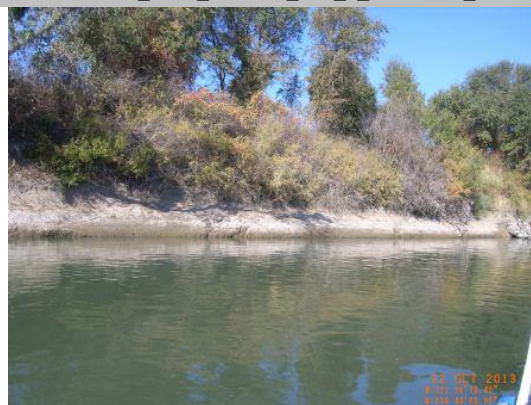
Photo 1 of 1 : FA_2017_RD1600_191_8_20170911_00011.jpg

LM Start	4.34	Rating **	M	Issue No.	8
LM End	4.86	Issue Type +	Ma	Location *	WS
Category	Supplemental			GPS Latitude/Longitude	
				Start	End
Item	2015 USACE Erosion Survey, DRAFT			38.728684 °	38.736110 °
				-121.605844 °	-121.604153 °
DWR ID	DWR_RD1600_01_s_2016_8				
Comment Code					
Inspector Comment					
1997 - Very steep bank. 2005 - Lots of small trees down along the bank at the upstream end. 2006 - Minor new erosion, but slow. 2010 - Almost all of the roots are exposed on the trees, appears ready to fall. 2011 - New erosion and tree popouts. 2012 - Site has become overgrown with vegetation, making it hard to observe. 2015: Dense vegetation made observation difficult. [2015 Site ID: SAC 75-3 R]

USACE 2013 Photo #1

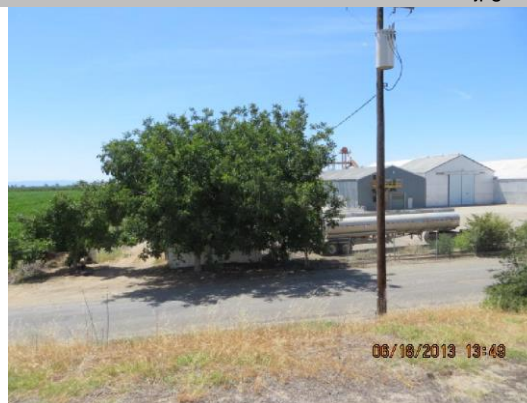
Photo 1 of 3 : UCIP_FA_2017_15125_24846.jpg

Comment Code						
Inspector Comment						
FS_ID:15125 DS_ID:21470 EP_NO: N/A Repair Type: Non-Urgent Crossing Status: Found UCIP Comments: Pumphouse abandoned with deep pit open. Safety issue. If plant is abandoned it should be done so properly. FIELD_STRUCT_DESC: 24-inch steel irrigation pipe through the levee, 21.4 feet below the crown. 16-inch pipe ties into 24-inch pipe at the waterside (WS) slope. Slant pump on metal platform and gate valve on the WS berm. Gate valve in pump house off the landside (LS). Two power poles at the LS toe. [Additional Reference(s): DWR Levee Log, 1988. USACE Sacramento O&M Manual 123, August 1955, (RM 75.2) (20-inch pipe listed)]. FS Date: 6/18/2013 7:36:00 AM

Pumphouse/distribution box off LS toe.

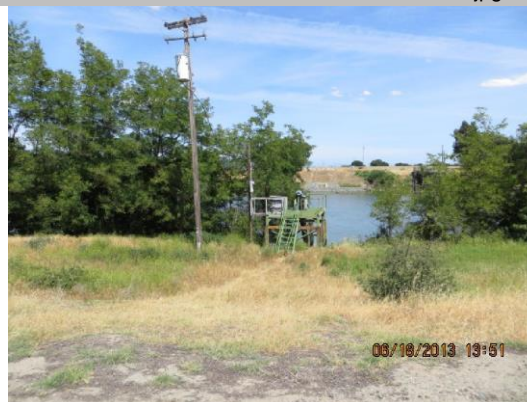
Photo 2 of 3 : UCIP_FA_2017_15125_24845.jpg

Slant pump on metal pier on WS berm.

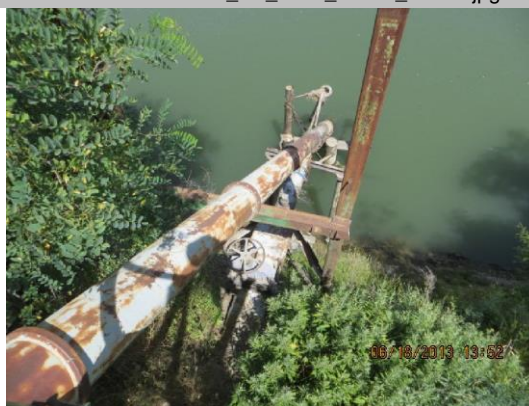
Photo 3 of 3 : UCIP_FA_2017_15125_24844.jpg

Comment Code						
Inspector Comment						
FS_ID:15125 DS_ID:21470 EP_NO: N/A Repair Type: Non-Urgent Crossing Status: Found UCIP Comments: Pumphouse abandoned with deep pit open. Safety issue. If plant is abandoned it should be done so properly. FIELD_STRUCT_DESC: 24-inch steel irrigation pipe through the levee, 21.4 feet below the crown. 16-inch pipe ties into 24-inch pipe at the waterside (WS) slope. Slant pump on metal platform and gate valve on the WS berm. Gate valve in pump house off the landside (LS). Two power poles at the LS toe. [Additional Reference(s): DWR Levee Log, 1988. USACE Sacramento O&M Manual 123, August 1955, (RM 75.2) (20-inch pipe listed)]. FS Date: 6/18/2013 7:36:00 AM

16-inch pipe ties into 24-inch pipe under pump platform at slide gate.

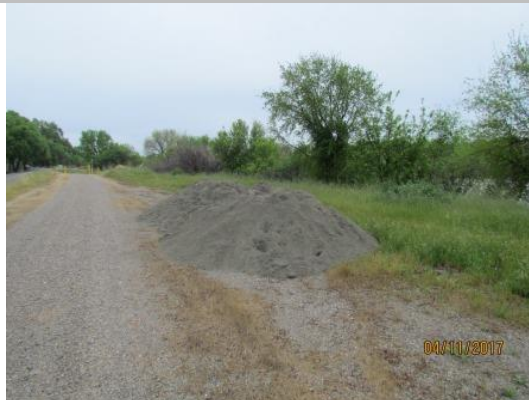
Photo 1 of 1 : FA_2017_RD1600_191_78_20170911_00074.jpg

LM Start	5.81	Rating **	M	Issue No.	78
LM End	5.81	Issue Type +	En	Location *	WS
Category	Earthen Levee			GPS Latitude/Longitude	
				Start	End
Item	Encroachments			38.748731 °	38.748731 °
				-121.597591 °	-121.597591 °
DWR ID	DWR_RD1600_01_s_2017_78				
Comment Code					
MA : Material					
Inspector Comment					
Sand pile on waterside levee shoulder.

View of sand pile on waterside levee shoulder. Spring 2017.

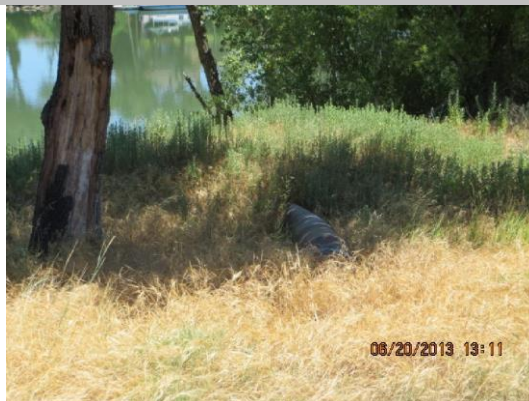
Photo 2 of 3 : UCIP_FA_2017_50101_25010.jpg

FS_ID:50101
 DS_ID:21476
 EP_NO: N/A
 Repair Type: Urgent
 Crossing Status: Found
 UCIP Comments: 08/15/2016 - no change since previous inspection (T. Hatch/UCIP)06/20/2013 - Pipe is abandoned and open on both ends. It should be abandoned properly. (W. Wylie/UCIP)
 FIELD_STRUCT_DESC: *ABANDONED* 18-inch steel irrigation pipe through the levee, 4.5 feet below the crown. Pump on pile structure on the waterside (WS), pump not found and only the piles remain. Walkway between levee crown and pile structure on the WS, not found. Overhead power line crosses the levee. Service pole on the WS slope. 6-foot by 6-foot concrete distribution box at the landside (LS) toe.
 [Additional Reference(s): DWR Levee Log, 1988. USACE Sacramento O&M Manual 123, August 1955, (RM 77.0)].
 FS Date: 8/15/2016

Pipe on WS slope.

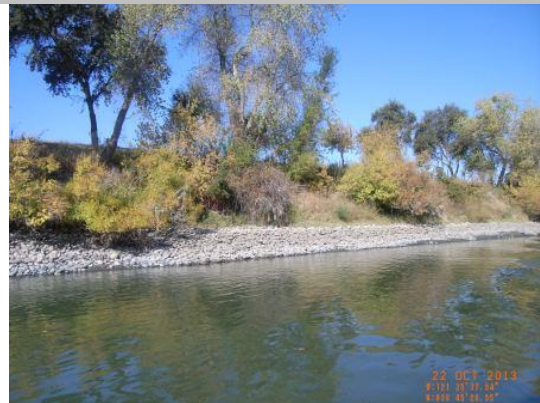
Photo 1 of 1 : FA_2017_RD1600_191_9_20170911_00012.jpg

LM Start	6.30	Rating **	A/W	Issue No.	9
LM End	6.36	Issue Type +	Ma	Location *	WS
Category	Supplemental			GPS Latitude/Longitude	
				Start	End
Item	2015 USACE Erosion Survey, DRAFT			38.755246 °	38.756186 °
				-121.594206 °	-121.594024 °
DWR ID	DWR_RD1600_01_s_2016_9				
Comment Code					
Inspector Comment					
2011 - Large vertical eroded face from a rotational failure just below pump. 2015: Does not meet criterial. [2015 Site ID: SAC_77-0_R]

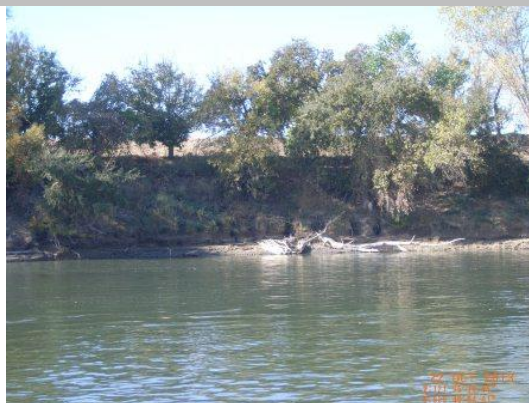
Photo 1 of 1 : FA_2017_RD1600_191_6_20170911_00009.jpg

LM Start	6.95	Rating **	M	Issue No.	6
LM End	6.98	Issue Type +	Ma	Location *	WS
Category	Supplemental			GPS Latitude/Longitude	
				Start	End
Item	2015 USACE Erosion Survey, DRAFT			38.764801 °	38.765219 °
				-121.594926 °	-121.595049 °
DWR ID	DWR_RD1600_01_s_2016_6				
Comment Code					
Inspector Comment					
2006 - Eddy scour off end of rock causing erosion and scour hole near levee. Sandy silt bank with rock on upstream end. 2010 - Trees are leaning more, minor new erosion. 2011 - Many of the tree roots have scoured out and trees look ready to fall. 2015: No observed changes. [2015 Site ID: SAC 77-7 R]

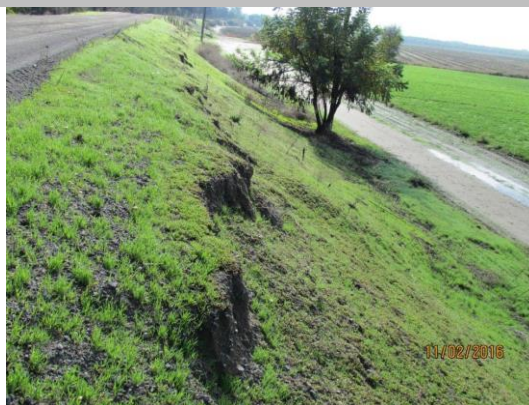
Photo 3 of 3 : FA_2017_RD1600_191_27_20170911_00027.jpg

LM Start	6.97	Rating **	A/W	Issue No.	27 (cont)	
LM End	6.97	Issue Type +	Ma	Location *	LS	
Category	Earthen Levee			GPS Latitude/Longitude		
				Start		End
Item	Erosion / Bank Caving			38.764974 °		38.764974 °
				-121.595533 °		-121.595533 °
DWR ID	DWR_RD1600_01_s_2012_27					
Comment Code						
E1 : Note and monitor erosion site.						
Inspector Comment						
The erosion appears to be fixed. Recommend monitoring due to previous activity.

Updated view of erosion site. Fall 2016.

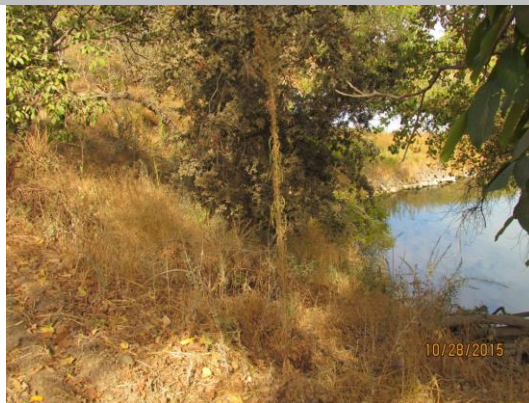
Photo 2 of 2 : FA_2017_RD1600_191_30_20170911_00034.jpg

LM Start	6.97	Rating **	A/W	Issue No.	30 (cont)	
LM End	6.97	Issue Type +	Ma	Location *	WS	
Category	Earthen Levee			GPS Latitude/Longitude		
				Start		End
Item	Erosion / Bank Caving			38.764980 °		38.764980 °
				-121.595513 °		-121.595513 °
DWR ID	DWR_RD1600_01_f_2017_30					
Comment Code						
E1 : Note and monitor erosion site.						
Inspector Comment

View of the erosion into the berm area that needs to be monitored. Fall 2015.

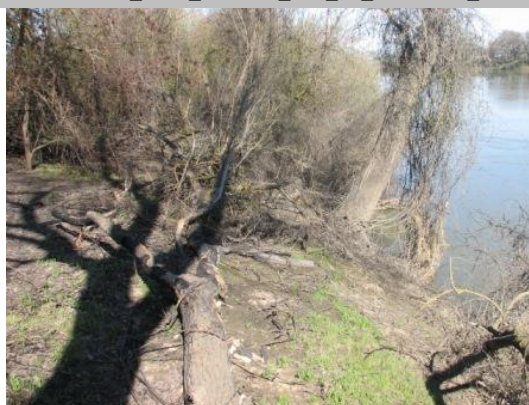
Photo 1 of 5 : FA_2017_RD1600_191_20_20170911_00014.jpg

LM Start	7.10	Rating **	A/W	Issue No.	20
LM End	7.10	Issue Type +	Ma	Location *	WS
Category	Earthen Levee			GPS Latitude/Longitude	
				Start	End
Item	Erosion / Bank Caving			38.766691 °	38.766691 °
				-121.596300 °	-121.596300 °
DWR ID	DWR_RD1600_01_s_2012_20				
Comment Code					
E1 : Note and monitor erosion site.					
Inspector Comment					
Erosion present at the berm, and it hasn't got into the levee prism yet.

This another view of the site.

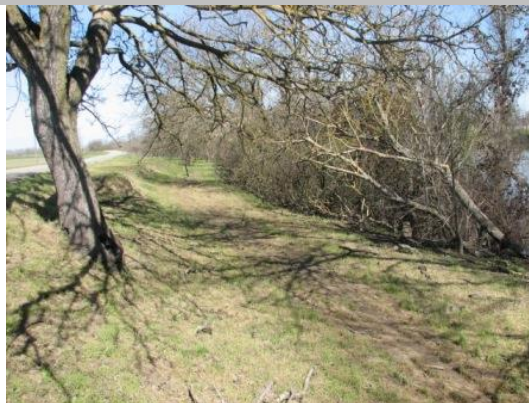
Photo 3 of 5 : FA_2017_RD1600_191_20_20170911_00016.jpg

LM Start	7.10	Rating **	A/W	Issue No.	20 (cont)	
LM End	7.10	Issue Type +	Ma	Location *	WS	
Category	Earthen Levee			GPS Latitude/Longitude		
				Start		End
Item	Erosion / Bank Caving			38.766691 °		38.766691 °
				-121.596300 °		-121.596300 °
DWR ID	DWR_RD1600_01_s_2012_20					
Comment Code						
E1 : Note and monitor erosion site.						
Inspector Comment						
Erosion present at the berm, and it hasn't got into the levee prism yet.

The erosion is eroding away at the berm area.

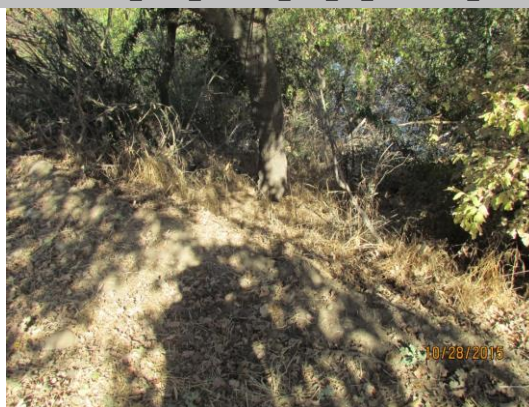
Photo 4 of 5 : FA_2017_RD1600_191_20_20170911_00017.jpg

Looking at the erosion site on the berm. Fall 2015.

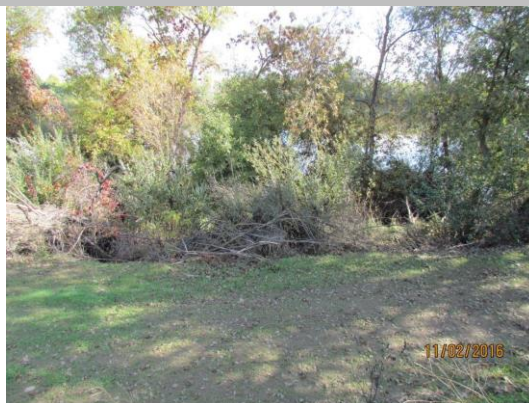
Photo 5 of 5 : FA_2017_RD1600_191_20_20170911_00018.jpg

Updated view of erosion site. Fall 2016.

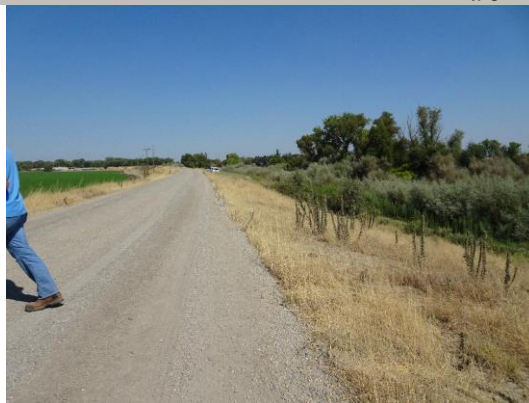
Photo 3 of 3 : UCIP_FA_2017_50169_75609.jpg

Comment Code						
Inspector Comment						
FS_ID:50169 DS_ID:25464 EP_NO: 18849 Repair Type: Non-Urgent Crossing Status: Found UCIP Comments: 08/15/2016 - Pipe appears in good condition overall. Standing water found in riser for siphon breaker. Pump was not in operation during field visit. (T. Hatch/UCIP) FIELD_STRUCT_DESC: 24-inch welded steel irrigation pipe through the levee, 2 feet below the crown. Positive closure device in a steel riser with a lid on the waterside (WS) hinge of the levee. Siphon breaker in a steel riser with lid on the landside (LS) hinge of the levee. Distribution box on the LS toe. (Installed under Permit No. 18849, 2014 - Bypass Farms). FS Date: 8/15/2016

view of levee crown looking upstream from pipe location.

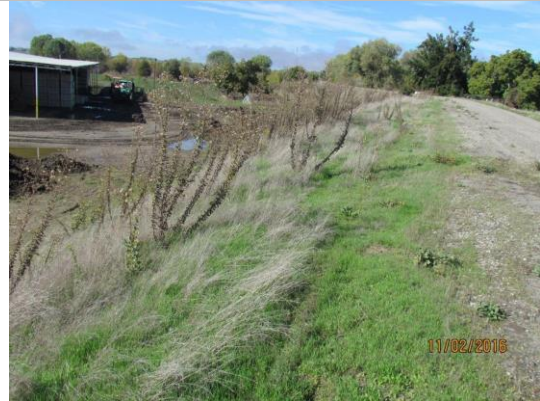
Photo 1 of 1 : FA_2017_RD1600_191_60_20170911_00058.jpg

LM Start	8.10	Rating **	M	Issue No.	60
LM End	8.26	Issue Type +	Ma	Location *	LS
Category	Earthen Levee			GPS Latitude/Longitude	
				Start	End
Item	Vegetation			38.778390 °	38.779128 °
				-121.606875 °	-121.609582 °
DWR ID	DWR_RD1600_01_f _ 2016_60				
Comment Code					
V2 : Remove the wild growth other than native grasses from the levee slopes.					
Inspector Comment

Vegetation on LS slope partially blocks visibility. Fall 2016.

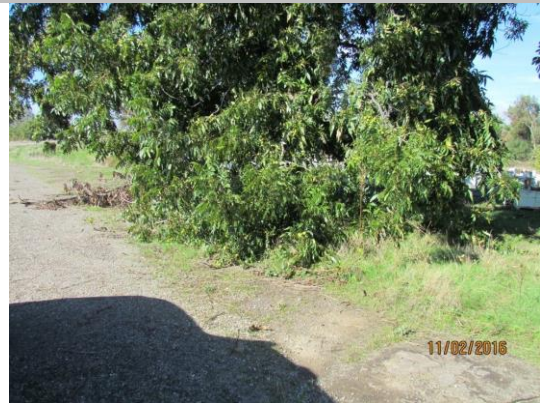
Photo 1 of 1 : FA_2017_RD1600_191_63_20170911_00060.jpg

LM Start	8.18	Rating **	M	Issue No.	63
LM End	8.18	Issue Type +	Ma	Location *	WS
Category	Earthen Levee			GPS Latitude/Longitude	
				Start	End
Item	Trim / Thin Trees			38.778922 °	38.778922 °
				-121.608075 °	-121.608075 °
DWR ID	DWR_RD1600_01_f_2015_63				
Comment Code					
T1 : Trim trees to at least five feet above ground level.					
Inspector Comment

Tree trimming on WS slope is needed. Fall 2016.

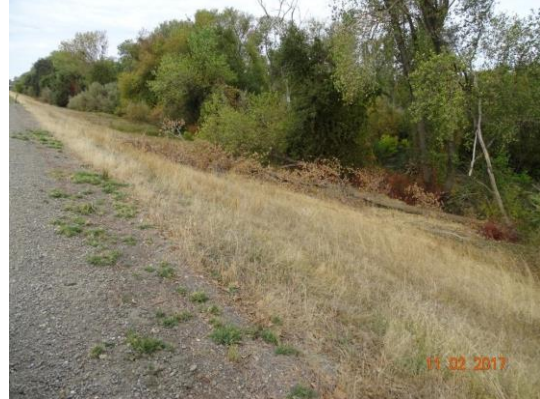
Photo 1 of 1 : FA_2017_RD1600_191_36_20171102_00117.jpg

LM Start	8.41	Rating **	M	Issue No.	36
LM End	8.41	Issue Type +	Ma	Location *	WS
Category	Earthen Levee			GPS Latitude/Longitude	
				Start	End
Item	Encroachments			38.779848 °	38.779848 °
				-121.612130 °	-121.612130 °
DWR ID	DWR_RD1600_01_f_2017_36				
Comment Code					
TR : Tree or limb					
Inspector Comment					
Fallen tree on landside slope.

View of fallen tree on waterside slope. Fall 2017.

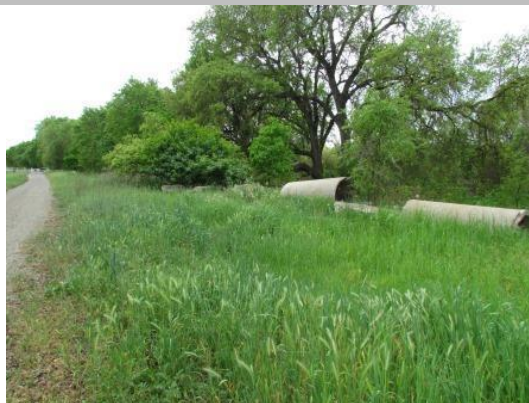
Photo 1 of 1 : FA_2017_RD1600_191_1202_20170911_00095.jpg

LM Start	10.38	Rating **	M	Issue No.	1202
LM End	10.45	Issue Type +	En	Location *	WS
Category	Earthen Levee			GPS Latitude/Longitude	
				Start	End
Item	Encroachments			38.766363 °	38.765402 °
				-121.634317 °	-121.635005 °
DWR ID	DWR_RD1600_01_s_2015_1202				
Comment Code					
DE : Debris					
Inspector Comment					
Concrete pipes and blocks on levee crown.

View of debris on the waterward side of the levee looking upstream.
Spring 2015.

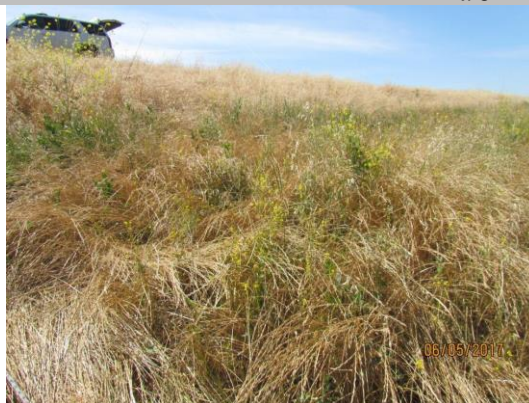
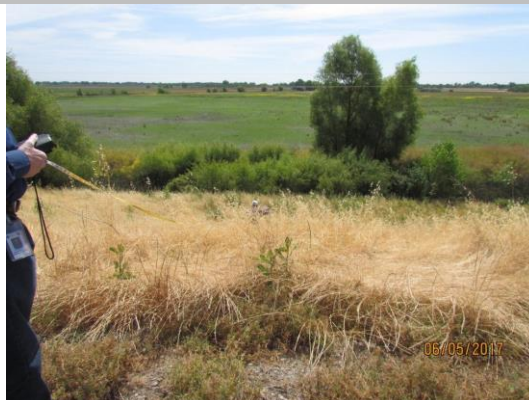
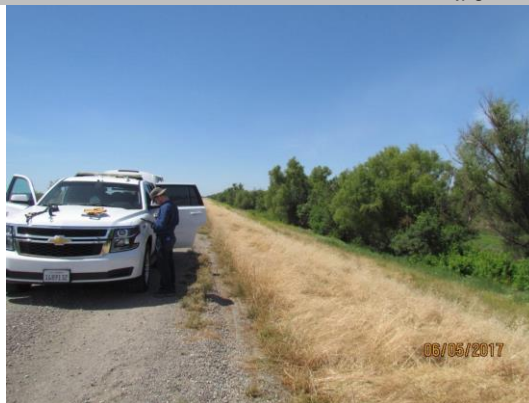
LM Start	0.20	Rating **	A/W	Issue No.	17 (cont)	
LM End	4.21	Issue Type +	Ma	Location *		
Category	Supplemental			GPS Latitude/Longitude		
				Start	End	
Item	2017 Storm Damage			38.733333 °	38.676750 °	
				-121.633611 °	-121.643250 °	
DWR ID	DWR_RD1600_02_f_2017_17					
Comment Code						
Inspector Comment						
Levee Evaluation Comments						
Description:						
Site ID No:202						
Site Designation:RD 1600-01						
Repair Type: Erosion						
Rating:Area of Concern						
Field Date:6/5/2017						
Notes: dense vegetation makes identification difficult

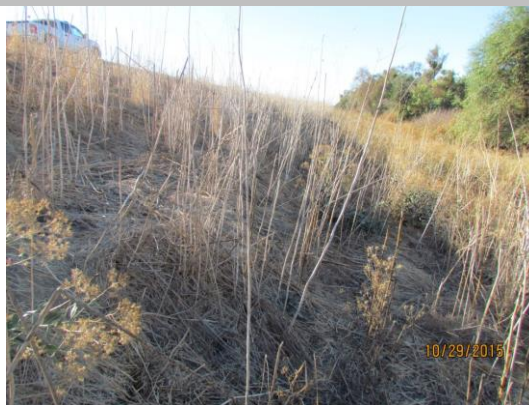
Photo 3 of 4 : FA_2017_RD1600_192_14_20170911_00014.jpg

View of the erosion on the waterward side of the levee looking downstream. Fall 2015.

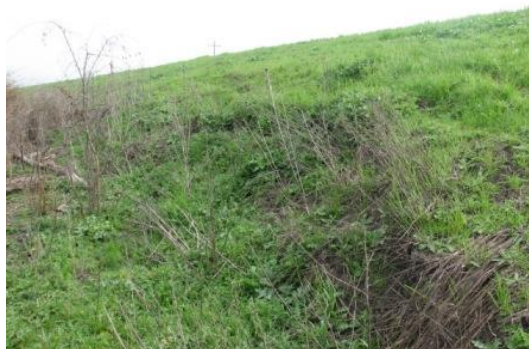
Photo 1 of 3 : FA_2017_RD1600_192_15_20170911_00016.jpg

LM Start	2.16	Rating **	M	Issue No.	15
LM End	2.27	Issue Type +	Ma	Location *	WS
Category	Earthen Levee			GPS Latitude/Longitude	
				Start	End
Item	Erosion / Bank Caving			38.705614 °	38.704052 °
				-121.639357 °	-121.640016 °
DWR ID	DWR_RD1600_02_s_2012_15				
Comment Code					
E1 : Note and monitor erosion site.					
Inspector Comment					
Previous erosion site. Recommend monitoring.

Looking upstream a deeper cut of 2'-3' damage.

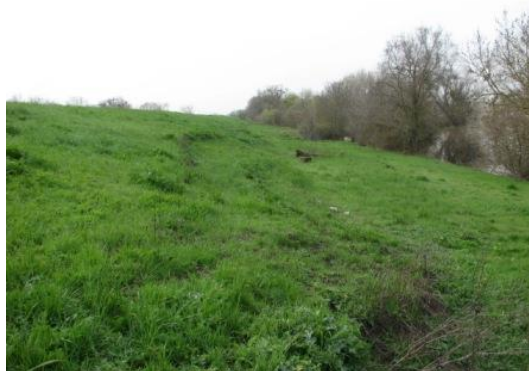
Photo 2 of 3 : FA_2017_RD1600_192_15_20170911_00017.jpg

This is wave wash damage along the toe of the levee looking downstream.

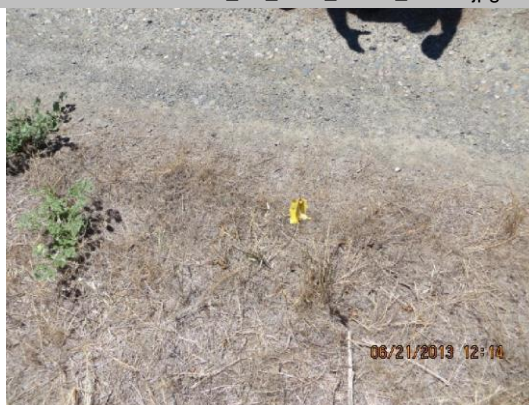
Photo 1 of 2 : UCIP_FA_2017_50099_27478.jpg

LM Start	3.71	Rating **	U	Issue No.	301
LM End	3.71	Issue Type +	En	Location *	
Category	Supplemental			GPS Latitude/Longitude	
				Start	End
Item	DWR UCIP Field Study			38.683971 °	38.683971 °
				-121.644522 °	-121.644522 °
DWR ID					
Comment Code					
Inspector Comment					
FS_ID:50099 DS_ID:21501 EP_NO: 10944 Repair Type: Urgent Crossing Status: Indicator Found UCIP Comments: 08/16/2016 - unable to locate pipe. Need to install gas line markers on LS and WS of levee crown to denote location. (T. Hatch/UCIP)06/21/2013 - Need to install gasoline markers on levee. (W. Wylie/UCIP) FIELD_STRUCT_DESC: 8.625-inch steel gas line through the levee, 2 feet below the crown. (Permit No. 10944, 1975 - Shell Oil Company). [Additional Reference(s): DWR Levee Log, 1988]. FS Date: 8/15/2016

PG&E marker flag on Crown.

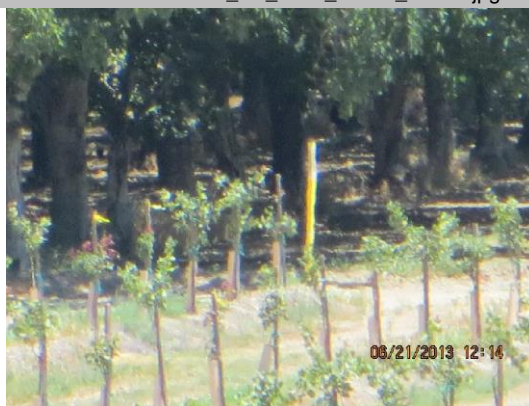
Photo 2 of 2 : UCIP_FA_2017_50099_27477.jpg

LM Start	3.71	Rating **	U	Issue No.	301 (cont)	
LM End	3.71	Issue Type +	En	Location *		
Category	Supplemental			GPS Latitude/Longitude		
				Start	End	
Item	DWR UCIP Field Study			38.683971 °	38.683971 °	
				-121.644522 °	-121.644522 °	
DWR ID						
Comment Code						
Inspector Comment						
FS_ID:50099 DS_ID:21501 EP_NO: 10944 Repair Type: Urgent Crossing Status: Indicator Found UCIP Comments: 08/16/2016 - unable to locate pipe. Need to install gas line markers on LS and WS of levee crown to denote location. (T. Hatch/UCIP)06/21/2013 - Need to install gasline markers on levee. (W. Wylie/UCIP) FIELD_STRUCT_DESC: 8.625-inch steel gas line through the levee, 2 feet below the crown. (Permit No. 10944, 1975 - Shell Oil Company). [Additional Reference(s): DWR Levee Log, 1988]. FS Date: 8/15/2016

Carsonite gasline marker visible approximately 1,000-feet east of levee crown.

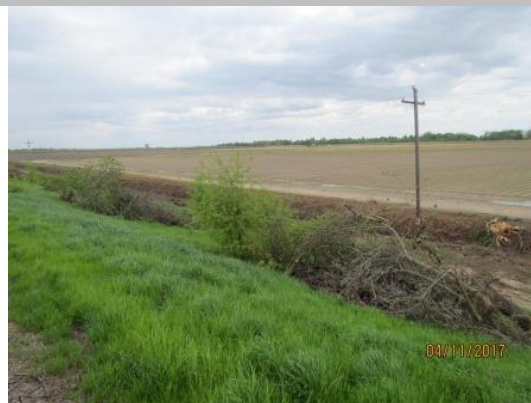
Photo 1 of 1 : FA_2017_RD1600_192_11_20170911_00010.jpg

LM Start	3.90	Rating **	M	Issue No.	11
LM End	3.90	Issue Type +	En	Location *	LS
Category	Earthen Levee			GPS Latitude/Longitude	
				Start	End
Item	Encroachments			38.681194 °	38.681194 °
				-121.644201 °	-121.644201 °
DWR ID	DWR_RD1600_02_s_2017_11				
Comment Code					
PR : Prunings					
Inspector Comment					
Prunings on landside levee slope.

Prunings on landside levee slope. Spring 2017.

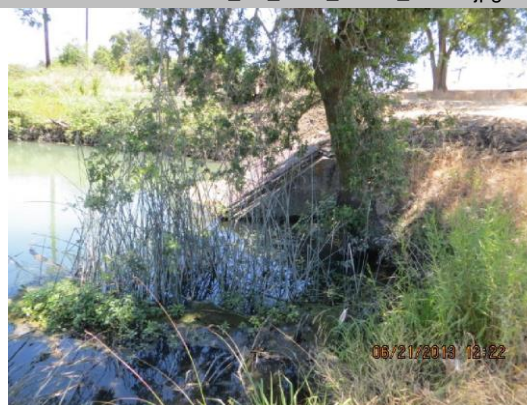
Photo 1 of 3 : UCIP_FA_2017_15303_25158.jpg

LM Start	4.17	Rating **	A/W	Issue No.	302
LM End	4.17	Issue Type +	Ma	Location *	
Category	Supplemental			GPS Latitude/Longitude	
				Start	End
Item	DWR UCIP LMA Responsibility			38.677286 °	38.677286 °
				-121.643683 °	-121.643683 °
DWR ID					
Comment Code					
Inspector Comment					
FS_ID:15303 DS_ID:21502 EP_NO: N/A Repair Type: No Action Needed Crossing Status: Found UCIP Comments: FIELD_STRUCT_DESC: 72-inch by 72-inch reinforced concrete box drainage culvert through the levee, 26 feet below the crown. Slide gate on the waterside (WS) slope in a 9-foot by 10-foot concrete box. Culvert passes under the bypass canal, the railroad, and County Road 22 and terminates in the canal on the southwest side of the County Road 22 bridge. [Additional Reference(s): DWR Levee Log, 1988. USACE Sacramento O&M Manual 123, August 1955, (Station 155+00)]. FS Date: 6/21/2013

Concrete intake structure on LS.

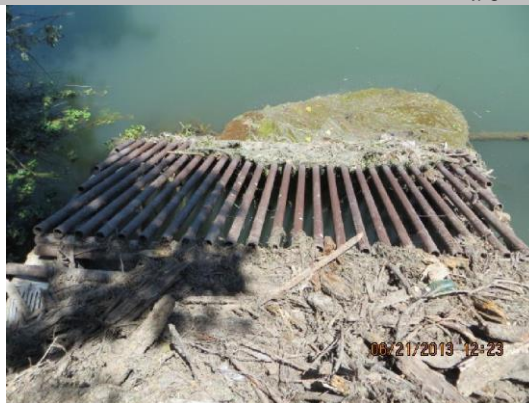
Photo 2 of 3 : UCIP_FA_2017_15303_25157.jpg

LM Start	4.17	Rating **	A/W	Issue No.	302 (cont)	
LM End	4.17	Issue Type +	Ma	Location *		
Category	Supplemental			GPS Latitude/Longitude		
				Start		End
Item	DWR UCIP LMA Responsibility			38.677286 °		38.677286 °
				-121.643683 °		-121.643683 °
DWR ID						
Comment Code						
Inspector Comment						
FS_ID:15303 DS_ID:21502 EP_NO: N/A Repair Type: No Action Needed Crossing Status: Found UCIP Comments: FIELD_STRUCT_DESC: 72-inch by 72-inch reinforced concrete box drainage culvert through the levee, 26 feet below the crown. Slide gate on the waterside (WS) slope in a 9-foot by 10-foot concrete box. Culvert passes under the bypass canal, the railroad, and County Road 22 and terminates in the canal on the southwest side of the County Road 22 bridge. [Additional Reference(s): DWR Levee Log, 1988. USACE Sacramento O&M Manual 123, August 1955, (Station 155+00)]. FS Date: 6/21/2013

Concrete intake structure on LS.

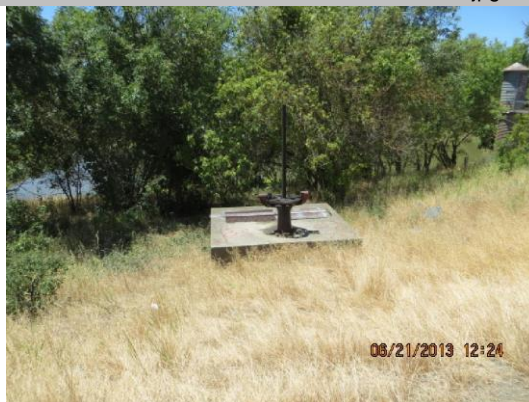
Photo 3 of 3 : UCIP_FA_2017_15303_25156.jpg

Slide gate in 9'x10' concrete box on WS slope.

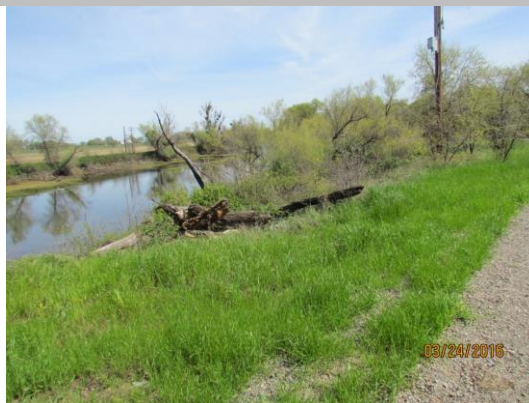
Photo 1 of 2 : FA_2017_RD1600_192_6_20170911_00005.jpg

LM Start	4.19	Rating **	M	Issue No.	6
LM End	4.19	Issue Type +	Ma	Location *	LS
Category	Earthen Levee			GPS Latitude/Longitude	
				Start	End
Item	Encroachments			38.677121 °	38.677121 °
				-121.643466 °	-121.643466 °
DWR ID	DWR_RD1600_02_s_2016_6				
Comment Code					
TR : Tree or limb					
Inspector Comment

View of the trees on the landward side of the levee looking downstream. Spring 2016.
