**Flood Control Project Maintenance
Levee Inspections**

Fall 2018 Levee Maintenance Deficiency Summary Report

Sacramento River Basin

Reclamation District No. 1600 Mull

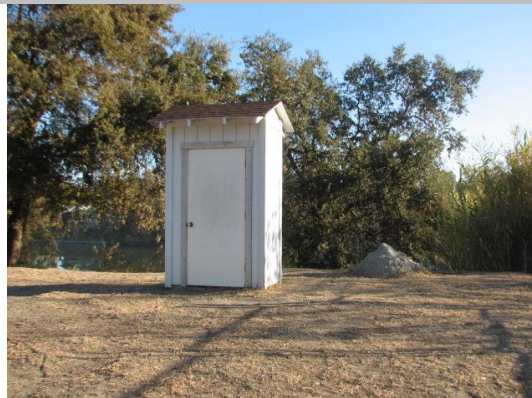
Photo 1 of 2 : FA_2018_RD1600_191_129_20180904_00044.jpg

LM Start	0.10	Rating **	M	Issue No.	129
LM End	0.10	Issue Type +	En	Location *	WS
Category	Earthen Levee			GPS Latitude/Longitude	
				Start	End
Item	Encroachments			38.676467 °	38.676467 °
				-121.631217 °	-121.631217 °
DWR ID	DWR_RD1600_01_f_2013_129				
Comment Code					
BU : Building					
Inspector Comment					
Well pump house.

The small building is a pump house for the well. It services the house with water. Fall 2013

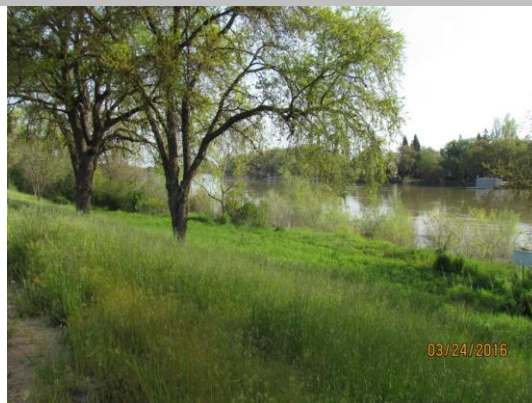
Photo 1 of 2 : FA_2018_RD1600_191_22_20180904_00014.jpg

LM Start	1.01	Rating **	A/W	Issue No.	22
LM End	1.10	Issue Type +	Ma	Location *	WS
Category	Earthen Levee			GPS Latitude/Longitude	
				Start	End
Item	Vegetation			38.689092 °	38.690368 °
				-121.635616 °	-121.635669 °
DWR ID	DWR_RD1600_01_f_2017_22				
Comment Code					
V8 : Environmental Requirements.					
Inspector Comment

View of the revegetation site at the berm edge on the waterward side of the levee looking upstream. Spring 2016.

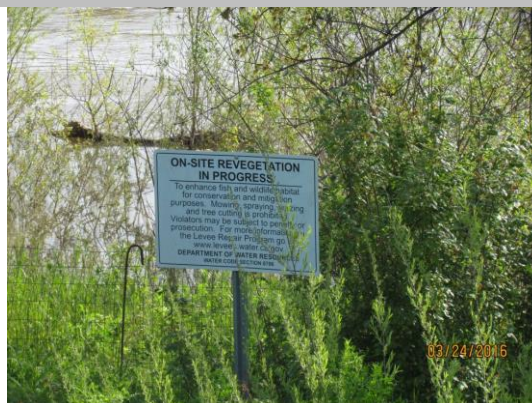
Photo 2 of 2 : FA_2018_RD1600_191_22_20180904_00015.jpg

Sign stating revegetation site. Spring 2016.

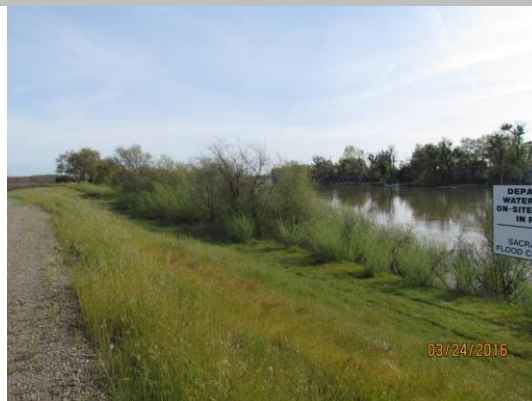
Photo 1 of 2 : FA_2018_RD1600_191_5_20180904_00004.jpg

LM Start	1.40	Rating **	A/W	Issue No.	5
LM End	1.40	Issue Type +	Ob	Location *	WS
Category	Earthen Levee			GPS Latitude/Longitude	
				Start	End
Item	Vegetation			38.694469 °	38.694469 °
				-121.634312 °	-121.634312 °
DWR ID	DWR_RD1600_01_f_2012_5				
Comment Code					
V8 : Environmental Requirements.					
Inspector Comment

View of the revegetation site on the berm of the waterward side of the levee looking upstream. Spring 2016.

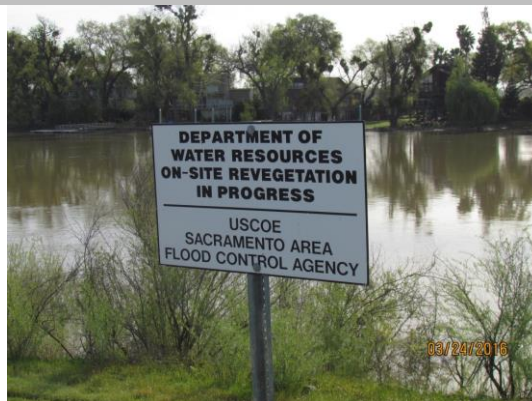
Photo 2 of 2 : FA_2018_RD1600_191_5_20180904_00005.jpg

DWR revegetation site. Spring 2016.

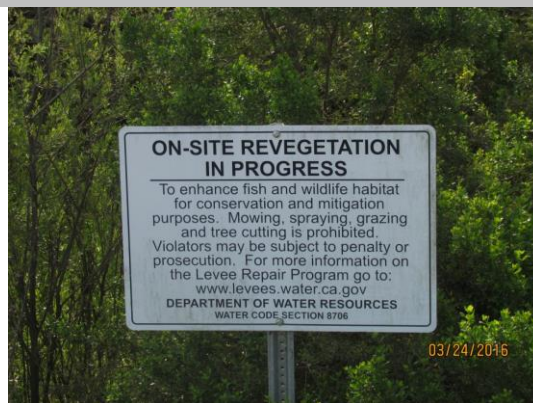
Photo 1 of 2 : FA_2018_RD1600_191_35_20180904_00023.jpg

LM Start	2.35	Rating **	A/W	Issue No.	35
LM End	2.40	Issue Type +	Ob	Location *	WS
Category	Earthen Levee			GPS Latitude/Longitude	
				Start	End
Item	Vegetation			38.704624 °	38.705152 °
				-121.623034 °	-121.622187 °
DWR ID	DWR_RD1600_01_s_2012_35				
Comment Code					
V8 : Environmental Requirements.					
Inspector Comment

Sign for revegetation site. Spring 2016.

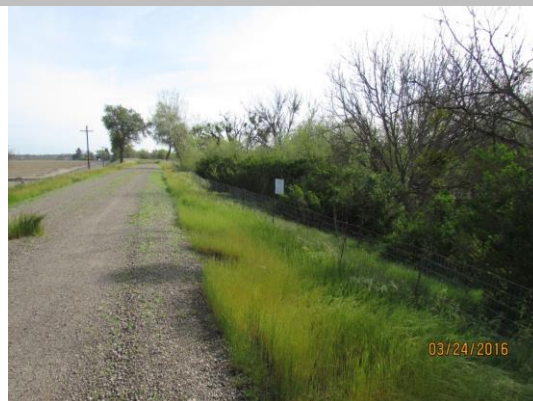
Photo 2 of 2 : FA_2018_RD1600_191_35_20180904_00024.jpg

View of the revegetation site on the waterward side of the levee looking upstream. Spring 2016.

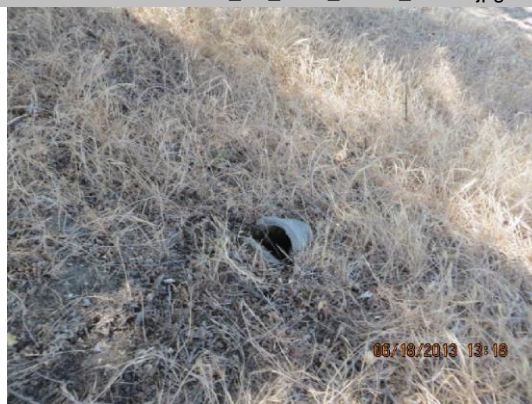
Photo 1 of 2 : UCIP_FA_2018_15110_24828.jpg

LM Start	2.93	Rating **	M	Issue No.	1206	
LM End	2.93	Issue Type +	En	Location *		
Category	Supplemental			GPS Latitude/Longitude		
				Start	End	
Item	DWR UCIP Field Study			38.710497°	38.710497°	
				-121.615381°	-121.615381°	
DWR ID	21490					
Comment Code						
Inspector Comment						
FS_ID:15110 DS_ID:21490 EP_NO: N/A Repair Type: Non-Urgent Crossing Status: Indicator Found UCIP Comments: Abandoned and should be removed from levee. FIELD_STRUCT_DESC: *ABANDONED* 10-inch reinforced concrete pipe of an unknown purpose through the levee, 5 feet below the crown. Pipe visible on the landside (LS) slope. [Additional Reference(s): USACE Sacramento O&M Manual 123, August 1955, (RM 73.5)]. FS Date: 6/18/2013

Pipe visible on LS slope.

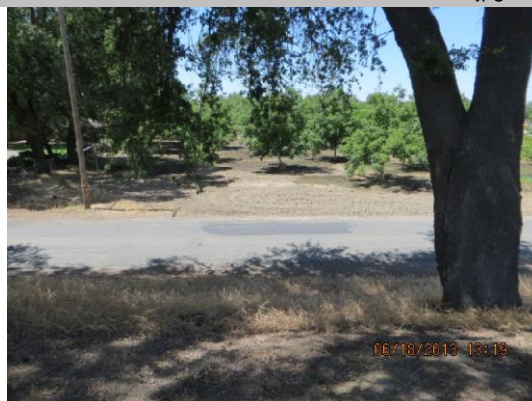
Photo 2 of 2 : UCIP_FA_2018_15110_24827.jpg

Pipe visible on LS slope.

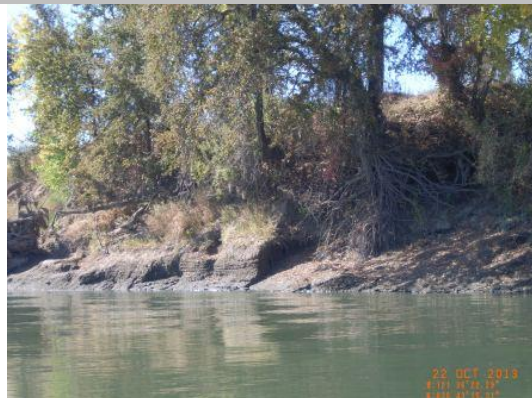
Photo 1 of 1 : FA_2018_RD1600_191_16_20181114_00002.jpg

Comment Code					
Inspector Comment					
2017 Site ID: SAC 74.4 R Status: Eroding 2017 Field Notes: Significant erosion at toe in the past year. Fresh tree popout. Site History: 1997 - Steep high bank. 2005 - Some small pockets in the low toe near the waterline. 2006 - Minor slope clearing. 2010 - Minor new erosion. 2011 - Multiple trees have fallen since last year. Some other trees look ready to fall. Significant new erosion since last year. 2012 - Minor new erosion. 2013 - Minor new erosion. 2015 - Minor new toe erosion. DWR Inspector Comment: Erosion within waterside bench and possibly sections of the waterside toe prism.

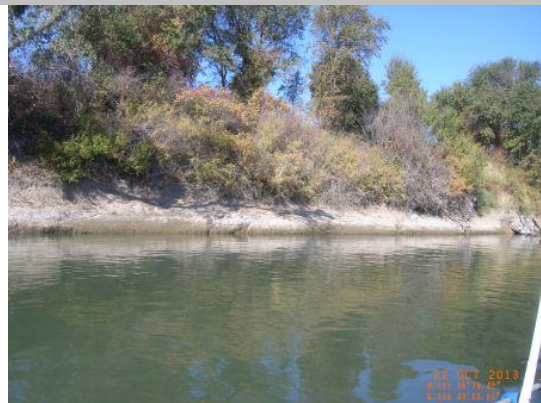
Photo 1 of 1 : FA_2018_RD1600_191_17_20181114_00008.jpg

LM Start	4.34	Rating **	M	Issue No.	17
LM End	4.86	Issue Type +	Ma	Location *	WS
Category	Supplemental			GPS Latitude/Longitude	
				Start	End
Item	2017 USACE Erosion Survey, DRAFT			38.728684 °	38.736110 °
				-121.605844 °	-121.604153 °
DWR ID	DWR_RD1600_01_f _ 2018_17				
Comment Code					
Inspector Comment					
2017 Site ID: SAC 75.3 R					
Status: Eroding					
2017 Field Notes: Fresh erosion along lower bank in sections.					
Site History: 1997 - Very steep bank. 2005 - Lots of small trees down along the bank at the upstream end. 2006 - Minor new erosion, but slow. 2010 - Almost all of the roots are exposed on the trees, appears ready to fall. 2011 - New erosion and tree popouts. 2012 - Site has become overgrown with vegetation, making it hard to observe. 2015 - Dense vegetation made the site difficult to observe.

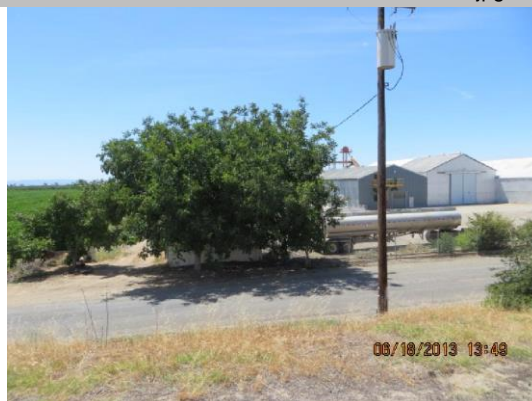
Photo 1 of 3 : UCIP_FA_2018_15125_24846.jpg

Comment Code						
Inspector Comment						
FS_ID:15125 DS_ID:21470 EP_NO: N/A Repair Type: Non-Urgent Crossing Status: Found UCIP Comments: Pumphouse abandoned with deep pit open. Safety issue. If plant is abandoned it should be done so properly. FIELD_STRUCT_DESC: 24-inch steel irrigation pipe through the levee, 21.4 feet below the crown. 16-inch pipe ties into 24-inch pipe at the waterside (WS) slope. Slant pump on metal platform and gate valve on the WS berm. Gate valve in pump house off the landside (LS). Two power poles at the LS toe. [Additional Reference(s): DWR Levee Log, 1988. USACE Sacramento O&M Manual 123, August 1955, (RM 75.2) (20-inch pipe listed)]. FS Date: 6/18/2013 7:36:00 AM

Pumphouse/distribution box off LS toe.

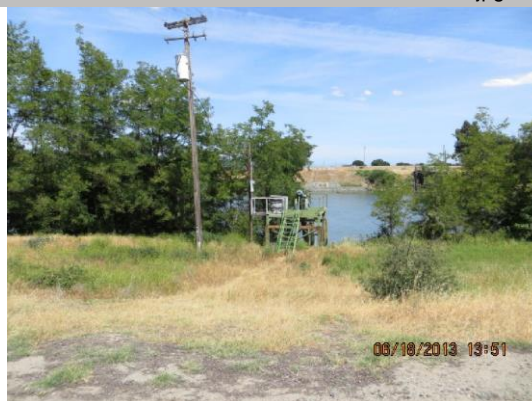
Photo 2 of 3 : UCIP_FA_2018_15125_24845.jpg

Slant pump on metal pier on WS berm.

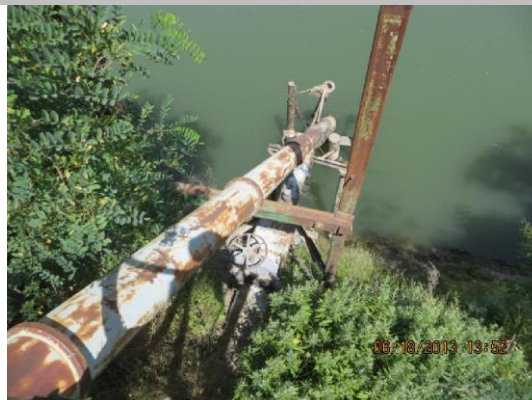
Photo 3 of 3 : UCIP_FA_2018_15125_24844.jpg

16-inch pipe ties into 24-inch pipe under pump platform at slide gate.

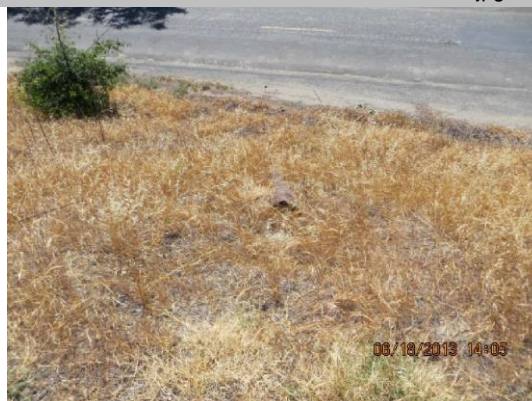
Photo 1 of 2 : UCIP_FA_2018_41563_27474.jpg

Pipe and remnants of grouted pipe on LS slope.

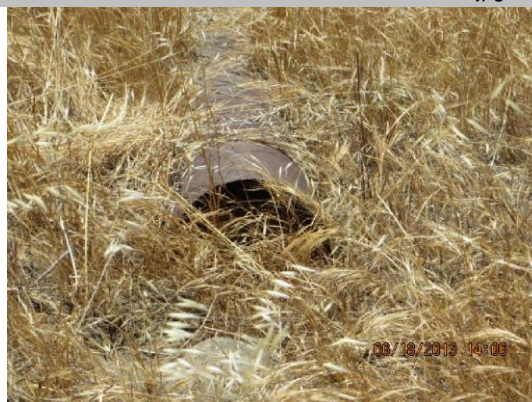
Photo 2 of 2 : UCIP_FA_2018_41563_27473.jpg

Pipe and remnants of grouted pipe on LS slope.

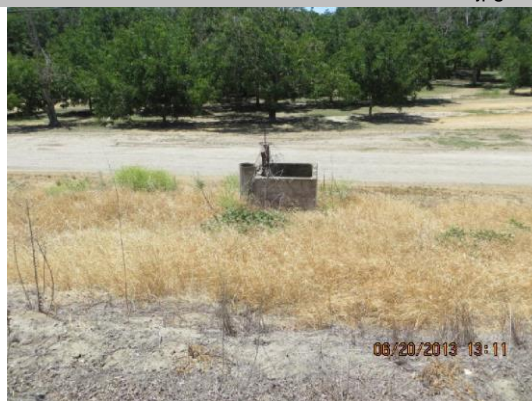
Photo 1 of 3 : UCIP_FA_2018_53410_25011.jpg

6'X6' concrete distribution box on LS toe.

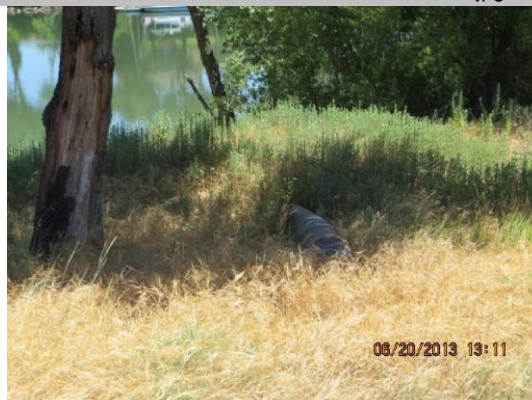
Photo 2 of 3 : UCIP_FA_2018_53410_25010.jpg

Pipe on WS slope.

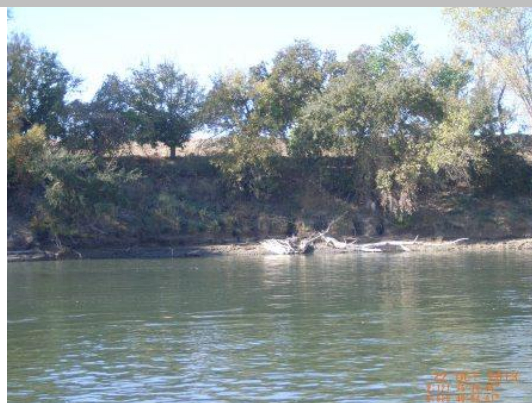
Photo 1 of 1 : FA_2018_RD1600_191_23_20181114_00009.jpg

LM Start	6.95	Rating **	M	Issue No.	23
LM End	6.98	Issue Type +	Ma	Location *	WS
Category	Supplemental			GPS Latitude/Longitude	
				Start	End
Item	2017 USACE Erosion Survey, DRAFT			38.764801 °	38.765219 °
				-121.594926 °	-121.595049 °
DWR ID	DWR_RD1600_01_f _ 2018_23				
Comment Code					
Inspector Comment					
2017 Site ID: SAC 77.7 R					
Status: Eroding					
2017 Field Notes: Minor new erosion.					
Site History: 2006 - Eddy scour off end of rock causing erosion and scour hole near levee. Sandy silt bank with rock on upstream end.					
2010 - Trees are leaning more, minor new erosion. 2011 - Many of the tree roots have scoured out and trees look ready to fall.					
DWR Inspector Comment: Continued erosion within the waterside berm.

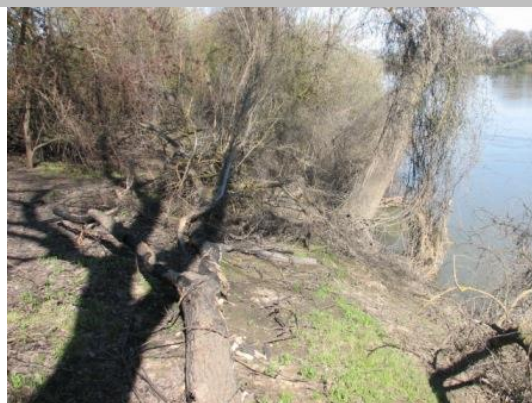
Photo 1 of 2 : FA_2018_RD1600_191_20_20180904_00006.jpg

LM Start	7.10	Rating **	A/W	Issue No.	20
LM End	7.10	Issue Type +	Ma	Location *	WS
Category	Earthen Levee			GPS Latitude/Longitude	
				Start	End
Item	Erosion / Bank Caving			38.766691 °	38.766691 °
				-121.596300 °	-121.596300 °
DWR ID	DWR_RD1600_01_s _ 2012_20				
Comment Code					
E1 : Note and monitor erosion site.					
Inspector Comment					
Continued erosion within the waterside berm. Not within the prism.

This another view of the site.

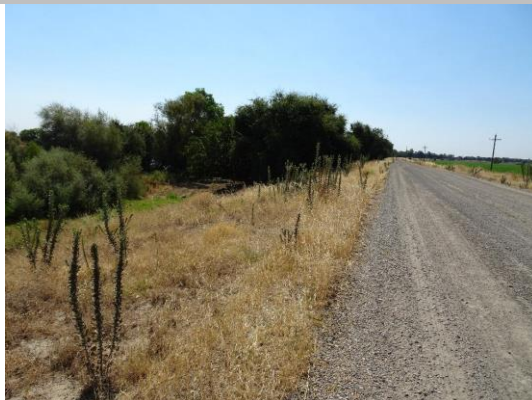
Photo 1 of 3 : UCIP_FA_2018_50169_75607.jpg

view along the levee crown looking downstream. WS slope of the levee is visible.

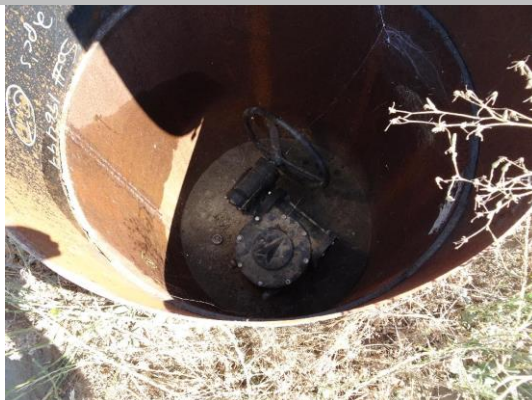
Photo 2 of 3 : UCIP_FA_2018_50169_75608.jpg

view of positive closure device in metal riser on WS shoulder of levee.

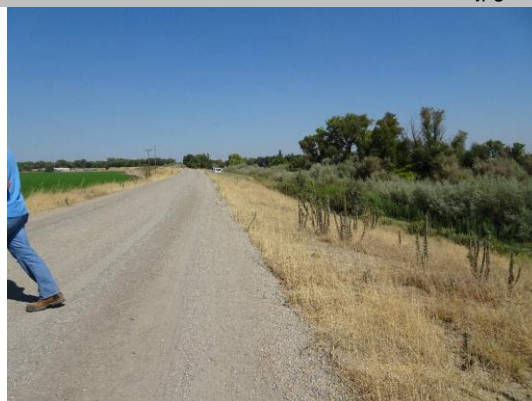
Photo 3 of 3 : UCIP_FA_2018_50169_75609.jpg

Comment Code						
Inspector Comment						
FS_ID:50169 DS_ID:25464 EP_NO: 18849 Repair Type: Non-Urgent Crossing Status: Found UCIP Comments: 08/15/2016 - Pipe appears in good condition overall. Standing water found in riser for siphon breaker. Pump was not in operation during field visit. (T. Hatch/UCIP) FIELD_STRUCT_DESC: 24-inch welded steel irrigation pipe through the levee, 2 feet below the crown. Positive closure device in a steel riser with a lid on the waterside (WS) hinge of the levee. Siphon breaker in a steel riser with lid on the landside (LS) hinge of the levee. Distribution box on the LS toe. (Installed under Permit No. 18849, 2014 - Bypass Farms). FS Date: 8/15/2016

view of levee crown looking upstream from pipe location.

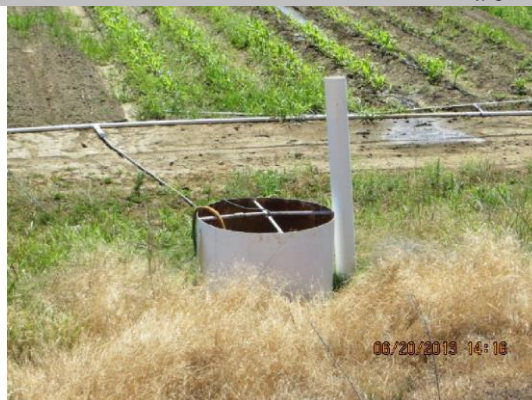
Photo 1 of 1 : UCIP_FA_2018_16310_27485.jpg

LM Start	8.03	Rating **	M	Issue No.	1211
LM End	8.03	Issue Type +	En	Location *	
Category	Supplemental			GPS Latitude/Longitude	
				Start	End
Item	DWR UCIP Field Study			38.777799 °	38.777799 °
				-121.605763 °	-121.605763 °
DWR ID	21480				
Comment Code					
Inspector Comment					
FS_ID:16310 DS_ID:21480 EP_NO: 7339 Repair Type: Non-Urgent Crossing Status: Indicator Found UCIP Comments: Need to determine disposition of pipe. If abandoned, it should be done so properly. FIELD_STRUCT_DESC: 24-inch steel irrigation pipe through the levee, 3.8 feet below the crown. Steel plate welded on the waterside (WS) end. Pipe not visible on either slope. Pylons in river at the WS toe, and a 4-foot-diameter steel standpipe on the landside (LS) toe. Seepage area at the landside (LS) toe. (Permit No. 7339, 1971 - Layton Knaggs). [Additional Reference(s): DWR Levee Log, 1988]. FS Date: 6/20/2013

4-foot diameter steel standpipe at LS toe, may be indicator of pipe location.

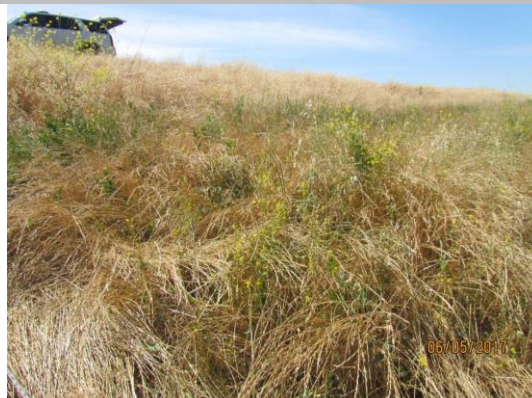
Photo 1 of 3 : LEVAL_FA_2018_202_1210.jpg

LM Start	0.20	Rating **	A/W	Issue No.	17
LM End	4.21	Issue Type +	Ma	Location *	
Category	Supplemental			GPS Latitude/Longitude	
				Start	End
Item	2017 Storm Damage			38.733333 °	38.676750 °
				-121.633611 °	-121.643250 °
DWR ID	DWR_RD1600_02_f_2017_17

Repair Type: Erosion

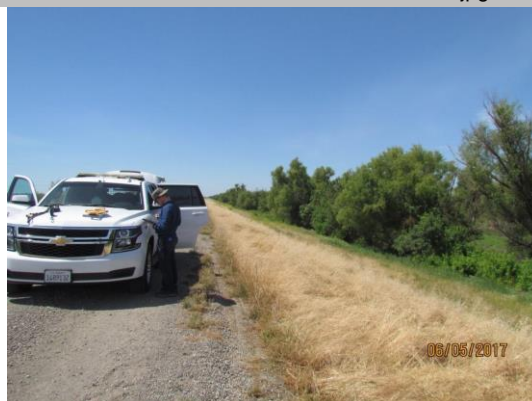
Photo 3 of 3 : LEVAL_FA_2018_202_371.jpg

LM Start	0.20	Rating **	A/W	Issue No.	17 (cont)	
LM End	4.21	Issue Type +	Ma	Location *		
Category	Supplemental			GPS Latitude/Longitude		
				Start		End
Item	2017 Storm Damage			38.733333	°	38.676750
				-121.633611	°	-121.643250
DWR ID	DWR_RD1600_02_f_2017_17					
Comment Code						
Inspector Comment						
Levee Evaluation Comments						
Description:						
Site ID No:202						
Site Designation:RD 1600-01						
Repair Type: Erosion						
Rating:Area of Concern						
Field Date:6/5/2017						
Notes: Long stretchs of wavewash on the waterside slope.

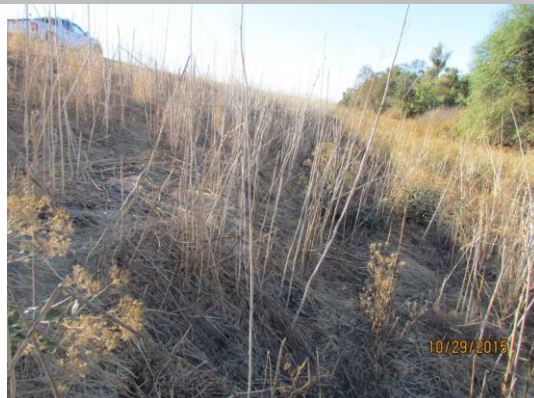
Photo 3 of 4 : FA_2018_RD1600_192_14_20180904_00007.jpg

LM Start	1.79	Rating **	A/W	Issue No.	14 (cont)	
LM End	2.05	Issue Type +	Ma	Location *	WS	
Category	Earthen Levee			GPS Latitude/Longitude		
				Start		End
Item	Erosion / Bank Caving			38.710763 °	38.707116 °	
				-121.637147 °	-121.638722 °	
DWR ID	DWR_RD1600_02_s_2012_14					
Comment Code						
E1 : Note and monitor erosion site.						
Inspector Comment

View of the erosion on the waterward side of the levee looking downstream. Fall 2015.

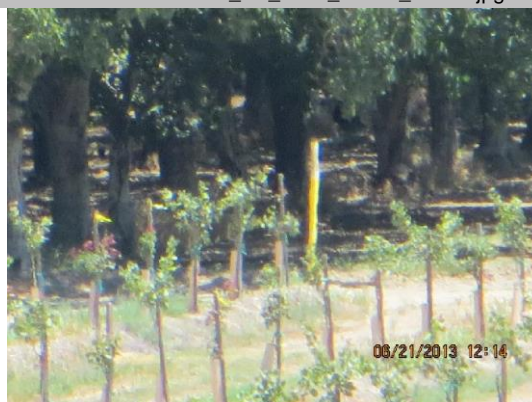
Photo 2 of 3 : UCIP_FA_2018_52738_27477.jpg

Carsonite gasline marker visible approximately 1,000-feet east of levee crown.

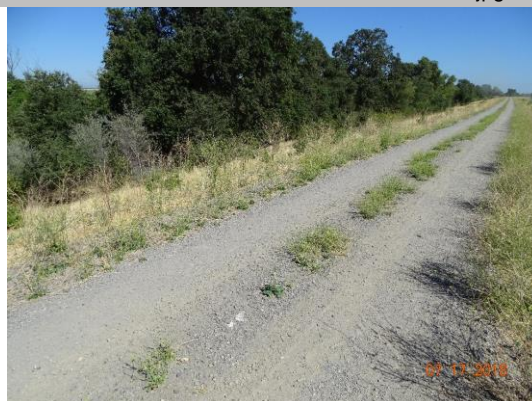
Photo 3 of 3 : UCIP_FA_2018_52738_77709.jpg

Comment Code						
Inspector Comment						
FS_ID:52738 DS_ID:21501 EP_NO: 10944 Repair Type: Non-Urgent Crossing Status: Indicator Found UCIP Comments: 07/17/2018 Gas line markers are not installed. Unable to determine exact location of pipe. Crossing has been downgraded to "Non-Urgent" due to reclassification of gas lines. (O.Yakimov-DWR UCIP)08/16/2016 - unable to locate pipe. Need to install gas line markers on LS and WS of levee crown to denote location. (T. Hatch/UCIP)06/21/2013 - Need to install gasline markers on levee. (W. Wylie/UCIP) FIELD_STRUCT_DESC: 8.625-inch steel gas line through the levee, 2 feet below the crown. (Permit No. 10944, 1975 - Shell Oil Company). [Additional Reference(s): DWR Levee Log, 1988]. FS Date: 7/17/2018 3:18:28 PM

View of levee crown at potential crossing looking upstream.

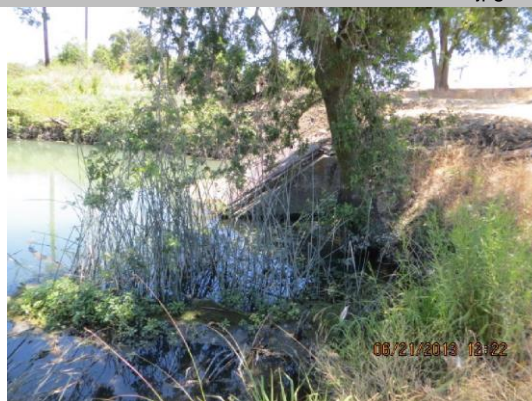
Photo 1 of 3 : UCIP_FA_2018_15303_25158.jpg

Concrete intake structure on LS.

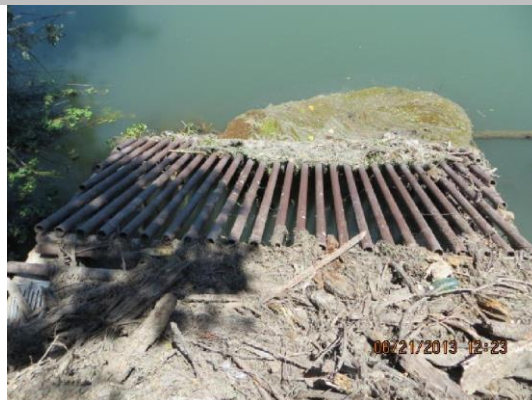
Photo 2 of 3 : UCIP_FA_2018_15303_25157.jpg

Concrete intake structure on LS.

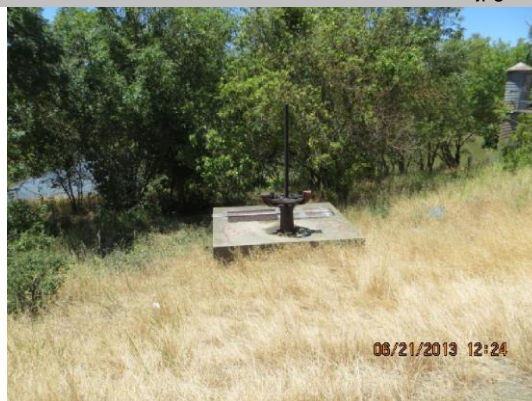
Photo 3 of 3 : UCIP_FA_2018_15303_25156.jpg

LM Start	4.17	Rating **	A/W	Issue No.	34 (cont)	
LM End	4.17	Issue Type +	Ma	Location *		
Category	Supplemental			GPS Latitude/Longitude		
				Start		End
Item	DWR UCIP LMA Responsibility			38.677286 °		38.677286 °
				-121.643683 °		-121.643683 °
DWR ID	21502					
Comment Code						
Inspector Comment						
FS_ID:15303 DS_ID:21502 EP_NO: N/A Repair Type: No Action Needed Crossing Status: Found UCIP Comments: FIELD_STRUCT_DESC: 72-inch by 72-inch reinforced concrete box drainage culvert through the levee, 26 feet below the crown. Slide gate on the waterside (WS) slope in a 9-foot by 10-foot concrete box. Culvert passes under the bypass canal, the railroad, and County Road 22 and terminates in the canal on the southwest side of the County Road 22 bridge. [Additional Reference(s): DWR Levee Log, 1988. USACE Sacramento O&M Manual 123, August 1955, (Station 155+00)]. FS Date: 6/21/2013

Slide gate in 9'X10' concrete box on WS slope.
