Flood Control Project Maintenance Levee Inspections

Fall 2020 Levee Maintenance Deficiency Summary Report

Sacramento River Basin

Reclamation District No. 1600 Mull

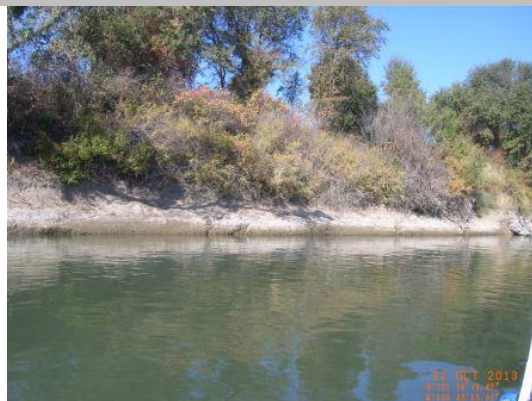
Photo 1 of 1 : FA_2020_RD1600_191_17_20200813_00005.jpg

Comment Code					
Inspector Comment					
2017 Site ID: SAC 75.3 R					
Status: Eroding					
2017 Field Notes: Fresh erosion along lower bank in sections.					
Site History: 1997 - Very steep bank. 2005 - Lots of small trees down along the bank at the upstream end. 2006 - Minor new erosion, but slow. 2010 - Almost all of the roots are exposed on the trees, appears ready to fall. 2011 - New erosion and tree popouts. 2012 - Site has become overgrown with vegetation, making it hard to observe. 2015 - Dense vegetation made the site difficult to observe.					
DWR Inspector Comment:					
Worst spot near LM 4.66. Recommend monitoring.

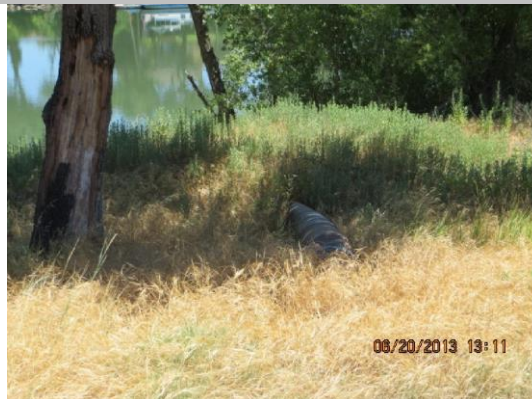
Photo 2 of 3 : UCIP_FA_2020_53410_25010.jpg

Pipe on WS slope.

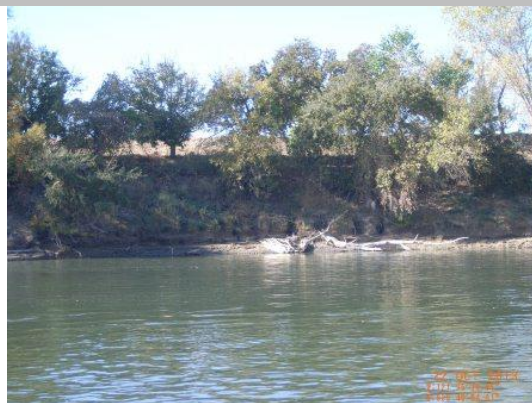
Photo 1 of 1 : FA_2020_RD1600_191_23_20200813_00011.jpg

LM Start	6.95	Rating **	M	Issue No.	23
LM End	6.98	Issue Type +	Ma	Location *	WS
Category	Supplemental			GPS Latitude/Longitude	
				Start	End
Item	2017 USACE Erosion Survey			38.764801 °	38.765219 °
				-121.594926 °	-121.595049 °
DWR ID	DWR_RD1600_01_f_2018_23				
Comment Code					
Inspector Comment					
2017 Site ID: SAC 77.7 R					
Status: Eroding					
2017 Field Notes: Minor new erosion.					
Site History: 2006 - Eddy scour off end of rock causing erosion and scour hole near levee. Sandy silt bank with rock on upstream end.					
2010 - Trees are leaning more, minor new erosion. 2011 - Many of the tree roots have scoured out and trees look ready to fall.

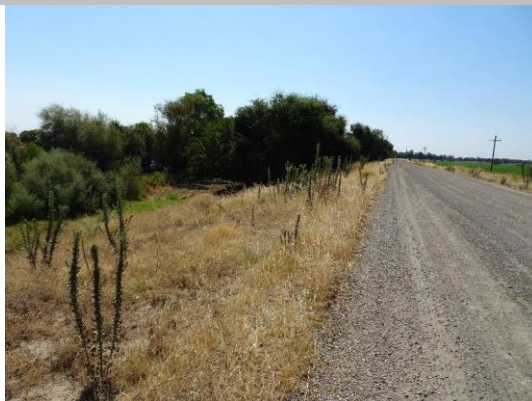
Photo 1 of 3 : UCIP_FA_2020_50169_75607.jpg

Comment Code					
Inspector Comment					
DS_ID:25464 FS_ID:50169 EP_NO: 18849 Repair Type: Non-Urgent EVAL Issue: Crossing Status: Found UCIP Comments: 08/15/2016 - Pipe appears in good condition overall. Standing water found in riser for siphon breaker. Pump was not in operation during field visit. (T. Hatch/UCIP) FIELD_STRUCT_DESC: 24-inch welded steel irrigation pipe through the levee, 2 feet below the crown. Positive closure device in a steel riser with a lid on the waterside (WS) hinge of the levee. Siphon breaker in a steel riser with lid on the landside (LS) hinge of the levee. Distribution box on the LS toe. (Installed under Permit No. 18849, 2014 - Bypass Farms). FS Date: 8/15/2016

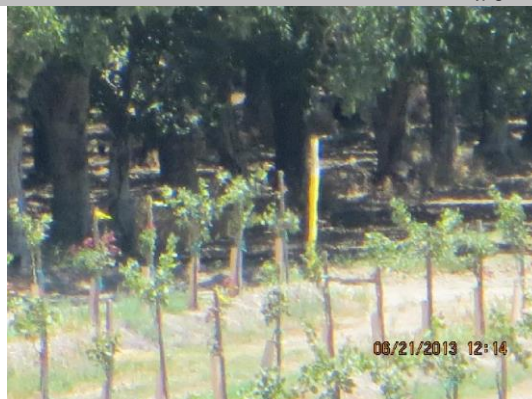
Photo 2 of 3 : UCIP_FA_2020_52738_27477.jpg

Carsonite gasline marker visible approximately 1,000-feet east of levee crown.
