Flood Control Project Maintenance Levee Inspections

Fall 2021 Levee Maintenance Deficiency Summary Report

Sacramento River Basin

Reclamation District No. 1600 Mull

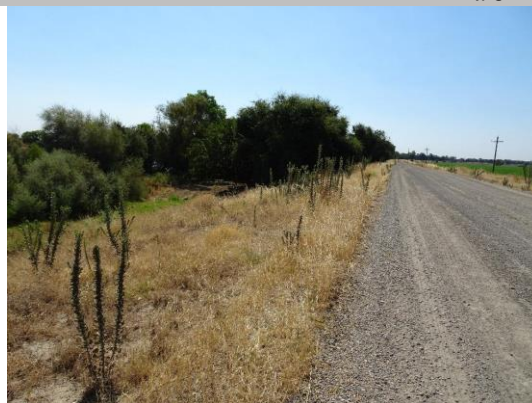
Photo 1 of 3 : UCIP_FA_2021_50169_75607.jpg

Comment Code					
Inspector Comment					
DS_ID:25464 FS_ID:50169 EP_NO: 18849 Repair Type: Non-Urgent EVAL Issue: Crossing Status: Found UCIP Comments: 08/15/2016 - Pipe appears in good condition overall. Standing water found in riser for siphon breaker. Pump was not in operation during field visit. (T. Hatch/UCIP) FIELD_STRUCT_DESC: 24-inch welded steel irrigation pipe through the levee, 2 feet below the crown. Positive closure device in a steel riser with a lid on the waterside (WS) hinge of the levee. Siphon breaker in a steel riser with lid on the landside (LS) hinge of the levee. Distribution box on the LS toe. (Installed under Permit No. 18849, 2014 - Bypass Farms). FS Date: 8/15/2016

view along the levee crown looking downstream. WS slope of the levee is visible.

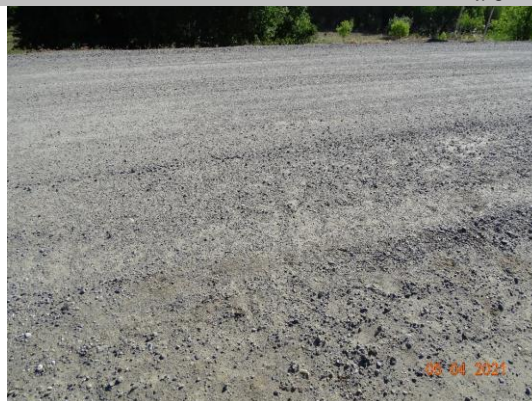
Photo 1 of 3 : UCIP_FA_2021_64693_97036.jpg

Comment Code						
Inspector Comment						
DS_ID:21480 FS_ID:64693 EP_NO: 7339 Repair Type: Non-Urgent EVAL Issue: Abandoned encroachment Crossing Status: Indicator Found UCIP Comments: 05/04/2021 Record remains Non-Urgent. Crossing appears abandoned. Pipe looks abandoned inside of a steel riser on landside. Sinkhole that measures 3'x 4'x 2'- deep located 4 feet downstream of approximate pipe alignment, runoff erosion goes down the slope. (O.Yakimov - DWR UCIP) 04/26/2021 Large sinkhole near this crossing reported by levee inspector Zach Jojola. Further investigation and observance is needed. (O.Yakimov - DWR UCIP) 06/20/2013 Need to determine disposition of pipe. If abandoned, it should be done so properly. (G.Wylie - DWR UCIP) FIELD_STRUCT_DESC: 24-inch steel irrigation pipe through the levee, 3.8 feet below the crown. Steel plate welded on the waterside (WS) end. Pipe not visible on either slope. Pylons in river at the WS toe, and a 4-foot-diameter steel standpipe on the landside (LS) toe. Seepage area at the landside (LS) toe. (Permit No. 7339, 1971 - Layton Knaggs). [Additional Reference(s): DWR Levee Log, 1988]. FS Date: 5/4/2021 1:06:16 PM

Top of Levee: View of levee crown at crossing

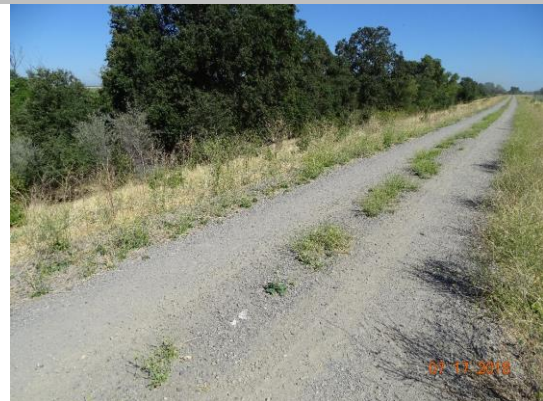
Photo 3 of 3 : UCIP_FA_2021_52738_77709.jpg

Comment Code						
Inspector Comment						
DS_ID:21501 FS_ID:52738 EP_NO: 10944 Repair Type: Non-Urgent EVAL Issue: Crossing Status: Indicator Found UCIP Comments: 07/17/2018 Gas line markers are not installed. Unable to determine exact location of pipe. Crossing has been downgraded to "Non-Urgent" due to reclassification of gas lines. (O.Yakimov-DWR UCIP)08/16/2016 - unable to locate pipe. Need to install gas line markers on LS and WS of levee crown to denote location. (T. Hatch/UCIP)06/21/2013 - Need to install gasline markers on levee. (W. Wylie/UCIP) FIELD_STRUCT_DESC: 8.625-inch steel gas line through the levee, 2 feet below the crown. (Permit No. 10944, 1975 - Shell Oil Company). [Additional Reference(s): DWR Levee Log, 1988]. FS Date: 7/17/2018 3:18:28 PM

View of levee crown at potential crossing looking upstream.
