Flood Control Project Maintenance Levee Inspections

Fall 2022 Levee Maintenance Deficiency Summary Report

Sacramento River Basin

Reclamation District No. 1600 Mull

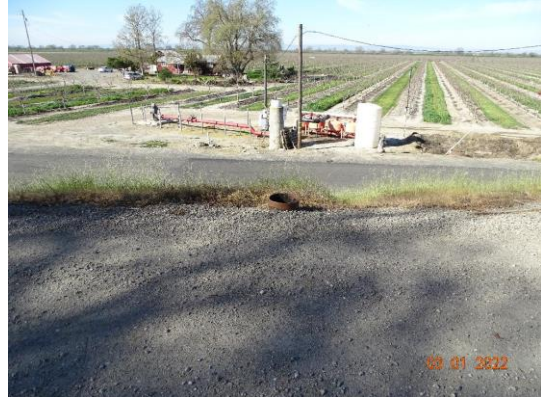
Photo 3 of 3 : UCIP_FA_2022_73427_109791.jpg

Land-Side: View of levee slope looking from crown

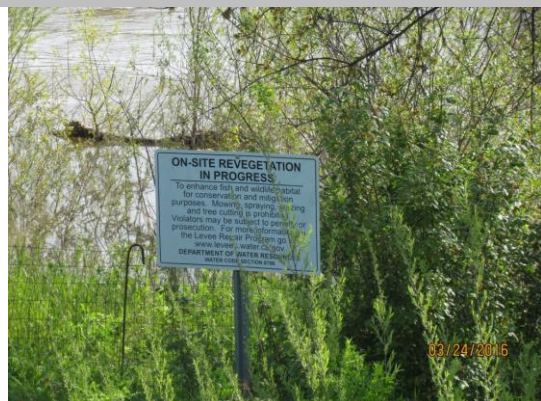
Photo 1 of 1 : FA_2022_RD1600_191_22_20220921_00012.jpg

LM Start	1.01	Rating **	A/W	Issue No.	22
LM End	1.10	Issue Type +	Ma	Location *	WS
Category	Earthen Levee			GPS Latitude/Longitude	
				Start	End
Item	Vegetation			38.689092 °	38.690368 °
				-121.635616 °	-121.635669 °
DWR ID	DWR_RD1600_01_f_2017_22				
Comment Code					
V5 : Environmental Requirements.					
Inspector Comment

Sign stating revegetation site. Spring 2016.

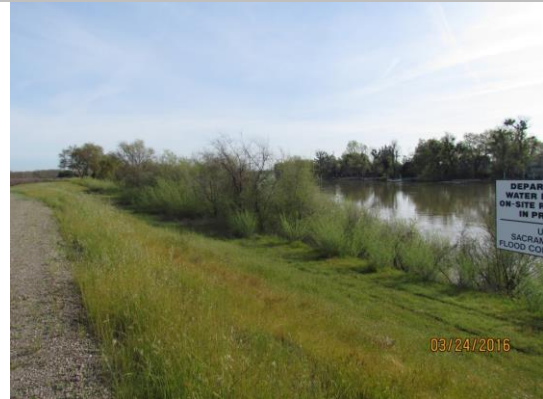
Photo 1 of 1 : FA_2022_RD1600_191_5_20220921_00002.jpg

LM Start	1.40	Rating **	A/W	Issue No.	5
LM End	1.40	Issue Type +	Ob	Location *	WS
Category	Earthen Levee			GPS Latitude/Longitude	
				Start	End
Item	Vegetation			38.694469 °	38.694469 °
				-121.634312 °	-121.634312 °
DWR ID	DWR_RD1600_01_f_2012_5				
Comment Code					
V5 : Environmental Requirements.					
Inspector Comment

View of the revegetation site on the berm of the waterward side of the levee looking upstream. Spring 2016.

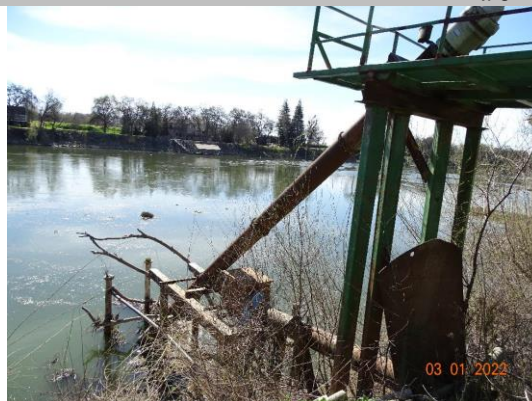
Photo 1 of 3 : UCIP_FA_2022_73455_109809.jpg

Comment Code					
Inspector Comment					
DS_ID:21466 FS_ID:73455 EP_NO: 14648 Repair Type: Non-Urgent EVAL Issue: 10, Unauthorized Modification or Non-Compliant Permit Crossing Status: Found UCIP Comments: 03/01/2022 Record updated from No Action Needed to Non-Urgent. Excavation was discovered to expose pipe section near steel standpipe on landside more that 15 feet from toe. Discharge pipe was cut open and its end was plugged with metal plate to re-route flow from steel standpipe to a booster pump and then to sand filters. Unable to find a permit for modification. Open hole on the top of pipe under the pump on waterside made for flow meter wrapped with tape. (O.Yakimov - DWR UCIP) FIELD_STRUCT_DESC: 24-inch steel irrigation pipe through the levee, 4 feet below the crown. Pump on metal platform on the waterside (WS). 8-foot-diameter steel distribution standpipe with gate valve, 45 feet from the landside (LS) toe. Diesel booster pump and sand filters on landside. (Permit No. 14648, 1987 - Layton Knaggs). [Additional Reference(s): DWR Levee Log, 1988]. FS Date: 3/1/2022 4:13:02 PM

Water-Side: Slant pump at riverbank

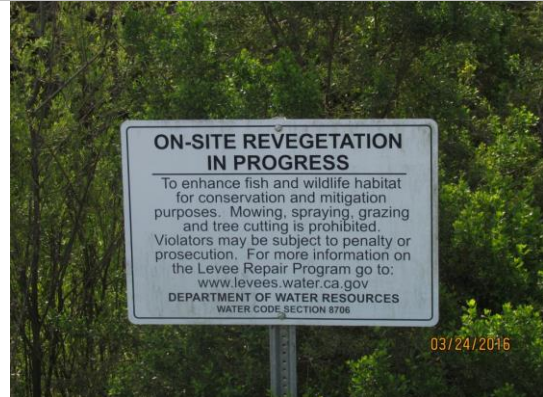
Photo 1 of 1 : FA_2022_RD1600_191_35_20220921_00016.jpg

LM Start	2.35	Rating **	A/W	Issue No.	35
LM End	2.40	Issue Type +	Ob	Location *	WS
Category	Earthen Levee			GPS Latitude/Longitude	
				Start	End
Item	Vegetation			38.704624 °	38.705152 °
				-121.623034 °	-121.622187 °
DWR ID	DWR_RD1600_01_s_2012_35				
Comment Code					
V5 : Environmental Requirements.					
Inspector Comment

Sign for revegetation site. Spring 2016.

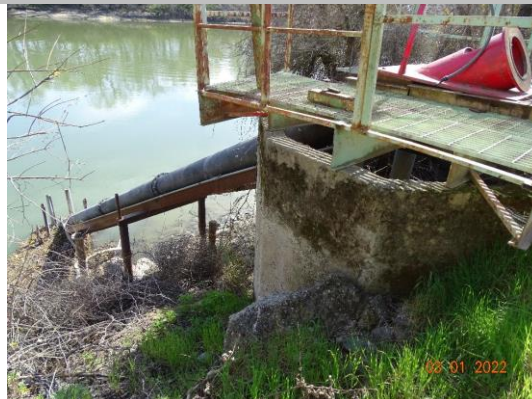
Photo 1 of 3 : UCIP_FA_2022_73513_109840.jpg

Comment Code					
Inspector Comment					
DS_ID:21468 FS_ID:73513 EP_NO: 6196 Repair Type: Urgent EVAL Issue: 2a, Levee Integrity Crossing Status: Found UCIP Comments: 03/01/2022 Record updated from No Action Needed to Urgent. Unauthorized excavation on waterside berm made to install flow meter and around pipe at the pumping platform. Electric motor removed from the pump. (O.Yakimov - DWR UCIP) FIELD_STRUCT_DESC: 18-inch steel irrigation pipe through the levee, 3 feet below the crown. Slant pump on the waterside (WS) berm. Siphon breaker in an 18-inch steel riser on the landside (LS) shoulder. 6-foot by 6-foot concrete distribution box off the LS toe. Water well on landside. [Additional Reference(s): DWR Levee Log, 1988]. FS Date: 3/1/2022 3:10:52 PM

Water-Side: Overview of slant pump at riverbank

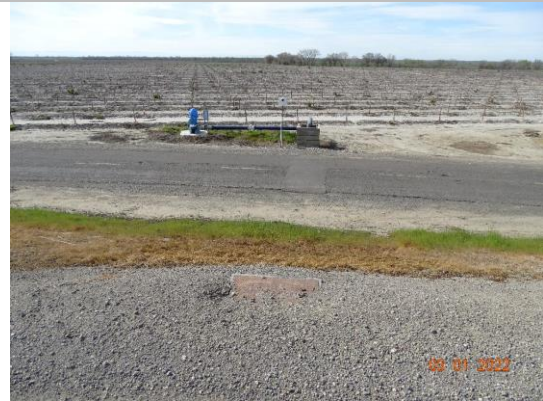
Photo 1 of 3 : UCIP_FA_2022_73530_109873.jpg

Comment Code						
Inspector Comment						
DS_ID:25463 FS_ID:73530 EP_NO: 18850 Repair Type: Non-Urgent EVAL Issue: 4b, Safety Issue Crossing Status: Found UCIP Comments: 03/01/2022 Record updated from No Action Needed to Non-Urgent. 36-inch CMP riser at waterside shoulder needs a cover. Pump removed from the pier. Water well on landside discharges to the same concrete distribution box on landside. (O.Yakimov - DWR UCIP) 08/15/2016 - pump in operation during field inspection. electricity provided via mobile generator unit parked on WS ramp adjacent to pump platform. (T. Hatch/UCIP) FIELD_STRUCT_DESC: 18-inch welded steel irrigation pipe through the levee, 2 feet below the crown. Vertical pump at wooden pump platform on the waterside, extending out into the river. Positive closure device in 36-inch CMP riser on the waterside (WS) hinge. Siphon breaker inside of christy box on the landside (LS) hinge. 5-foot by 5-foot distribution box on the LS toe, across County Road 117. Water well on LS. (Permit No. 18850, 2014 - Bypass Farms). FS Date: 3/1/2022 9:39:17 AM

Land-Side: View of levee slope looking from crown. Concrete distribution box and water well on landside

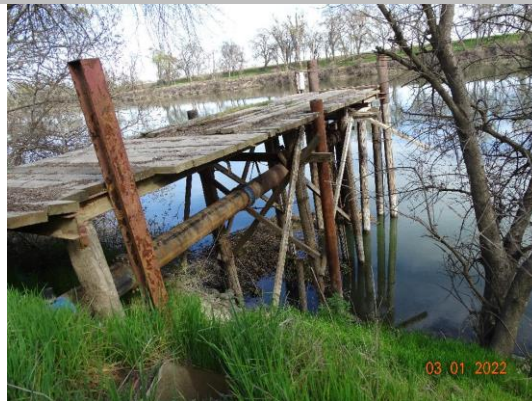
Photo 3 of 3 : UCIP_FA_2022_73530_109871.jpg

Water-Side: Pumping pier in river stream with pump currently removed

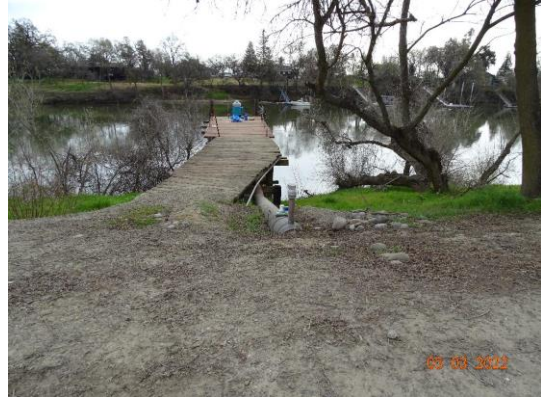
Photo 1 of 3 : UCIP_FA_2022_73691_110131.jpg

Water-Side: View of levee slope looking from crown. Wooden walkway to the pump

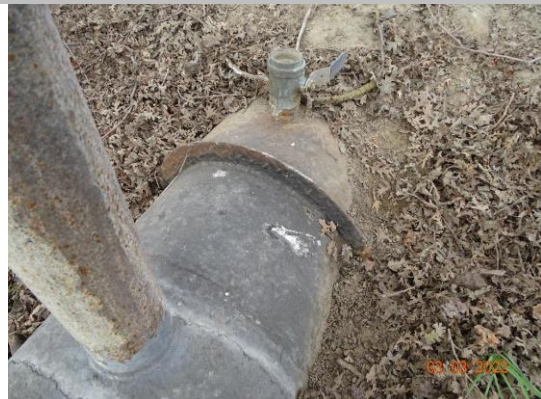
Photo 2 of 3 : UCIP_FA_2022_73691_110133.jpg

Water-Side: View of pipe sleeved through larger pipe on waterside shoulder

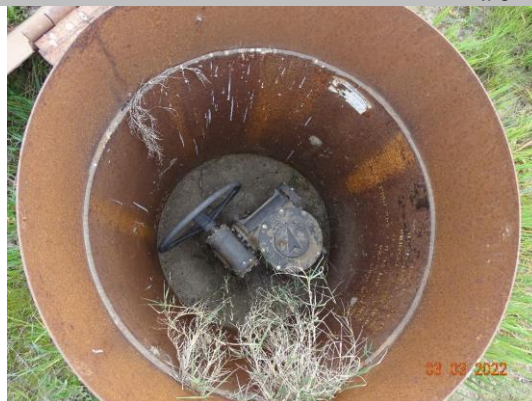
Photo 1 of 3 : UCIP_FA_2022_73694_110146.jpg

Water-Side: Closure device in steel riser

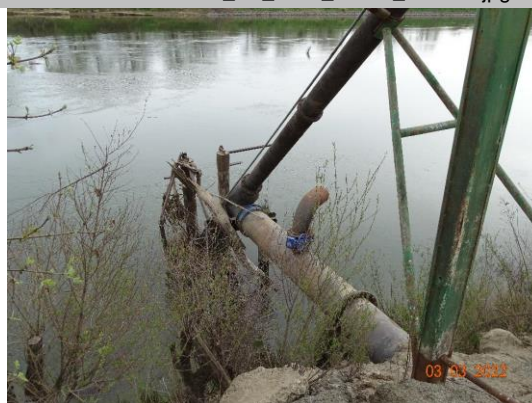
Photo 2 of 3 : UCIP_FA_2022_73694_110147.jpg

Water-Side: View of pipe at riverbank

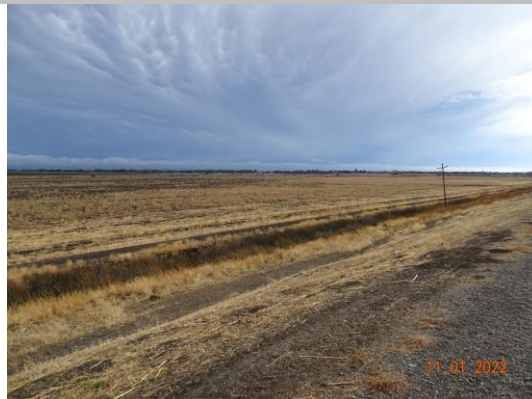
Photo 1 of 1 : FA_2022_RD1600_192_5_20221102_00007.jpg

LM Start	0.44	Rating **	A	Issue No.	5
LM End	0.44	Issue Type +	Ma	Location *	LS
Category	Earthen Levee			GPS Latitude/Longitude	
				Start	End
Item	Vegetation			38.729879 °	38.729879 °
				-121.633453 °	-121.633453 °
DWR ID	DWR_RD1600_02_f_2022_5				
Comment Code					
V1 : Control annual grass and weeds on the levee slopes and easements.					
Inspector Comment					
LMA maintains the vegetation at a high level.

View of maintained landside slope. Fall 2022.

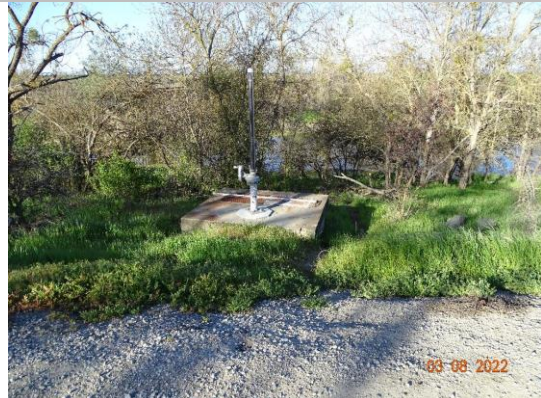
Photo 2 of 3 : UCIP_FA_2022_73790_110272.jpg

Water-Side: View of levee slope looking from crown. Concrete box with slide gate on levee slope
