Flood Control Project Maintenance Levee Inspections

Fall 2023 Levee Maintenance Deficiency Summary Report

Reclamation District No. 1600 Mull

Levee Inspection Report By Mile - Fall 2023

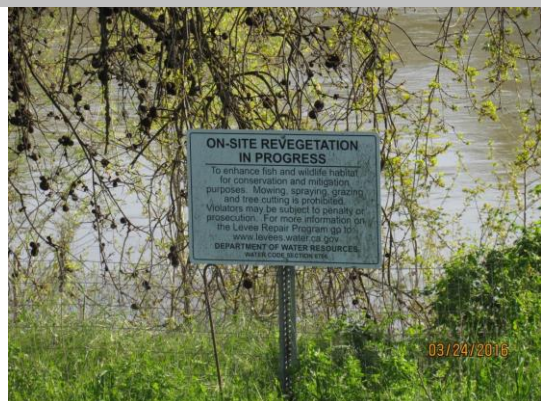
Photo 1 of 1 : FA_2023_RD1600_191_49_20231024_00028.jpg

LM Start	0.11	Rating **	A/W	Issue No.	49
LM End	0.23	Issue Type +	Ob	Location *	WS
Category	Earthen Levee			GPS Latitude/Longitude	
				Start	End
Item	Vegetation			38.676577°	38.678131°
				-121.631290°	-121.632324°
DWR ID	DWR_RD1600_01_s_2012_49				
Comment Code					
V5 : Environmental Requirements.					
Inspector Comment

Sign stating revegetation site. Spring 2016.

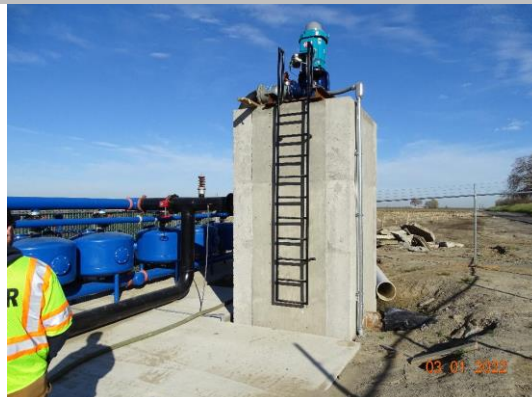
Photo 3 of 3 : UCIP_FA_2023_73418_109774.jpg

LM Start	0.53	Rating **	M	Issue No.	1198 (cont)
LM End	0.53	Issue Type +	En	Location *	
Category	Supplemental			GPS Latitude/Longitude	
				Start	End
Item	DWR UCIP Field Study			38.682155°	38.682155°
				-121.634070°	-121.634070°
DWR ID	21460

Land-Side: New concrete distribution box, pump on the top, and sand filters installed on landside

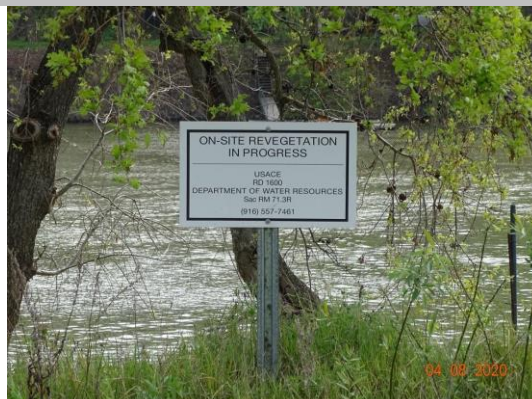
Photo 1 of 1 : FA_2023_RD1600_191_26_20231024_00017.jpg

LM Start	0.56	Rating **	A/W	Issue No.	26
LM End	0.66	Issue Type +	Ob	Location *	WS
Category	Earthen Levee			GPS Latitude/Longitude	
				Start	End
Item	Vegetation			38.682661 °	38.684099 °
				-121.634238 °	-121.634625 °
DWR ID	DWR_RD1600_01_s_2020_26				
Comment Code					
V5 : Environmental Requirements.					
Inspector Comment					
USACE, DWR, and RD 1600 revegetation site.

View of revegetation sign on the waterside berm. Spring 2020.

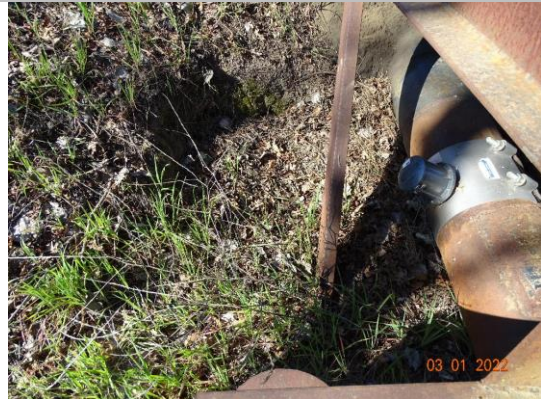
Photo 1 of 3 : UCIP_FA_2023_73427_109788.jpg

Comment Code						
Inspector Comment						
DS_ID:21463 FS_ID:73427 EP_NO: 6100 Repair Type: Urgent EVAL Issue: 2a, Levee Integrity Crossing Status: Found UCIP Comments: 03/01/2022 Record updated from Non-Urgent to Urgent. Found unauthorized excavation under the pump on waterside to install flow meter. Excavation is 36 inches in diameter and 10 inches deep. Gate valve at the pump is in operable condition. (O.Yakimov - DWR UCIP) 06/18/2013 Gate valve will not open or close. (W.Wylie - DWR UCIP) FIELD_STRUCT_DESC: 12-inch steel irrigation pipe through the levee, 3.4 feet below the crown. Slant pump and gate valve on the waterside (WS) slope. Siphon breaker in a 12-inch steel riser on the landside (LS) shoulder. Filter, booster pump, and butterfly valve on the LS toe. 2.25-inch galvanized iron electrical conduit at the same location. (Permit No. 6100, 1968 - Charles Plumb Jr., replaced 8-inch pipe at same location). [Additional Reference(s): DWR Levee Log, 1988]. FS Date: 3/1/2022 2:36:45 PM

LM Start	0.94	Rating **	U	Issue No.	1199 (cont)
LM End	0.94	Issue Type +	En	Location *

Water-Side: Excavation made to install flow meter under the pump

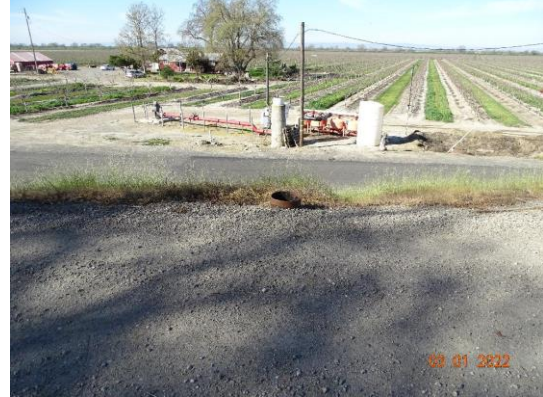
Photo 3 of 3 : UCIP_FA_2023_73427_109791.jpg

LM Start	0.94	Rating **	U	Issue No.	1199 (cont)
LM End	0.94	Issue Type +	En	Location *	
Category	Supplemental			GPS Latitude/Longitude	
				Start	End
Item	DWR UCIP Field Study			38.688030°	38.688030°
				-121.635367°	-121.635367°
DWR ID	21463

Land-Side: View of levee looking from crown

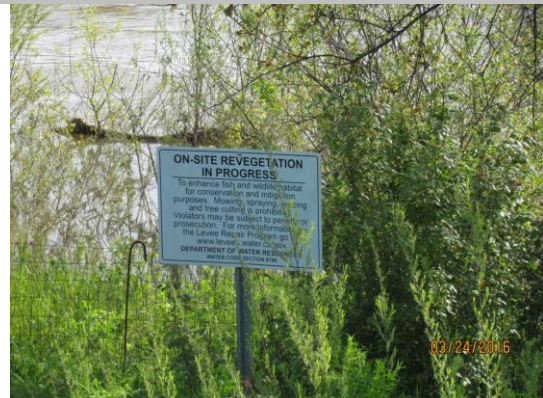
Photo 1 of 1 : FA_2023_RD1600_191_22_20231024_00013.jpg

LM Start	1.01	Rating **	A/W	Issue No.	22
LM End	1.10	Issue Type +	Ob	Location *	WS
Category	Earthen Levee			GPS Latitude/Longitude	
				Start	End
Item	Vegetation			38.689092°	38.690368°
				-121.635616°	-121.635669°
DWR ID	DWR_RD1600_01_f_2017_22				
Comment Code					
V5 : Environmental Requirements.					
Inspector Comment

Sign stating revegetation site. Spring 2016.

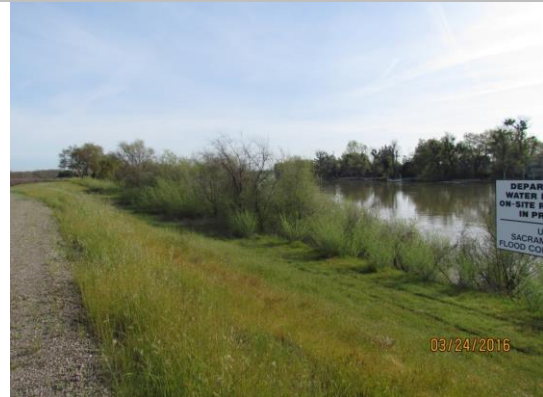
Photo 1 of 1 : FA_2023_RD1600_191_5_20231024_00001.jpg

LM Start	1.40	Rating **	A/W	Issue No.	5
LM End	1.40	Issue Type +	Ob	Location *	WS
Category	Earthen Levee			GPS Latitude/Longitude	
				Start	End
Item	Vegetation			38.694469°	38.694469°
				-121.634312°	-121.634312°
DWR ID	DWR_RD1600_01_f_ 2012_5				
Comment Code					
V5 : Environmental Requirements.					
Inspector Comment

View of the revegetation site on the berm of the waterward side of the levee looking upstream. Spring 2016.

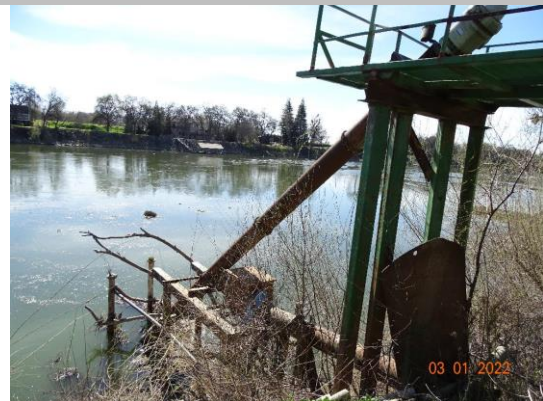
Photo 1 of 3 : UCIP_FA_2023_73455_109809.jpg

Comment Code					
Inspector Comment					
DS_ID:21466 FS_ID:73455 EP_NO: 14648 Repair Type: Non-Urgent EVAL Issue: 10, Unauthorized Modification or Non-Compliant Permit Crossing Status: Found UCIP Comments: 03/01/2022 Record updated from No Action Needed to Non-Urgent. Excavation was discovered to expose pipe section near steel standpipe on landside more that 15 feet from toe. Discharge pipe was cut open and its end was plugged with metal plate to re-route flow from steel standpipe to a booster pump and then to sand filters. Unable to find a permit for modification. Open hole on the top of pipe under the pump on waterside made for flow meter wrapped with tape. (O.Yakimov - DWR UCIP) FIELD_STRUCT_DESC: 24-inch steel irrigation pipe through the levee, 4 feet below the crown. Pump on metal platform on the waterside (WS). 8-foot-diameter steel distribution standpipe with gate valve, 45 feet from the landside (LS) toe. Diesel booster pump and sand filters on landside. (Permit No. 14648, 1987 - Layton Knaggs). [Additional Reference(s): DWR Levee Log, 1988]. FS Date: 3/1/2022 4:13:02 PM

Water-Side: Slant pump at riverbank

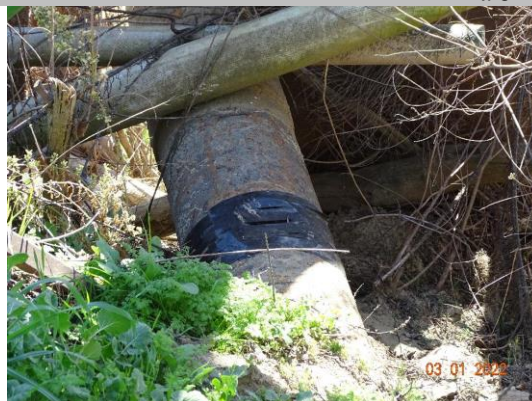
Photo 2 of 3 : UCIP_FA_2023_73455_109814.jpg

LM Start	2.16	Rating **	M	Issue No.	1200 (cont)
LM End	2.16	Issue Type +	En	Location *	
Category	Supplemental			GPS Latitude/Longitude	
				Start	End
Item	DWR UCIP Field Study			38.702981°	38.702981°
				-121.625644°	-121.625644°
DWR ID	21466

Water-Side: Taped hole made for flow meter under the pump

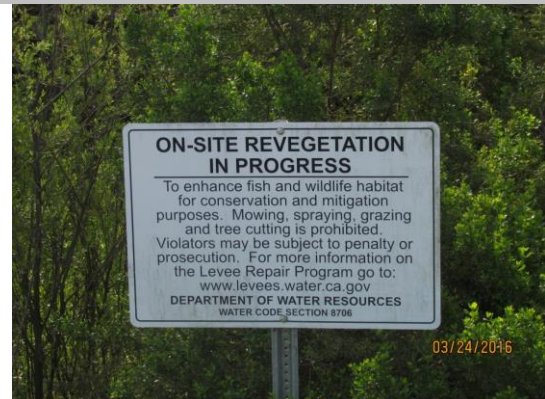
Photo 1 of 1 : FA_2023_RD1600_191_35_20231024_00021.jpg

LM Start	2.35	Rating **	A/W	Issue No.	35
LM End	2.40	Issue Type +	Ob	Location *	WS
Category	Earthen Levee			GPS Latitude/Longitude	
				Start	End
Item	Vegetation			38.704624°	38.705152°
				-121.623034°	-121.622187°
DWR ID	DWR_RD1600_01_s _ 2012_35				
Comment Code					
V5 : Environmental Requirements.					
Inspector Comment

Sign for revegetation site. Spring 2016.

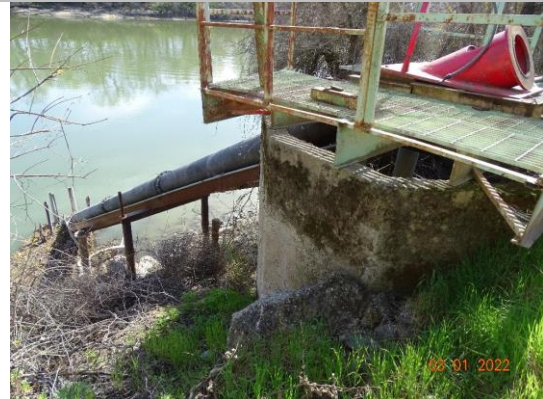
Photo 1 of 3 : UCIP_FA_2023_73513_109840.jpg

LM Start	3.58	Rating **	U	Issue No.	1201 (cont)
LM End	3.58	Issue Type +	En	Location *

Water-Side: Overview of slant pump at riverbank

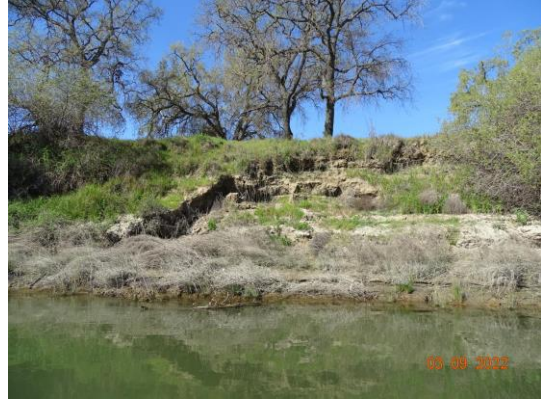
Photo 2 of 3 : FA_2023_RD1600_191_16_20231024_00007.jpg

LM Start	3.58	Rating **	A/W	Issue No.	16 (cont)
LM End	3.83	Issue Type +	Ma	Location *	WS
Category	Supplemental			GPS Latitude/Longitude	
				Start	End
Item	2018 USACE Erosion Survey			38.717770°	38.721351°
				-121.607423°	-121.606414°
DWR ID	DWR_RD1600_01_s_2022_16

View of erosion at the worst location. Spring 2022.

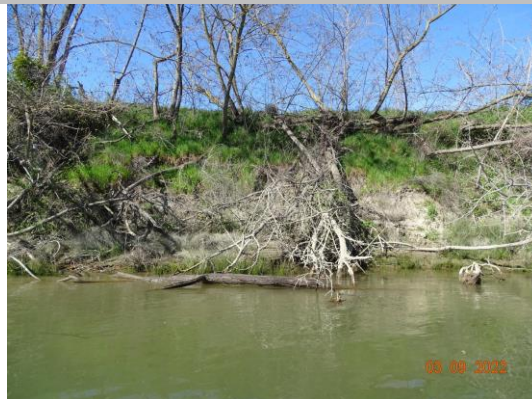
Photo 1 of 2 : FA_2023_RD1600_191_17_20231024_00009.jpg

LM Start	4.34	Rating **	A/W	Issue No.	17 (cont)
LM End	4.86	Issue Type +	Ma	Location *	WS

View of erosion near downstream end. Spring 2022.

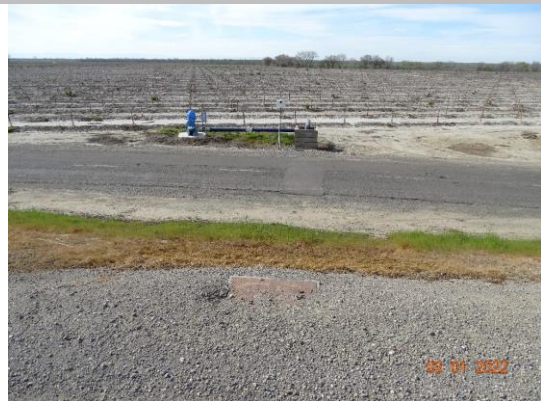
Photo 1 of 3 : UCIP_FA_2023_73530_109873.jpg

Comment Code					
Inspector Comment					
DS_ID:25463 FS_ID:73530 EP_NO: 18850 Repair Type: Non-Urgent EVAL Issue: 4b, Safety Issue Crossing Status: Found UCIP Comments: 03/01/2022 Record updated from No Action Needed to Non-Urgent. 36-inch CMP riser at waterside shoulder needs a cover. Pump removed from the pier. Water well on landside discharges to the same concrete distribution box on landside. (O.Yakimov - DWR UCIP) 08/15/2016 - pump in operation during field inspection. electricity provided via mobile generator unit parked on WS ramp adjacent to pump platform. (T. Hatch/UCIP) FIELD_STRUCT_DESC: 18-inch welded steel irrigation pipe through the levee, 2 feet below the crown. Vertical pump at wooden pump platform on the waterside, extending out into the river. Positive closure device in 36-inch CMP riser on the waterside (WS) hinge. Siphon breaker inside of christy box on the landside (LS) hinge. 5-foot by 5-foot distribution box on the LS toe, across County Road 117. Water well on LS. (Permit No. 18850, 2014 - Bypass Farms). FS Date: 3/1/2022 9:39:17 AM

Land-Side: View of levee slope looking from crown. Concrete distribution box and water well on landside

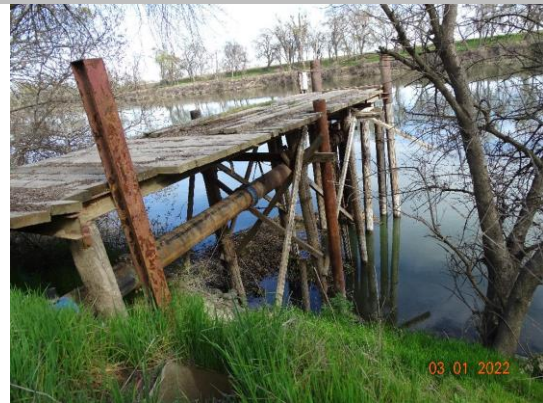
Photo 3 of 3 : UCIP_FA_2023_73530_109871.jpg

LM Start	4.87	Rating **	M	Issue No.	1202 (cont)
LM End	4.87	Issue Type +	En	Location *

Water-Side: Pumping pier in river stream with pump currently removed

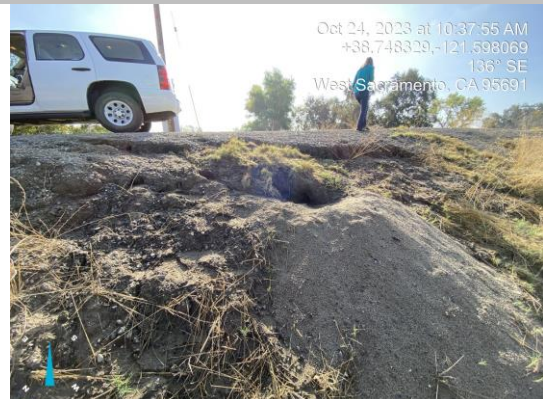
Photo 1 of 1 : FA_2023_RD1600_191_72_20231025_00073.jpg

LM Start	5.78	Rating **	U	Issue No.	72
LM End	5.78	Issue Type +	Ma	Location *	LS
Category	Earthen Levee			GPS Latitude/Longitude	
				Start	End
Item	Animal Control			38.748297°	38.748297°
				-121.597978°	-121.597978°
DWR ID	DWR_RD1600_01_f_2023_72				
Comment Code					
A3 : No rodents visible, but rodent burrows visible; need to backfill and compact or grout burrows.					
Inspector Comment

View of rodent hole on the landside slope (Fall 2023).

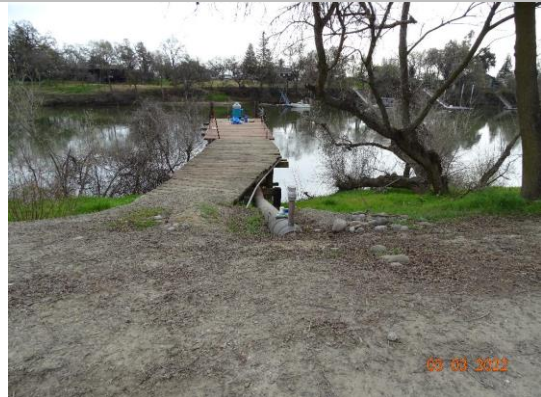
Photo 1 of 3 : UCIP_FA_2023_73691_110131.jpg

LM Start	6.39	Rating **	M	Issue No.	1204 (cont)
LM End	6.39	Issue Type +	En	Location *

Water-Side: View of levee slope looking from crown. Wooden walkway to the pump

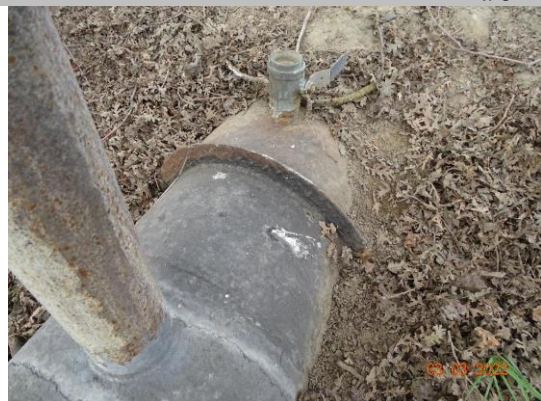
Photo 2 of 3 : UCIP_FA_2023_73691_110133.jpg

Water-Side: View of pipe sleeved through larger pipe on waterside shoulder

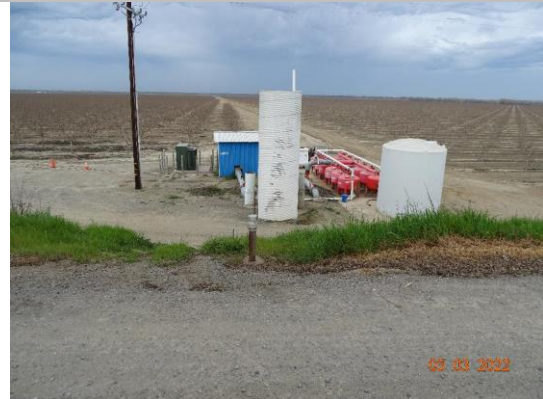
Photo 3 of 3 : UCIP_FA_2023_73691_110132.jpg

LM Start	6.39	Rating **	M	Issue No.	1204 (cont)	
LM End	6.39	Issue Type +	En	Location *		
Category	Supplemental			GPS Latitude/Longitude		
				Start	End	
Item	DWR UCIP Field Study			38.756585°	38.756585°	
				-121.594334°	-121.594334°	
DWR ID	21478

Land-Side: View of levee slope looking from crown

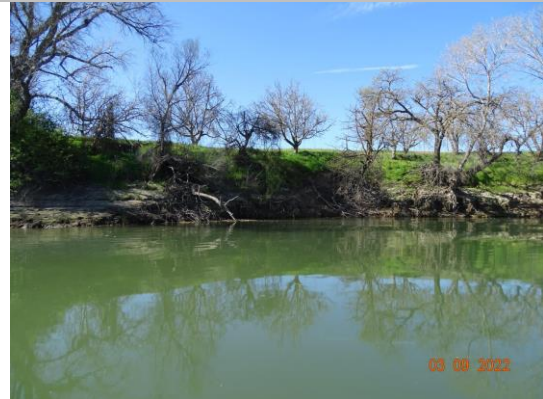
Photo 1 of 1 : FA_2023_RD1600_191_23_20231024_00014.jpg

LM Start	6.95	Rating **	M	Issue No.	23
LM End	6.98	Issue Type +	Ma	Location *	WS
Category	Supplemental			GPS Latitude/Longitude	
				Start	End
Item	2018 USACE Erosion Survey			38.764801°	38.765219°
				-121.594926°	-121.595049°
DWR ID	DWR_RD1600_01_s_2022_23				
Comment Code					
Inspector Comment					
2018 Site ID: SAC 77.7 R					
Status: Eroding					
2018 Field Notes: Minor new erosion.					
Site History: 2006 - Eddy scour off end of rock causing erosion and scour hole near levee. Sandy silt bank with rock on upstream end.					
2010 - Trees are leaning more, minor new erosion. 2011 - Many of the tree roots have scoured out and trees look ready to fall. 2017 - Minor new erosion.

View of erosion from the waterside. Spring 2022.

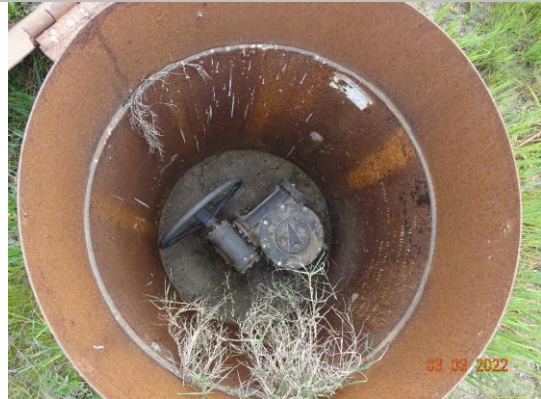
Photo 1 of 3 : UCIP_FA_2023_73694_110146.jpg

LM Start	7.56	Rating **	M	Issue No.	1205 (cont)
LM End	7.56	Issue Type +	En	Location *

Water-Side: Closure device in steel riser

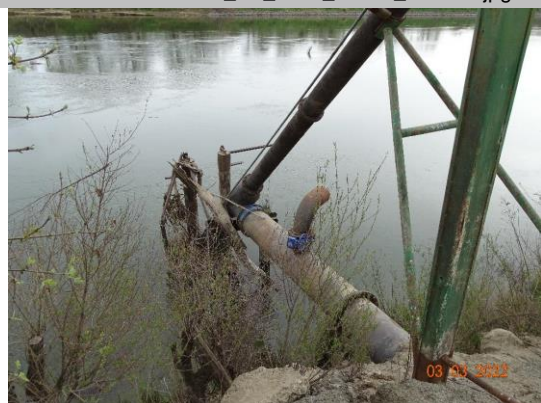
Photo 2 of 3 : UCIP_FA_2023_73694_110147.jpg

Water-Side: View of pipe at riverbank

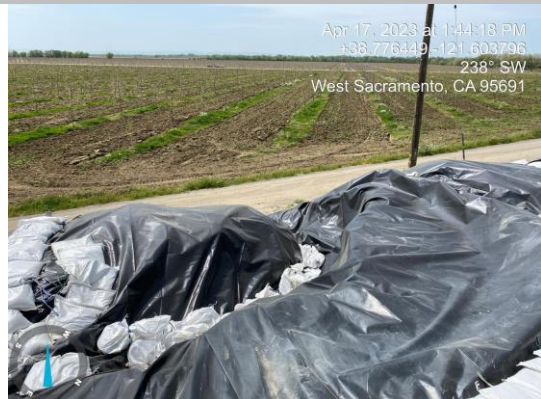
Photo 1 of 1 : FA_2023_RD1600_191_53_20231024_00030.jpg

Approximately 50' section of erosion on the landside shoulder. MBK has covered the site with a raincoat.

View of landside erosion with raincoat placed over the site (Spring 2023).

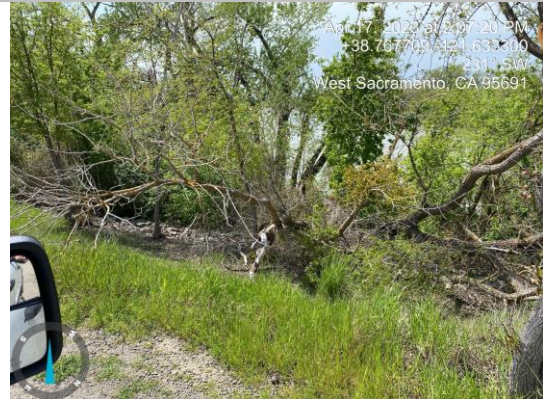
Photo 1 of 1 : FA_2023_RD1600_191_60_20231024_00036.jpg

LM Start	10.27	Rating **	M	Issue No.	60
LM End	10.27	Issue Type +	Ma	Location *	WS
Category	Earthen Levee			GPS Latitude/Longitude	
				Start	End
Item	Vegetation			38.767638°	38.767638°
				-121.633173°	-121.633173°
DWR ID	DWR_RD1600_01_s_2023_60				
Comment Code					
V2 : Remove the wild growth and woody vegetation other than native grasses from the levee slopes.					
Inspector Comment					
Fallen tree on the waterside shoulder.

View of fallen trees partially blocking access and visibility to the levee (Spring 2023).

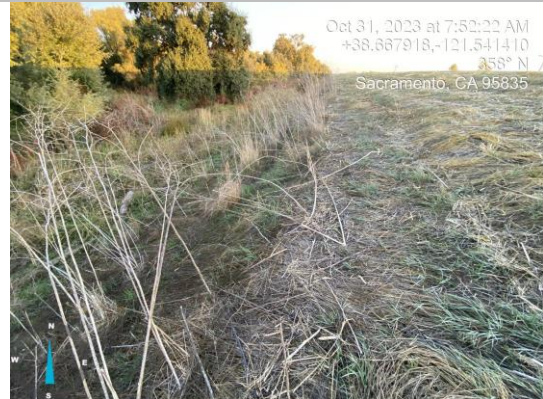
Photo 1 of 1 : FA_2023_RD1600_192_14_20231103_00015.jpg

LM Start	1.79	Rating **	M	Issue No.	14
LM End	2.05	Issue Type +	Ma	Location *	WS
Category	Earthen Levee			GPS Latitude/Longitude	
				Start	End
Item	Erosion / Bank Caving			38.710763°	38.707116°
				-121.637147°	-121.638722°
DWR ID	DWR_RD1600_02_s_2019_14				
Comment Code					
E1 : Note and monitor erosion site.					
Inspector Comment					
Wavewash on the waterside slope.					
Site ID No:202					
Site Designation:RD 1600-01

View of wave wash on the waterside slope (Fall 2023).

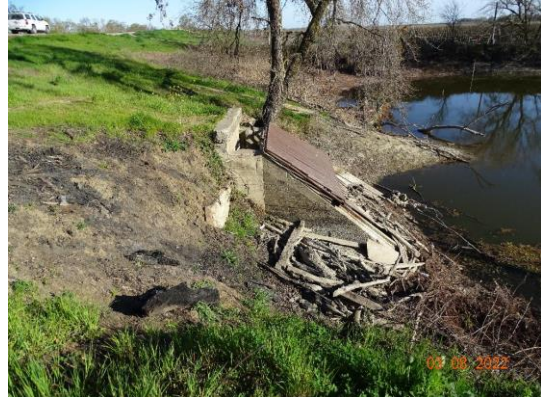
Photo 1 of 3 : UCIP_FA_2023_73790_110274.jpg

Comment Code						
Inspector Comment						
DS_ID:21502 FS_ID:73790 EP_NO: N/A Repair Type: Non-Urgent EVAL Issue: 5, Pipe Damage Crossing Status: Found UCIP Comments: 09/28/2023 MBK Engineers confirmed this pipe belongs to RD2035. (O. Yakimov - DWR UCIP) 03/08/2022 Record updated from No Action Needed to Non-Urgent. DMP internal video inspection has found pipe integrity issues. LOF of crossing is greater than or equal to 4.1 and less than 5. Crossing will be monitored until funding becomes available for rehabilitation. New slide gate actuator installed. No permit has been identified authorizing pipe. (O.Yakimov - DWR UCIP) FIELD_STRUCT_DESC: 72-inch by 72-inch dual purpose drainage-irrigation reinforced concrete box culvert through the levee, 26 feet below the crown. Steel grate at culvert inlet in a ditch on landside (LS) flow meter at this location. Slide gate on the waterside (WS) slope in a 9-foot by 10-foot concrete box. Culvert passes under the bypass canal, the railroad, and County Road 22 and terminates in Conaway irrigation canal on the southwest side of the County Road 22 bridge. [Additional Reference(s): DWR Levee Log, 1988. USACE Sacramento O&M Manual 123, August 1955, (Station 155+00). USACE As-Built Drawing No. 06-13-0573, Sheet 5, Station 153+65, unknown date of drawing]. FS Date: 3/8/2022 11:37:25 AM

Land-Side: Steel grate, flow meter at culvert inlet in a ditch

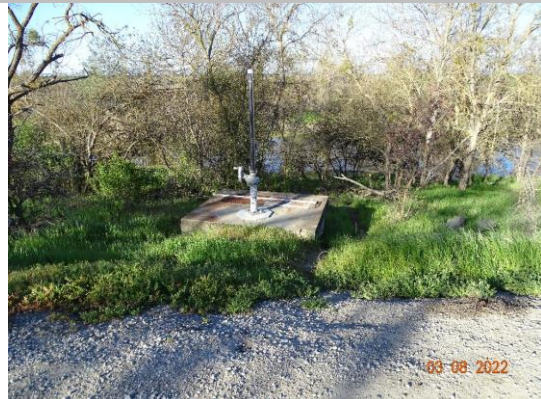
Photo 2 of 3 : UCIP_FA_2023_73790_110272.jpg

Water-Side: View of levee slope looking from crown. Concrete box with slide gate on levee slope

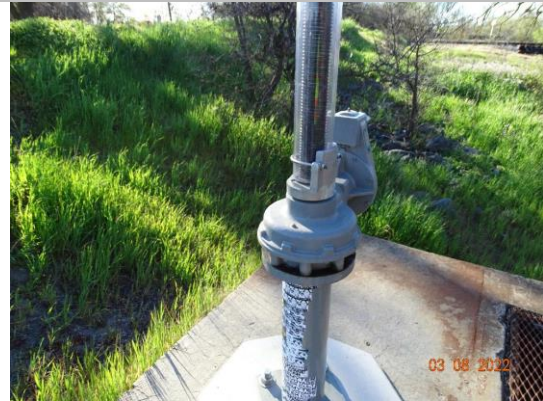
Photo 3 of 3 : UCIP_FA_2023_73790_110273.jpg

Water-Side: New slide gate actuator installed
