Flood Control Project Maintenance Levee Inspections

Fall 2024 Levee Maintenance Deficiency Summary Report

Reclamation District No. 1600 Mull

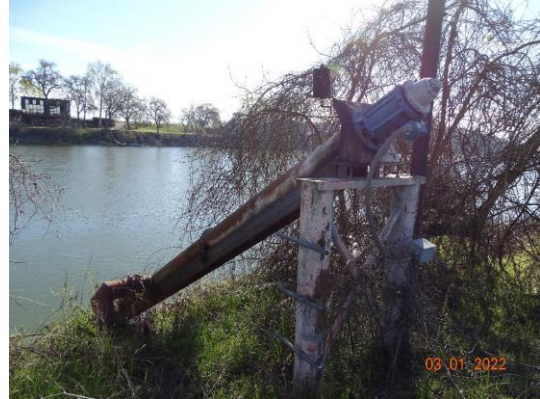
Photo 1 of 3 : UCIP_FA_2024_73418_109776.jpg

Water-Side: Slant pump at riverbank

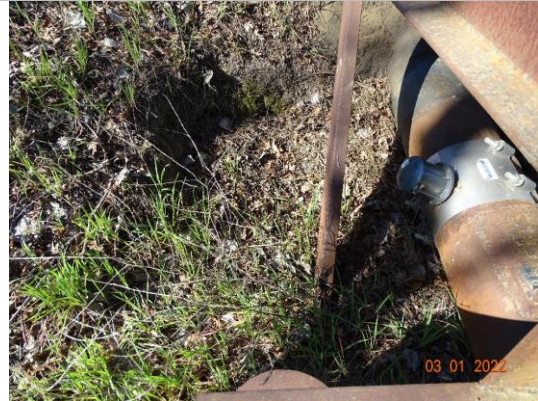
Photo 1 of 3 : UCIP_FA_2024_73427_109788.jpg

Comment Code						
Inspector Comment						
DS_ID:21463 FS_ID:73427 EP_NO: 6100 Repair Type: Urgent EVAL Issue: 2a, Levee Integrity Crossing Status: Found UCIP Comments: 03/01/2022 Record updated from Non-Urgent to Urgent. Found unauthorized excavation under the pump on waterside to install flow meter. Excavation is 36 inches in diameter and 10 inches deep. Gate valve at the pump is in operable condition. (O.Yakimov - DWR UCIP) 06/18/2013 Gate valve will not open or close. (W.Wylie - DWR UCIP) FIELD_STRUCT_DESC: 12-inch steel irrigation pipe through the levee, 3.4 feet below the crown. Slant pump and gate valve on the waterside (WS) slope. Siphon breaker in a 12-inch steel riser on the landside (LS) shoulder. Filter, booster pump, and butterfly valve on the LS toe. 2.25-inch galvanized iron electrical conduit at the same location. This crossing replaces 8-inch pipe (see DSID 21462). (12-inch pipe authorized under Permit No. 6100, 1968 - Charles Plumb Jr.). [Additional Reference(s): DWR Levee Log, 1988 (HLM 0.94)]. FS Date: 3/1/2022 2:36:45 PM

Water-Side: Excavation made to install flow meter under the pump

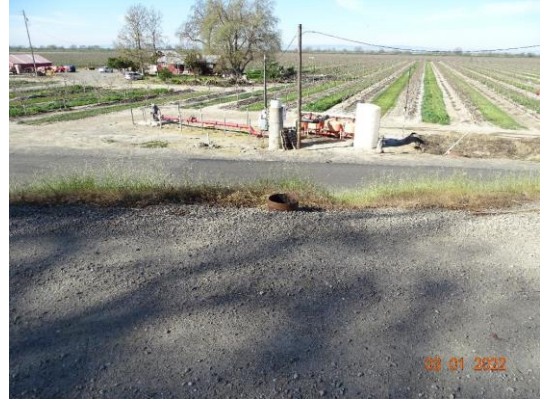
Photo 3 of 3 : UCIP_FA_2024_73427_109791.jpg

Land-Side: View of levee slope looking from crown

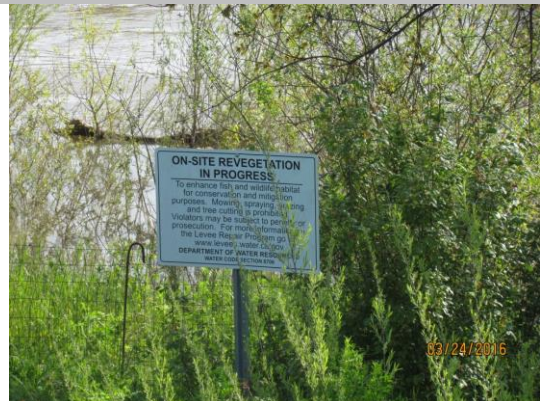
Photo 1 of 1 : FA_2024_RD1600_191_22_20241028_00014.jpg

LM Start	1.01	Rating **	A/W	Issue No.	22
LM End	1.10	Issue Type +	Ob	Location *	WS
Category	Earthen Levee			GPS Latitude/Longitude	
				Start	End
Item	Vegetation			38.689092°	38.690368°
				-121.635616°	-121.635669°
DWR ID	DWR_RD1600_01_f_2017_22				
Comment Code					
V5 : Environmental Requirements.					
Inspector Comment

Sign stating revegetation site. Spring 2016.

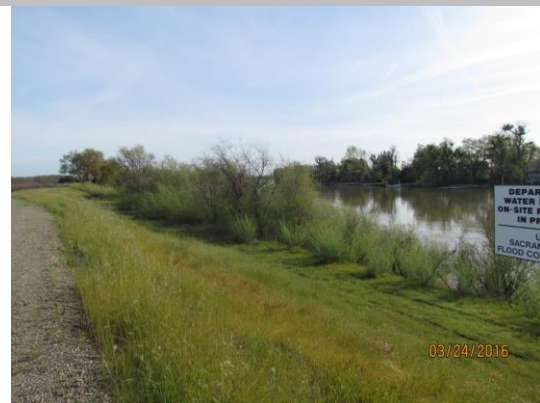
Photo 1 of 1 : FA_2024_RD1600_191_5_20241028_00001.jpg

LM Start	1.40	Rating **	A/W	Issue No.	5
LM End	1.40	Issue Type +	Ob	Location *	WS
Category	Earthen Levee			GPS Latitude/Longitude	
				Start	End
Item	Vegetation			38.694469°	38.694469°
				-121.634312°	-121.634312°
DWR ID	DWR_RD1600_01_f_2012_5				
Comment Code					
V5 : Environmental Requirements.					
Inspector Comment

View of the revegetation site on the berm of the waterward side of the levee looking upstream. Spring 2016.

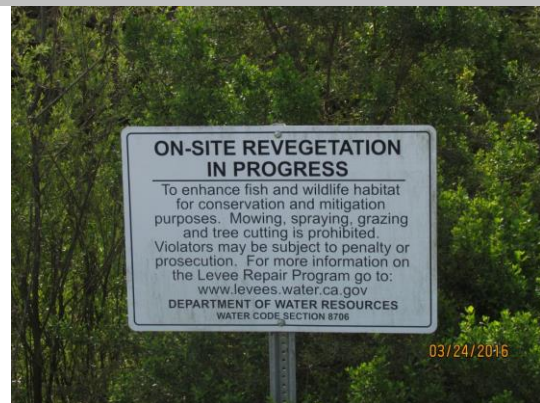
Photo 1 of 1 : FA_2024_RD1600_191_35_20241028_00021.jpg

LM Start	2.35	Rating **	A/W	Issue No.	35
LM End	2.40	Issue Type +	Ob	Location *	WS
Category	Earthen Levee			GPS Latitude/Longitude	
				Start	End
Item	Vegetation			38.704624°	38.705152°
				-121.623034°	-121.622187°
DWR ID	DWR_RD1600_01_s_2012_35				
Comment Code					
V5 : Environmental Requirements.					
Inspector Comment

Sign for revegetation site. Spring 2016.

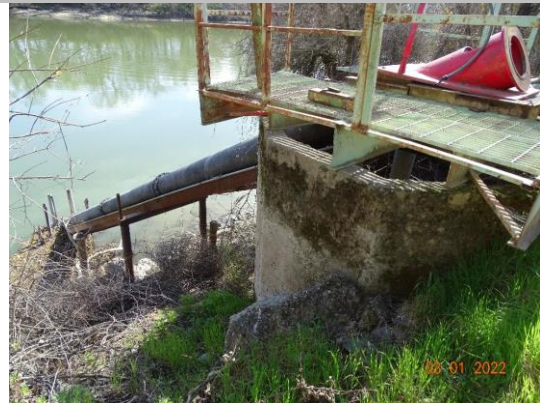
Photo 1 of 3 : UCIP_FA_2024_73513_109840.jpg

Comment Code						
Inspector Comment						
DS_ID:21468 FS_ID:73513 EP_NO: 6196 Repair Type: Urgent EVAL Issue: 2a, Levee Integrity Crossing Status: Found UCIP Comments: 03/01/2022 Record updated from No Action Needed to Urgent. Unauthorized excavation on waterside berm made to install flow meter and around pipe at the pumping platform. Electric motor removed from the pump. (O.Yakimov - DWR UCIP) FIELD_STRUCT_DESC: 18-inch steel irrigation pipe through the levee, 3 feet below the crown. Slant pump on the waterside (WS) berm. Siphon breaker in an 18-inch steel riser on the landside (LS) shoulder. 6-foot by 6-foot concrete distribution box off the LS toe. Water well on landside. This crossing replaces 18-inch pipe (see DSID 21489). (Replacement of 75-foot section of pipe within levee prism authorized under Permit No. 6196, 1968 - The Church of Jesus Christ of Latter Day Saints). [Additional Reference(s): DWR Levee Log, 1988 (HLM 3.59)]. FS Date: 3/1/2022 3:10:52 PM

Water-Side: Overview of slant pump at riverbank

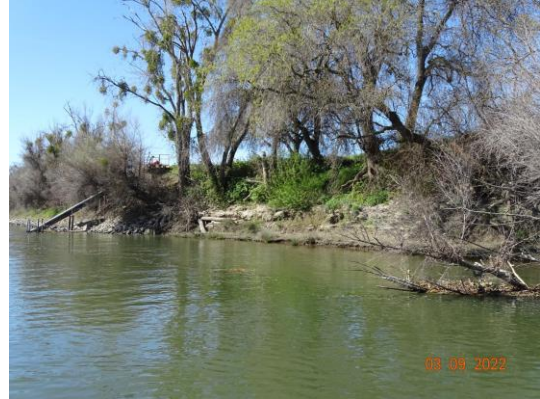
Photo 1 of 3 : FA_2024_RD1600_191_16_20241028_00007.jpg

View of beginning of erosion from downstream end. Spring 2022.

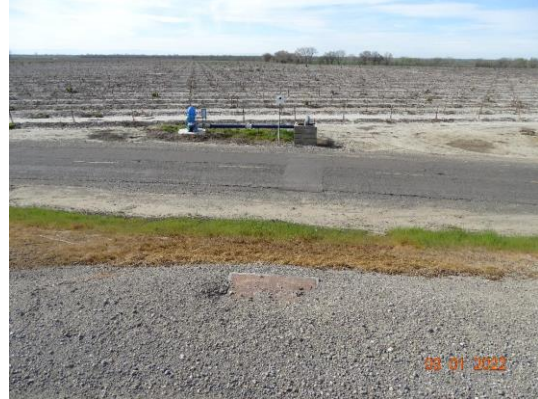
Photo 1 of 3 : UCIP_FA_2024_73530_109873.jpg

Land-Side: View of levee slope looking from crown. Concrete distribution box and water well on landside

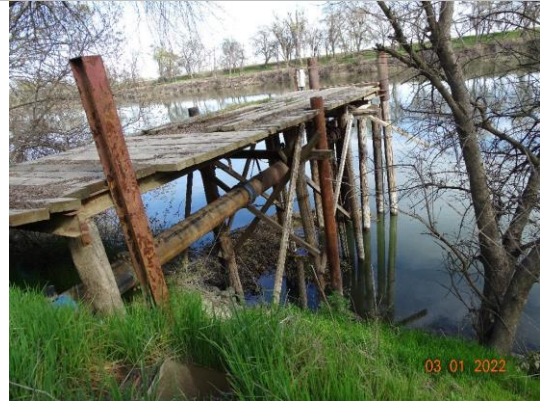
Photo 3 of 3 : UCIP_FA_2024_73530_109871.jpg

Water-Side: Pumping pier in river stream with pump currently removed

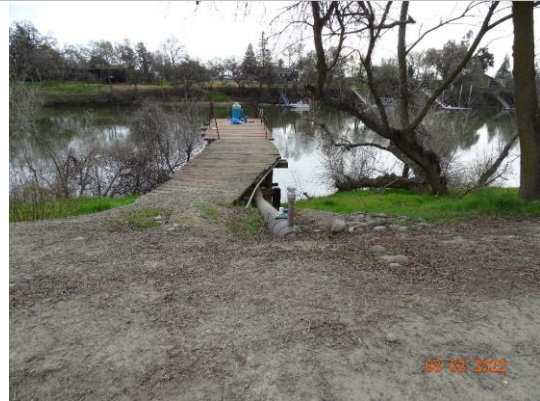
Photo 1 of 3 : UCIP_FA_2024_73691_110131.jpg

Comment Code						
Inspector Comment						
DS_ID:21478 FS_ID:73691 EP_NO: N/A Repair Type: Non-Urgent EVAL Issue: 10, Unauthorized Modification or Non-Compliant Permit Crossing Status: Found UCIP Comments: 03/03/2022 Record updated from No Action Needed to Non-Urgent. 22-inch pipe sleeved through 24-inch pipe as observed on waterside shoulder. Unable to find a permit for modification. A sinkhole or excavation on upstream side of landside CMP standpipe measured 3' x 3' x 12" deep located more than 15 feet from levee toe. Keep watching this issue to see if it grows towards the toe. Unauthorized encroachment. (O.Yakimov - DWR UCIP) FIELD_STRUCT_DESC: 22-inch pipe sleeved through 24-inch steel irrigation pipe through the levee 4.5 feet below the crown. Pump on pier in the stream, siphon breaker and air release valve on pipe at waterside shoulder. Siphon breaker on landside (LS) slope, 64-inch CMP standpipe on LS off levee toe. Water well and sand filters on LS. Overhead power line crosses the levee with poles on both slopes. 6-foot by 6-foot concrete distribution box behind CMP standpipe on LS. (24-inch pipe authorized under Permit No. 652, 1935 - California-Western States Life Insurance Company. Replacement of 22-inch pipe with a 20-inch pipe-inch pipe authorized under Permit No. 17264, 2001 - Deseret Farms of California). [Additional Reference(s): DWR Levee Log, 1988 (HLM 6.42), listed as 24-inch pipe. USACE Sacramento O&M Manual, Unit 123, August 1955, Revised 17 December 2020, (RM 77.3), listed as 24-inch pipe]. FS Date: 3/3/2022 1:25:43 PM

Water-Side: View of levee slope looking from crown. Wooden walkway to the pump

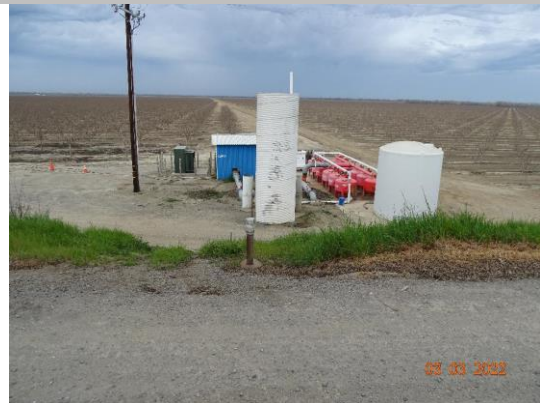
Photo 3 of 3 : UCIP_FA_2024_73691_110132.jpg

Land-Side: View of levee slope looking from crown

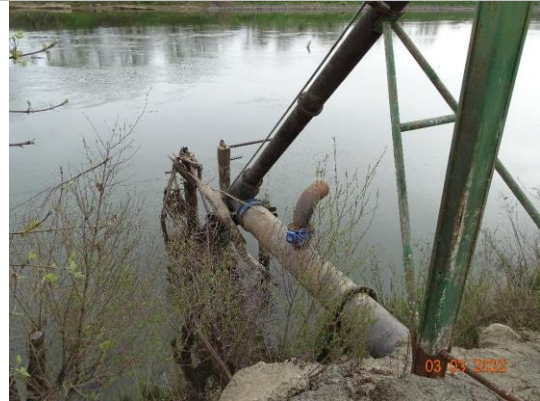
Photo 2 of 3 : UCIP_FA_2024_73694_110147.jpg

Water-Side: View of pipe at riverbank

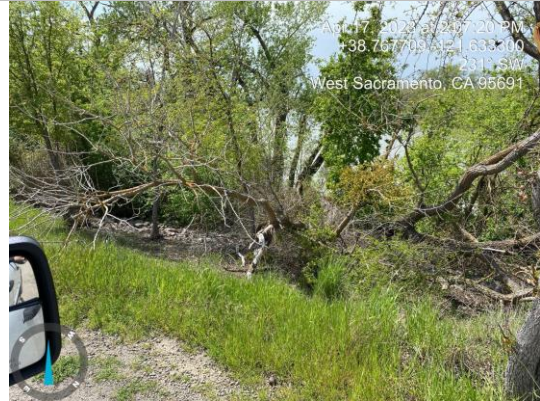
Photo 1 of 1 : FA_2024_RD1600_191_60_20241028_00033.jpg

LM Start	10.27	Rating **	M	Issue No.	60
LM End	10.27	Issue Type +	Ma	Location *	WS
Category	Earthen Levee			GPS Latitude/Longitude	
				Start	End
Item	Vegetation			38.767638°	38.767638°
				-121.633173°	-121.633173°
DWR ID	DWR_RD1600_01_s_2023_60				
Comment Code					
V2 : Remove the wild growth and woody vegetation other than native grasses from the levee slopes.					
Inspector Comment					
Fallen tree on the waterside shoulder.

View of fallen trees partially blocking access and visibility to the levee (Spring 2023).

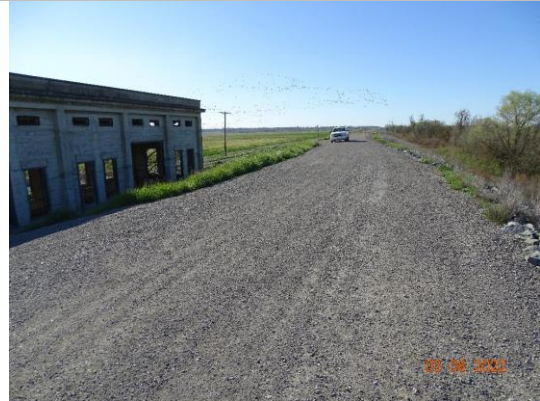
Photo 1 of 3 : UCIP_FA_2024_73777_110235.jpg

Top of Levee: View of levee crown looking downstream

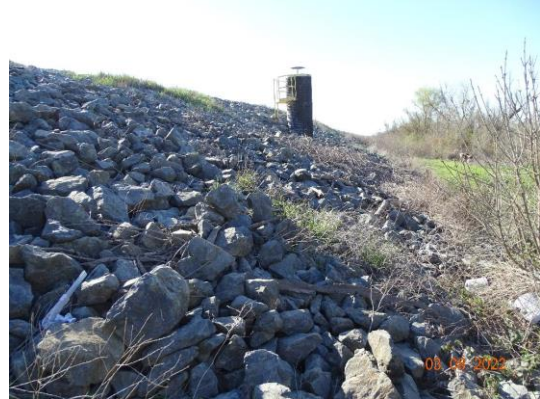
Photo 3 of 3 : UCIP_FA_2024_73777_110236.jpg

Water-Side: CMP riser with screw gate on waterside slope

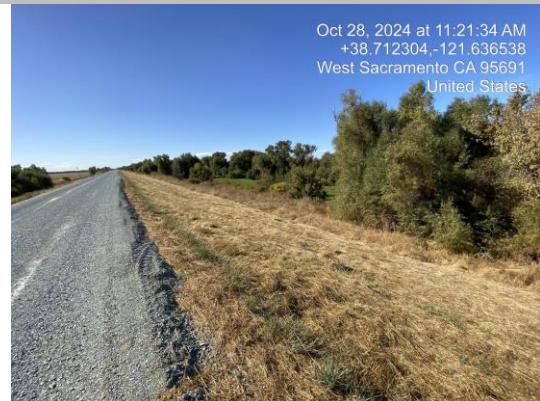
Photo 1 of 1 : FA_2024_RD1600_192_5_20241101_00013.jpg

LM Start	1.68	Rating **	A	Issue No.	5
LM End	1.68	Issue Type +	Ma	Location *	WS
Category	Earthen Levee			GPS Latitude/Longitude	
				Start	End
Item	Vegetation			38.712274°	38.712274°
				-121.636472°	-121.636472°
DWR ID	DWR_RD1600_02_f_2024_5				
Comment Code					
V1 : Control annual grass and weeds on the levee slopes and easements.					
Inspector Comment

View of good vegetation on the waterside slope (Fall 2024).

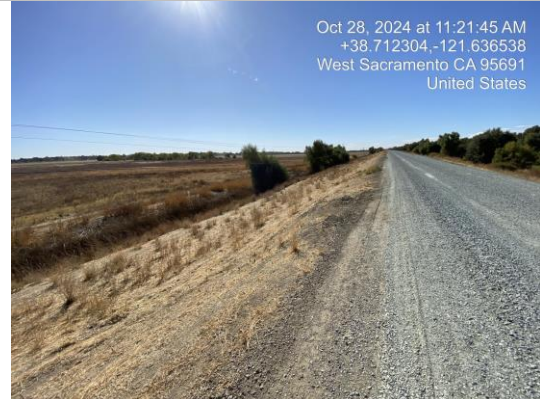
Photo 1 of 1 : FA_2024_RD1600_192_7_20241101_00014.jpg

LM Start	1.68	Rating **	A	Issue No.	7
LM End	1.68	Issue Type +	Ma	Location *	LS
Category	Earthen Levee			GPS Latitude/Longitude	
				Start	End
Item	Vegetation			38.712275°	38.712275°
				-121.636479°	-121.636479°
DWR ID	DWR_RD1600_02_f_2024_7				
Comment Code					
V1 : Control annual grass and weeds on the levee slopes and easements.					
Inspector Comment

View of good vegetation on the landside slope (Fall 2024).

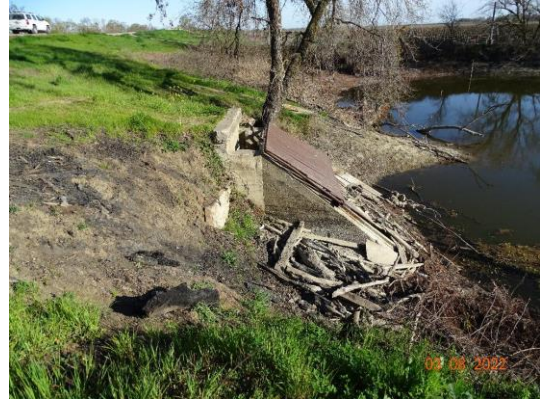
Photo 1 of 3 : UCIP_FA_2024_73790_110274.jpg

Comment Code						
Inspector Comment						
DS_ID:21502 FS_ID:73790 EP_NO: N/A Repair Type: Non-Urgent EVAL Issue: 5, Pipe Damage Crossing Status: Found UCIP Comments: 09/28/2023 MBK Engineers confirmed this pipe belongs to RD2035. (O. Yakimov - DWR UCIP) 03/08/2022 Record updated from No Action Needed to Non-Urgent. DMP internal video inspection has found pipe integrity issues. LOF of crossing is greater than or equal to 4.1 and less than 5. Crossing will be monitored until funding becomes available for rehabilitation. New slide gate actuator installed. No permit has been identified authorizing pipe. (O.Yakimov - DWR UCIP) FIELD_STRUCT_DESC: 72-inch by 72-inch dual purpose drainage-irrigation reinforced concrete box culvert through the levee, 26 feet below the crown. Steel grate at culvert inlet in a ditch on landside (LS) flow meter at this location. Slide gate on the waterside (WS) slope in a 9-foot by 10-foot concrete box. Culvert passes under the bypass canal, the railroad, and County Road 22 and terminates in Conaway irrigation canal on the southwest side of the County Road 22 bridge. [Additional Reference(s): DWR Levee Log, 1988 (HLM 4.12). USACE Sacramento O&M Manual, Unit 123, August 1955, Revised 29 December 2016, (Station 155+00), listed as 6-foot by 6-foot concrete culvert. USACE As-Built Drawing No. 06-13-0573, November 1922, Sheet 5. USACE As-Built Drawing No. 50-04-1310, October 1931, Sheet 1, Station 155+00]. FS Date: 3/8/2022 11:37:25 AM

Land-Side: Steel grate, flow meter at culvert inlet in a ditch

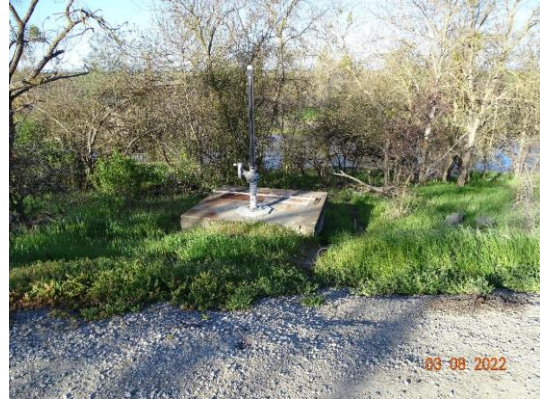
Photo 2 of 3 : UCIP_FA_2024_73790_110272.jpg

Water-Side: View of levee slope looking from crown. Concrete box with slide gate on levee slope
