**Flood Control Project Maintenance
Levee Inspections**
LMA District Cover Sheet
Spring 2014 Levee Inspection Results

Reclamation District No. 1600 Mull

Spring 2014 Levee Inspection Results

Waterway	Bank	Unit Miles
Unit No. 01 Sacramento River	Right	10.51

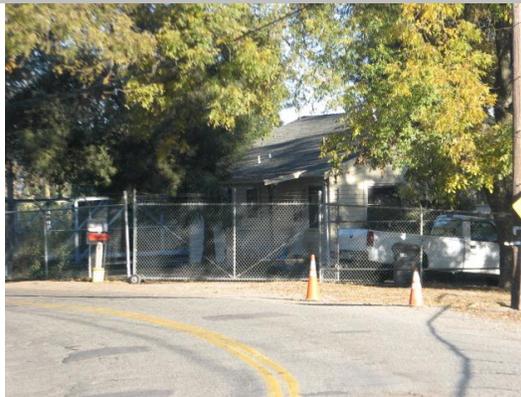
Photo 1 of 1 : johngw_s_20140414_519.jpg

LM Start	0.06	Rating **	M	Issue No.	1
LM End	0.06	Issue Type +	En	Location *	WS
Category	Earthen Levee			GPS Latitude/Longitude	
				Start	End
Item	Encroachments			38.675998 °	38.675998 °
				-121.630732 °	-121.630732 °
DWR ID	DWR_RD1600_01_s_2012_1				
Action/Comments					
Building Inspector Comments: This is the home and pumping plant for RD 2035.

The caretakers home for the operator of the pumping plant (RD 2035).
Fall 2013

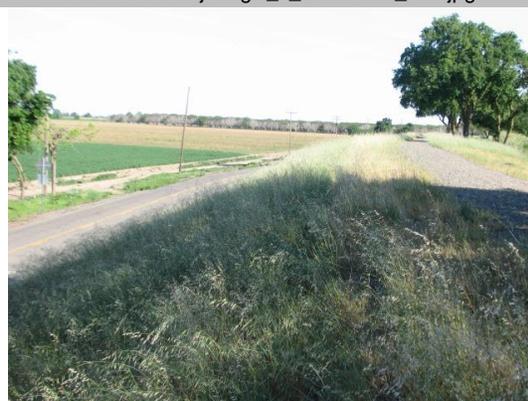
Photo 1 of 1 : johngw_s_20140421_814.jpg

Tall grasses partially blocks visibility. Spring 2014

LM Start	0.10	Rating **	M	Issue No.	622
LM End	6.59	Issue Type +	Ma	Location *	LS
Category	Earthen Levee			GPS Latitude/Longitude	
				Start	End
Item	Vegetation			38.676472 °	38.758996 °
				-121.631226 °	-121.594092 °
DWR ID	DWR_RD1600_01_s_2014_622				
Action/Comments					
Control annual grass and weeds on the levee slopes and easements.

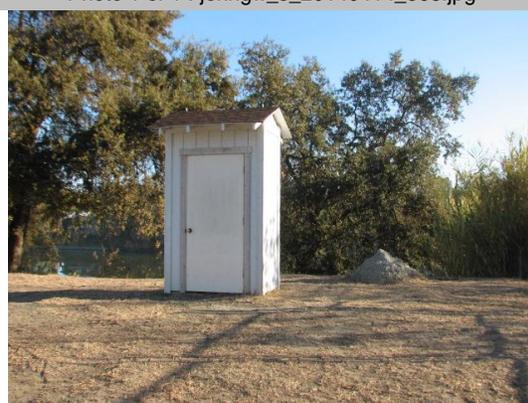
Photo 1 of 1 : johngw_s_20140414_568.jpg

LM Start	0.10	Rating **	M	Issue No.	129
LM End	0.10	Issue Type +	En	Location *	WS
Category	Earthen Levee			GPS Latitude/Longitude	
				Start	End
Item	Encroachments			38.676467 °	38.676467 °
				-121.631217 °	-121.631217 °
DWR ID	DWR_RD1600_01_f_2013_129				
Action/Comments					
Building Inspector Comments: This is a well pump house. It is potable water for the house and pumping plant.

The small building is a pump house for the well. It services the house with water. Fall 2013

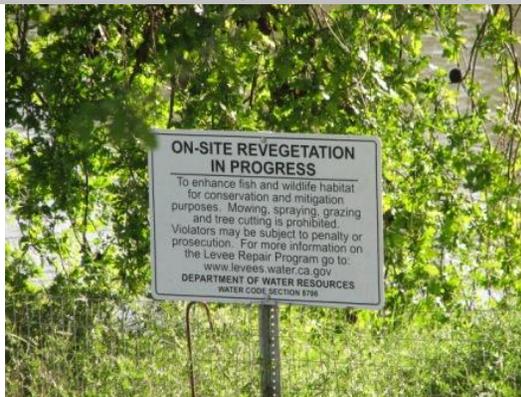
Photo 1 of 2 : johngw_s_20140414_566.jpg

LM Start	0.10	Rating **	A/W	Issue No.	49
LM End	0.24	Issue Type +	Ob	Location *	WS
Category	Earthen Levee			GPS Latitude/Longitude	
				Start	End
Item	Vegetation			38.676480 °	38.678140 °
				-121.631220 °	-121.632330 °
DWR ID	DWR_RD1600_01_s_2012_49				
Action/Comments					
Environmental Requirements.

Revegetation site. Photo taken spring 2012.

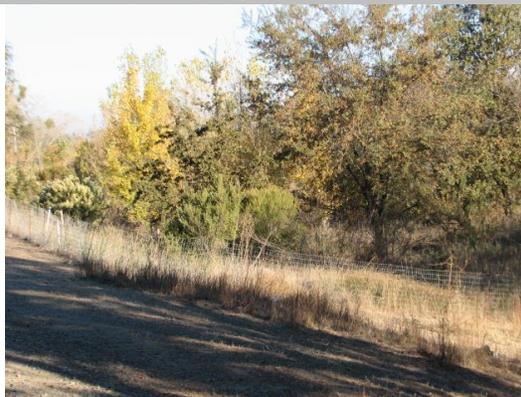
Photo 2 of 2 : johngw_s_20140414_567.jpg

The revegetation area is fenced off but nobody has been caring for it. Fall 2013

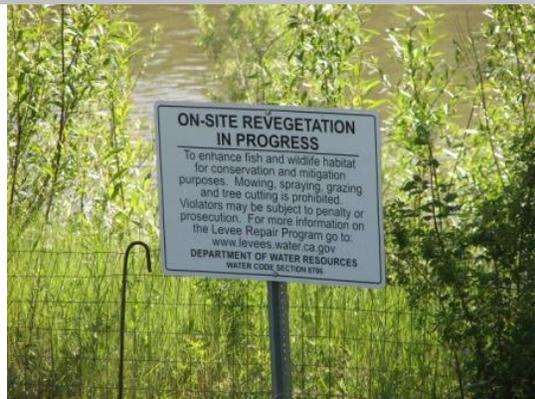
Photo 1 of 2 : johngw_s_20140414_551.jpg

LM Start	1.02	Rating **	A/W	Issue No.	22
LM End	1.11	Issue Type +	Ma	Location *	WS
Category	Earthen Levee		GPS Latitude/Longitude		
			Start	End	
Item	Vegetation		38.689078 °	38.690267 °	
			-121.635605 °	-121.635650 °	
DWR ID	DWR_RD1600_01_s_2012_22				
Action/Comments					
Environmental Requirements.

Revegetation site. Photo taken spring 2012.

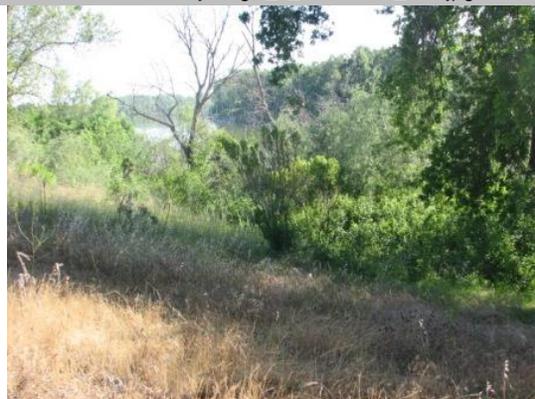
Photo 2 of 2 : johngw_s_20140414_552.jpg

The revegetation site along the berm and shoulder of the river.

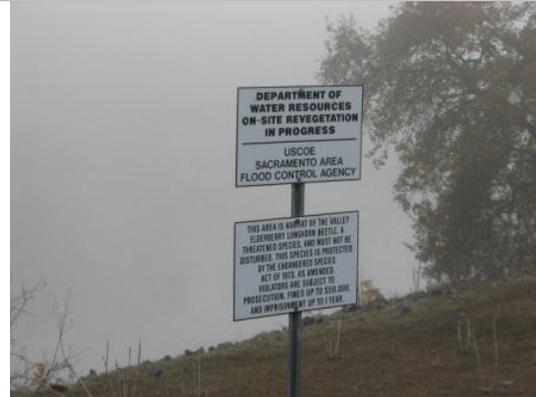
Photo 1 of 2 : johngw_s_20140414_524.jpg

LM Start	1.42	Rating **	A/W	Issue No.	5
LM End	1.42	Issue Type +	Ma	Location *	WS
Category	Earthen Levee		GPS Latitude/Longitude		
			Start	End	
Item	Vegetation		38.694589 °	38.694589 °	
			-121.634286 °	-121.634286 °	
DWR ID	DWR_RD1600_01_f_2012_5				
Action/Comments					
Environmental Requirements.

Revegetation site. Fall 2012.

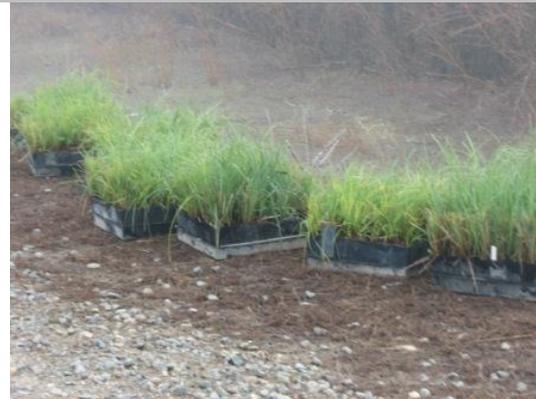
Photo 2 of 2 : johngw_s_20140414_525.jpg

Flats of plant material to be planted at the site. Fall 2012

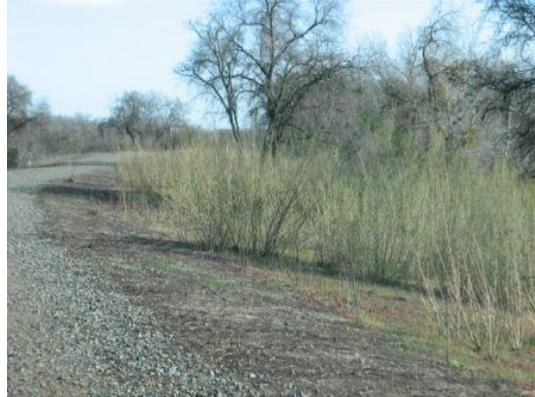
Photo 2 of 2 : johngw_s_20140414_530.jpg

Willows are starting to come back creeping up on to the shoulder. Spring 2013

LM Start	1.58	Rating **	M	Issue No.	7 (cont)
LM End	1.58	Issue Type +	Ma	Location *	WS
Category	Earthen Levee			GPS Latitude/Longitude	
				Start	End
Item	Vegetation			38.696748 °	38.696748 °
				-121.633201 °	-121.633201 °
DWR ID	DWR_RD1600_01_f_2012_7				
Action/Comments					
Remove the wild growth other than native grasses from the levee slopes.

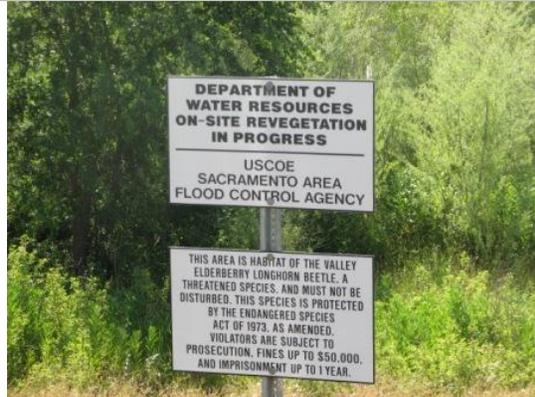
Photo 1 of 2 : johngw_s_20140414_561.jpg

LM Start	1.73	Rating **	A/W	Issue No.	31
LM End	1.73	Issue Type +	En	Location *	WS
Category	Earthen Levee			GPS Latitude/Longitude	
				Start	End
Item	Vegetation			38.698613 °	38.698613 °
				-121.631710 °	-121.631710 °
DWR ID	DWR_RD1600_01_s_2012_31				
Action/Comments					
Environmental Requirements.

Revegetation site with the Elderberry Beetle. Photo taken spring 2012.

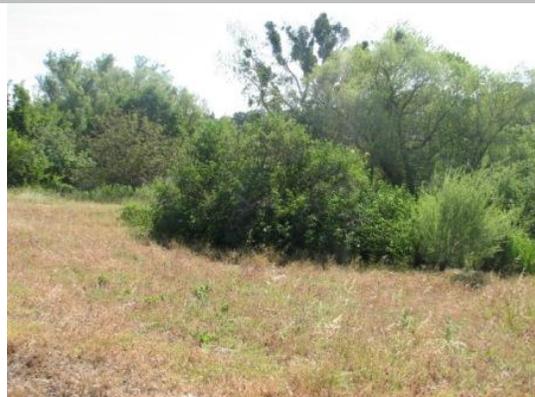
Photo 2 of 2 : johngw_s_20140414_562.jpg

A photo of a Elderberry bush in the area.

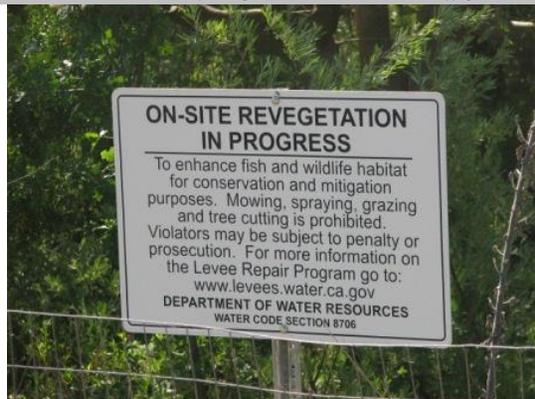
Photo 1 of 2 : johngw_s_20140414_563.jpg

LM Start	2.36	Rating **	A/W	Issue No.	35
LM End	2.42	Issue Type +	Ma	Location *	WS
Category	Earthen Levee			GPS Latitude/Longitude	
				Start	End
Item	Vegetation			38.704592 °	38.705152 °
				-121.623067 °	-121.622187 °
DWR ID	DWR_RD1600_01_s_2012_35				
Action/Comments					
Environmental Requirements.

Revegetation site, photo taken spring 2012.

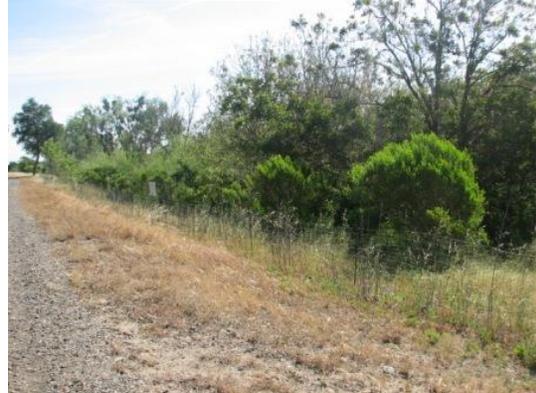
Photo 2 of 2 : johngw_s_20140414_564.jpg

The revegetation site extends almost to the hinge point.

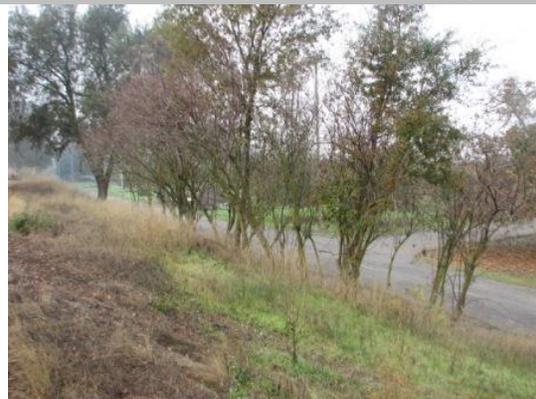
Photo 1 of 1 : johngw_s_20140414_565.jpg

LM Start	3.06	Rating **	A/W	Issue No.	37
LM End	3.06	Issue Type +	Ma	Location *	LS
Category	Earthen Levee		GPS Latitude/Longitude		
			Start	End	
Item	Vegetation		38.711597 °	38.711597 °	
			-121.613890 °	-121.613890 °	
DWR ID	DWR_RD1600_01_s_2012_37				
Action/Comments					
Elderberries are blocking visibility and flood fight capability.

A large stand of elderberries on the landside slope. Fall 2012

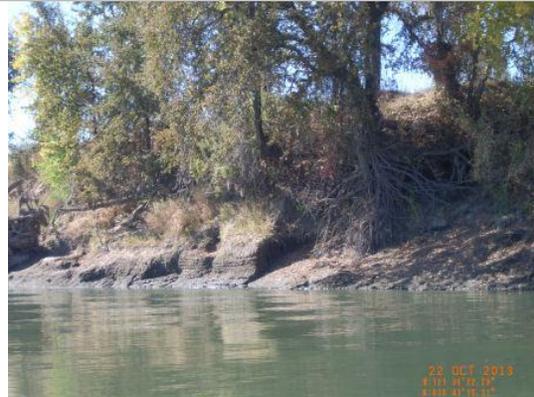
Photo 1 of 1 : USACE2013A_SAC_74-4_R_3.jpg

LM Start	3.55	Rating **	M	Issue No.	8
LM End	3.55	Issue Type +	Ma	Location *	WS
Category	Supplemental			GPS Latitude/Longitude	
				Start	End
Item	USACE Erosion Survey			38.717770 °	38.721351 °
				-121.607423 °	-121.606414 °
DWR ID					
Action/Comments					
Inspector Comments: 1997 - Steep high bank. 2005 - Some small pockets in the low toe near the waterline. 2006 - Minor slope clearing. 2010 - Minor new erosion. 2011 - Multiple trees have fallen since last year. Some other trees look ready to fall. Significant new erosion since last year. 2012 - Minor new erosion. 2013: Minor new erosion. [2013 Site ID: SAC_74-4_R]

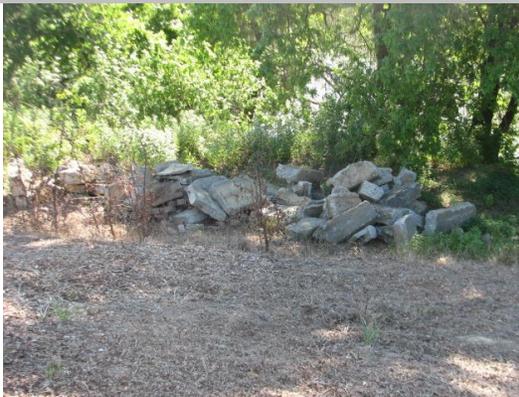
Photo 1 of 1 : johngw_s_20140421_822.jpg

LM Start	3.62	Rating **	M	Issue No.	628
LM End	3.62	Issue Type +	En	Location *	WS
Category	Earthen Levee		GPS Latitude/Longitude		
			Start	End	
Item	Encroachments		38.718080 °	38.718080 °	
			-121.607815 °	-121.607815 °	
DWR ID	DWR_RD1600_01_s_2014_628				
Action/Comments					
Debris

Concrete debris is on the waterside berm. Spring 2014

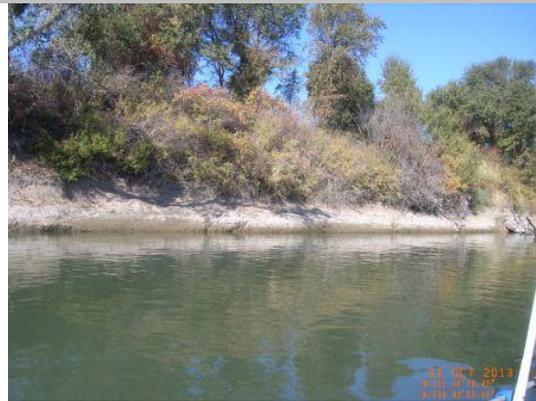
Photo 1 of 1 : USACE2013A_SAC_75-3_R_11.jpg

LM Start	4.21	Rating **	M	Issue No.	10
LM End	4.21	Issue Type +	Ma	Location *	WS
Category	Supplemental			GPS Latitude/Longitude	
				Start	End
Item	USACE Erosion Survey			38.728684 °	38.736110 °
				-121.605844 °	-121.604153 °
DWR ID					
Action/Comments					
Inspector Comments: 1997 - Very steep bank. 2005 - Lots of small trees down along the bank at the upstream end. 2006 - Minor new erosion, but slow. 2010 - Almost all of the roots are exposed on the trees, appears ready to fall. 2011 - New erosion and tree popouts. 2012 - Site has become overgrown with vegetation, making it hard to observe. 2013: No observed changes. [2013 Site ID: SAC_75-3_R]

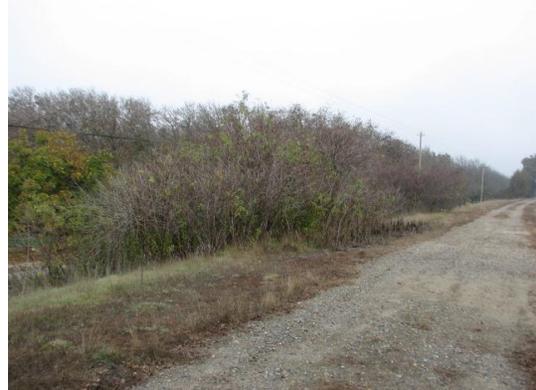
Photo 1 of 1 : johngw_s_20140414_543.jpg

LM Start	5.43	Rating **	A/W	Issue No.	13
LM End	5.43	Issue Type +	Ma	Location *	LS
Category	Earthen Levee		GPS Latitude/Longitude		
			Start	End	
Item	Vegetation		38.743632 °	38.743632 °	
			-121.601173 °	-121.601173 °	
DWR ID	DWR_RD1600_01_s_2012_13				
Action/Comments					
Elderberries are blocking visibility and flood fight capability.

A thick stand of elderberries on the landside. Fall 2012

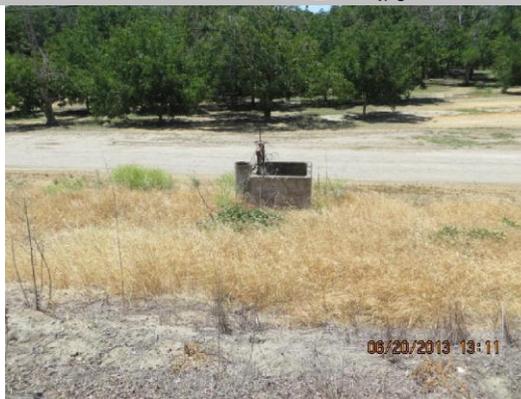
Photo 1 of 1 : UCIP_1246.jpg

LM Start	6.22	Rating **	M	Issue No.	619
LM End	6.22	Issue Type +	En	Location *	WS
Category	Supplemental			GPS Latitude/Longitude	
				Start	End
Item	DWR UCIP Field Study			38.753820 °	38.753820 °
				-121.595012 °	-121.595012 °
DWR ID	DWR_RD1600_01_s_2014_619				
Action/Comments					
Inspector Comments: FS_ID:15207 EP_NO: N/A Repair Type: Crossing Status: UCIP Comments: Pipe is abandoned and open on both ends. It should be abandoned properly. FIELD_STRUCT_DESC: 18-inch pipe through levee 4.5 feet below crown. Walkway from berm to pump on pile structure in stream. Overhead power line crosses levee, service pole on the waterward slope. 6'X6' Concrete distribution box at the toe of the landward slope. Originally included in the 1955 O+M manual at RM 77. FS Date: 6/20/2013

6'X6' concrete distribution box on LS toe.

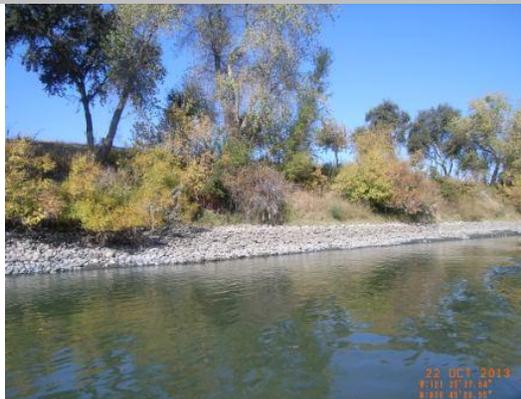
Photo 1 of 1 : USACE2013A_SAC_77-0_R_1.jpg

LM Start	6.23	Rating **	M	Issue No.	11
LM End	6.23	Issue Type +	Ma	Location *	WS
Category	Supplemental			GPS Latitude/Longitude	
				Start	End
Item	USACE Erosion Survey			38.755246 °	38.756186 °
				-121.594206 °	-121.594024 °
DWR ID					
Action/Comments					
Inspector Comments: 2011 - Large vertical eroded face from a rotational failure just below pump. 2013: No observed changes. [2013 Site ID: SAC_77-0_R]

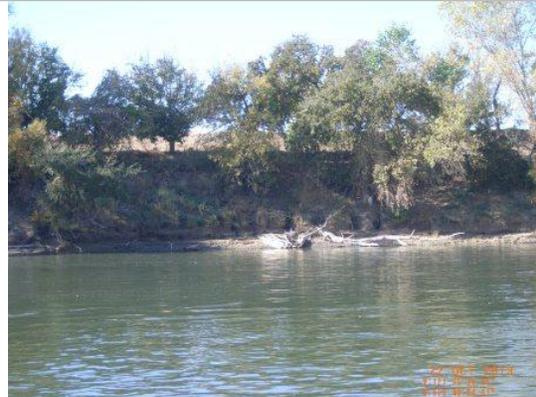
Photo 1 of 1 : USACE2013A_SAC_77-7_R_3.jpg

LM Start	6.98	Rating **	M	Issue No.	12
LM End	6.98	Issue Type +	Ma	Location *	WS
Category	Supplemental		GPS Latitude/Longitude		
			Start	End	
Item	USACE Erosion Survey		38.764801 °	38.765219 °	
			-121.594926 °	-121.595049 °	
DWR ID					
Action/Comments					
Inspector Comments: 2006 - Eddy scour off end of rock causing erosion and scour hole near levee. Sandy silt bank with rock on upstream end. 2010 - Trees are leaning more, minor new erosion. 2011 - Many of the tree roots have scoured out and trees look ready to fall. 2013: No observed changes. [2013 Site ID: SAC_77-7_R]

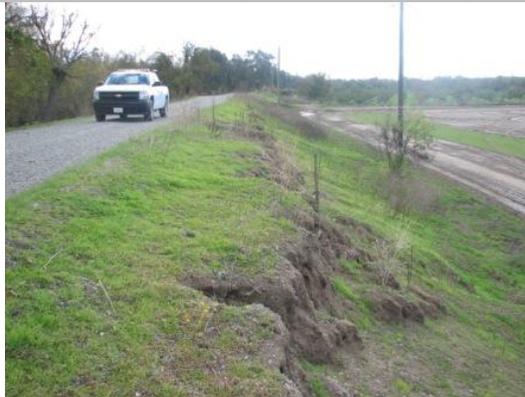
Photo 1 of 1 : johngw_s_20140414_557.jpg

LM Start	7.02	Rating **	M	Issue No.	27
LM End	7.02	Issue Type +	Ma	Location *	LS
Category	Earthen Levee			GPS Latitude/Longitude	
				Start	End
Item	Erosion / Bank Caving			38.764974 °	38.764974 °
				-121.595533 °	-121.595533 °
DWR ID	DWR_RD1600_01_s_2012_27				
Action/Comments					
Note and monitor erosion site.

The erosion appears to be moving closer to the shoulder.

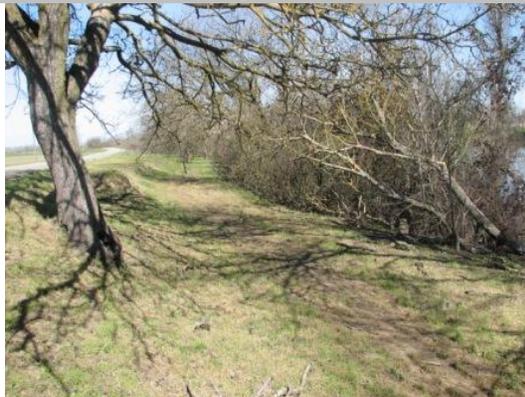
Photo 1 of 2 : johngw_s_20140414_547.jpg

LM Start	7.13	Rating **	M	Issue No.	20
LM End	7.13	Issue Type +	Ma	Location *	WS
Category	Earthen Levee			GPS Latitude/Longitude	
				Start	End
Item	Erosion / Bank Caving			38.766505 °	38.766505 °
				-121.596214 °	-121.596214 °
DWR ID	DWR_RD1600_01_s_2012_20				
Action/Comments					
Note and monitor erosion site.

The erosion is eroding away at the berm area.

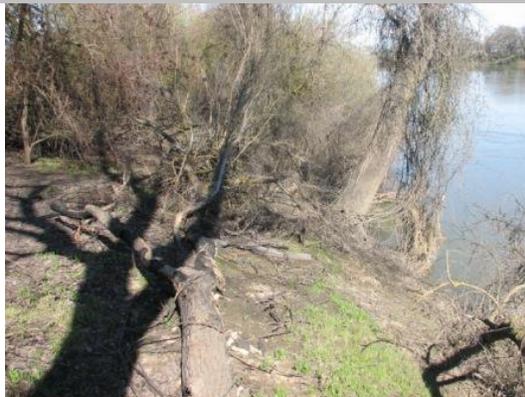
Photo 2 of 2 : johngw_s_20140414_548.jpg

LM Start	7.13	Rating **	M	Issue No.	20 (cont)
LM End	7.13	Issue Type +	Ma	Location *	WS

This another view of the site.

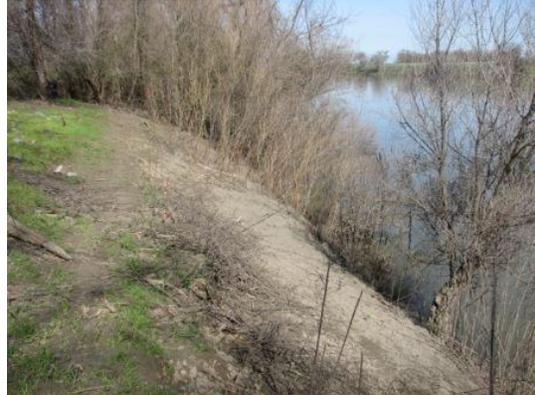
Photo 1 of 2 : johngw_s_20140414_549.jpg

LM Start	7.27	Rating **	M	Issue No.	21
LM End	7.27	Issue Type +	Ma	Location *	WS
Category	Earthen Levee			GPS Latitude/Longitude	
				Start	End
Item	Erosion / Bank Caving			38.768409 °	38.768409 °
				-121.597213 °	-121.597213 °
DWR ID	DWR_RD1600_01_s_2012_21				
Action/Comments					
Note and monitor erosion site.

The bank is eroding away and has become very steep.

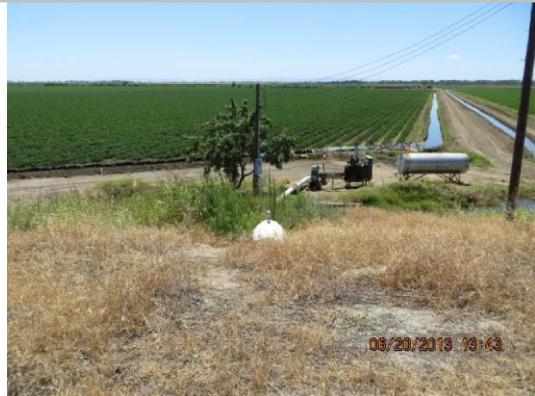
Photo 1 of 1 : UCIP_1250.jpg

LM Start	7.60	Rating **	M	Issue No.	620
LM End	7.60	Issue Type +	En	Location *	WS
Category	Supplemental			GPS Latitude/Longitude	
				Start	End
Item	DWR UCIP Field Study			38.772560 °	38.772560 °
				-121.600153 °	-121.600153 °
DWR ID	DWR_RD1600_01_s_2014_620				
Action/Comments					
Inspector Comments: FS_ID:15264

Pipe on LS shoulder.

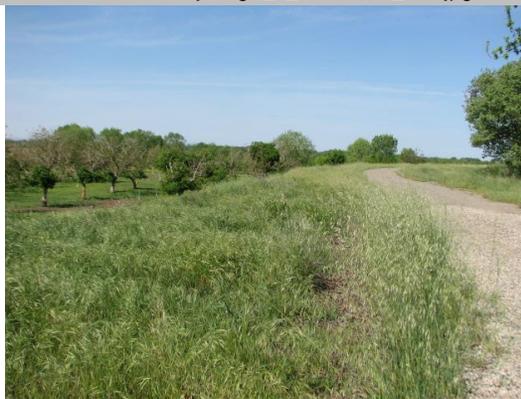
Photo 1 of 1 : johngw_s_20140421_827.jpg

LM Start	8.14	Rating **	M	Issue No.	632
LM End	10.51	Issue Type +	Ma	Location *	LS
Category	Earthen Levee		GPS Latitude/Longitude		
			Start	End	
Item	Vegetation		38.778327 °	38.765488 °	
			-121.606661 °	-121.634943 °	
DWR ID	DWR_RD1600_01_s_2014_632				
Action/Comments					
Control annual grass and weeds on the levee slopes and easements.

Tall grasses partially blocks visibility. Spring 2014

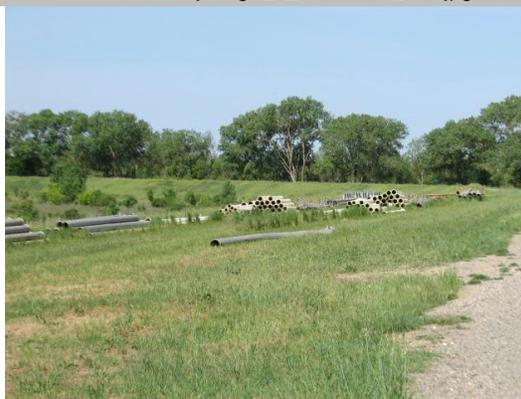
Photo 1 of 1 : johngw_s_20140421_828.jpg

LM Start	8.93	Rating **	M	Issue No.	634
LM End	8.93	Issue Type +	En	Location *	LS
Category	Earthen Levee		GPS Latitude/Longitude		
			Start	End	
Item	Encroachments		38.782002 °	38.782002 °	
			-121.620403 °	-121.620403 °	
DWR ID	DWR_RD1600_01_s_2014_634				
Action/Comments					
Pipe

Irrigation pipe is being stored on the landside. Spring 2014

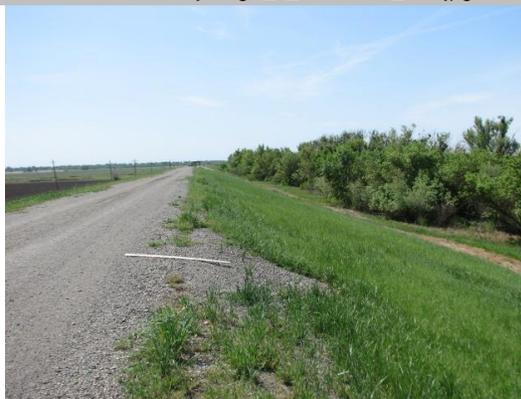
Photo 1 of 1 : johngw_s_20140421_829.jpg

LM Start	0.00	Rating **	A	Issue No.	152
LM End	0.81	Issue Type +	Ma	Location *	WS
Category	Earthen Levee		GPS Latitude/Longitude		
			Start	End	
Item	Vegetation		38.736018 °	38.724343 °	
			-121.633660 °	-121.633418 °	
DWR ID	DWR_RD1600_02_s_2014_152				
Action/Comments					
Control annual grass and weeds on the levee slopes and easements.

The vegetation complies with standards. Spring 2014

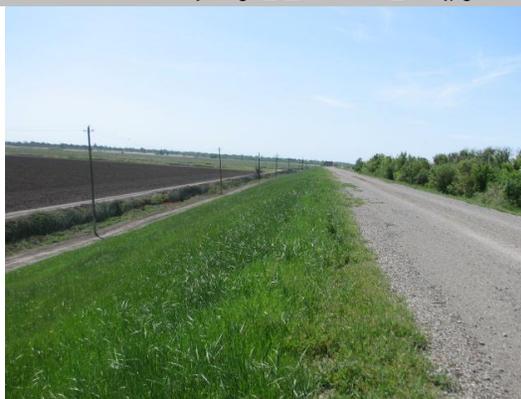
Photo 1 of 1 : johngw_s_20140421_830.jpg

LM Start	0.00	Rating **	A	Issue No.	151
LM End	0.81	Issue Type +	Ma	Location *	LS
Category	Earthen Levee		GPS Latitude/Longitude		
			Start	End	
Item	Vegetation		38.736017 °	38.724343 °	
			-121.633661 °	-121.633418 °	
DWR ID	DWR_RD1600_02_s_2014_151				
Action/Comments					
Control annual grass and weeds on the levee slopes and easements.

The vegetation c omplies with standards. Spring 2014

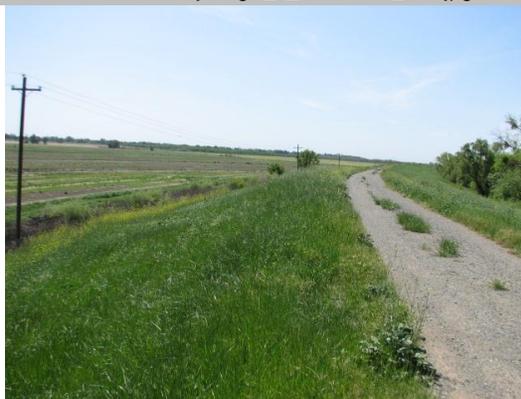
Photo 1 of 1 : johngw_s_20140421_831.jpg

LM Start	0.81	Rating **	M	Issue No.	5
LM End	2.95	Issue Type +	Ma	Location *	LS
Category	Earthen Levee		GPS Latitude/Longitude		
			Start	End	
Item	Vegetation		38.724344 °	38.694531 °	
			-121.633418 °	-121.644119 °	
DWR ID	DWR_RD1600_02_s_2014_5				
Action/Comments					
Control annual grass and weeds on the levee slopes and easements.

Tall grasses partially blocks visibility. Spring 2014

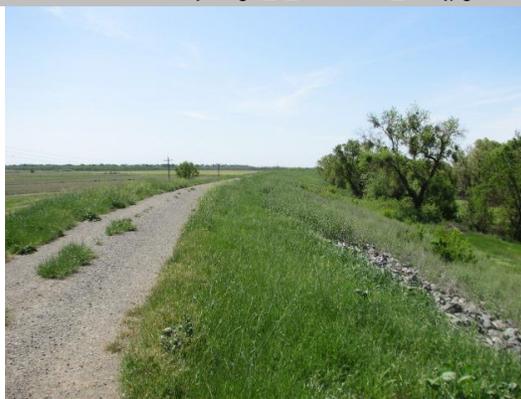
Photo 1 of 1 : johngw_s_20140421_832.jpg

LM Start	0.81	Rating **	M	Issue No.	8
LM End	2.95	Issue Type +	Ma	Location *	WS
Category	Earthen Levee		GPS Latitude/Longitude		
			Start	End	
Item	Vegetation		38.724344 °	38.694529 °	
			-121.633418 °	-121.644117 °	
DWR ID	DWR_RD1600_02_s_2014_8				
Action/Comments					
Control annual grass and weeds on the levee slopes and easements.

Tall grasses partially blocks visibility. Spring 2014

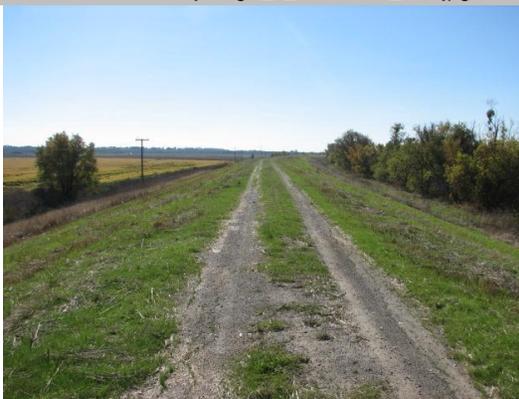
Photo 2 of 2 : johngw_s_20140414_699.jpg

LM Start	0.85	Rating **	M	Issue No.	31 (cont)
LM End	4.08	Issue Type +	Ma	Location *	CR
Category	Earthen Levee			GPS Latitude/Longitude	
				Start	End
Item	Crown Surface / Depressions / Rutting			38.723730 °	38.678393 °
				-121.633372 °	-121.643858 °
DWR ID	DWR_RD1600_02_s_2012_31				
Action/Comments					
Add appropriate gravel or road base. Grade and compact.

The crown of the levee needs to be weed free. Fall 2012

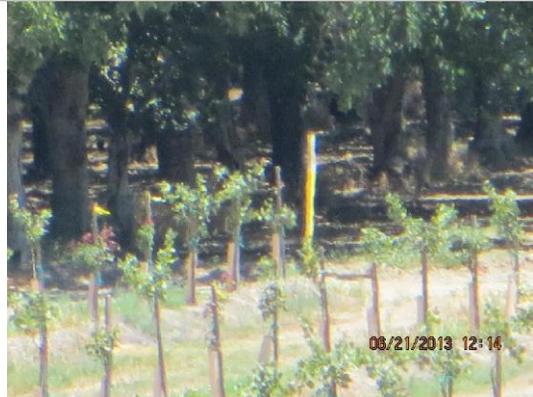
Photo 1 of 1 : UCIP_1450.jpg

LM Start	3.69	Rating **	M	Issue No.	150
LM End	3.69	Issue Type +	En	Location *	WS
Category	Supplemental			GPS Latitude/Longitude	
				Start	End
Item	DWR UCIP Field Study			38.683971 °	38.683971 °
				-121.644522 °	-121.644522 °
DWR ID	DWR_RD1600_02_s_2014_150				
Action/Comments					
Inspector Comments: FS_ID:16308

Carsonite gasoline marker visible approximately 1,000-feet east of levee crown.
