**Flood Control Project Maintenance
Levee Inspections**
LMA District Cover Sheet
Spring 2016 Levee Inspection Results

Reclamation District No. 1600 Mull

Spring 2016 Levee Inspection Results

Waterway		Bank	Unit Miles	
Unit No. 01 Sacramento River		Right	10.46	
	Spring (March - May)	Summer (June - August)	(September - November) Fall	Winter (December - February)
Unit Maintenance Rating (Fall Only)				
Date of Inspection	3/24/2016 - 3/24/2016			
DWR Inspector	Jai Lor			
Accompanied By

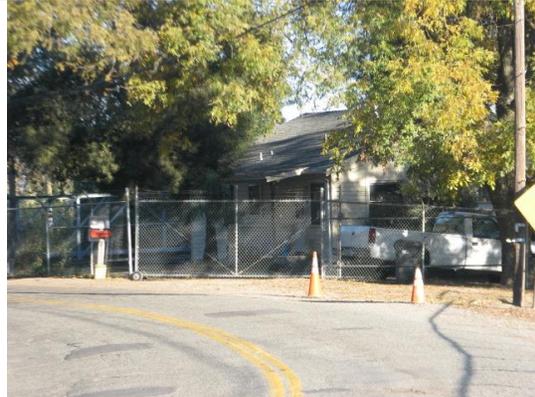
Photo 1 of 1 : SP_2016_RD1600_191_1_20160304_00001.jpg

LM Start	0.06	Rating **	M	Issue No.	1
LM End	0.06	Issue Type +	En	Location *	WS
Category	Earthen Levee		GPS Latitude/Longitude		
			Start	End	
Item	Encroachments		38.675998 °	38.675998 °	
			-121.630732 °	-121.630732 °	
DWR ID	DWR_RD1600_01_s_2012_1				
Comment Code					
BU : Building					
Inspector Comment					
This is the home and pumping plant for RD 2035.

The caretakers home for the operator of the pumping plant (RD 2035).
Fall 2013

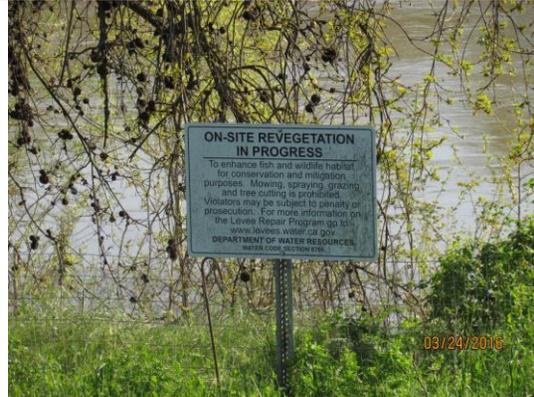
Photo 1 of 2 : SP_2016_RD1600_191_49_20160407_00099.jpg

LM Start	0.11	Rating **	A/W	Issue No.	49
LM End	0.23	Issue Type +	Ob	Location *	WS
Category	Earthen Levee		GPS Latitude/Longitude		
			Start	End	
Item	Vegetation		38.676577 °	38.678131 °	
			-121.631290 °	-121.632324 °	
DWR ID	DWR_RD1600_01_s_2012_49				
Comment Code					
V8 : Environmental Requirements.					
Inspector Comment

Sign stating revegetation site. Spring 2016.

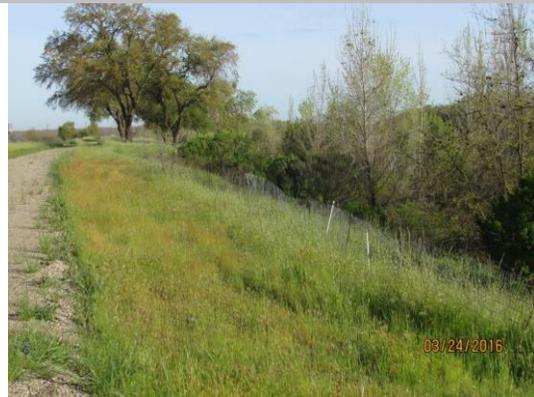
Photo 2 of 2 : SP_2016_RD1600_191_49_20160407_00100.jpg

View of the revegetation site and fence on the waterward side of the levee looking upstream. Spring 2016.

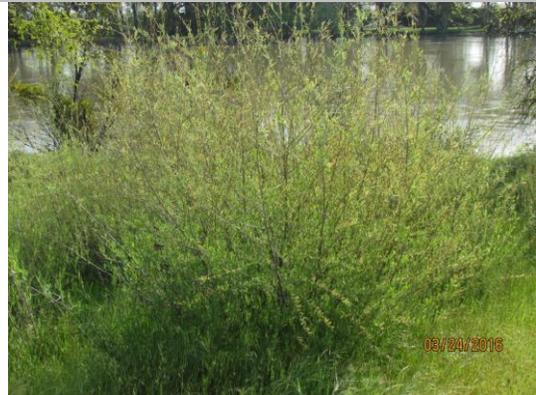
Photo 2 of 2 : SP_2016_RD1600_191_29_20160407_00103.jpg

Willows are growing on the waterward side of the levee. Spring 2016.

LM Start	0.62	Rating **	M	Issue No.	29
LM End	0.62	Issue Type +	Ma	Location *	WS
Category	Earthen Levee		GPS Latitude/Longitude		
			Start	End	
Item	Vegetation		38.683415 °	38.683415 °	
			-121.634448 °	-121.634448 °	
DWR ID	DWR_RD1600_01_s_2016_29				
Comment Code					
V2 : Remove the wild growth other than native grasses from the levee slopes.					
Inspector Comment					
Recommend removal of willow trees.

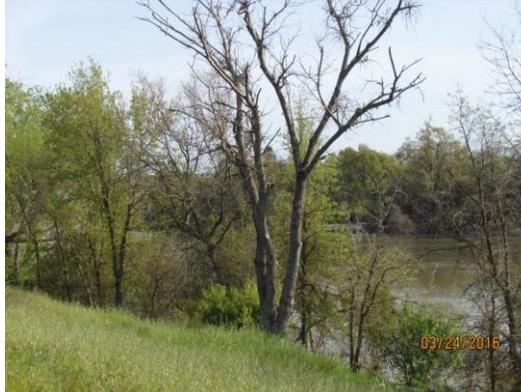
Photo 1 of 1 : SP_2016_RD1600_191_625_20160407_00105.jpg

LM Start	0.83	Rating **	A/W	Issue No.	625
LM End	0.83	Issue Type +	Ma	Location *	WS
Category	Earthen Levee			GPS Latitude/Longitude	
				Start	End
Item	Vegetation			38.686515 °	38.686515 °
				-121.635134 °	-121.635134 °
DWR ID	DWR_RD1600_01_s_2014_625				
Comment Code					
V7 : Trees / Woody Vegetation					
Inspector Comment					
The tree is dying and needs to be monitored so there is no threat to the levee

View of the tree on the waterward side of the levee. Spring 2016.

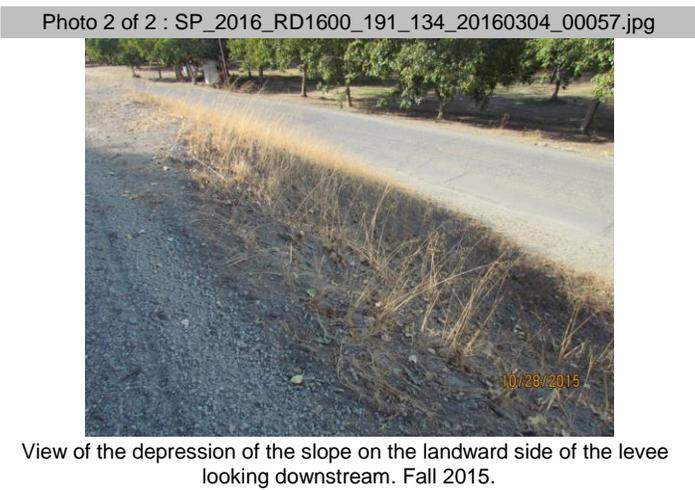
The levee has a deep depression caused by slope stability. Fall 2013

LM Start	0.97	Rating **	M	Issue No.	134 (cont)
LM End	0.97	Issue Type +	Ma	Location *	LS
Category	Earthen Levee			GPS Latitude/Longitude	
				Start	End
Item	Slope Stability			38.688454 °	38.688454 °
				-121.635528 °	-121.635528 °
DWR ID	DWR_RD1600_01_f_2013_134				
Comment Code					
S1 : Repair slope instability.					
Inspector Comment

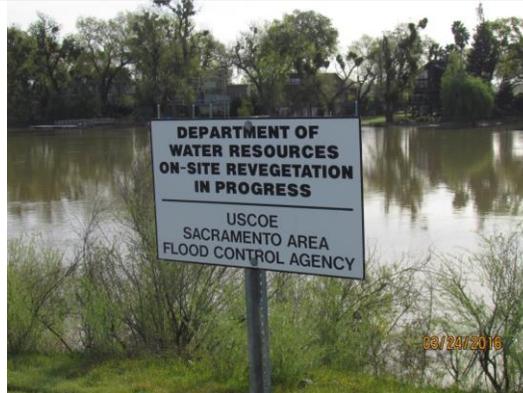
Photo 2 of 2 : SP_2016_RD1600_191_5_20160407_00109.jpg

LM Start	1.40	Rating **	A/W	Issue No.	5 (cont)
LM End	1.40	Issue Type +	Ob	Location *	WS
Category	Earthen Levee		GPS Latitude/Longitude		
			Start	End	
Item	Vegetation		38.694469 °	38.694469 °	
			-121.634312 °	-121.634312 °	
DWR ID	DWR_RD1600_01_f_2012_5				
Comment Code					
V8 : Environmental Requirements.					
Inspector Comment

DWR revegetation site. Spring 2016.

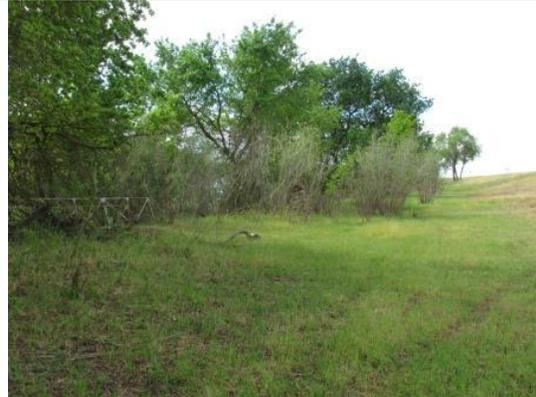
Photo 1 of 1 : SP_2016_RD1600_191_626_20160304_00062.jpg

LM Start	1.70	Rating **	M	Issue No.	626
LM End	1.70	Issue Type +	En	Location *	WS
Category	Earthen Levee		GPS Latitude/Longitude		
			Start	End	
Item	Encroachments		38.698415 °	38.698415 °	
			-121.631850 °	-121.631850 °	
DWR ID	DWR_RD1600_01_s_2015_626				
Comment Code					
DE : Debris					
Inspector Comment

View of debris on the waterward side of the levee looking downstream. Spring 2015.

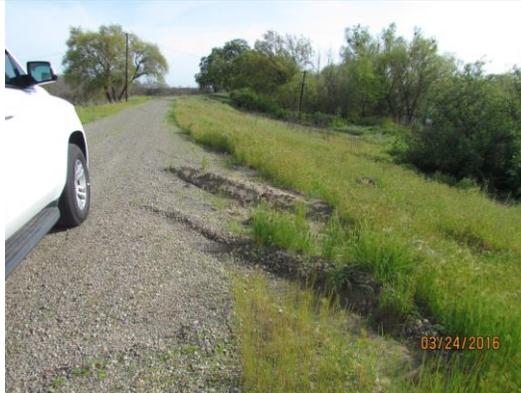
Photo 1 of 1 : SP_2016_RD1600_191_71_20160407_00111.jpg

LM Start	1.72	Rating **	M	Issue No.	71
LM End	1.72	Issue Type +	Ma	Location *	WS
Category	Earthen Levee			GPS Latitude/Longitude	
				Start	End
Item	Slope Stability			38.698628 °	38.698628 °
				-121.631694 °	-121.631694 °
DWR ID	DWR_RD1600_01_s_2016_71				
Comment Code					
S3 : Repair the levee slope damaged by vehicle traffic and prevent access where possible.					
Inspector Comment

View of the ruts on the shoulder of the levee on the waterward side. Spring 2016.

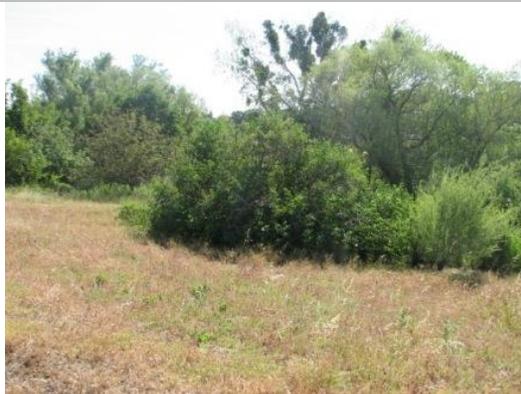
Photo 1 of 2 : SP_2016_RD1600_191_31_20160304_00028.jpg

LM Start	1.72	Rating **	A/W	Issue No.	31
LM End	1.72	Issue Type +	Ob	Location *	WS
Category	Earthen Levee			GPS Latitude/Longitude	
				Start	End
Item	Vegetation			38.698639 °	38.698639 °
				-121.631687 °	-121.631687 °
DWR ID	DWR_RD1600_01_s_2012_31				
Comment Code					
V8 : Environmental Requirements.					
Inspector Comment

A photo of a Elderberry bush in the area.

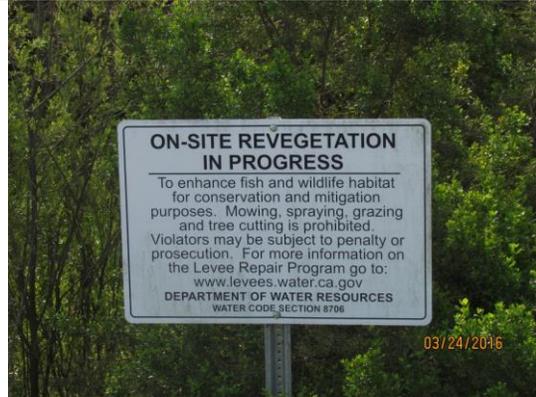
Photo 1 of 2 : SP_2016_RD1600_191_35_20160407_00116.jpg

LM Start	2.35	Rating **	A/W	Issue No.	35
LM End	2.40	Issue Type +	Ma	Location *	WS
Category	Earthen Levee			GPS Latitude/Longitude	
				Start	End
Item	Vegetation			38.704624 °	38.705152 °
				-121.623034 °	-121.622187 °
DWR ID	DWR_RD1600_01_s_2012_35				
Comment Code					
V8 : Environmental Requirements.					
Inspector Comment

Sign for revegetation site. Spring 2016.

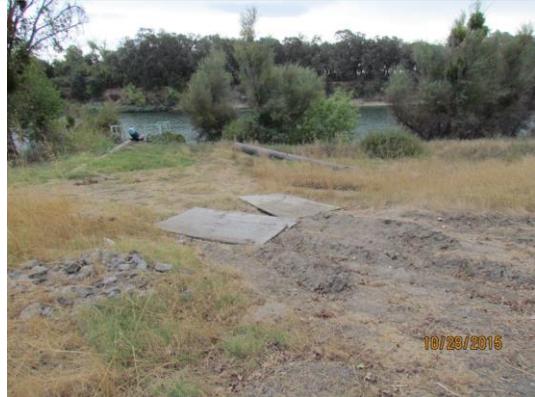
Photo 2 of 2 : SP_2016_RD1600_191_627_20160304_00064.jpg

LM Start	3.57	Rating **	M	Issue No.	627 (cont)
LM End	3.57	Issue Type +	En	Location *	WS
Category	Earthen Levee			GPS Latitude/Longitude	
				Start	End
Item	Encroachments			38.717717 °	38.717717 °
				-121.608015 °	-121.608015 °
DWR ID	DWR_RD1600_01_s_2014_627				
Comment Code					
DE : Debris					
Inspector Comment

View of the metal pipe and wood debris on the berm of the waterward side of the levee. Fall 2015.

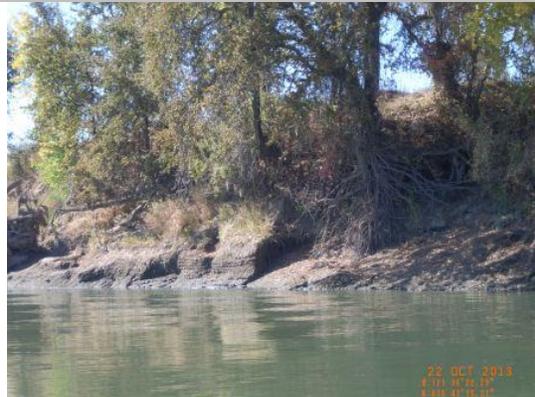
Photo 1 of 1 : SP_2016_RD1600_191_3_20160304_00003.jpg

LM Start	3.58	Rating **	M	Issue No.	3
LM End	3.83	Issue Type +	Ma	Location *	WS
Category	Supplemental			GPS Latitude/Longitude	
				Start	End
Item	2015 USACE Erosion Survey, DRAFT			38.717770 °	38.721351 °
				-121.607423 °	-121.606414 °
DWR ID	DWR_RD1600_01_s_2016_3				
Comment Code					
Inspector Comment					
1997 - Steep high bank. 2005 - Some small pockets in the low toe near the waterline. 2006 - Minor slope clearing. 2010 - Minor new erosion. 2011 - Multiple trees have fallen since last year. Some other trees look ready to fall. Significant new erosion since last year. 2012 - Minor new erosion. 2013 - Minor new erosion. 2015: New minor erosion at toe. [2015 Site ID: SAC_74-4_R]

USACE 2013 Photo #1

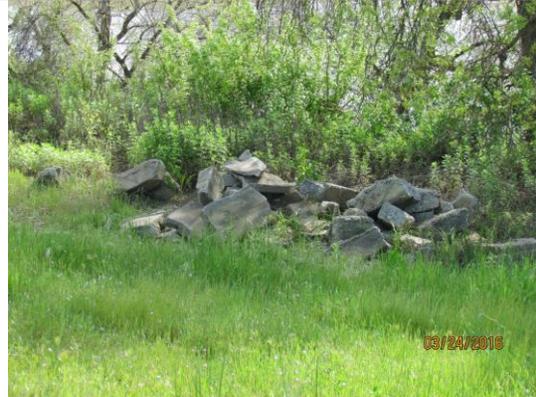
Photo 1 of 2 : SP_2016_RD1600_191_628_20160407_00117.jpg

LM Start	3.59	Rating **	M	Issue No.	628
LM End	3.59	Issue Type +	En	Location *	WS
Category	Earthen Levee			GPS Latitude/Longitude	
				Start	End
Item	Encroachments			38.718080 °	38.718080 °
				-121.607815 °	-121.607815 °
DWR ID	DWR_RD1600_01_s_2014_628				
Comment Code					
DE : Debris					
Inspector Comment

View of the concrete pile on the berm of the waterward side of the levee. Spring 2016.

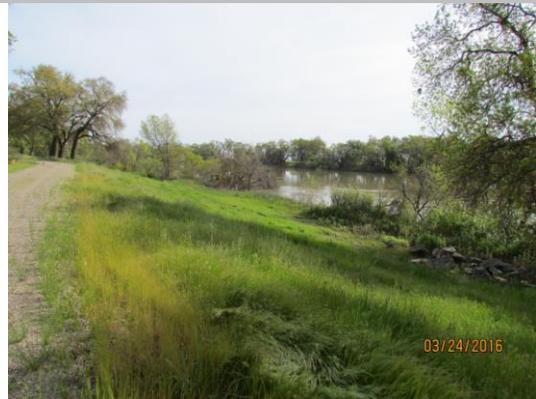
Photo 2 of 2 : SP_2016_RD1600_191_628_20160407_00118.jpg

Perspective view of the concrete pile looking upstream. Spring 2016.

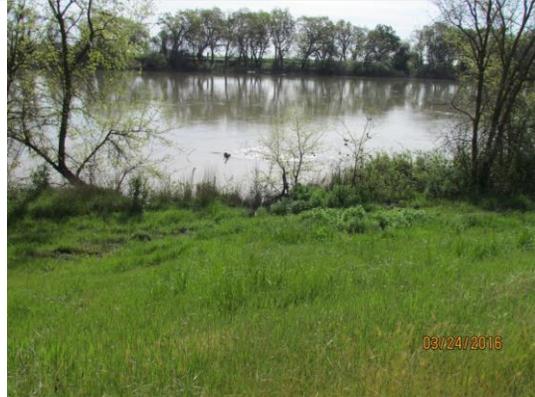
Photo 2 of 2 : SP_2016_RD1600_191_2_20160407_00119.jpg

LM Start	3.76	Rating **	M	Issue No.	2 (cont)
LM End	3.76	Issue Type +	En	Location *	WS
Category	Earthen Levee			GPS Latitude/Longitude	
				Start	End
Item	Erosion / Bank Caving			38.720385 °	38.720385 °
				-121.606953 °	-121.606953 °
DWR ID	DWR_RD1600_01_s_2013_2				
Comment Code					
E1 : Note and monitor erosion site.					
Inspector Comment					
Trees have fallen over and created bank erosion.

View of the erosion from the top of the levee. Spring 2016.

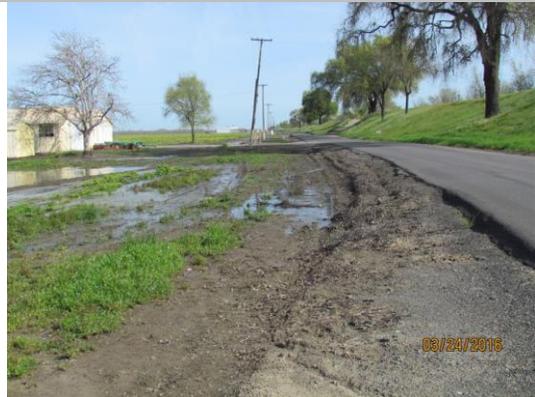
Photo 1 of 2 : SP_2016_RD1600_191_73_20160407_00120.jpg

LM Start	3.76	Rating **	U	Issue No.	73
LM End	3.93	Issue Type +	Ob	Location *	LS
Category	Earthen Levee			GPS Latitude/Longitude	
				Start	End
Item	Seepage / Sandboils			38.720407 °	38.722850 °
				-121.606953 °	-121.606899 °
DWR ID	DWR_RD1600_01_s_2016_73				
Comment Code					
Inspector Comment					
There appears to be a ponding issue and will have to be monitored during next inspection.

View of the seepage by the road looking upstream. Spring 2016.

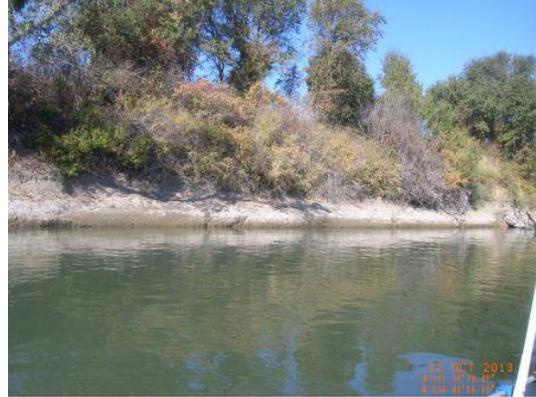
Photo 1 of 1 : SP_2016_RD1600_191_8_20160304_00010.jpg

LM Start	4.34	Rating **	M	Issue No.	8
LM End	4.86	Issue Type +	Ma	Location *	WS
Category	Supplemental			GPS Latitude/Longitude	
				Start	End
Item	2015 USACE Erosion Survey, DRAFT			38.728684 °	38.736110 °
				-121.605844 °	-121.604153 °
DWR ID	DWR_RD1600_01_s_2016_8				
Comment Code					
Inspector Comment					
1997 - Very steep bank. 2005 - Lots of small trees down along the bank at the upstream end. 2006 - Minor new erosion, but slow. 2010 - Almost all of the roots are exposed on the trees, appears ready to fall. 2011 - New erosion and tree popouts. 2012 - Site has become overgrown with vegetation, making it hard to observe. 2015: Dense vegetation made observation difficult. [2015 Site ID: SAC_75-3_R]

USACE 2013 Photo #1

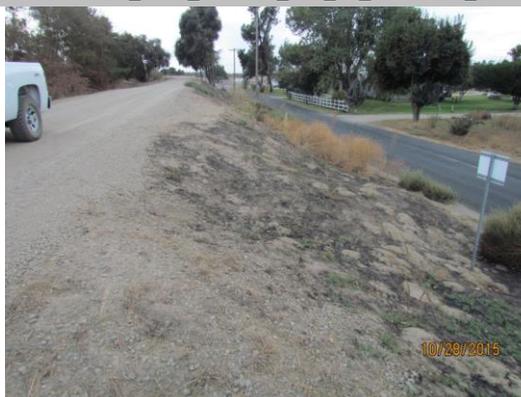
Photo 1 of 1 : SP_2016_RD1600_191_41_20160304_00036.jpg

LM Start	4.66	Rating **	M	Issue No.	41
LM End	4.66	Issue Type +	Ma	Location *	LS
Category	Earthen Levee			GPS Latitude/Longitude	
				Start	End
Item	Slope Stability			38.733294 °	38.733294 °
				-121.605484 °	-121.605484 °
DWR ID	DWR_RD1600_01_f_2015_41				
Comment Code					
S1 : Repair slope instability.					
Inspector Comment

View of the bulge at the toe of the levee on the landward side looking downstream. Fall 2015.

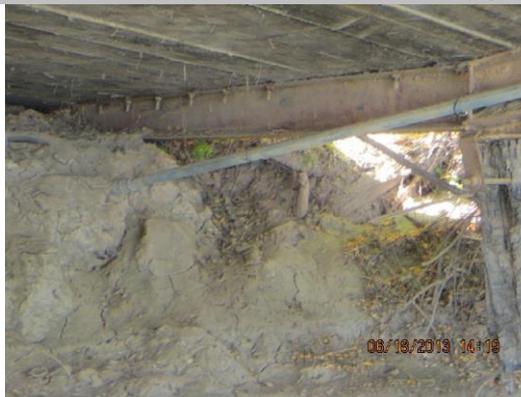
Photo 2 of 2 : UCIP_SP_2016_15130_24856.jpg

LM Start	4.87	Rating **	U	Issue No.	1207 (cont)
LM End	4.87	Issue Type +	En	Location *	WS
Category	Supplemental			GPS Latitude/Longitude	
				Start	End
Item	DWR UCIP Field Study			38.736299 °	38.736299 °
				-121.604582 °	-121.604582 °
DWR ID					
Comment Code					
Inspector Comment					
FS_ID:15130 DS_ID:21487 EP_NO: N/A Repair Type: Urgent Crossing Status: Found UCIP Comments: No pump on pier and pipe open on both ends without a closure device. FIELD_STRUCT_DESC: 18-inch steel pipe through levee 6.7-feet below crown. Pump on wooden pier off waterward side. Air vents on WS slope and meter at outlet on LS toe. 6'X14' concrete distribution box off LS toe. 2-inch galvanized iron electrical conduit through the levee at same location. Originally included in the 1955 O&M manual. FS Date: 6/18/2013

2-inch galvanized iron electrical conduit at under pier.

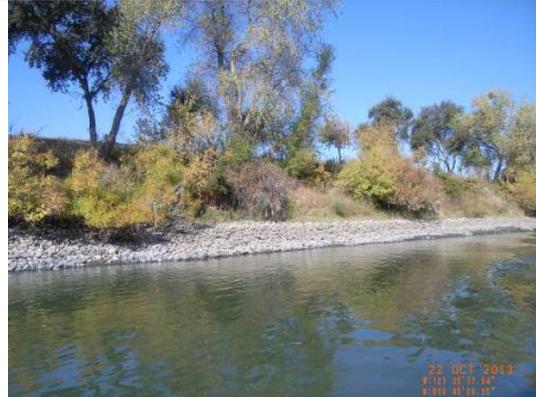
Photo 1 of 1 : SP_2016_RD1600_191_9_20160304_00011.jpg

LM Start	6.30	Rating **	A/W	Issue No.	9
LM End	6.36	Issue Type +	Ma	Location *	WS
Category	Supplemental			GPS Latitude/Longitude	
				Start	End
Item	2015 USACE Erosion Survey, DRAFT			38.755246 °	38.756186 °
				-121.594206 °	-121.594024 °
DWR ID	DWR_RD1600_01_s_2016_9				
Comment Code					
Inspector Comment					
2011 - Large vertical eroded face from a rotational failure just below pump. 2015: Does not meet criterial. [2015 Site ID: SAC_77-0_R]

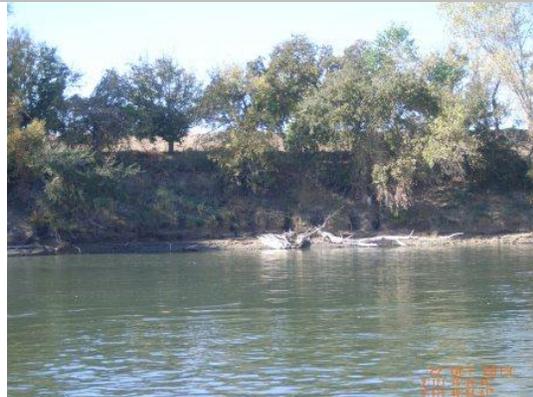
Photo 1 of 1 : SP_2016_RD1600_191_6_20160304_00008.jpg

LM Start	6.95	Rating **	M	Issue No.	6
LM End	6.98	Issue Type +	Ma	Location *	WS
Category	Supplemental			GPS Latitude/Longitude	
				Start	End
Item	2015 USACE Erosion Survey, DRAFT			38.764801 °	38.765219 °
				-121.594926 °	-121.595049 °
DWR ID	DWR_RD1600_01_s_2016_6				
Comment Code					
Inspector Comment					
2006 - Eddy scour off end of rock causing erosion and scour hole near levee. Sandy silt bank with rock on upstream end. 2010 - Trees are leaning more, minor new erosion. 2011 - Many of the tree roots have scoured out and trees look ready to fall. 2015: No observed changes. [2015 Site ID: SAC_77-7_R]

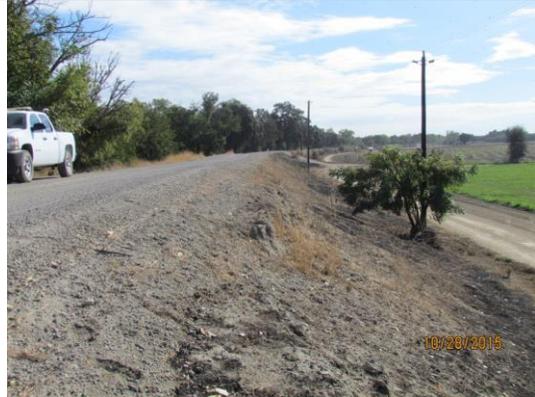
Photo 2 of 2 : SP_2016_RD1600_191_27_20160304_00023.jpg

LM Start	6.97	Rating **	M	Issue No.	27 (cont)
LM End	6.97	Issue Type +	Ma	Location *	LS
Category	Earthen Levee			GPS Latitude/Longitude	
				Start	End
Item	Erosion / Bank Caving			38.764974 °	38.764974 °
				-121.595533 °	-121.595533 °
DWR ID	DWR_RD1600_01_s_2012_27				
Comment Code					
E1 : Note and monitor erosion site.					
Inspector Comment

The erosion seems to have been fixed. There still seems to be some erosion on the landward side of the levee looking downstream. Fall 2015.

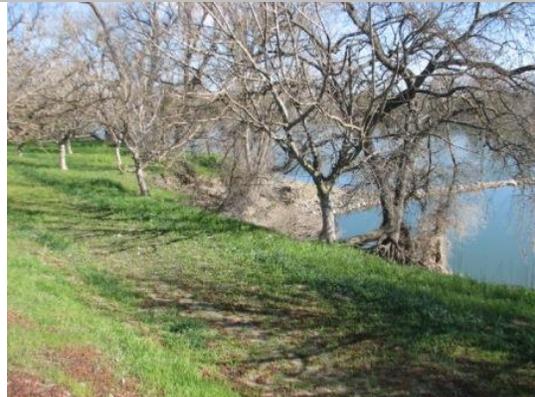
Photo 1 of 2 : SP_2016_RD1600_191_30_20160304_00026.jpg

LM Start	6.97	Rating **	M	Issue No.	30
LM End	6.97	Issue Type +	Ma	Location *	WS
Category	Earthen Levee			GPS Latitude/Longitude	
				Start	End
Item	Erosion / Bank Caving			38.764980 °	38.764980 °
				-121.595513 °	-121.595513 °
DWR ID	DWR_RD1600_01_s_2013_30				
Comment Code					
E1 : Note and monitor erosion site.					
Inspector Comment

Erosion is into the berm area and needs to be monitored. Spring 2013

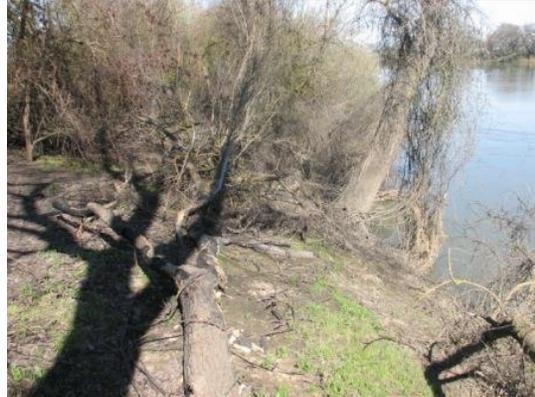
Photo 1 of 4 : SP_2016_RD1600_191_20_20160304_00013.jpg

LM Start	7.10	Rating **	M	Issue No.	20
LM End	7.10	Issue Type +	Ma	Location *	WS
Category	Earthen Levee		GPS Latitude/Longitude		
			Start	End	
Item	Erosion / Bank Caving		38.766691 °	38.766691 °	
			-121.596300 °	-121.596300 °	
DWR ID	DWR_RD1600_01_s_2012_20				
Comment Code					
E1 : Note and monitor erosion site.					
Inspector Comment

This another view of the site.

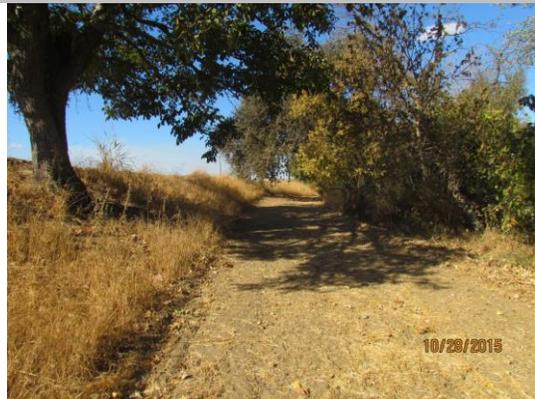
Photo 2 of 4 : SP_2016_RD1600_191_20_20160304_00014.jpg

View of the erosion in the berm area on the waterward side looking upstream. Fall 2015.

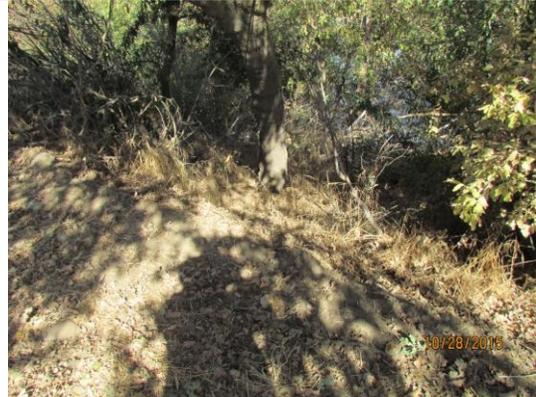
Photo 4 of 4 : SP_2016_RD1600_191_20_20160304_00016.jpg

LM Start	7.10	Rating **	M	Issue No.	20 (cont)
LM End	7.10	Issue Type +	Ma	Location *	WS
Category	Earthen Levee			GPS Latitude/Longitude	
				Start	End
Item	Erosion / Bank Caving			38.766691 °	38.766691 °
				-121.596300 °	-121.596300 °
DWR ID	DWR_RD1600_01_s_2012_20				
Comment Code					
E1 : Note and monitor erosion site.					
Inspector Comment

Looking at the erosion site on the berm. Fall 2015.

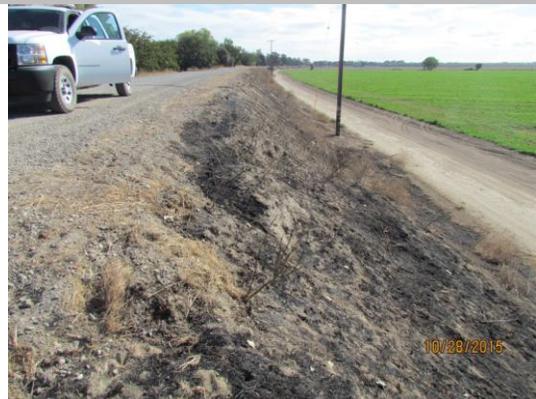
Photo 1 of 1 : SP_2016_RD1600_191_61_20160304_00050.jpg

LM Start	7.21	Rating **	M	Issue No.	61
LM End	7.21	Issue Type +	Ma	Location *	LS
Category	Earthen Levee			GPS Latitude/Longitude	
				Start	End
Item	Erosion / Bank Caving			38.768094 °	38.768094 °
				-121.597075 °	-121.597075 °
DWR ID	DWR_RD1600_01_f_2015_61				
Comment Code					
E1 : Note and monitor erosion site.					
Inspector Comment

View of the erosion on the landward side of the levee looking downstream. Fall 2015.

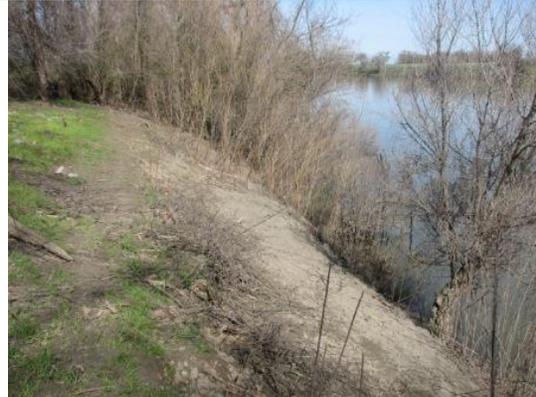
Photo 2 of 3 : SP_2016_RD1600_191_21_20160304_00018.jpg

LM Start	7.23	Rating **	M	Issue No.	21 (cont)
LM End	7.23	Issue Type +	Ma	Location *	WS
Category	Earthen Levee			GPS Latitude/Longitude	
				Start	End
Item	Erosion / Bank Caving			38.768409 °	38.768409 °
				-121.597213 °	-121.597213 °
DWR ID	DWR_RD1600_01_s_2012_21				
Comment Code					
E1 : Note and monitor erosion site.					
Inspector Comment

The bank is eroding away and has become very steep.

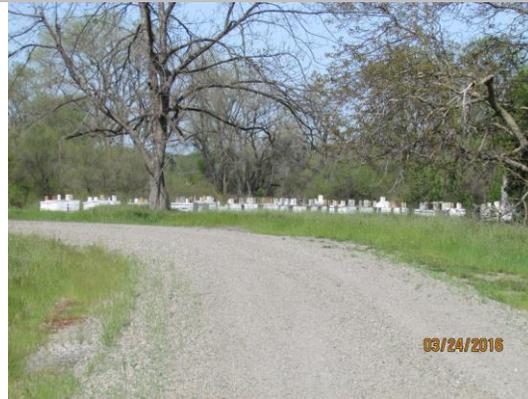
Photo 1 of 1 : SP_2016_RD1600_191_48_20160407_00122.jpg

LM Start	8.18	Rating **	M	Issue No.	48
LM End	8.18	Issue Type +	En	Location *	WS
Category	Earthen Levee		GPS Latitude/Longitude		
			Start	End	
Item	Encroachments		38.778963 °	38.778963 °	
			-121.608106 °	-121.608106 °	
DWR ID	DWR_RD1600_01_s_2016_48				
Comment Code					
BU : Building					
Inspector Comment

View of the beehives on the waterward side of the levee looking upstream. Spring 2016.

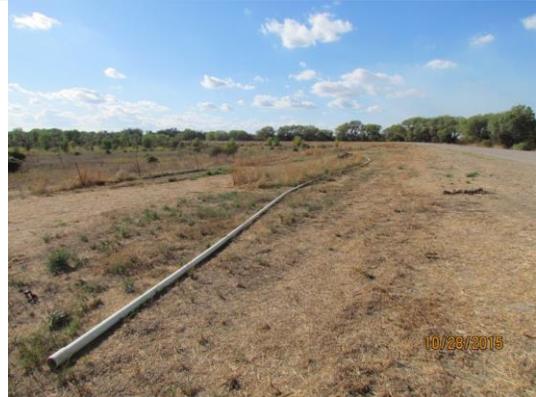
Photo 2 of 2 : SP_2016_RD1600_191_634_20160304_00069.jpg

LM Start	8.88	Rating **	A/W	Issue No.	634 (cont)
LM End	8.88	Issue Type +	En	Location *	LS
Category	Earthen Levee			GPS Latitude/Longitude	
				Start	End
Item	Encroachments			38.782002 °	38.782002 °
				-121.620403 °	-121.620403 °
DWR ID	DWR_RD1600_01_s_2014_634				
Comment Code					
EQ : Equipment					
Inspector Comment					
Most of the equipment has been removed. Continue to monitor sight for more placement of equipment.

View of the equipment on the landward side of the levee looking upstream. Fall 2015.

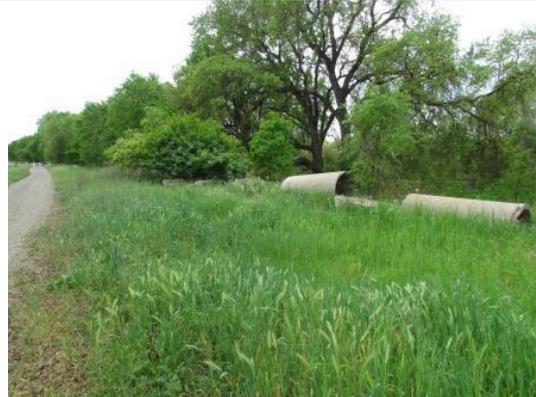
Photo 1 of 1 : SP_2016_RD1600_191_1202_20160304_00072.jpg

LM Start	10.38	Rating **	M	Issue No.	1202
LM End	10.38	Issue Type +	En	Location *	WS
Category	Earthen Levee			GPS Latitude/Longitude	
				Start	End
Item	Encroachments			38.766363 °	38.766363 °
				-121.634317 °	-121.634317 °
DWR ID	DWR_RD1600_01_s_2015_1202				
Comment Code					
DE : Debris					
Inspector Comment

View of debris on the waterward side of the levee looking upstream. Spring 2015.

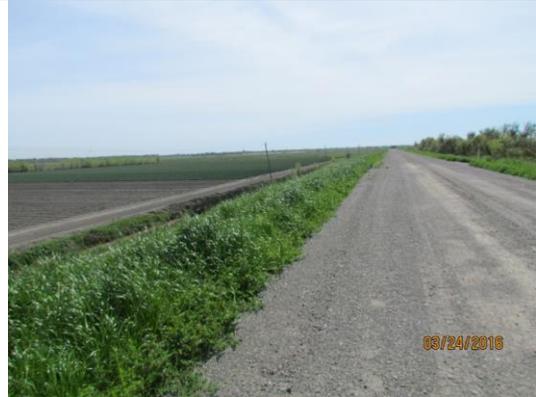
Photo 1 of 1 : SP_2016_RD1600_192_4_20160407_00012.jpg

LM Start	0.00	Rating **	M	Issue No.	4
LM End	4.21	Issue Type +	Ma	Location *	LS
Category	Earthen Levee		GPS Latitude/Longitude		
			Start	End	
Item	Vegetation		38.736225 °	38.676787 °	
			-121.633653 °	-121.643178 °	
DWR ID	DWR_RD1600_02_f_2015_4				
Comment Code					
V1 : Control annual grass and weeds on the levee slopes and easements.					
Inspector Comment

View of the vegetation on the landward side of the levee looking downstream. Spring 2016.

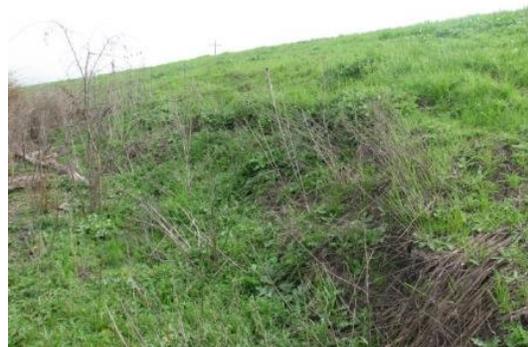
Photo 1 of 2 : SP_2016_RD1600_192_15_20160304_00008.jpg

LM Start	2.16	Rating **	M	Issue No.	15
LM End	2.27	Issue Type +	Ma	Location *	WS
Category	Earthen Levee			GPS Latitude/Longitude	
				Start	End
Item	Erosion / Bank Caving			38.705614 °	38.704052 °
				-121.639357 °	-121.640016 °
DWR ID	DWR_RD1600_02_s_2012_15				
Comment Code					
E1 : Note and monitor erosion site.					
Inspector Comment					
This is wave wash damage caused by last high water.

Looking upstream a deeper cut of 2'-3' damage.

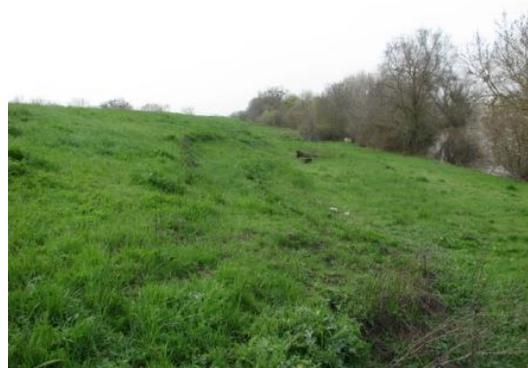
Photo 2 of 2 : SP_2016_RD1600_192_15_20160304_00009.jpg

This is wave wash damage along the toe of the levee looking downstream.

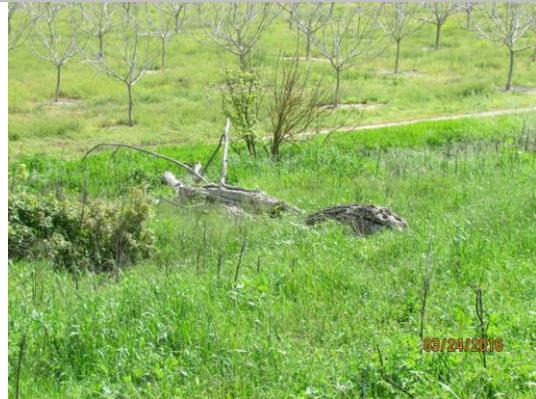
Photo 1 of 2 : SP_2016_RD1600_192_2_20160407_00014.jpg

LM Start	2.40	Rating **	M	Issue No.	2
LM End	2.40	Issue Type +	En	Location *	LS
Category	Earthen Levee		GPS Latitude/Longitude		
			Start	End	
Item	Encroachments		38.702366 °	38.702366 °	
			-121.640732 °	-121.640732 °	
DWR ID	DWR_RD1600_02_s_2016_2				
Comment Code					
TR : Tree or limb					
Inspector Comment

A tree has fallen on the landward side of the levee. Spring 2016.

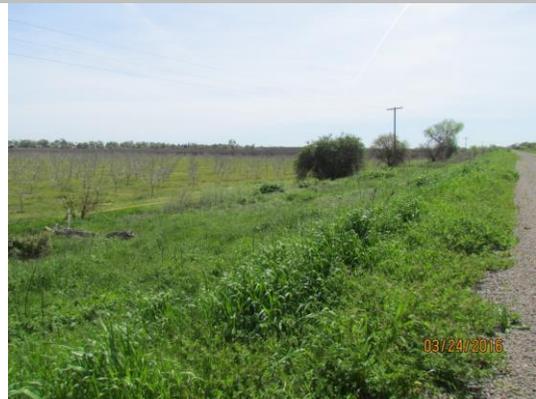
Photo 2 of 2 : SP_2016_RD1600_192_2_20160407_00016.jpg

View of the fallen tree on the landward side of the levee looking downstream. Spring 2016.
