**Flood Control Project Maintenance
Levee Inspections**

Fall 2011 Levee Maintenance Deficiency Summary Report

San Joaquin River Basin

Reclamation District No. 1602 Del Puerto

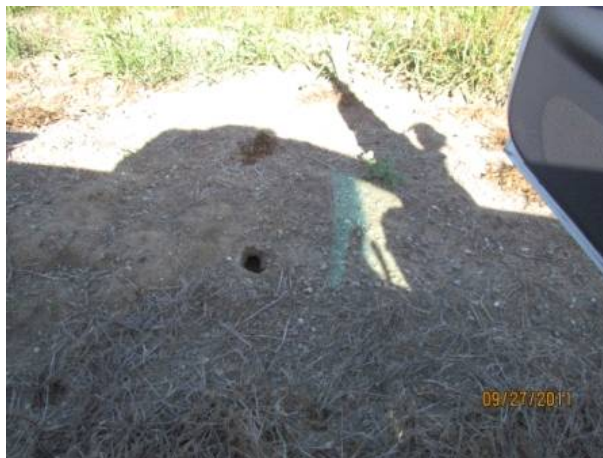
pkazi_f_20111102_097.jpg

Rodent hole was found on the waterside of the slope. The picture was taken from the crown looking toward waterside of the slope.

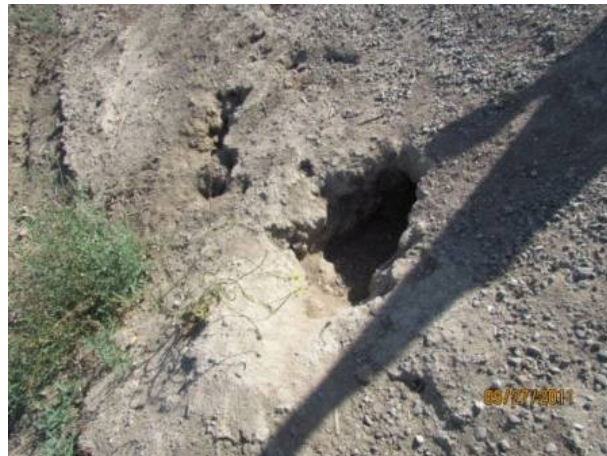
Levee Mile Report Line	6
Start Levee Mile	0.45
End Levee Mile	0.45
Location	Water Side
Category	Earthen Levee
Item	Animal Control

A rodent hole was found on the waterside of the slope. The picture was taken from the toe of the levee looking towards the crown.

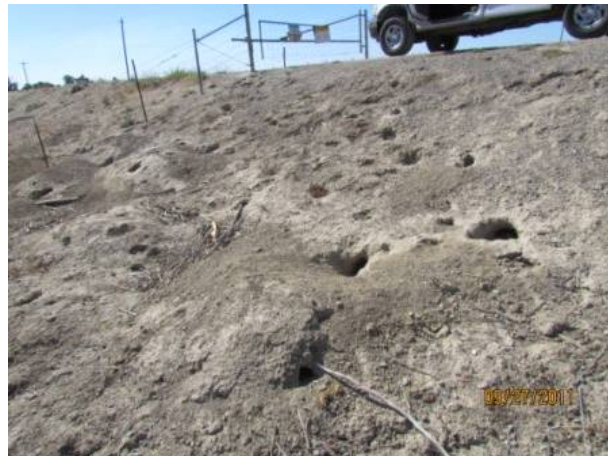
Levee Mile Report Line	8
Start Levee Mile	0.59
End Levee Mile	0.59
Location	Water Side
Category	Earthen Levee
Item	Animal Control

Pictures of the rodent holes on the waterside of the slope looking towards the crown. The picture was taken during Fall 2011 inspection.

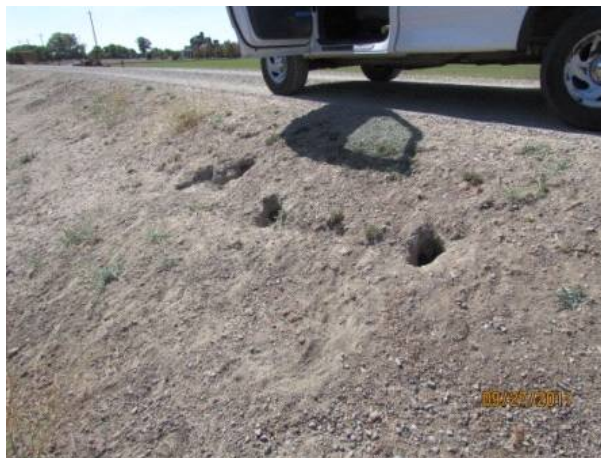
Levee Mile Report Line	11
Start Levee Mile	0.67
End Levee Mile	0.67
Location	Water Side
Category	Earthen Levee
Item	Animal Control

The rodent holes were found on the waterside of the levee. The picture was taken from toe looking towards the crown.

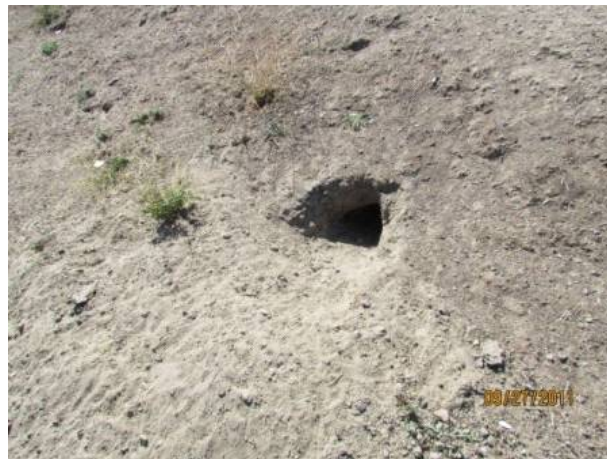
Levee Mile Report Line	13
Start Levee Mile	0.69
End Levee Mile	0.69
Location	Land Side
Category	Earthen Levee
Item	Animal Control
Animal burrow was found on the landside of the levee. The picture was taken from the toe of the levee looking upstream.	
pkazi_f_20111103_104.jpg

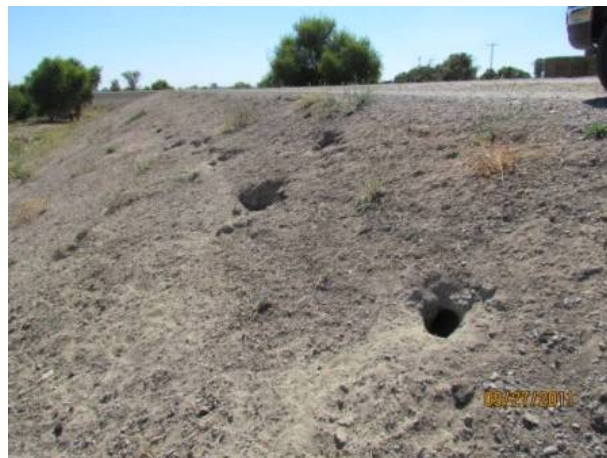
Levee Mile Report Line	14
Start Levee Mile	0.71
End Levee Mile	0.71
Location	Water Side
Category	Earthen Levee
Item	Animal Control
Rodent holes were found on the waterside of the levee. The picture was taken from toe of the levee looking upstream.	
pkazi_f_20111103_105.jpg

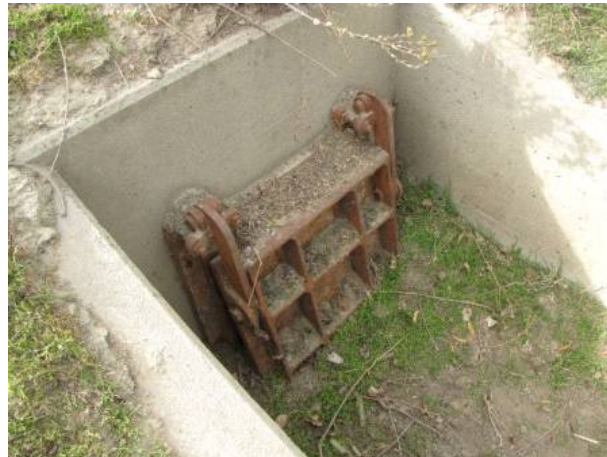
Levee Mile Report Line	16
Start Levee Mile	0.78
End Levee Mile	0.78
Location	Water Side
Category	Interior Drainage & Piping Systems
Item	Flap Gates

View of a flap gate with sediment preventing it from closing.

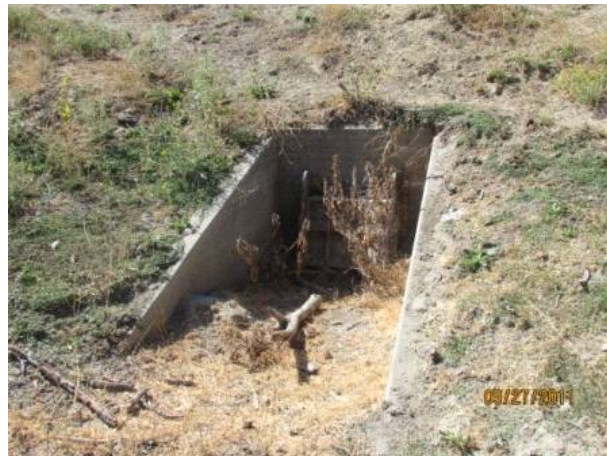
Levee Mile Report Line	16
Start Levee Mile	0.78
End Levee Mile	0.78
Location	Water Side
Category	Interior Drainage & Piping Systems
Item	Flap Gates

Debris and sediments were obstructing the flap gate. The picture was taken from toe of waterside of the levee looking towards the crown. This picture was taken during Fall 2011 inspection.

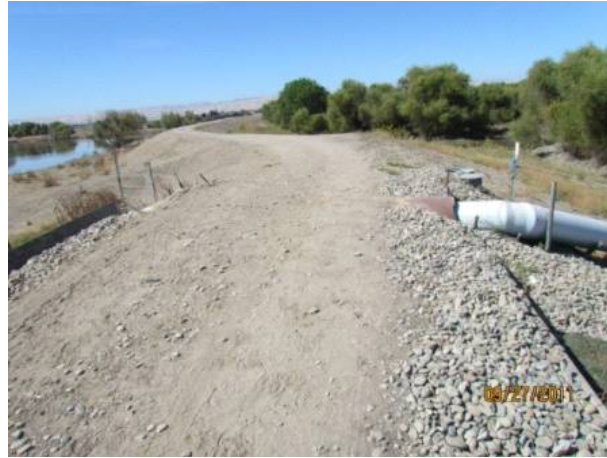
pkazi_f_20111103_108.jpg

View of the ramp on the crown. The picture was taken from crown looking downstream.

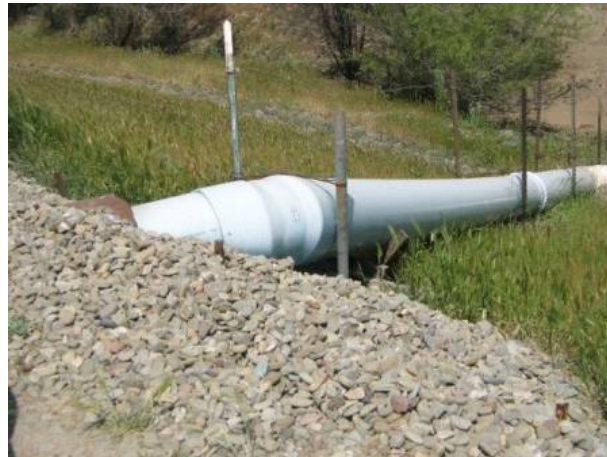
Levee Mile Report Line	18
Start Levee Mile	1.02
End Levee Mile	1.02
Location	Water Side
Category	Interior Drainage & Piping Systems
Item	Encroachments

PVC sleeve through steel pipe on waterward slope at LM 1.02

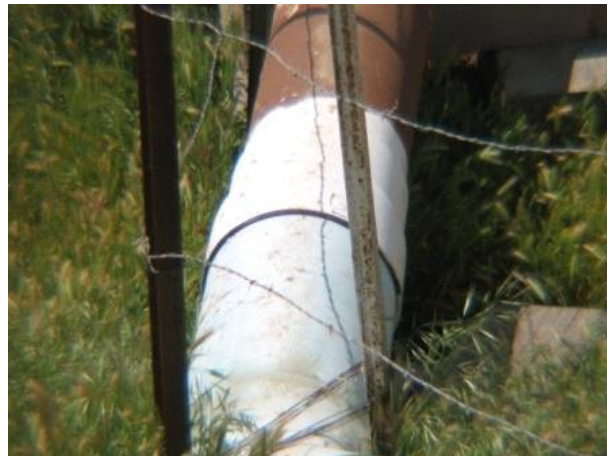
Levee Mile Report Line	18
Start Levee Mile	1.02
End Levee Mile	1.02
Location	Water Side
Category	Interior Drainage & Piping Systems
Item	Encroachments

PVC pipe connected to steel pipe on landward toe at LM 1.02

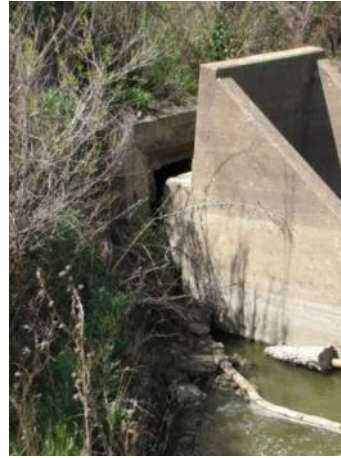
pkazi_f_20110923_059.jpg

Separation of outfall structure from the outlet pipe at LM 1.04.

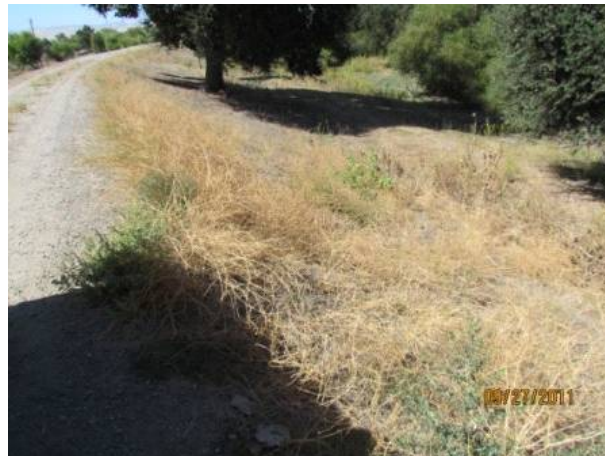
pkazi_f_20111103_110.jpg

Wild grown vegetation was found on the waterside slope of the levee. The picture was taken from the crown looking downstream.

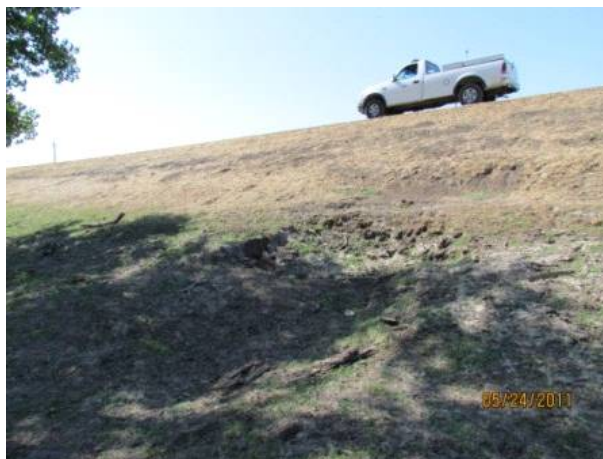
pkazi_f_20110923_055.jpg

Depression at the waterside slope of the levee during Spring 2011 inspection.

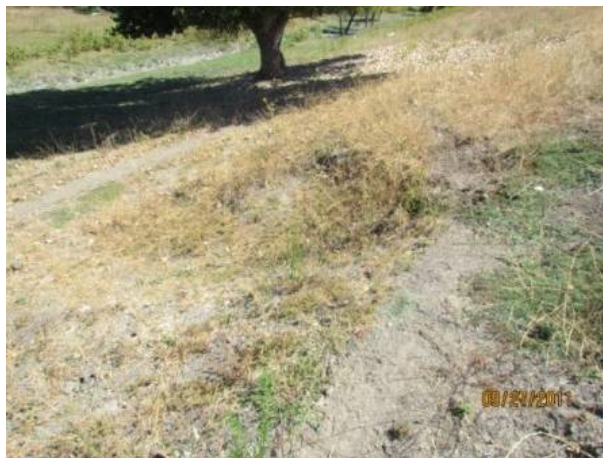
Levee Mile Report Line	21
Start Levee Mile	1.07
End Levee Mile	1.07
Location	Water Side
Category	Earthen Levee
Item	Slope Stability

21	1.07	1.07	Earthen Levee	Slope Stability	WS	M	Repair slope instability. Inspector Comments: small amount of slumping at waterside toe of the levee.	37.478567 ° -121.067847 °	37.478567 ° -121.067847 °	37 Y	
22	1.10	1.10	Earthen Levee	Animal Control	WS	M	Exterminate rodents and backfill and compact or grout burrows.	37.478454 ° -121.067209 °	37.478454 ° -121.067209 °	8 Y	
23	1.13	1.13	Earthen Levee	Animal Control	LS	M	Exterminate rodents and backfill and compact or grout burrows.	37.478331 ° -121.066705 °	37.478331 ° -121.066705 °	7 Y	
24	1.16	1.16	Earthen Levee	Animal Control	WS	C	Exterminate rodents and backfill and compact or grout burrows.	37.478274 ° -121.066114 °	37.478274 ° -121.066114 °	18	
25	1.32	1.32	Earthen Levee	Animal Control	WS	C	No rodents visible, but rodent burrows visible; need to backfill and compact or grout burrows.	37.479265 ° -121.063560 °	37.479265 ° -121.063560 °	20

Updated picture of the depression at the waterside toe of the levee. The picture was taken from the crown of the levee looking upstream.

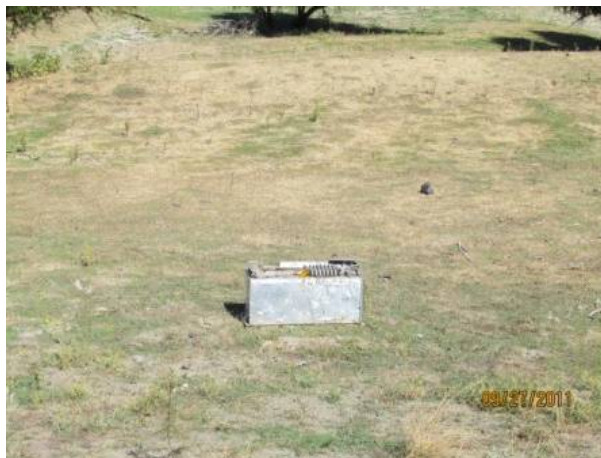
pkazi_f_20111103_112.jpg

An abandon equipment was found on waterside slope of the levee. The picture was taken from the crown looking upstream.

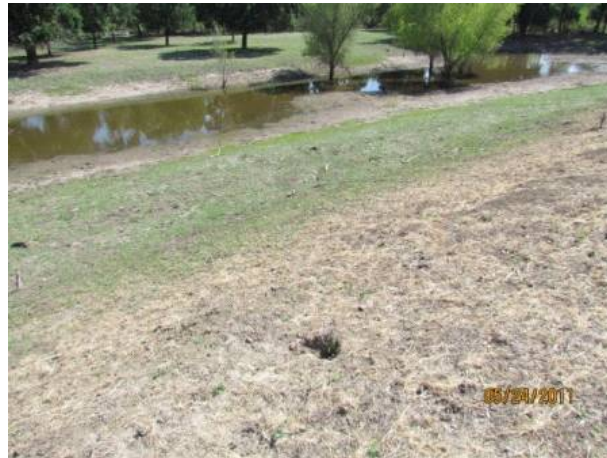
pkazi_f_20110923_042.jpg

Rodent hole on the waterside of the levee. The picture was taken from the crown looking upstream.

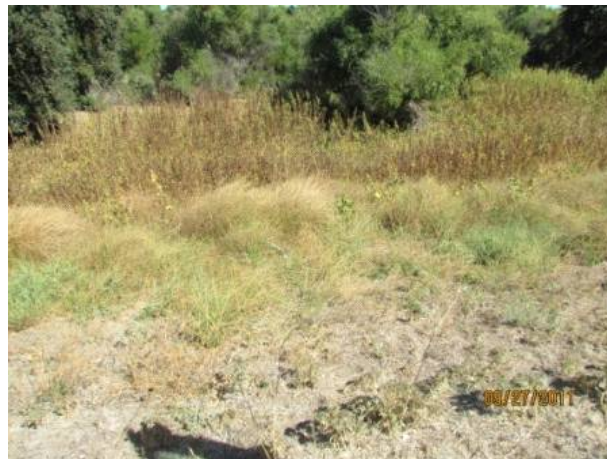
Levee Mile Report Line	28
Start Levee Mile	1.52
End Levee Mile	2.41
Location	Water Side
Category	Earthen Levee
Item	Vegetation

View of the wild grown vegetation on the waterside of the levee. The picture was taken from crown looking towards the toe.

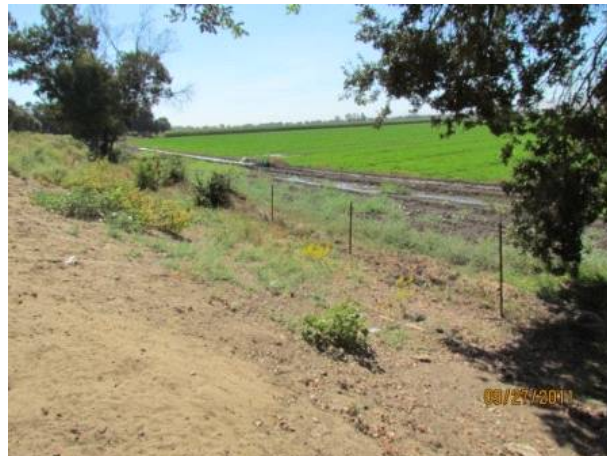
Levee Mile Report Line	29
Start Levee Mile	1.62
End Levee Mile	2.29
Location	Land Side
Category	Earthen Levee
Item	Encroachments

View of the fence on the landside toe of the levee. The picture was taken from crown looking upstream.

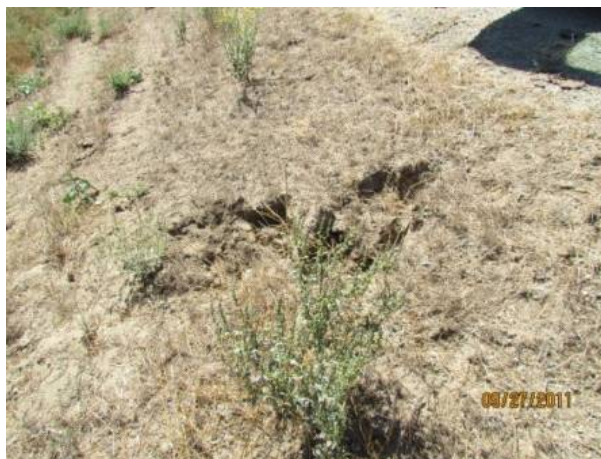
pkazi_f_20111103_116.jpg

Rodent holes were found on the waterside of the levee. The picture was taken from crown of the levee looking upstream.

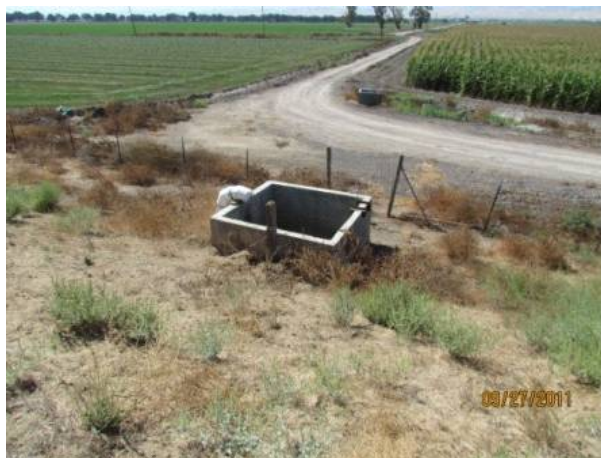
Levee Mile Report Line	33
Start Levee Mile	2.03
End Levee Mile	2.03
Location	Land Side
Category	Earthen Levee
Item	Encroachments

An well is located at the landside toe of the levee. The picture was taken from the crown looking toward the landside of the levee.

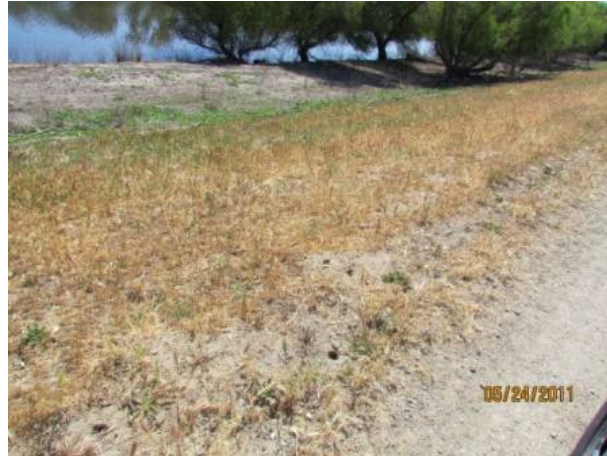
Levee Mile Report Line	35
Start Levee Mile	2.08
End Levee Mile	2.08
Location	Water Side
Category	Earthen Levee
Item	Animal Control
Gopher holes on the waterside of the levee. The picture was taken from the crown looking upstream.	
pkazi_f_20110923_056.jpg

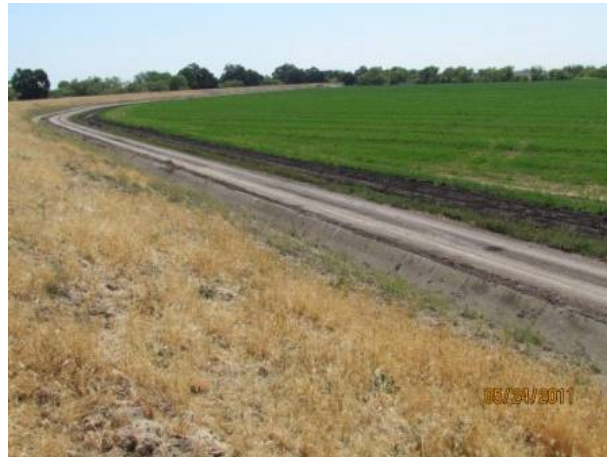
Levee Mile Report Line	37
Start Levee Mile	2.24
End Levee Mile	3.45
Location	Land Side
Category	Earthen Levee
Item	Encroachments
Concrete drain was built at the toe of the levee. The picture was taken from the crown looking upstream.	
pkazi_f_20110923_062.jpg

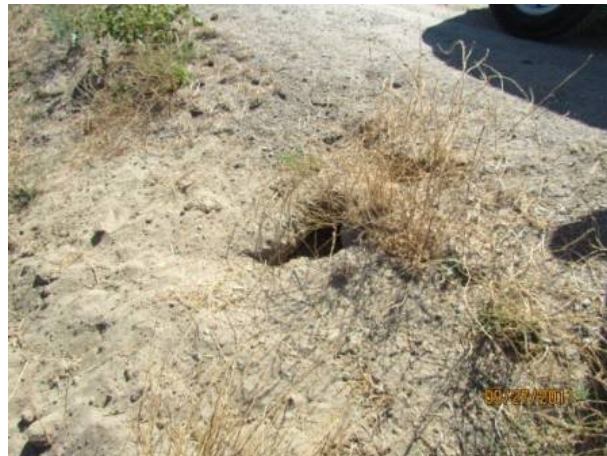
Levee Mile Report Line	38
Start Levee Mile	2.49
End Levee Mile	2.49
Location	Water Side
Category	Earthen Levee
Item	Animal Control
Animal burrow was found on the waterside of the levee. The picture was taken from the toe of the levee looking upstream.	
pkazi_f_20111103_118.jpg

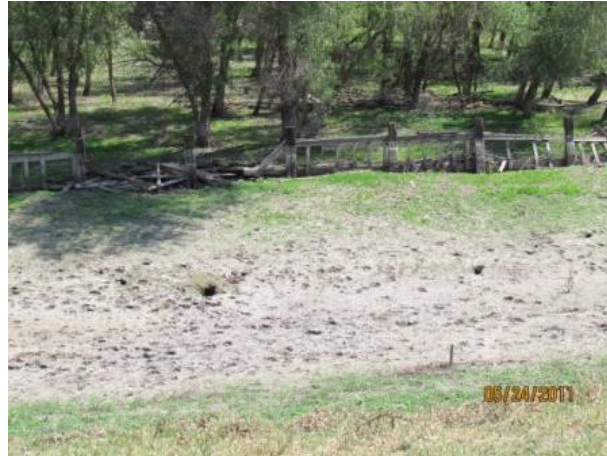
pkazi_f_20110923_044.jpg

Rodent holes were found on the waterside of the levee. The picture was taken from the crown looking upstream.

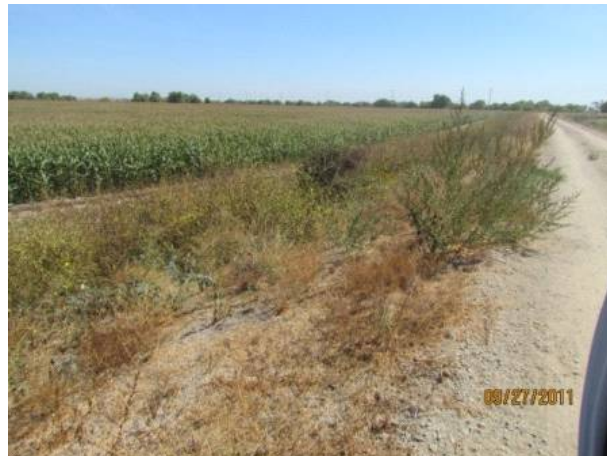
pkazi_f_20111103_120.jpg

Wild growth was found on the waterside of the levee. The picture was taken from the crown looking upstream.

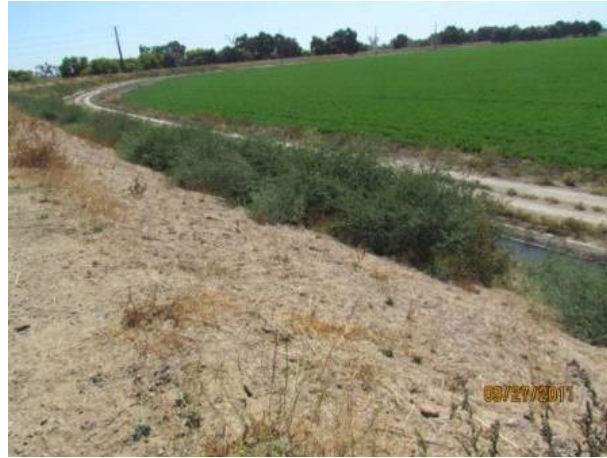
pkazi_f_20111103_121.jpg

Wild growth was found on the toe of the landside of the levee. The picture was taken from crown looking upstream.

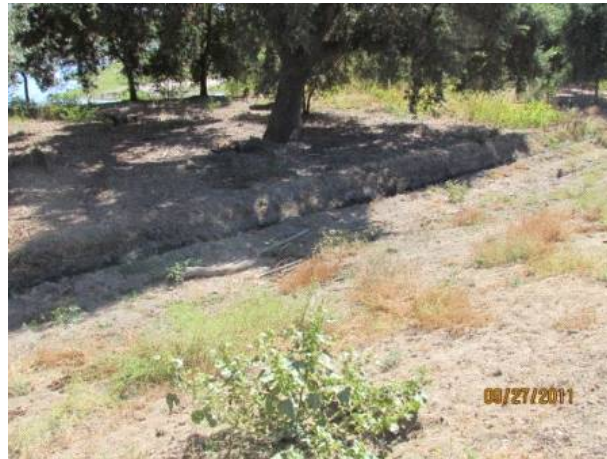
Levee Mile Report Line	43
Start Levee Mile	3.49
End Levee Mile	3.56
Location	Water Side
Category	Earthen Levee
Item	Encroachments

A ditch was located on the waterside toe of the levee. The picture was taken from the crown looking upstream.

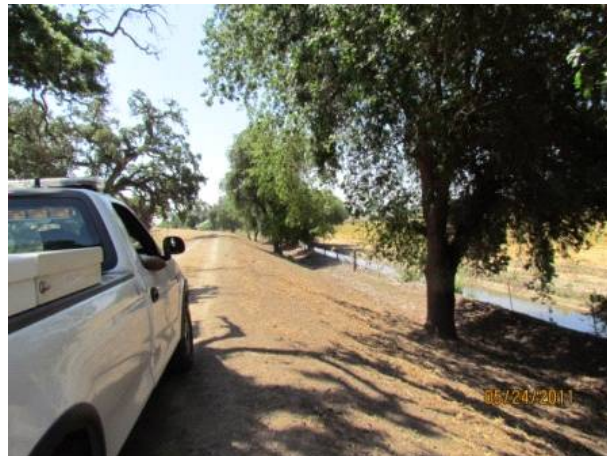
Levee Mile Report Line	44
Start Levee Mile	3.73
End Levee Mile	3.73
Location	Land Side
Category	Earthen Levee
Item	Trim / Thin Trees

Trees and vegetation complies with standards on the landside of the slope. The picture was taken from the crown looking upstream.

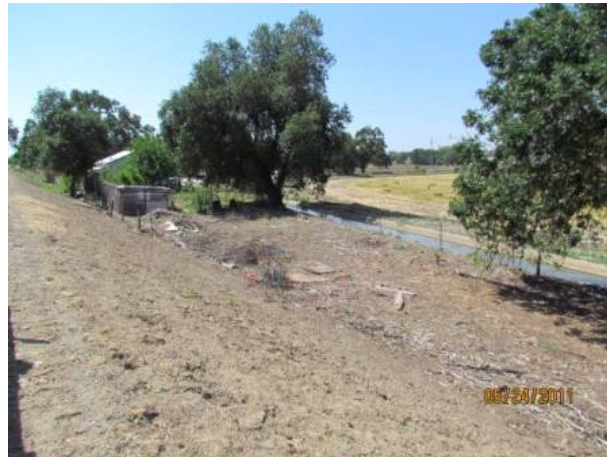
pkazi_f_20110923_047.jpg

Garbage was found on the landside of the levee. The picture was taken from the crown looking upstream.

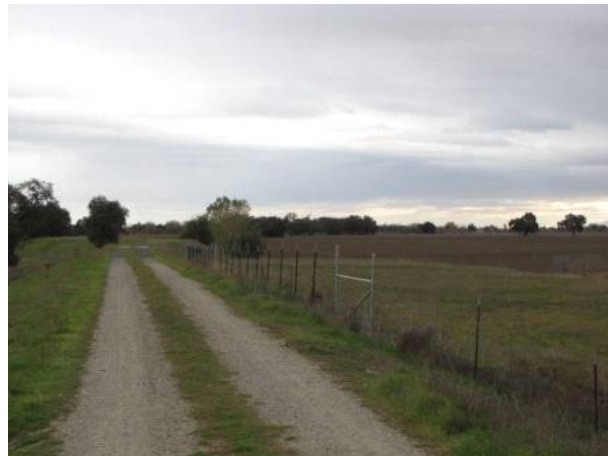
Levee Mile Report Line	51
Start Levee Mile	3.97
End Levee Mile	4.07
Location	Land Side
Category	Earthen Levee
Item	Encroachments
View of a barbed wire fence on the landward slope looking upstream.	
pkazi_f_20110923_065.jpg

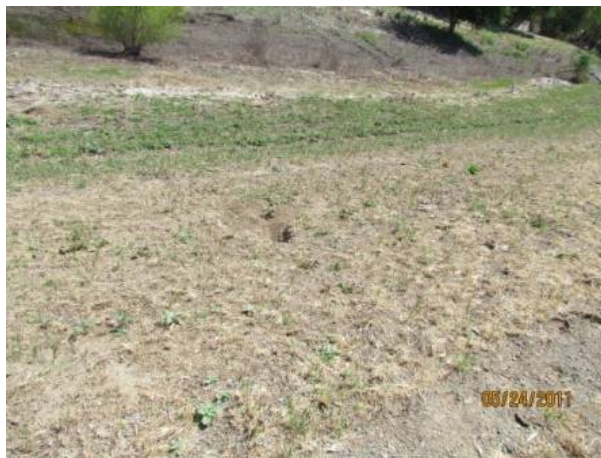
pkazi_f_20110923_058.jpg

Rodent hole was found the waterside of the levee. The picture was taken from the crown looking upstream.

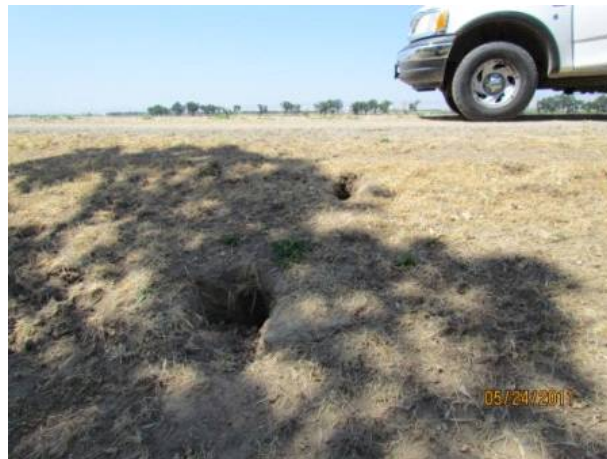
pkazi_f_20110923_049.jpg

Rodent hole was found on the waterside of the levee. The picture was taken from the crown looking upstream.

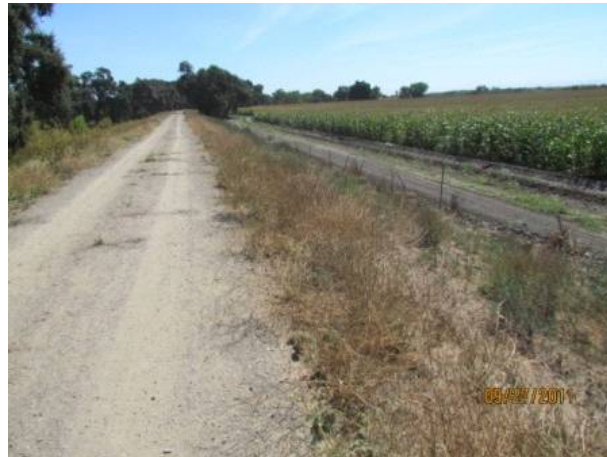
pkazi_f_20111103_129.jpg

Wild growth was found on the landside of the levee looking upstream.

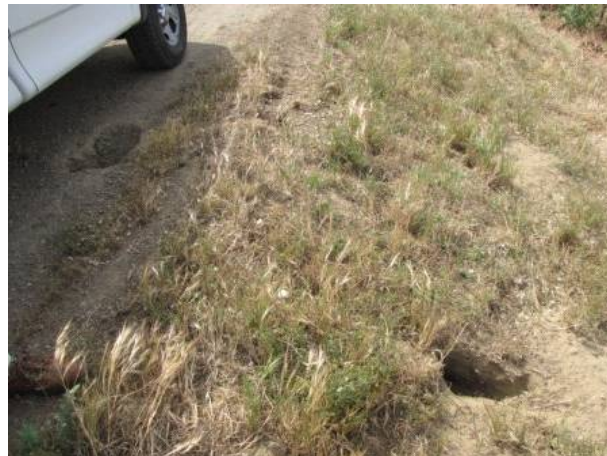
Levee Mile Report Line	64
Start Levee Mile	4.72
End Levee Mile	4.72
Location	Land Side
Category	Earthen Levee
Item	Animal Control

View of rodent holes on the landward slope looking upstream.

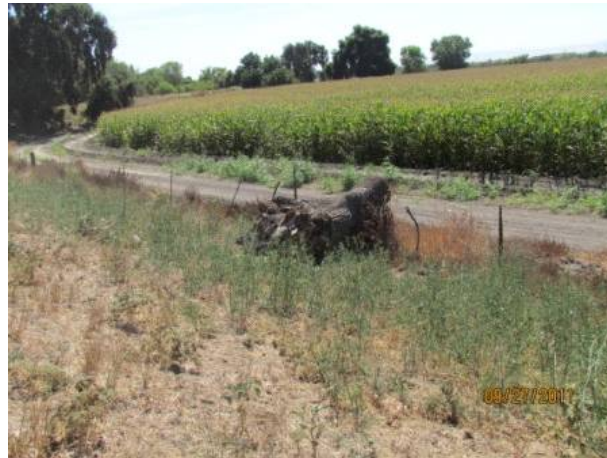
pkazi_f_20111103_130.jpg

65	4.81	4.81	Earthen Levee	Encroachments	LS	M	Debris Inspector Comments: A broken tree trunk is found on the landside of the levee.	37.442369 ° -121.036911 °	37.442369 ° -121.036911 °	69 Y

A broken tree trunk was found on the toe of the landside of the levee. The picture was taken from the crown looking upstream.

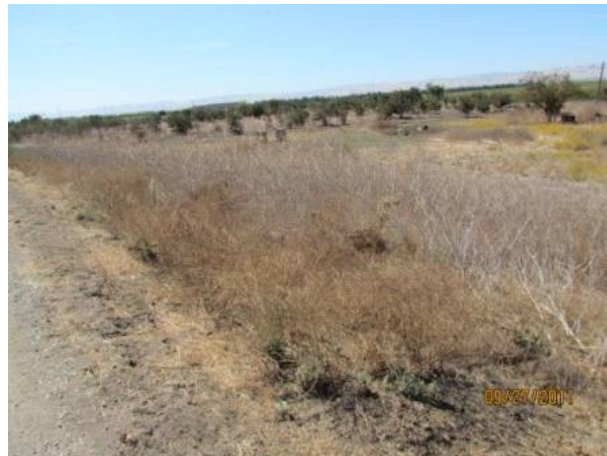
pkazi_f_20111103_131.jpg

Wild growth was found on the landside of the levee looking upstream.

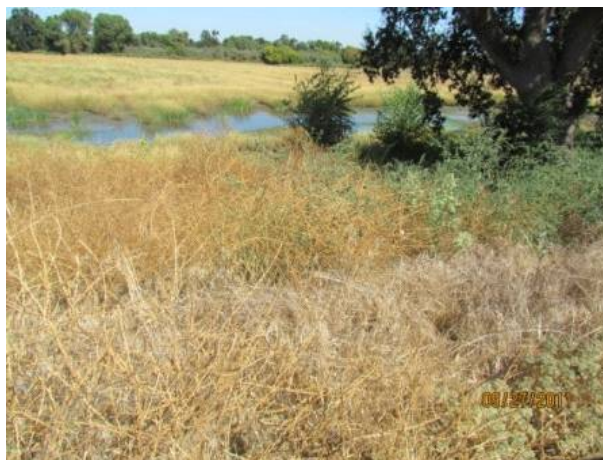
pkazi_f_20111103_132.jpg

Wild growth was found on the waterside of the levee looking upstream.

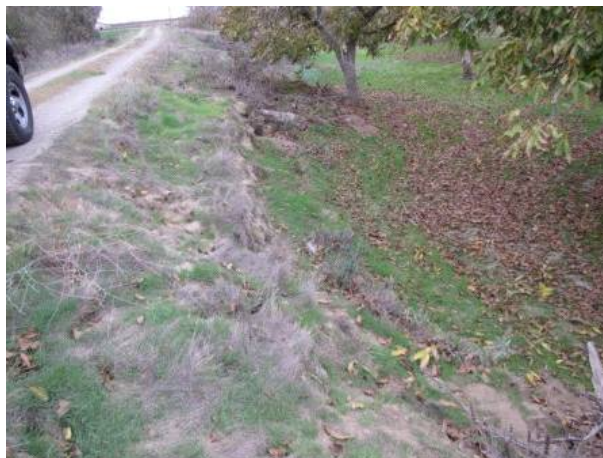
pkazi_f_20110923_068.jpg

View of significant damage and erosion to the landward slope looking upstream.

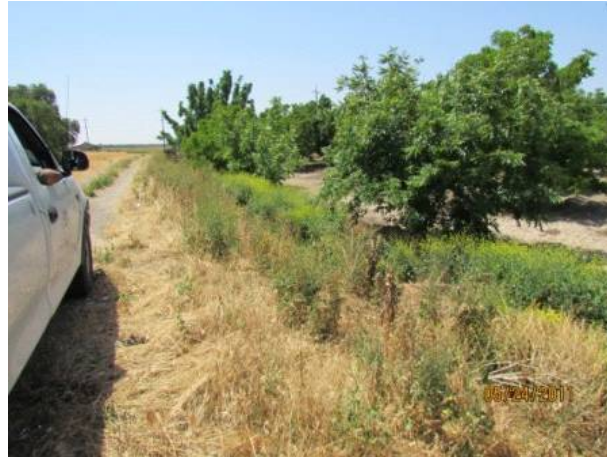
pkazi_f_20110923_063.jpg

Vegetation was obstructing the view of the landside of the levee. The picture was taken from the crown looking upstream.

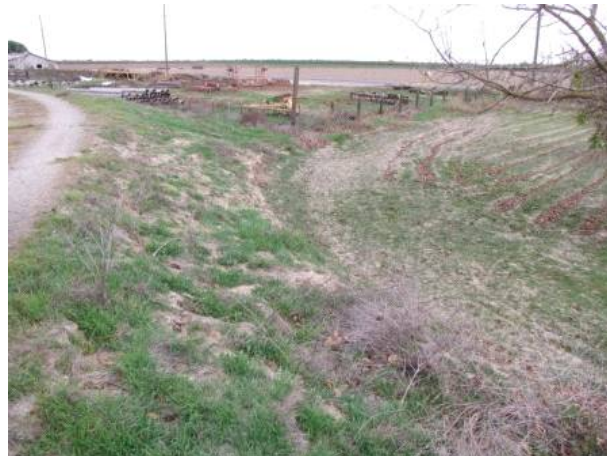
pkazi_f_20110923_069.jpg

View of tilling into the landward slope of the levee looking upstream. This slope has also been significantly damaged by rodent activity.
