**Flood Control Project Maintenance  
Levee Inspections**

**Fall 2013 Levee Maintenance Deficiency Summary Report**

**Reclamation District No. 1602 Del Puerto**

Waterway		Bank	Unit Miles
Unit No. 01 San Joaquin River		Left	6.29

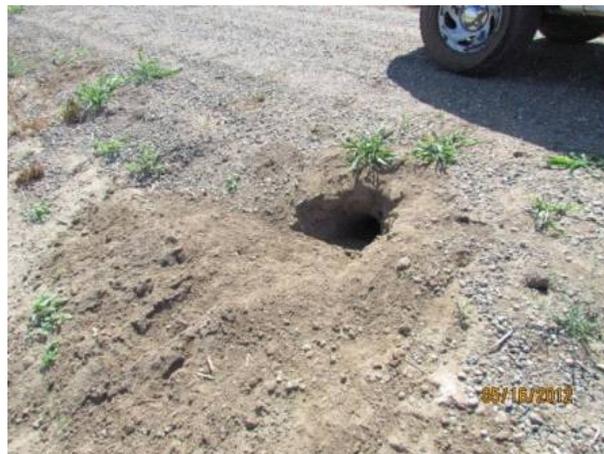
Levee Mile Report Line	5
Start Levee Mile	0.32
End Levee Mile	0.32
Location	Water Side
Category	Earthen Levee
Item	Animal Control
A rodent hole was found on the waterside of the slope taken from the toe looking toward the crown. This picture was taken during the spring 2012 inspection.	
pkazi_f_20131001_842.jpg

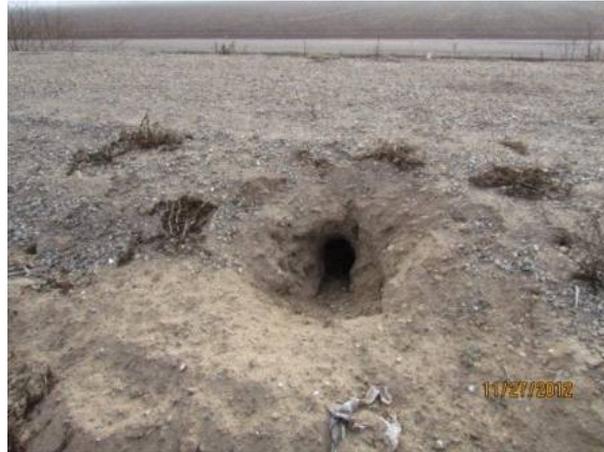
Levee Mile Report Line	5
Start Levee Mile	0.32
End Levee Mile	0.32
Location	Water Side
Category	Earthen Levee
Item	Animal Control
<p>Updated picture of the rodent hole on the waterside shoulder of the levee looking from toe of the levee. The picture was taken during the fall 2012 inspection.</p>	
<p>pkazi_f_20131001_843.jpg</p>

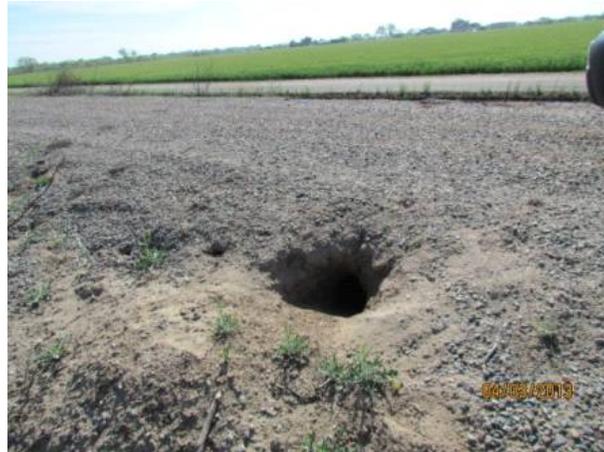
Levee Mile Report Line	5
Start Levee Mile	0.32
End Levee Mile	0.32
Location	Water Side
Category	Earthen Levee
Item	Animal Control
<p>Updated picture of the animal hole on the waterside shoulder of the levee during spring 2013 inspection.</p>	
<p>pkazi_f_20131001_844.JPG</p>

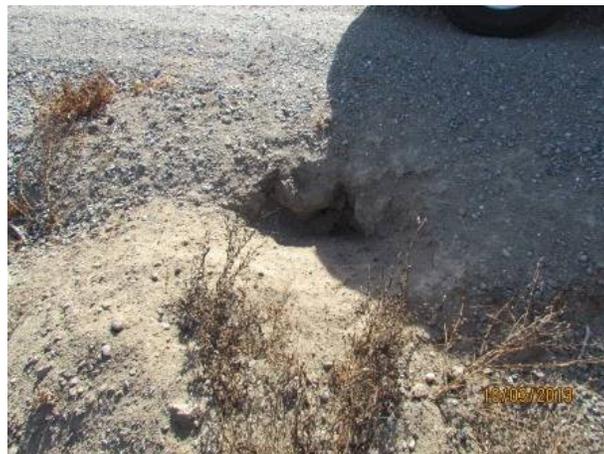
Levee Mile Report Line	5
Start Levee Mile	0.32
End Levee Mile	0.32
Location	Water Side
Category	Earthen Levee
Item	Animal Control
<p>Updated picture of the animal hole on the waterside shoulder of the levee during fall 2013 inspection.</p>	
<p>pkazi_f_20131019_960.JPG</p>

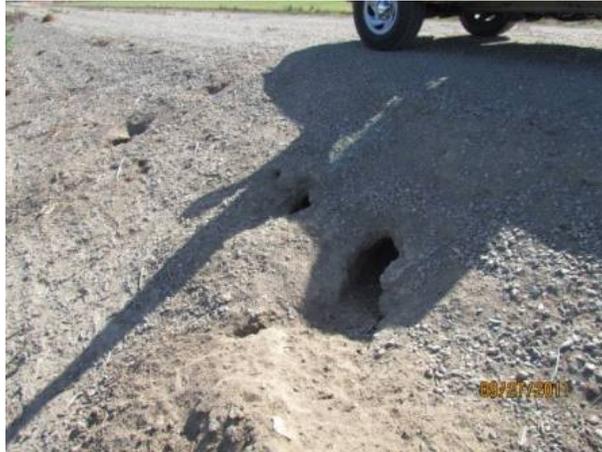
Levee Mile Report Line	6
Start Levee Mile	0.37
End Levee Mile	0.37
Location	Water Side
Category	Earthen Levee
Item	Animal Control
<p>Rodent holes were found on the waterside of the slope. The picture was taken from the toe looking towards the crown of the levee.</p>	
<p>pkazi_f_20131001_846.jpg</p>

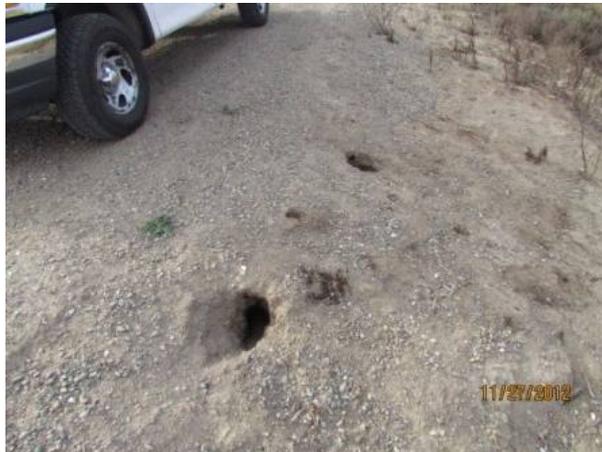
Levee Mile Report Line	6
Start Levee Mile	0.37
End Levee Mile	0.37
Location	Water Side
Category	Earthen Levee
Item	Animal Control
<p>Updated picture of the rodent holes on the waterside shoulder of the levee looking downstream taken during the fall 2012 inspection.</p>	
<p>pkazi_f_20131001_847.jpg</p>

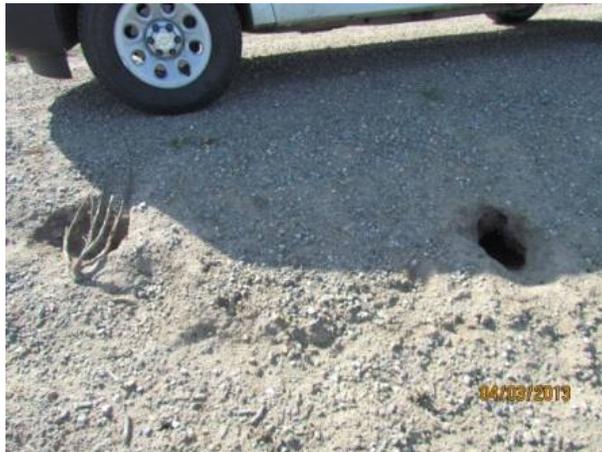
Levee Mile Report Line	6
Start Levee Mile	0.37
End Levee Mile	0.37
Location	Water Side
Category	Earthen Levee
Item	Animal Control
<p>Updated picture of the rodent hole on the waterside shoulder of the levee looking upstream during spring 2013 inspection.</p>	
<p>pkazi_f_20131001_848.JPG</p>

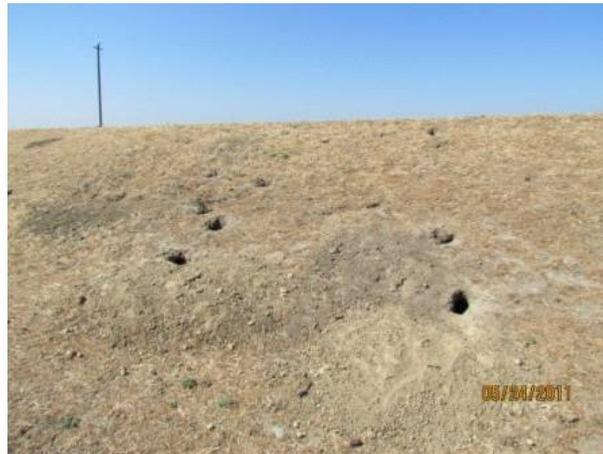
Levee Mile Report Line	9
Start Levee Mile	0.60
End Levee Mile	0.60
Location	Water Side
Category	Earthen Levee
Item	Animal Control
<p>Rodent holes were found on the waterside of the levee. The picture was taken from the toe of the waterside of the levee looking upstream.</p>	
<p>pkazi_f_20131001_820.jpg</p>

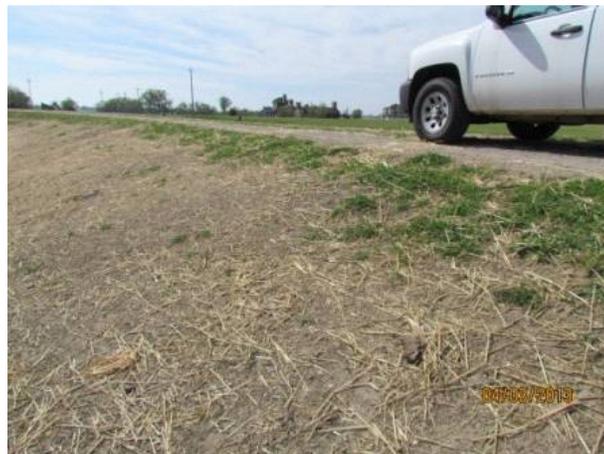
Levee Mile Report Line	11
Start Levee Mile	0.63
End Levee Mile	0.63
Location	Water Side
Category	Earthen Levee
Item	Animal Control
<p>Rodent holes were repaired on the waterside slope of the levee looking upstream.</p>	
<p>pkazi_f_20131001_818.JPG</p>

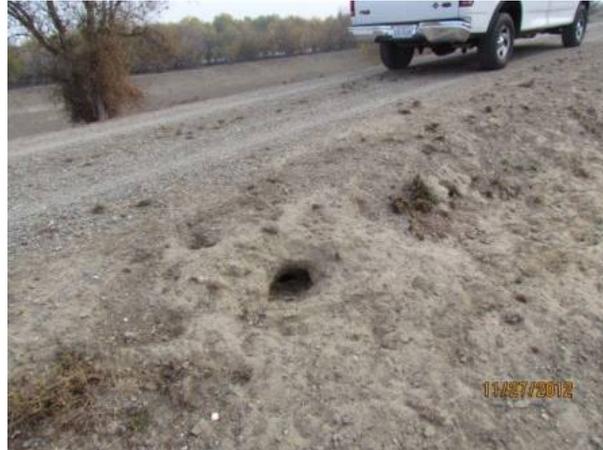
A rodent hole was found on the landside shoulder of the levee looking upstream.

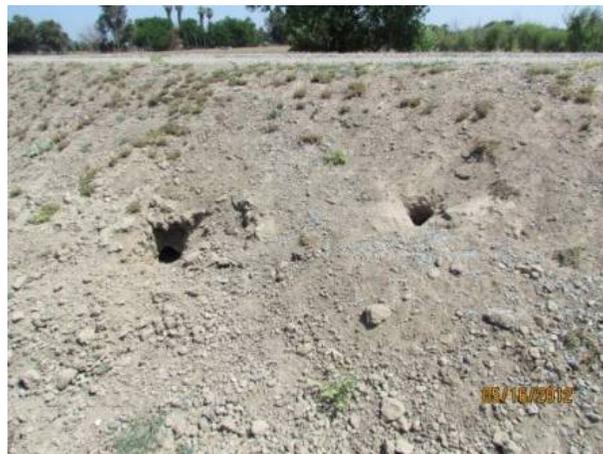
Rodent holes were found on the landside of the levee. The picture was taken from the toe of the levee looking towards the crown.

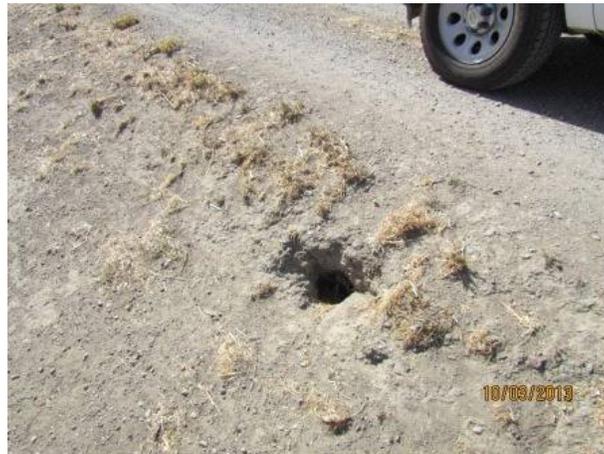
Levee Mile Report Line	15
Start Levee Mile	0.69
End Levee Mile	0.69
Location	Water Side
Category	Earthen Levee
Item	Animal Control
<p>An animal hole was found on the waterside shoulder of the levee looking upstream.</p>	
<p>pkazi_f_20131020_965.JPG</p>

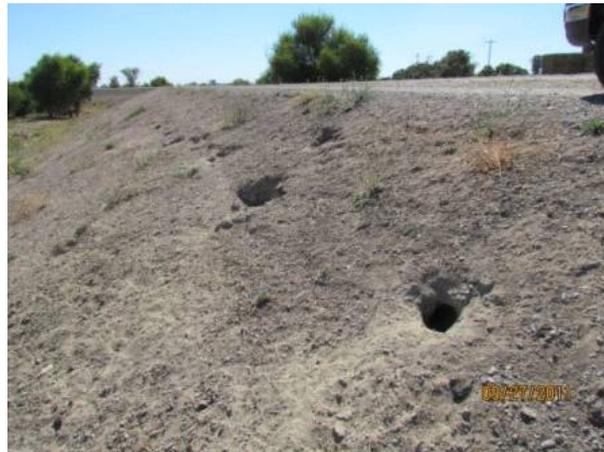
Levee Mile Report Line	17
Start Levee Mile	0.71
End Levee Mile	0.71
Location	Water Side
Category	Earthen Levee
Item	Animal Control
Rodent holes were found on the waterside of the levee. The picture was taken from toe of the levee looking upstream.	
pkazi_f_20131001_858.jpg

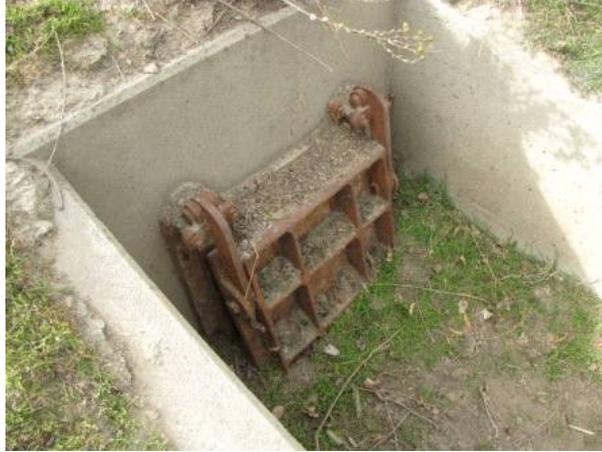
View of a flap gate with sediment preventing it from closing.

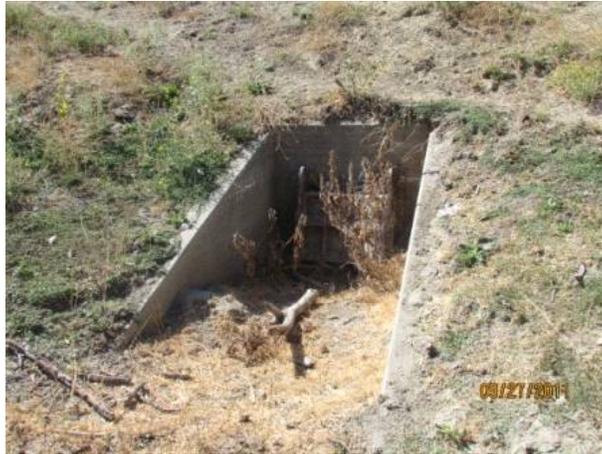
Debris and sediments were obstructing the flap gate. The picture was taken from toe of waterside of the levee looking towards the crown. This picture was taken during the fall 2011 inspection.

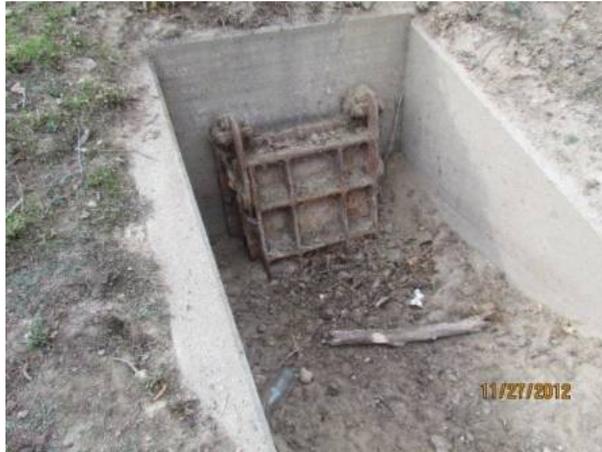
Debris and sediments were obstructing the flap gate from closing completely. The picture was taken from toe of waterside of the levee during the fall 2012 inspection.

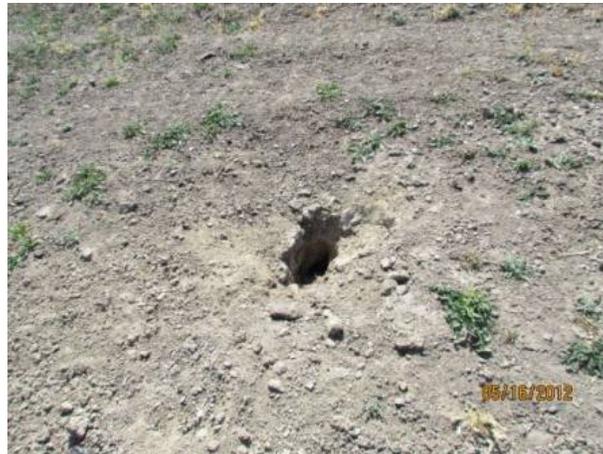
A rodent hole was found on the waterside of the levee looking upstream.

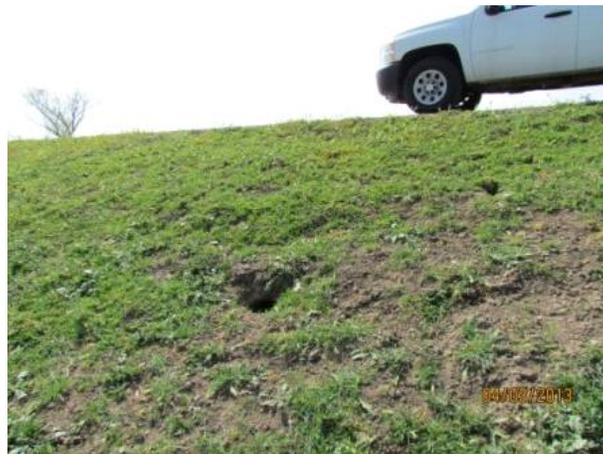
Updated picture of the rodent hole on the waterside slope of the levee looking upstream during spring spring 2013 inspection.

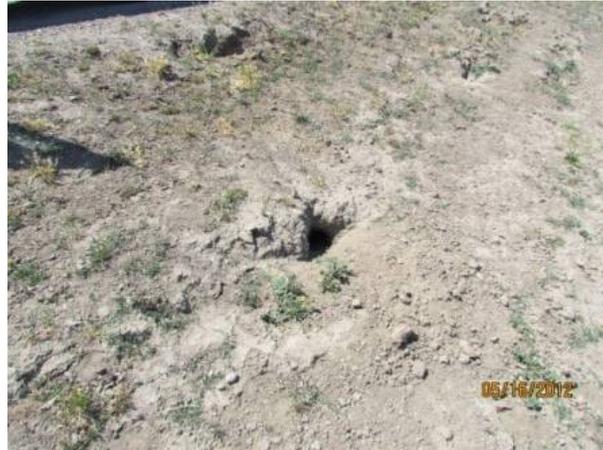
Levee Mile Report Line	21
Start Levee Mile	0.83
End Levee Mile	0.83
Location	Water Side
Category	Earthen Levee
Item	Animal Control
A rodent hole was found on the waterside of the levee looking downstream.	
pkazi_f_20131001_892.jpg

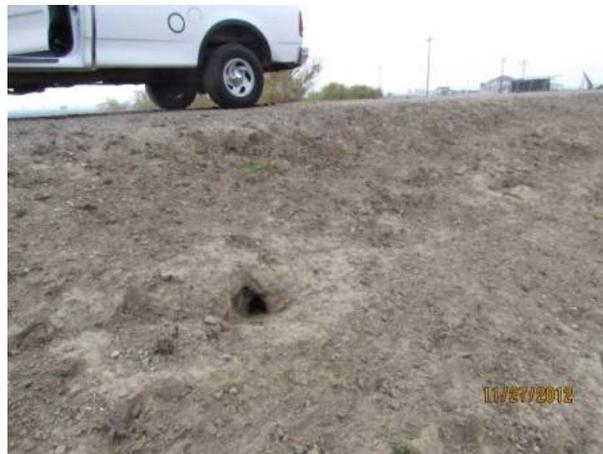
Levee Mile Report Line	21
Start Levee Mile	0.83
End Levee Mile	0.83
Location	Water Side
Category	Earthen Levee
Item	Animal Control
Updated picture of the rodent hole on the waterside slope of the levee looking downstream.	
pkazi_f_20131001_893.jpg

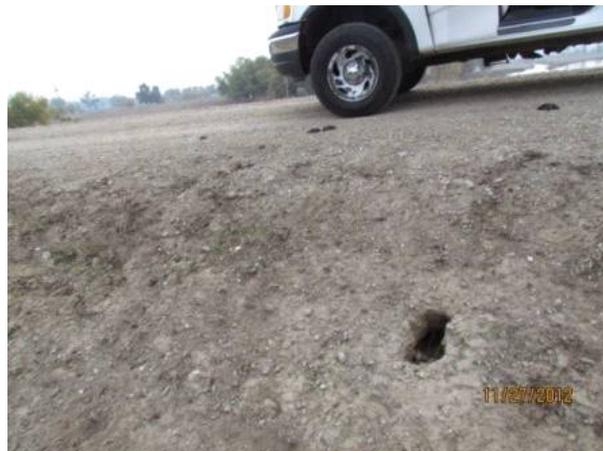
Levee Mile Report Line	23
Start Levee Mile	0.95
End Levee Mile	0.95
Location	Water Side
Category	Earthen Levee
Item	Animal Control
A rodent hole was found on the waterside slope of the levee looking upstream.	
pkazi_f_20131001_871.jpg

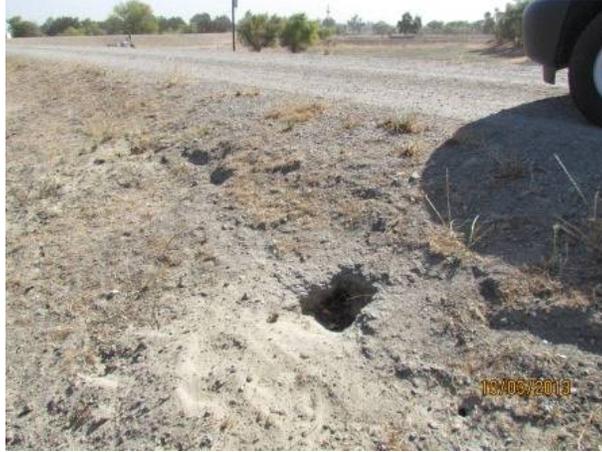
Levee Mile Report Line	23
Start Levee Mile	0.95
End Levee Mile	0.95
Location	Water Side
Category	Earthen Levee
Item	Animal Control
Updated picture of a rodent hole on the waterside slope of the levee looking upstream during fall 2013 inspection.	
pkazi_f_20131020_967.JPG

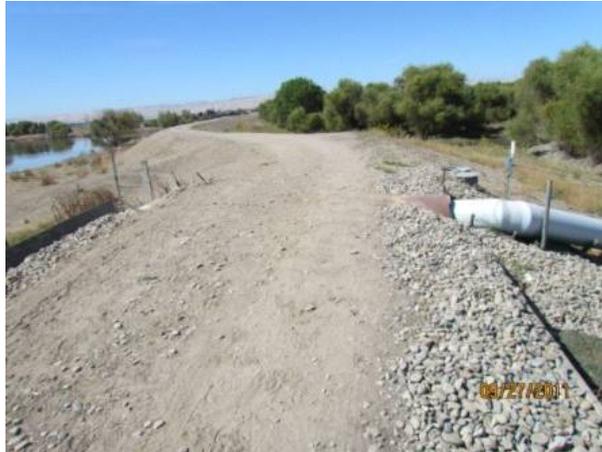
Levee Mile Report Line	24
Start Levee Mile	0.99
End Levee Mile	0.99
Location	Water Side
Category	Earthen Levee
Item	Encroachments
View of the ramp on the crown. The picture was taken from crown looking downstream.	
pkazi_f_20131001_859.jpg

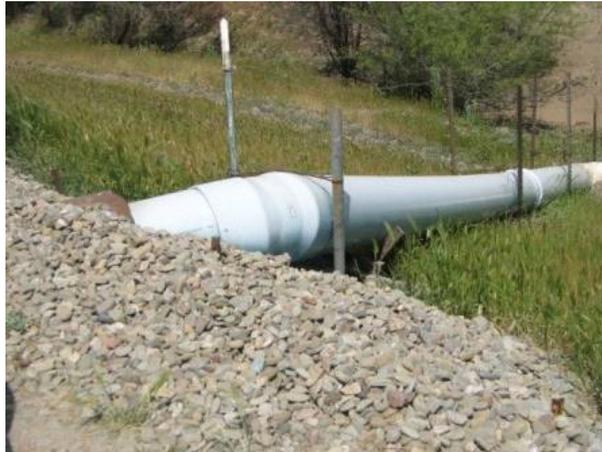
Levee Mile Report Line	25
Start Levee Mile	1.02
End Levee Mile	1.02
Location	Water Side
Category	Interior Drainage & Piping Systems
Item	Encroachments
PVC sleeve through steel pipe on waterward slope at LM 1.02.	
pkazi_f_20131001_827.jpg

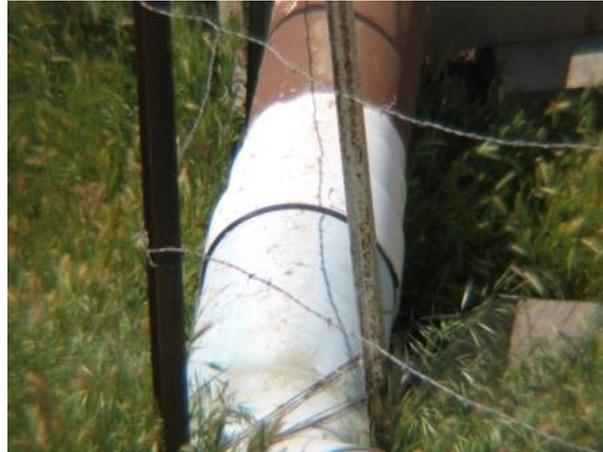
Levee Mile Report Line	25
Start Levee Mile	1.02
End Levee Mile	1.02
Location	Water Side
Category	Interior Drainage & Piping Systems
Item	Encroachments
PVC pipe connected to steel pipe on landward toe at LM 1.02.	
pkazi_f_20131001_828.jpg

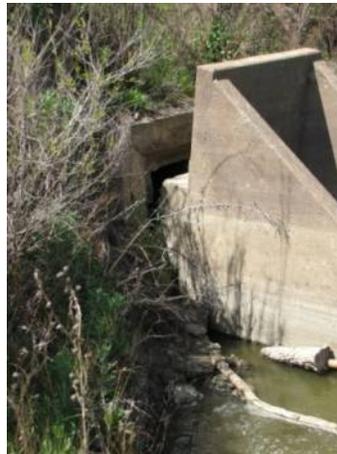
LMIR No.	Levee Mile		Category	Item	Location	Rating	Action/Comment	GPS Latitude/Longitude		Issue No. Photo
	Start	End						Start	End	
26	1.04	1.04	Interior Drainage & Piping Systems	Concrete Tilting / Settlement	WS	M Ma	Inspector Comments: The outlet headwall is tilting away from the pipe rendering the existing flap gate ineffective. Repair gap between pipe and headwall and stabilize headwall to prevent further damage.	37.478678 ° -121.068305 °	37.478678 ° -121.068305 °	55 Y
								DWR ID: DWR_RD1602_01_s_2012_55		
27	1.06	1.06	Earthen Levee	Animal Control	WS	M Ma	A3 : No rodents visible, but rodent burrows visible; need to backfill and compact or grout burrows.	37.478577 ° -121.067920 °	37.478577 ° -121.067920 °	28 Y
								DWR ID: DWR_RD1602_01_f_2013_28		
28	1.07	1.07	Earthen Levee	Slope Stability	WS	M Ma	S1 : Repair slope instability. Inspector Comments: Small amount of slumping at waterside toe of the levee.	37.478567 ° -121.067847 °	37.478567 ° -121.067847 °	37 Y

Levee Mile Report Line	26
Start Levee Mile	1.04
End Levee Mile	1.04
Location	Water Side
Category	Interior Drainage & Piping Systems
Item	Concrete Tilting / Settlement
Separation of outfall structure from the outlet pipe at LM 1.04.	
pkazi_f_20131001_876.jpg

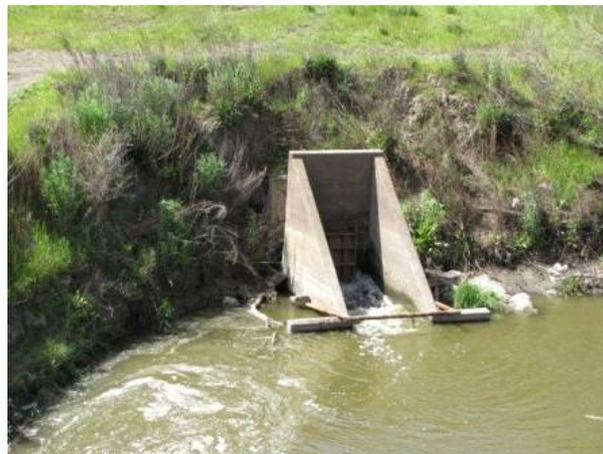
Levee Mile Report Line	26
Start Levee Mile	1.04
End Levee Mile	1.04
Location	Water Side
Category	Interior Drainage & Piping Systems
Item	Concrete Tilting / Settlement
Additional view of outfall structure at LM 1.04.	
pkazi_f_20131001_877.jpg

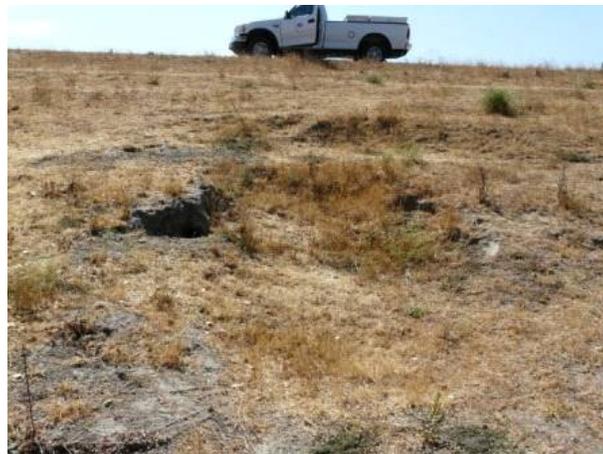
Levee Mile Report Line	28
Start Levee Mile	1.07
End Levee Mile	1.07
Location	Water Side
Category	Earthen Levee
Item	Slope Stability
<p>Small amount of slumping at water toe.</p>	
<p>pkazi_f_20131001_860.JPG</p>

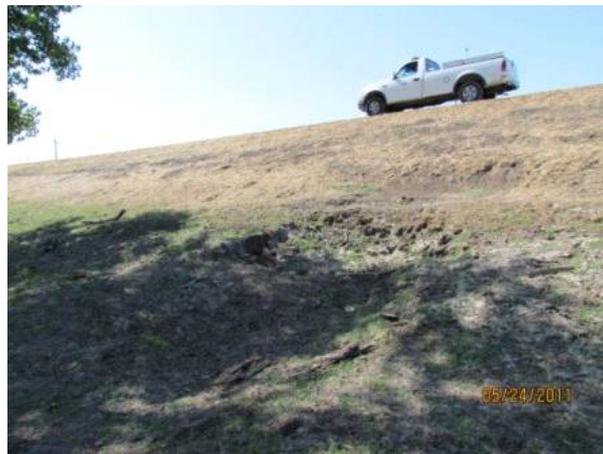
Levee Mile Report Line	28
Start Levee Mile	1.07
End Levee Mile	1.07
Location	Water Side
Category	Earthen Levee
Item	Slope Stability
<p>Depression at the waterside slope of the levee during Spring 2011 inspection.</p>	
<p>pkazi_f_20131001_861.jpg</p>

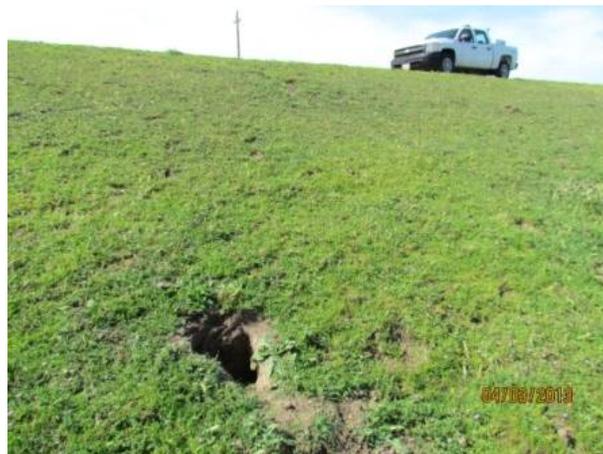
pkazi\_f\_20131001\_830.JPG

A rodent hole was found on the waterside toe of the levee looking downstream.

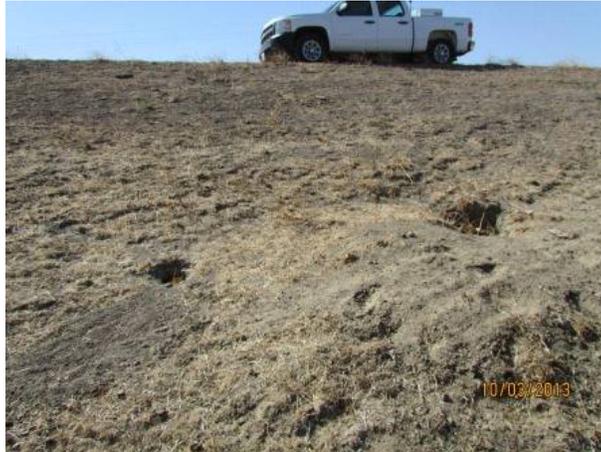
Levee Mile Report Line	31
Start Levee Mile	1.11
End Levee Mile	1.11
Location	Water Side
Category	Earthen Levee
Item	Animal Control
Rodent holes were found on the waterside slope of the levee looking downstream.	
pkazi_f_20131020_969.JPG

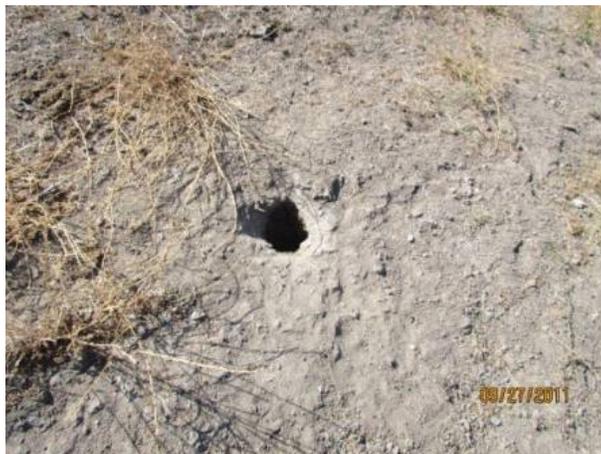
Levee Mile Report Line	33
Start Levee Mile	1.13
End Levee Mile	1.13
Location	Land Side
Category	Earthen Levee
Item	Animal Control
Animal burrow was found on the landside of the levee. The picture was taken from the toe of the levee looking upstream.	
pkazi_f_20131001_825.jpg

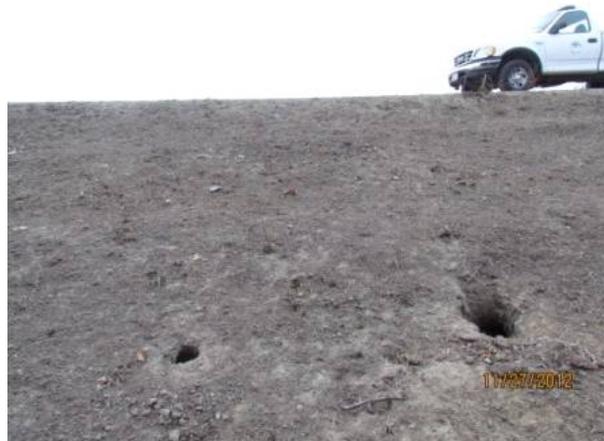
Levee Mile Report Line	34
Start Levee Mile	1.15
End Levee Mile	1.15
Location	Water Side
Category	Earthen Levee
Item	Animal Control
<p>Rodent holes were found on the waterside toe of the levee. The picture was taken from toe of the levee looking towards the crown.</p>	
<p>pkazi_f_20131001_885.jpg</p>

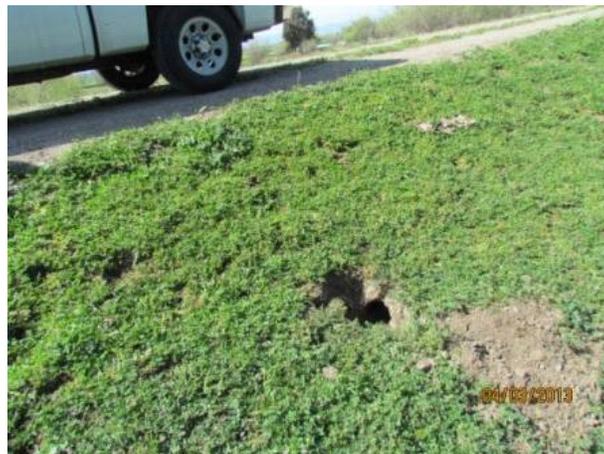
Levee Mile Report Line	35
Start Levee Mile	1.16
End Levee Mile	1.16
Location	Water Side
Category	Earthen Levee
Item	Animal Control
<p>A rodent hole was found on the waterside shoulder of the levee looking downstream.</p>	
<p>pkazi_f_20131001_831.JPG</p>

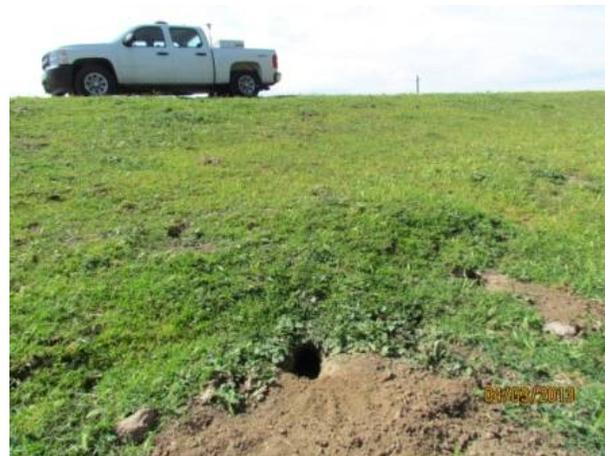
pkazi\_f\_20131001\_895.JPG

A rodent hole was found on the waterside toe of the levee looking downstream.

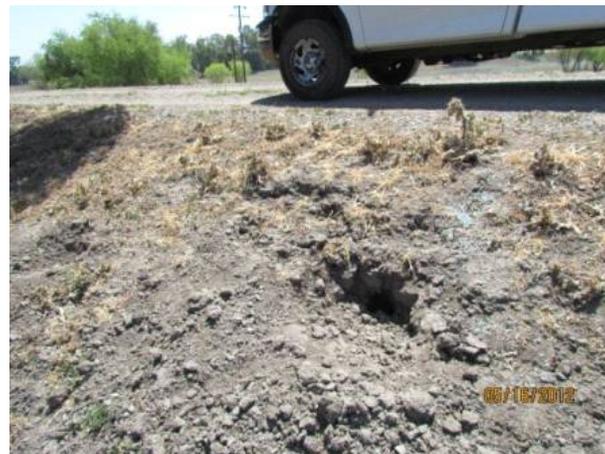
pkazi\_f\_20131001\_896.jpg

Levee Mile Report Line	38
Start Levee Mile	1.21
End Levee Mile	1.21
Location	Water Side
Category	Earthen Levee
Item	Animal Control

Rodent hole on the waterside shoulder of the levee looking upstream.

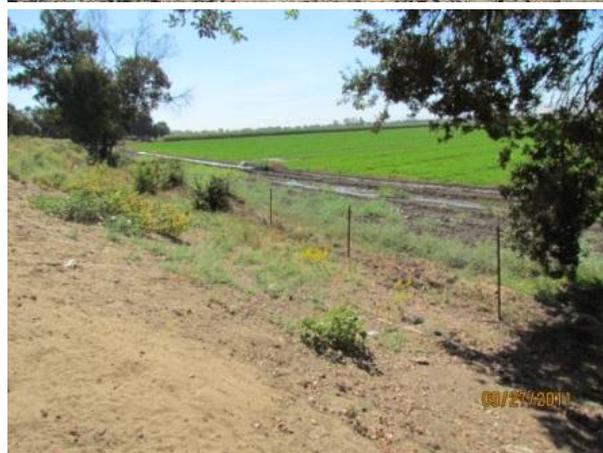
Levee Mile Report Line	41
Start Levee Mile	1.62
End Levee Mile	2.29
Location	Land Side
Category	Earthen Levee
Item	Encroachments
View of the fence on the landside toe of the levee. The picture was taken from crown looking upstream.	
pkazi_f_20131001_867.jpg

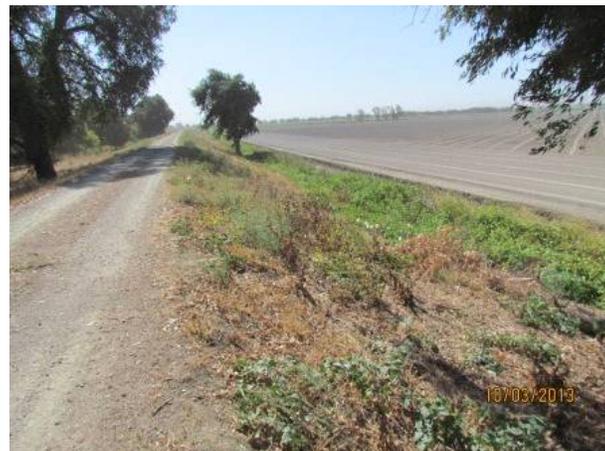
Levee Mile Report Line	45
Start Levee Mile	1.81
End Levee Mile	2.65
Location	Land Side
Category	Earthen Levee
Item	Vegetation
Vegetation was found on the landside of the levee looking upstream.	
pkazi_f_20131020_972.JPG

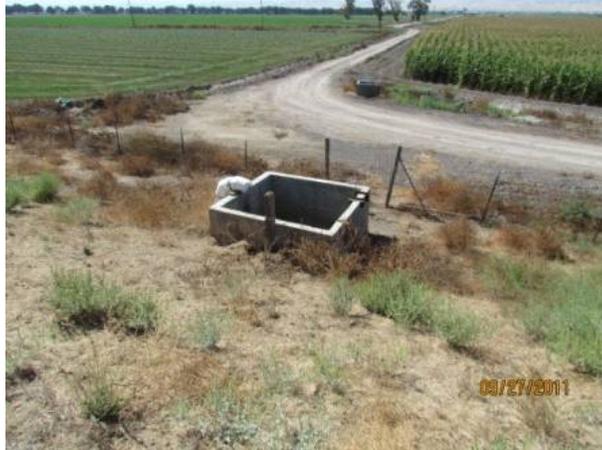
Levee Mile Report Line	48
Start Levee Mile	2.03
End Levee Mile	2.03
Location	Land Side
Category	Earthen Levee
Item	Encroachments
<p>A well is located at the landside toe of the levee. The picture was taken from the crown looking toward the landside of the levee.</p>	
<p>pkazi_f_20131001_869.jpg</p>

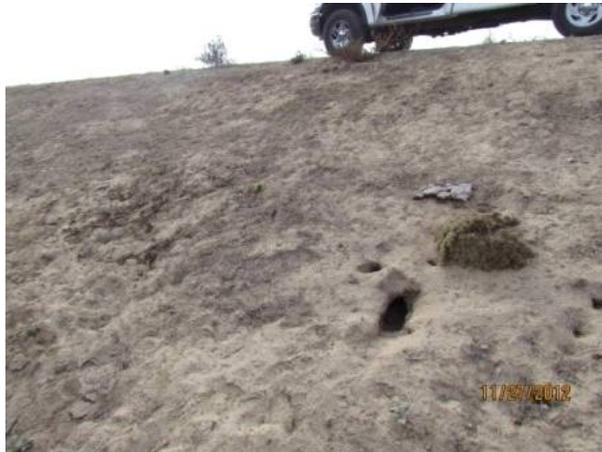
Levee Mile Report Line	49
Start Levee Mile	2.06
End Levee Mile	2.06
Location	Water Side
Category	Earthen Levee
Item	Animal Control
<p>Rodent holes were found on the waterside toe of the levee looking upstream.</p>	
<p>pkazi_f_20131001_897.jpg</p>

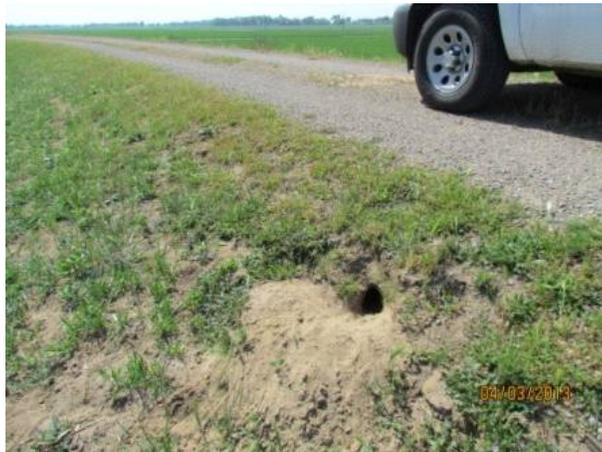
Levee Mile Report Line	51
Start Levee Mile	2.11
End Levee Mile	2.11
Location	Water Side
Category	Earthen Levee
Item	Animal Control
<p>A rodent hole was found on the waterside shoulder of the levee looking upstream.</p>	
<p>pkazi_f_20131001_900.JPG</p>

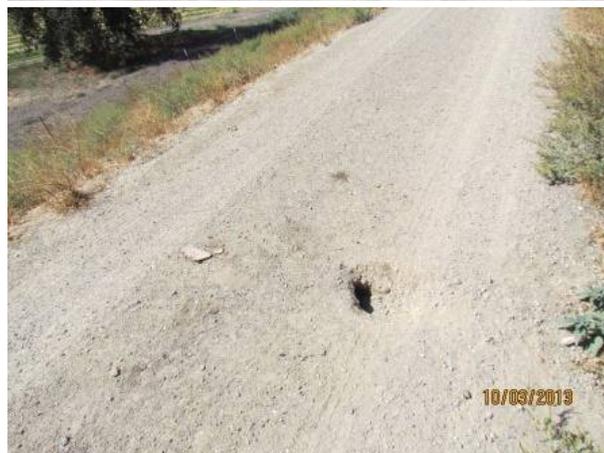
Levee Mile Report Line	54
Start Levee Mile	2.20
End Levee Mile	2.20
Location	Crown
Category	Earthen Levee
Item	Animal Control
A rodent hole was found on the crown of the levee looking downstream.	
pkazi_f_20131020_974.JPG

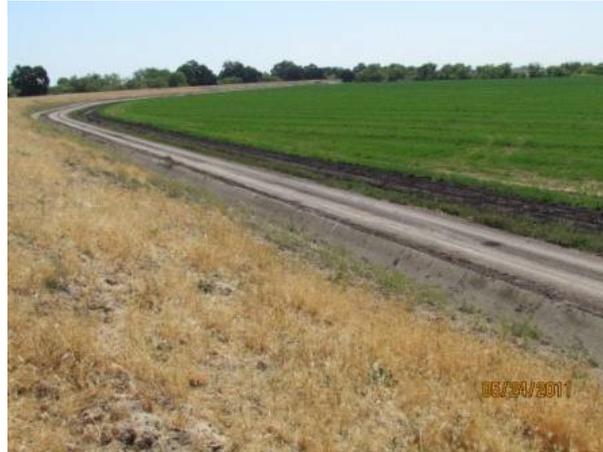
Levee Mile Report Line	55
Start Levee Mile	2.24
End Levee Mile	3.45
Location	Land Side
Category	Earthen Levee
Item	Encroachments
Concrete drain was built at the toe of the levee. The picture was taken from the crown looking upstream.	
pkazi_f_20131001_881.jpg

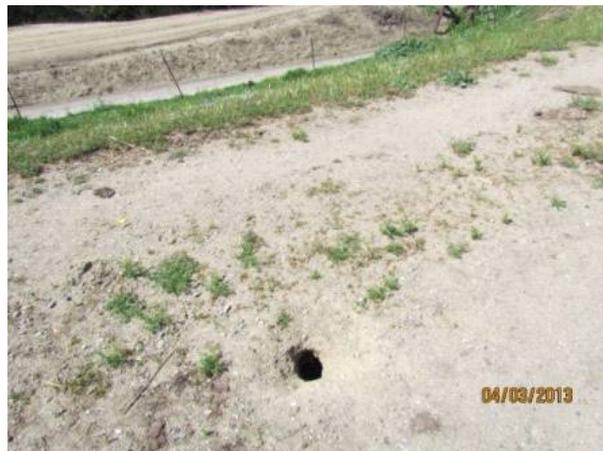
Levee Mile Report Line	58
Start Levee Mile	2.59
End Levee Mile	2.59
Location	Crown
Category	Earthen Levee
Item	Animal Control
A rodent hole was found on the crown of the levee looking downstream.	
pkazi_f_20131001_840.JPG

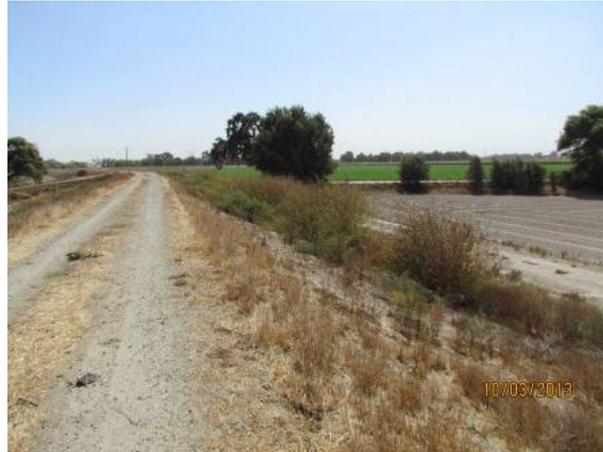
Levee Mile Report Line	64
Start Levee Mile	2.99
End Levee Mile	3.10
Location	Land Side
Category	Earthen Levee
Item	Vegetation
Vegetation was found on the landside of the levee looking upstream.	
pkazi_f_20131020_976.JPG

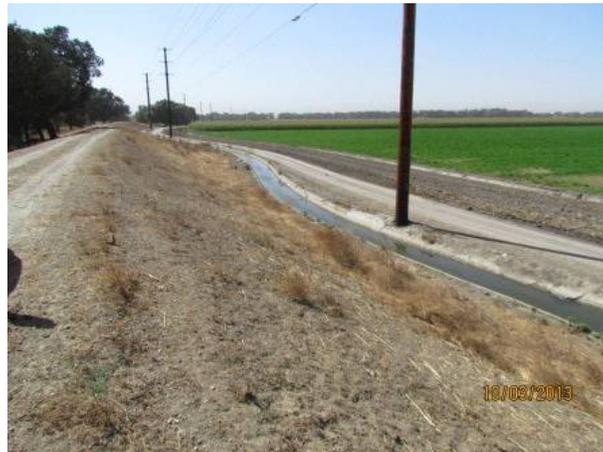
Levee Mile Report Line	66
Start Levee Mile	3.32
End Levee Mile	3.49
Location	Land Side
Category	Earthen Levee
Item	Encroachments
A concrete lined ditch was found on the landside toe of the levee looking upstream.	
pkazi_f_20131020_977.JPG

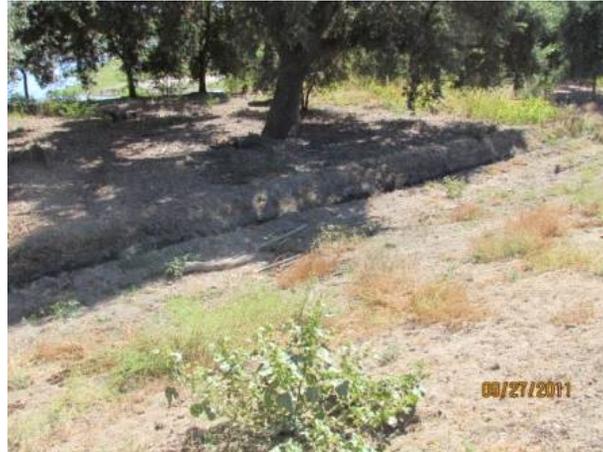
Levee Mile Report Line	67
Start Levee Mile	3.39
End Levee Mile	3.56
Location	Water Side
Category	Earthen Levee
Item	Encroachments
<p>A ditch was located on the waterside toe of the levee. The picture was taken from the crown looking upstream.</p>	
<p>pkazi_f_20131001_873.jpg</p>

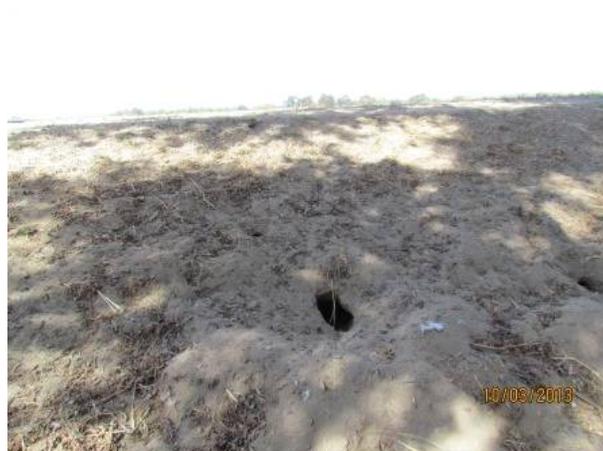
Levee Mile Report Line	69
Start Levee Mile	3.47
End Levee Mile	3.47
Location	Water Side
Category	Earthen Levee
Item	Animal Control
<p>Updated picture of rodent hole on the waterside shoulder of the levee looking downstream.</p>	
<p>pkazi_f_20131020_978.JPG</p>

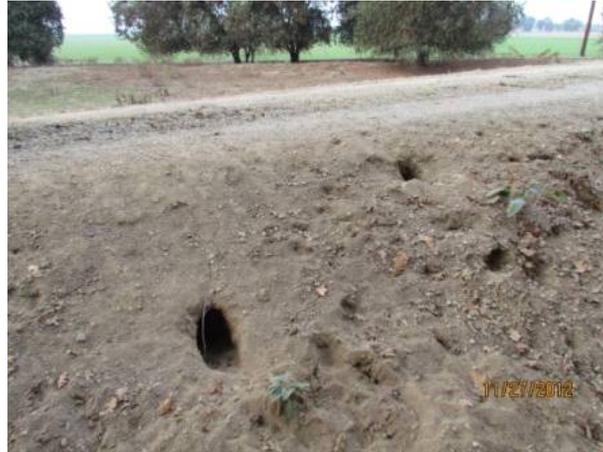
Levee Mile Report Line	70
Start Levee Mile	3.52
End Levee Mile	3.52
Location	Water Side
Category	Earthen Levee
Item	Animal Control
Rodent holes were found on the waterside slope of the levee looking downstream.	
pkazi_f_20131001_911.jpg

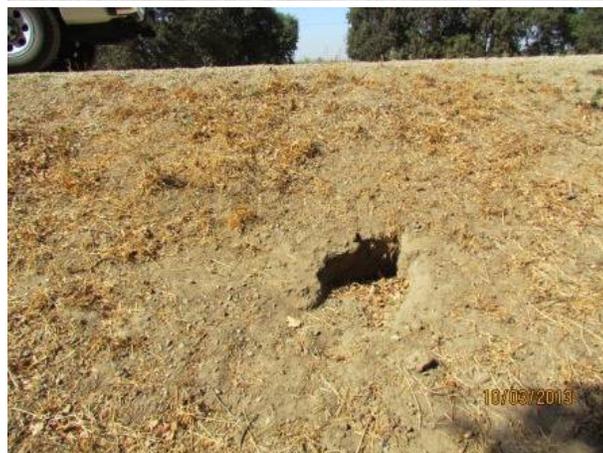
Levee Mile Report Line	71
Start Levee Mile	3.53
End Levee Mile	3.53
Location	Water Side
Category	Earthen Levee
Item	Animal Control
Updated picture of rodent hole on the waterside shoulder of the levee looking upstream.	
pkazi_f_20131020_979.JPG

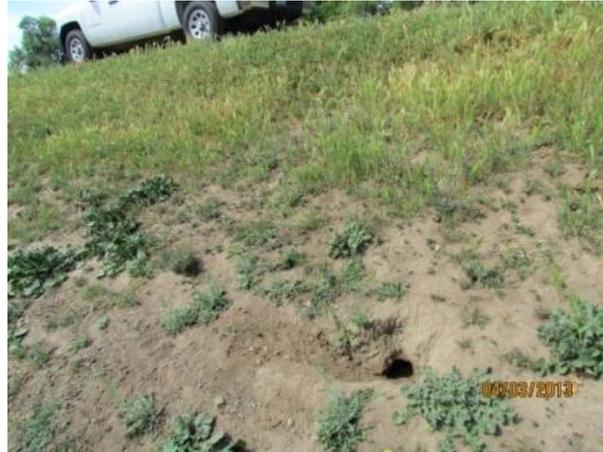
Levee Mile Report Line	72
Start Levee Mile	3.54
End Levee Mile	3.54
Location	Water Side
Category	Earthen Levee
Item	Animal Control
<p>A rodent hole was found on the waterside toe of the levee looking upstream.</p>	
<p>pkazi_f_20131001_853.JPG</p>

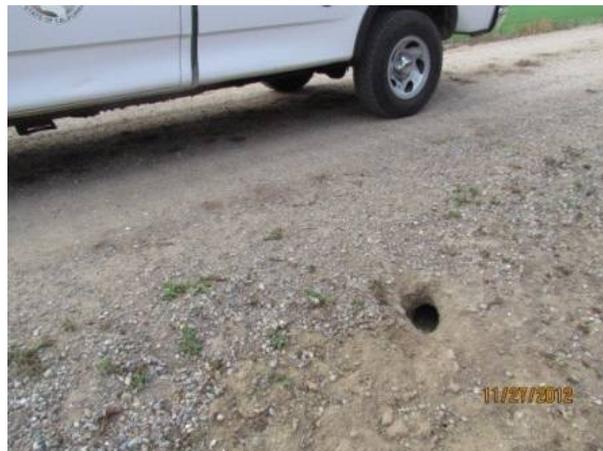
Levee Mile Report Line	74
Start Levee Mile	3.80
End Levee Mile	3.80
Location	Water Side
Category	Earthen Levee
Item	Animal Control
<p>A rodent hole was found on the waterside shoulder of the levee looking downstream.</p>	
<p>pkazi_f_20131001_898.jpg</p>

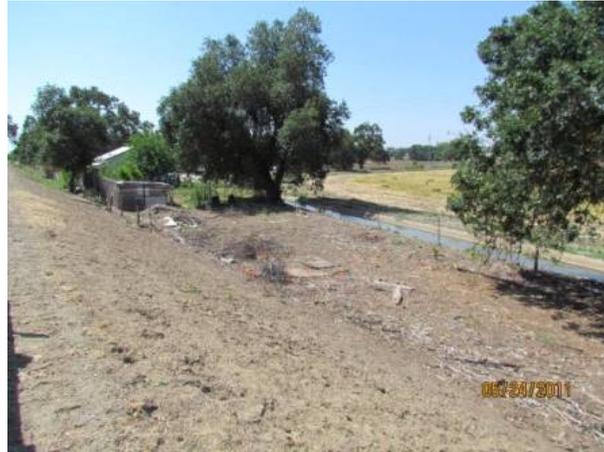
pkazi\_f\_20131001\_833.jpg

Garbage was found on the landside of the levee. The picture was taken from the crown looking upstream.

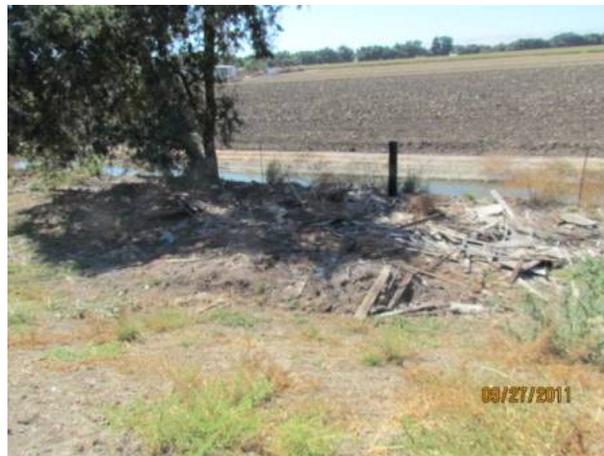
pkazi\_f\_20131001\_834.jpg

Levee Mile Report Line	75
Start Levee Mile	3.83
End Levee Mile	3.83
Location	Land Side
Category	Earthen Levee
Item	Encroachments

Debris was located on the landside of the levee. The picture was taken from the crown looking upstream.

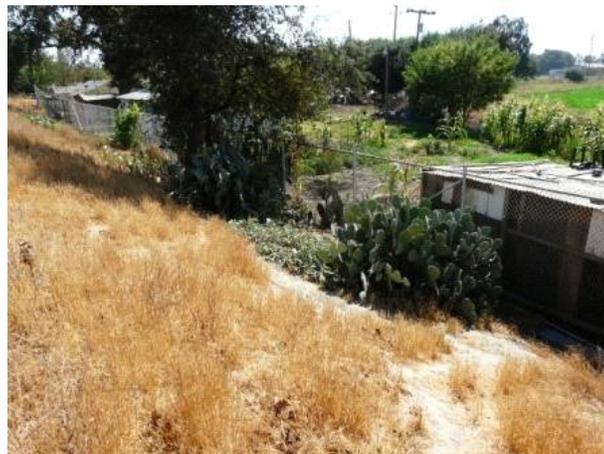
pkazi\_f\_20131001\_866.JPG

Levee Mile Report Line	76
Start Levee Mile	3.85
End Levee Mile	3.85
Location	Land Side
Category	Earthen Levee
Item	Vegetation

Remove landscaping from within 10' of landside toe.

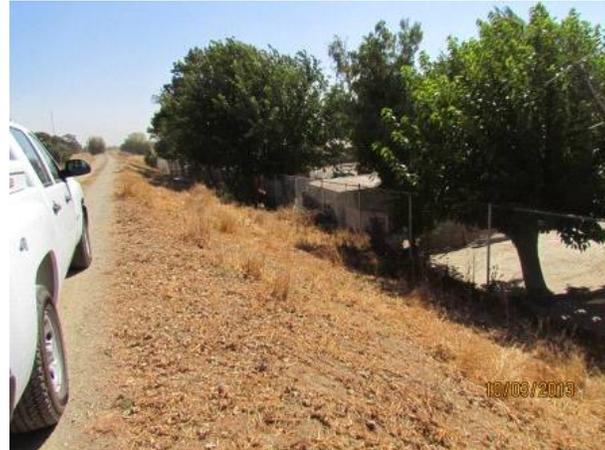
Levee Mile Report Line	77
Start Levee Mile	3.90
End Levee Mile	3.96
Location	Land Side
Category	Earthen Levee
Item	Encroachments
Fences were found on the landside toe of the levee looking upstream.	
pkazi_f_20131020_981.JPG

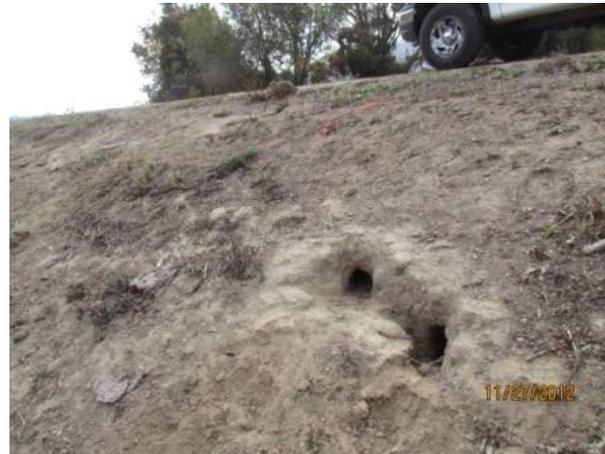
Levee Mile Report Line	78
Start Levee Mile	3.91
End Levee Mile	3.91
Location	Water Side
Category	Earthen Levee
Item	Animal Control
Rodent holes were found on the waterside toe of the levee looking upstream.	
pkazi_f_20131001_905.jpg

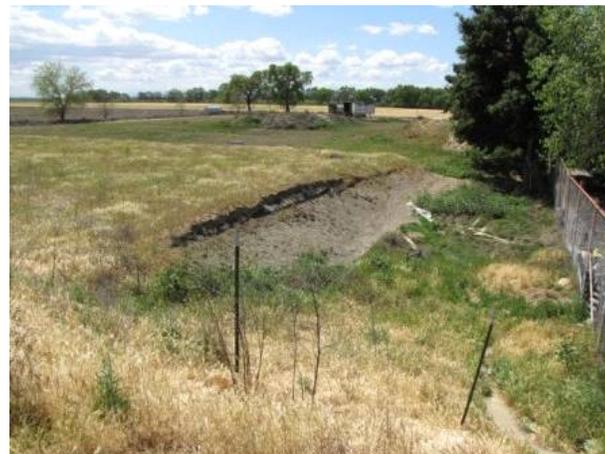
Levee Mile Report Line	79
Start Levee Mile	3.96
End Levee Mile	3.96
Location	Land Side
Category	Earthen Levee
Item	Slope Stability
Repair damage to USACE constructed seepage berm by pedestrian and cycle traffic at LM 3.96.	
pkazi_f_20131001_883.jpg

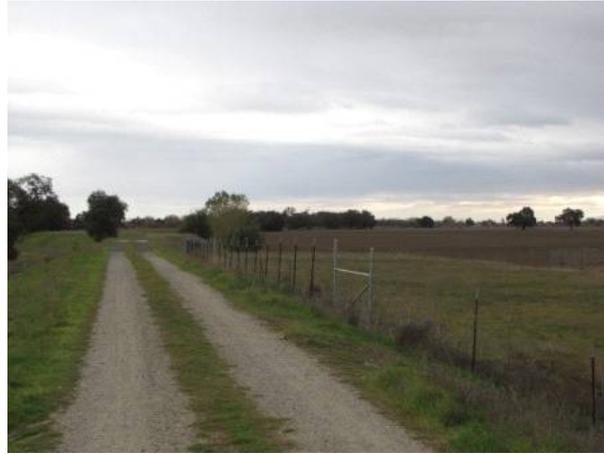
Levee Mile Report Line	80
Start Levee Mile	3.97
End Levee Mile	4.07
Location	Land Side
Category	Earthen Levee
Item	Encroachments
View of a barbed wire fence on the landward slope looking upstream.	
pkazi_f_20131001_884.jpg

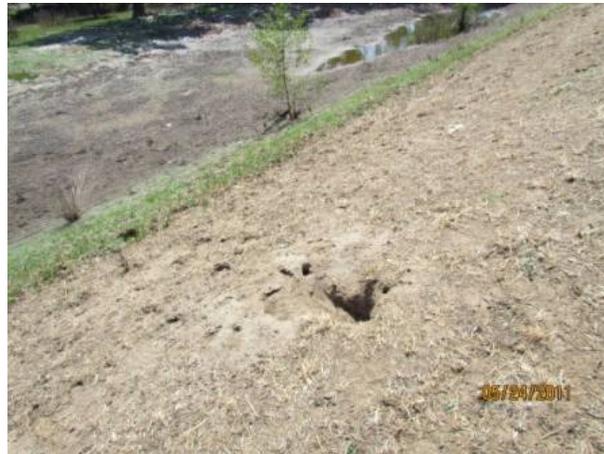
Levee Mile Report Line	81
Start Levee Mile	3.99
End Levee Mile	3.99
Location	Water Side
Category	Earthen Levee
Item	Animal Control
Rodent hole at the waterside slope of the levee. The picture was taken from the crown looking upstream.	
pkazi_f_20131001_835.jpg

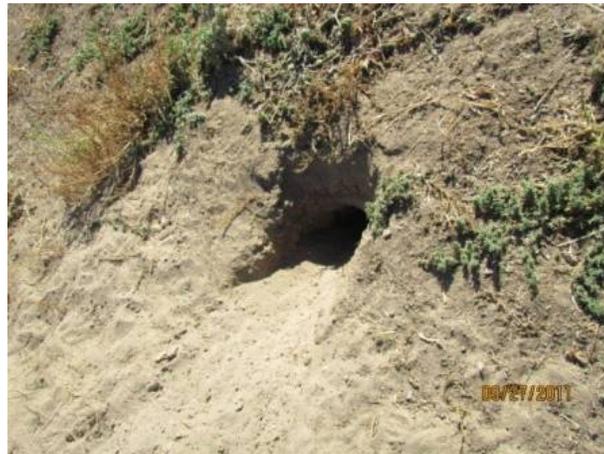
Levee Mile Report Line	81
Start Levee Mile	3.99
End Levee Mile	3.99
Location	Water Side
Category	Earthen Levee
Item	Animal Control
Animal burrow was found on the waterside of the levee. The picture was taken from the toe of the levee looking upstream.	
pkazi_f_20131001_836.jpg

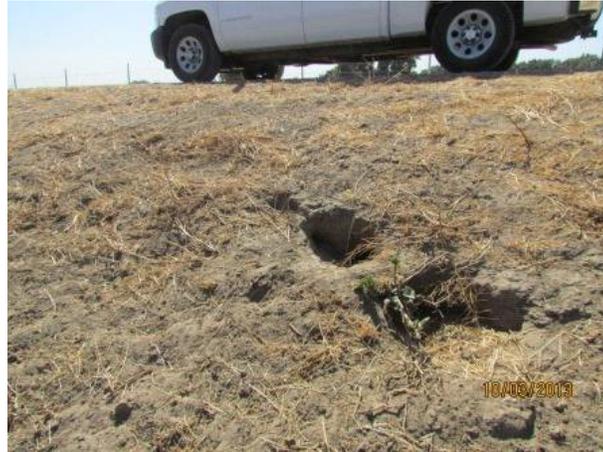
Levee Mile Report Line	81
Start Levee Mile	3.99
End Levee Mile	3.99
Location	Water Side
Category	Earthen Levee
Item	Animal Control
<p>Updated view of the rodent holes on the waterside slope of the levee looking upstream during fall 2013 inspection.</p>	
<p>pkazi_f_20131020_982.JPG</p>

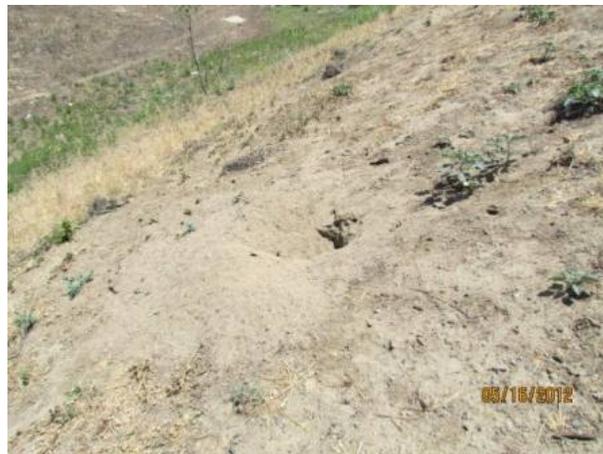
Levee Mile Report Line	82
Start Levee Mile	4.00
End Levee Mile	4.00
Location	Water Side
Category	Earthen Levee
Item	Animal Control
<p>A rodent hole was found on the waterside of the levee looking upstream.</p>	
<p>pkazi_f_20131001_906.jpg</p>

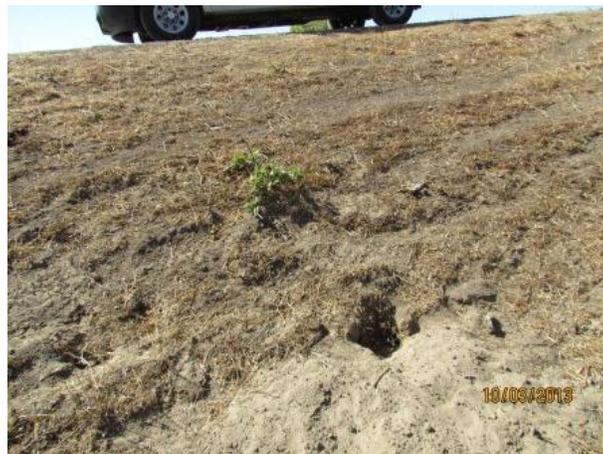
Levee Mile Report Line	83
Start Levee Mile	4.05
End Levee Mile	4.05
Location	Water Side
Category	Earthen Levee
Item	Animal Control
<p>A rodent hole was found on the waterside toe of the levee looking downstream.</p>	
<p>pkazi_f_20131020_983.JPG</p>

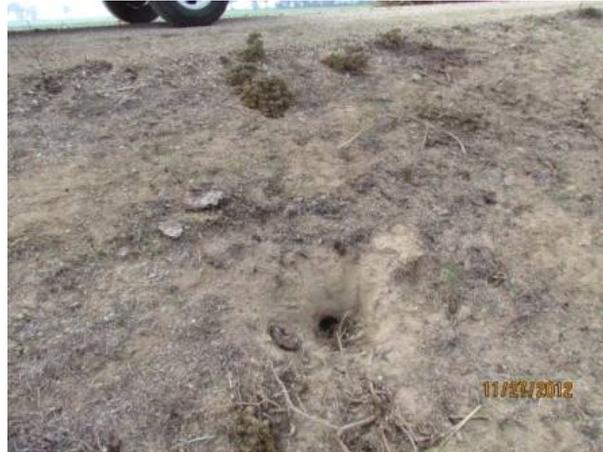
Levee Mile Report Line	84
Start Levee Mile	4.11
End Levee Mile	4.11
Location	Water Side
Category	Earthen Levee
Item	Animal Control
<p>A rodent hole was found on the waterside toe of the levee looking downstream.</p>	
<p>pkazi_f_20131001_874.jpg</p>

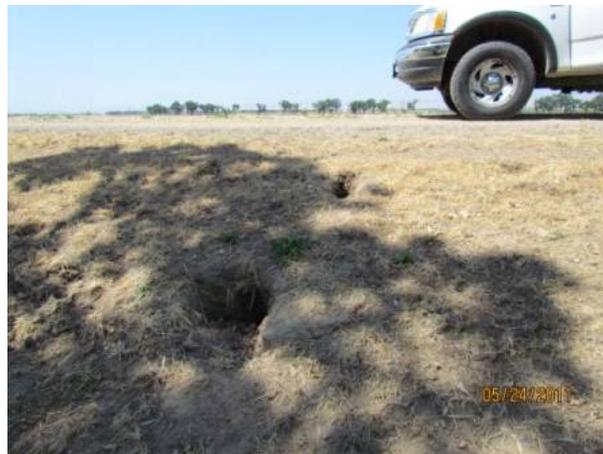
Levee Mile Report Line	85
Start Levee Mile	4.15
End Levee Mile	4.15
Location	Water Side
Category	Earthen Levee
Item	Animal Control
<p>Rodent hole was found on the waterside of the levee. The picture was taken from the crown looking upstream.</p>	
<p>pkazi_f_20131001_837.jpg</p>
