**Flood Control Project Maintenance  
Levee Inspections**

**Fall 2013 Levee Maintenance Deficiency Summary Report**

**Reclamation District No. 1602 Del Puerto**

Waterway		Bank	Unit Miles
Unit No. 01 San Joaquin River		Left	6.29

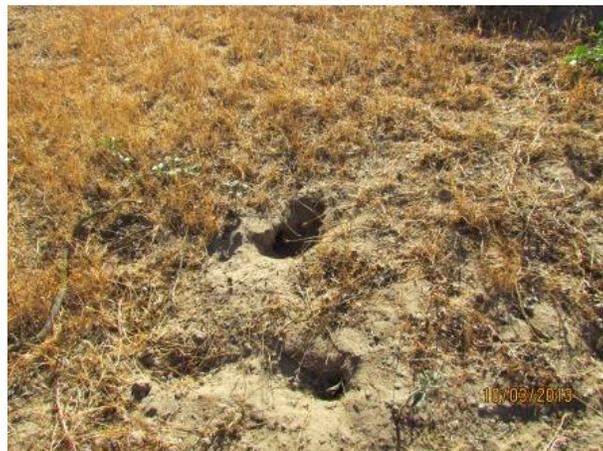
Levee Mile Report Line	86
Start Levee Mile	4.23
End Levee Mile	4.23
Location	Water Side
Category	Earthen Levee
Item	Animal Control
<p>Rodent holes were found on the waterside slope of the levee looking upstream.</p>	
<p>pkazi_f_20131020_984.JPG</p>

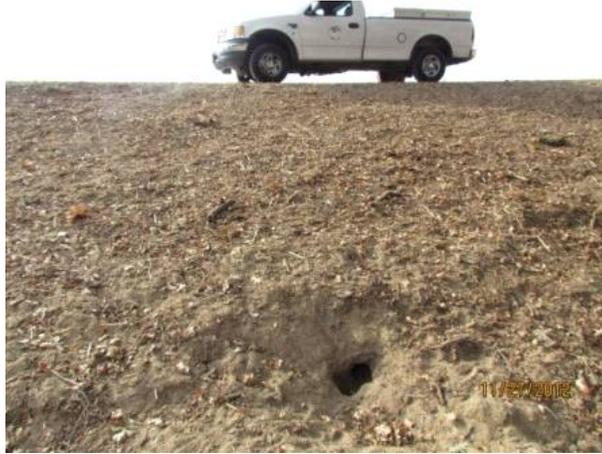
pkazi\_f\_20131001\_875.jpg

A rodent hole was found on the waterside toe of the levee looking downstream.

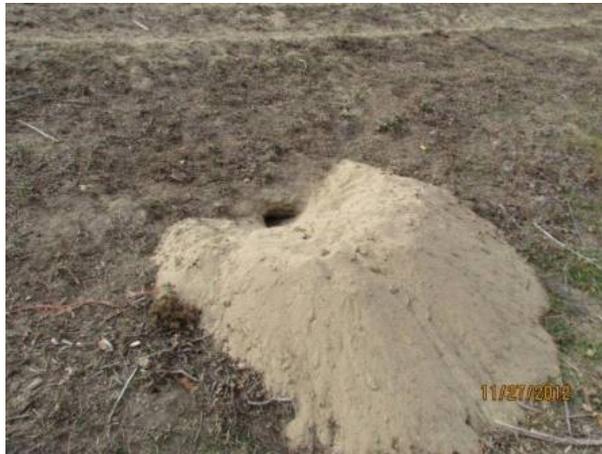
pkazi\_f\_20131001\_914.jpg

Levee Mile Report Line	88
Start Levee Mile	4.39
End Levee Mile	4.39
Location	Water Side
Category	Earthen Levee
Item	Animal Control

A rodent hole was found on the waterside toe of the levee looking downstream.

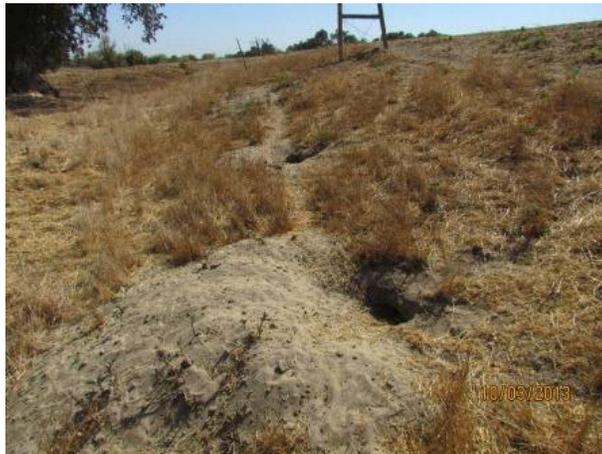
pkazi\_f\_20131020\_985.JPG

Levee Mile Report Line	88
Start Levee Mile	4.39
End Levee Mile	4.39
Location	Water Side
Category	Earthen Levee
Item	Animal Control

Updated pictures of rodent holes were found on the waterside toe of the levee looking upstream.

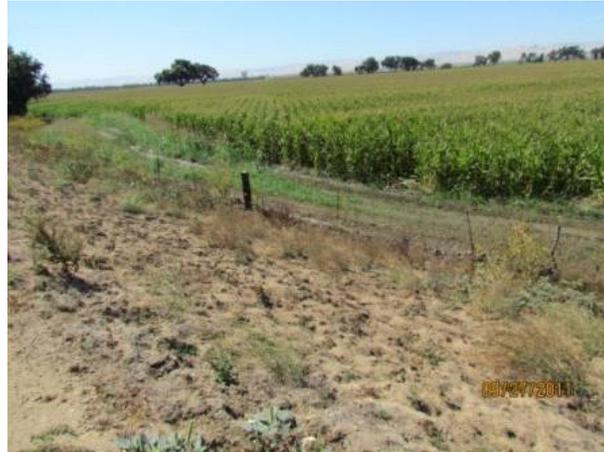
Levee Mile Report Line	89
Start Levee Mile	4.45
End Levee Mile	4.92
Location	Land Side
Category	Earthen Levee
Item	Encroachments
View of the fence on the landside toe of the levee. The picture was taken from the crown looking upstream.	
pkazi_f_20131001_886.jpg

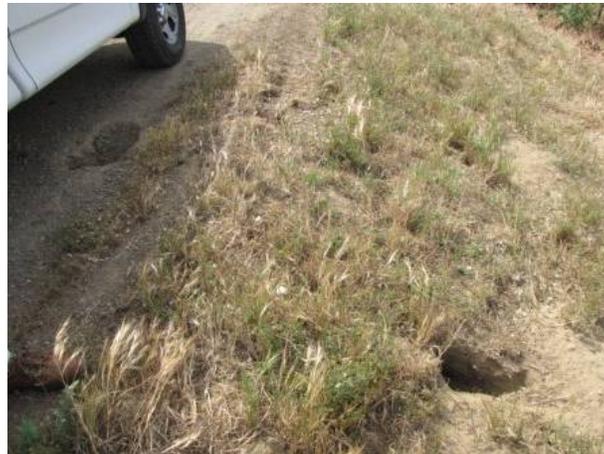
Levee Mile Report Line	91
Start Levee Mile	4.72
End Levee Mile	4.72
Location	Land Side
Category	Earthen Levee
Item	Animal Control
View of rodent holes on the landward slope looking upstream.	
pkazi_f_20131001_832.jpg

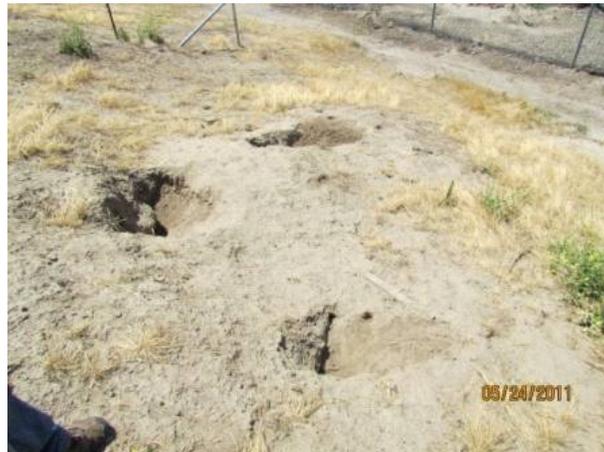
Levee Mile Report Line	92
Start Levee Mile	5.25
End Levee Mile	5.25
Location	Land Side
Category	Earthen Levee
Item	Animal Control
Rodent holes possibly made worse by a dog digging in it. It is located on the landside of the levee. The picture was taken from the crown looking upstream.	
pkazi_f_20131001_849.jpg

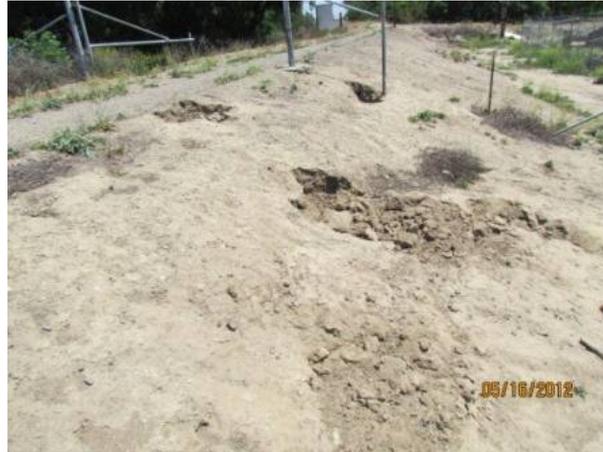
Levee Mile Report Line	92
Start Levee Mile	5.25
End Levee Mile	5.25
Location	Land Side
Category	Earthen Levee
Item	Animal Control
<p>Rodent holes found possible were damaged further by dogs on the landside of the levee looking upstream. This picture was taken during spring 2012 inspection.</p>	
<p>pkazi_f_20131001_850.jpg</p>

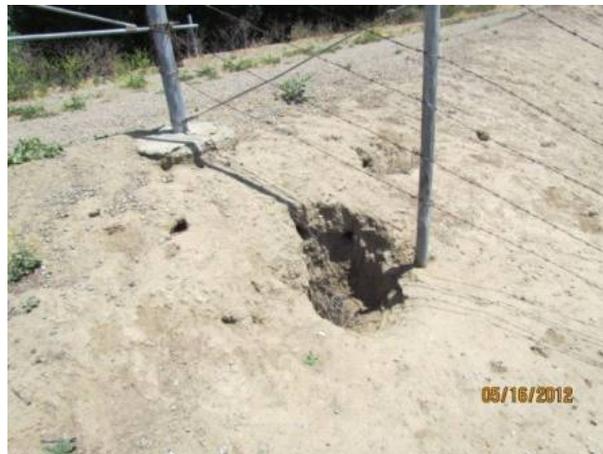
Levee Mile Report Line	92
Start Levee Mile	5.25
End Levee Mile	5.25
Location	Land Side
Category	Earthen Levee
Item	Animal Control
<p>Rodent hole damage possible due to other factor was found on the landside of the levee looking upstream. This picture was taken during spring 2012 inspection.</p>	
<p>pkazi_f_20131001_851.jpg</p>

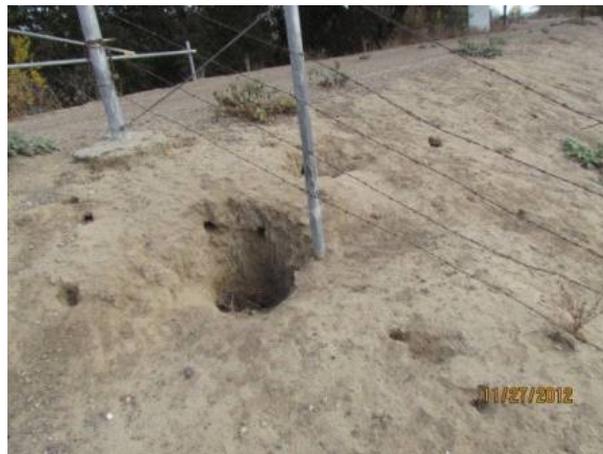
Levee Mile Report Line	92
Start Levee Mile	5.25
End Levee Mile	5.25
Location	Land Side
Category	Earthen Levee
Item	Animal Control
<p>Updated picture of the holes primarily made by rodents and then possibly worsened by dogs on the landside slope of the levee looking upstream.</p>	
<p>pkazi_f_20131001_852.jpg</p>

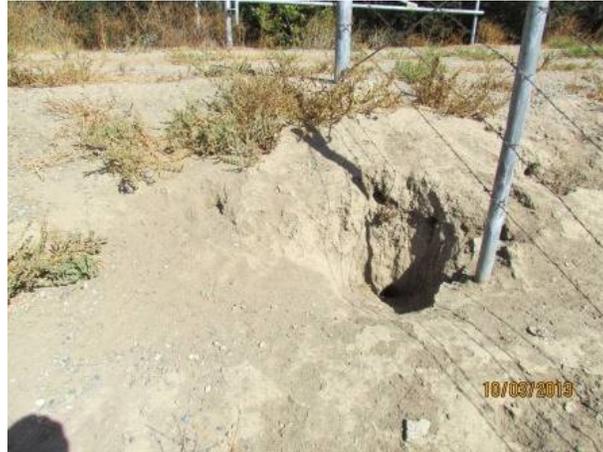
Levee Mile Report Line	92
Start Levee Mile	5.25
End Levee Mile	5.25
Location	Land Side
Category	Earthen Levee
Item	Animal Control
<p>Holes primarily made by rodents and then possibly worsened by dogs on the landside slope of the levee looking upstream. This picture was taken during fall 2013 inspection.</p>	
<p>pkazi_f_20131020_986.JPG</p>

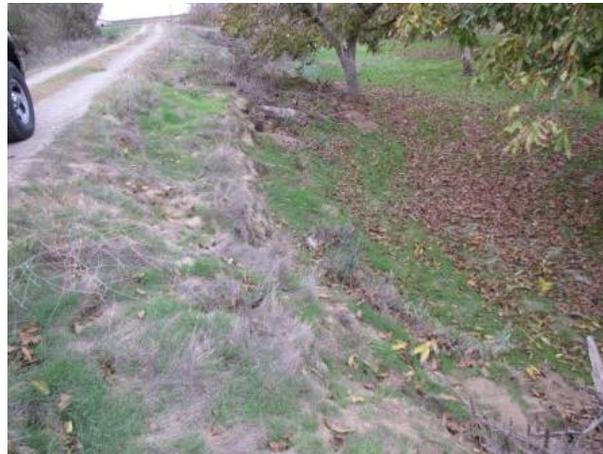
Levee Mile Report Line	93
Start Levee Mile	5.34
End Levee Mile	5.34
Location	Land Side
Category	Earthen Levee
Item	Slope Stability
<p>View of significant damage and erosion to the landward slope looking upstream.</p>	
<p>pkazi_f_20131001_908.jpg</p>

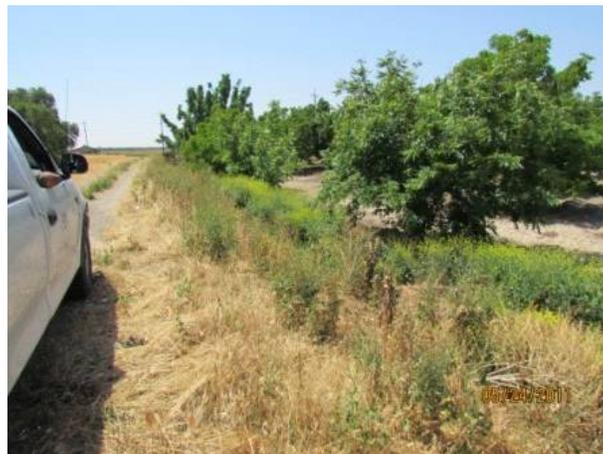
Levee Mile Report Line	95
Start Levee Mile	5.36
End Levee Mile	5.36
Location	Land Side
Category	Earthen Levee
Item	Vegetation
<p>Vegetation was obstructing the view of the landside of the levee. The picture was taken from the crown looking upstream.</p>	
<p>pkazi_f_20131001_882.jpg</p>

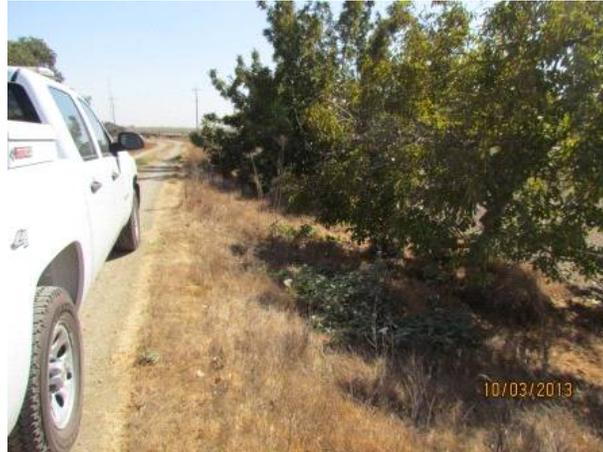
Levee Mile Report Line	95
Start Levee Mile	5.36
End Levee Mile	5.36
Location	Land Side
Category	Earthen Levee
Item	Vegetation
Updated picture of vegetation on the landside of the levee. The picture was taken from the crown looking upstream during fall 2013 inspection.	
pkazi_f_20131020_987.JPG

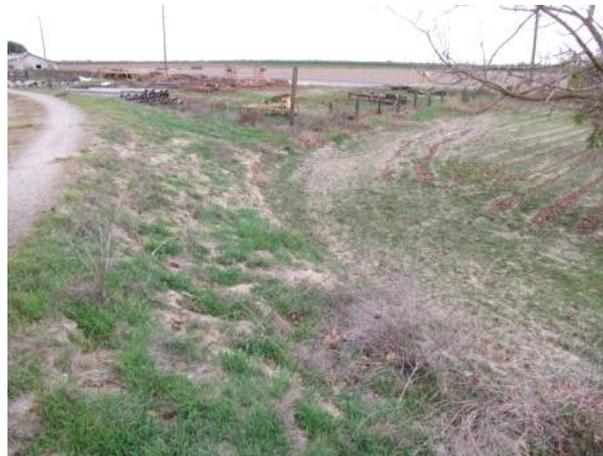
Levee Mile Report Line	96
Start Levee Mile	5.40
End Levee Mile	5.40
Location	Land Side
Category	Earthen Levee
Item	Slope Stability
View of tilling into the landward slope of the levee looking upstream. This slope has also been significantly damaged by rodent activity.	
pkazi_f_20131001_910.jpg

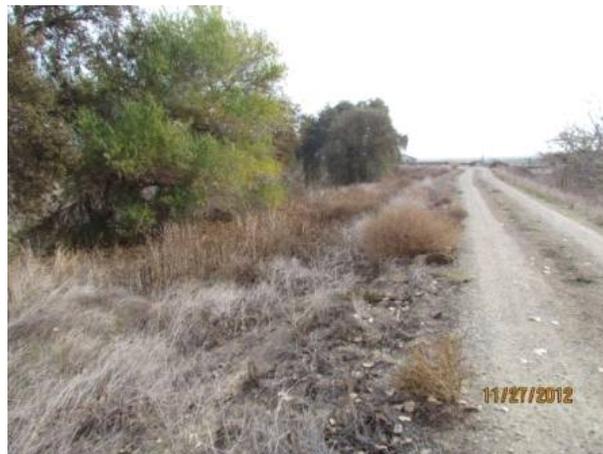
Levee Mile Report Line	97
Start Levee Mile	5.40
End Levee Mile	5.54
Location	Water Side
Category	Earthen Levee
Item	Vegetation
Overgrown vegetation was found on the waterside slope of the levee looking upstream.	
pkazi_f_20131001_891.jpg

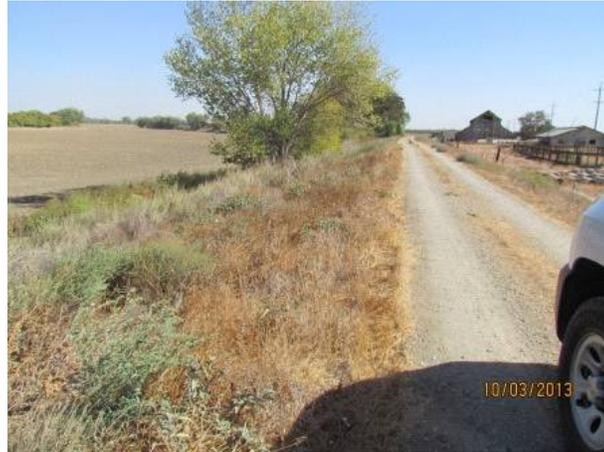
Levee Mile Report Line	97
Start Levee Mile	5.40
End Levee Mile	5.54
Location	Water Side
Category	Earthen Levee
Item	Vegetation
Vegetation was found on the waterside slope of the levee looking upstream during fall 2013 inspection.	
pkazi_f_20131020_988.JPG

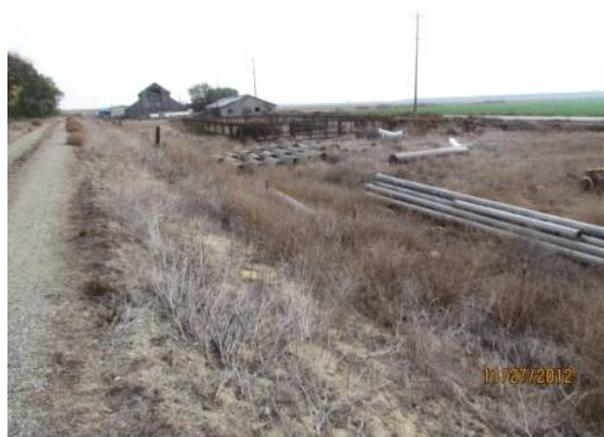
Levee Mile Report Line	98
Start Levee Mile	5.42
End Levee Mile	5.49
Location	Land Side
Category	Earthen Levee
Item	Encroachments
A fence was found on the landside toe of the levee looking upstream.	
pkazi_f_20131001_845.jpg
