**Flood Control Project Maintenance
Levee Inspections**

**Fall 2014 Levee Maintenance Deficiency Summary Report
Overall LMA & Unit Ratings, including DWR Erosion Survey**

Reclamation District No. 1602 Del Puerto

Waterway		Bank	Unit Miles	
Unit No. 01 San Joaquin River		Left	6.24	
	Spring (March - May)	Summer (June - August)	(September - November) Fall	Winter (December - February)
Unit Maintenance Rating (Fall Only)			U	
Date of Inspection	04/24/2014 - 04/24/2014		10/24/2014 - 10/24/2014	
DWR Inspector	Pavel Kazi		Pavel Kazi	
Accompanied By	Tony Martinez RD1602

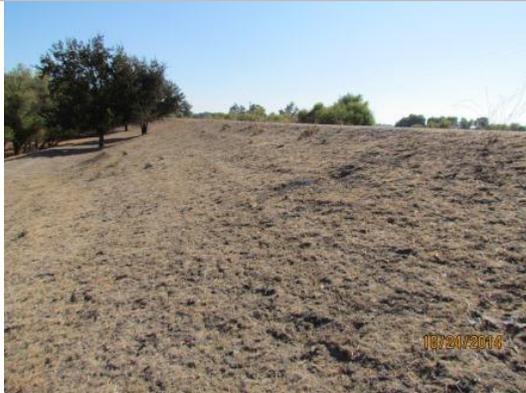
Photo 1 of 2 : FA_2014_RD1602_110_8_20141027_00119.jpg

LM Start	1.10	Rating **	A	Issue No.	8
LM End	1.10	Issue Type +	Ma	Location *	WS
Category	Earthen Levee		GPS Latitude/Longitude		
			Start	End	
Item	Animal Control		37.478454 °	37.478454 °	
			-121.067209 °	-121.067209 °	
DWR ID	DWR_RD1602_01_s_2012_8				
Action/Comments					
Exterminate rodents and backfill and compact or grout burrows. Inspector Comments: LMA fixed the holes on the waterside slopes of the levee.

LMA grouted the rodent holes on the waterside slope of the levee looking upstream. The picture was taken during fall 2014 inspection.

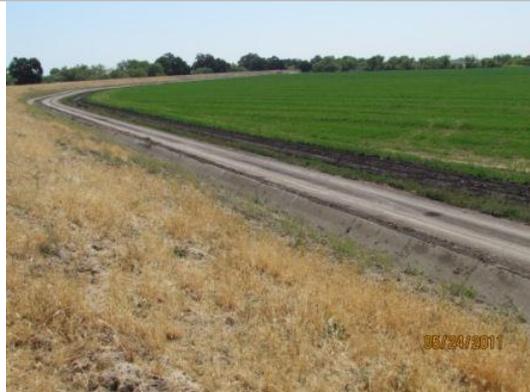
Photo 1 of 1 : FA_2014_RD1602_110_59_20141021_00044.jpg

LM Start	2.24	Rating **	M	Issue No.	59
LM End	3.45	Issue Type +	En	Location *	LS
Category	Earthen Levee			GPS Latitude/Longitude	
				Start	End
Item	Encroachments			37.470119 °	37.459606 °
				-121.055117 °	-121.043240 °
DWR ID	DWR_RD1602_01_s_2012_59				
Action/Comments					
Ditch Inspector Comments: Concrete ditch was constructed before the levee was built.

Concrete drain was built at the toe of the levee. The picture was taken from the crown looking upstream.
