**Flood Control Project Maintenance
Levee Inspections**

Fall 2015 Levee Maintenance Deficiency Summary Report

San Joaquin River Basin

Reclamation District No. 1602 Del Puerto

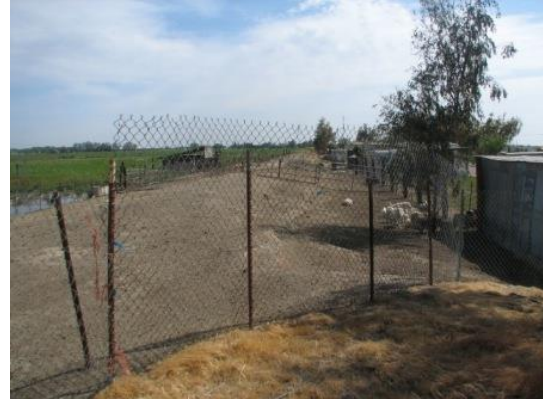
Photo 1 of 1 : FA_2015_RD1602_110_1_20150911_00001.jpg

LM Start	0.00	Rating **	M	Issue No.	1
LM End	0.11	Issue Type +	En	Location *	CR
Category	Earthen Levee			GPS Latitude/Longitude	
				Start	End
Item	Encroachments			37.476560 °	37.477295 °
				-121.083862 °	-121.082087 °
DWR ID	DWR_RD1602_01_s_2012_1				
Action/Comments					
Building					
Inspector Comments: Animal pens across levee crown.

Looking at animal pens on crown of levee from LM 0.00 to 0.11.

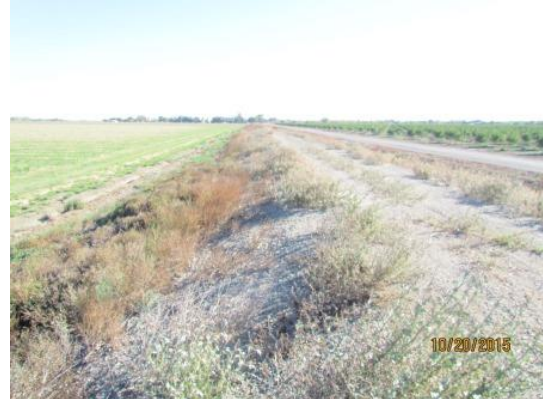
Photo 1 of 1 : FA_2015_RD1602_110_21_20151023_00087.jpg

View of the vegetation on the waterside of the levee.

LM Start	0.13	Rating **	M	Issue No.	21
LM End	0.56	Issue Type +	Ma	Location *	WS
Category	Earthen Levee			GPS Latitude/Longitude	
				Start	End
Item	Vegetation			37.477233 °	37.480269 °
				-121.081740 °	-121.075104 °
DWR ID	DWR_RD1602_01_f_2015_21				
Action/Comments					
Control annual grass and weeds on the levee slopes and easements.

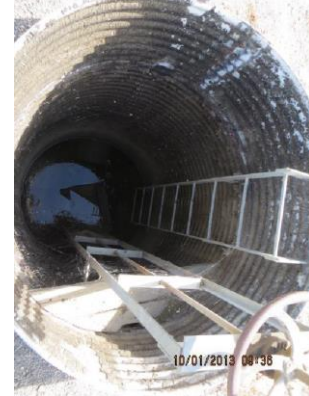
Photo 2 of 3 : UCIP_FA_2015_2267.jpg

Inspector Comments: FS_ID:21623
 DS_ID:20215
 EP_NO: N/A
 FS_HLM: 0.58
 Repair Type: Urgent
 Crossing Status: Found
 UCIP Comments: Open 60-inch CMP riser on WS needs lid as it's depth may be a hazard to the public.
 FIELD_STRUCT_DESC: 16-inch pipe through levee 11.3 feet below crown. Slide gate in 60-inch corrugated metal pipe riser on the waterward side. Concrete inlet 110-feet west of the levee crown. Originally included in 1964 O&M manual.
 FS Date: 10/01/2013

CMP riser with slide gate on WS shoulder.

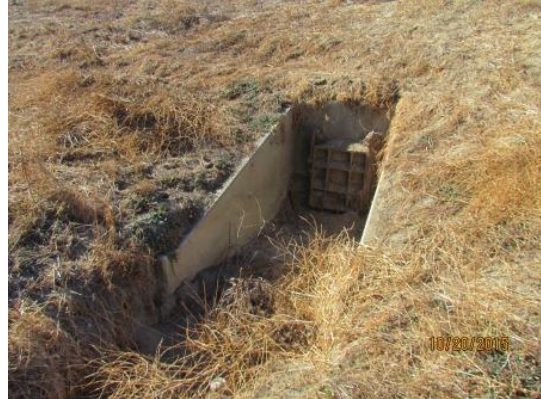
Photo 1 of 2 : FA_2015_RD1602_110_72_20151023_00089.jpg

LM Start	0.77	Rating **	A/W	Issue No.	72
LM End	0.77	Issue Type +	Ma	Location *	WS
Category	Interior Drainage & Piping Systems			GPS Latitude/Longitude	
				Start	End
Item	Flap Gates			37.477965 °	37.477965 °
				-121.072595 °	-121.072595 °
DWR ID	DWR_RD1602_01_s _ 2012_72				
Action/Comments					
Inspector Comments: Sediment around the flap gate was cleaned, and the area should be watched for future sediment deposits.

View of the flap gate on the waterside of the levee during fall 2015 inspection.

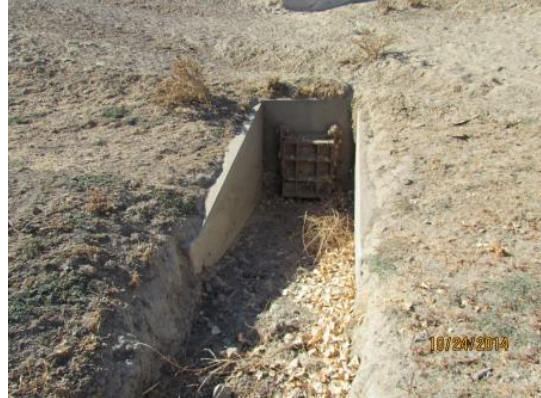
Photo 2 of 2 : FA_2015_RD1602_110_72_20150911_00050.jpg

View of the flap gate on the waterside of the levee during fall 2014 inspection.

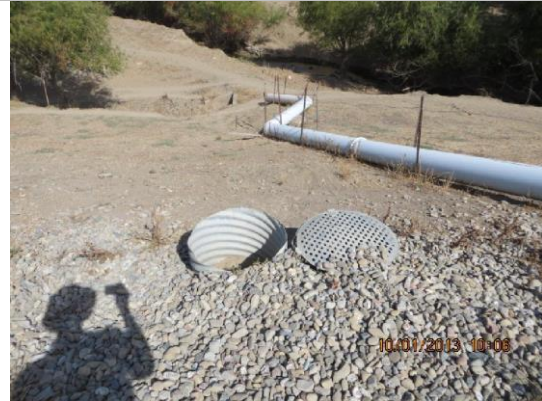
Photo 2 of 3 : UCIP_FA_2015_2284.jpg

Inspector Comments: FS_ID:21639
 DS_ID:20217
 EP_NO: N/A
 FS_HLM: 1.006
 Repair Type: Urgent
 Crossing Status: Found
 UCIP Comments: Appears abandoned and if so should be done so properly. Flapgate missing.
 FIELD_STRUCT_DESC: 1 of 2: 16-inch pipe through levee 17.0 feet below crown. Pumps on pump platform on the landward side. Siphon breaker in 24-inch CMP risers on the waterward shoulder. Concrete "U" headwall and flap gate on the waterward end. Originally included in 1964 O&M manual.
 FS Date: 10/01/2013

Siphon breaker in 24-inch CMP riser on WS shoulder.

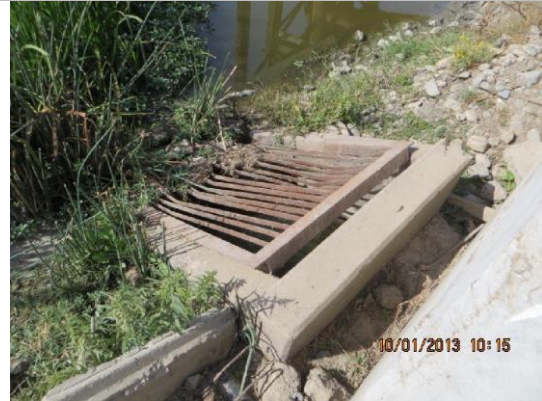
Photo 1 of 2 : UCIP_FA_2015_2289.jpg

Grated inlet at LS toe.

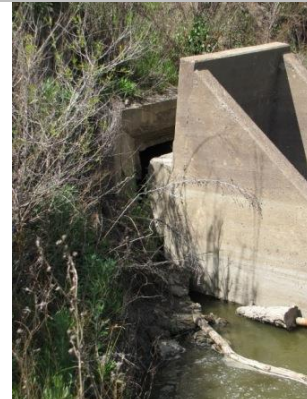
Photo 3 of 3 : FA_2015_RD1602_110_55_20150911_00033.jpg

Separation of outfall structure from the outlet pipe.

LM Start	1.02	Rating **	U	Issue No.	55
LM End	1.02	Issue Type +	Ma	Location *	WS
Category	Interior Drainage & Piping Systems			GPS Latitude/Longitude	
				Start	End
Item	Concrete Tilting / Settlement			37.478772 °	37.478772 °
				-121.068454 °	-121.068454 °
DWR ID	DWR_RD1602_01_s_2012_55				
Action/Comments					
Inspector Comments: The outlet headwall is tilting away from the pipe rendering the existing flap gate ineffective. The LMA is planning to repair gap between pipe and headwall and stabilize headwall to prevent further damage.

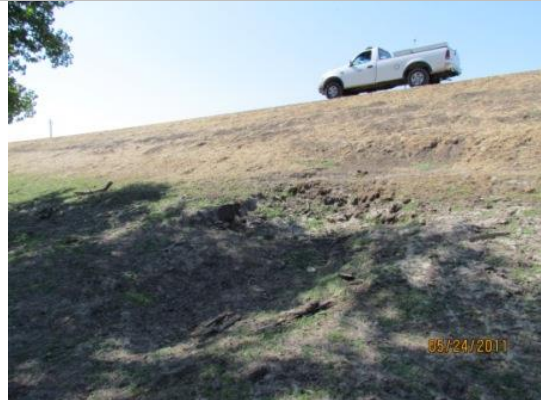
Photo 2 of 2 : FA_2015_RD1602_110_37_20150911_00018.jpg

LM Start	1.05	Rating **	M	Issue No.	37
LM End	1.05	Issue Type +	Ma	Location *	WS
Category	Earthen Levee			GPS Latitude/Longitude	
				Start	End
Item	Slope Stability			37.478567 °	37.478567 °
				-121.067847 °	-121.067847 °
DWR ID	DWR_RD1602_01_s _ 2012_37				
Action/Comments					
Repair slope instability. Inspector Comments: Small amount of slumping at waterside toe of the levee.

Depression at the waterside slope of the levee during Spring 2011 inspection.

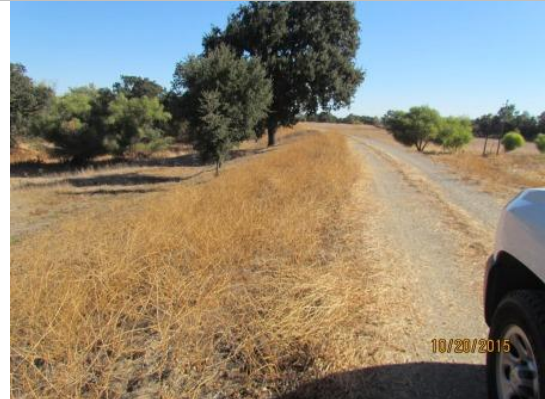
Photo 1 of 1 : FA_2015_RD1602_110_29_20151023_00092.jpg

View of the vegetation on the waterside of the levee.

LM Start	1.19	Rating **	M	Issue No.	29
LM End	1.76	Issue Type +	Ma	Location *	WS
Category	Earthen Levee			GPS Latitude/Longitude	
				Start	End
Item	Vegetation			37.478297 °	37.475610 °
				-121.065500 °	-121.057955 °
DWR ID	DWR_RD1602_01_f_2015_29				
Action/Comments					
Control annual grass and weeds on the levee slopes and easements.

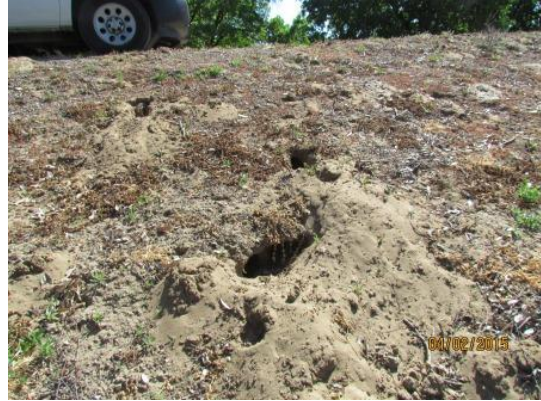
Photo 1 of 1 : FA_2015_RD1602_110_20_20150911_00008.jpg

View of rodent holes on the landside of the levee looking upstream.

LM Start	1.66	Rating **	U	Issue No.	20
LM End	1.66	Issue Type +	Ma	Location *	LS
Category	Earthen Levee			GPS Latitude/Longitude	
				Start	End
Item	Animal Control			37.477007 °	37.477007 °
				-121.058372 °	-121.058372 °
DWR ID	DWR_RD1602_01_s_2015_20				
Action/Comments					
No rodents visible, but rodent burrows visible; need to backfill and compact or grout burrows.

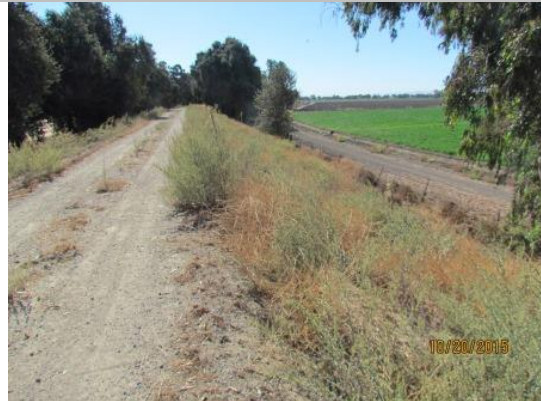
Photo 1 of 1 : FA_2015_RD1602_110_78_20151023_00093.jpg

View of the vegetation on the landside of the levee.

LM Start	1.66	Rating **	M	Issue No.	78
LM End	1.76	Issue Type +	Ma	Location *	LS
Category	Earthen Levee			GPS Latitude/Longitude	
				Start	End
Item	Vegetation			37.477004 °	37.475614 °
				-121.058379 °	-121.057953 °
DWR ID	DWR_RD1602_01_f_2015_78				
Action/Comments					
Remove the wild growth other than native grasses from the levee slopes.

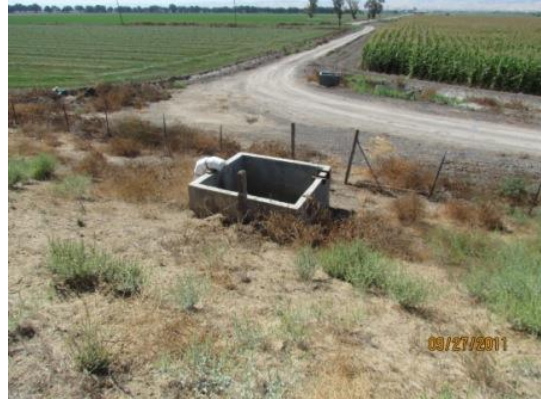
Photo 1 of 1 : FA_2015_RD1602_110_45_20150911_00023.jpg

LM Start	2.03	Rating **	M	Issue No.	45
LM End	2.03	Issue Type +	En	Location *	LS
Category	Earthen Levee			GPS Latitude/Longitude	
				Start	End
Item	Encroachments			37.471734 °	37.471734 °
				-121.057670 °	-121.057670 °
DWR ID	DWR_RD1602_01_s_2012_45				
Action/Comments					
Equipment					
Inspector Comments: A well is present at the toe of the landside of the slope.

A well is located at the landside toe of the levee. The picture was taken from the crown looking toward the landside of the levee.

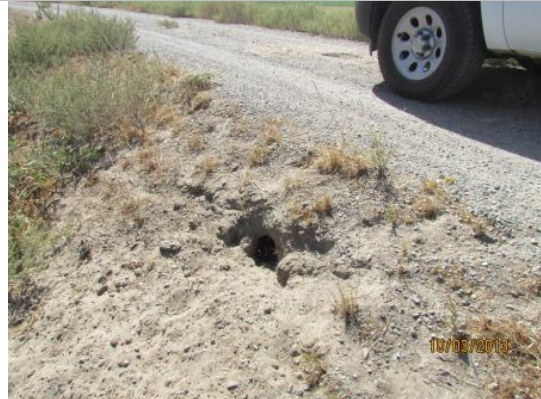
Photo 1 of 2 : FA_2015_RD1602_110_85_20150911_00062.jpg

Updated picture of a rodent hole on the waterside shoulder of the levee looking upstream during fall 2013 inspection.

LM Start	2.10	Rating **	M	Issue No.	85
LM End	2.10	Issue Type +	Ma	Location *	WS
Category	Earthen Levee			GPS Latitude/Longitude	
				Start	End
Item	Animal Control			37.470858 °	37.470858 °
				-121.057140 °	-121.057140 °
DWR ID	DWR_RD1602_01_s_2012_85				
Action/Comments					
No rodents visible, but rodent burrows visible; need to backfill and compact or grout burrows.

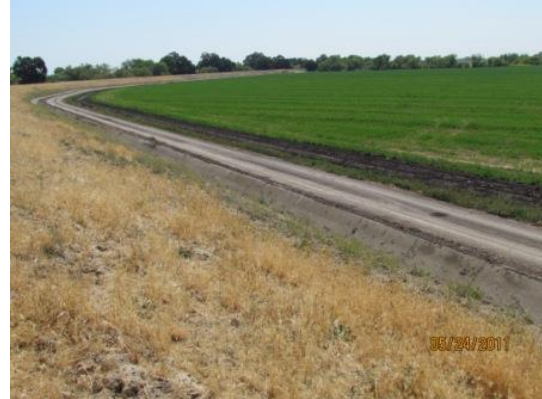
Photo 1 of 1 : FA_2015_RD1602_110_59_20150911_00036.jpg

LM Start	2.23	Rating **	M	Issue No.	59
LM End	3.43	Issue Type +	En	Location *	LS
Category	Earthen Levee			GPS Latitude/Longitude	
				Start	End
Item	Encroachments			37.470119 °	37.459606 °
				-121.055117 °	-121.043240 °
DWR ID	DWR_RD1602_01_s _ 2012_59				
Action/Comments					
Ditch Inspector Comments: Concrete ditch was constructed before the levee was built.

Concrete drain was built at the toe of the levee. The picture was taken from the crown looking upstream.

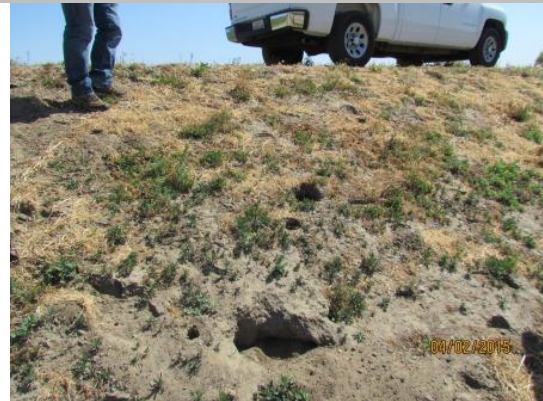
Photo 1 of 1 : FA_2015_RD1602_110_23_20150911_00010.jpg

View of rodent holes on the landside slope of the levee looking upstream.

LM Start	2.97	Rating **	M	Issue No.	23
LM End	2.97	Issue Type +	Ma	Location *	LS
Category	Earthen Levee			GPS Latitude/Longitude	
				Start	End
Item	Animal Control			37.464955 °	37.464955
				-121.044415 °	-121.044415
DWR ID	DWR_RD1602_01_s _ 2015_23				
Action/Comments					
No rodents visible, but rodent burrows visible; need to backfill and compact or grout burrows.

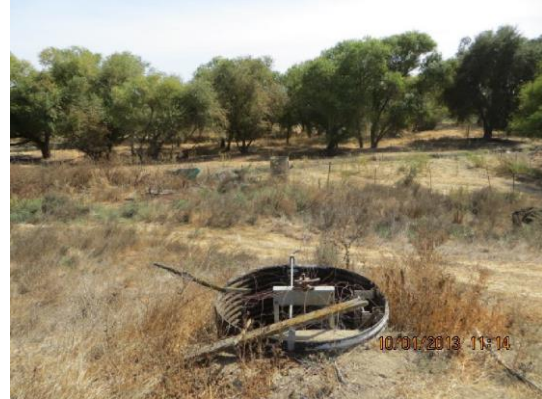
Photo 1 of 2 : UCIP_FA_2015_2291.jpg

Slide gate in 60-inch CMP riser on WS shoulder.

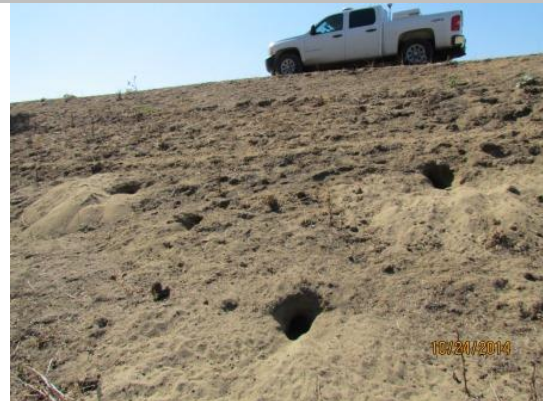
Photo 1 of 1 : FA_2015_RD1602_110_46_20150911_00024.jpg

View of the rodent holes on the waterside slope of the levee. The picture was taken from the toe of the levee during fall 2014 inspection.

LM Start	4.19	Rating **	U	Issue No.	46
LM End	4.19	Issue Type +	Ma	Location *	WS
Category	Earthen Levee			GPS Latitude/Longitude	
				Start	End
Item	Animal Control			37.450195 °	37.450195 °
				-121.039406 °	-121.039406 °
DWR ID	DWR_RD1602_01_f_2014_46				
Action/Comments					
No rodents visible, but rodent burrows visible; need to backfill and compact or grout burrows.

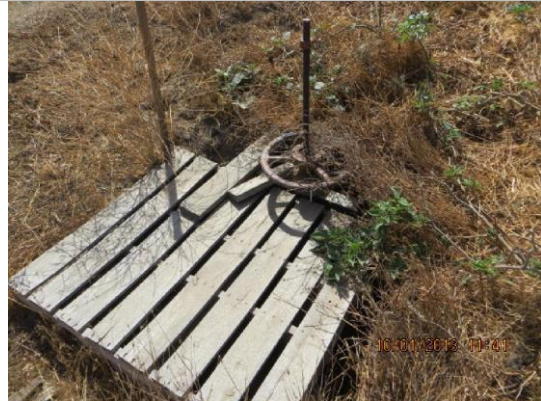
Photo 2 of 3 : UCIP_FA_2015_0559.jpg

Slide gate in CMP riser on WS slope.

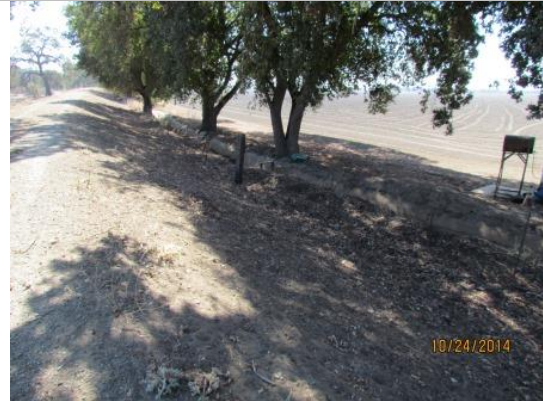
Photo 1 of 1 : FA_2015_RD1602_110_64_20150911_00042.jpg

View of a ditch on the landside toe of the levee looking upstream.

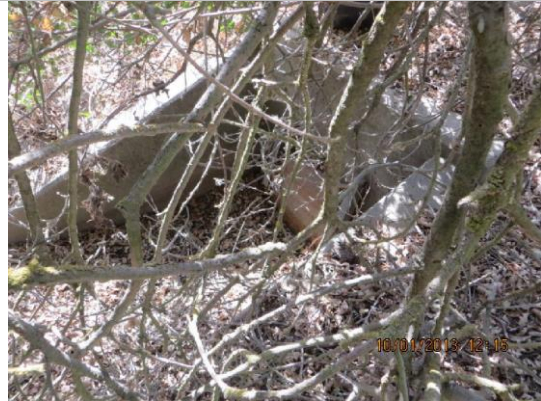
Photo 2 of 3 : UCIP_FA_2015_0562.jpg

Flapgate in Concrete headwall on WS toe under tree.

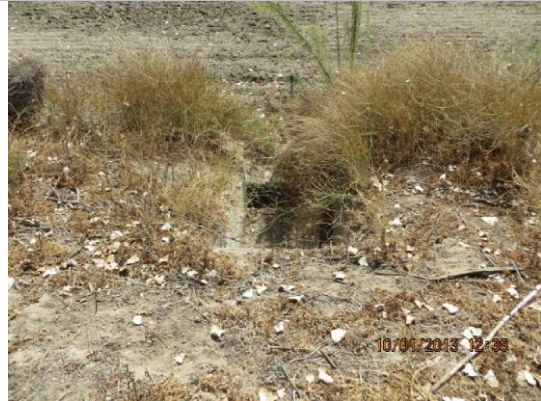
Photo 2 of 3 : UCIP_FA_2015_0726.jpg

Concrete U-shaped headwall on LS toe.
