**Flood Control Project Maintenance
Levee Inspections**

Fall 2017 Levee Maintenance Deficiency Summary Report

Reclamation District No. 1602 Del Puerto

Waterway			Bank	Unit Miles
Unit No. 01 San Joaquin River			Left	6.24
	Spring (March - May)	Summer (June - August)	(September - November) Fall	Winter (December - February)
Unit Maintenance Rating (Fall Only)			U	
Date of Inspection	4/6/2017 - 4/6/2017		11/2/2017 - 11/2/2017	
DWR Inspector	Pavel Kazi		Pavel Kazi	
Accompanied By	Tony Martinez RD 1602		Tony Martinez RD 1602

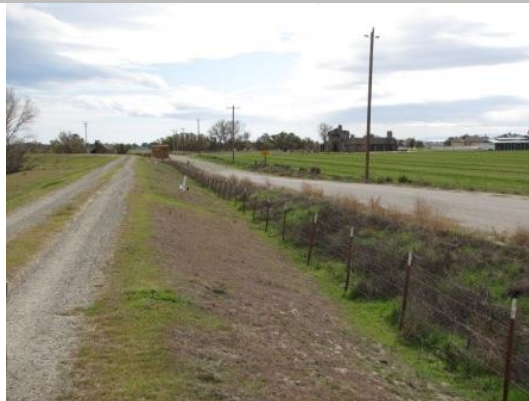
Photo 1 of 1 : FA_2017_RD1602_110_70_20170921_00033.jpg

LM Start	0.60	Rating **	M	Issue No.	70
LM End	0.71	Issue Type +	En	Location *	WS
Category	Earthen Levee			GPS Latitude/Longitude	
				Start	End
Item	Encroachments			37.479967 °	37.478514 °
				-121.074582 °	-121.073435 °
DWR ID	DWR_RD1602_01_s_2012_70				
Comment Code					
FE : Fence					
Inspector Comment					
Barbed wire fence along the landward toe.

View of barbed wire fence at landward toe looking upstream.

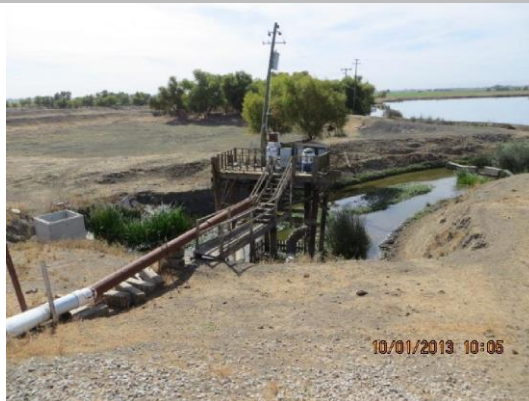
Photo 1 of 3 : UCIP_FA_2017_51636_36758.jpg

Comment Code						
Inspector Comment						
FS_ID:51636 DS_ID:20217 EP_NO: N/A Repair Type: Non-Urgent Crossing Status: Found UCIP Comments: 11/18/2016 Crossing has been downgraded from Urgent to Non-Urgent a flap gate has been added to the WS but pipe is currently not connected to pump. According to Tony Martinez, LMA representative, this crossing is currently not in use. Owner will need to coordinate with CVFPB to obtain permit. (O. Magana - DWR UCIP)10/01/2013 Appears abandoned and if so should be done so properly. Flapgate missing. (W. Wylie - DWR UCIP) FIELD_STRUCT_DESC: *ABANDONED* 1 of 2: 16-inch steel drainage pipe through levee, 17 feet below crown. Pumps on the pump platform are located on the landside (LS). Siphon breaker in 24-inch corrugated metal pipe (CMP) riser is located on the waterside (WS) shoulder. Concrete "U" headwall and flap gate are located on the WS end. [Additional Reference(s): DWR Levee Log, 1992. USACE San Joaquin River O&M Manual Unit 13, April 1964, (HLM 1.01), Drawing No. 7-4-1784]. FS Date: 11/18/2016

Pumping plant on LS toe. Pipe visible under walkway.

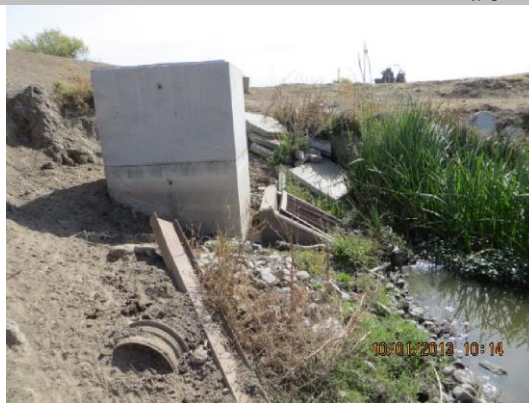
Photo 1 of 3 : UCIP_FA_2017_51329_36786.jpg

Grated inlet and 5'X5' concrete box on LS toe.

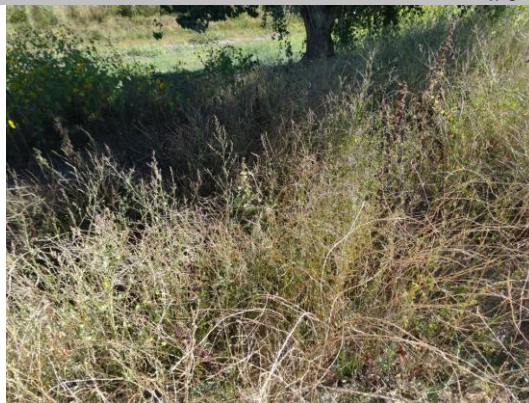
Photo 2 of 4 : SJR2017_RD1602U01RM97.68_2.jpg

Close view of the erosion.

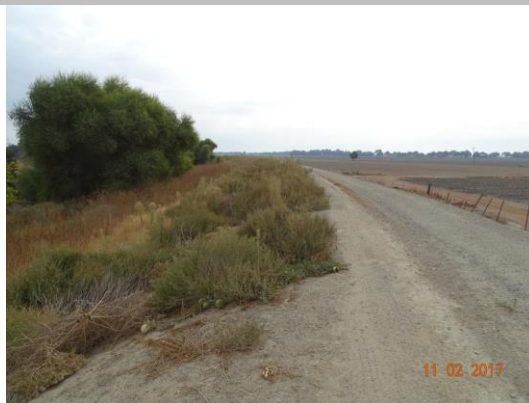
Photo 1 of 1 : FA_2017_RD1602_110_38_20171109_00127.jpg

LM Start	1.99	Rating **	M	Issue No.	38
LM End	2.81	Issue Type +	Ma	Location *	WS
Category	Earthen Levee			GPS Latitude/Longitude	
				Start	End
Item	Vegetation			37.472347 °	37.466694 °
				-121.057904 °	-121.046188 °
DWR ID	DWR_RD1602_01_f_2017_38				
Comment Code					
V1 : Control annual grass and weeds on the levee slopes and easements.					
Inspector Comment

View of vegetation on the waterside of the levee looking upstream. Fall 2017

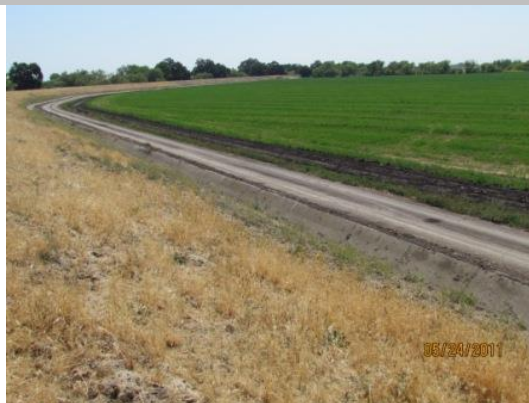
Photo 1 of 1 : FA_2017_RD1602_110_59_20170921_00025.jpg

LM Start	2.23	Rating **	M	Issue No.	59
LM End	3.30	Issue Type +	En	Location *	LS
Category	Earthen Levee			GPS Latitude/Longitude	
				Start	End
Item	Encroachments			37.470119 °	37.461147 °
				-121.055117 °	-121.041785 °
DWR ID	DWR_RD1602_01_s_2012_59				
Comment Code					
DT : Ditch					
Inspector Comment					
Concrete ditch was constructed before the levee was built.

Concrete drain was built at the toe of the levee. The picture was taken from the crown looking upstream.

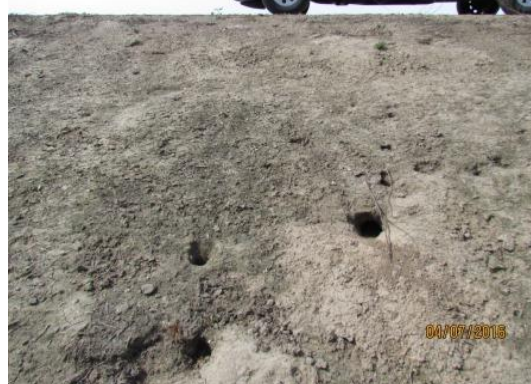
Photo 1 of 1 : FA_2017_RD1602_110_19_20170921_00002.jpg

LM Start	2.67	Rating **	M	Issue No.	19
LM End	2.67	Issue Type +	Ma	Location *	WS
Category	Earthen Levee			GPS Latitude/Longitude	
				Start	End
Item	Animal Control			37.468212 °	37.468212 °
				-121.048096 °	-121.048096 °
DWR ID	DWR_RD1602_01_s_2016_19				
Comment Code					
A3 : No rodents visible, but rodent burrows visible; need to backfill and compact or grout burrows.					
Inspector Comment

View of rodent holes on the waterside of the levee.

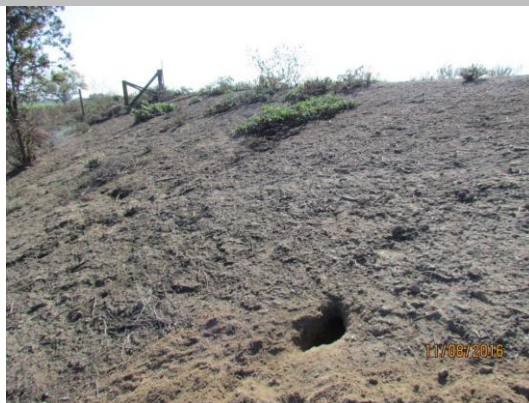
Photo 1 of 1 : FA_2017_RD1602_110_41_20170921_00014.jpg

LM Start	2.79	Rating **	M	Issue No.	41
LM End	2.79	Issue Type +	Ma	Location *	WS
Category	Earthen Levee			GPS Latitude/Longitude	
				Start	End
Item	Animal Control			37.466887 °	37.466887 °
				-121.046460 °	-121.046460 °
DWR ID	DWR_RD1602_01_f_2016_41				
Comment Code					
A3 : No rodents visible, but rodent burrows visible; need to backfill and compact or grout burrows.					
Inspector Comment

View of rodent holes on the waterside slope of the levee. Fall 2016

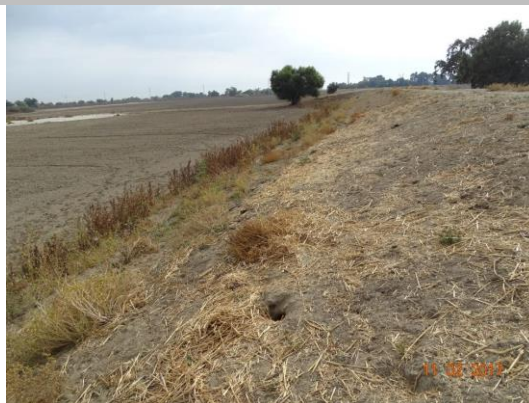
Photo 1 of 1 : FA_2017_RD1602_110_51_20171109_00129.jpg

LM Start	2.95	Rating **	M	Issue No.	51
LM End	2.95	Issue Type +	Ma	Location *	WS
Category	Earthen Levee			GPS Latitude/Longitude	
				Start	End
Item	Animal Control			37.465190 °	37.465190 °
				-121.044584 °	-121.044584 °
DWR ID	DWR_RD1602_01_f_2016_51				
Comment Code					
A3 : No rodents visible, but rodent burrows visible; need to backfill and compact or grout burrows.					
Inspector Comment

View of a rodent hole on the waterside of the levee.

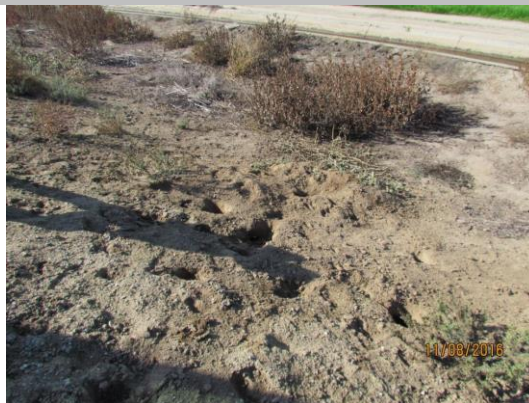
Photo 1 of 1 : FA_2017_RD1602_110_56_20170921_00024.jpg

LM Start	3.32	Rating **	M	Issue No.	56
LM End	3.32	Issue Type +	Ma	Location *	LS
Category	Earthen Levee			GPS Latitude/Longitude	
				Start	End
Item	Animal Control			37.460811 °	37.460811 °
				-121.042078 °	-121.042078 °
DWR ID	DWR_RD1602_01_s_2017_56				
Comment Code					
A3 : No rodents visible, but rodent burrows visible; need to backfill and compact or grout burrows.					
Inspector Comment

View of rodent holes on the landside of the levee. Fall 2016

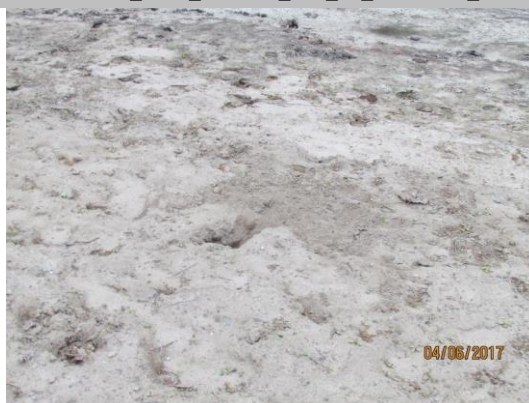
Photo 1 of 1 : FA_2017_RD1602_110_88_20170921_00042.jpg

LM Start	4.35	Rating **	M	Issue No.	88
LM End	4.35	Issue Type +	Ma	Location *	WS
Category	Earthen Levee			GPS Latitude/Longitude	
				Start	End
Item	Animal Control			37.448170 °	37.448170 °
				-121.038072 °	-121.038072 °
DWR ID	DWR_RD1602_01_s_2017_88				
Comment Code					
A3 : No rodents visible, but rodent burrows visible; need to backfill and compact or grout burrows.					
Inspector Comment

View of a rodent hole on the waterside slope of the levee.

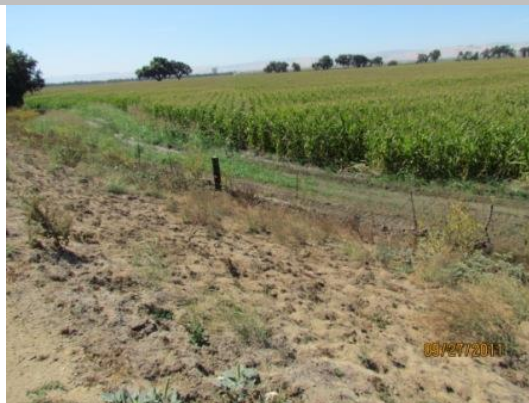
Photo 1 of 1 : FA_2017_RD1602_110_67_20170921_00032.jpg

LM Start	4.42	Rating **	M	Issue No.	67
LM End	4.88	Issue Type +	En	Location *	LS
Category	Earthen Levee			GPS Latitude/Longitude	
				Start	End
Item	Encroachments			37.447213 °	37.441014 °
				-121.037665 °	-121.036932 °
DWR ID	DWR_RD1602_01_s_2012_67				
Comment Code					
FE : Fence					
Inspector Comment

View of the fence on the landside toe of the levee. The picture was taken from the crown looking upstream.

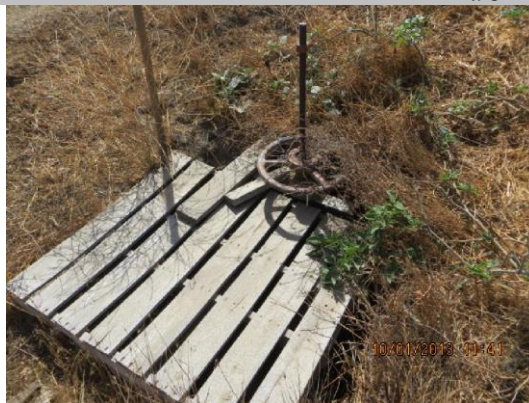
Photo 2 of 3 : UCIP_FA_2017_51332_36818.jpg

Slide gate in CMP riser on WS slope.

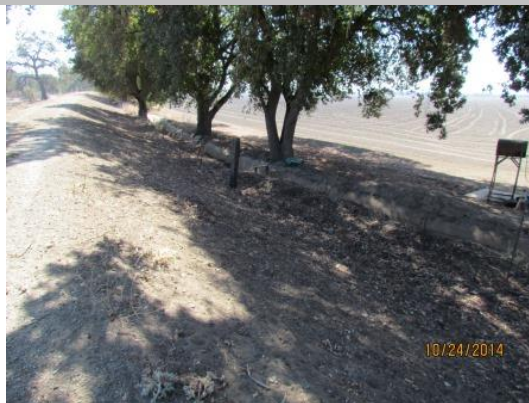
Photo 1 of 1 : FA_2017_RD1602_110_64_20170921_00030.jpg

LM Start	4.47	Rating **	M	Issue No.	64
LM End	4.63	Issue Type +	En	Location *	LS
Category	Earthen Levee			GPS Latitude/Longitude	
				Start	End
Item	Encroachments			37.446485 °	37.444290 °
				-121.038037 °	-121.037953 °
DWR ID	DWR_RD1602_01_s_2012_64				
Comment Code					
DT : Ditch					
Inspector Comment

View of a ditch on the landside toe of the levee looking upstream.

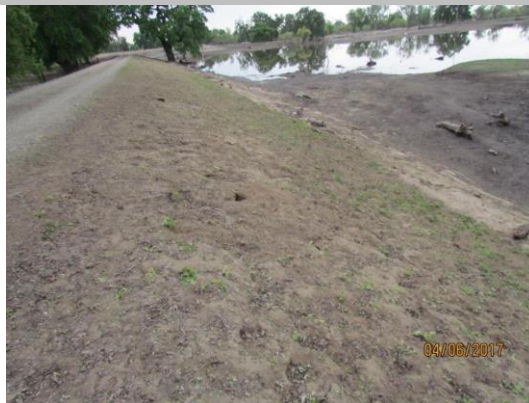
Photo 1 of 1 : FA_2017_RD1602_110_91_20170921_00045.jpg

LM Start	4.55	Rating **	M	Issue No.	91
LM End	4.55	Issue Type +	Ma	Location *	WS
Category	Earthen Levee			GPS Latitude/Longitude	
				Start	End
Item	Animal Control			37.445402 °	37.445402 °
				-121.037706 °	-121.037706 °
DWR ID	DWR_RD1602_01_s_2017_91				
Comment Code					
A3 : No rodents visible, but rodent burrows visible; need to backfill and compact or grout burrows.					
Inspector Comment

View of rodent holes on the waterside of the levee looking downstream.
Spring 2017

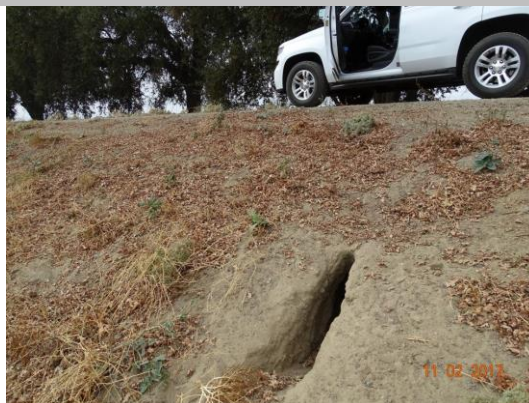
Photo 1 of 1 : FA_2017_RD1602_110_65_20171109_00133.jpg

LM Start	4.60	Rating **	U	Issue No.	65
LM End	4.60	Issue Type +	Ma	Location *	WS
Category	Earthen Levee			GPS Latitude/Longitude	
				Start	End
Item	Animal Control			37.444666 °	37.444666 °
				-121.037748 °	-121.037748 °
DWR ID	DWR_RD1602_01_f_2017_65				
Comment Code					
A3 : No rodents visible, but rodent burrows visible; need to backfill and compact or grout burrows.					
Inspector Comment

View of a rodent hole on the waterside of the levee. Fall 2017

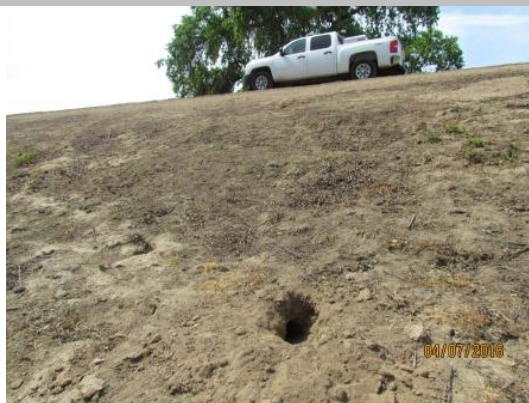
Photo 1 of 1 : FA_2017_RD1602_110_74_20170921_00034.jpg

LM Start	4.77	Rating **	M	Issue No.	74
LM End	4.77	Issue Type +	Ma	Location *	WS
Category	Earthen Levee			GPS Latitude/Longitude	
				Start	End
Item	Animal Control			37.442465 °	37.442465 °
				-121.036947 °	-121.036947 °
DWR ID	DWR_RD1602_01_s_2015_74				
Comment Code					
A3 : No rodents visible, but rodent burrows visible; need to backfill and compact or grout burrows.					
Inspector Comment

View of a rodent hole on the waterside toe of the levee.

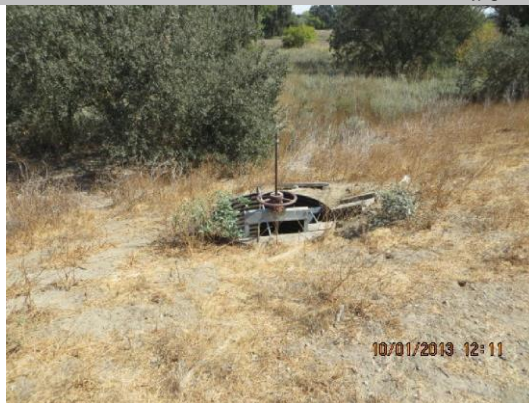
Photo 1 of 3 : UCIP_FA_2017_51336_36822.jpg

Slide gate in CMP riser on WS slope. Outlet visible under tree in background.

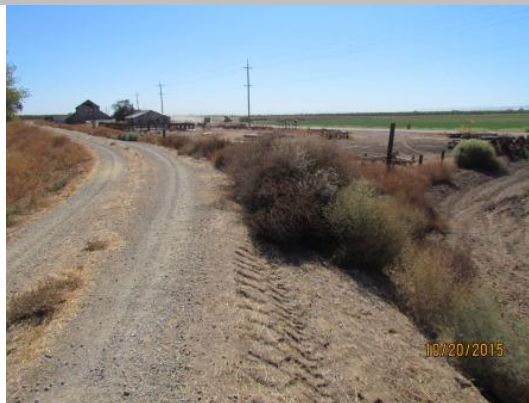
Photo 1 of 1 : FA_2017_RD1602_110_61_20170921_00027.jpg

LM Start	5.35	Rating **	M	Issue No.	61
LM End	6.22	Issue Type +	Ma	Location *	LS
Category	Earthen Levee			GPS Latitude/Longitude	
				Start	End
Item	Vegetation			37.434732 °	37.429165 °
				-121.035088 °	-121.029682 °
DWR ID	DWR_RD1602_01_s_2012_61				
Comment Code					
V2 : Remove the wild growth other than native grasses from the levee slopes.					
Inspector Comment

Vegetation was obstructing the view of the landside of the levee.
