**Flood Control Project Maintenance
Levee Inspections**

Fall 2018 Levee Maintenance Deficiency Summary Report

Reclamation District No. 1602 Del Puerto

Waterway			Bank	Unit Miles
Unit No. 01 San Joaquin River			Left	6.24
	Spring (March - May)	Summer (June - August)	(September - November) Fall	Winter (December - February)
Unit Maintenance Rating (Fall Only)			U	
Date of Inspection	3/13/2018 - 3/13/2018		11/6/2018 - 11/6/2018	
DWR Inspector	Richard Willoughby		Corey Fujitani	
Accompanied By	Tony Martinez RD 1602		Tony Martinez RD 1602

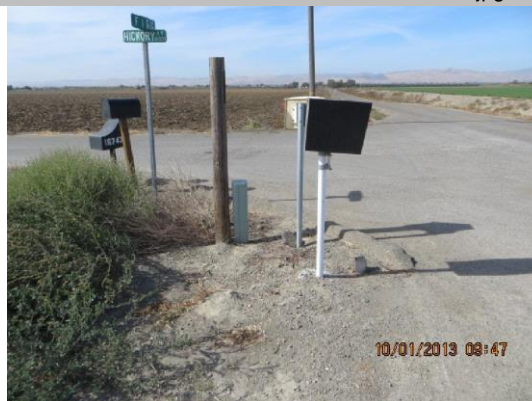
Photo 1 of 3 : UCIP_FA_2018_22937_39050.jpg

LM Start	0.58	Rating **	M	Issue No.	201
LM End	0.58	Issue Type +	En	Location *	
Category	Supplemental			GPS Latitude/Longitude	
				Start	End
Item	DWR UCIP Field Study			37.480176°	37.480176°
				-121.074736°	-121.074736°
DWR ID	24681				
Comment Code					
Inspector Comment					
FS_ID:22937 DS_ID:24681 EP_NO: N/A Repair Type: Non-Urgent Crossing Status: Found UCIP Comments: 10/01/2013 No permit identified for this crossing. (W. Wylie - DWR UCIP) FIELD_STRUCT_DESC: Communications line of an unknown size or material through the levee, at an unknown depth. FS Date: 10/1/2013

Communication line access box on LS shoulder.

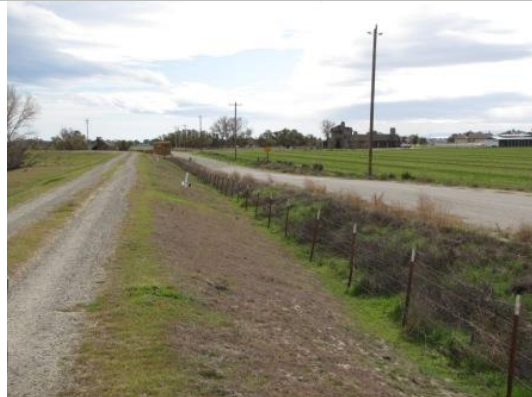
Photo 1 of 1 : FA_2018_RD1602_110_70_20180905_00043.jpg

LM Start	0.60	Rating **	M	Issue No.	70
LM End	0.71	Issue Type +	En	Location *	WS
Category	Earthen Levee			GPS Latitude/Longitude	
				Start	End
Item	Encroachments			37.479967 °	37.478514 °
				-121.074582 °	-121.073435 °
DWR ID	DWR_RD1602_01_s_2012_70				
Comment Code					
FE : Fence					
Inspector Comment					
Barbed wire fence along the landward toe.

View of barbed wire fence at landward toe looking upstream.

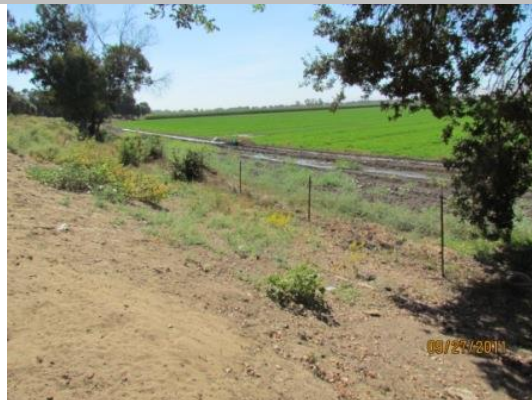
Photo 1 of 1 : FA_2018_RD1602_110_43_20180905_00018.jpg

LM Start	1.61	Rating **	M	Issue No.	43
LM End	2.22	Issue Type +	En	Location *	LS
Category	Earthen Levee			GPS Latitude/Longitude	
				Start	End
Item	Encroachments			37.477663 °	37.470125 °
				-121.058716 °	-121.055244 °
DWR ID	DWR_RD1602_01_s_2012_43				
Comment Code					
FE : Fence					
Inspector Comment					
Fence at the landside toe of the levee.

View of the fence on the landside toe of the levee. The picture was taken from crown looking upstream.

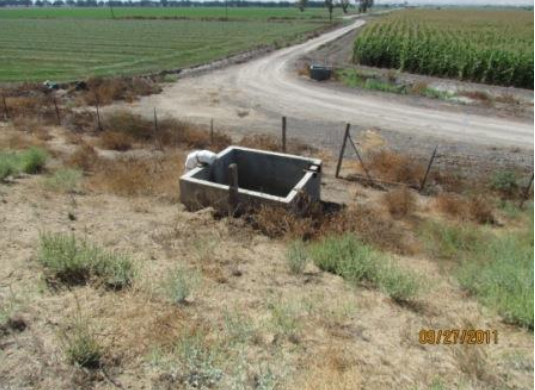
Photo 1 of 1 : FA_2018_RD1602_110_45_20180905_00020.jpg

A well is located at the landside toe of the levee. The picture was taken from the crown looking toward the landside of the levee.

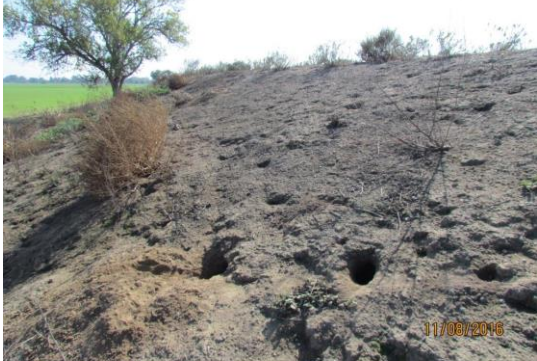
Photo 1 of 1 : FA_2018_RD1602_110_47_20180905_00021.jpg

View of rodent holes on the waterside of the levee. Fall 2016

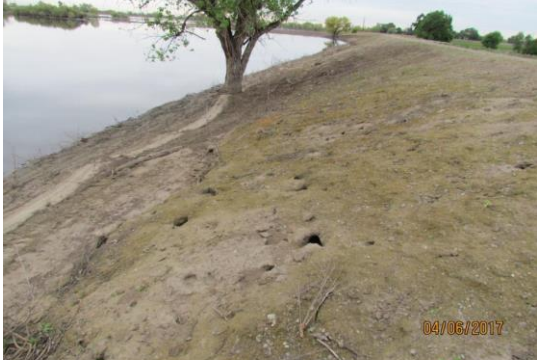
Photo 1 of 1 : FA_2018_RD1602_110_49_20180905_00023.jpg

View of rodent holes on the waterside slope of the levee. Spring 2017

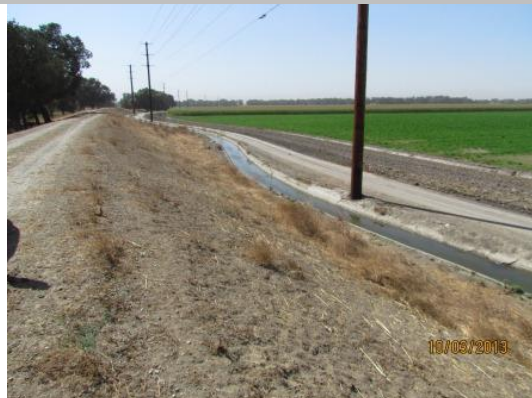
Photo 1 of 1 : FA_2018_RD1602_110_54_20180905_00027.jpg

LM Start	3.30	Rating **	M	Issue No.	54
LM End	3.46	Issue Type +	En	Location *	LS
Category	Earthen Levee			GPS Latitude/Longitude	
				Start	End
Item	Encroachments			37.461147 °	37.459242 °
				-121.041785 °	-121.043582 °
DWR ID	DWR_RD1602_01_f_2013_54				
Comment Code					
DT : Ditch					
Inspector Comment					
Concrete lined ditch on the landside toe of the levee.

A concrete lined ditch was found on the landside toe of the levee looking upstream.

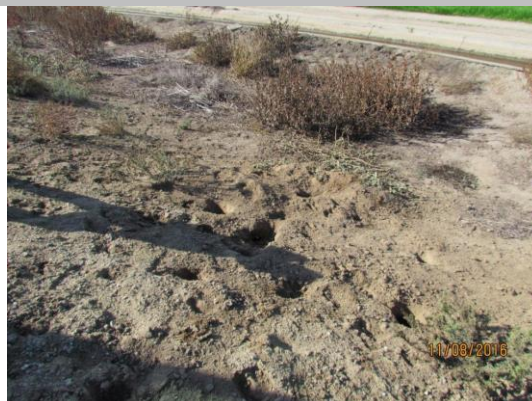
Photo 1 of 1 : FA_2018_RD1602_110_56_20180905_00028.jpg

LM Start	3.32	Rating **	M	Issue No.	56
LM End	3.32	Issue Type +	Ma	Location *	LS
Category	Earthen Levee			GPS Latitude/Longitude	
				Start	End
Item	Animal Control			37.460811 °	37.460811 °
				-121.042078 °	-121.042078 °
DWR ID	DWR_RD1602_01_s_2017_56				
Comment Code					
A3 : No rodents visible, but rodent burrows visible; need to backfill and compact or grout burrows.					
Inspector Comment

View of rodent holes on the landside of the levee. Fall 2016

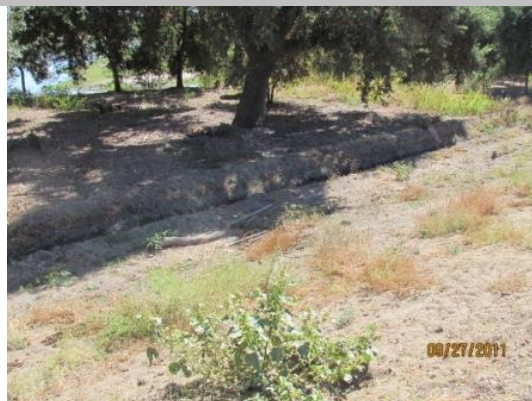
Photo 1 of 1 : FA_2018_RD1602_110_50_20180905_00024.jpg

LM Start	3.34	Rating **	M	Issue No.	50
LM End	3.53	Issue Type +	En	Location *	WS
Category	Earthen Levee			GPS Latitude/Longitude	
				Start	End
Item	Encroachments			37.460644 °	37.458373 °
				-121.042231 °	-121.044081 °
DWR ID	DWR_RD1602_01_s_2012_50				
Comment Code					
DT : Ditch					
Inspector Comment					
A ditch is located on waterside toe of the levee.

A ditch was located on the waterside toe of the levee. The picture was taken from the crown looking upstream.

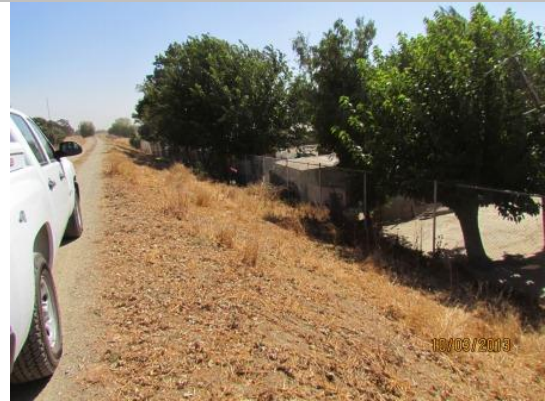
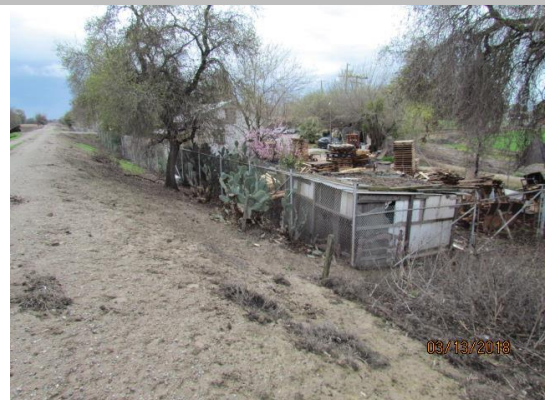
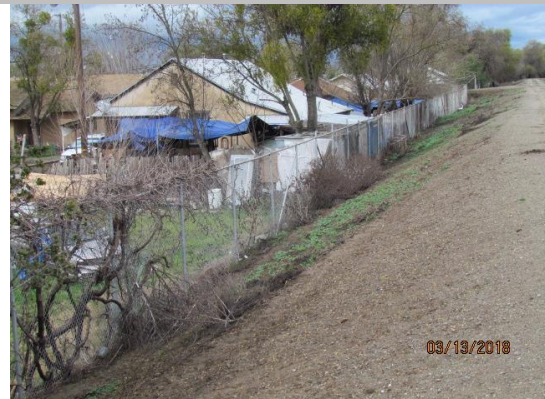
LM Start	3.82	Rating **	M	Issue No.	66 (cont)
LM End	3.92	Issue Type +	En	Location *	LS

Looking northwest at fence at landward toe. (Spring 2018)

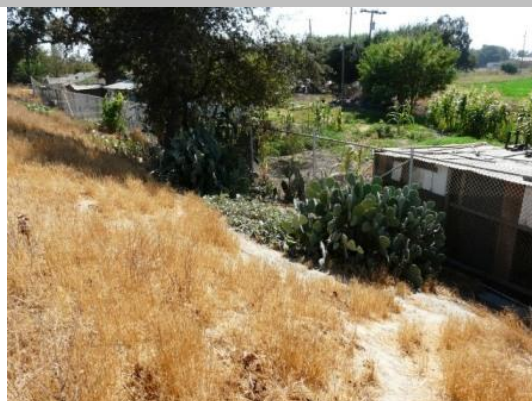
Photo 1 of 1 : FA_2018_RD1602_110_42_20180905_00017.jpg

LM Start	3.82	Rating **	M	Issue No.	42
LM End	3.82	Issue Type +	En	Location *	LS
Category	Earthen Levee			GPS Latitude/Longitude	
				Start	End
Item	Vegetation			37.454574 °	37.454574 °
				-121.043142 °	-121.043142 °
DWR ID	DWR_RD1602_01_s_2012_42				
Comment Code					
V6 : Landscaping					
Inspector Comment

Remove landscaping from within 10' of landside toe.

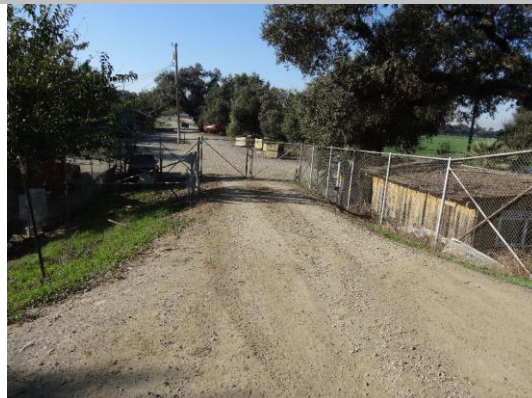
Photo 2 of 3 : UCIP_FA_2018_53523_76535.jpg

View of LS.

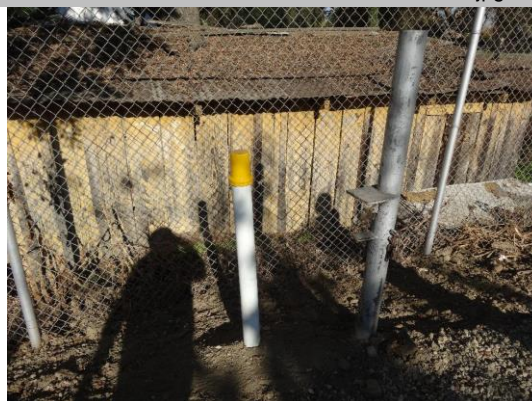
Photo 3 of 3 : UCIP_FA_2018_53523_76536.jpg

PVC riser with yellow cover located along fence on LS.

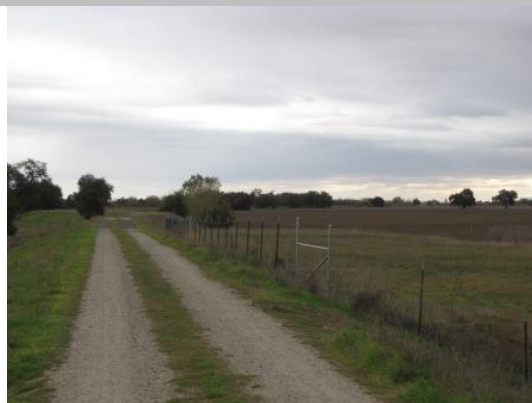
Photo 1 of 2 : FA_2018_RD1602_110_63_20180905_00035.jpg

LM Start	3.94	Rating **	M	Issue No.	63
LM End	4.04	Issue Type +	En	Location *	LS
Category	Earthen Levee			GPS Latitude/Longitude	
				Start	End
Item	Encroachments			37.452983 °	37.451866 °
				-121.042301 °	-121.041206 °
DWR ID	DWR_RD1602_01_s_2012_63				
Comment Code					
FE : Fence					
Inspector Comment					
New fence on landward slope.

View of a barbed wire fence on the landward slope looking upstream.

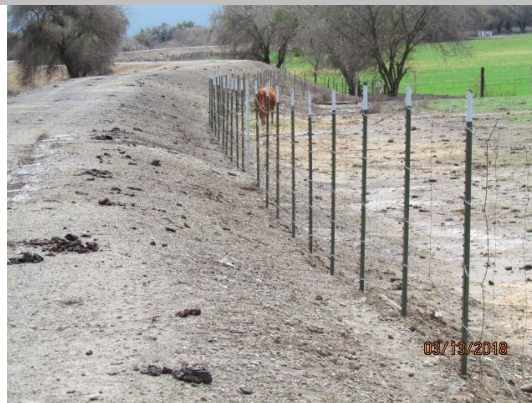
Photo 2 of 2 : FA_2018_RD1602_110_63_20180905_00036.jpg

LM Start	3.94	Rating **	M	Issue No.	63 (cont)
LM End	4.04	Issue Type +	En	Location *	LS

Looking upstream at new fence on landward slope. (Spring 2018)

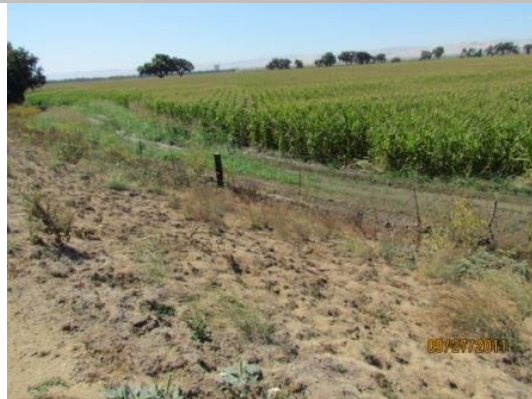
Photo 1 of 1 : FA_2018_RD1602_110_67_20180905_00042.jpg

LM Start	4.42	Rating **	M	Issue No.	67
LM End	4.88	Issue Type +	En	Location *	LS
Category	Earthen Levee			GPS Latitude/Longitude	
				Start	End
Item	Encroachments			37.447213 °	37.441014 °
				-121.037665 °	-121.036932 °
DWR ID	DWR_RD1602_01_s_2012_67				
Comment Code					
FE : Fence					
Inspector Comment

View of the fence on the landside toe of the levee. The picture was taken from the crown looking upstream.

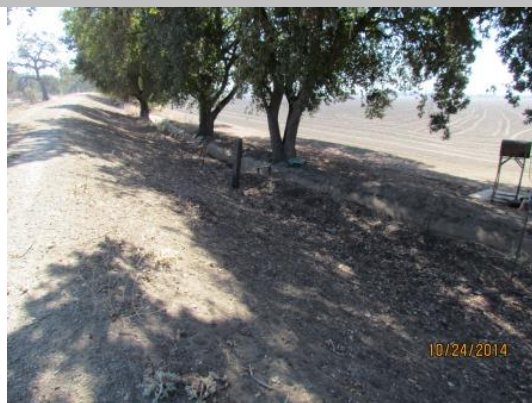
Photo 1 of 1 : FA_2018_RD1602_110_64_20180905_00037.jpg

LM Start	4.47	Rating **	M	Issue No.	64
LM End	4.74	Issue Type +	En	Location *	LS
Category	Earthen Levee			GPS Latitude/Longitude	
				Start	End
Item	Encroachments			37.446485 °	37.442772 °
				-121.038037 °	-121.037196 °
DWR ID	DWR_RD1602_01_s_2012_64				
Comment Code					
DT : Ditch					
Inspector Comment

View of a ditch on the landside toe of the levee looking upstream.

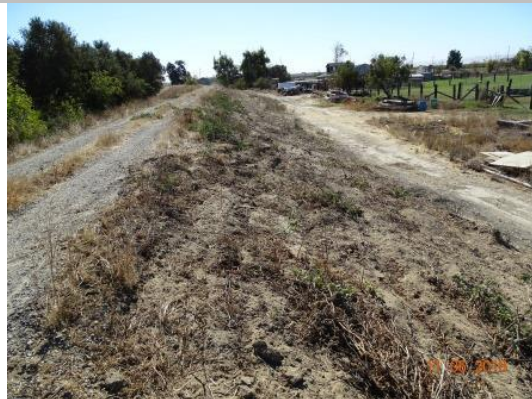
Photo 1 of 2 : FA_2018_RD1602_110_89_20181109_00113.jpg

LM Start	5.08	Rating **	M	Issue No.	89
LM End	5.13	Issue Type +	Ma	Location *	LS
Category	Earthen Levee			GPS Latitude/Longitude	
				Start	End
Item	Slope Stability			37.438249 °	°
				-121.037100 °	°
DWR ID	DWR_RD1602_01_f_2018_89				
Comment Code					
S3 : Repair the levee slope damaged by vehicle traffic and prevent access where possible.					
Inspector Comment					
damage to slope appears to be from vehicle traffic

View along landside slope looking upstream. (Fall 2018)

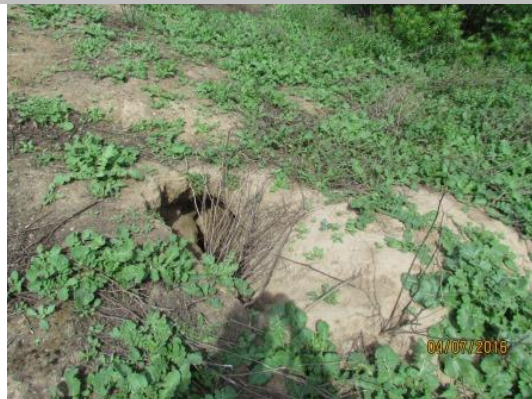
Photo 1 of 1 : FA_2018_RD1602_110_48_20180905_00022.jpg

LM Start	5.18	Rating **	U	Issue No.	48
LM End	5.18	Issue Type +	Ma	Location *	WS
Category	Earthen Levee			GPS Latitude/Longitude	
				Start	End
Item	Animal Control			37.436785 °	37.436785 °
				-121.036593 °	-121.036593 °
DWR ID	DWR_RD1602_01_s_2016_48				
Comment Code					
A3 : No rodents visible, but rodent burrows visible; need to backfill and compact or grout burrows.					
Inspector Comment					
Rodent holes possibly worsen by dogs.

View of rodent holes on the waterside of the levee looking downstream.

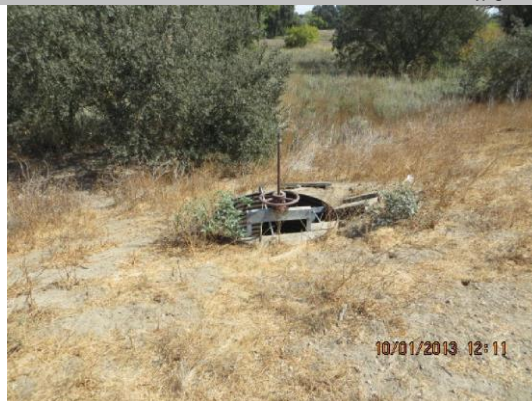
Photo 1 of 3 : UCIP_FA_2018_51336_36822.jpg

LM Start	5.19	Rating **	M	Issue No.	209	
LM End	5.19	Issue Type +	Ma	Location *		
Category	Supplemental			GPS Latitude/Longitude		
				Start	End	
Item	DWR UCIP LMA Responsibility			37.436748 °	37.436748 °	
				-121.036597 °	-121.036597 °	
DWR ID	20208

Comment Code						
Inspector Comment						
FS_ID:51336 DS_ID:20208 EP_NO: N/A Repair Type: Non-Urgent Crossing Status: Found UCIP Comments: 11/18/2016 Same as previous inspection soil and debris prevent flap gate from properly functioning and slide gate won't close due to sediment build up. Crossing has been downgraded from Urgent to Non-Urgent due to no pipe or levee integrity issues observed during the site visit. Need to contact owner to determine status of crossing. If crossing is no longer in use owner will need to coordinate with CVFPB to properly abandon or remove according to Title 23 requirements. (O. Magana - DWR UCIP)10/01/2013 Soil and debris prevent flapgate from proper function. Slide gate won't close completely due to sediment buildup. CMP riser needs cover. (W. Wylie - DWR UCIP) FIELD_STRUCT_DESC: 24-inch steel pipe through levee, 11.6 feet below crown. Concrete headwall on the landside (LS) end. Concrete "U" headwall and flap gate located on the waterside (WS) end. Slide gate in 60-inch corrugated metal pipe (CMP) riser is located on the WS slope. [Additional Reference(s): DWR Levee Log, 1992. USACE San Joaquin River O&M Manual Unit 13, April 1964, (HLM 5.23), Drawing No. 7-4-1784]. FS Date: 11/18/2016

Slide gate in CMP riser on WS slope. Outlet visible under tree in background.

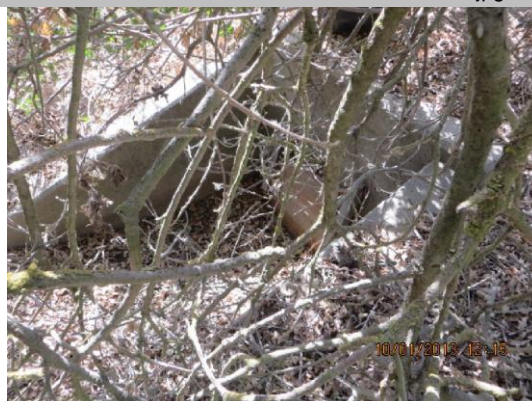
Photo 2 of 3 : UCIP_FA_2018_51336_36821.jpg

Comment Code						
Inspector Comment						
FS_ID:51336 DS_ID:20208 EP_NO: N/A Repair Type: Non-Urgent Crossing Status: Found UCIP Comments: 11/18/2016 Same as previous inspection soil and debris prevent flap gate from properly functioning and slide gate won't close due to sediment build up. Crossing has been downgraded from Urgent to Non-Urgent due to no pipe or levee integrity issues observed during the site visit. Need to contact owner to determine status of crossing. If crossing is no longer in use owner will need to coordinate with CVFPB to properly abandon or remove according to Title 23 requirements. (O. Magana - DWR UCIP)10/01/2013 Soil and debris prevent flapgate from proper function. Slide gate won't close completely due to sediment buildup. CMP riser needs cover. (W. Wylie - DWR UCIP) FIELD_STRUCT_DESC: 24-inch steel pipe through levee, 11.6 feet below crown. Concrete headwall on the landside (LS) end. Concrete "U" headwall and flap gate located on the waterside (WS) end. Slide gate in 60-inch corrugated metal pipe (CMP) riser is located on the WS slope. [Additional Reference(s): DWR Levee Log, 1992. USACE San Joaquin River O&M Manual Unit 13, April 1964, (HLM 5.23), Drawing No. 7-4-1784]. FS Date: 11/18/2016

Flapgate in Concrete headwall on WS toe under tree.

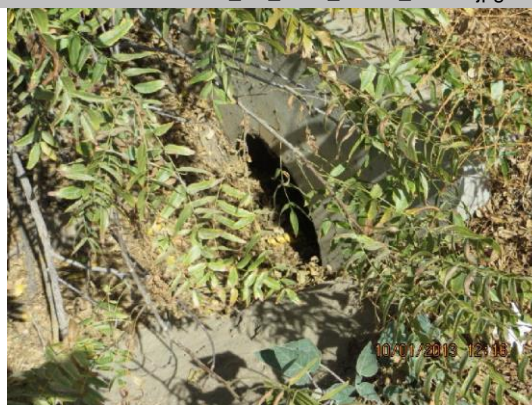
Photo 3 of 3 : UCIP_FA_2018_51336_36820.jpg

Concrete headwall at inlet on LS toe.

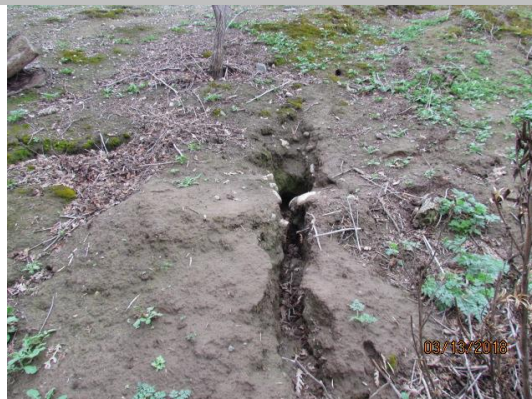
Photo 1 of 1 : FA_2018_RD1602_110_52_20180905_00026.jpg

LM Start	5.22	Rating **	M	Issue No.	52
LM End	5.22	Issue Type +	Ma	Location *	WS
Category	Earthen Levee			GPS Latitude/Longitude	
				Start	End
Item	Animal Control			37.436393 °	37.436393 °
				-121.036296 °	-121.036296 °
DWR ID	DWR_RD1602_01_s_2018_52				
Comment Code					
A3 : No rodents visible, but rodent burrows visible; need to backfill and compact or grout burrows.					
Inspector Comment					
Large rodent hole on waterward slope.

Looking at rodent hole and erosion around rodent hole on waterward slope.

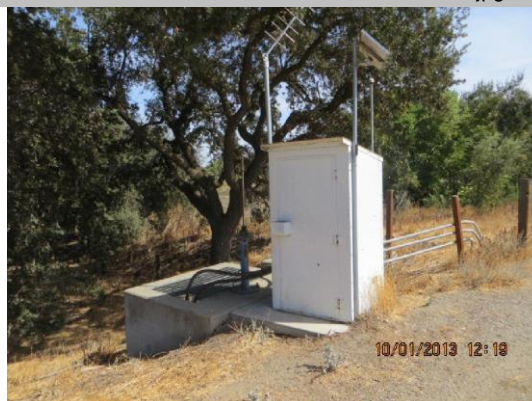
Photo 1 of 2 : UCIP_FA_2018_21665_36829.jpg

Comment Code						
Inspector Comment						
FS_ID:21665						
DS_ID:20209						
EP_NO: 8192						
Repair Type: No Action Needed						
Crossing Status: Found						
UCIP Comments:						
FIELD_STRUCT_DESC: 1 of 2: 36-inch by 36-inch reinforced concrete box drainage culvert through the levee, 15.8 feet below the crown. Slide gate in a 6-foot by 7-foot concrete surge box on the waterside (WS) slope. 36-inch concrete pipes buried on both sides of the levee and connected to the reinforced concrete box culvert. Constructed through the levee section. (two 36-inch by 36-inch culvert [HLM 5.27] authorized under Automatic Board Order (ABO) issued as Permit No. 8192, 1972 - Stanislaus County). [Additional Reference(s): DWR Levee Log, 1992. USACE San Joaquin O&M Manual 13, April 1964, (HLM 5.27), Drawing No. 7-4-1784].						
FS Date: 10/1/2013

Shed with slide gate in Concrete riser on WS shoulder.

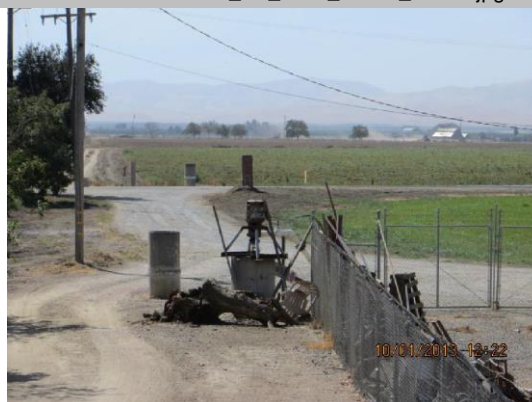
Photo 2 of 2 : UCIP_FA_2018_21665_36828.jpg

Likely risers for pipe off LS toe.

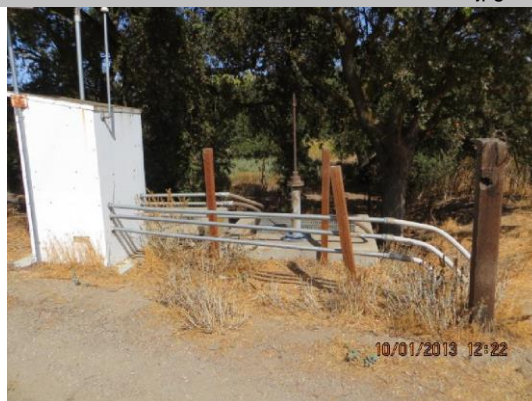
Photo 1 of 2 : UCIP_FA_2018_21668_36835.jpg

Comment Code						
Inspector Comment						
FS_ID:21668						
DS_ID:20222						
EP_NO: 8192						
Repair Type: No Action Needed						
Crossing Status: Found						
UCIP Comments:						
FIELD_STRUCT_DESC: 2 of 2: 36-inch by 36-inch reinforced concrete box drainage culvert through the levee, 15.8 feet below the crown. Slide gate in a 6-foot by 7-foot concrete surge box on the waterside (WS) slope. 36-inch concrete pipes buried on both sides of the levee and connected to the reinforced concrete box culvert. Constructed through the levee section. (two 36-inch by 36-inch culvert [HLM 5.27] authorized under Automatic Board Order (ABO) issued as Permit No. 8192, 1972 - Stanislaus County). [Additional Reference(s): DWR Levee Log, 1992. USACE San Joaquin O&M Manual 13, April 1964, (HLM 5.27), Drawing No. 7-4-1784].						
FS Date: 10/1/2013

Slide gate in Concrete vault on WS shoulder.

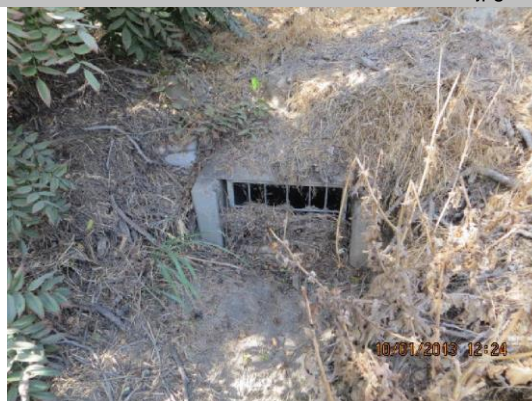
Photo 3 of 3 : UCIP_FA_2018_21672_36846.jpg

LM Start	5.24	Rating **	A/W	Issue No.	212 (cont)	
LM End	5.24	Issue Type +	Ma	Location *		
Category	Supplemental			GPS Latitude/Longitude		
				Start	End	
Item	DWR UCIP LMA Responsibility			37.436129 °	37.436129 °	
				-121.036065 °	-121.036065 °	
DWR ID	20210					
Comment Code						
Inspector Comment						
FS_ID:21672 DS_ID:20210 EP_NO: N/A Repair Type: No Action Needed Crossing Status: Found UCIP Comments: FIELD_STRUCT_DESC: 30-inch by 30-inch reinforced concrete box drainage culvert through the levee, 12.9 feet below the crown. Slide gate in a concrete surge box on the waterside (WS) slope. Concrete discharge boxes on both ends. [Additional Reference(s): DWR Levee Log, 1992. USACE San Joaquin O&M Manual 13, April 1964, (HLM 5.28), Drawing No. 7-4-1784]. FS Date: 10/1/2013

Concrete inlet on LS toe.

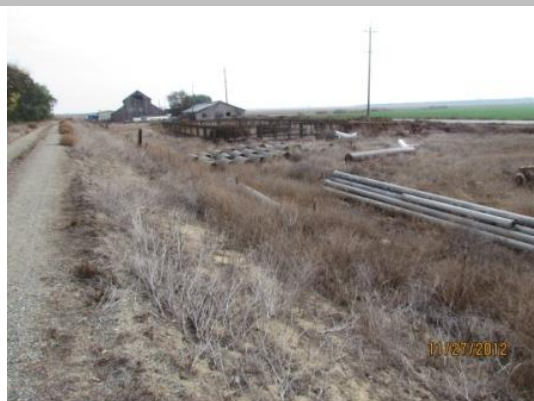
Photo 1 of 1 : FA_2018_RD1602_110_22_20180905_00006.jpg

LM Start	5.38	Rating **	M	Issue No.	22
LM End	5.44	Issue Type +	En	Location *	LS
Category	Earthen Levee			GPS Latitude/Longitude	
				Start	End
Item	Encroachments			37.434447 °	37.433791 °
				-121.034865 °	-121.034000 °
DWR ID	DWR_RD1602_01_f_2012_22				
Comment Code					
FE : Fence					
Inspector Comment

A fence was found on the landside toe of the levee looking upstream.

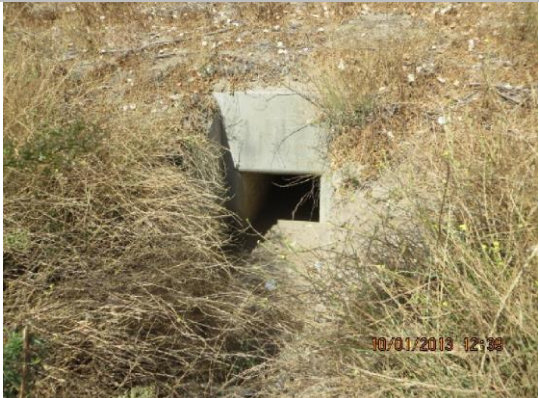
Photo 3 of 3 : UCIP_FA_2018_51337_36876.jpg

Concrete U-shaped headwall on LS toe.

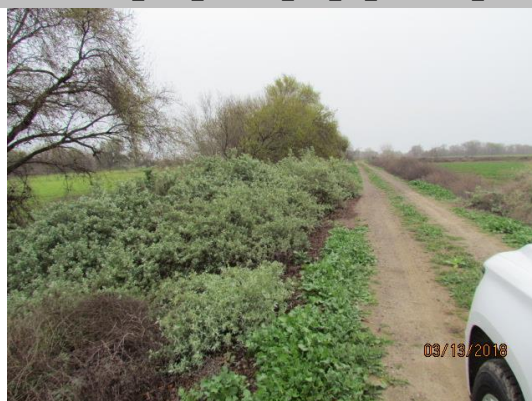
Photo 2 of 2 : FA_2018_RD1602_110_75_20180905_00046.jpg

LM Start	5.82	Rating **	U	Issue No.	75 (cont)
LM End	5.93	Issue Type +	Ma	Location *	WS

Looking at upstream at dense vegetation on waterward slope. (Spring 2018)

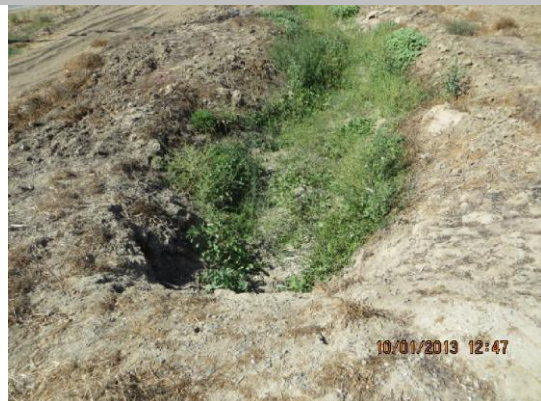
Photo 1 of 3 : UCIP_FA_2018_21683_36882.jpg

Comment Code						
Inspector Comment						
FS_ID:21683 DS_ID:20214 EP_NO: 8194 Repair Type: Non-Urgent Crossing Status: Found UCIP Comments: 10/01/2013 Pipe heavily deteriorated on LS toe. May indicate condition of rest of pipe is bad. Good candidate for video inspection. (W. Wylie - DWR UCIP) FIELD_STRUCT_DESC: 18-inch reinforced concrete irrigation pipe through the levee, 3 feet below the crown. Slide gate in a 36-inch concrete standpipe on the waterside (WS) shoulder. (Permit No. 8194, 1972 - Ernest F. Nunes). [Additional Reference(s): DWR Levee Log, 1992. USACE San Joaquin O&M Manual 13, April 1964, (HLM 6.28), Drawing No. 7-4-1784]. FS Date: 10/1/2013

Drainage/irrigation canal on LS toe.
