**Flood Control Project Maintenance  
Levee Inspections**

**Fall 2019 Levee Maintenance Deficiency Summary Report**

**Reclamation District No. 1602 Del Puerto**

Waterway			Bank	Unit Miles
Unit No. 01 San Joaquin River			Left	6.24
	Spring (March - May)	Summer (June - August)	(September - November) Fall	Winter (December - February)
Unit Maintenance Rating (Fall Only)			<b>U</b>	
Date of Inspection	4/16/2019 - 4/16/2019		11/6/2019 - 11/6/2019	
DWR Inspector	Corey Fujitani		Corey Fujitani	
Accompanied By	Tony Martinez RD 1602		Tony Martinez RD 1602

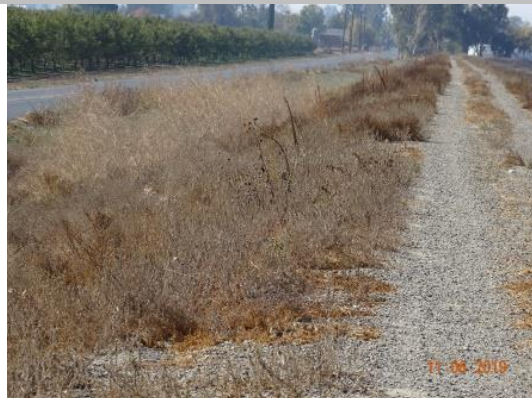
Photo 1 of 1 : FA\_2019\_RD1602\_110\_131\_20191114\_00110.jpg

LM Start	0.13	Rating **	M	Issue No.	131
LM End	0.55	Issue Type +	Ma	Location *	LS
Category	Earthen Levee			GPS Latitude/Longitude	
				Start	End
Item	Vegetation			37.477227 °	37.480251 °
				-121.081811 °	-121.075140 °
DWR ID	DWR_RD1602_01_f_2019_131				
Comment Code					
V1 : Control annual grass and weeds on the levee slopes and easements.					
Inspector Comment

Looking West along the landside slope. (Fall 2019)

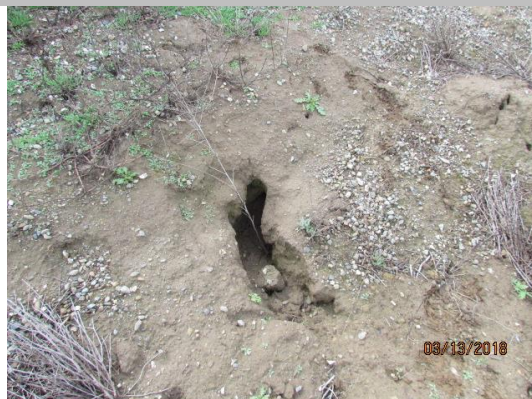
Photo 2 of 2 : FA\_2019\_RD1602\_110\_29\_20190912\_00011.jpg

LM Start	<b>0.26</b>	Rating **	M	Issue No.	<b>29 (cont)</b>
LM End	<b>0.26</b>	Issue Type +	Ma	Location *	WS

Looking at typical rodent holes on waterward slope. (Spring 2018)

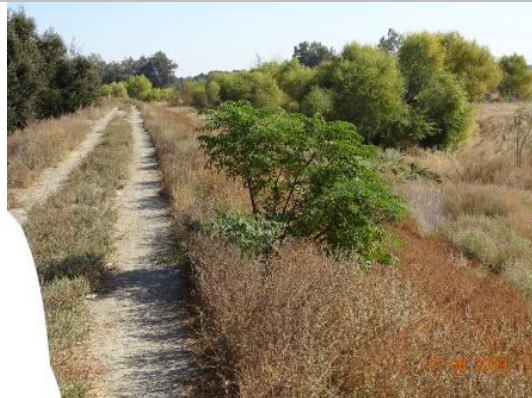
Photo 1 of 1 : FA\_2019\_RD1602\_110\_127\_20191114\_00113.jpg

LM Start	1.09	Rating **	M	Issue No.	127
LM End	1.09	Issue Type +	Ma	Location *	LS
Category	Earthen Levee			GPS Latitude/Longitude	
				Start	End
Item	Trim / Thin Trees			37.478449 °	37.478449 °
				-121.067261 °	-121.067261 °
DWR ID	DWR_RD1602_01_f_2019_127				
Comment Code					
T2 : Thin trees to allow visibility of the ground and room to flood fight.					
Inspector Comment					
Young tree growing in the landside shoulder should be removed before it can establish.

Young tree growing on the landside shoulder should be removed. (Fall 2019)

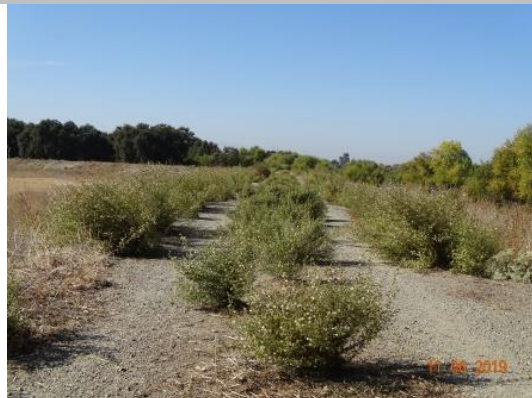
Photo 1 of 1 : FA\_2019\_RD1602\_110\_123\_20191114\_00114.jpg

LM Start	1.33	Rating **	U	Issue No.	123
LM End	1.41	Issue Type +	Ma	Location *	CR
Category	Earthen Levee			GPS Latitude/Longitude	
				Start	End
Item	Vegetation			37.479307 °	37.479071 °
				-121.063262 °	-121.061849 °
DWR ID	DWR_RD1602_01_f_2019_123				
Comment Code					
V9 : Keep the crown roadway free of vegetation.					
Inspector Comment

View of vegetation on the levee crown. (Fall 2019)

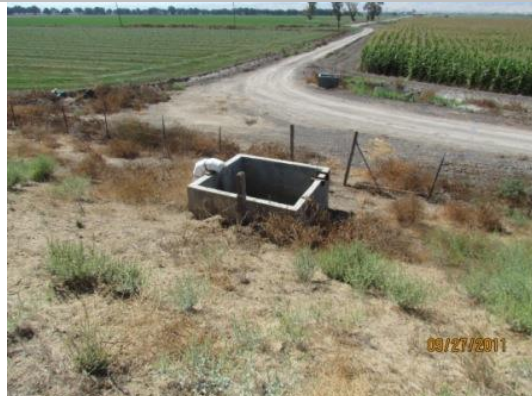
Photo 1 of 1 : FA\_2019\_RD1602\_110\_45\_20190912\_00020.jpg

LM Start	2.03	Rating **	M	Issue No.	45
LM End	2.03	Issue Type +	En	Location *	LS
Category	Earthen Levee			GPS Latitude/Longitude	
				Start	End
Item	Encroachments			37.471734 °	37.471734 °
				-121.057670 °	-121.057670 °
DWR ID	DWR_RD1602_01_s_2012_45				
Comment Code					
EQ : Equipment					
Inspector Comment					
A well is present at the toe of the landside of the slope.

A well is located at the landside toe of the levee. The picture was taken from the crown looking toward the landside of the levee.

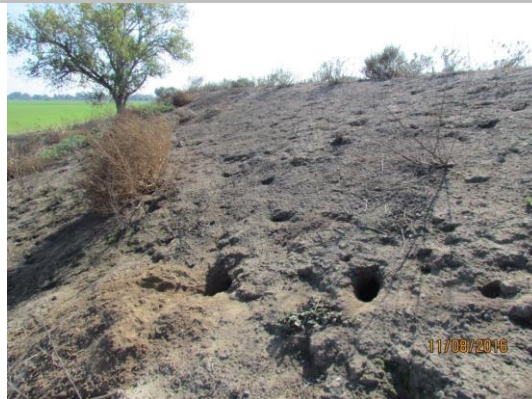
Photo 1 of 1 : FA\_2019\_RD1602\_110\_47\_20190912\_00021.jpg

LM Start	2.86	Rating **	M	Issue No.	47
LM End	2.86	Issue Type +	Ma	Location *	WS
Category	Earthen Levee			GPS Latitude/Longitude	
				Start	End
Item	Animal Control			37.466166 °	37.466166 °
				-121.045527 °	-121.045527 °
DWR ID	DWR_RD1602_01_f_2016_47				
Comment Code					
A3 : No rodents visible, but rodent burrows visible; need to backfill and compact or grout burrows.					
Inspector Comment

View of rodent holes on the waterside of the levee. Fall 2016

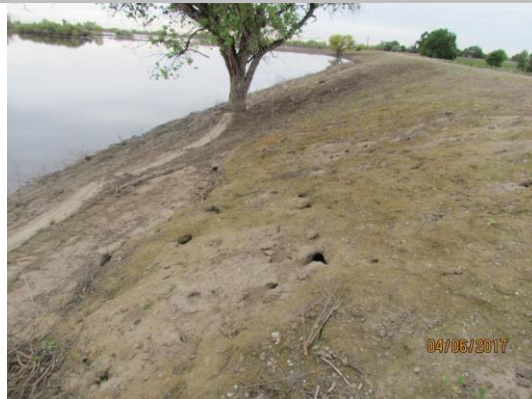
Photo 1 of 1 : FA\_2019\_RD1602\_110\_49\_20190912\_00023.jpg

LM Start	2.89	Rating **	M	Issue No.	49
LM End	2.89	Issue Type +	Ma	Location *	WS
Category	Earthen Levee			GPS Latitude/Longitude	
				Start	End
Item	Animal Control			37.465898 °	37.465898 °
				-121.045209 °	-121.045209 °
DWR ID	DWR_RD1602_01_f_2016_49				
Comment Code					
A3 : No rodents visible, but rodent burrows visible; need to backfill and compact or grout burrows.					
Inspector Comment

View of rodent holes on the waterside slope of the levee. Spring 2017

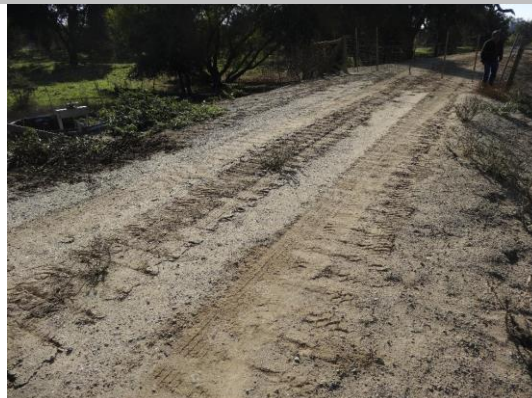
Photo 3 of 3 : UCIP\_FA\_2019\_53522\_76527.jpg

Comment Code						
Inspector Comment						
DS_ID:20204 FS_ID:53522 EP_NO: 8193 Repair Type: Urgent Crossing Status: Found UCIP Comments: 10/19/2018 Pipe is deteriorated on the LS toe (pipe section missing at inlet). This crossing remains Urgent due to the wall deterioration at the inlet. If wall is rusted out at the inlet, need to determine the condition of the pipe section through the levee. According to the LMA representative, this crossing is no longer in use (crossing is abandoned). LMA is interested in abandoning crossing in place. LMA was referred to the CVFPB staff for direction regarding proper action under Title 23 for this crossing. (O. Magana - DWR UCIP)11/18/2016 Same as previous inspection riser cover and handle on slide gate are still missing. Crossing remains Urgent due to the public safety issue of the 60-inch CMP cover still missing. According to Tony Martinez, LMA representative, the condition and future use of this crossing is being evaluated. Owner will need to coordinate with CVFPB for future use requirements or proper abandonment/removal. (O. Magana - DWR UCIP)10/01/2013 Appears abandoned, and if so should be done so properly. No handle on slide gate, no cover on CMP standpipe on WS shoulder. (W. Wylie - DWR UCIP) FIELD_STRUCT_DESC: 16-inch steel irrigation pipe through levee, 11.5 feet below crown. Slide gate in 60-inch corrugated metal pipe riser is located on the waterside (WS) slope. Pipe discharges into concrete-lined ditch on the landside (LS) (irrigation pipe was authorized under Automatic Board Order (ABO) issued as Permit No. 8193, 1964 - Sabatte). [Additional Reference(s): DWR Levee Log, 1992. USACE San Joaquin River O&M Manual Unit 13, April 1964, (HLM 0.58), Drawing No. 7-4-1784]. FS Date: 10/19/2018 10:25:00 AM

Overview of levee crown at pipe crossing.

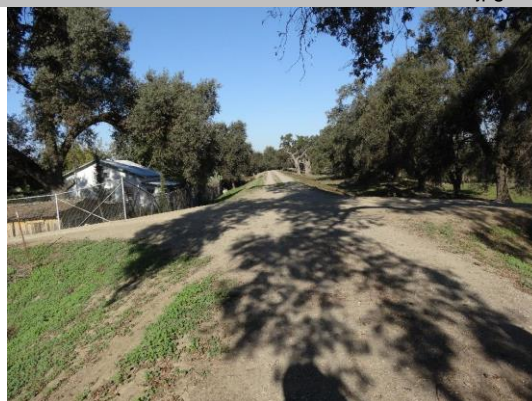
Photo 1 of 3 : UCIP\_FA\_2019\_53523\_76534.jpg

UCIP Comments: 10/19/2018 Pipe section through the WS ramp was exposed during the 2017 storms. According to LMA representative, adjacent property owner has backfilled the pipe with soil to avoid damage to line. Contacted Mr. Chris Williams with PG&E and Mr. Williams mentioned that PG&E is planning to abandon the line and install a new line. The new line will be bored through the levee. Mr. Williams also mentioned that the line was inspected in 2016-17 and was found to be functional. However, due to the pipe exposure in 2017 PG&E has decided to abandon the current line. PG&E is working with the CVFPB to obtain the proper permits and complete the final design for the new line. This crossing has been downgraded from Urgent to Non-Urgent due to the updated UCIP reclassification evaluations. Pending action for this crossing includes line abandonment documentation from CVFPB and closeout files for this crossing. Primary PG&E contact for this crossing is Carlos Carbrera, Stanislaus and San Joaquin PG&E Local Engineer. He can be reached at 1-925-789-0509 or by email at c4ch@pge.com. (O. Magana - DWR UCIP)11/18/2016 Same as previous inspection crossing is missing markers visible from levee crown. PG&E completed some construction work on this line from September - November 3rd, 2016 and installed a marker on WS approximately 341 feet from levee crown. UCIP inspector will need to contact Mr. Chris Williams, Associate Construction Specialist, Gas Construction Management Central Valley Region with PG&E at 1-209-272-2811 to determine extent of inspection through levee. (O. Magana - DWR UCIP)10/01/2013 Gasline needs sign markers at levee. (W. Wylie - DWR UCIP) FIELD\_STRUCT\_DESC: 12.75-inch gas line crossing through levee, 3 feet below crown. Gas line is near Prune Avenue and Paradise Avenue. For emergencies call PG&E at 1-800-811-4111. (12.75-inch line authorized under Permit No. 7796, 1972 - Pacific Gas and Electric Company [PG&E], related permits include Permit No. 7796-A issued to amend plans to allow installing gas line under river by boring method, and Permit No. 7796-B issued to modify condition no. 18 by allowing work before July 20, 1972) [Additional Reference(s): DWR Levee Log, 1992. USACE San Joaquin River O&M Manual Unit 13, April 1964, (HLM 3.90), Drawing No. 7-4-1784]. FS Date: 10/19/2018 10:26:00 AM

Overview of levee crown at pipe crossing.

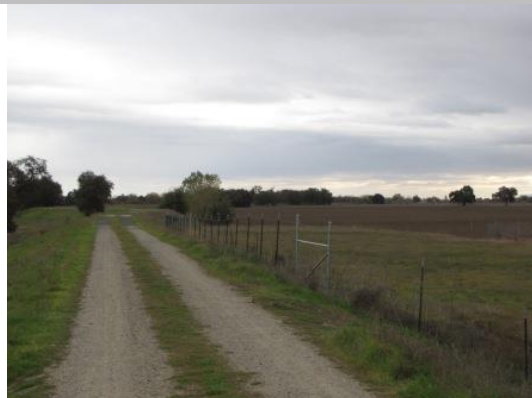
Photo 1 of 2 : FA\_2019\_RD1602\_110\_63\_20190912\_00033.jpg

LM Start	3.94	Rating **	M	Issue No.	63
LM End	4.04	Issue Type +	En	Location *	LS
Category	Earthen Levee			GPS Latitude/Longitude	
				Start	End
Item	Encroachments			37.452983°	37.451866°
				-121.042301°	-121.041206°
DWR ID	DWR_RD1602_01_s_2012_63				
Comment Code					
FE : Fence					
Inspector Comment					
New fence on landward slope.

View of a barbed wire fence on the landward slope looking upstream.

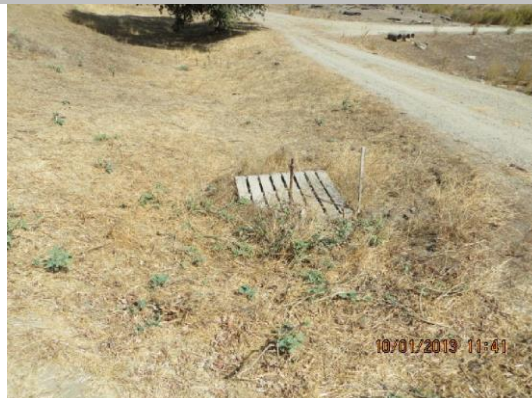
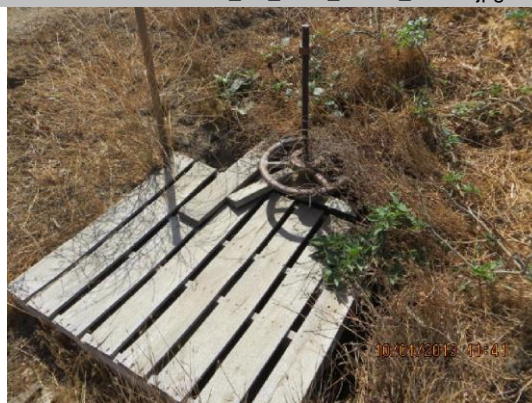
Comment Code					
Inspector Comment					
DS_ID:20207 FS_ID:51332 EP_NO: 8195 Repair Type: Non-Urgent Crossing Status: Found UCIP Comments: 11/18/2016 60-inch riser has a temporary cover therefore crossing has been downgraded from Urgent to Non-Urgent. (O. Magana - DWR UCIP) 10/01/2013 Lid missing from 60-inch CMP riser, may be an attractive nuisance or hazard to public. (W. Wylie - DWR UCIP) FIELD_STRUCT_DESC: 18-inch steel pipe through levee, 10 feet below crown. Slide gate in 60-inch corrugated metal pipe riser located on the waterside (WS) slope. Concrete discharge box is located on landside (LS) end. Pipe is buried across WS berm to pump located on the riverbank approximately 1,000 feet from the levee. (18-inch pipe authorized under Automatic Board Order (ABO) issued as Permit No. 8195, 1972 - Larry Buehner). [Additional Reference(s): DWR Levee Log, 1992. USACE San Joaquin River O&M Manual Unit 13, April 1964, (HLM 4.51), Drawing No. 7-4-1784]. FS Date: 11/18/2016

Slide gate in CMP riser on WS slope.

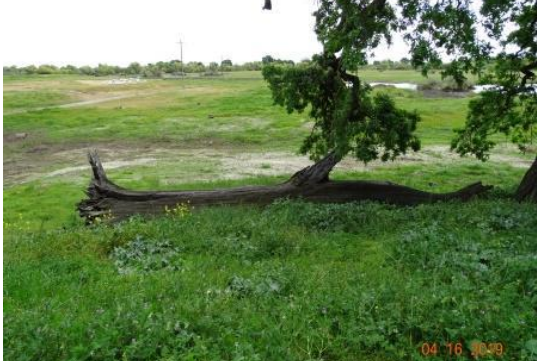
Photo 1 of 1 : FA\_2019\_RD1602\_110\_69\_20190912\_00040.jpg

View of fallen tree trunk on waterside slope. (Spring 2019)

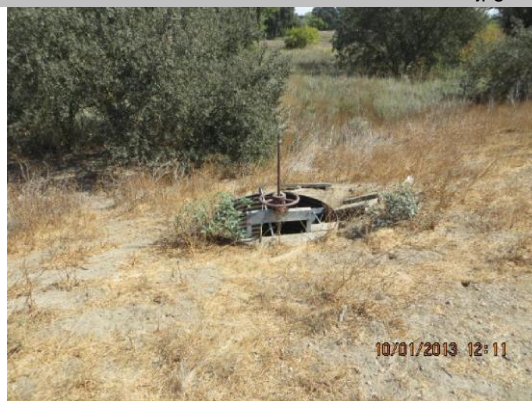
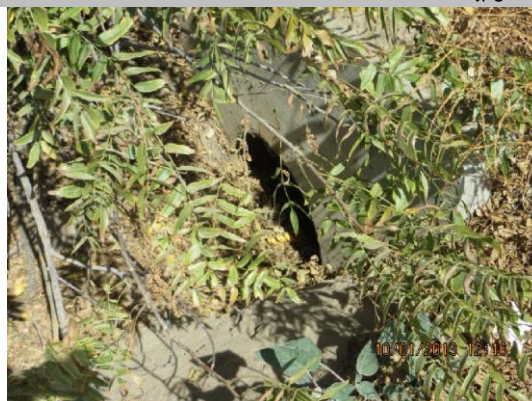
Slide gate in CMP riser on WS slope. Outlet visible under tree in background.

Comment Code						
Inspector Comment						
DS_ID:20208 FS_ID:51336 EP_NO: N/A Repair Type: Non-Urgent Crossing Status: Found UCIP Comments: 11/18/2016 Same as previous inspection soil and debris prevent flap gate from properly functioning and slide gate won't close due to sediment build up. Crossing has been downgraded from Urgent to Non-Urgent due to no pipe or levee integrity issues observed during the site visit. Need to contact owner to determine status of crossing. If crossing is no longer in use owner will need to coordinate with CVFPB to properly abandon or remove according to Title 23 requirements. (O. Magana - DWR UCIP)10/01/2013 Soil and debris prevent flapgate from proper function. Slide gate won't close completely due to sediment buildup. CMP riser needs cover. (W. Wylie - DWR UCIP) FIELD_STRUCT_DESC: 24-inch steel pipe through levee, 11.6 feet below crown. Concrete headwall on the landside (LS) end. Concrete "U" headwall and flap gate located on the waterside (WS) end. Slide gate in 60-inch corrugated metal pipe (CMP) riser is located on the WS slope. [Additional Reference(s): DWR Levee Log, 1992. USACE San Joaquin River O&M Manual Unit 13, April 1964, (HLM 5.23), Drawing No. 7-4-1784]. FS Date: 11/18/2016

Concrete headwall at inlet on LS toe.

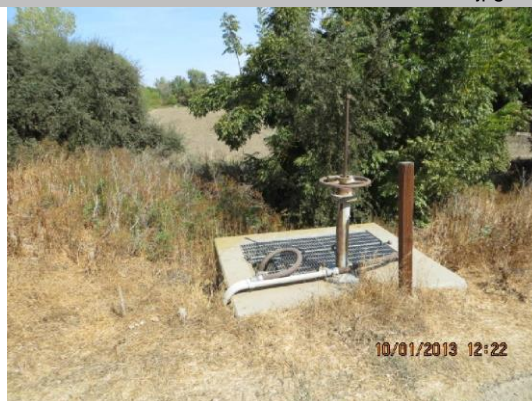
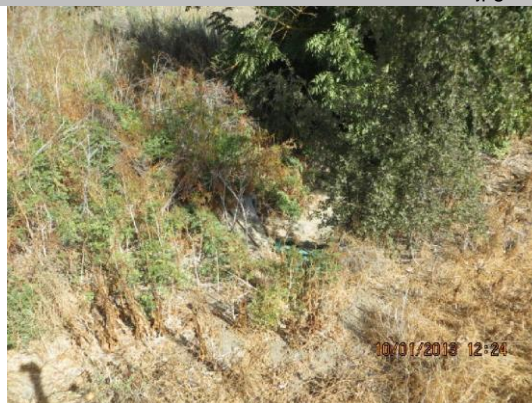
LM Start	5.24	Rating **	A/W	Issue No.	212
LM End	5.24	Issue Type +	Ma	Location *	
Category	Supplemental			GPS Latitude/Longitude	
				Start	End
Item	DRAFT DWR UCIP LMA Responsibility			37.436129 °	37.436129 °
				-121.036065 °	-121.036065 °
DWR ID	20210				
Comment Code					
Inspector Comment					
DS_ID:20210					
FS_ID:21672					
EP_NO: N/A					
Repair Type: No Action Needed					
Crossing Status: Found					
UCIP Comments:					
FIELD_STRUCT_DESC: 30-inch by 30-inch reinforced concrete box drainage culvert through the levee, 12.9 feet below the crown. Slide gate in a concrete surge box on the waterside (WS) slope. Concrete discharge boxes on both ends. [Additional Reference(s): DWR Levee Log, 1992. USACE San Joaquin O&M Manual 13, April 1964, (HLM 5.28), Drawing No. 7-4-1784].					
FS Date: 10/1/2013

Slidegate in concrete riser on WS shoulder.

Concrete outlet on WS toe.

Concrete inlet on LS toe.

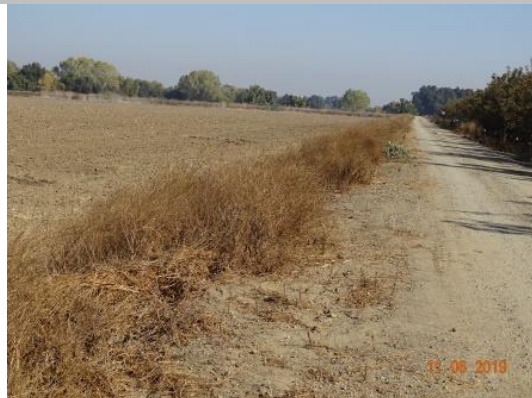
Photo 1 of 1 : FA\_2019\_RD1602\_110\_24\_20191114\_00127.jpg

LM Start	5.55	Rating **	U	Issue No.	24
LM End	6.22	Issue Type +	Ma	Location *	LS
Category	Earthen Levee			GPS Latitude/Longitude	
				Start	End
Item	Vegetation			37.433115 °	37.429200 °
				-121.032327 °	-121.029660 °
DWR ID	DWR_RD1602_01_f_2019_24				
Comment Code					
V1 : Control annual grass and weeds on the levee slopes and easements.					
Inspector Comment

Looking East along the landside slope. (Fall 2019)

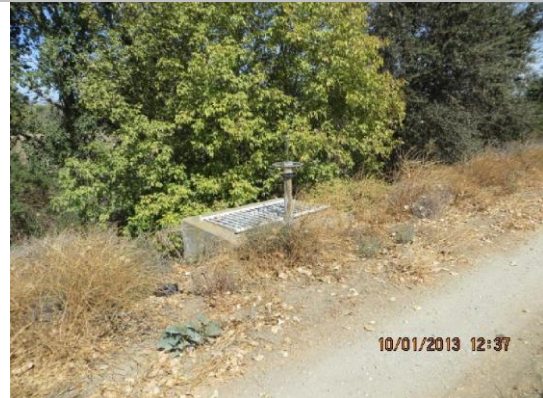
Photo 1 of 3 : UCIP\_FA\_2019\_51337\_36878.jpg

Comment Code					
Inspector Comment					
DS_ID:20212 FS_ID:51337 EP_NO: N/A Repair Type: Non-Urgent Crossing Status: Found UCIP Comments: 11/18/2016 Crossing has been downgraded from Urgent to Non-Urgent flap gate is functional. Recommend clearing dense vegetation from WS and LS slopes. (O. Magana - DWR UCIP)10/01/2013 Flapgate has minor blockage preventing gate from fully closing. (W. Wylie - DWR UCIP) FIELD_STRUCT_DESC: 30-inch square reinforced concrete box culvert through levee, 9 feet below crown. Slide gate in concrete surge box is located on the waterside (WS) slope. Concrete "U" headwalls are located on both the waterside (WS) and landside (LS) ends. Flap gate is located on the WS end. [Additional Reference(s): DWR Levee Log, 1992. USACE San Joaquin River O&M Manual Unit 13, April 1964, (HLM 5.28), Drawing No. 7-4-1784]. FS Date: 11/18/2016

Slide gate in concrete riser on WS shoulder.

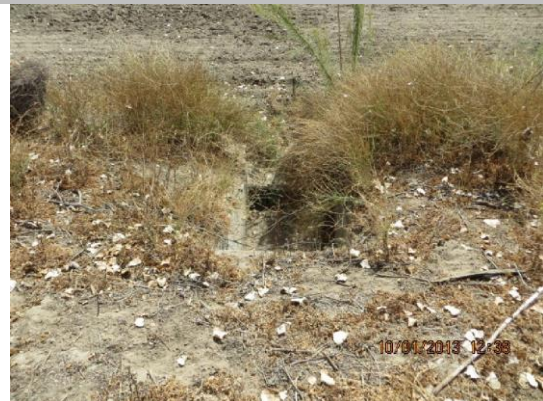
Photo 2 of 3 : UCIP\_FA\_2019\_51337\_36877.jpg

Concrete U-shaped headwall on LS toe.

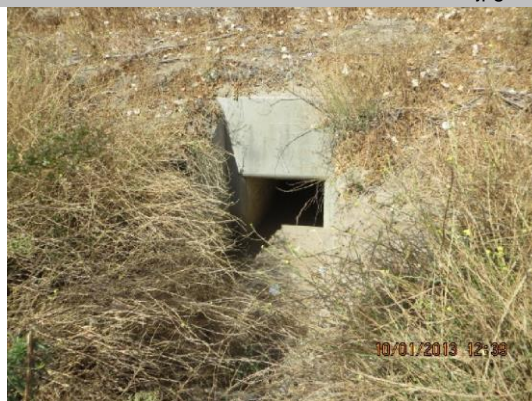
Photo 3 of 3 : UCIP\_FA\_2019\_51337\_36876.jpg

Comment Code						
Inspector Comment						
DS_ID:20212 FS_ID:51337 EP_NO: N/A Repair Type: Non-Urgent Crossing Status: Found UCIP Comments: 11/18/2016 Crossing has been downgraded from Urgent to Non-Urgent flap gate is functional. Recommend clearing dense vegetation from WS and LS slopes. (O. Magana - DWR UCIP)10/01/2013 Flapgate has minor blockage preventing gate from fully closing. (W. Wylie - DWR UCIP) FIELD_STRUCT_DESC: 30-inch square reinforced concrete box culvert through levee, 9 feet below crown. Slide gate in concrete surge box is located on the waterside (WS) slope. Concrete "U" headwalls are located on both the waterside (WS) and landside (LS) ends. Flap gate is located on the WS end. [Additional Reference(s): DWR Levee Log, 1992. USACE San Joaquin River O&M Manual Unit 13, April 1964, (HLM 5.28), Drawing No. 7-4-1784]. FS Date: 11/18/2016

Concrete U-shaped headwall on LS toe.

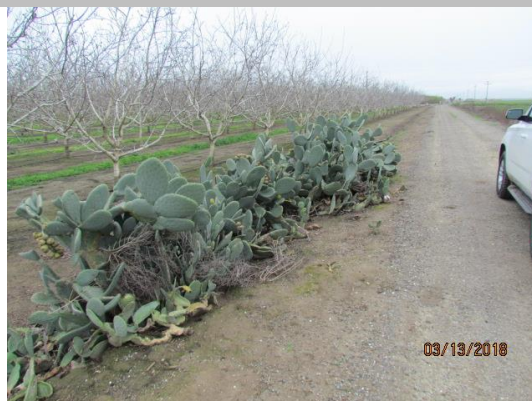
Photo 2 of 2 : FA\_2019\_RD1602\_110\_86\_20190912\_00050.jpg

LM Start	6.13	Rating **	U	Issue No.	86 (cont)	
LM End	6.13	Issue Type +	En	Location *	WS	
Category	Earthen Levee			GPS Latitude/Longitude		
				Start		End
Item	Vegetation			37.430181 °		37.430181 °
				-121.028679 °		-121.028679 °
DWR ID	DWR_RD1602_01_s_2018_86					
Comment Code						
V6 : Landscaping						
Inspector Comment						
Cactus blocking view of waterward slope.

Looking south at dense cactus on waterward slope.

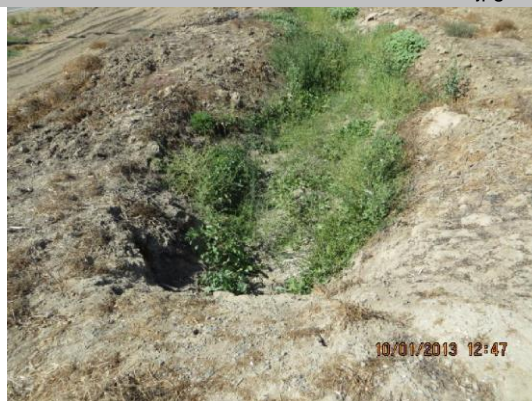
Photo 1 of 3 : UCIP\_FA\_2019\_21683\_36882.jpg

Comment Code						
Inspector Comment						
DS_ID:20214						
FS_ID:21683						
EP_NO: 8194						
Repair Type: Non-Urgent						
Crossing Status: Found						
UCIP Comments: 10/01/2013 Pipe heavily deteriorated on LS toe. May indicate condition of rest of pipe is bad. Good candidate for video inspection. (W. Wylie - DWR UCIP)						
FIELD_STRUCT_DESC: 18-inch reinforced concrete irrigation pipe through the levee, 3 feet below the crown. Slide gate in a 36-inch concrete standpipe on the waterside (WS) shoulder. (18-inch concrete pipe was authorized under Automatic Board Order (ABO) issued as Permit No. 8194, 1972 - Ernest F. Nunes). [Additional Reference(s): DWR Levee Log, 1992. USACE San Joaquin O&M Manual 13, April 1964, (HLM 6.28), Drawing No. 7-4-1784].						
FS Date: 10/1/2013

Drainage/irrigation canal on LS toe.
