Flood Control Project Maintenance Levee Inspections

Fall 2020 Levee Maintenance Deficiency Summary Report

San Joaquin River Basin

Reclamation District No. 1602 Del Puerto

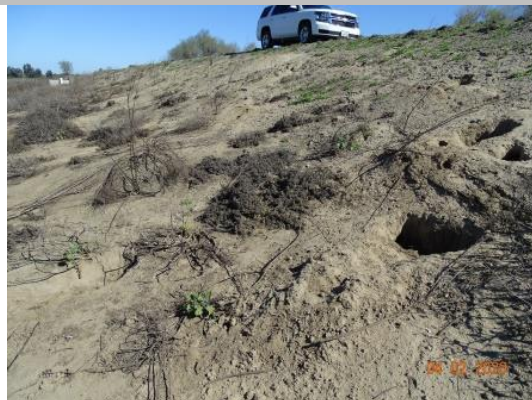
Photo 1 of 1 : FA_2020_RD1602_110_93_20200901_00050.jpg

LM Start	2.07	Rating **	U	Issue No.	93
LM End	2.07	Issue Type +	Ma	Location *	LS
Category	Earthen Levee			GPS Latitude/Longitude	
				Start	End
Item	Animal Control			37.471195 °	37.471195 °
				-121.057356 °	-121.057356 °
DWR ID	DWR_RD1602_01_s_2020_93				
Comment Code					
A3 : No rodents visible, but rodent burrows visible; need to backfill and compact or grout burrows.					
Inspector Comment

View rodent burrows in landside slope. (Spring 2020)

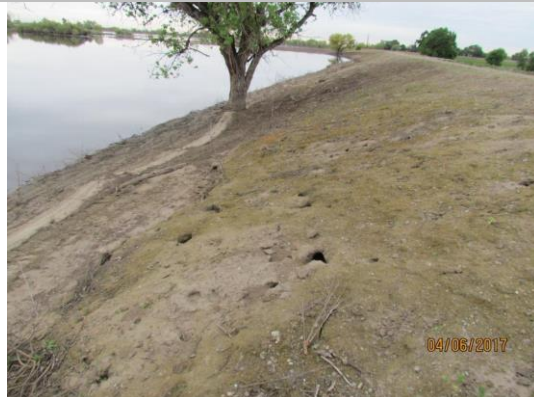
Photo 1 of 1 : FA_2020_RD1602_110_49_20200901_00019.jpg

View of rodent holes on the waterside slope of the levee. Spring 2017

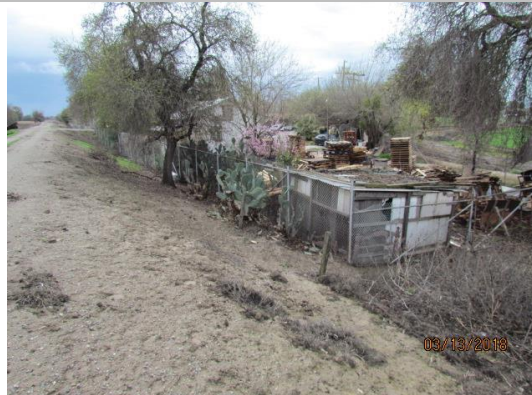
Photo 1 of 1 : FA_2020_RD1602_110_66_20200901_00032.jpg

LM Start	3.82	Rating **	M	Issue No.	66
LM End	3.92	Issue Type +	En	Location *	LS
Category	Earthen Levee			GPS Latitude/Longitude	
				Start	End
Item	Encroachments			37.454611 °	37.453309 °
				-121.043193 °	-121.042191 °
DWR ID	DWR_RD1602_01_f _ 2013_66				
Comment Code					
FE : Fence					
Inspector Comment					
Fence, animal pen and other encroachments at landward toe.

Looking southwest at animal pens and other encroachments on landward toe. (Spring 2018)

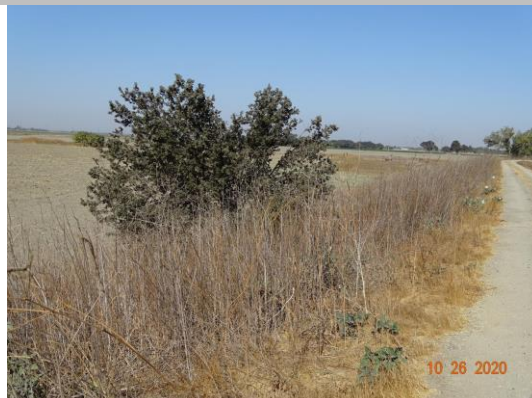
Photo 1 of 1 : FA_2020_RD1602_110_37_20201109_00120.jpg

LM Start	4.85	Rating **	M	Issue No.	37
LM End	5.07	Issue Type +	Ma	Location *	LS
Category	Earthen Levee			GPS Latitude/Longitude	
				Start	End
Item	Vegetation			37.441382 °	37.438399 °
				-121.036709 °	-121.037146 °
DWR ID	DWR_RD1602_01_f _ 2020_37				
Comment Code					
V1 : Control annual grass and weeds on the levee slopes and easements.					
Inspector Comment

View of the landside slope looking downstream. (Fall 2020)

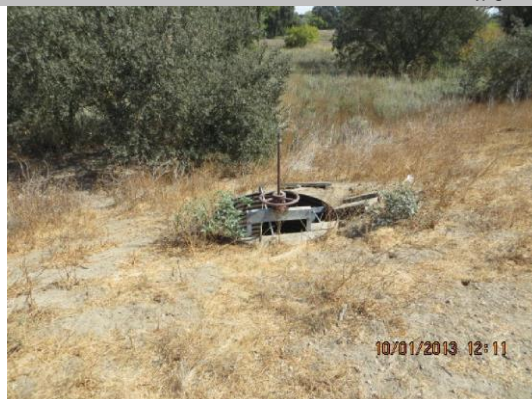
Photo 1 of 3 : UCIP_FA_2020_51336_36822.jpg

Slide gate in CMP riser on WS slope. Outlet visible under tree in background.

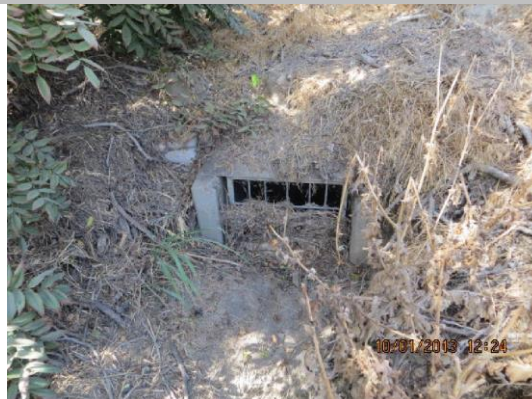
Photo 3 of 3 : UCIP_FA_2020_21672_36846.jpg

Concrete inlet on LS toe.

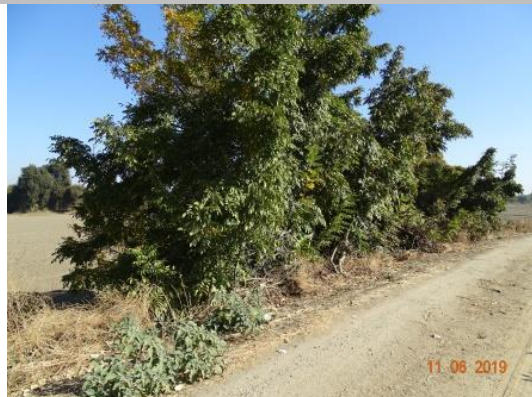
Photo 1 of 1 : FA_2020_RD1602_110_26_20200901_00006.jpg

LM Start	5.86	Rating **	M	Issue No.	26
LM End	5.86	Issue Type +	Ma	Location *	WS
Category	Earthen Levee			GPS Latitude/Longitude	
				Start	End
Item	Trim / Thin Trees			37.433142 °	37.433142 °
				-121.026702 °	-121.026702 °
DWR ID	DWR_RD1602_01_f_2018_26				
Comment Code					
T1 : Trim trees to at least five feet above ground level.					
Inspector Comment

View of trees growing on the waterside slope. (Fall 2019)

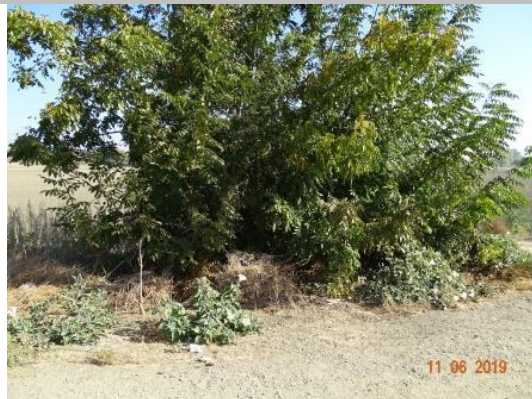
Photo 1 of 1 : FA_2020_RD1602_110_38_20200901_00012.jpg

LM Start	5.90	Rating **	M	Issue No.	38
LM End	5.90	Issue Type +	Ma	Location *	WS
Category	Earthen Levee			GPS Latitude/Longitude	
				Start	End
Item	Trim / Thin Trees			37.432756 °	37.432756 °
				-121.026147 °	-121.026147 °
DWR ID	DWR_RD1602_01_f _ 2019_38				
Comment Code					
T1 : Trim trees to at least five feet above ground level.					
Inspector Comment

View of a tree growing on the waterside slope. (Fall 2019)
