Flood Control Project Maintenance Levee Inspections

Fall 2021 Levee Maintenance Deficiency Summary Report

San Joaquin River Basin

Reclamation District No. 1602 Del Puerto

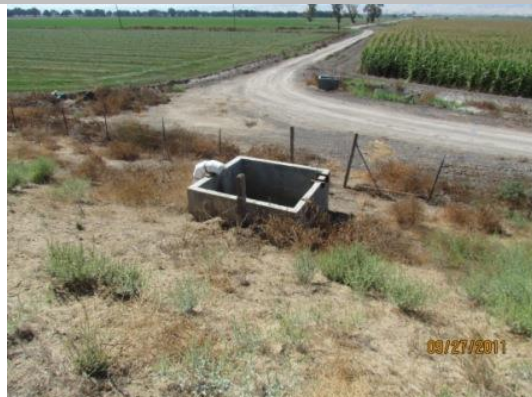
Photo 1 of 1 : FA_2021_RD1602_110_45_20210830_00014.jpg

LM Start	2.03	Rating **	M	Issue No.	45
LM End	2.03	Issue Type +	En	Location *	LS
Category	Earthen Levee			GPS Latitude/Longitude	
				Start	End
Item	Encroachments			37.471734 °	37.471734 °
				-121.057670 °	-121.057670 °
DWR ID	DWR_RD1602_01_s_2012_45				
Comment Code					
EQ : Equipment					
Inspector Comment					
A well is present at the toe of the landside slope.

A well is located at the landside toe of the levee. The picture was taken from the crown looking toward the landside of the levee.

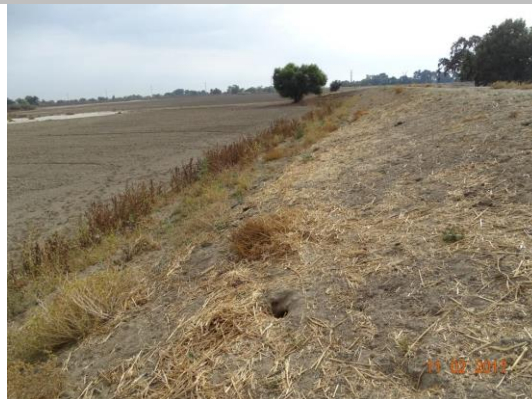
Photo 1 of 1 : FA_2021_RD1602_110_51_20210830_00017.jpg

LM Start	2.95	Rating **	A/W	Issue No.	51
LM End	2.95	Issue Type +	Ma	Location *	WS
Category	Earthen Levee			GPS Latitude/Longitude	
				Start	End
Item	Animal Control			37.465190 °	37.465190 °
				-121.044584 °	-121.044584 °
DWR ID	DWR_RD1602_01_f_2016_51				
Comment Code					
A3 : No rodents visible, but rodent burrows visible; need to backfill and compact or grout burrows.					
Inspector Comment

View of a rodent hole on the waterside of the levee.

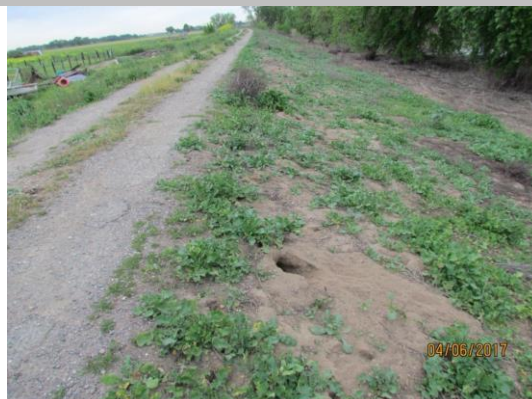
Photo 1 of 1 : FA_2021_RD1602_110_92_20210830_00038.jpg

LM Start	5.13	Rating **	M	Issue No.	92
LM End	5.13	Issue Type +	Ma	Location *	WS
Category	Earthen Levee			GPS Latitude/Longitude	
				Start	End
Item	Animal Control			37.437527 °	37.437527 °
				-121.036967 °	-121.036967 °
DWR ID	DWR_RD1602_01_s_2017_92				
Comment Code					
A3 : No rodents visible, but rodent burrows visible; need to backfill and compact or grout burrows.					
Inspector Comment

View of a rodent hole on the waterside shoulder of the levee looking downstream.
