## Flood Control Project Maintenance Levee Inspections

### Fall 2022 Levee Maintenance Deficiency Summary Report

#### ***San Joaquin River Basin***

**Reclamation District No. 1602 Del Puerto**

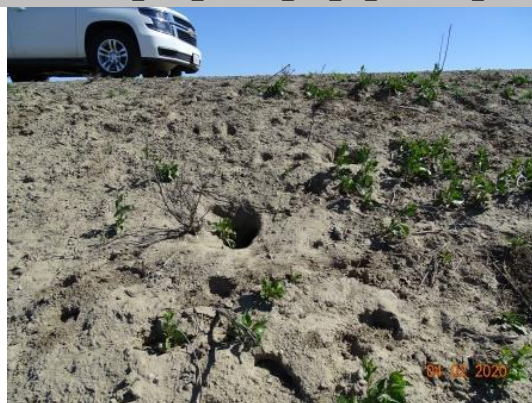
Photo 1 of 1 : FA\_2022\_RD1602\_110\_95\_20220822\_00041.jpg

LM Start	2.98	Rating **	M	Issue No.	95
LM End	2.98	Issue Type +	Ma	Location *	LS
Category	Earthen Levee			GPS Latitude/Longitude	
				Start	End
Item	Animal Control			37.464810 °	37.464810 °
				-121.044248 °	-121.044248 °
DWR ID	DWR_RD1602_01_f_2018_95				
Comment Code					
A3 : No rodents visible, but rodent burrows visible; need to backfill and compact or grout burrows.					
Inspector Comment

View of the landside slope from the toe of the levee. (Spring 2020)

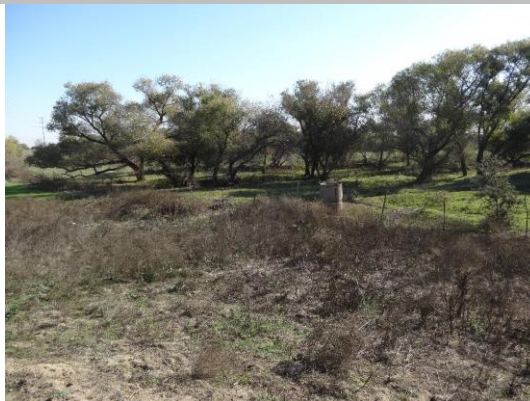
Photo 3 of 3 : UCIP\_FA\_2022\_74530\_76530.jpg

Comment Code					
Inspector Comment					
DS_ID:20204 FS_ID:74530 EP_NO: 8193 Repair Type: Urgent EVAL Issue: 1, Pipe Integrity Crossing Status: Found UCIP Comments: 04/05/2022 Record remains Urgent. Pipe inlet within CMP riser is deteriorated. CMP riser cover has broken and fallen into the riser; no cover on the riser causing a safety hazard. Crossing appears abandoned. Recommend owner to contact CVFPB to abandon or remove pipe from levee. (M.Thao - DWR UCIP) 10/19/2018 Pipe is deteriorated on the LS toe (pipe section missing at inlet). This crossing remains Urgent due to the wall deterioration at the inlet. If wall is rusted out at the inlet, need to determine the condition of the pipe section through the levee. According to the LMA representative, this crossing is no longer in use (crossing is abandoned). LMA is interested in abandoning crossing in place. LMA was referred to the CVFPB staff for direction regarding proper action under Title 23 for this crossing. (O. Magana - DWR UCIP) 11/18/2016 Same as previous inspection riser cover and handle on slide gate are still missing. Crossing remains Urgent due to the public safety issue of the 60-inch CMP cover still missing. According to Tony Martinez, LMA representative, the condition and future use of this crossing is being evaluated. Owner will need to coordinate with CVFPB for future use requirements or proper abandonment/removal. (O. Magana - DWR UCIP) 10/01/2013 Appears abandoned, and if so should be done so properly. No handle on slide gate, no cover on CMP standpipe on WS shoulder. (W. Wylie - DWR UCIP) FIELD_STRUCT_DESC: 16-inch steel irrigation pipe through levee, 11.5 feet below crown. Slide gate in 60-inch corrugated metal pipe riser is located on the waterside (WS) slope. Pipe discharges into concrete-lined ditch on the landside (LS) (irrigation pipe was authorized under Automatic Board Order (ABO) issued as Permit No. 8193, 1964 - Sabatte). [Additional Reference(s): DWR Levee Log, 1992. USACE San Joaquin River O&M Manual Unit 13, April 1964, (HLM 0.58), Drawing No. 7-4-1784]. FS Date: 4/5/2022

Concrete riser located in the floodway, photo 1 of 2.

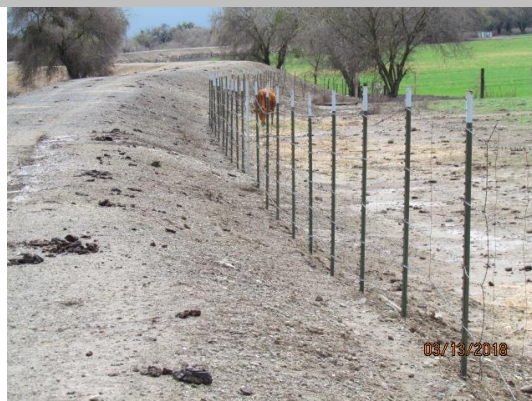
Photo 1 of 1 : FA\_2022\_RD1602\_110\_63\_20220822\_00025.jpg

LM Start	3.93	Rating **	M	Issue No.	63
LM End	4.04	Issue Type +	En	Location *	LS
Category	Earthen Levee			GPS Latitude/Longitude	
				Start	End
Item	Encroachments			37.453226 °	37.451866 °
				-121.042118 °	-121.041206 °
DWR ID	DWR_RD1602_01_s_2012_63				
Comment Code					
FE : Fence					
Inspector Comment					
Fence on landward slope.

Looking upstream at fence on landward slope. (Spring 2018)

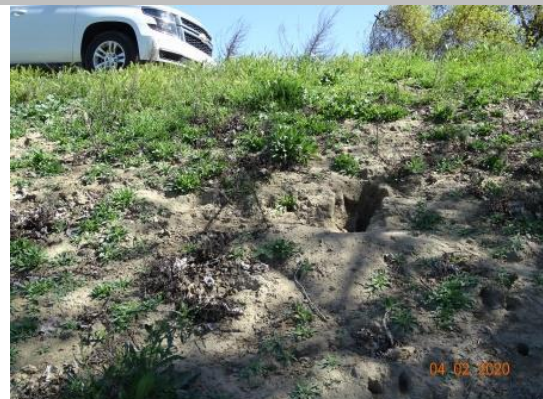
Photo 1 of 1 : FA\_2022\_RD1602\_110\_74\_20220822\_00032.jpg

LM Start	4.04	Rating **	U	Issue No.	74
LM End	4.32	Issue Type +	Ma	Location *	LS
Category	Earthen Levee			GPS Latitude/Longitude	
				Start	End
Item	Animal Control			37.451892 °	37.448492 °
				-121.041168 °	-121.038303 °
DWR ID	DWR_RD1602_01_s_2019_74				
Comment Code					
A1 : Exterminate rodents and backfill and compact or grout burrows.					
Inspector Comment

Looking at the landside slope from the levee toe. (Spring 2020)

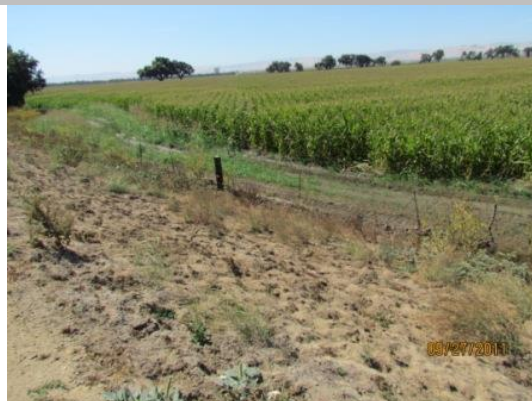
Photo 1 of 1 : FA\_2022\_RD1602\_110\_67\_20220822\_00027.jpg

LM Start	4.42	Rating **	M	Issue No.	67
LM End	4.88	Issue Type +	En	Location *	LS
Category	Earthen Levee			GPS Latitude/Longitude	
				Start	End
Item	Encroachments			37.447213 °	37.441014 °
				-121.037665 °	-121.036932 °
DWR ID	DWR_RD1602_01_s_2012_67				
Comment Code					
FE : Fence					
Inspector Comment

View of the fence on the landside toe of the levee. The picture was taken from the crown looking upstream.

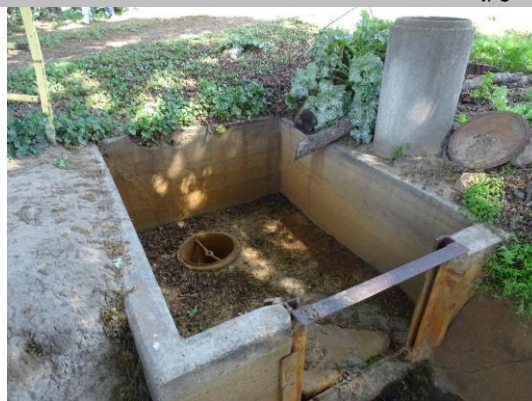
Photo 1 of 2 : UCIP\_FA\_2022\_74531\_111172.jpg

Comment Code						
Inspector Comment						
DS_ID:20207 FS_ID:74531 EP_NO: 8195 Repair Type: Urgent EVAL Issue: 1, Pipe Integrity Crossing Status: Found UCIP Comments: 04/05/2022 Record updated from Non-Urgent to Urgent. Pipe inlet and outlet within CMP riser is deteriorated. Broken wood pallet was used as a cover causing a safety hazard. No handle on slide gate in CMP riser on WS slope. Alfalfa valve was not capped in concrete distribution box on LS toe. (M.Thao - DWR UCIP) 11/18/2016 60-inch riser has a temporary cover therefore crossing has been downgraded from Urgent to Non-Urgent. (O. Magana - DWR UCIP) 10/01/2013 Lid missing from 60-inch CMP riser, may be an attractive nuisance or hazard to public. (W. Wylie - DWR UCIP) FIELD_STRUCT_DESC: 18-inch steel pipe through levee, 10 feet below crown. Slide gate in 60-inch corrugated metal pipe riser located on the waterside (WS) slope. Concrete discharge box is located on landside (LS) end. Pipe is buried across WS berm to pump located on the riverbank approximately 1,000 feet from the levee. (18-inch pipe authorized under Automatic Board Order (ABO) issued as Permit No. 8195, 1972 - Larry Buehner). [Additional Reference(s): DWR Levee Log, 1992. USACE San Joaquin River O&M Manual Unit 13, April 1964, (HLM 4.51), Drawing No. 7-4-1784]. FS Date: 4/5/2022

LS view: Pipe outlet on toe within concrete ditch.

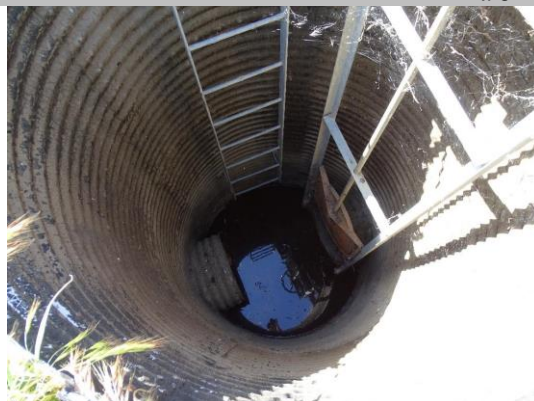
Photo 2 of 2 : UCIP\_FA\_2022\_74358\_111161.jpg

Comment Code						
Inspector Comment						
DS_ID:20208 FS_ID:74358 EP_NO: N/A Repair Type: Urgent EVAL Issue: 1, Pipe Integrity Crossing Status: Found UCIP Comments: 04/05/2022 Record remains Urgent. DMP internal video inspection has found pipe integrity issues. LOF of crossing is between 5 and 6. Crossing will be monitored until funding becomes available to address the issues. No cover present on CMP riser causing a safety hazard. Vegetation is growing and partially blocking the inlet on LS; recommend removing vegetation. No cover was present on CMP riser causing a safety hazard. Soil and debris, previously mentioned, have been cleared so flap gate and slide gate was operational. (M.Thao - DWR UCIP) 11/18/2016 Same as previous inspection soil and debris prevent flap gate from properly functioning and slide gate won't close due to sediment build up. Crossing has been downgraded from Urgent to Non-Urgent due to no pipe or levee integrity issues observed during the site visit. Need to contact owner to determine status of crossing. If crossing is no longer in use owner will need to coordinate with CVFPB to properly abandon or remove according to Title 23 requirements. (O. Magana - DWR UCIP)10/01/2013 Soil and debris prevent flapgate from proper function. Slide gate won't close completely due to sediment buildup. CMP riser needs cover. (W. Wylie - DWR UCIP) FIELD_STRUCT_DESC: 24-inch steel pipe through levee, 11.6 feet below crown. Concrete headwall on the landside (LS) end. Concrete "U" headwall and flap gate located on the waterside (WS) end. Slide gate in 60-inch corrugated metal pipe (CMP) riser is located on the WS slope. [Additional Reference(s): DWR Levee Log, 1992. USACE San Joaquin River O&M Manual Unit 13, April 1964, (HLM 5.23), Drawing No. 7-4-1784]. FS Date: 4/5/2022

WS view: Looking into CMP riser.

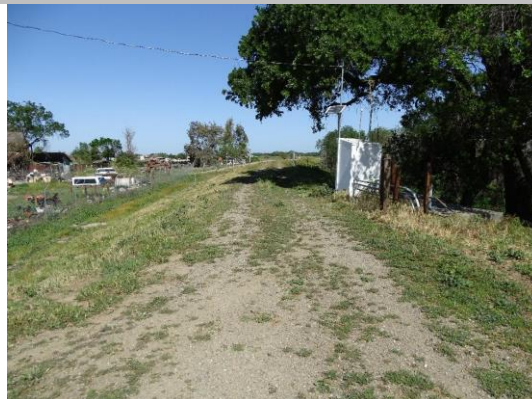
Photo 1 of 3 : UCIP\_FA\_2022\_75653\_111146.jpg

Comment Code						
Inspector Comment						
DS_ID:20209 FS_ID:75653 EP_NO: 8192 Repair Type: No Action Needed EVAL Issue: Crossing Status: Found UCIP Comments: 04/05/2022 Record remains No Action Needed. No issues observed during inspection. (M.Thao - DWR UCIP) FIELD_STRUCT_DESC: 1 of 2: 36-inch by 36-inch reinforced concrete box drainage culvert through the levee, 15.8 feet below the crown. Slide gate in a 6-foot by 7-foot concrete surge box on the waterside (WS) slope. 36-inch concrete pipes buried on both sides of the levee and connected to the reinforced concrete box culvert. Constructed through the levee section. (two 36-inch by 36-inch culvert [HLM 5.27] authorized under Automatic Board Order (ABO) issued as Permit No. 8192, 1972 - Stanislaus County). [Additional Reference(s): DWR Levee Log, 1992. USACE San Joaquin O&M Manual 13, April 1964, (HLM 5.27), Drawing No. 7-4-1784]. FS Date: 4/5/2022

Levee crown looking downstream.

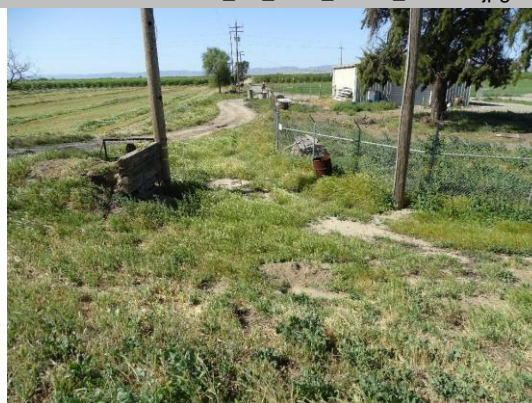
Photo 2 of 3 : UCIP\_FA\_2022\_75653\_111141.jpg

LS view: Looking from crown; general overview.

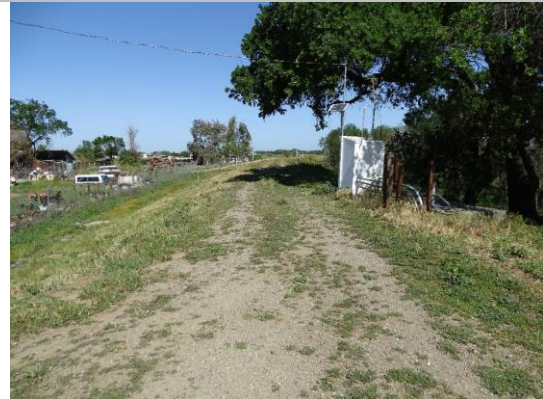
Photo 1 of 3 : UCIP\_FA\_2022\_75654\_111150.jpg

DS\_ID:20222  
 FS\_ID:75654  
 EP\_NO: 8192  
 Repair Type: No Action Needed  
 EVAL Issue:  
 Crossing Status: Found  
 UCIP Comments: 04/05/2022 Record remains No Action Needed. No issues observed during inspection. (M.Thao - DWR UCIP)  
 FIELD\_STRUCT\_DESC: 2 of 2: 36-inch by 36-inch reinforced concrete box drainage culvert through the levee, 15.8 feet below the crown. Slide gate in a 6-foot by 7-foot concrete surge box on the waterside (WS) slope. 36-inch concrete pipes buried on both sides of the levee and connected to the reinforced concrete box culvert. Constructed through the levee section. (two 36-inch by 36-inch culvert [HLM 5.27] authorized under Automatic Board Order (ABO) issued as Permit No. 8192, 1972 - Stanislaus County). [Additional Reference(s): DWR Levee Log, 1992. USACE San Joaquin O&M Manual 13, April 1964, (HLM 5.27), Drawing No. 7-4-1784].  
 FS Date: 4/5/2022

Levee crown looking downstream.

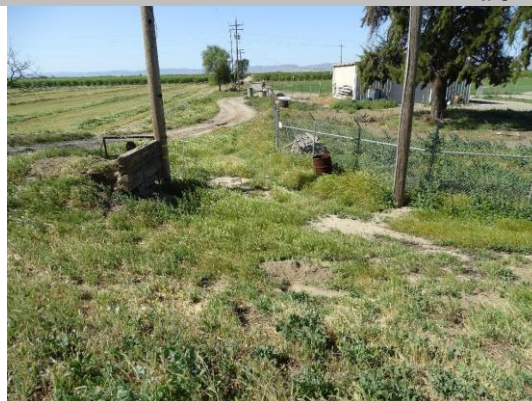
Photo 2 of 3 : UCIP\_FA\_2022\_75654\_111147.jpg

LS view: Looking from crown; general overview.

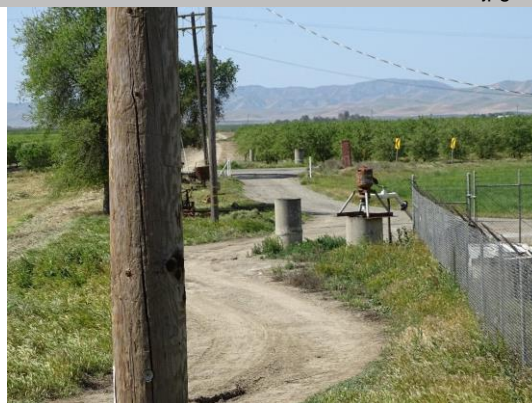
Photo 3 of 3 : UCIP\_FA\_2022\_75654\_111149.jpg

LS view: Likely risers for pipe off LS toe.

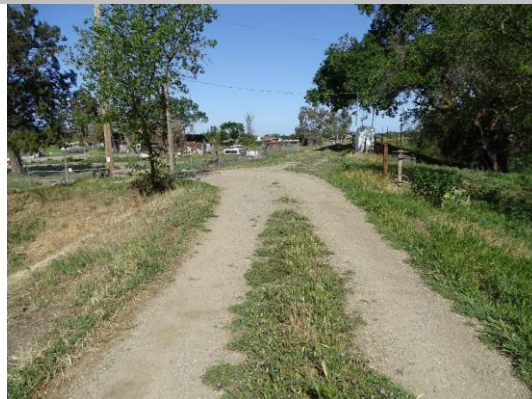
Photo 1 of 3 : UCIP\_FA\_2022\_74559\_111126.jpg

Comment Code						
Inspector Comment						
DS_ID:20210 FS_ID:74559 EP_NO: N/A Repair Type: No Action Needed EVAL Issue: Crossing Status: Found UCIP Comments: 04/05/2022 Record remains No Action Needed. DWR DMP internal video inspection has not found pipe integrity issues. LOF of crossing is less or equal to 4.0. Recommend next video inspection in 5 years. No issues observed during inspection. (M.Thao - DWR UCIP) FIELD_STRUCT_DESC: 30-inch by 30-inch reinforced concrete box drainage culvert through the levee, 12.9 feet below the crown. Slide gate in a concrete surge box on the waterside (WS) slope. Concrete discharge boxes on both ends. [Additional Reference(s): DWR Levee Log, 1992. USACE San Joaquin O&M Manual 13, April 1964, (HLM 5.28), Drawing No. 7-4-1784]. FS Date: 4/5/2022

Levee crown looking downstream.

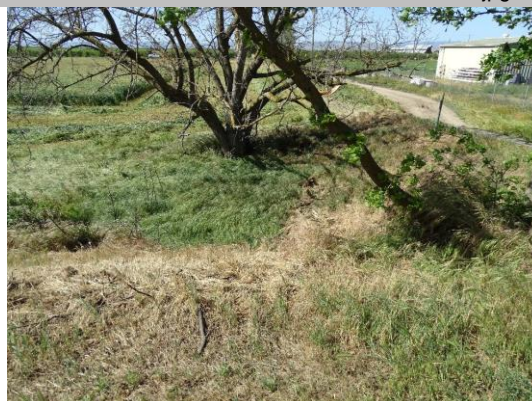
Photo 2 of 3 : UCIP\_FA\_2022\_74559\_111127.jpg

LS view: Looking from levee crown; general overview.

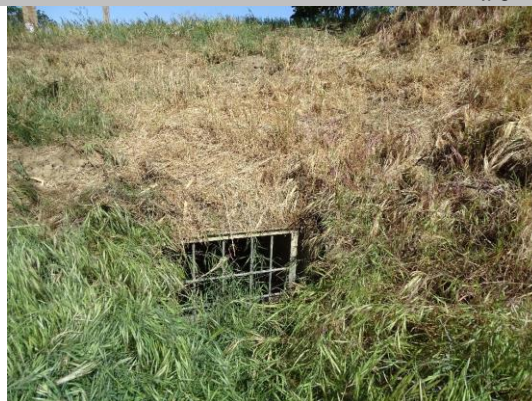
Photo 3 of 3 : UCIP\_FA\_2022\_74559\_111128.jpg

LS view: Concrete inlet on toe.

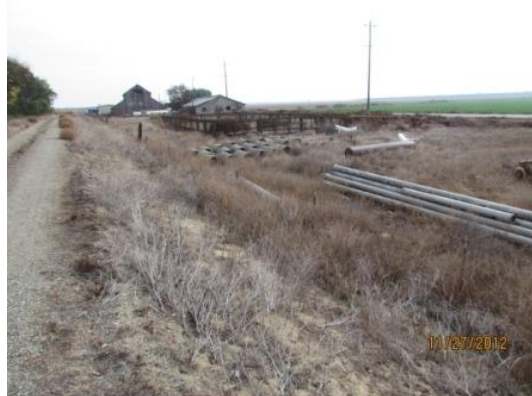
Photo 1 of 1 : FA\_2022\_RD1602\_110\_22\_20220822\_00003.jpg

LM Start	5.38	Rating **	M	Issue No.	22
LM End	5.44	Issue Type +	En	Location *	LS
Category	Earthen Levee			GPS Latitude/Longitude	
				Start	End
Item	Encroachments			37.434447 °	37.433791 °
				-121.034865 °	-121.034000 °
DWR ID	DWR_RD1602_01_f_2012_22				
Comment Code					
FE : Fence					
Inspector Comment

A fence was found on the landside toe of the levee looking upstream.

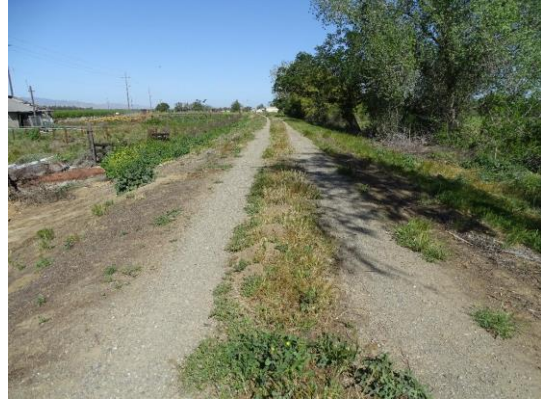
Photo 1 of 3 : UCIP\_FA\_2022\_75650\_111112.jpg

Comment Code					
Inspector Comment					
DS_ID:20211 FS_ID:75650 EP_NO: N/A Repair Type: Non-Urgent EVAL Issue: Crossing Status: Found UCIP Comments: 04/05/2022 Record remains Non-Urgent. Crossing appears abandoned. Recommend owner to contact CVFPB to abandon or remove pipe from levee. DWR DMP internal video inspection has not found pipe integrity issues. LOF of crossing is less or equal to 4.0. Recommend next video inspection in 5 years. (M.Thao - DWR UCIP) 10/01/2013 Pipe appears abandoned and if so should be done so properly. (W. Wylie - DWR UCIP) FIELD_STRUCT_DESC: *ABANDONED* 12-inch CMP drainage pipe through the levee, 6.9 feet below the crown. Flap gate on the waterside (WS) end. Could not locate, March 1984. (Reclamation District No. 1602). [Additional Reference(s): DWR Levee Log, 1992. USACE San Joaquin O&M Manual 13, April 1964, (HLM 5.50), Drawing No. 7-4-1784]. FS Date: 4/5/2022

Levee crown looking downstream.

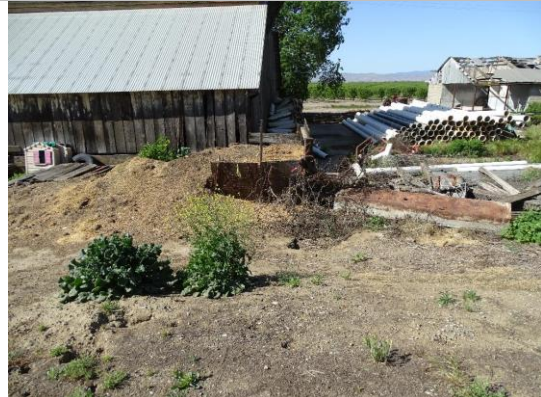
Photo 2 of 3 : UCIP\_FA\_2022\_75650\_111113.jpg

LS view: Looking from crown; general overview.

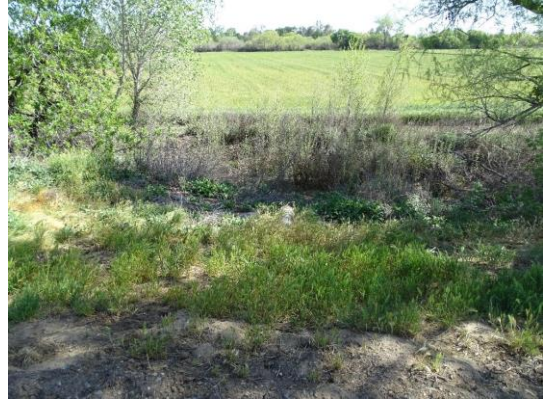
Photo 3 of 3 : UCIP\_FA\_2022\_75650\_111114.jpg

WS view: Looking from crown; 12-inch CMP outlet with flap gate on toe.

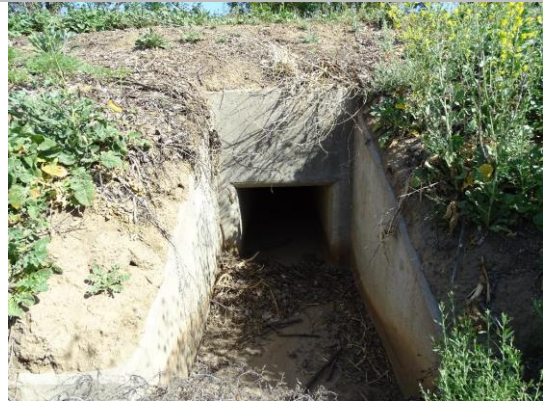
Photo 1 of 2 : UCIP\_FA\_2022\_74470\_111109.jpg

LS view: Close-up view of concrete headwall on toe.

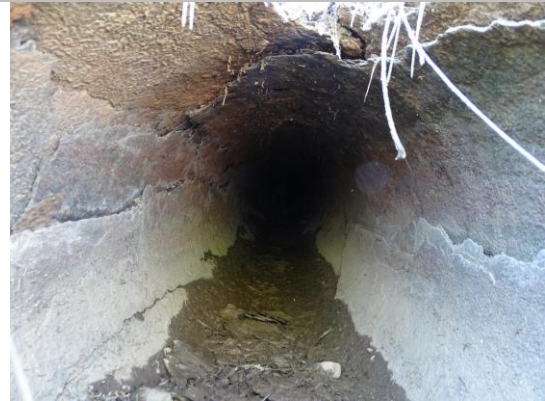
Photo 2 of 2 : UCIP\_FA\_2022\_74345\_111106.jpg

LS view: View of inside of pipe outlet.
