Flood Control Project Maintenance Levee Inspections

Fall 2023 Levee Maintenance Deficiency Summary Report

San Joaquin River Basin

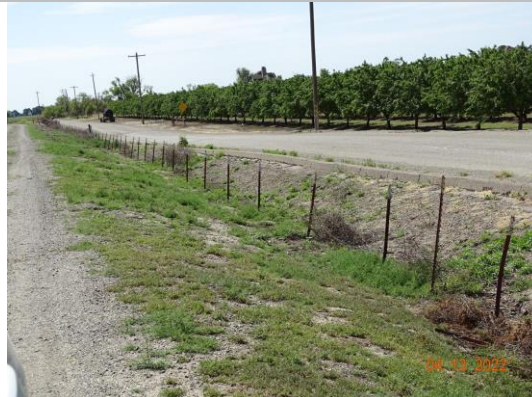
Photo 1 of 1 : FA_2023_RD1602_110_70_20230905_00031.jpg

| Barbed wire fence along the landward toe. | | | | | |

View of barbed wire fence at landward toe looking upstream. (Spring 2022)

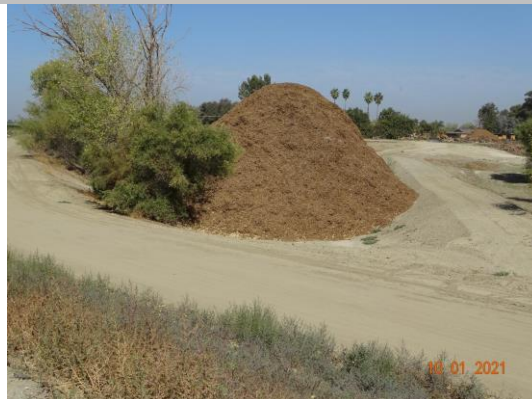
Photo 1 of 1 : FA_2023_RD1602_110_29_20230905_00008.jpg

| Material piled within the channel. Part of bmx course. | | | | | |

Haul road constructed by an adjacent landowner and material piled in the channel. (Fall 2021)

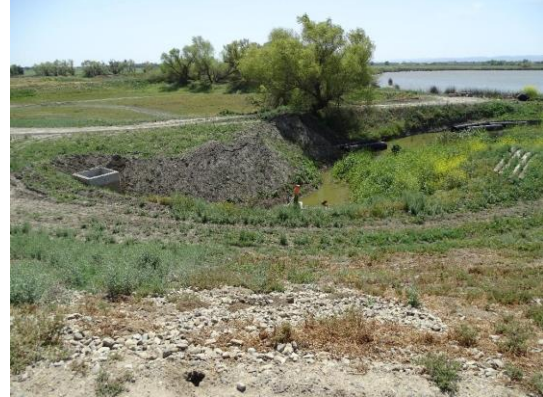
Photo 1 of 2 : UCIP_FA_2023_74536_111245.jpg

| DS_ID:20219 FS_ID:74536 EP_NO: N/A Repair Type: Non-Urgent EVAL Issue: 10, Unauthorized Modification or Non-Compliant Permit Crossing Status: Found UCIP Comments: 04/05/2022 Record remains Non-Urgent. Pump and platform on LS has been removed. The crossing has been capped and exposed on the LS toe. Unable to find a permit for modification. Crossing appears abandoned. Unable to locate a permit and confirm proper pipe abandonment. Recommend owner to contact CVFPB to abandon or remove pipe from levee. (M. Thao - DWR UCIP) 11/18/2016 Crossing has been downgraded from Urgent to Non-Urgent a flap gate has been added to the WS. According to Tony Martinez, LMA representative, this crossing is currently not in use. Owner will need to coordinate with CVFPB to obtain permit. (O. Magana - DWR UCIP) 10/01/2013 Appears abandoned siphon breakers covered in soil and flapgate missing. (W. Wylie - DWR UCIP) FIELD_STRUCT_DESC: 2 of 2: 16-inch steel drainage pipe through levee, 17 feet below crown. Pipe is capped on the landside (LS) end. Pumps on the pump platform are located on LS. Siphon breaker in 24-inch riser located on the waterside (WS) shoulder. Concrete "U" headwall and flap gate are located on the WS end. [Additional Reference(s): DWR Levee Log, 1992 (HLM 1.01). USACE San Joaquin River O&M Manual Unit 13, April 1964, (HLM 1.01), Station 266+68, listed as 16-inch pipe, Drawing No. 7-4-1784]. FS Date: 4/5/2022 | | | | | |

LS view: Looking from crown; general overview.

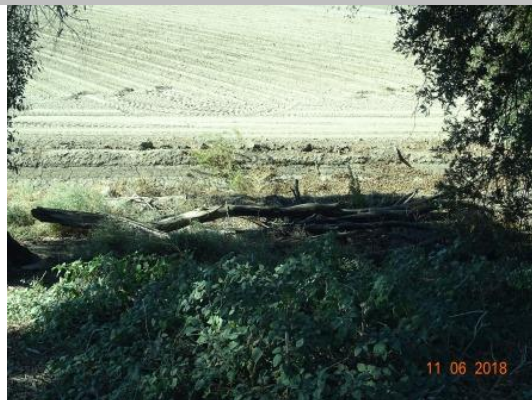
Photo 1 of 1 : FA_2023_RD1602_110_104_20230905_00042.jpg

| Tree limbs are on the landside toe. | | | | | |

View of tree limbs on the landside toe. (Fall 2018)

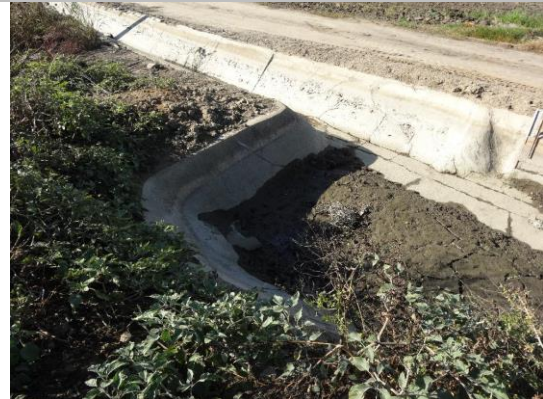
Photo 1 of 3 : UCIP_FA_2023_74530_76528.jpg

| DS_ID:20204 FS_ID:74530 EP_NO: 8193 Repair Type: Urgent EVAL Issue: 1, Pipe Integrity Crossing Status: Found UCIP Comments: 04/05/2022 Record remains Urgent. Pipe inlet within CMP riser is deteriorated. CMP riser cover has broken and fallen into the riser; no cover on the riser causing a safety hazard. Crossing appears abandoned. Recommend owner to contact CVFPB to abandon or remove pipe from levee. (M. Thao - DWR UCIP) 10/19/2018 Pipe is deteriorated on the LS toe (pipe section missing at inlet). This crossing remains Urgent due to the wall deterioration at the inlet. If wall is rusted out at the inlet, need to determine the condition of the pipe section through the levee. According to the LMA representative, this crossing is no longer in use (crossing is abandoned). LMA is interested in abandoning crossing in place. LMA was referred to the CVFPB staff for direction regarding proper action under Title 23 for this crossing. (O. Magana - DWR UCIP) 11/18/2016 Same as previous inspection riser cover and handle on slide gate are still missing. Crossing remains Urgent due to the public safety issue of the 60-inch CMP cover still missing. According to Tony Martinez, LMA representative, the condition and future use of this crossing is being evaluated. Owner will need to coordinate with CVFPB for future use requirements or proper abandonment/removal. (O. Magana - DWR UCIP) 10/01/2013 Appears abandoned, and if so should be done so properly. No handle on slide gate, no cover on CMP standpipe on WS shoulder. (W. Wylie - DWR UCIP) FIELD_STRUCT_DESC: 16-inch steel irrigation pipe through levee, 11.5 feet below crown. Slide gate in 60-inch corrugated metal pipe riser is located on the waterside (WS) slope. Pipe discharges into concrete-lined ditch on the landside (LS) (irrigation pipe was authorized under Automatic Board Order (ABO) issued as Permit No. 8193, 1964 - Sabatte). [Additional Reference(s): DWR Levee Log, 1992 (HLM 3.30). USACE San Joaquin River O&M Manual Unit 13, April 1964, (HLM 3.30), Station 146+62, listed as 16-inch pipe, Drawing No. 7-4-1784]. FS Date: 4/5/2022 | | | | | |

Concrete drain channel located on LS toe.

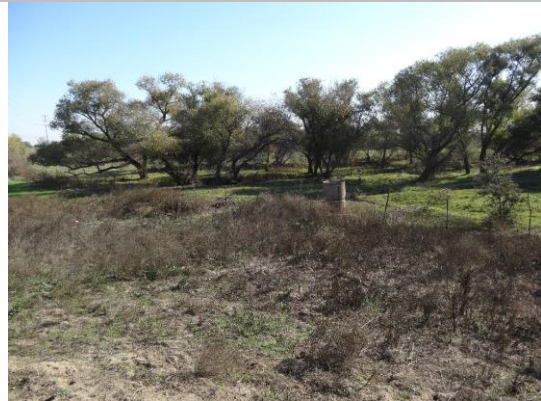
Photo 3 of 3 : UCIP_FA_2023_74530_76530.jpg

Concrete riser located in the floodway, photo 1 of 2.

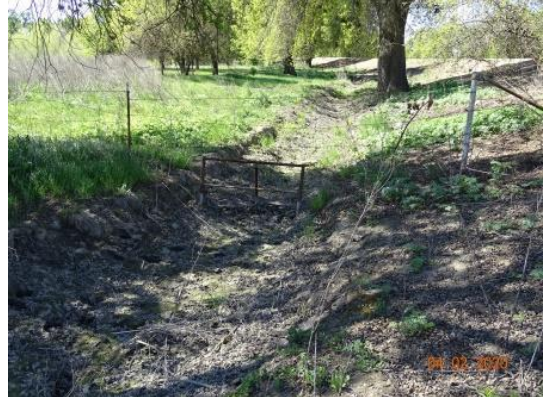
Photo 1 of 1 : FA_2023_RD1602_110_50_20230905_00018.jpg

| A ditch is located on the waterside toe of the levee. | | | | | |

Looking upstream along the waterside toe. (Spring 2020)

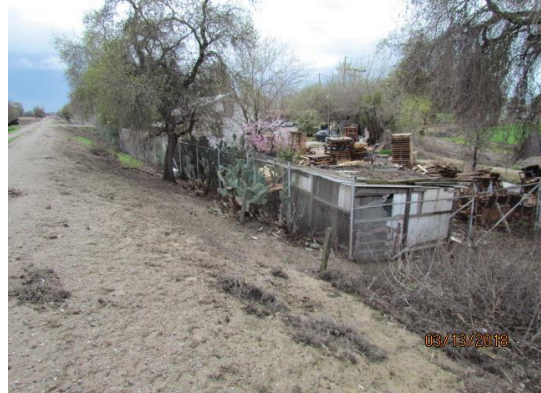
Photo 1 of 1 : FA_2023_RD1602_110_66_20230905_00028.jpg

| Fence, animal pen and other encroachments at landward toe. | | | | | |

Looking southwest at animal pens and other encroachments on landward toe. (Spring 2018)

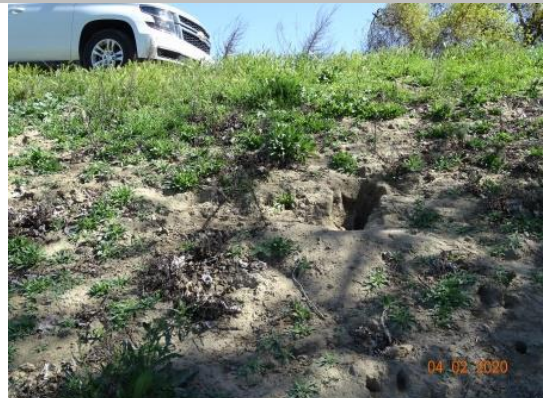
Photo 1 of 1 : FA_2023_RD1602_110_74_20230905_00033.jpg

Looking at the landside slope from the levee toe. (Spring 2020)

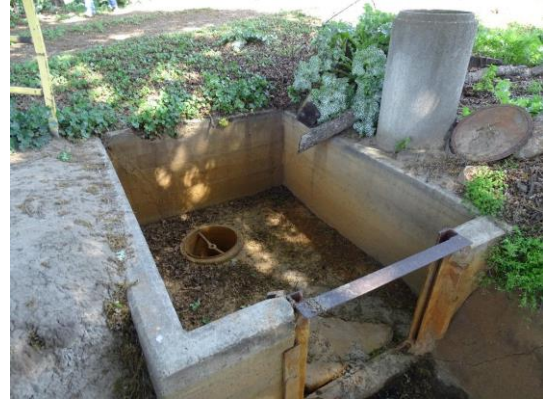
Photo 1 of 2 : UCIP_FA_2023_74531_111172.jpg

LS view: Pipe outlet on toe within concrete ditch.

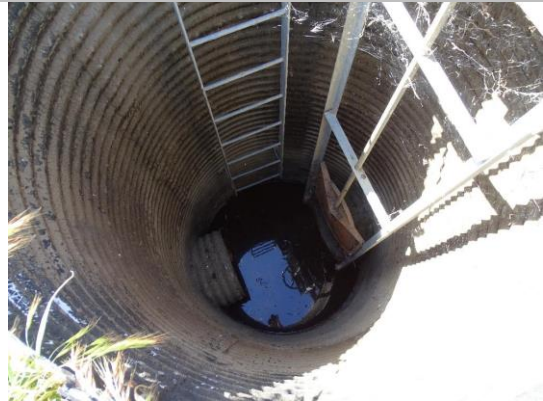
Photo 2 of 2 : UCIP_FA_2023_74358_111161.jpg

WS view: Looking into CMP riser.

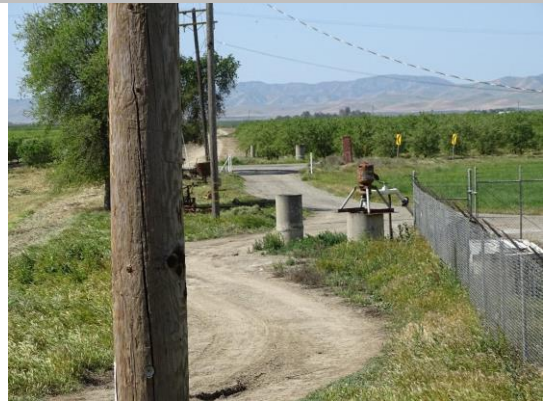
Photo 3 of 3 : UCIP_FA_2023_77639_111145.jpg

LS view: Likely risers for pipe off LS toe.

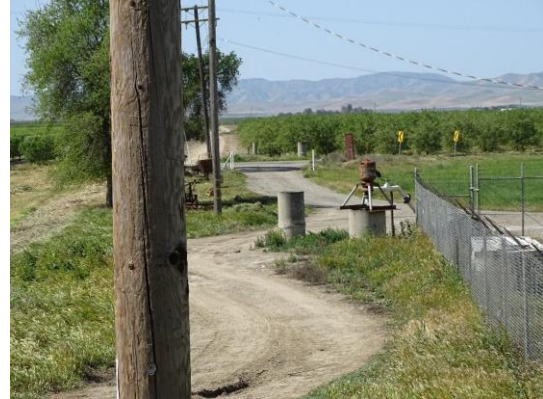
Photo 3 of 3 : UCIP_FA_2023_77640_111149.jpg

LS view: Likely risers for pipe off LS toe.

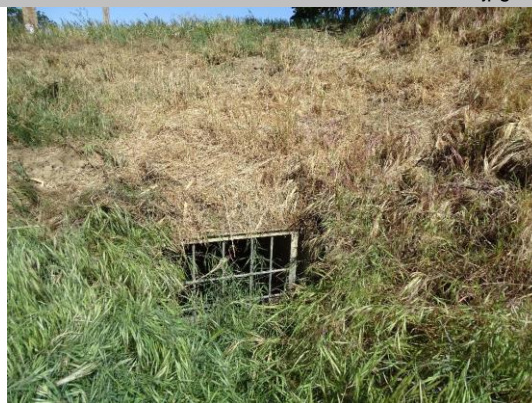
Photo 3 of 3 : UCIP_FA_2023_81195_111128.jpg

LS view: Concrete inlet on toe.

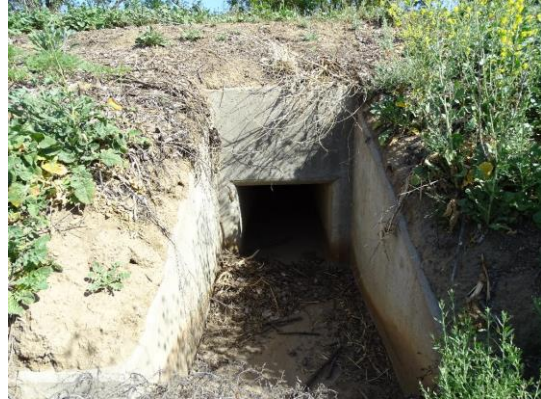
Photo 1 of 2 : UCIP_FA_2023_81197_111109.jpg

LS view: Close-up view of concrete headwall on toe.

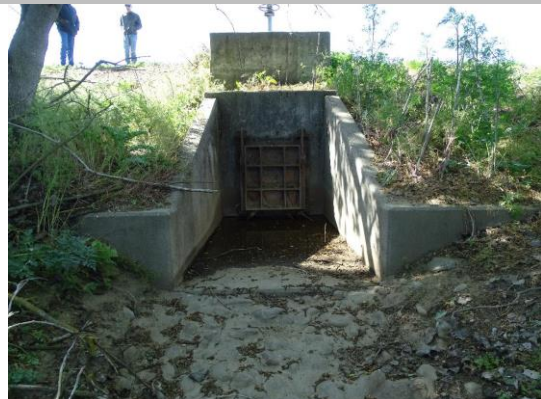
Photo 2 of 2 : UCIP_FA_2023_81197_111111.jpg

WS view: Concrete headwall and flap gate; surge box in the background.

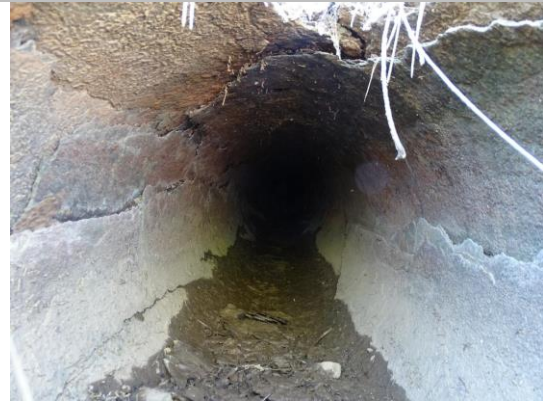
Photo 2 of 2 : UCIP_FA_2023_77638_111106.jpg

LS view: View of inside of pipe outlet.
