**Flood Control Project Maintenance
Levee Inspections
Fall 2024 Levee Maintenance Deficiency Summary Report**

San Joaquin River Basin

Reclamation District No. 1602 Del Puerto

Waterway			Bank	Unit Miles
Unit No. 01 San Joaquin River			Left	6.24
	Spring (March - May)	Summer (June - August)	(September - November) Fall	Winter (December - February)
Unit Maintenance Rating (Fall Only)			U	
Date of Inspection	3/27/2024 - 3/27/2024		10/15/2024 - 10/15/2024	
DWR Inspector	Nate Hicks		Nate Hicks	
Accompanied By	Nick Short RD1602

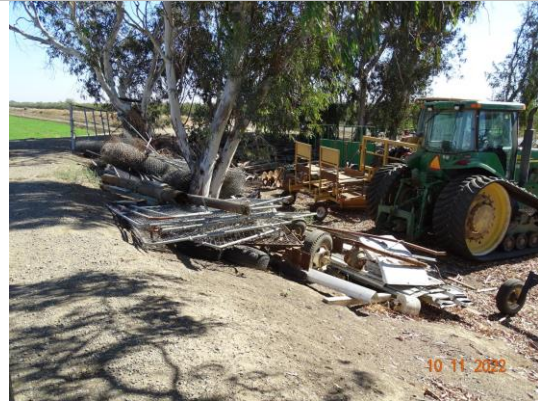
Photo 1 of 1 : FA_2024_RD1602_110_60_20241015_00018.jpg

LM Start	0.11	Rating **	M	Issue No.	60
LM End	0.11	Issue Type +	En	Location *	LS
Category	Earthen Levee			GPS Latitude/Longitude	
				Start	End
Item	Encroachments			37.477289°	37.477289°
				-121.082183°	-121.082183°
DWR ID	DWR_RD1602_01_f_2022_60				
Comment Code					
EQ : Equipment					
Inspector Comment					
Farming equipment should be moved off of the landside slope and toe.

Equipment should be moved off of the landside slope and toe. (Fall 2022)

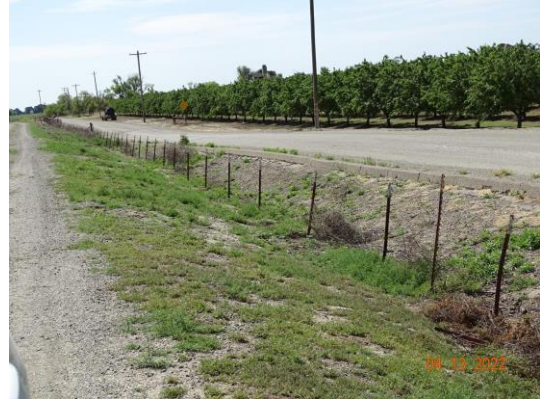
Photo 1 of 1 : FA_2024_RD1602_110_70_20241015_00023.jpg

LM Start	0.60	Rating **	M	Issue No.	70
LM End	0.71	Issue Type +	En	Location *	LS
Category	Earthen Levee			GPS Latitude/Longitude	
				Start	End
Item	Encroachments			37.479967°	37.478514°
				-121.074582°	-121.073435°
DWR ID	DWR_RD1602_01_s_2012_70				
Comment Code					
FE : Fence					
Inspector Comment					
Barbed wire fence along the landward toe.

View of barbed wire fence at landward toe looking upstream. (Spring 2022)

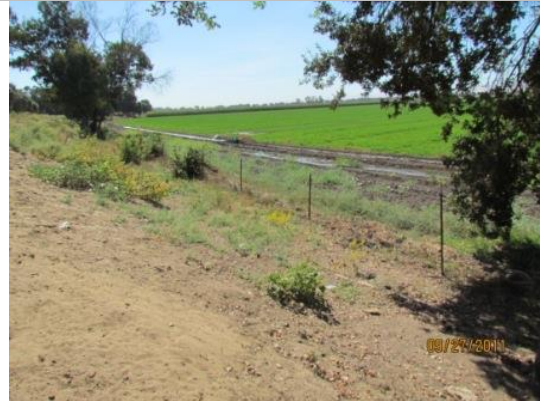
Photo 1 of 1 : FA_2024_RD1602_110_43_20241015_00011.jpg

LM Start	1.61	Rating **	M	Issue No.	43
LM End	2.22	Issue Type +	En	Location *	LS
Category	Earthen Levee			GPS Latitude/Longitude	
				Start	End
Item	Encroachments			37.477663 °	37.470125 °
				-121.058716 °	-121.055244 °
DWR ID	DWR_RD1602_01_s_2012_43				
Comment Code					
FE : Fence					
Inspector Comment					
Fence at the landside toe of the levee.

View of the fence on the landside toe of the levee. The picture was taken from crown looking upstream.

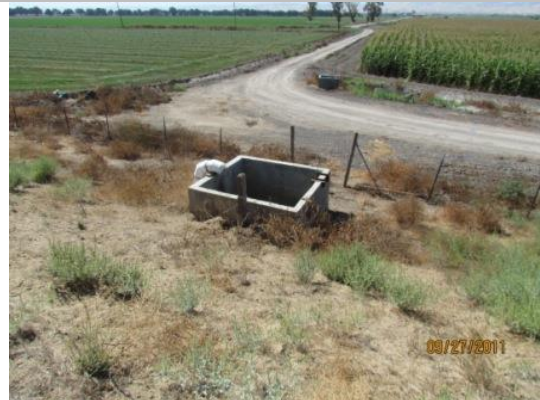
Photo 1 of 1 : FA_2024_RD1602_110_45_20241015_00013.jpg

LM Start	2.03	Rating **	M	Issue No.	45
LM End	2.03	Issue Type +	En	Location *	LS
Category	Earthen Levee			GPS Latitude/Longitude	
				Start	End
Item	Encroachments			37.471734 °	37.471734 °
				-121.057670 °	-121.057670 °
DWR ID	DWR_RD1602_01_s_2012_45				
Comment Code					
EQ : Equipment					
Inspector Comment					
A well is present at the toe of the landside slope.

A well is located at the landside toe of the levee. The picture was taken from the crown looking toward the landside of the levee.

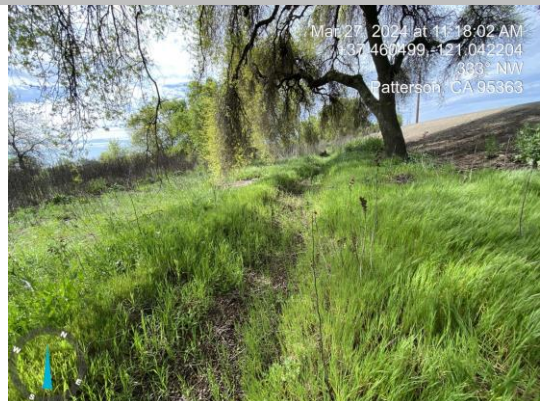
Photo 1 of 1 : FA_2024_RD1602_110_50_20241015_00015.jpg

LM Start	3.34	Rating **	M	Issue No.	50
LM End	3.53	Issue Type +	En	Location *	WS
Category	Earthen Levee			GPS Latitude/Longitude	
				Start	End
Item	Encroachments			37.460644 °	37.458373 °
				-121.042231 °	-121.044081 °
DWR ID	DWR_RD1602_01_s_2012_50				
Comment Code					
DT : Ditch					
Inspector Comment					
A ditch is located on the waterside toe of the levee.

Looking upstream along the waterside toe (Spring 2024).

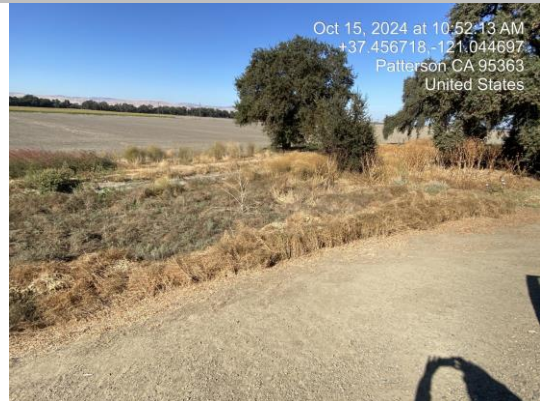
Photo 1 of 1 : FA_2024_RD1602_110_42_20241021_00081.jpg

LM Start	3.65	Rating **	M	Issue No.	42
LM End	3.65	Issue Type +	Ma	Location *	LS
Category	Earthen Levee			GPS Latitude/Longitude	
				Start	End
Item	Vegetation			37.456621 °	37.456621 °
				-121.044676 °	-121.044676 °
DWR ID	DWR_RD1602_01_f_2024_42				
Comment Code					
V1 : Control annual grass and weeds on the levee slopes and easements.					
Inspector Comment					
Remove vegetation off the landside toe.

View of vegetation on the landside hinge and easement (Fall 2024).

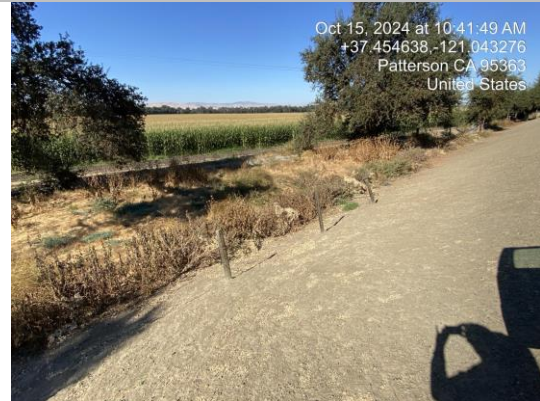
Photo 1 of 1 : FA_2024_RD1602_110_40_20241021_00080.jpg

LM Start	3.79	Rating **	M	Issue No.	40
LM End	3.82	Issue Type +	Ma	Location *	LS
Category	Earthen Levee			GPS Latitude/Longitude	
				Start	End
Item	Vegetation			37.455024 °	37.454644 °
				-121.043489 °	-121.043192 °
DWR ID	DWR_RD1602_01_f_2024_40				
Comment Code					
V1 : Control annual grass and weeds on the levee slopes and easements.					
Inspector Comment					
Remove vegetation off the landside toe.

View of vegetation on the landside hinge and easement (Fall 2024).

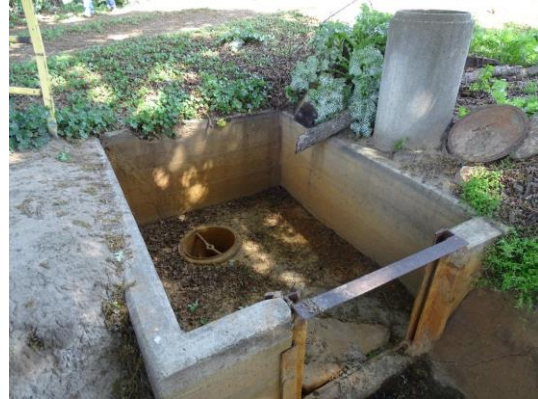
Photo 1 of 2 : UCIP_FA_2024_74531_111172.jpg

LM Start	4.47	Rating **	U	Issue No.	120 (cont)
LM End	4.47	Issue Type +	En	Location *

LS view: Pipe outlet on toe within concrete ditch.

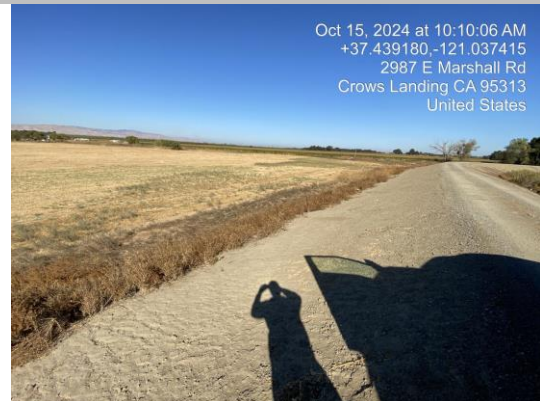
Photo 1 of 1 : FA_2024_RD1602_110_37_20241021_00077.jpg

LM Start	4.88	Rating **	M	Issue No.	37
LM End	5.07	Issue Type +	Ma	Location *	LS
Category	Earthen Levee			GPS Latitude/Longitude	
				Start	End
Item	Vegetation			37.440993 °	37.438315 °
				-121.036955 °	-121.037106 °
DWR ID	DWR_RD1602_01_f_2024_37				
Comment Code					
V1 : Control annual grass and weeds on the levee slopes and easements.					
Inspector Comment					
Remove vegetation off the landside slope and easement.

View of vegetation on the landside hinge and easement (Fall 2024).

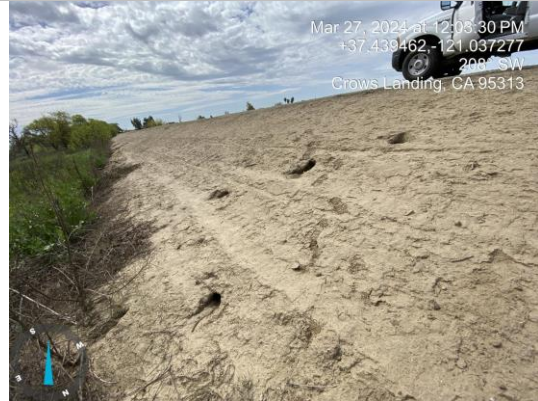
Photo 1 of 1 : FA_2024_RD1602_110_95_20241015_00030.jpg

LM Start	5.00	Rating **	A/W	Issue No.	95
LM End	5.00	Issue Type +	Ma	Location *	WS
Category	Earthen Levee			GPS Latitude/Longitude	
				Start	End
Item	Animal Control			37.439326 °	37.439326 °
				-121.037455 °	-121.037455 °
DWR ID	DWR_RD1602_01_s_2024_95				
Comment Code					
A3 : No rodents visible, but rodent burrows visible; need to backfill and compact or grout burrows.					
Inspector Comment					
Animal burrow appears to be back filled but monitor for future activity.

View of rodent holes along the waterside slope (Spring 2024).

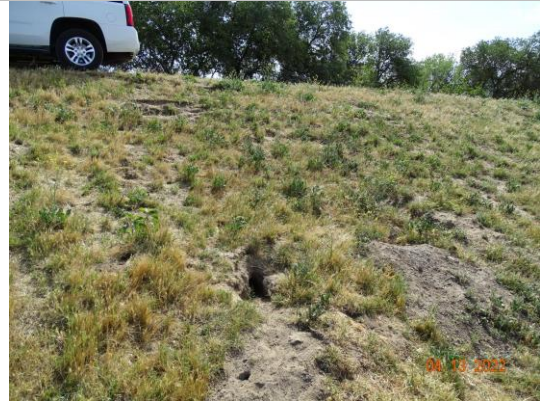
Photo 1 of 1 : FA_2024_RD1602_110_25_20241015_00003.jpg

LM Start	5.07	Rating **	A/W	Issue No.	25
LM End	5.11	Issue Type +	Ma	Location *	LS
Category	Earthen Levee			GPS Latitude/Longitude	
				Start	End
Item	Animal Control			37.438335 °	37.437817 °
				-121.037133 °	-121.037029 °
DWR ID	DWR_RD1602_01_s _ 2022_25				
Comment Code					
A3 : No rodents visible, but rodent burrows visible; need to backfill and compact or grout burrows.					
Inspector Comment					
Animal burrow appears to be back filled but monitor for future activity.

View of rodent burrows in the landside slope. (Spring 2022)

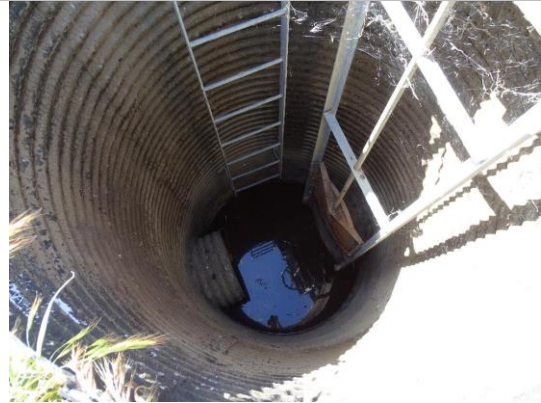
Photo 2 of 2 : UCIP_FA_2024_74358_111161.jpg

LM Start	5.19	Rating **	U	Issue No.	121 (cont)
LM End	5.19	Issue Type +	Ma	Location *	
Category	Supplemental			GPS Latitude/Longitude	
				Start	End
Item	DWR UCIP LMA Responsibility			37.436748 °	37.436748 °
				-121.036597 °	-121.036597 °
DWR ID	20208

WS view: Looking into CMP riser.

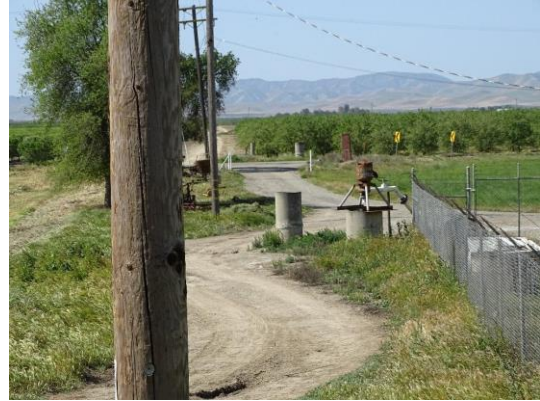
Photo 3 of 3 : UCIP_FA_2024_77639_111145.jpg

LM Start	5.23	Rating **	A	Issue No.	122 (cont)
LM End	5.23	Issue Type +	Ma	Location *	
Category	Supplemental			GPS Latitude/Longitude	
				Start	End
Item	DWR UCIP LMA Responsibility			37.436246°	37.436246°
				-121.036193°	-121.036193°
DWR ID	20209

LS view: Likely risers for pipe off LS toe.

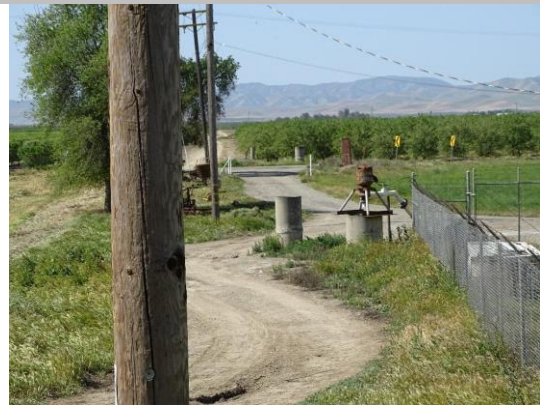
Photo 3 of 3 : UCIP_FA_2024_77640_111149.jpg

DS_ID:20222
FS_ID:77640
EP_NO: 8192
Repair Type: No Action Needed
EVAL Issue:
Crossing Status: Found
UCIP Comments: 04/05/2022 Record remains No Action Needed. No issues observed during inspection. (M. Thao - DWR UCIP)
FIELD_STRUCT_DESC: 2 of 2: 36-inch by 36-inch reinforced concrete box drainage culvert through the levee, 15.8 feet below the crown. Slide gate in a 6-foot by 7-foot concrete surge box on the waterside (WS) slope. 36-inch concrete pipes buried on both sides of the levee and connected to the reinforced concrete box culvert. Constructed through the levee section. (two 36-inch by 36-inch culvert [HLM 5.27] authorized under Automatic Board Order (ABO) issued as Permit No. 8192, 1972 - Stanislaus County). [Additional Reference(s): DWR Levee Log, 1992 (HLM 5.27). USACE San Joaquin O&M Manual 13, April 1964, (HLM 5.27), Station 39+05, Drawing No. 7-4-1784].
FS Date: 4/5/2022

LS view: Likely risers for pipe off LS toe.

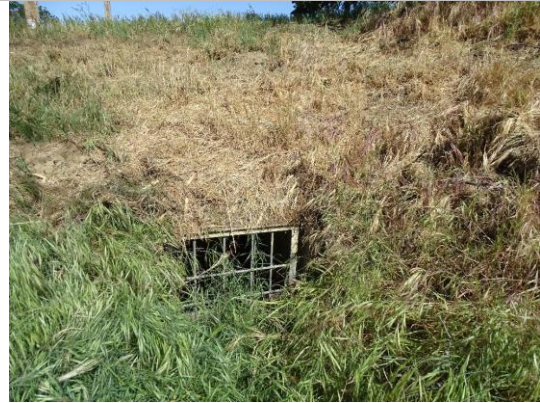
Photo 3 of 3 : UCIP_FA_2024_81195_111128.jpg

LM Start	5.24	Rating **	A	Issue No.	124 (cont)
LM End	5.24	Issue Type +	Ma	Location *	
Category	Supplemental			GPS Latitude/Longitude	
				Start	End
Item	DWR UCIP LMA Responsibility			37.436129°	37.436129°
				-121.036065°	-121.036065°
DWR ID	20210

LS view: Concrete inlet on toe.

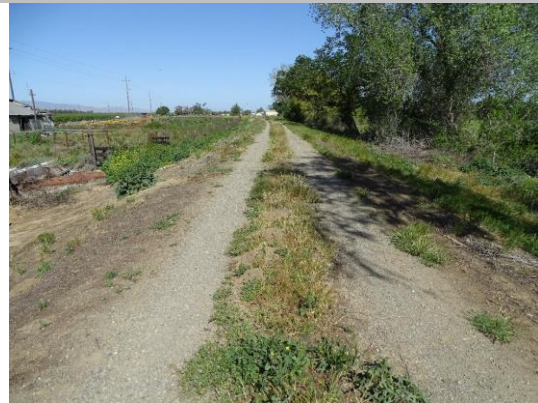
Photo 1 of 3 : UCIP_FA_2024_75650_111112.jpg

LM Start	5.46	Rating **	M	Issue No.	125
LM End	5.46	Issue Type +	Ma	Location *	
Category	Supplemental			GPS Latitude/Longitude	
				Start	End
Item	DWR UCIP LMA Responsibility			37.433646 °	37.433646 °
				-121.033846 °	-121.033846 °
DWR ID	20211

Comment Code					
Inspector Comment					
DS_ID:20211 FS_ID:75650 EP_NO: N/A Repair Type: Non-Urgent EVAL Issue: Crossing Status: Found UCIP Comments: 04/05/2022 Record remains Non-Urgent. Crossing appears abandoned. Recommend owner to contact CVFPB to abandon or remove pipe from levee. DWR DMP internal video inspection has not found pipe integrity issues. LOF of crossing is less or equal to 4.0. Recommend next video inspection in 5 years. (M. Thao - DWR UCIP) 10/01/2013 Pipe appears abandoned and if so should be done so properly. (W. Wylie - DWR UCIP) FIELD_STRUCT_DESC: 12-inch CMP drainage pipe through the levee, 6.9 feet below the crown. Flap gate on the waterside (WS) end. [Additional Reference(s): DWR Levee Log, 1992 (HLM 5.50). USACE San Joaquin O&M Manual 13, April 1964, (HLM 5.50), listed as 12-inch pipe, Drawing No. 7-4-1784]. FS Date: 4/5/2022

Levee crown looking downstream.

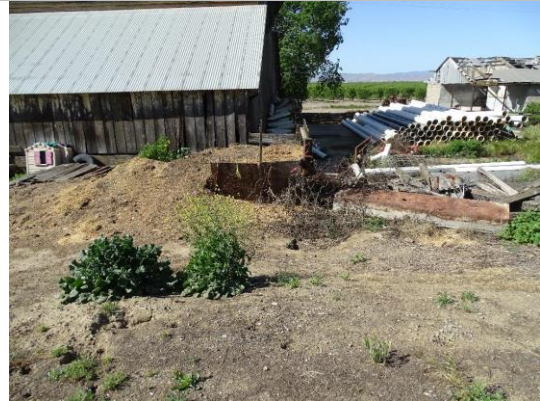
Photo 2 of 3 : UCIP_FA_2024_75650_111113.jpg

LS view: Looking from crown; general overview.

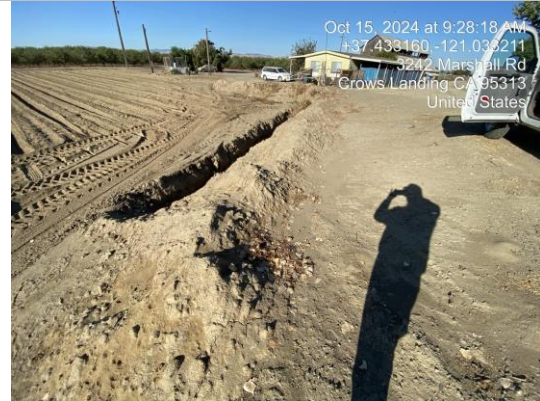
Photo 1 of 1 : FA_2024_RD1602_110_32_20241021_00073.jpg

LM Start	5.50	Rating **	M	Issue No.	32
LM End	5.50	Issue Type +	En	Location *	LS
Category	Earthen Levee			GPS Latitude/Longitude	
				Start	End
Item	Encroachments			37.433200°	37.433200°
				-121.033141°	-121.033141°
DWR ID	DWR_RD1602_01_f_2024_32				
Comment Code					
DT : Ditch					
Inspector Comment

View of ditch on the landside toe (Fall 2024).

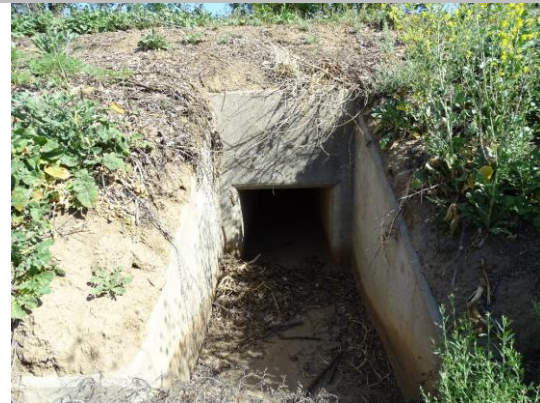
Photo 1 of 2 : UCIP_FA_2024_81197_111109.jpg

LM Start	5.72	Rating **	M	Issue No.	126
LM End	5.72	Issue Type +	Ma	Location *	
Category	Supplemental			GPS Latitude/Longitude	
				Start	End
Item	DWR UCIP LMA Responsibility			37.433003°	37.433003°
				-121.029346°	-121.029346°
DWR ID	20212

Comment Code					
Inspector Comment					
DS_ID:20212 FS_ID:81197 EP_NO: N/A Repair Type: Non-Urgent EVAL Issue: 5, Pipe Damage Crossing Status: Found UCIP Comments: 04/05/2022 Record remains Non-Urgent. DMP internal video inspection has found pipe integrity issues. LOF of crossing is greater than or equal to 4.1 and less than 5. Crossing will be monitored until funding becomes available for rehabilitation. (M. Thao - DWR UCIP) 11/18/2016 Crossing has been downgraded from Urgent to Non-Urgent flap gate is functional. Recommend clearing dense vegetation from WS and LS slopes. (O. Magana - DWR UCIP) 01/01/2013 Flapgate has minor blockage preventing gate from fully closing. (W. Wylie - DWR UCIP) FIELD_STRUCT_DESC: 30-inch square reinforced concrete drainage box culvert through levee, 9 feet below crown. Slide gate in concrete riser located on the waterside (WS) slope. Concrete "U" headwalls are located on both the waterside (WS) and landside (LS) ends. Flap gate is located on the WS end. [Additional Reference(s): DWR Levee Log, 1992 (HLM 5.76). USACE San Joaquin River O&M Manual Unit 13, April 1964, (HLM 5.28), Drawing No. 7-4-1784]. FS Date: 4/5/2022

LS view: Close-up view of concrete headwall on toe.

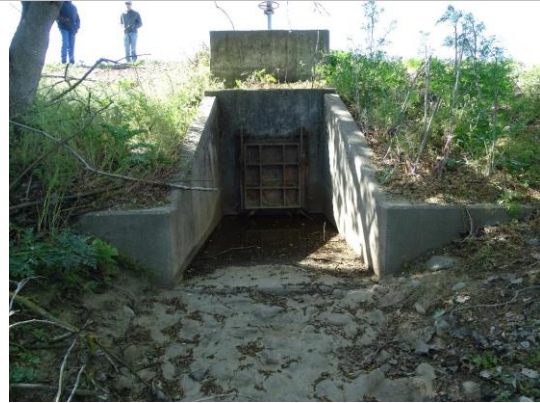
Photo 2 of 2 : UCIP_FA_2024_81197_111111.jpg

WS view: Concrete headwall and flap gate; surge box in the background.

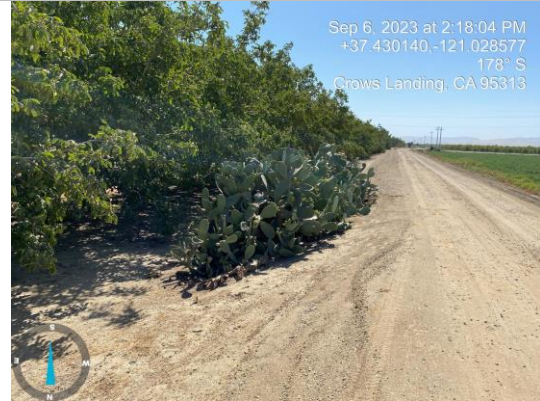
Photo 1 of 1 : FA_2024_RD1602_110_86_20241015_00029.jpg

LM Start	6.13	Rating **	U	Issue No.	86
LM End	6.13	Issue Type +	En	Location *	WS
Category	Earthen Levee			GPS Latitude/Longitude	
				Start	End
Item	Vegetation			37.430181°	37.430181°
				-121.028679°	-121.028679°
DWR ID	DWR_RD1602_01_s_2020_86				
Comment Code					
V6 : Landscaping					
Inspector Comment					
Cactus blocking view of waterward slope.

Looking at dense cactus growth on the waterside slope (Fall 2023).

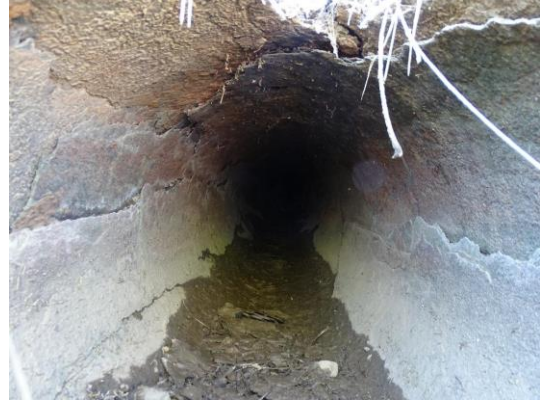
Photo 2 of 2 : UCIP_FA_2024_77638_111106.jpg

Comment Code					
Inspector Comment					
DS_ID:20214 FS_ID:77638 EP_NO: 8194 Repair Type: Urgent EVAL Issue: 1, Pipe Integrity Crossing Status: Found UCIP Comments: 04/05/2022 Record remains Urgent. DMP internal video inspection has found pipe integrity issues. LOF of crossing is between 5 and 6. Crossing will be monitored until funding becomes available to address the issues. (M. Thao - DWR UCIP) 10/01/2013 Pipe heavily deteriorated on LS toe. May indicate condition of rest of pipe is bad. Good candidate for video inspection. (W. Wylie - DWR UCIP) FIELD_STRUCT_DESC: 18-inch reinforced concrete irrigation pipe through the levee, 3 feet below the crown. Slide gate in a 36-inch concrete standpipe on the waterside (WS) shoulder. (18-inch concrete pipe was authorized under Automatic Board Order (ABO) issued as Permit No. 8194, 1972 - Ernest F. Nunes). [Additional Reference(s): DWR Levee Log, 1992 (HLM 6.28). USACE San Joaquin O&M Manual 13, April 1964, (HLM 6.28), Station 0+50A, listed as 18-inch pipe, Drawing No. 7-4-1784]. FS Date: 4/5/2022

LM Start	6.24	Rating **	U	Issue No.	127 (cont)
LM End	6.24	Issue Type +	En	Location *	
Category	Supplemental			GPS Latitude/Longitude	
				Start	End
Item	DWR UCIP Field Study			37.429032 °	37.429032 °
				-121.029867 °	-121.029867 °
DWR ID	20214

LS view: View of inside of pipe outlet.
