**Flood Control Project Maintenance
Levee Inspections**
LMA District Cover Sheet
Spring 2011 Levee Inspection Results

Reclamation District No. 1602 Del Puerto

Levee Inspection Report By Mile - Spring 2011

| Waterway | Bank | Unit Miles | Inspection Start/End | Inspector |
|---|---|---|---|---|
| Unit No. 01 San Joaquin River | Left | 6.29 | 05/24/2011 05/24/2011 | Pavel Kazi |

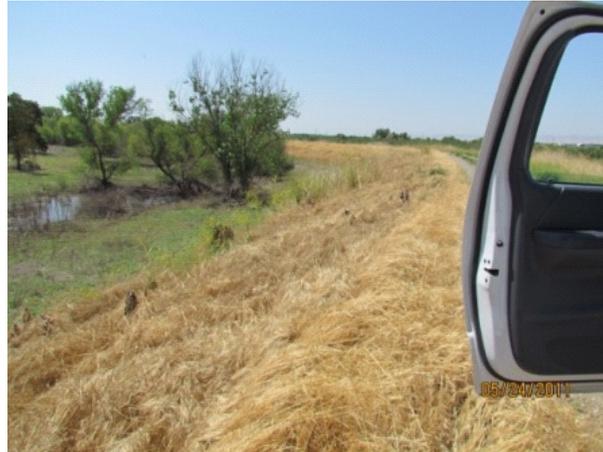
| <p>pkazi_s_20110527_634.jpg</p> | |

| <p>Vegetation obstructing the view of the waterside slope of the levee. The picture was taken from the crown looking upstream.</p> | |

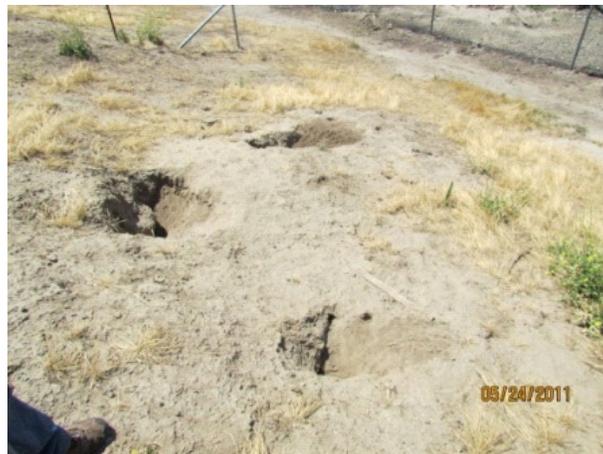
| <p>pkazi_s_20110527_635.jpg</p> | |

| <p>Rodent holes possibly made worsen by dog digging through it. It is located on the landside of the levee. The picture was taken from the crown looking upstream.</p> | |

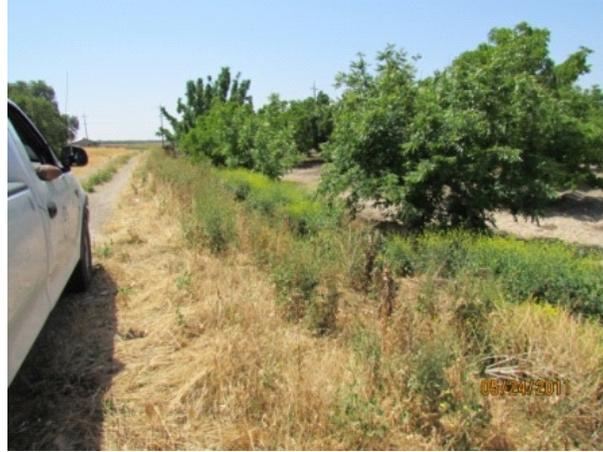
| <p>pkazi_s_20110527_636.jpg</p> | |

| <p>Vegetation was obstructing the view of the landside of the levee. The picture was taken from the crown looking upstream.</p> | |
