**Flood Control Project Maintenance
Levee Inspections****LMA District Cover Sheet****Spring 2012 Levee Inspection Results****Reclamation District No. 1602 Del Puerto**

Spring 2012 Levee Inspection Results

Reclamation District No. 1602 Del Puerto

Levee Inspection Report By Mile - Spring 2012

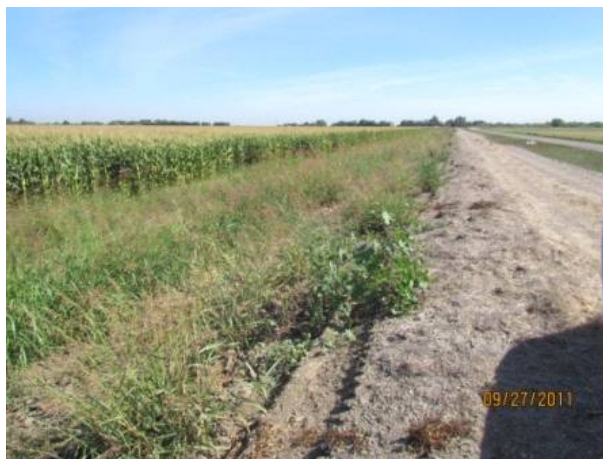
pkazi_s_20120305_670.jpg

View of the vegetation on the waterside of the levee. The picture was taken from the crown looking upstream.

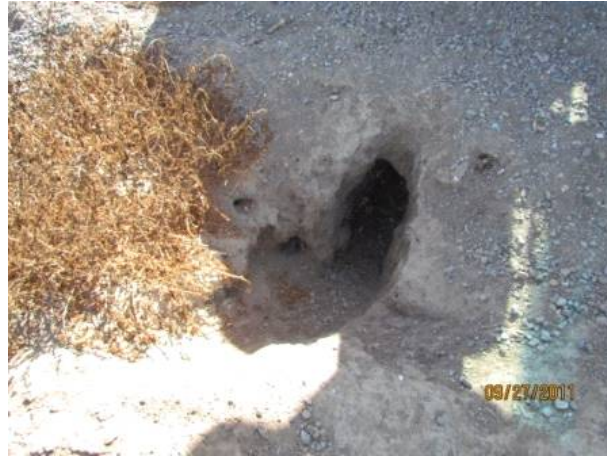
Levee Mile Report Line	9
Start Levee Mile	0.32
End Levee Mile	0.32
Location	Water Side
Category	Earthen Levee
Item	Animal Control

A rodent hole was found on the waterside of the slope. The picture was taken from the toe looking toward the crown.

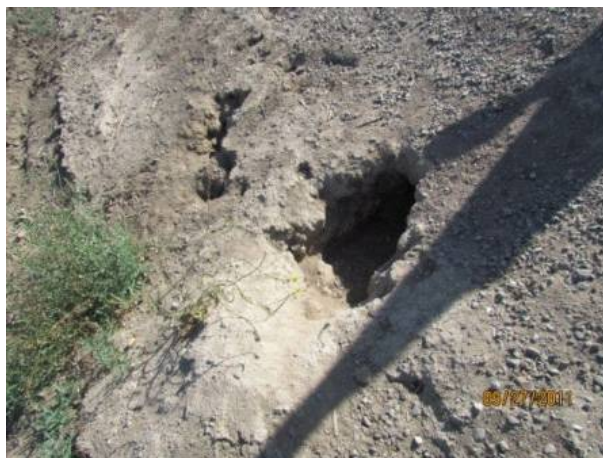
pkazi_s_20120305_695.jpg

A rodent hole was found on the waterside of the slope. The picture was taken from the toe of the levee looking towards the crown.

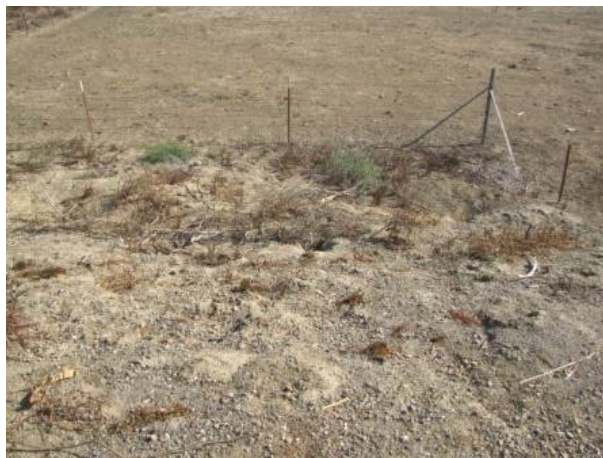
pkazi_s_20120305_674.jpg

View of rodent holes on the waterward slope looking waterward.

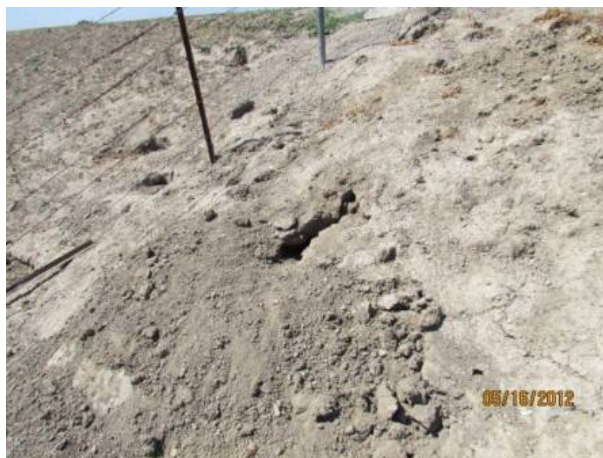
pkazi_s_20120518_044.jpg

Animal holes were found on the waterside of the levee looking upstream. This picture was taken during spring 2012 inspection.

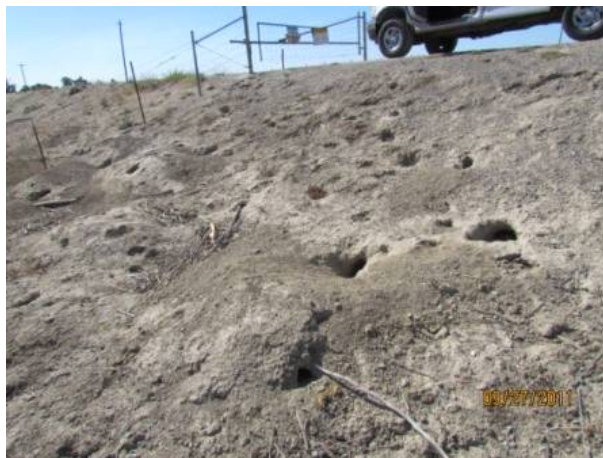
pkazi_s_20120305_672.jpg

Pictures of the rodent holes on the waterside of the slope looking towards the crown. The picture was taken during Fall 2011 inspection.

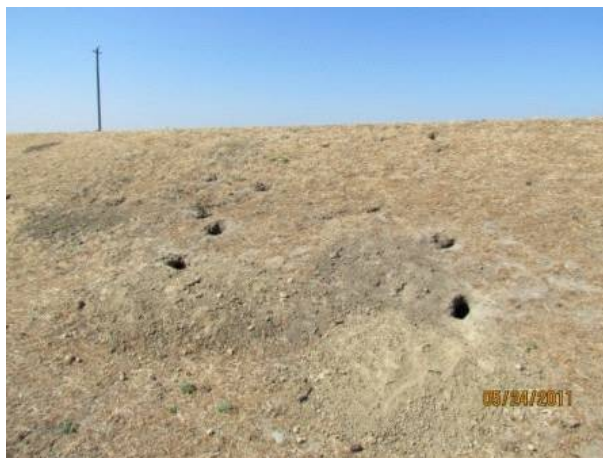
pkazi_s_20120305_673.jpg

Rodent holes were found on the waterside of the levee. The picture was taken from the toe of the waterside of the levee looking upstream.

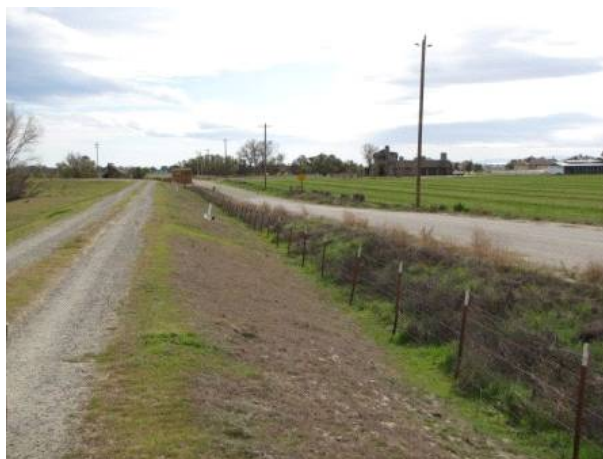
Levee Mile Report Line	16
Start Levee Mile	0.60
End Levee Mile	0.72
Location	Water Side
Category	Earthen Levee
Item	Encroachments

View of barbed wire fence at landward toe looking upstream.

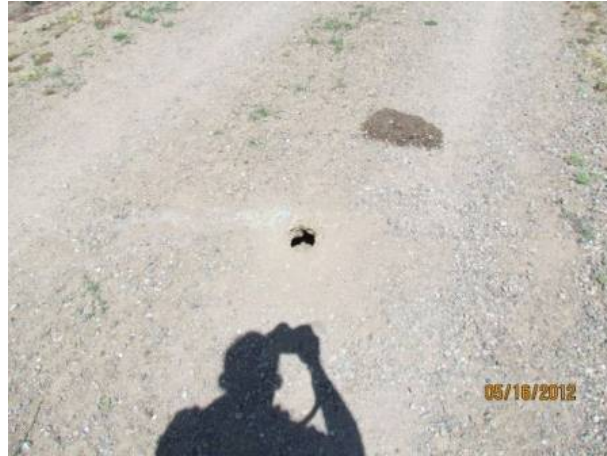
pkazi_s_20120518_046.jpg

A rodent hole was found crown of the levee looking downstream.

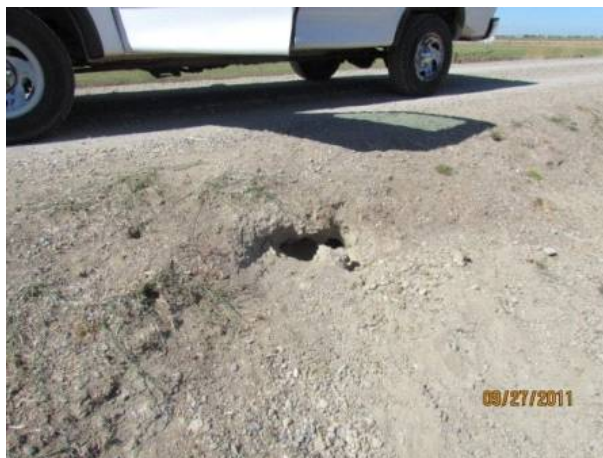
pkazi_s_20120305_697.jpg

Animal burrow was found on the waterside shoulder of the levee. The picture was taken from the toe looking towards the crown.

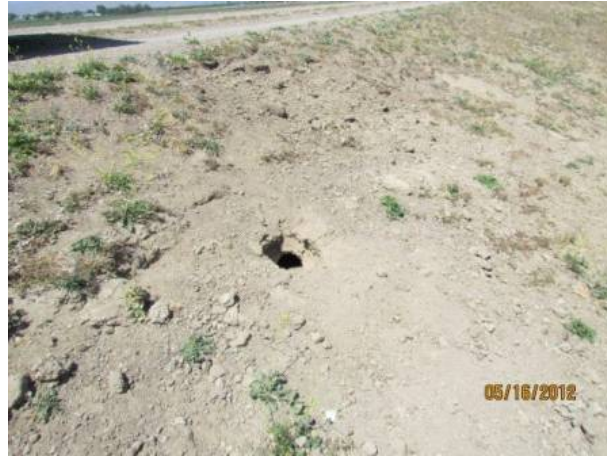
pkazi_s_20120518_048.jpg

An animal hole was found on the waterside of the levee looking downstream.

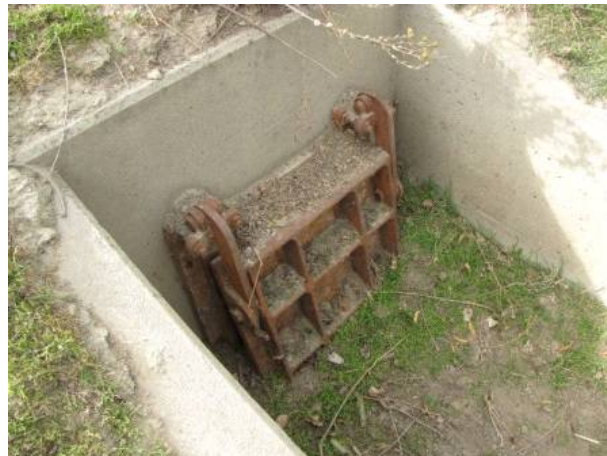
pkazi_s_20120305_731.jpg

View of a flap gate with sediment preventing it from closing.

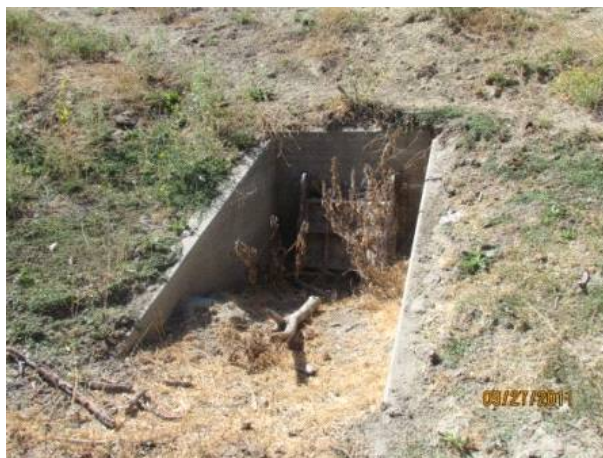
pkazi_s_20120305_732.jpg

Debris and sediments were obstructing the flap gate. The picture was taken from toe of waterside of the levee looking towards the crown. This picture was taken during Fall 2011 inspection.

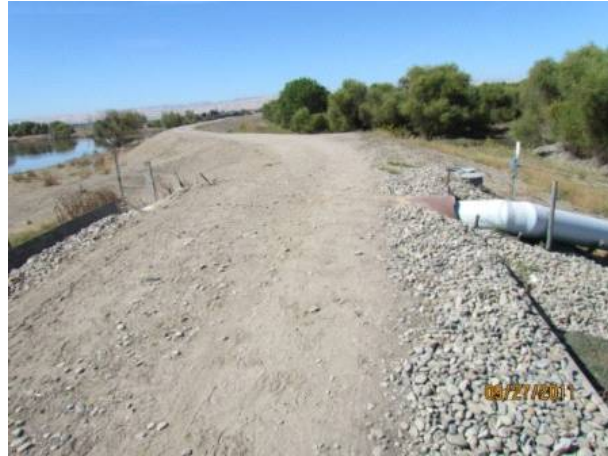
pkazi_s_20120305_701.jpg

View of the ramp on the crown. The picture was taken from crown looking downstream.

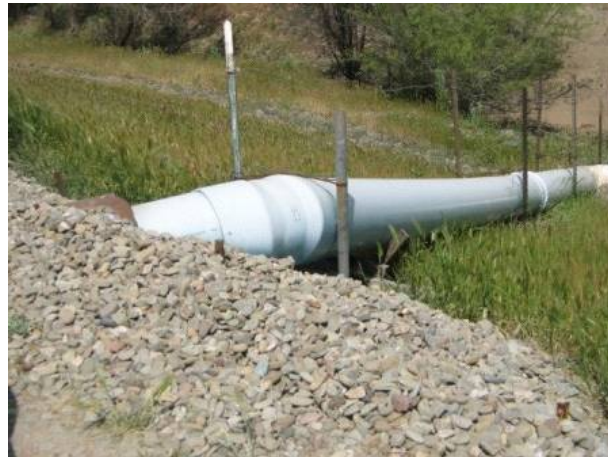
Levee Mile Report Line	31
Start Levee Mile	1.02
End Levee Mile	1.02
Location	Water Side
Category	Interior Drainage & Piping Systems
Item	Encroachments

PVC sleeve through steel pipe on waterward slope at LM 1.02

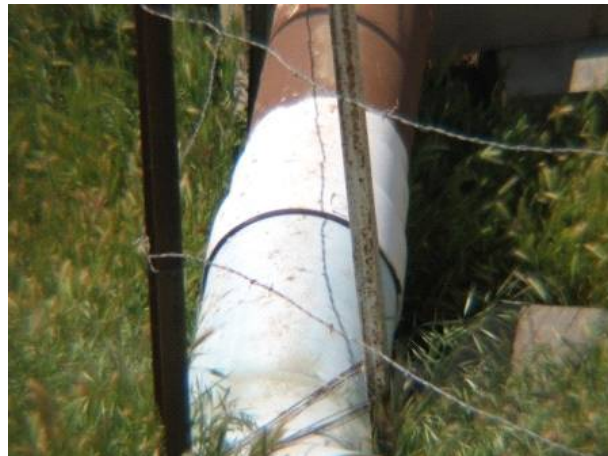
Levee Mile Report Line	31
Start Levee Mile	1.02
End Levee Mile	1.02
Location	Water Side
Category	Interior Drainage & Piping Systems
Item	Encroachments

PVC pipe connected to steel pipe on landward toe at LM 1.02

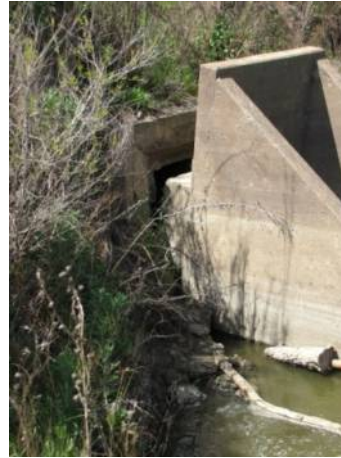
pkazi_s_20120305_719.jpg

Separation of outfall structure from the outlet pipe at LM 1.04.

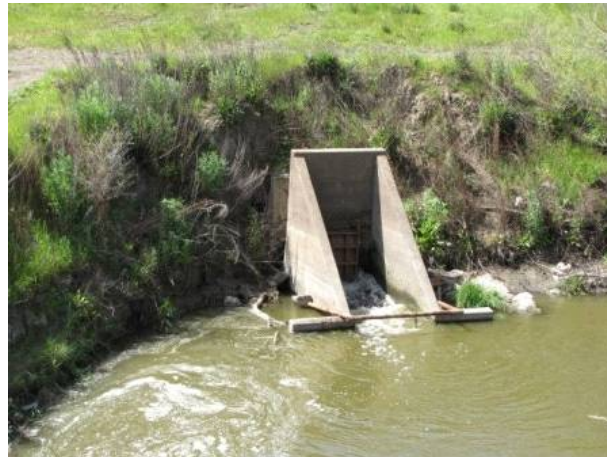
Levee Mile Report Line	32
Start Levee Mile	1.04
End Levee Mile	1.04
Location	Water Side
Category	Interior Drainage & Piping Systems
Item	Concrete Tilting / Settlement

Additional view of outfall structure at LM 1.04.

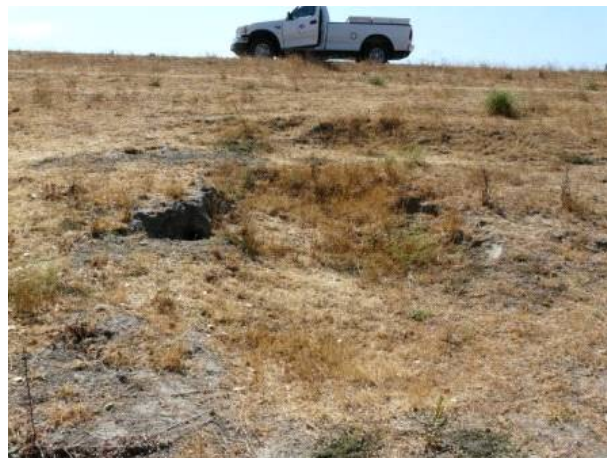
Levee Mile Report Line	34
Start Levee Mile	1.07
End Levee Mile	1.07
Location	Water Side
Category	Earthen Levee
Item	Slope Stability

Small amount of slumping at water toe.

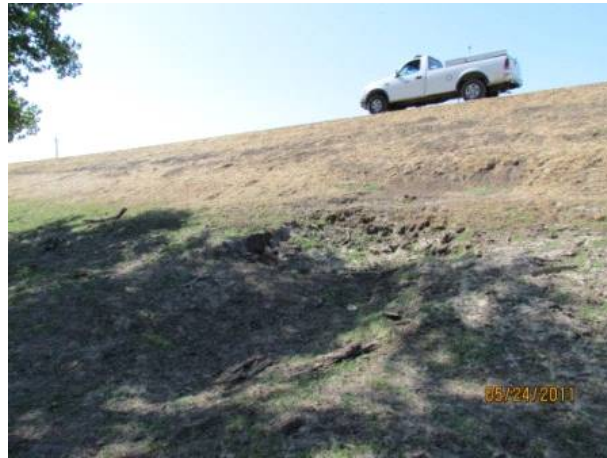
pkazi_s_20120305_703.jpg

Depression at the waterside slope of the levee during Spring 2011 inspection.

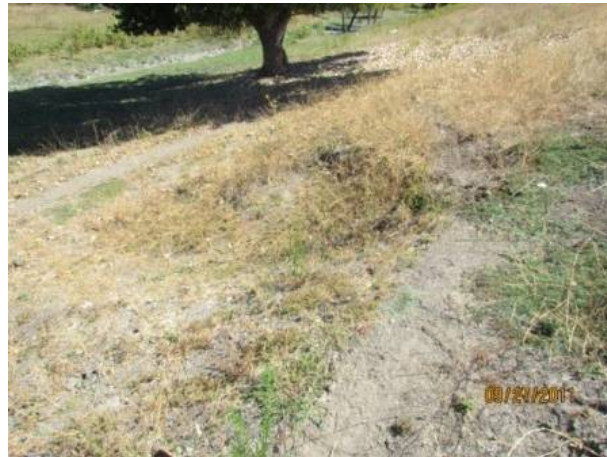
Levee Mile Report Line	34
Start Levee Mile	1.07
End Levee Mile	1.07
Location	Water Side
Category	Earthen Levee
Item	Slope Stability

Updated picture of the depression at the waterside toe of the levee. The picture was taken from the crown of the levee looking upstream.

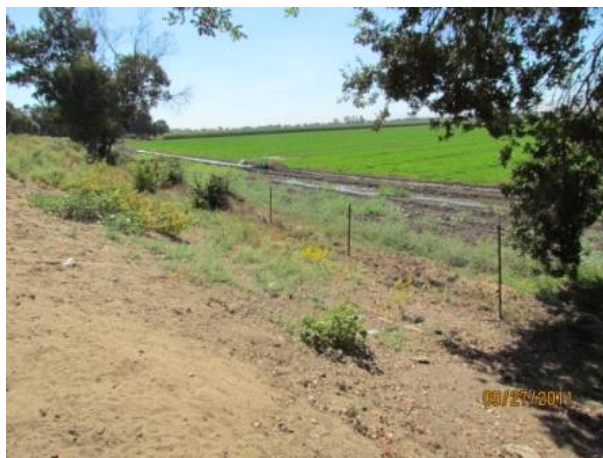
pkazi_s_20120305_709.jpg

View of the fence on the landside toe of the levee. The picture was taken from crown looking upstream.

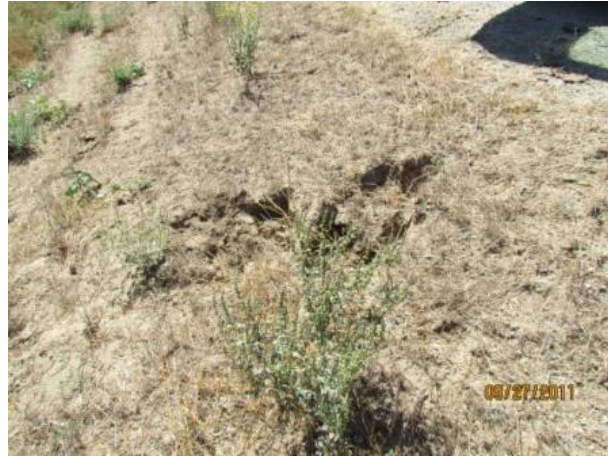
pkazi_s_20120305_694.jpg

Rodent holes were found on the waterside of the levee. The picture was taken from crown of the levee looking upstream.

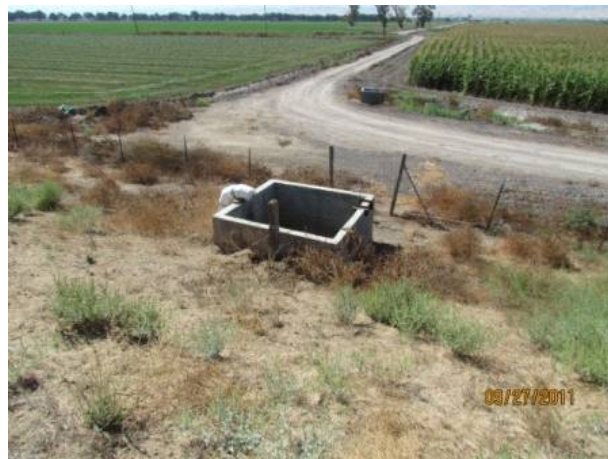
Levee Mile Report Line	48
Start Levee Mile	2.03
End Levee Mile	2.03
Location	Land Side
Category	Earthen Levee
Item	Encroachments

A well is located at the landside toe of the levee. The picture was taken from the crown looking toward the landside of the levee.

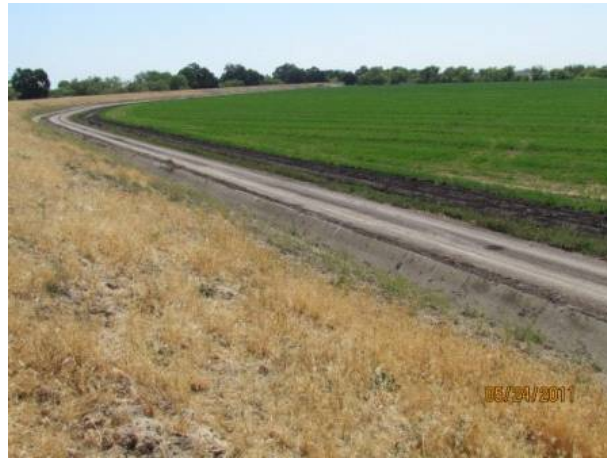
pkazi_s_20120305_721.jpg

Concrete drain was built at the toe of the levee. The picture was taken from the crown looking upstream.

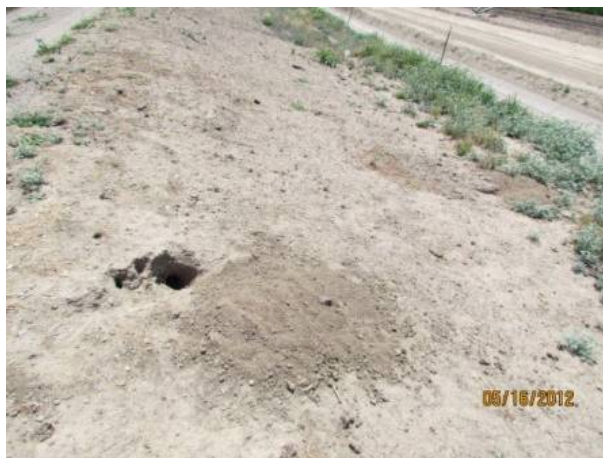
pkazi_s_20120518_054.jpg

Animal holes were found on the landside of the levee looking upstream.

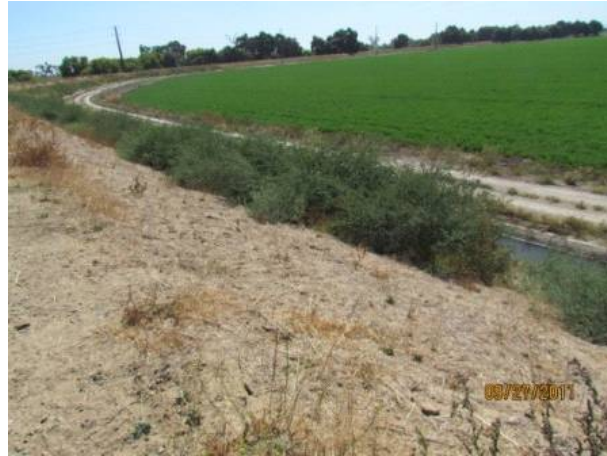
pkazi_s_20120305_715.jpg

Wild growth was found on the toe of the landside of the levee. The picture was taken from crown looking upstream.

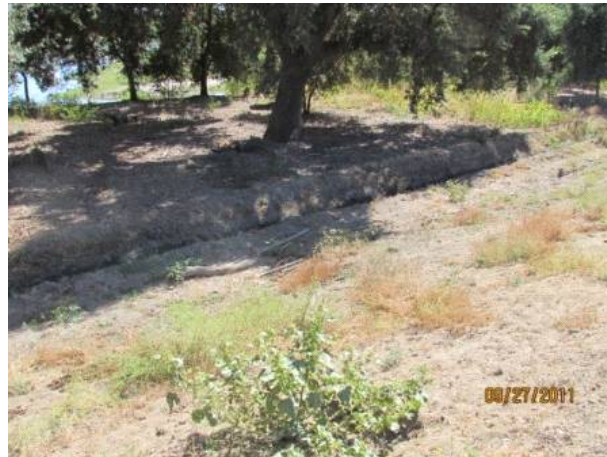
Levee Mile Report Line	66
Start Levee Mile	3.49
End Levee Mile	3.56
Location	Water Side
Category	Earthen Levee
Item	Encroachments

A ditch was located on the waterside toe of the levee. The picture was taken from the crown looking upstream.

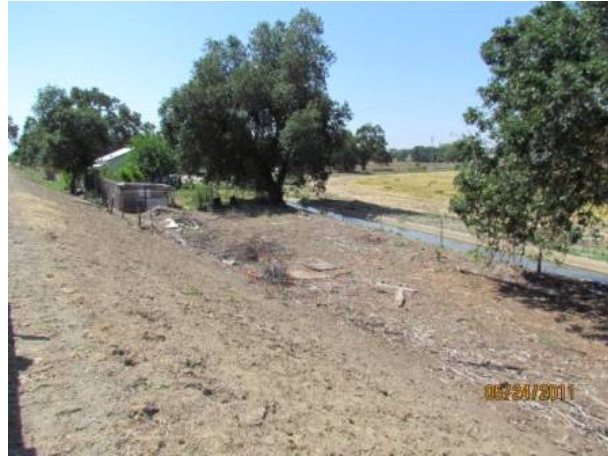
pkazi_s_20120305_684.jpg

Garbage was found on the landside of the levee. The picture was taken from the crown looking upstream.

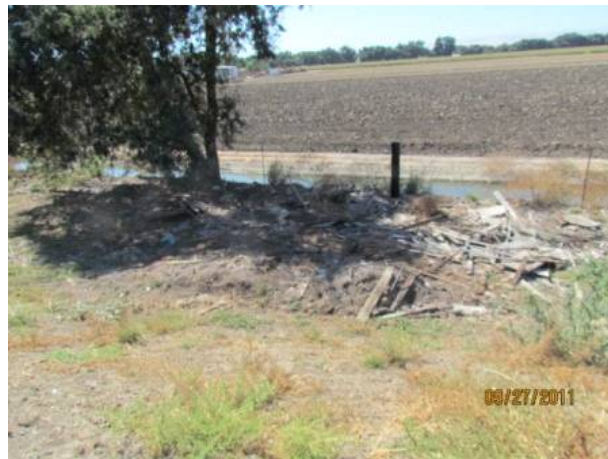
Levee Mile Report Line	70
Start Levee Mile	3.83
End Levee Mile	3.83
Location	Land Side
Category	Earthen Levee
Item	Encroachments

Debris was located on the landside of the levee. The picture was taken from the crown looking upstream.

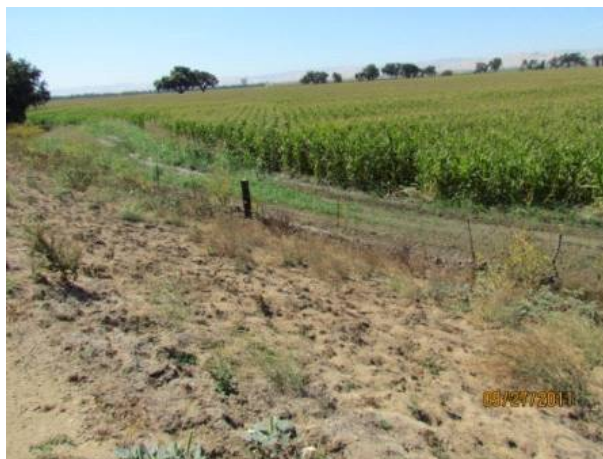
Levee Mile Report Line	81
Start Levee Mile	4.45
End Levee Mile	4.92
Location	Land Side
Category	Earthen Levee
Item	Encroachments

View of the fence on the landside toe of the levee. The picture was taken from the crown looking upstream.

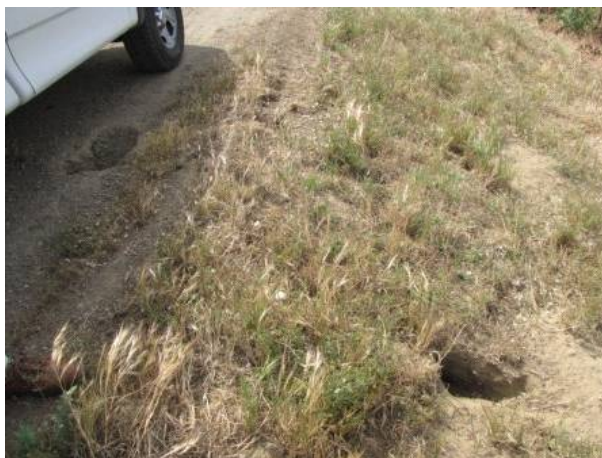
pkazi_s_20120305_682.jpg

View of rodent holes on the landward slope looking upstream.

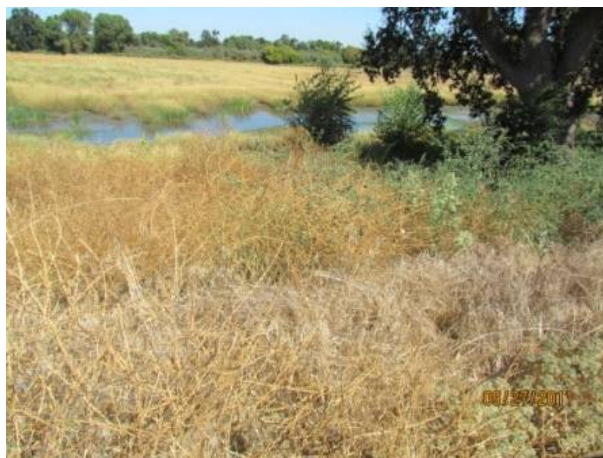
pkazi_s_20120305_733.jpg

Wild growth was found on the waterside of the levee looking upstream.

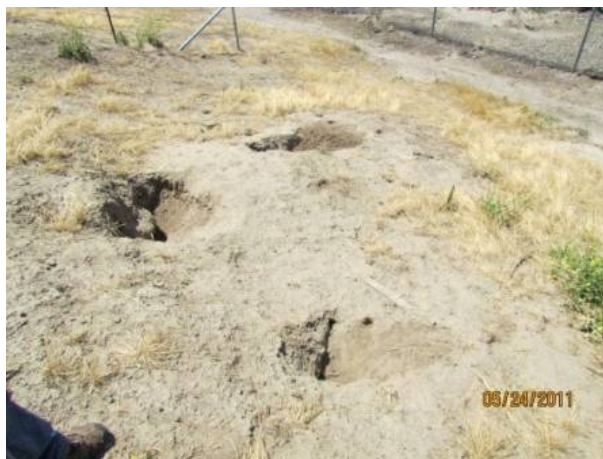
Levee Mile Report Line	90
Start Levee Mile	5.25
End Levee Mile	5.25
Location	Land Side
Category	Earthen Levee
Item	Animal Control

Rodent holes possibly made worsen by dog digging through it. It is located on the landside of the levee. The picture was taken from the crown looking upstream.

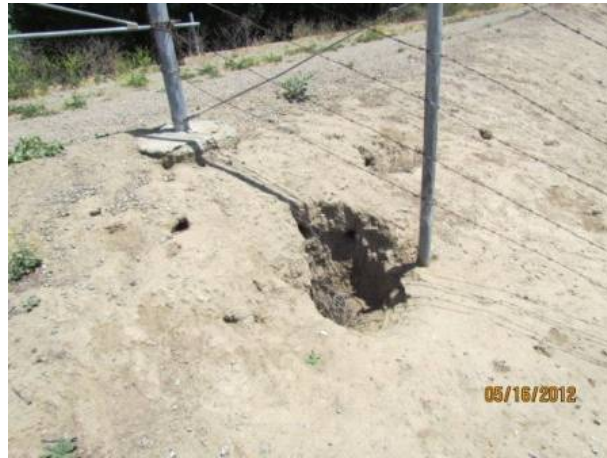
pkazi_s_20120518_058.jpg

Rodent hole damage possible due to other factor was found on the landside of the levee looking upstream. This picture was taken during spring 2012 inspection.

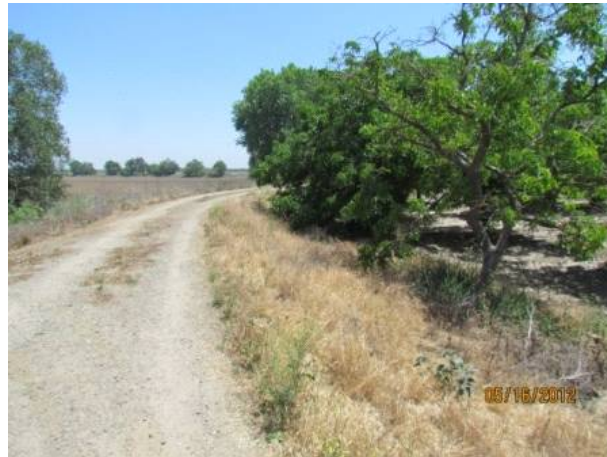
Levee Mile Report Line	93
Start Levee Mile	5.31
End Levee Mile	5.31
Location	Water Side
Category	Earthen Levee
Item	Trim / Thin Trees

Trees are need to be trimmed for flood fighting access on the landside of the levee. The picture was taken from the crown of the levee looking upstream.

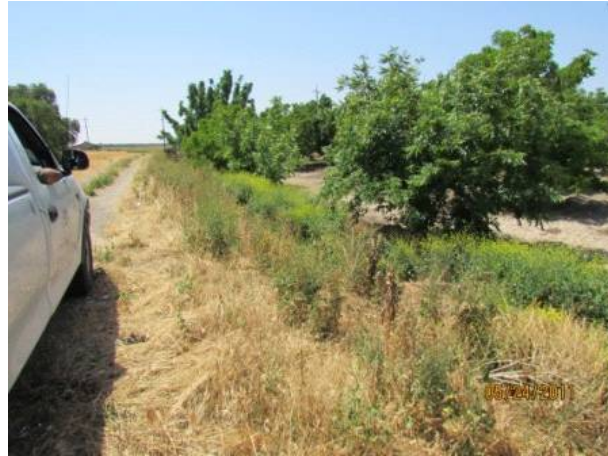
pkazi_s_20120305_722.jpg

Vegetation was obstructing the view of the landside of the levee. The picture was taken from the crown looking upstream.

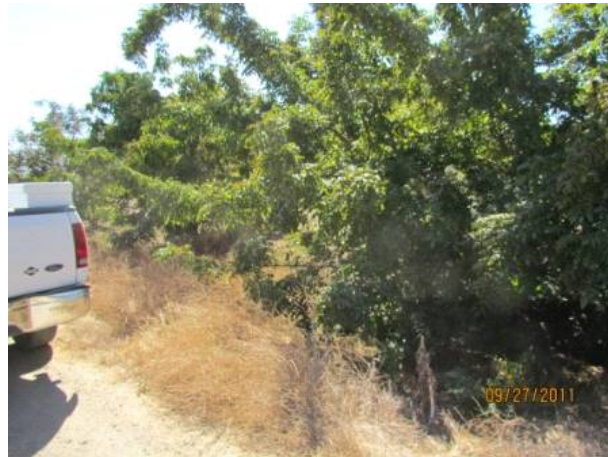
Levee Mile Report Line	97
Start Levee Mile	5.38
End Levee Mile	5.38
Location	Land Side
Category	Earthen Levee
Item	Trim / Thin Trees

View of the trees which block the access and visibility on the landside slope of the levee. The picture was taken from the crown looking upstream.
