**Flood Control Project Maintenance  
Levee Inspections**  
**LMA District Cover Sheet**  
**Spring 2013 Levee Inspection Results**

**Reclamation District No. 1602 Del Puerto**

**Levee Inspection Report By Mile - Spring 2013**

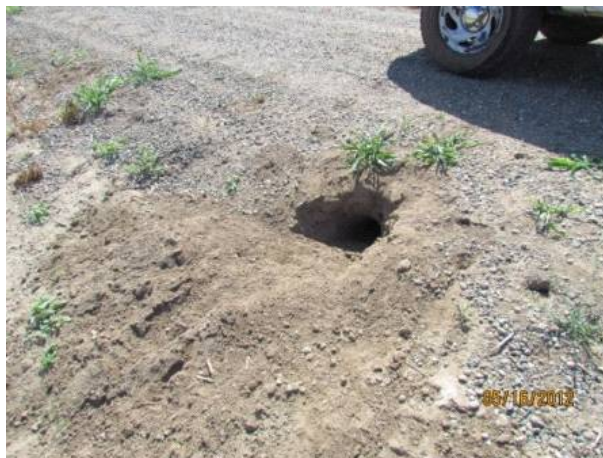
pkazi\_s\_20130404\_750.jpg

A rodent hole was found on the waterside of the slope taken from the toe looking toward the crown. This picture was taken during the spring 2012 inspection.

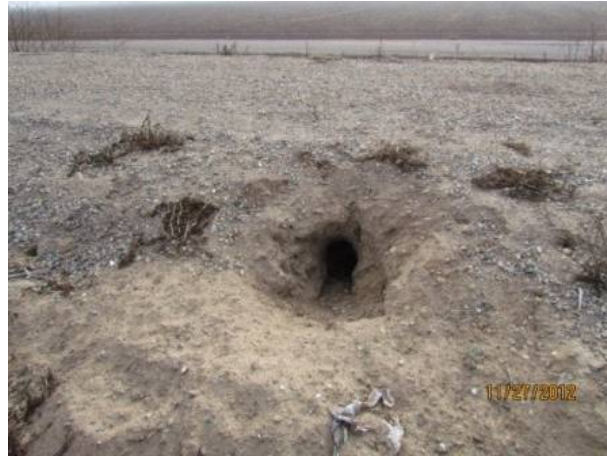
pkazi\_s\_20130404\_751.jpg

Updated picture of the rodent hole on the waterside shoulder of the levee looking from toe of the levee. The picture was taken during the fall 2012 inspection.

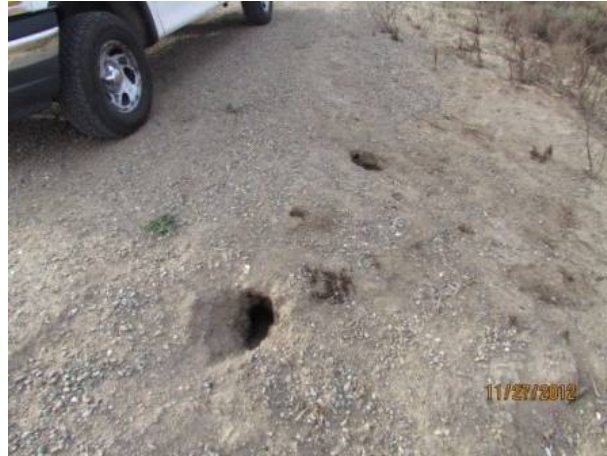
pkazi\_s\_20130404\_754.jpg

Updated picture of the rodent holes on the waterside shoulder of the levee looking downstream taken during the fall 2012 inspection.

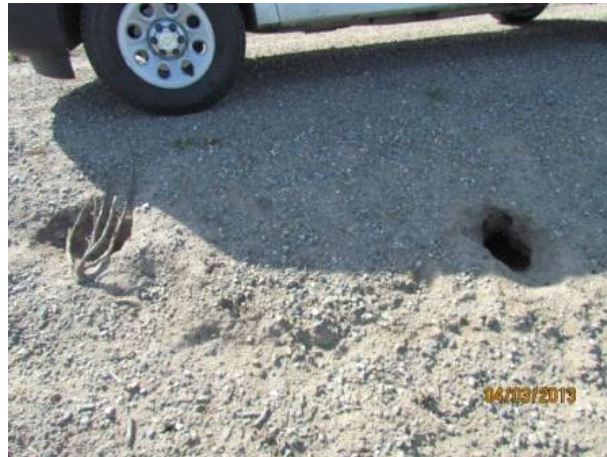
pkazi\_s\_20130405\_839.JPG

Updated picture of the rodent hole on the waterside shoulder of the levee looking upstream during spring 2013 inspection.

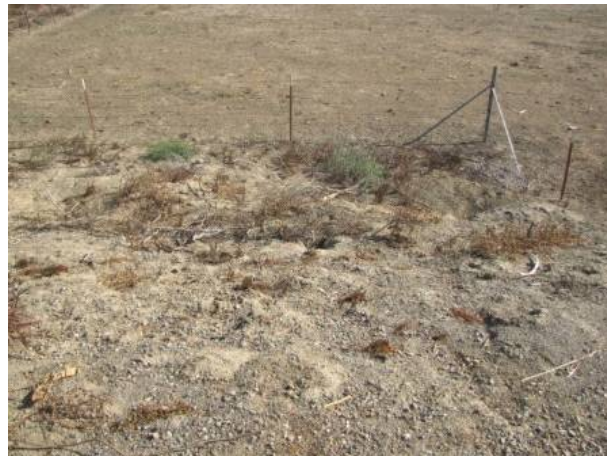
pkazi\_s\_20130404\_735.jpg

View of rodent holes on the waterward slope looking waterward.

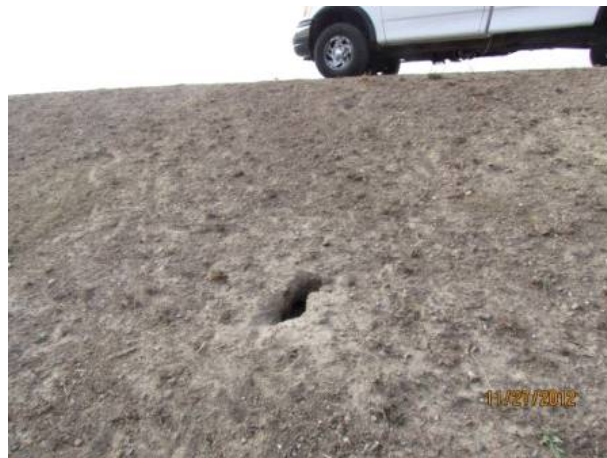
pkazi\_s\_20130404\_734.jpg

A rodent hole was found on the waterside slope looking from the toe of the levee.

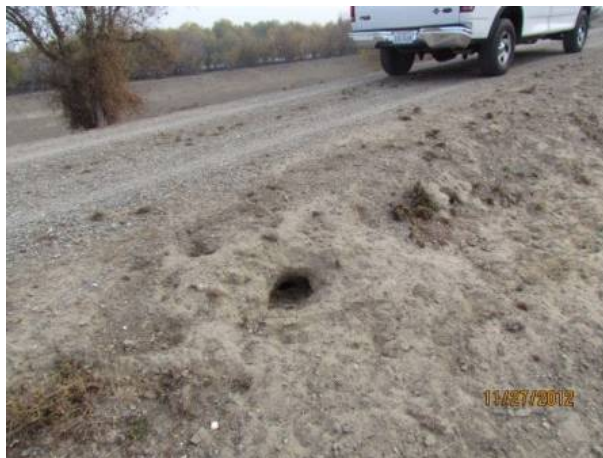
pkazi\_s\_20130404\_772.jpg

A rodent hole was found on the landside shoulder of the levee looking upstream.

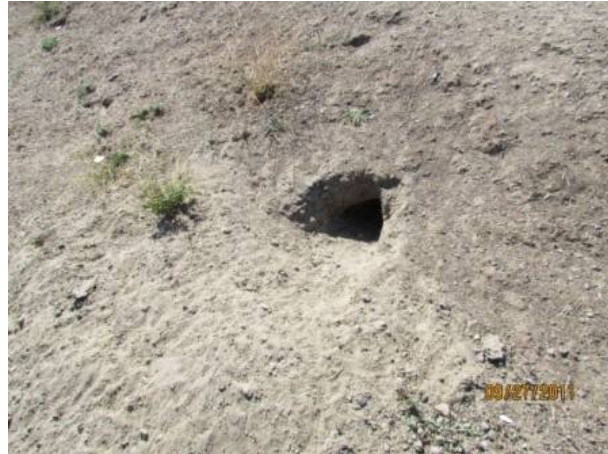
Levee Mile Report Line	18
Start Levee Mile	0.69
End Levee Mile	0.69
Location	Land Side
Category	
Item	Animal Control
Animal burrow was found on the landside of the levee. The picture was taken from the toe of the levee looking upstream.	
pkazi_s_20130404_763.jpg

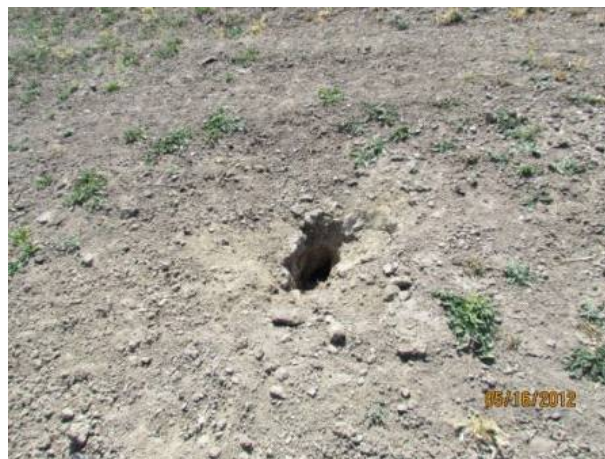
pkazi\_s\_20130404\_787.jpg

A rodent hole was found on the waterside of the levee looking upstream.

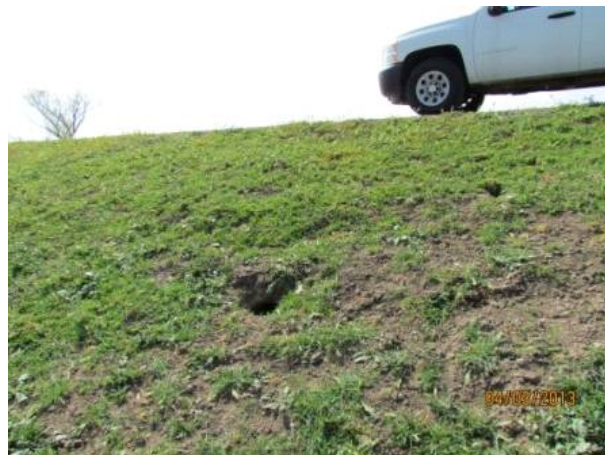
pkazi\_s\_20130405\_842.JPG

Updated picture of the rodent hole on the waterside slope of the levee looking upstream during spring 2013 inspection.

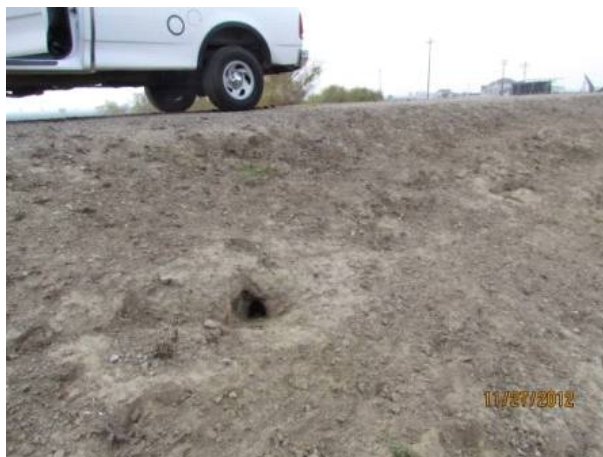
Levee Mile Report Line	23
Start Levee Mile	0.83
End Levee Mile	0.83
Location	Water Side
Category	
Item	Animal Control
Updated picture of the rodent hole on the waterside slope of the levee looking downstream.	
pkazi_s_20130404_803.jpg

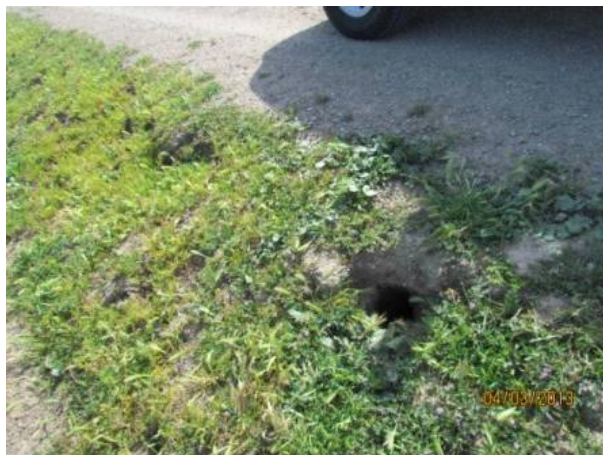
Levee Mile Report Line	24
Start Levee Mile	0.91
End Levee Mile	0.91
Location	Water Side
Category	
Item	Animal Control
A rodent hole was found on the waterside shoulder of the levee looking upstream.	
pkazi_s_20130405_843.JPG

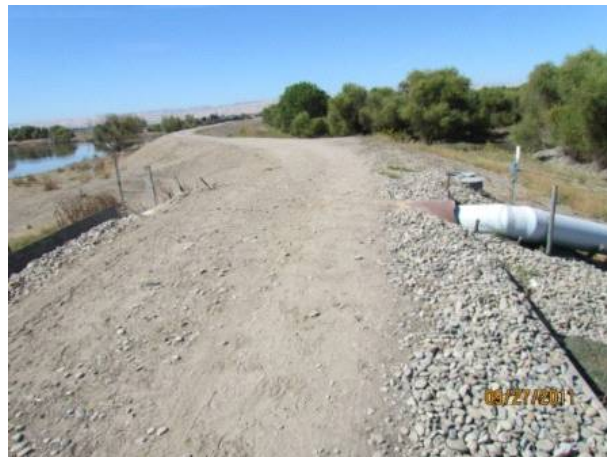
Levee Mile Report Line	26
Start Levee Mile	0.99
End Levee Mile	0.99
Location	Water Side
Category	
Item	Encroachments
View of the ramp on the crown. The picture was taken from crown looking downstream.	
pkazi_s_20130404_768.jpg

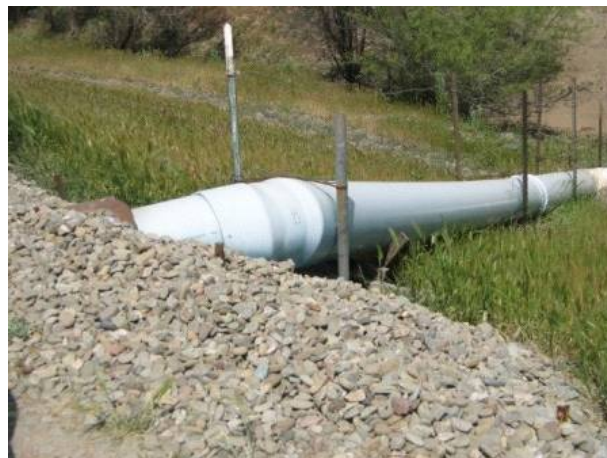
Levee Mile Report Line	27
Start Levee Mile	1.02
End Levee Mile	1.02
Location	Water Side
Category	Interior Drainage & Piping Systems
Item	Encroachments
PVC sleeve through steel pipe on waterward slope at LM 1.02.	
pkazi_s_20130404_740.jpg

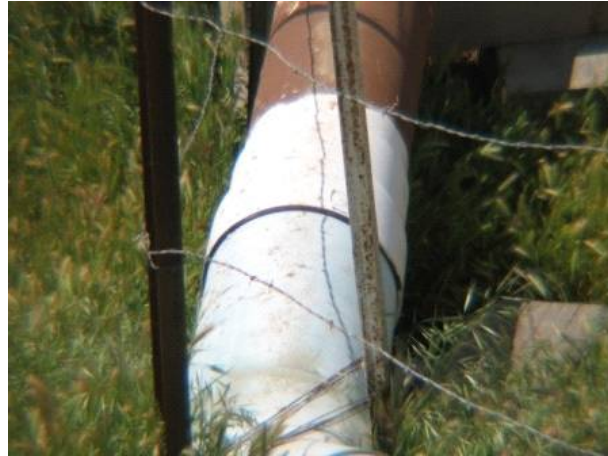
pkazi\_s\_20130404\_741.jpg

PVC pipe connected to steel pipe on landward toe at LM 1.02.

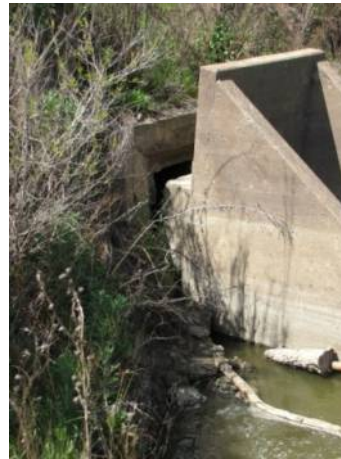
pkazi\_s\_20130404\_784.jpg

Separation of outfall structure from the outlet pipe at LM 1.04.

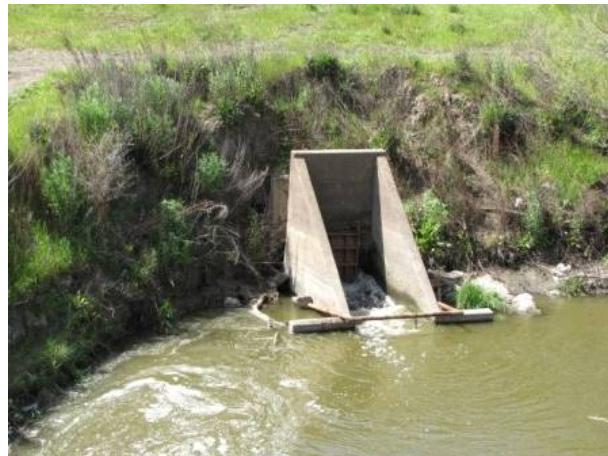
pkazi\_s\_20130404\_785.jpg

Additional view of outfall structure at LM 1.04.

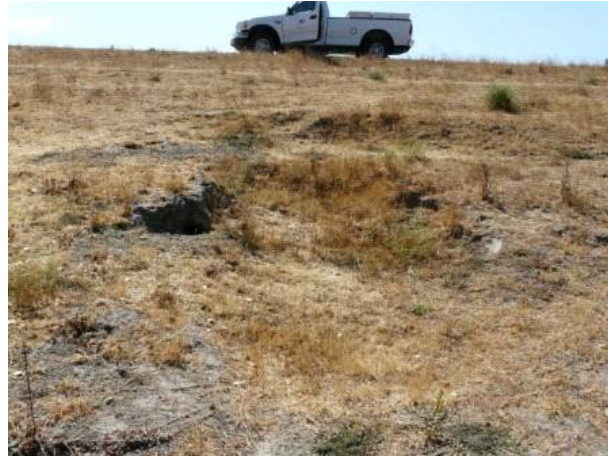
Levee Mile Report Line	29
Start Levee Mile	1.07
End Levee Mile	1.07
Location	Water Side
Category	
Item	Slope Stability
Small amount of slumping at water toe.	
pkazi_s_20130404_769.JPG

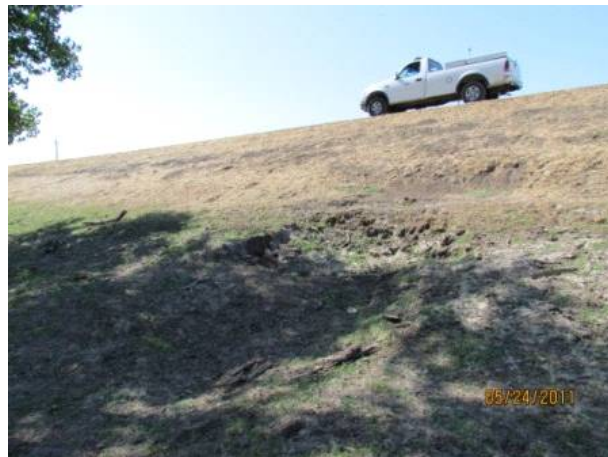
Levee Mile Report Line	29
Start Levee Mile	1.07
End Levee Mile	1.07
Location	Water Side
Category	
Item	Slope Stability
Depression at the waterside slope of the levee during Spring 2011 inspection.	
pkazi_s_20130404_770.jpg

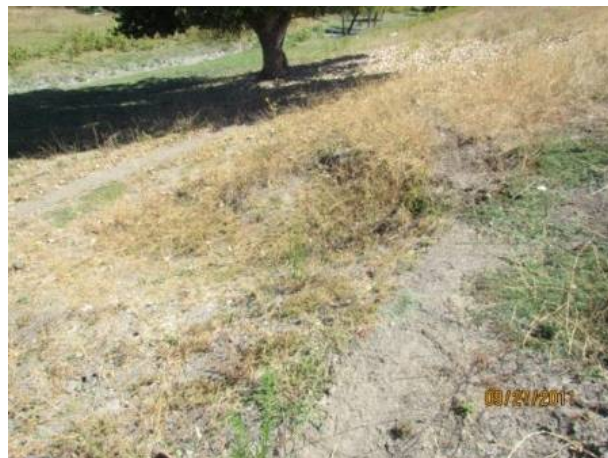
Levee Mile Report Line	29
Start Levee Mile	1.07
End Levee Mile	1.07
Location	Water Side
Category	
Item	Slope Stability
Updated picture of the depression at the waterside toe of the levee. The picture was taken from the crown of the levee looking upstream.	
pkazi_s_20130404_771.jpg

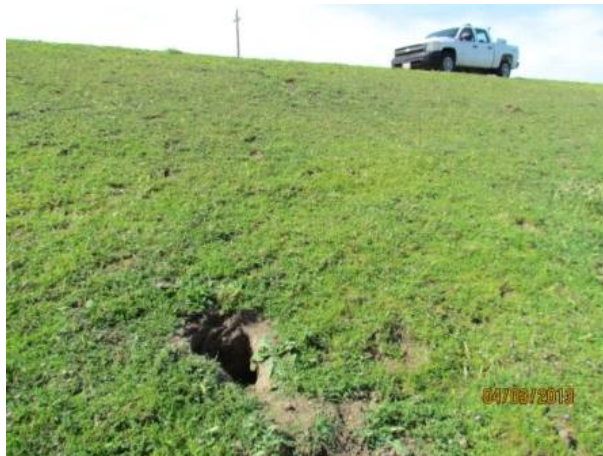
pkazi\_s\_20130405\_845.JPG

A rodent hole was found on the waterside toe of the levee looking downstream.

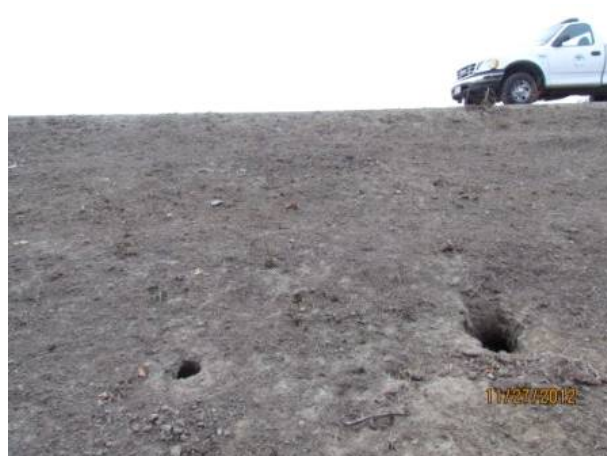
pkazi\_s\_20130404\_792.jpg

Rodent holes were found on the waterside toe of the levee. The picture was taken from toe of the levee looking towards the crown.

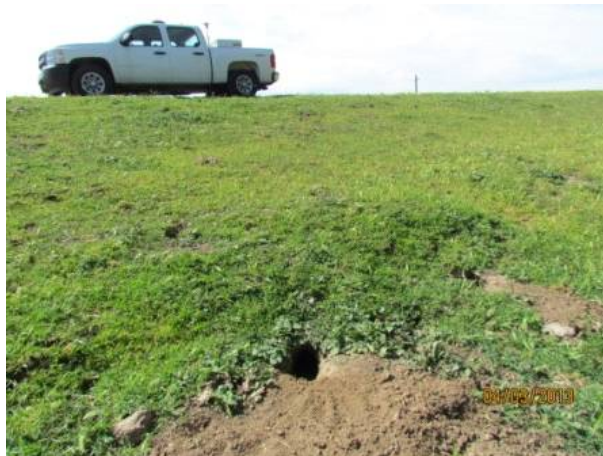
pkazi\_s\_20130405\_847.JPG

A rodent hole was found on the waterside toe of the levee looking downstream.

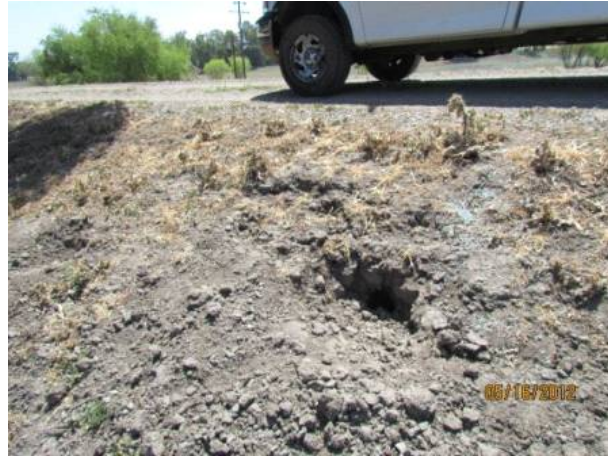
Levee Mile Report Line	39
Start Levee Mile	1.21
End Levee Mile	1.21
Location	Water Side
Category	
Item	Animal Control
Rodent hole on the waterside shoulder of the levee looking upstream.	
pkazi_s_20130404_805.jpg

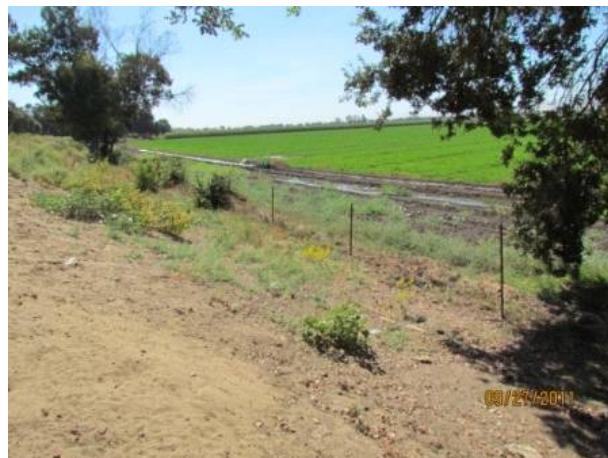
Levee Mile Report Line	42
Start Levee Mile	1.62
End Levee Mile	2.29
Location	Land Side
Category	
Item	Encroachments
View of the fence on the landside toe of the levee. The picture was taken from crown looking upstream.	
pkazi_s_20130404_775.jpg

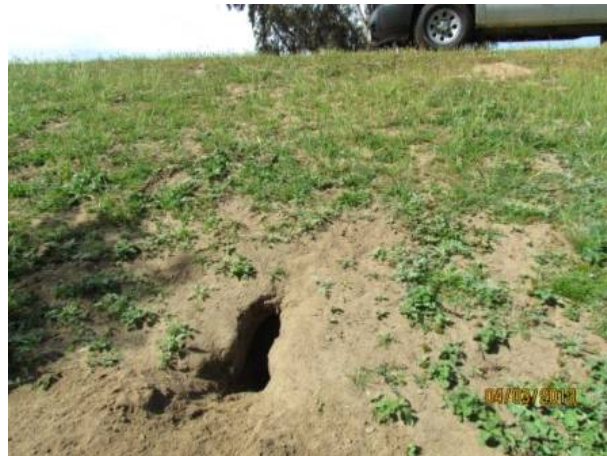
pkazi\_s\_20130405\_852.JPG

A rodent hole was found on the waterside toe of the levee looking downstream.

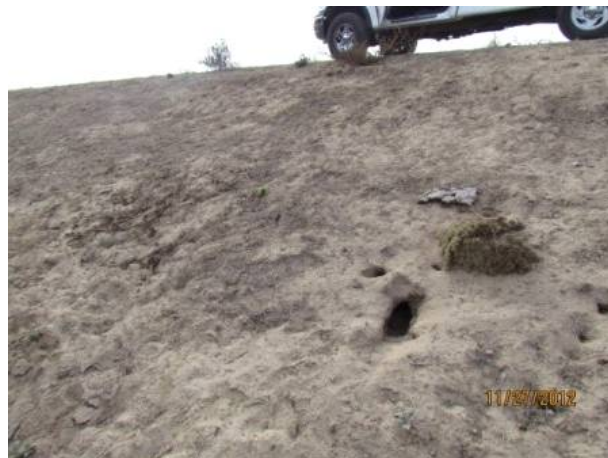
pkazi\_s\_20130404\_806.jpg

Rodent holes were found on the waterside toe of the levee looking upstream.

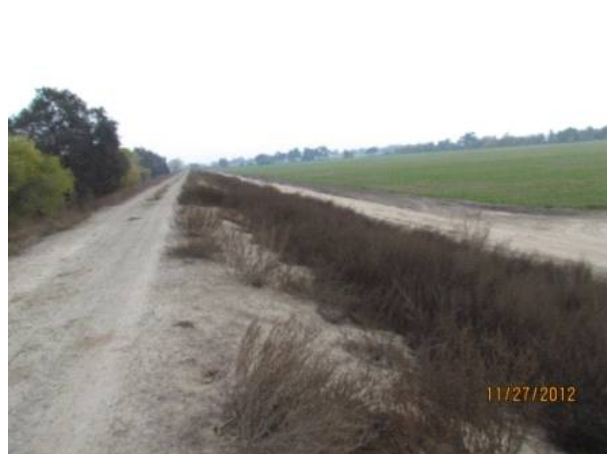
Levee Mile Report Line	58
Start Levee Mile	2.61
End Levee Mile	3.13
Location	Land Side
Category	
Item	Vegetation
Vegetation was found on the landside slope of the levee looking upstream.	
pkazi_s_20130404_819.jpg

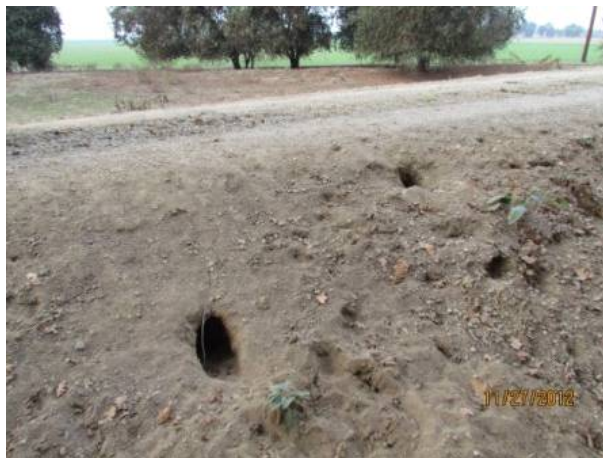
Levee Mile Report Line	66
Start Levee Mile	3.52
End Levee Mile	3.52
Location	Water Side
Category	
Item	Animal Control
Rodent holes were found on the waterside slope of the levee looking downstream.	
pkazi_s_20130404_821.jpg

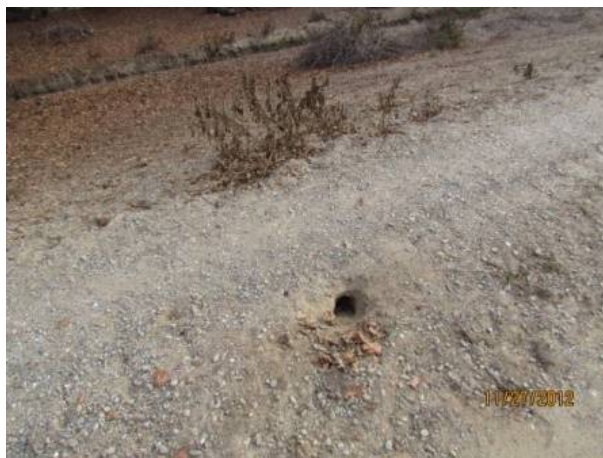
pkazi\_s\_20130404\_822.jpg

A rodent hole was found on the waterside shoulder of the levee looking upstream.

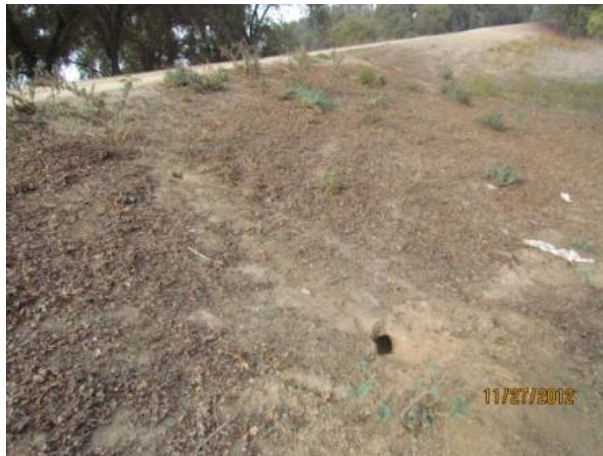
pkazi\_s\_20130404\_823.jpg

A rodent hole was found on the waterside toe of the levee looking downstream.

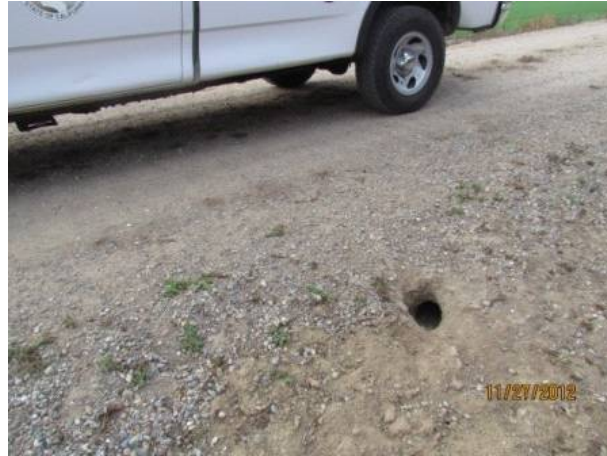
pkazi\_s\_20130404\_807.jpg

A rodent hole was found on the waterside shoulder of the levee looking downstream.

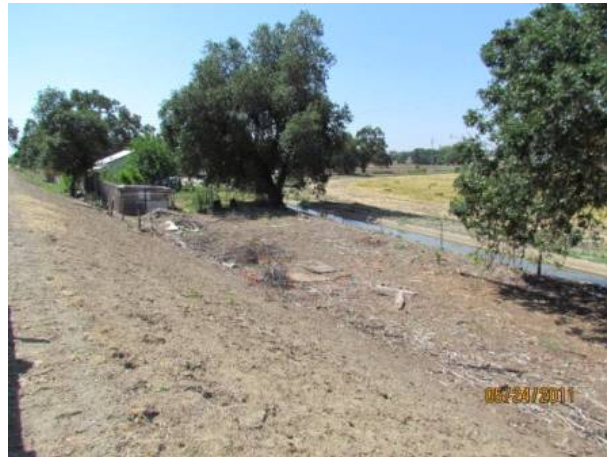
pkazi\_s\_20130404\_744.jpg

Levee Mile Report Line	71
Start Levee Mile	3.83
End Levee Mile	3.83
Location	Land Side
Category	
Item	Encroachments

Garbage was found on the landside of the levee. The picture was taken from the crown looking upstream.

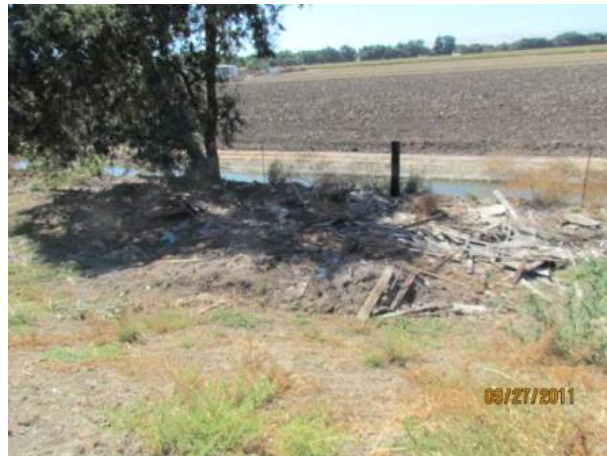
pkazi\_s\_20130404\_745.jpg

Levee Mile Report Line	71
Start Levee Mile	3.83
End Levee Mile	3.83
Location	Land Side
Category	
Item	Encroachments

Debris was located on the landside of the levee. The picture was taken from the crown looking upstream.

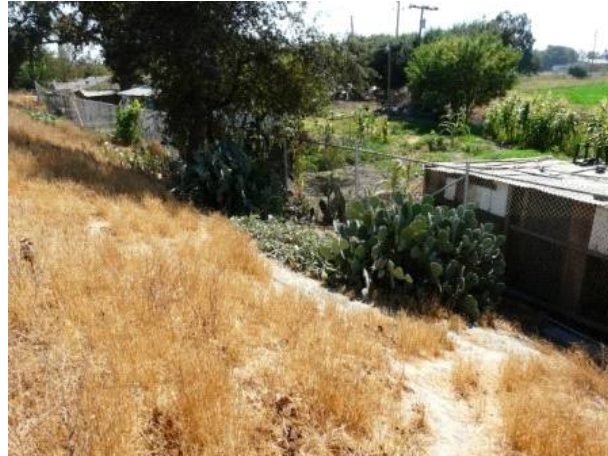
Levee Mile Report Line	72
Start Levee Mile	3.85
End Levee Mile	3.85
Location	Land Side
Category	
Item	Vegetation
Remove landscaping from within 10' of landside toe.	
pkazi_s_20130404_774.JPG

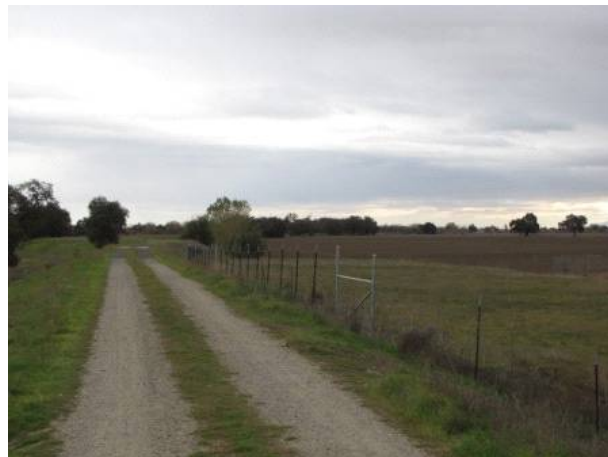
Levee Mile Report Line	76
Start Levee Mile	3.97
End Levee Mile	4.07
Location	Land Side
Category	
Item	Encroachments
View of a barbed wire fence on the landward slope looking upstream.	
pkazi_s_20130404_791.jpg

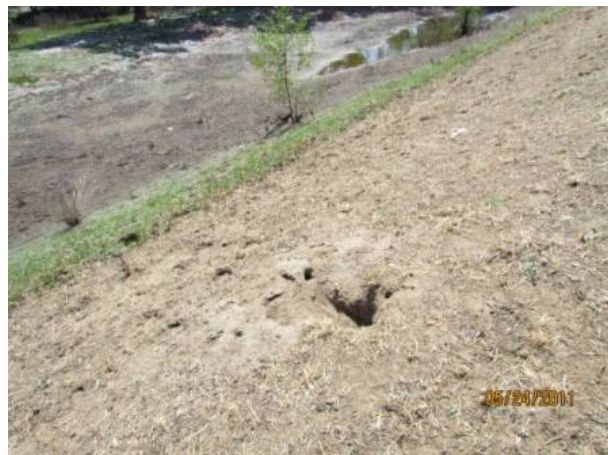
Levee Mile Report Line	77
Start Levee Mile	3.99
End Levee Mile	3.99
Location	Water Side
Category	
Item	Animal Control
Rodent hole at the waterside slope of the levee. The picture was taken from the crown looking upstream.	
pkazi_s_20130404_746.jpg

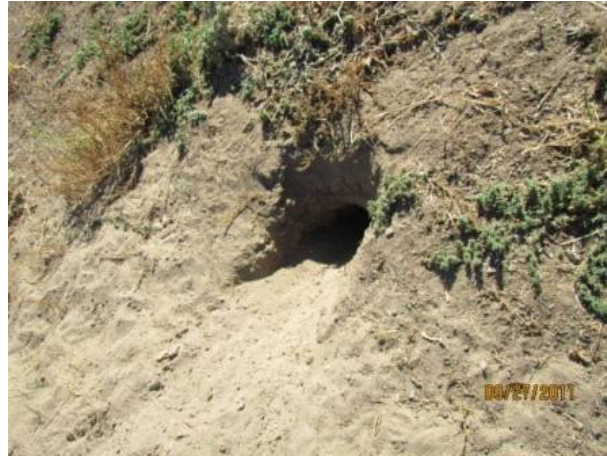
Levee Mile Report Line	77
Start Levee Mile	3.99
End Levee Mile	3.99
Location	Water Side
Category	
Item	Animal Control
Animal burrow was found on the waterside of the levee. The picture was taken from the toe of the levee looking upstream.	
pkazi_s_20130404_747.jpg

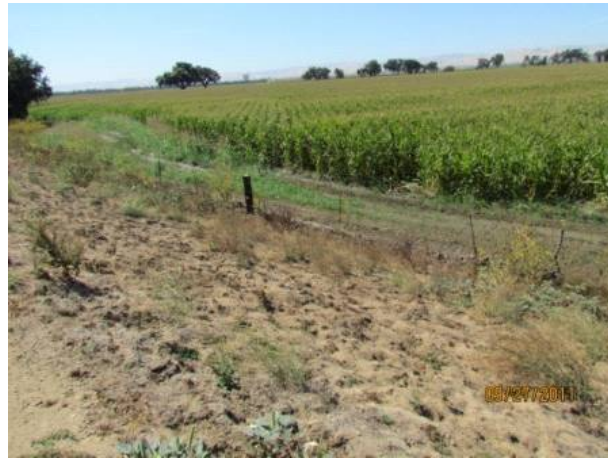
pkazi\_s\_20130404\_793.jpg

View of the fence on the landside toe of the levee. The picture was taken from the crown looking upstream.

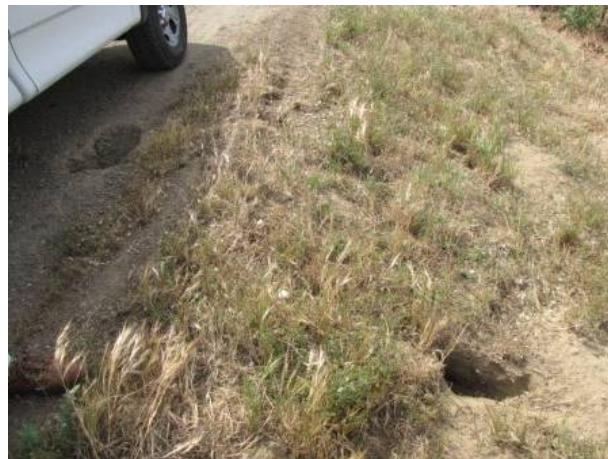
pkazi\_s\_20130404\_742.jpg

Levee Mile Report Line	86
Start Levee Mile	4.72
End Levee Mile	4.72
Location	Land Side
Category	
Item	Animal Control

View of rodent holes on the landward slope looking upstream.

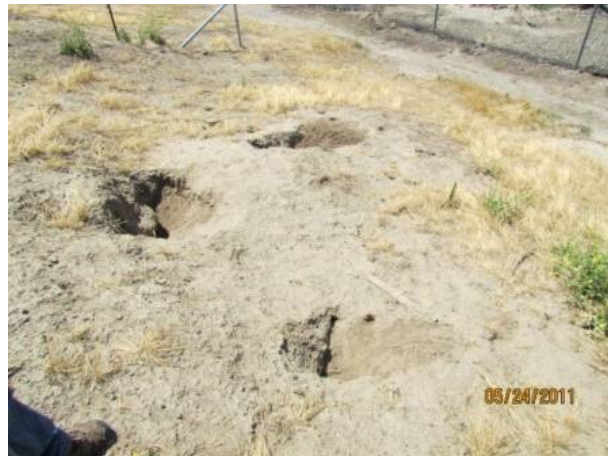
pkazi\_s\_20130404\_755.jpg

Levee Mile Report Line	91
Start Levee Mile	5.25
End Levee Mile	5.25
Location	Land Side
Category	
Item	Animal Control

Rodent holes possibly made worse by a dog digging in it. It is located on the landside of the levee. The picture was taken from the crown looking upstream.

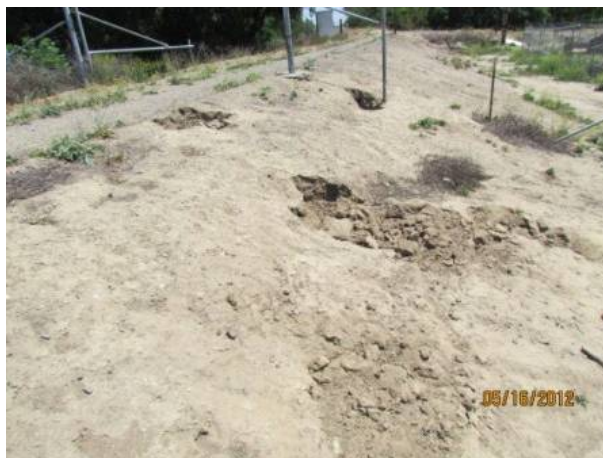
pkazi\_s\_20130404\_756.jpg

Rodent holes found possible were damaged further by dogs on the landside of the levee looking upstream. This picture was taken during spring 2012 inspection.

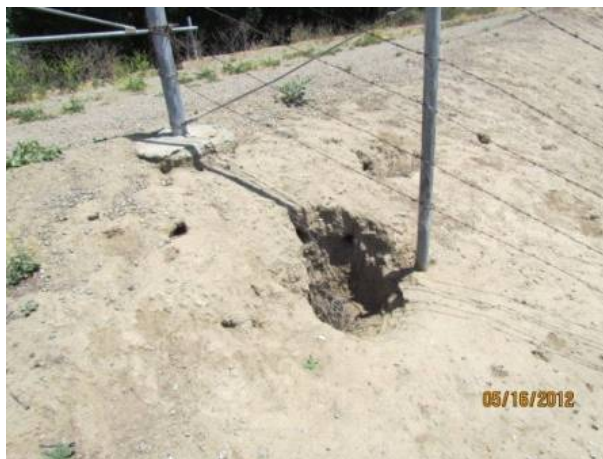
pkazi\_s\_20130404\_757.jpg

Levee Mile Report Line	91
Start Levee Mile	5.25
End Levee Mile	5.25
Location	Land Side
Category	
Item	Animal Control

Rodent hole damage possible due to other factor was found on the landside of the levee looking upstream. This picture was taken during spring 2012 inspection.

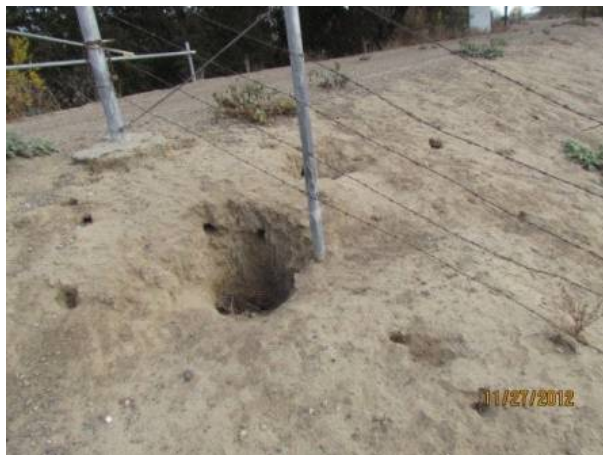
pkazi\_s\_20130404\_758.jpg

Levee Mile Report Line	91
Start Levee Mile	5.25
End Levee Mile	5.25
Location	Land Side
Category	
Item	Animal Control

Updated picture of the holes primarily made by rodents and then possibly worsened by dogs on the landside slope of the levee looking upstream.

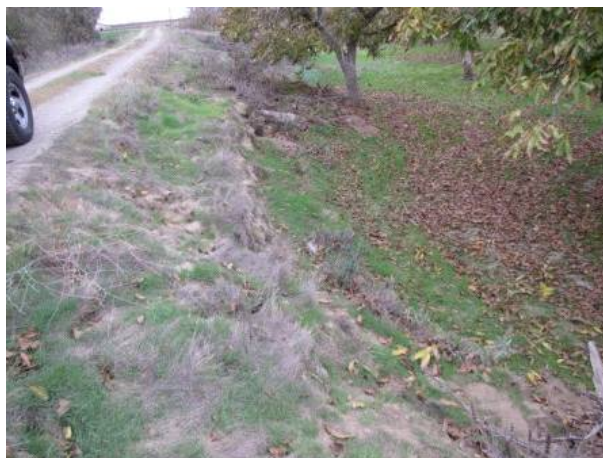
pkazi\_s\_20130404\_817.jpg

View of significant damage and erosion to the landward slope looking upstream.

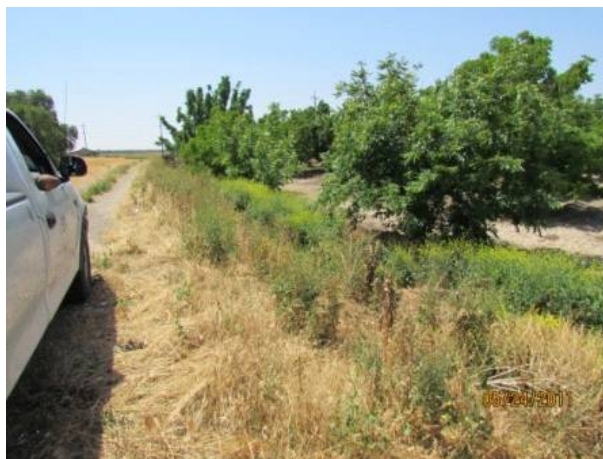
pkazi\_s\_20130404\_789.jpg

Levee Mile Report Line	95
Start Levee Mile	5.36
End Levee Mile	5.36
Location	Land Side
Category	
Item	Vegetation

Vegetation was obstructing the view of the landside of the levee. The picture was taken from the crown looking upstream.

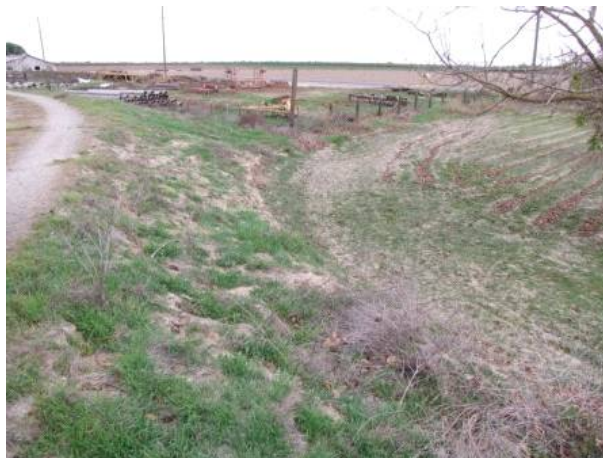
pkazi\_s\_20130404\_820.jpg

Levee Mile Report Line	96
Start Levee Mile	5.40
End Levee Mile	5.40
Location	Land Side
Category	
Item	Slope Stability

View of tilling into the landward slope of the levee looking upstream. This slope has also been significantly damaged by rodent activity.

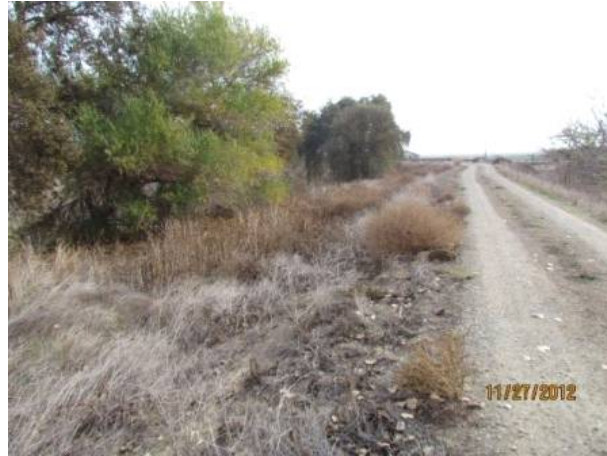
pkazi\_s\_20130404\_801.jpg

Overgrown vegetation was found on the waterside slope of the levee looking upstream.

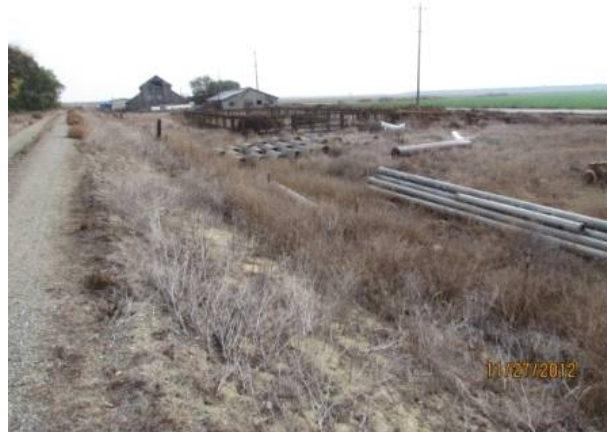
pkazi\_s\_20130404\_752.jpg

Levee Mile Report Line	98
Start Levee Mile	5.42
End Levee Mile	5.49
Location	Land Side
Category	
Item	Encroachments

A fence was found on the landside toe of the levee looking upstream.
