**Flood Control Project Maintenance  
Levee Inspections**  
**LMA District Cover Sheet**  
**Spring 2014 Levee Inspection Results**

**Reclamation District No. 1602 Del Puerto**

**Spring 2014 Levee Inspection Results**

Waterway	Bank	Unit Miles
Unit No. 01 San Joaquin River	Left	6.29

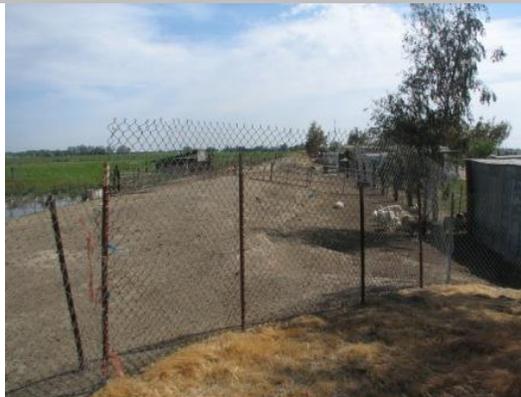
Photo 1 of 1 : pkazi\_s\_20140415\_638.jpg

LM Start	<b>0.00</b>	Rating **	M	Issue No.	<b>1</b>
LM End	<b>0.11</b>	Issue Type +	En	Location *	CR
Category	Earthen Levee		GPS Latitude/Longitude		
			Start	End	
Item	Encroachments		37.476560 °	37.477295 °	
			-121.083862 °	-121.082087 °	
DWR ID	DWR_RD1602_01_s_2012_1				
Action/Comments					
Building Inspector Comments: Animal pens across levee crown.

Looking at animal pens on crown of levee from LM 0.00 to 0.11.

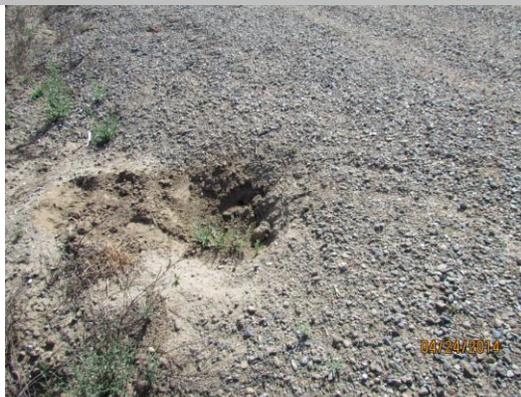
Photo 1 of 1 : pkazi\_s\_20140428\_909.jpg

LM Start	<b>0.32</b>	Rating **	A	Issue No.	<b>172</b>
LM End	<b>0.32</b>	Issue Type +	Ma	Location *	WS
Category	Earthen Levee		GPS Latitude/Longitude		
			Start	End	
Item	Animal Control		37.478581 °	37.478581 °	
			-121.078811 °	-121.078811 °	
DWR ID	DWR_RD1602_01_s_2014_172				
Action/Comments					
No rodents visible, but rodent burrows visible; need to backfill and

The rodent hole was filled with material on the waterside shoulder of the levee looking downstream.

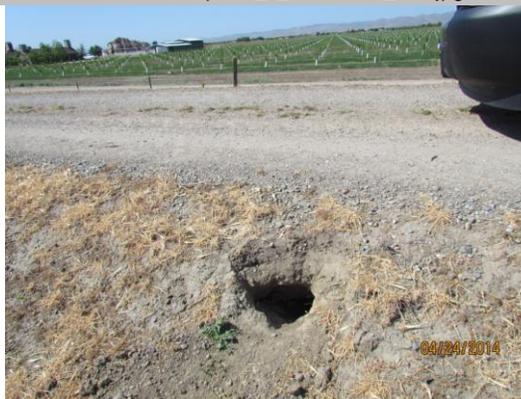
Photo 1 of 2 : pkazi\_s\_20140428\_911.jpg

LM Start	<b>0.69</b>	Rating **	M	Issue No.	<b>26</b>
LM End	<b>0.69</b>	Issue Type +	Ma	Location *	WS
Category	Earthen Levee			GPS Latitude/Longitude	
				Start	End
Item	Animal Control			37.478792 °	37.478792 °
				-121.073740 °	-121.073740 °
DWR ID	DWR_RD1602_01_f_2013_26				
Action/Comments					
No rodents visible, but rodent burrows visible; need to backfill and compact or grout burrows.

Updated picture of the rodent hole on the waterside shoulder of the levee during spring 2014 inspection.

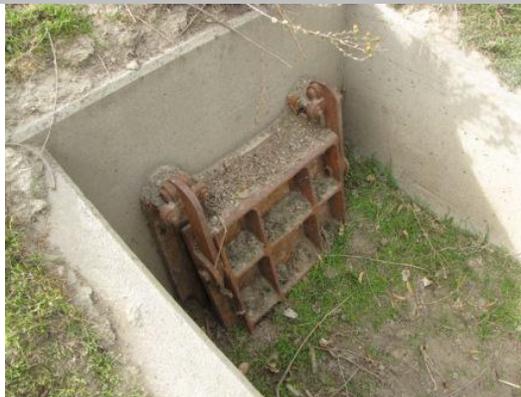
Photo 1 of 4 : pkazi\_s\_20140415\_720.jpg

LM Start	<b>0.78</b>	Rating **	A/W	Issue No.	<b>72</b>
LM End	<b>0.78</b>	Issue Type +	Ma	Location *	WS
Category	Interior Drainage & Piping Systems		GPS Latitude/Longitude		
			Start	End	
Item	Flap Gates		37.477965 °	37.477965 °	
			-121.072595 °	-121.072595 °	
DWR ID	DWR_RD1602_01_s_2012_72				
Action/Comments					
Inspector Comments: Sediment around the flap gate was cleaned, and the area should be watched for future sediment deposits.

View of a flap gate with sediment preventing it from closing.

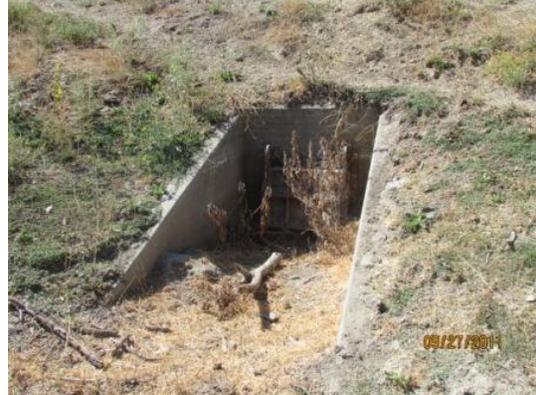
Photo 2 of 4 : pkazi\_s\_20140415\_721.jpg

Debris and sediments were obstructing the flap gate. The picture was taken from toe of waterside of the levee looking towards the crown. This picture was taken during the fall 2011 inspection.

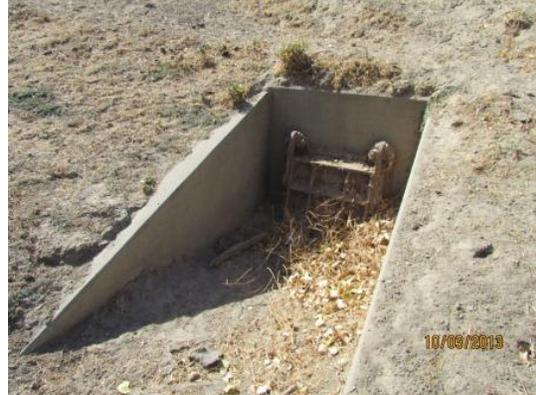
Photo 4 of 4 : pkazi\_s\_20140415\_723.jpg

Debris were obstructing the flap gate from closing completely. The picture was taken from toe of waterside of the levee during the fall 2013 inspection.

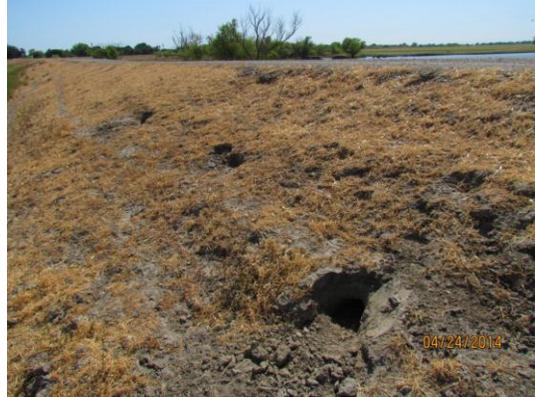
Photo 1 of 3 : pkazi\_s\_20140428\_913.jpg

LM Start	<b>0.83</b>	Rating **	M	Issue No.	<b>76</b>
LM End	<b>0.83</b>	Issue Type +	Ma	Location *	WS
Category	Earthen Levee			GPS Latitude/Longitude	
				Start	End
Item	Animal Control			37.477907 °	37.477907 °
				-121.071754 °	-121.071754 °
DWR ID	DWR_RD1602_01_s_2012_76				
Action/Comments					
No rodents visible, but rodent burrows visible; need to backfill and

Updated picture of the rodent holes on the waterside of the levee looking upstream during spring 2014 inspection.

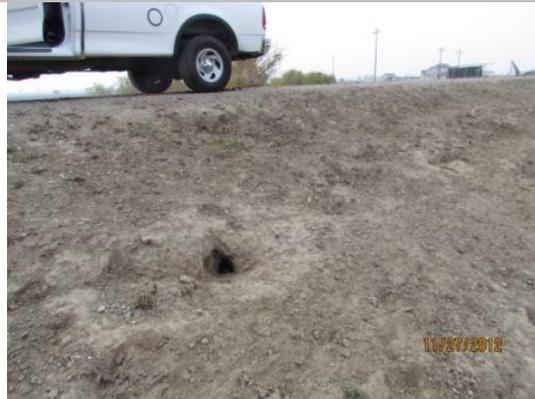
Photo 2 of 3 : pkazi\_s\_20140415\_727.jpg

Updated picture of the rodent hole on the waterside slope of the levee looking downstream.

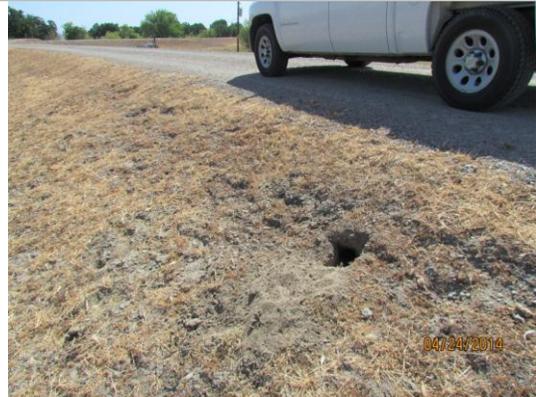
Photo 1 of 1 : pkazi\_s\_20140428\_914.jpg

LM Start	<b>0.95</b>	Rating **	M	Issue No.	<b>175</b>
LM End	<b>0.95</b>	Issue Type +	Ma	Location *	WS
Category	Earthen Levee			GPS Latitude/Longitude	
				Start	End
Item	Animal Control			37.478487 °	37.478487 °
				-121.069591 °	-121.069591 °
DWR ID	DWR_RD1602_01_s_2014_175				
Action/Comments					
No rodents visible, but rodent burrows visible; need to backfill and

View of the rodent hole on the waterside shoulder of the levee looking upstream.

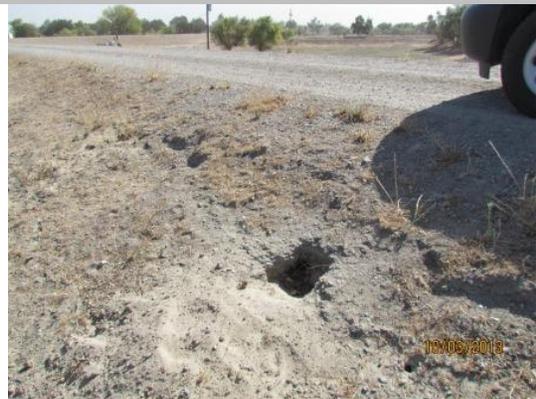
Photo 1 of 2 : pkazi\_s\_20140415\_696.jpg

LM Start	<b>0.95</b>	Rating **	M	Issue No.	<b>47</b>
LM End	<b>0.95</b>	Issue Type +	Ma	Location *	WS
Category	Earthen Levee			GPS Latitude/Longitude	
				Start	End
Item	Animal Control			37.478474 °	37.478474 °
				-121.069586 °	-121.069586 °
DWR ID	DWR_RD1602_01_f_2012_47				
Action/Comments					
No rodents visible, but rodent burrows visible; need to backfill and compact or grout burrows.

Updated picture of a rodent hole on the waterside slope of the levee looking upstream during fall 2013 inspection.

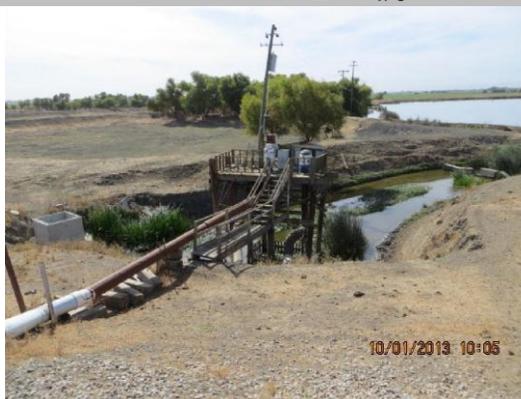
Photo 1 of 1 : UCIP\_2667.jpg

LM Start	<b>1.01</b>	Rating **	M	Issue No.	<b>162</b>
LM End	<b>1.01</b>	Issue Type +	En	Location *	WS
Category	Supplemental			GPS Latitude/Longitude	
				Start	End
Item	DWR UCIP Field Study			37.478817 °	37.478817 °
				-121.068772 °	-121.068772 °
DWR ID	DWR_RD1602_01_s_2014_162				
Action/Comments					
Inspector Comments: FS_ID:21642 EP_NO: N/A Repair Type: Crossing Status: UCIP Comments: Appears abandoned siphon breakers covered in soil and flapgate missing. FIELD_STRUCT_DESC: 2 of 2: 16-inch pipe through levee 17.0 feet below crown. Pumps on pump platform on the landward side. Siphon breakers in 24-inch risers on the waterward shoulder. Concrete "U" headwall and flap gate on the waterward end. Originally included in 1964 O&M manual. FS Date: 10/1/2013

Pipe visible under walkway at puming plant on LS toe.

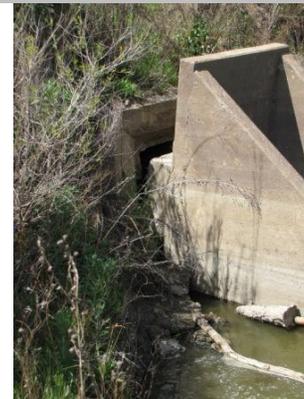
Photo 1 of 2 : pkazi\_s\_20140415\_704.jpg

LM Start	<b>1.04</b>	Rating **	M	Issue No.	<b>55</b>
LM End	<b>1.04</b>	Issue Type +	Ma	Location *	WS
Category	Interior Drainage & Piping Systems			GPS Latitude/Longitude	
				Start	End
Item	Concrete Tilting / Settlement			37.478678 °	37.478678 °
				-121.068305 °	-121.068305 °
DWR ID	DWR_RD1602_01_s_2012_55				
Action/Comments					
Inspector Comments: The outlet headwall is tilting away from the pipe rendering the existing flap gate ineffective. Repair gap between pipe and headwall and stabilize headwall to prevent further damage.

Separation of outfall structure from the outlet pipe at LM 1.04.

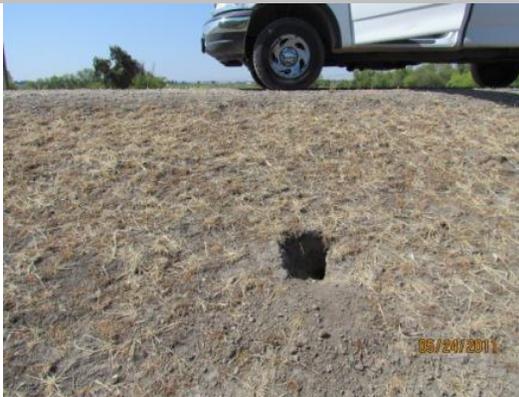
Photo 1 of 1 : pkazi\_s\_20140415\_642.jpg

LM Start	<b>1.10</b>	Rating **	M	Issue No.	<b>8</b>
LM End	<b>1.10</b>	Issue Type +	Ma	Location *	WS
Category	Earthen Levee		GPS Latitude/Longitude		
			Start	End	
Item	Animal Control		37.478454 °	37.478454 °	
			-121.067209 °	-121.067209 °	
DWR ID	DWR_RD1602_01_s_2012_8				
Action/Comments					
Exterminate rodents and backfill and compact or grout burrows.

Rodent hole was found on the waterside of the levee. The picture was taken from waterside looking upstream.

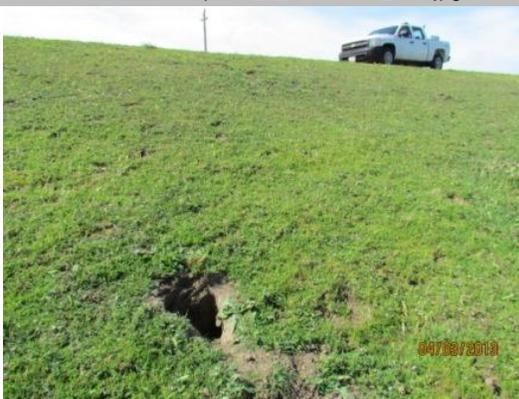
Photo 1 of 2 : pkazi\_s\_20140415\_645.jpg

LM Start	<b>1.11</b>	Rating **	M	Issue No.	<b>11</b>
LM End	<b>1.11</b>	Issue Type +	Ma	Location *	WS
Category	Earthen Levee		GPS Latitude/Longitude		
			Start	End	
Item	Animal Control		37.478371 °	37.478371 °	
			-121.066793 °	-121.066793 °	
DWR ID	DWR_RD1602_01_s_2013_11				
Action/Comments					
No rodents visible, but rodent burrows visible; need to backfill and compact or grout burrows.

A rodent hole was found on the waterside toe of the levee looking downstream.

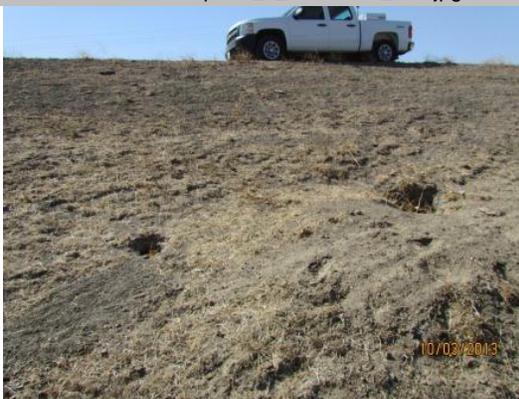
Photo 2 of 2 : pkazi\_s\_20140415\_646.jpg

Rodent holes were found on the waterside slope of the levee looking downstream.

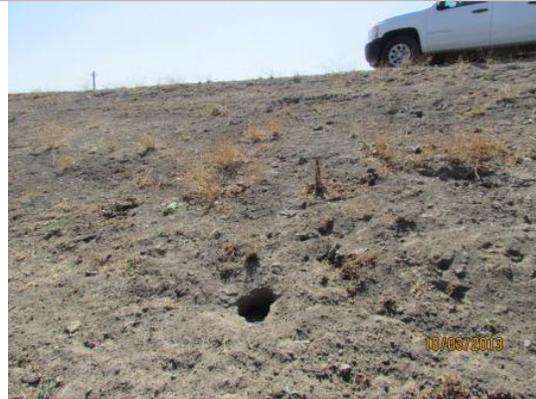
Photo 2 of 2 : pkazi\_s\_20140415\_715.jpg

LM Start	<b>1.15</b>	Rating **	M	Issue No.	<b>65 (cont)</b>
LM End	<b>1.15</b>	Issue Type +	Ma	Location *	WS
Category	Earthen Levee		GPS Latitude/Longitude		
			Start	End	
Item	Animal Control		37.478285 °	37.478285 °	
			-121.066299 °	-121.066299 °	
DWR ID	DWR_RD1602_01_f_2012_65				
Action/Comments					
No rodents visible, but rodent burrows visible; need to backfill and compact or grout burrows.

Updated picture of rodent hole on the waterside slope of the levee looking upstream during fall 2013 inspection.

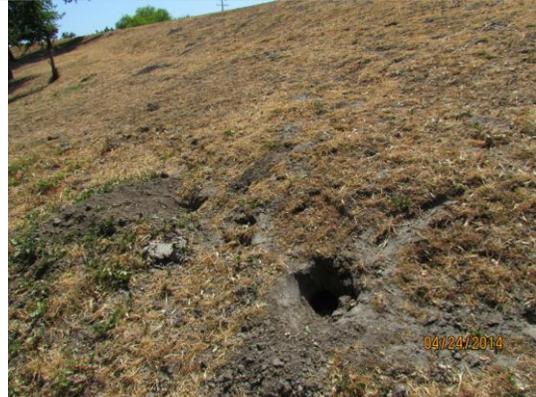
Photo 1 of 2 : pkazi\_s\_20140428\_916.jpg

LM Start	<b>1.19</b>	Rating **	M	Issue No.	<b>79</b>
LM End	<b>1.19</b>	Issue Type +	Ma	Location *	WS
Category	Earthen Levee		GPS Latitude/Longitude		
			Start	End	
Item	Animal Control		37.478324 °	37.478324 °	
			-121.065444 °	-121.065444 °	
DWR ID	DWR_RD1602_01_s_2012_79				
Action/Comments					
No rodents visible, but rodent burrows visible; need to backfill and compact or grout burrows.

Updated picture of the rodent holes on the waterside toe of the levee during spring 2014 inspection.

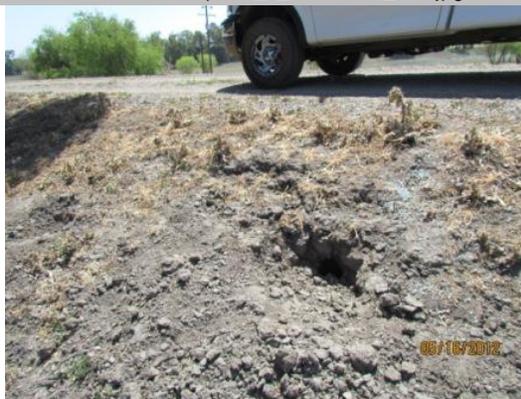
Photo 2 of 2 : pkazi\_s\_20140415\_730.jpg

LM Start	<b>1.21</b>	Rating **	M	Issue No.	<b>80 (cont)</b>
LM End	<b>1.21</b>	Issue Type +	Ma	Location *	WS
Category	Earthen Levee			GPS Latitude/Longitude	
				Start	End
Item	Animal Control			37.478391 °	37.478391 °
				-121.065111 °	-121.065111 °
DWR ID	DWR_RD1602_01_s_2012_80				
Action/Comments					
No rodents visible, but rodent burrows visible; need to backfill and compact or grout burrows.

Rodent hole on the waterside shoulder of the levee looking upstream.

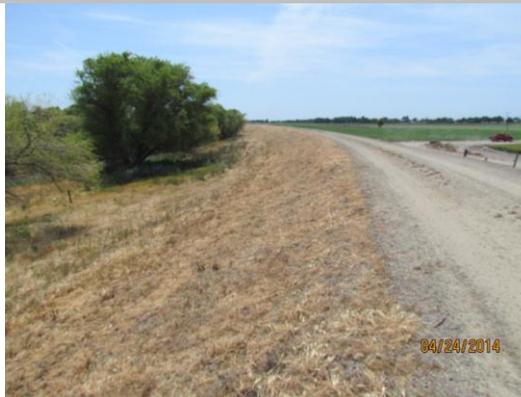
Photo 1 of 1 : pkazi\_s\_20140428\_919.jpg

LM Start	<b>2.00</b>	Rating **	A	Issue No.	<b>179</b>
LM End	<b>2.00</b>	Issue Type +	Ma	Location *	WS
Category	Earthen Levee		GPS Latitude/Longitude		
			Start	End	
Item	Vegetation		37.472321 °	37.472321 °	
			-121.057900 °	-121.057900 °	
DWR ID	DWR_RD1602_01_s_2014_179				
Action/Comments					
Control annual grass and weeds on the levee slopes and easements. Inspector Comments: LMA worked on the clearing up vegetation on the slopes of the levee.

View of the waterside slope of the levee looking upstream.

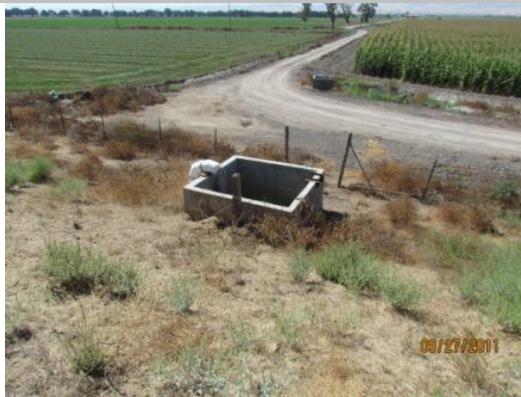
Photo 1 of 1 : pkazi\_s\_20140415\_694.jpg

LM Start	<b>2.03</b>	Rating **	M	Issue No.	<b>45</b>
LM End	<b>2.03</b>	Issue Type +	Ma	Location *	LS
Category	Earthen Levee		GPS Latitude/Longitude		
			Start	End	
Item	Encroachments		37.471734 °	37.471734 °	
			-121.057670 °	-121.057670 °	
DWR ID	DWR_RD1602_01_s_2012_45				
Action/Comments					
Equipment Inspector Comments: A well is present at the toe of the landside of the slope.

A well is located at the landside toe of the levee. The picture was taken from the crown looking toward the landside of the levee.

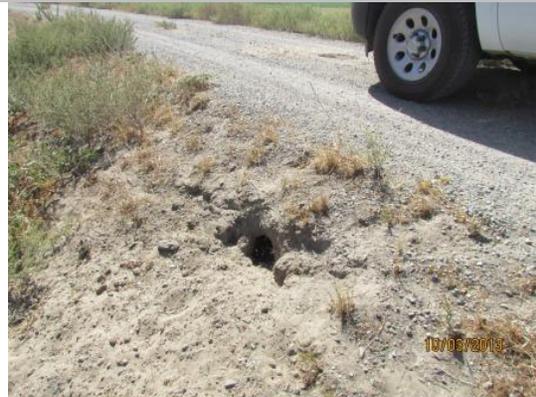
Photo 2 of 2 : pkazi\_s\_20140415\_734.jpg

LM Start	<b>2.11</b>	Rating **	M	Issue No.	<b>85 (cont)</b>
LM End	<b>2.11</b>	Issue Type +	Ma	Location *	WS

Updated picture of a rodent hole on the waterside shoulder of the levee looking upstream during fall 2013 inspection.

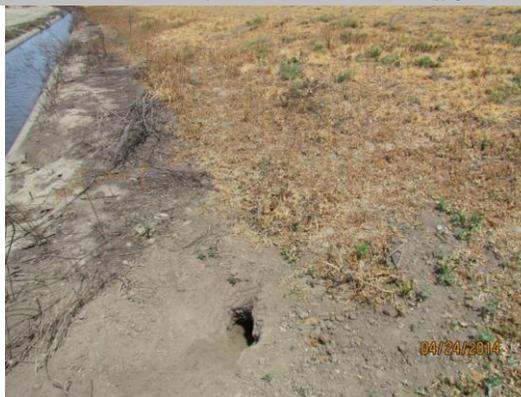
Photo 1 of 1 : pkazi\_s\_20140428\_920.jpg

LM Start	<b>2.98</b>	Rating **	M	Issue No.	<b>182</b>
LM End	<b>2.98</b>	Issue Type +	Ma	Location *	LS
Category	Earthen Levee		GPS Latitude/Longitude		
			Start	End	
Item	Animal Control		37.465132 °	37.465132 °	
			-121.044529 °	-121.044529 °	
DWR ID	DWR_RD1602_01_s_2014_182				
Action/Comments					
No rodents visible, but rodent burrows visible; need to backfill and compact or grout burrows.

A rodent hole was found on the landside toe of the levee looking downstream.

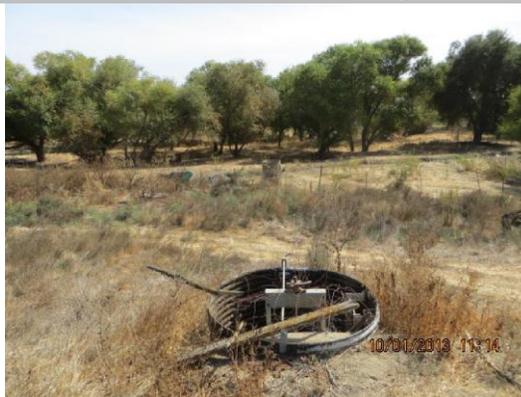
Photo 1 of 1 : UCIP\_2694.jpg

LM Start	<b>3.30</b>	Rating **	M	Issue No.	<b>165</b>
LM End	<b>3.30</b>	Issue Type +	En	Location *	LS
Category	Supplemental		GPS Latitude/Longitude		
			Start	End	
Item	DWR UCIP Field Study		37.461507 °	37.461507 °	
			-121.041609 °	-121.041609 °	
DWR ID	DWR_RD1602_01_s_2014_165				
Action/Comments					
Inspector Comments: FS_ID:21652 EP_NO: 8193 Repair Type: Crossing Status: UCIP Comments: Appears abandoned, and if so should be done so properly. No handle on slide gate, no cover on CMP standpipe on WS shoulder. FIELD_STRUCT_DESC: 16-inch pipe through levee 11.5 feet below crown. Slide gate in 60-inch corrugated metal pipe riser on the waterward slope. Discharge into concrete-lined ditch on the landward side (Permit No. 8193, 1964). Originally included in 1964 O&M manual. FS Date: 10/1/2013

Slide gate in 60-inch CMP riser on WS shoulder.

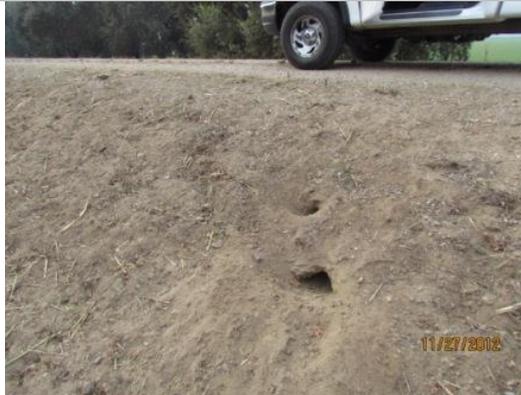
Photo 1 of 2 : pkazi\_s\_20140415\_736.jpg

LM Start	<b>3.47</b>	Rating **	M	Issue No.	<b>93</b>
LM End	<b>3.47</b>	Issue Type +	Ma	Location *	WS
Category	Earthen Levee		GPS Latitude/Longitude		
			Start	End	
Item	Animal Control		37.459511 °	37.459511 °	
			-121.043350 °	-121.043350 °	
DWR ID	DWR_RD1602_01_s_2012_93				
Action/Comments					
No rodents visible, but rodent burrows visible; need to backfill and compact or grout burrows.

Rodent holes were found on the waterside slope of the levee looking upstream.

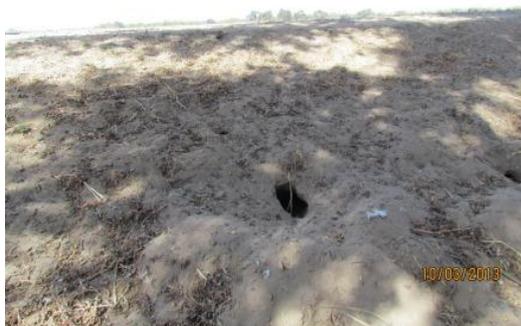
Photo 2 of 2 : pkazi\_s\_20140415\_737.jpg

LM Start	<b>3.47</b>	Rating **	M	Issue No.	<b>93 (cont)</b>
LM End	<b>3.47</b>	Issue Type +	Ma	Location *	WS

Updated picture of rodent hole on the waterside shoulder of the levee looking downstream.

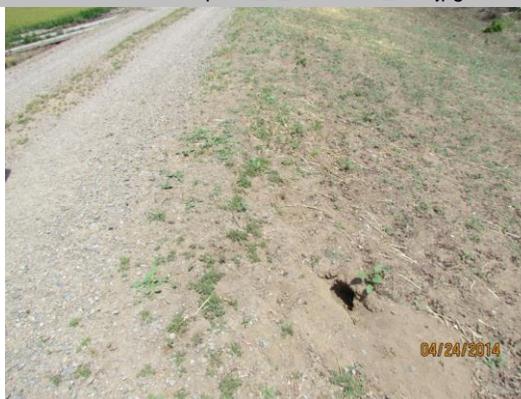
Photo 1 of 1 : pkazi\_s\_20140428\_921.jpg

LM Start	<b>3.49</b>	Rating **	M	Issue No.	<b>183</b>
LM End	<b>3.49</b>	Issue Type +	Ma	Location *	WS
Category	Earthen Levee		GPS Latitude/Longitude		
			Start	End	
Item	Animal Control		37.459279 °	37.459279 °	
			-121.043578 °	-121.043578 °	
DWR ID	DWR_RD1602_01_s_2014_183				
Action/Comments					
No rodents visible, but rodent burrows visible; need to backfill and

A rodent hole was found on the waterside shoulder of the levee looking downstream.

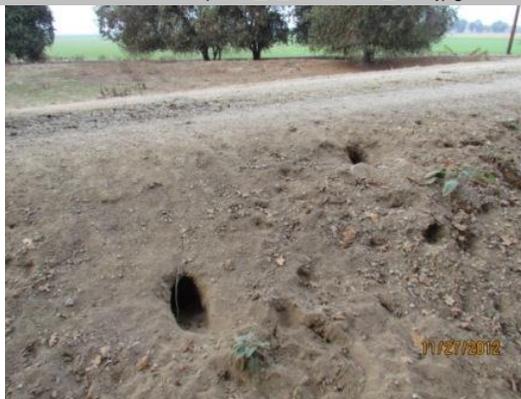
Photo 1 of 1 : pkazi\_s\_20140415\_744.jpg

LM Start	<b>3.52</b>	Rating **	M	Issue No.	<b>106</b>
LM End	<b>3.52</b>	Issue Type +	Ma	Location *	WS
Category	Earthen Levee		GPS Latitude/Longitude		
			Start	End	
Item	Animal Control		37.458810 °	37.458810 °	
			-121.043850 °	-121.043850 °	
DWR ID	DWR_RD1602_01_f_2012_106				
Action/Comments					
No rodents visible, but rodent burrows visible; need to backfill and compact or grout burrows.

Rodent holes were found on the waterside slope of the levee looking downstream.

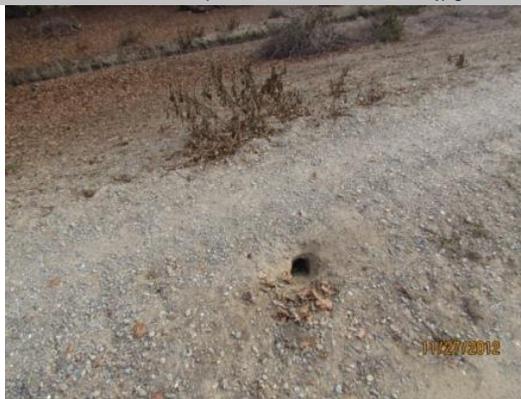
Photo 1 of 2 : pkazi\_s\_20140415\_745.jpg

LM Start	<b>3.53</b>	Rating **	M	Issue No.	<b>107</b>
LM End	<b>3.53</b>	Issue Type +	Ma	Location *	WS
Category	Earthen Levee		GPS Latitude/Longitude		
			Start	End	
Item	Animal Control		37.458762 °	37.458762 °	
			-121.043875 °	-121.043875 °	
DWR ID	DWR_RD1602_01_f_2012_107				
Action/Comments					
No rodents visible, but rodent burrows visible; need to backfill and compact or grout burrows.

A rodent hole was found on the waterside shoulder of the levee looking upstream.

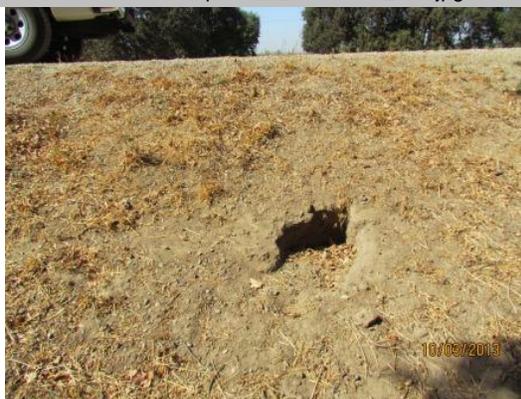
Photo 2 of 2 : pkazi\_s\_20140415\_746.jpg

LM Start	<b>3.53</b>	Rating **	M	Issue No.	<b>107 (cont)</b>
LM End	<b>3.53</b>	Issue Type +	Ma	Location *	WS

Updated picture of rodent hole on the waterside shoulder of the levee looking upstream.

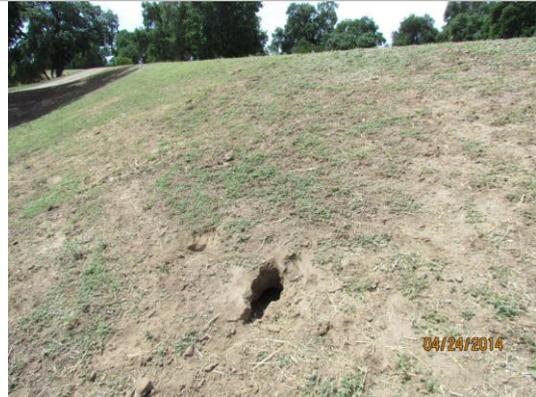
Photo 1 of 2 : pkazi\_s\_20140428\_922.jpg

LM Start	<b>3.54</b>	Rating **	M	Issue No.	<b>25</b>
LM End	<b>3.54</b>	Issue Type +	Ma	Location *	WS
Category	Earthen Levee			GPS Latitude/Longitude	
				Start	End
Item	Animal Control			37.458139 °	37.458139 °
				-121.044225 °	-121.044225 °
DWR ID	DWR_RD1602_01_s_2013_25				
Action/Comments					
No rodents visible, but rodent burrows visible; need to backfill and

Updated picture of the rodent hole on the waterside toe of the levee looking upstream.

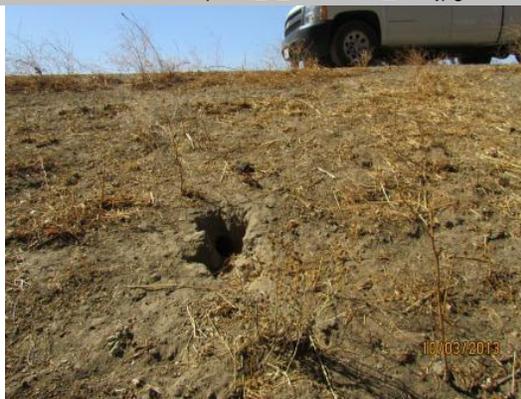
Photo 1 of 1 : pkazi\_s\_20140415\_747.jpg

LM Start	<b>3.67</b>	Rating **	M	Issue No.	<b>108</b>
LM End	<b>3.67</b>	Issue Type +	Ma	Location *	WS
Category	Earthen Levee		GPS Latitude/Longitude		
			Start	End	
Item	Animal Control		37.456775 °	37.456775 °	
			-121.044704 °	-121.044704 °	
DWR ID	DWR_RD1602_01_f_2012_108				
Action/Comments					
No rodents visible, but rodent burrows visible; need to backfill and compact or grout burrows.

A rodent hole was found on the waterside slope of the levee looking upstream.

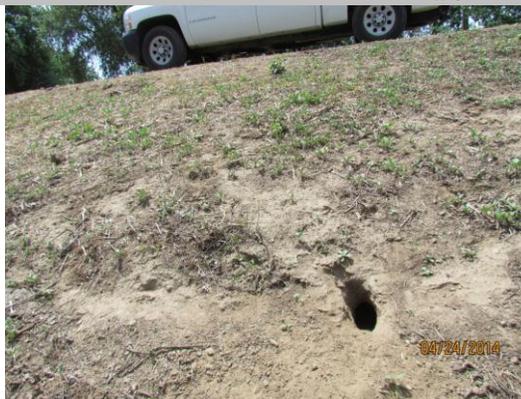
Photo 1 of 1 : pkazi\_s\_20140428\_924.jpg

LM Start	<b>3.71</b>	Rating **	M	Issue No.	<b>186</b>
LM End	<b>3.71</b>	Issue Type +	Ma	Location *	WS
Category	Earthen Levee		GPS Latitude/Longitude		
			Start	End	
Item	Animal Control		37.456304 °	37.456304 °	
			-121.044242 °	-121.044242 °	
DWR ID	DWR_RD1602_01_s_2014_186				
Action/Comments					
No rodents visible, but rodent burrows visible; need to backfill and compact or grout burrows.

A rodent hole was found on the waterside slope of the levee looking upstream.

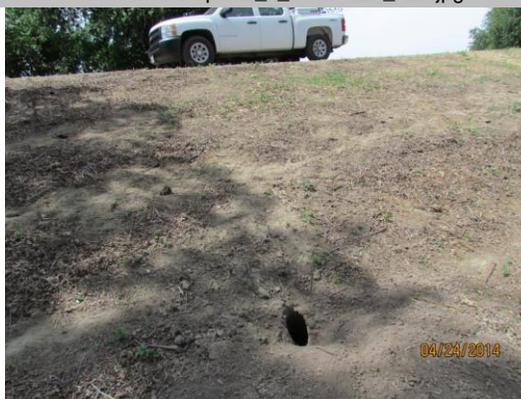
Photo 1 of 1 : pkazi\_s\_20140428\_925.jpg

LM Start	<b>3.77</b>	Rating **	M	Issue No.	<b>188</b>
LM End	<b>3.77</b>	Issue Type +	Ma	Location *	WS
Category	Earthen Levee		GPS Latitude/Longitude		
			Start	End	
Item	Animal Control		37.455671 °	37.455671 °	
			-121.043898 °	-121.043898 °	
DWR ID	DWR_RD1602_01_s_2014_188				
Action/Comments					
No rodents visible, but rodent burrows visible; need to backfill and compact or grout burrows.

A rodent hole was found on the waterside toe of the levee looking downstream.

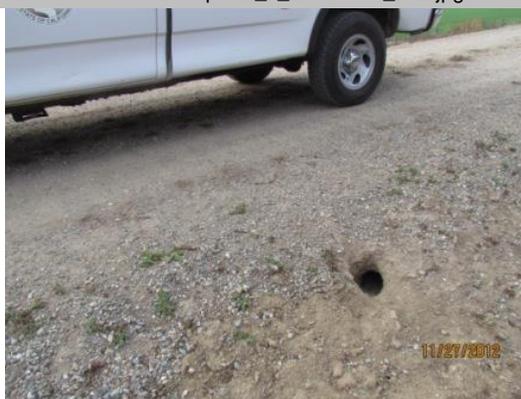
Photo 1 of 1 : pkazi\_s\_20140415\_732.jpg

LM Start	<b>3.80</b>	Rating **	M	Issue No.	<b>83</b>
LM End	<b>3.80</b>	Issue Type +	Ma	Location *	WS
Category	Earthen Levee		GPS Latitude/Longitude		
			Start	End	
Item	Animal Control		37.455238 °	37.455238 °	
			-121.043635 °	-121.043635 °	
DWR ID	DWR_RD1602_01_s_2012_83				
Action/Comments					
Exterminate rodents and backfill and compact or grout burrows.

A rodent hole was found on the waterside shoulder of the levee looking downstream.

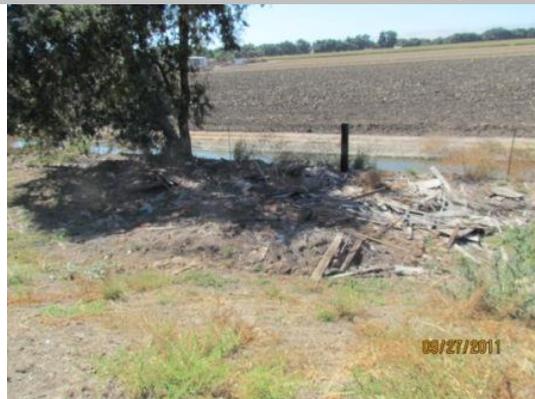
Photo 2 of 2 : pkazi\_s\_20140415\_651.jpg

LM Start	<b>3.83</b>	Rating **	M	Issue No.	<b>15 (cont)</b>
LM End	<b>3.83</b>	Issue Type +	Ma	Location *	LS

Debris was located on the landside of the levee. The picture was taken from the crown looking upstream.

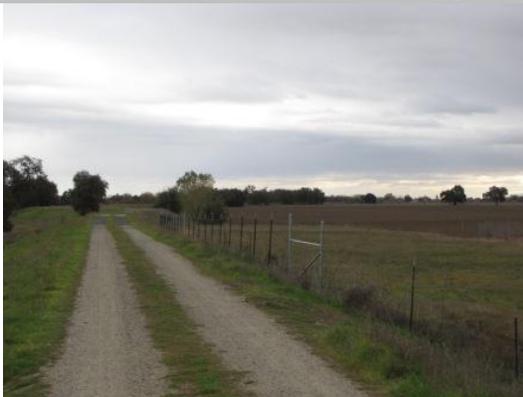
Photo 1 of 1 : pkazi\_s\_20140415\_713.jpg

LM Start	<b>3.97</b>	Rating **	M	Issue No.	<b>63</b>
LM End	<b>4.07</b>	Issue Type +	En	Location *	LS
Category	Earthen Levee		GPS Latitude/Longitude		
			Start	End	
Item	Encroachments		37.452983 °	37.451866 °	
			-121.042301 °	-121.041206 °	
DWR ID	DWR_RD1602_01_s_2012_63				
Action/Comments					
Fence

View of a barbed wire fence on the landward slope looking upstream.

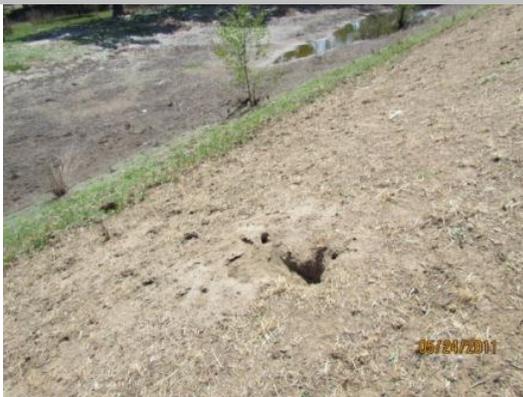
Photo 1 of 3 : pkazi\_s\_20140415\_652.jpg

LM Start	<b>3.99</b>	Rating **	M	Issue No.	<b>16</b>
LM End	<b>3.99</b>	Issue Type +	Ma	Location *	WS
Category	Earthen Levee		GPS Latitude/Longitude		
			Start	End	
Item	Animal Control		37.452805 °	37.452805 °	
			-121.041769 °	-121.041769 °	
DWR ID	DWR_RD1602_01_s_2012_16				
Action/Comments					
Exterminate rodents and backfill and compact or grout burrows.

Rodent hole at the waterside slope of the levee. The picture was taken from the crown looking upstream.

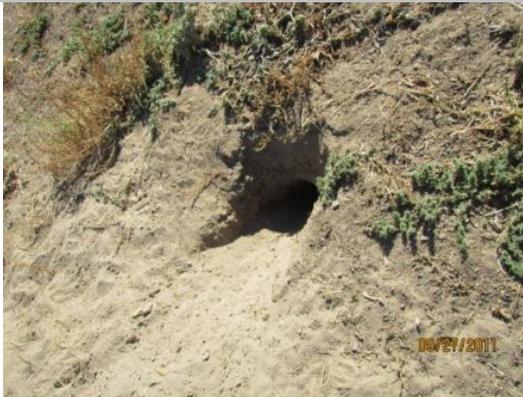
Photo 2 of 3 : pkazi\_s\_20140415\_653.jpg

LM Start	<b>3.99</b>	Rating **	M	Issue No.	<b>16 (cont)</b>
LM End	<b>3.99</b>	Issue Type +	Ma	Location *	WS

Animal burrow was found on the waterside of the levee. The picture was taken from the toe of the levee looking upstream.

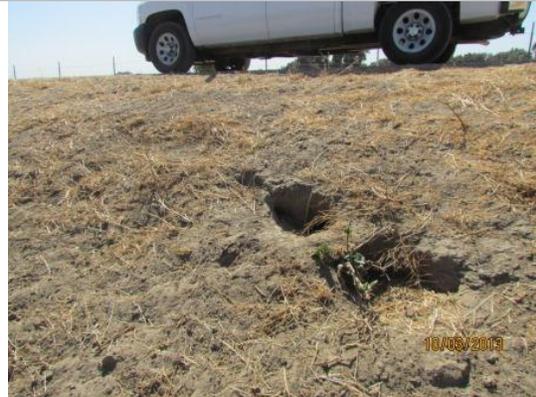
Photo 3 of 3 : pkazi\_s\_20140415\_654.jpg

LM Start	<b>3.99</b>	Rating **	M	Issue No.	<b>16 (cont)</b>
LM End	<b>3.99</b>	Issue Type +	Ma	Location *	WS
Category	Earthen Levee			GPS Latitude/Longitude	
				Start	End
Item	Animal Control			37.452805 °	37.452805 °
				-121.041769 °	-121.041769 °
DWR ID	DWR_RD1602_01_s_2012_16				
Action/Comments					
Exterminate rodents and backfill and compact or grout burrows.

Updated view of the rodent holes on the waterside slope of the levee looking upstream during fall 2013 inspection.

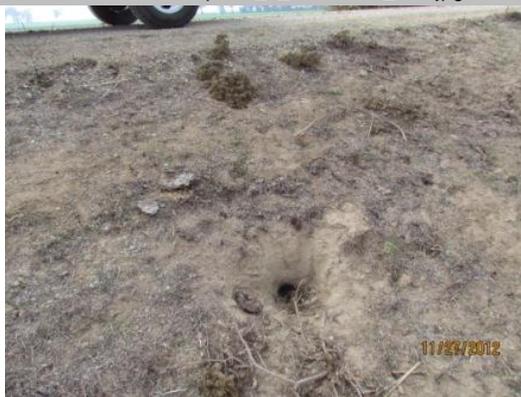
Photo 1 of 1 : pkazi\_s\_20140415\_700.jpg

LM Start	<b>4.11</b>	Rating **	M	Issue No.	<b>51</b>
LM End	<b>4.11</b>	Issue Type +	Ma	Location *	WS
Category	Earthen Levee			GPS Latitude/Longitude	
				Start	End
Item	Animal Control			37.451520 °	37.451520 °
				-121.040699 °	-121.040699 °
DWR ID	DWR_RD1602_01_f_2012_51				
Action/Comments					
No rodents visible, but rodent burrows visible; need to backfill and compact or grout burrows.

A rodent hole was found on the waterside toe of the levee looking downstream.

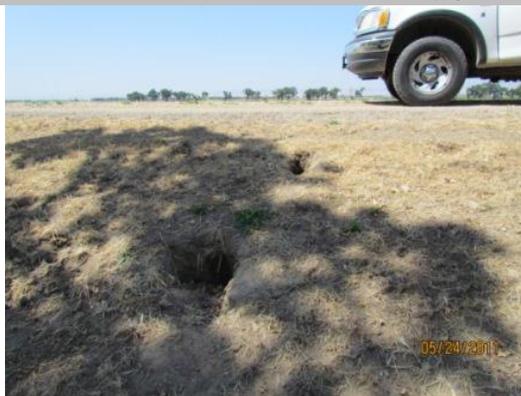
Photo 1 of 1 : pkazi\_s\_20140415\_655.jpg

LM Start	<b>4.15</b>	Rating **	M	Issue No.	<b>17</b>
LM End	<b>4.15</b>	Issue Type +	Ma	Location *	WS
Category	Earthen Levee			GPS Latitude/Longitude	
				Start	End
Item	Animal Control			37.451051 °	37.451051 °
				-121.040109 °	-121.040109 °
DWR ID	DWR_RD1602_01_s_2012_17				
Action/Comments					
No rodents visible, but rodent burrows visible; need to backfill and compact or grout burrows.

Rodent hole was found on the waterside of the levee. The picture was taken from the crown looking upstream.

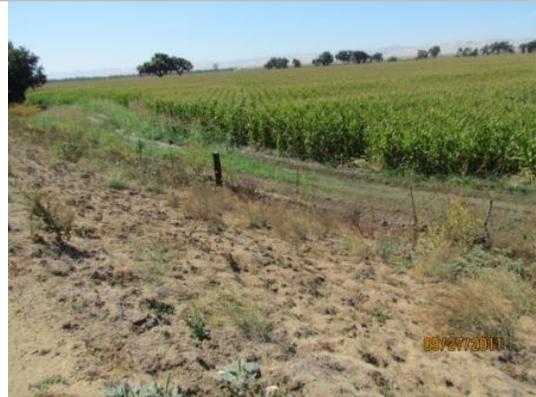
Photo 1 of 1 : pkazi\_s\_20140415\_717.jpg

LM Start	<b>4.45</b>	Rating **	M	Issue No.	<b>67</b>
LM End	<b>4.92</b>	Issue Type +	En	Location *	LS
Category	Earthen Levee		GPS Latitude/Longitude		
			Start	End	
Item	Encroachments		37.447213 °	37.441014 °	
			-121.037665 °	-121.036932 °	
DWR ID	DWR_RD1602_01_s_2012_67				
Action/Comments					
Fence

View of the fence on the landside toe of the levee. The picture was taken from the crown looking upstream.

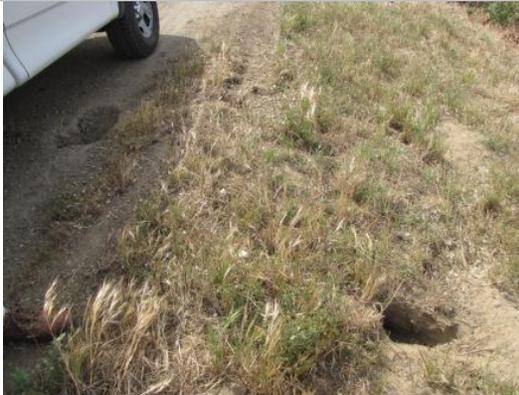
Photo 1 of 1 : pkazi\_s\_20140415\_648.jpg

LM Start	<b>4.72</b>	Rating **	M	Issue No.	<b>13</b>
LM End	<b>4.72</b>	Issue Type +	Ma	Location *	LS
Category	Earthen Levee		GPS Latitude/Longitude		
			Start	End	
Item	Animal Control		37.443481 °	37.443481 °	
			-121.037736 °	-121.037736 °	
DWR ID	DWR_RD1602_01_s_2012_13				
Action/Comments					
Exterminate rodents and backfill and compact or grout burrows.

View of rodent holes on the landward slope looking upstream.

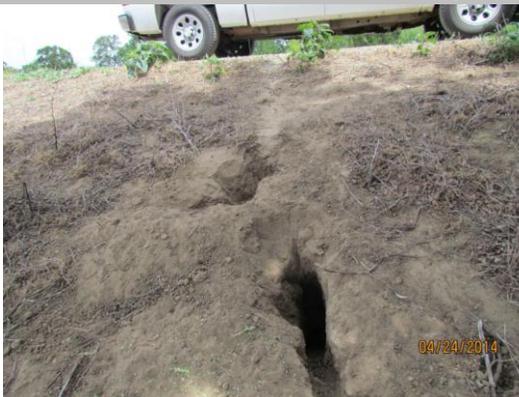
Photo 1 of 1 : pkazi\_s\_20140428\_929.jpg

LM Start	<b>4.78</b>	Rating **	U	Issue No.	<b>197</b>
LM End	<b>4.78</b>	Issue Type +	Ma	Location *	LS
Category	Earthen Levee		GPS Latitude/Longitude		
			Start	End	
Item	Animal Control		37.442819 °	37.442819 °	
			-121.037214 °	-121.037214 °	
DWR ID	DWR_RD1602_01_s_2014_197				
Action/Comments					
No rodents visible, but rodent burrows visible; need to backfill and compact or grout burrows.

Few rodent holes were found on the landside shoulder of the levee looking downstream.

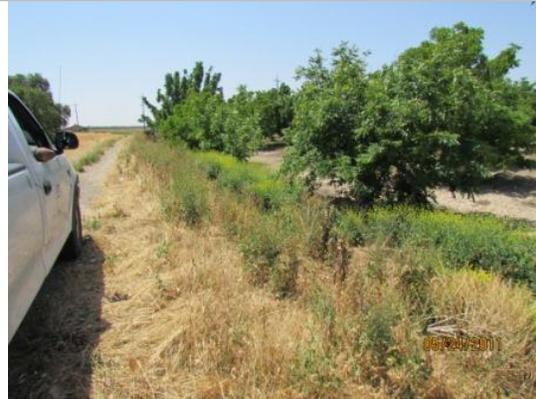
Photo 1 of 2 : pkazi\_s\_20140415\_710.jpg

LM Start	<b>5.36</b>	Rating **	M	Issue No.	<b>61</b>
LM End	<b>5.36</b>	Issue Type +	Ma	Location *	LS
Category	Earthen Levee			GPS Latitude/Longitude	
				Start	End
Item	Vegetation			37.435236 °	37.435236 °
				-121.035271 °	-121.035271 °
DWR ID	DWR_RD1602_01_s_2012_61				
Action/Comments					
Remove the wild growth other than native grasses from the levee

Vegetation was obstructing the view of the landside of the levee. The picture was taken from the crown looking upstream.

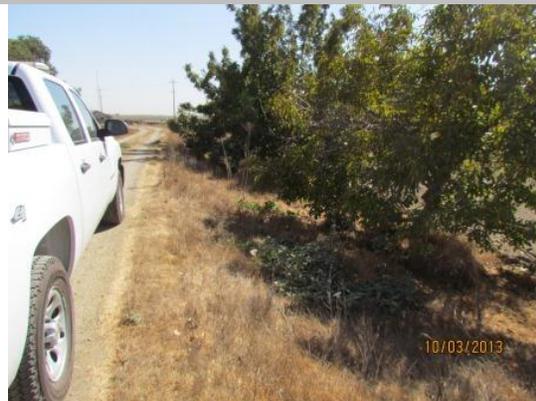
Photo 2 of 2 : pkazi\_s\_20140415\_711.jpg

Updated picture of vegetation on the landside of the levee. The picture was taken from the crown looking upstream during fall 2013 inspection.
