**Flood Control Project Maintenance  
Levee Inspections****LMA District Cover Sheet  
Spring 2015 Levee Inspection Results****Reclamation District No. 1602 Del Puerto**

**Spring 2015 Levee Inspection Results**

**Reclamation District No. 1602 Del Puerto**

Waterway			Bank	Unit Miles
Unit No. 01 San Joaquin River			Left	6.24
	Spring (March - May)	Summer (June - August)	(September - November) Fall	Winter (December - February)
Unit Maintenance Rating (Fall Only)				
Date of Inspection	04/02/2015 - 04/02/2015			
DWR Inspector	Pavel Kazi			
Accompanied By	Tony Martinez RD 1602

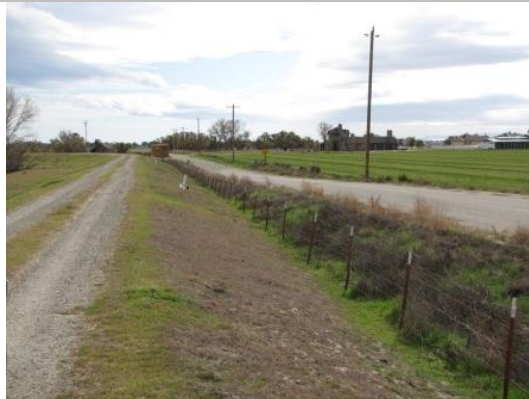
Photo 1 of 1 : SP\_2015\_RD1602\_110\_70\_20150313\_00041.jpg

LM Start	0.60	Rating **	M	Issue No.	70
LM End	0.71	Issue Type +	En	Location *	WS
Category	Earthen Levee			GPS Latitude/Longitude	
				Start	End
Item	Encroachments			37.479967 °	37.478514 °
				-121.074582 °	-121.073435 °
DWR ID	DWR_RD1602_01_s_2012_70				
Action/Comments					
Fence					
Inspector Comments: Barbed wire fence along the landward toe.

View of barbed wire fence at landward toe looking upstream.

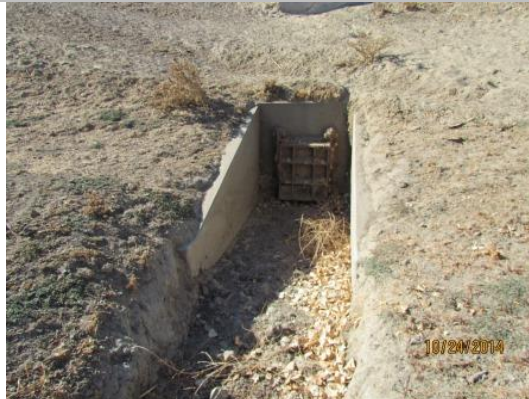
Photo 1 of 4 : SP\_2015\_RD1602\_110\_72\_20150313\_00042.jpg

LM Start	0.77	Rating **	A/W	Issue No.	72
LM End	0.77	Issue Type +	Ma	Location *	WS
Category	Interior Drainage & Piping Systems			GPS Latitude/Longitude	
				Start	End
Item	Flap Gates			37.477965 °	37.477965 °
				-121.072595 °	-121.072595 °
DWR ID	DWR_RD1602_01_s _ 2012_72				
Action/Comments					
Inspector Comments: Sediment around the flap gate was cleaned, and the area should be watched for future sediment deposits.

View of the flap gate on the waterside of the levee during fall 2014 inspection.

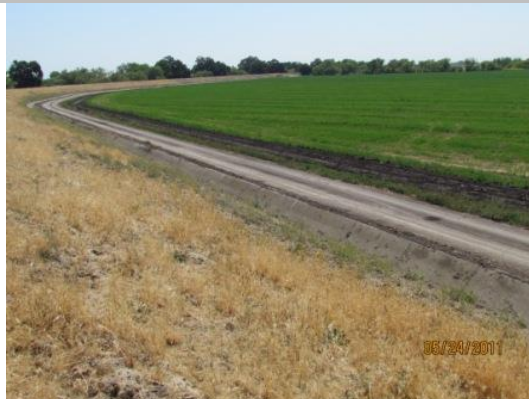
Photo 1 of 1 : SP\_2015\_RD1602\_110\_59\_20150313\_00031.jpg

LM Start	2.23	Rating **	M	Issue No.	59
LM End	3.43	Issue Type +	En	Location *	LS
Category	Earthen Levee			GPS Latitude/Longitude	
				Start	End
Item	Encroachments			37.470119 °	37.459606 °
				-121.055117 °	-121.043240 °
DWR ID	DWR_RD1602_01_s _ 2012_59				
Action/Comments					
Ditch Inspector Comments: Concrete ditch was constructed before the levee was built.

Concrete drain was built at the toe of the levee. The picture was taken from the crown looking upstream.

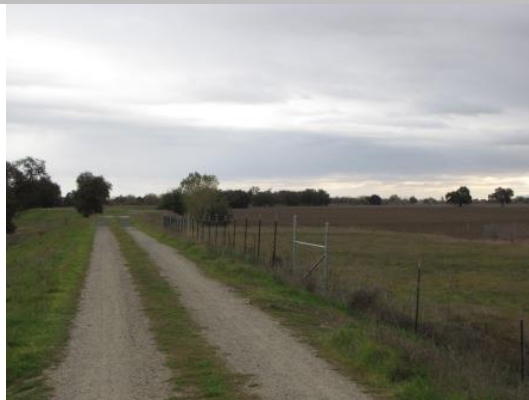
Photo 1 of 1 : SP\_2015\_RD1602\_110\_63\_20150313\_00035.jpg

LM Start	3.94	Rating **	M	Issue No.	63
LM End	4.04	Issue Type +	En	Location *	LS
Category	Earthen Levee			GPS Latitude/Longitude	
				Start	End
Item	Encroachments			37.452983 °	37.451866 °
				-121.042301 °	-121.041206 °
DWR ID	DWR_RD1602_01_s _ 2012_63				
Action/Comments					
Fence

View of a barbed wire fence on the landward slope looking upstream.
